SAFETY PERFORMANCE EVALUATION ON THE NEBRASKA  
TURNED-DOWN APPROACH TERMINAL SECTION

Project RES 1 (0099) P464  
TRANSPORTATION RESEARCH REPORT TRP-03-32-92

October 1992

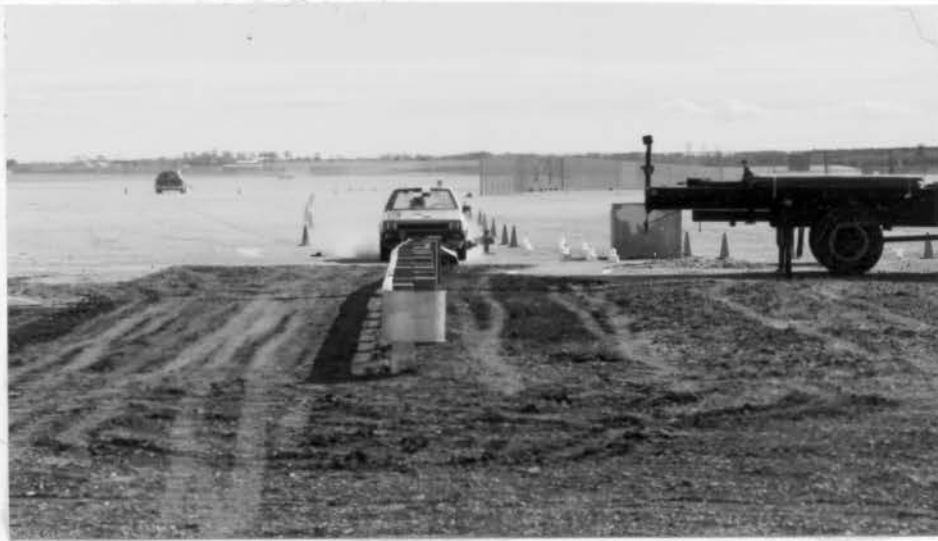
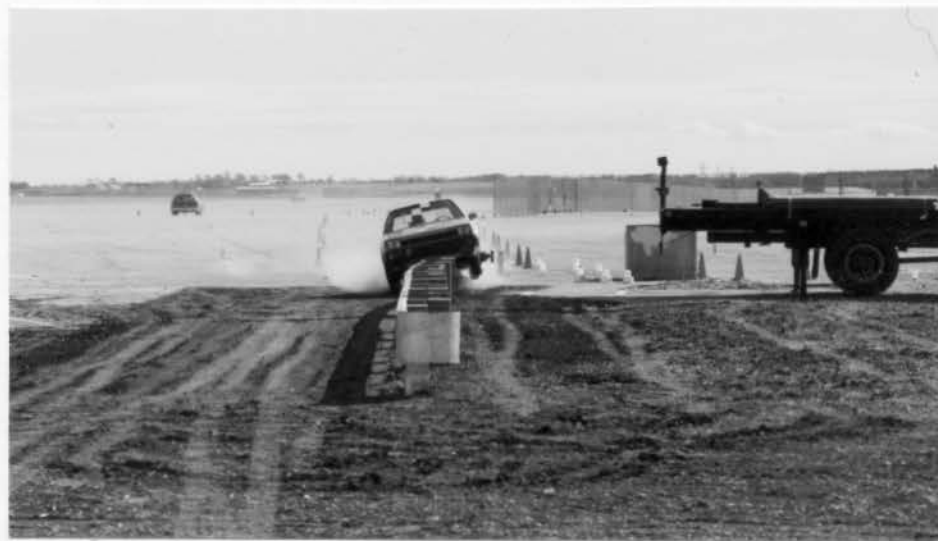
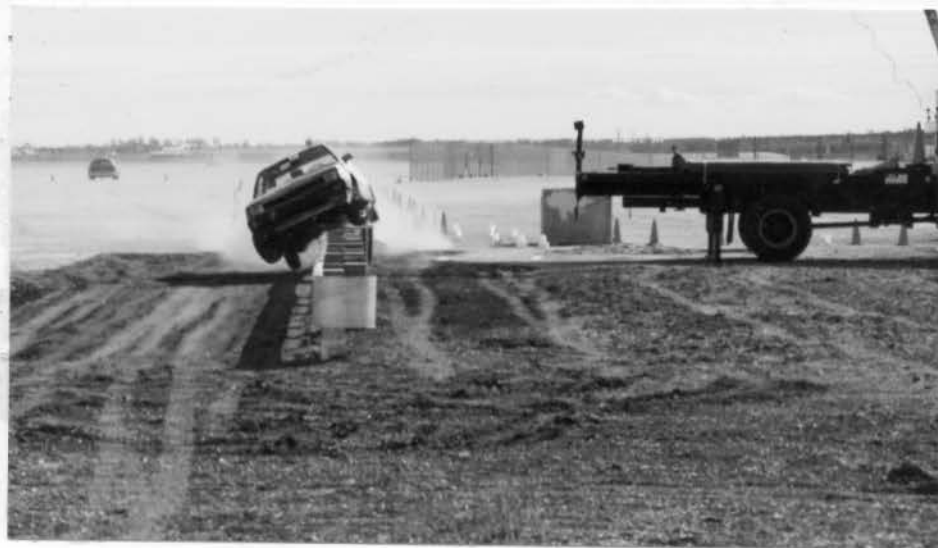
FIGURE 15. Full-Scale Vehicle Crash Test, Test NETD-1

After the initial impact with the Turned-Down Approach Terminal Section, the left-front tire came off the ground at approximately 0.036-sec as the vehicle rode up the twisted guardrail section. From 0.084-sec to 0.276-sec, the vehicle continued to travel upward along the twisted guardrail section. This action occurred in conjunction with the clockwise roll motion away from the guardrail. The left-front tire impacted Post No. 1 and blew out at approximately 0.344-sec. At 0.436-sec, the left-rear tire impacted Post No. 1 but did not blow out. The vehicle became airborne at approximately 0.480-sec. The front of the vehicle began to nosedive downward at 0.625-sec, and the right-front tire contacted the ground at approximately 0.700-sec. The friction between the ground and the right front corner of the vehicle caused the vehicle's rear end to rotate upward, hinged about the vehicle's front end. At 1.422-sec, the vehicle was near a vertical position with the front end downward. The vehicle continued to rotate, and at 1.938-sec, the left-rear corner of the vehicle contacted the ground. The vehicle again obtained a vertical position with the front end upward at approximately 2.797-sec. Subsequently, the vehicle dropped to the ground in an upright position and came to rest 127-ft downstream from impact and offset 14-ft laterally on the traffic-side from a line parallel to the traffic-side face of the guardrail.

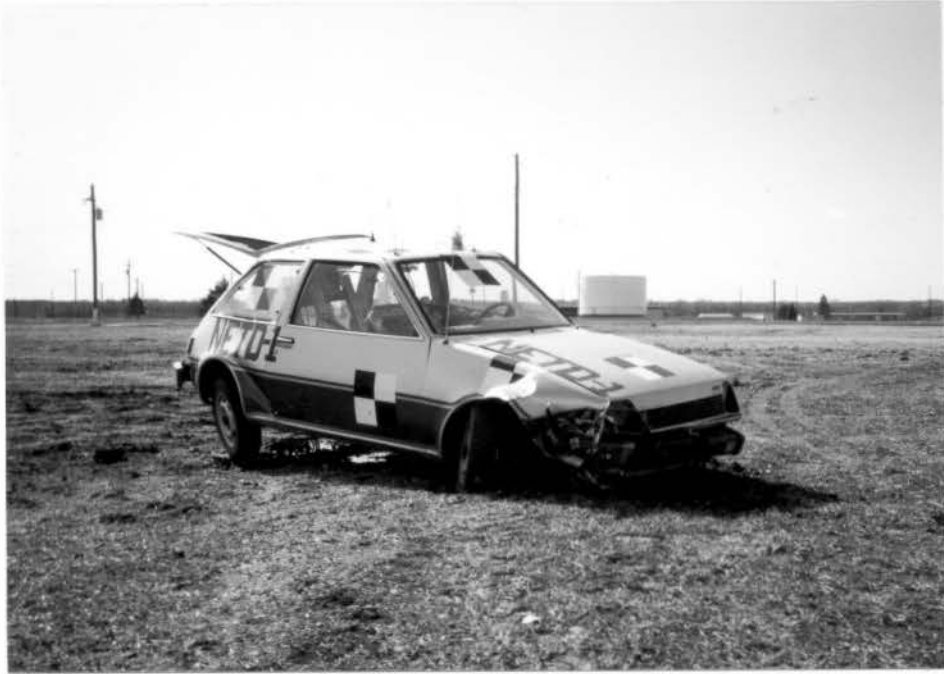
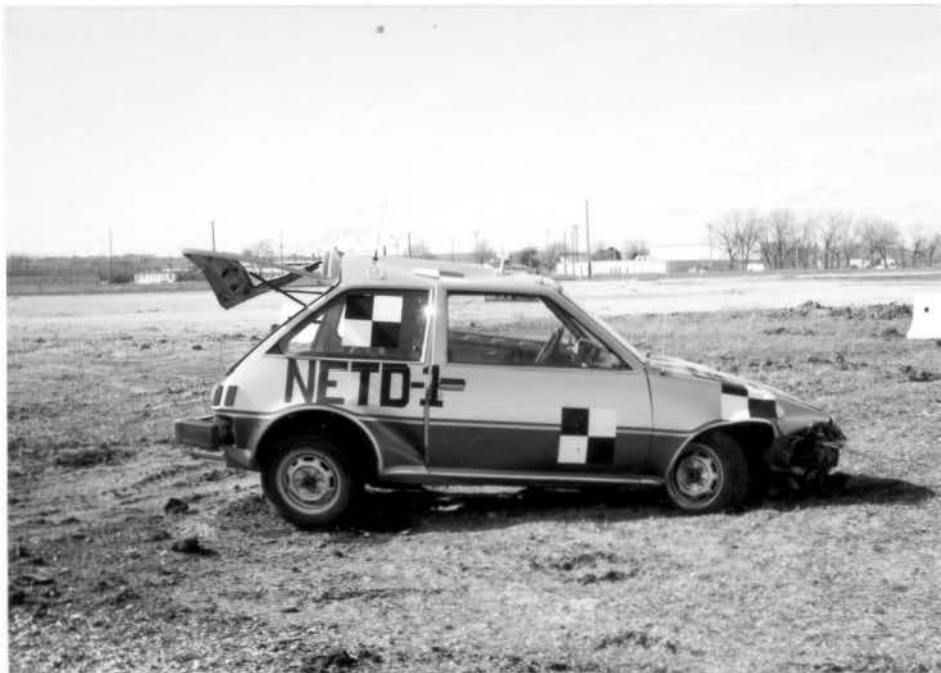
FIGURE 17. Vehicle Damage, Test NETD-1

Exterior vehicle damage is shown in Figures 17 and 18, while the interior vehicle deformations are shown in Figure 19. The majority of the vehicle damage occurred at three body

panel locations, the right-front quarter, the left-rear quarter, and the rear end. The right-front quarter damage occurred primarily to the fender, axle, and bumper. The left-rear quarter damage occurred primarily to fender (18-in. crush depth), undercarriage, axle, bumper, and hatchback. In addition, excessive interior deformations occurred at the left-side rear seat position as a result of the excessive, exterior left-rear quarter damage (Figure 19).

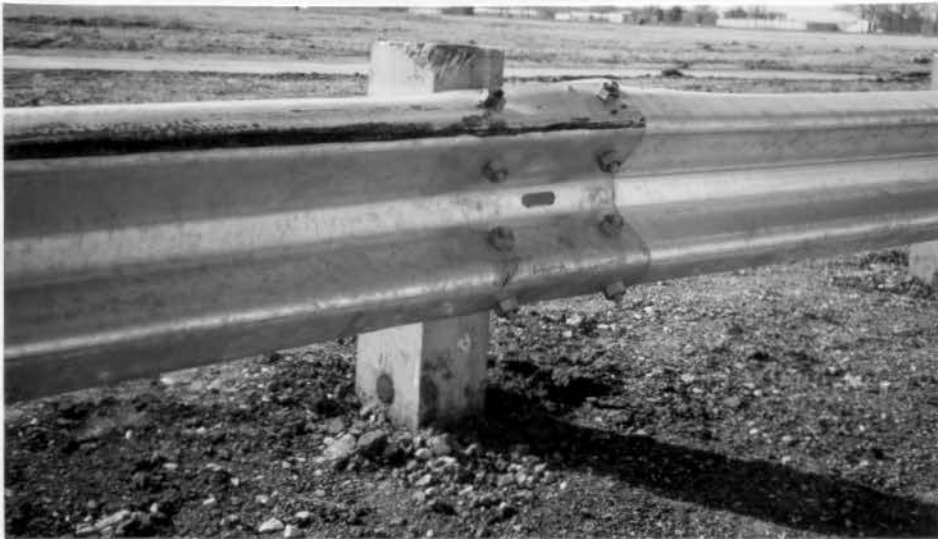
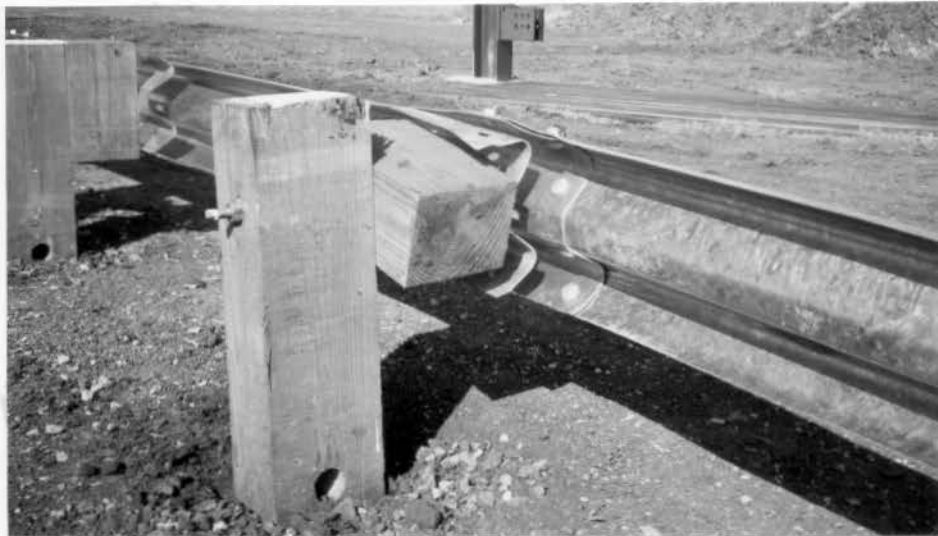
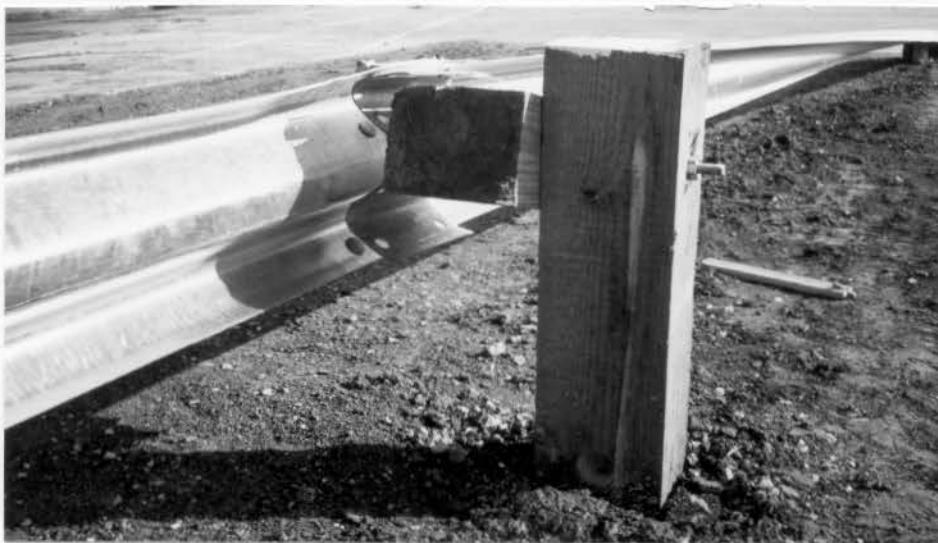
FIGURE 21. Damage at Post No. 1, Test NETD-1

Guardrail damage is shown in Figures 20 through 22. The Michigan end shoe received dents, scrapes, and tire marks (Figure 20). Additional tire marks were evident on the surface of the twisted, 25-ft terminal section. Minor gouging was evident on the top of Post No. 1 and the attached spacer block (Figure 21). In addition, the spacer block was rotated approximately 85 deg clockwise in the direction of traffic (Figures 20 and 21). The back-up plate at Post No. 1 was also deformed. The shear bolts at Post Nos. 1 and 3 had also failed (Figures 21 and 22).

Third, the release mechanism did not activate properly. This may have been due to the insufficient length over which the W-beam was allowed to release from its mounted position. The CRT design incorporated a guardrail release mechanism which extended over the length of twelve posts spaced at 6-ft 3-in. (8,9). This distance was found to be necessary for preventing vehicle uplift when impacted with an 1,800-lb vehicle. To further maintain vehicle stability, drilled holes should be provided in at least the first ten posts with diameters of approximately 3 1/2-in.
