# **SAFETY PERFORMANCE EVALUATION OF MICHIGAN'S 4X5 PORTABLE SIGN SUPPORT**

### **Michigan Department of Transportation**

MwRSF Research Report No. TRP-03-135-03

June 20, 2003

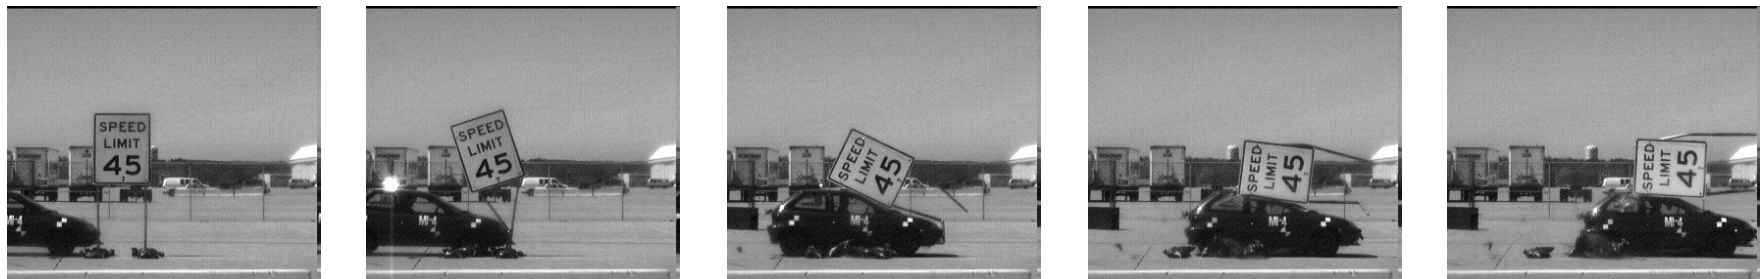
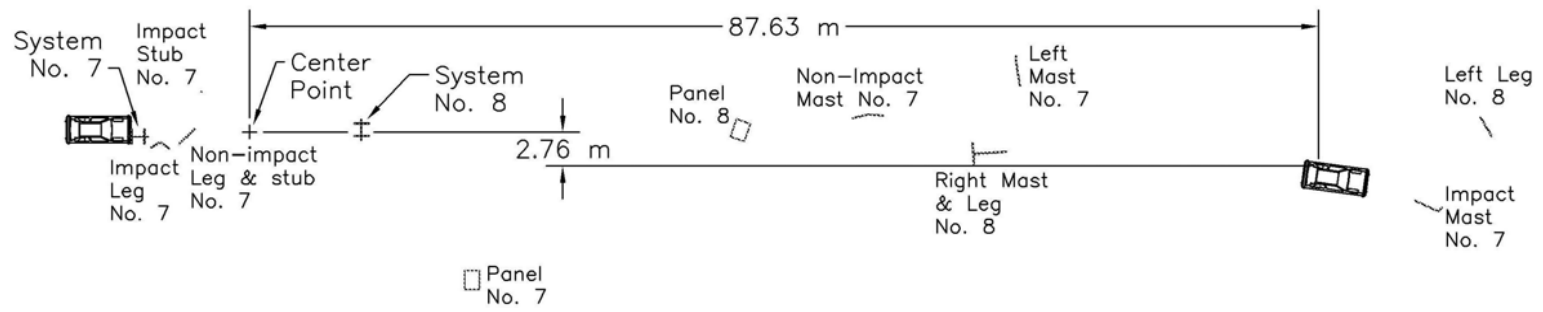
Figure 8. Summary of Test Results and Sequential Photographs, Test MI-4, Impact No. 1

- Longitudinal . . . . . NA
  - Lateral (not required) . . . . . NA
- Vehicle Damage . . . . . Roof and windshield penetration
  - TAD<sup>29</sup> . . . . . 12-FR-1

- SAE<sup>30</sup> . . . . . 12-FRAN9
- Vehicle Stopping Distance . . . . . 87.63 m downstream
  - 2.76 m right
- Test Article Damage . . . . . Moderate – Broke apart

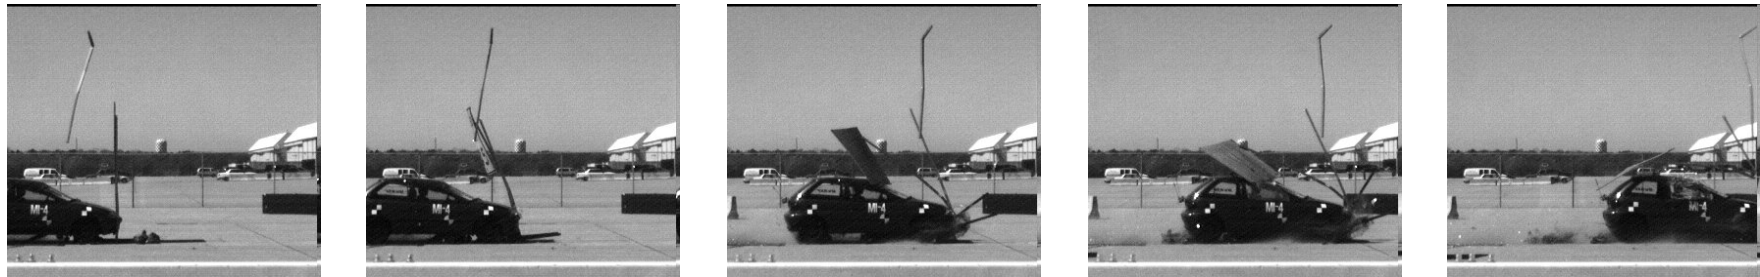
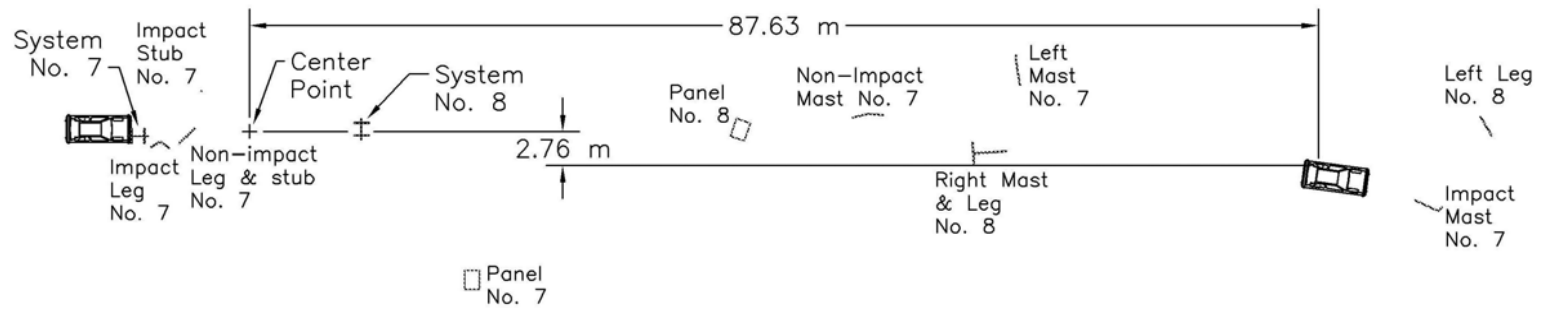
- Longitudinal . . . . . NA
  - Lateral (not required) . . . . . NA
- Vehicle Damage . . . . . Windshield cracking and indentation
  - TAD<sup>29</sup> . . . . . 12-FC-1

- SAE<sup>30</sup> . . . . . 12-FCAW9
- Vehicle Stopping Distance . . . . . 87.63 m downstream
  - 2.76 m right
- Test Article Damage . . . . . Moderate – Broke apart

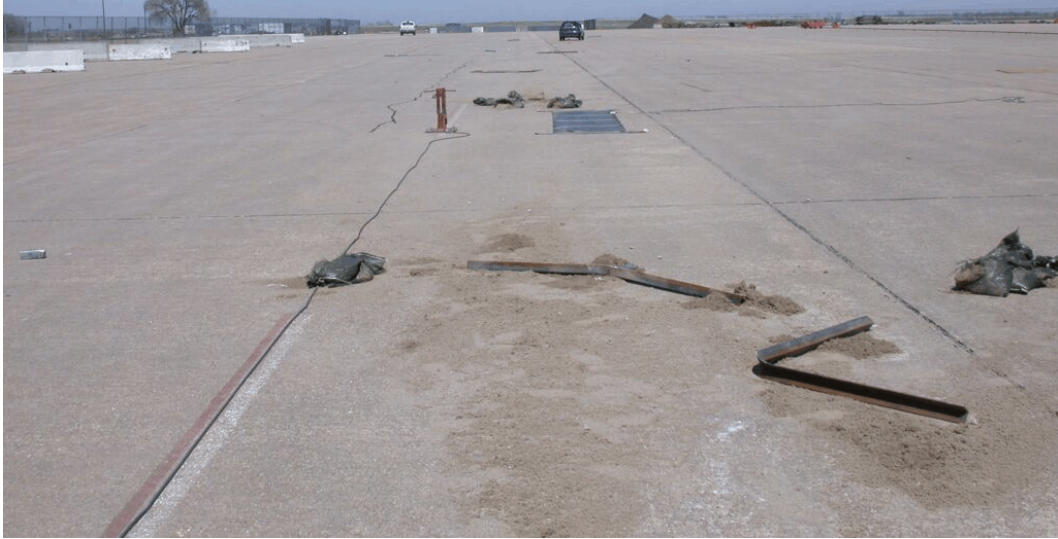
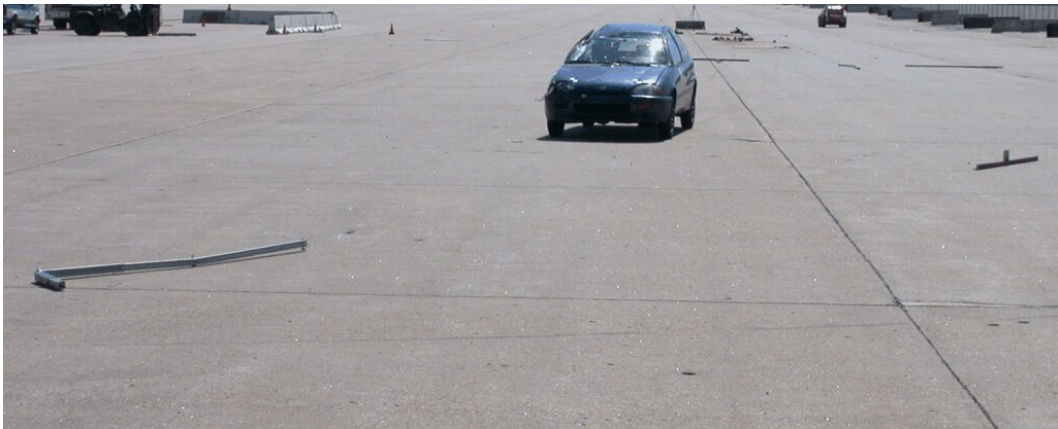
Figure 17. Overall Damage and Final Positions, Test MI-4

Damage to System Nos. 7 and 8 is shown in Figures 17 through 22. System No. 7 encountered moderate damage. Both legs disengaged from the masts. The impacted leg's vertical upright tube disengaged from the angle portion due to fracture of the welds. The disengaged vertical upright tube was deformed on the non-impacted side. Both legs' angles were deformed near their center points. The impacted outer tube and mast were deformed at bumper height and near the lower panel bolts and also fractured near bumper height. The non-impacted outer tube and mast were deformed near the lower panel bolts. The sign panel disengaged from both masts and the panel bolts

System No. 8 encountered moderate damage. The right mast, outer tube, and leg remained attached, and the mast and outer tube encountered minor deformations. The left leg disengaged from the mast and was undamaged. The left mast and outer tube were deformed near the center of the outer tube. The sign panel disengaged from both masts and the panel bolts remained attached to the masts. The sign panel encountered moderate deformations on all edges. The sign panel also deformed at each of the four panel bolt holes and was slightly torn at the bottom right hole. All eight of the sandbags were torn open with the sand scattered along the path of the vehicle, starting at the initial position of the second sign support.

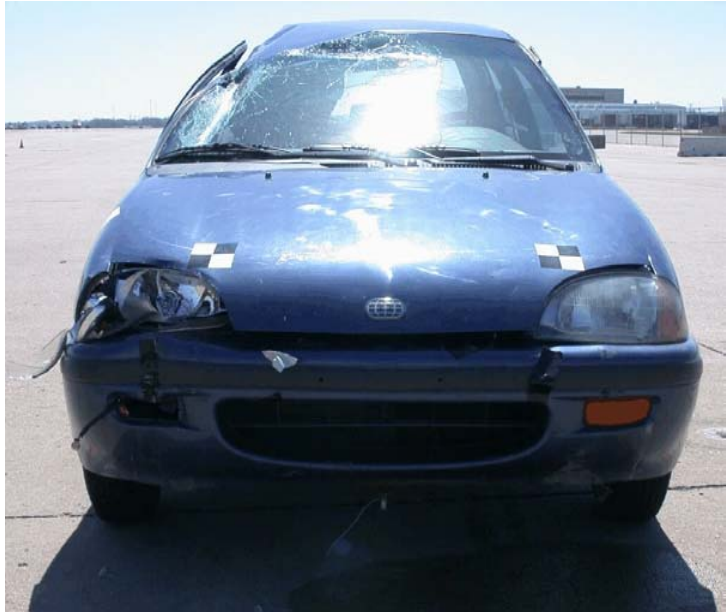
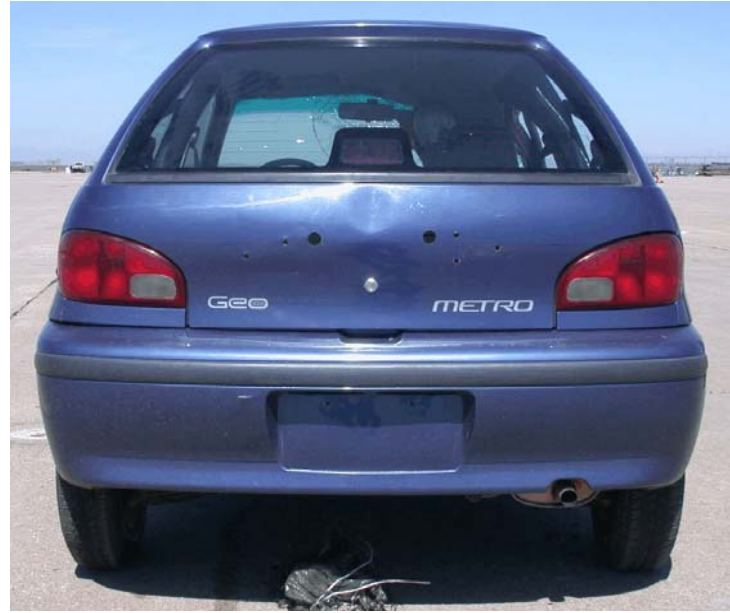
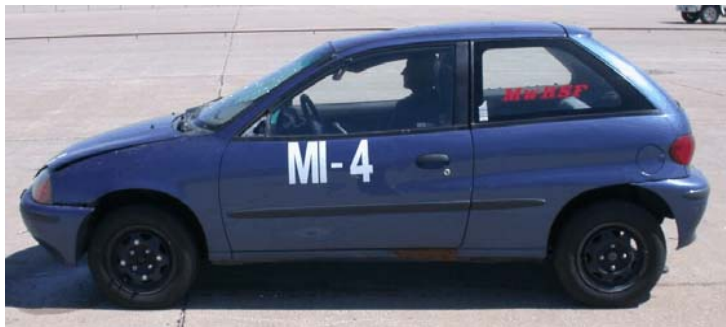
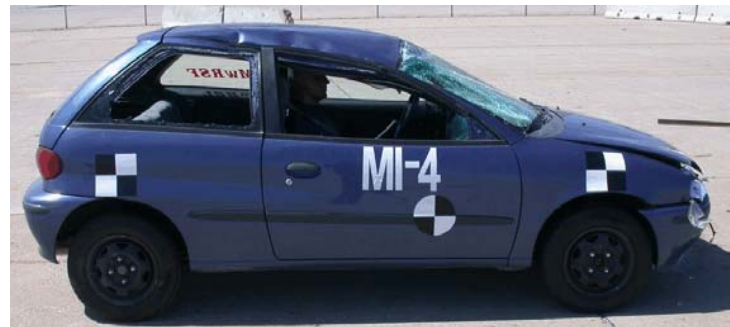
Figure 23. Vehicle Damage, Test MI-4

Exterior vehicle damage is shown in Figures 23 through 25. The front bumper and lower plastic shield encountered minor dents and contact marks. The hood encountered minor scuff and scrape marks. The right side of the roof encountered major indentation (maximum of 133 mm) and subsequent penetration. The right-side A-pillar was crushed extensively in toward the occupant compartment. The roof also sustained scuff and scrape marks. The right-side headlight and park light broke, while the left-side park light was cracked. The right-side door and right-rear windows were shattered. The windshield sustained major “spider web” cracking throughout, with both layers of the right-side and upper-middle regions of the windshield being cracked. Most of the structural

integrity of the windshield on the right side and upper middle was lost and the windshield indented inward toward the occupant compartment. A large hole (slice) through the windshield was located near the center region of the right side. No damage was found to have occurred to the left side, rear end, left-side headlight, nor parking lights.

The work-zone traffic control device performed unsatisfactorily according to the test evaluation criteria set forth in NCHRP Report No. 350 and is not recommended for field applications. This work-zone traffic control device includes:

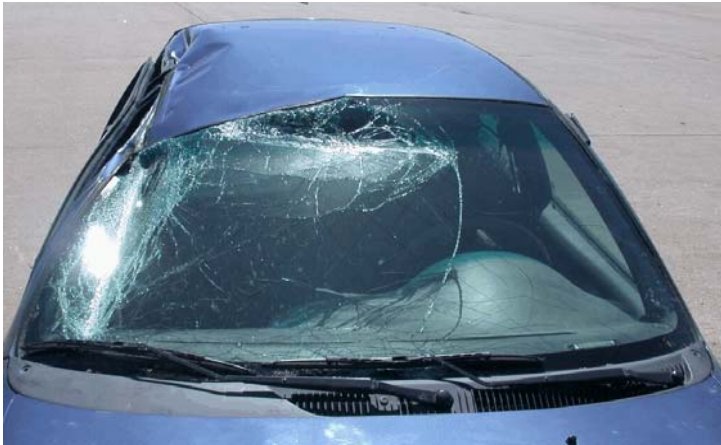
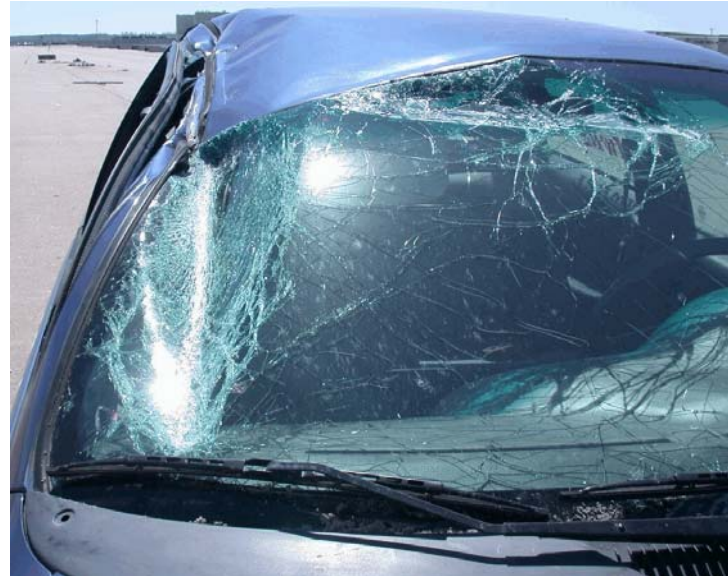
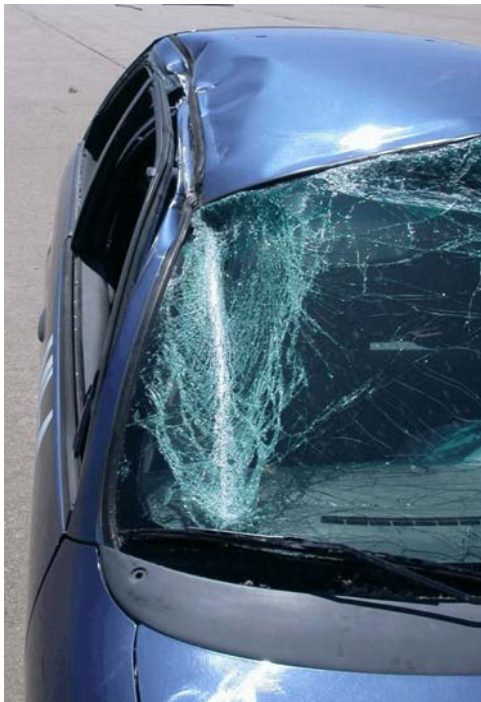
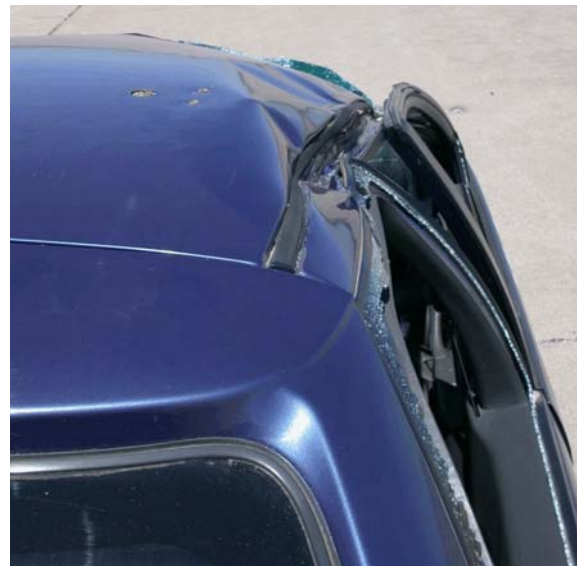
Figure 25. Windshield and Roof Damage, Test MI-4

During the 0-degree impact event, the vehicle struck the masts, causing the right mast to separate from the sign panel. Furthermore, the panel was supported in the air by the top of the left mast. Subsequently, the mast rotated about the front of the vehicle causing the panel to contact the roof and windshield. As a result of the panel contact, the vehicle's right-side door window was shattered and the windshield encountered major "spider web" cracking with a concentrated impact area.
