DEVELOPMENT OF A STEEL H-SECTION TEMPORARY BARRIER FOR USE IN LIMITED DEFLECTION APPLICATIONS

MIDWEST ROADSIDE SAFETY FACILITY

MwRSF Research Report No. TRP-03-120-03

May 30, 2003

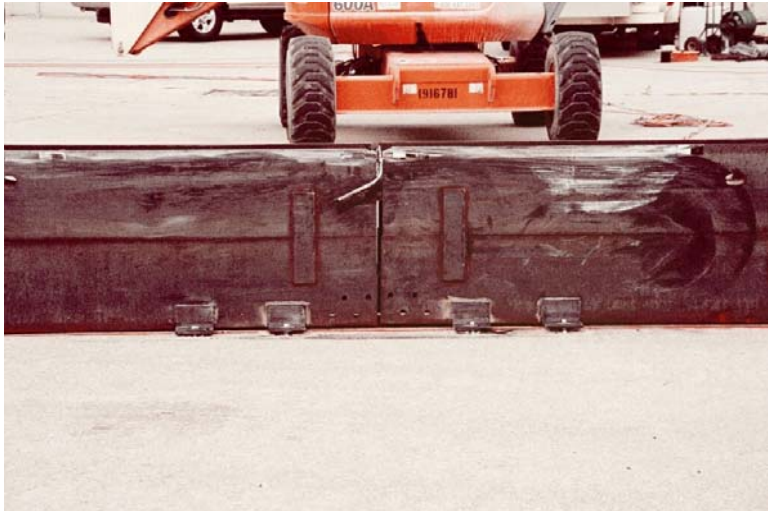
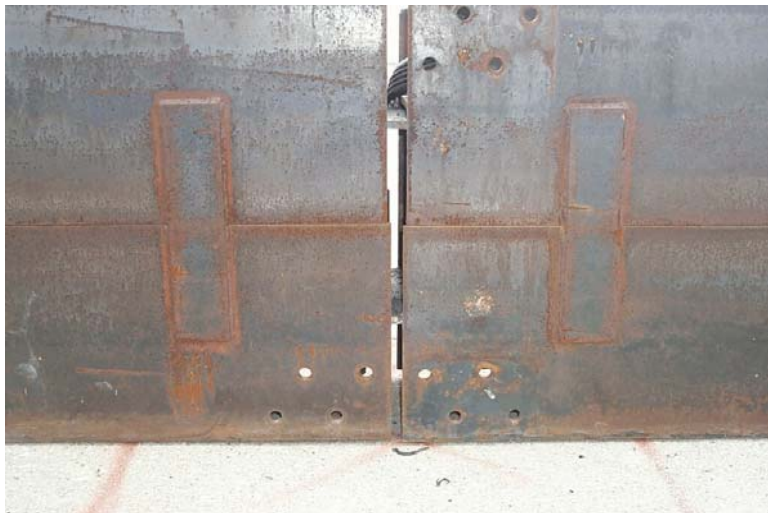
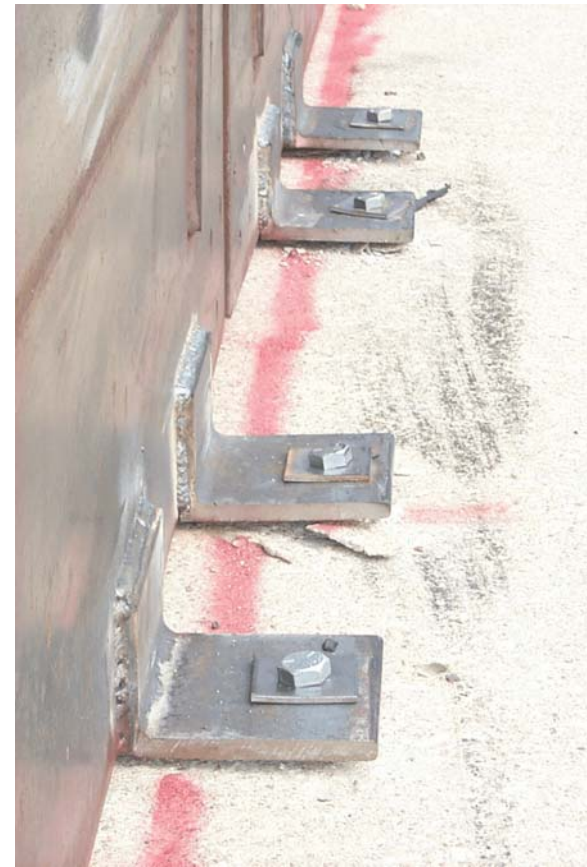
Figure 24. Steel H-section Barrier System Damage, Test HTB-1

Damage to the barrier was minimal, as shown in Figures 24 through 27. Barrier damage consisted mostly of minor damage to the tie-down angle brackets, cracking of the concrete near a few of the drop-in anchors, and scraping and tire marks on the barrier. Contact marks were found on barrier nos. 5 and 6 from impact to approximately 2,540-mm downstream of initial contact. Slight concrete failure occurred around the drop-in anchors at the joint between barrier nos. 5 and 6. Minor deformations to the tie-down angle brackets were found at the downstream end of barrier no. 5 and upstream end of barrier no. 6.

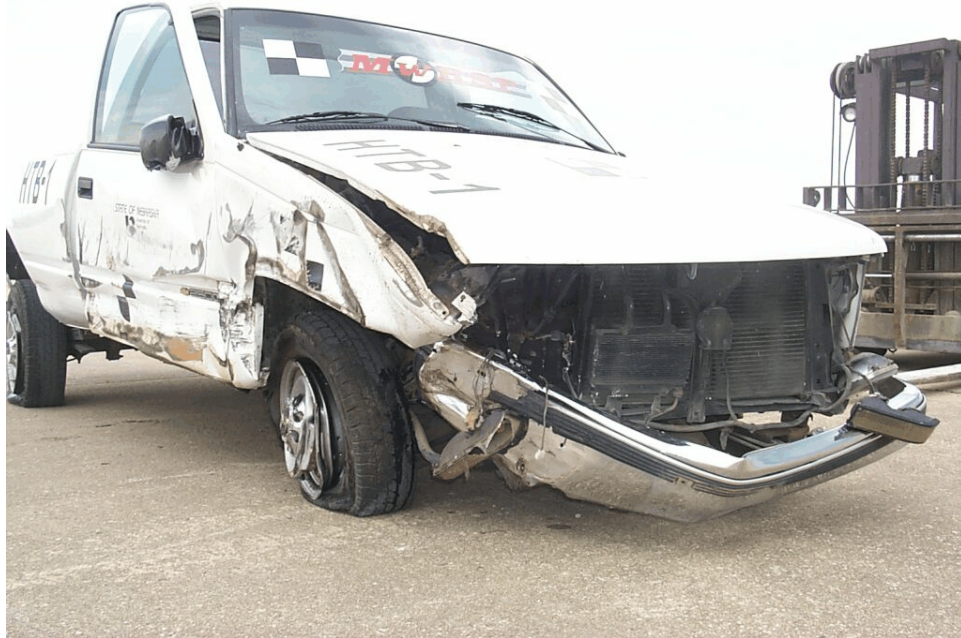
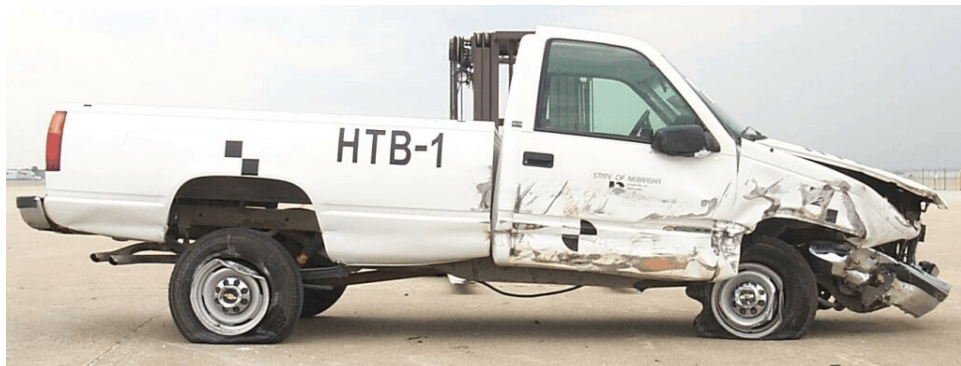
Figure 28. Vehicle Damage, Test HTB-1

Exterior vehicle damage was moderate, as shown in Figures 28 through 32. Moderate occupant compartment deformations occurred with deformations to the firewall, the right-side floor pan, and the dashboard, as shown in Figure 32. Occupant compartment deformations and the corresponding locations are provided in Appendix A.

Damage was concentrated on the right-front corner and right side of the vehicle. The entire right-front corner of the vehicle was crushed inward and back including the fender, bumper, and frame rail. The right-front wheel was pushed up and back into the firewall, deflating the tire, and deforming the steel rim. The steel rim on the right-rear wheel was deformed, and the tire was torn and deflated. The right-side door was flattened and pulled away from the upper portion of the occupant compartment. Contact marks were found along the entire right side of the vehicle. The left-front fender was deformed slightly. The grill broke around the right-side headlight and remained attached by the wiring harness. The windshield sustained minor cracks. The roof, the hood, the left-side, and the rear of the vehicle remained undamaged. The left-side, right-side, and rear window glass also remained undamaged.

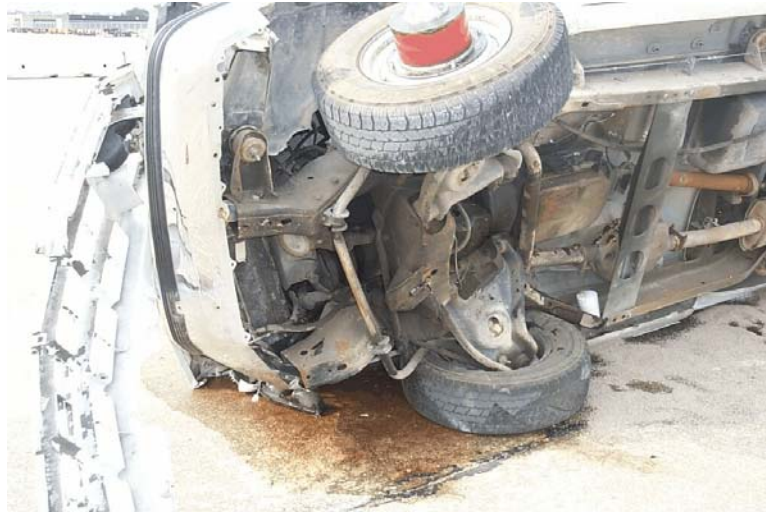
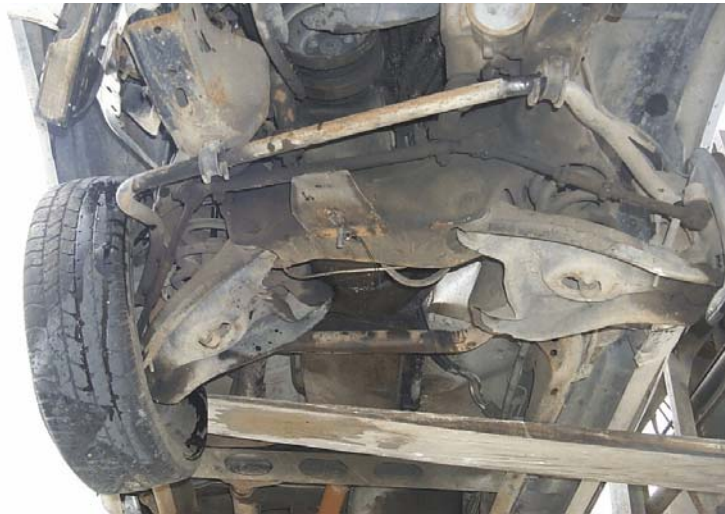
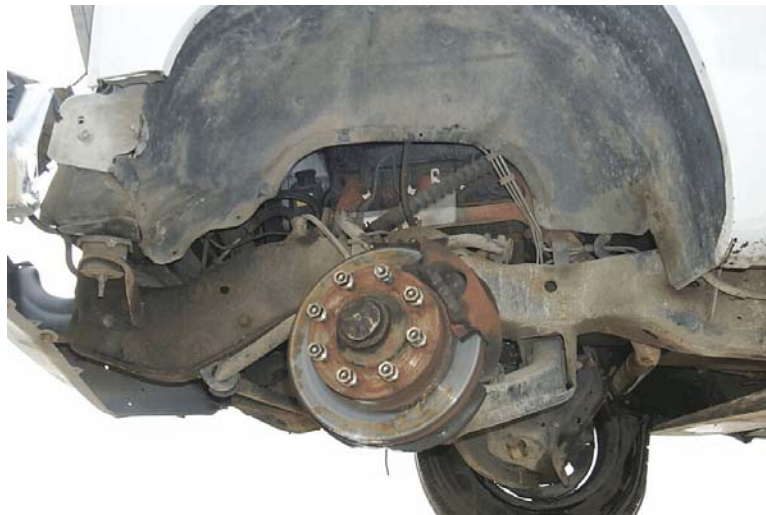
Figure 30. Rim and Tire Damage, Test HTB-1

From an analysis of the test results, MwRSF researchers believe that the rollover was caused by snagging of the pickup truck on the barrier. More specifically, the steel rims and sheet metal snagged on the 12.7-mm thick vertical straps holding the barriers together, the separation between the barrier joints, and the top of the barrier section. This conclusion was based on the damage to the vehicle's right-side sheet metal and steel wheel rims as well as the right-front fender being pulled down during the test as observed on the high-speed film.

Following this investigation, MwRSF researchers determined that the safety performance of the H-section temporary barrier tie-down system (Design No. 1) could be significantly improved by reducing the potential for snag. In order to eliminate the snag potential, two modifications were made to the barrier tie-down system. First, the vertical steel straps positioned on the traffic-side face of the barrier were removed and replaced with a longitudinal seam weld. Second, the anchor bolts used in conjunction with the drop-in anchors were changed from ASTM A325 to ASTM A307 grade bolts. The bolt grade reduction was made in order to reduce the load capacity of the tie-down attachments and allow for a slight increase in the deflection of the system. It was believed that allowing slightly higher deflections would potentially reduce any additional vehicle snag on the top

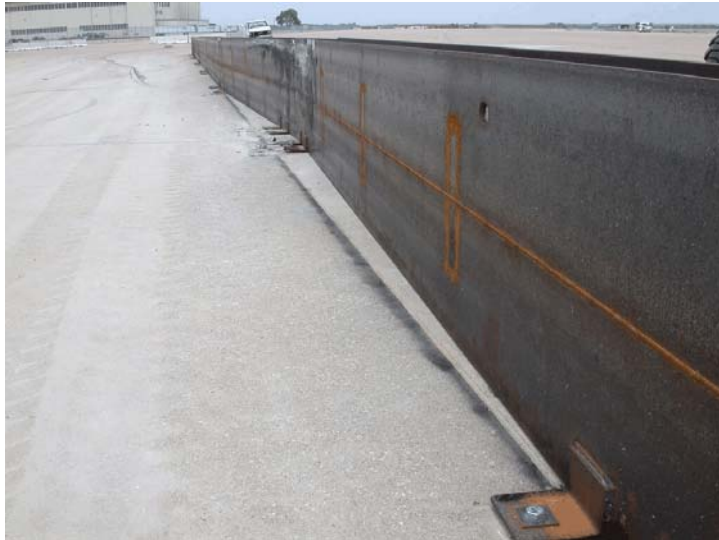
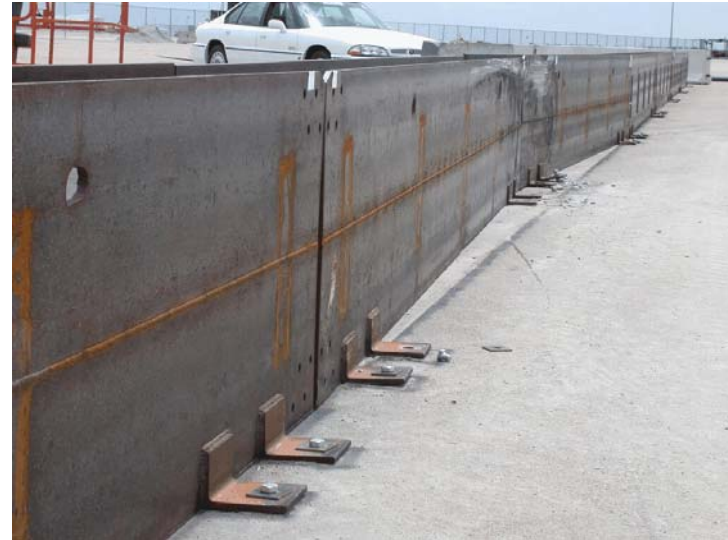
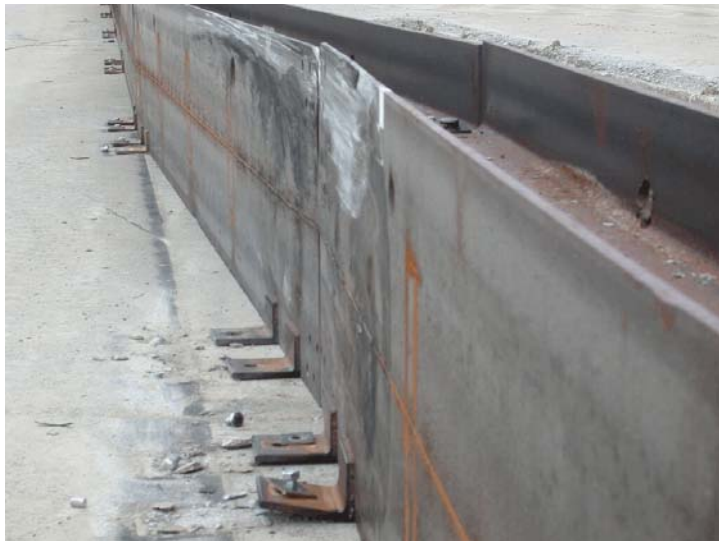
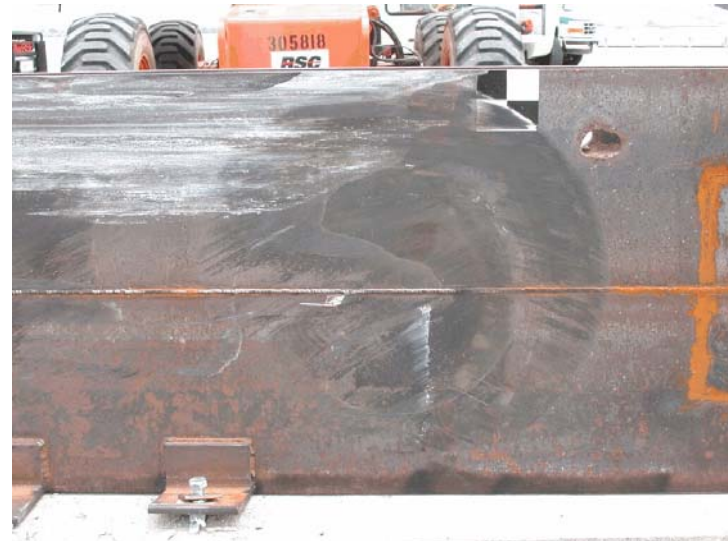
Figure 50. Steel H-section Barrier System Damage, Test HTB-2

Damage to the barrier was minimal, as shown in Figures 50 through 54. Barrier damage consisted mostly of scraping and tire marks on the barrier as well as release of several of the tie-down attachments. Contact marks were found on barrier nos. 5 and 6 from impact to approximately 3,048-mm downstream of initial contact. Contact marks were also found on the four tie-down angle brackets at the joint between barrier nos. 5 and 6. Tie-down failure occurred at the two angle brackets at the downstream end of barrier no. 5, the two angle brackets at the upstream end of barrier no. 6, and the upstream angle bracket at the downstream end of barrier no. 6. Four of the failures occurred due to fracture of the anchor bolts and the fifth was due to pullout of the drop-in anchor. In addition, the fifth failed angle bracket displayed partial fracture of the weld used to attach the

bracket to the steel barrier and minor deformation. Slight concrete failure occurred around the drop-in anchors at the joints between barrier nos. 4, 5, 6, and 7.

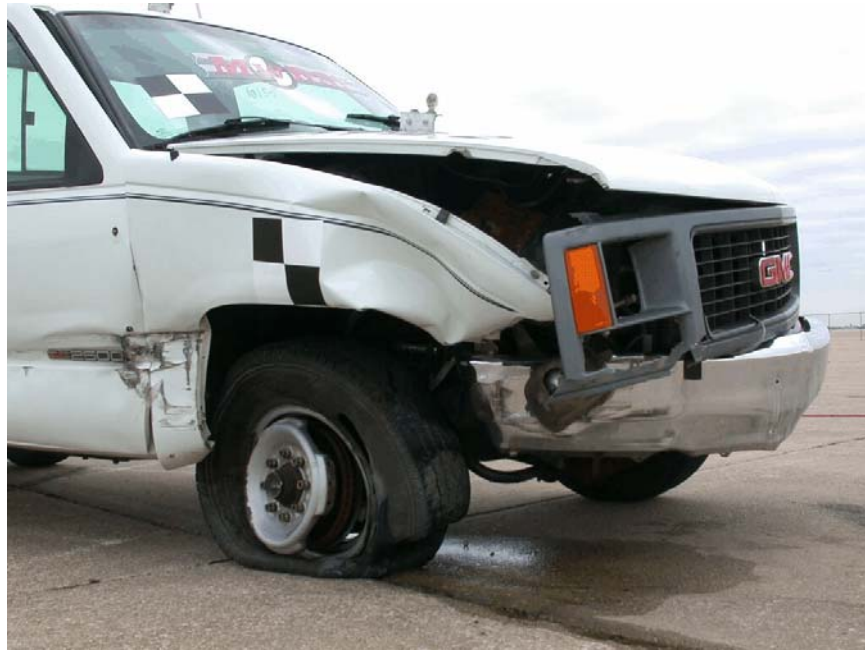
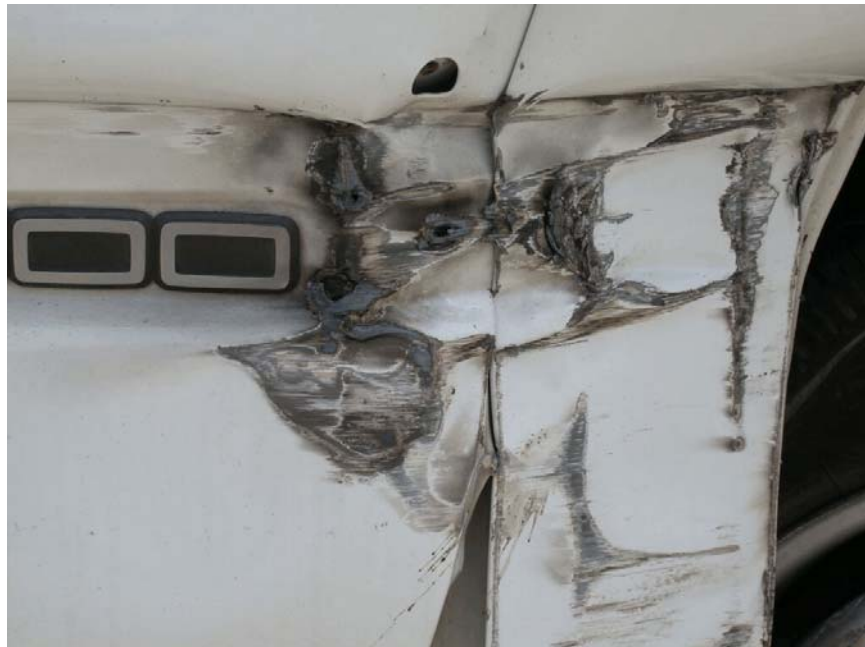
Figure 55. Vehicle Damage, Test HTB-2

Exterior vehicle damage was moderate, as shown in Figures 55 through 59. Moderate occupant compartment deformations occurred with deformations to the right-side floor pan and dash, as shown in Figure 59. Occupant compartment deformations and the corresponding locations are provided in Appendix D.

Damage was concentrated on the right-front corner and right side of the vehicle. The right-front corner of the vehicle was crushed inward and back including the fender, bumper, and frame rail. A buckling point was found at the center of the front bumper. Deformation of the right-side door and the right side of the truck bed were also observed. Both of the tires on the right side of the vehicle were torn and deflated. The right-front wheel was pushed backwards, but was not disengaged from the suspension. In addition, the right-front steel rim encountered major damage. Contact marks were found along the entire right side of the vehicle. The top of the right-side door was jarred open. The rear tailgate disengaged from the truck box. The right rear of the truck box was deformed at the top and near the box bed connections. The right side of the rear bumper was also deformed. The grill was broken and deformed around the right-side headlight. The roof, the hood, the left side of the vehicle, and all the window glass remained undamaged.
