SAFETY PERFORMANCE EVALUATION OF MICHIGAN'S TEMPORARY TRAFFIC CONTROL DEVICES

Michigan Department of Transportation

MwRSF Research Report No. TRP-03-128-02

January 27, 2003

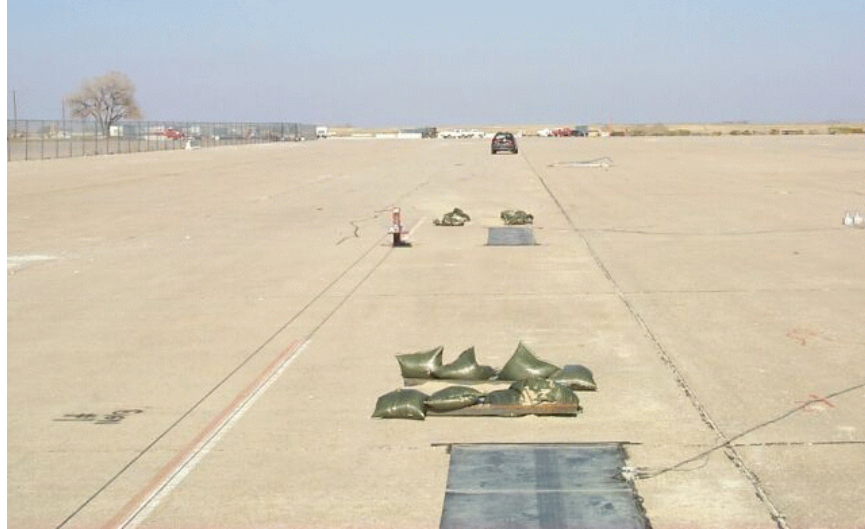
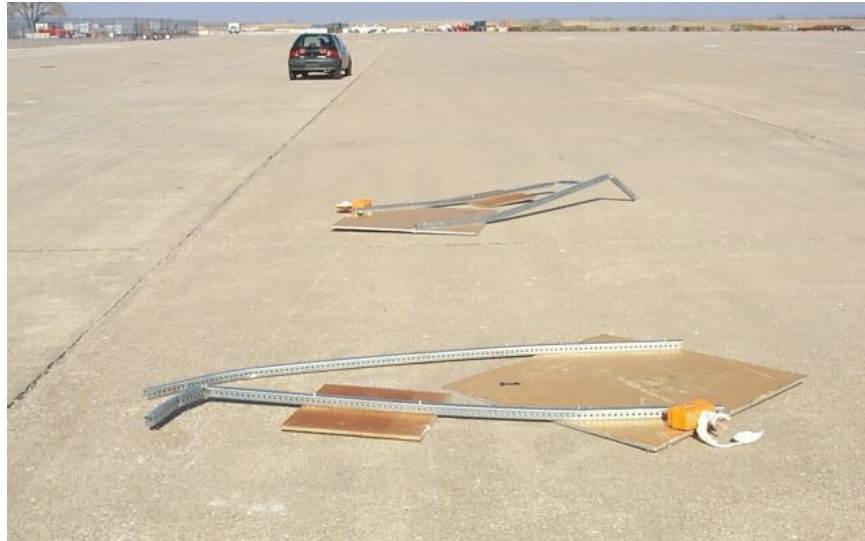
Figure 28. Overall Damage and Final Positions, Test MI-1

Damage to System Nos. 1 and 2 is shown in Figures 28 through 30. System No. 1 encountered moderate damage. Both legs disengaged from the masts but remained undamaged at their original positions. Both masts were deformed at the bumper height with the impacted mast encountering more significant damage. The light portion of the warning light broke off and was shattered, while the bottom box portion was still attached to the sign panel. The sign panel encountered moderate deformations on the impact side as well as scuff and scrape marks. Windshield glass was found embedded in the safety layer of the speed advisory sign panel. Scuff and scrape marks were also found on the speed advisory sign panel. The masts remained attached to the sign panel. Five of the sandbags were torn open with the sand scattered along the path of the vehicle, starting at the initial position of the first sign support. The other three sandbags remained undamaged.

System No. 2 encountered moderate damage. Both legs disengaged from the masts. The welds holding the vertical tubes to both legs fractured, resulting in both tubes disengaging from the angle legs. Both masts remained attached to both signs, but were deformed and bent at the bumper height. The mast without the attached speed advisory sign panel was also deformed at the bottom

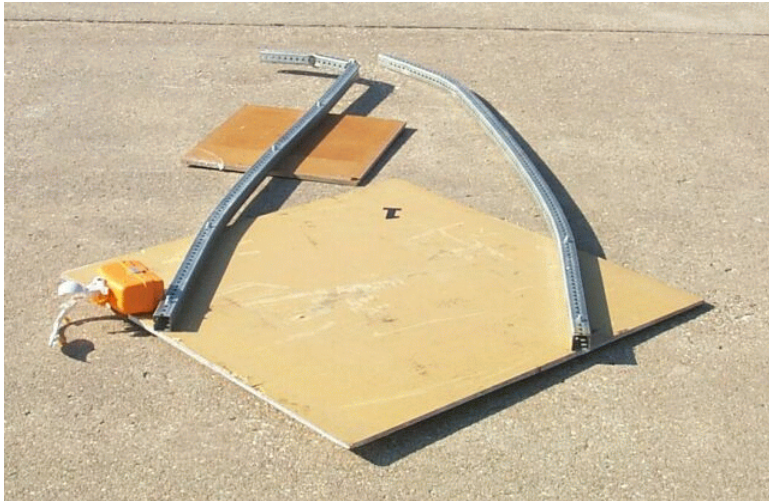
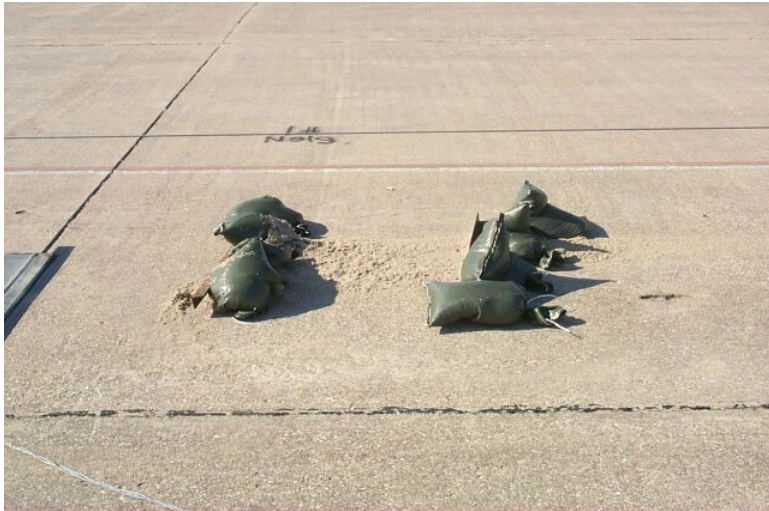
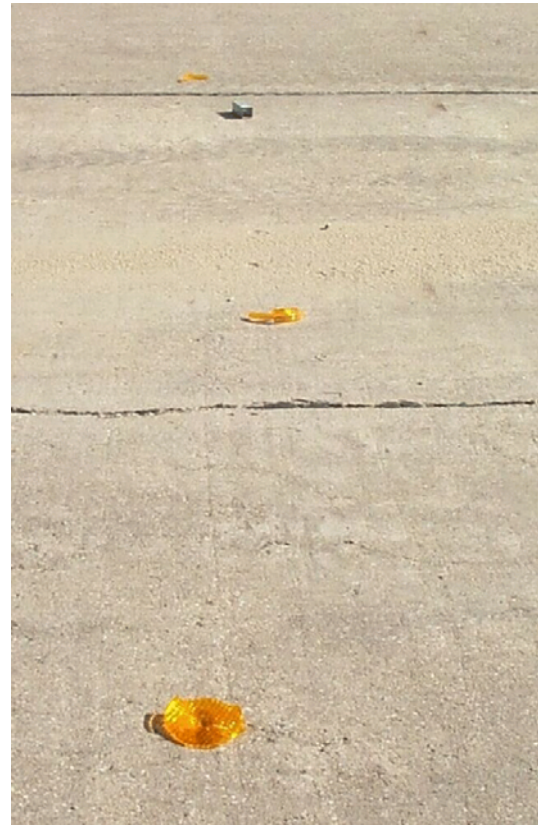
Figure 29. System No. 1 Damage, Test MI-1

traffic control device, System No. 1 was determined to be unacceptable according to the NCHRP Report No. 350 criteria. It was deemed unacceptable due to the “spider web” cracking, indentation, and hole in the windshield, resulting in obstructed driver visibility and loss of structure of both glass layers. In addition, deformations of, or intrusion into, the occupant compartment did occur as detached elements and debris from System No. 1 penetrated the right region of the windshield and the right side of the roof.

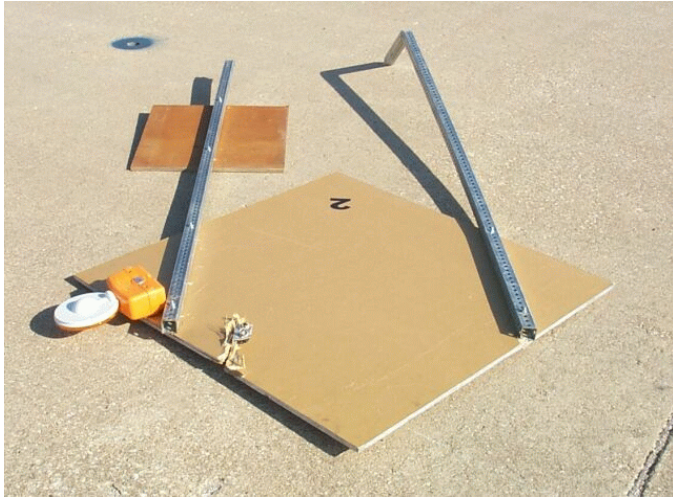
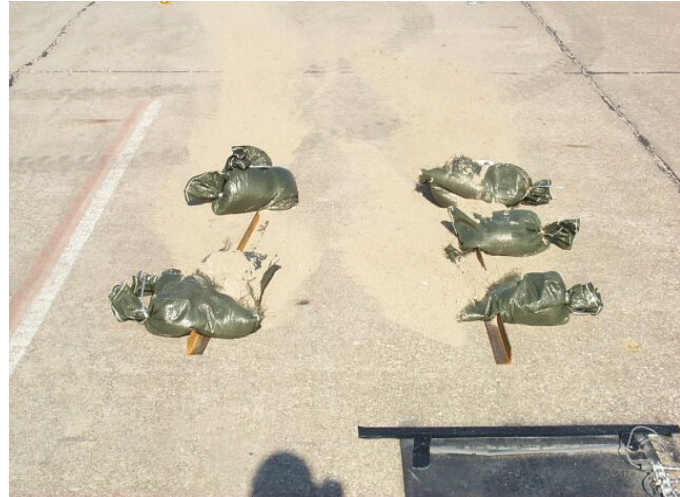
Figure 30. System No. 2 Damage, Test MI-1

System No. 2 was determined to be acceptable according to the NCHRP Report No. 350 criteria. Detached elements and debris from System No. 2 did not penetrate nor show potential for penetrating the occupant compartment. Deformations of, or intrusion into, the occupant compartment did occur as the roof was indented slightly downward toward the occupant compartment. However, the insignificant roof deformation was acceptable. The vehicle’s trajectory did not intrude into adjacent traffic lanes.

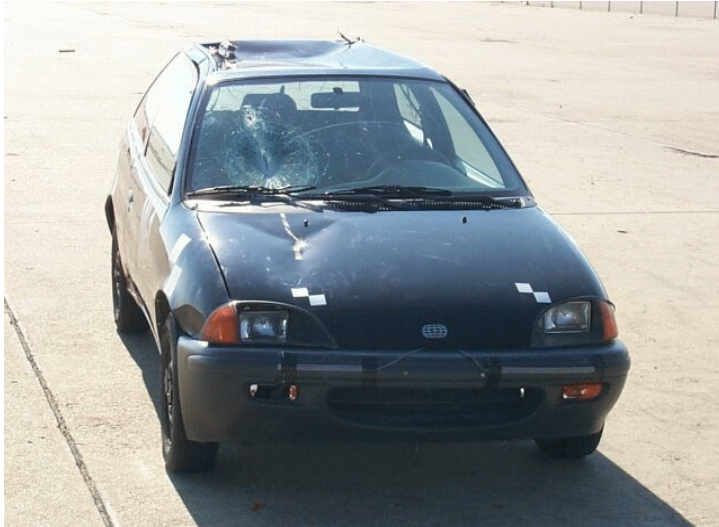
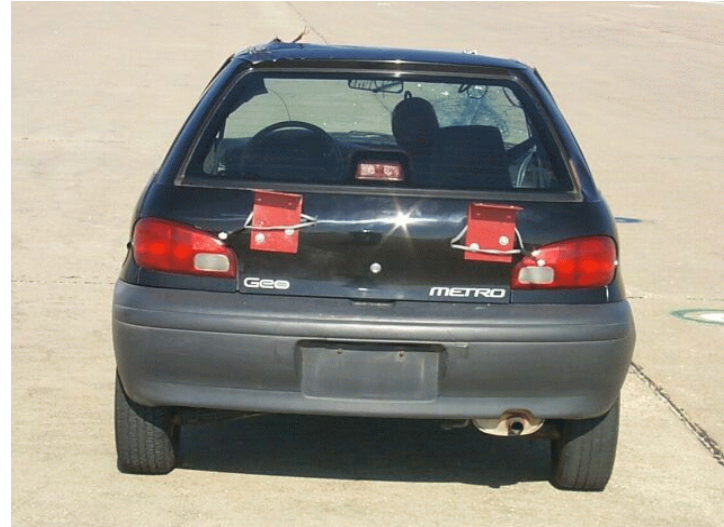
Figure 31. Vehicle Damage, Test MI-1

Exterior vehicle damage is shown in Figures 31 through 33. The front bumper and lower plastic shield encountered minor dents and contact marks. Both sides of the bumper disengaged from the bumper clips. The right-front fender was dented and scratched. A small dent was located along the right-side quarter point of the engine hood. The right side of the roof encountered a major indentation and subsequent penetration. The left-rear of the roof encountered a minor dent. The entire roof also sustained scuff and scrape marks. Both fog lights broke. The right-side headlight was pushed inward toward the engine compartment but remained undamaged. The windshield sustained major “spider web” cracking on the right side, with both layers of the right-side windshield being cracked. Most of the structural integrity of the windshield on the right side was lost and the windshield indented inward toward the occupant compartment. A large hole (slice) through the windshield was located near the center region of the right side. No damage was found to have occurred to the left side, rear-end, left-side headlight, nor parking lights.

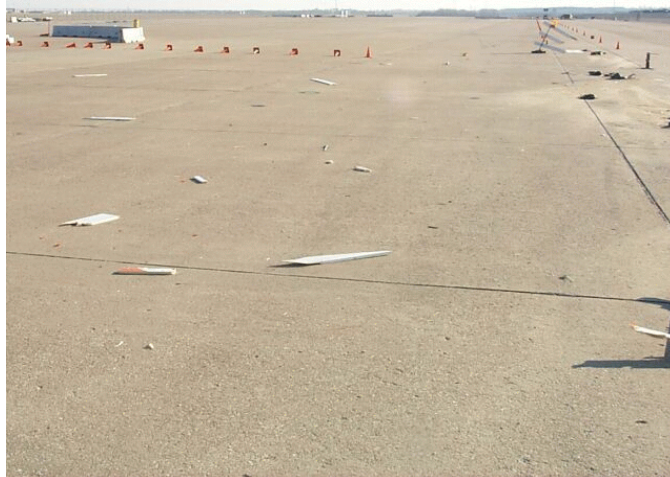
Figure 40. Overall Damage and Final Positions, Test MI-2

Damage to System Nos. 3 and 4 is shown in Figures 40 through 44. System No. 3 encountered moderate damage. The non-impacted mast, leg, and warning light remained intact with half of all three barricade panels and undamaged. The impacted leg disengaged from the mast. The welds holding the vertical tubes to the impacted leg fractured, causing the tube to be disengaged from the angle leg. The impacted mast was disengaged from the rest of the system and was deformed at the bumper height. The warning lights near the impacted mast and at the center of the barricade disengaged from the rest of the system. The barricade panels fractured into many small pieces and were scattered downstream. Two of the sandbags were torn open with the sand scattered along the path of the vehicle, starting at the initial position of the first barricade. The other six sandbags remained undamaged.

System No. 4 encountered moderate damage. Both legs disengaged from the masts. The impacted leg fractured at the bumper height and disengaged from the rest of the system. The non-impacted leg and a portion of the top barricade panel along with the middle and nonimpact-side warning lights remained attached. The impact-side warning light disengaged from the top barricade panel. The barricade panels fractured into many small pieces and were scattered downstream from the original position. All eight of the sandbags were torn open with the sand scattered along the path of the vehicle, starting at the initial position of the second barricade.

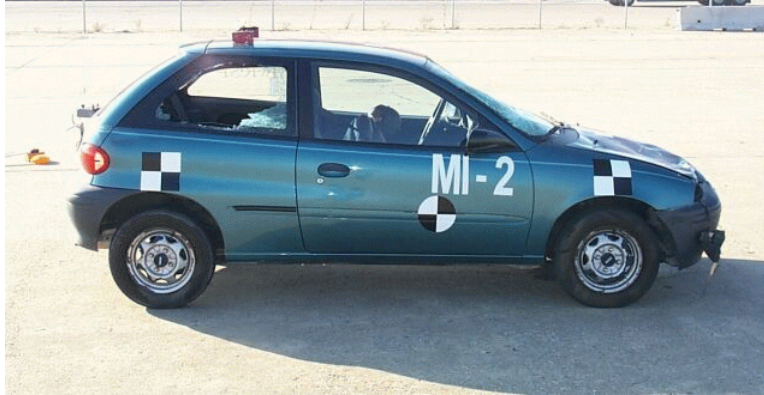
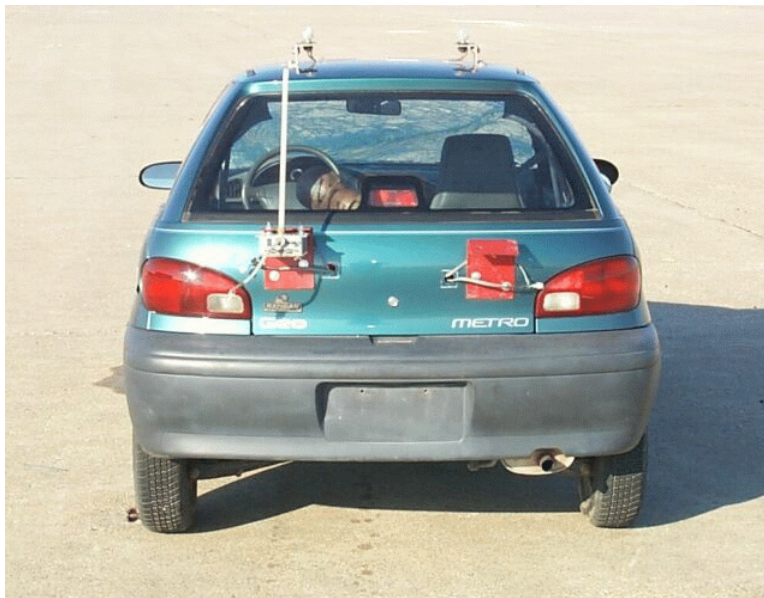
Figure 45. Vehicle Damage, Test MI-2

Exterior vehicle damage is shown in Figures 45 through 47. The vehicle sustained significant front-end damage. The bumper was deformed and pushed inward toward the radiator. The hood encountered dents and major scrape marks. The right-side quarter point of the hood also encountered a buckle point. The right-side fog light broke and the park light was removed from the light housing. The windshield sustained major “spider web” cracking throughout, with both layers of the windshield being cracked. Major indentation and penetration through the windshield was located near the central region of the left side. The right-rear window was shattered. Part of the lower barricade panel was embedded in the right-side of the engine compartment. No damage was found to have occurred to the roof, rear-end, headlights, nor the left-side fog and parking lights.

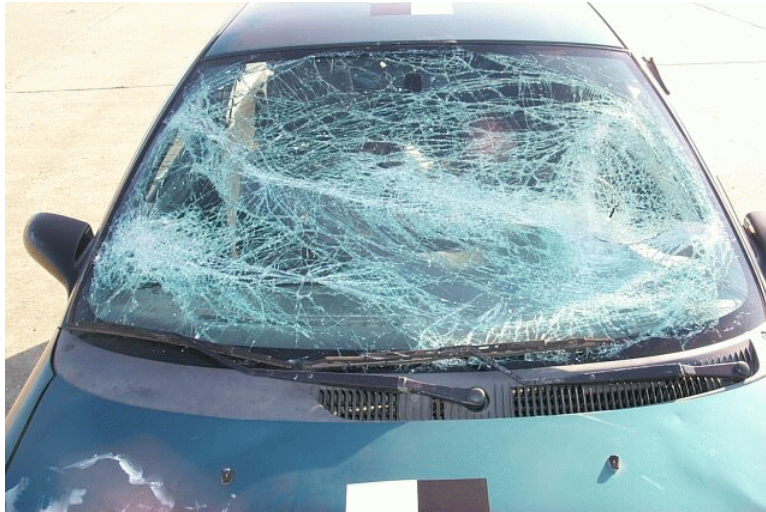
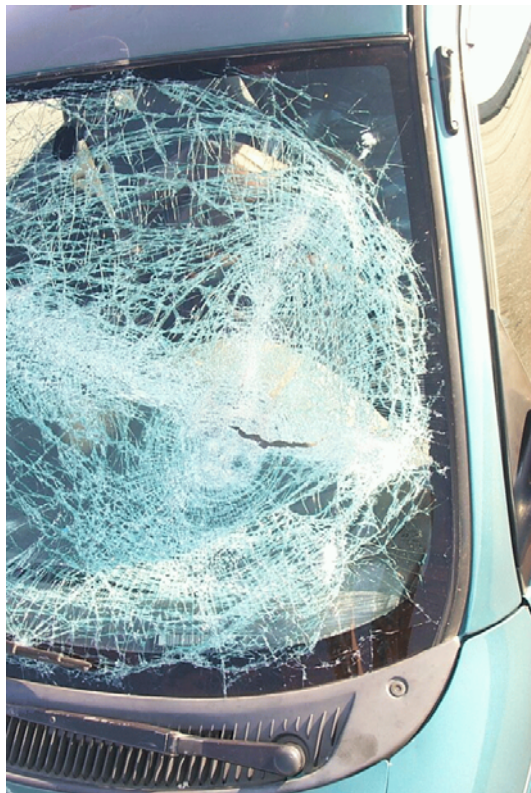
Figure 47. Windshield Damage, Test MI-2

Following test MI-2, a safety performance evaluation was conducted, and the work-zone traffic control device, System No. 3, was determined to be unacceptable according to the NCHRP Report No. 350 criteria. It was deemed unacceptable due to the “spider web” cracking, indentation, and hole in the windshield, resulting in obstructed drive visibility and loss of structure of both glass

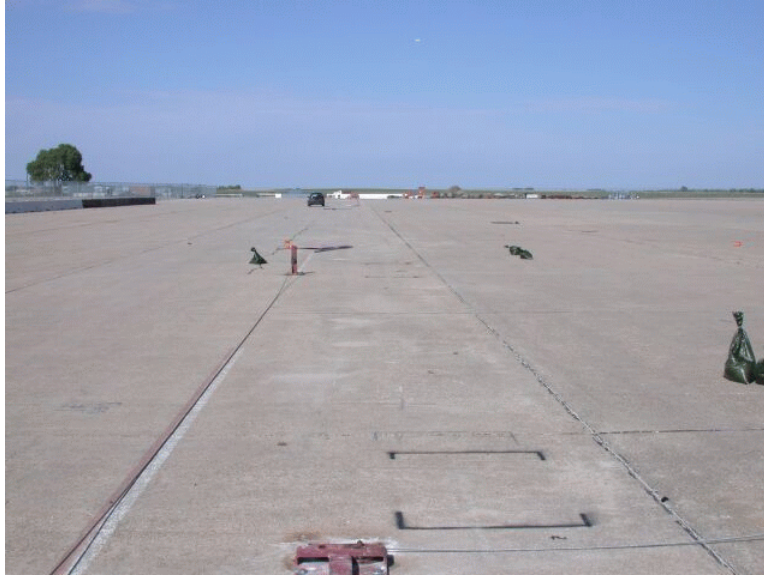
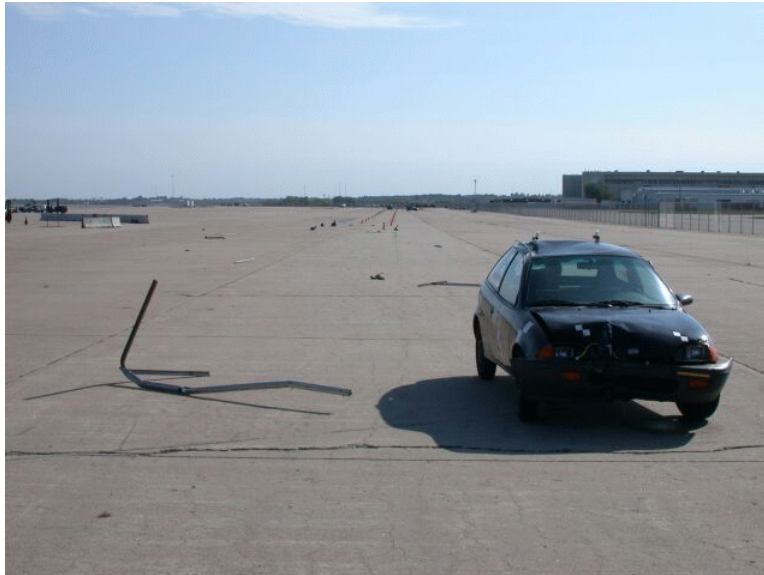
Figure 54. Overall Damage and Final Positions, Test MI-3

Damage to System Nos. 5 and 6 is shown in Figures 54 through 59. System No. 5 encountered moderate damage. The impacted mast, outer tube, and leg remained attached, and the top of the mast encountered minor deformations. The legs' angles were deformed into approximate 90 degree angles. The non-impacted leg disengaged from the mast and outer tube. The non-impacted leg's vertical upright tube disengaged from the angle portion due to fracture of the welds. The sign panel disengaged from both masts. The sign panel encountered scuff and scrape marks as well as damage to the impact-side corner. The light portion of the warning light broke off and the bottom box portion disengaged from the sign panel. Two of the sandbags were torn open with the sand scattered along the path of the vehicle, starting at the initial position of the first sign support. The other two sandbag remained undamaged.

System No. 6 encountered moderate damage. The right mast, outer tube, and leg remained attached, and the mast encountered minor deformations. The left leg disengaged from the mast and outer tube. The left leg's vertical upright tube disengaged from the undeformed angle portion but remained attached to the mast. The sign panel disengaged from both masts and encountered minor scuff and scrape marks. The warning light remained intact and attached to the sign panel. The sandbags were torn open with the sand scattered along the path of the vehicle, starting at the initial position of the second sign support.

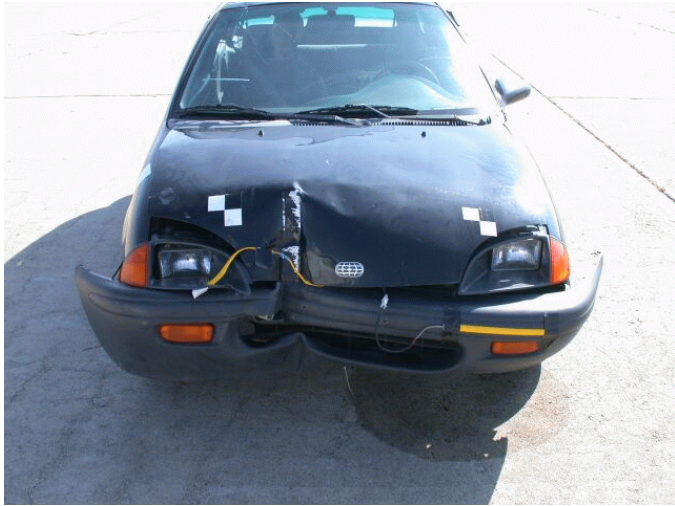
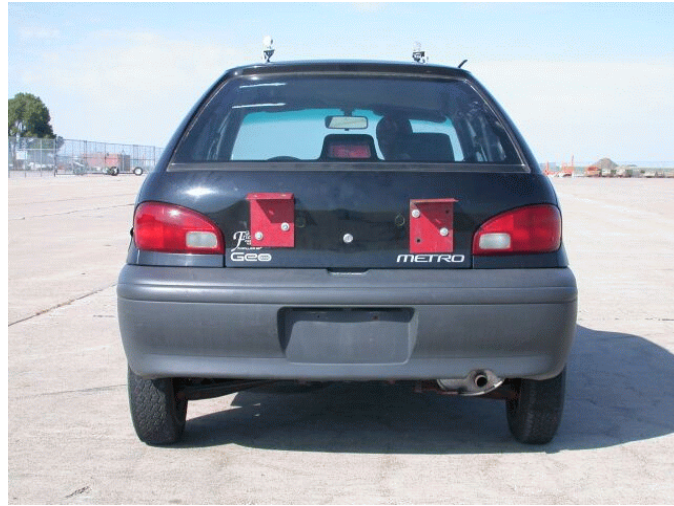
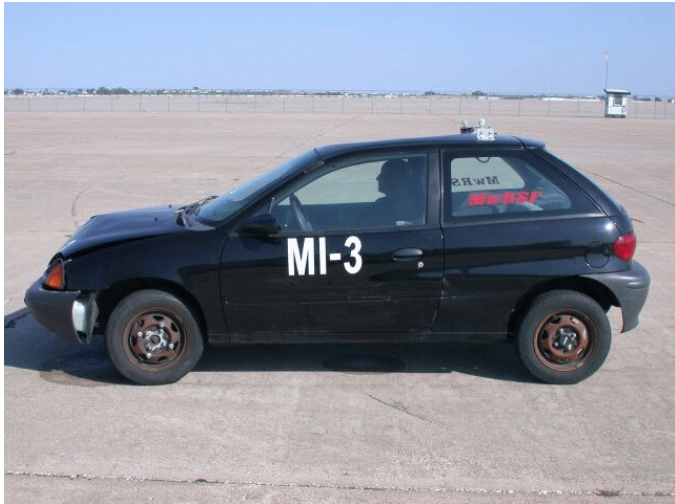
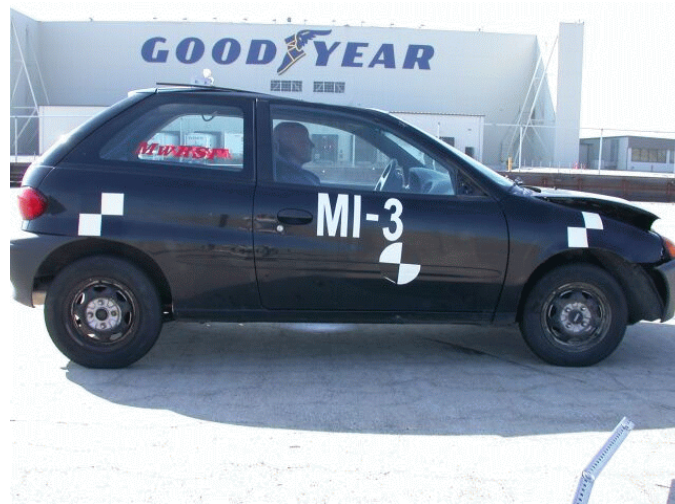
Figure 60. Vehicle Damage, Test MI-3

Exterior vehicle damage is shown in Figures 60 through 62. The vehicle sustained significant front-end damage. Light contact marks were found on the front bumper, the hood, the roof, and the left-side door. The bumper, grill, and radiator were deformed and pushed inward toward the engine compartment. The right-quarter point of the hood encountered a buckle point and major deformation. The front-right quarter point of the roof was indented near the roof/windshield interface. The right-side of the roof was indented a maximum of 95 mm at 445-mm back from the top of the windshield and 114-mm inward from the roof's right edge. The right-side mirror fractured off while the glass from the left-side mirror was disengaged. The upper-right region of the windshield sustained "spider web" cracking of the glass but without a concentrated impact point or indentation. However, the degree of cracking was judged insufficient to hinder visibility nor cause weak spots in both layers of glass. No damage was found to have occurred to the rear-end, headlights, fog lights, nor parking lights.

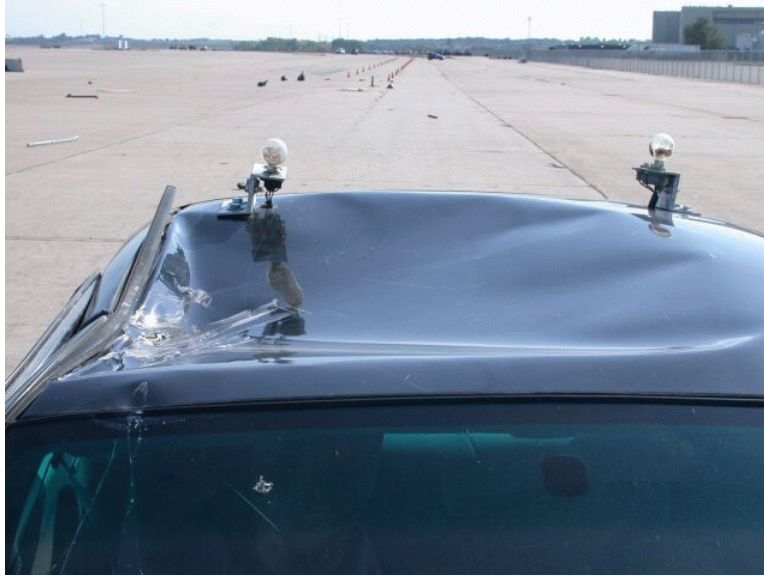
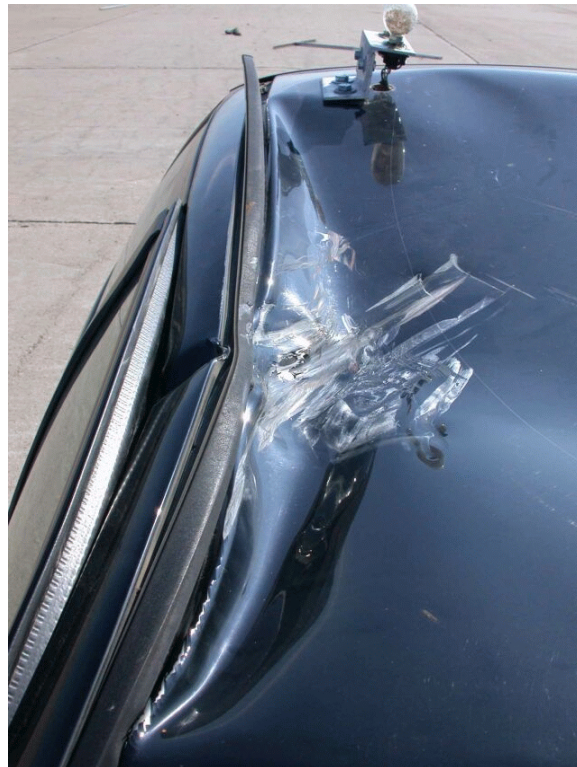
Figure 61. Vehicle Roof Damage, Test MI-3

During the 90-degree impact event, the vehicle struck the left mast, causing it to deform slightly near the vehicle's front-end as well as near the top of the outer stiffening sleeve. Deformation occurred to the impact-side leg angle as the lower part of the mast was pushed in front of the vehicle. The impact-side leg was held in place by two sandbags. As a result, the impact side of the panel rotated and was pulled down toward the vehicle. Following this, the impact-side corner of the panel with the attached warning light contacted the vehicle's roof. No roof penetration was observed, and the maximum roof crush was measured to be approximately 95 mm which is acceptable according to FHWA.
