COMPLIANCE TESTING OF IOWA'S SKID-MOUNTED SIGN DEVICE

MIDWEST ROADSIDE SAFETY FACILITY

MwRSF Research Report No. TRP-03-86-99

July 23, 1999

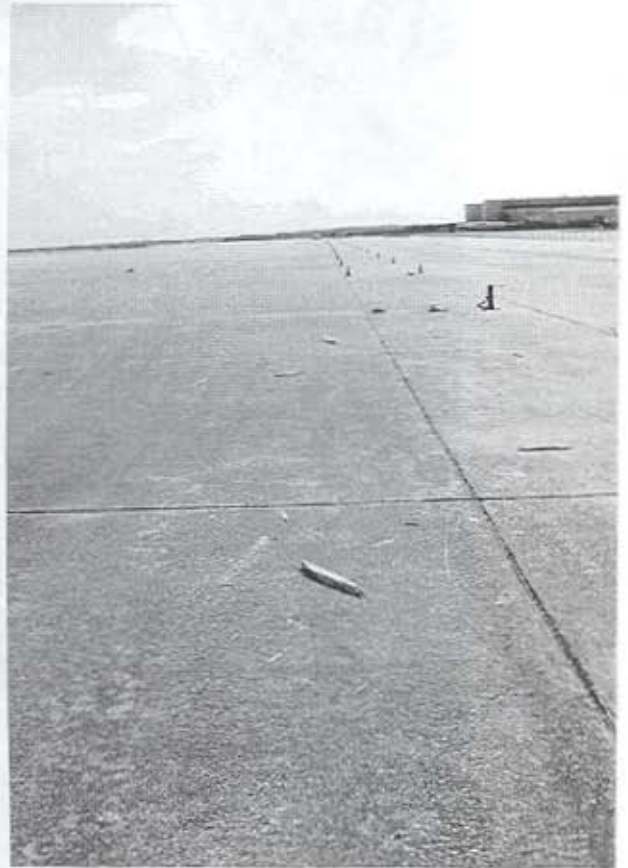
Figure 14. System No. 1 Overall Damage, Test I-1

Damage to System No. 1 is shown in Figures 14 and 15. System No. 1 encountered moderate damage to the sign support. The wooden base broke into two larger pieces and many smaller pieces. The pipe base, vertical tubing, mast, support rod, and sign panel all remained intact, but encountered deformations. Each leg of the pipe base bent to a 30 degree angle in opposite directions. The vertical tubing was bent in the shape of the nose of the vehicle. The support rod was bent into a 90 degree angle about the top third of the rod. The sign panel encountered scrape marks near the bottom front of the impacted side. The two bolts furthest away from the impact were slightly pulled through the plywood. No major damage was found to have occurred to the mast.
