PHASE I DEVELOPMENT OF A NON-PROPRIETARY, FOUR-CABLE, HIGH TENSION MEDIAN BARRIER

MwRSF Research Report No. TRP-03-213-11

December 28, 2011

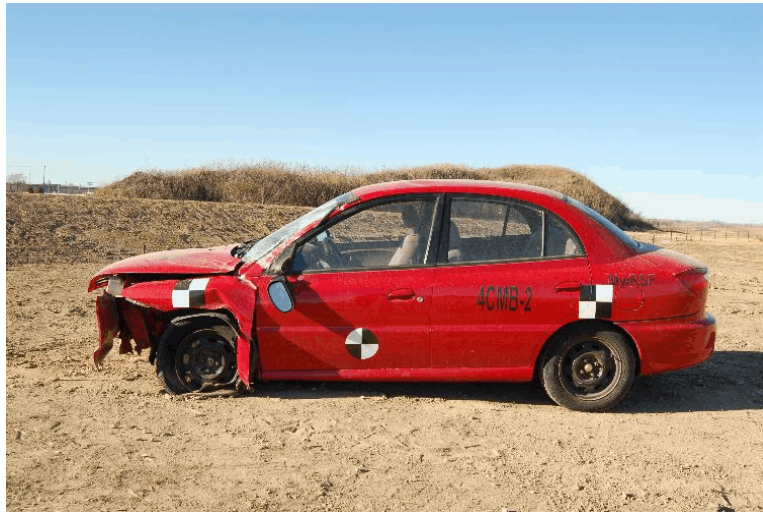
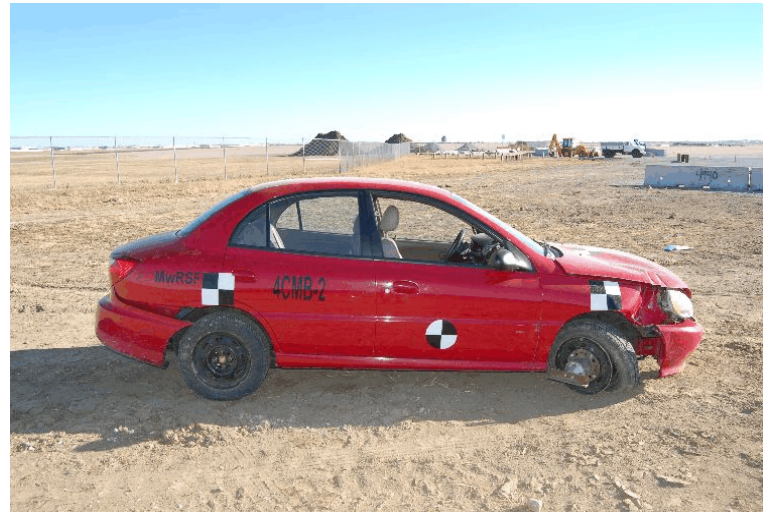
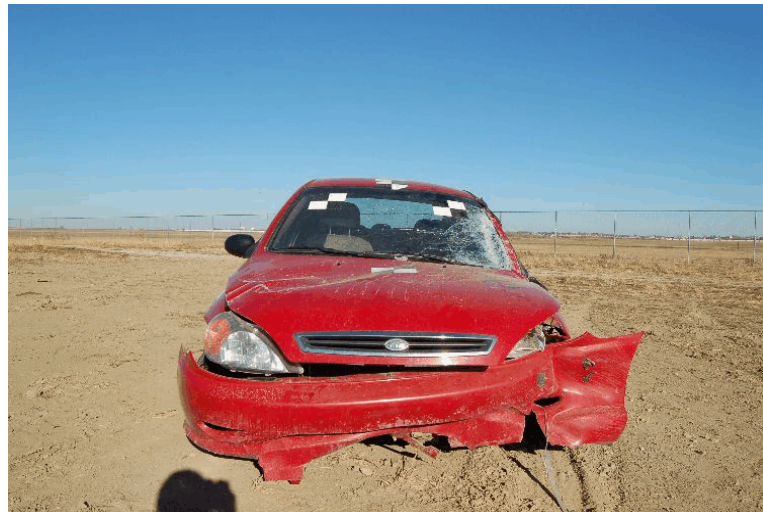
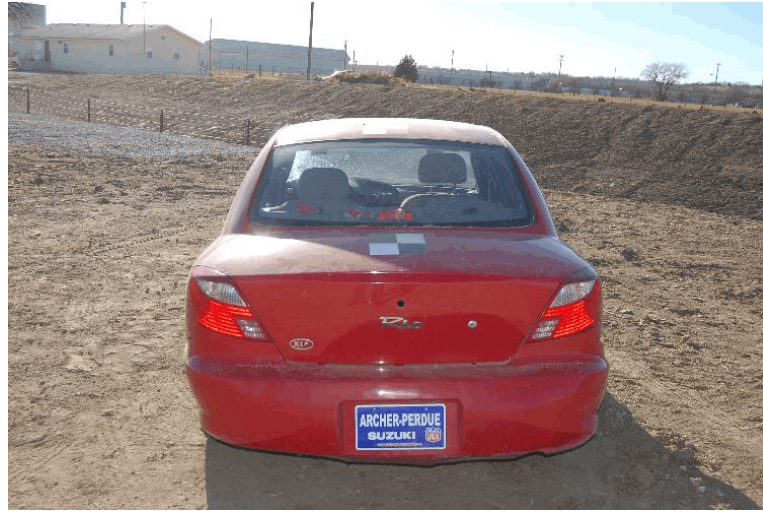
Figure 75. Vehicle Damage, Test No. 4CMB-2

Exterior vehicle damage was moderate, as shown in Figures 75 through 77. Minimal damage was observed in the interior occupant compartment of the vehicle, as shown in Figure 78.

The left-front fender was severely damaged and heavily creased toward the front of the car. It was also torn near the door joint. There was heavy cable contact and loading damage at the bottom of the A-pillar, and scrapes from the cables continued along the entire length of the pillar to the roof line. The left-front steel rim had an 8 in. (203 mm) long by 3 in. (76 mm) deep indent, and the tire was completely disengaged from the rim. The right-rear bumper cover attachment was pulled off, and there was heavy damage to the right-front fender. The right-front window was also broken out. The right-front steel rim was slightly dented, and the tire was deflated and disengaged. There were minor contact marks on the right-front quarter panel, and the entire wheel assembly was pushed in toward the engine.

The face of the front bumper was heavily damaged from cable contact. The radiator support brackets were buckled, crushing other components in the engine compartment. The hood was also deformed on the front end and buckled toward the center. There was major damage along the bottom-left side of the windshield and along the A-pillar where it had disengaged from the frame. Interior damage included a buckled and broken dash. On the left-front suspension, the vertical
