# **CABLE GUARDRAIL WITH STRONG J-BOLTS**

## **MIDWEST ROADSIDE SAFETY FACILITY**

## **NEW YORK STATE DEPARTMENT OF TRANSPORTATION**

MwRSF Research Report No. TRP-03-299-14

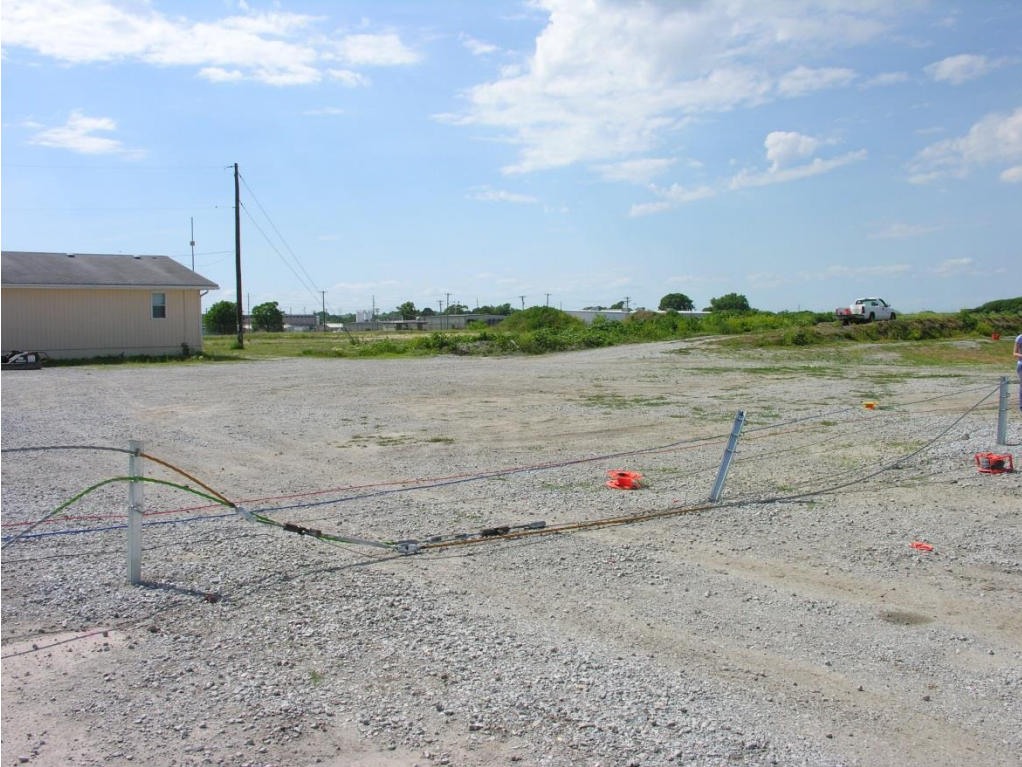
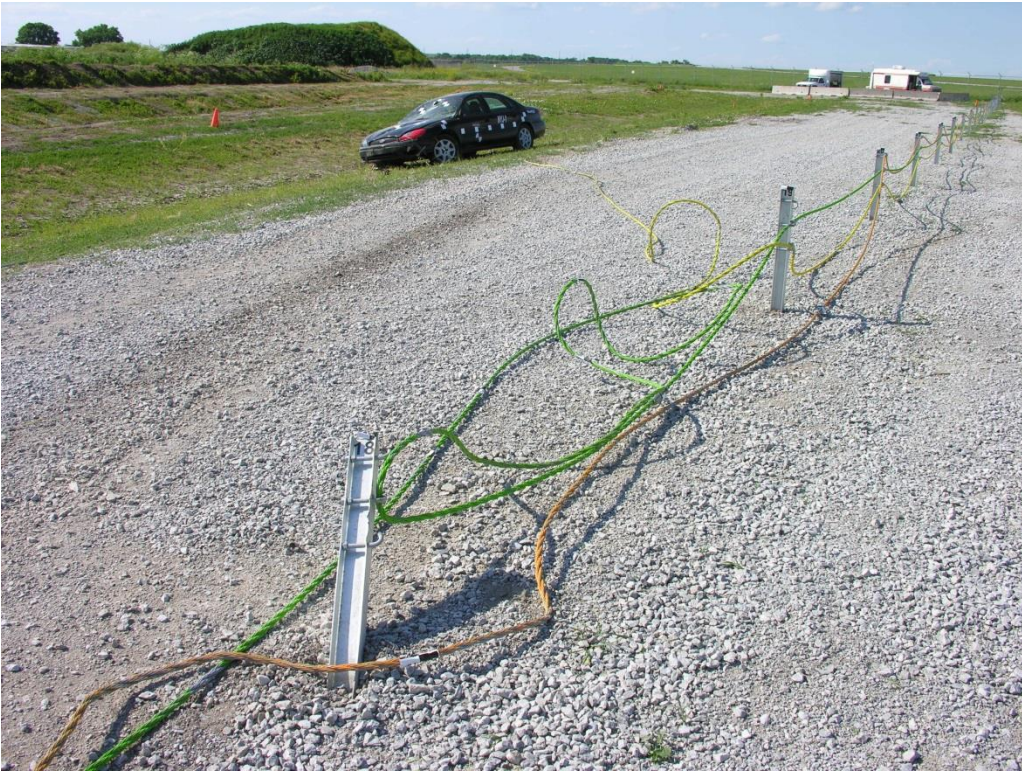
Figure 47. Post Damage in Impact Region, Test No. NYJ-1

Damage to the barrier was severe, as shown in Figures 47 through 52. Barrier damage consisted of fractured J-bolts, deformed posts, and disengaged cables. The permanent set, dynamic deflection, and working width were not recorded due to release of the cables from end fittings on the upstream and downstream ends. The permanent displacements of the upstream and downstream anchors were 0.17 in. (4 mm) and 0.29 in. (7 mm), respectively.

Post no. 1 deflected slightly downstream and the front flange cracked at the weld. Post nos. 3, 7, and 8 through 10 rotated downstream, and post nos. 4 through 6 bent and twisted downstream. Post no. 16 deflected backward, while post nos. 17 and 18 bent backward and downstream. Post nos. 19 and 38 rotated backward, post no. 36 rotated upstream, and post no. 40 bent upstream.

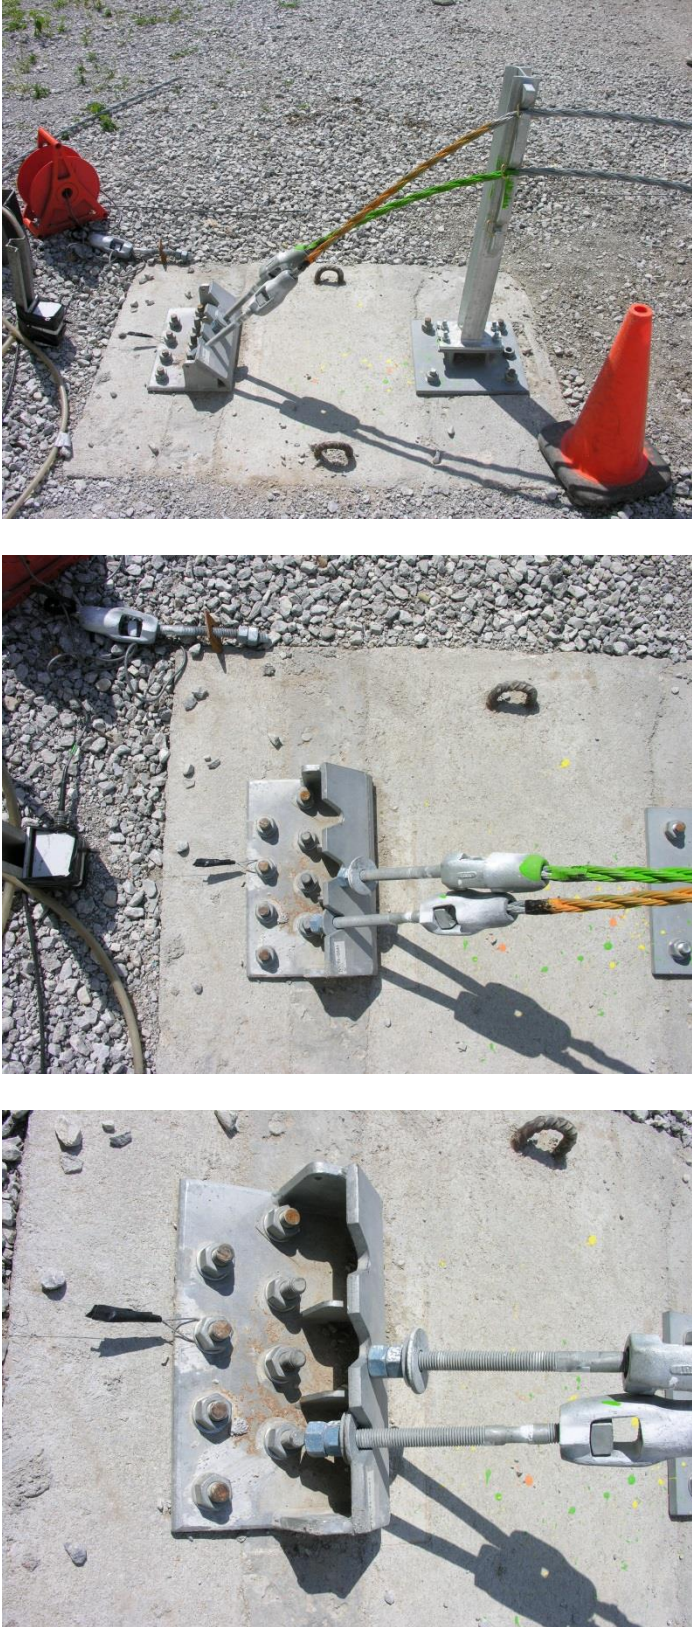
Figure 48. Upstream Anchor Damage, Test No. NYJ-1

The bottom cable disengaged from the cable end fitting at the upstream anchor. At the downstream end of the upstream load cell, the bottom cable threaded rod fractured and the bottom cable disengaged from the downstream end of the cable end fitting. At the downstream

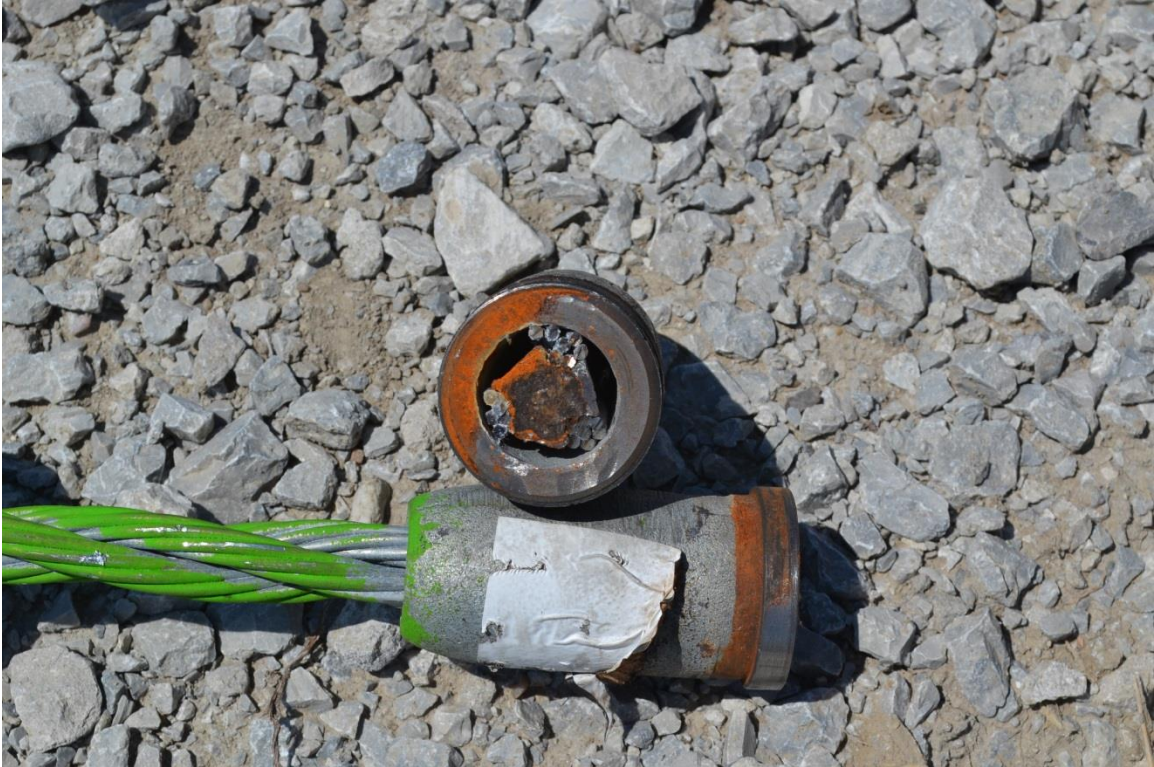
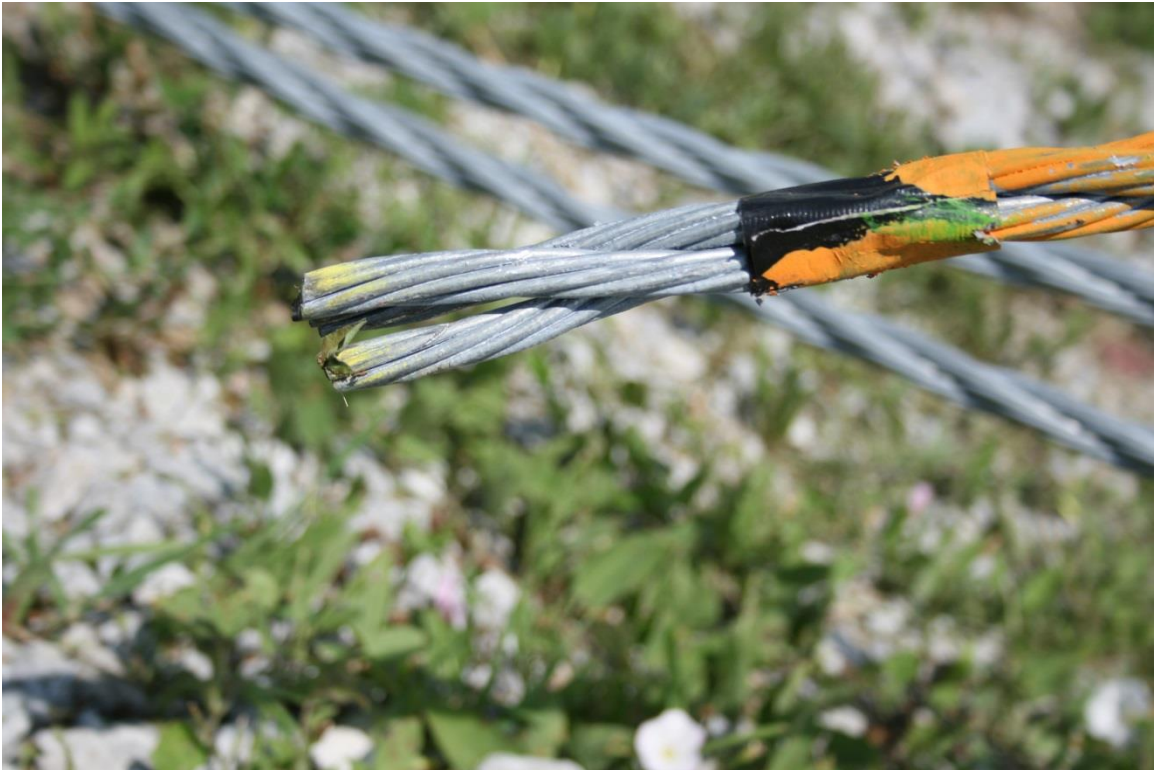
Figure 50. Hardware Fractures and Frayed Cable, Test No. NYJ-1

The top cable disengaged from post nos. 4, 17, 18, 19, and 40. The middle cable disengaged from post nos. 2, 4, 5, and 17. The bottom cable disengaged from post nos. 1 through 10 and post no. 18. The bottom J-bolt at post no. 4 fractured and localized gouging occurred at the location of the bottom J-bolt on the front, upstream flange of post nos. 7 and 8. On the front, upstream edge of the flange of post nos. 17 and 18, denting and gouging from the cable were observed. Contact marks were observed on the top of post no. 18. The bottom J-bolt of post no. 18 fractured.

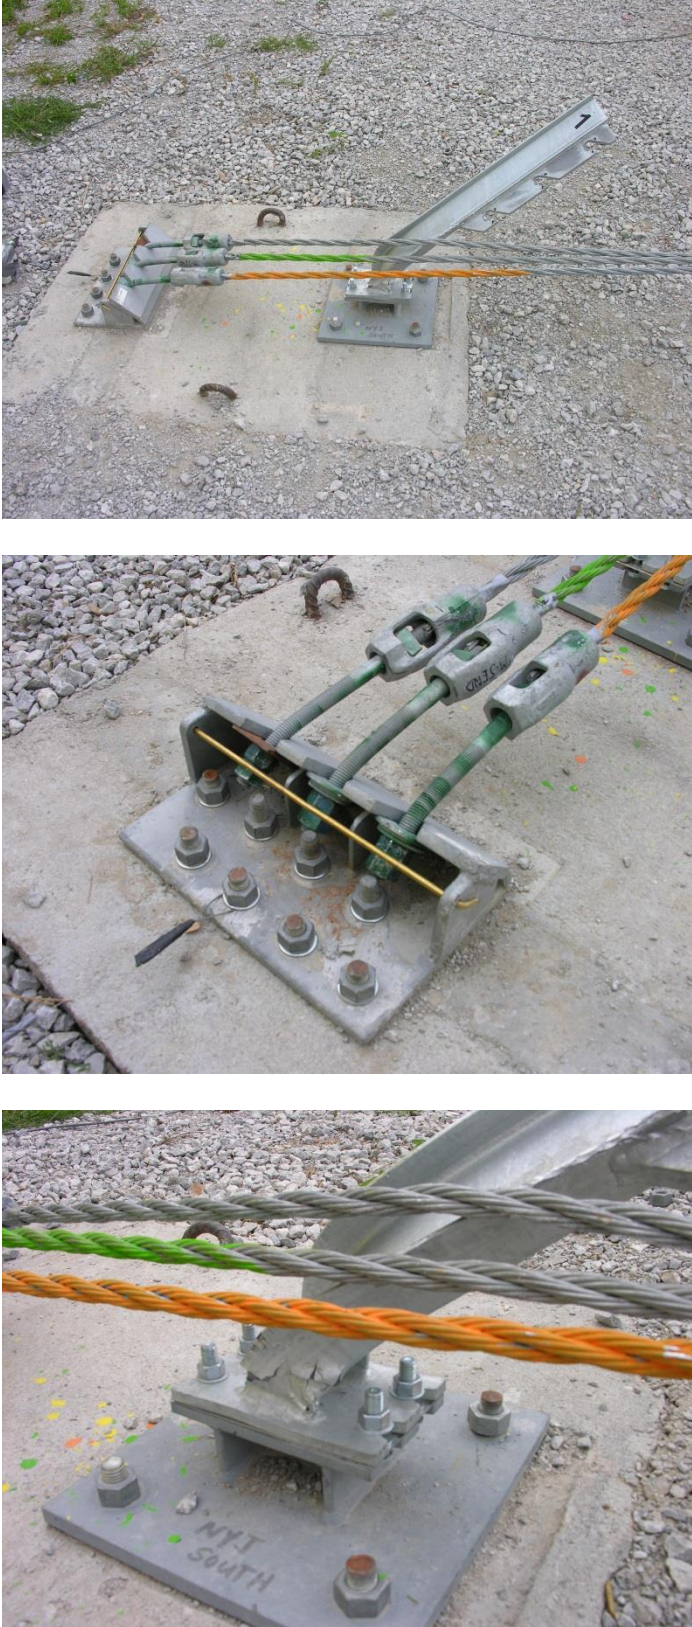
Figure 79. Upstream Anchor Damage, Test No. NYJ-2

Significantly more anchor rod deformation occurred at the upstream anchor than the downstream anchor, as shown in Figure 88.

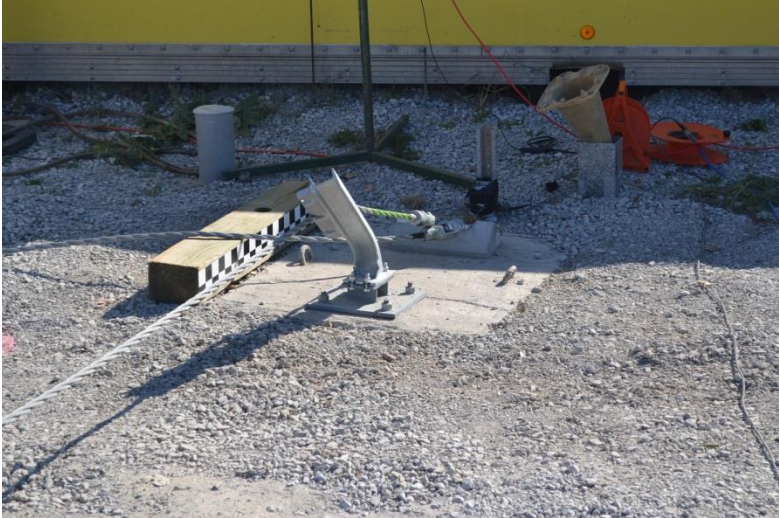
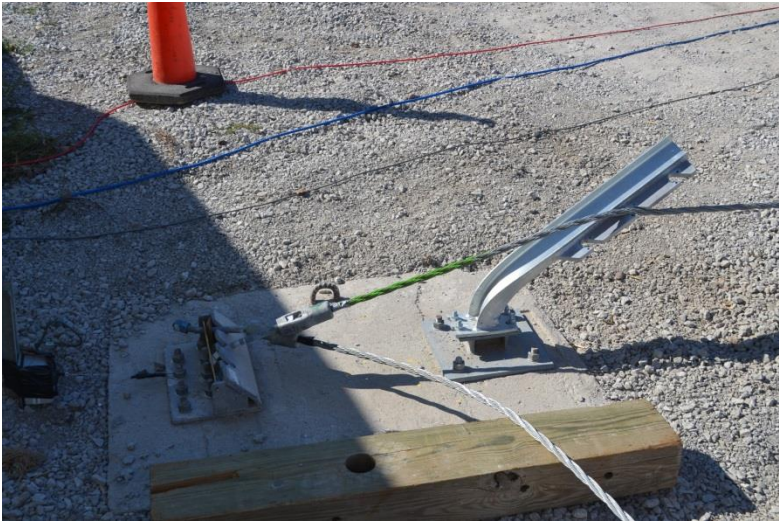
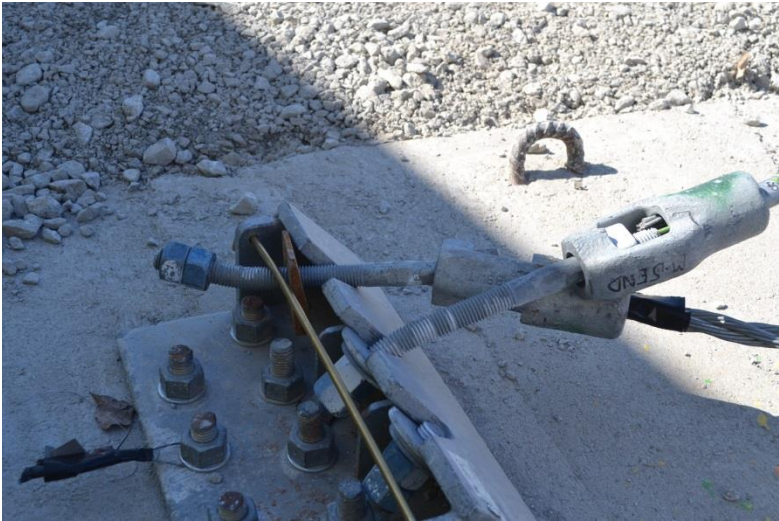
Figure 94. Upstream Anchor Damage, Test No. NYJ-3

After the hanger posts buckled and bent downstream, the angle formed between the cables and the anchor bracket was reduced. The top, middle, and bottom cable pre-test approach angles transitioned from 43, 36, and 26 degrees, to 7, 5, and 3 degrees, respectively, after the hanger post buckled and released the cables. The top, middle, and bottom cables therefore experienced 36, 31, and 23 degrees changes in approach angles, respectively. The anchor rods were bent due to the contributions of the cable tension, angled cable anchor plate, and partial constraint against rotation due to the presence of the vertical J-hooks and nuts. The threaded anchor rods are shown in Figure 101 and Figure 102. Figure 103 provides a schematic representation of the forces acting on the threaded anchor rods and indicates how the interference with the J-hook anchor bolts can significantly increase the bending stresses.

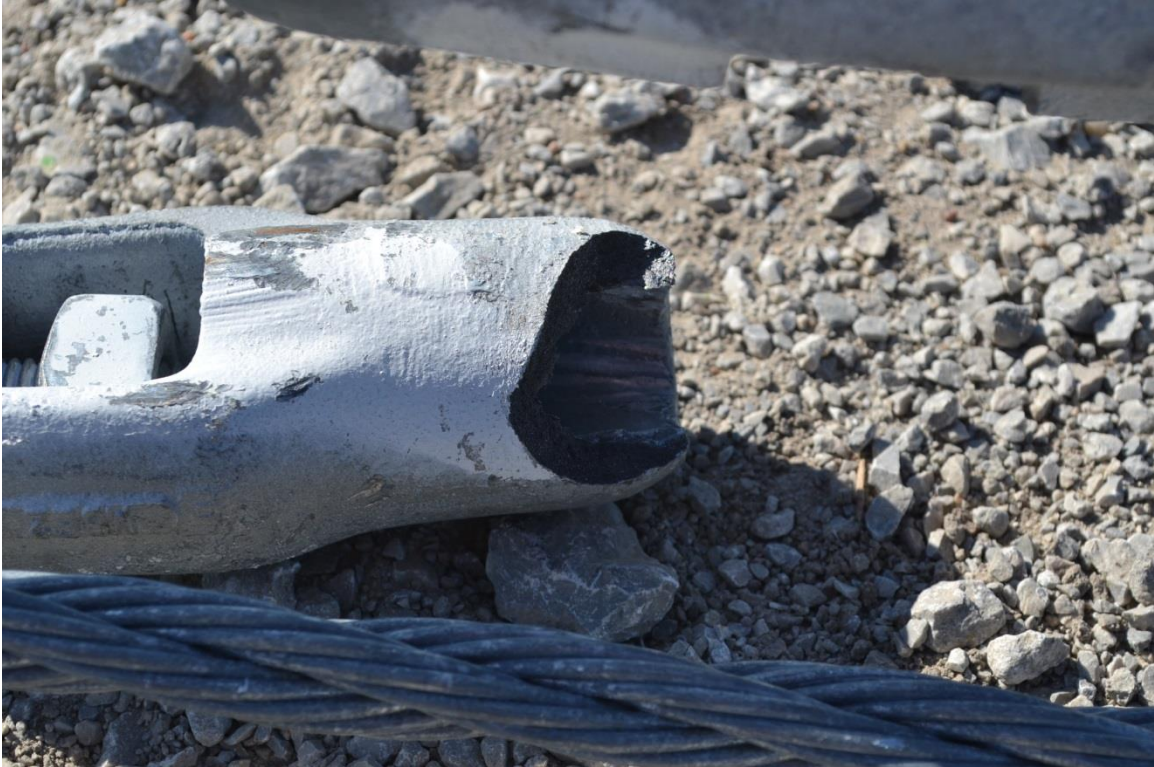
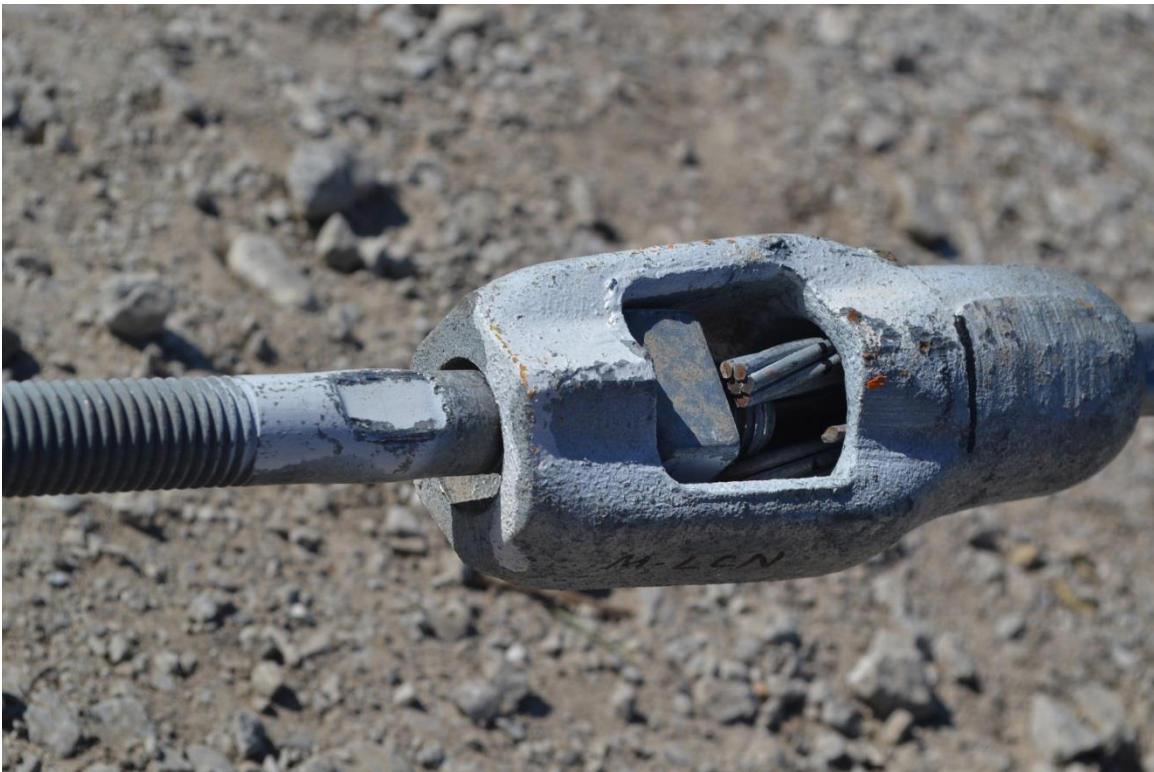
Figure 97. Cable End Fitting Damage, Test No. NYJ-3

Several threaded end termination rods fractured due to the cable ends being constrained by the threaded J-hooks in the concrete anchor block. It was believed that if the height of the J-hooks in the end anchorage were reduced, and if the hanger post had not bent toward impact, the cable ends may not have fractured. The cable threaded ends may have been constrained against rotation during test nos. NYJ-1 and NYJ-2 as well. Recall, 4 of 6 anchor rods were bent in test no. NYJ-2. Cable tensions never reached maximum levels during test no. NYJ-1 due to failure of the end fittings and splices.
