MASH TEST NOS. 3-11 AND 3-10 ON A NON-PROPRIETARY CABLE MEDIAN BARRIER

MIDWEST ROADSIDE SAFETY FACILITY

MwRSF Research Report No. TRP-03-327-16

May 17, 2016

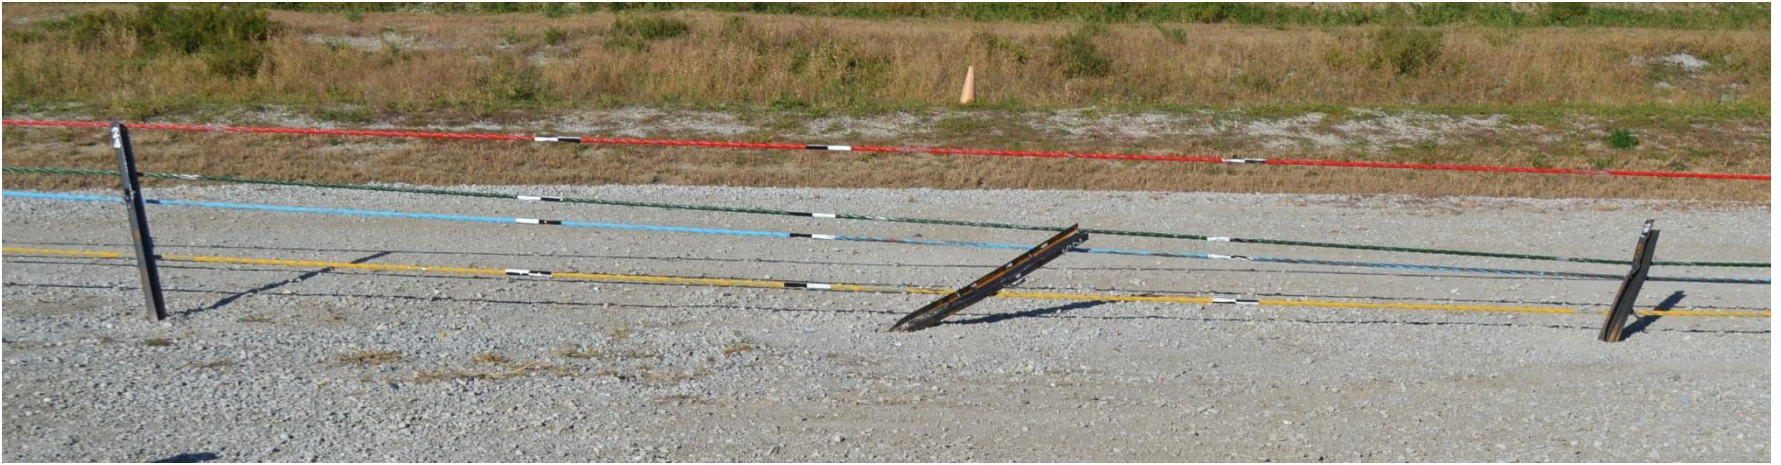
Figure 54. System Damage, Post Nos. 24 through 26, Test No. MWP-4

Damage to the barrier was moderate, as shown in Figures 49 through 59. Barrier damage consisted of bent posts, disengaged cables, and deformed brackets. At its final resting position, the vehicle was still in contact with the cables. Cable nos. 1 and 2 were beneath the vehicle, cable no. 4 was on the impact side of the vehicle, and cable no. 3 was on the non-impact side of the vehicle.

Cable no. 4 disengaged from post nos. 18 through 40 due to fracture of the brass keeper rods. Cable no. 3 disengaged from post nos. 25, 27, 32 and 33, as well as post nos. 36 through 39. Cable no. 2 disengaged from post nos. 15 through 40. Cable no. 1 disengaged from post nos. 24, 26, 29, and post nos. 36 through 39. Nearly all of the releases of cable nos. 1 through 3 were due to the tabs rotating through the key to release the cables vertically. However, the release of cable no. 2 at post no. 37 was due to bracket fracture at the tab. Displacement of the cable splices were documented, but they were deemed small. The maximum displacement within a splice measured ½ in. (13 mm) at the load cell splice found in cable no. 4.

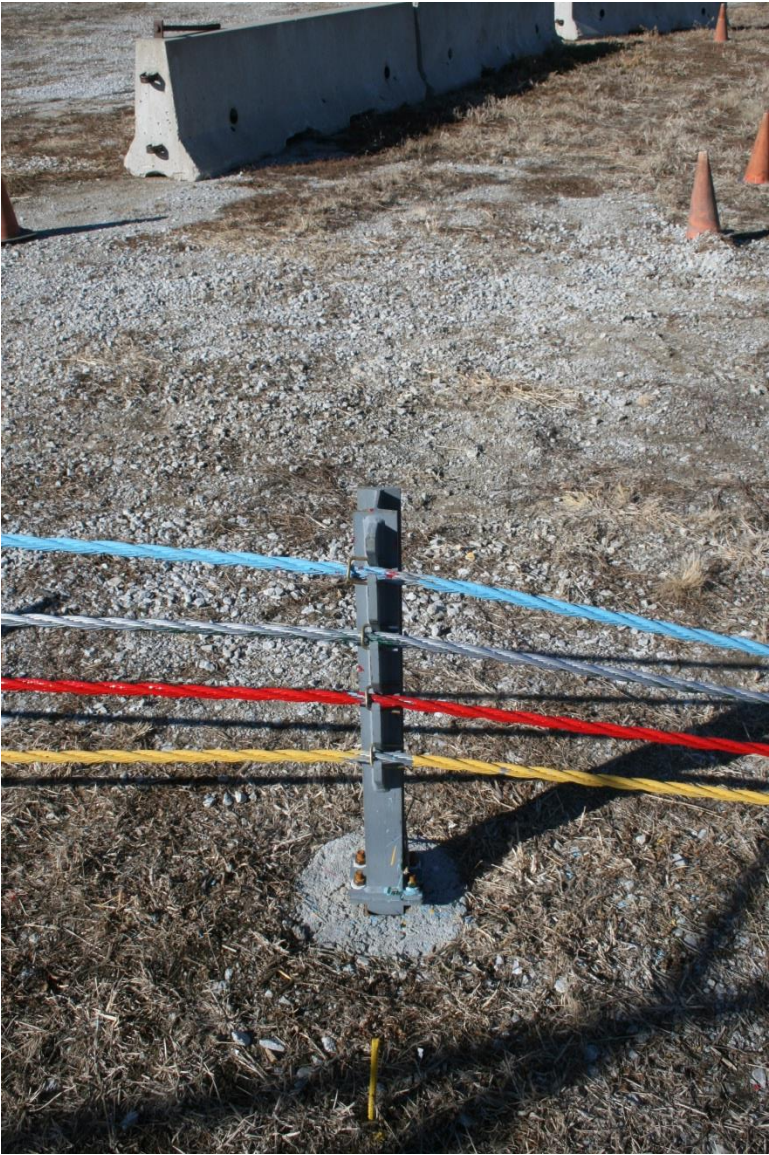
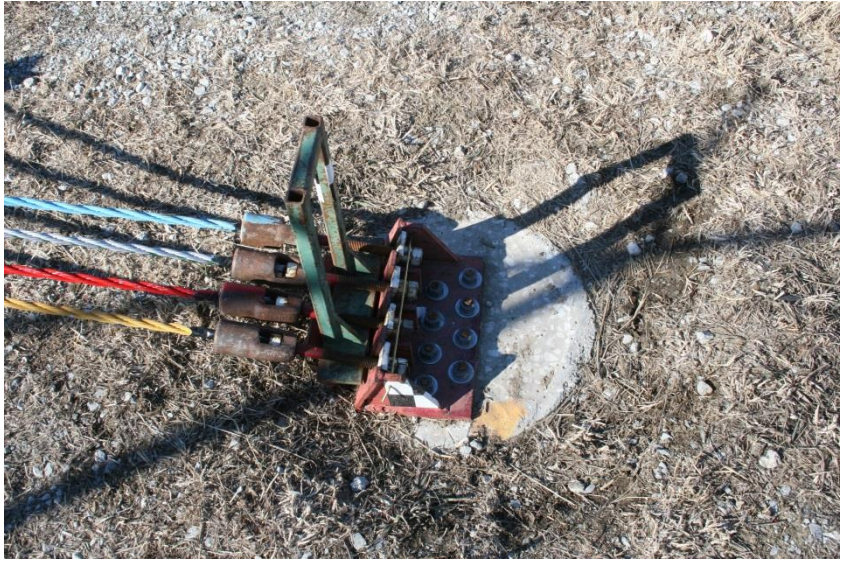
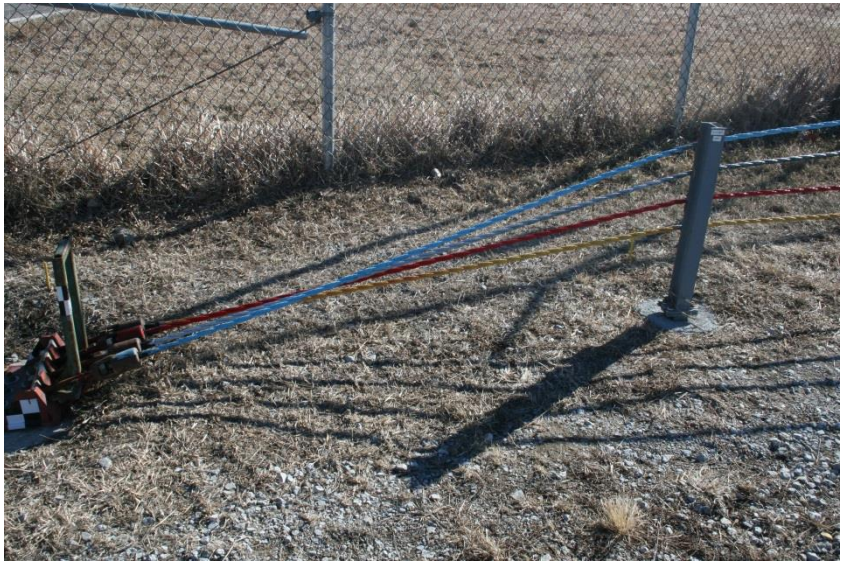
Figure 97. System Damage, End Anchorages, Test No. MWP-6

Damage to the barrier was moderate, as shown in Figures 96 through 104. Barrier damage consisted of bent posts, disengaged cables, and bent and fractured brackets. At its final resting position, the vehicle was no longer in contact with the system.

Cable no. 4 disengaged from post nos. 29 through 52 due to fracturing of the brass keeper rods. Cable no. 3 disengaged from post nos. 24 through 49. Cable no. 2 disengaged from post nos. 32 through 40. Cable no. 1 disengaged from post nos. 32, 33, as well as from post nos. 35 through 39. Two of the brackets that released cable no. 2 fractured at the neck of the bracket. All of the other brackets released cable nos. 1 through 3 through rotation of the bracket tab through the key, allowing cables to release vertically. Displacement of the cable within the splices was documented. The maximum cable displacement within a splice was ½ in. (13 mm), found on the load cell splice located upstream from impact on cable no. 2.

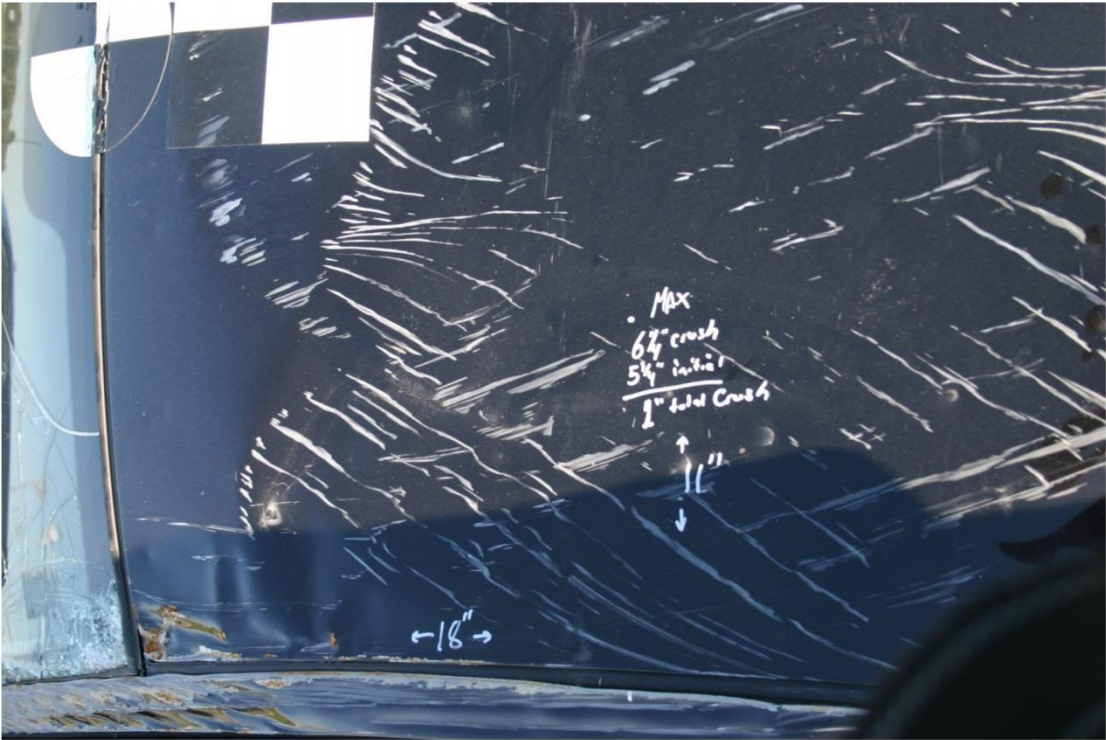
Figure D-11. Roof Deformation Documentation, Test No. MWP-6

MWP-6 at max point of crush	6.25"
Undamaged vehicle	5.25"
Total crush	<u>1"</u>

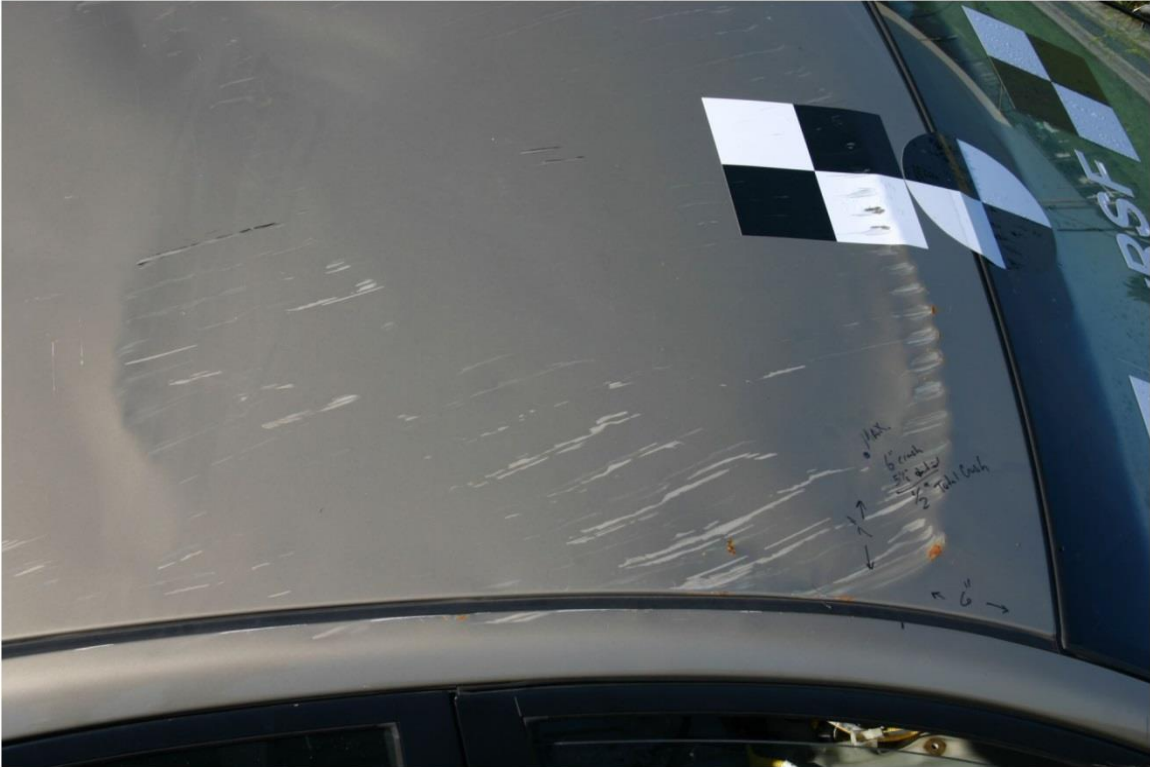
Figure D-18. Roof Deformation Documentation, Test No. MWP-7

MWP-7 at max point of crush	6.00"
Undamaged vehicle	<u>5.5"</u>
Total crush	.5"
