*Midwest States Pooled Fund Research Program  
Fiscal Years 2013 (Years 23)  
Research Project Number TPF-5(193) Supplement #56  
NDOR Sponsoring Agency Code RFPF-13-MGS-3*

# **INCREASED SPAN LENGTH FOR THE MGS LONG-SPAN GUARDRAIL SYSTEM PART III: FAILURE ANALYSIS**

MwRSF Research Report No. TRP-03-362-17

September 29, 2017

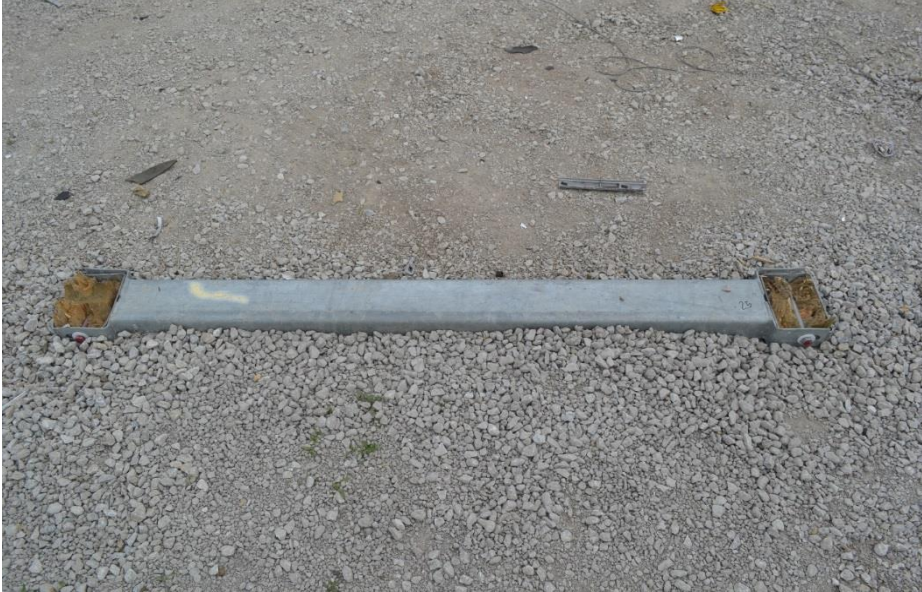
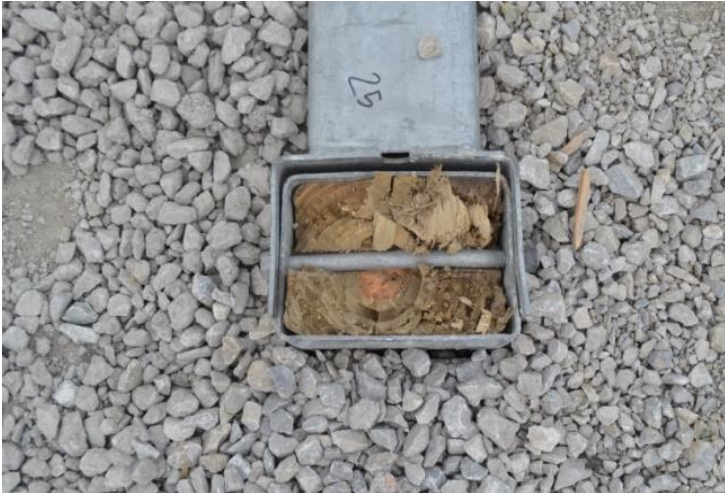
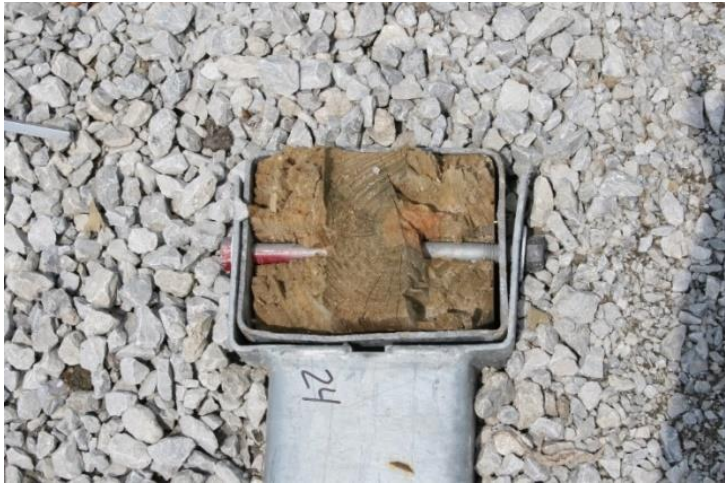
Figure 8. Post-Test Photographs of End Anchorage System, Test No. MGSLs-2

As the vehicle was redirected, the BCT posts at the downstream end anchorage, post nos. 24 and 25, were deflected longitudinally upstream due to tensile loads in the guardrail and the cable anchorage. Vertical cracking in post no. 24 was initiated at approximately 0.095 sec due to longitudinal loading of the post through the post bolt connecting the post to the guardrail, as shown in Figure 6 and Figure 7. As loading of the downstream anchorage continued, a diagonal crack initiated near the top of the BCT cable anchor plate on the downstream face of post no. 25. This crack propagated down to the hole in the base of the BCT post and caused complete fracture and release of post no. 25 at approximately 0.140 sec after impact. Following the release of the cable anchorage at post no. 25, post no. 24 fractured and released as well. Release of the downstream end anchorage caused the guardrail to lose tensile on the downstream end of the system and allowed the 2270P vehicle to penetrate into the barrier system in an uncontrolled manner.

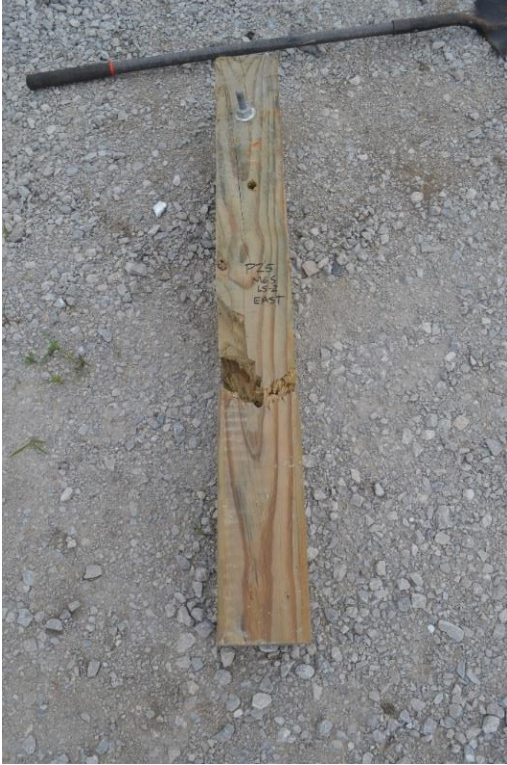
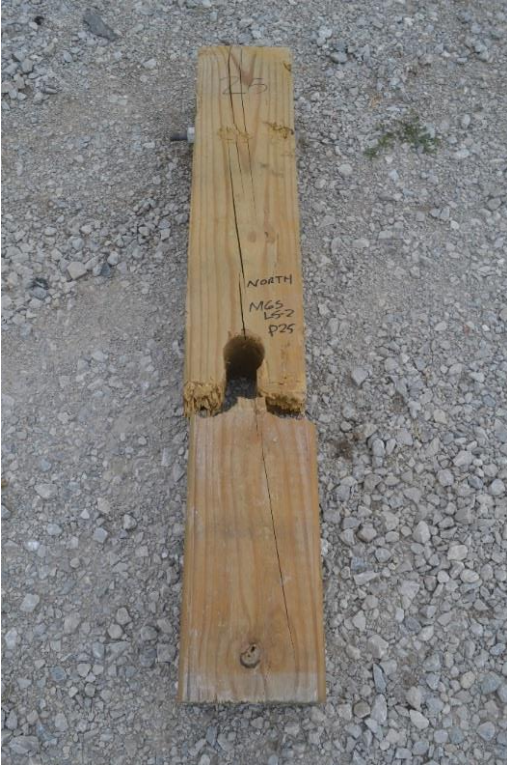
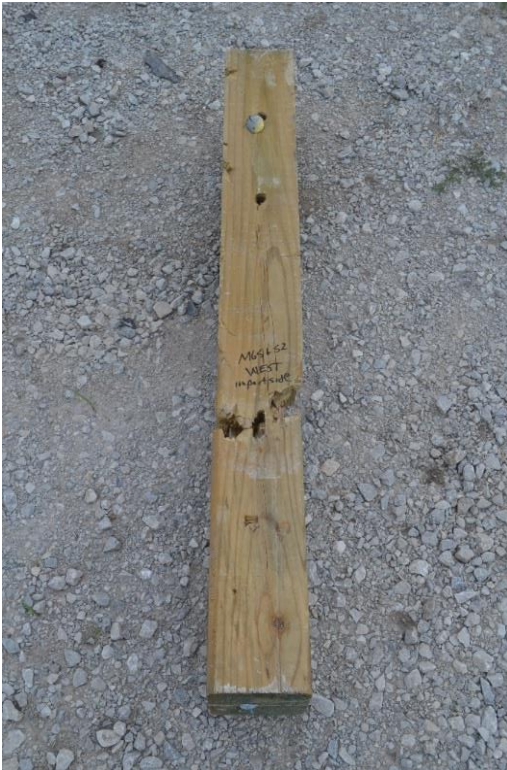
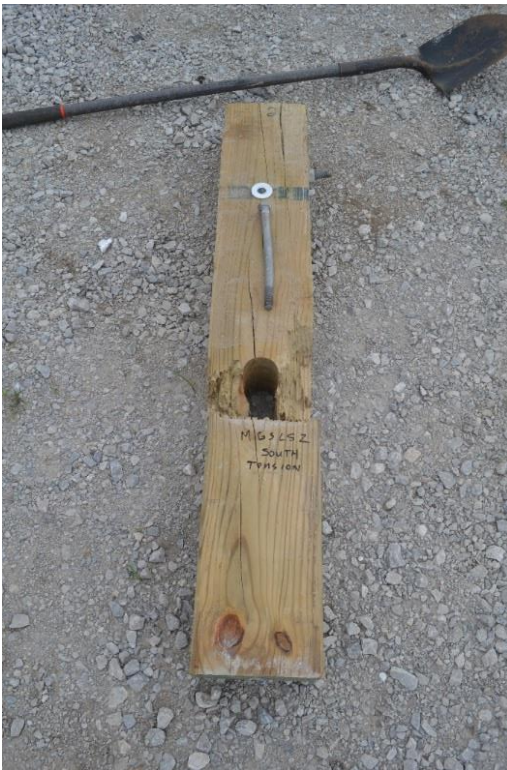
Figure 9. Post No. 25 Damage, Test No. MGSLs-2

Wood post damage included fracturing, gouging, and displacement of posts. Post no. 1 had gouging on the front face due to rail contact. Post no. 2 split vertically along the height of the post through the guardrail bolt hole on the front side. Post nos. 24 and 25 fractured at the ground line and post no. 24 also split along the vertical plane of the centerline of the post. Post no. 25 had a 7½-in. (191-mm) deep by 3-in. (76-mm) wide crack located 2¼ in. (57 mm) downward from the top of the back face of the post, as well as a 3-in. (76-mm) diameter dent on the back downstream face of the post. The post-test photographs of the end anchorage system for test no. MGSLs-2 are shown in Figure 8. No knots or asperities were observed in the fracture region of post no. 25, as shown in Figure 9.

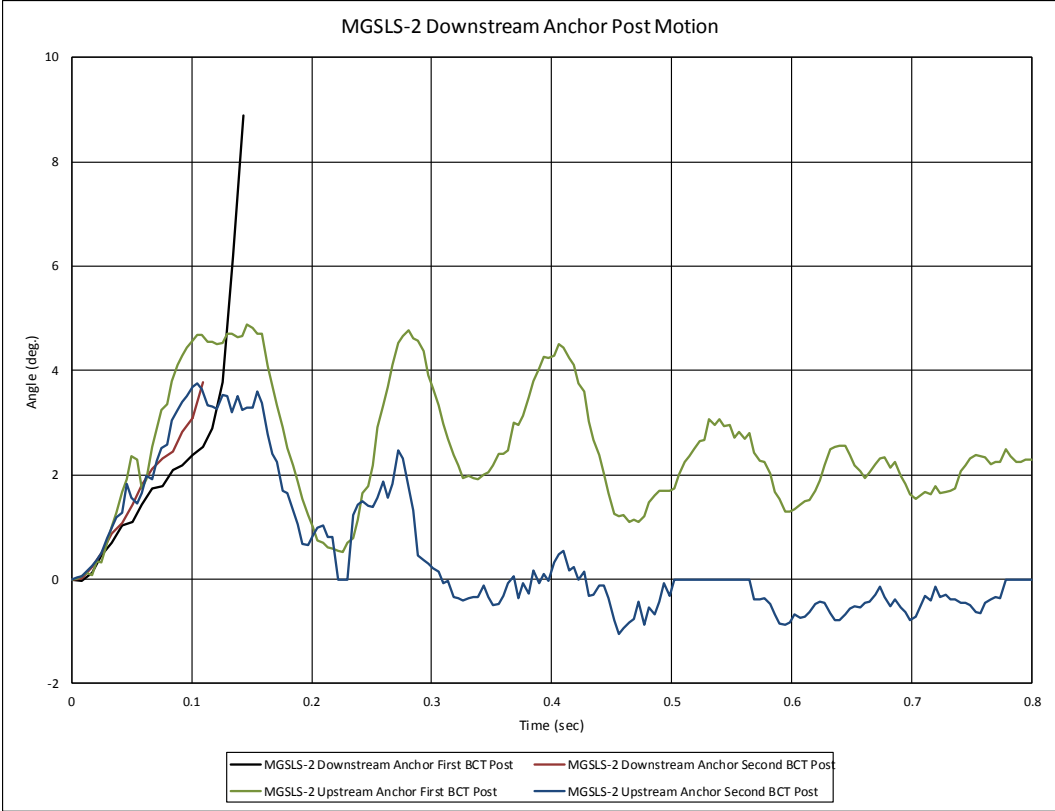
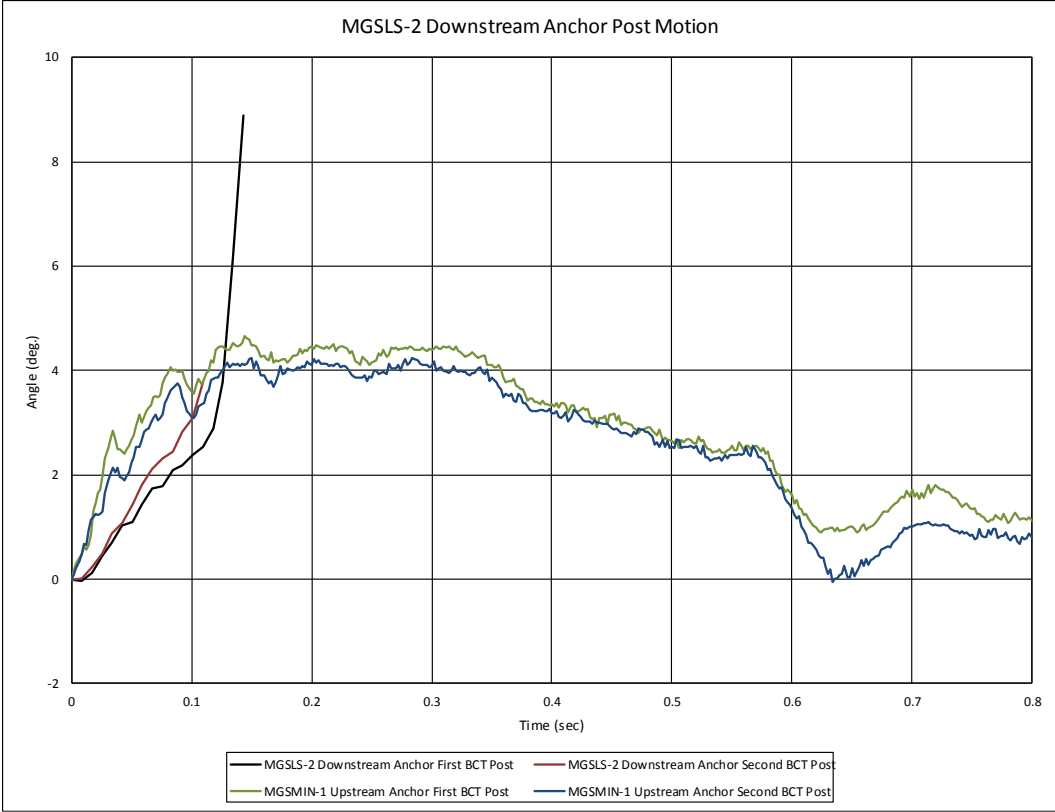
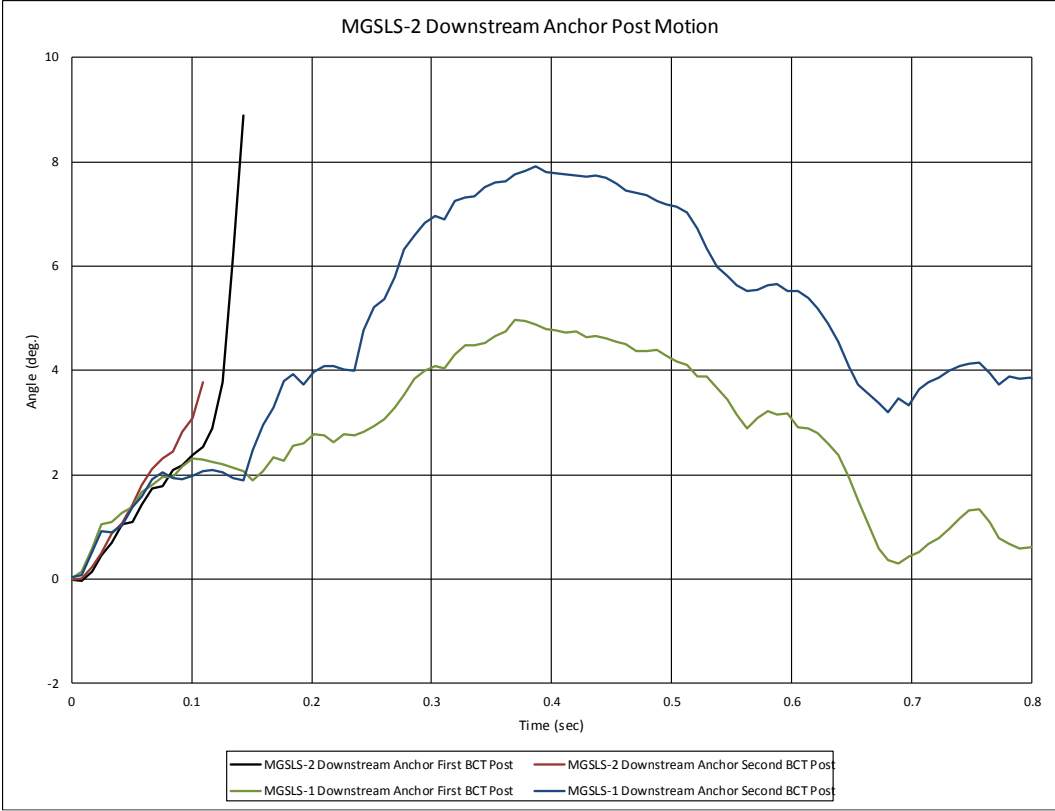
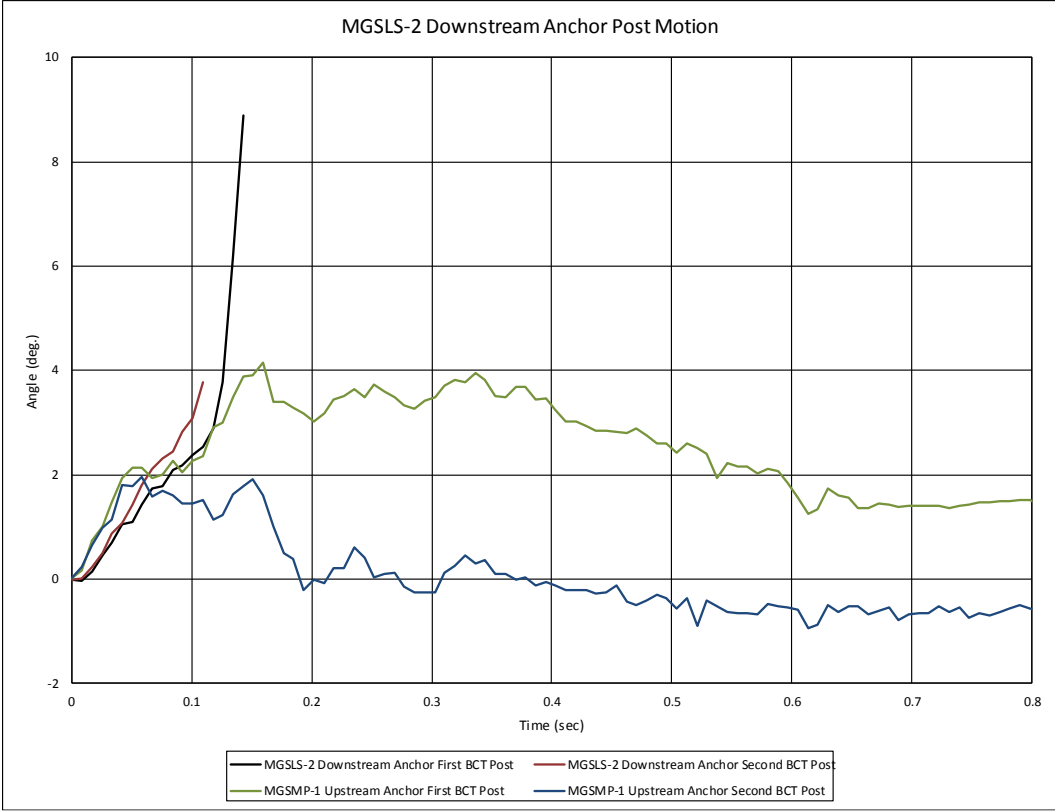
Figure 18. MGSL-2 Downstream Anchor Post Motion

Film analysis was used to compare the deflection angle of the posts from vertical as the anchorages were loaded, as shown in Figures 18 and 19. Note that the deflection angle of the second BCT post from vertical for in test no. MGSLS-2 was not measured after the vertical splitting of the anchor post, and the angle of the first BCT post in test no. MGSLS-2 increased rapidly after 0.120 sec due to the formation of the crack near the top of the cable anchor plate noted previously. Comparison of the deflection angles found that the deflection of the BCT posts in the downstream anchor from test no. MGSLS-2 was not markedly different or excessive as compared to previous tests without anchor failure prior to fracture of the anchor posts.

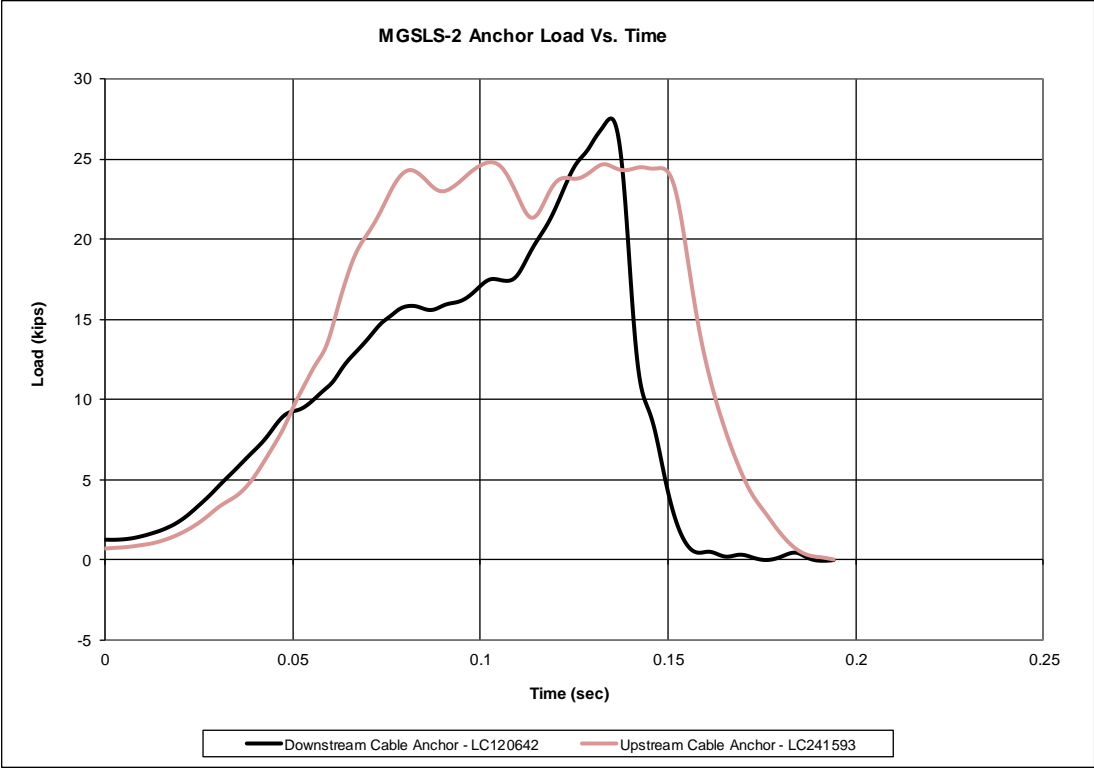
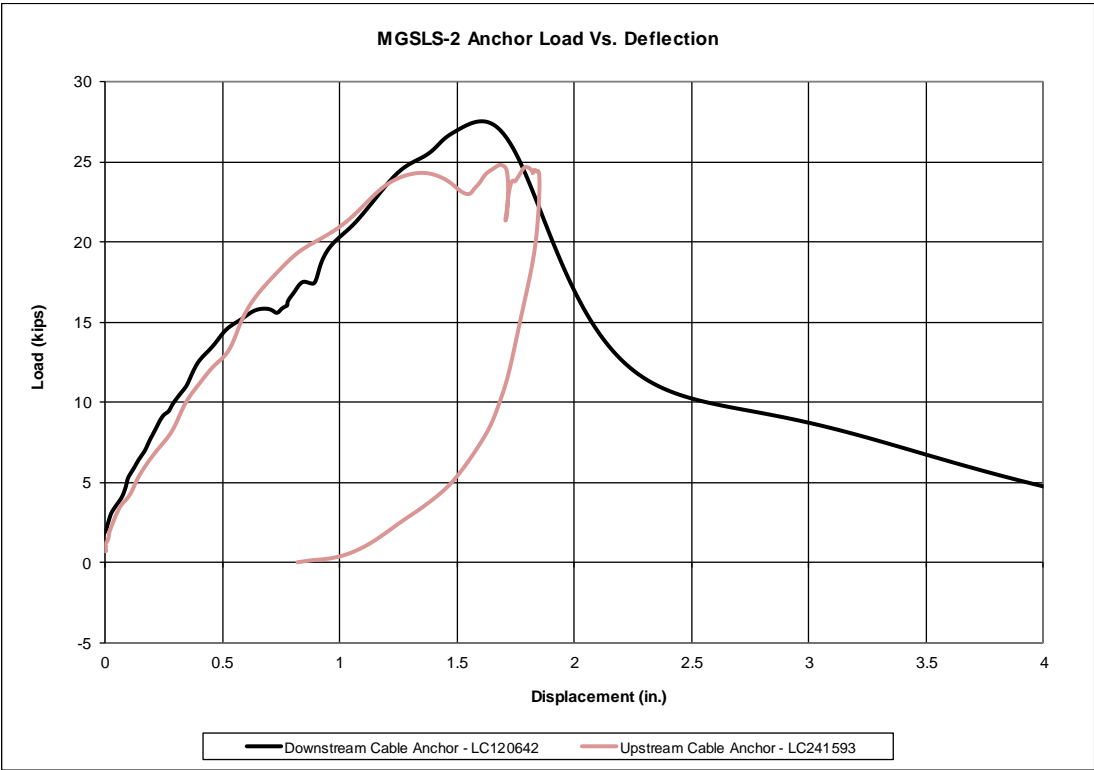
Figure 20. Anchor Load Vs. Time, Test No. MGSL-2

The anchor loading of failed test no. MGSLS-2 was reviewed first. Anchor load versus time and anchor load versus foundation tube deflection for the upstream end anchorage and the downstream end anchorage that failed in test no. MGSLS-2 are shown in Figure 20 and Figure 21, respectively. The downstream anchorage in test no. MGSLS-2 developed a peak load of 27.5 kips (122.3 kN) at approximately 1.6 in. (41 mm) of deflection prior to failure of post no. 25 and release of the anchor cable. The upstream anchorage in test no. MGSLS-2 developed a peak load of 24.4 kips (108.5 kN) at approximately 1.8 in. (46 mm) of deflection, but the upstream end anchorage did not show any signs of anchor failure. Thus, similar load and deflection were observed in the upstream and downstream anchorages, but only the downstream anchorage failed.

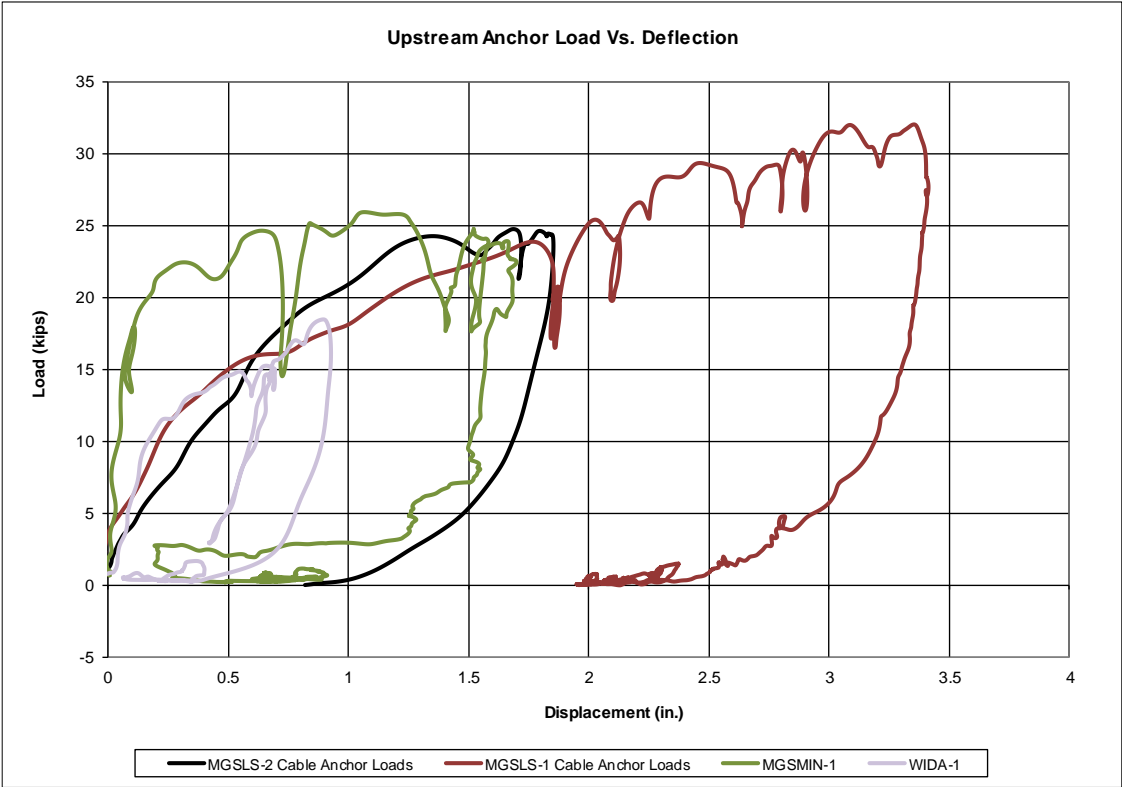
Figure 25. Upstream Anchor Load vs Deflection, Test Nos. MGSL-2, MGSL-1, MGSMIN-1, and WIDA-1

In order to further investigate, a comparison of the anchor load versus time and anchor load versus foundation tube deflection for the available upstream and downstream anchor data from test nos. MGSL-1, MGSMIN-1, and WIDA-1 were compared with the results from the failed downstream end anchorage in test no. MGSL-2. The results were divided between upstream and downstream anchor data, and the comparisons are shown in Figure 25 and Figure 26. Review of the upstream end anchor load versus deflection data from the selected tests found that the peak upstream end anchor load was similar to or less than several previous full-scale crash tests, including test nos. MGSMIN-1 and MGSL-1. This would suggest that the tensile rail loads developed in test no. MGSL-2 were not excessive as compared to previous MGS barrier tests that did not experience anchor failure. It was also noted that the upstream end anchorage in test no. MGSL-1 developed a peak load of 34.0 kips (151.2 kN) without anchor failure, which was 23.6% more than the measured peak load in the downstream end anchorage that failed in test no. MGSL-2. The load versus deflection plot also displayed similar slopes for the four tests. Test nos. MGSL-2, MGSL-1, and WIDA-1 had very similar slopes, while test no. MGSMIN-1 displayed increased slope during loading of the end anchorage. This would suggest that the upstream anchors had similar stiffness in the compared tests.

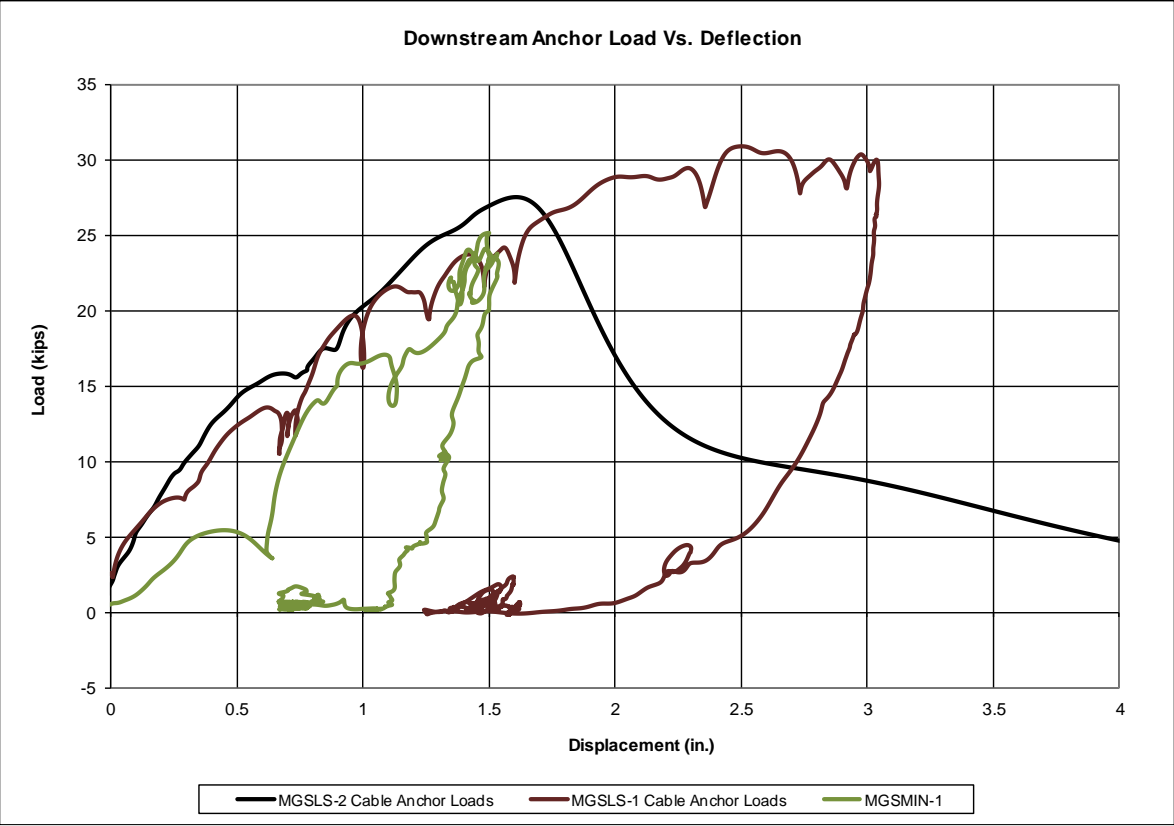
Figure 26. Downstream Anchor Load vs Deflection, Test Nos. MGSLS-2, MGSLS-1, and MGSMIN-1

Comparison of the downstream end anchorage load versus deflection data from test nos. MGSL-1, MGSMIN-1, and MGSL-2 showed similar trends. The stiffness or slope of the load versus deflection curves were similar for each of the three tests with available data. Additionally, test no. MGSL-1 developed a peak load in the downstream end anchor of 30.9 kips (137.5 kN) without failure, which was 12.3% higher than the measured peak load in the downstream end anchorage that failed in test no. MGSL-2.

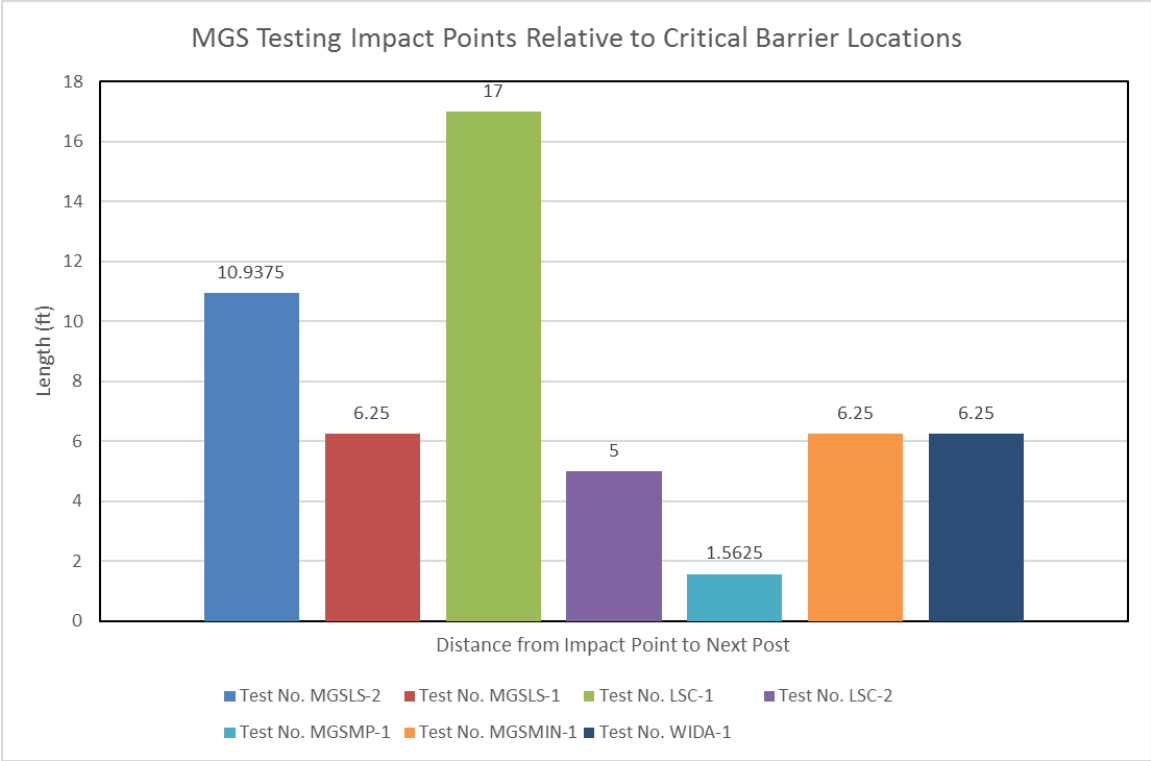
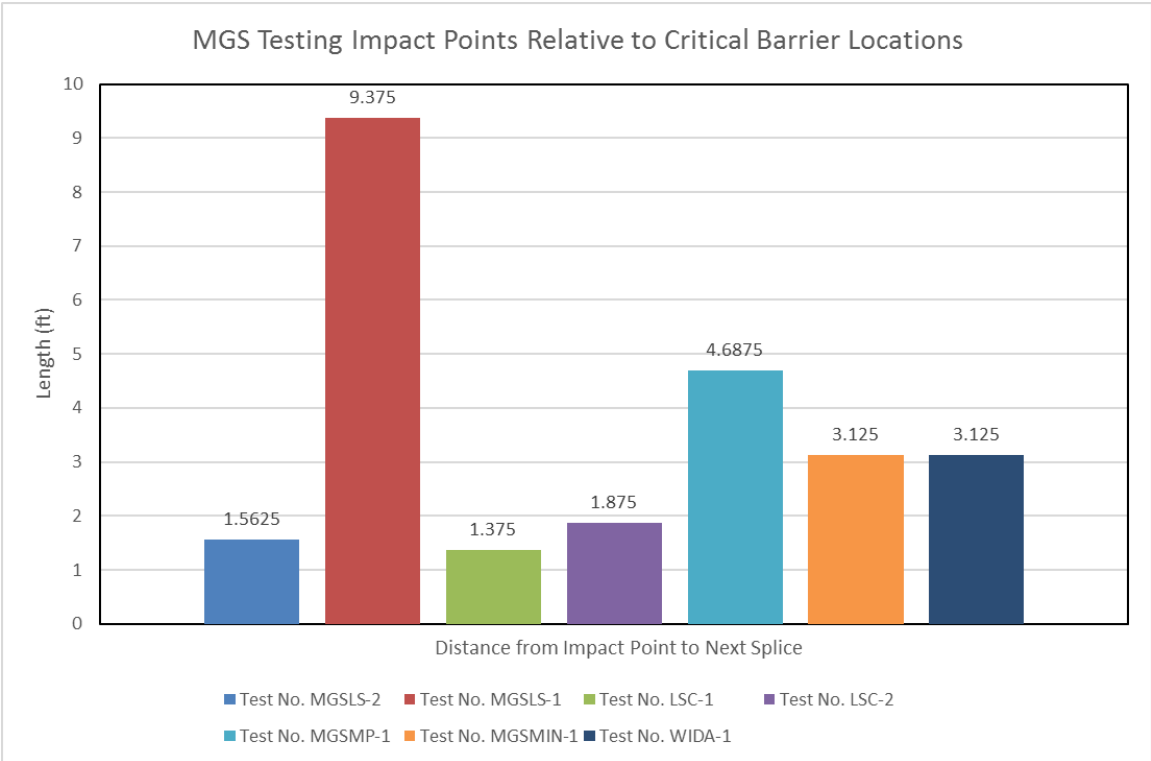
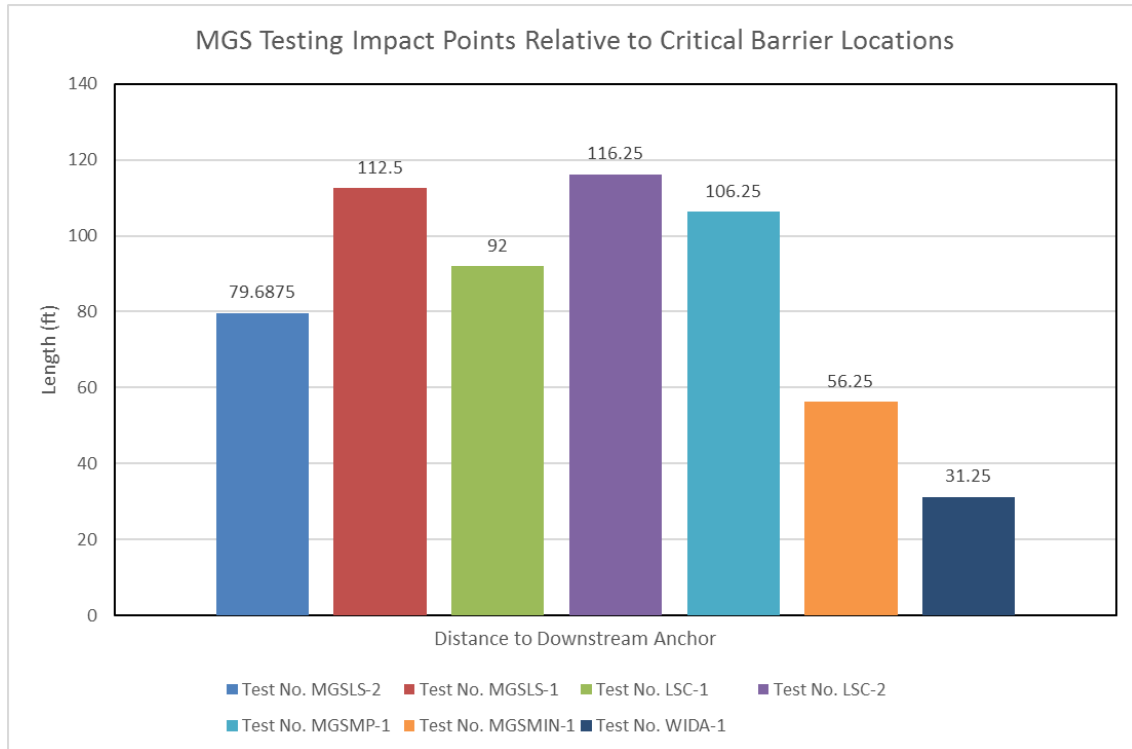
Review of the data found that the impact point for test no. MGSL-2 fell into the mid-range with respect to distance to the first post downstream of impact, which suggested that the impact point with respect to the first impacted post likely had little effect on loading of the end anchorage. However, rail pocketing caused by the impact location relative to a post may have increased anchor loads, as noted previously. Similarly, the distance from the impact point to the first splice downstream for test no. MGSL-2 fell into the mid-range of the comparable systems. It was noted that in test no. MGSL-2 the impact was closer to the downstream end anchorage than in previous long span guardrail tests and was closer to the end of the guardrail system than all comparable tests except test nos. WIDA-1 and MGSMIN-1. Test no. LSC-1 was impacted farther from the first post downstream of the unsupported span than test no. MGSL-2, but no concerns with anchor failure were associated with the former test. Test no. WIDA-1 evaluated an impact near the end of the redirective length of the MGS with a trailing end terminal. In this test, the end anchor failed, but it did not release until the 2270P vehicle had nearly reached the end of the barrier system, and high lateral and longitudinal loads were imparted on the trailing end anchorage. Thus, the failure mode was not similar to the failure under longitudinal loading observed in test no. MGSL-2. Test no. MGSMIN-1 evaluated a 75-ft (22.9-m) long MGS and impacted 56 ft-3 in. (17.1 m) from the end anchorage. However, the 2270P vehicle was safely redirected and no failure of the end anchorage occurred as a result of the impact closer to the downstream end anchorage. Thus, while the impact point for test no. MGSL-2 was different as compared to previous tests of the MGS and MGS long span, no evidence was found that suggested the impact point directly contributed to the anchor failure.

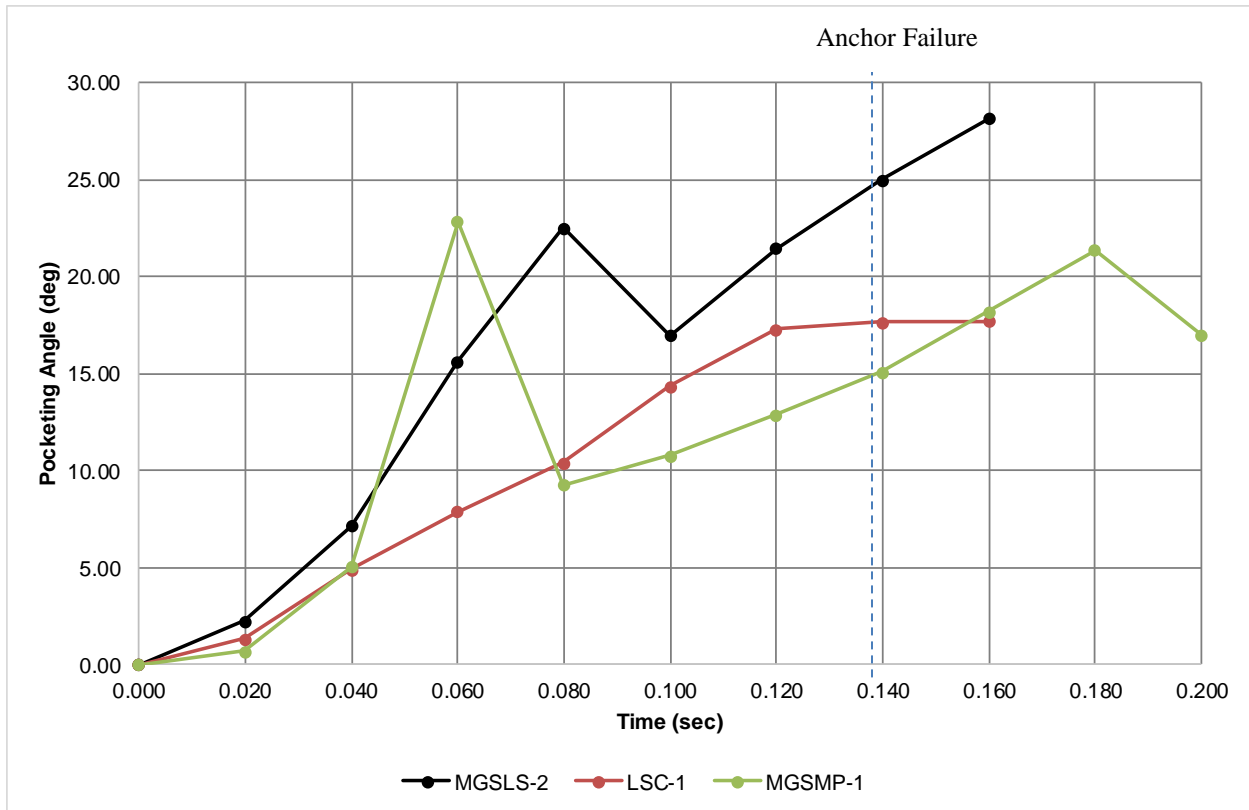
Figure 38. Pocketing Angle Versus Time, Test Nos. MGSLS-2, MGSMP-1, and LSC-1

the threshold of 23 degrees that has previously been deemed acceptable. Additionally, the maximum pocketing angles for test nos. MGSLS-2 and MGSMP-1 were very similar prior to anchor failure, but the end anchor in test no. MGSMP-1 did not fail. The pocketing analysis also noted that some kinking of the rail was observed at the first post downstream of the unsupported span in test no. MGSLS-2 which was not observed in test nos. MGSMP-1 and LSC-1. This may indicate that the UBSP provided additional stiffness prior to fracture and potentially affected rail loading as compared the other tested systems. However, the kinking observed was not sufficient to believe to be a direct cause of the failure of the end anchorage.

Thus, the analysis indicated that the rail pocketing observed in test no. MGSLS-2 was more than observed in previous testing of the MGS long-span guardrail and may have affected rail loading, but the magnitude did not appear to be large enough to indicate a serious concern that would lead the researchers to suspect it as the cause of the downstream end anchorage failure. Additionally, while pocketing of the guardrail was similar to previous testing rail loading may have been affected based on the kinking of the rail prior to anchor failure.

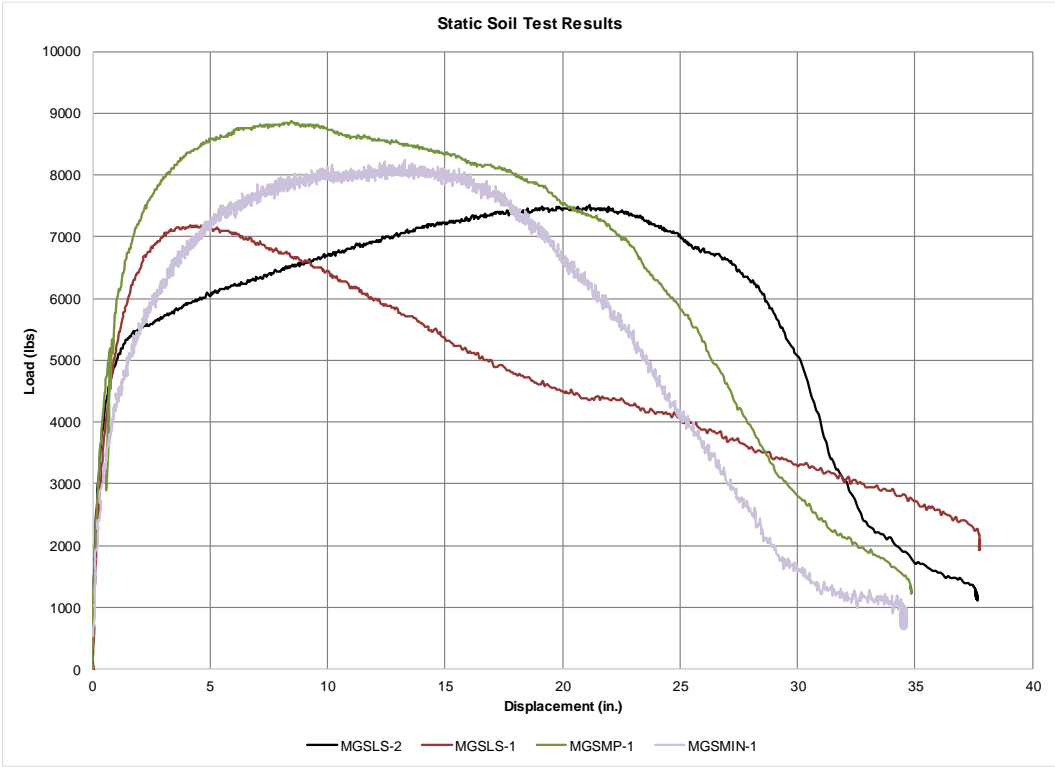
Figure 43. Static Soil Test Comparisons

A comparison of the force versus deflection data from test nos. MGSLs-2, MGSLs-1, MGSMIN-1, and MGSMP-1 is shown in Figure 43. The data showed that the peak load developed in the static soil test for test no. MGSLs-2 was similar to that of previous tests. The initial slope or stiffness of the soil response was similar as well. The general shape of the curves shown do differ from test to test, but all the soil tests reviewed were acceptable under the MASH soil requirements for full-scale crash testing. Based on these results, the soil response from test no. MGSLs-2 would not have been expected to produce more severe loading of the end anchorage. This conclusion would be consistent with the anchor load comparison, which indicated that the loading of the end anchor was consistent with previous tests of similar anchorages.
