CRASH TESTING AND EVALUATION OF THE HDOT 34-IN. TALL AESTHETIC CONCRETE BRIDGE RAIL: MASH TEST DESIGNATION NOS. 3-10 AND 3-11

MIDWEST ROADSIDE SAFETY FACILITY

MwRSF Research Report No. TRP-03-420-19

October 21, 2019

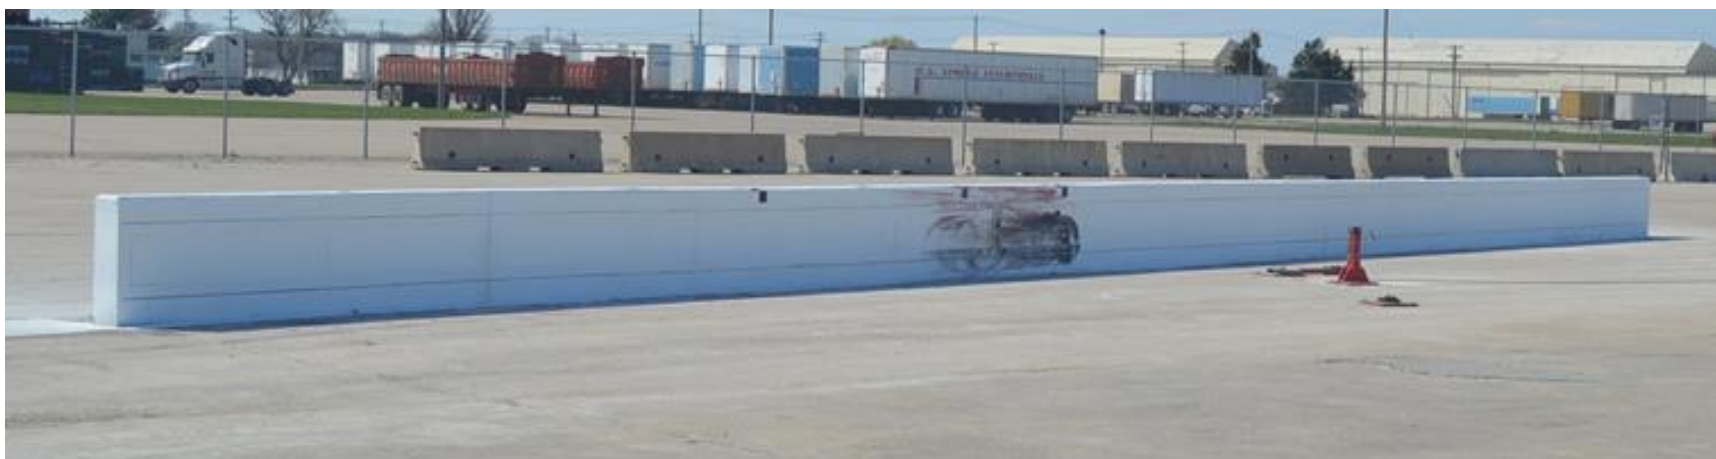
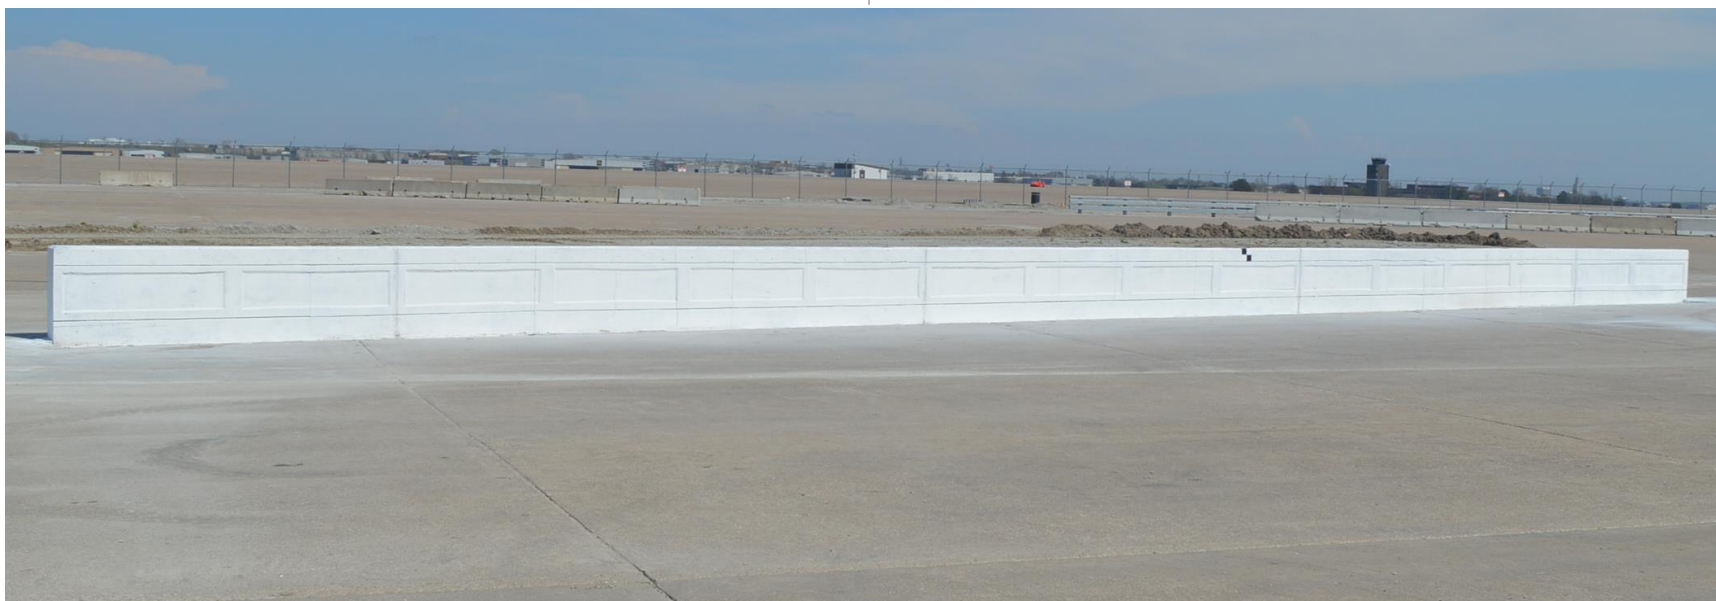
Figure 35. System Damage, Test No. H34BR-1

Damage to the barrier was minor, as shown in Figures 35 through 39. Barrier damage consisted of minor cracking, spalling, and contact marks on the parapet and minor cracking and spalling at the expansion joint between barrier nos. 3 and 4. The locations for all of the listed damage were measured from the expansion joint between barrier nos. 3 and 4 as a reference point. The length of vehicle contact along the barrier was approximately 11 ft – 3 in. which spanned from 4 ft – 9 in. upstream from the expansion joint to 6 ft – 6 in. downstream from the expansion joint.

A 45-in. long and 1½-in. tall spall on the aesthetic asperity was observed 51 in. upstream from the expansion joint. Spalling measuring 4 in. long and 2½ in. wide was found 45 in. upstream from the expansion joint and 14 in. above the ground. Spalling measuring 11 in. long and ½ in. wide was found 34 in. upstream from the expansion joint and 23 in. above the ground. Spalling measuring 5½ in. long and 2½ in. wide was found 33 in. upstream from the expansion joint and 15 in. above the ground. Spalling measuring 61½ in. long was found 32 in. upstream from the expansion joint to 29½ in. downstream of the expansion joint and 32 in. above the ground. Spalling measuring 5 in. long, 10 in. wide, and ½ in. deep was found 3 in. upstream from the expansion joint and 14 in. above the ground. Spalling measuring 6 in. long was found 2 in. upstream from the expansion joint and 24 in. above the ground. A ½-in. diameter by ½-in. deep hole was observed 53 in. upstream from the expansion joint and 17½ in. above the ground. A 1-in. diameter by ½-in. deep hole was observed 24 in. upstream from the expansion joint and 23½ in. above the ground. Grout was disengaged over a 12½ in. height at the expansion joint was observed located 9½ in. above the ground.

Minor cracking of the barrier was also observed in several locations. A 19½-in. diagonal crack that started 18½ in. above the ground and ended 33½ in. above the ground was found 70½ in. upstream from the expansion joint. An 18½-in. diagonal crack that started 11 in. above the ground and ended 18½ in. above the ground was found 60 in. upstream from the expansion joint. A third smaller crack was noted on the top of the barrier starting near the middle of the expansion joint between barrier nos. 3 and 4 and extending diagonally approximately 8 in. downstream and toward the back of the barrier.

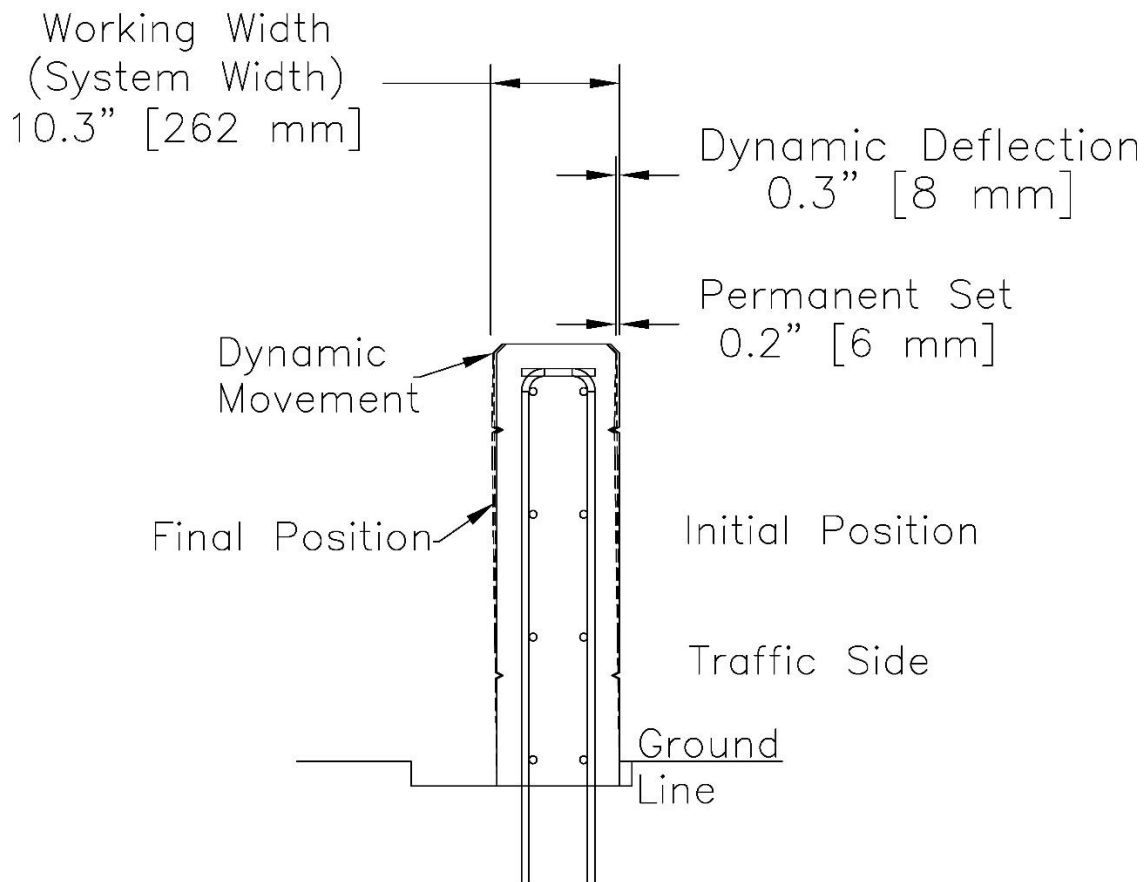
Figure 40. Permanent Set Deflection, Dynamic Deflection, and Working Width, Test No. H34BR-1

The maximum lateral permanent set of the barrier system was 0.2 in., which occurred at the downstream end of barrier no. 2, as measured in the field. The maximum lateral dynamic barrier deflection, including tipping of the barrier along the top surface, was 0.3 in. at the upstream end of barrier no. 3, as determined from high-speed digital video analysis. The working width of the system was found to be 10.3 in., also determined from high-speed digital video analysis. A schematic of the permanent set deflection, dynamic deflection, and working width is shown in Figure 40.

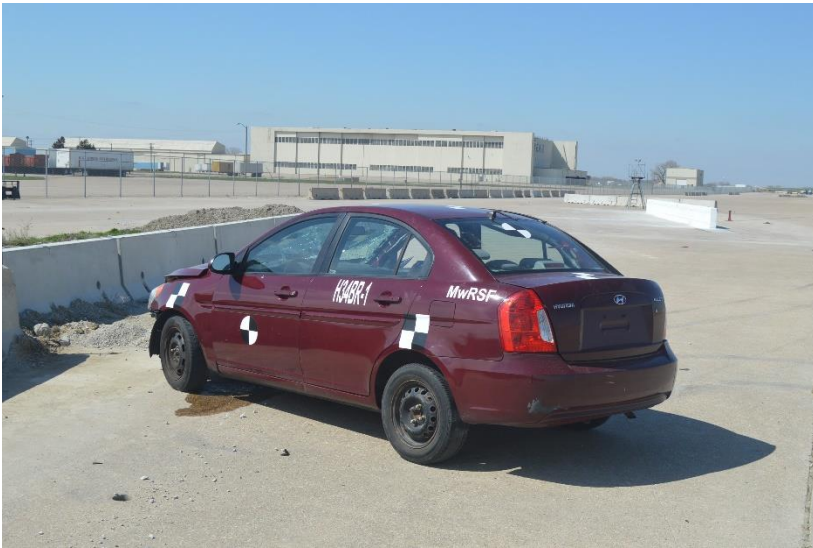
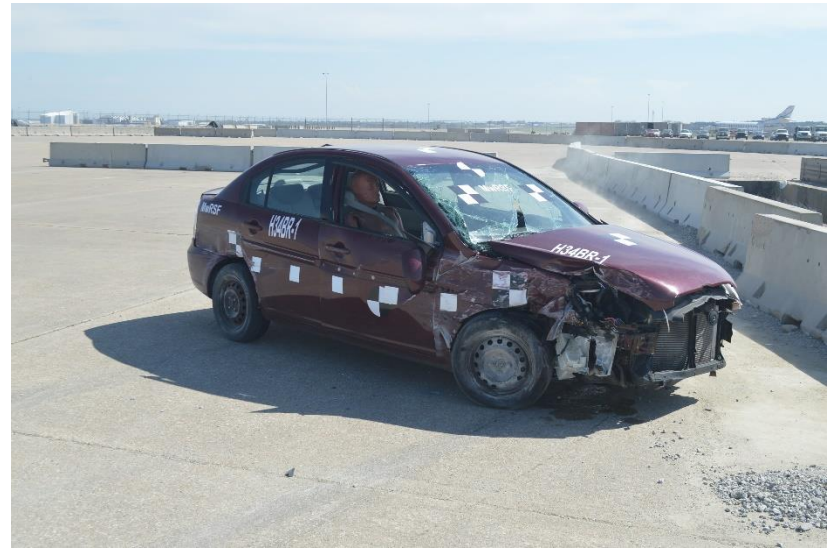
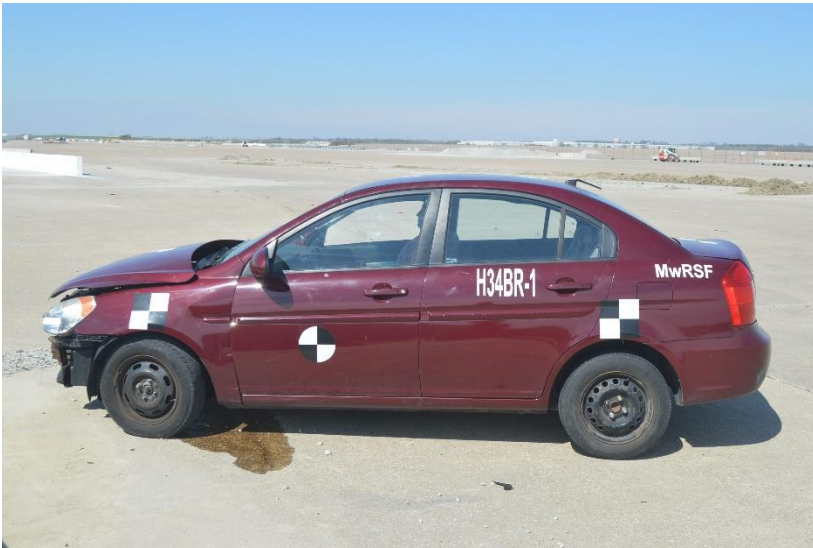
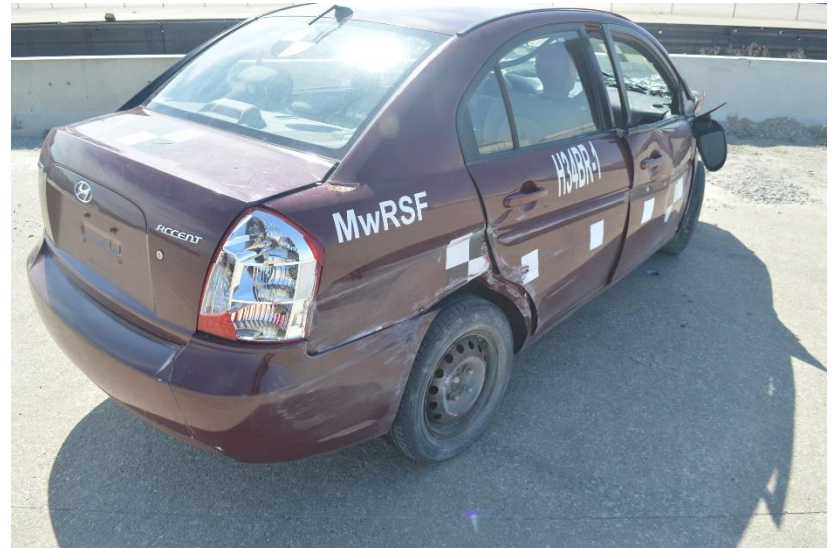
Figure 41. Vehicle Damage, Test No. H34BR-1

The damage to the vehicle was moderate, as shown in Figures 41 through 45. The maximum occupant compartment intrusions are listed in Table 5 along with the intrusion limits established in MASH 2016 for various areas of the occupant compartment. MASH 2016 defines intrusion or deformation as the occupant compartment being deformed and reduced in size with no observed penetration. Note that none of the established MASH 2016 intrusion limits were violated. The lateral B-Pillar and side door above and below the seat deformed slightly outward, which is not considered crush toward the occupant, is denoted as negative numbers in Table 5, and is not evaluated by MASH 2016 criteria. Complete occupant compartment and vehicle intrusions and the corresponding locations are provided in Appendix C.

The majority of the damage was concentrated on the right-front fender and right-front wheel of the vehicle where the impact had occurred. A small section of the seam where the floor pan and toe pan connected near the left-front corner of the right-side floor pan split due to floor pan deformation. The split seam was not due to intrusion of the barrier or a component of the vehicle. The vehicle's engine hood partially disengaged, but it remained attached to the vehicle's body. The front bumper and bumper cover disengaged from the vehicle. Kinks were found on the bottom support of the radiator, and the right radiator support was bent toward the engine compartment. A 23 $\frac{1}{8}$ -in. dent on the right side of the hood crushed 5 in. inward and toward the engine compartment. The right-front fender was crushed and had contact marks with the most significant occurring near the front of the wheel well. A 38 $\frac{1}{2}$ -in. long x 7 $\frac{1}{8}$ -in. wide x 1 $\frac{1}{2}$ -in. deep dent was found on the right-front door. The right-rear door was dented and scraped just ahead of the rear quarter panel.

It should be noted that the passenger side window fractured, and a large tear was visible in the vehicle windshield. Review of the high-speed video revealed that the side window damage was due to crush of the side of the vehicle door and not due to direct contact with the test article. Similarly, the video data showed that the tearing of the windshield was formed due to crushing of the right front corner of the windshield which propagated a shear crack through the glass and the liner. Neither of these items were in violation of the MASH 2016 criteria as none of the damage occurred due to contact with the test article or debris, nor was there the potential for the barrier to intrude into the occupant compartment.

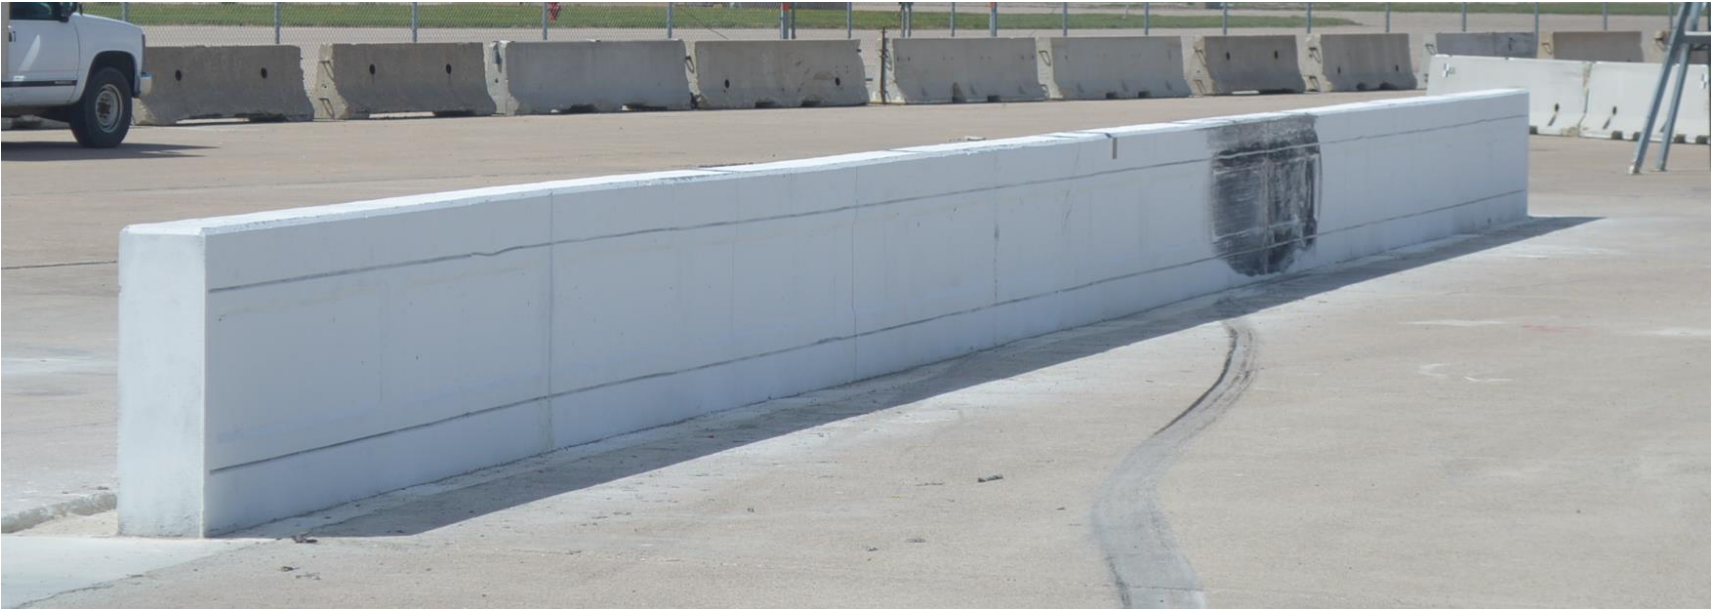
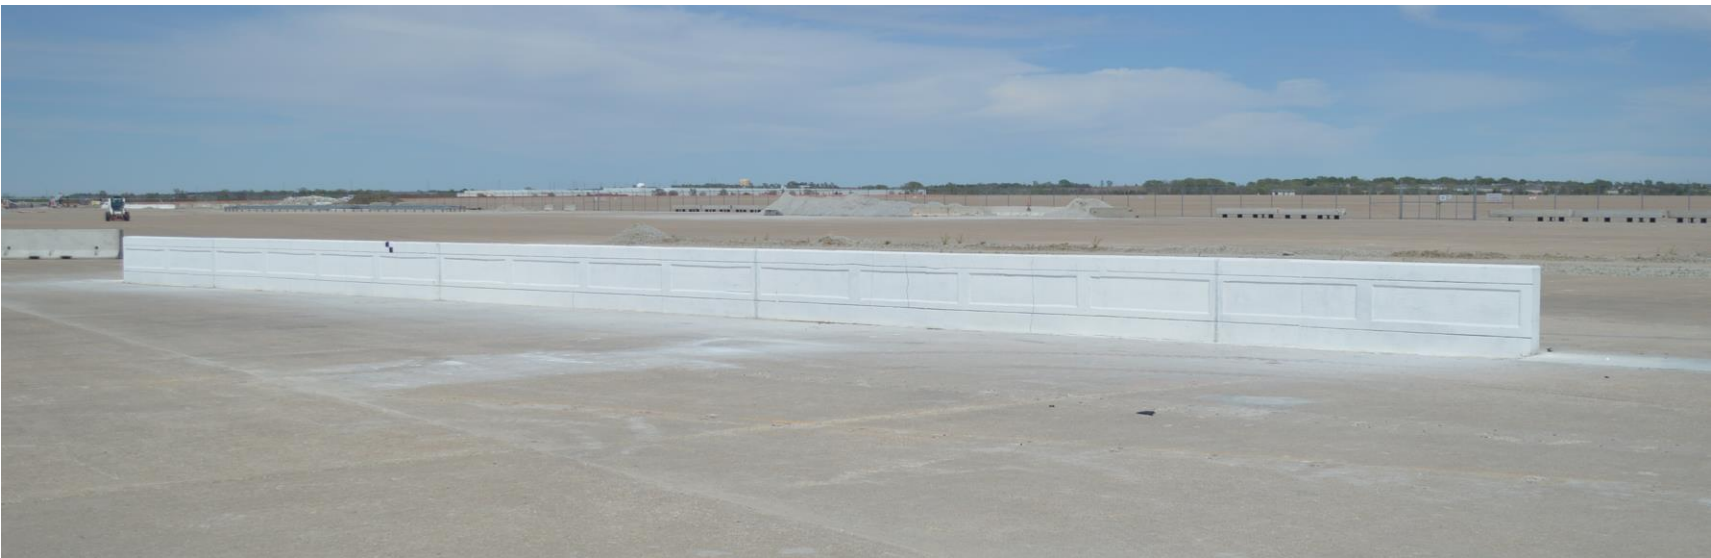
Figure 55. System Damage, Test No. H34BR-2

Damage to the barrier was minimal, as shown in Figures 55 through 58. Barrier damage consisted of contact marks on the front face of the concrete segments, spalling of the concrete, and concrete cracking. The length of vehicle contact along the barrier was approximately 12 ft – 9 in. which spanned from 5 ft – 6¼ in. upstream from the center of the joint between barrier nos. 2 and 3 to 7 ft – 3 in. downstream from the center of the joint between barrier nos. 2 and 3. The locations for all of the listed damage were measured using the expansion joint between barrier nos. 2 and 3 as a reference point.

Tire marks and scuff marks were visible on the front face of barrier nos. 2 and 3. Concrete spalling and cracking occurred at the downstream end of barrier no. 2 and upstream end of barrier no. 3. A 17½-in. x 5-in. x 1-in. piece of concrete was removed 2 in. upstream from the center of the expansion joint between barrier nos. 2 and 3. A 6½-in. long x 2½-in. wide concrete piece that was located 16½ in. from the ground was removed 54 in. upstream from the expansion joint. A 12-in. long x 9½-in. wide piece of concrete, which was located 19½ in. from the ground, was removed 46½ in. upstream from the expansion joint. An 8-in. long x 3¾-in. wide concrete piece that was located 8¾ in. from the ground was removed 4½ in. upstream from the expansion joint.

A 2¼-in. long crack that began on the top face of the barrier was found 56½ in. upstream from the expansion joint. A longer crack was found 42 in. upstream from the expansion joint starting 6½ in. from the ground on the back side of the barrier and extending across the top face to 7 in. A crack was found 68¼ in. upstream from the expansion joint that started 29¾ in. above the ground and extended diagonally upstream and ended 18½ in. above the ground. The most significant crack formed on the back-side surface, which started at the bottom of the barrier and extended on top of the barrier. It started from the bottom and 3 in. upstream of the expansion joint, extending 6¼ in. upstream of the expansion joint and 11¼ in. above the ground, and ended at the top of the barrier and 1 in. upstream of the expansion joint.

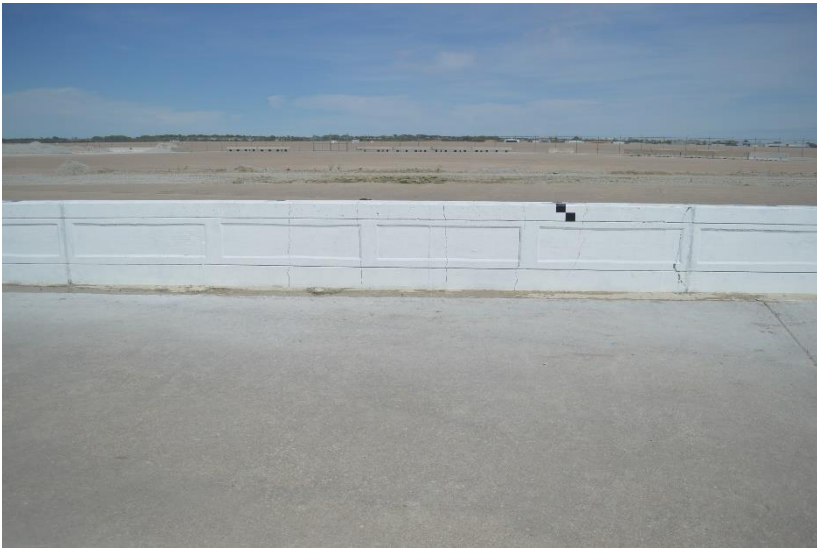
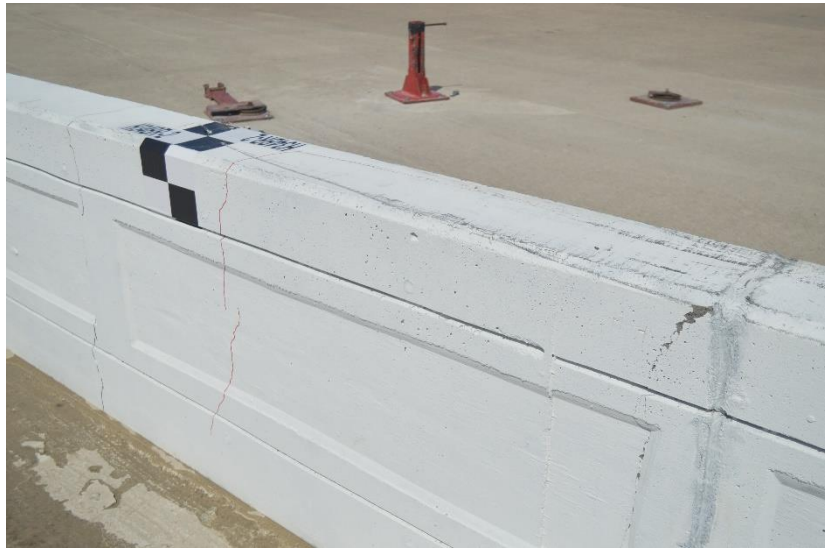
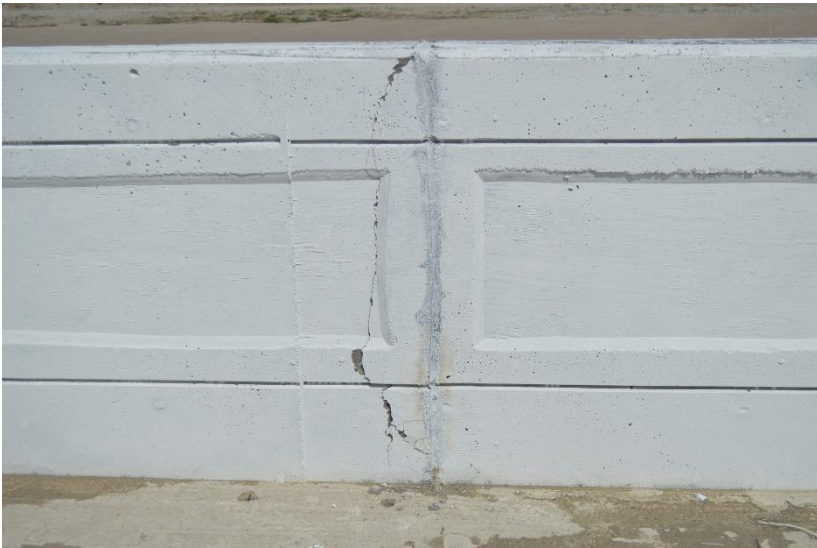
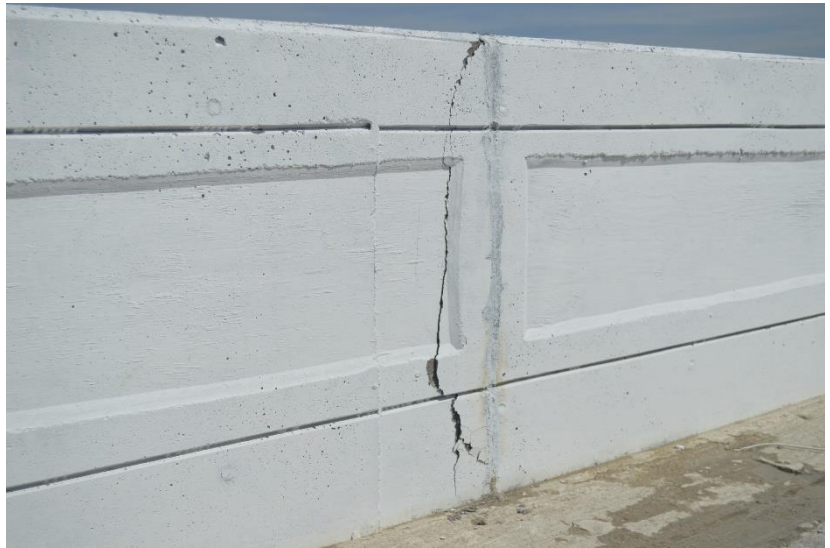
Figure 58. Back-Side System Damage, Test No. H34BR-2

on the barrier system near the ends of the bridge rail segments in both tests. Additionally, a long vertical crack that started at the bottom and extended to the top of the barrier was observed on the back side in test no. H34BR-2 due to loading of the dowel bars that transferred shear loads across the expansion joint. Cracking and damage of the barrier, especially near the expansion joint discontinuity, could weaken the bridge rail section and adversely affect its capacity and performance under secondary impacts. It is noted that reducing the spacing of the vertical reinforcement near the end sections of the barrier could potentially mitigate some of the cracking and damage that was observed in the full-scale crash tests and reduce the need for repair of the bridge rail. HDOT should consider reviewing the end sections of the bridge rail following accidents to determine if repair of the barrier is needed due to cracking similar to that observed in the testing herein.

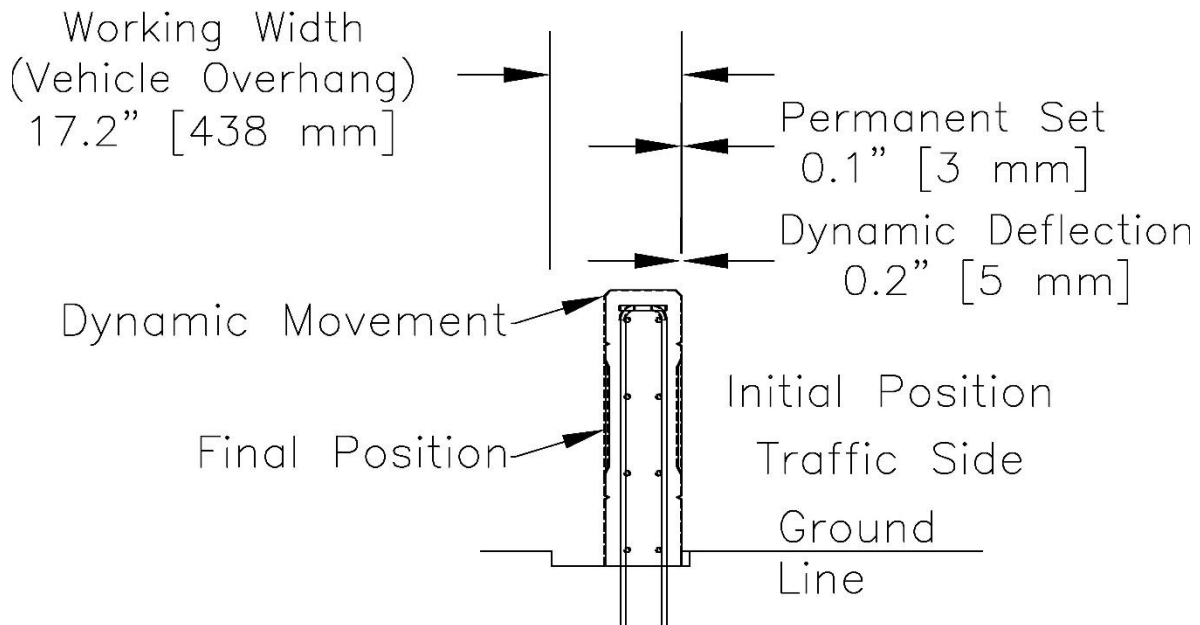
Figure 59. Permanent Set Deflection, Dynamic Deflection, and Working Width, Test No. H34BR-2

The maximum lateral permanent set of the barrier system was 0.1 in., including barrier and deck panel shift, which occurred at the downstream end of barrier no. 2, as measured in the field. The maximum lateral dynamic barrier deflection, including tipping of the barrier along the top surface, was 0.2 in. at the upstream end of barrier no. 3, as determined from high-speed digital video analysis. The working width of the system was found to be 17.2 in. also determined from high-speed digital video analysis. A schematic of the permanent set deflection, dynamic deflection, and working width is shown in Figure 59.

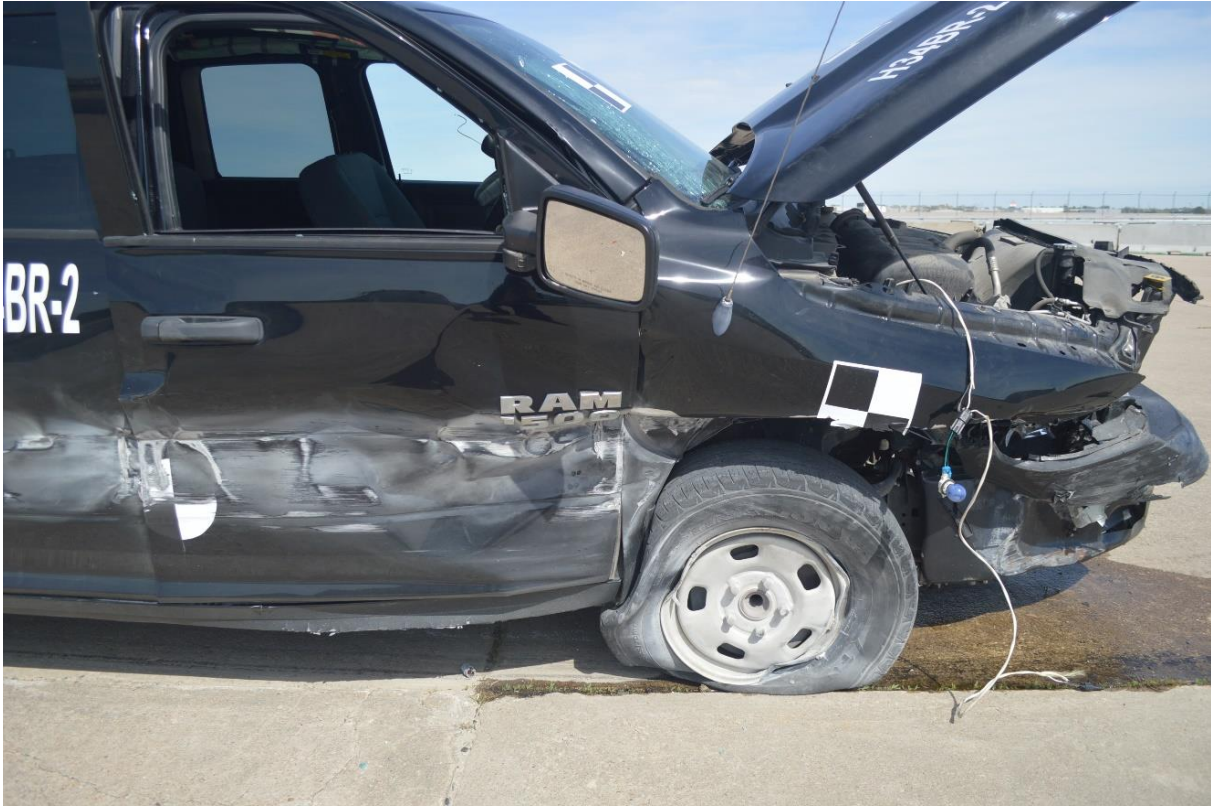
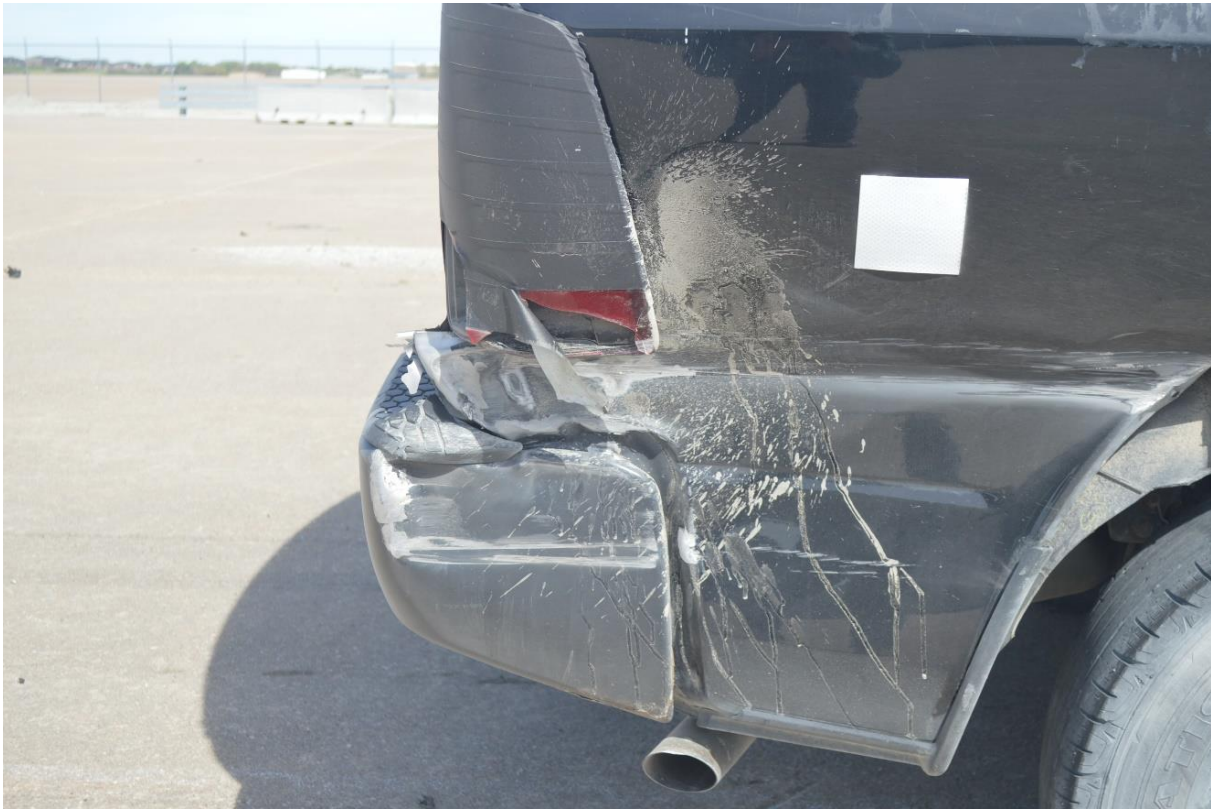
Figure 61. Vehicle Damage, Test No. H34BR-2

The majority of the damage was concentrated on the right-front corner and right side of the vehicle where the impact had occurred. The right side of the bumper was crushed inward and backward. The right-front fender was crushed inward toward the centerline of the vehicle and engine compartment. The right-front steel rim was deformed and crushed, and the right-front tire was torn and deformed. The right upper control arm was fractured. The grille was disengaged away

from the vehicle. The left-side headlight was disengaged away from the vehicle and right-side headlight and fog light were shattered. The right side of the radiator was pushed backward. A 16 $\frac{1}{2}$ -in. long x 21-in. wide x 2 $\frac{1}{2}$ -in. deep dent and scraping were observed on the entire right side. The right-front door was ajar, and creases were found in the door's sheet metal. The right-rear steel rim was crushed, and the tire was torn. The right side of the rear bumper was dented and scuffed. It should be noted that the window on the right-front side was shattered. It should be noted that the passenger side window was fractured. Review of the high-speed video revealed that the side window damage was due to crush of the side of the vehicle door and not due to direct contact with the test article. Thus, the side window damage was not in violation of the MASH criteria as it did not occur due to contact with the test article or debris. The bottom-right side of the windshield had a hairline crack, and no cracks were found on the left side of the windshield. The left-front fender was dented at the top and back. Minor scrapes and dents were found at the left-front and left-rear doors. The roof and remaining window glass remained undamaged.

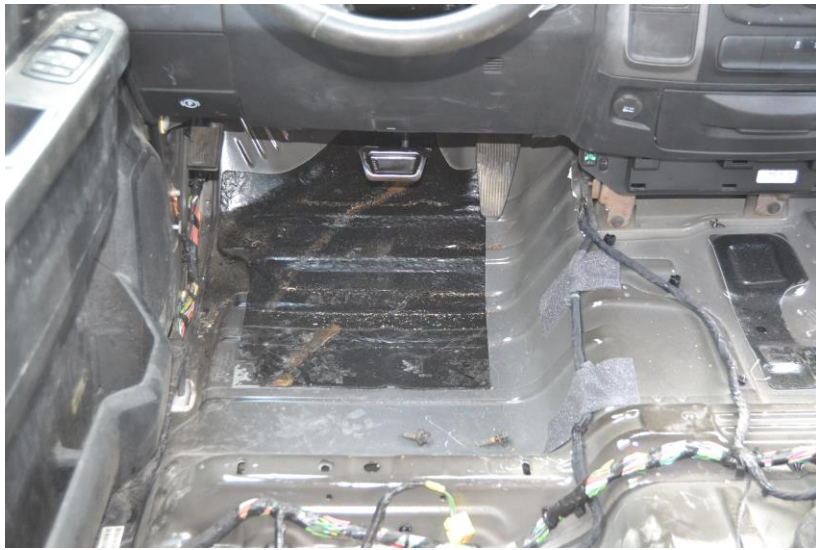
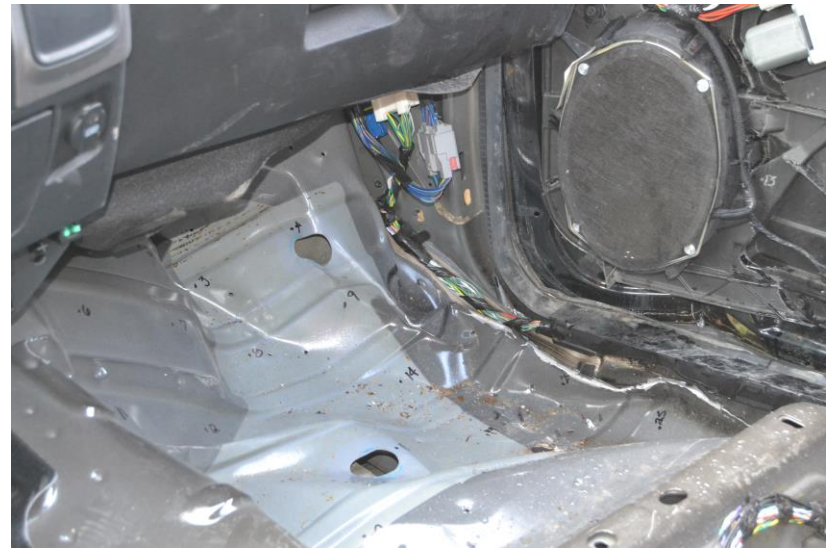
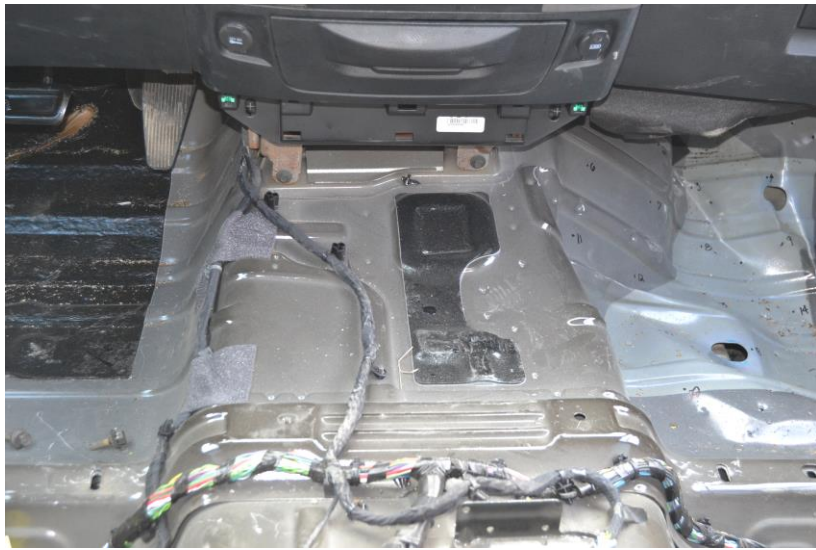
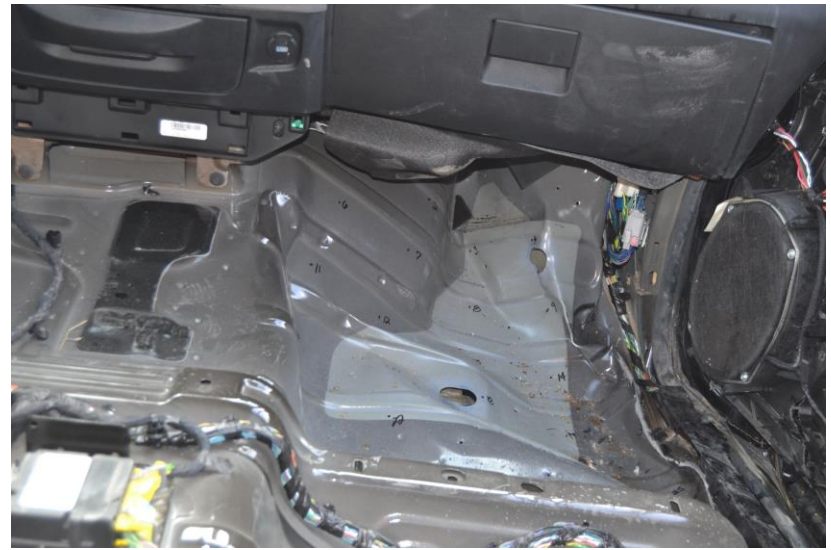
Figure 63. Interior Floorboard Damage, Test No. H34BR-2

The damage to the vehicle was moderate, as shown in Figures 60 through 64. The maximum occupant compartment intrusions are listed in Table 9 along with the intrusion limits established in MASH 2016 for various areas of the occupant compartment. MASH 2016 defines intrusion or deformation as the occupant compartment being deformed and reduced in size with no observed penetration. Note that none of the established MASH 2016 intrusion limits were violated. The lateral A- and B-pillars and the side door above the seat deformed slightly outward, which is not considered crush toward the occupant, is denoted as negative numbers in Table 9, and is not evaluated by MASH 2016 criteria. Complete occupant compartment and vehicle intrusions and the corresponding locations are provided in Appendix C.
