Approach Slope for Midwest Guardrail System

MIDWEST ROADSIDE SAFETY FACILITY

MwRSF Research Report No. TRP-03-188-08

December 4, 2008

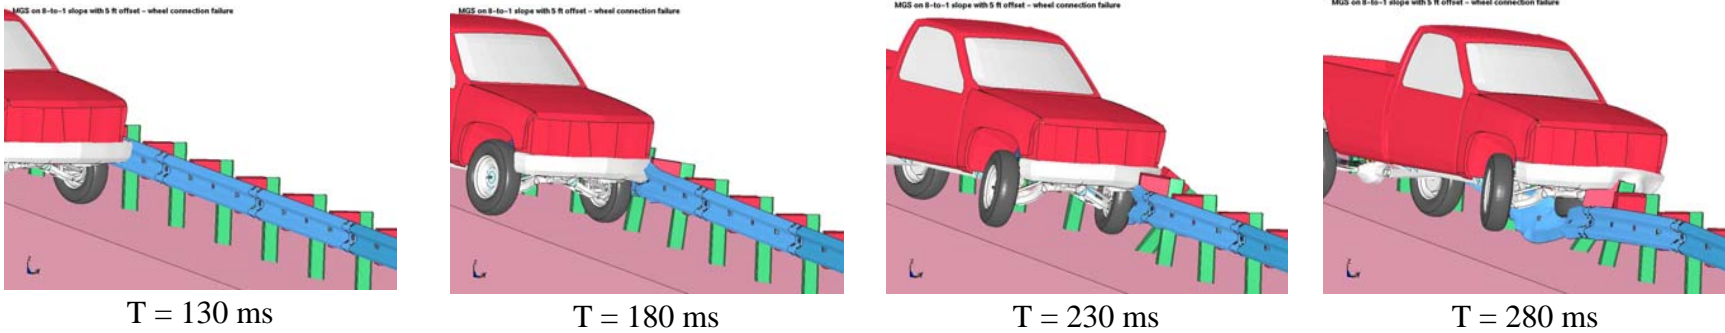
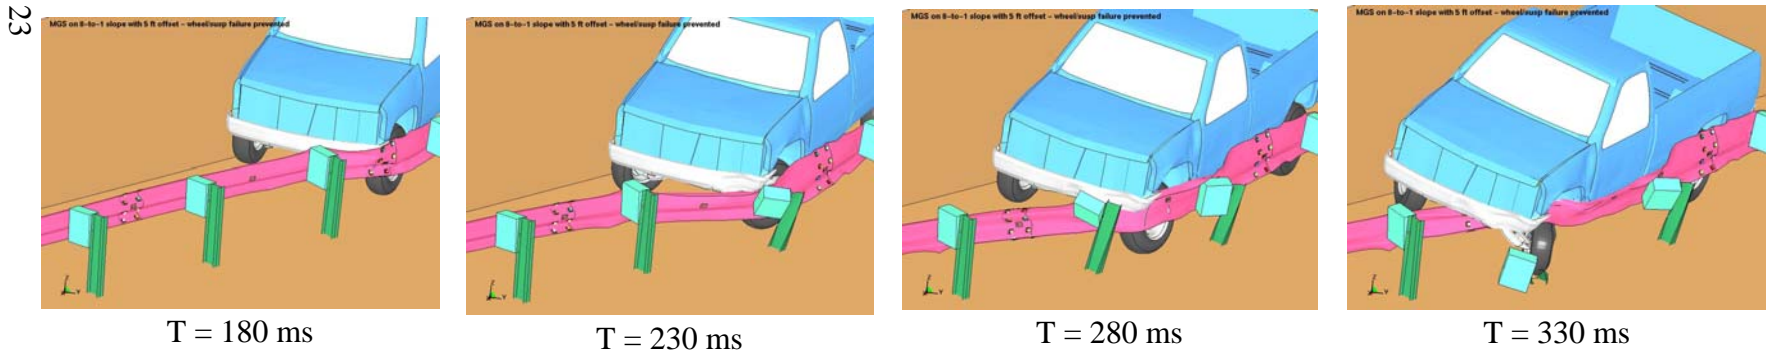
Figure 9. Simulation Results, MGS on 8-to-1 Slope with Rail 1.5 m (5 ft) Offset from Slope Break Point

Some results of the refined simulations are shown in Figure 9. The 1.5 m (5 ft) offset, once again, proved to be the worst-case offset for the 8:1 slope system, using the pickup truck impact condition. Results, as indicated in Figure 9, were inconclusive; which supports this slope and barrier

Wheel-Suspension Connection Failure Allowed – wheel comes off, truck overrides system

No Connection Failure Allowed – rail tries to capture via tire, gets jammed up into wheel-well
 This could cause rail rupture or vehicle roll-over.

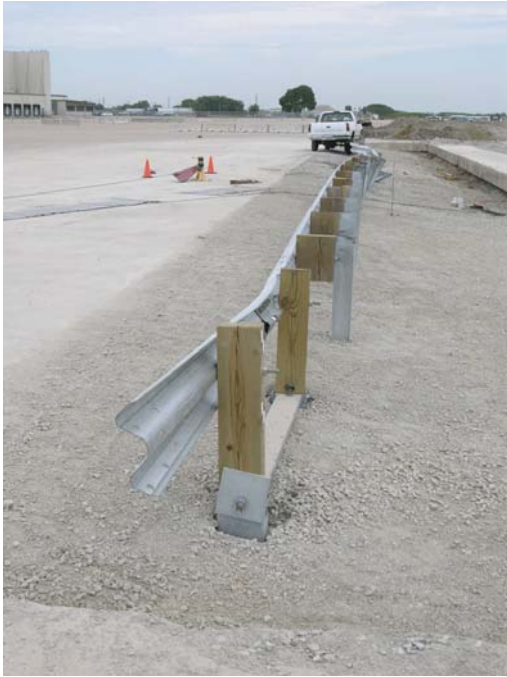
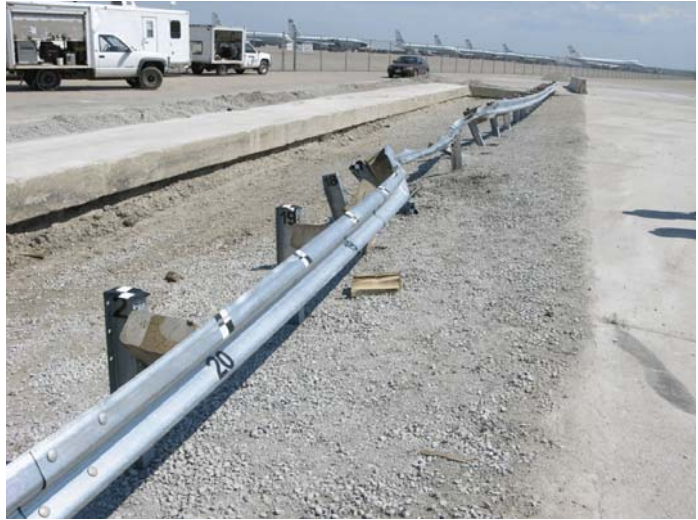
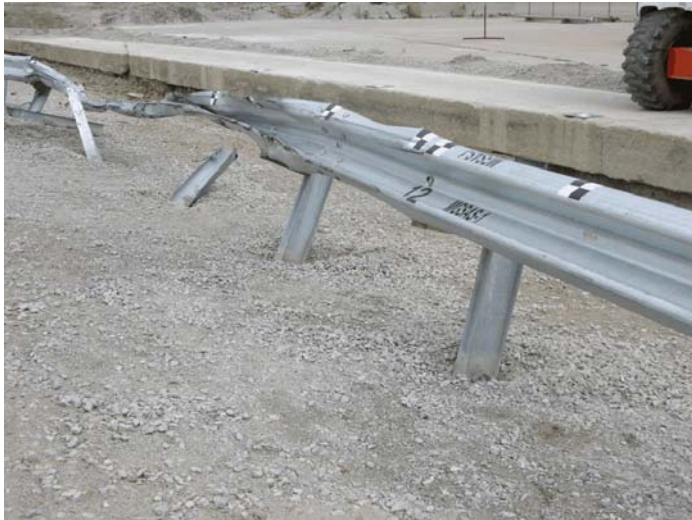
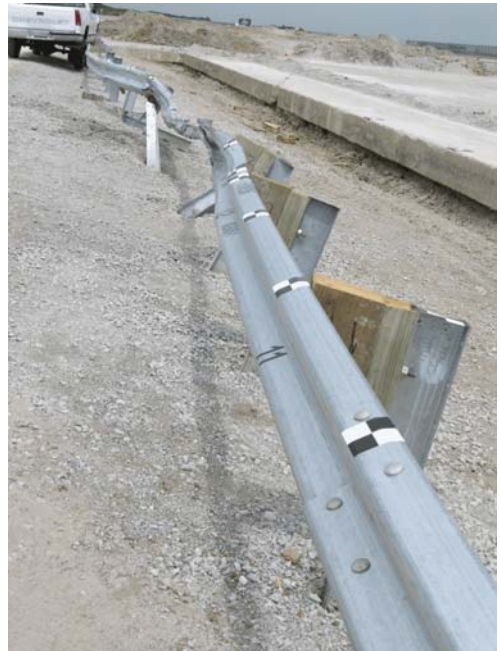
Figure 27. System Damage, Test No. MGSAS-1

Damage to the barrier was moderate, as shown in Figures 27 through 32. Barrier damage consisted of deformed guardrail posts, disengaged and fractured wooden blockouts, contact marks on a guardrail section, and deformed W-beam rail. The length of vehicle contact along the system was approximately 24.7 m (81 ft - 1 in.), which spanned from 64 mm (2.5 in.) upstream from the centerline of post no. 12 through the centerline of post no. 24.

Moderate deformation and flattening of the impacted section of W-beam rail occurred between post nos. 13 and 18. Contact marks were also found on the guardrail between post nos. 13 and 18. A minor buckle occurred in the rail near post no. 2. A major portion of the buckling occurred between post nos. 13 and 17. Substantial buckling of the rail occurred at post no. 18 and minor buckling occurred between post nos. 19 and 23. The W-beam pulled off of post nos. 2, 3, 6, 7, 14 through 16, 18, and 21. Tearing was found at the post bolt slots at post nos. 13 through 18. A 114-mm (4.5-in.) long tear occurred in the top corrugation at post no. 14. A 152-mm (6-in.) long tear was found in the top corrugation of the W-beam at post no. 17. No significant guardrail damage occurred downstream of post no. 23.

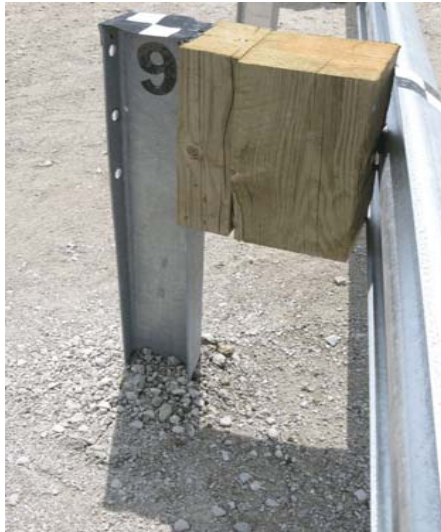
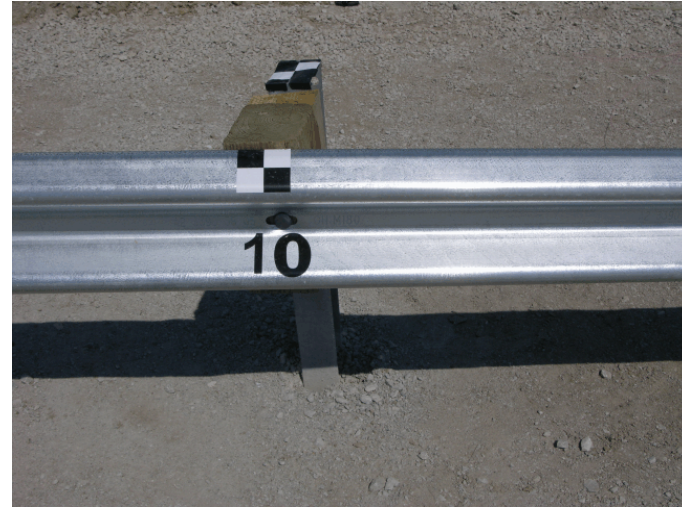
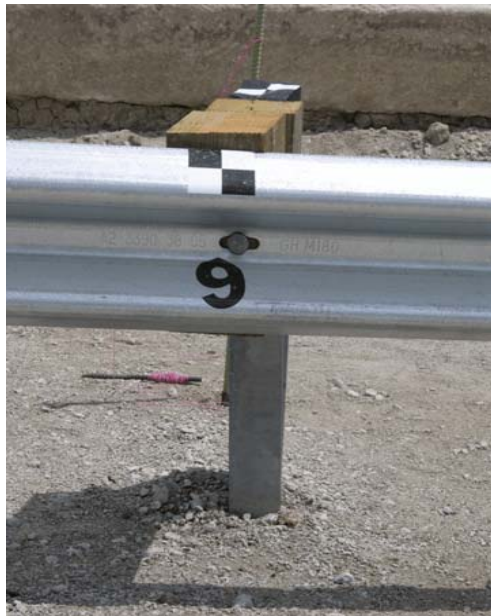
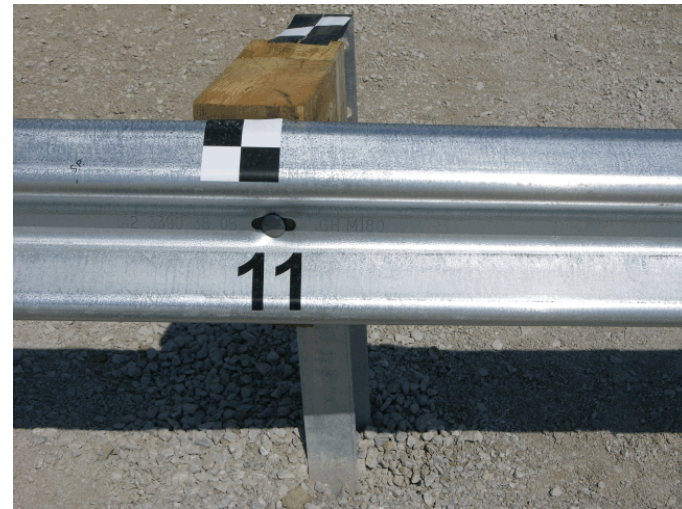
Figure 29. Post Nos. 9 through 11 Damage, Test No. MGSAS-1

Steel post nos. 3 through 5, 8 through 12, and 19 were twisted slightly. Post nos. 10 through 13 rotated and bent backward. Post no. 14 rotated backward and bent downstream with the top of the post only 280 mm (11 in.) from the ground. Post no. 15 rotated 90 degrees and bent downstream. Post no. 16 remained undeformed, but was completely uprooted from the ground. Post no. 17 rotated and bent downstream to a 45 degree angle. Post no. 18 deflected backward. No damage occurred to post nos. 19 through 25. The upstream anchor moved longitudinally downstream approximately 51 mm (2 in.). All four wood BCT posts remained undamaged.

The wooden blockouts at post nos. 3 through 12 rotated slightly downstream. The wooden blockout at post nos. 13 and 22 were split, but remained attached to the posts. The wooden blockouts at post nos. 14 through 16 and 18 were fractured and removed from the post. The wooden blockouts at post nos. 17, 19, 20, 23, and 24 were rotated downstream.

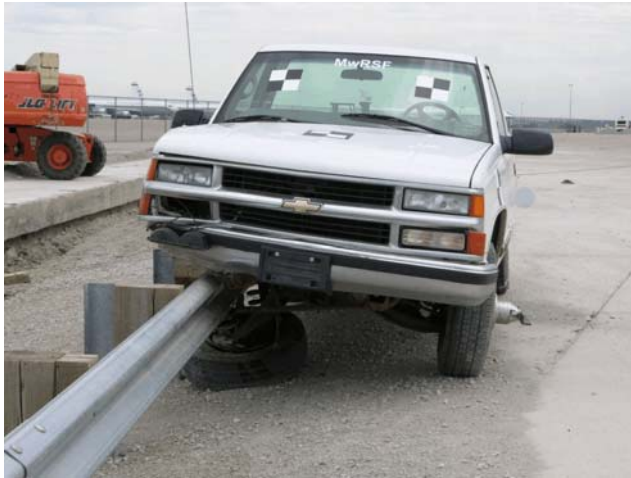
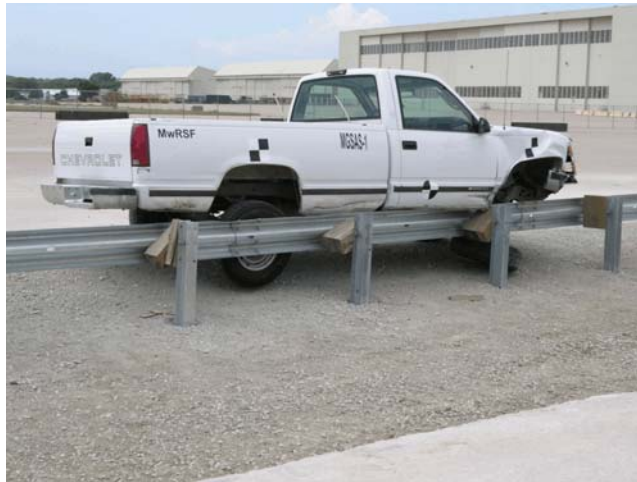
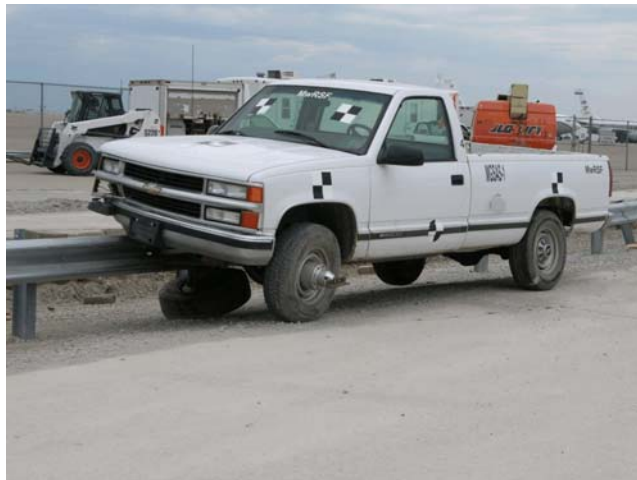
Figure 33. Vehicle Damage, Test No. MGSAS-1

Exterior vehicle damage was minimal, as shown in Figures 33 through 35. Occupant compartment deformations to the right side and center of the floorboard were judged insufficient to cause serious injury to the vehicle occupants, as shown in Figure 35. Maximum longitudinal deflections of 6 mm (0.25 in.) were located near the left side of the right side floorboard. Maximum lateral deflections of 19 mm (0.75 in.) were located near the front of the right-side floorboard. Maximum vertical deflections of 19 mm (0.75 in.) were located near the left side of the right-side floorboard. Complete occupant compartment deformations and the corresponding locations are provided in Appendix C.

Damage was concentrated on the right-front corner of the vehicle. The right-front tire disengaged from the upper control arm and rotated to parallel with the ground. The right-front wheel well was deformed. The right-front tire bead was broken and the steel rim was severely damaged. The right-front corner of the bumper was deformed upward and inward toward the engine compartment, and the left-front corner of the bumper deformed away from the truck. The right-front quarter panel encountered buckling and was pushed upward and inward into the engine compartment. The right-front frame was buckled. The right-side door encountered scratches along the lower portion of the door. Deformation on the cab was found near the right-side door. The truck

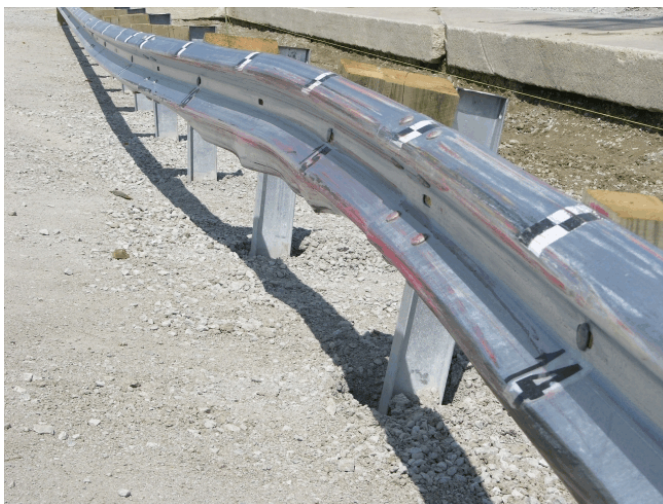
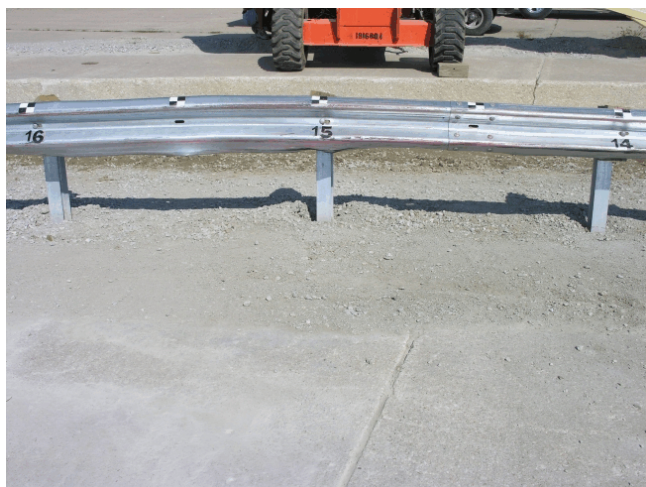
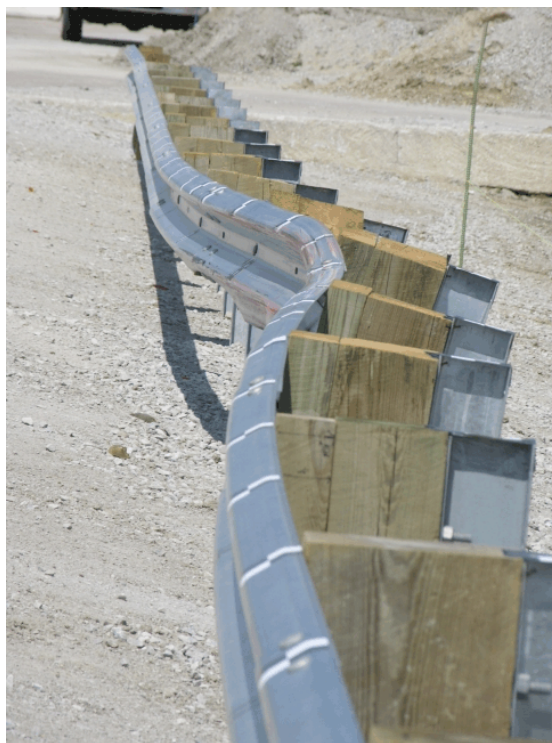
Figure 43. System Damage, Test No. MGSAS-2

Damage to the barrier was moderate, as shown in Figures 43 through 46. Barrier damage consisted of deformed guardrail posts, contact marks on a guardrail section and posts, and deformed W-beam rail. The length of vehicle contact along the system was approximately 6.0 m (19 ft - 8 in.), which spanned from 1,359 mm (53.5 in.) downstream from the centerline of post no. 13 through 267 mm (10.5 in.) upstream from the centerline of post no. 17.

Contact marks, along with moderate deformation and flattening, occurred between post nos. 13 and 17. Buckling of the guardrail occurred at post nos. 15 and 16 and at the midspan between post nos. 15 and 16. The W-beam remained attached to all of the posts. No significant guardrail damage occurred upstream of post no. 13 nor downstream of post no. 17.

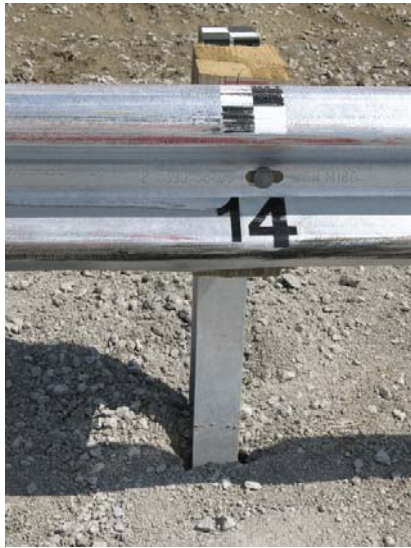
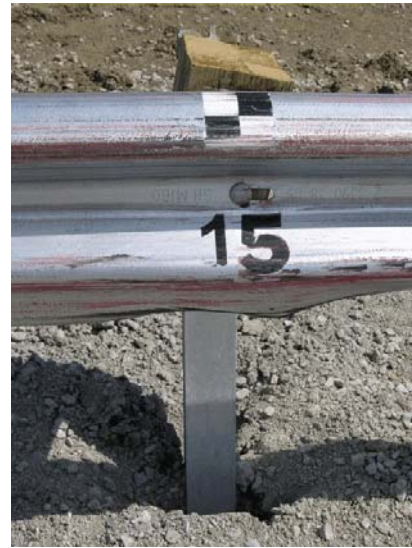
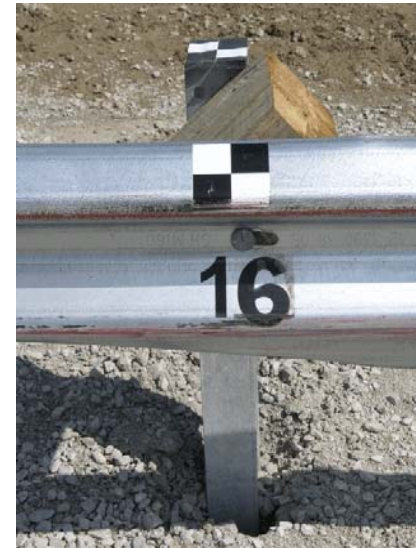
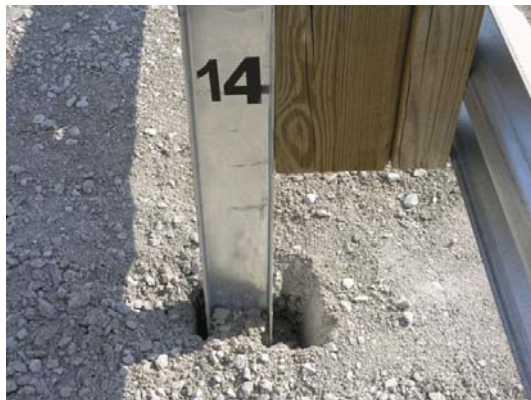
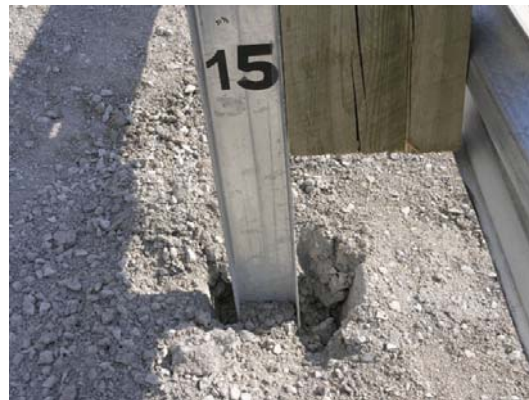
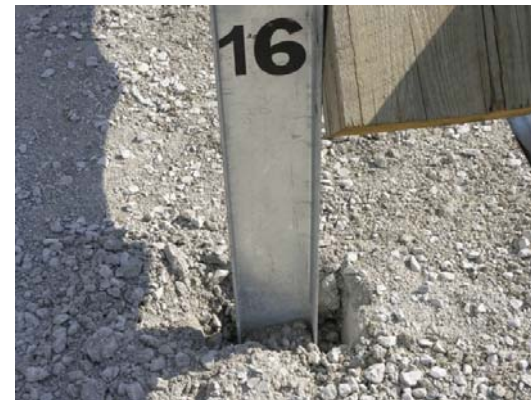
Figure 44. Post Nos. 14 through 16 Damage, Test No. MGSAS-2

Steel post nos. 13 through 17 rotated backward. Steel post nos. 3 through 13 encountered minor twisting. Contact marks were found on the blockouts at post nos. 14 and 15. The blockout at post no. 16 was twisted upstream to an angle of 45 degrees. The upstream anchor moved 12.7 mm (0.5 in.) longitudinally. All four wood BCT posts remained undamaged.

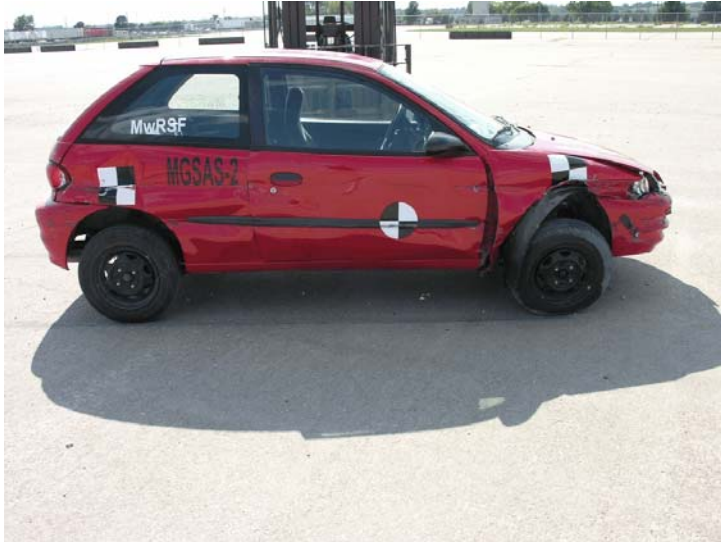
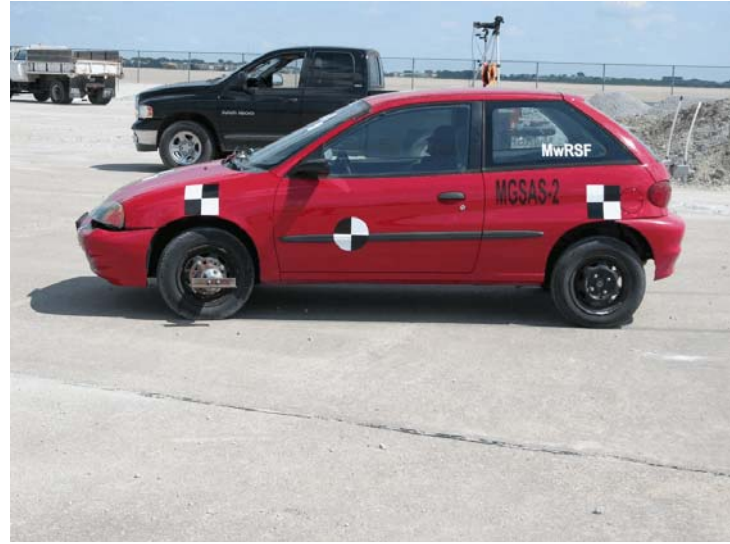
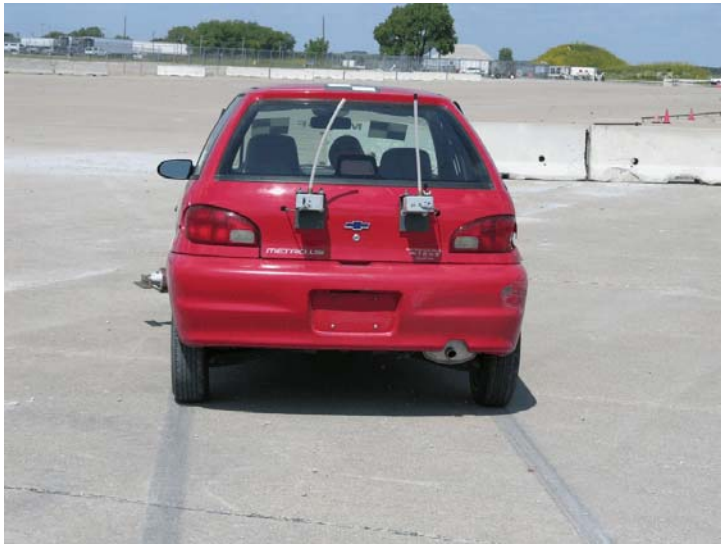
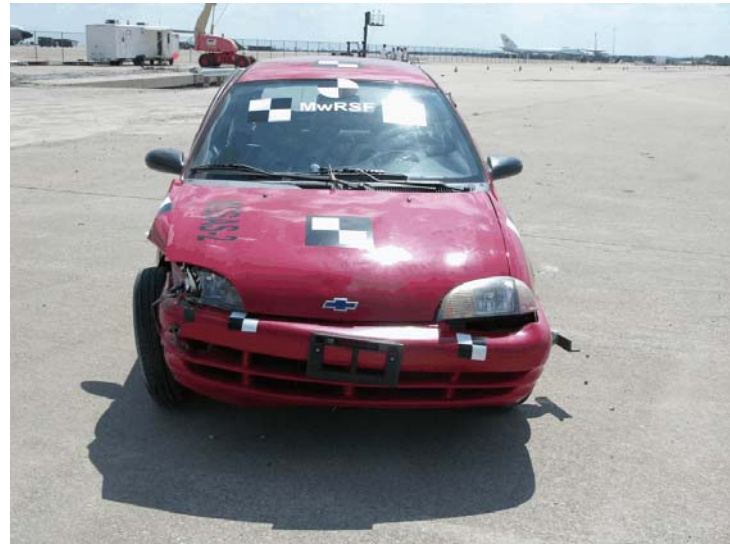
Figure 47. Vehicle Damage, Test No. MGSAS-2

Exterior vehicle damage was minimal, as shown in Figures 47 and 48. Occupant compartment deformations to the right side and center of the floorboard were judged insufficient to cause serious injury to the vehicle occupants. Complete occupant compartment deformations and the corresponding locations are provided in Appendix E.

Damage was concentrated on the front-right corner of the vehicle. The right-side door separated from the right-front quarter panel. The top of the right-side door was ajar. The right-front quarter panel crushed inward toward the engine compartment. The right-side headlight was intact, but the glass and the turn signal were fractured. The bumper shifted toward the left and was separated from the left mount. Scratches were found along the entire right side of the vehicle and the right corner of the front and back bumpers. The right-front tire encountered contact marks. The right-side control arm was deformed downward. The roof, hood, left side, and rear of the vehicle, and all window glass remained undamaged.
