**FULL-SCALE 4,500 LB. VEHICLE CRASH TEST
ON THE
PERMANENT PRECAST CONCRETE MEDIAN BARRIER**

Project RES1 (0099) P451
TRANSPORTATION RESEARCH REPORT TRP-03-24-90

Midwest Roadside Safety Facility
Civil Engineering Department
W348 Nebraska Hall
University of Nebraska-Lincoln
Lincoln, Nebraska 68588-0531

March 1991

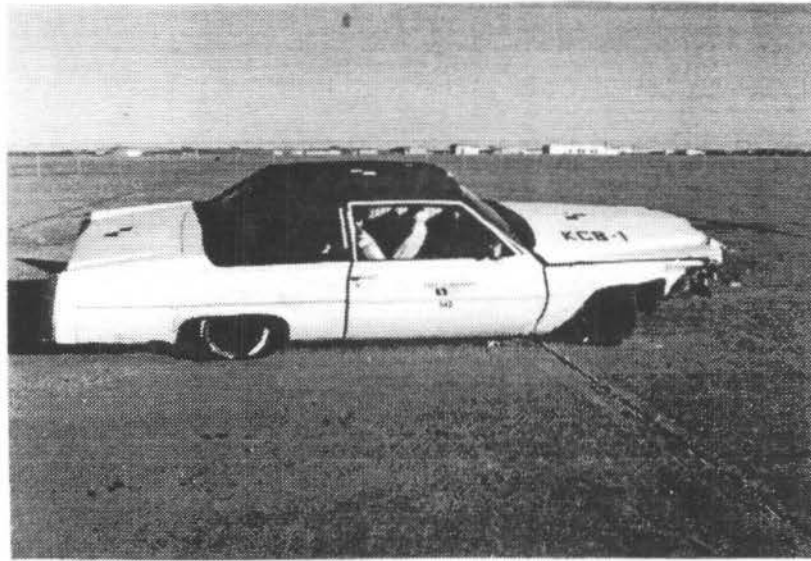
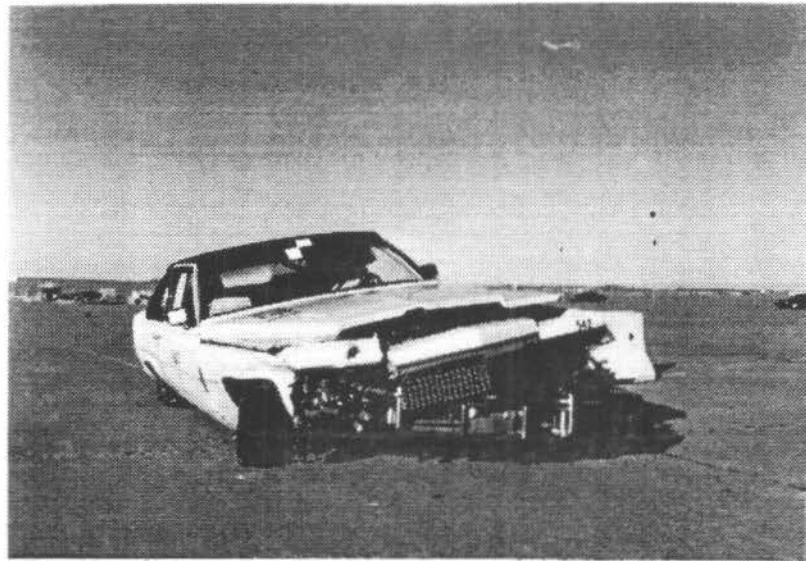
Figure 15. Photographs of Vehicle Damage

Photographs of the vehicle damage are shown in Figure 15. The vehicle damage was marginal, meaning that it was on the lower limit of acceptability. The TAD and VDI damage classifications are shown in Figure 11. Photographs of the damage to the permanent precast CMB are shown in Figures 16 through 21. As evident from the photographs, the barrier section rotated as a result of two different failure mechanisms: First, the concrete keyway fractured at multiple joint locations; second, the barrier was lifted off the grouted dowel bars located on the traffic side of the barrier. Portions of the concrete fractured off the lower edge near the grouted dowel bars. Appendix B contains graphs of longitudinal and lateral deceleration, occupant impact velocity, and occupant displacement versus time.

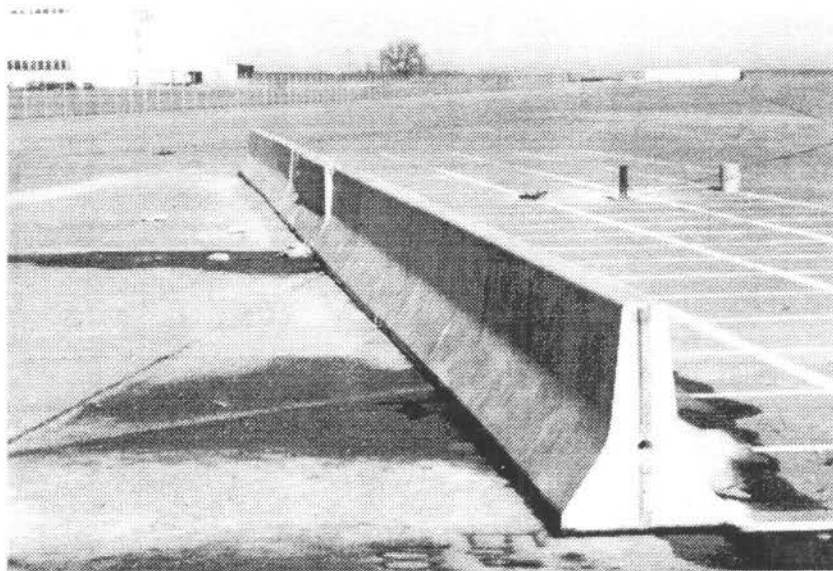
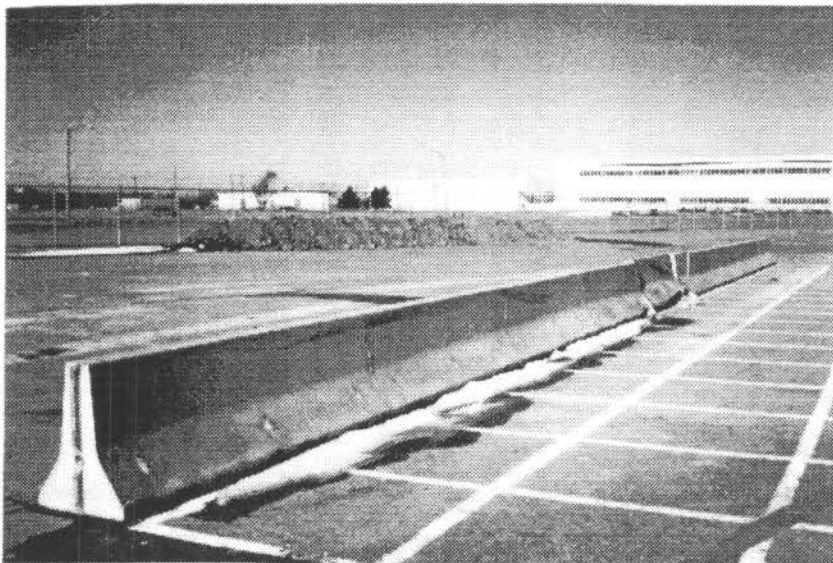
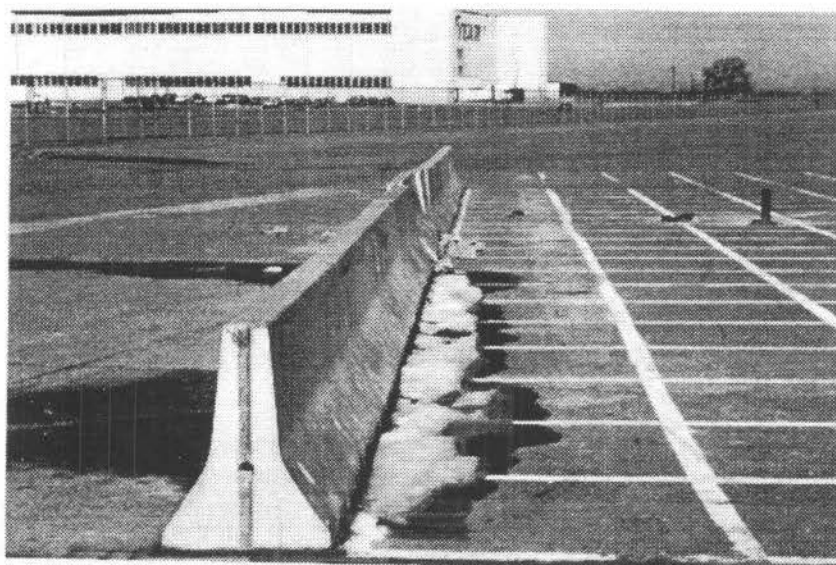
Figure 16. Photographs of the overall damage to the Permanent Precast CMB

After the post-crash examination of the permanent barrier installation, it was evident that the structural integrity of the barrier had some known deficiencies. These are evident in the photographs shown in Figures 17 through 21 and will be discussed in the following section.

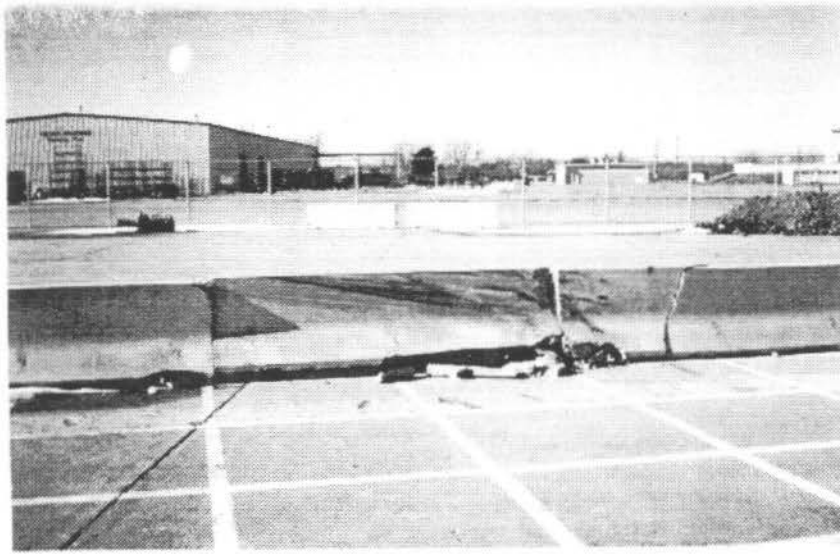
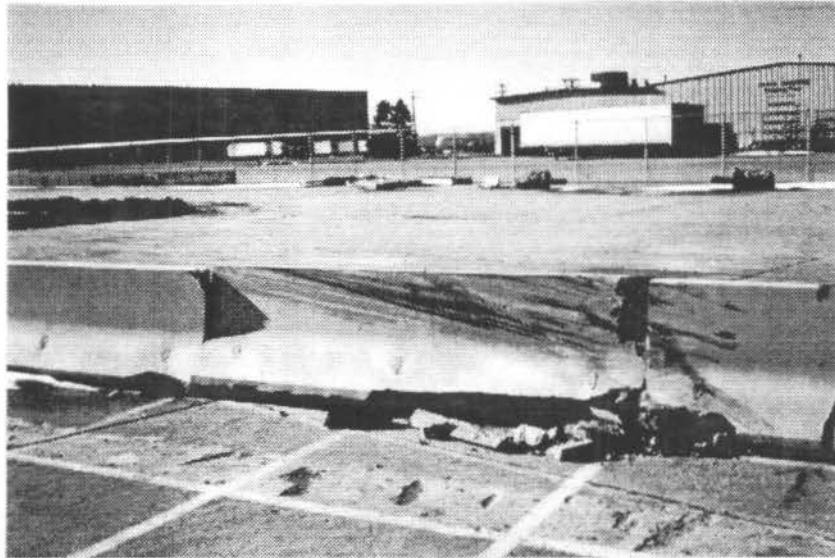
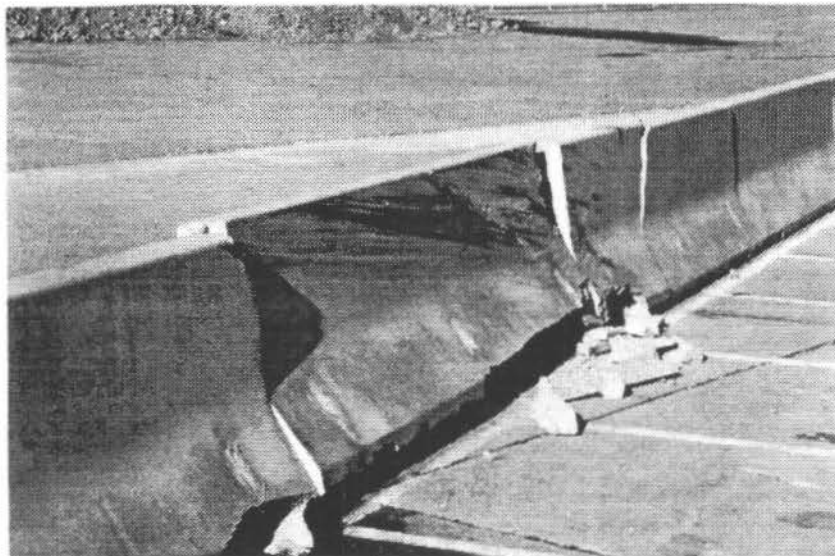
Figure 17. Photographs of the barrier damage at the location of impact (front side)

As shown in Figures 17 and 18, the concrete barrier section located immediately following the impact location showed the largest amount of permanent rotation. At the location of impact, a large crack had formed which projected through the entire cross-section of the barrier. This may be minimized by the addition of more longitudinal steel and shear pins located in an arrangement similar to that which is recommended in the article in the Portland Cement Association (2). This recommendation comes from the previous research which was conducted on permanent precast concrete median barriers by Southwest Research Institute (7,8).

The excessive rotation of the barrier section was due to a combination of two failure mechanisms. First, the concrete keyway fractured at multiple joint locations. Second, the barrier was lifted approximately 3 in. off the grouted dowel bars located on the traffic side of the barrier. Portions of the concrete fractured off the lower edge near the grouted dowel bars.

As can be seen in Figure 17, 1ft - 10 in. of the base of the impacted barrier was fractured near the downstream splice. The first 5 ft - 4 in. of the next barrier was also fractured at the base. A 1 ft - 6 in. length of concrete was broken from the second barrier downstream from impact. This fracture occurred in front of the upstream dowel at the base of the barrier.

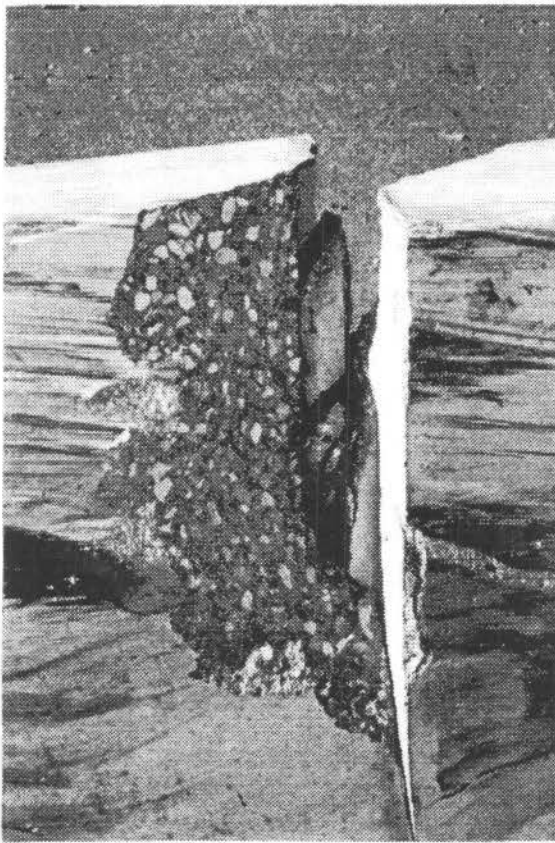
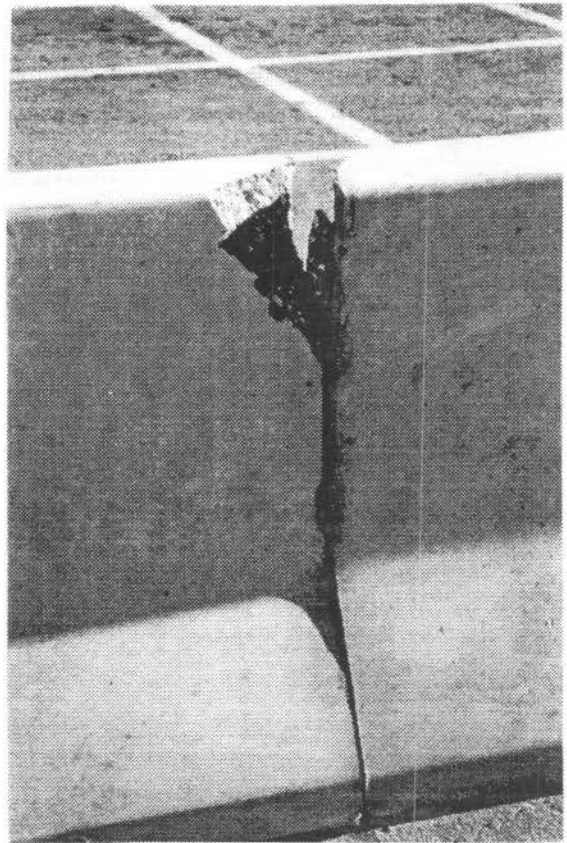
Figure 19. Photographs of damage to the key-way located 3 feet downstream from impact

As shown in Figures 19 and 20, the concrete keyway fractured at two locations, on both ends of the permanently rotated barrier, in two modes of failure. First, at the joint located 3 ft downstream of impact, the male end of the concrete keyway fractured off along with portions of the female end, as shown in Figure 19. Second, at the joint located 13 ft downstream from

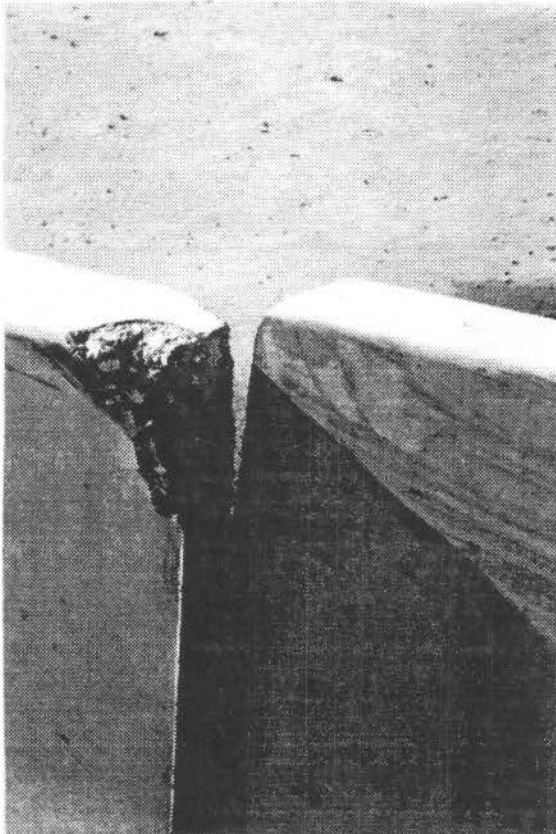
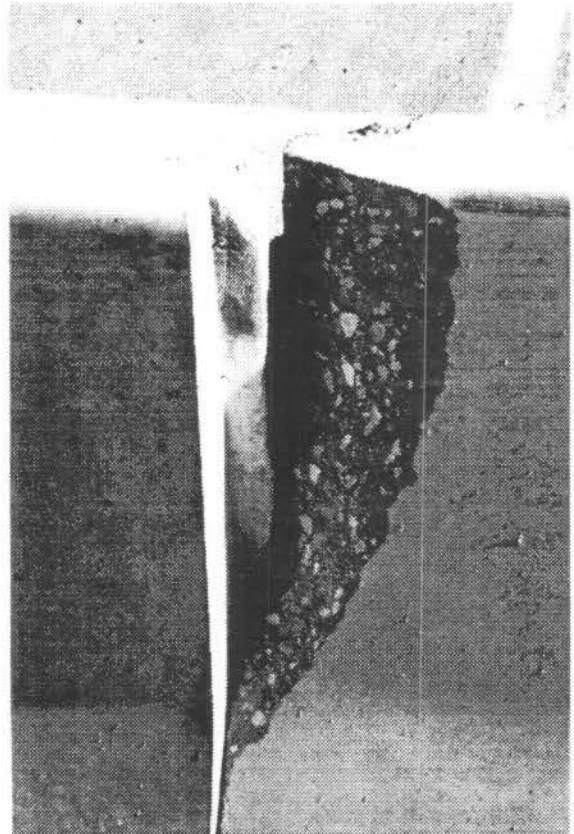
Figure 20. Photographs of damage to the key-way located 13 feet downstream from impact

impact, the female end of the concrete keyway fractured off, as shown in Figure 20.

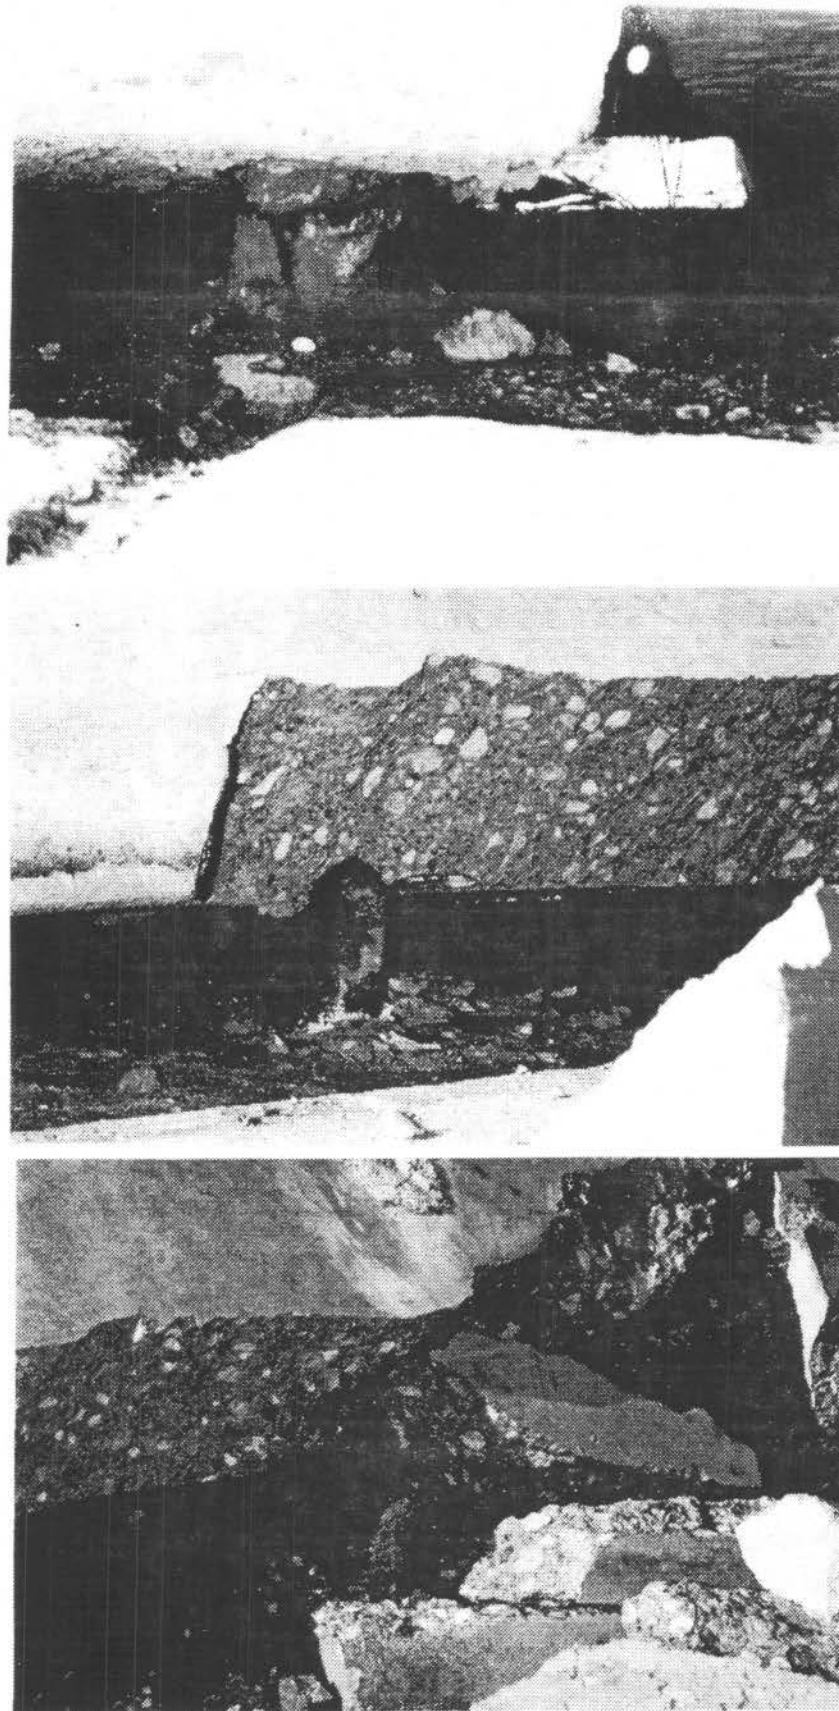
Figure 21. Photographs of barrier uplift and concrete fracture near grouted dowel bars

As shown in Figure 21, the precast concrete median barrier located immediately after impact was lifted off the grouted dowel bars along the traffic face side of the installation. This physical evidence would suggest that the number of dowel bars available for tension reinforcement was inadequate as well as there being an insufficient amount of development length on the dowel bars.
