PERFORMANCE EVALUATION OF SAFETY GRATES FOR CROSS-DRAINAGE CULVERTS

MIDWEST ROADSIDE SAFETY FACILITY

MwRSF Research Report No. TRP-03-196-08

October 23, 2008

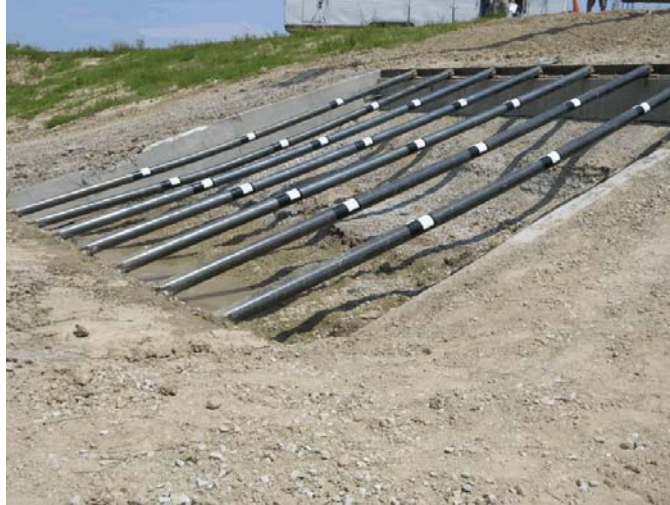
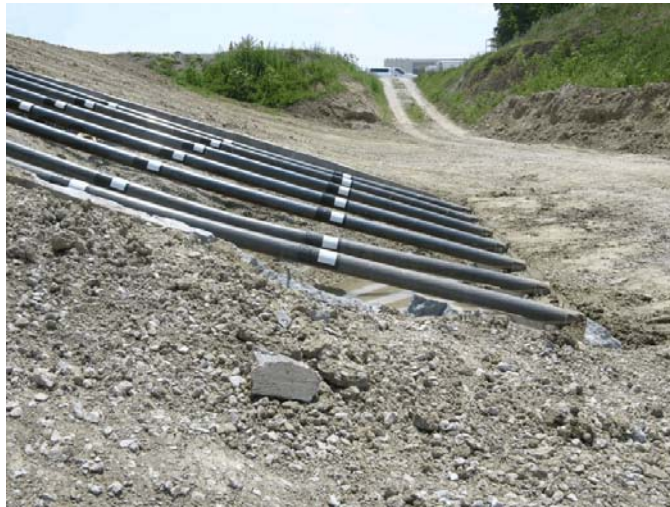
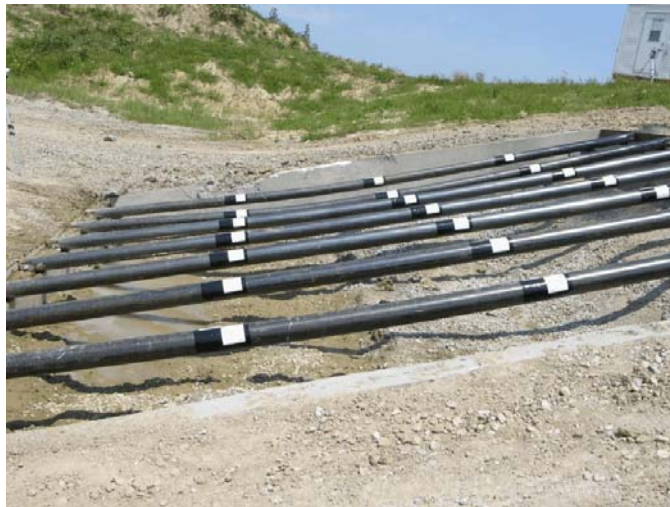
Figure 29. Culvert Grate System Damage, Test KSCG-1

Damage to the barrier was moderate, as shown in Figures 29 and 30. System damage consisted mostly of deformed pipes, contact marks on the grate and the concrete culvert wall, and damaged concrete.

All of the culvert pipes displayed some permanent deformation. The highest deformations were found on the first and second upstream culvert grate pipes. Dynamic deflections of the culvert pipes were not obtainable, but the maximum permanent deflection of the culvert pipes was 184 mm (7.25 in.) which was found on the second pipe. Contact marks were also found on all seven grate pipes.

Concrete damage was most significant on the downstream edge of the culvert wall due to the impact of the wheels and tires. The concrete damage consisted of broken and spalled concrete beginning 1,118 mm (44 in.) from the lower, downstream corner of the culvert and extending up the downstream culvert wall for 1,930 mm (76 in.).

During the pickup truck test (test no. KSCG-1), the second pipe of the grate system had a maximum permanent set of 184 mm (7.25 in.). Unfortunately, no research was performed in order to determine the ability of a deformed pipe grate system to withstand a second impact event. Therefore, future research is recommended to explore the effect of multiple impacts on a grate system as well as to develop guidelines for repairing and/or replacing the deformed pipes and associated attachment hardware.

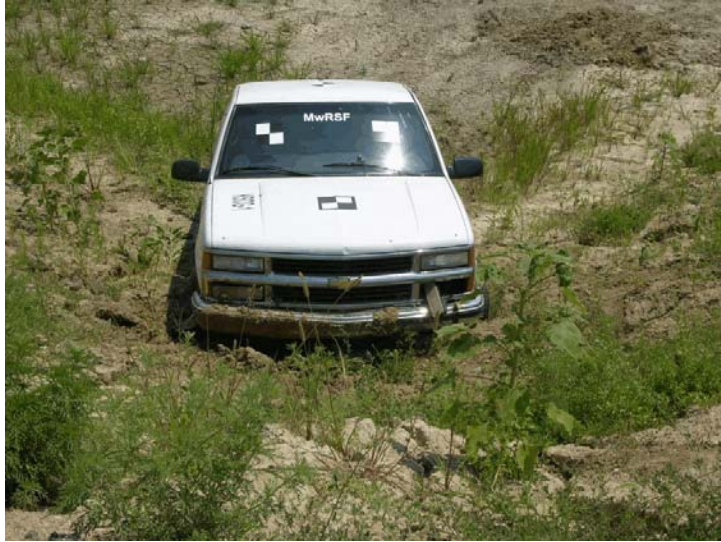
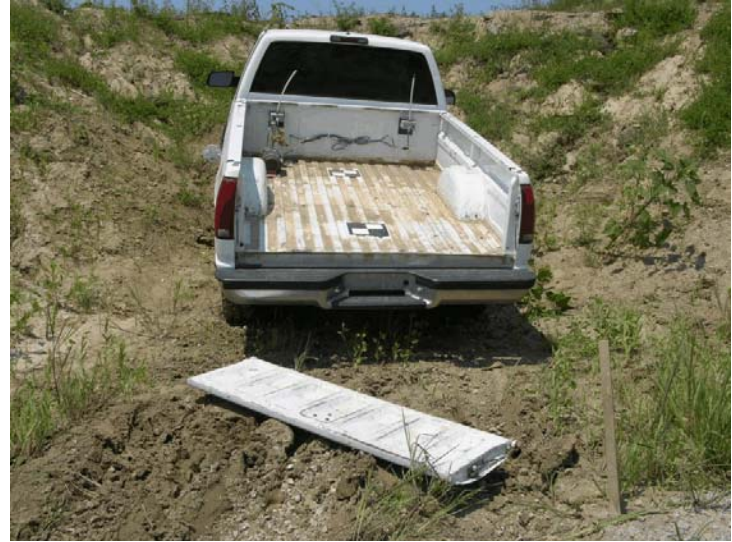
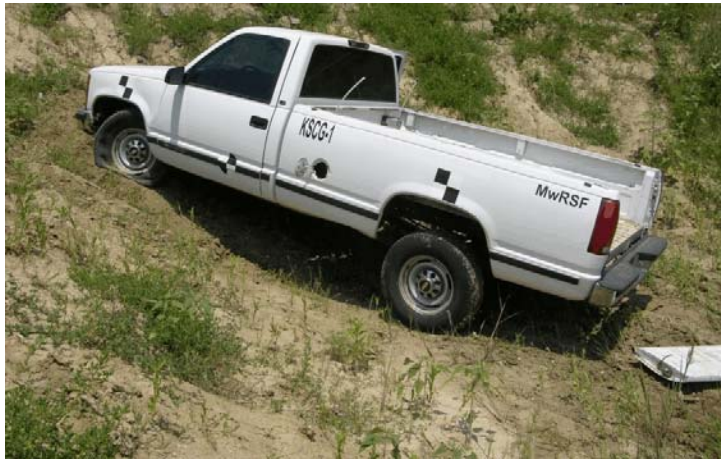
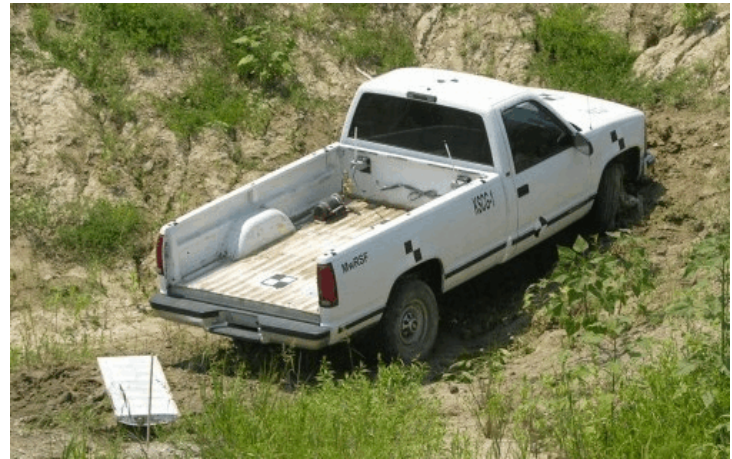
Figure 31. Vehicle Damage, Test KSCG-1

Exterior vehicle damage was minimal, as shown in Figures 31 through 33. Occupant compartment deformations to the right side and center of the floorboard were judged insufficient to cause serious injury to the vehicle occupants. Maximum longitudinal deflections of 6 mm (0.25 in.) were located at several points throughout the right-side floor pan. Maximum lateral deflections of

Minor deformations were observed on the front bumper. The right-front tire was completely deflated due to a 305-mm (12-in.) long cut in the tire. The right-front wheel also displayed major deformation of the rim. The left-front tire was deflated as well. Minor deformations were found on the bottom of both front fenders near the doors. The tailgate of the pickup truck became disengaged from the bed during the impact.

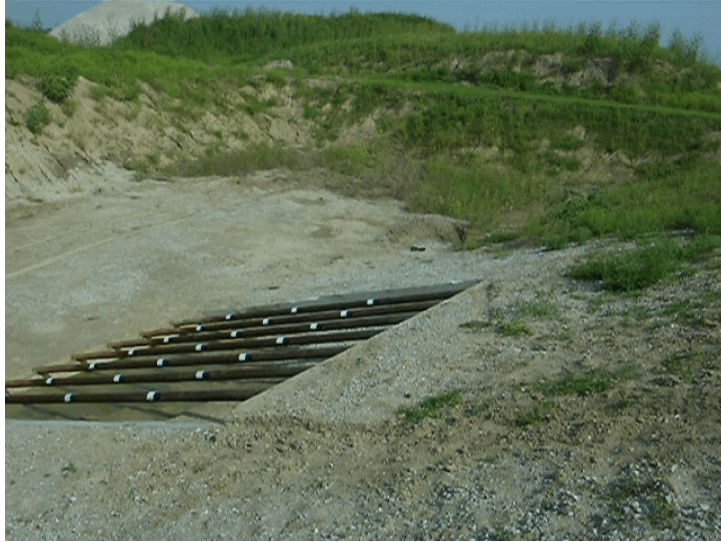
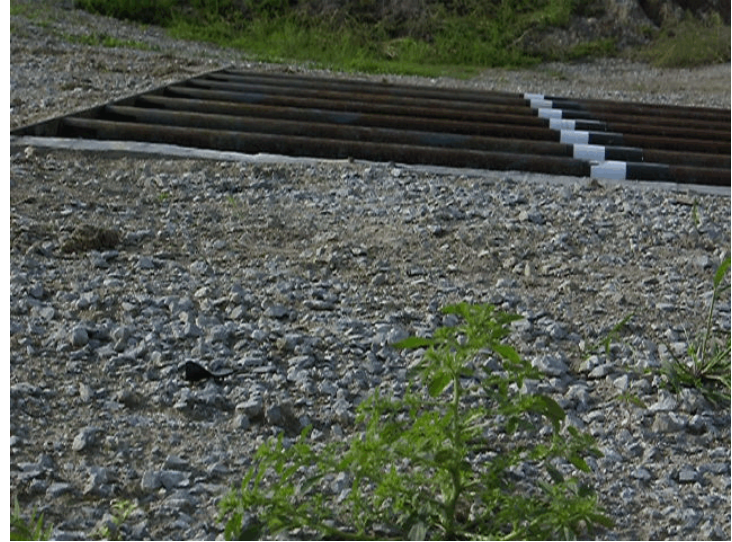
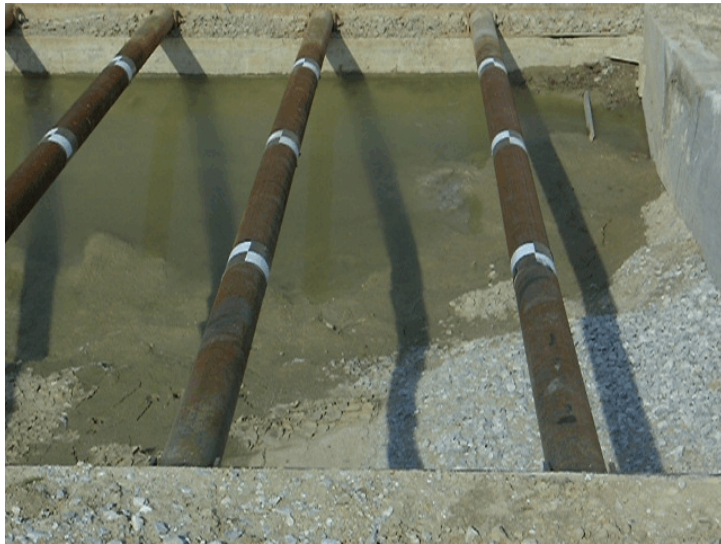
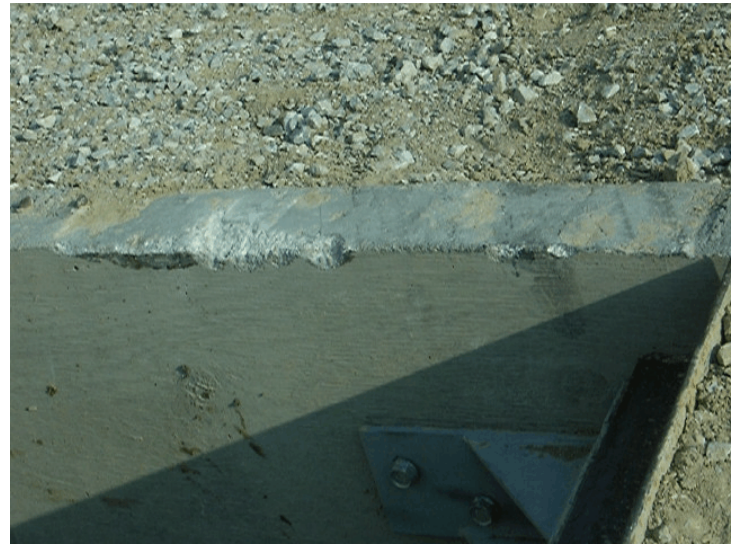
Figure 39. Culvert Grate System Damage, Test KSCG-2

Damage to the system was minimal, as shown in Figure 39. System damage consisted of contact marks on the grate pipes and concrete culvert wall and damaged concrete. None of the culvert pipes displayed permanent deformation. Contact marks were found on all seven grate pipes. Concrete damage was observed on the upper portion of the downstream edge of the culvert wall due to the impact of the wheels and tires. The concrete damage consisted of broken and spalled concrete beginning 508 mm (20 in.) from the upper, downstream corner of the culvert and extending down the downstream culvert wall for 559 mm (22 in.).

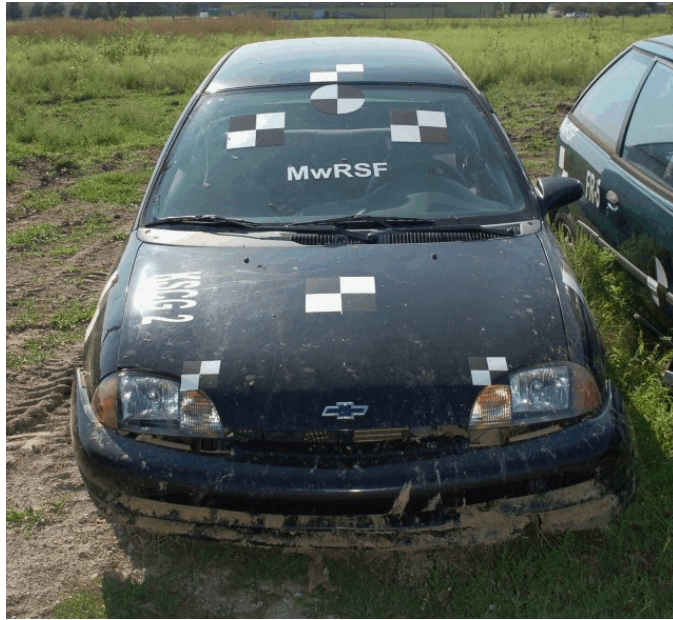
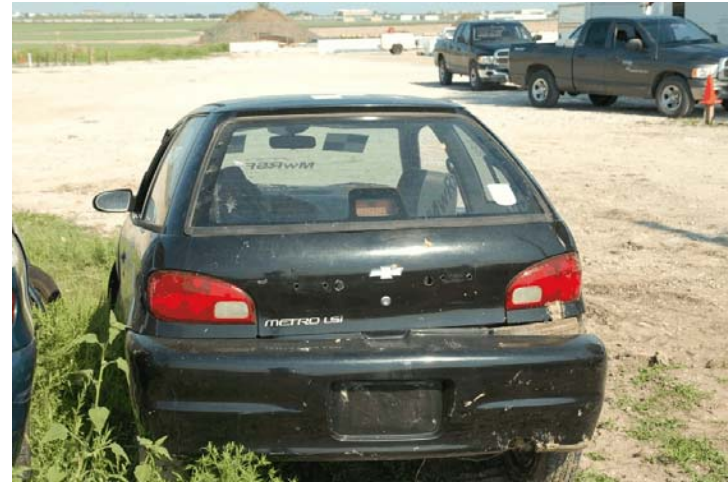
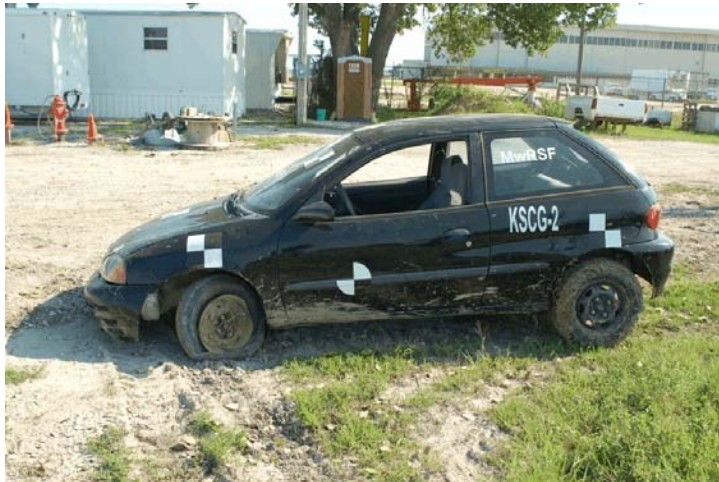
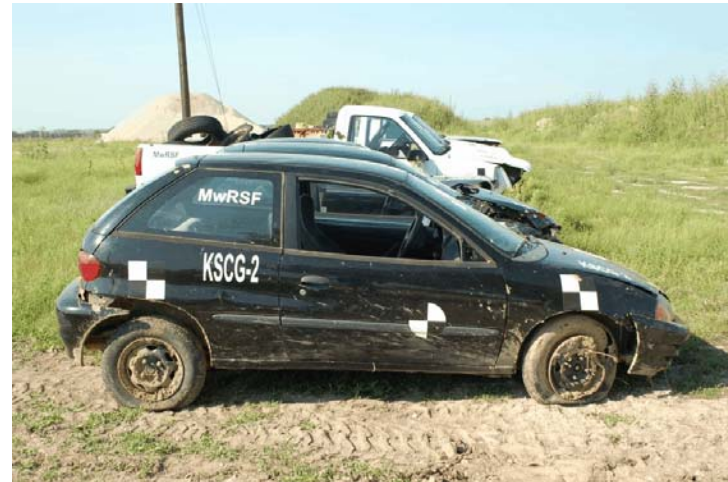
Figure 40. Vehicle Damage, Test KSCG-2

Exterior vehicle damage was minimal, as shown in Figures 40 through 43. Interior occupant compartment damage was negligible with no significant observable deformations of the occupant compartment observed. The occupant compartment deformations and the corresponding locations are provided in Appendix D.

Deformations were observed on the front bumper and the radiator. Both of the front tires were completely deflated and unseated from the rims. The right-rear tire was deflated as well. The rims of both front wheels displayed large deformations due to impact with the culvert pipes. Minor deformation was found on both front fenders. Deformations were also observed on both the oil pan and the exhaust pipe. The right side of the rear bumper became partially disengaged.
