SAFETY PERFORMANCE EVALUATION OF THE NON-BLOCKED MIDWEST GUARDRAIL SYSTEM (MGS)

MwRSF Research Report No. TRP-03-262-12

January 24, 2013

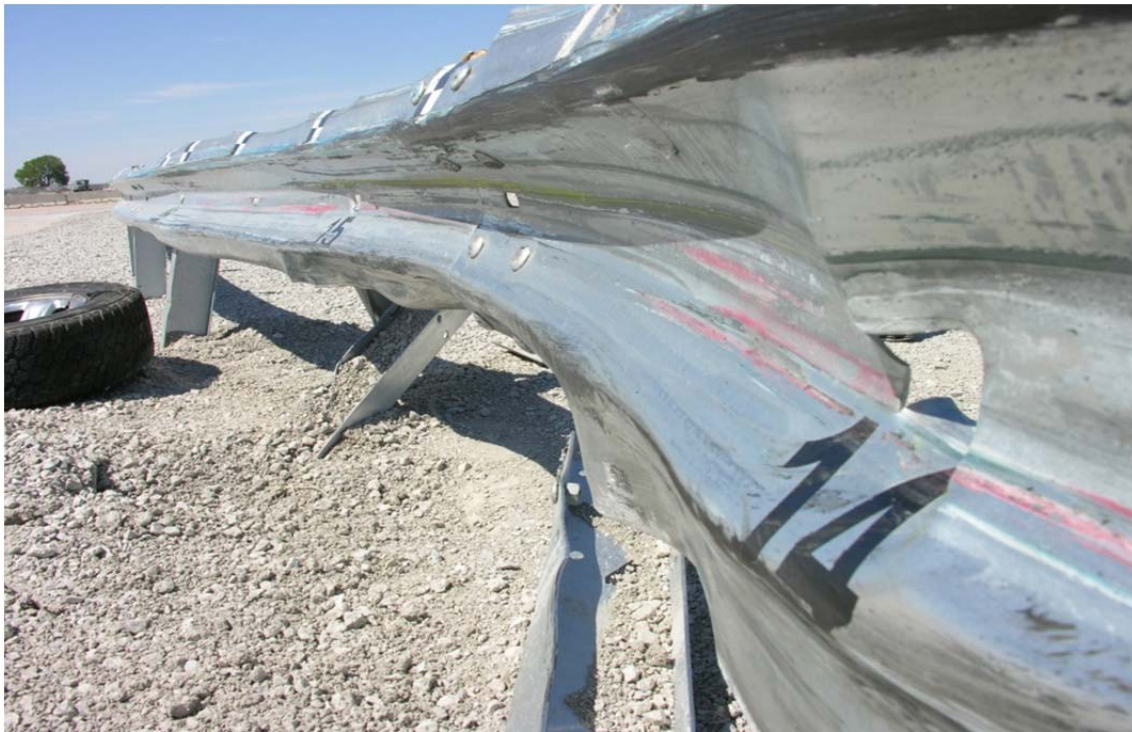
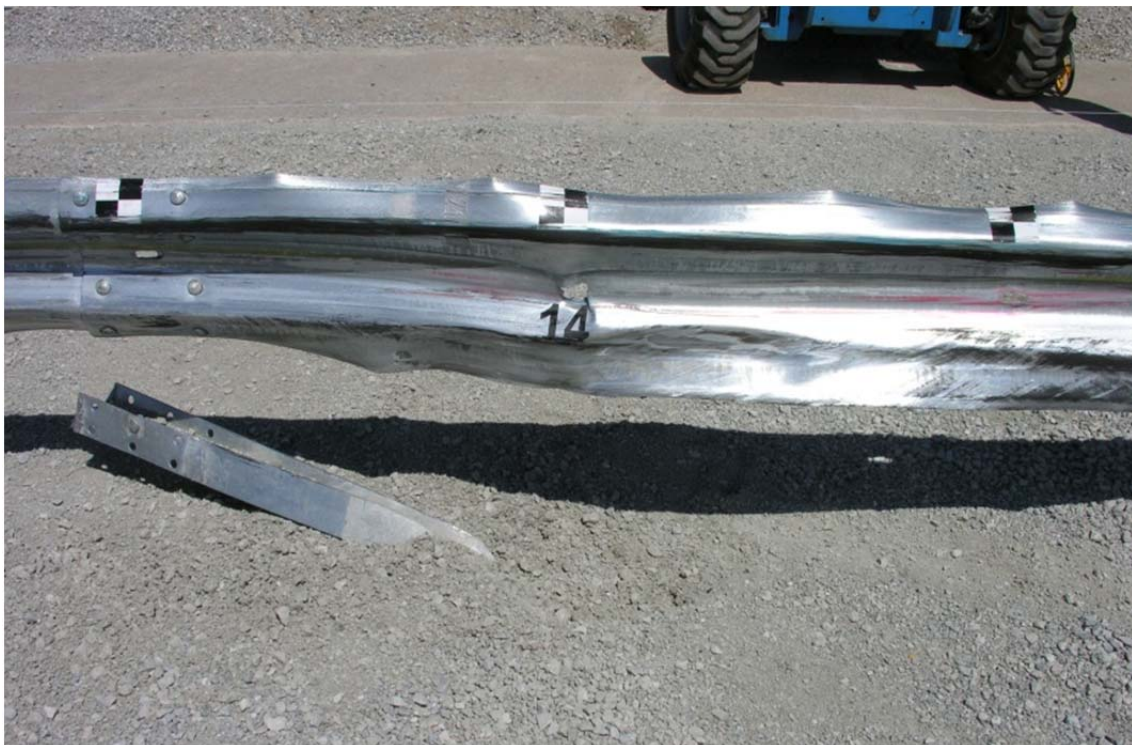
Figure 39. System Damage, Test No. MGSNB-1

Damage to the barrier was moderate, as shown in Figures 39 through 42. Barrier damage consisted of deformed W-beam rail, deformed posts, and contact marks on sections of guardrail and posts. The length of vehicle contact along the barrier was approximately 23 ft – 6 in. (7.2 m) which spanned from 21 in. (533 mm) upstream of the centerline of post no. 13 to 41¾ in. (1,060 mm) downstream of the centerline of post no. 16.

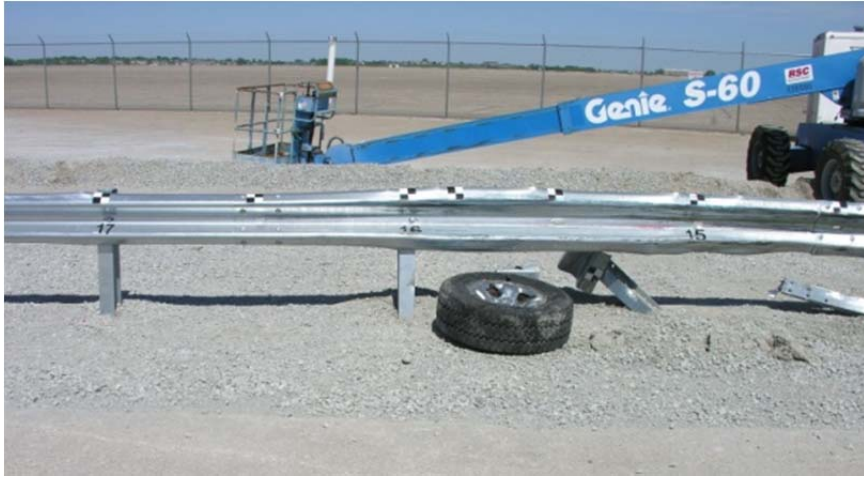
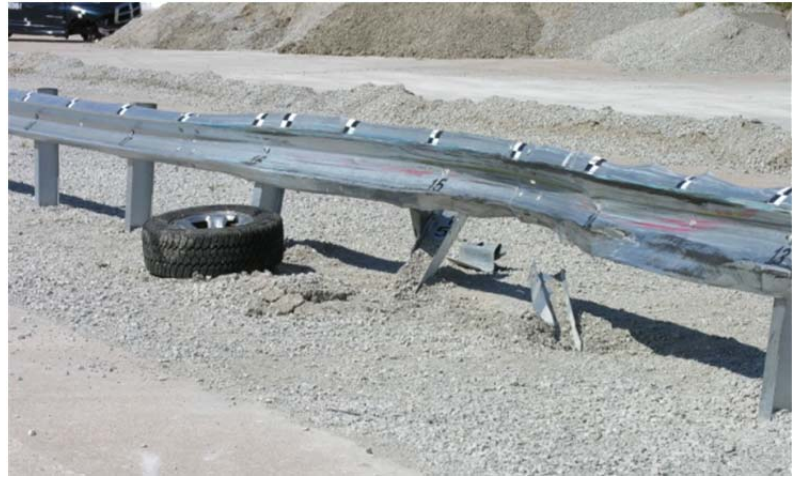
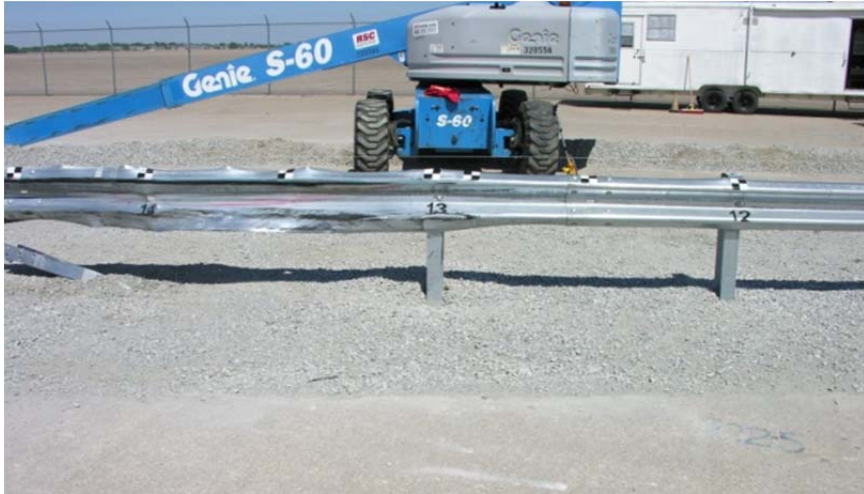
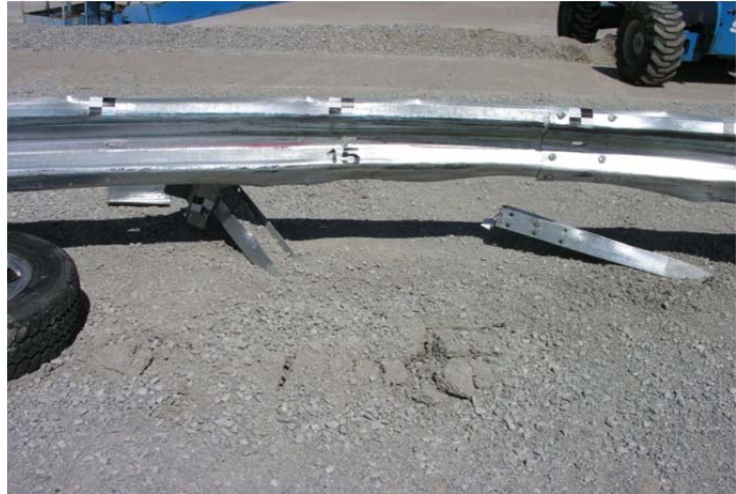
Figure 40. Guardrail Damage between Post Nos. 13 and 17, Test No. MGSNB-1

The W-beam backup plate at post no. 14 disengaged and the top corrugation was deformed. The bottom corrugation of the W-beam backup plate at post no. 15 was buckled. A 1 $\frac{1}{4}$ -in. (32-mm) gap between the top of the backup plate and the rail section was formed at post no. 16. A $\frac{1}{2}$ -in (13-mm) gap between the backup plate and the top of the rail section was found at post no. 17.

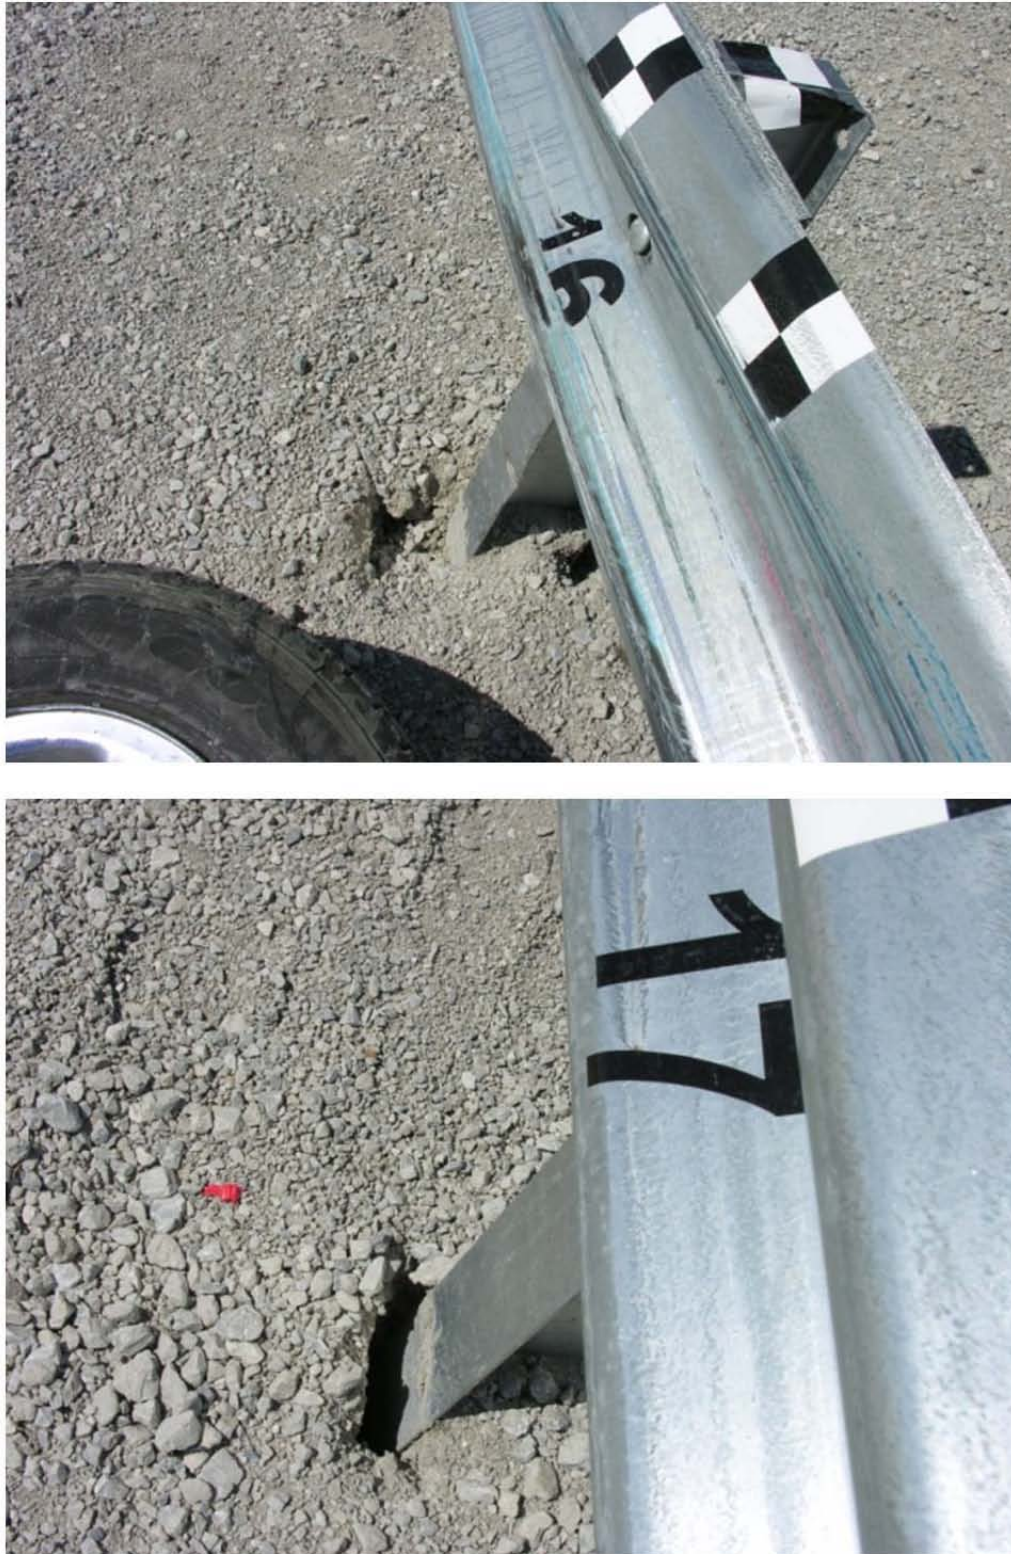
Figure 42. Post Damage between Post Nos. 13 and 15, Test No. MGSNB-1

Post nos. 12 through 17 rotated backward. Post no. 14 also bent downstream, and post no. 15 rotated downstream. Tire marks and scratches were observed on the front face of post nos. 13 and 14 just below the rail. The front flange of post no. 14 buckled 15 in. (381 mm) from the top, and the post twisted such that the front flange faced upstream. The upstream edge of the front flange of post no. 15 encountered tire marks and buckle points at 15 in. (381 mm) and 24 in. (610 mm) from the top of the post. The front flange of post no. 16 twisted upstream. A gouge was found on the upstream edge of the front flange of post no. 16 at 22 $\frac{3}{4}$ in. (578 mm) from the top of the post.

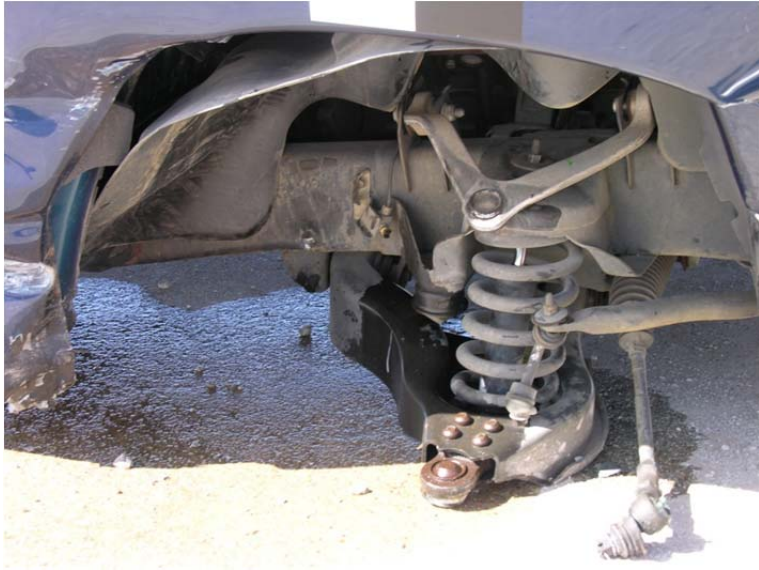
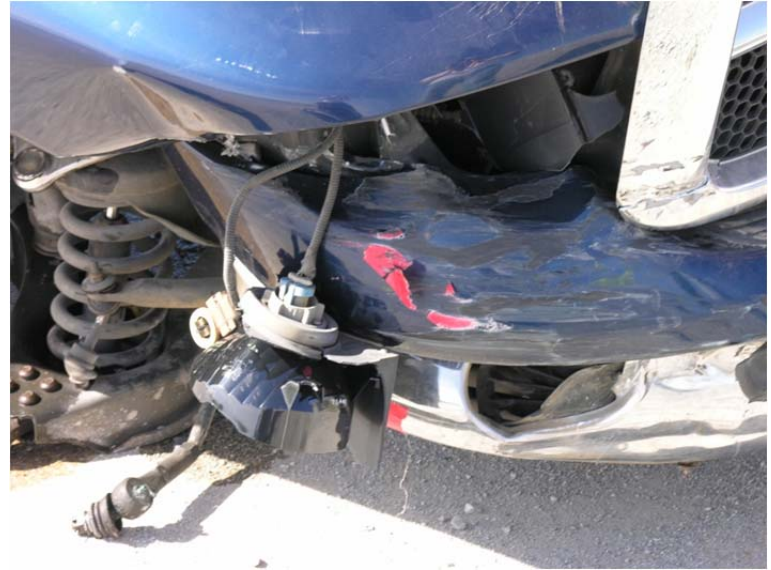
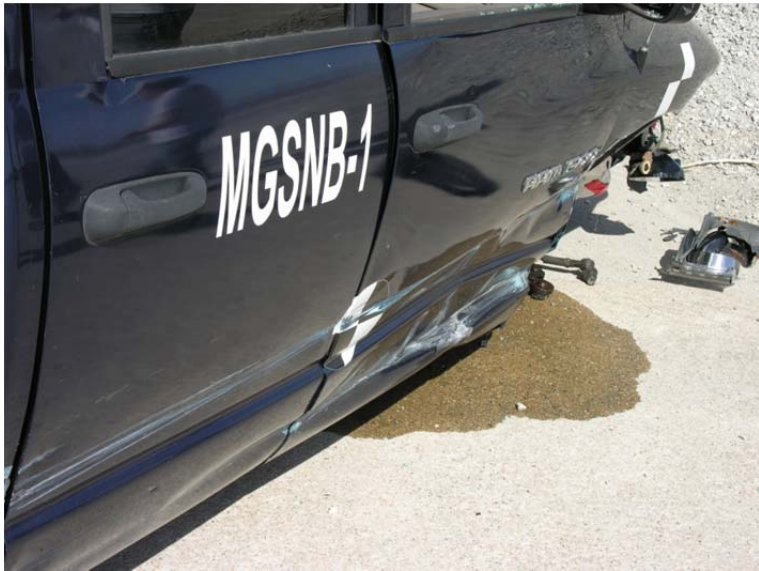
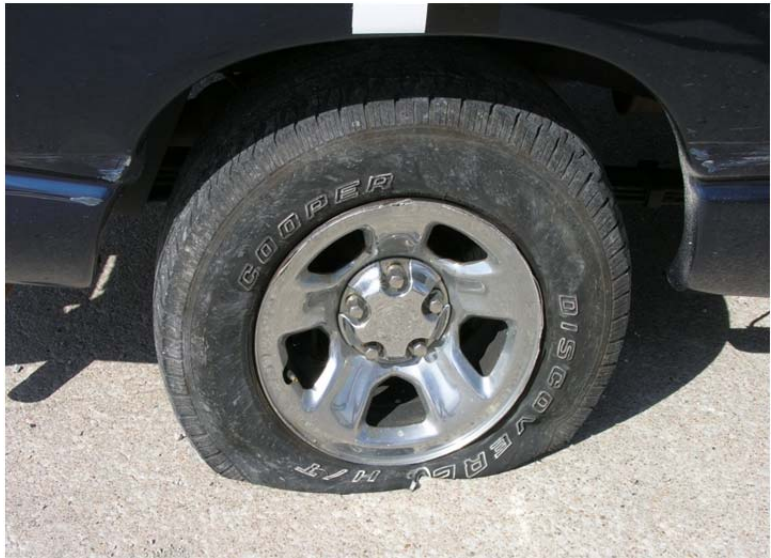
Figure 44. Vehicle Damage, Test No. MGSNB-1

Damage to the vehicle was moderate, as shown in Figures 44 and 45. The maximum occupant compartment deformations are listed in Table 5 along with the deformation limits established in MASH for various areas of the occupant compartment. None of the MASH

The majority of the damage was concentrated on the right-front corner and right side of the vehicle. The right-front tire was detached from the vehicle at the ball joint. The right-front tire was torn, and the steel rim was scratched and deformed. The right-front lower control arm fractured at the tie rod. The right-front tie rod and sway bar linkage were bent. The right-front wheel well was deformed inward and downward, and the right-front fender was bent inward. The right-side headlight was disengaged from the vehicle and fractured. The right-side of the front bumper was deformed inward toward the engine compartment. The left side of the front bumper was scraped, and a 1¾-in. (44-mm) gap was found between the front bumper and the left-side headlight. The lower portion of the center of the grill was fractured. The left side of the hood was ajar 1 in. (25 mm). The left-front wheel well was torn. The right side of the rear bumper was deformed and deflected downward 3½ in. (89 mm). The right side of the box rotated outward at the top and crushed inward at the bottom. The right-rear tire was torn and deflated. Deformations and contact marks extended along the entire right side of the vehicle. Both right-side doors were

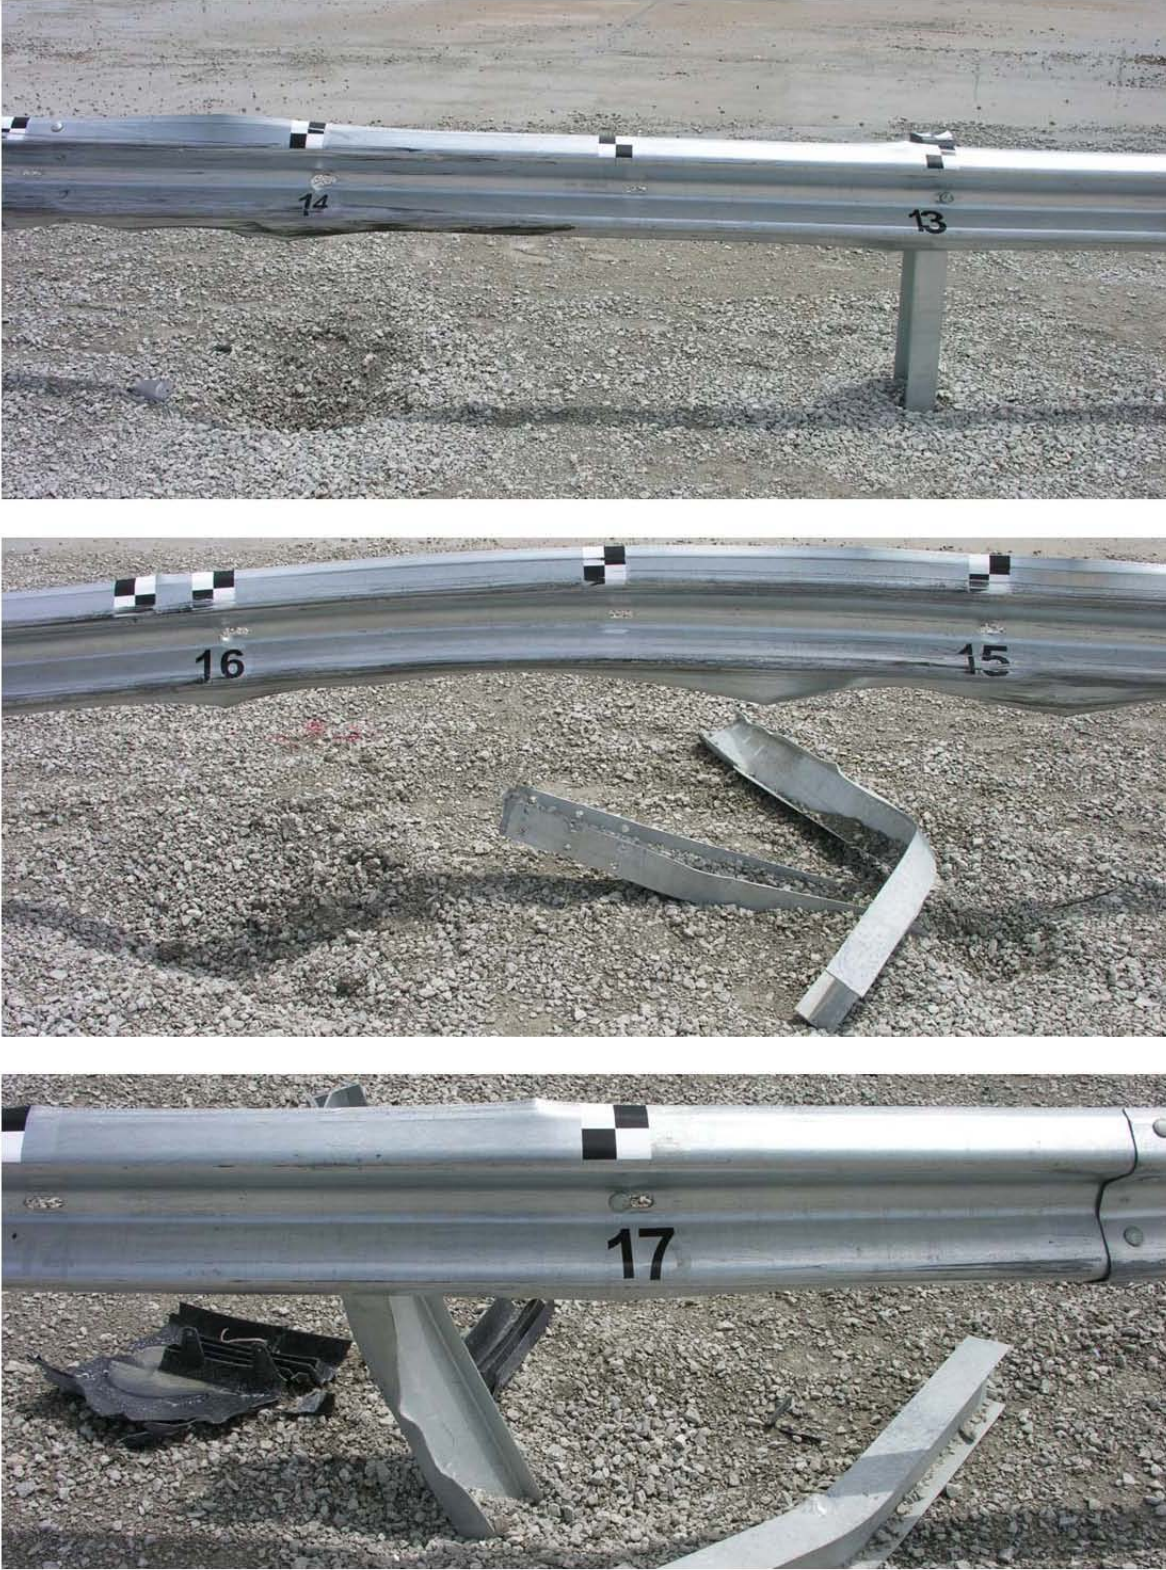
Figure 54. System Barrier Damage, Test No. MGSNB-2

Damage to the barrier was moderate, as shown in Figures 54 through 56. Barrier damage consisted of deformed W-beam rail, deformed posts, and contact marks on sections of guardrail and posts. The length of vehicle contact along the barrier was approximately 20 ft – 7¼ in. (6.3 m) which spanned from 2 ft – 8¼ in. (0.8 m) upstream from the center of post no. 14 to 10 in. (254 mm) upstream from the center of post no. 17. Secondary vehicle contact was 9 ft – 10 in.

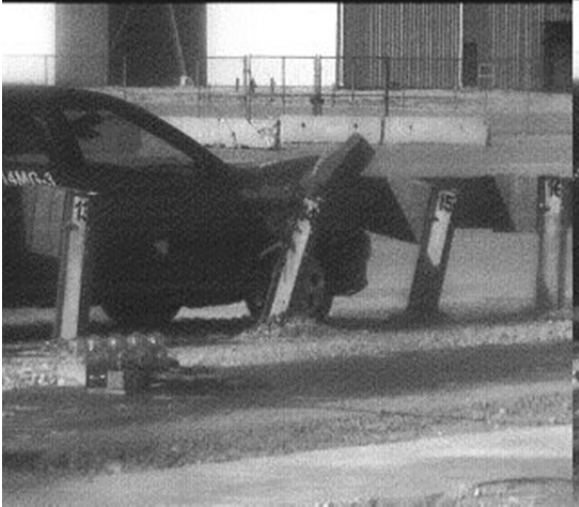
2214MG-3 – Blocked

A significant wheel snag occurred at post 14 during test no. MGSNB-2, which did not occur during test no. 2214MG-3, as shown in Figure 67. Initial impact for both tests was just upstream of post no. 13, and each vehicle easily cleared post no. 13 without tire-post overlap. The wheel snag at post no. 14 during test no. MGSNB-1 was the cause for the relatively abrupt change in longitudinal velocity (see Figure 64), as well as the relatively high OIV compared to the blocked test, test no. 2214MG-3 (31.3 ft/s versus 14.8 ft/s). It also helped pull post no. 14 out-of-the-ground as well as helped disengage the tire/wheel during the test.

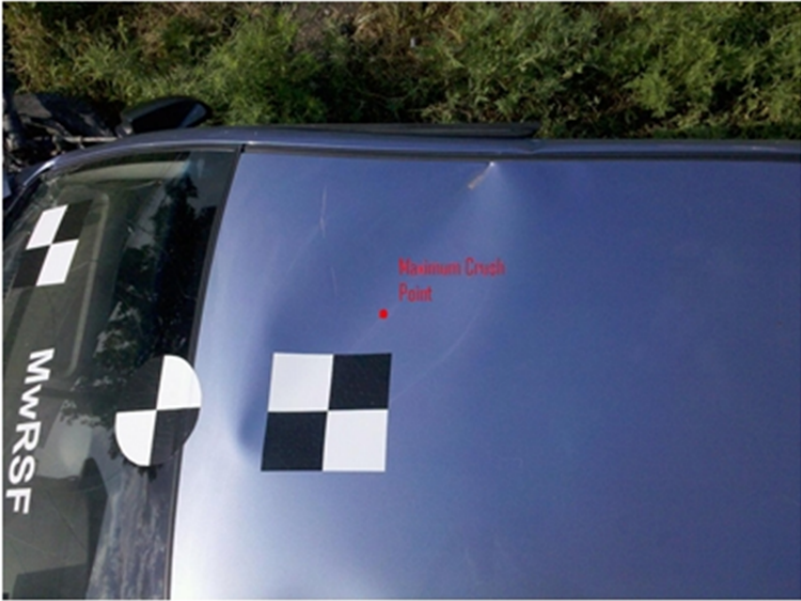
Figure D-13. Roof Crush Measurement, Test No. MGSNB-2

MGSNB-2 roof damage was located at one point on the right front quarter of the roof panel.

Pre-crush	Post Crush	Total Crush
Max Crush Point	6.25	7.5	1.25
