**SAFETY PERFORMANCE EVALUATION
OF MISSOURI'S SELF-DRIVING
TEMPORARY SIGN STANDS**

MISSOURI DEPARTMENT OF TRANSPORTATION

MwRSF Research Report No. TRP-03-97-00

December 13, 2000

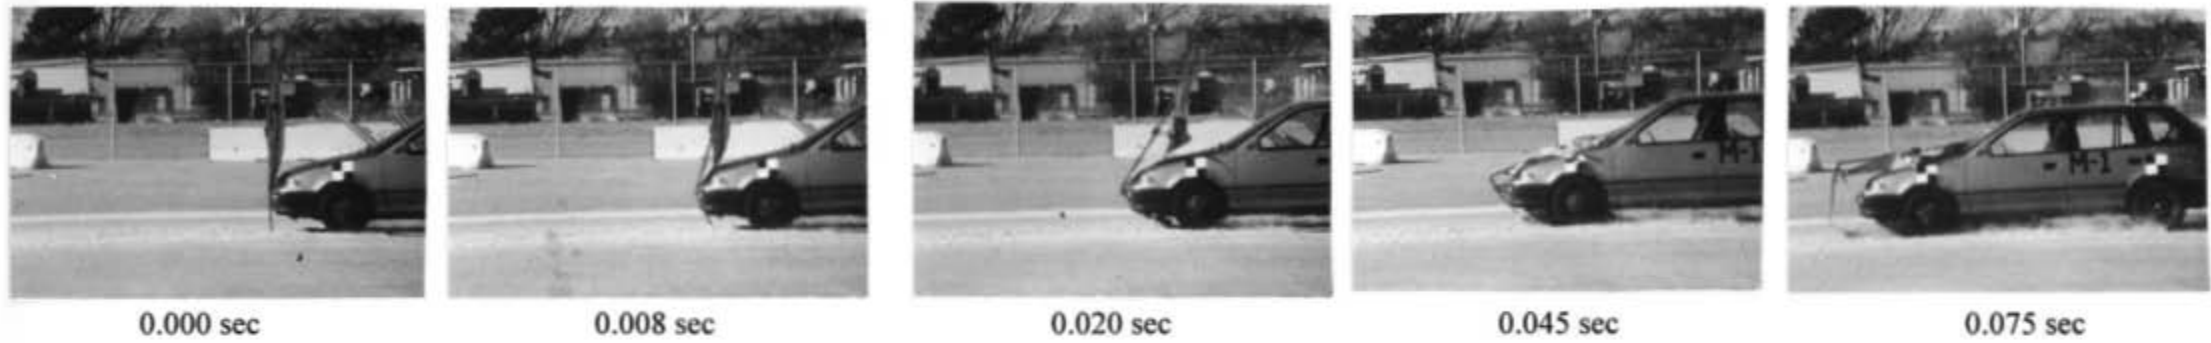
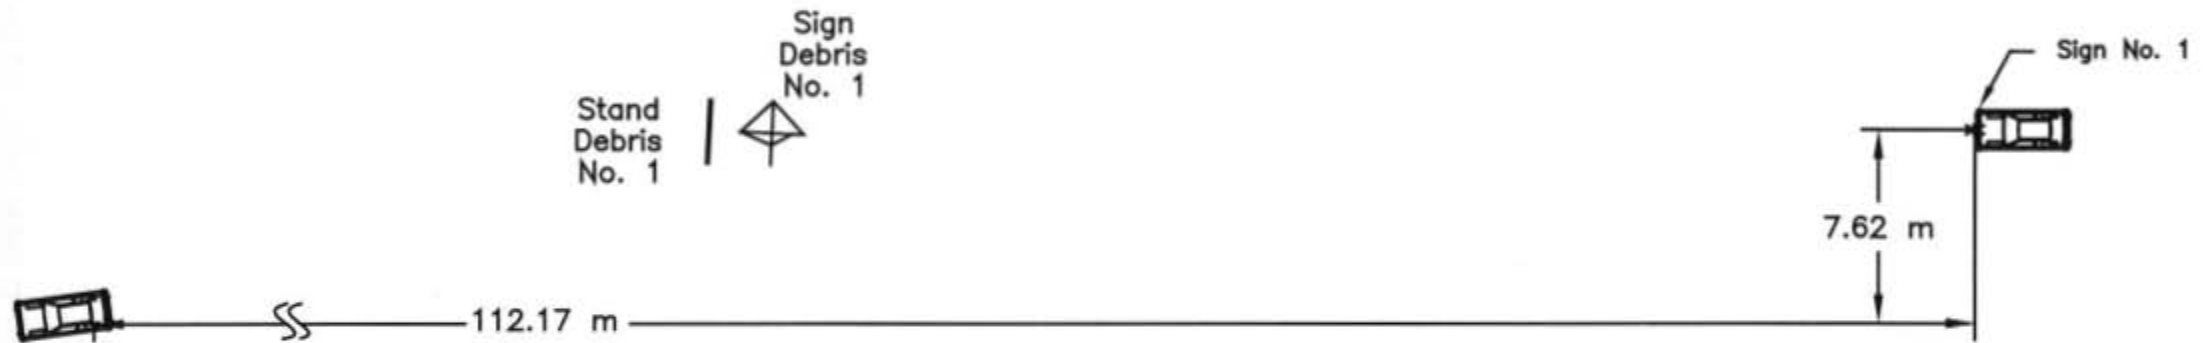
Figure 12. Summary of Test Results and Sequential Photographs, Test M-1

Following test M-1, a safety performance evaluation was conducted, and the work-zone traffic control device, System No. 1, was determined to be unacceptable according to the NCHRP Report No. 350 criteria. It was deemed unacceptable due to the extensive “spider web” cracking, hole, and indentation in the windshield which resulted in obstructed driver visibility and loss of structure of both glass layers. Detached elements and debris from System No. 1 penetrated the central region of the windshield. Deformations of, or intrusion into, the occupant compartment did occur. The vehicle’s trajectory did not intrude into adjacent traffic lanes.

- Longitudinal NA
 - Lateral (not required) NA
- Occupant Impact Velocity (Normalized)
 - Longitudinal NA
 - Lateral (not required) NA
- Vehicle Damage Severe windshield cracking, indentation, and penetration

- TAD²⁰ 12-FC-1
 - SAE²¹ 12-FCAW6
- Vehicle Stopping Distance 112.17 m downstream
7.62 m left
- Test Article Damage Moderate – Broke apart

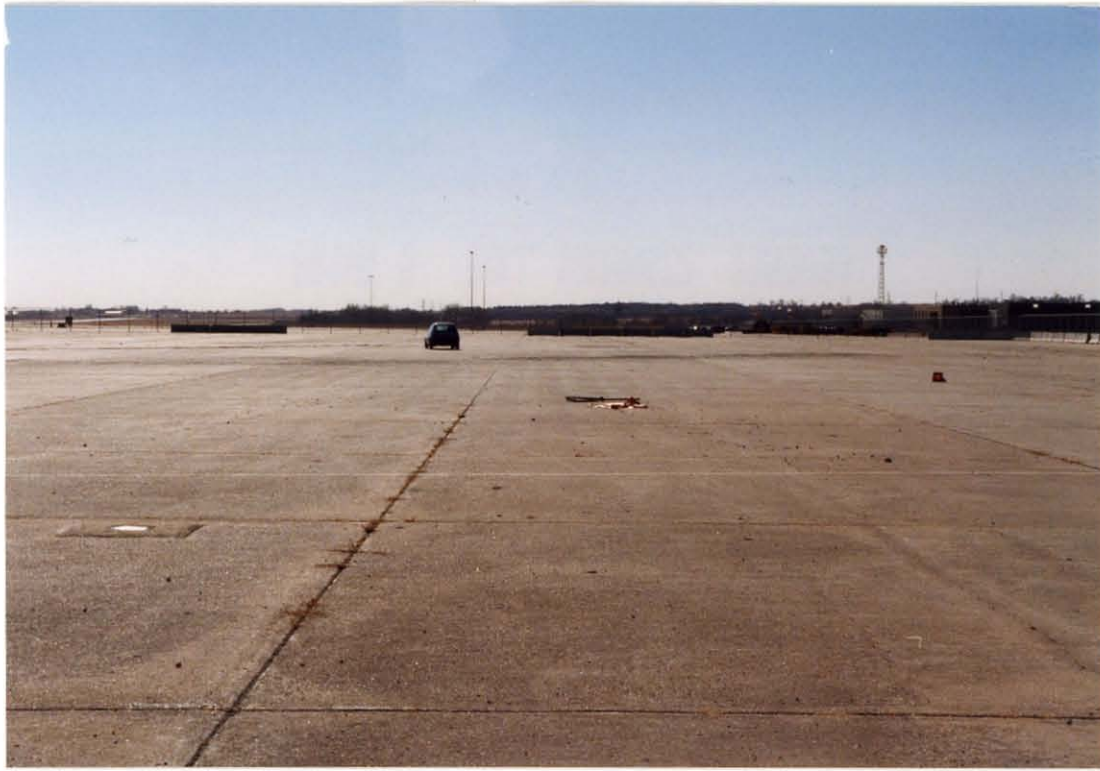
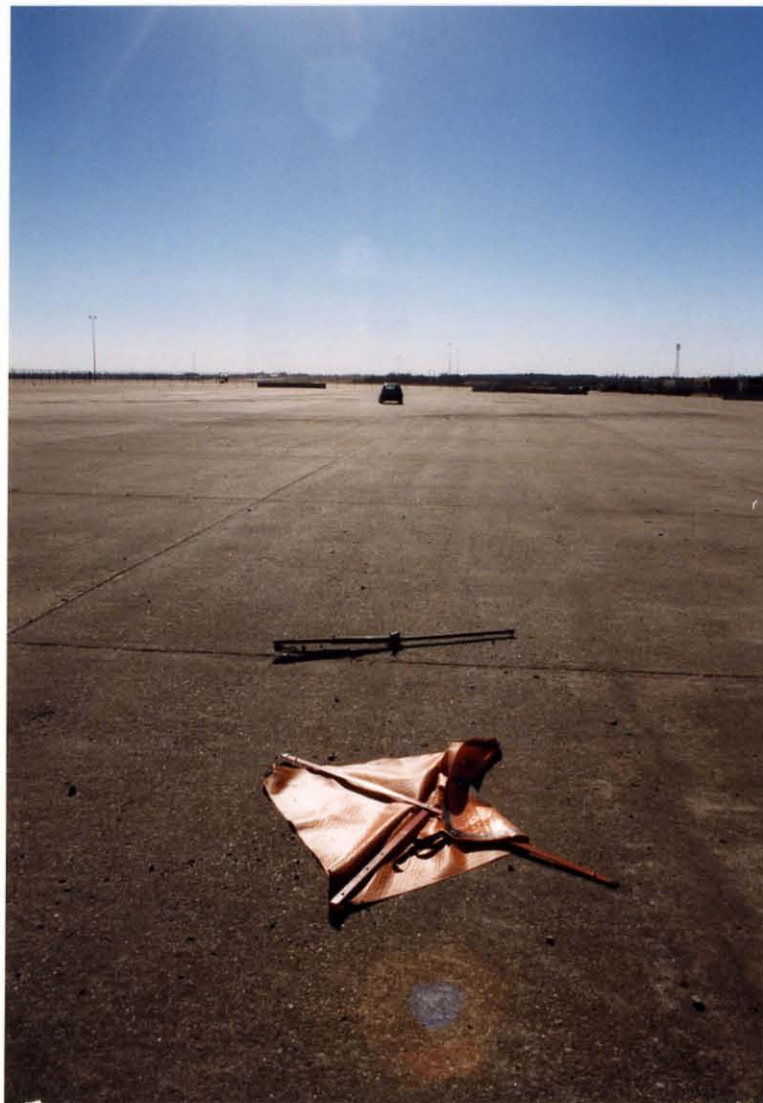
Figure 15. Overall Damage and Final Positions, Test M-1

embedded in the windshield and was positioned nearly parallel to the ground except for the fractured anchor portion. At this same time, the sign post continued to rotate upward. The self-driving sign post support came to rest 49.68 m-downstream from the original position. The sign panel was located 47.24-m downstream from the initial position. The vehicle subsequently came to rest 112.17-m downstream from the midpoint of the impact point and 7.62-m left from the centerline of the vehicle's original path. The final positions of the vehicle and the sign support are shown in Figures 12 and 15.

Damage to System No. 1 is shown in Figures 15 through 18. System No. 1 encountered moderate damage. The sign panel was removed from the horizontal and vertical crossbraces, except for the top of the vertical crossbrace. The velcro straps were removed from the sign support and the sign panel. The self-driving sign post fractured above the bottom sign panel bracket. The self-driving sign post also pulled completely out of the ground. The vinyl sign panel and the fiberglass crossbraces remained undamaged.

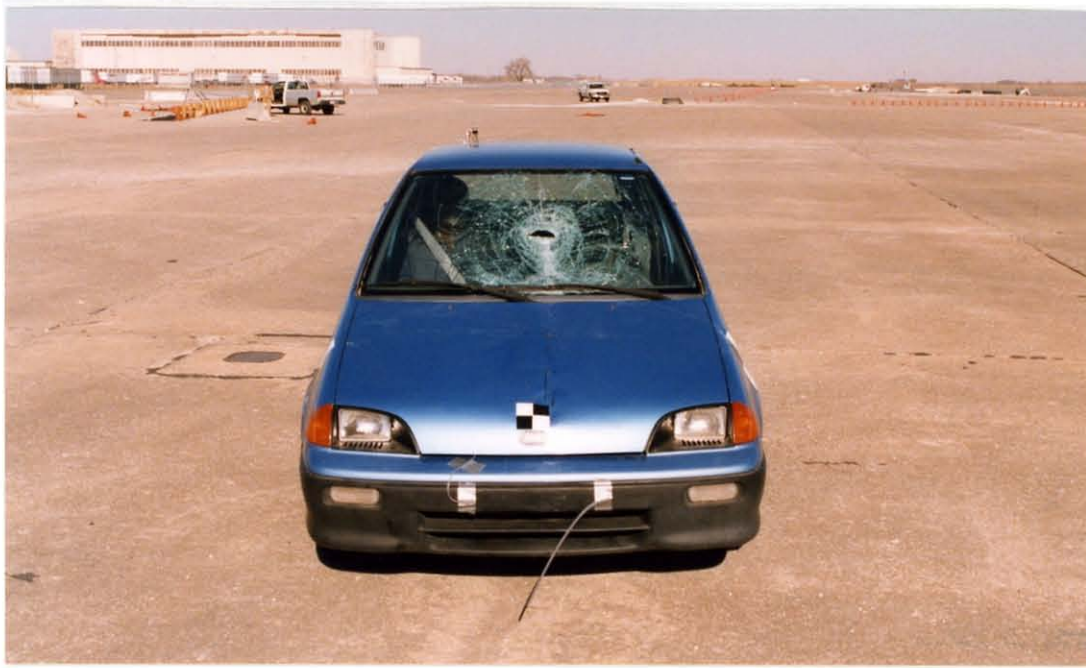
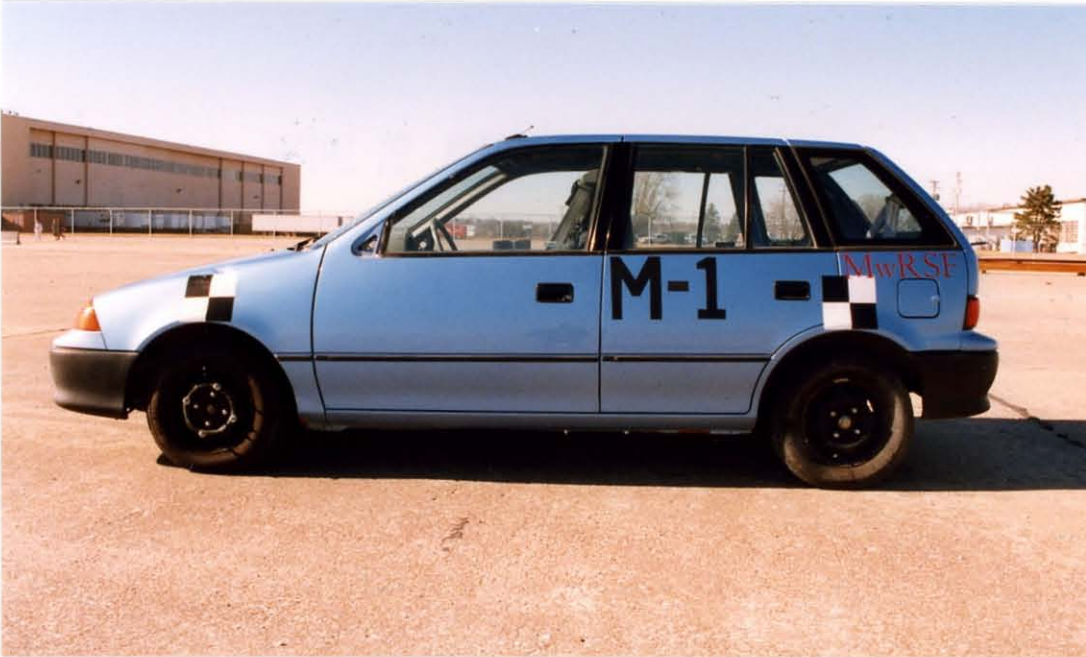
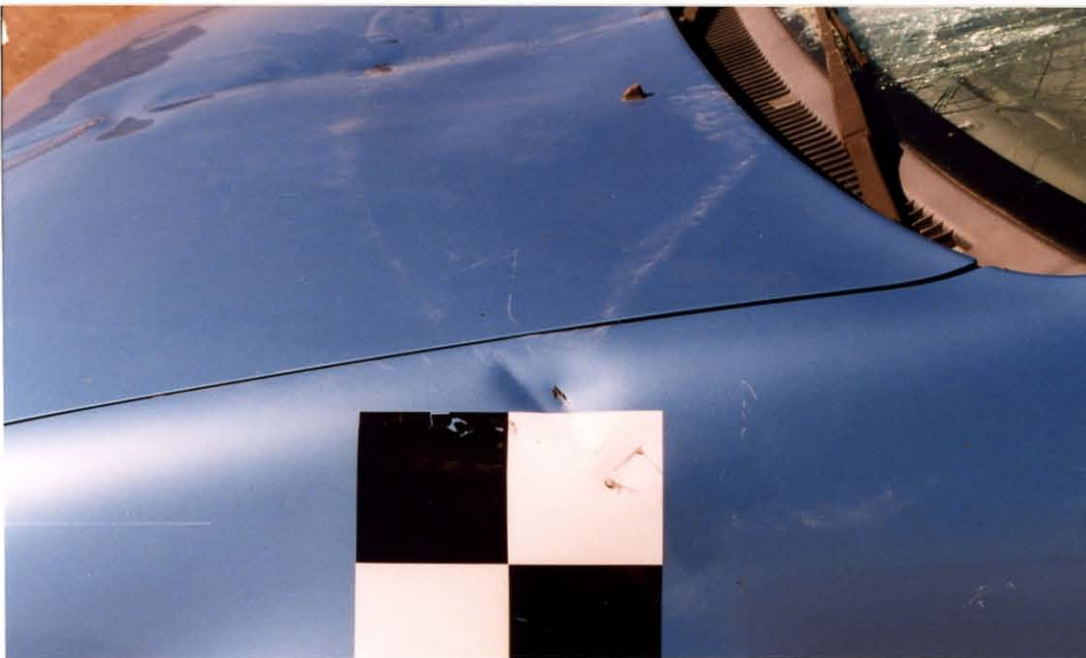
Figure 19. Vehicle Damage, Test M-1

Exterior vehicle damage is shown in Figures 19 and 20. The front bumper and lower plastic shield encountered light contact marks near the center. Contact and scrape marks were also found on the hood. The left-front quarter panel was dented above the tire. The center of the windshield sustained extensive "spider web" cracking of both layers of the glass, causing weak spots. This region of the windshield was also deformed toward the interior of the vehicle with a concentrated indentation. The middle region of the windshield had a hole in the glass. A significant amount of windshield glass had fractured off and was found in the interior of the vehicle. No damage was

found to have occurred to the roof, parking lights, headlights, and fog lights.

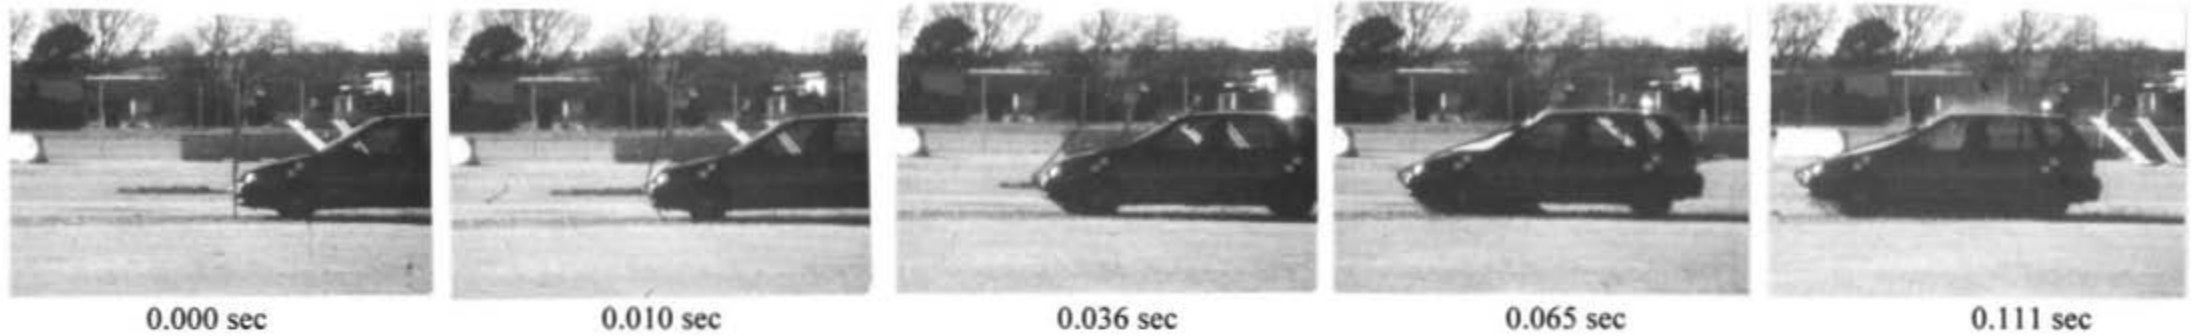
Figure 21. Summary of Test Results and Sequential Photographs, Test M-2

Following test M-2, a safety performance evaluation was conducted, and the work-zone traffic control device, System No. 2, was determined to be unacceptable according to the NCHRP Report No. 350 criteria. It was deemed unacceptable due to the extensive “spider web” cracking, hole, and indentations in the windshield which resulted in obstructed driver visibility and loss of structure of both glass layers. Detached elements and debris from System No. 2 penetrated the upper-central region of the windshield. Deformations of, or intrusion into, the occupant compartment did occur. The vehicle’s trajectory did not intrude into adjacent traffic lanes.

- Longitudinal NA
 - Lateral (not required) NA
- Occupant Impact Velocity (Normalized)
 - Longitudinal NA
 - Lateral (not required) NA
- Vehicle Damage Severe windshield cracking, indentation, and penetration

- TAD²⁰ 12-FC-1
 - SAE²¹ 12-FCAW7
- Vehicle Stopping Distance 51.82 m downstream
0.0 m laterally
- Test Article Damage Moderate – Broke apart

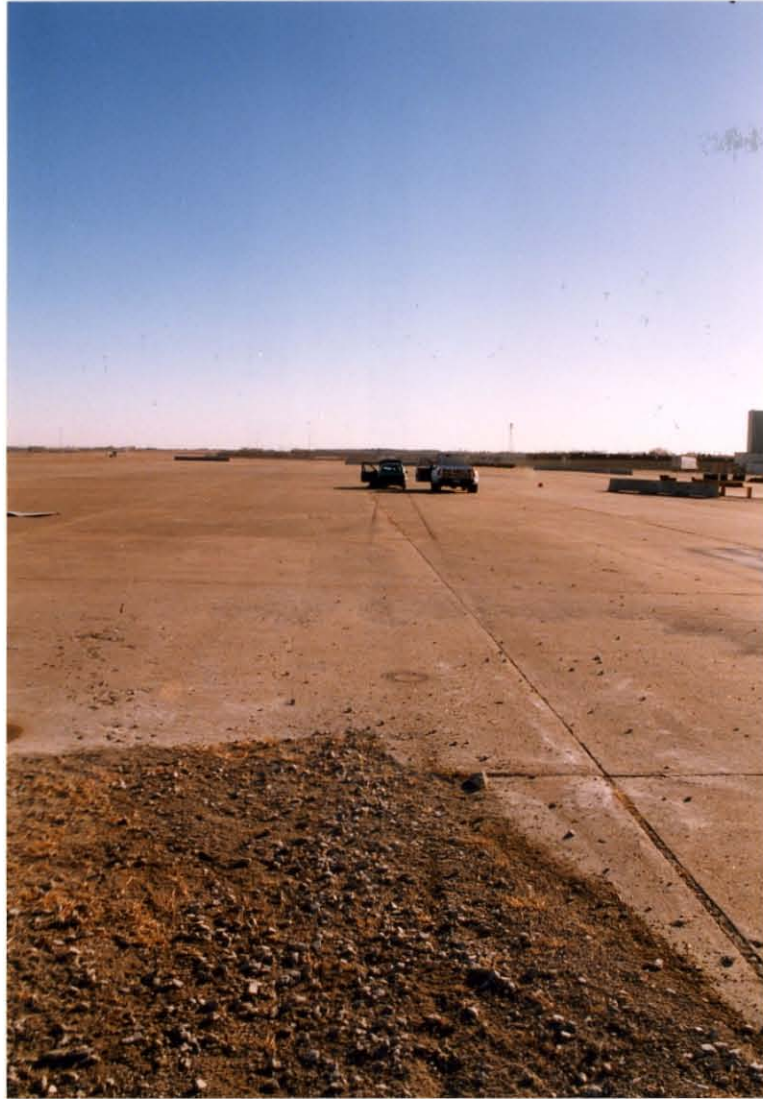
Figure 24. Overall Damage and Final Positions, Test M-2

Damage to System No. 2 is shown in Figures 24 through 26. System No. 2 encountered moderate damage. The aluminum sign panel encountered slight deformations. Light scuff marks were found on the front side of the sign panel. The sign panel also disengaged from the sign panel locking brackets. The self-driving sign post fractured above the bottom sign panel bracket. The self-driving sign post also pulled completely out of the ground.

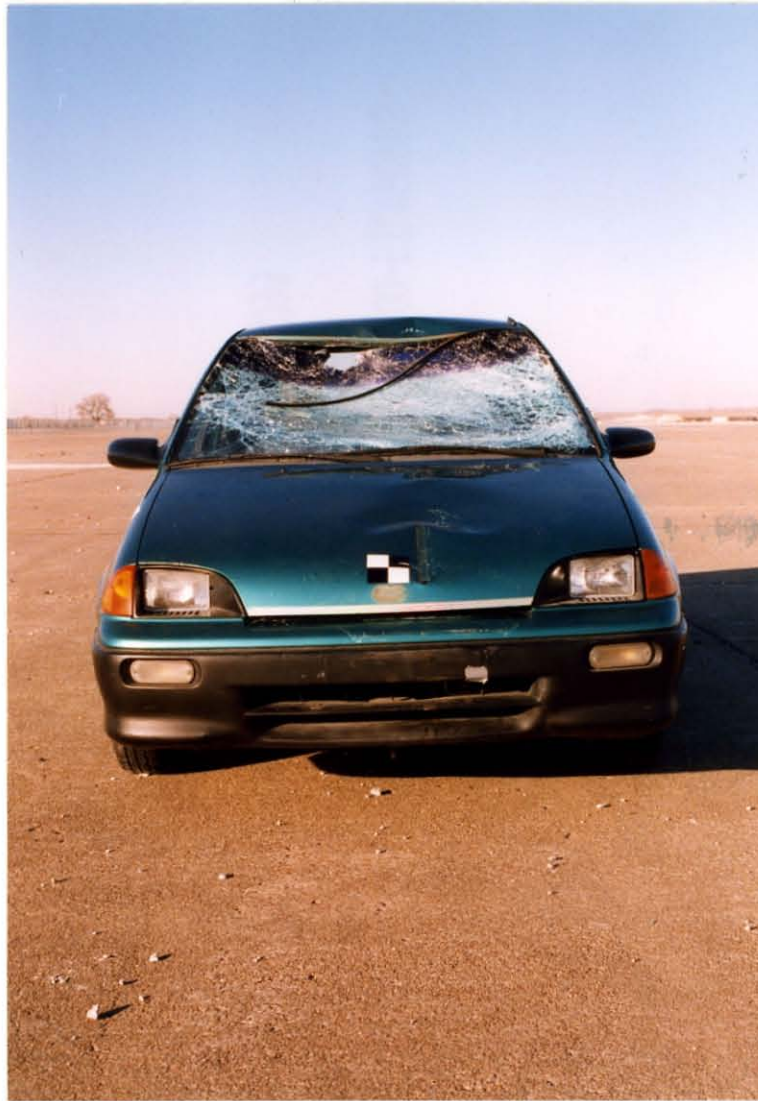
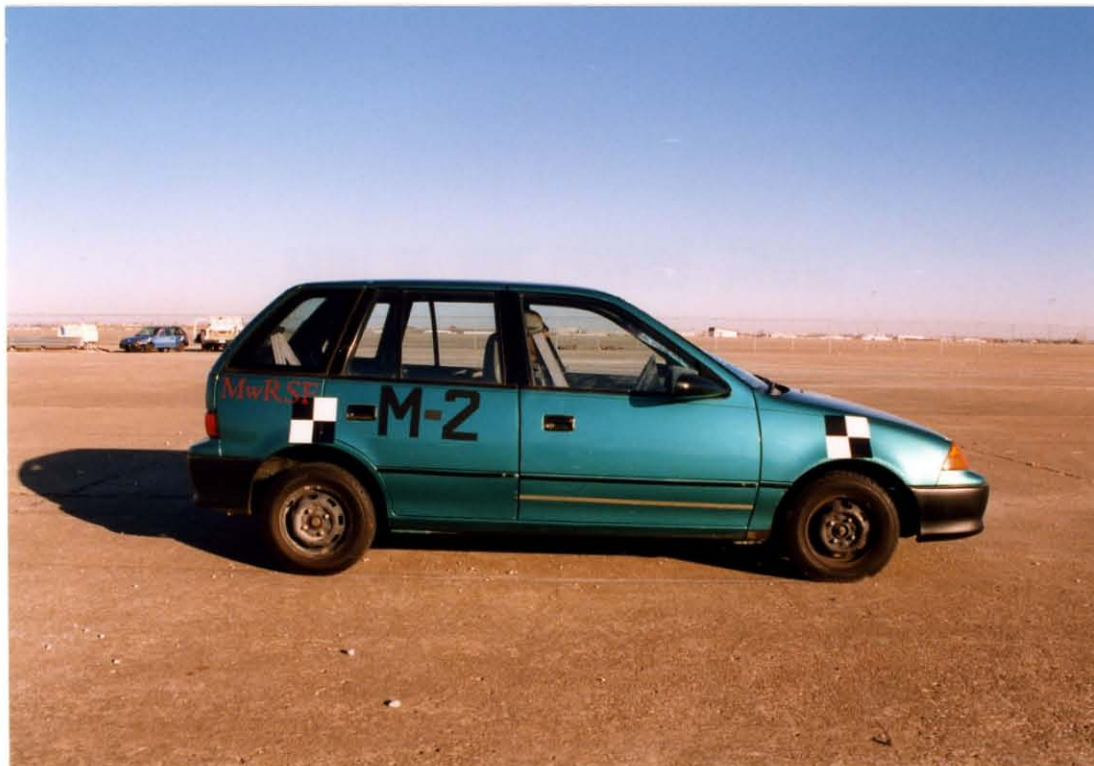
Figure 27. Vehicle Damage, Test M-2

Exterior vehicle damage is shown in Figures 27 and 28. The front bumper and lower plastic shield encountered light contact marks near the center. Contact and scrape marks were also found on the hood. The front-central region of the roof encountered scrape marks and dents. The center of the windshield sustained extensive "spider web" cracking of both layers of the glass, causing weak spots. This region of the windshield was also deformed toward the interior of the vehicle with a concentrated indentation. The upper-middle region of the windshield had a large hole in the glass. A significant amount of windshield glass had fractured off and was found in the interior of the vehicle. No damage was found to have occurred to the parking lights, headlights, and fog lights.

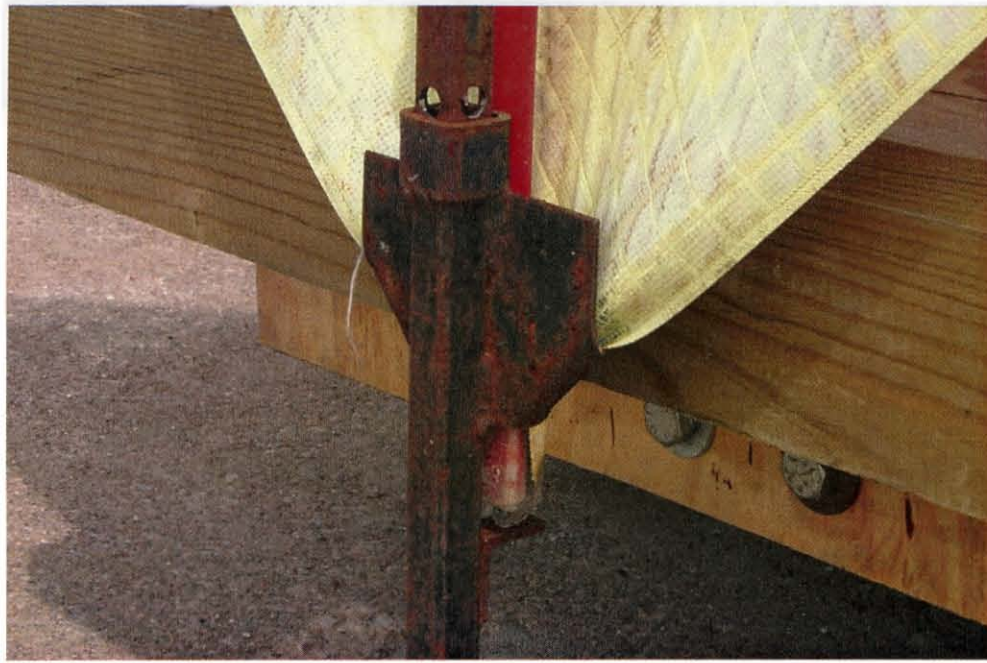
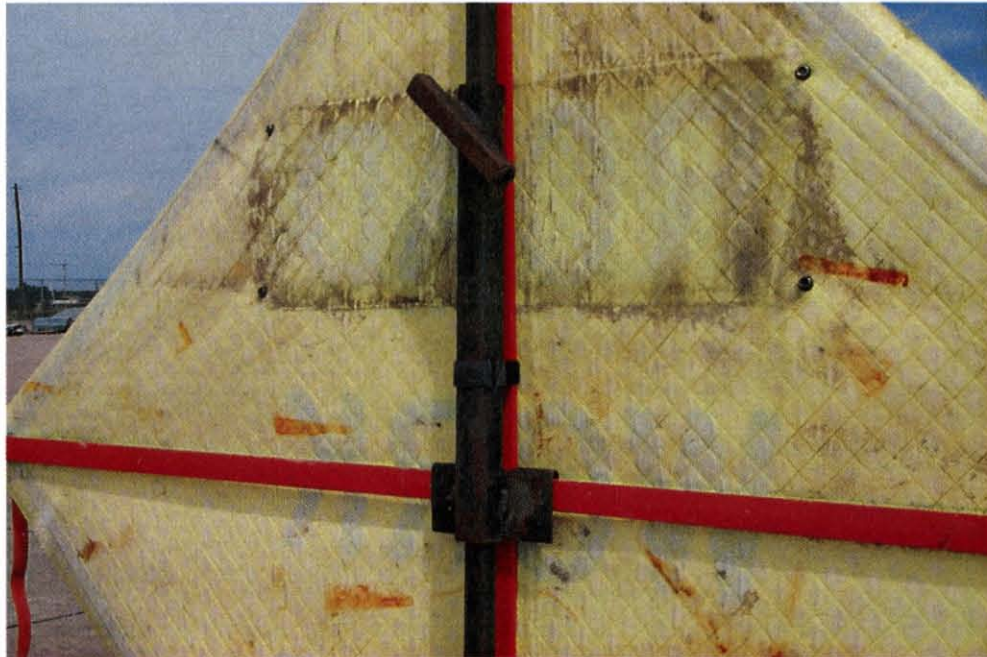
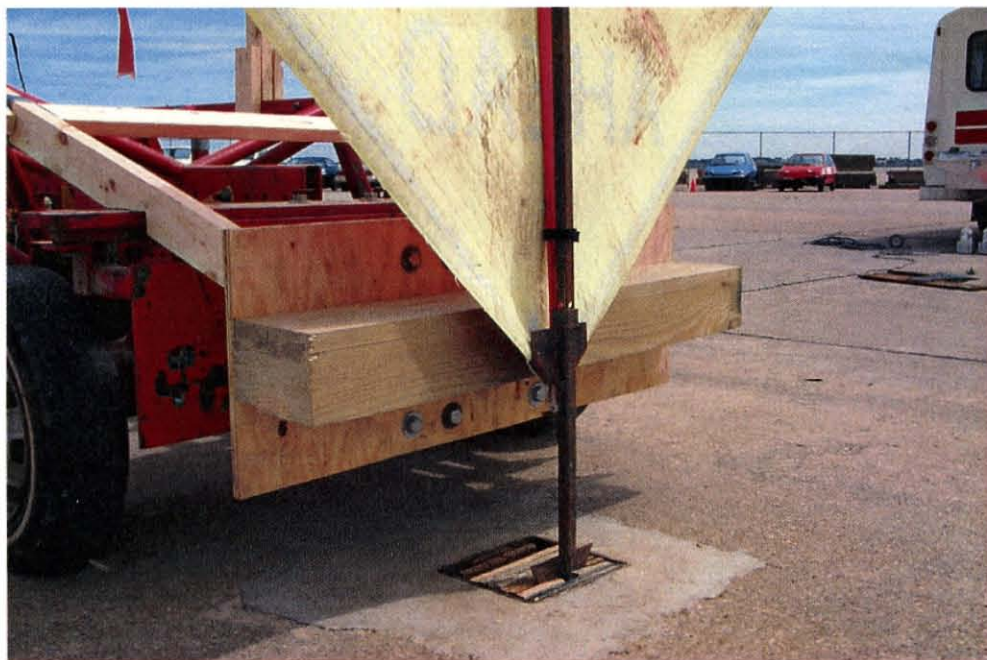
Figure 29. System Design Modifications, Bogie Test MOBOG1

Following an analysis of the test results, the researchers believe that the partial post fracture versus a quick, clean fracture significantly lead to both system failures. As a result, the delayed post fracture caused the deformed system to be pushed by the vehicle's front end, thus causing the sign panel and support to be pulled down toward the windshield. For the crash test with a flexible roll-up sign panel, test no. M-1, the top of the support post caused the windshield damage. For the crash test with a rigid, aluminum sign panel, test no. M-2, the sign panel and the top of the post caused the windshield damage. From these crash tests, in both cases, the entire support post began to pull out of the soil before partial post fracture occurred.

These holes would help to activate the fracture of the sign post system, thus reducing the delayed post fracture, forward movement, and the downward post/panel motion toward the windshield. It was believed that these modifications would reduce the potential for severe windshield contact and fracture. However, the improvement in the safety performance due to these modifications are highly dependent on how well the post stub remains in place in the soil.

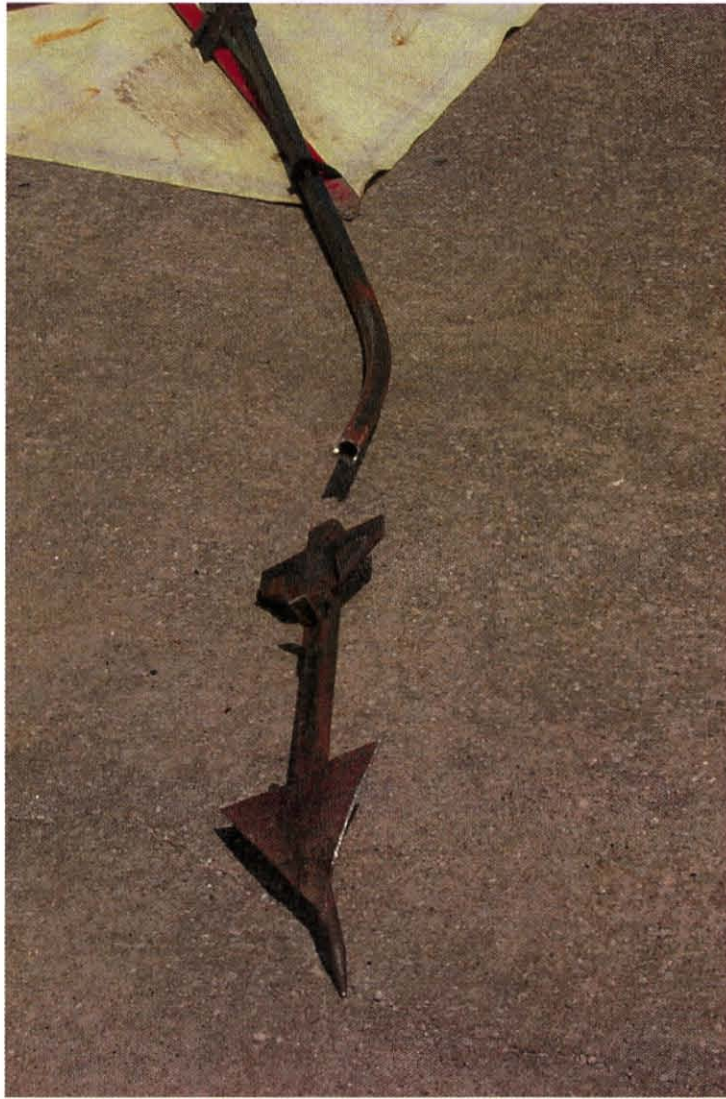
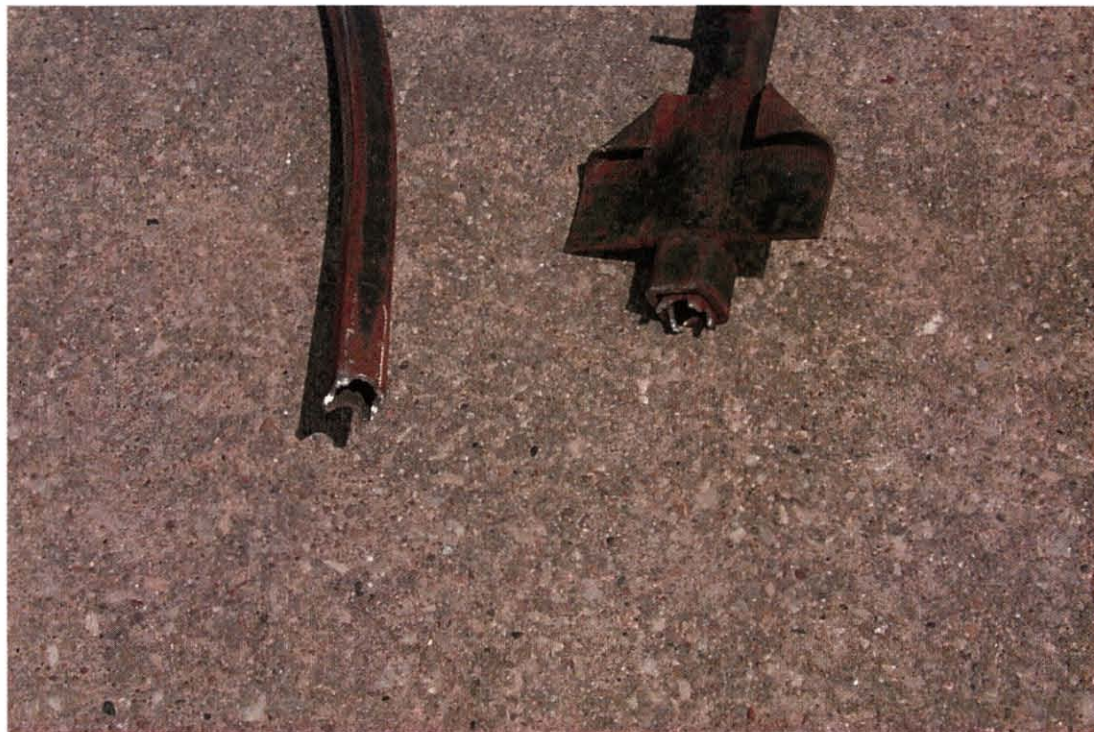
Figure 36. System Damage, Bogie Test MOBOG1

Damage to the modified system is shown in Figures 36 and 37. The system encountered moderate damage. The self-driving sign post fractured at the location of the drilled holes. The remaining stub of the self-driving sign post also pulled completely out of the fixed base, as seen in Figure 36. A few of the plywood shims came out of the fixed base, as shown in Figure 37. Deformations in the self-driving sign post were very prominent near the impact area of the bumper, as seen in Figure 36. The vinyl sign panel and fiberglass crossbraces remained undamaged and attached to the self-driving sign post.

perform as expected, since the sign post did not break cleanly through all of the drilled, post-weakening holes. If a small car would have been used in place of the bogie vehicle, the system would have deformed around the bumper at the front of the small car. Along with the deformation around the front of the small car, the top of the sign post would have impacted and severely punctured the center region of the windshield.

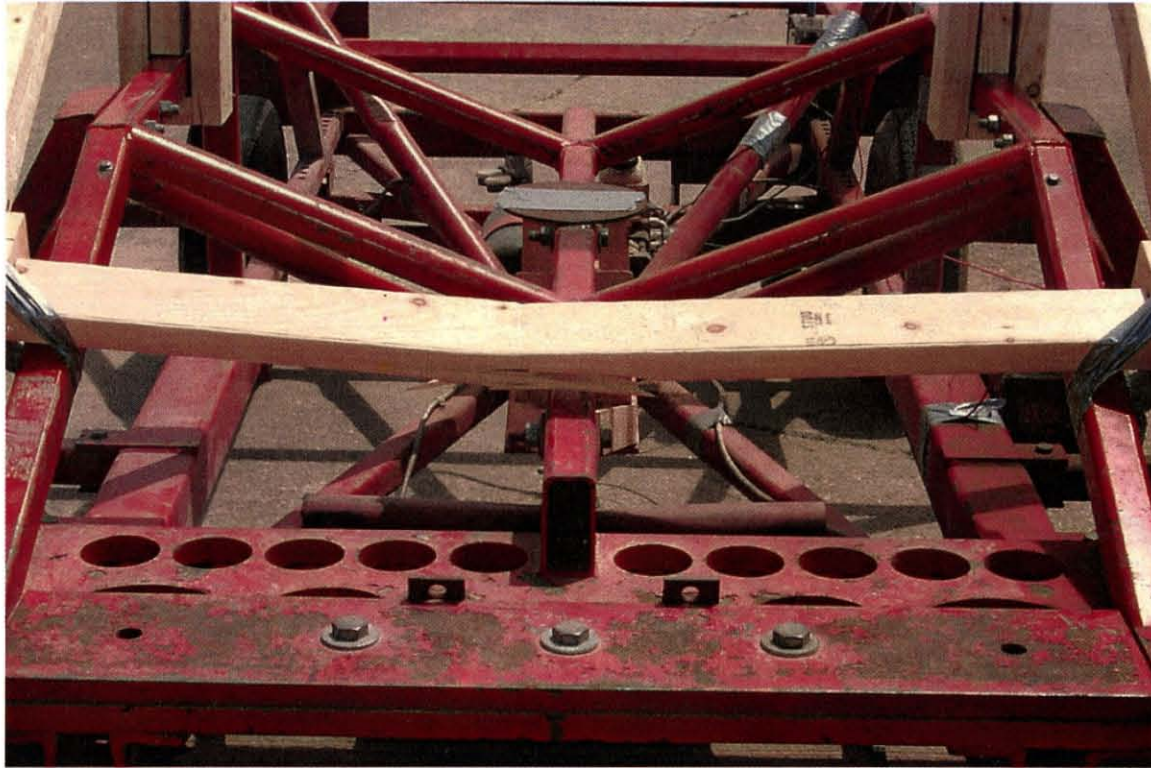
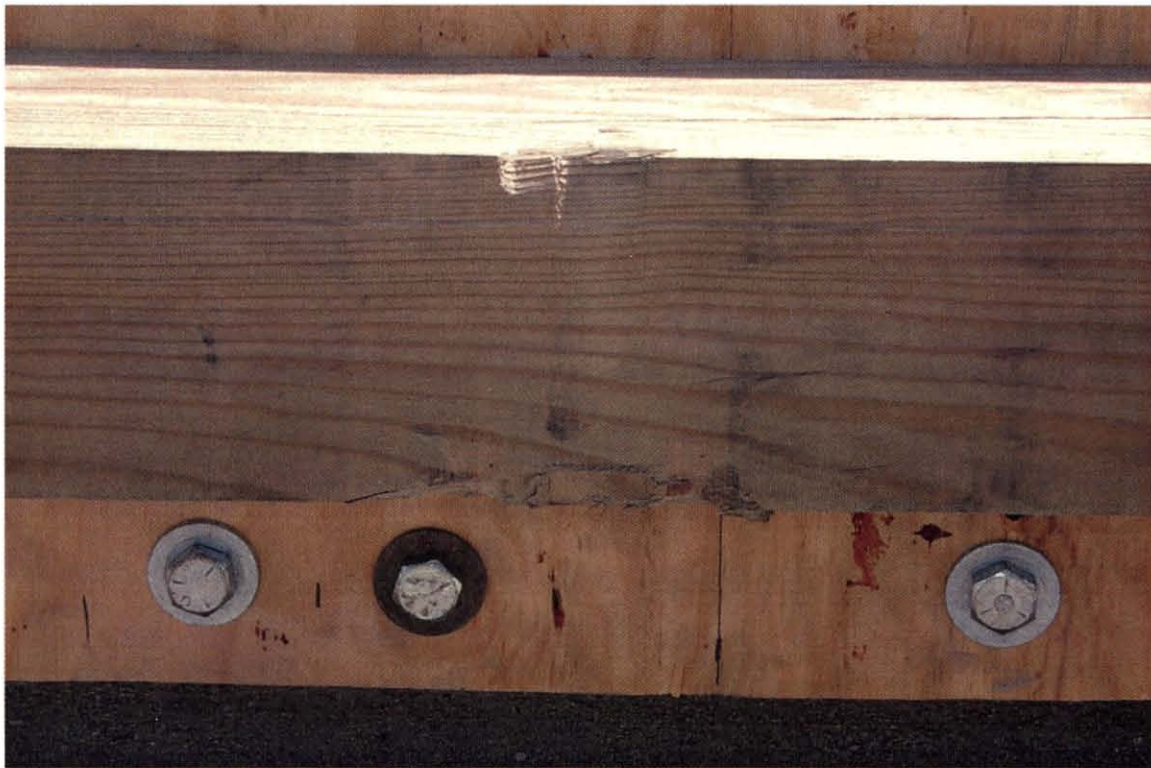
Figure 38. Bogie Vehicle Damage, Bogie Test MOBOG1

The bogie vehicle damage is shown in Figure 38. The center of the wooden simulated bumper was dented. The simulated windshield frame was fractured in the center of the lower frame section. No other damage was found to have occurred to the rest of the bogie vehicle.
