Phase IV Development of a Short-Radius Guardrail for Intersecting Roadways

MwRSF Research Report No. TRP-03-199-08

February 29, 2008

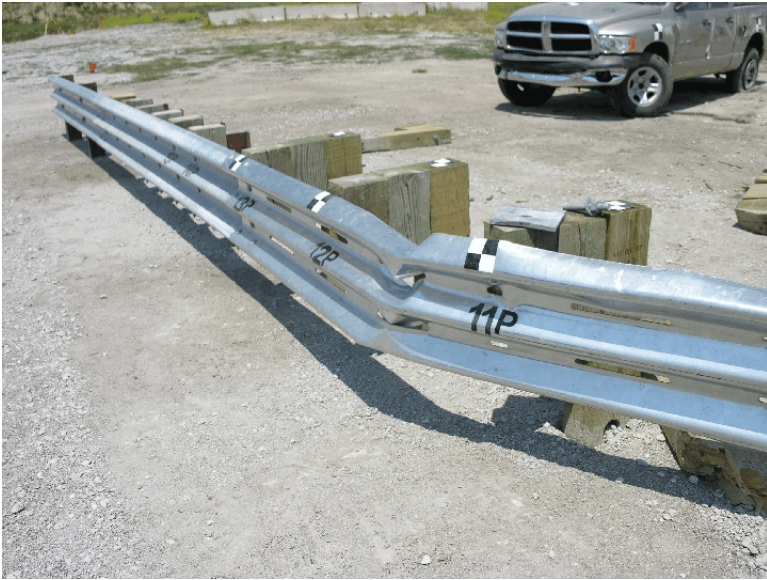
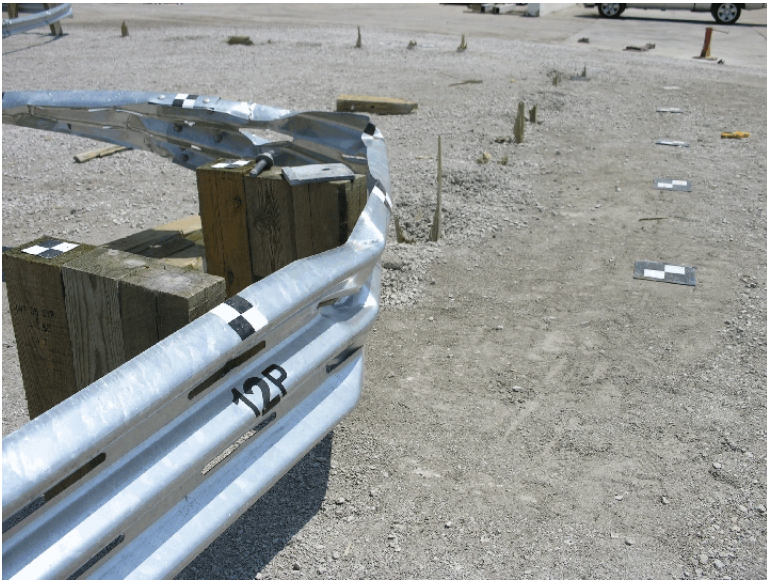
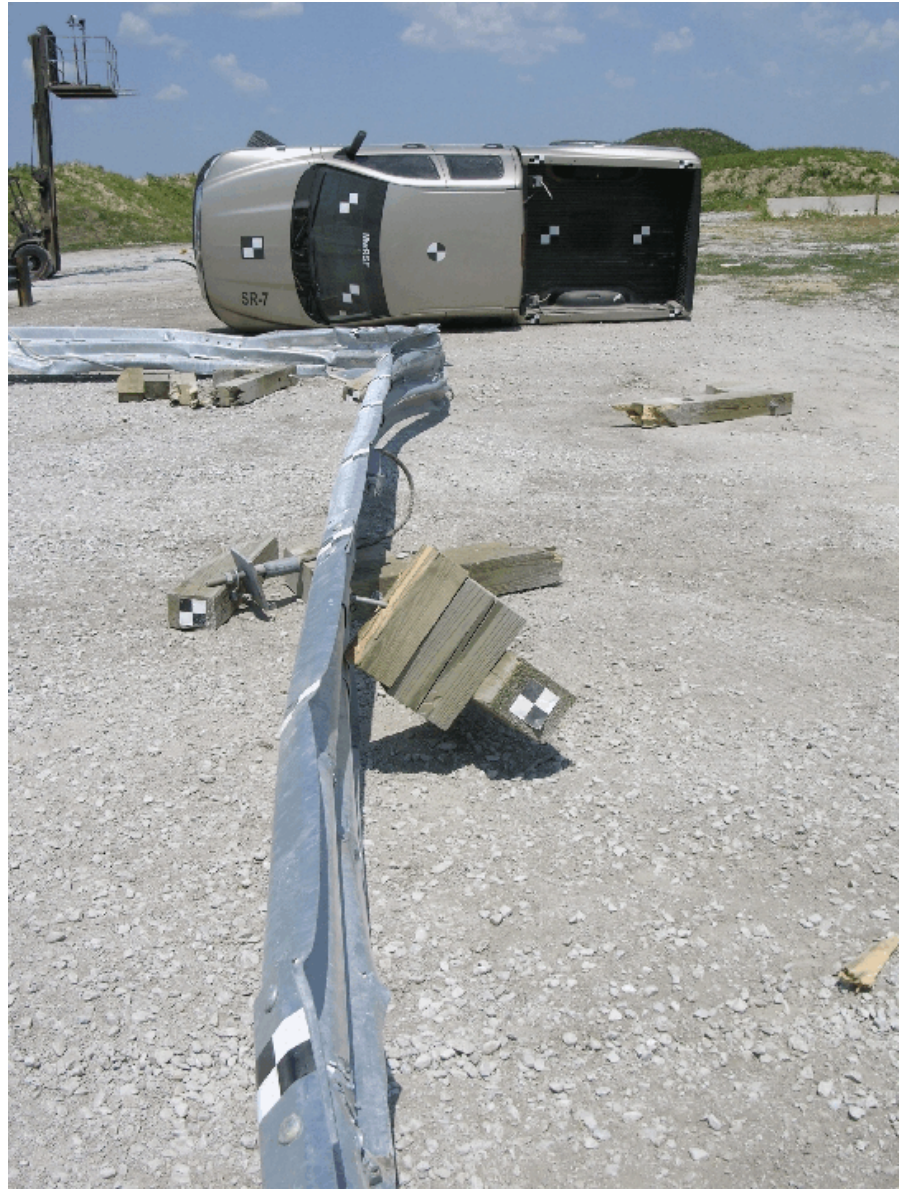
Figure 43. System Damage, Test SR-7

Barrier damage was extensive, as shown in Figures 43 through 58. Damage consisted mostly of fractured posts, fractured blockouts, damaged cable anchor hardware, and flattened and deformed guardrail.

Contact marks were found between the nose section of the rail and post no. 8P. The guardrail was flattened and deformed between post nos. 5P and 3S. Rail buckling was observed in the nose section and between post nos. 1P through 13P and 1S through 8S. The post bolts pulled through the

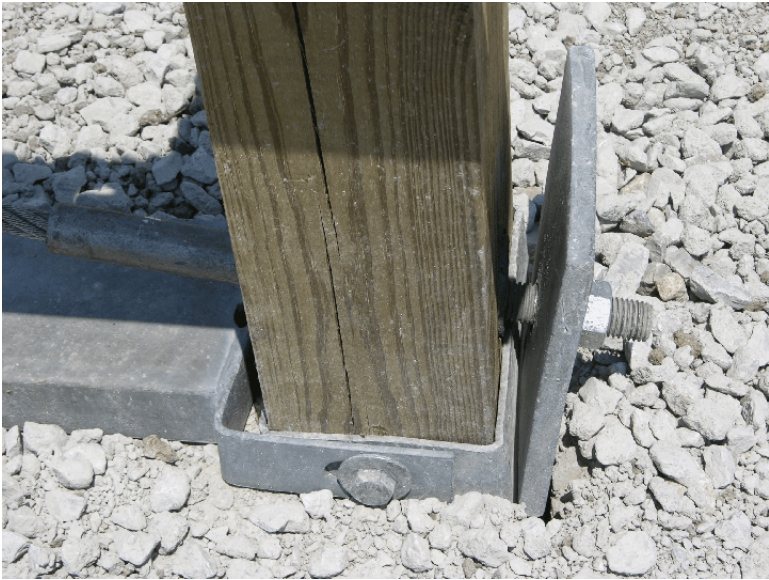
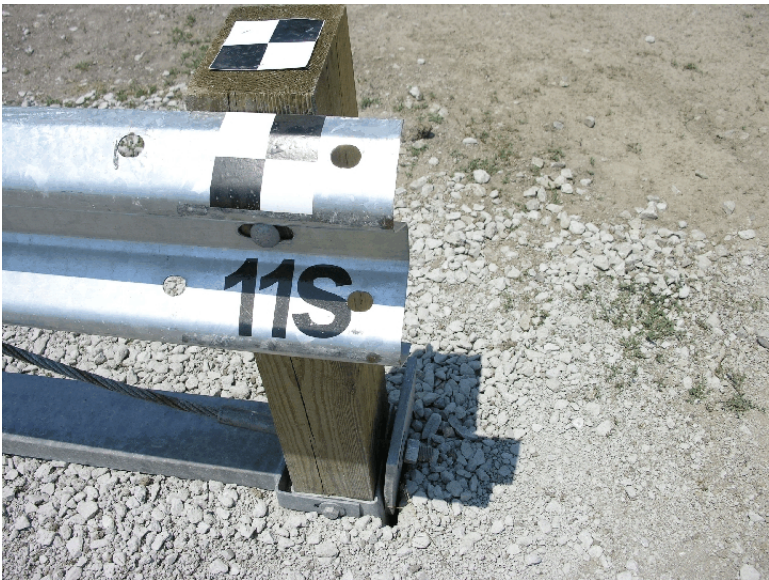
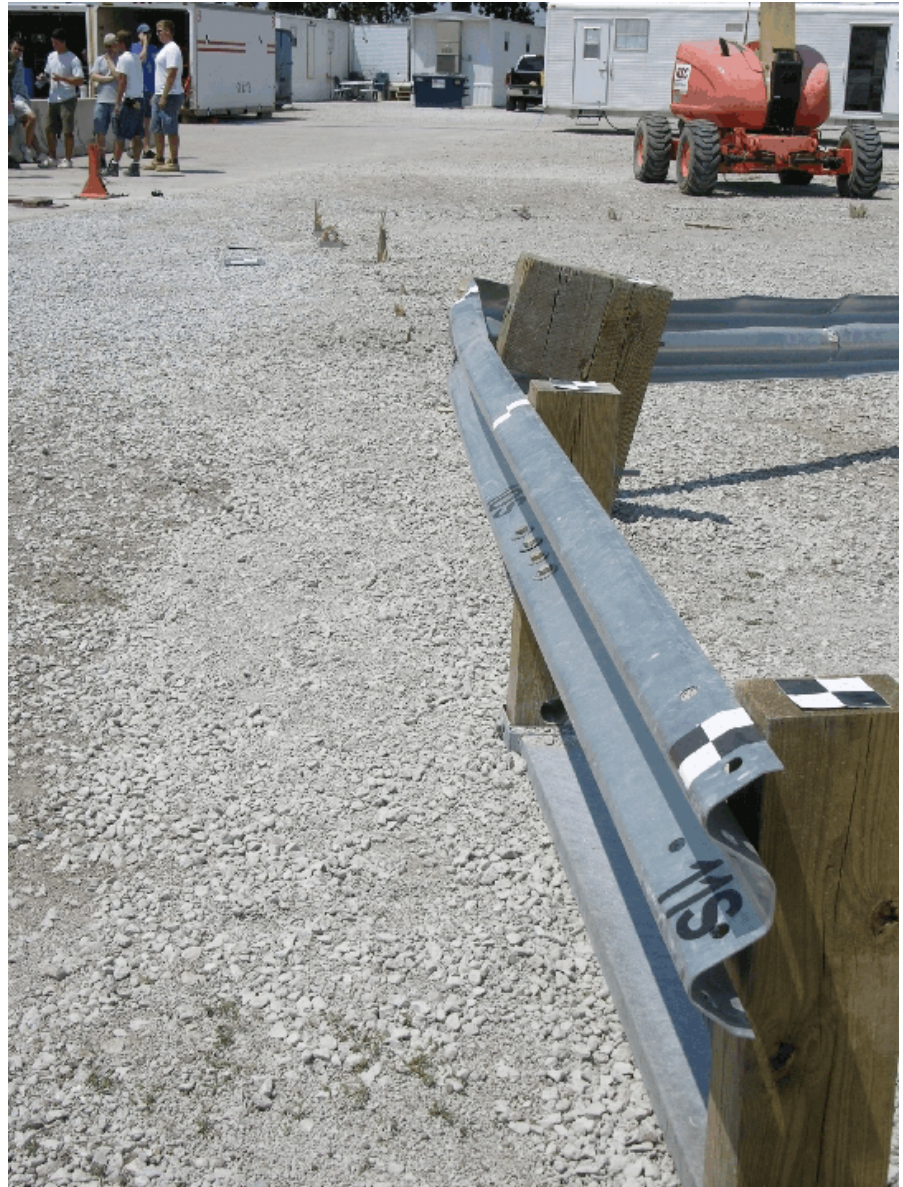
Figure 49. Post Nos. 10 and 11 Damage, Test SR-7

Post nos. 1P, 1S and 2S fractured at the foundation tubes. The foundation tube at post no. 2S was dented and bent along the bolt centerline. Post nos. 2P through 10P fractured and disengaged from the rest of the system. Post no. 11P rotated backwards in the soil and cracked at the groundline. Post nos. 12P and 13P rotated backwards in the soil. Post nos. 1S and 2S fractured in the foundation tubes and were disengaged from the rest of the system. Post nos. 3S through 8S fractured at ground level and disengaged from the rest of the system. Post no. 9S rotated backwards in the soil and cracked through the transverse CRT hole, but remained in the ground.

The blockouts at post nos. 2P through 10P deformed and were damaged around the bolt holes. The blockout at post no. 11P twisted on the bolt and the front face was deformed. The blockout at post no. 9S was compressed on the traffic-side face and the upstream top edge of the traffic face was chipped.

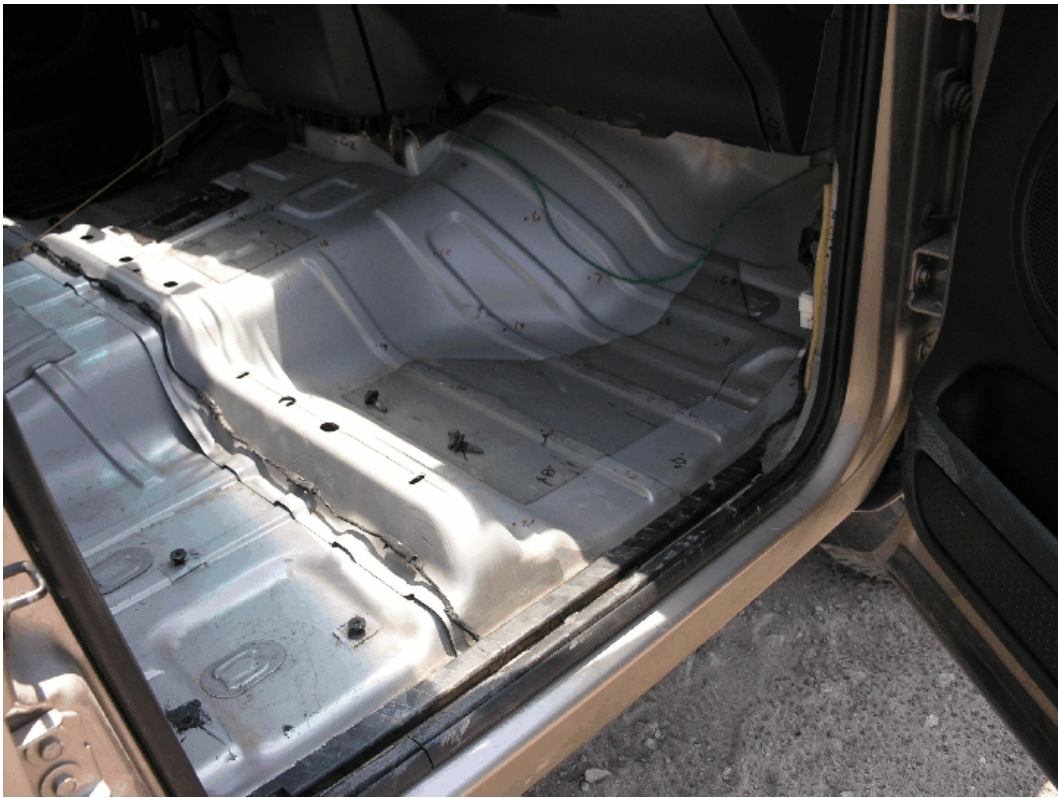
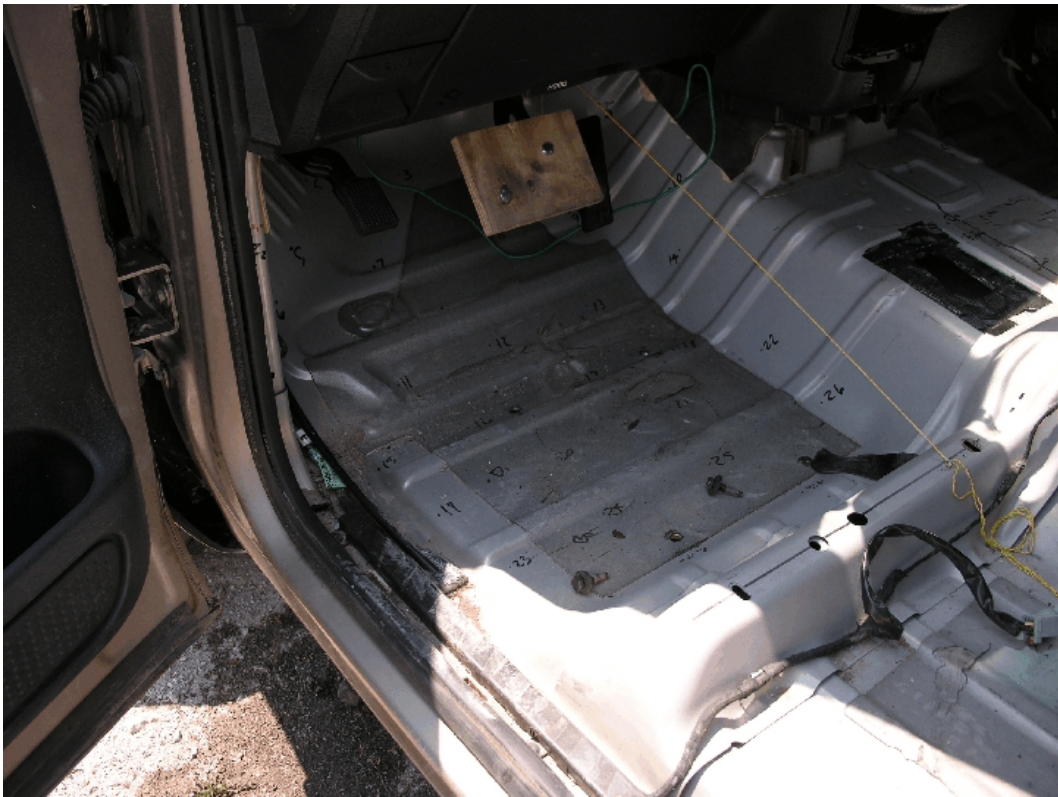
Figure 62. Occupant Compartment Deformation, Test SR-7

Exterior vehicle damage was moderate, as shown in Figures 59 through 62. Occupant compartment deformations to the right side and center of the floorboard were judged insufficient to cause serious injury to the vehicle occupants. A maximum longitudinal deflection of 13 mm (0.5 in.) was located in the right-front corner of the right-side floor pan. A maximum lateral deflection of 13 mm (0.5 in.) was located at the center of the right side of the right-side floor pan. Maximum vertical deflections of 6 mm (0.25 in.) were located throughout the right-side floor pan. Complete occupant compartment deformations and the corresponding locations are provided in Appendix C.

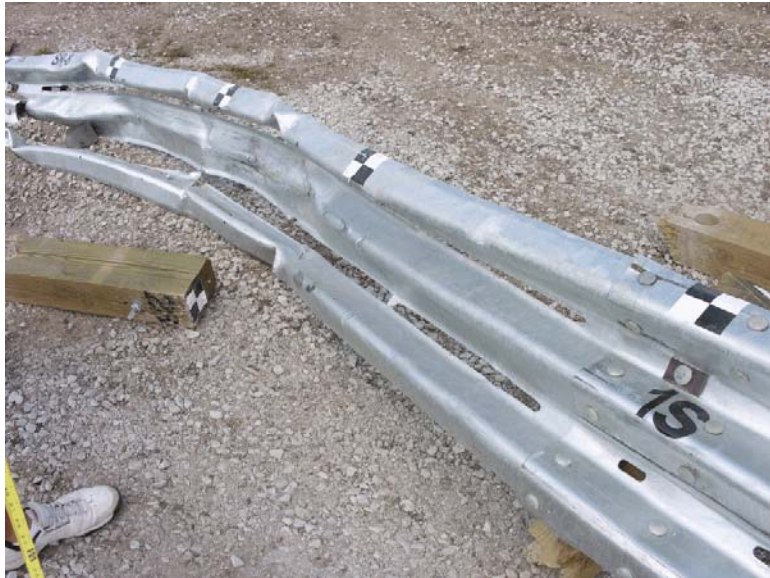
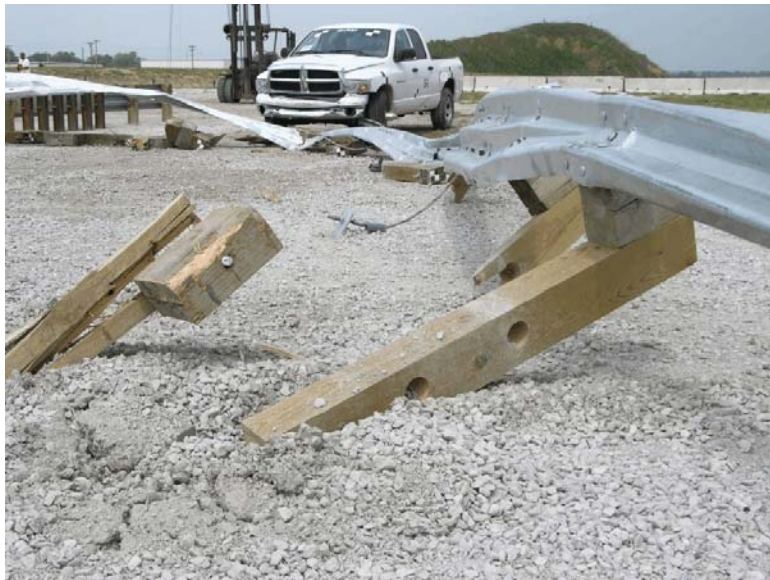
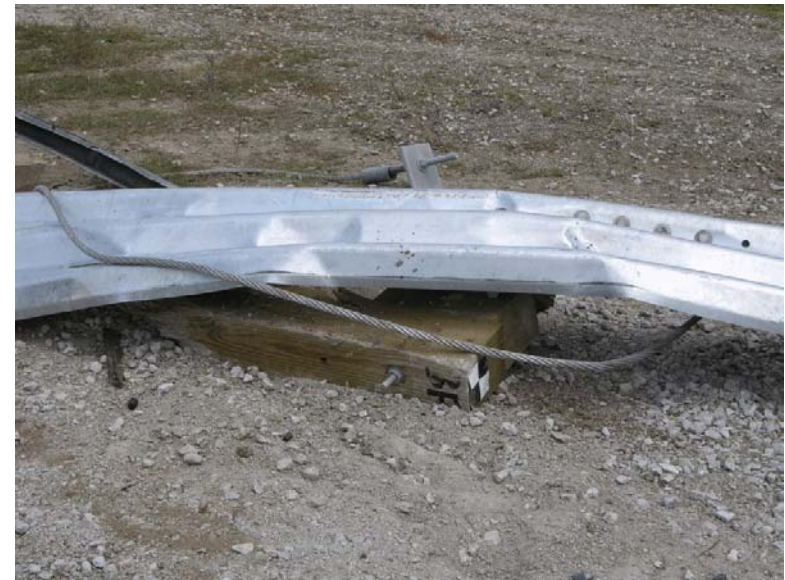
Figure 88. Secondary-Side Post Damage, Test SR-8

Post nos. 1S and 2S fractured at the foundation tubes. Post nos. 3S through 5S fractured in

the soil. Post nos. 2S through 4S also disengaged from the rest of the system. Post no. 6S split vertically. Post no. 7S was removed from the ground without damaged and remained attached to the system. Post no. 8S rotated backward in the soil. Post nos. 9S and 10S rotated downstream in the soil.

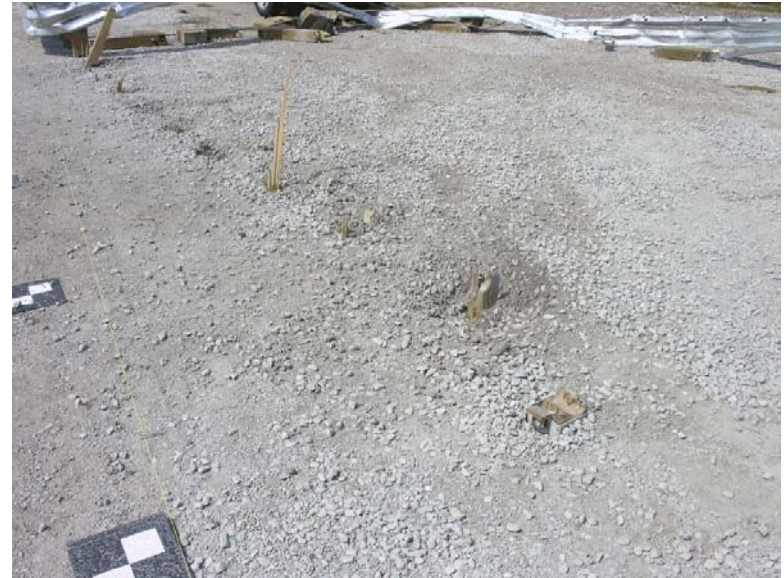
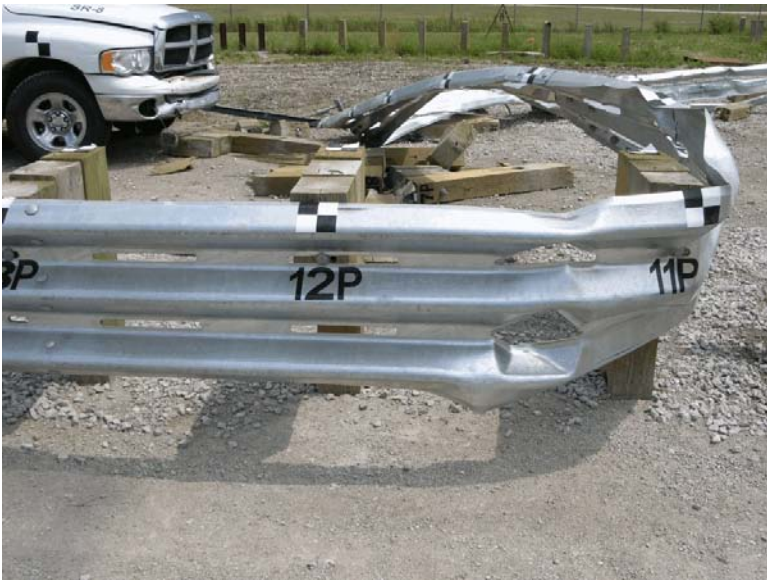
Figure 91. Post Nos. 1P through 12P Damage, Test SR-8

Post nos. 1P through 9P fractured at the ground line. Post nos. 2P through 9 disengaged from the rest of the system. Post no. 10P split vertically through the transverse CRT hole to the top of the post. Post no. 11P rotated backward in the soil. Post no. 12P disengaged from the guardrail but was not damaged.

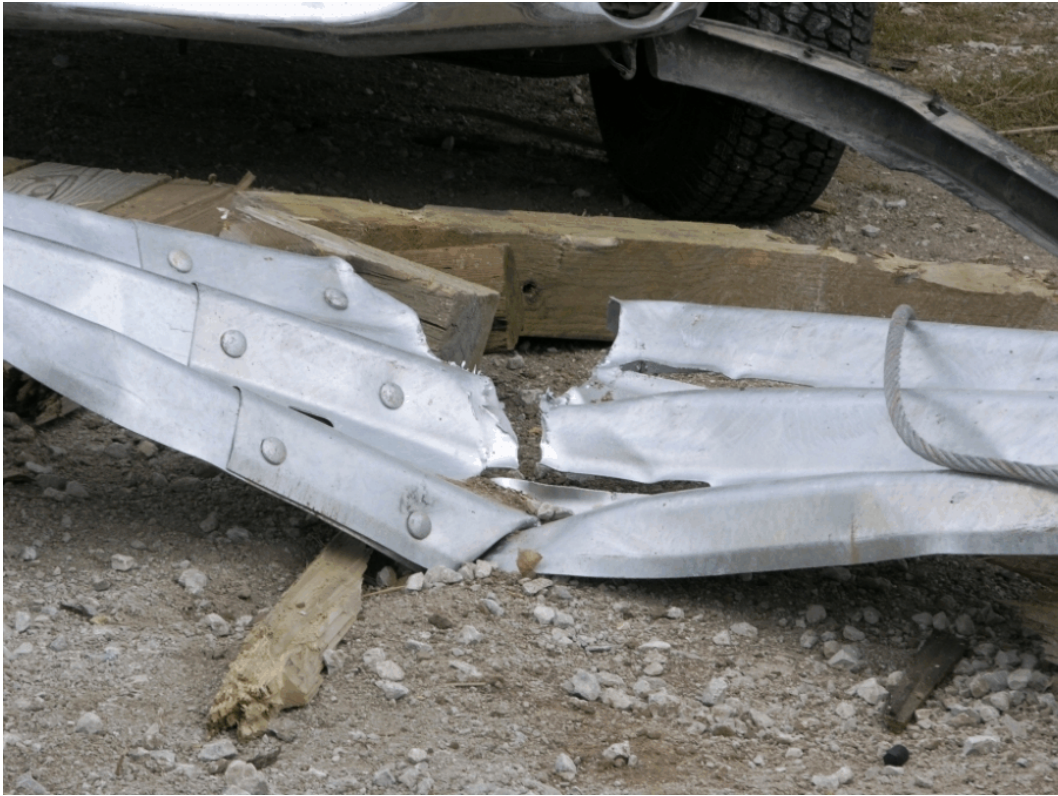
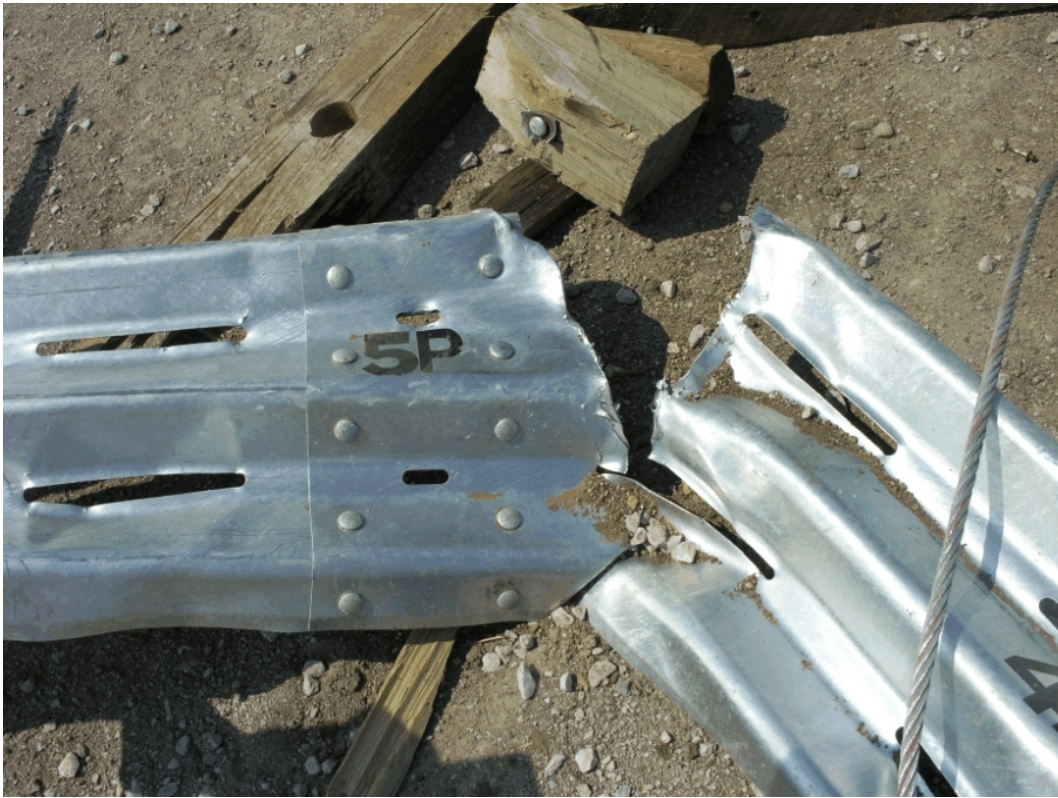
Figure 93. Rail Tear, Test SR-8

Contact marks were found on the nose section and on the primary side between post nos. 1P and 13P. Buckling was also found in the rail between post nos. 1S and 8S. Three of the bottom corrugation slot tabs were torn in the nose section. A 152-mm (6-in.) long tear occurred 330 mm (13 in.) downstream of impact on the primary side, and another small tear occurred 1,168 mm (46 in.) downstream of impact on the primary side. A 457-mm (18-in.) long tear occurred at the splice at post no. 5 and extended from the top of the thrie beam to the slot in the lower valley. A small tear occurred in the nose section, downstream of post no. 1. A 152-mm (6 in.) tear was also located between post nos. 1S and 2S. The rail slots at post nos. 2P and 4P opened up, and the post bolt washers pulled through. The lower nose cable was detached from the guardrail.

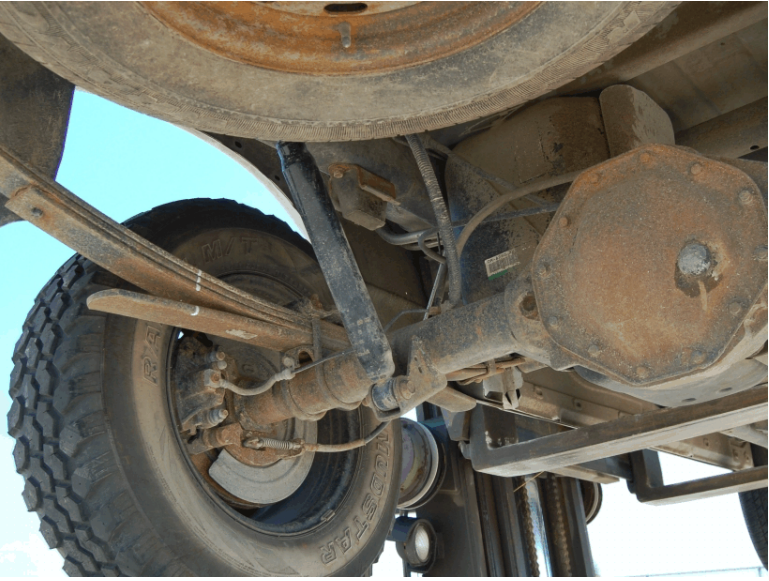
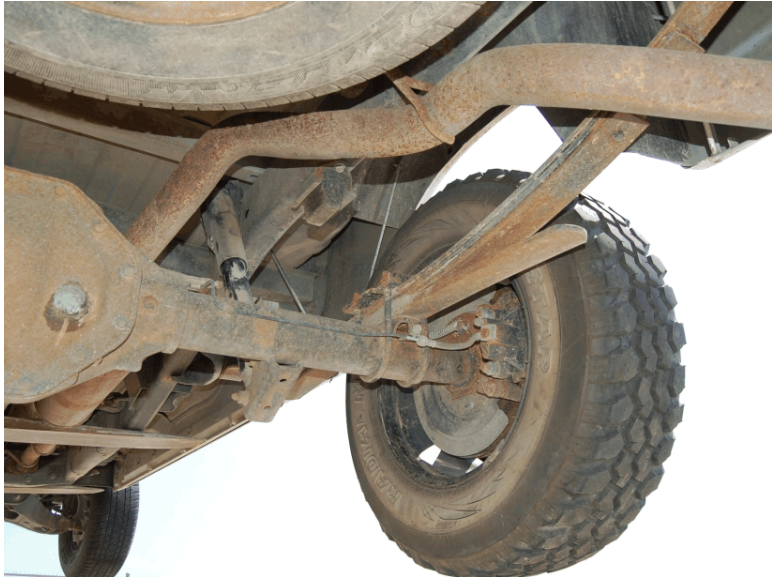
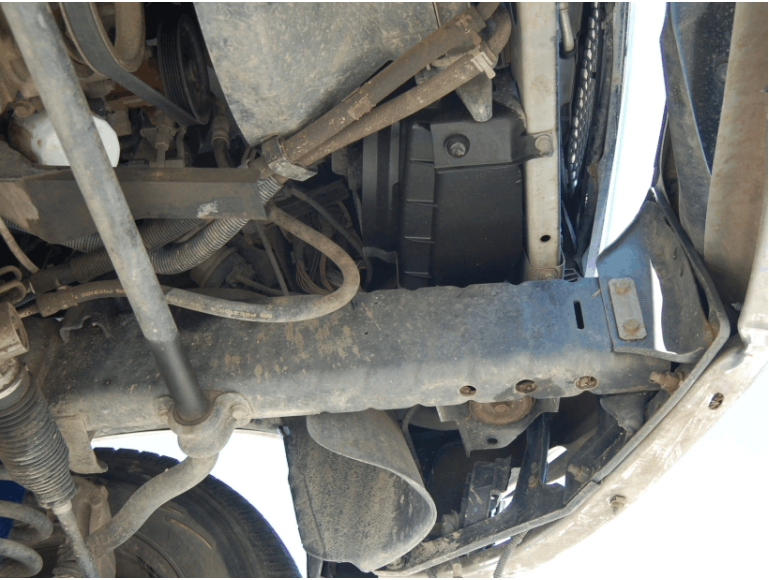
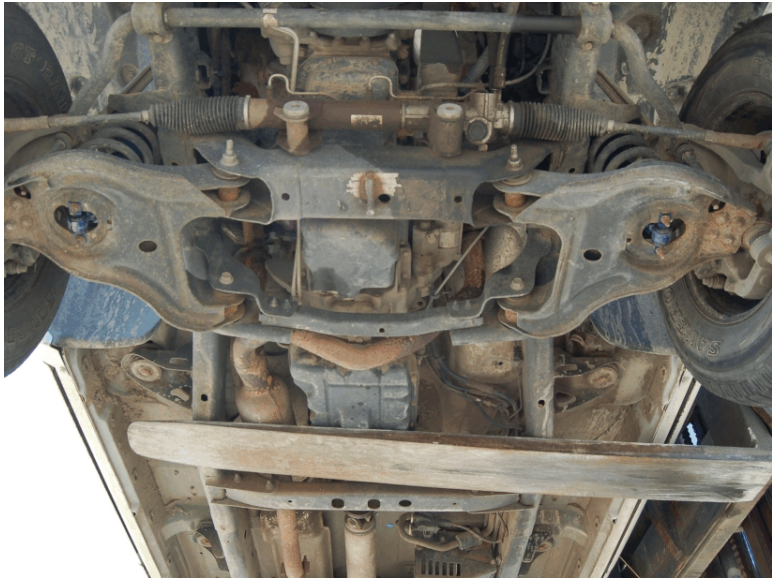
Figure 96. Undercarriage Damage, Test SR-8

Exterior vehicle damage was minimal, as shown in Figures 94 through 96. Occupant compartment deformations to the right side and front of the floorboard were deemed insufficient to cause injury to the vehicle occupants. Maximum longitudinal displacements of 6 mm (0.25 in.) occurred throughout the right side of the floorboard. Maximum lateral displacements of 19 mm (0.75 in.) occurred at the left-front corner of the right-side floorboard. Maximum vertical displacements of 6 mm (0.25 in.) were located throughout the right-side floorpan. Complete occupant compartment deformations and the corresponding locations are provided in Appendix G.

Damage was concentrated on the front of the vehicle. The left-front bumper corner of the bumper was shifted and deformed into the frame and encountered tearing. The grill was crushed and deformed into the engine compartment, and the bumper bowed outward in the center. The vehicle's hood deformed upward approximately 25 mm (1 in.) above the grill. Both right-front and left-front foglights were broken. Contact marks, scrapes, scratches, and kinks occurred throughout the length of the bumper. A 102-mm (4 in.) tear occurred at the bottom of the left-front door. Dents were found
