ISO 17025 LABORATORY
TESTING CERT # 2937.01

TESTING AND EVALUATION OF MASH TL-3 TRANSITION BETWEEN GUARDRAIL AND PORTABLE CONCRETE BARRIERS

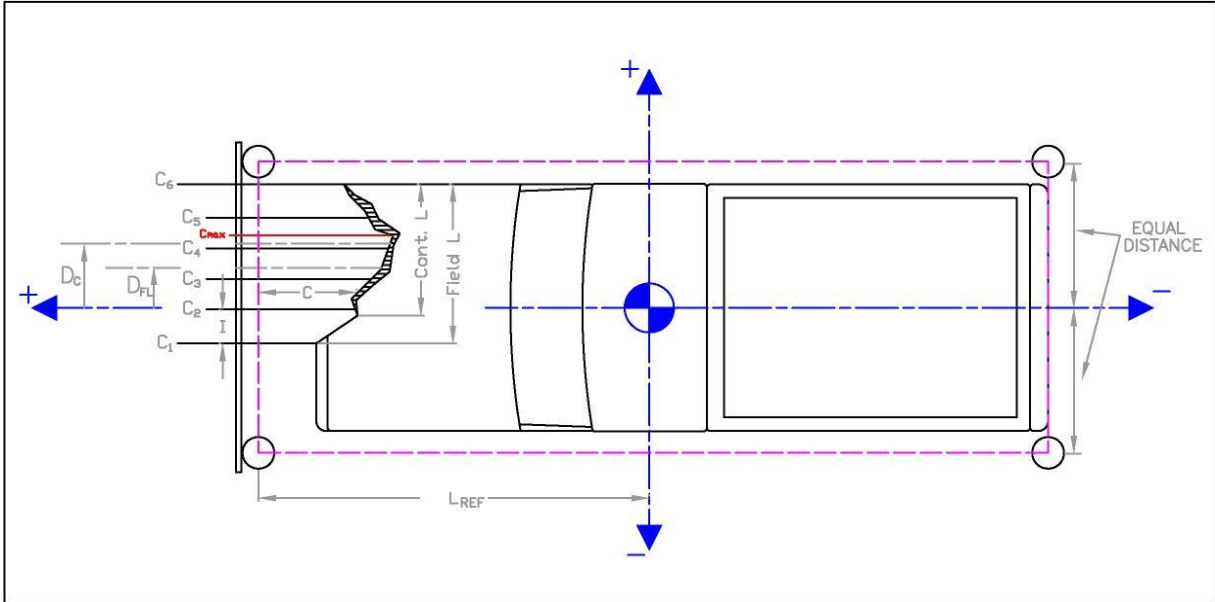
in.	(mm)
Distance from C.G. to reference line - L-REF:	100	(2540)
Total Vehicle Width:	78.5	(1994)
Width of contact and induced crush - Field L:	78 1/2	(1994)
Crush measurement spacing interval (L/5) - I:	15.7	(399)
Distance from center of vehicle to center of Field L - D _{FL} :	0	(0)
Width of Contact Damage:	78 1/2	(1994)
Distance from center of vehicle to center of contact damage - D _C :	0	(0)

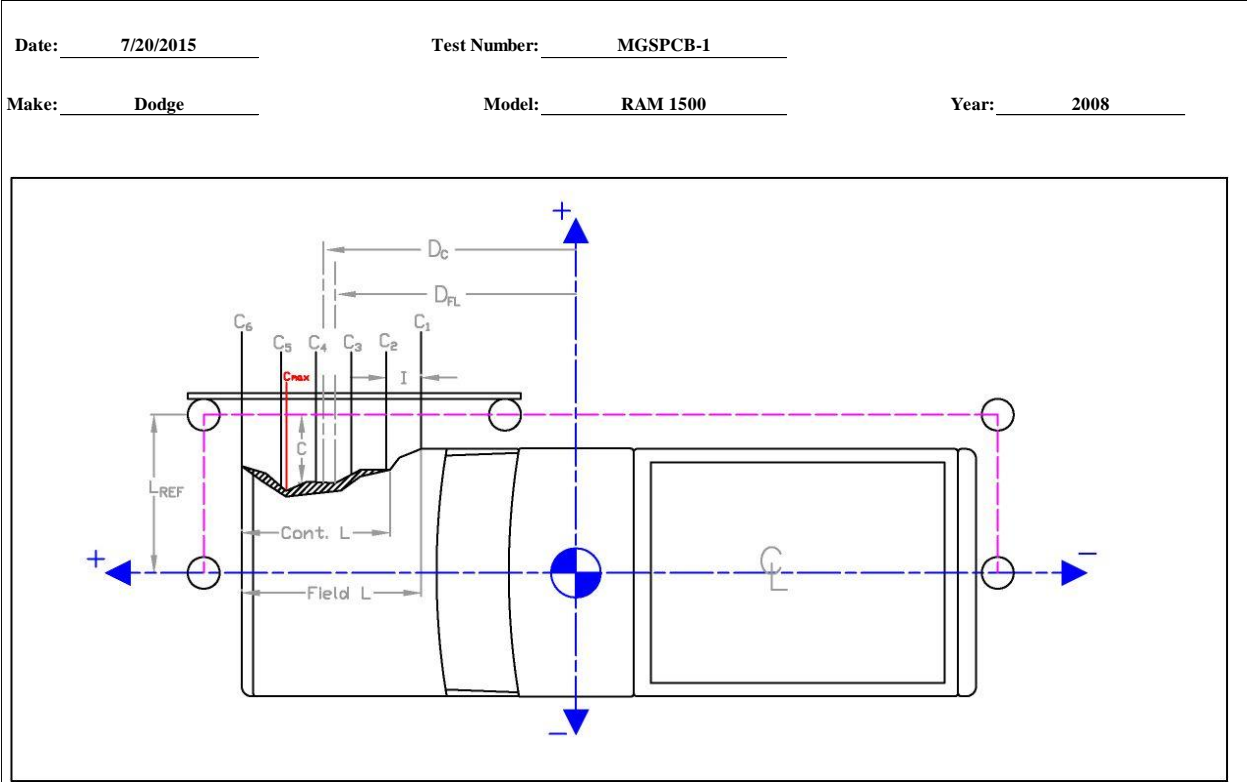
in.	(mm)
Distance from centerline to reference line - L _{REF} :	45	(1143)
Total Vehicle Length: 227.5 (5779)		
Width of contact and induced crush - Field L: 227 1/2 (5779)		
Crush measurement spacing interval (L/5) - I: 45.5 (1156)		
Distance from vehicle c.g. to center of Field L - D _{FL} :	-13	-(330)
Width of Contact Damage: 227 1/2 (5779)		
Distance from vehicle c.g. to center of contact damage - D _C :	-13	-(330)

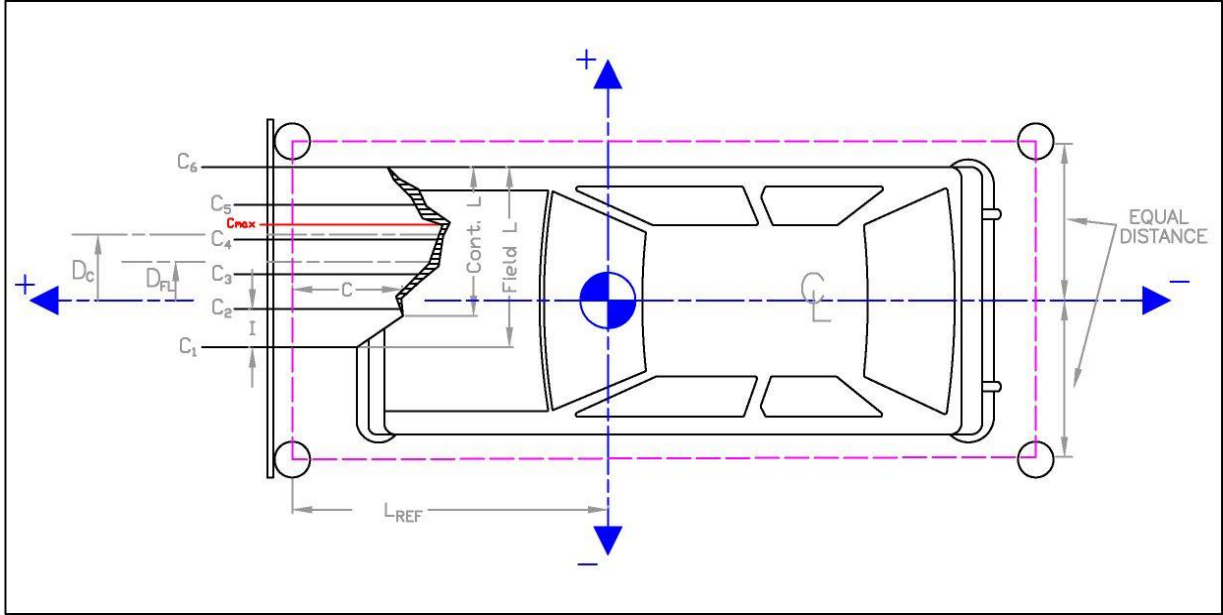
in.	(mm)
Distance from C.G. to reference line - L _{REF} :	74	(1880)
Total Width of Vehicle:	61 3/4	(1568)
Width of contact and induced crush - Field L:	61 3/4	(1568)
Crush measurement spacing interval (L/5) - I:	12 1/3	(314)
Distance from center of vehicle to center of Field L - D _{FL} :	0	(0)
Width of Contact Damage:	24 3/8	(619)
Distance from center of vehicle to center of contact damage - D _C :	18 5/8	(473)

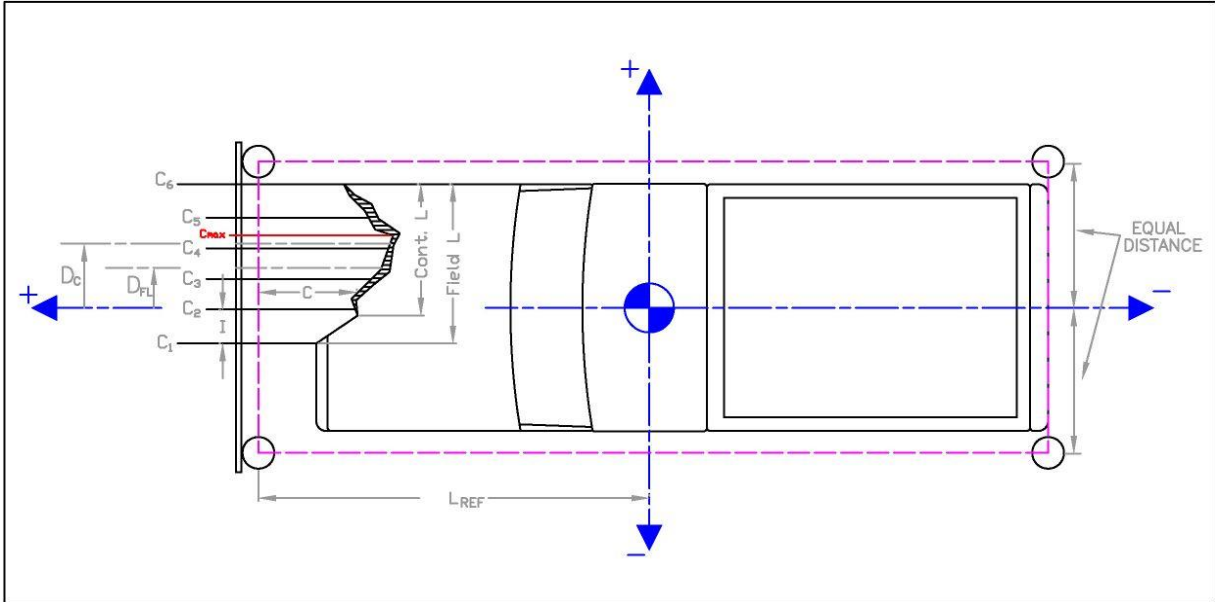
in.	(mm)
Distance from C.G. to reference line - L-REF:	110	(2794)
Total Vehicle Width:	78	(1981)
Width of contact and induced crush - Field L:	39	(991)
Crush measurement spacing interval (L/5) - I:	7.8	(198)
Distance from center of vehicle to center of Field L - D _{FL} :	19 1/2	(495)
Width of Contact Damage:	19 1/2	(495)
Distance from center of vehicle to center of contact damage - D _C :	29 1/4	(743)

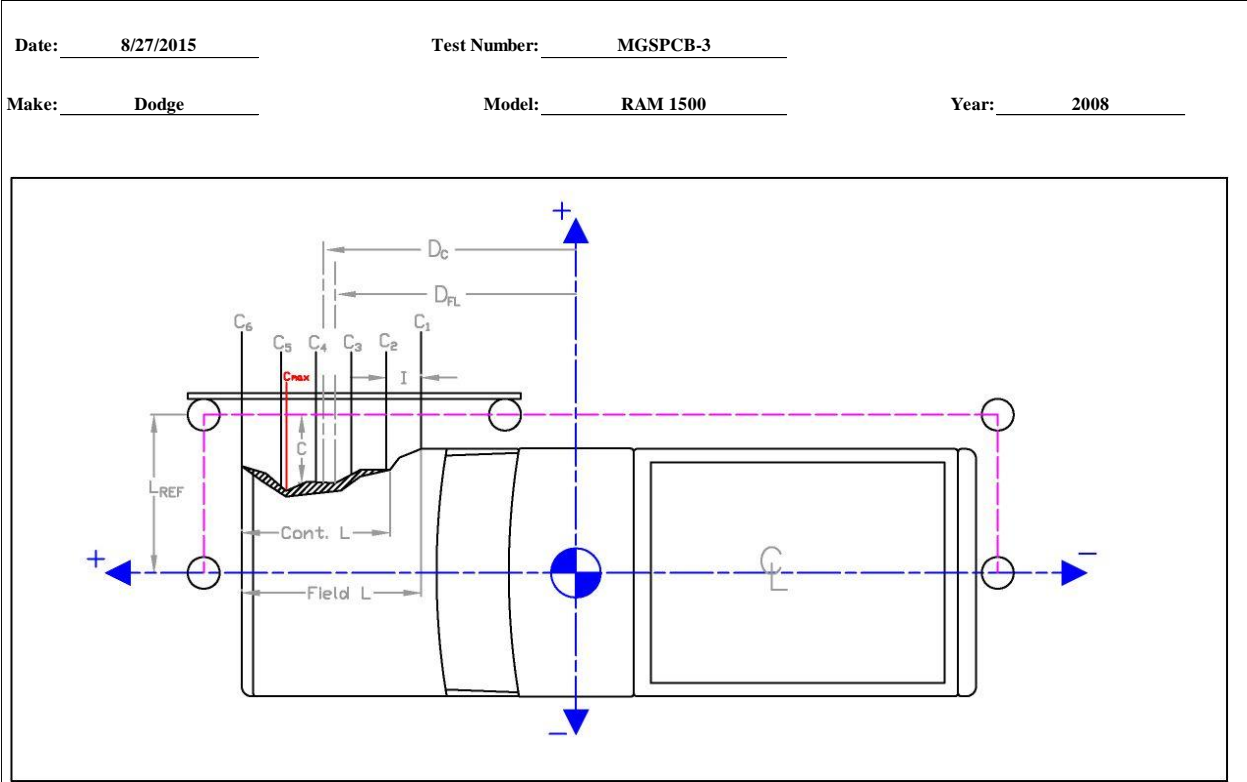
in.	(mm)
Distance from centerline to reference line - L_{REF} :	45	(1143)
Total Vehicle Length: 227.5 (5779)		
Width of contact and induced crush - Field L: 227 1/2 (5779)		
Crush measurement spacing interval (L/5) - I: 45.5 (1156)		
Distance from vehicle c.g. to center of Field L - D_{FL} :	-11 1/3	-(288)
Width of Contact Damage: 227 1/2 (5779)		
Distance from vehicle c.g. to center of contact damage - D_C :	-11 1/3	-(288)
