ISO 17025 LABORATORY
TESTING CERT # 2937.01

MASH TEST NO. 3-10 OF A NON-PROPRIETARY, HIGH-TENSION, CABLE MEDIAN BARRIER FOR USE IN 6H:1V V-DITCH (TEST NO. MWP-9)

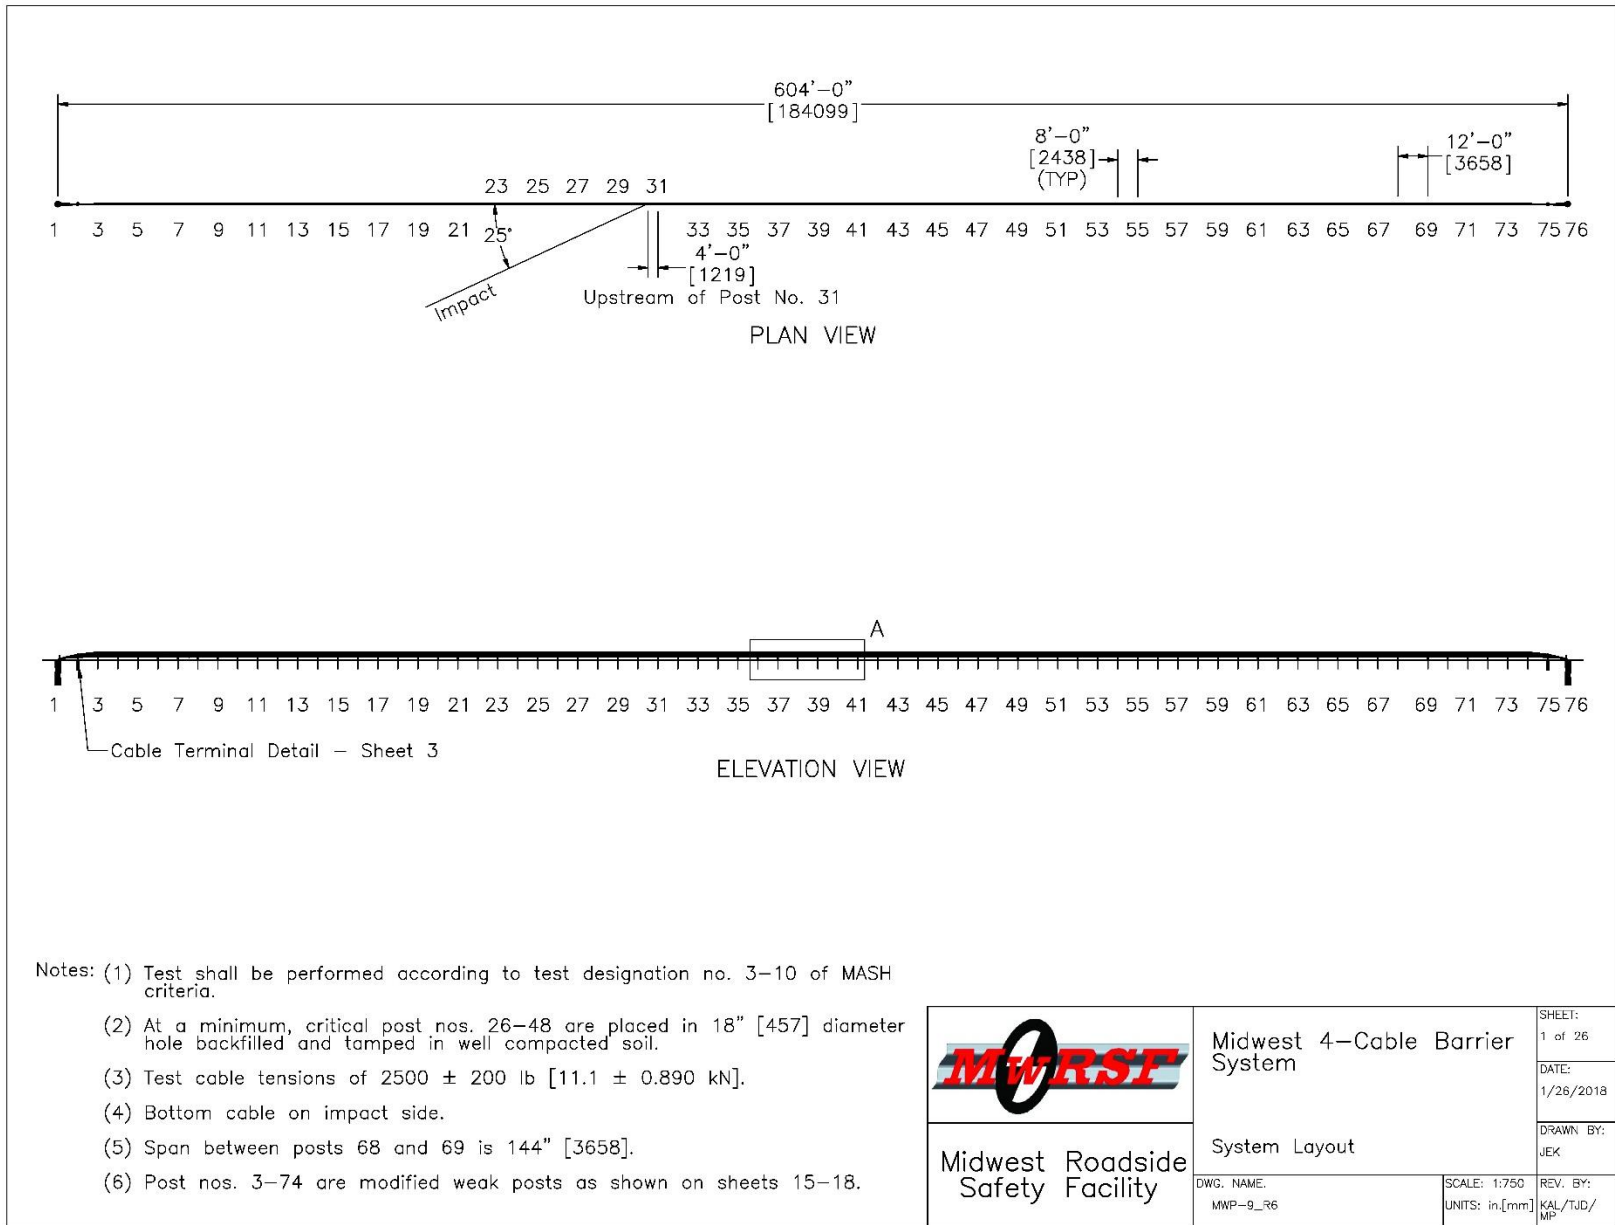
Figure 1. System Layout, Test No. MWP-9

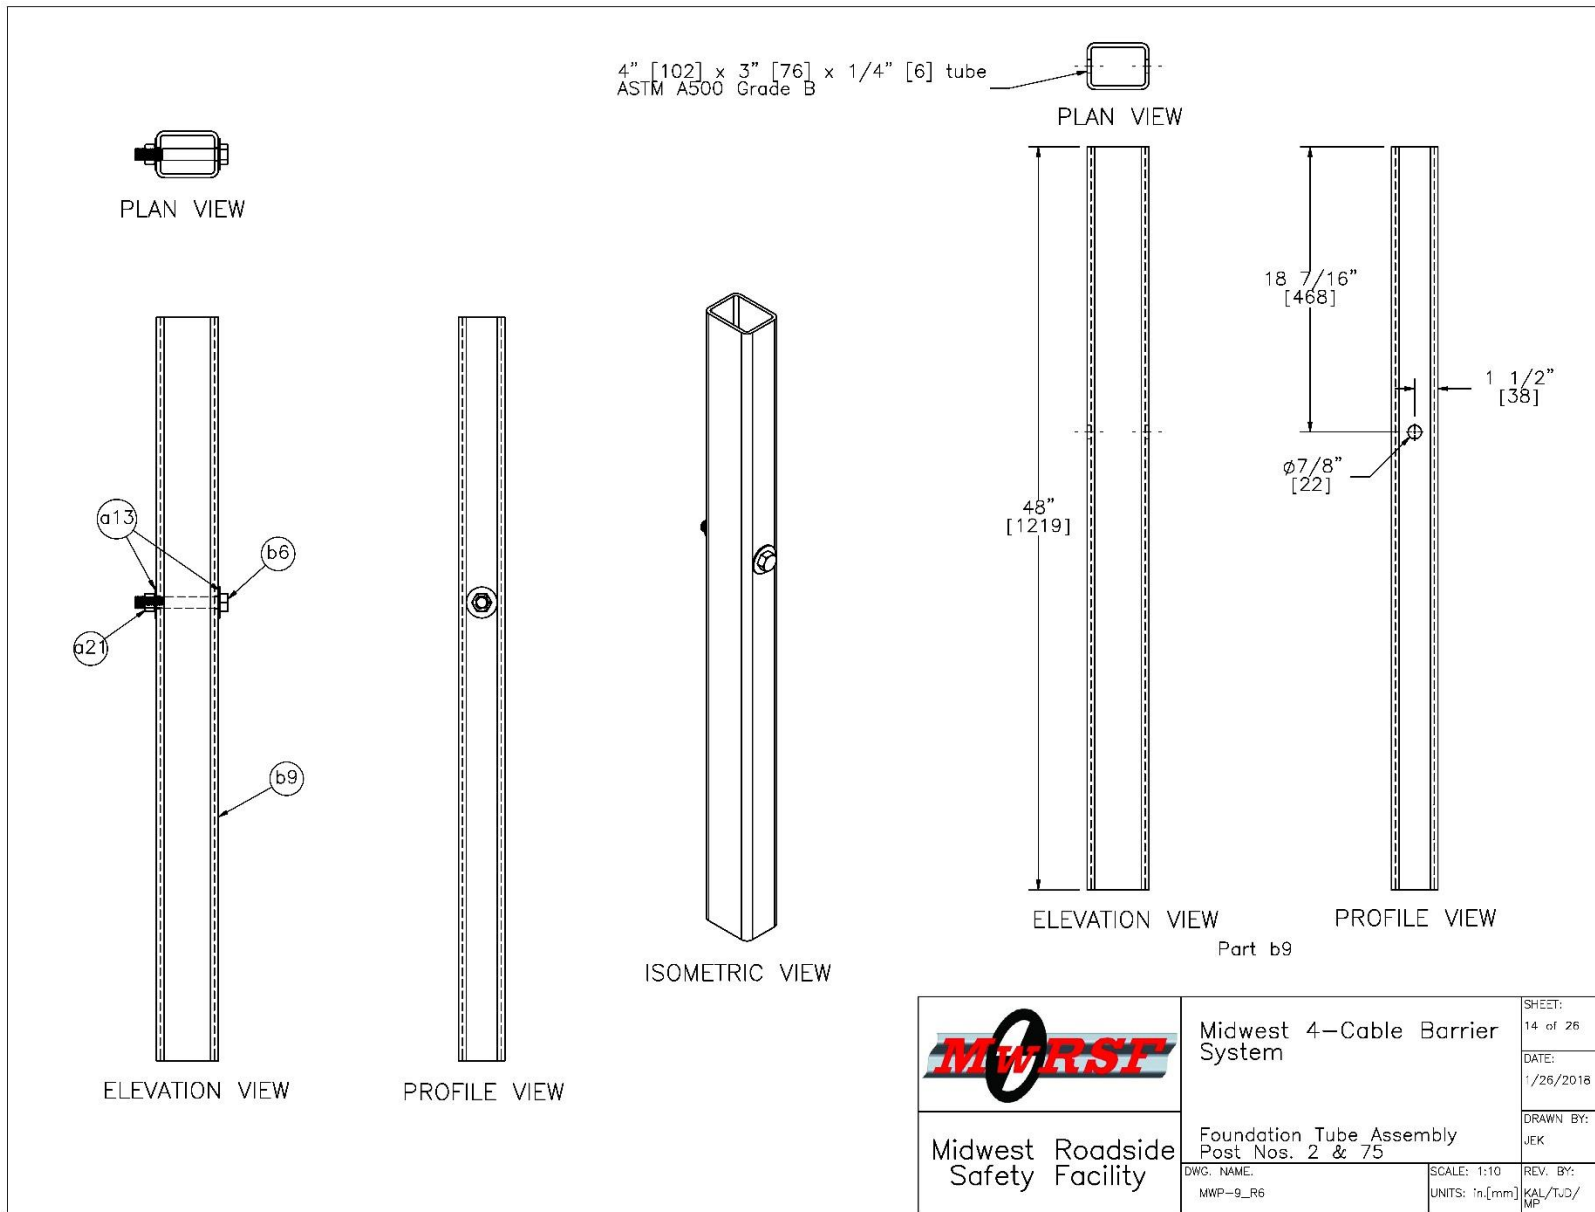
Figure 14. Foundation Tube Assembly, Post Nos. 2 and 75, Test No. MWP-9

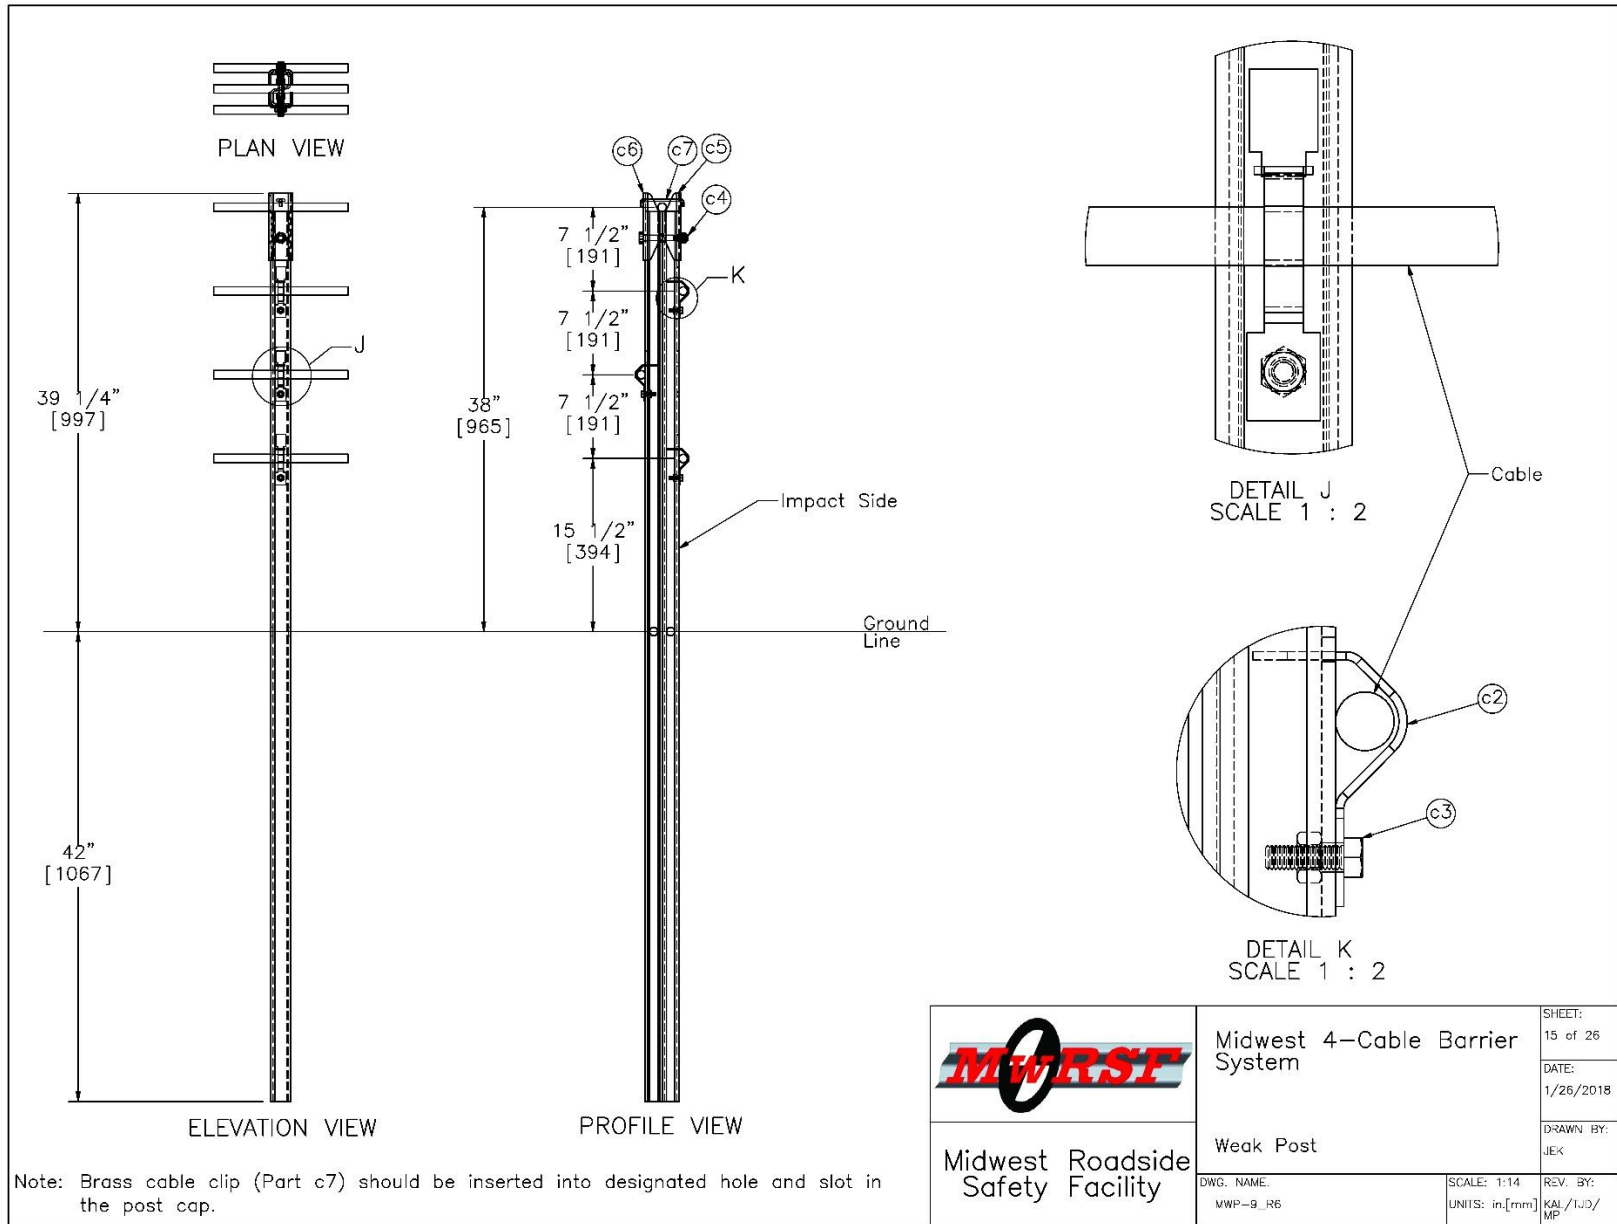
Figure 15. Midwest Weak Post (MWP) Details, Test No. MWP-9

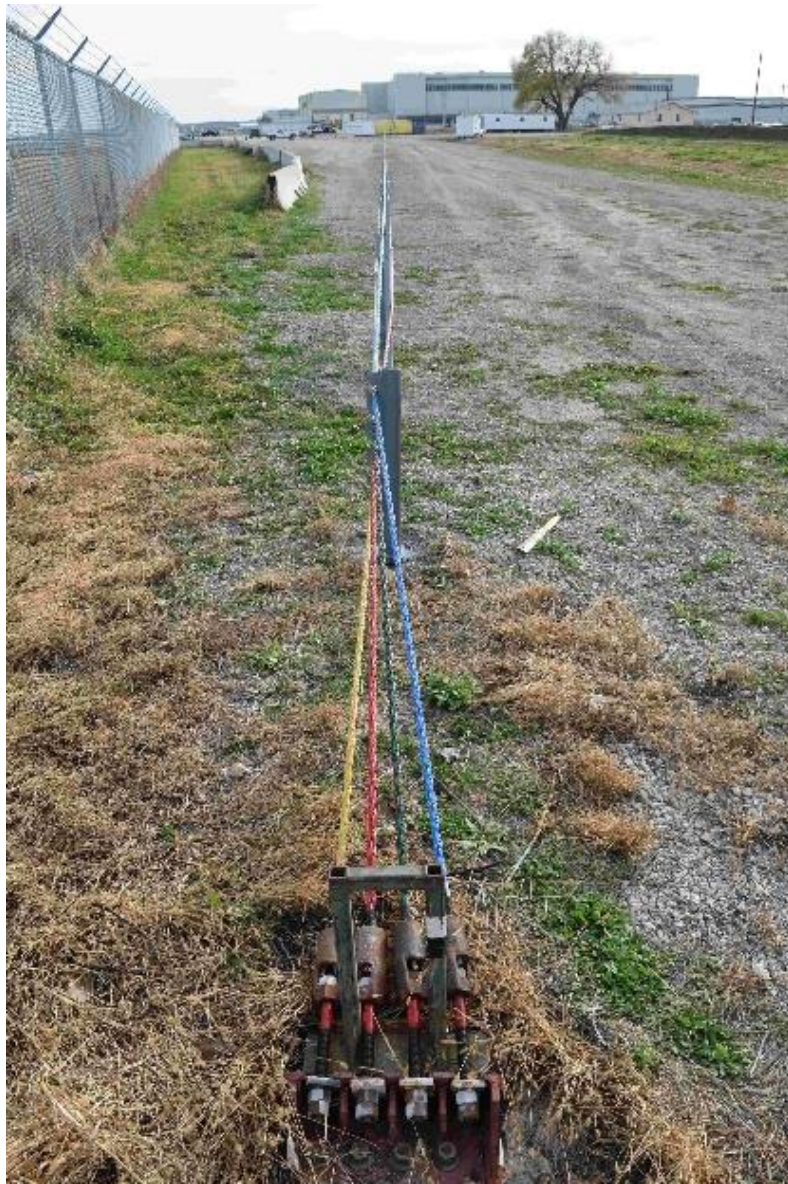
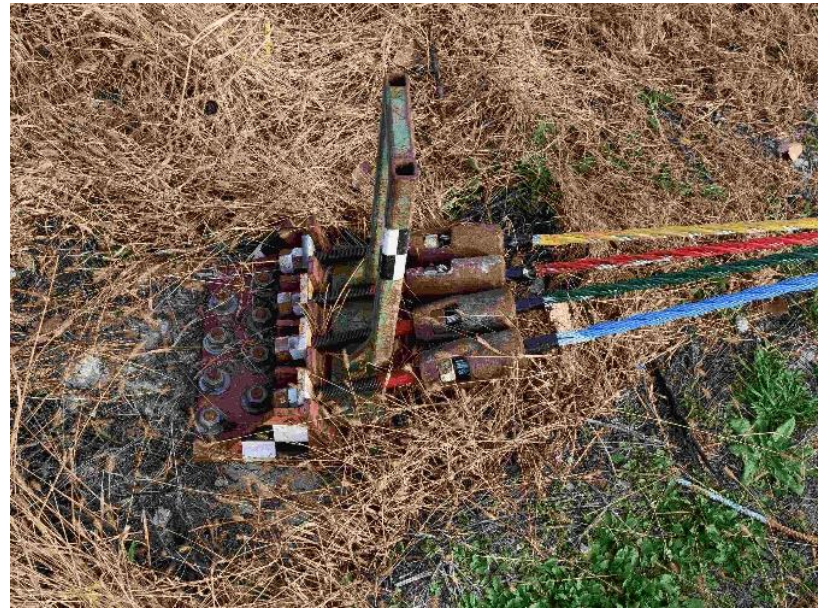
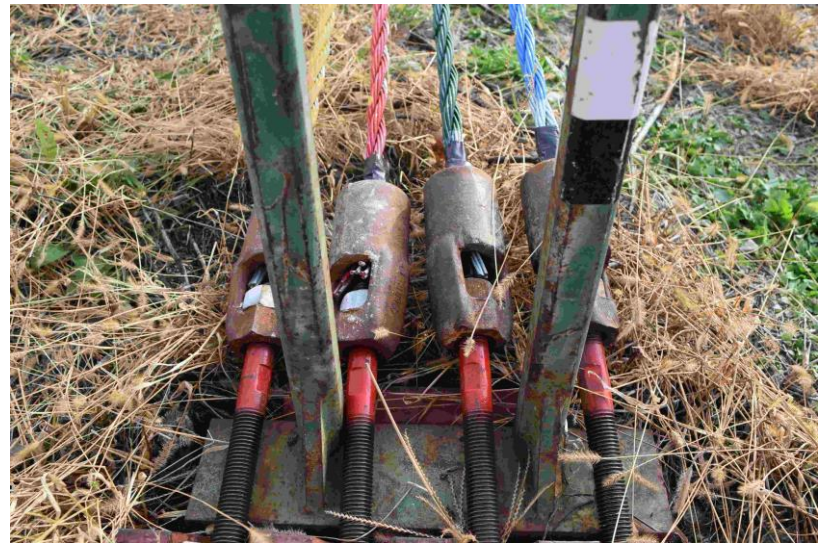
Figure 33. Downstream Anchorage, Test No. MWP-9

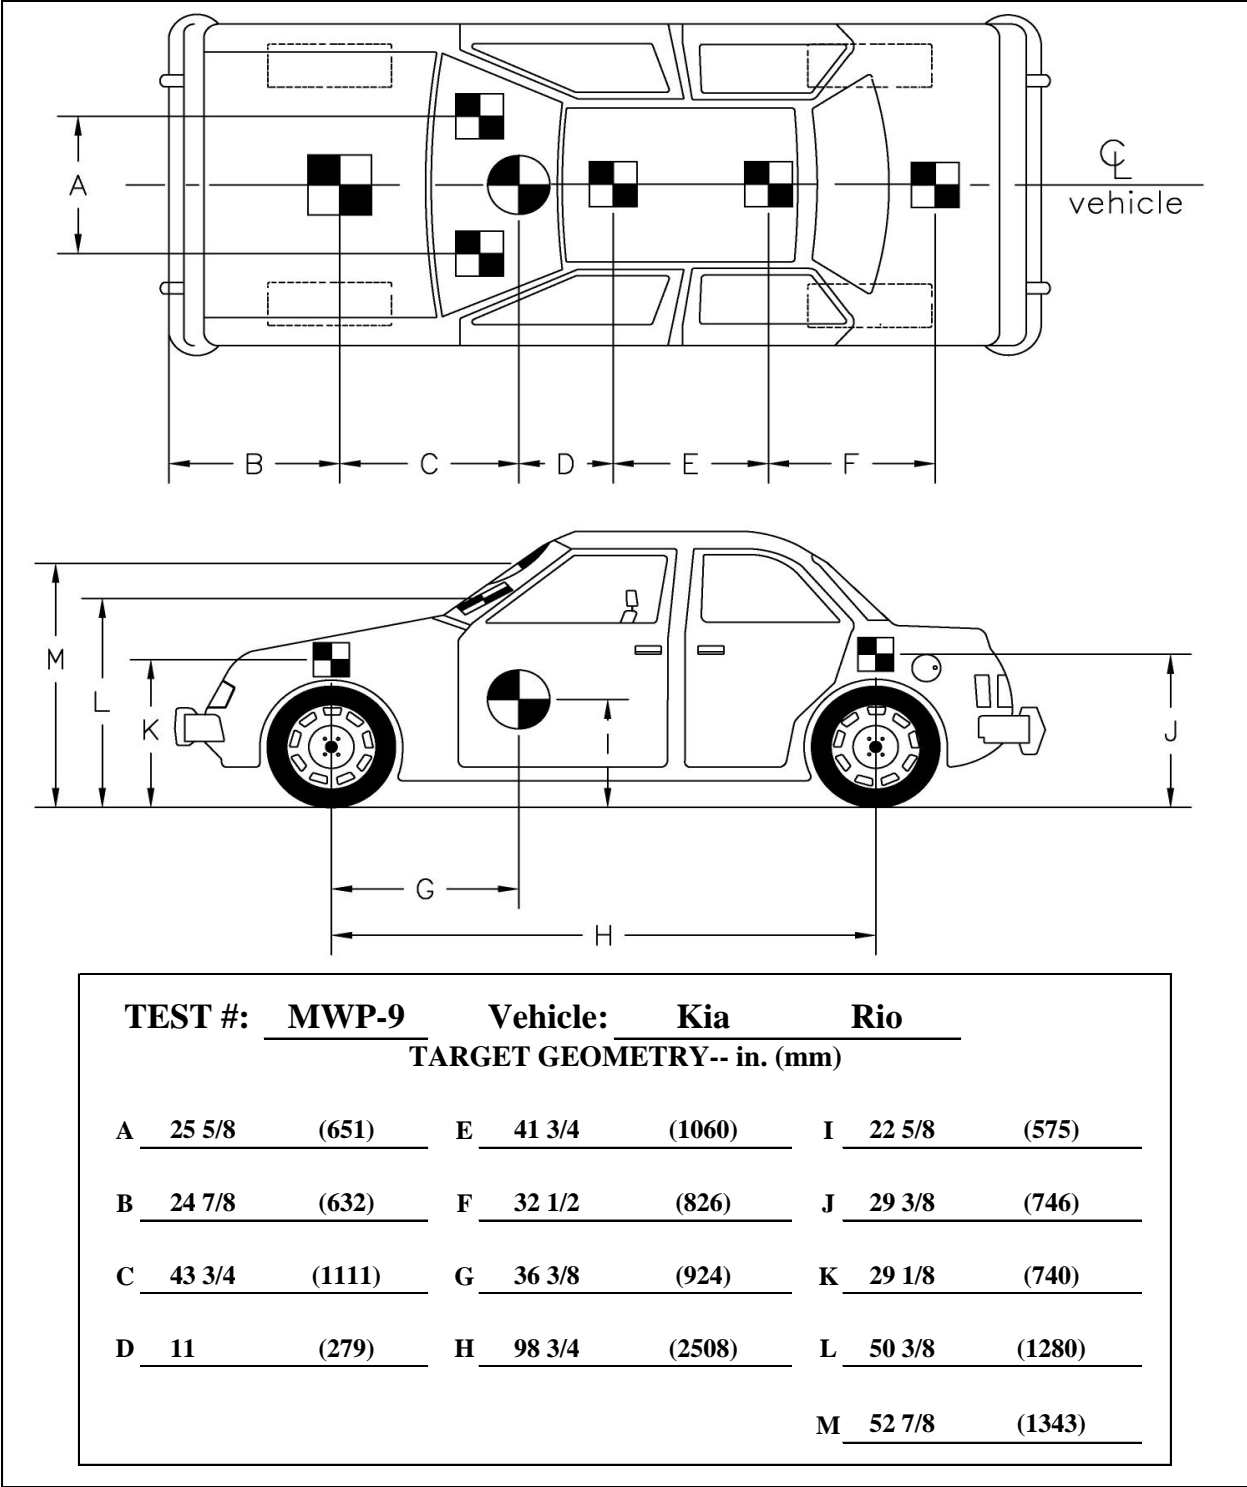
Figure 37. Target Geometry, Test No. MWP-9

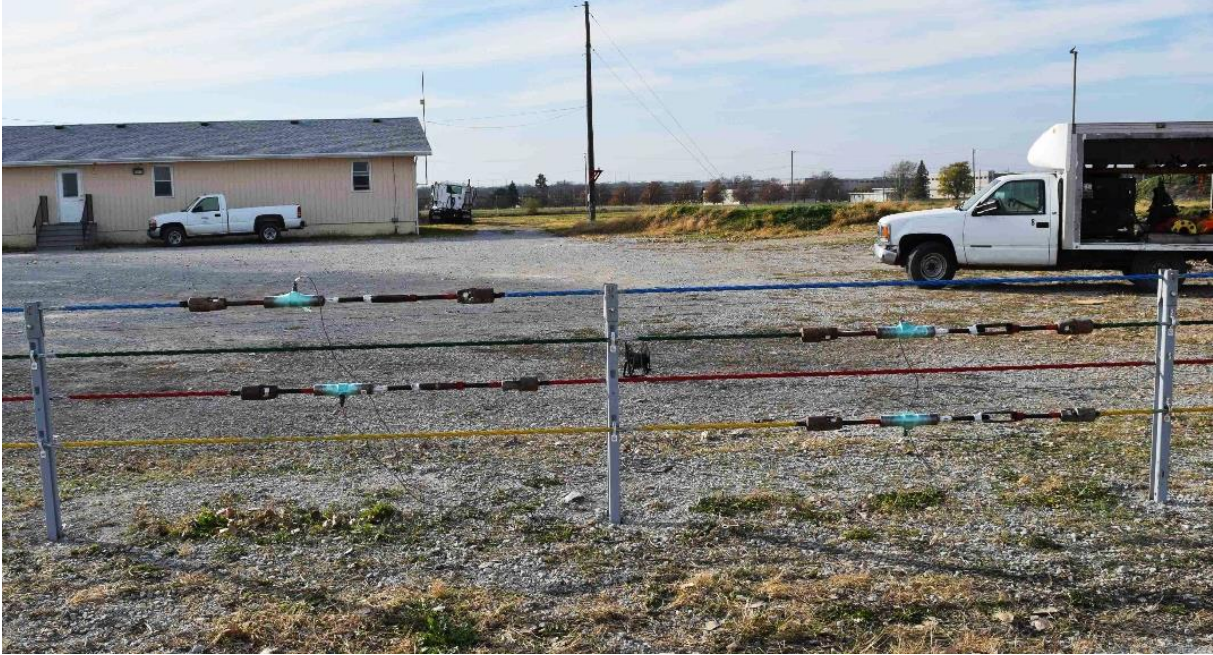
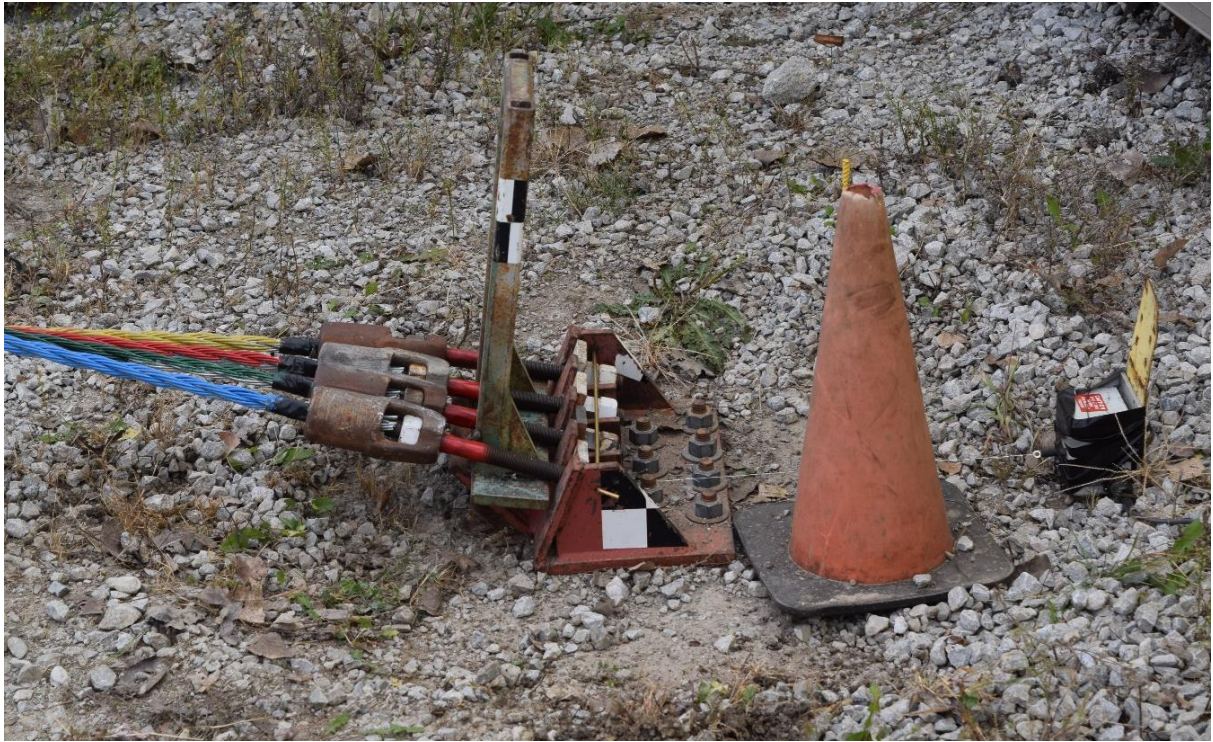
Figure 38. Location of Load Cells and String Potentiometers, Test No. MWP-9

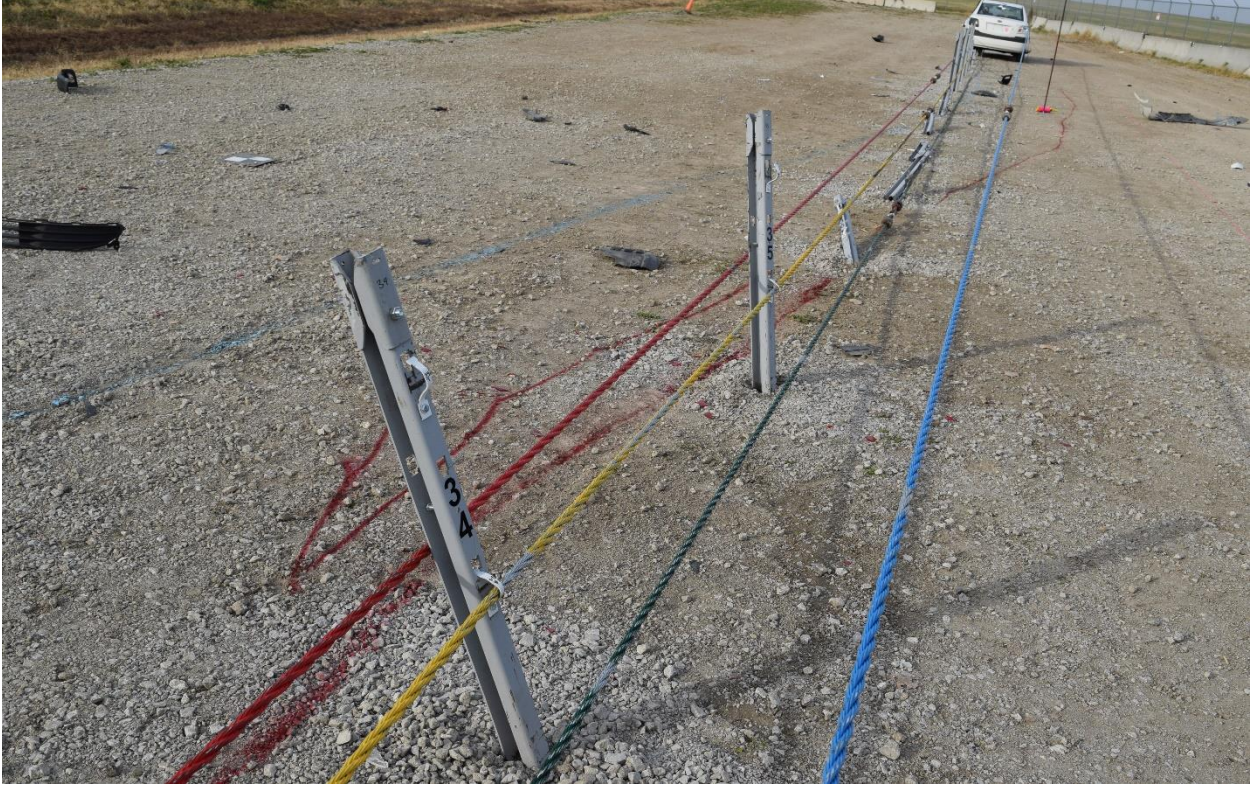
Figure 49. System Damage, Test No. MWP-9

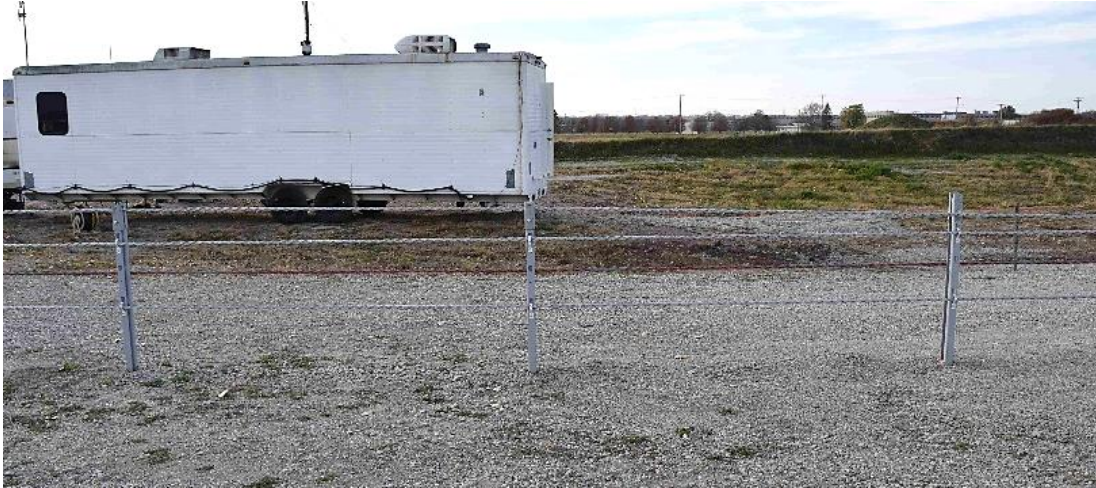
Post Nos. 21 through 23

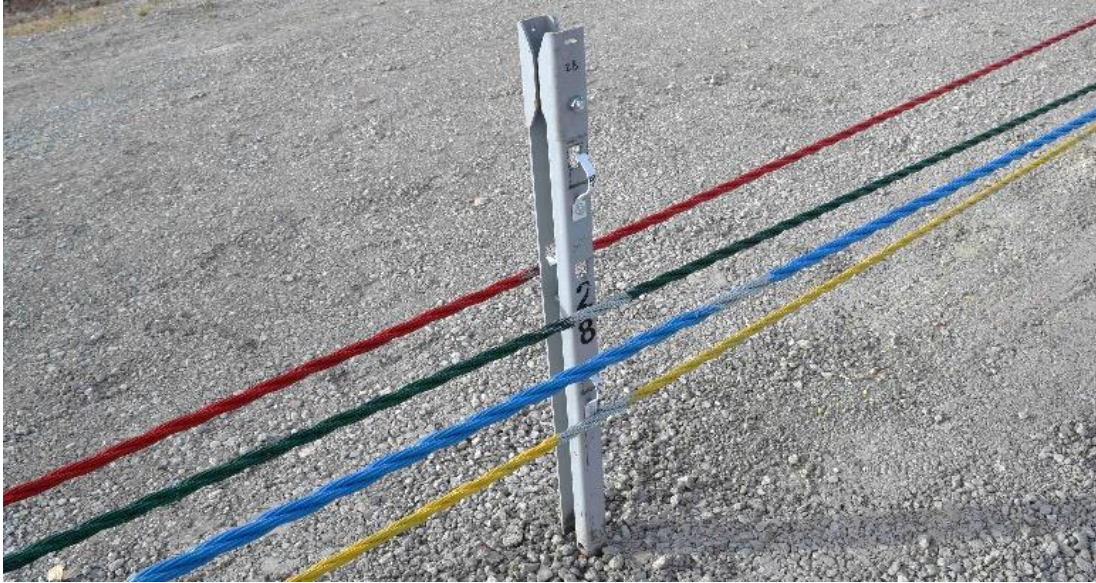
Figure 50. Post Nos. 21 through 27 Damage, Test No. MWP-9

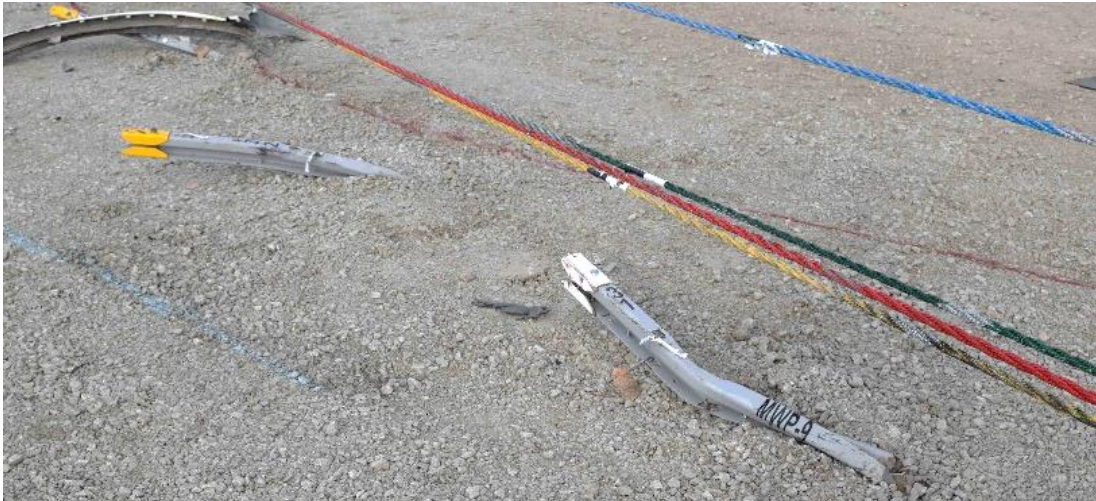
Post Nos. 31 through 33

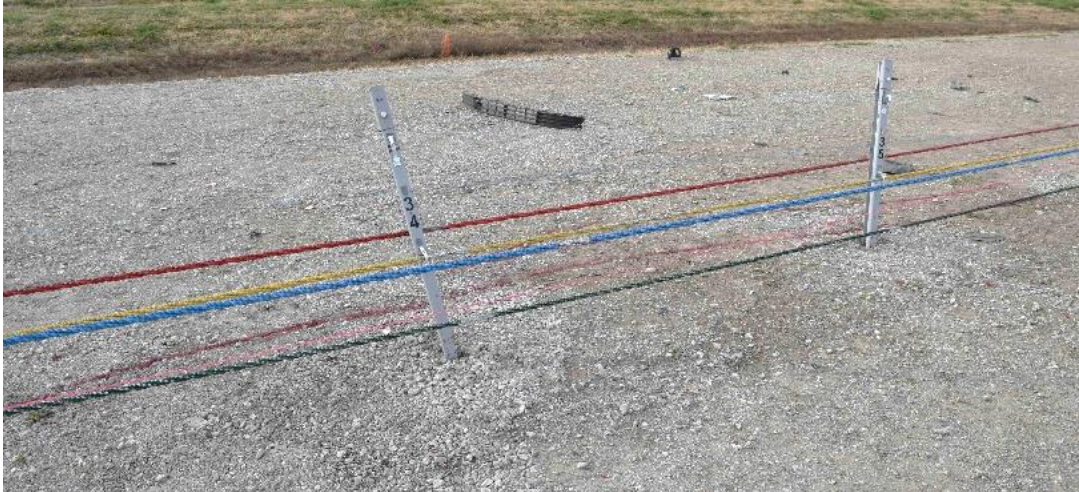
Figure 51. Post Nos. 28 through 33 Damage, Test No. MWP-9

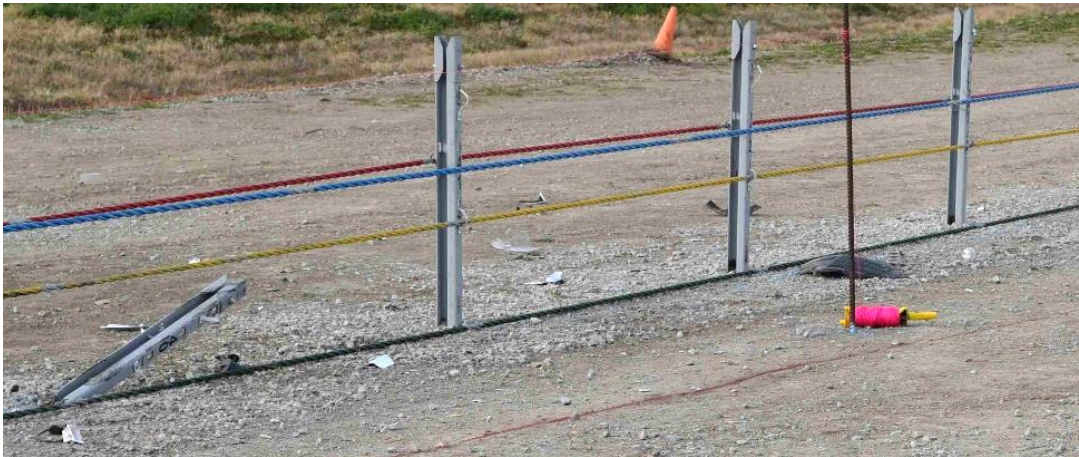
Post Nos. 40 through 43

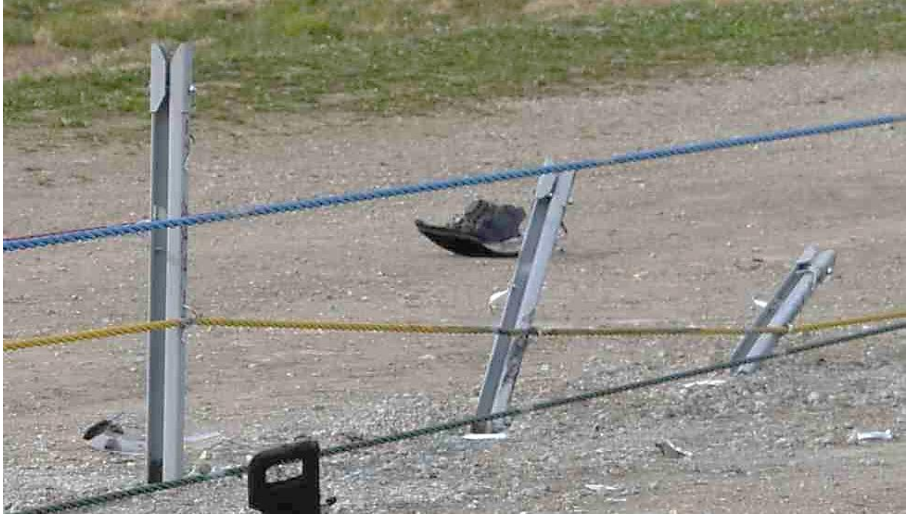
Post Nos. 44 through 46

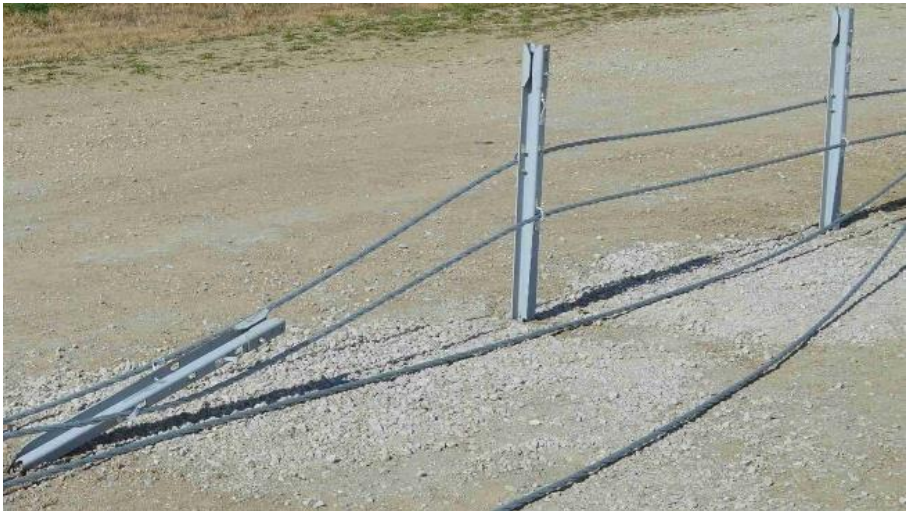
Post Nos. 49 through 51

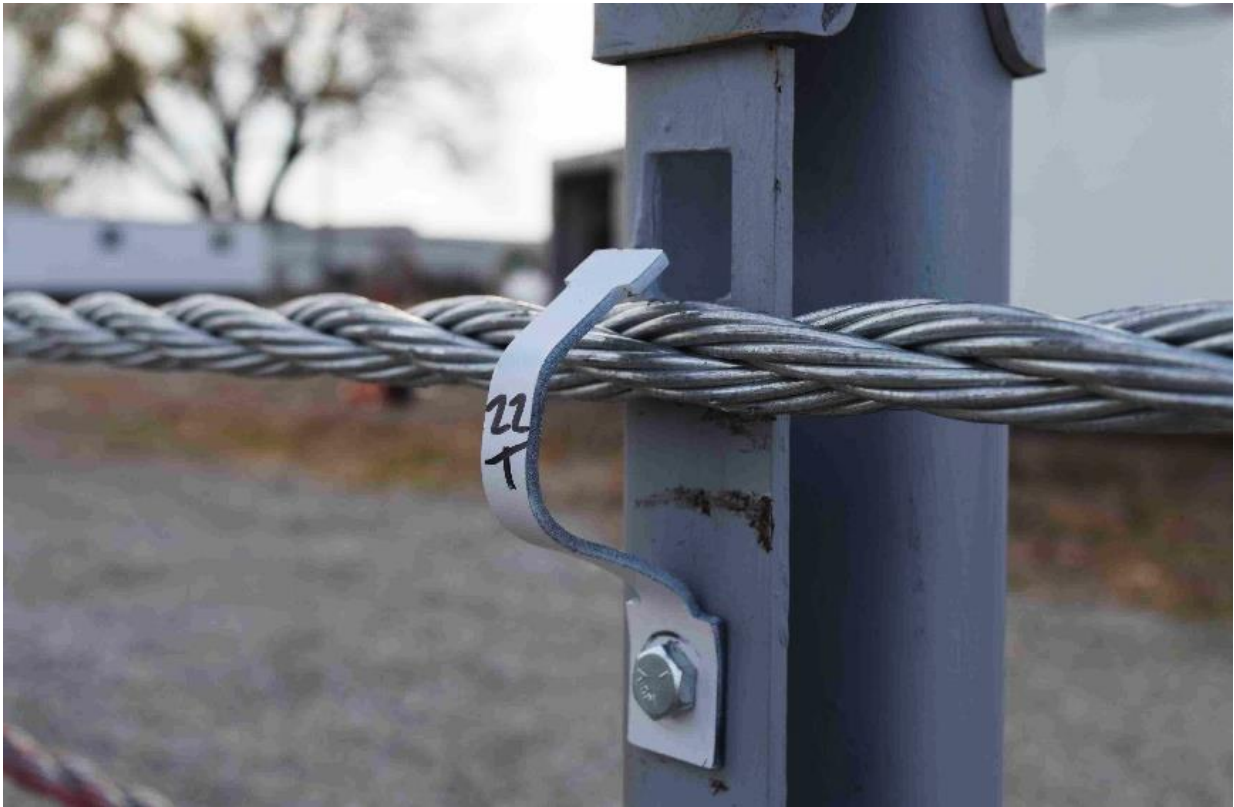
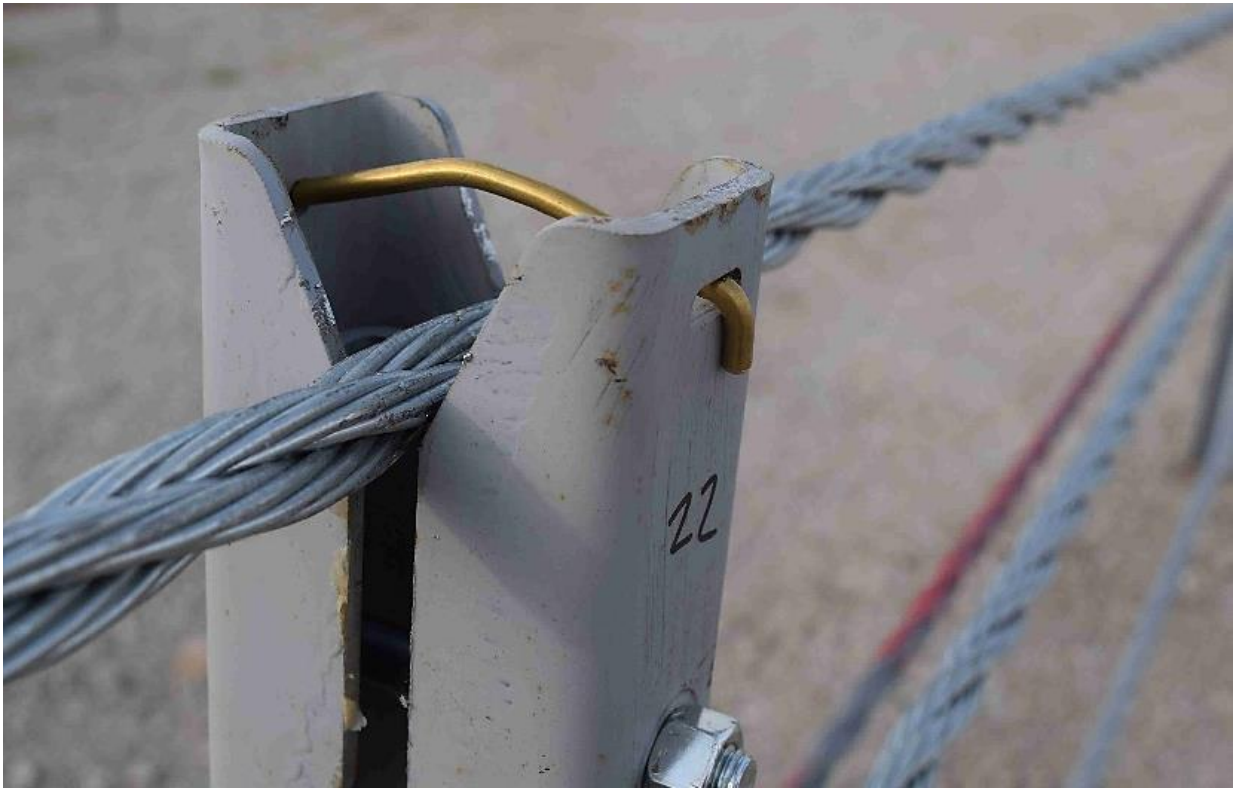
Figure 54. Post No. 22 Damage, Test No. MWP-9

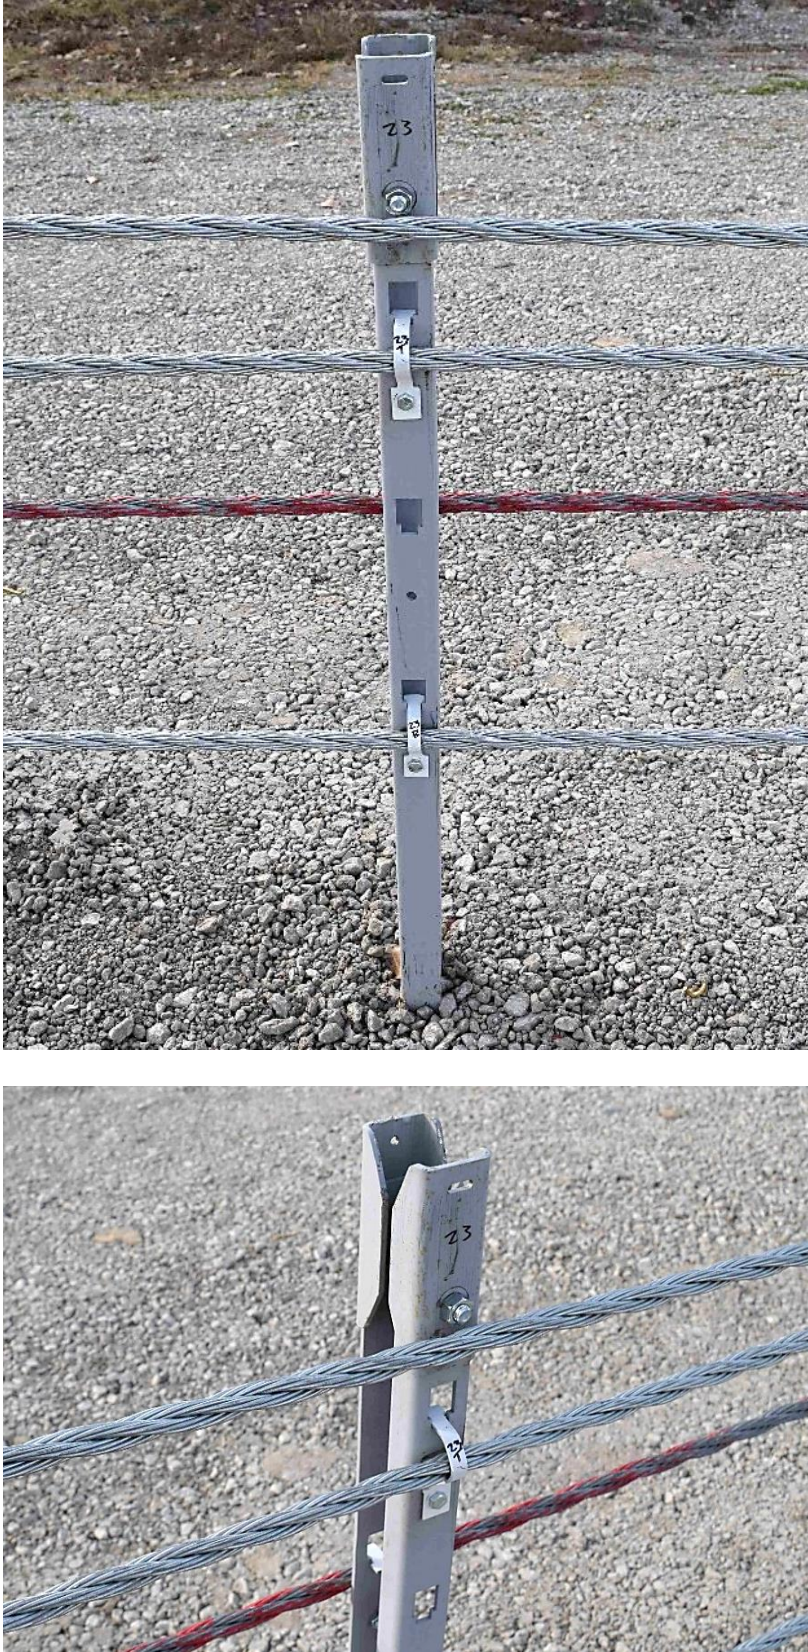
Figure 55. Post No. 23 Damage, Test No. MWP-9

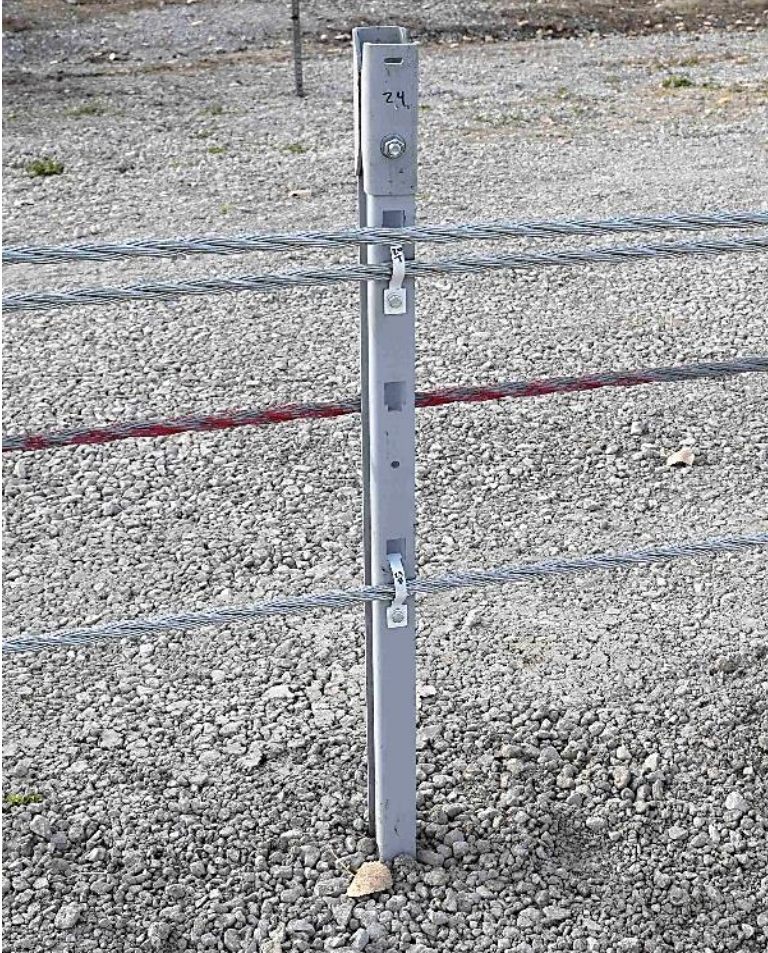
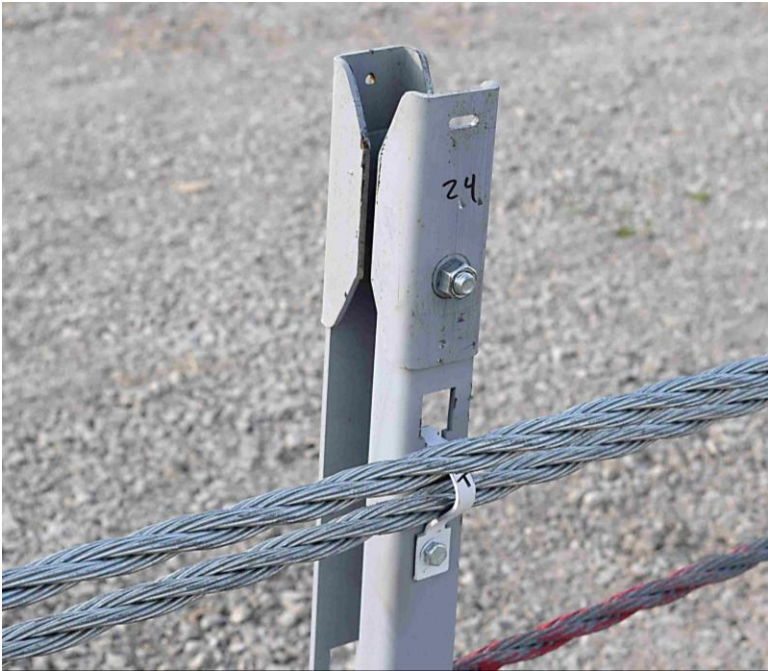
Figure 56. Post No. 24 Damage, Test No. MWP-9

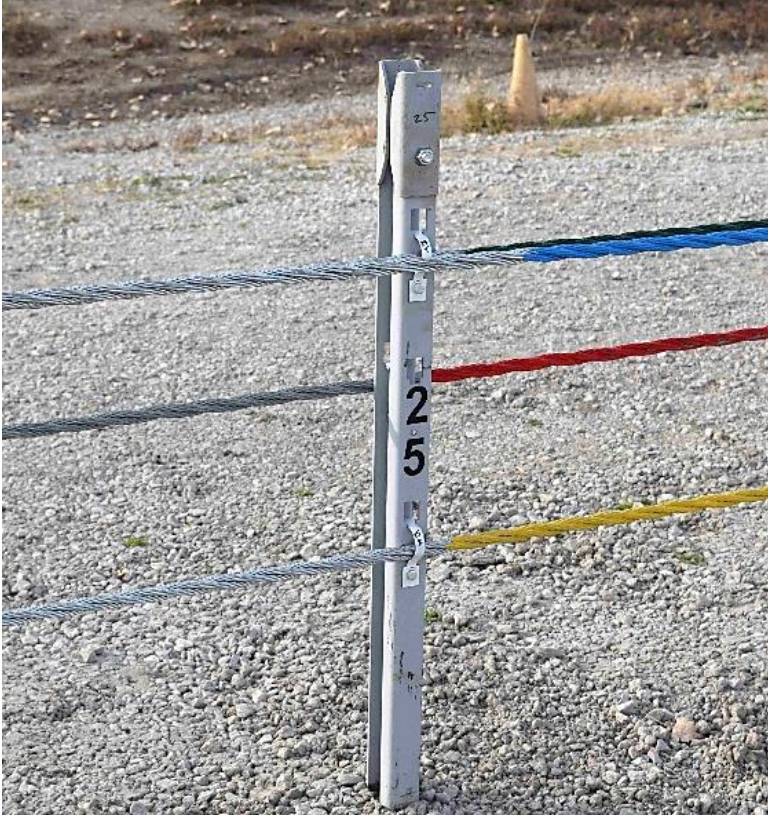
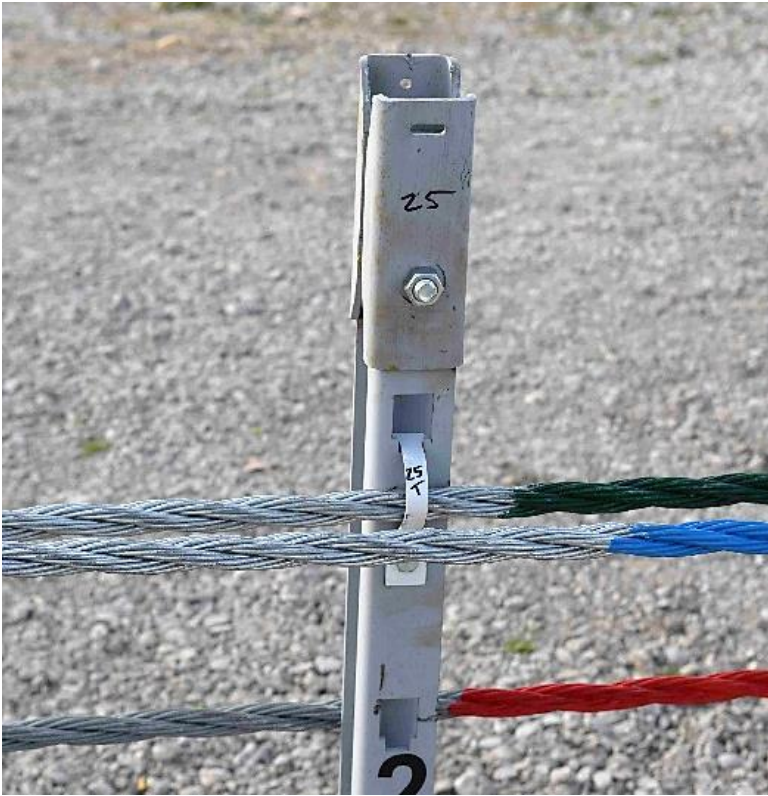
Figure 57. Post No. 25 Damage, Test No. MWP-9
