ISO 17025 LABORATORY
TESTING CERT # 2937.01

MASH TEST NO. 3-10 OF A NON-PROPRIETARY, HIGH-TENSION, CABLE MEDIAN BARRIER FOR USE IN 6H:1V V-DITCH (TEST NO. MWP-9)

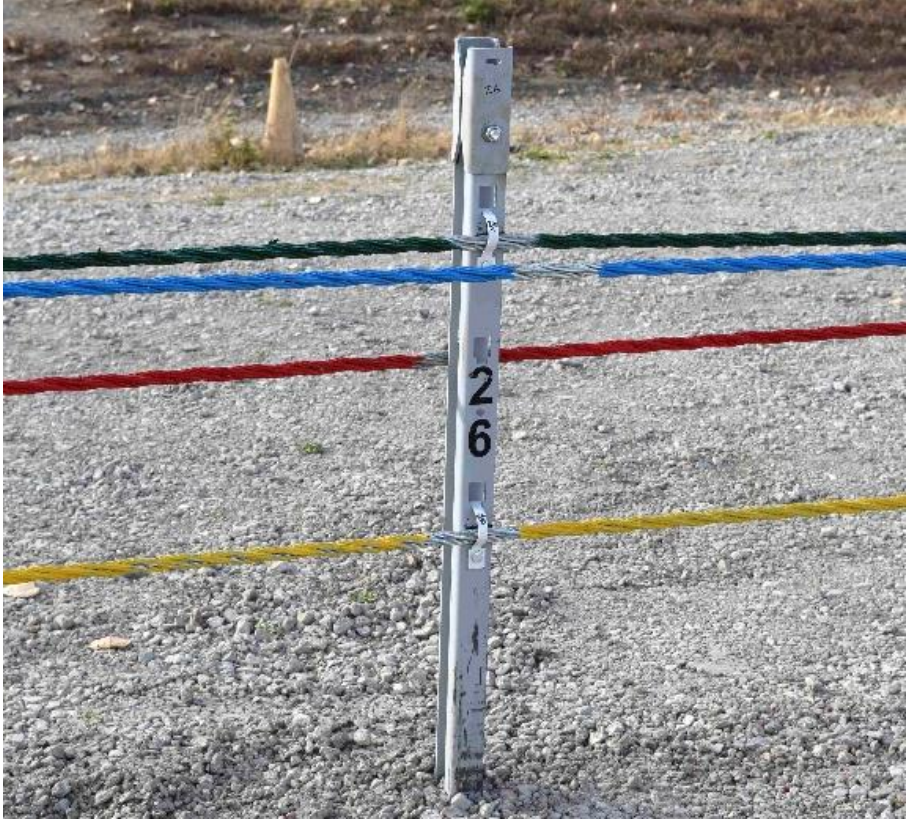
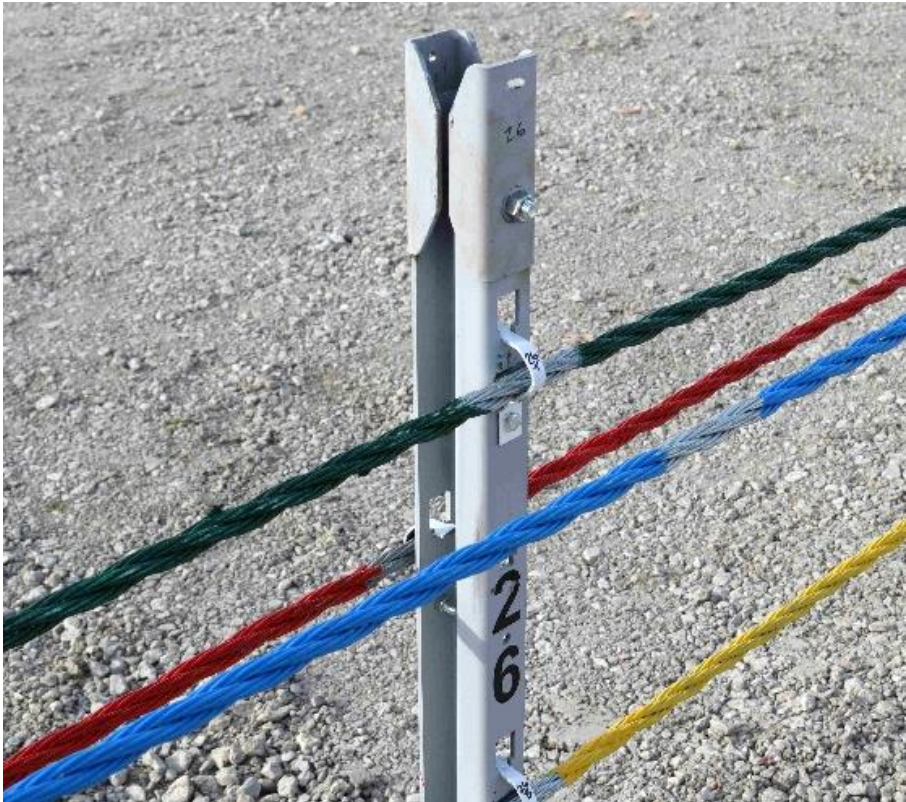
Figure 58. Post No. 26 Damage, Test No. MWP-9

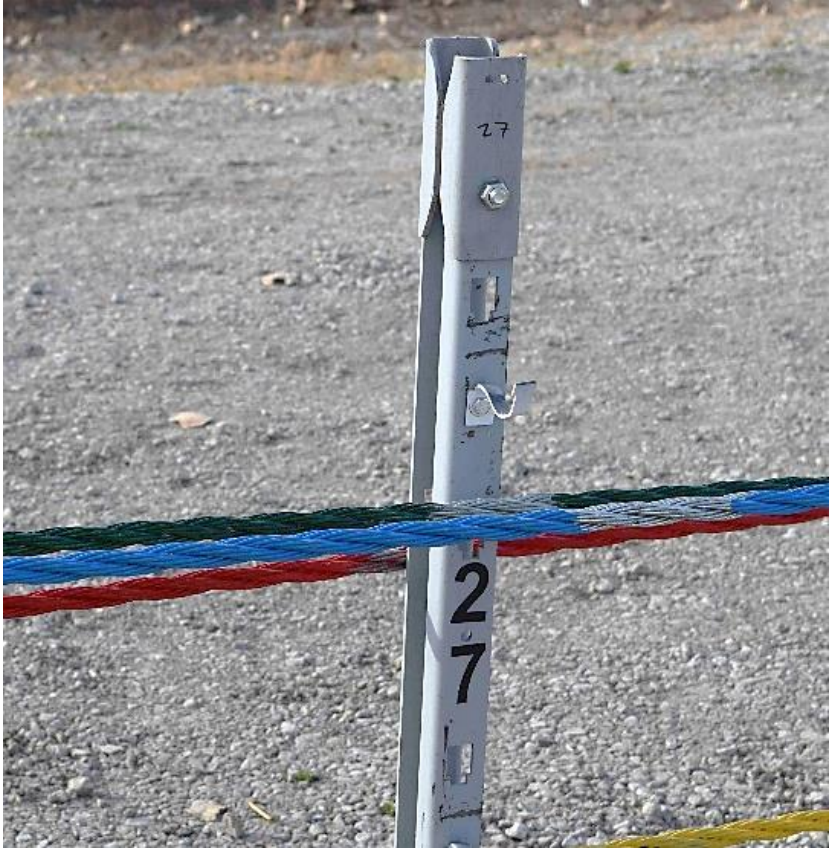
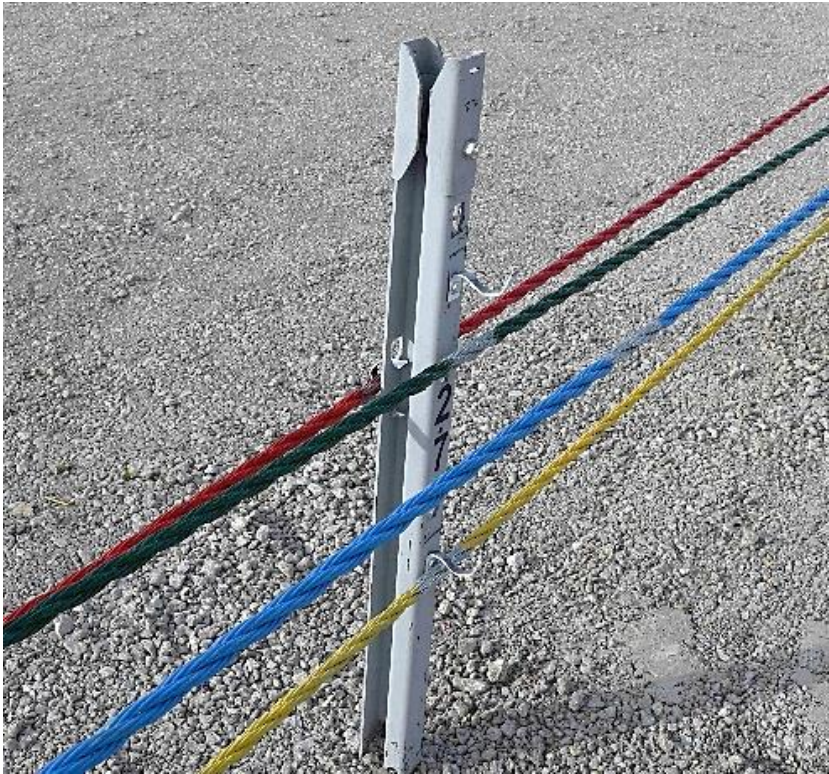
Figure 59. Post No. 27 Damage, Test No. MWP-9

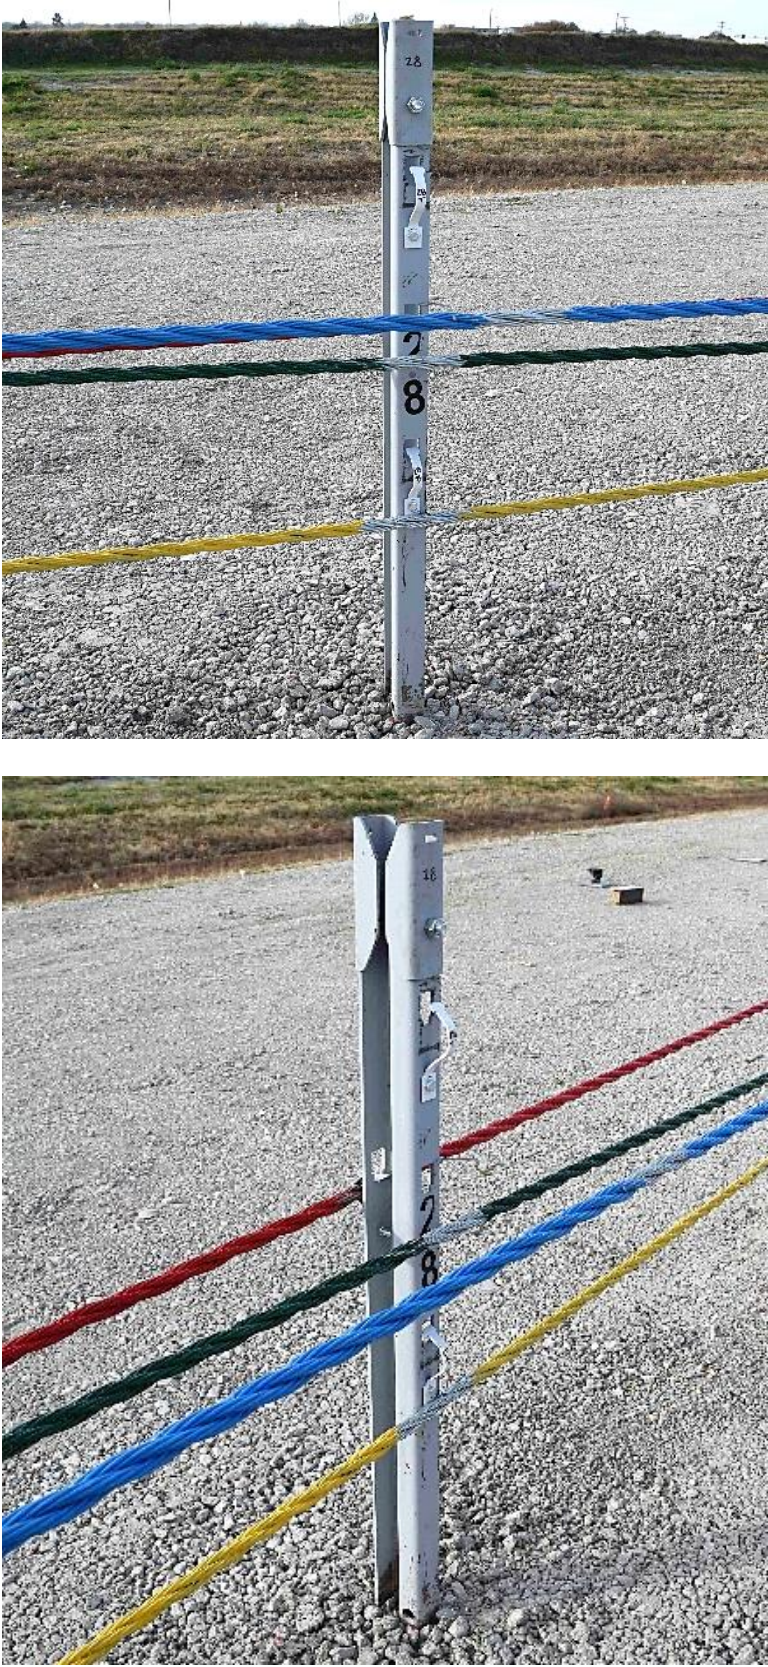
Figure 60. Post No. 28 Damage, Test No. MWP-9

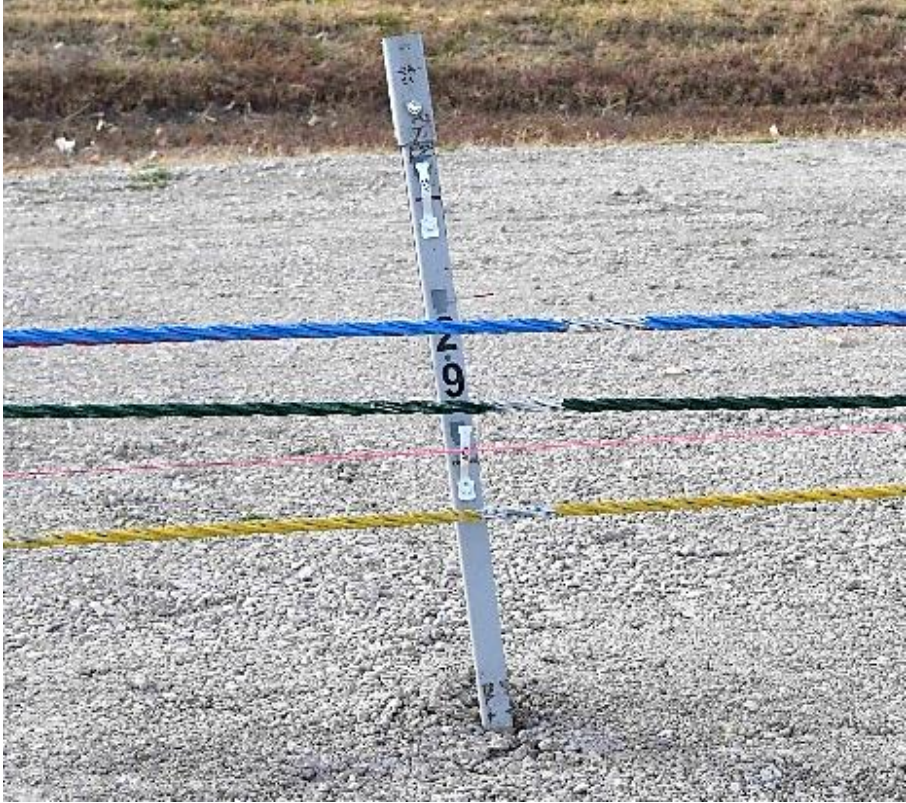
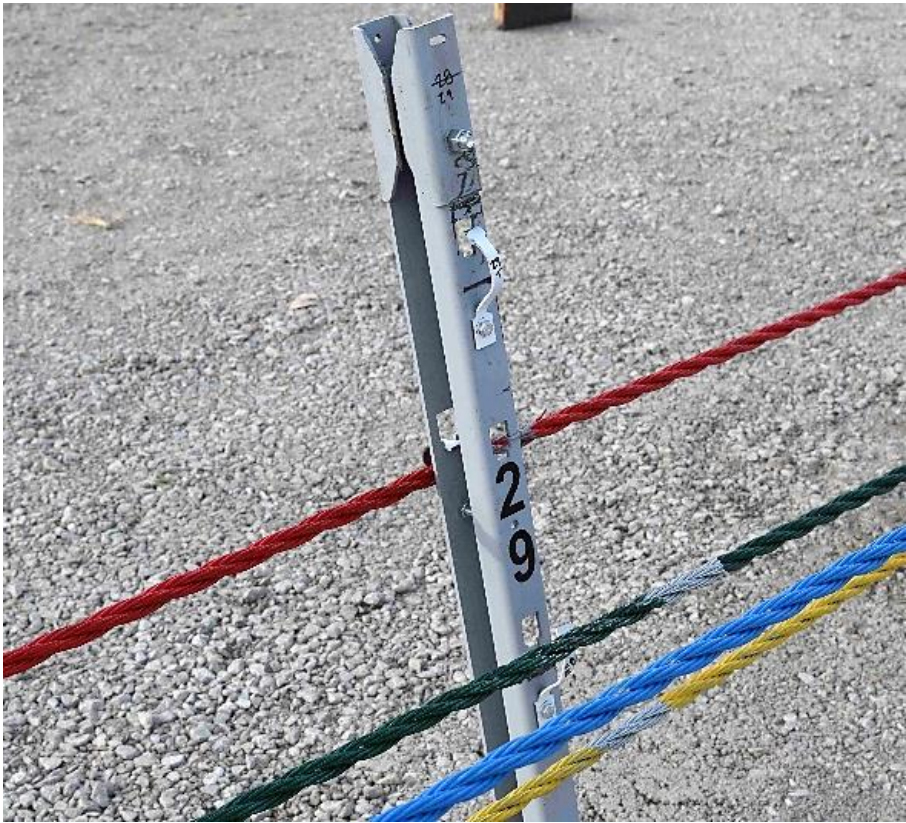
Figure 61. Post No. 29 Damage, Test No. MWP-9

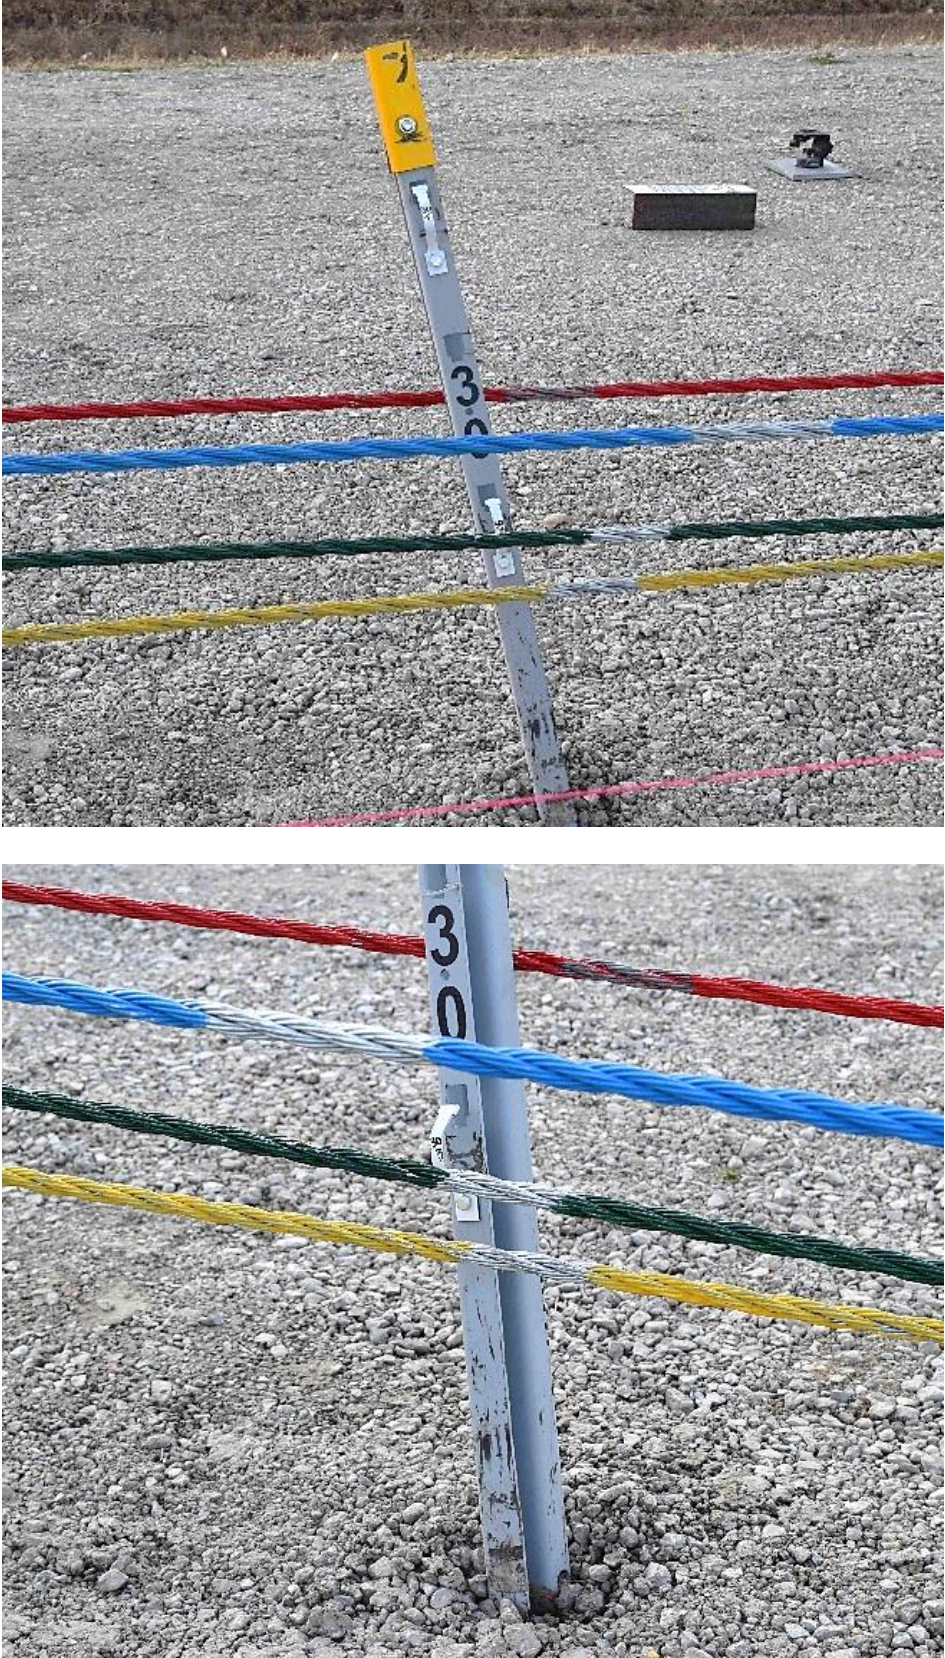
Figure 62. Post No. 30 Damage, Test No. MWP-9

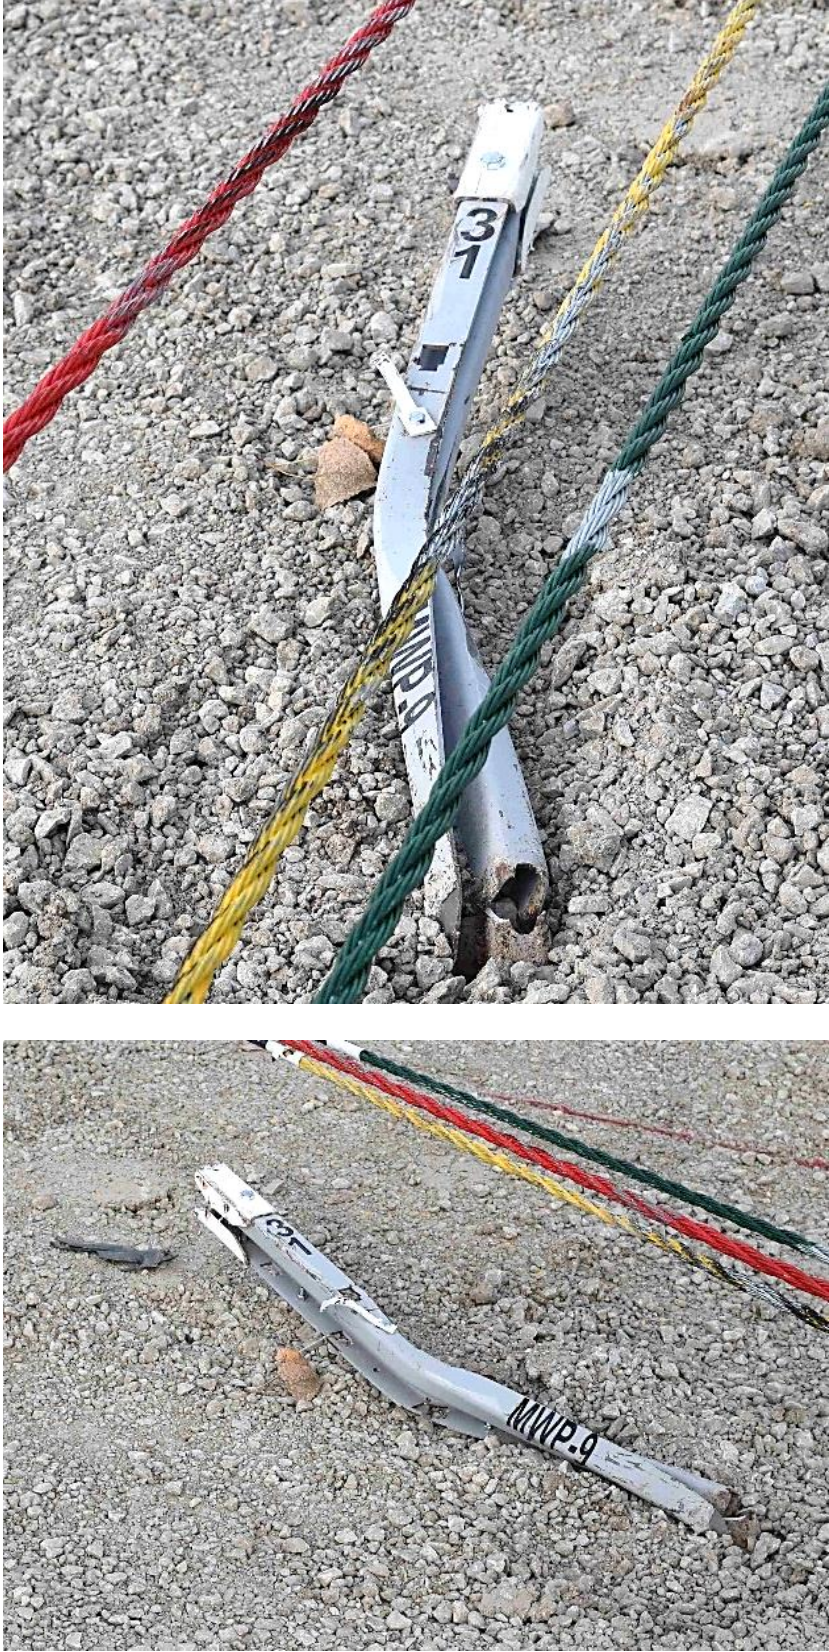
Figure 63. Post No. 31 Damage, Test No. MWP-9

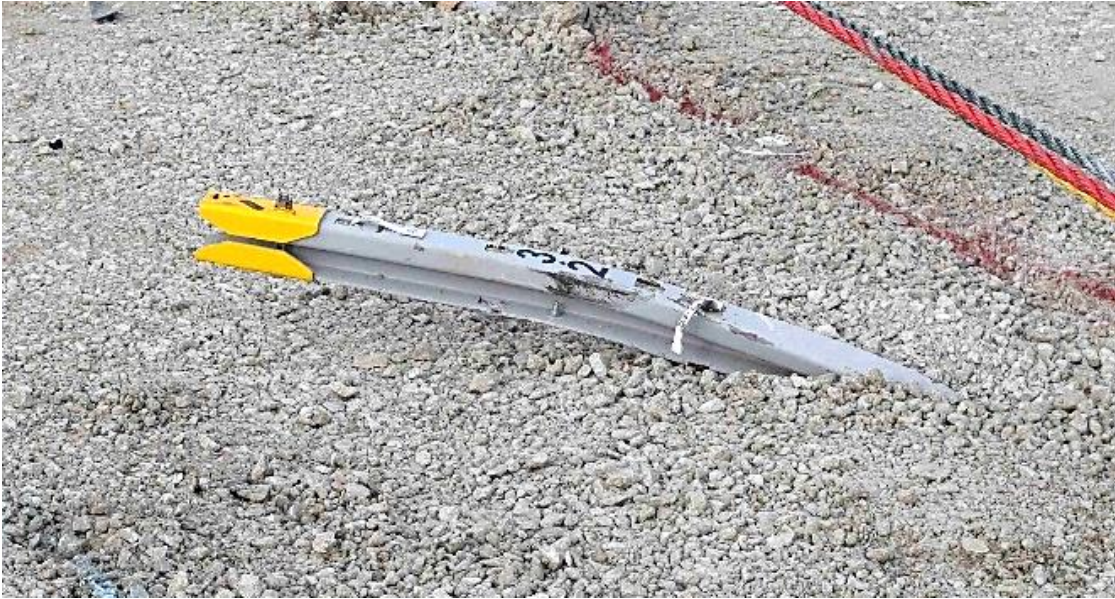
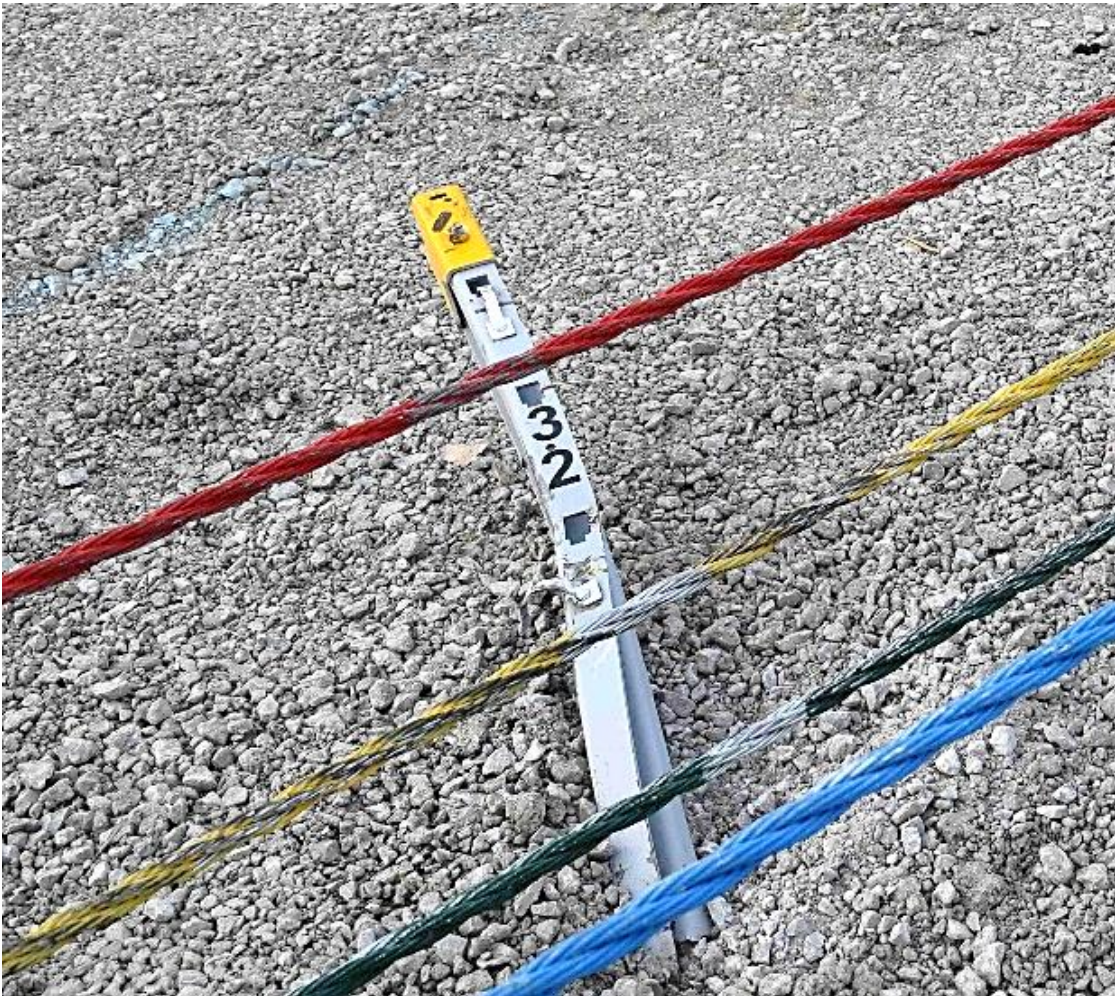
Figure 64. Post No. 32 Damage, Test No. MWP-9

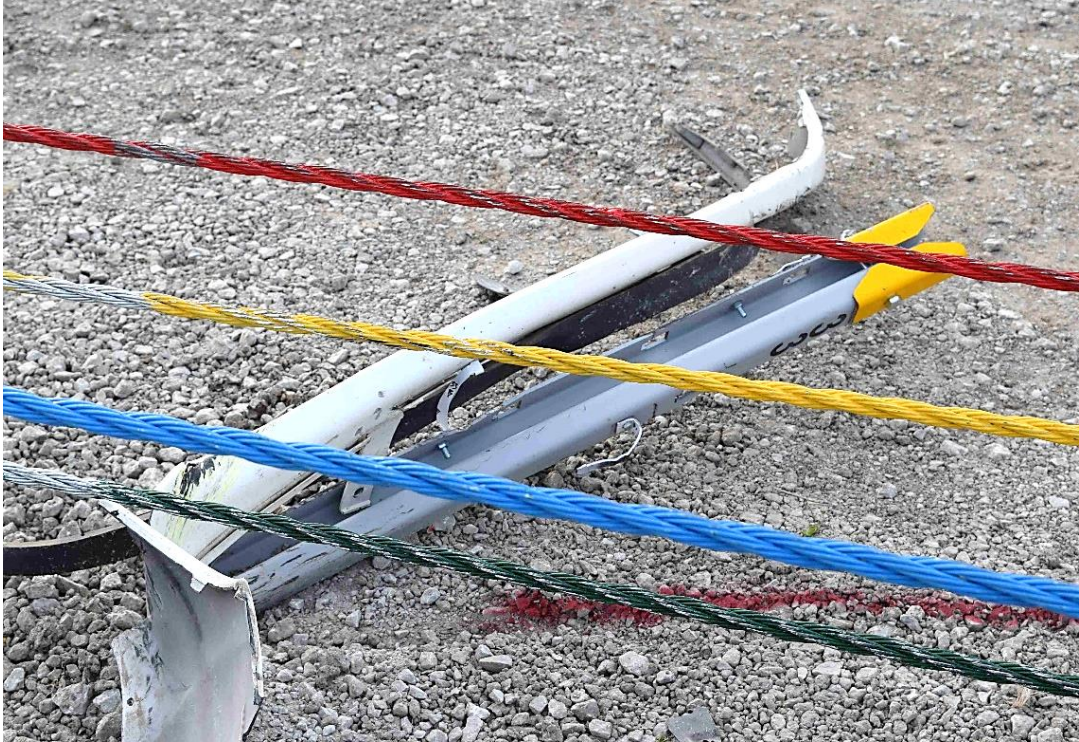
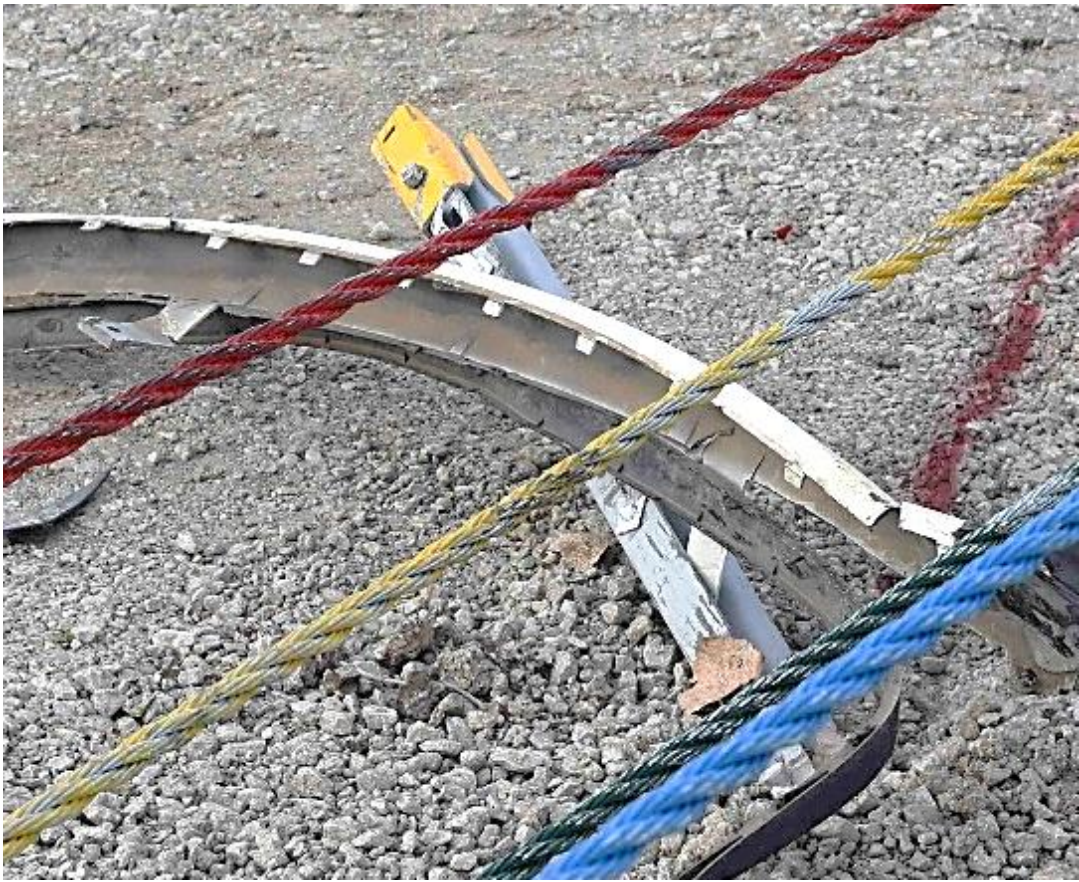
Figure 65. Post No. 33 Damage, Test No. MWP-9

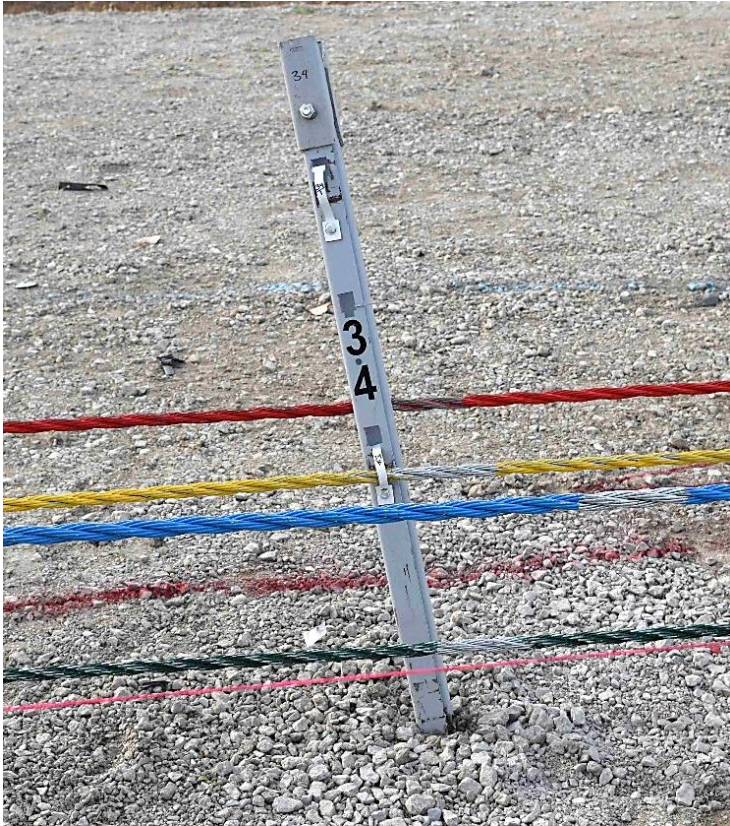
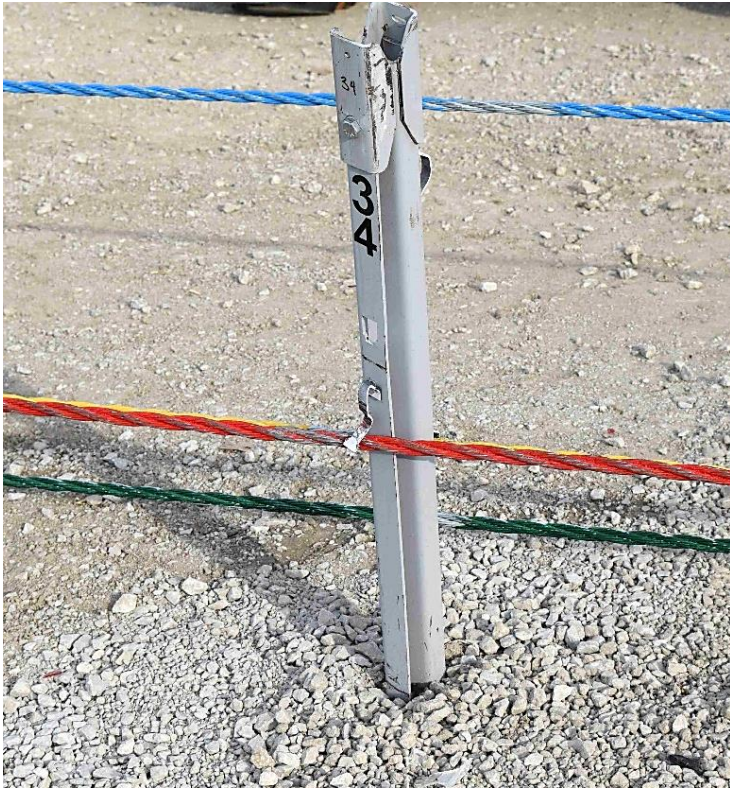
Figure 66. Post No. 34 Damage, Test No. MWP-9

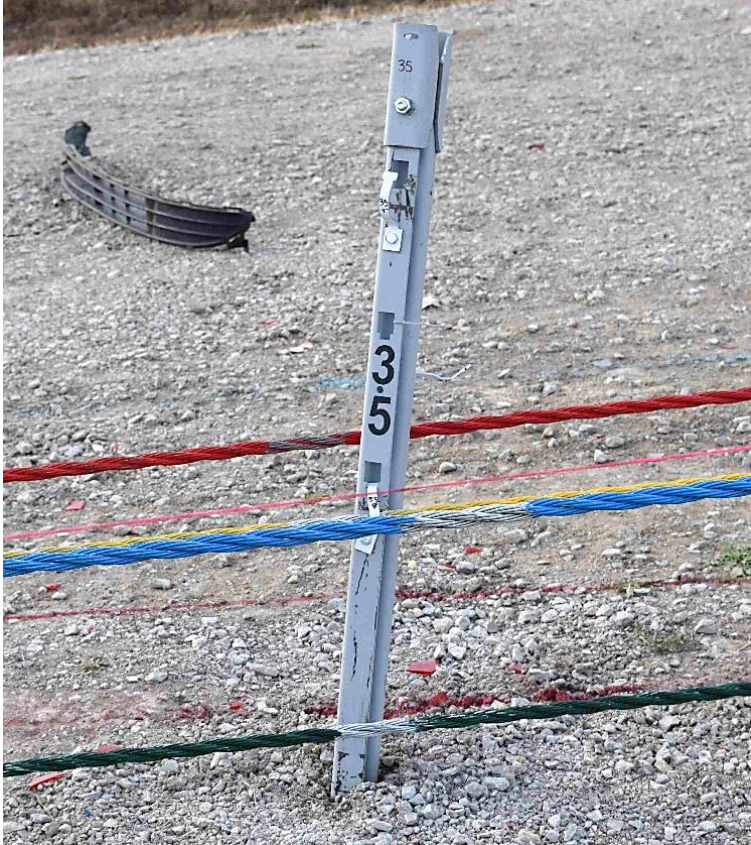
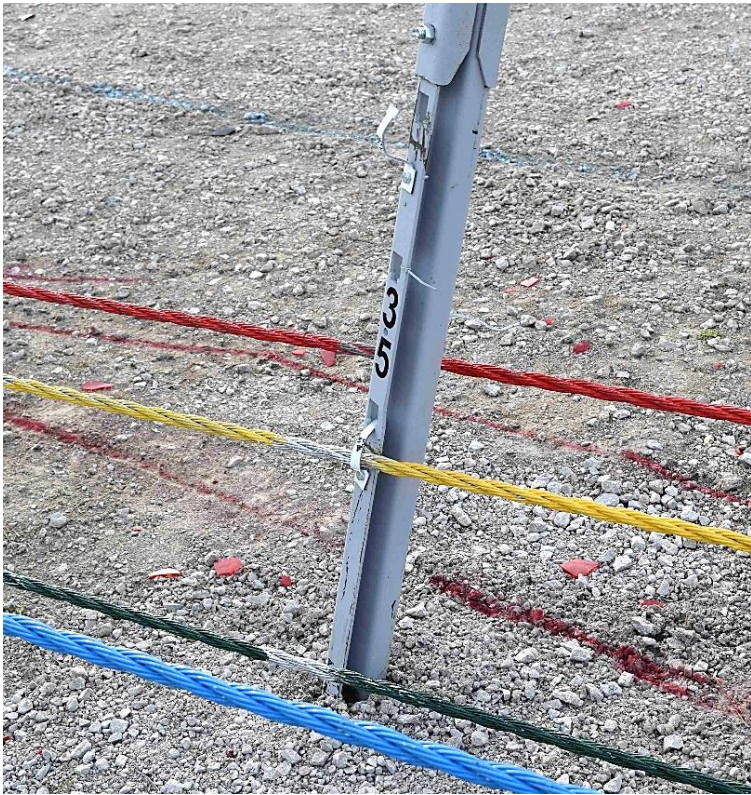
Figure 67. Post No. 35 Damage, Test No. MWP-9

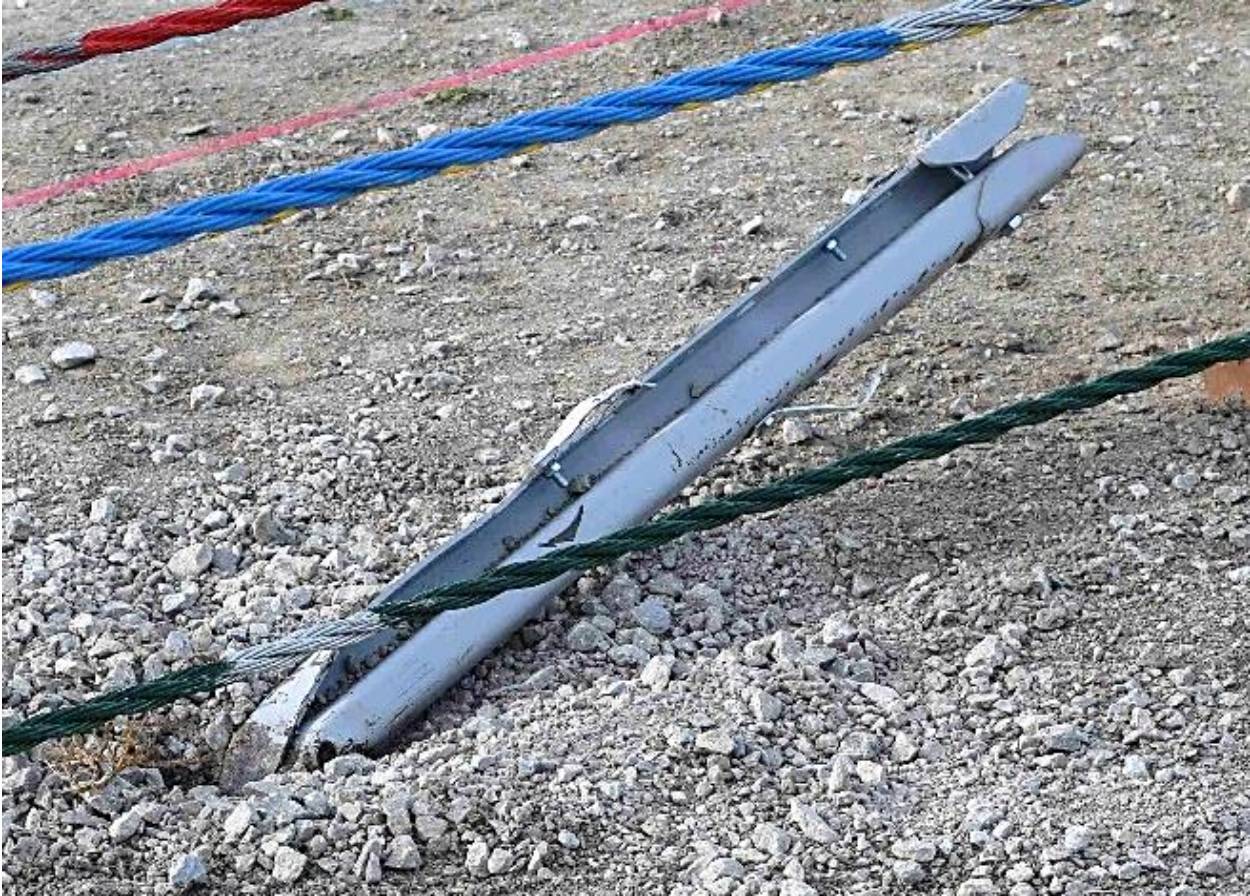
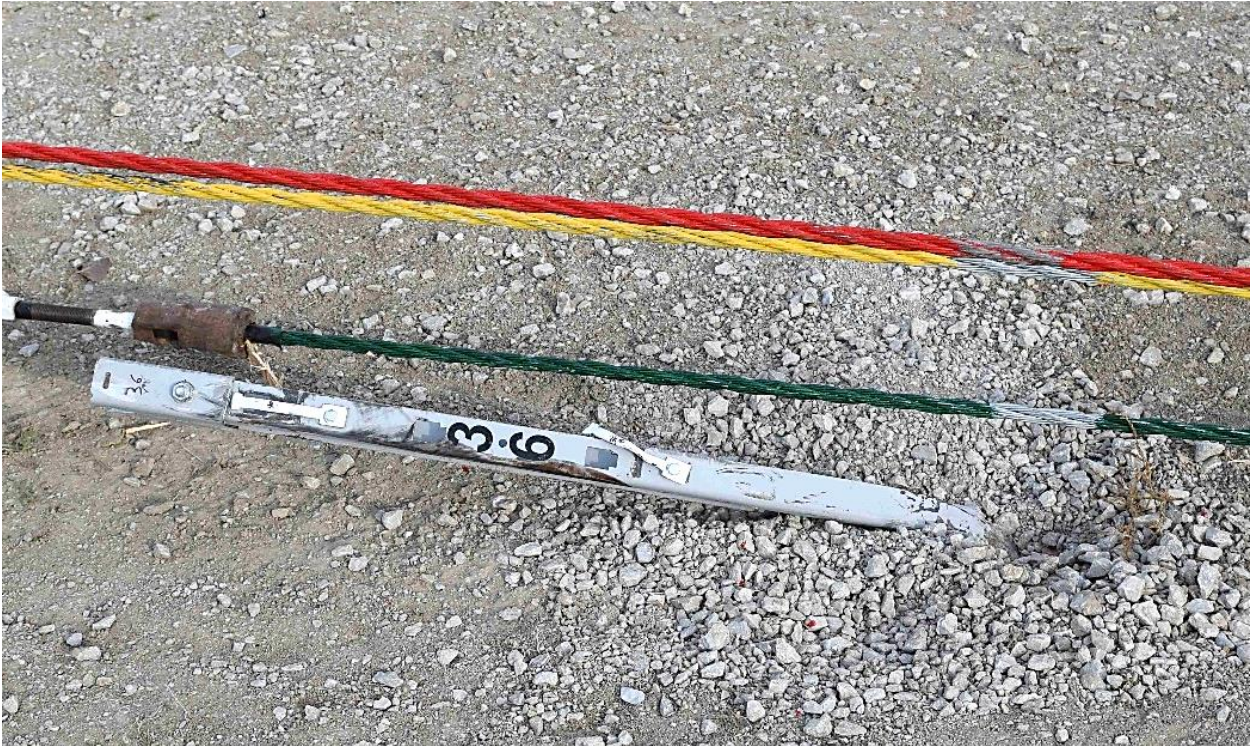
Figure 68. Post No. 36 Damage, Test No. MWP-9

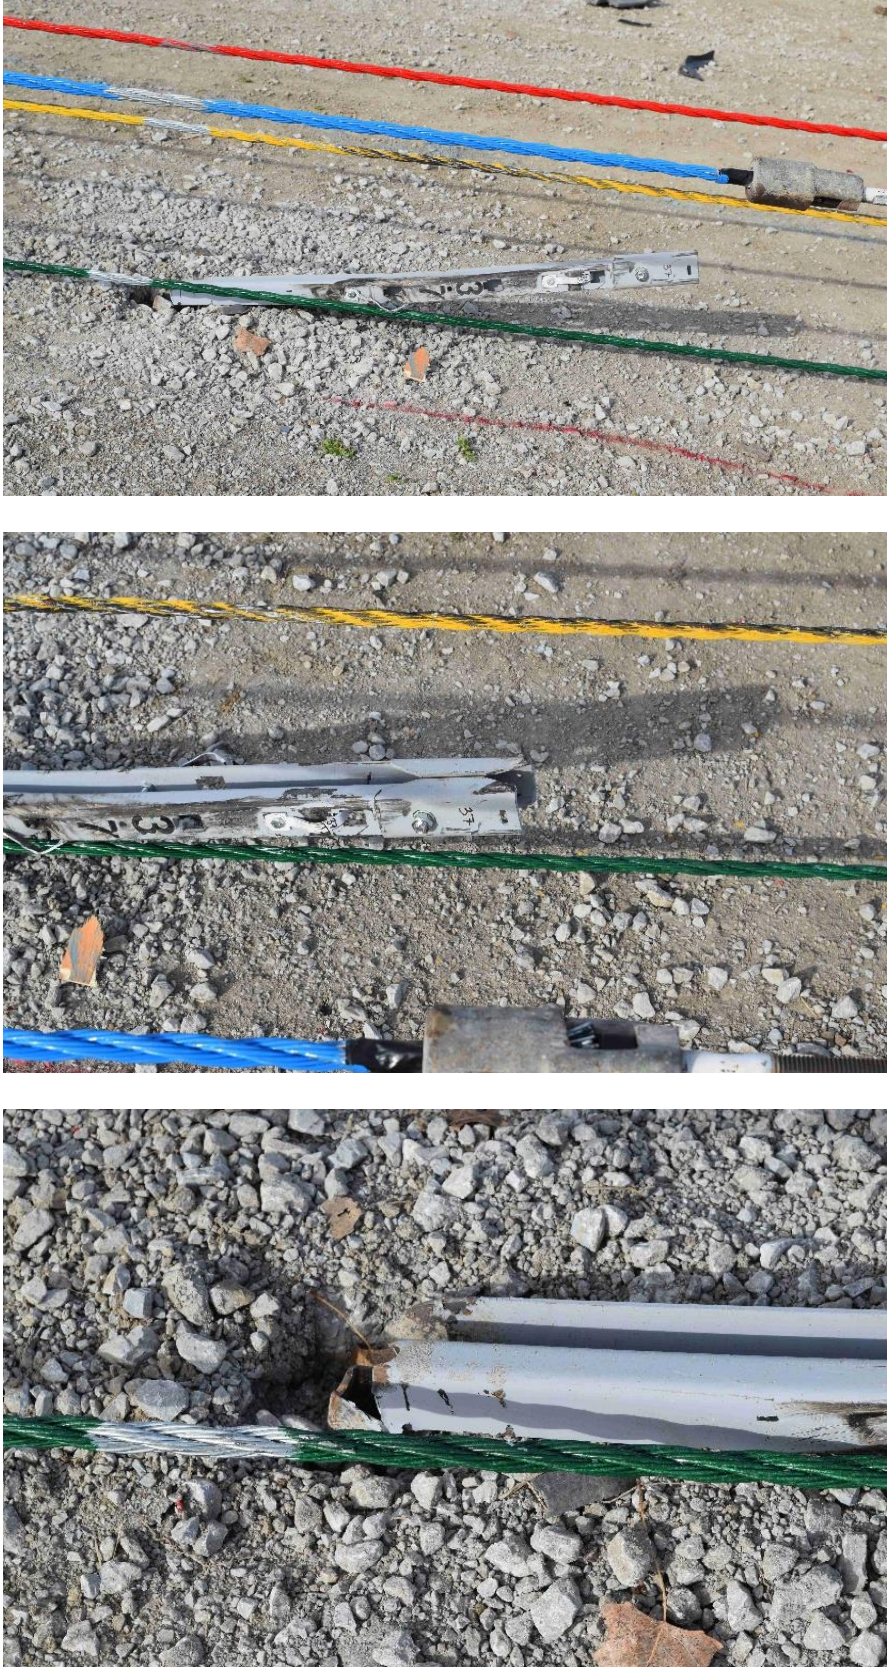
Figure 69. Post No. 37 Damage, Test No. MWP-9

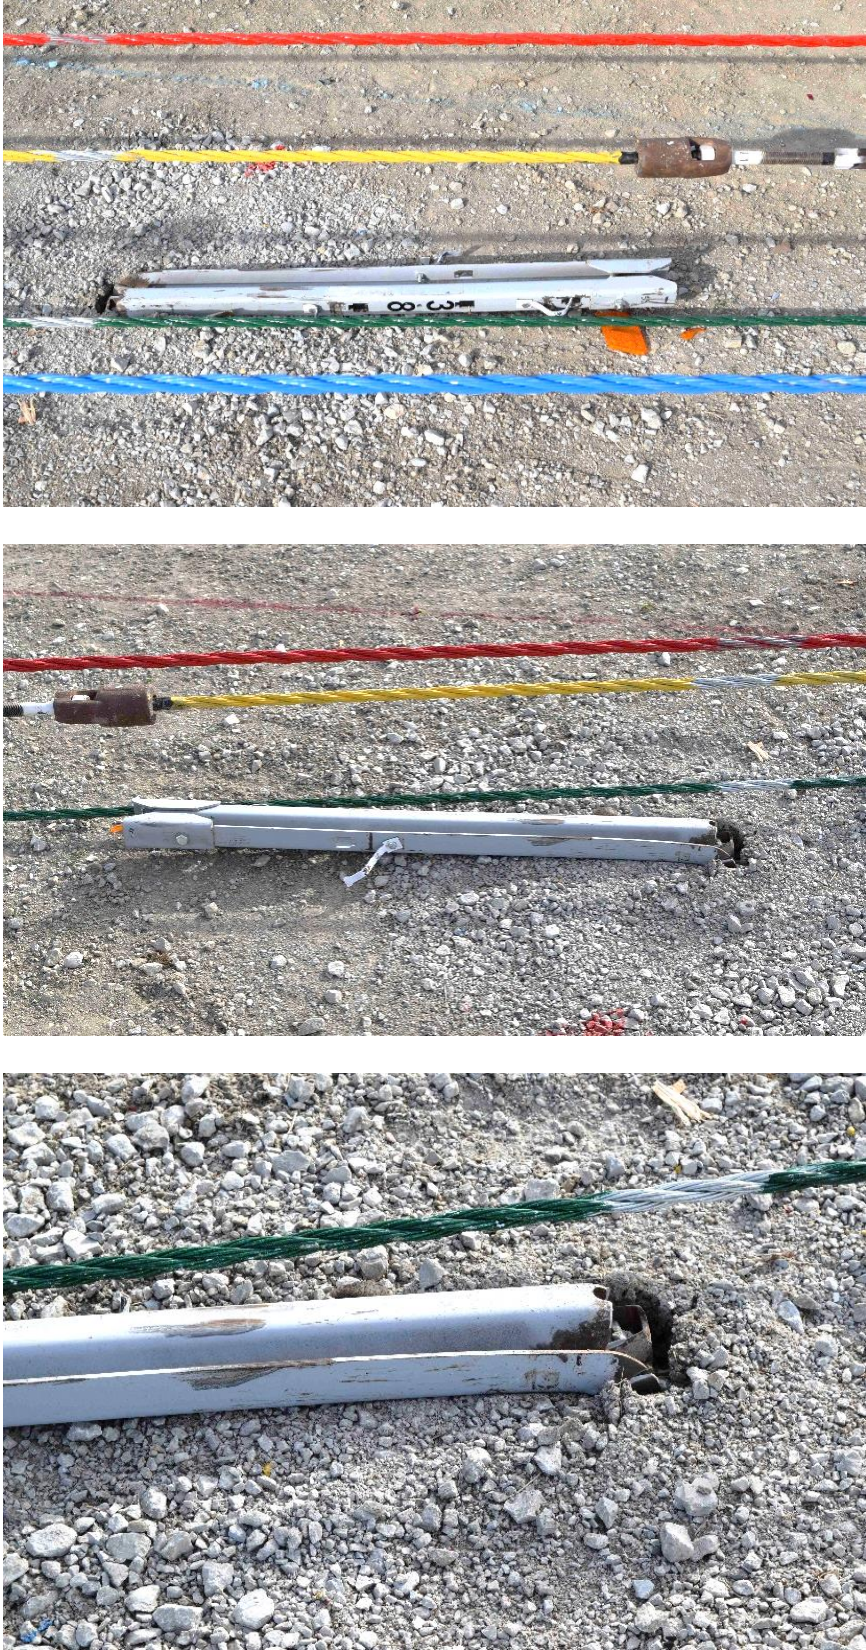
Figure 70. Post No. 38 Damage, Test No. MWP-9

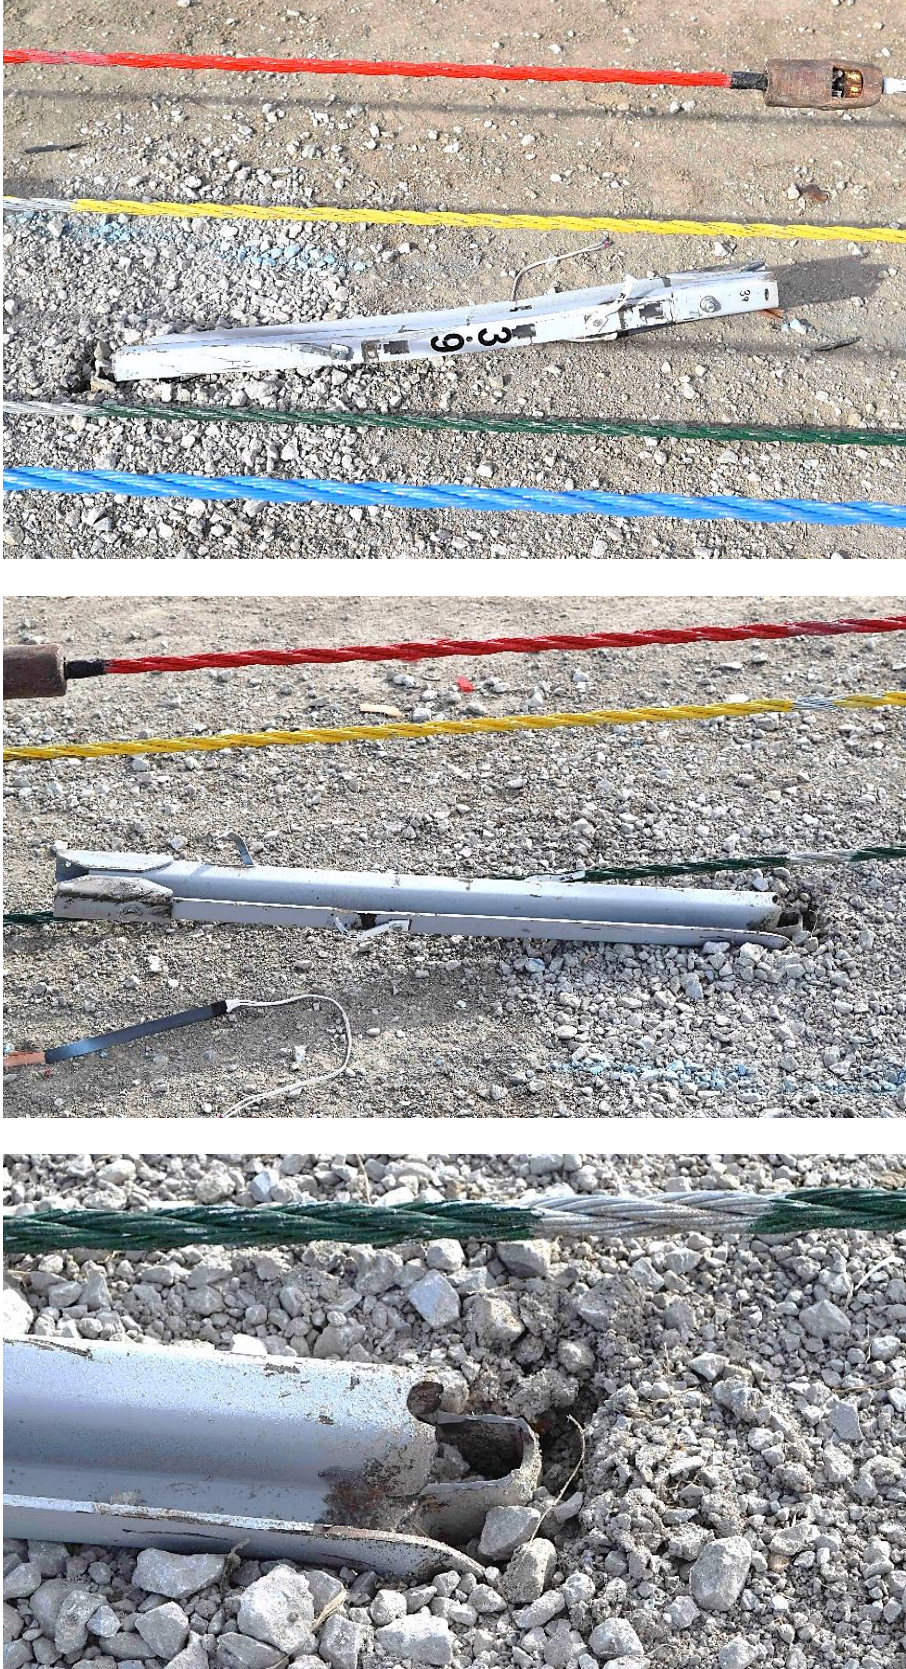
Figure 71. Post No. 39 Damage, Test No. MWP-9

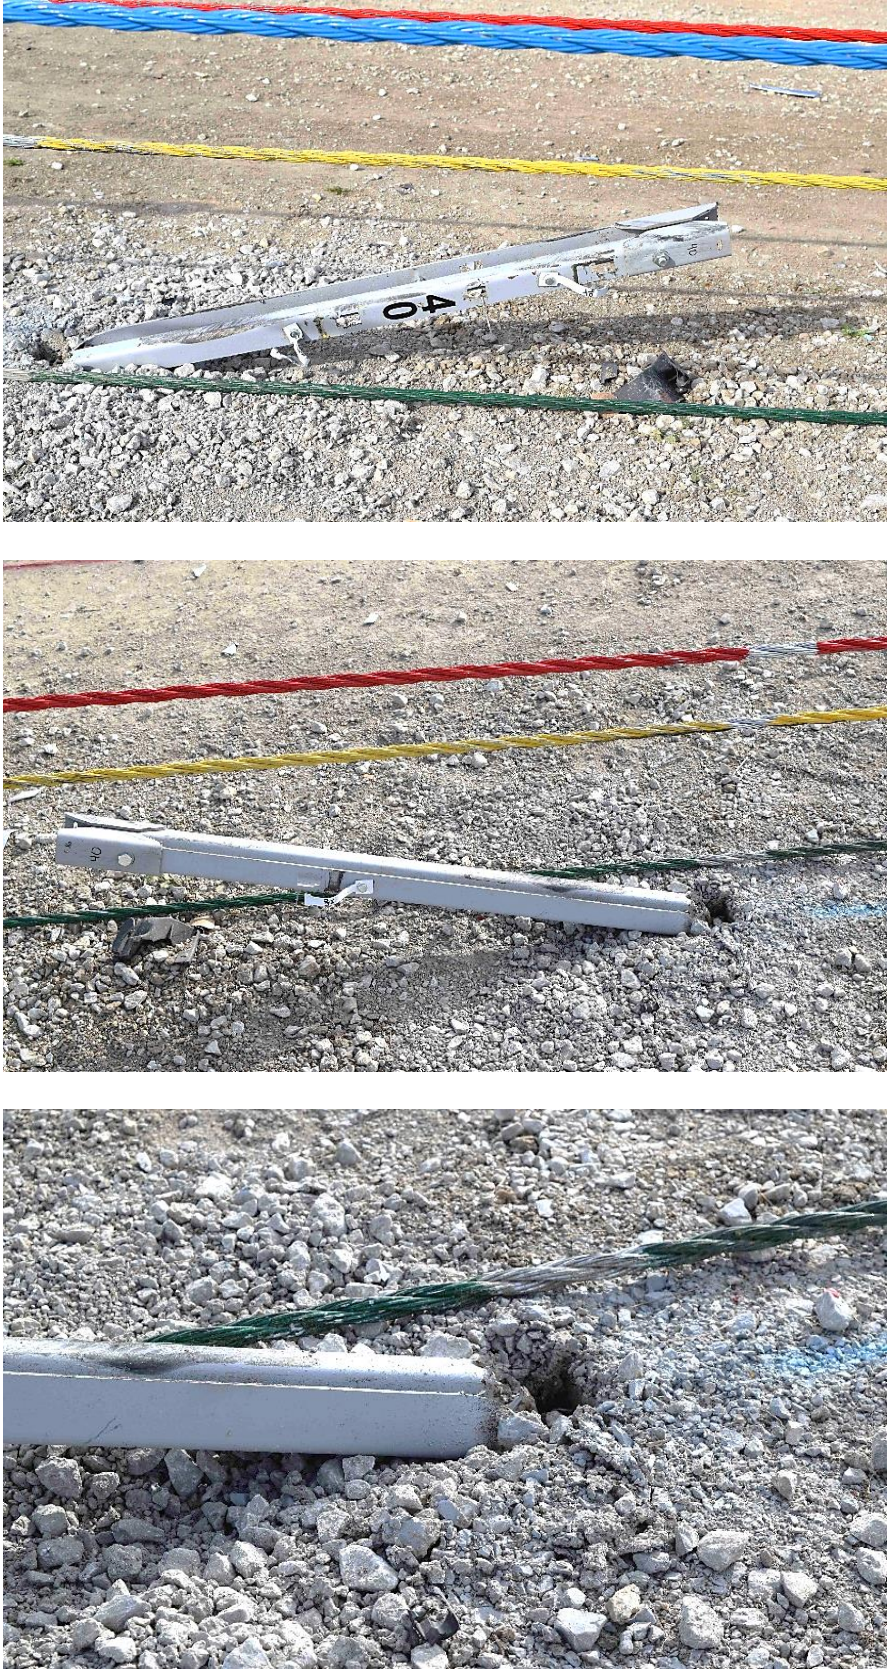
Figure 72. Post No. 40 Damage, Test No. MWP-9
