ISO 17025 LABORATORY
TESTING CERT # 2937.01

MASH TEST NO. 3-10 OF A NON-PROPRIETARY, HIGH-TENSION, CABLE MEDIAN BARRIER FOR USE IN 6H:1V V-DITCH (TEST NO. MWP-9)

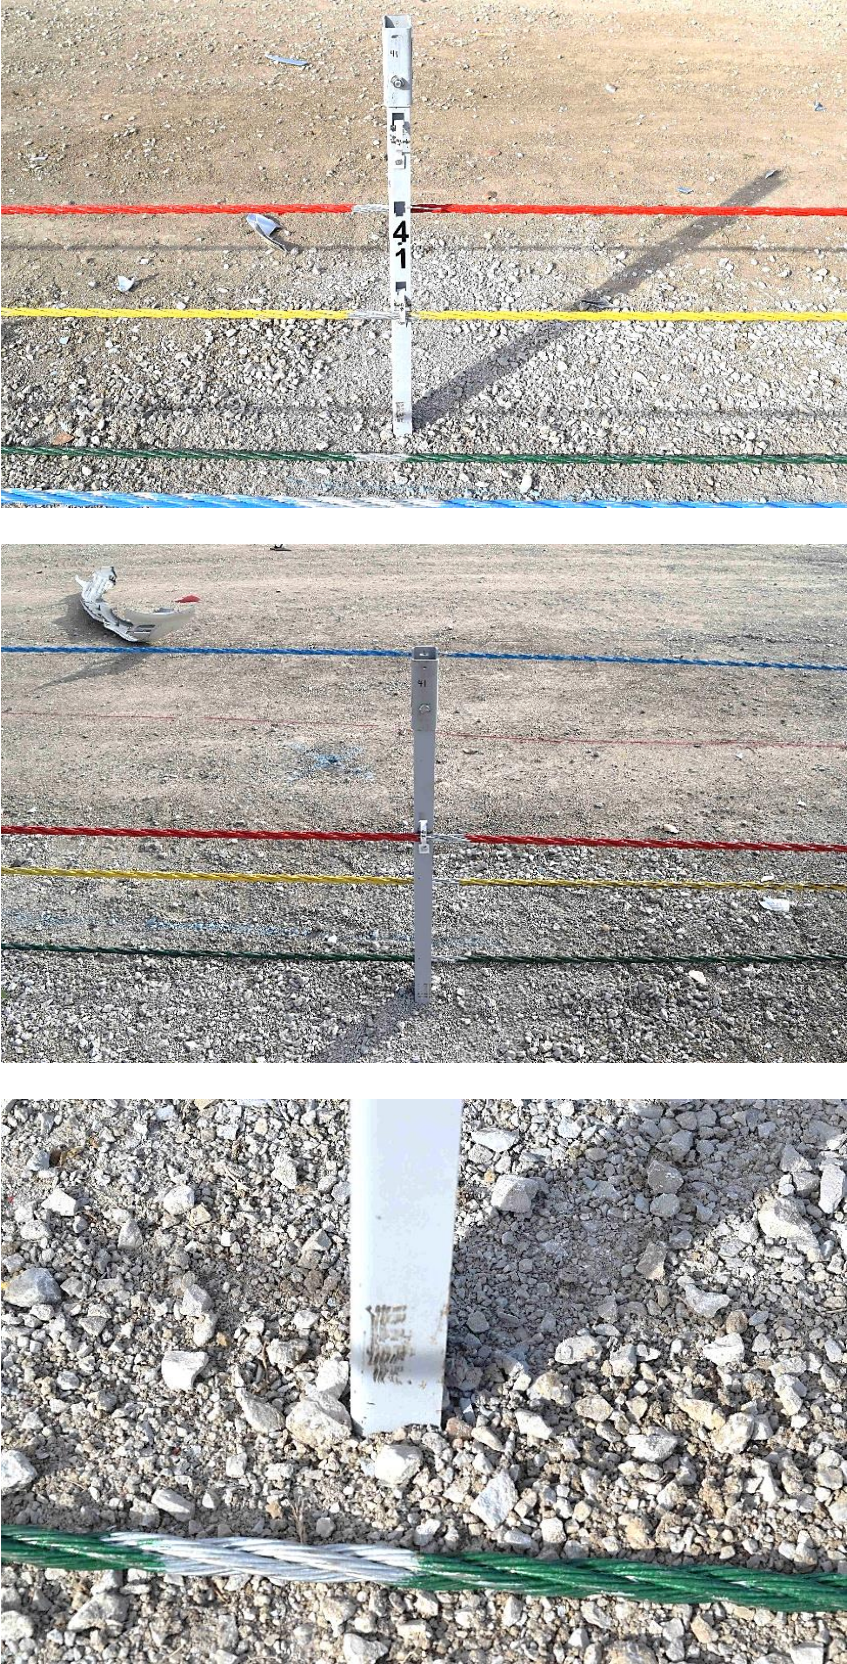
Figure 73. Post No. 41 Damage, Test No. MWP-9

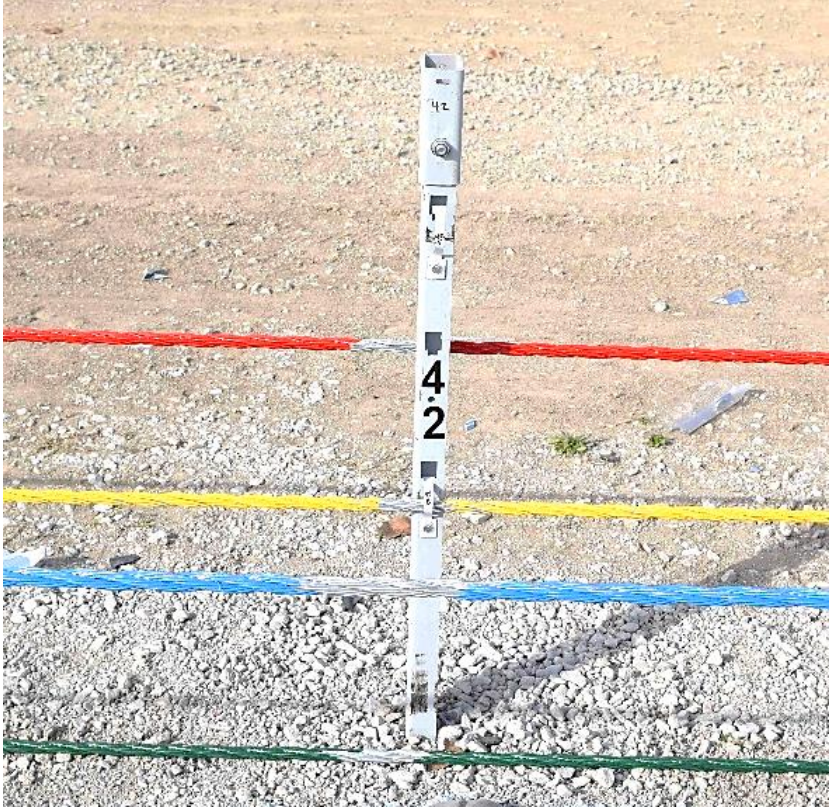
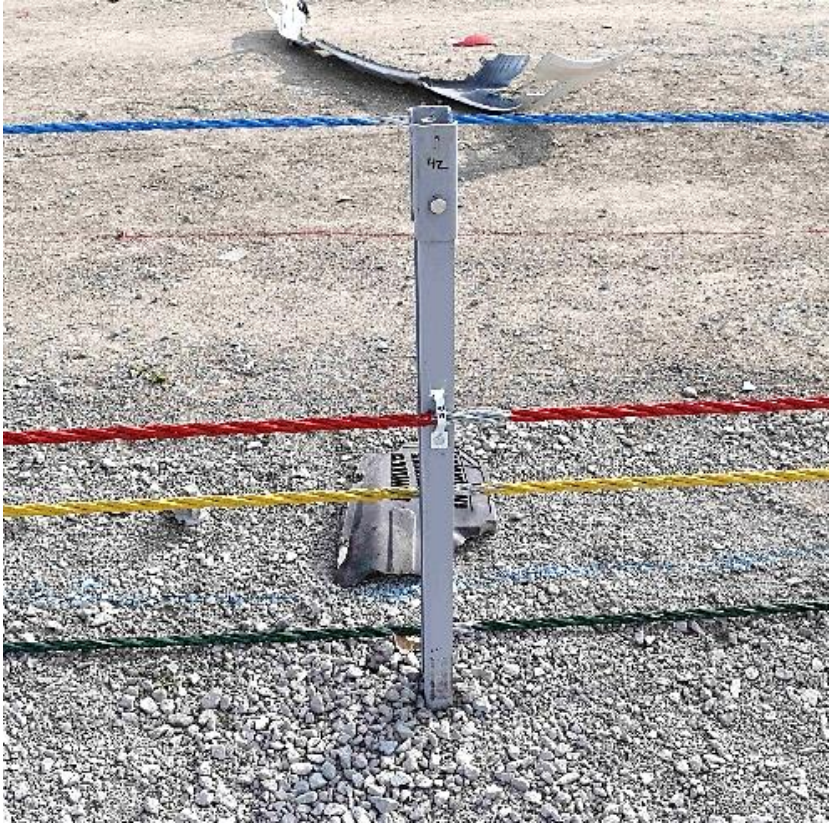
Figure 74. Post No. 42 Damage, Test No. MWP-9

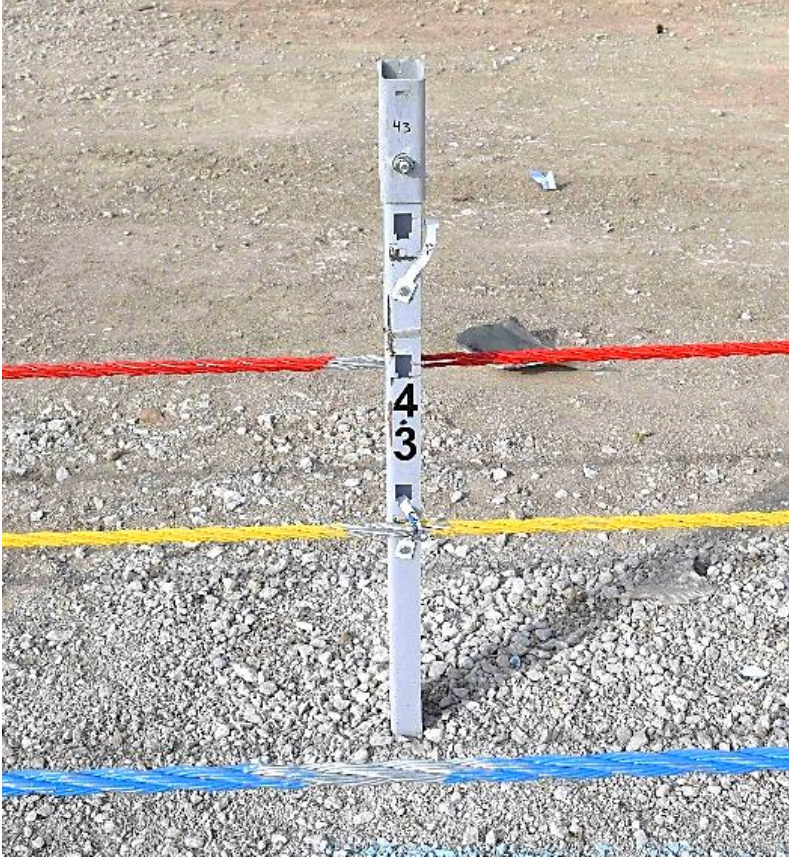
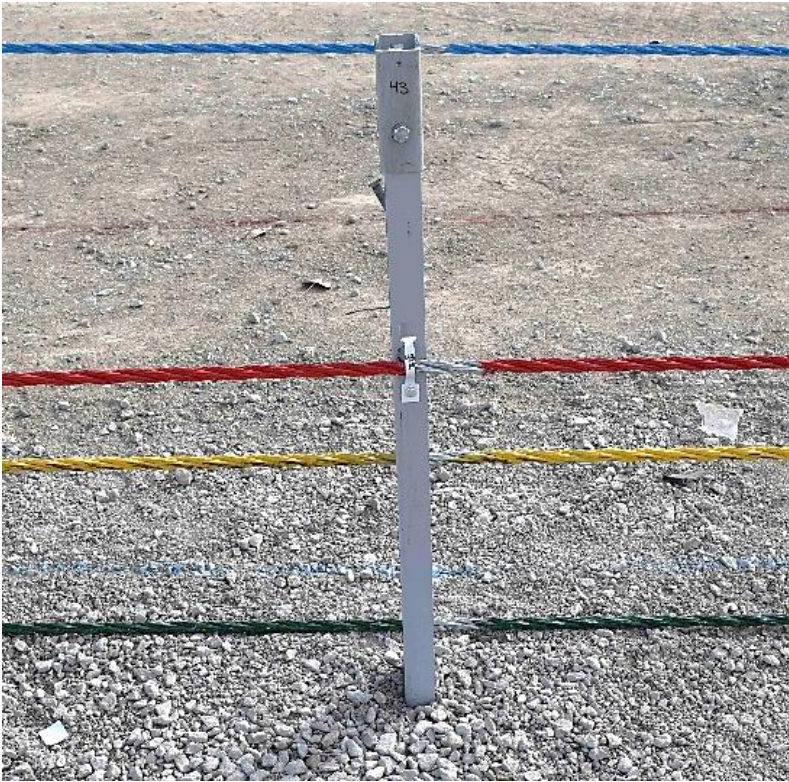
Figure 75. Post No. 43 Damage, Test No. MWP-9

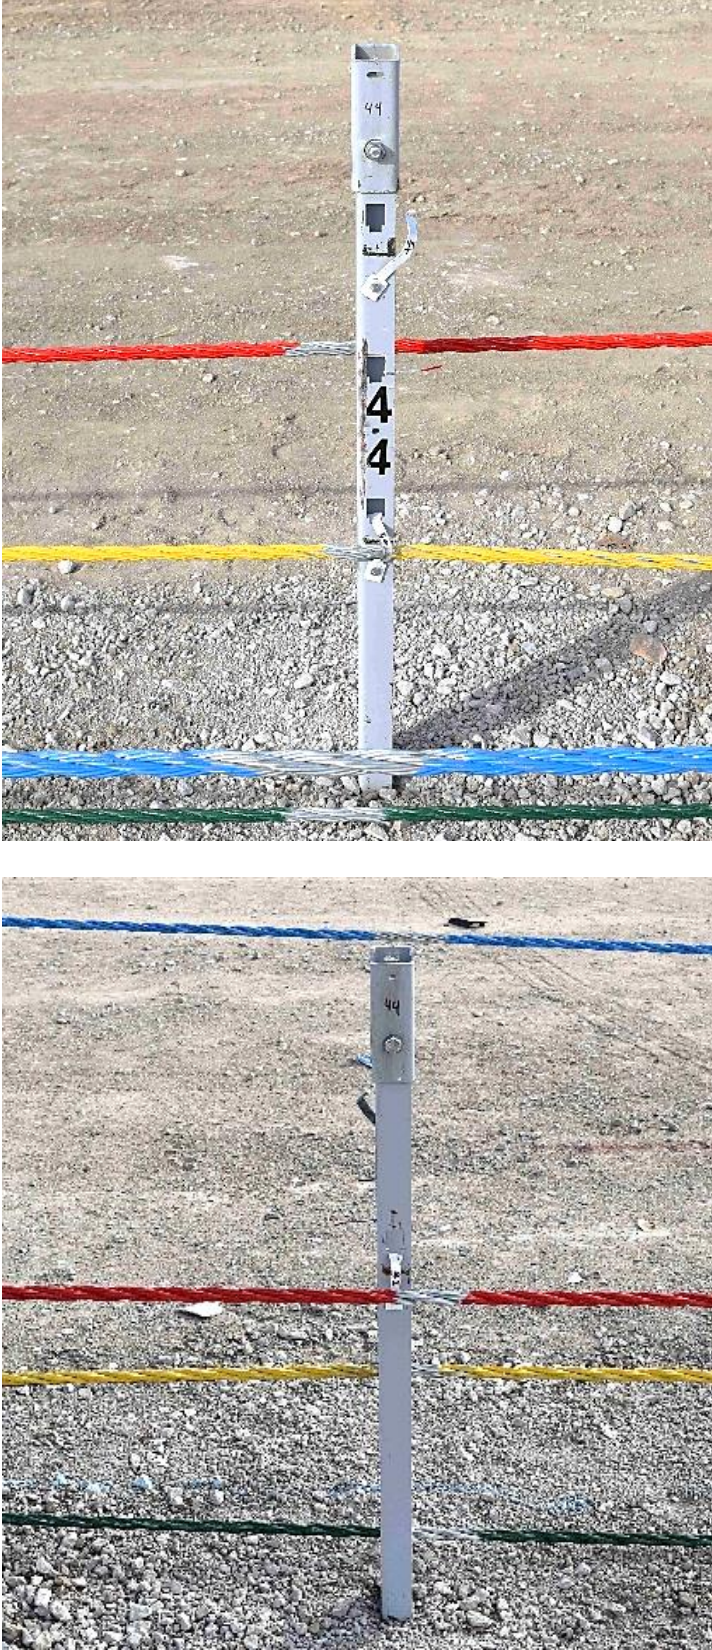
Figure 76. Post No. 44 Damage, Test No. MWP-9

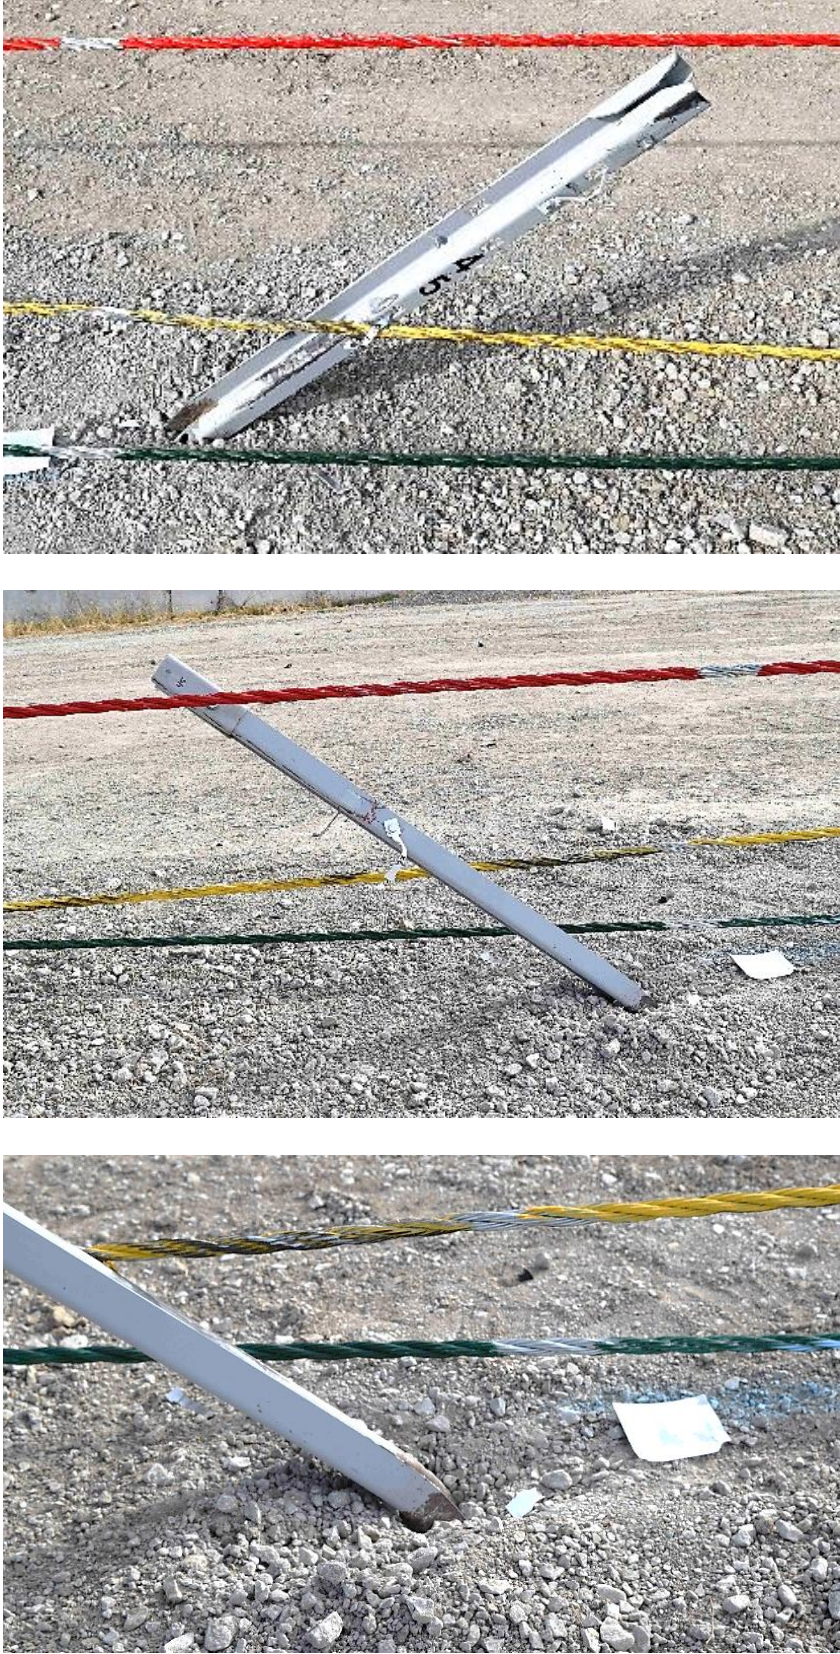
Figure 77. Post No. 45 Damage, Test No. MWP-9

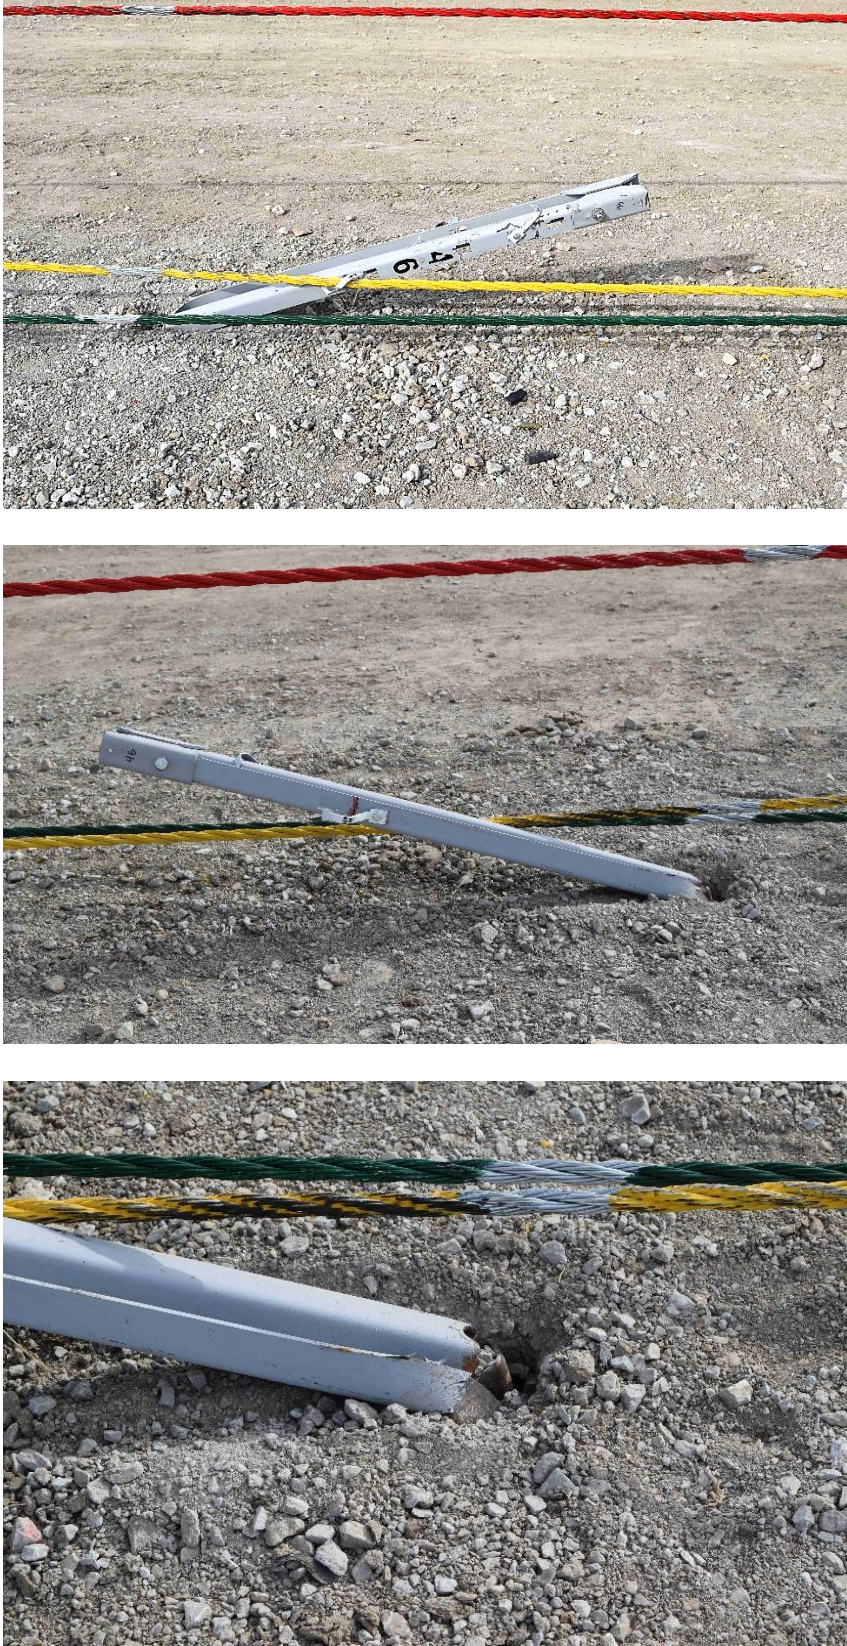
Figure 78. Post No. 46 Damage, Test No. MWP-9

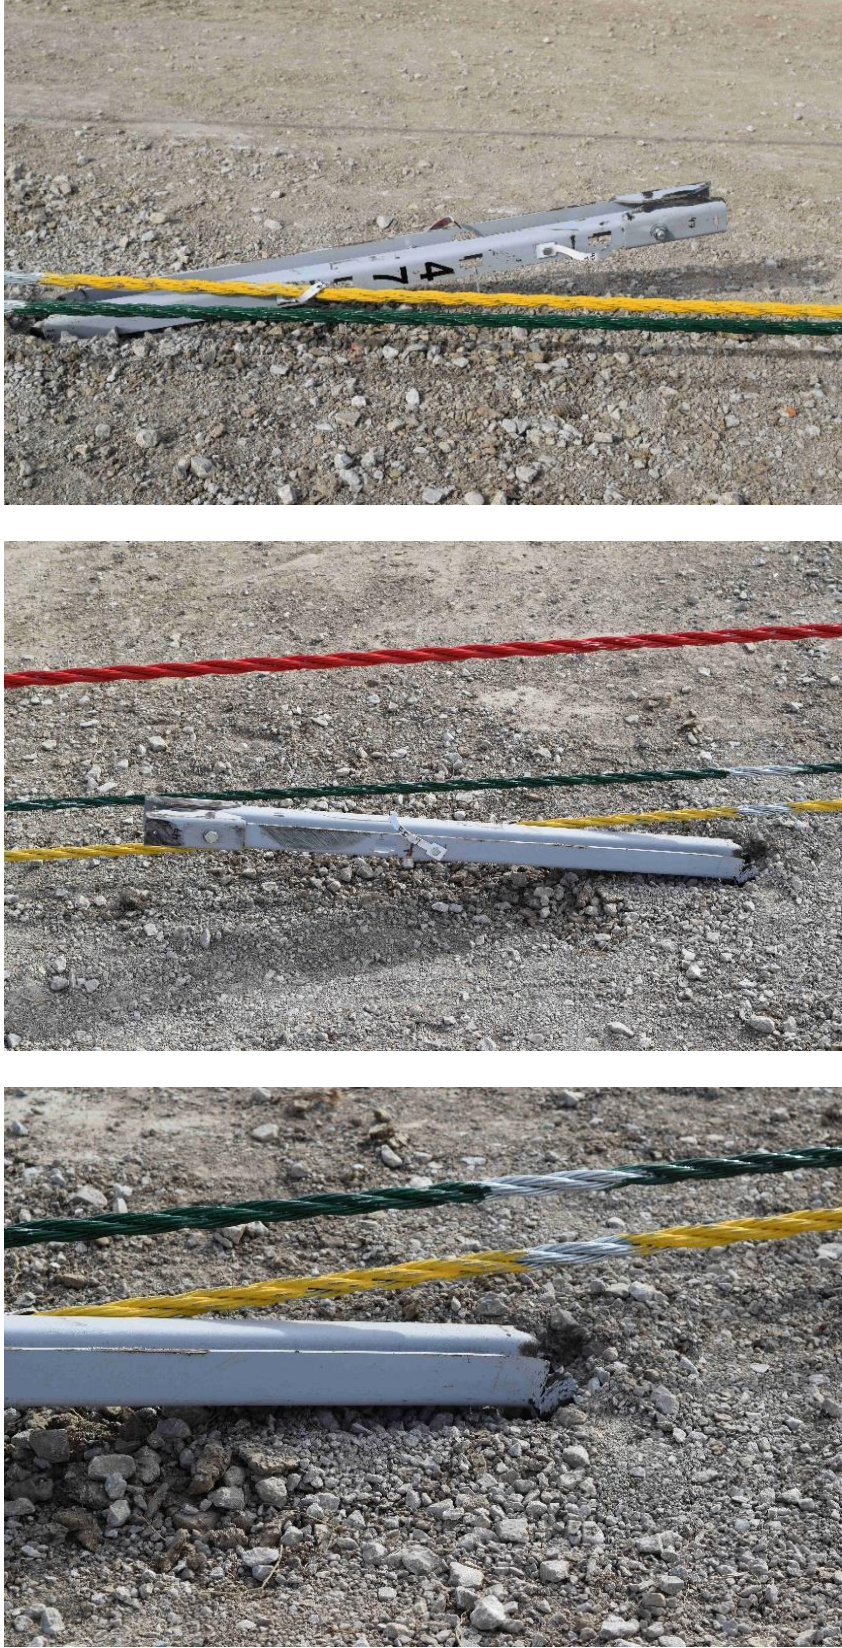
Figure 79. Post No. 47 Damage, Test No. MWP-9

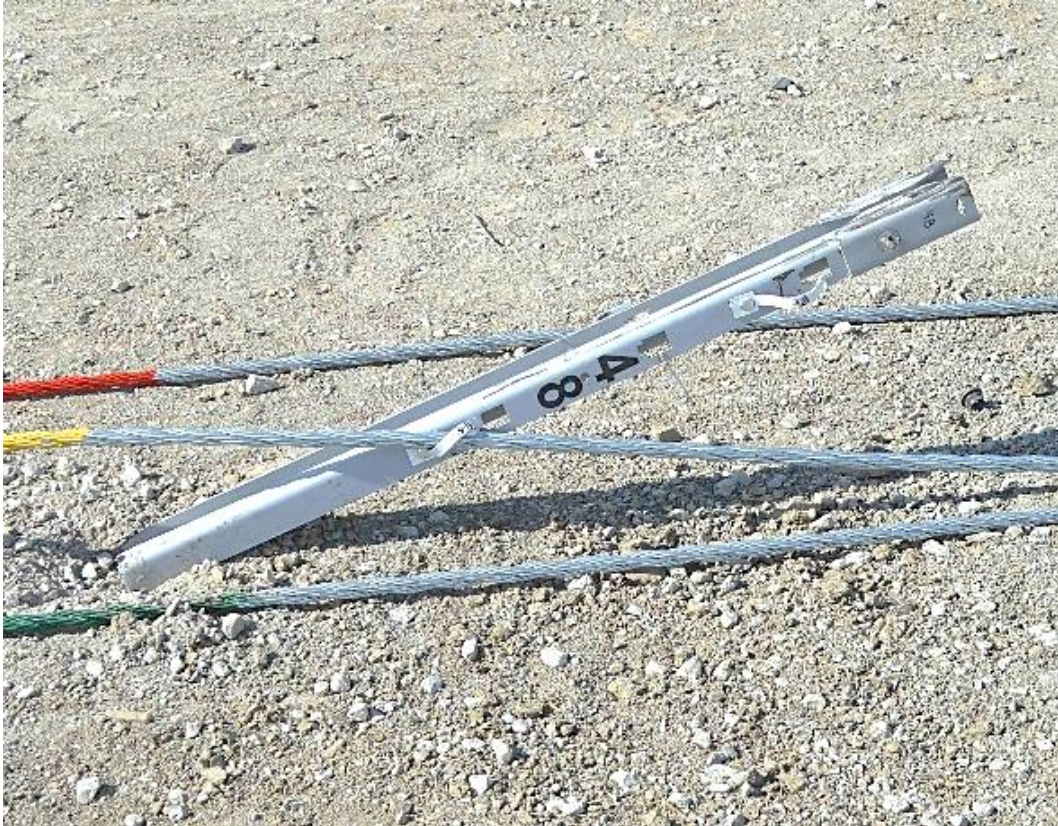
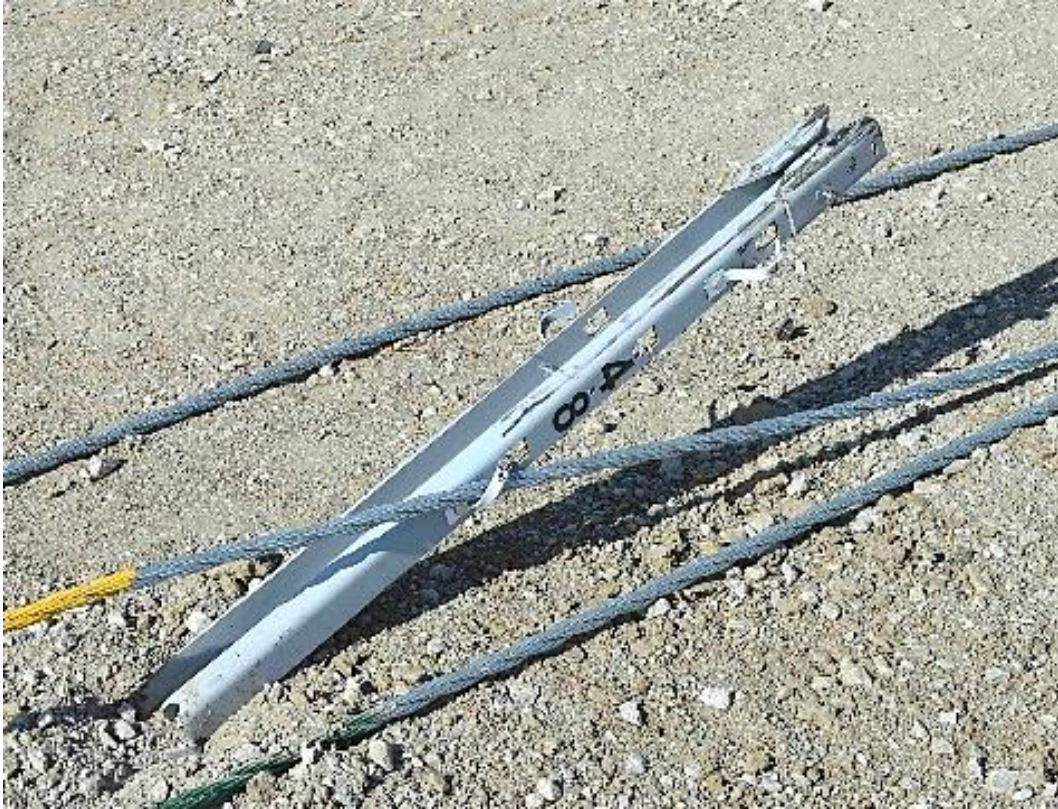
Figure 80. Post No. 48 Damage, Test No. MWP-9
96

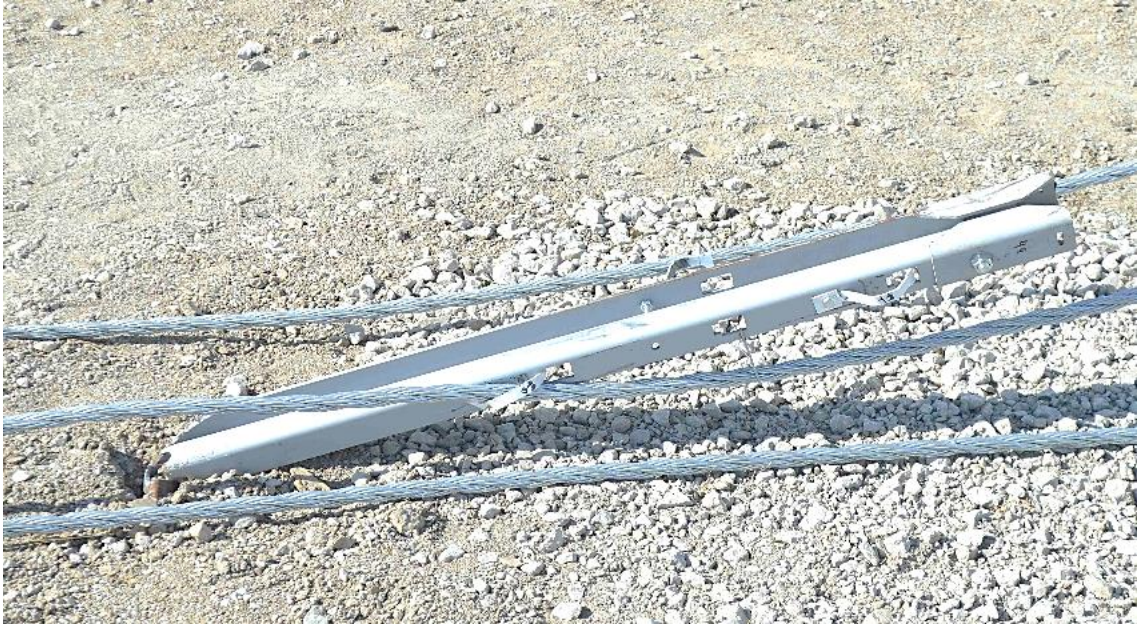
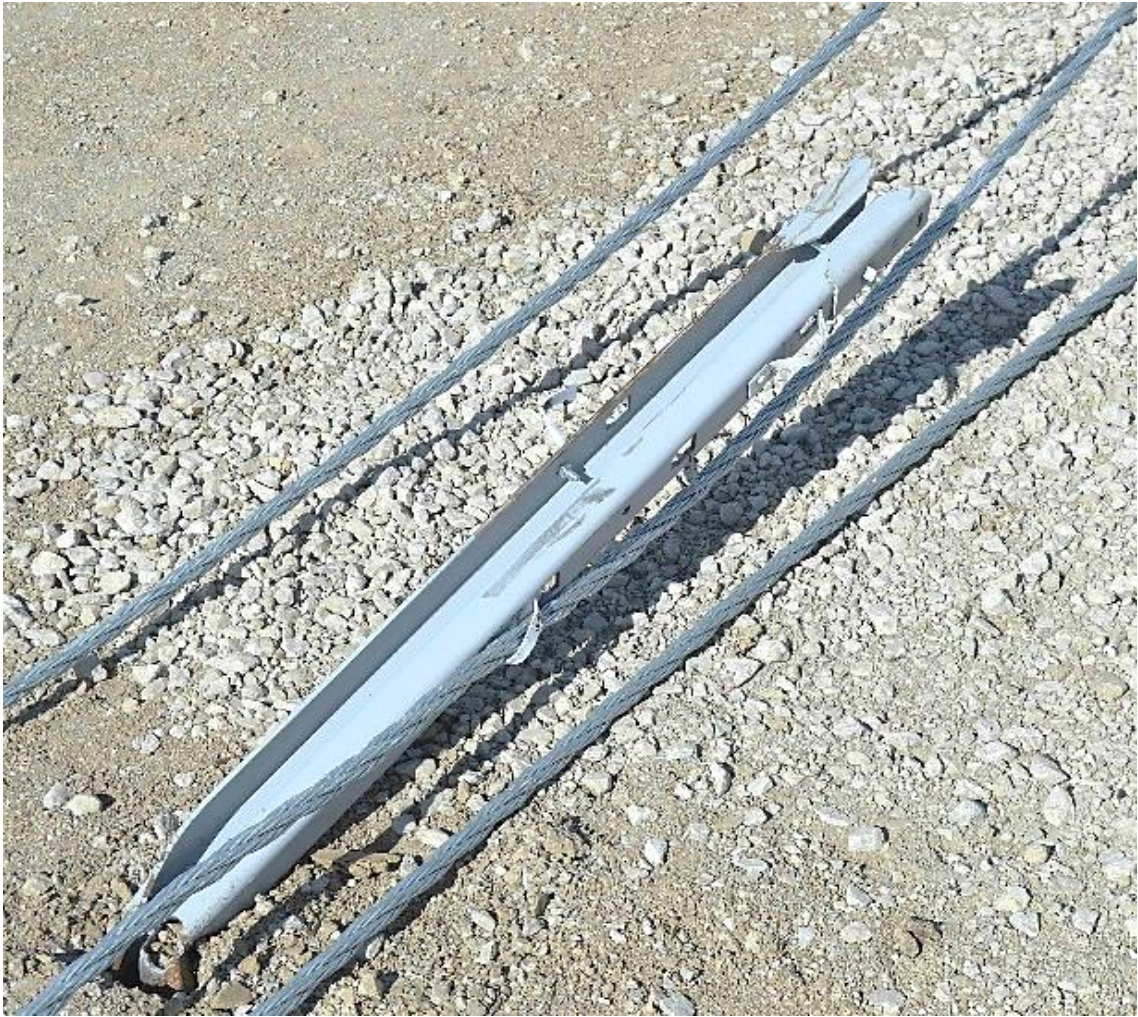
Figure 81. Post No. 49 Damage, Test No. MWP-9

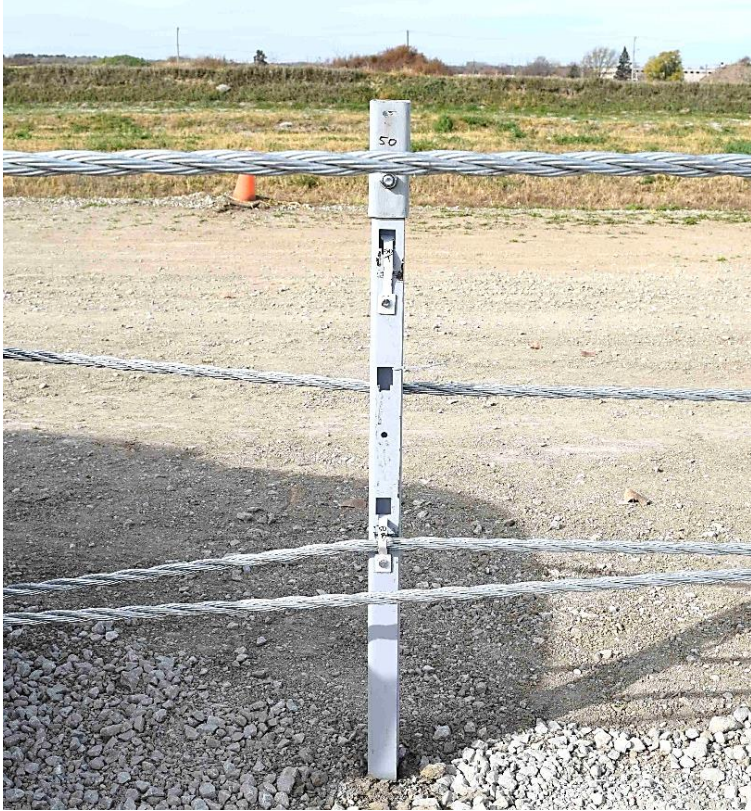
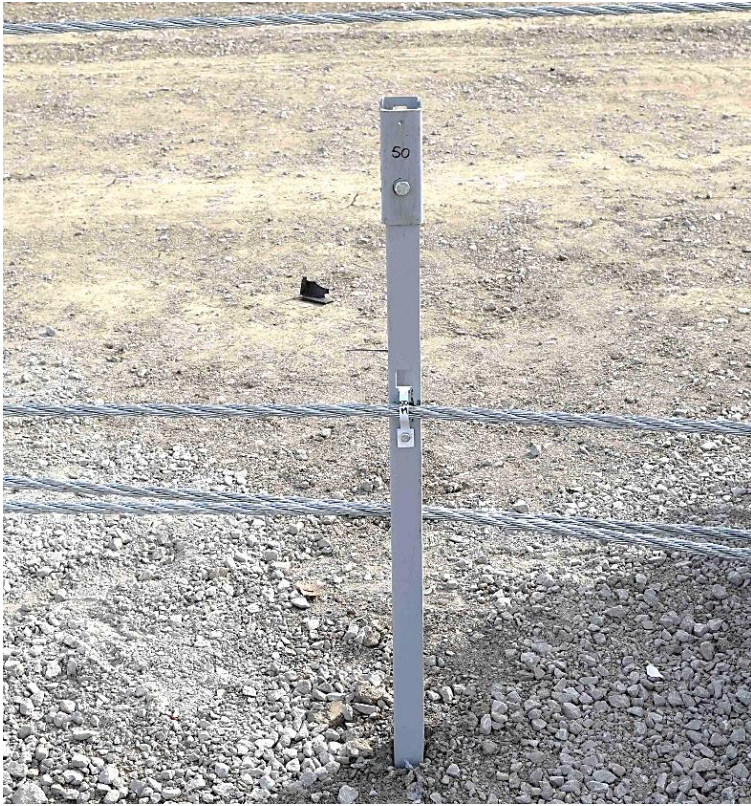
Figure 82. Post No. 50 Damage, Test No. MWP-9

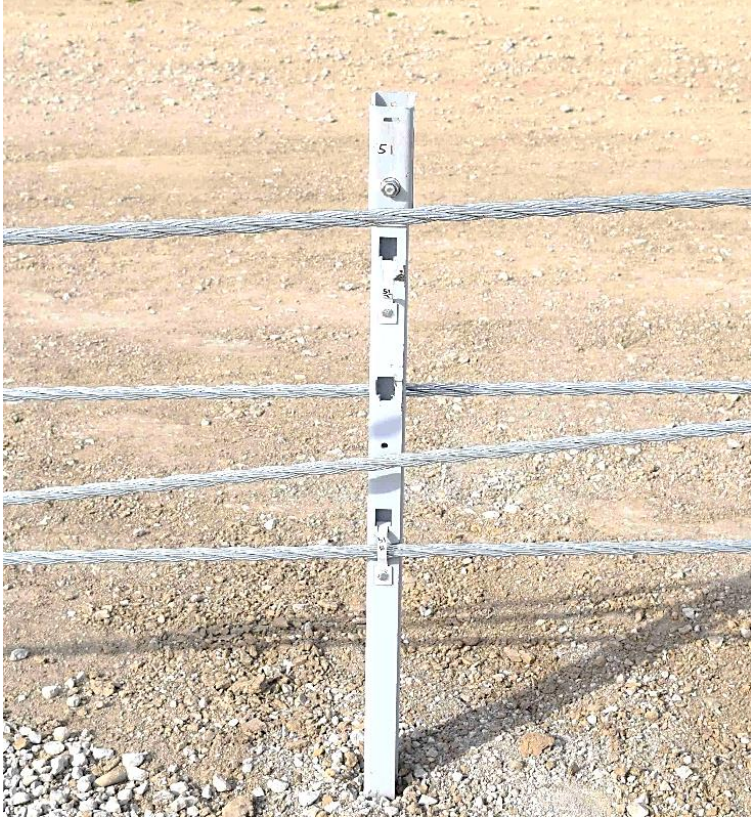
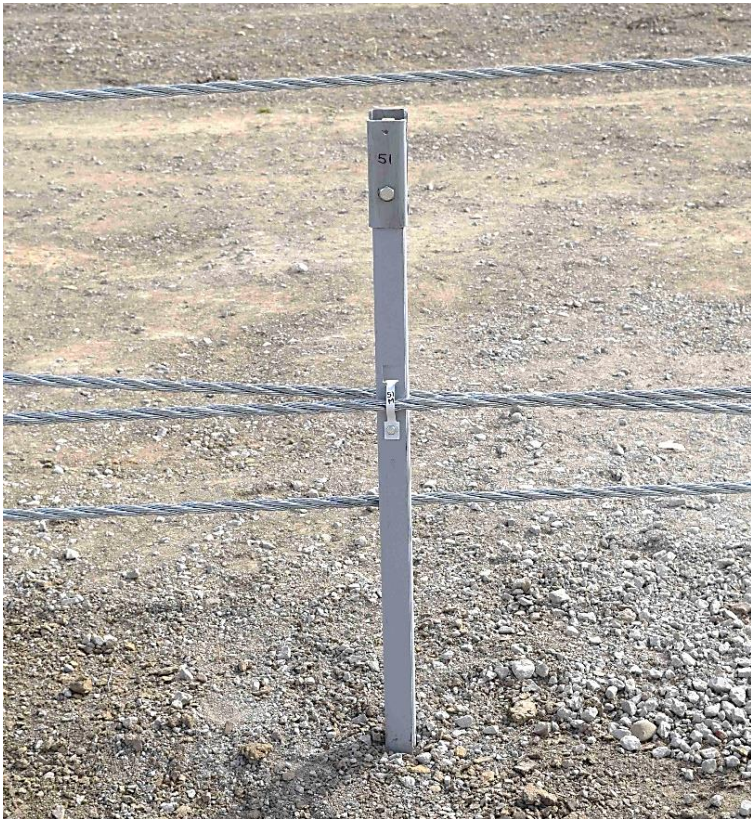
Figure 83. Post No. 51 Damage, Test No. MWP-9
99

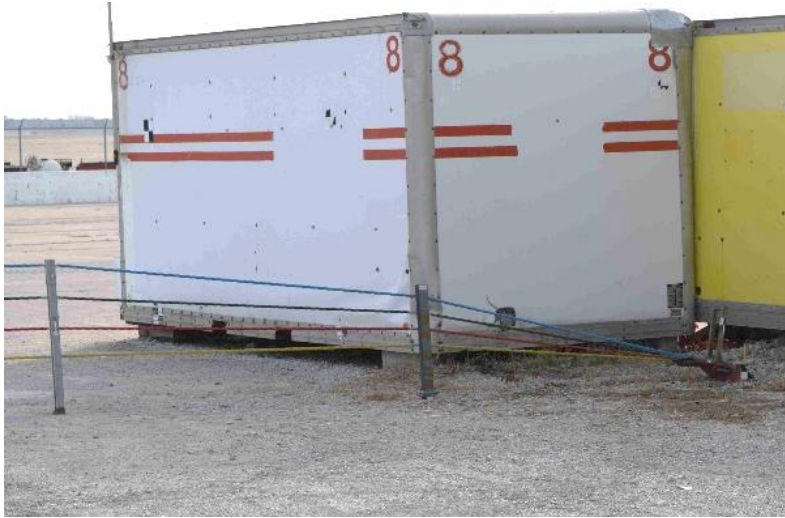
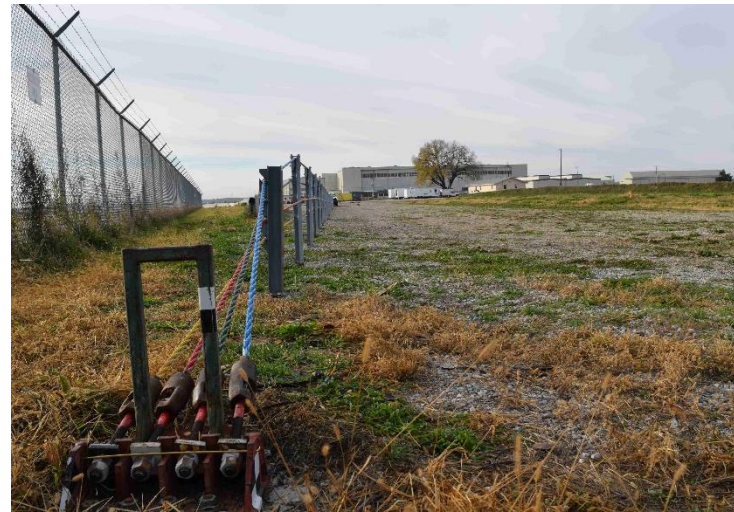
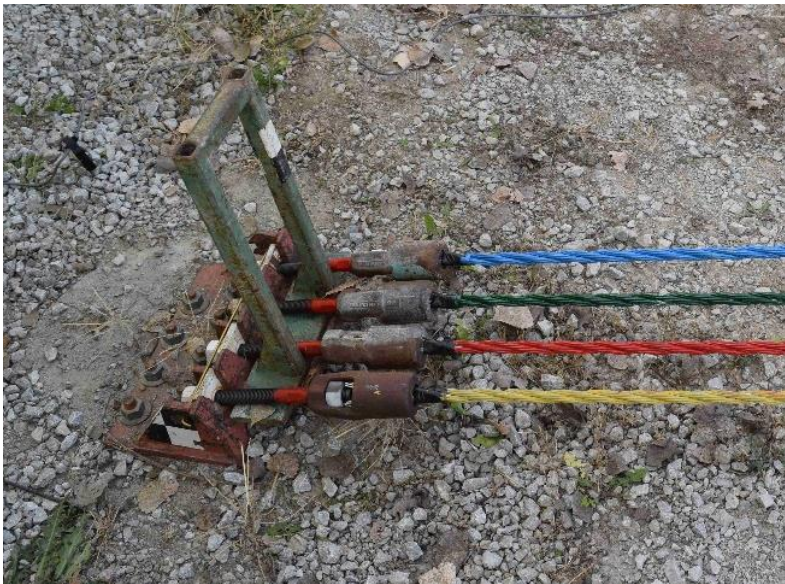
Figure 84. Post Nos. 52 and 53 Damage, Test No. MWP-9

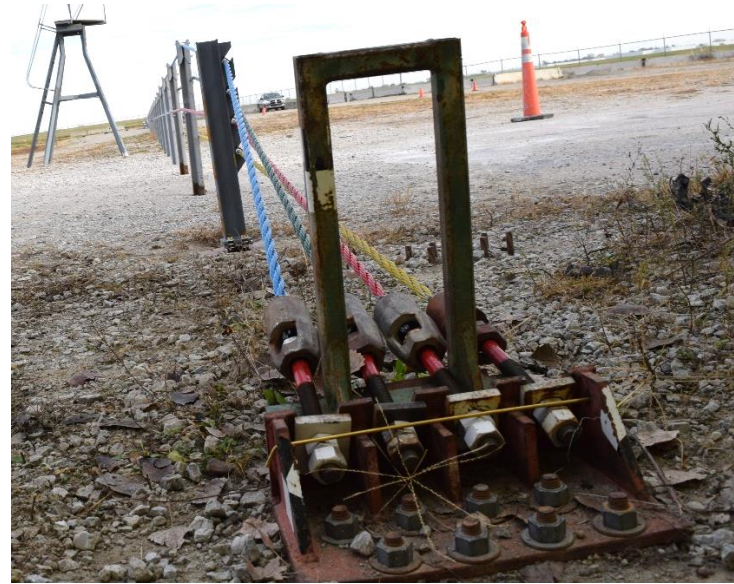
Downstream Anchorage

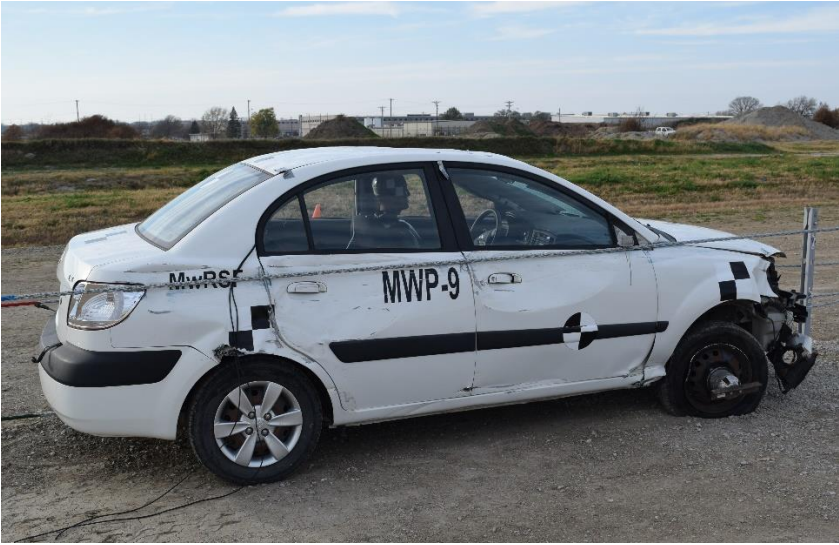
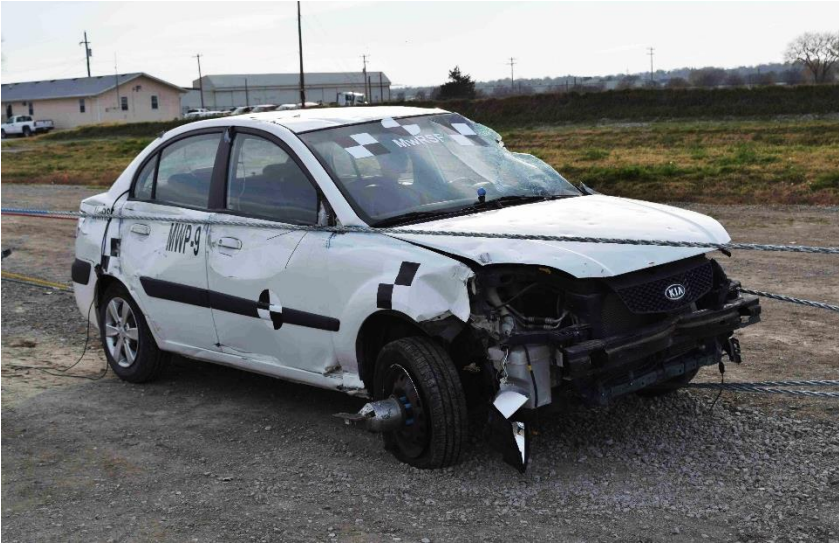
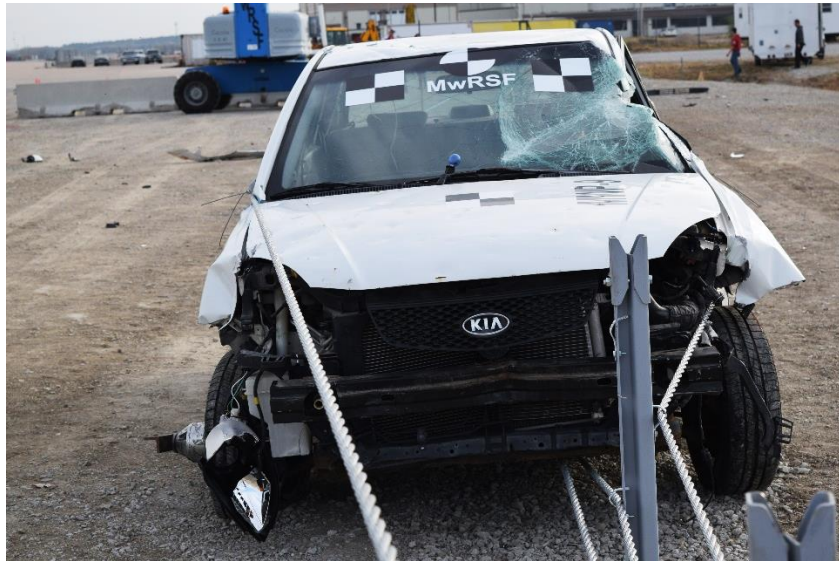
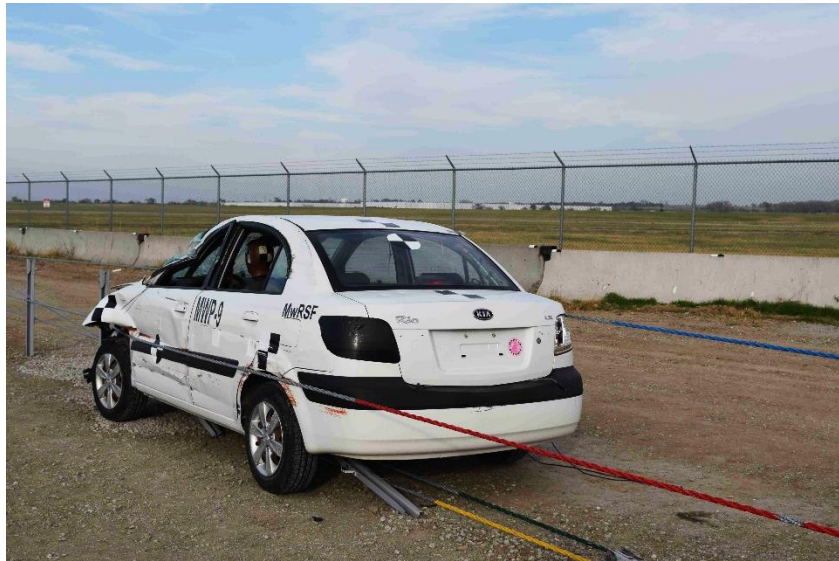
Figure 86. Vehicle Damage, Test No. MWP-9

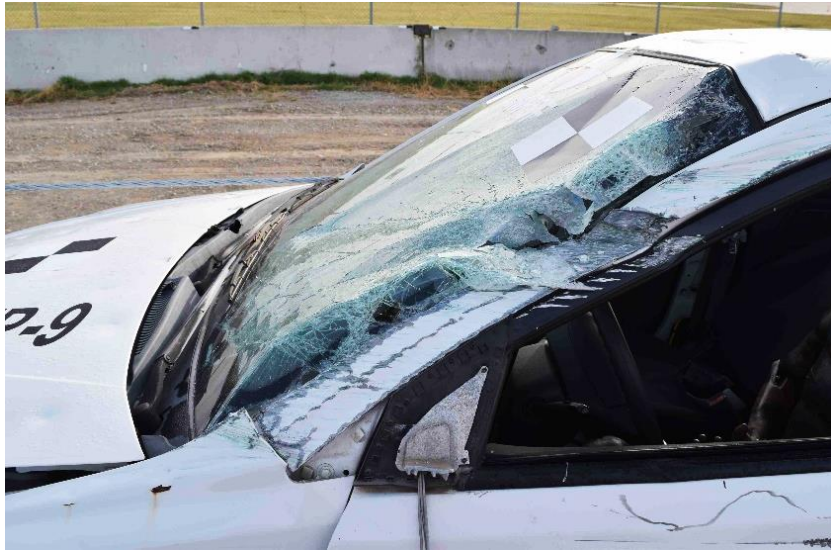
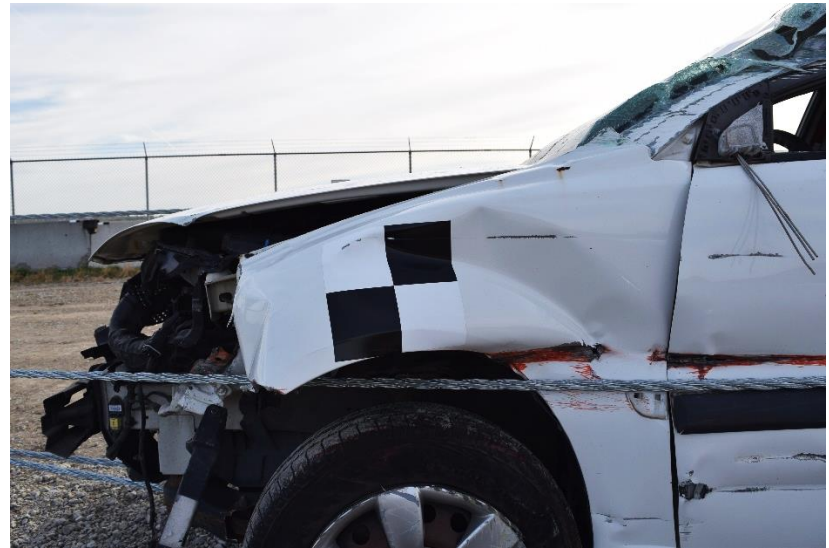
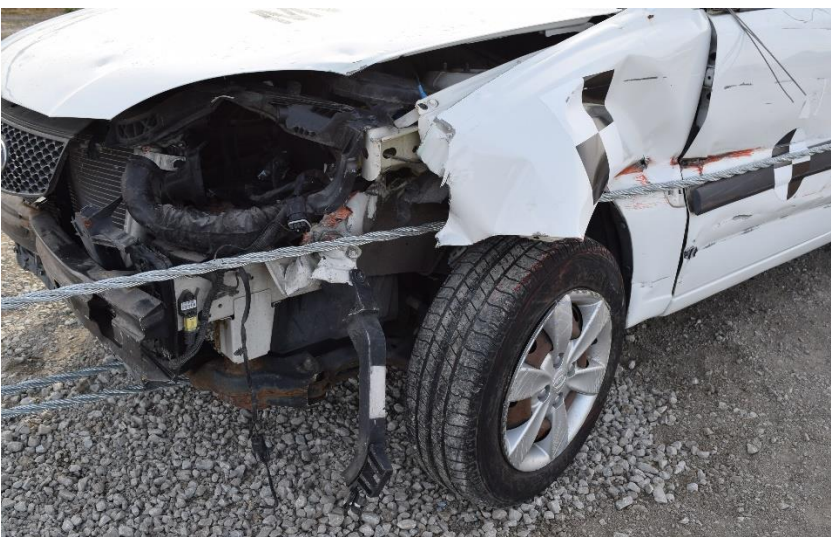
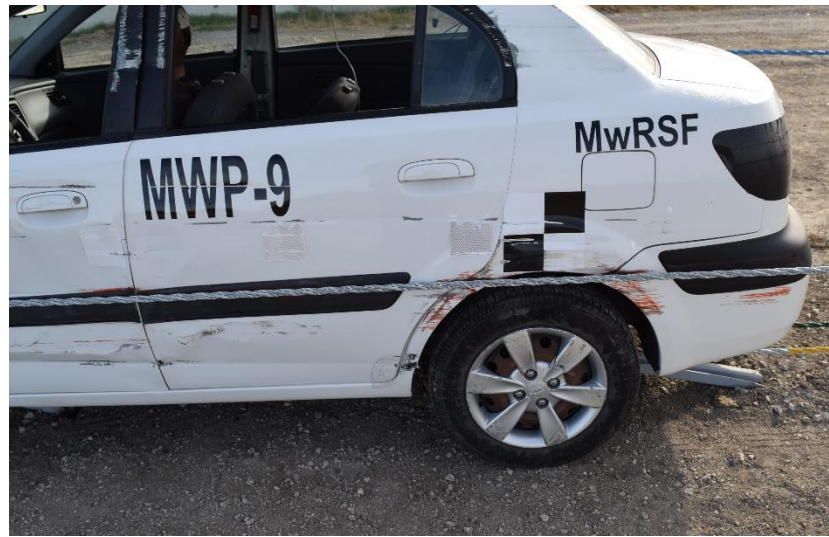
Figure 87. Vehicle Damage, Test No. MWP-9

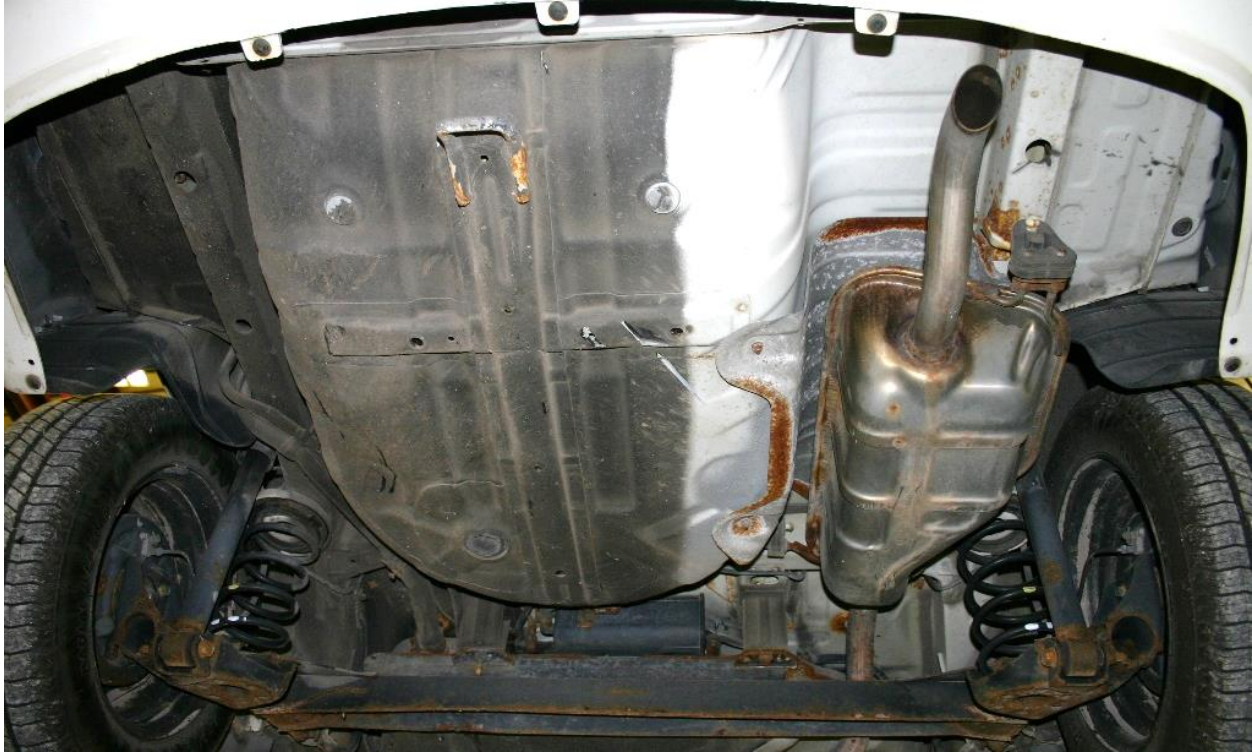
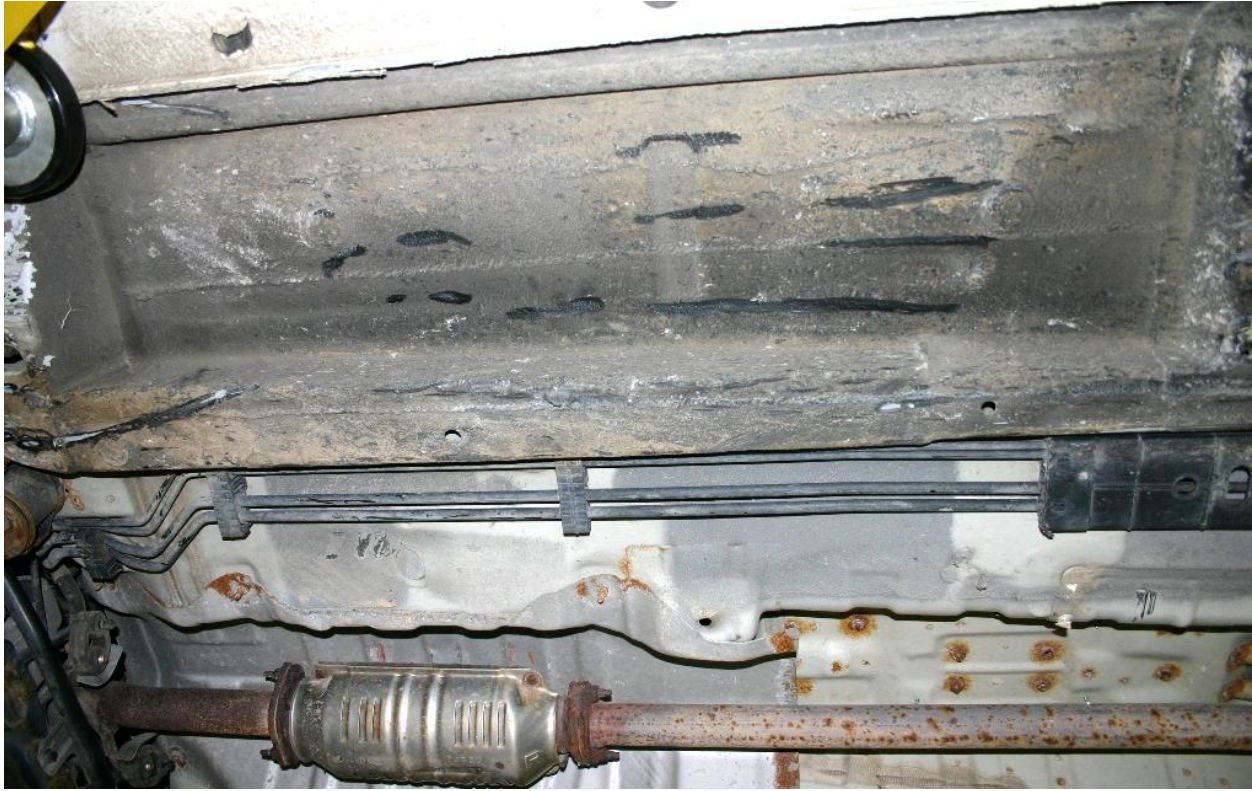
Figure 88. Vehicle Damage, Floor pan, Test No. MWP-9
