DEVELOPMENT AND TESTING OF A NEW VERTICAL-FACED TEMPORARY CONCRETE BARRIER FOR USE ON COMPOSITE PANEL BRIDGE DECKS

MwRSF Research Report No. TRP-03-220-09

October 13, 2009

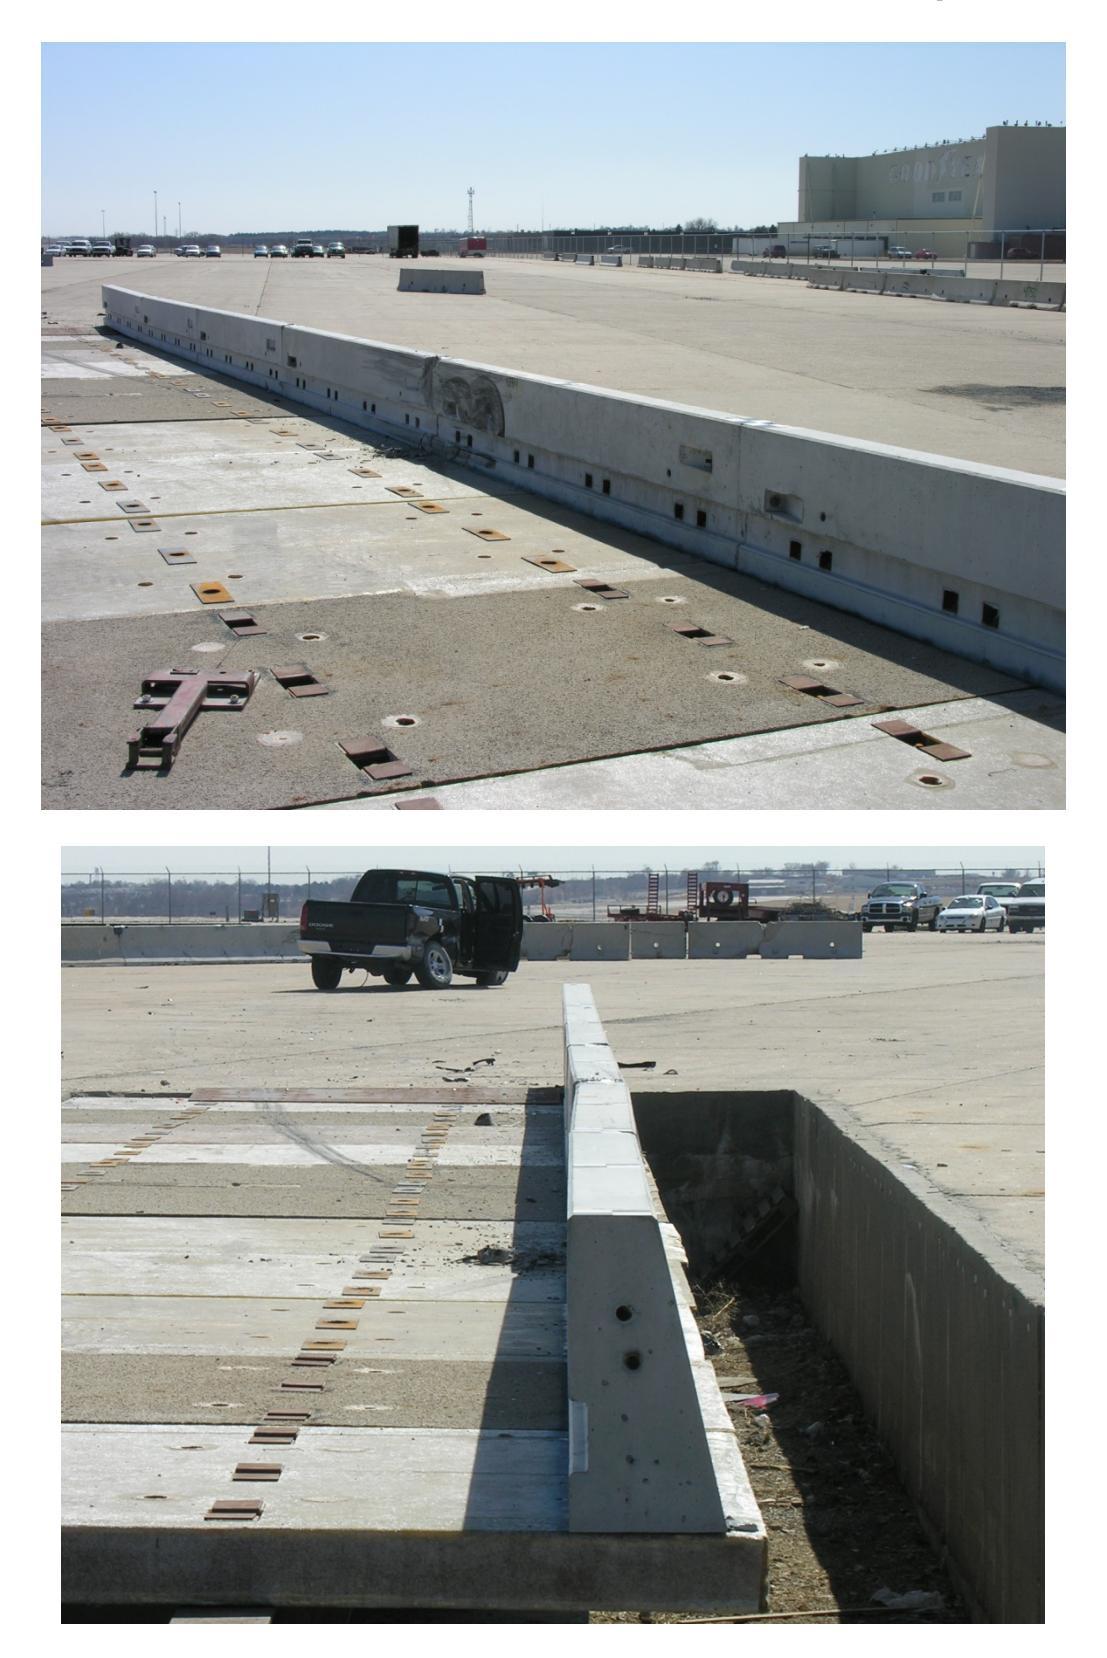
Figure 28. System Damage, Test No. KSFRP-1

Damage to the barrier was minimal, as shown in Figures 28 through 32. Barrier damage consisted of contact marks on the front face of the concrete segments, spalling of the concrete, and concrete cracking and failure. The length of vehicle contact along the barrier was approximately 11 ft – 5 in. (3.48 m), which spanned from 5 ft – 5 in. (1.65 m) upstream from the center of the joint between barrier nos. 2 and 3 to 6 ft (1.83 m) downstream from the center of the joint between barrier nos. 2 and 3.

Tire marks were visible on the front face of barrier nos. 2 and 3. Scuff marks were also found on the front and top faces of barrier nos. 2 and 3. The upper-rear corner at the downstream end of barrier no. 1 was fractured. Concrete spalling and cracking occurred at the downstream end of barrier no. 2 and upstream end of barrier no. 3. A 3-in. x 6-in. x $4\frac{1}{2}$ -in. (76-mm x 152-mm x 114-mm) piece of concrete was removed from the top corner of the downstream end of barrier no. 2. A $4\frac{1}{2}$ -in. x 8-in. x 10-in. (114-mm x 203-mm x 254-mm) piece of concrete was removed from the top-upstream corner of barrier no. 3. Another piece of concrete was fractured just below the removed corner of barrier no. 3, but it remained attached to the barrier. Concrete spalling occurred along the upper and lower edges of the shelf as well as around the edges of the threaded rod insets at the downstream end of barrier no. 2. Concrete spalling also occurred on the vertical face of the joint between barrier nos. 2 and 3.

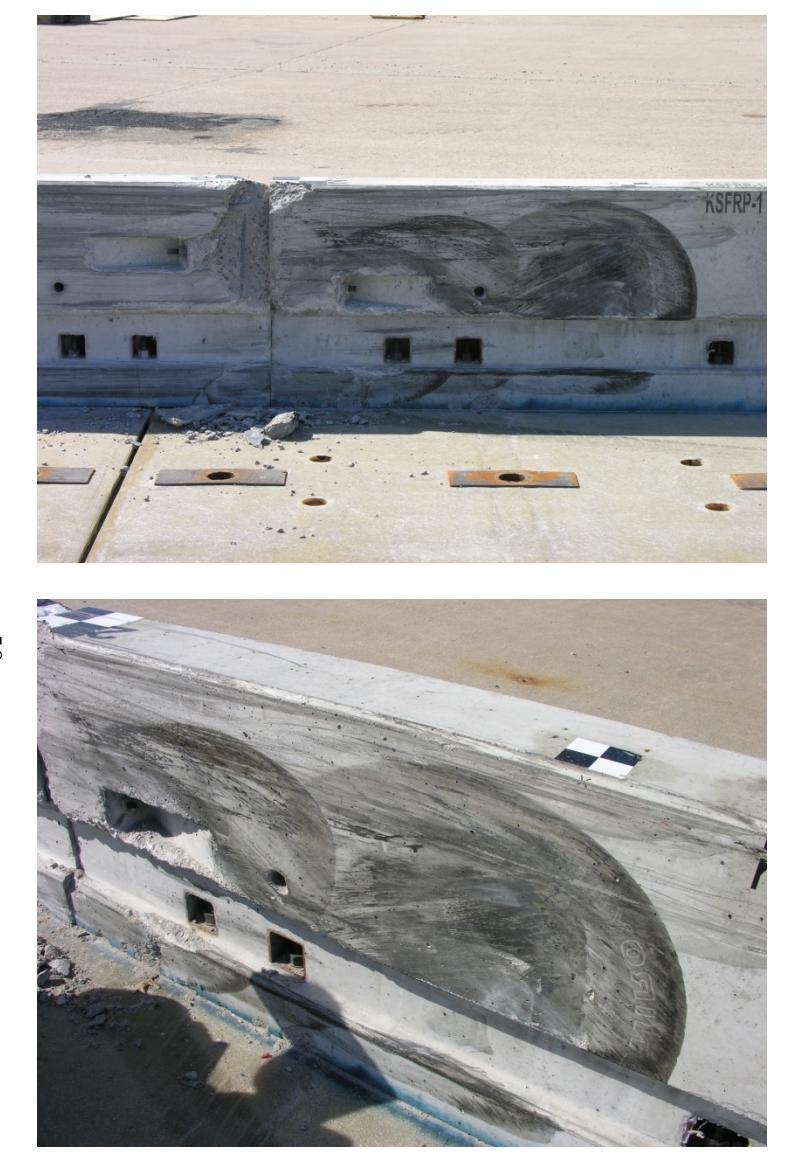
Figure 29. Barrier No. 2 Damage, Test No. KSFRP-1

A small gouge and crack were found 34 in. (864 mm) upstream from the downstream end of barrier no. 2 at its base. A larger gouge and crack were found 13 in. (330 mm) upstream from the downstream end of barrier no. 2 at its base. Small gouges and scratches were located across the front faces of barrier nos. 2 and 3. A 21-in. (533-mm) long crack was found at the base of barrier no. 3 starting 7 in. (178 mm) downstream from the upstream end of the barrier. A vertical

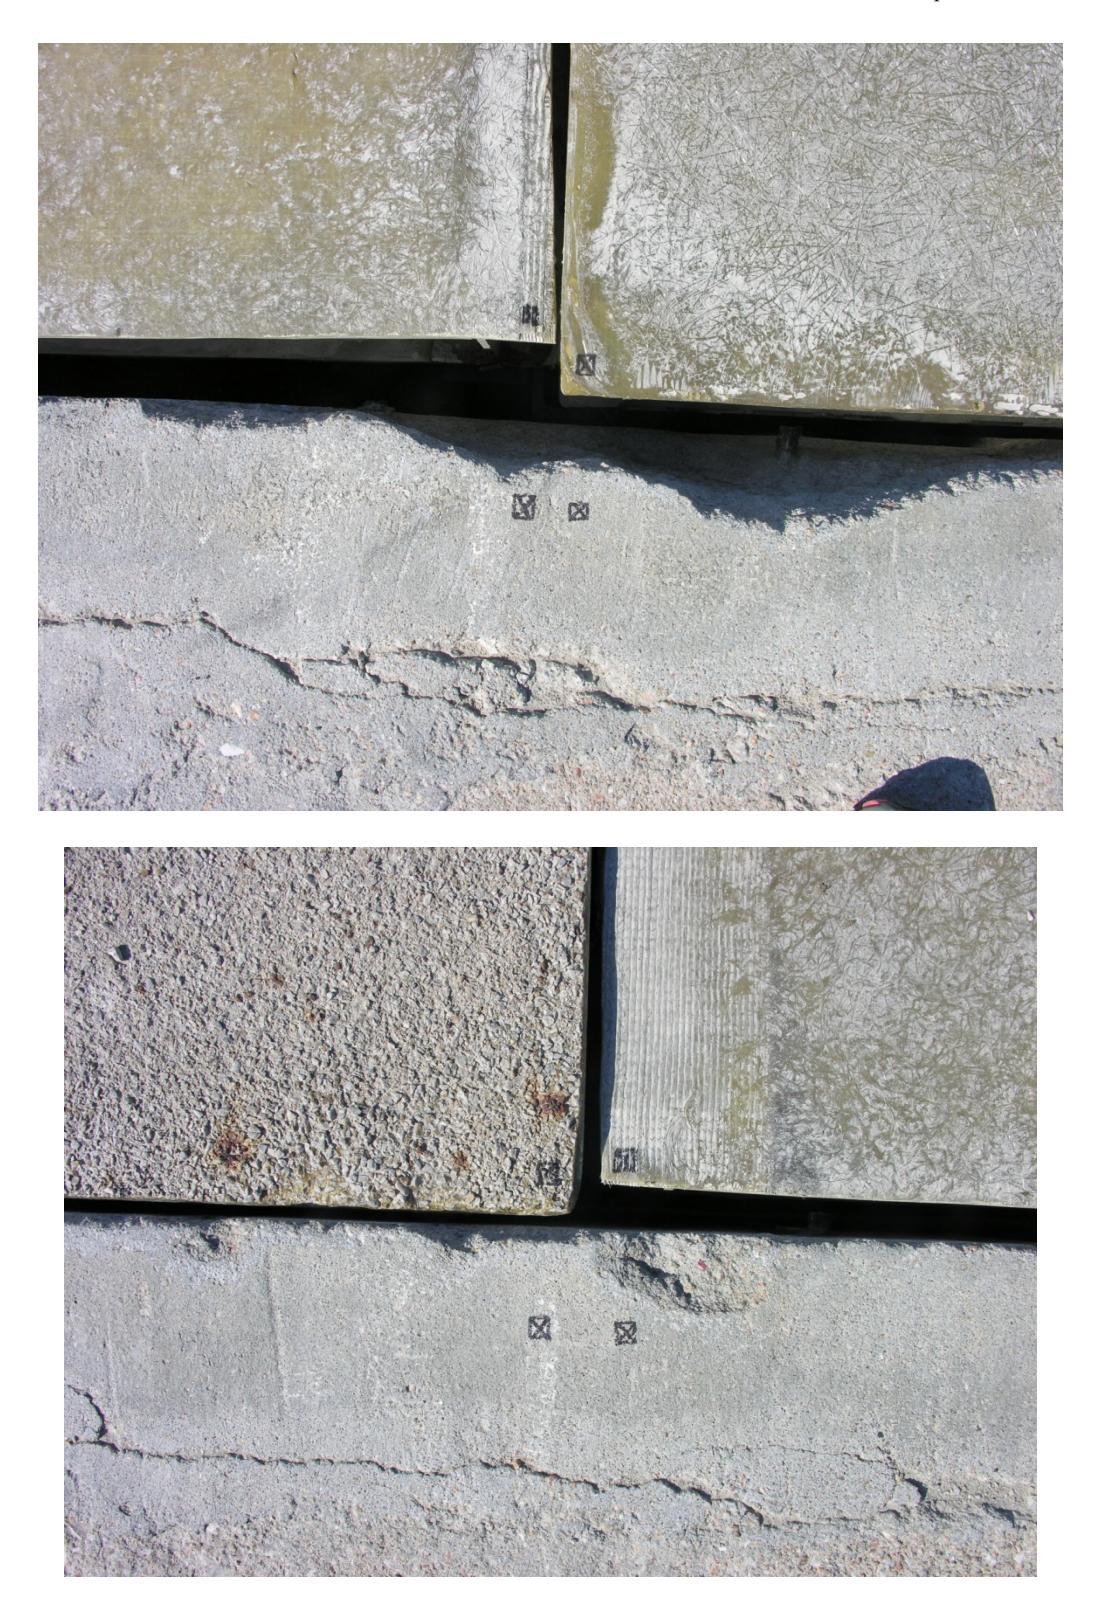
Figure 31. Panel Shift - Joints 3 and 4 (Top) and 4 and 5 (Bottom), Test No. KSFRP-1

No failure was observed in the FRP composite deck panels or at any of the anchor locations. Panel nos. 3 through 6 were laterally displaced, with panel no. 5 having a maximum displacement of $\frac{1}{2}$ in. (13 mm), as shown in Figure 31.
