Development of a Flexible Bridge Railing for Longitudinal Timber Decks

MwRSF Research Report No. TRP-03-62-96

June 1997

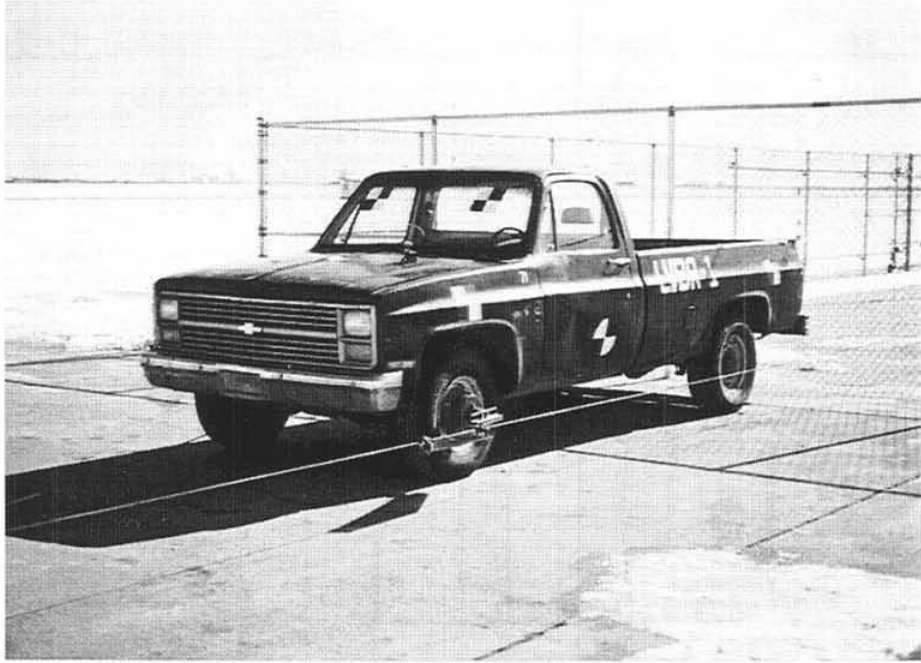
Figure 5. Test Vehicle, Test LVBR-1

For test LVBR-1, a 1984 Chevrolet C-20 ¾-ton pickup truck was used as the test vehicle. The test inertial and gross static weights were 4,499 lbs (2,041 kg). The test vehicle is shown in Figure 5, and vehicle dimensions are shown in Figure 6.

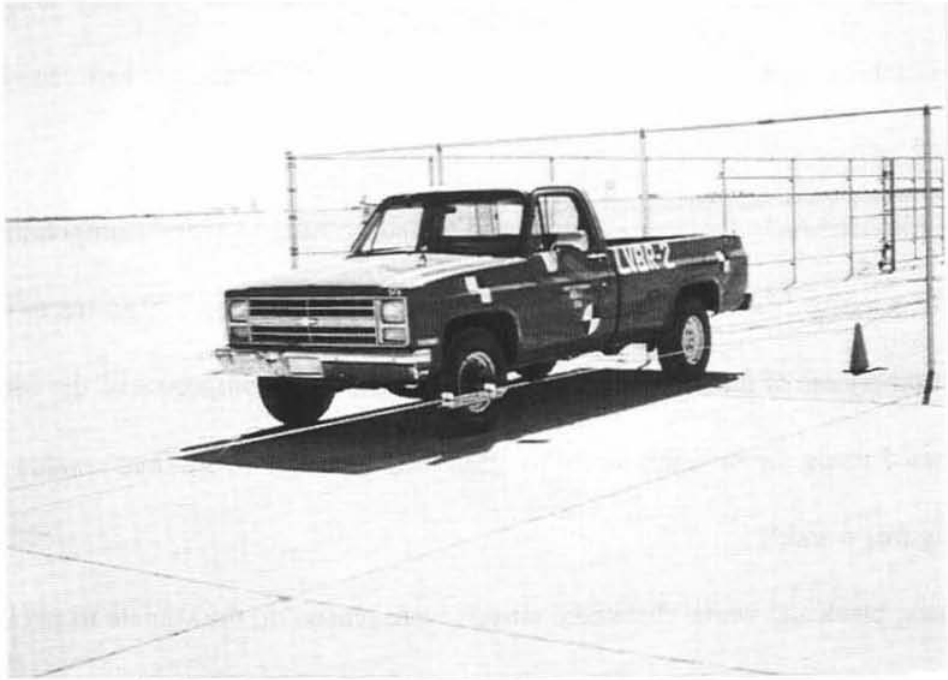
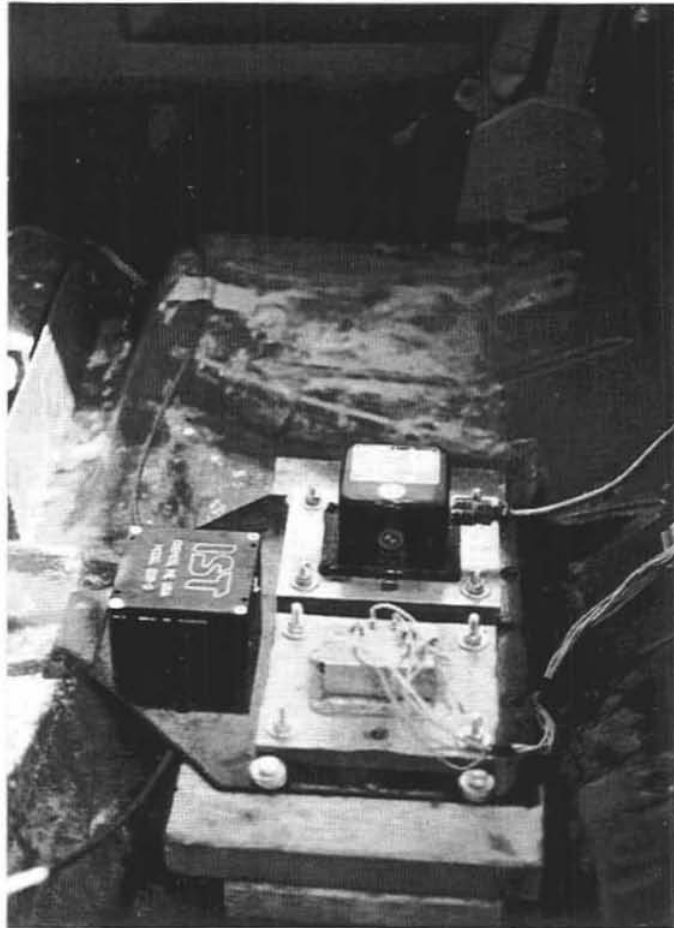
Figure 7. Test Vehicle, Test LVBR-2

For test LVBR-2, a 1985 Chevrolet C-20 $\frac{3}{4}$ -ton pickup truck was used as the test vehicle. The test inertial and gross static weights were 4,504 lbs (2,043 kg). The test vehicle is shown in Figure 7, and vehicle dimensions are shown in Figure 8.

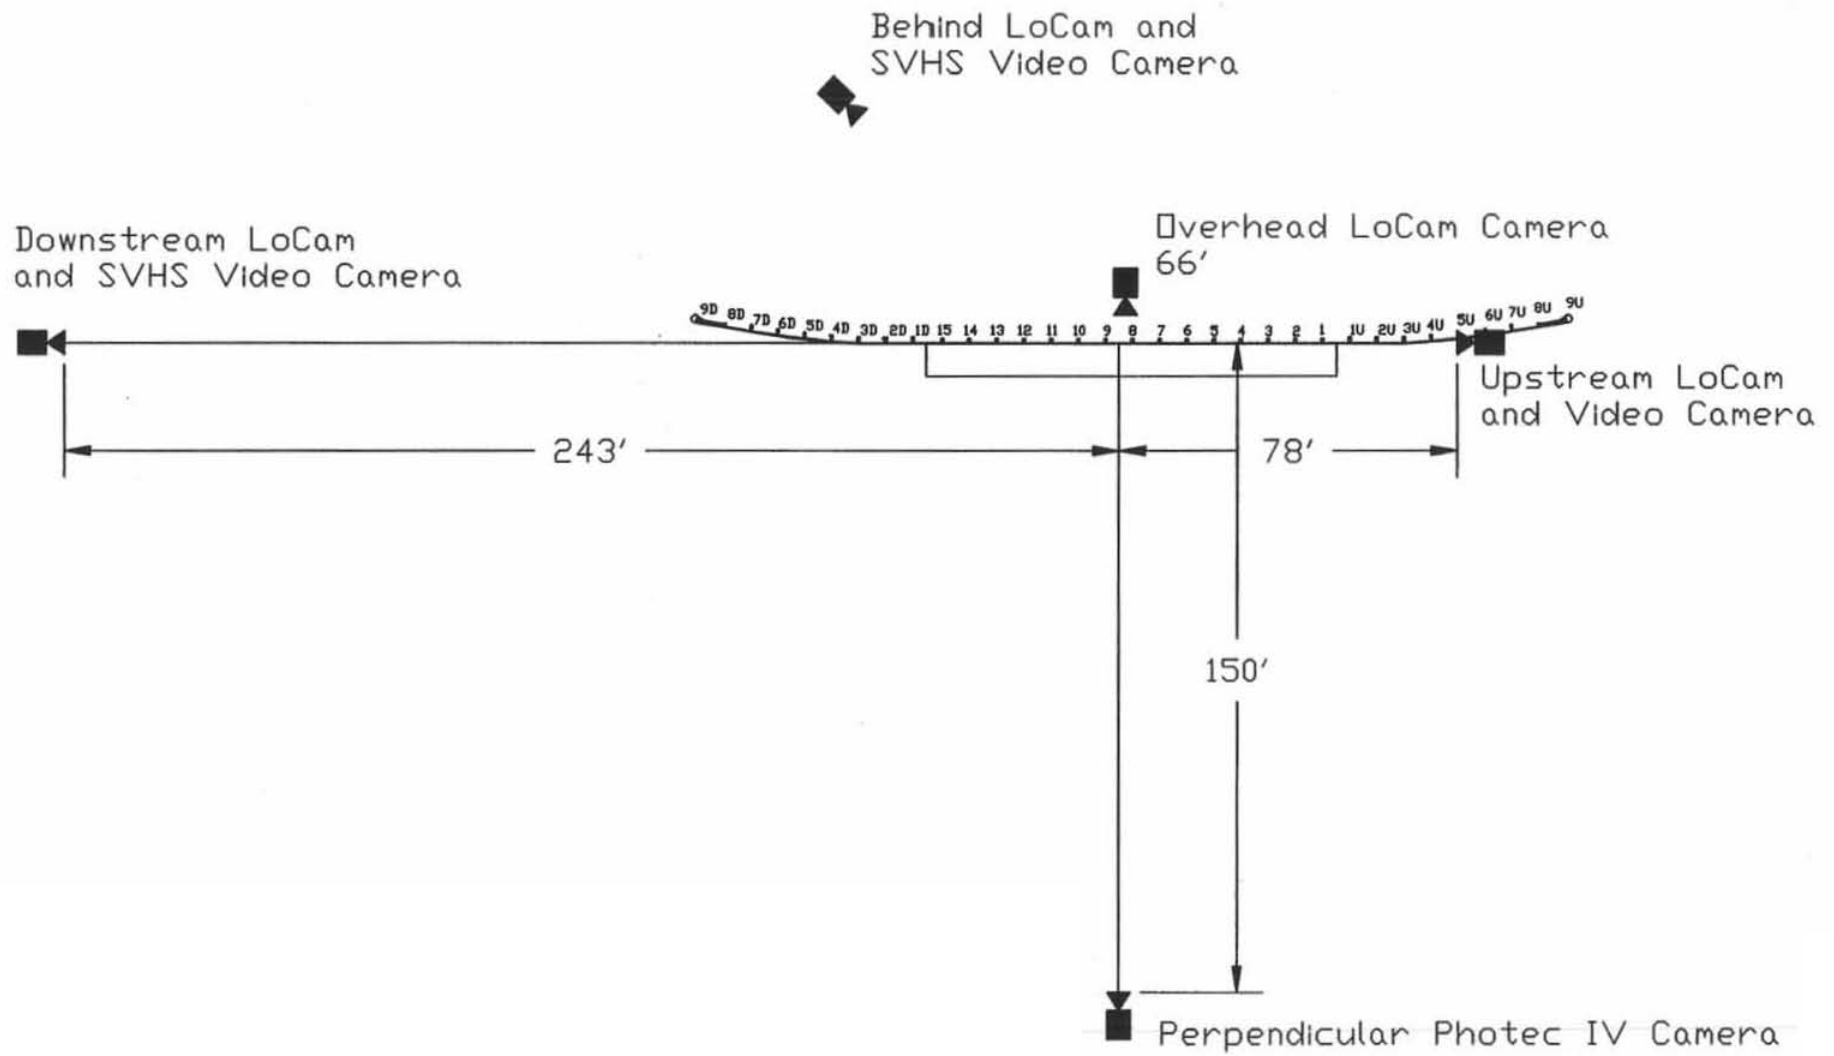
Figure 11. Location of High-Speed Cameras, Test LVBR-1

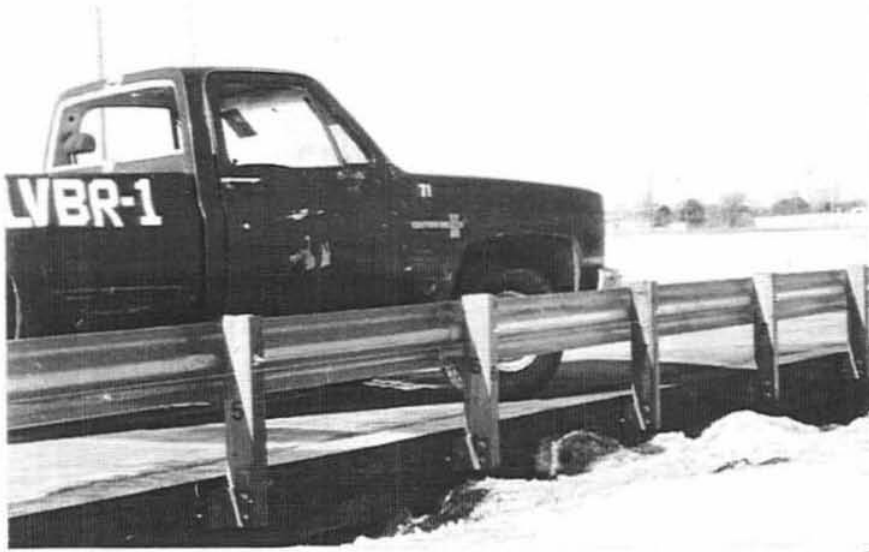
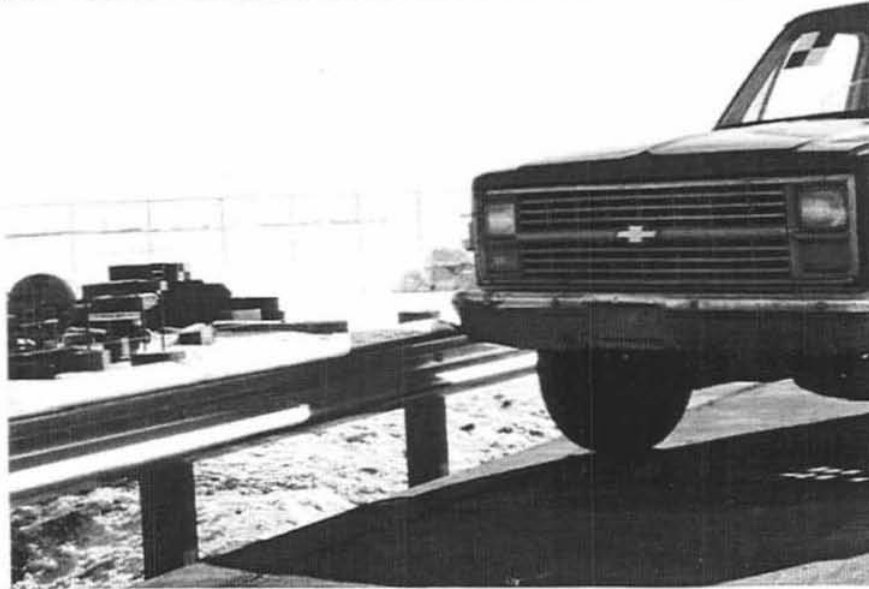
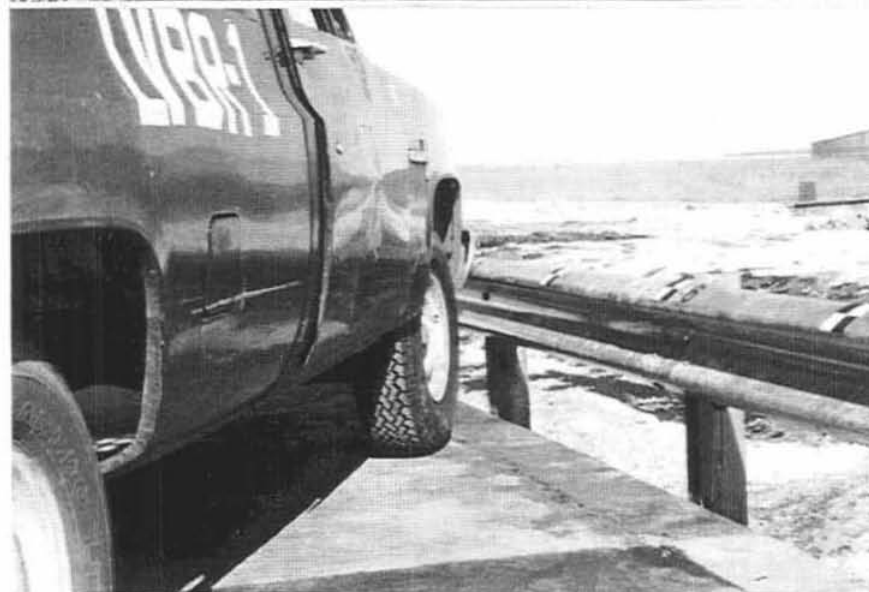
Figure 13. Impact Location, Test LVBR-1

A 1984 Chevrolet C-20 pickup truck impacted the W-beam bridge railing at post no. 7, as shown in Figure 13. A summary of the test results and the sequential photographs is presented in Figure 14. Additional sequential photographs are shown in Figure 15. Documentary photographs of the crash test are shown in Figures 16 through 18.

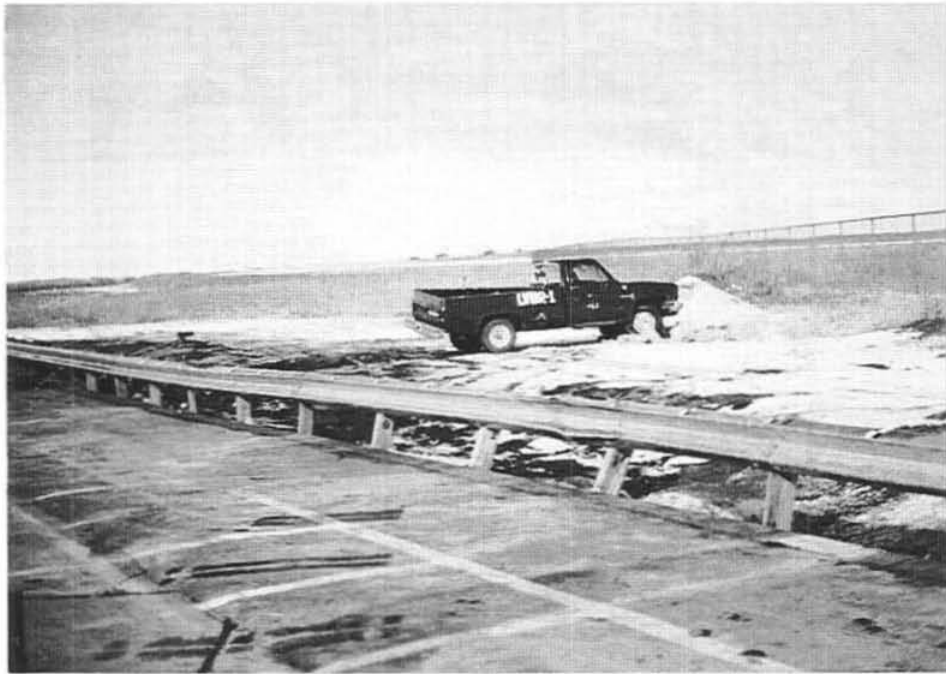
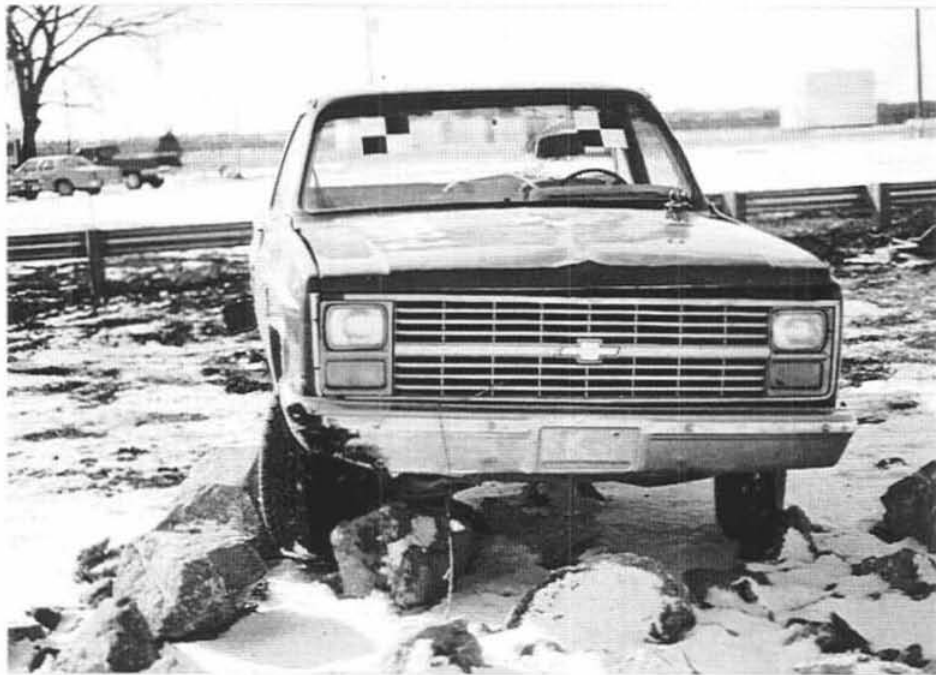
Figure 19. Vehicle Position at Rest, Test LVBR-1

Following the upward motions of both the front bumper and right-front tire, the vehicle's front bumper was eventually forced over the top of the W-beam rail. The vehicle's tires climbed up the face of the W-Beam rail, causing the vehicle to vault over the bridge rail. The vehicle came to rest on the back side of the bridge rail, approximately 59 ft (18 m) downstream from impact, as shown in Figure 19. The vehicle's post-test trajectory is shown in Figure 14.

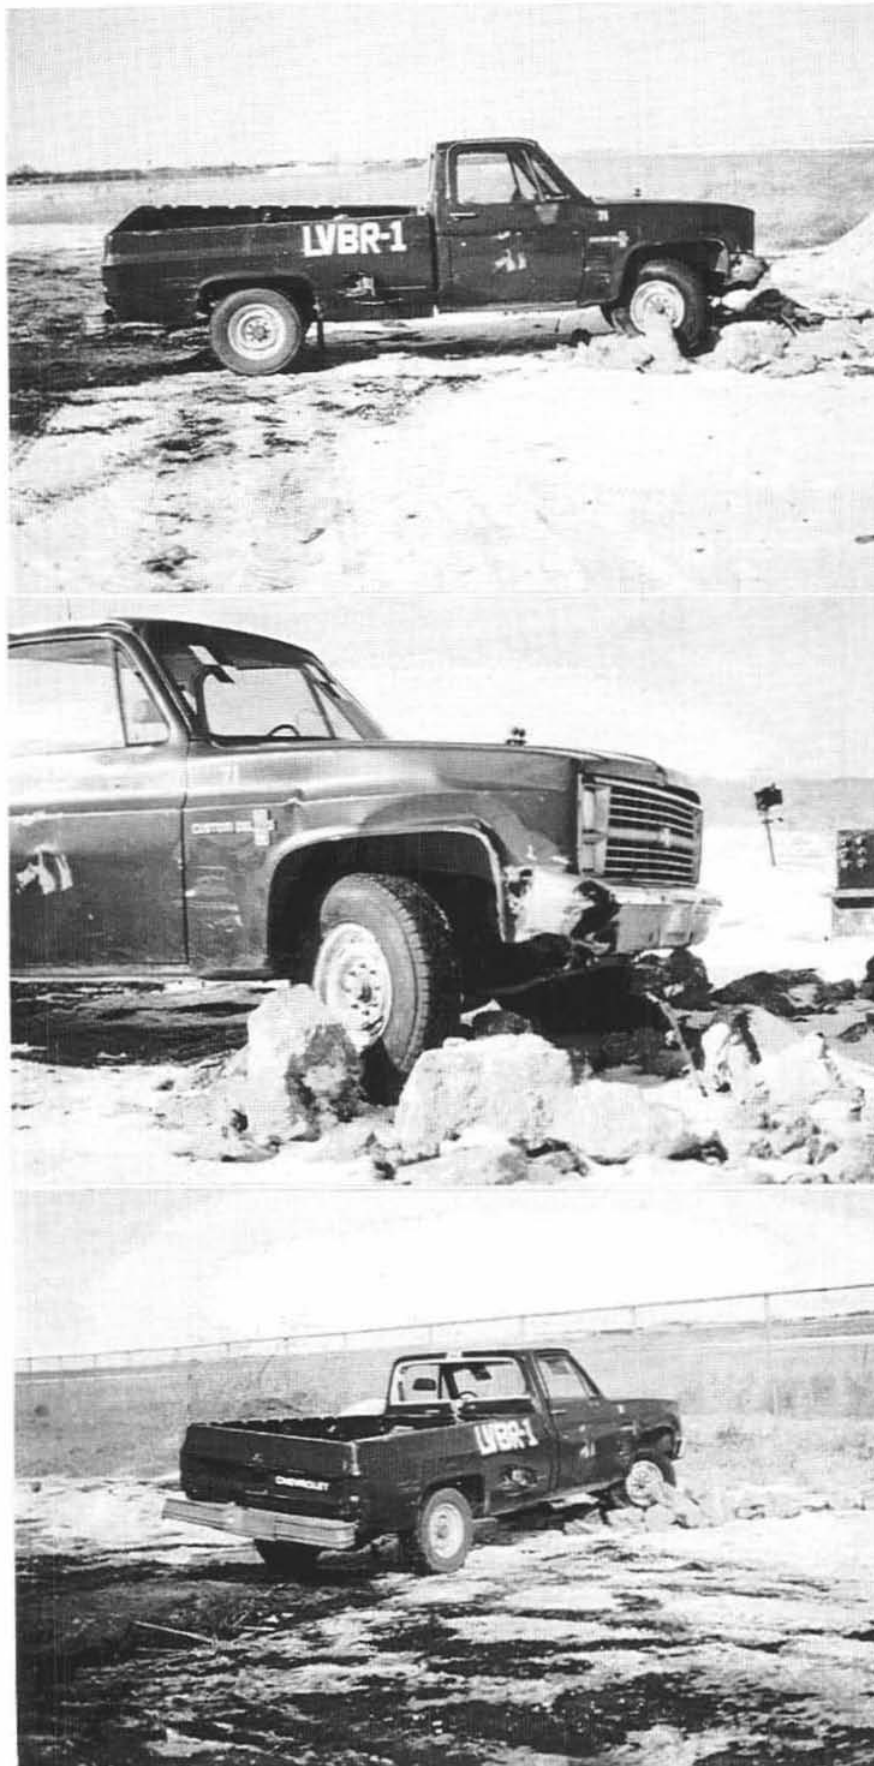
Figure 20. Vehicle Damage, Test LVBR-1

Exterior vehicle damage was relatively minor and was limited to deformations of the steel frame, right-front quarter panel, and front bumper, as shown in Figure 20. The steel frame was

twisted due to the pickup vaulting over the bridge rail and impacting the ground behind the bridge rail. The right-side corner of the front bumper and the right-front quarter panel contained minor deformations, likely caused from the impact with the ground. No damage occurred to the interior occupant compartment. The vehicle damage was also assessed by the traffic accident scale (TAD) (23) and the vehicle damage index (SAE) (24), as shown in Figure 14.

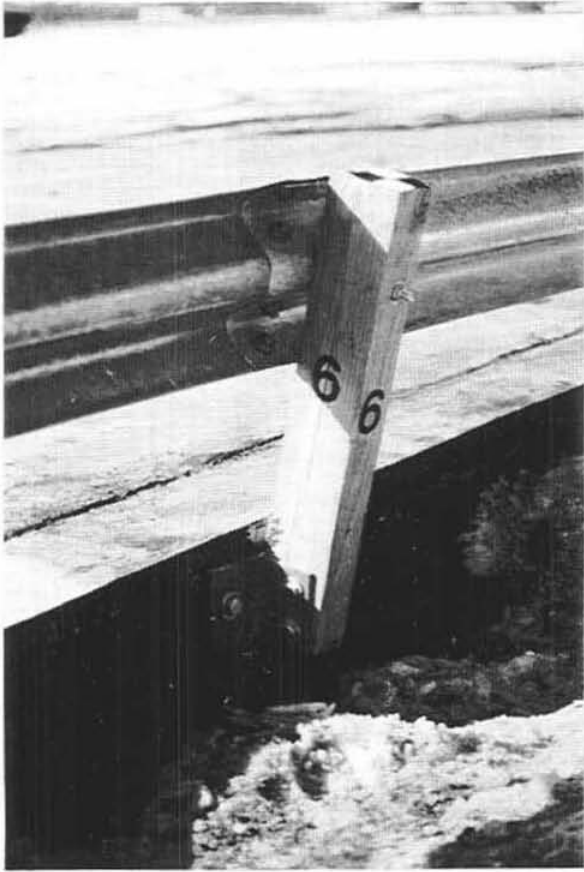
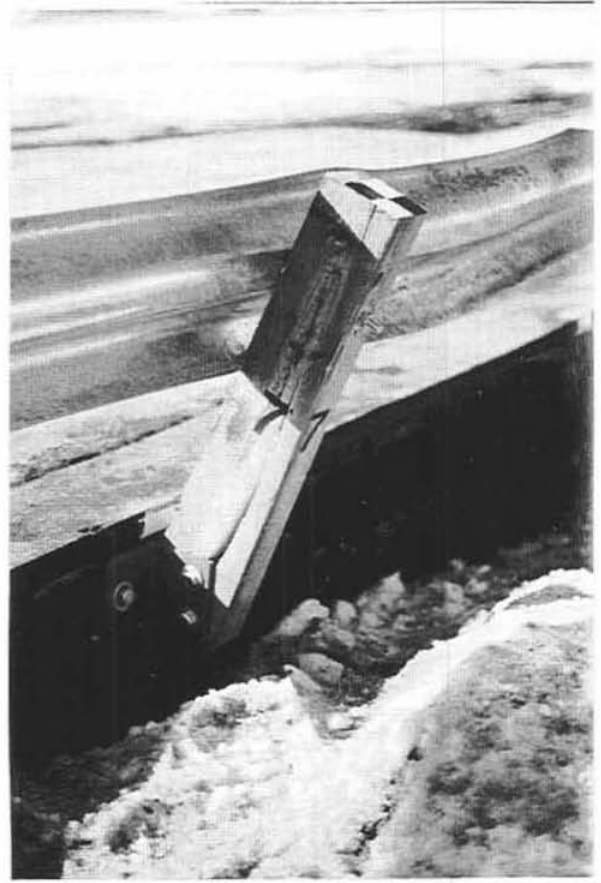
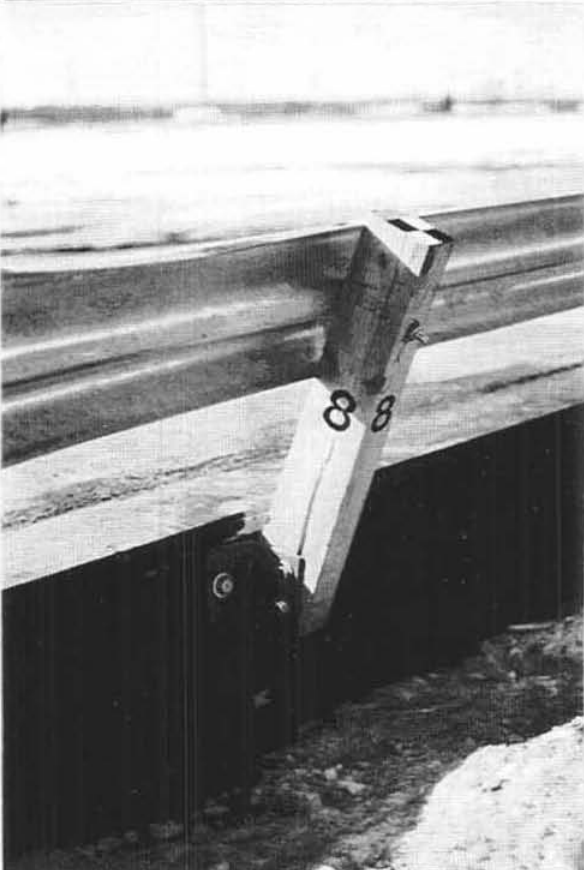
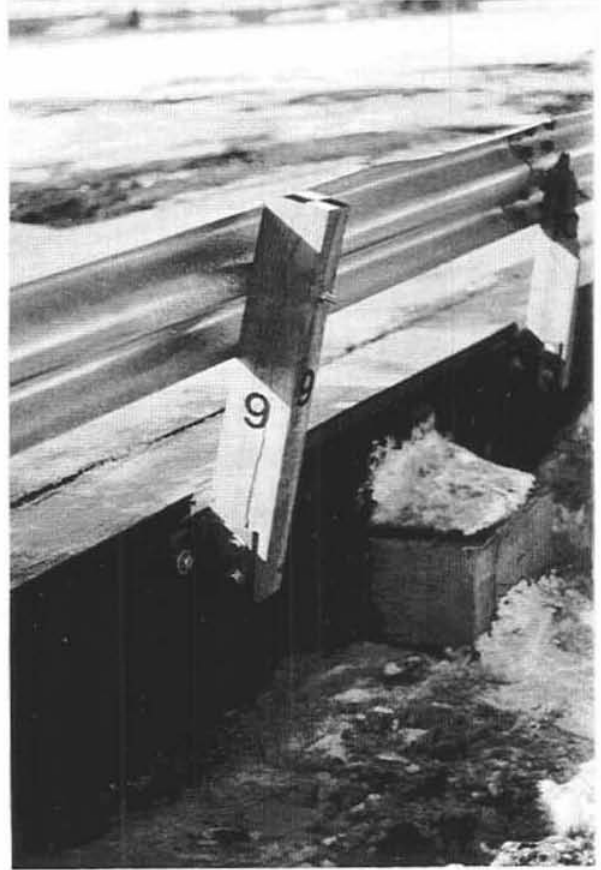
Figure 22. Bridge Post Damage, Test LVBR-1

The minor damage to the bridge railing system is shown in Figures 21 through 23. Six timber posts were cracked or fractured. Plastic deformations to the connection angles and lag screws were also noticed. Contact marks, consisting of tire marks, gouges and indentations, and grease residue, were found along the length of the deformed W-beam rail. At post no. 7, the top of the W-beam rail pulled away from the top traffic-side face of the timber post. In addition, the washer, located under the head of the bolt and used to attach the rail to the post, had begun to pull through the slot. The maximum permanent set rail and post deflections were 14.3 in. (363 mm) and 13.8 in. (351 mm), respectively. No damage occurred to the timber bridge deck.

Originally, the post-to-deck attachment was designed so that little or no damage would occur to the timber deck or connection hardware. However, following test LVBR-1, plastic deformations were found in the connection angles and lag screws, probably as a result of the lateral loads imparted to the railing system. In order to minimize the deformations to the connection hardware, the concept of placing sawcuts in the timber posts was considered for weakening the posts to fracture or "breakaway" at a lower force level.

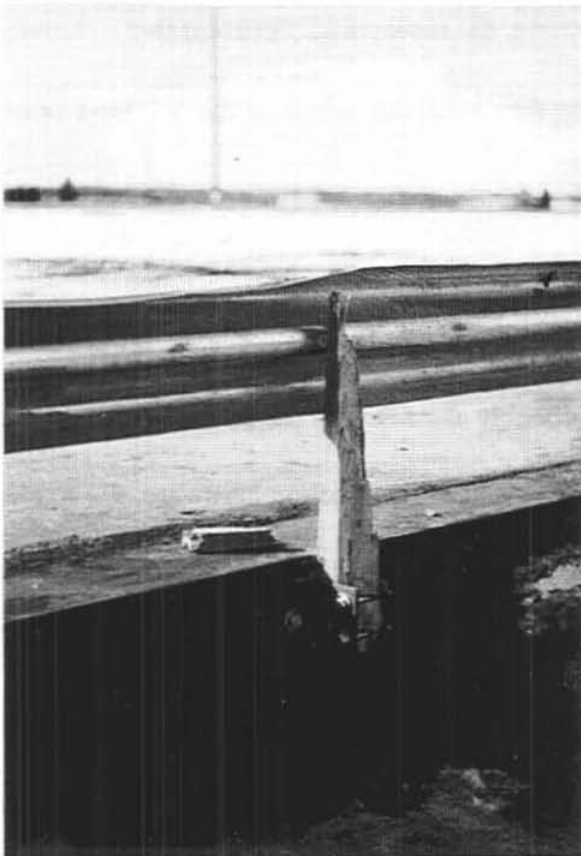
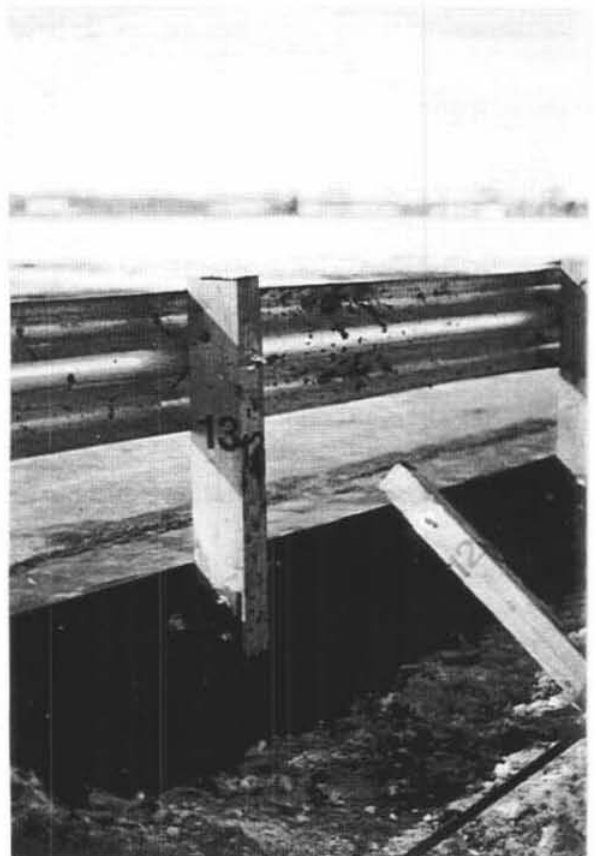
Figure 23. Bridge Post Damage, Test LVBR-1

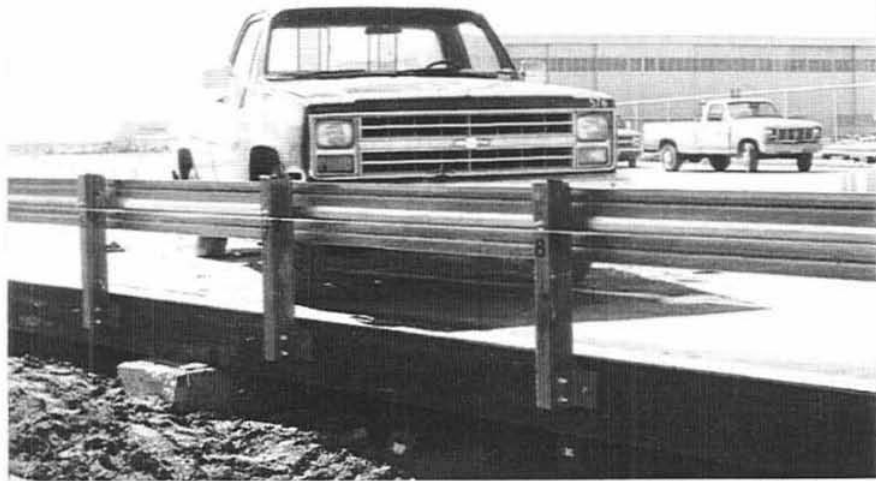
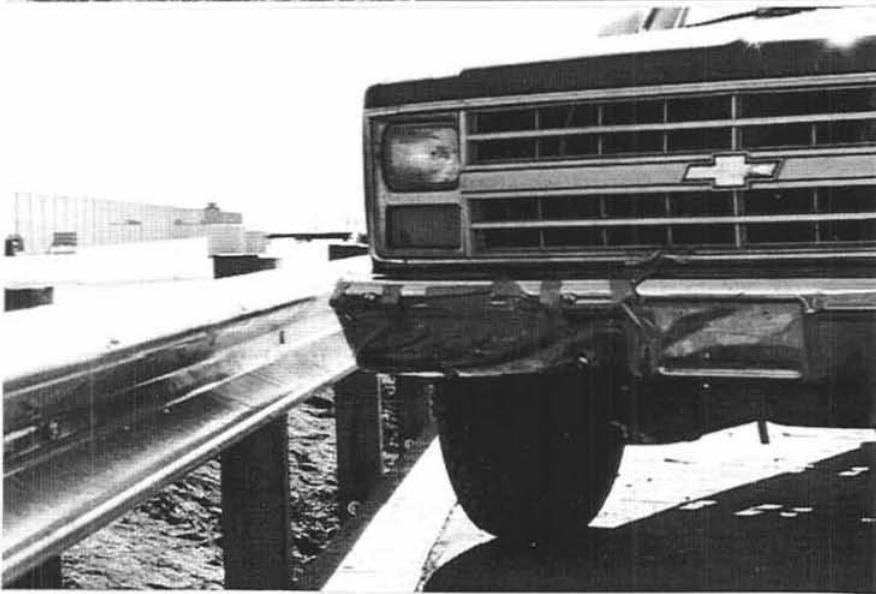
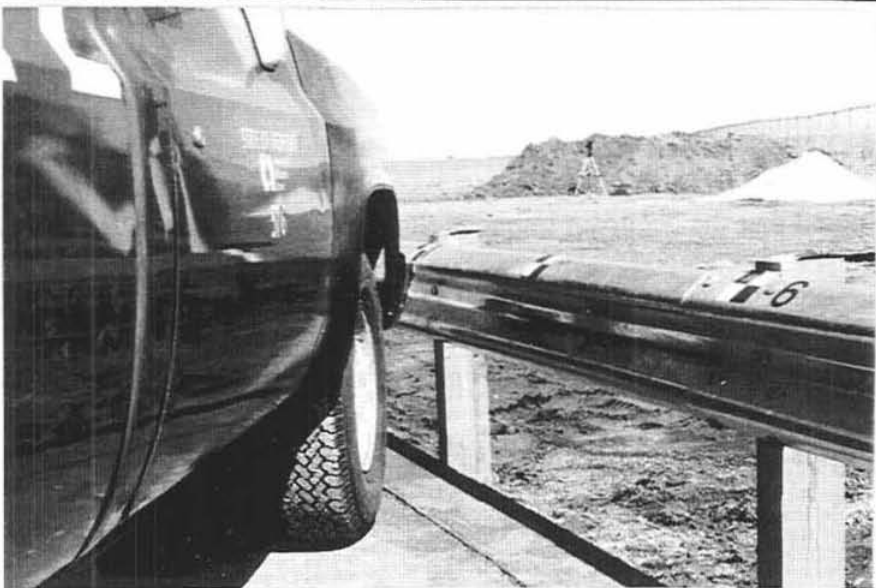
Figure 27. Impact Location, Test LVBR-2

A 1985 Chevrolet C-20 pickup truck impacted the W-beam bridge railing at post no. 7, as shown in Figure 27. A summary of the test results and the sequential photographs is presented in Figure 28. Additional sequential photographs are shown in Figure 29. Documentary photographs of the crash test are shown in Figures 30 through 31.

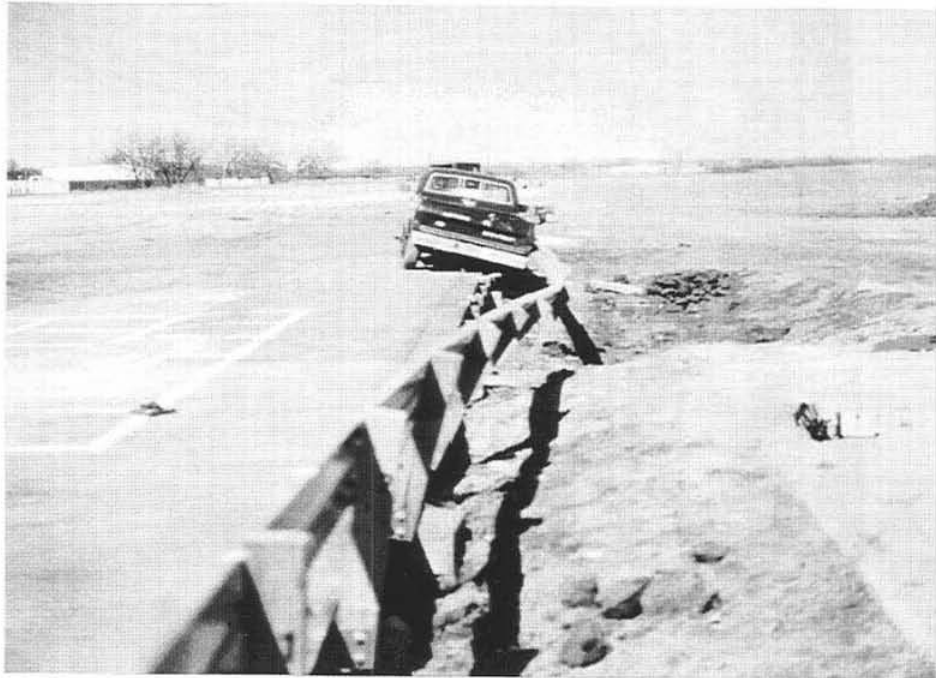
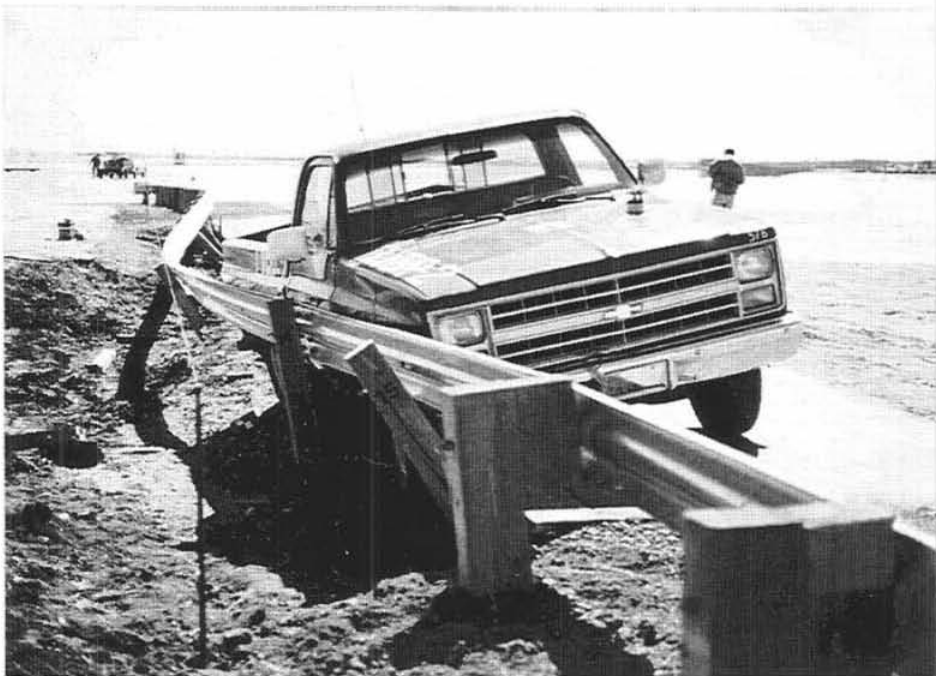
Figure 32. Vehicle Position at Rest, Test LVBR-2

Following the initial impact with the bridge rail, the W-beam rail began to deflect laterally as several timber posts began to fracture. At 0.158 sec after impact, the right-front corner of the vehicle was near post no. 8. As the W-beam continued to deflect laterally, the vehicle contact caused the W-beam rail to rotate and move downward. At 0.316 and 0.474 sec after impact, the right-front corner of the vehicle was near post no. 9 and 10, respectively. The vehicle became parallel to the bridge railing at 0.652 sec with a velocity of 24.1 mph (38.8 km/h). From the overhead high-speed film, the maximum dynamic lateral deflection was 51.9 in. (1,318 mm) at the midspan between post nos. 9 and 10 at 0.890 sec. Although the vehicle was redirected, it did not exit the bridge railing. The vehicle came to rest 44 ft (13.4 m) downstream from impact with the vehicle's left-side tires and right-side undercarriage resting on the deck surface, as shown in Figure 32. It is noted that at no time, during impact or any time thereafter, did the vehicle's right-side tires contact the ground. The vehicle's post-test trajectory is shown in Figure 28.

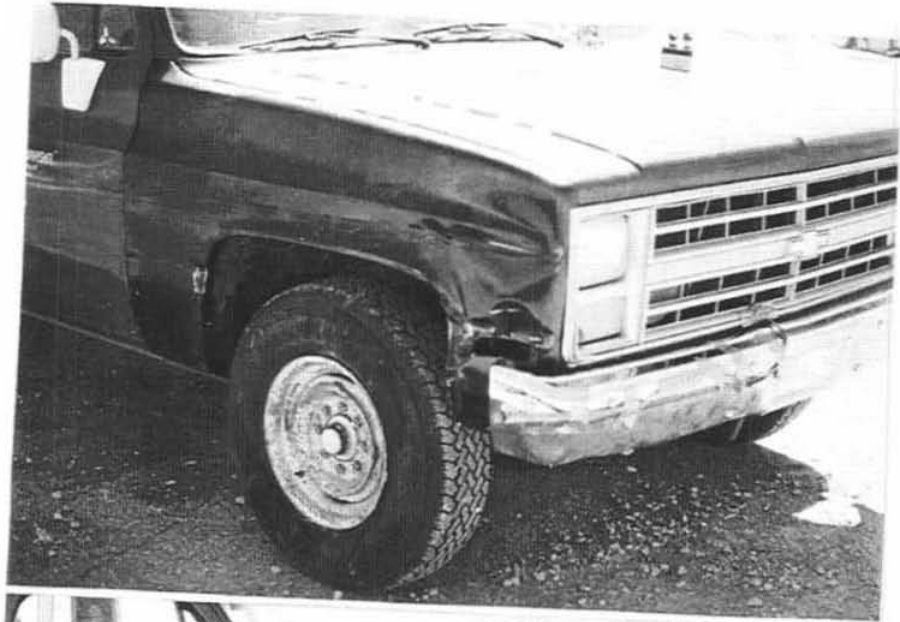
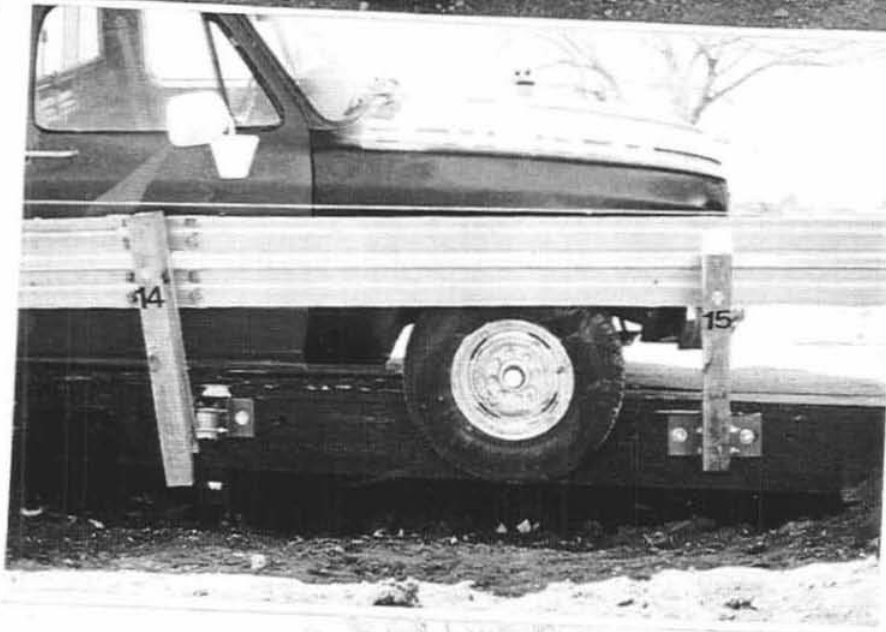
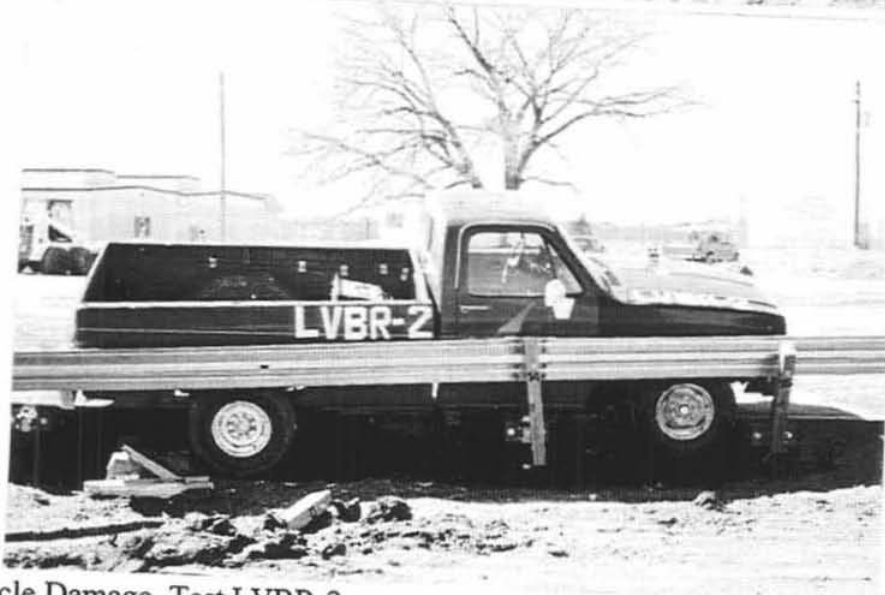
Figure 33. Vehicle Damage, Test LVBR-2

Exterior vehicle damage was minor. Damage was evident on the right-front quarter panel due to vehicle-rail contact and the right-side undercarriage due to contact with the outer top surface of

the deck, as shown in Figure 33. No damage occurred to the interior occupant compartment. Following the crash test, the vehicle's right-side tires were lifted onto the deck, and the vehicle was driven away. The vehicle damage was also assessed by the traffic accident scale (TAD) (23) and the vehicle damage index (SAE) (24), as shown in Figure 28.

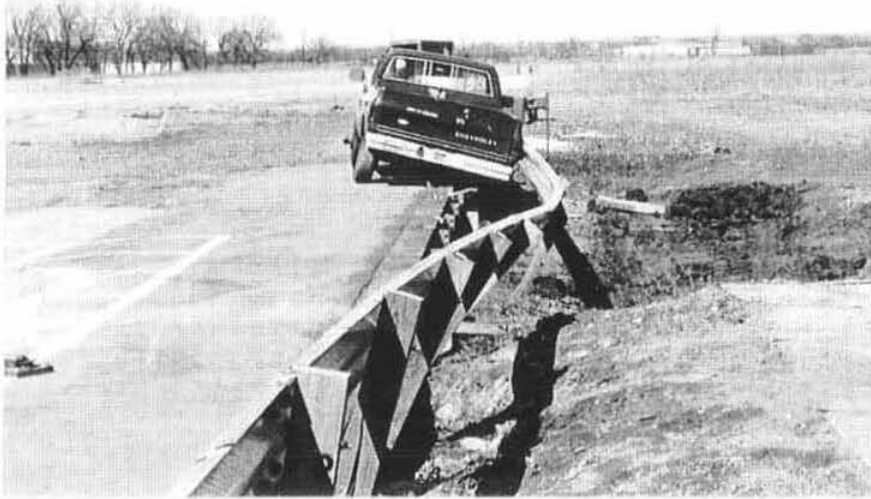
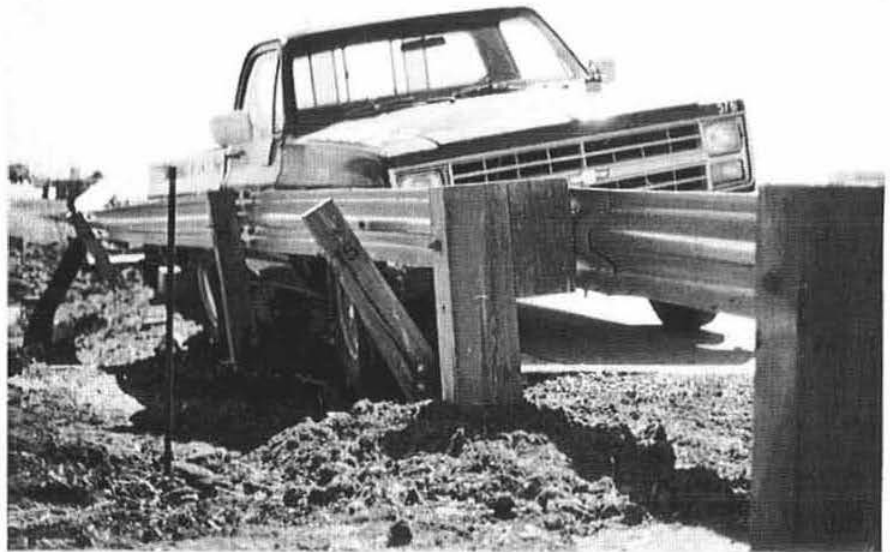
Figure 34. Typical Bridge Rail and Post Damage, Test LVBR-2

The moderate damage to the bridge railing system is shown in Figure 34, as well as in photographs provided in Figures 32 through 33. One 6-ft 3-in. (1.90-m) section of W-Beam rail was permanently damaged. Eleven posts, post nos. 4 through 14 fractured away from the deck attachment. In addition, five steel angles were deformed downstream of impact due to contact between the angles and the undercarriage of the vehicle. The timber deck surface near the edge was also scraped due contact from the vehicle undercarriage. The maximum permanent set and dynamic rail deflections were 45.4 in. (1,153 mm) and 51.9 in. (1,318 mm), respectively. No damage occurred to the timber bridge deck.

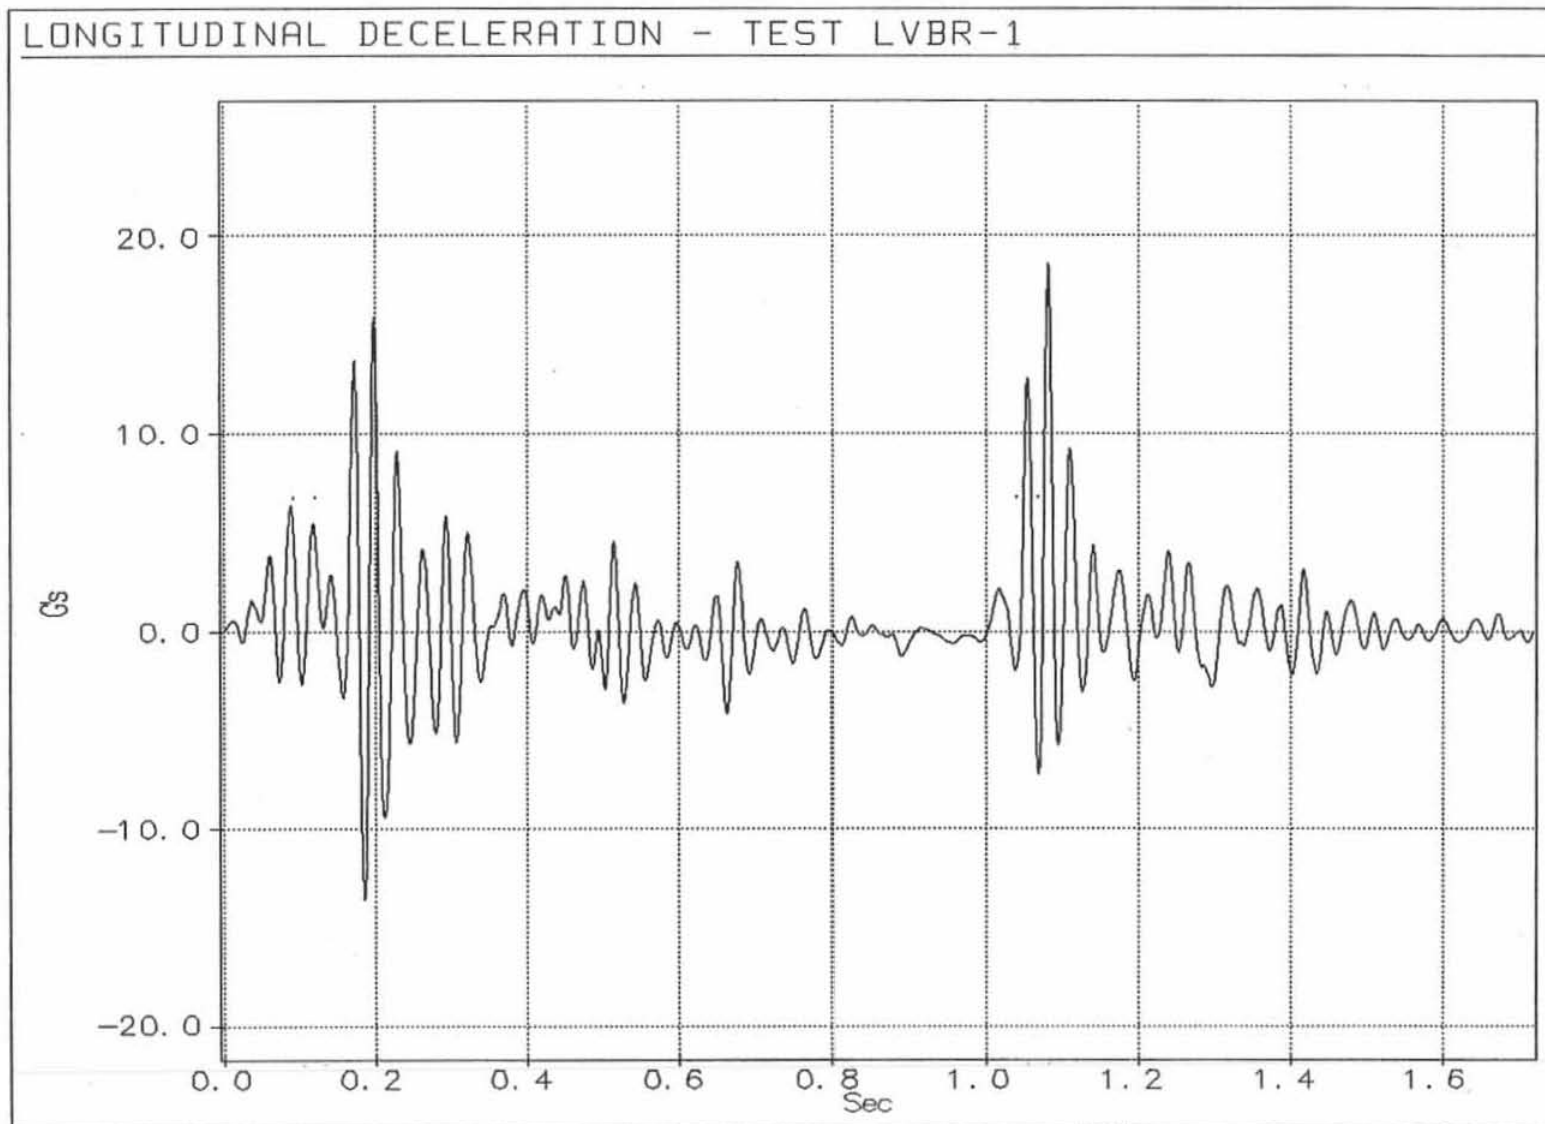
Figure A-1. Graph of Longitudinal Deceleration, Test LVBR-1

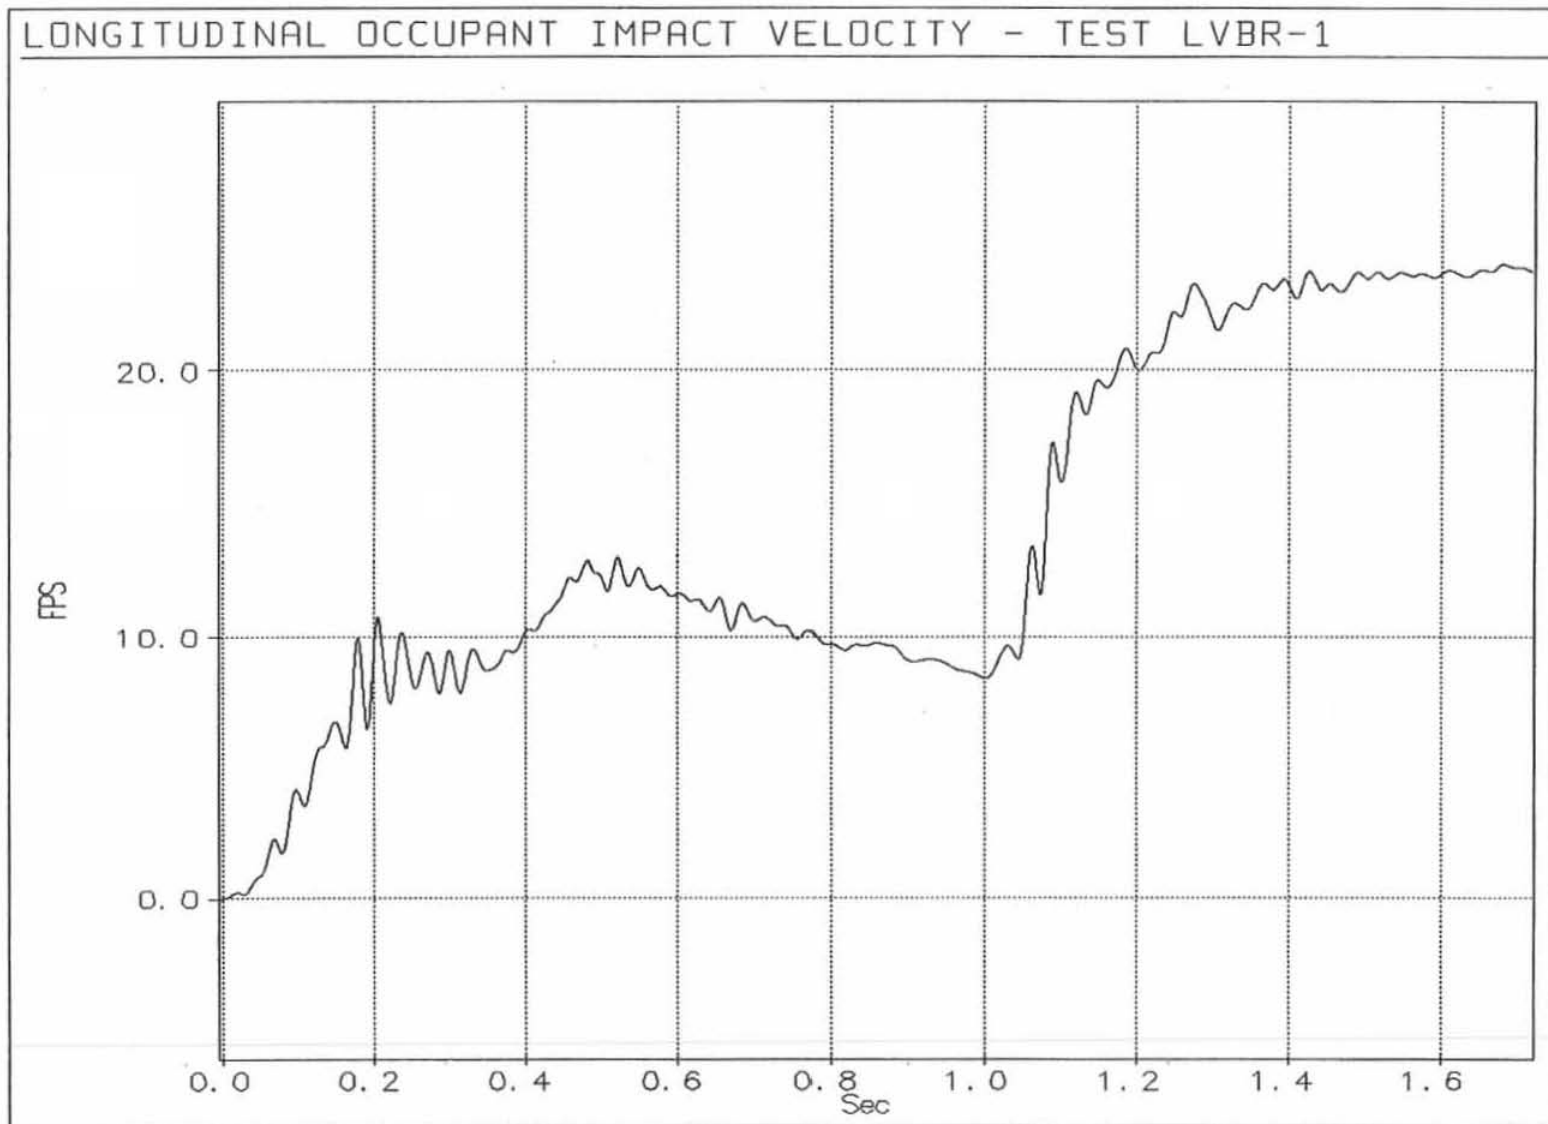
Figure A-2. Graph of Longitudinal Occupant Impact Velocity, Test LVBR-1
