Development of a Flexible Bridge Railing for Longitudinal Timber Decks

MwRSF Research Report No. TRP-03-62-96

June 1997

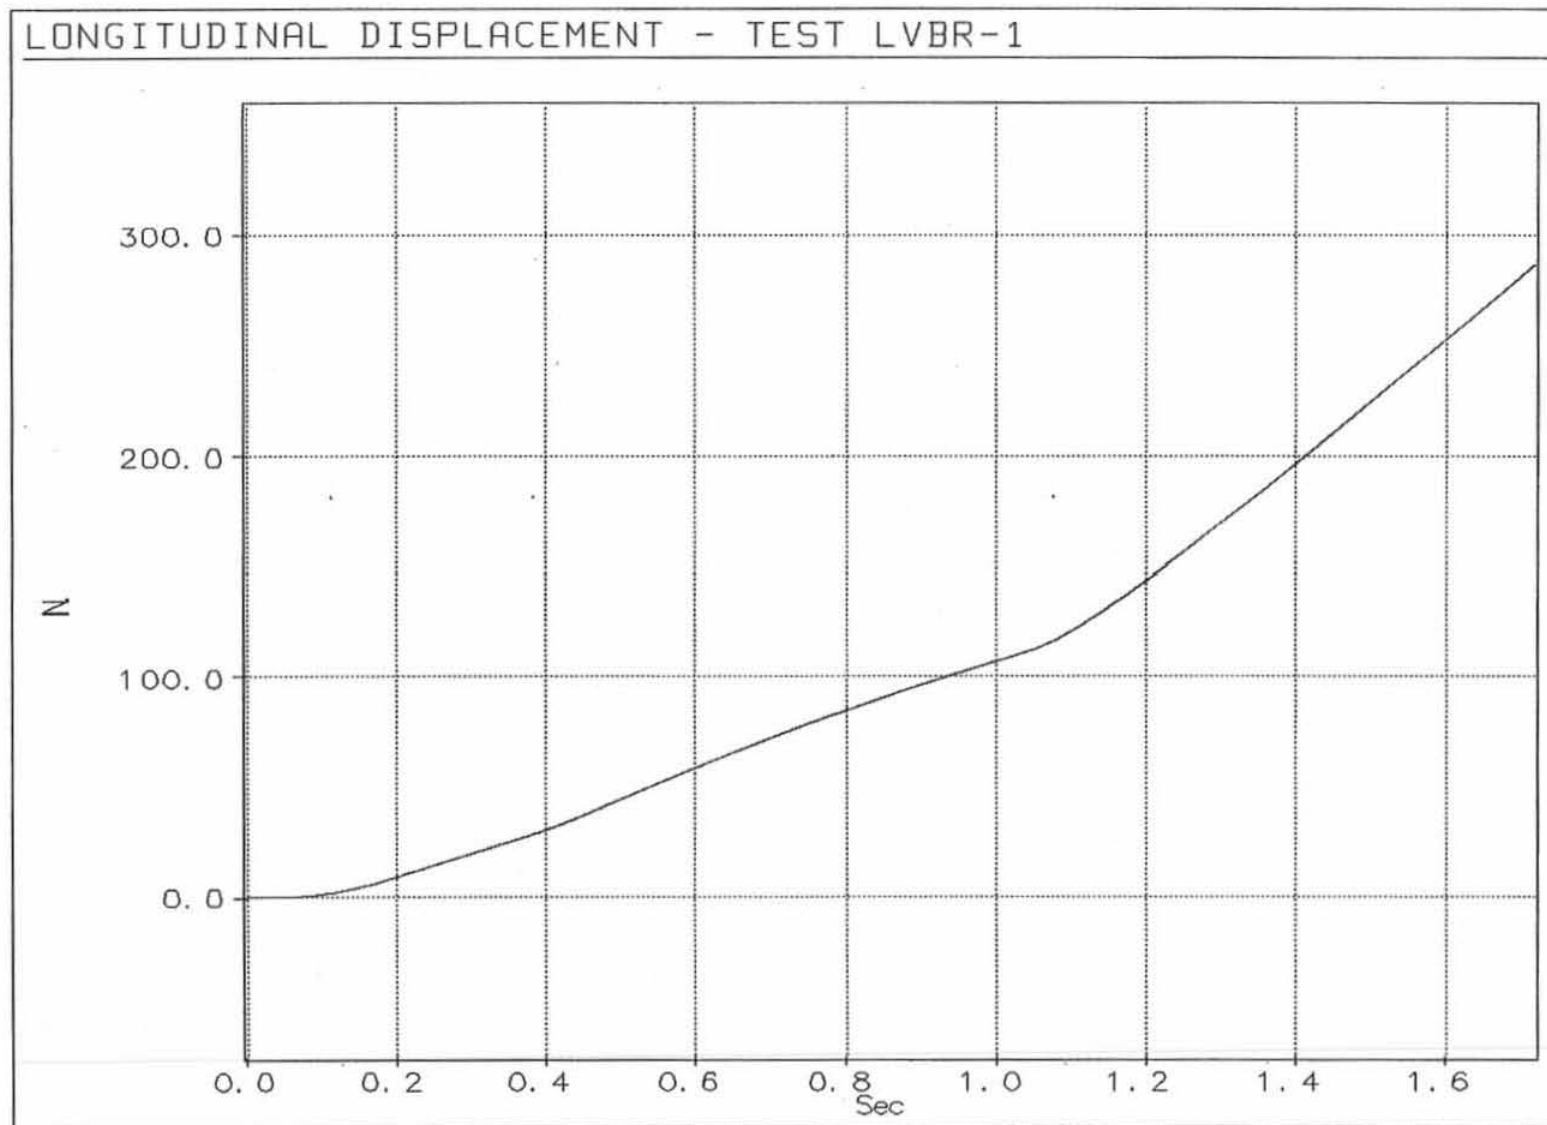
Figure A-3. Graph of Longitudinal Occupant Displacement, Test LVBR-1

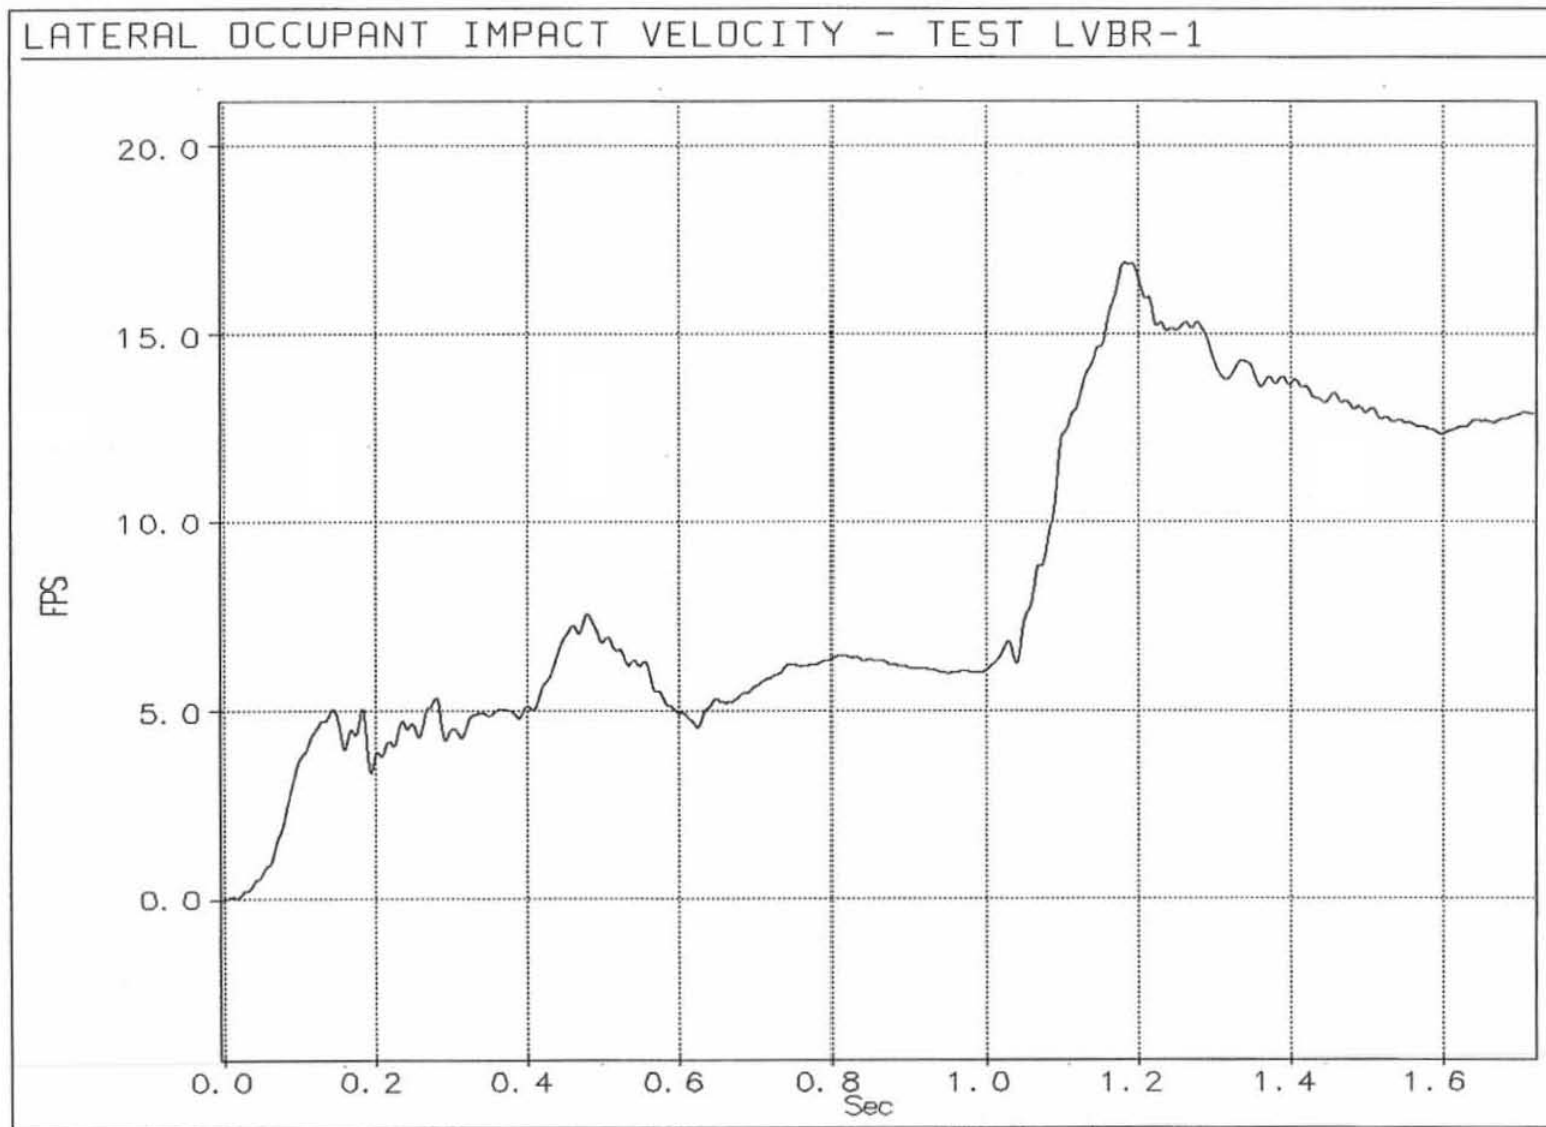
Figure A-5. Graph of Lateral Occupant Impact Velocity, Test LVBR-1

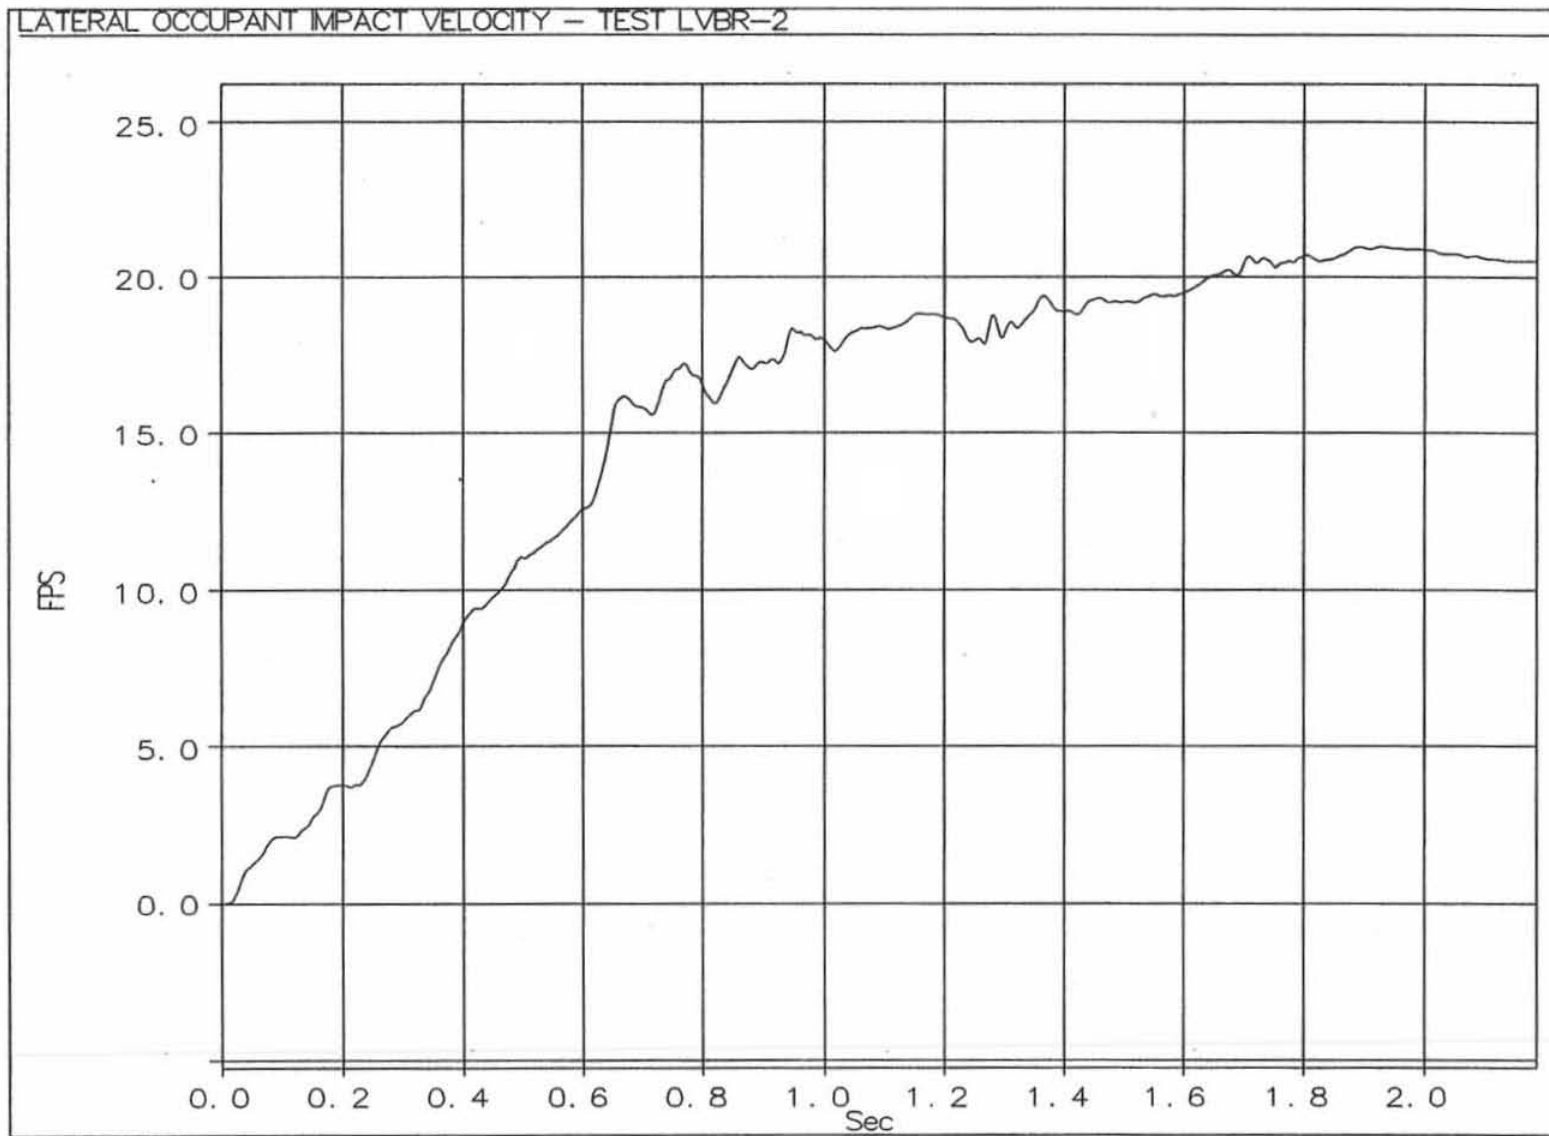
Figure A-11. Graph of Lateral Occupant Impact Velocity, Test LVBR-2
