# PERFORMANCE LEVEL 1 TESTS ON THE NEBRASKA OPEN CONCRETE BRIDGE RAIL

TRANSPORTATION RESEARCH REPORT TRP-03-28-91

Midwest Roadside Safety Facility  
Civil Engineering Department  
W348 Nebraska Hall  
University of Nebraska-Lincoln  
Lincoln, Nebraska 68588-0531

February 1992

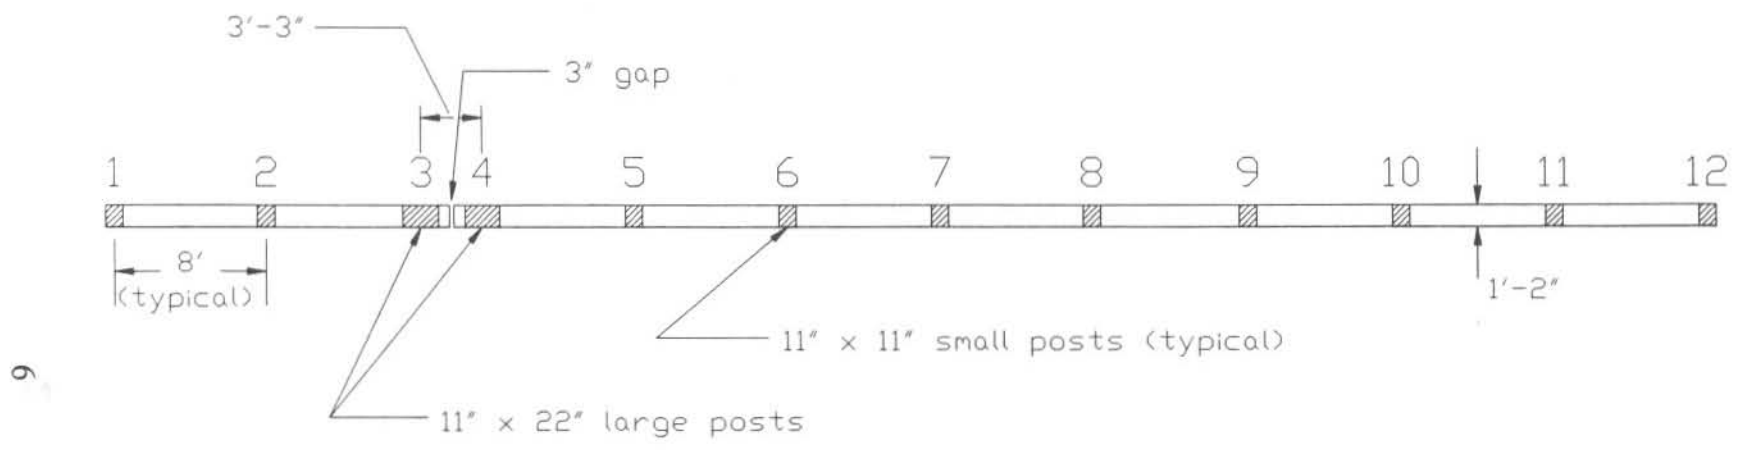
FIGURE 2. Nebraska Open Concrete Bridge Rail, Design No.1

As shown in Figure 2, Design No.1 called for two small posts and one large post to be constructed upstream of the gap. This scenario would provide the worst case conditions and any subsequent analysis and redesign would provide conservative results. The steel reinforcement in the small posts consisted of three No. 6 bars in the traffic side face and two No. 6 bars in the back side face of the post (Figure 3). The steel reinforcement in the large posts consisted of four No. 6 bars in both the traffic side and back side faces of the post (Figure 3). The 1-ft 2-in. wide by 1-ft 4-in. deep bridge rail contained six No. 5 reinforcing bars, three bars in both the traffic and back side faces of the rail (Figure 3).

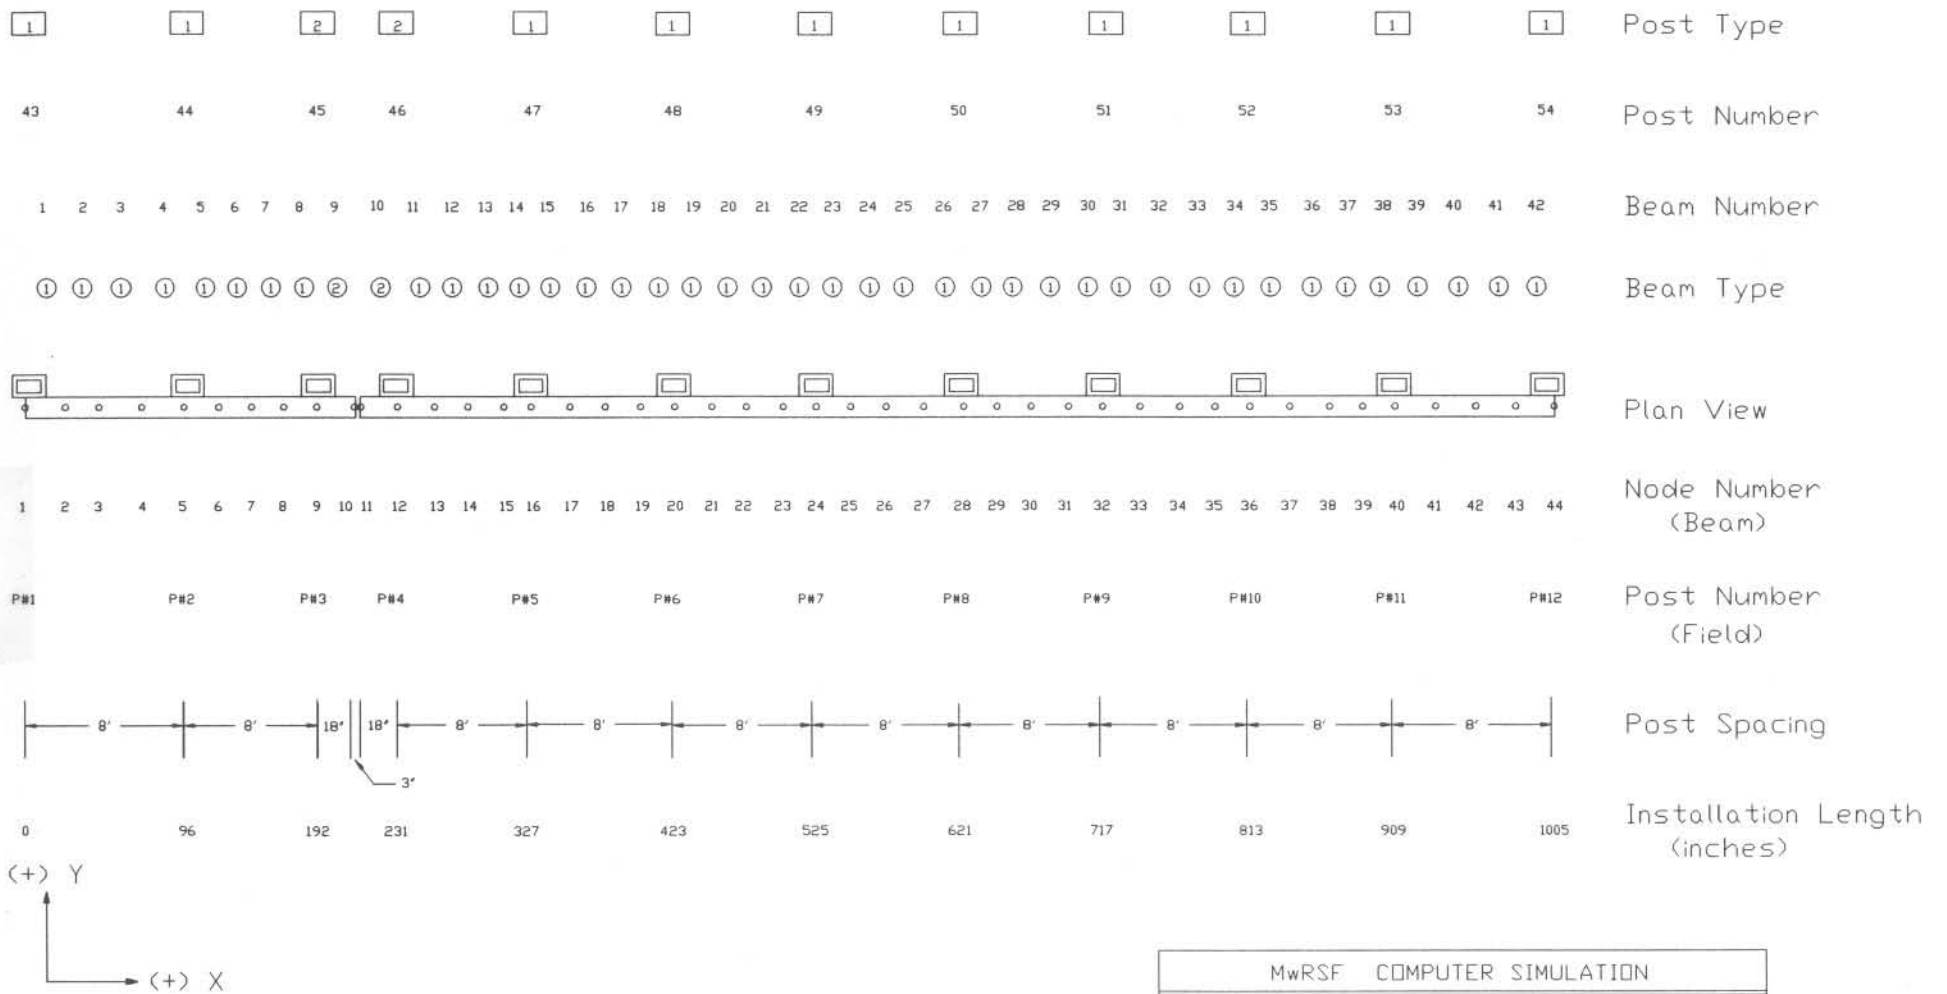
MwRSF COMPUTER SIMULATION
NDOR OPEN CONCRETE BRIDGE RAIL
DESIGN #'S 1, 2, and 3
BARRIER VII COMPUTER MODEL
DRAW BY: SYED ATAULLAH and TERRY ATKINS
DATE: 04/3/91 NO SCALE

FIGURE 4. Computer Simulation Model Configuration, Design No.'s 1,2, and 3

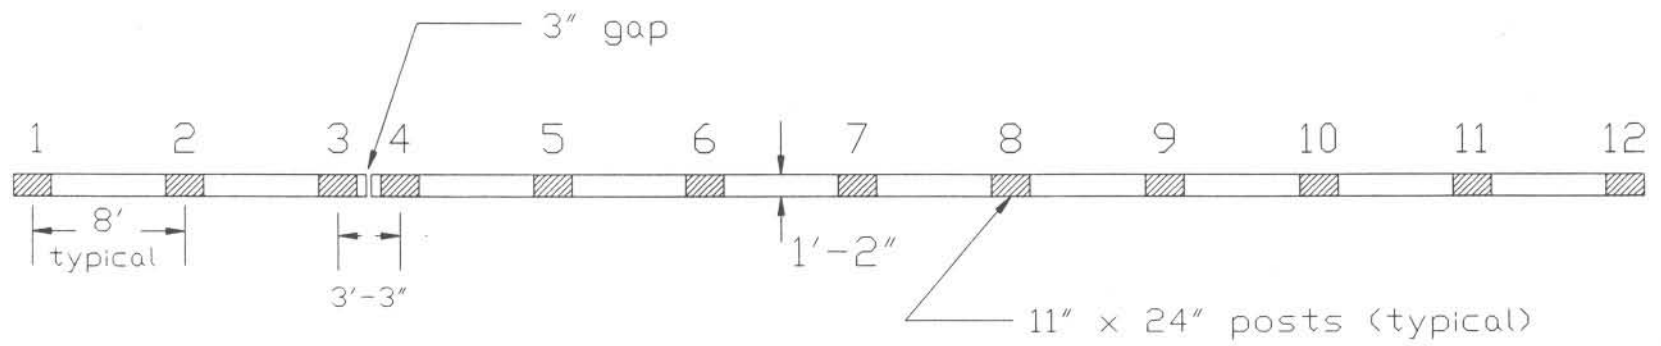
FIGURE 5. Nebraska Open Concrete Bridge Rail (Design No.2 and No. 3)

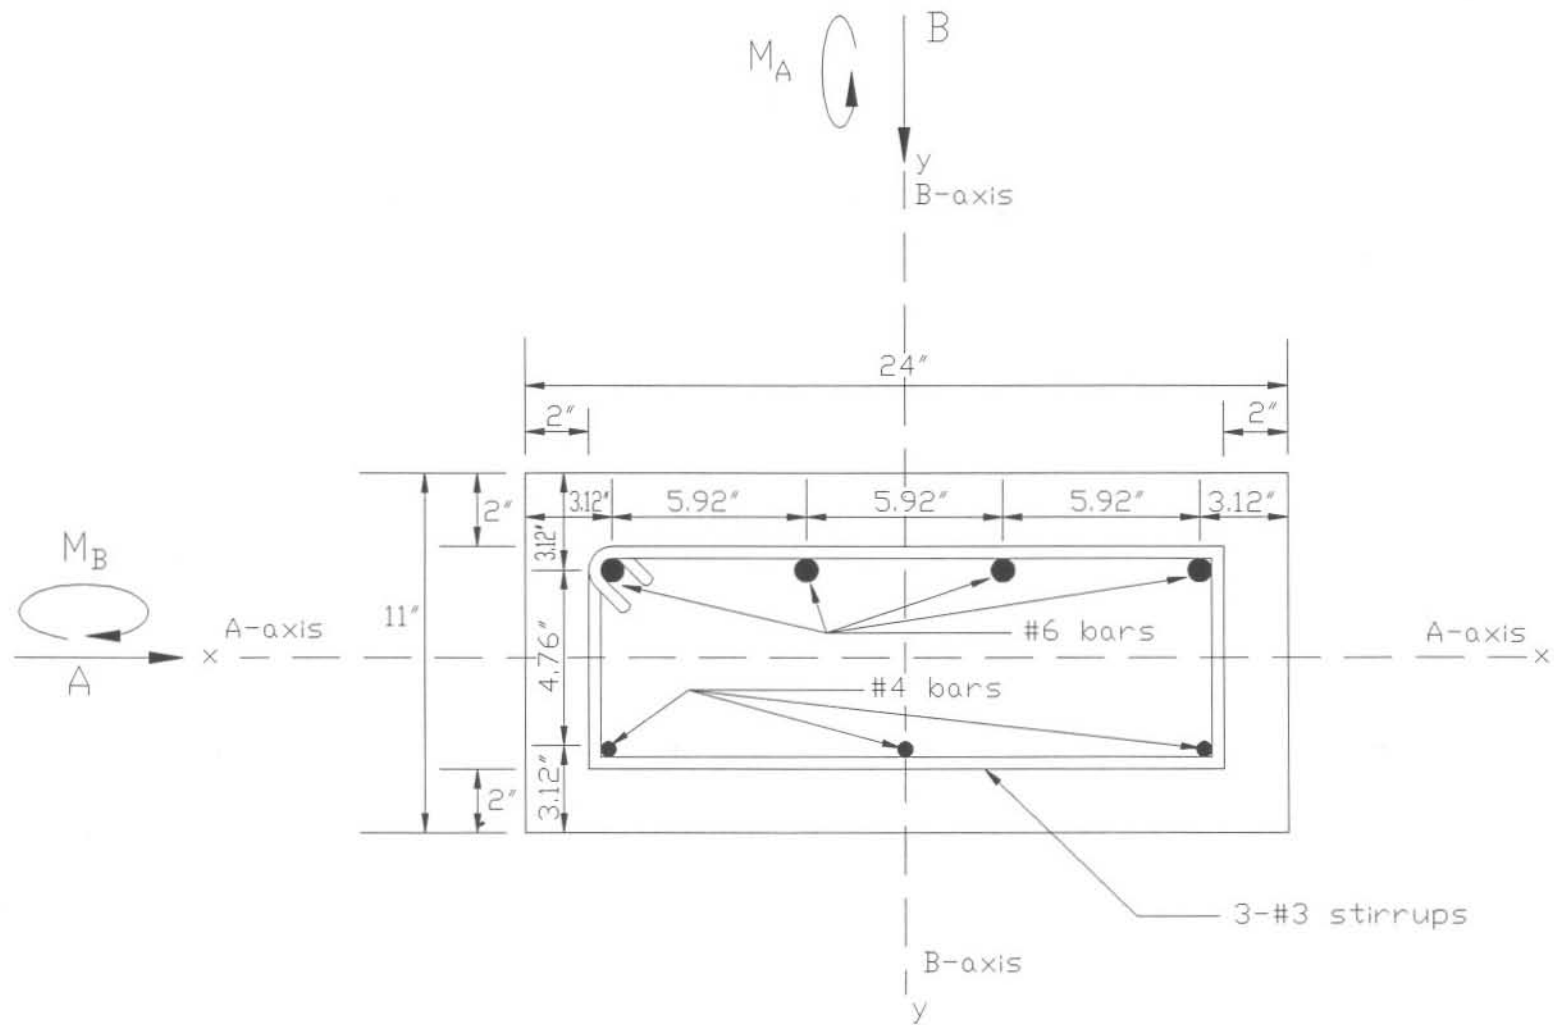
FIGURE 6. Design No. 2 Strong Post (11-in. x 24-in.)

The steel reinforcement in the 11-in. x 36-in. posts consisted of five No. 6 bars in both the traffic and back side faces of the post (Figure 9). The reinforcement in the 11-in. x 24-in. posts not adjacent to the gap consisted of four No. 6 bars in the traffic side face and three No.4 bars in the back side face of the post (Figure 6). Six No. 5 bars were used for bridge rail

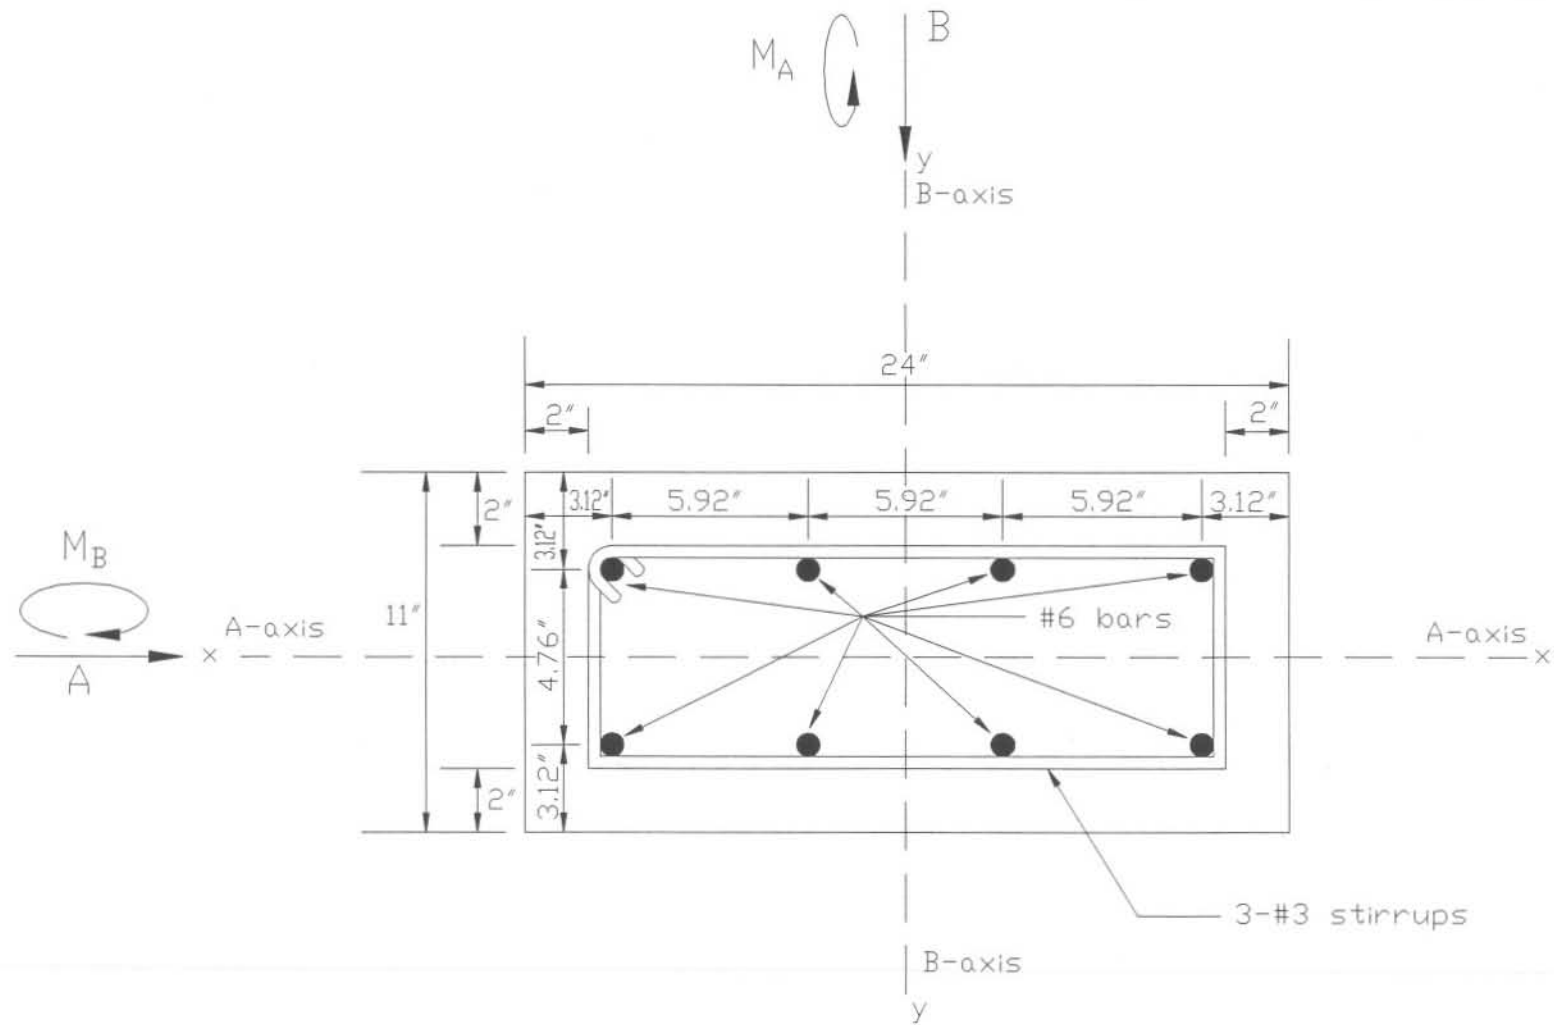
FIGURE 7. Design No. 3 Strong Post at Gap (11-in. x 24-in.)

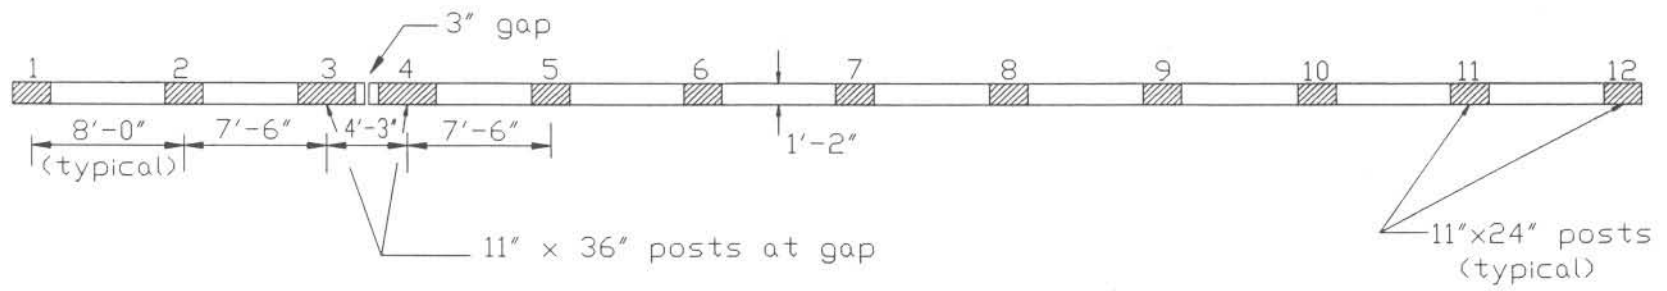
FIGURE 8. Modification of Design No. 3

Design No. 4 incorporated an increase in the size of the post adjacent to the gap from 11-in. wide x 24-in. long to 11-in. wide x 36-in. long. Vertical reinforcement was also increased (Figure 8).

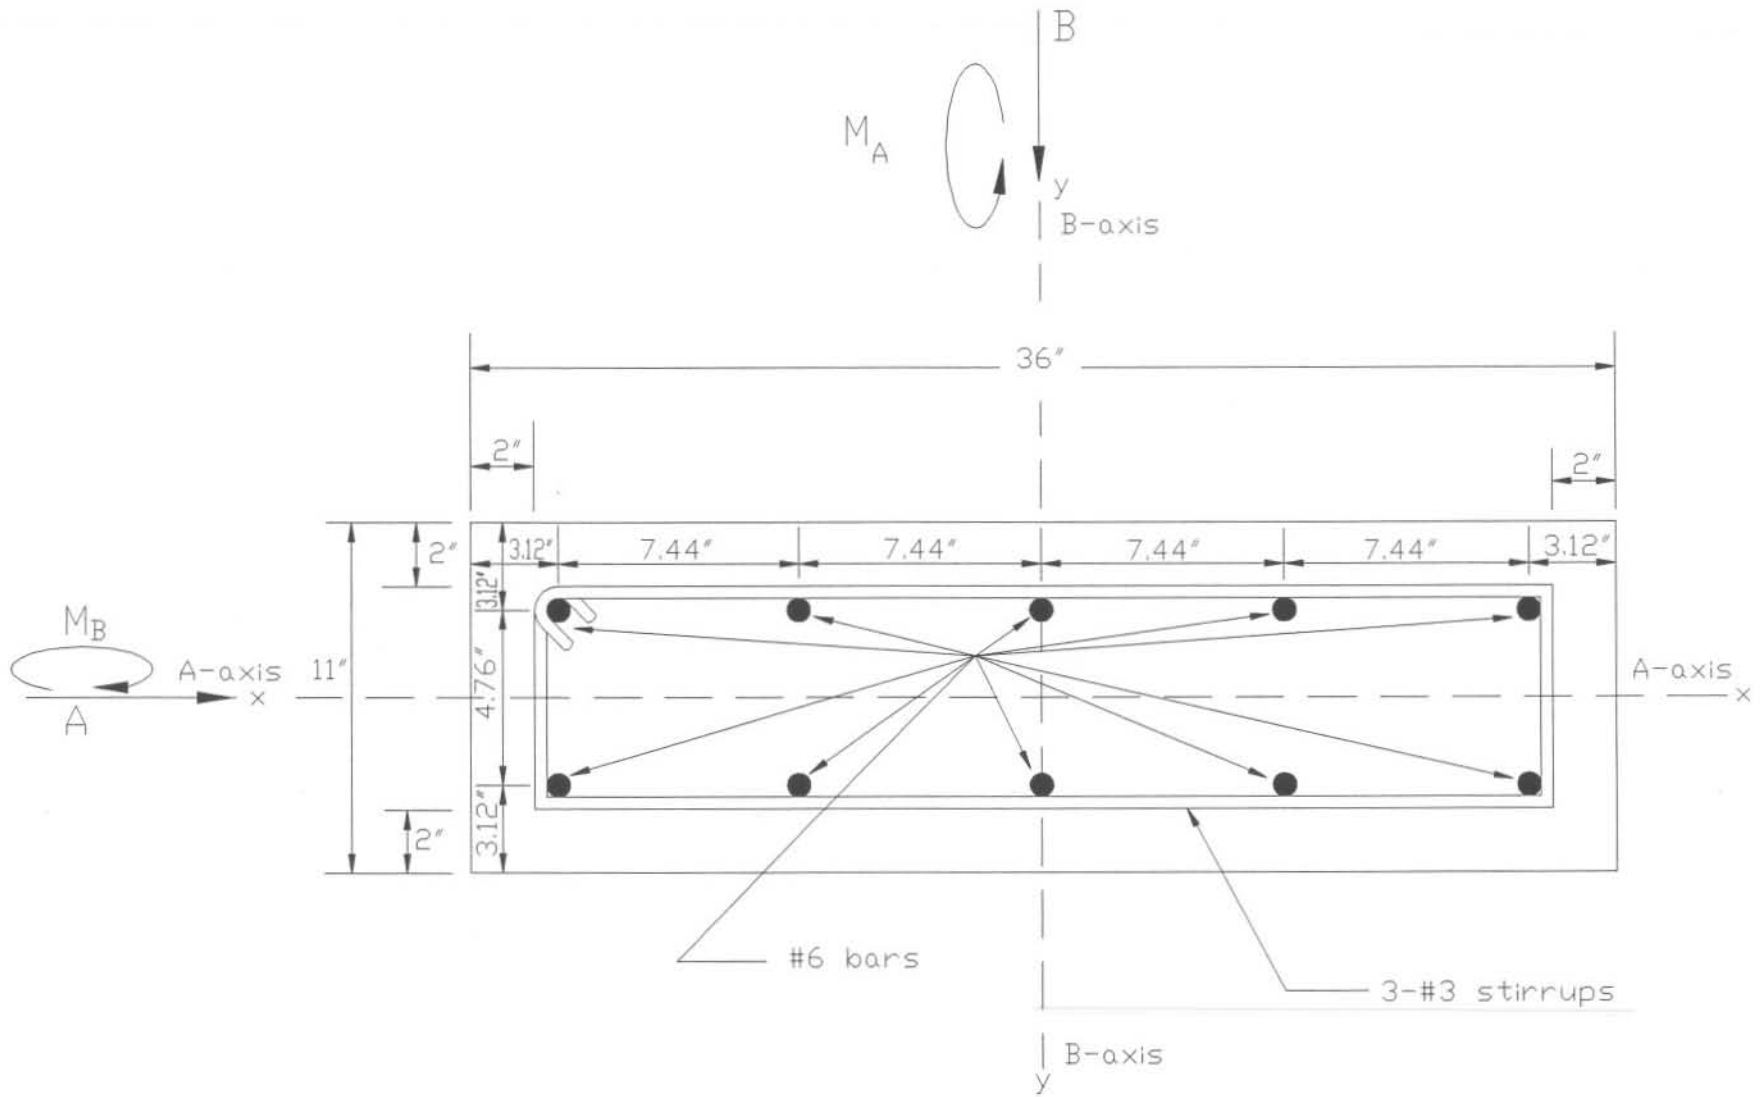
FIGURE 9. Design No. 4 Strong Post at Gap (11-in. x 36-in.)

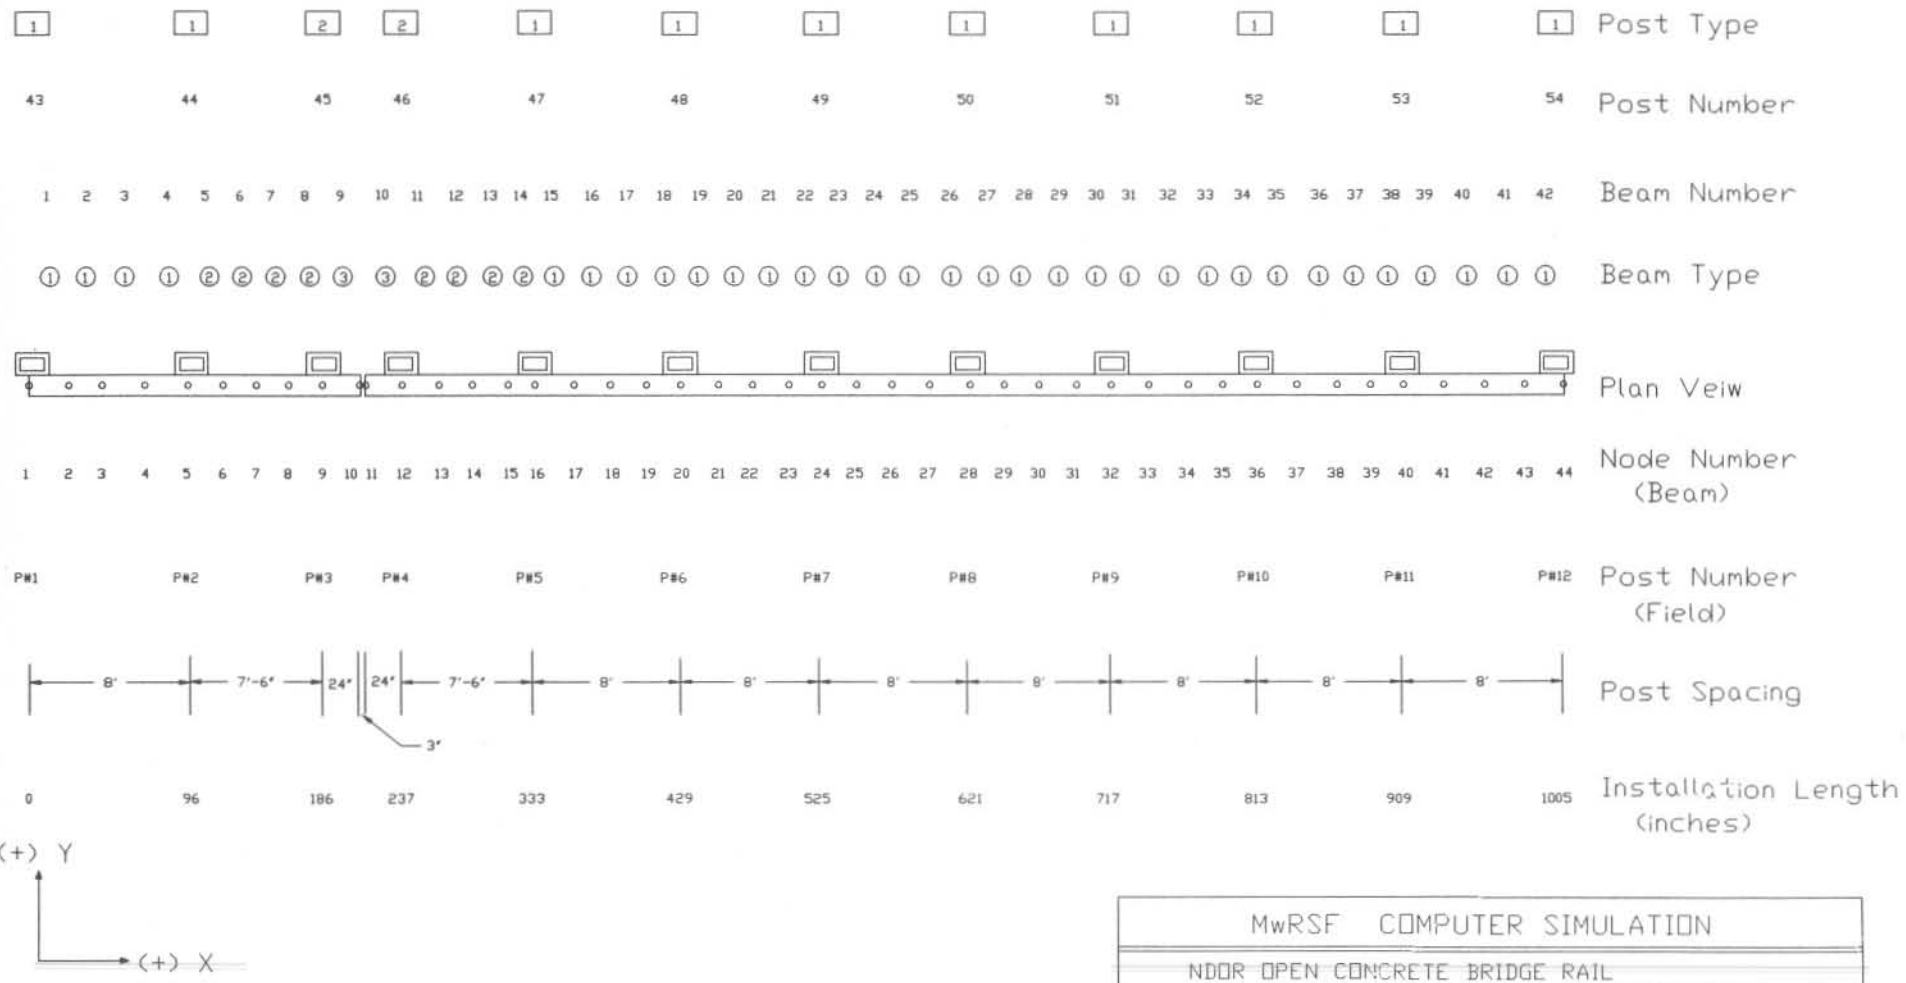
**FIGURE 10.** Computer Simulation Model Configuration, Design No. 4

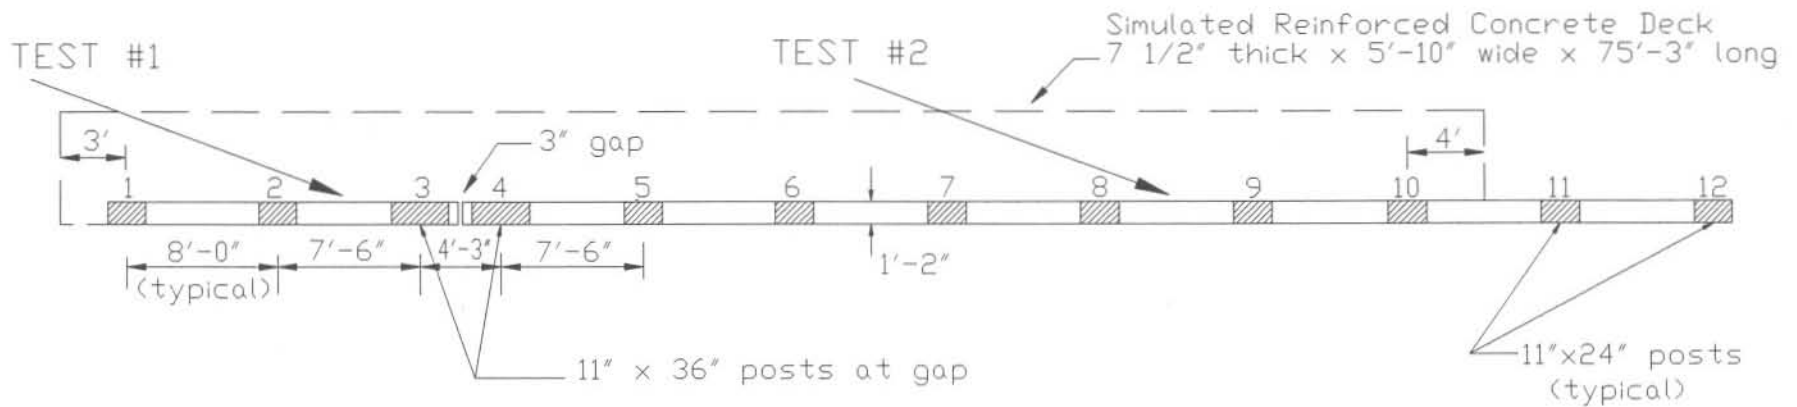
TEST #1 - 5400#, 45mph, 20°, 5'-10 1/2" upstream from centerline of gap

Note: Longitudinal Beam Steel  
 Post#1-6: 6-#6's (see footnote)  
 Between Post#6 and 7:  
 Lap splice #5's and #6's  
 Post#7-12: 6-#5's  
 Total Rail Length: 85'-3"

FIGURE 11. Nebraska Open Concrete Bridge Rail, Design No. 4

The final design as constructed in the field and full-scale vehicle crash tested is discussed in Chapter 3. The plan view of this final design is shown in Figure 11.

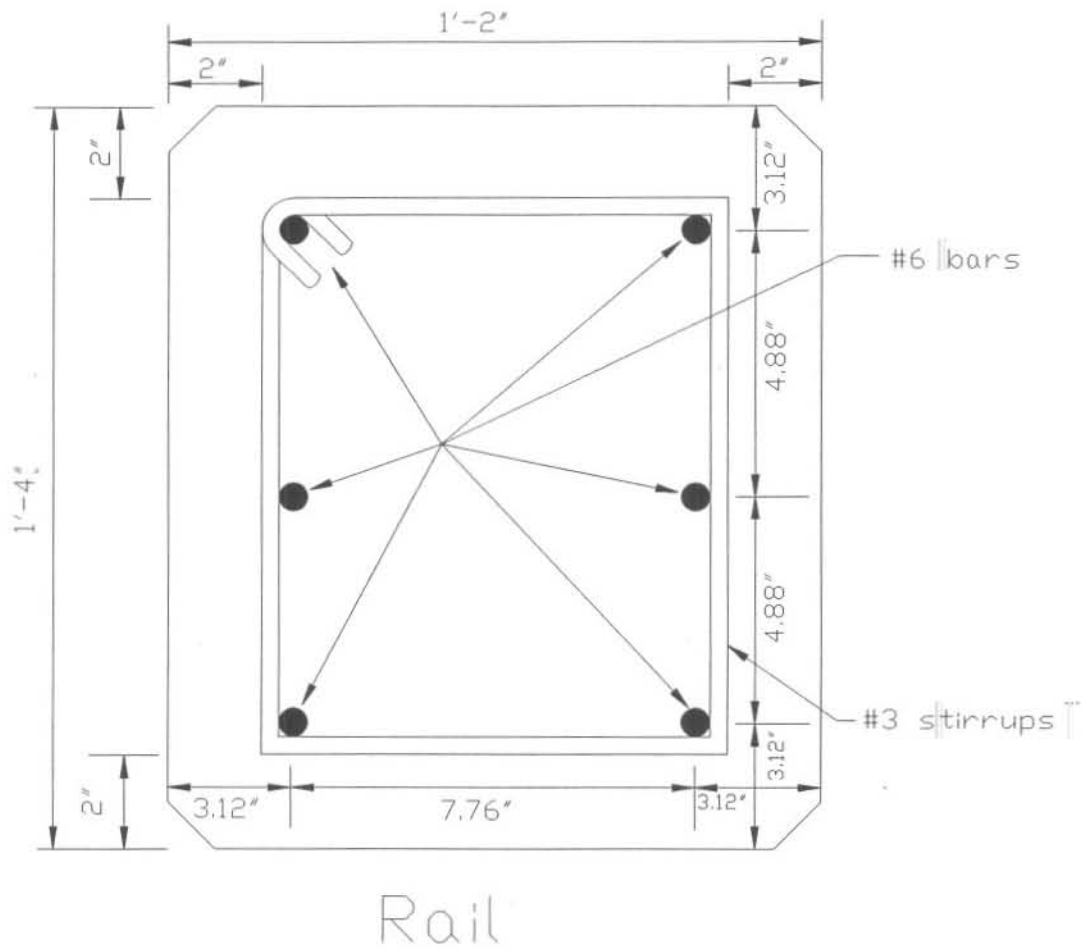
\*Note: Stirrup spacing varies. See bridge rail design details.

**FIGURE 12.** Reinforcement Modification to Design No. 4

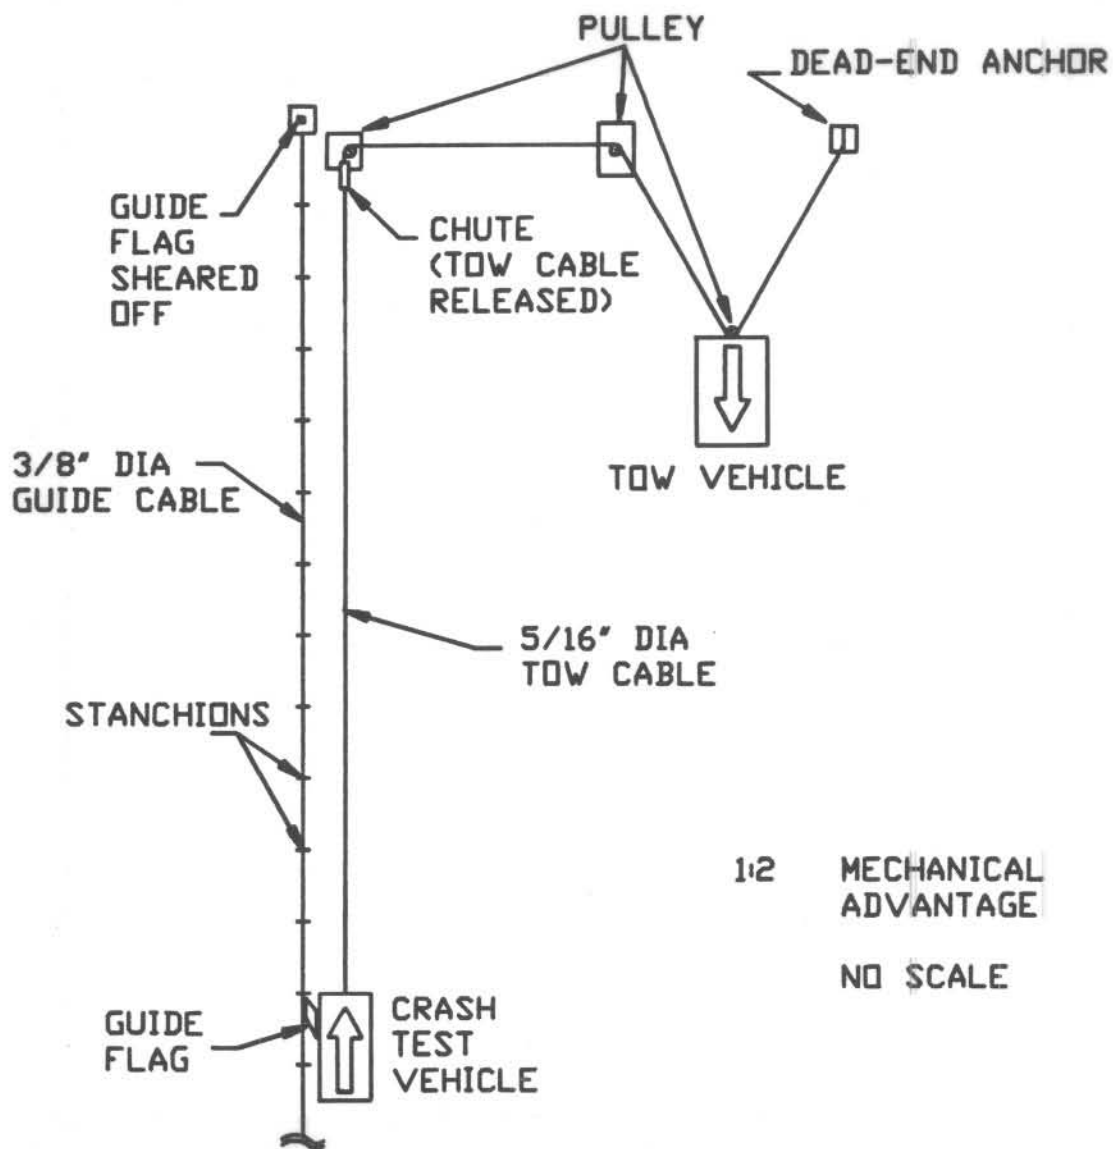
FIGURE 13. Cable Tow and Guidance System.

A vehicle guidance system developed by Hinch (5) was used to steer the test vehicle. The guidance system is shown in Figure 13. A guide flag attached to the front left wheel and the guide cable was sheared off before impact. The 3/8-in. diameter guide cable was tensioned to 3,000 lbs, and supported laterally and vertically every 100 ft by hinged stanchions. The hinged stanchions stood upright while holding up the guide cable, but as the vehicle was towed down the line, the guide-flag struck and knocked each stanchion to the ground. The vehicle guidance system was 1,500-ft long for both tests.

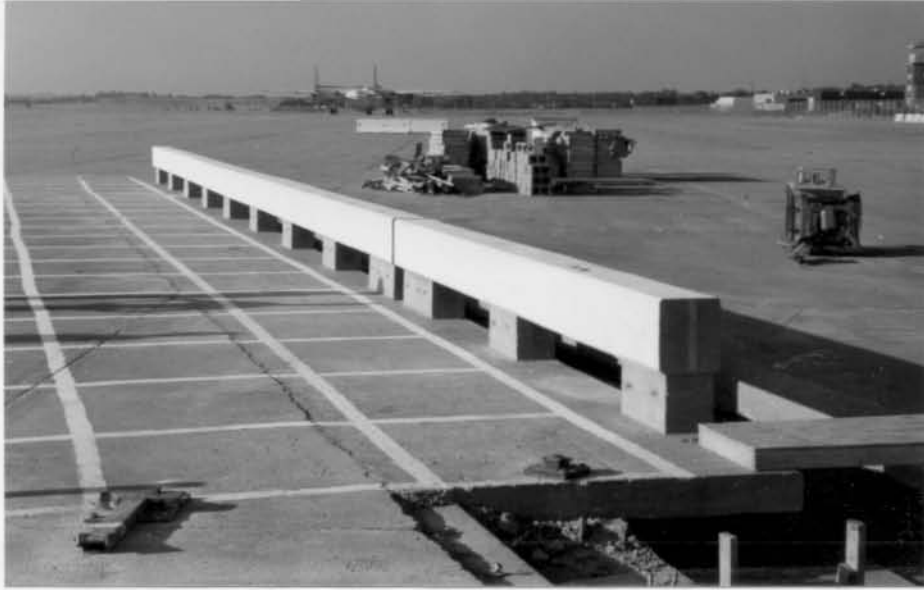
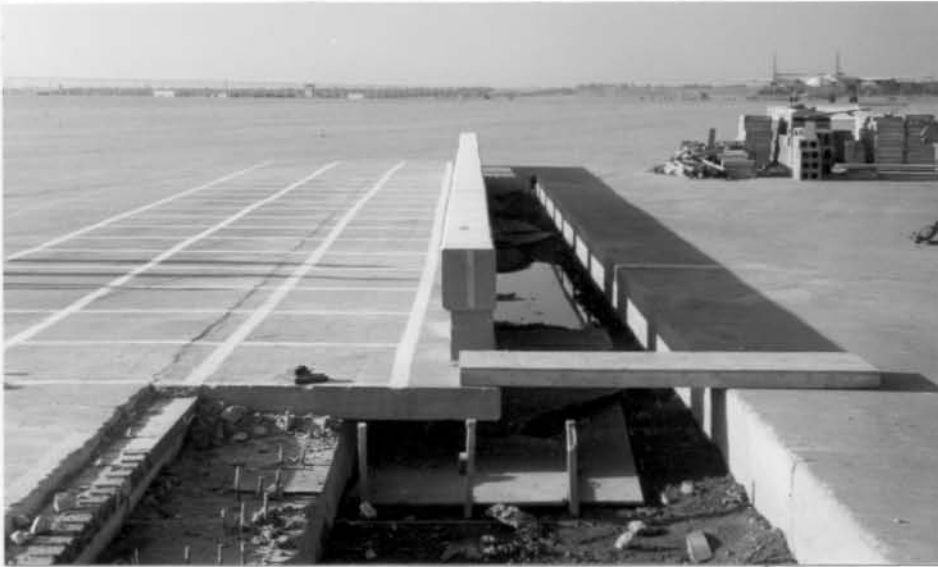
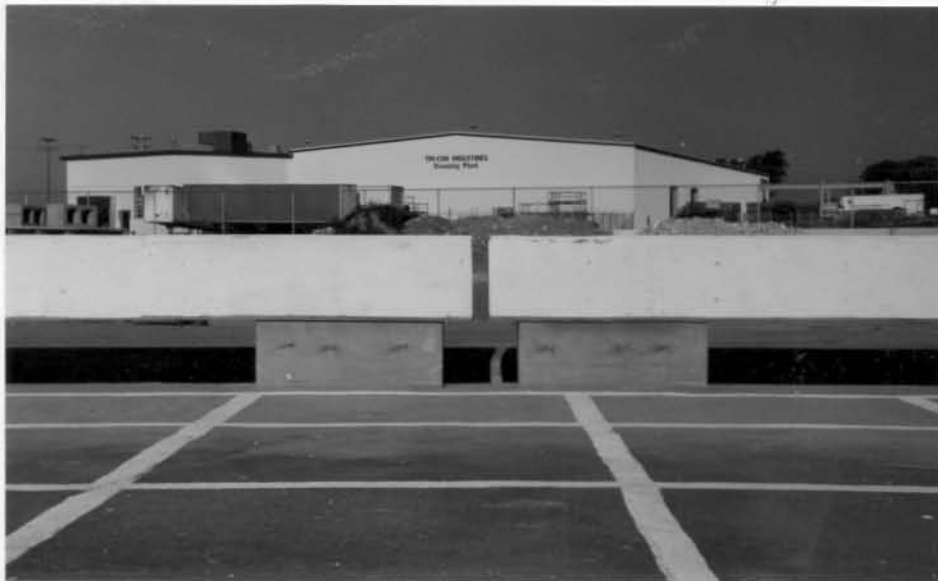
**FIGURE 16.** Nebraska Open Concrete Bridge Rail

A detailed drawing of the Nebraska Open Concrete Bridge Rail is shown in Figure 15. Photographs of the actual installation are shown in Figure 16. The total length of the installation was 85-ft 3-in. The installation consisted of three major structural components: (1) simulated concrete bridge deck, (2) concrete posts, and (3) concrete bridge rail. The design details for each of these components are shown in Figure 15.

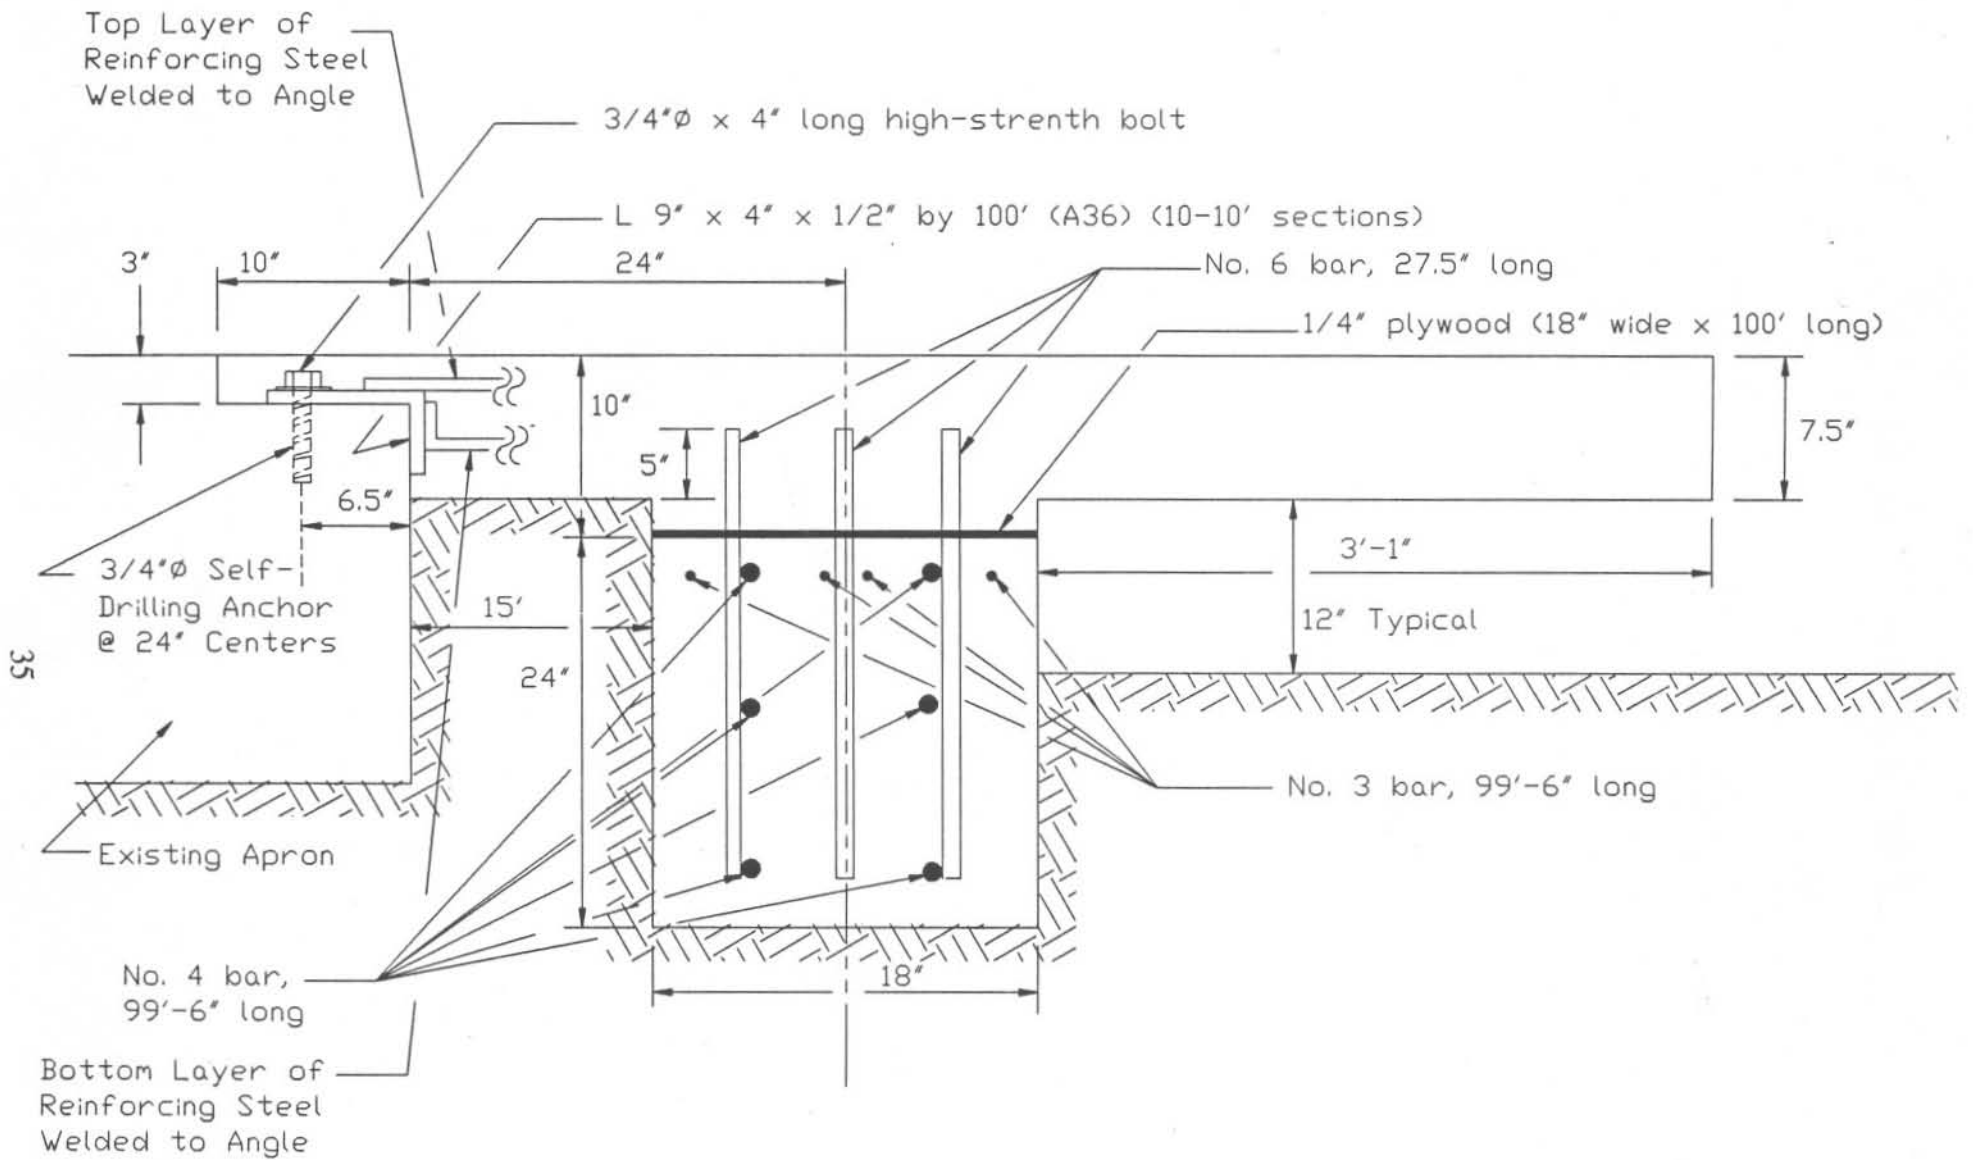
**FIGURE 17. Concrete Deck Attachment Detail**

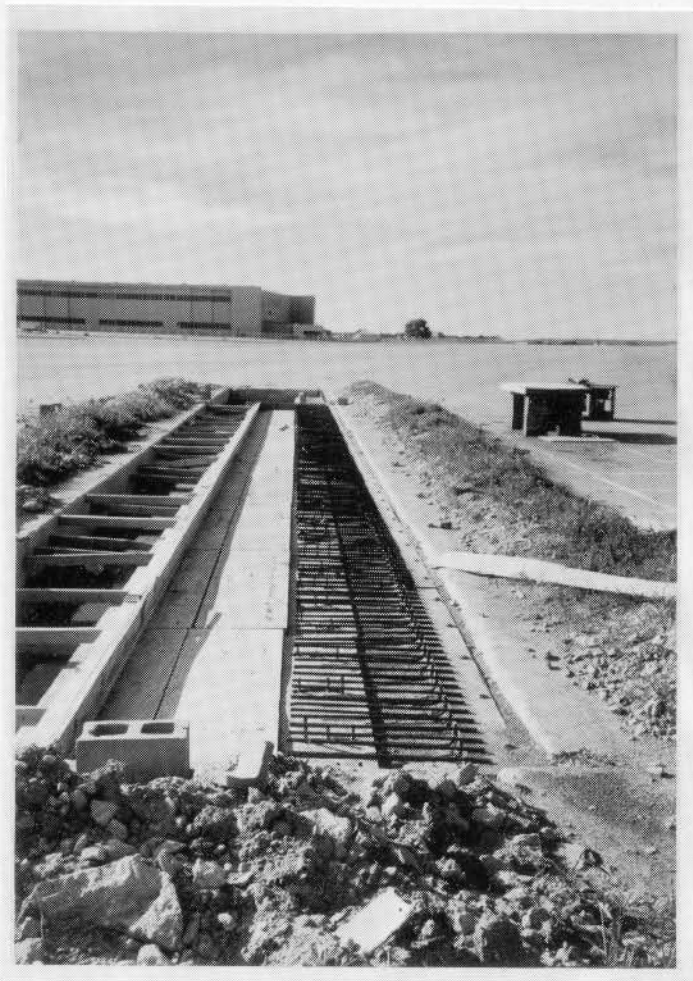
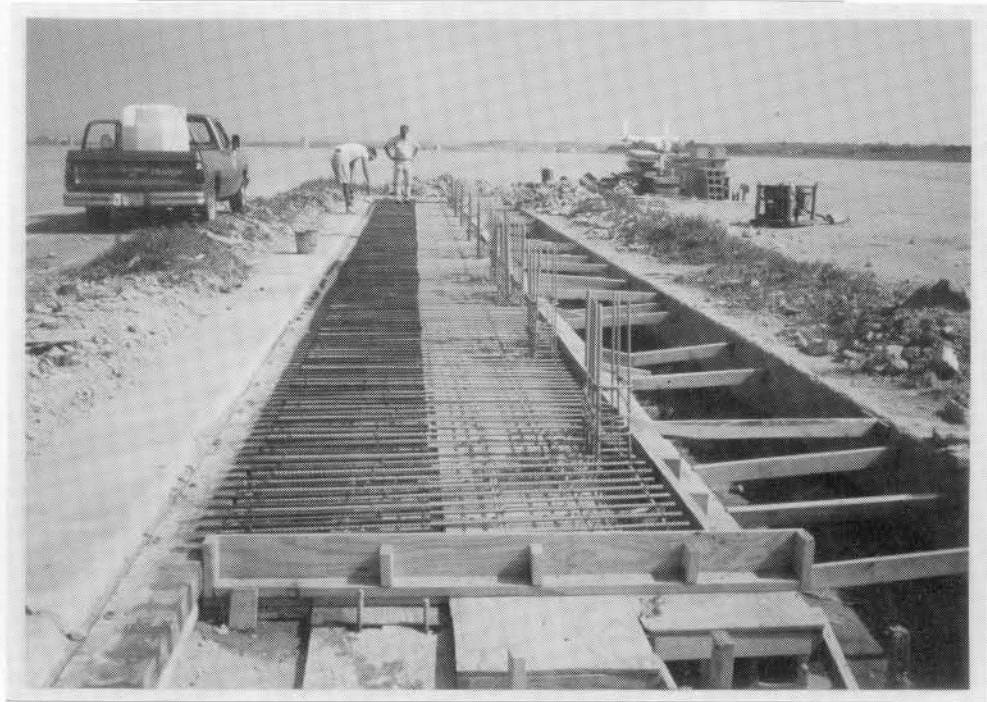
FIGURE 18. Reinforcement Layout for Bridge Deck

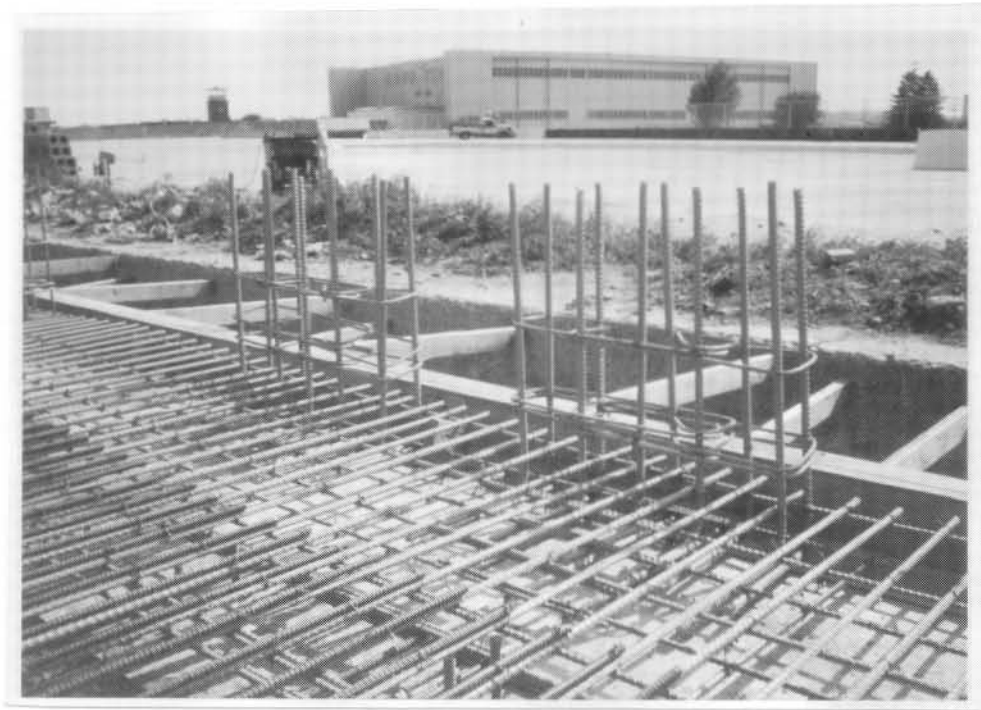
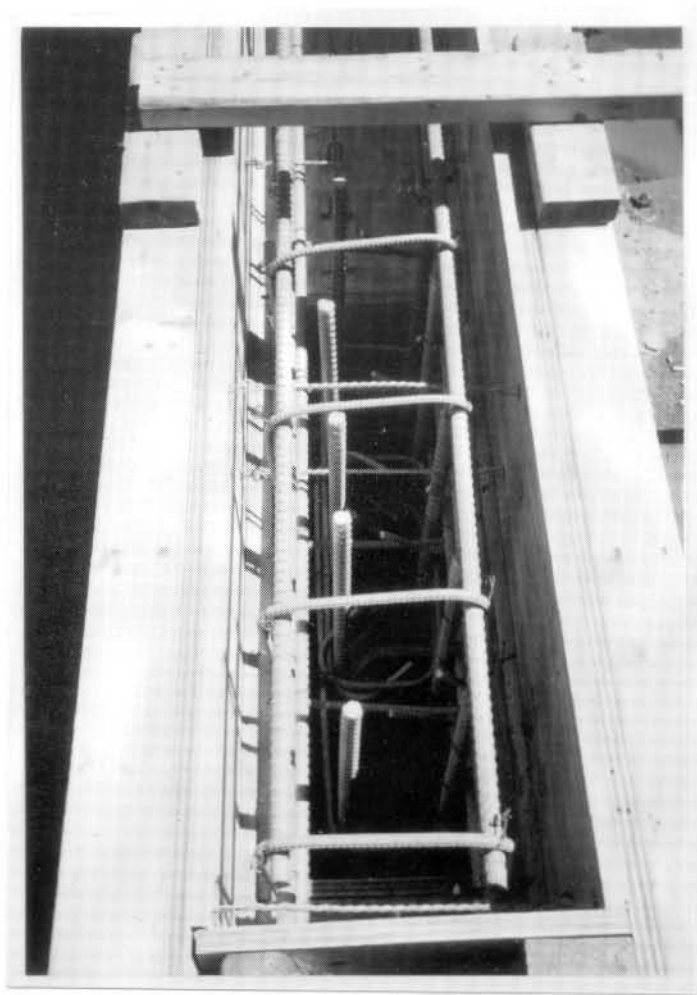
FIGURE 19. Steel Reinforcement in the 3-ft Posts Adjacent to the 3-in. Gap

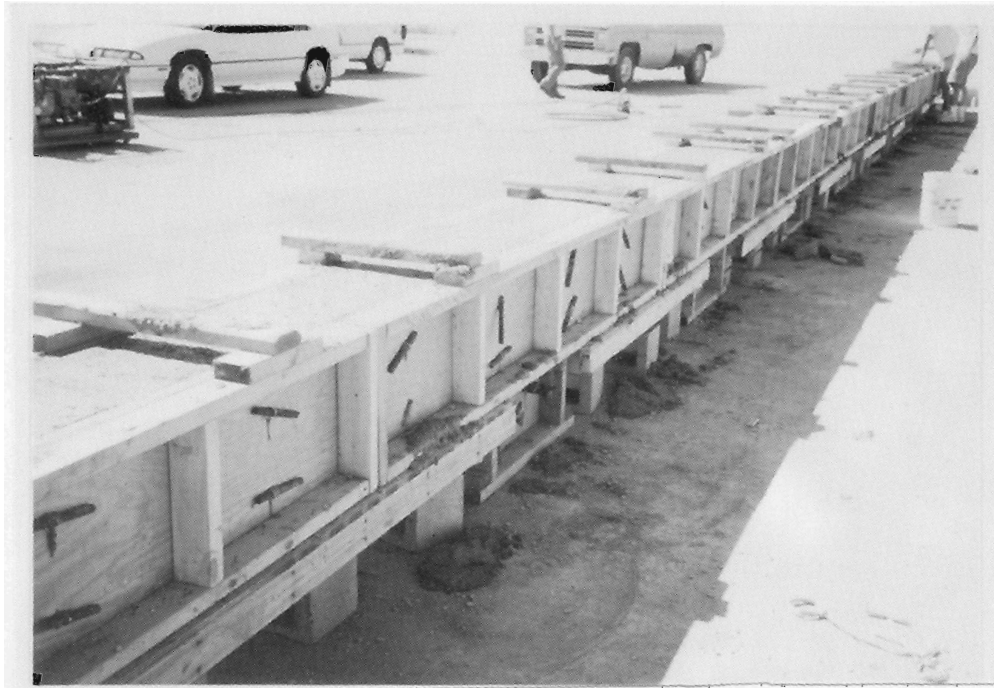
FIGURE 20. Bridge Rail Construction

The third major component of the installation was the concrete bridge rail. The construction of the rail is shown in Figure 20. The bridge rail was 1-ft 2-in. wide x 1-ft 4-in. deep x 85-ft 3-in. long, including a 3-in. expansion gap between the third and fourth posts. The reinforcement in the rail consisted of six longitudinal Grade 60 epoxy-coated bars. Six No. 6 bars were placed from Post Nos. 1 through 6, while six No. 5 bars were placed from Post Nos. 7 through 12. The No. 5 and No. 6 bars were lapped between the sixth and seventh posts, as shown in Figure 15.
