# PERFORMANCE LEVEL 1 TESTS ON THE NEBRASKA OPEN CONCRETE BRIDGE RAIL

TRANSPORTATION RESEARCH REPORT TRP-03-28-91

Midwest Roadside Safety Facility  
Civil Engineering Department  
W348 Nebraska Hall  
University of Nebraska-Lincoln  
Lincoln, Nebraska 68588-0531

February 1992

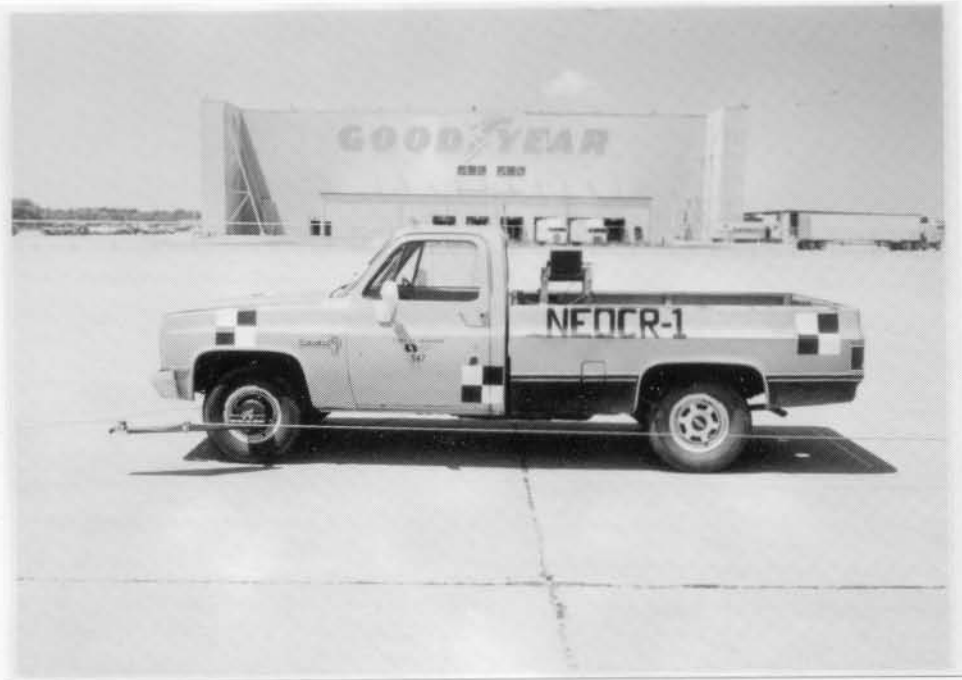
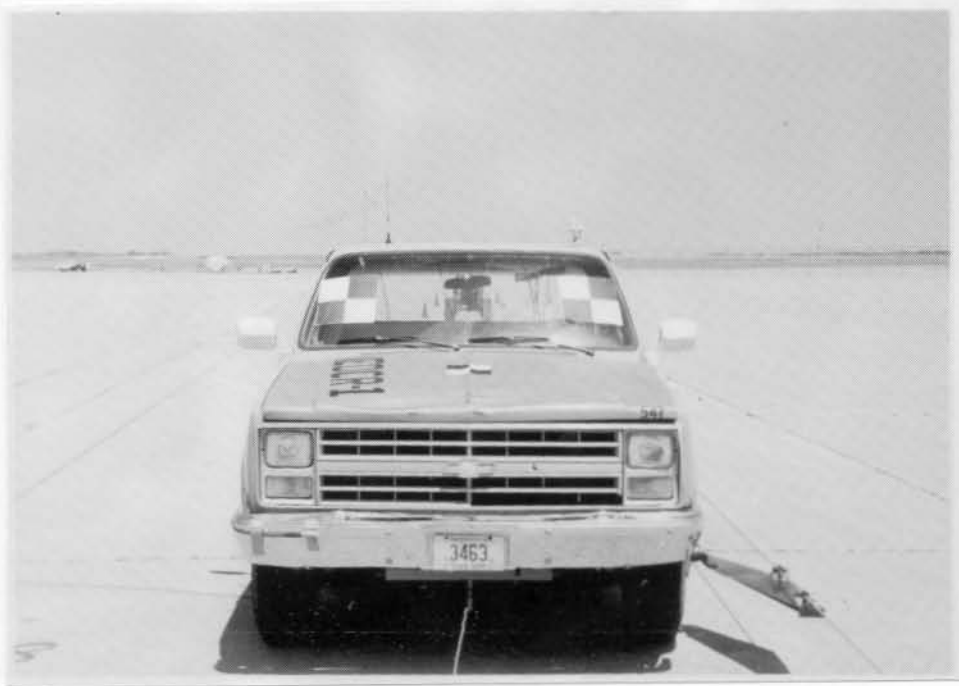
FIGURE 21. Test Vehicle, NEOCR-1

The test vehicle used for Test NEOCR-1 was a 1985 Chevrolet 3/4-ton Custom Deluxe-20 pickup. The test vehicle had a test inertial and a gross static weight of 5,300-lb. The test vehicle is shown in Figure 21 and the vehicle dimensions are shown in Figure 22.

Eight 12-in., square, black and white-checked targets were placed on the vehicle. These targets were used in the high-speed film analysis. Two targets were located on the center of gravity, one on the top and one on the driver's side of the test vehicle. The remaining targets were located such that they could be viewed from all three cameras.

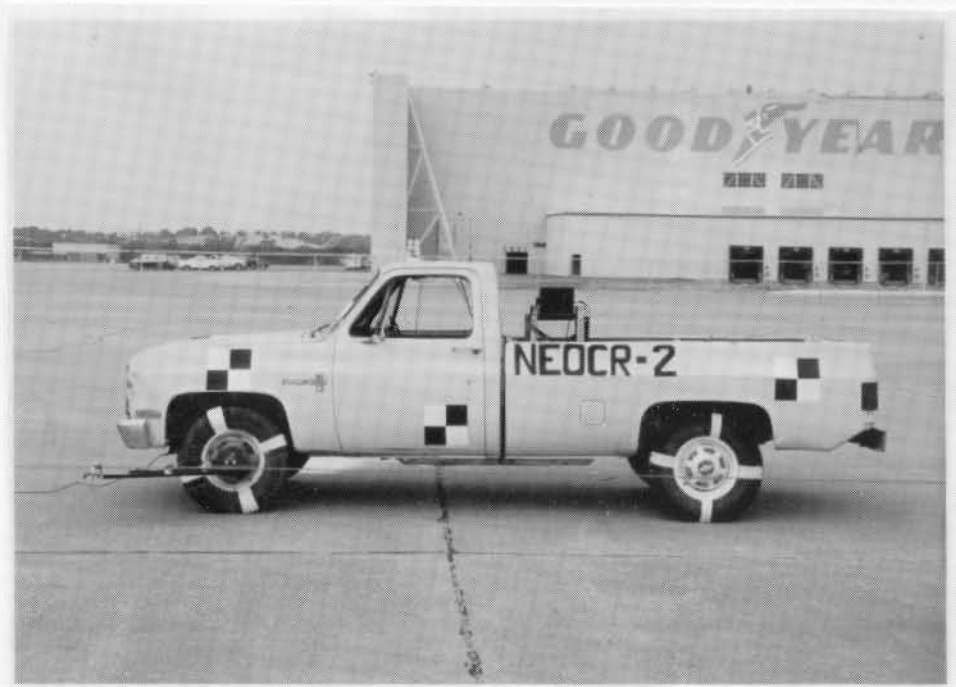
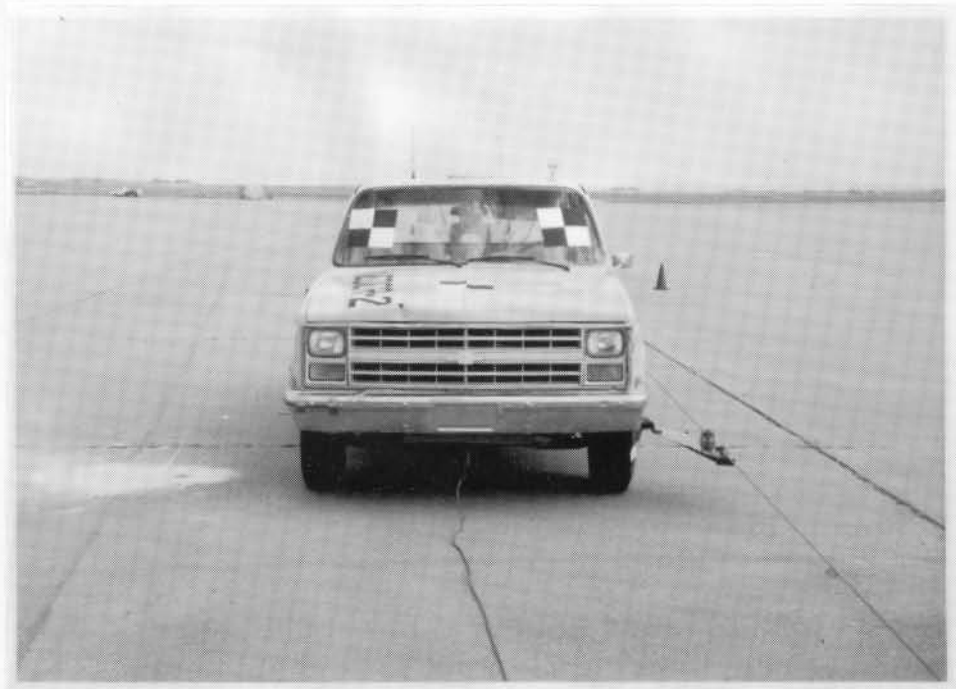
FIGURE 23. Test Vehicle, NEOCR-2

The test vehicle used for Test NEOCR-2 was a 1986 Chevrolet 3/4-ton Custom Deluxe-20 pickup. This test vehicle had a test inertial and a gross static weight of 5,390-lb. The test vehicle is shown in Figure 23, and the vehicle dimensions are shown in Figure 24.

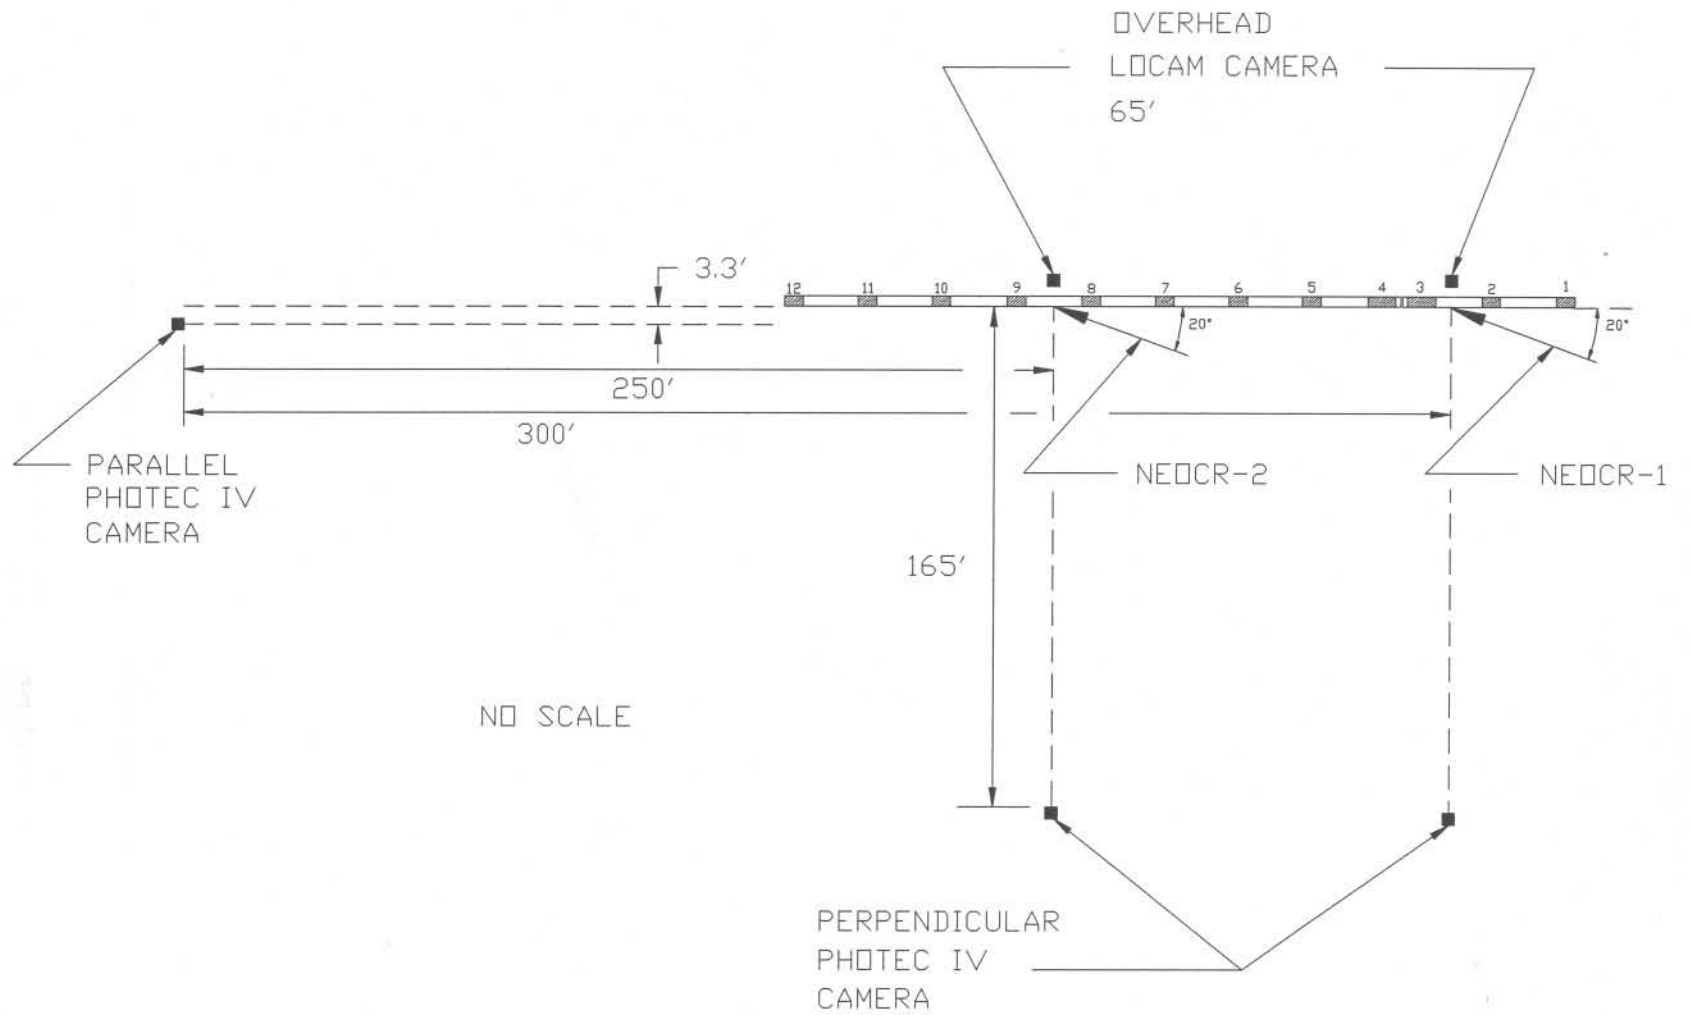
FIGURE 26. Layout of High Speed Cameras, NEOCR-1, 2

Three high-speed 16-mm cameras were used to film the crash tests. The cameras' normal operating speed is approximately 500 frames/sec. The overhead camera was a Red Lake Locam with a wide-angle 12.5-mm lens. The parallel camera was a Photec IV with a 80-mm lens. The perpendicular camera was a Photec IV with a 55-mm lens. A schematic of all three camera locations for each test is shown in Figure 26.

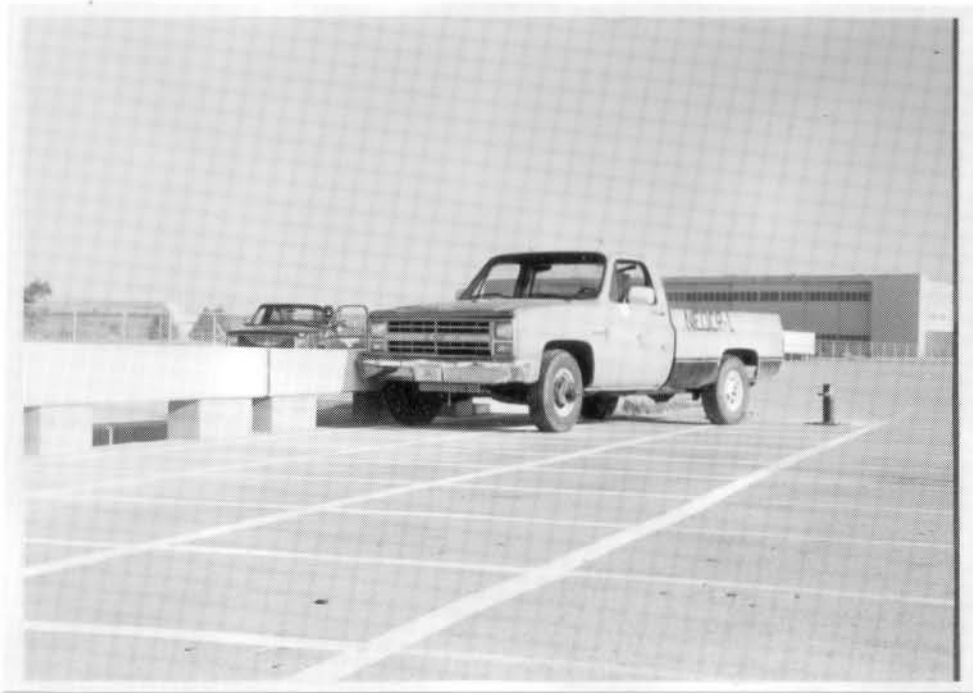
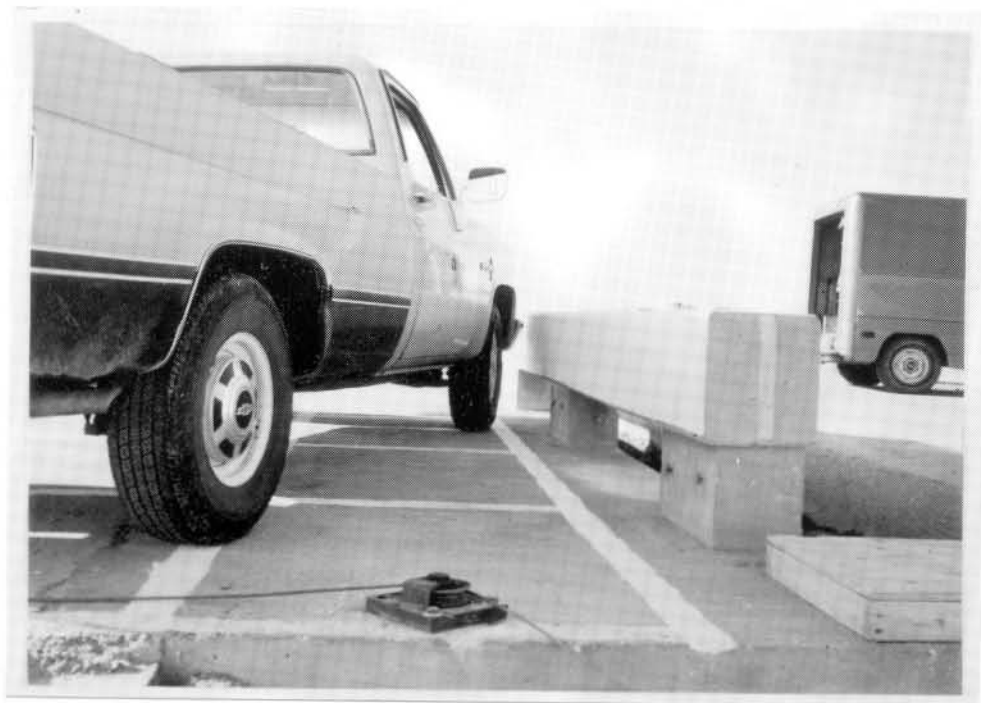
FIGURE 27. Impact Location, Test NEOCR-1

Two full-scale vehicle crash tests were conducted on the Nebraska Open Concrete Bridge Rail in order to satisfy the AASHTO (3) PL-1 performance level. Test NEOCR-1 was conducted with a 1985 3/4 ton Chevy pickup weighing approximately 5,300-lb. The impact speed was 47.7 mph, with an impact angle of 20 deg. The location of impact was 5-ft 10½-in. upstream of the centerline of the 3-in. gap. The impact point is shown in Figure 27.

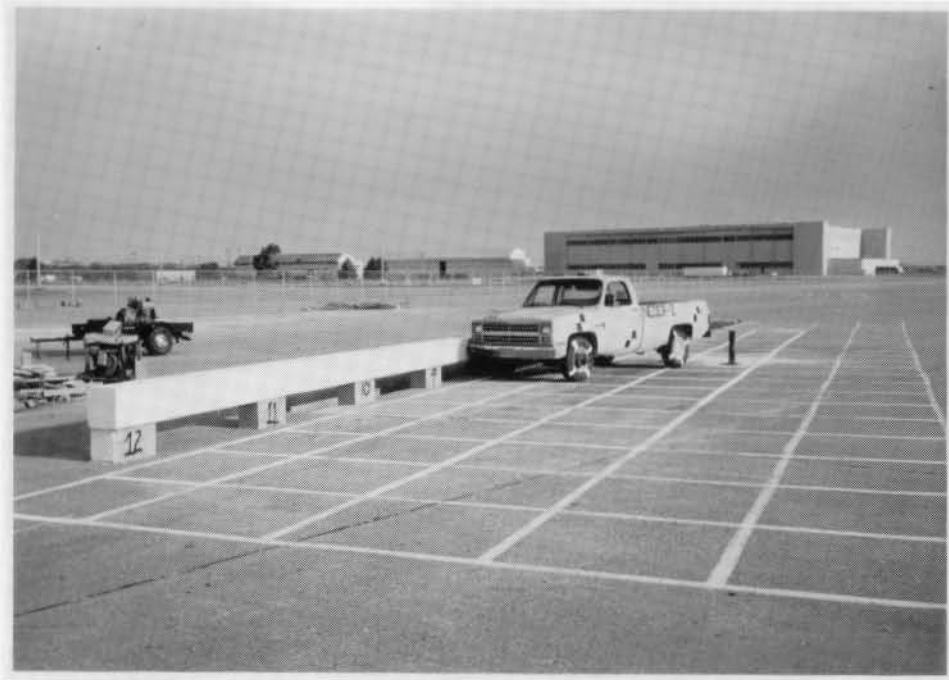
FIGURE 28. Impact Location, Test NEOCR-2

Test NEOCR-2 was conducted with a 1986 3/4-ton Chevy pickup weighing approximately 5,390-lb. The impact speed was 45.9 mph, with an impact angle of 20 deg. The impact location was midspan of the section between Post Nos. 8 and 9. The impact point is shown in Figure 28.

The longitudinal occupant impact velocity was determined to be 13.2 fps and the lateral occupant impact velocity was 19.0 fps. The highest 0.010-sec average occupant ridedown decelerations were 10.1 g's (longitudinal) and 9.5 g's (lateral). The results of the occupant risk, as determined from the accelerometer data are summarized in Figure 28 and Table 12. The results are shown graphically in Appendix E.

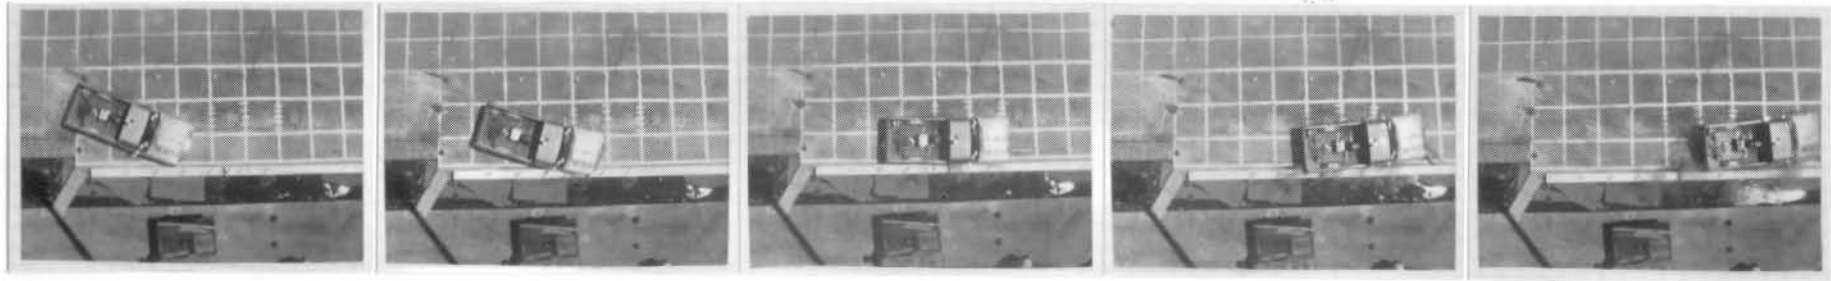
<b>Vehicle</b>	
Model	1985 Chevy 3/4-ton Custom Deluxe 20
<b>Weight</b>	
Test Inertial	5,300 lbs.
Gross Static	5,300 lbs.
<b>Vehicle Speed</b>	
Impact	47.7 mph
Exit	32.5 mph
<b>Vehicle Angle</b>	
Impact	20.0 deg.
Exit	2.8 deg.
Snagging	None
Vehicle Stability	Satisfactory
<b>Occupant Ridedown Velocity</b>	
Longitudinal	14.3 fps << 30
Lateral	20.2 fps < 25
<b>Occupant Ridedown Deceleration</b>	
Longitudinal	5.7 G's << 15
Lateral	11.5 G's < 15
<b>Vehicle Damage</b>	
TAD	1-RFQ-3
VDI	O1RFES2
Vehicle Rebound Distance	18 ft.
Vehicle Rail Damage	Minor

FIGURE 29. Summary and Sequential Photographs, NEOCR-1

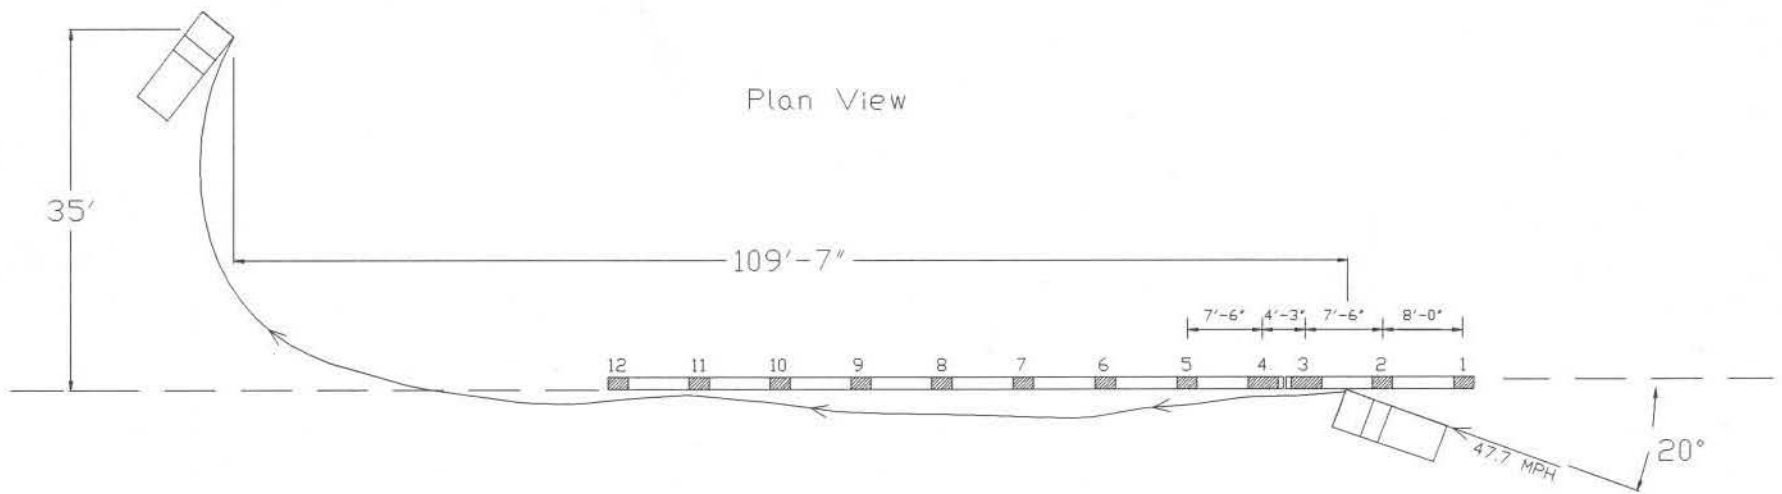
FIGURE 31. Vehicle Trajectory, NEOCR-1

The vehicle began to be redirected at 0.43 sec. The vehicle's exit angle (2.8 deg) was measured at the loss of contact between the vehicle and the rail (0.50 sec). This angle was much lower than the 12 deg limit shown in Table 10. The right side tire blowouts caused the vehicle to veer back towards the rail resulting in a second impact with the bridge rail. This second impact occurred 56 ft downstream of impact at approximately 1.23 sec. The vehicle's trajectory is shown in Figure 31. The maximum rebound distance on the traffic side face of the railing was approximately 3 ft, and the maximum rebound distance on the back side of the railing was approximately 18 ft. Both of these rebound distances were measured from the right side of the vehicle to a line extended parallel to the traffic side face of the bridge railing. The effective coefficient of friction was determined to be fair ( $\mu = 0.45$ ).

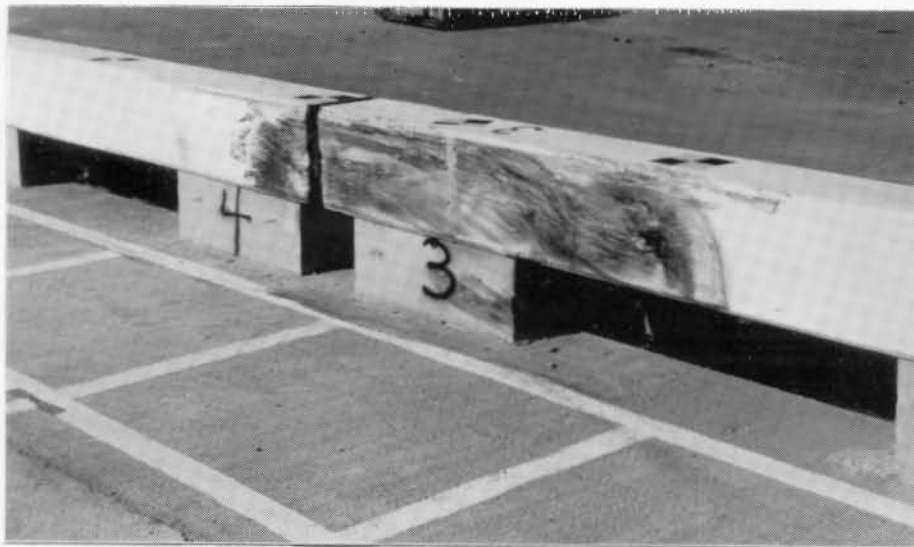
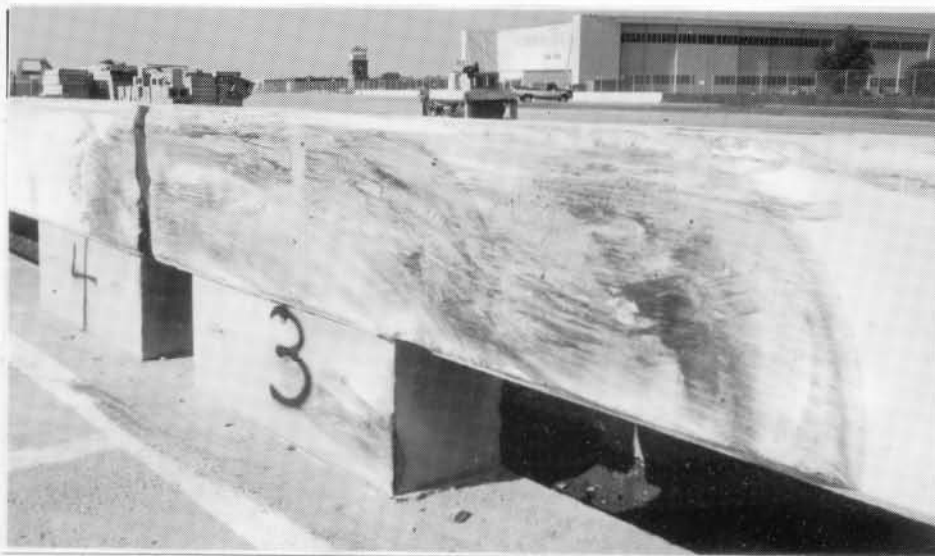
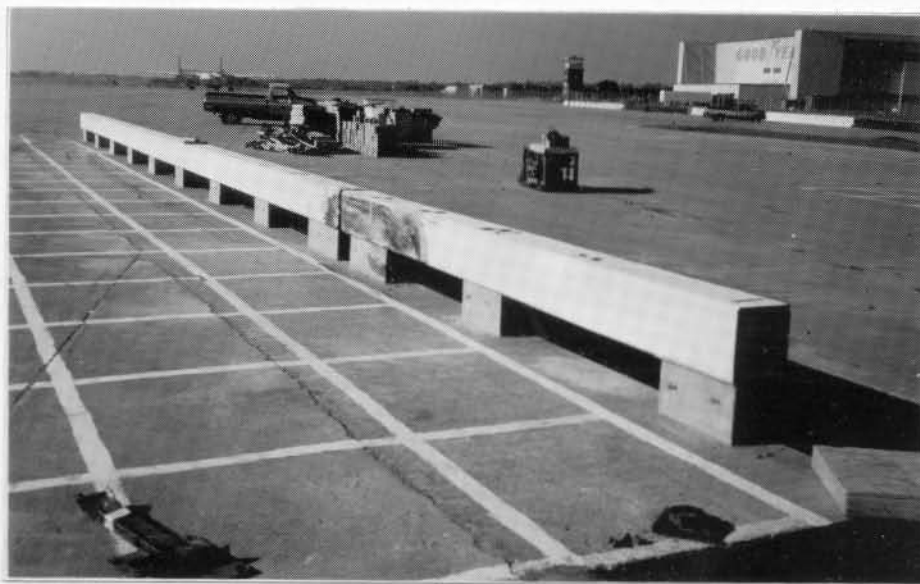
FIGURE 32. Bridge Rail Damage, NEOCR-1

Bridge rail damage is shown in Figure 32. Tire marks and scrapes accounted for the majority of the damage. Tire marks on the face of the rail were approximately 10-ft long, as shown in Figure 32. Tire marks were also visible on Post No. 3, and may have occurred when the tire impacted the post and then blew out. The length of the tire mark on Post No. 3 was approximately 17-in. The minimal bridge rail damage at the 3-in. gap is shown in Figure 33. Bridge rail damage which resulted from the second impact is shown in Figure 34.

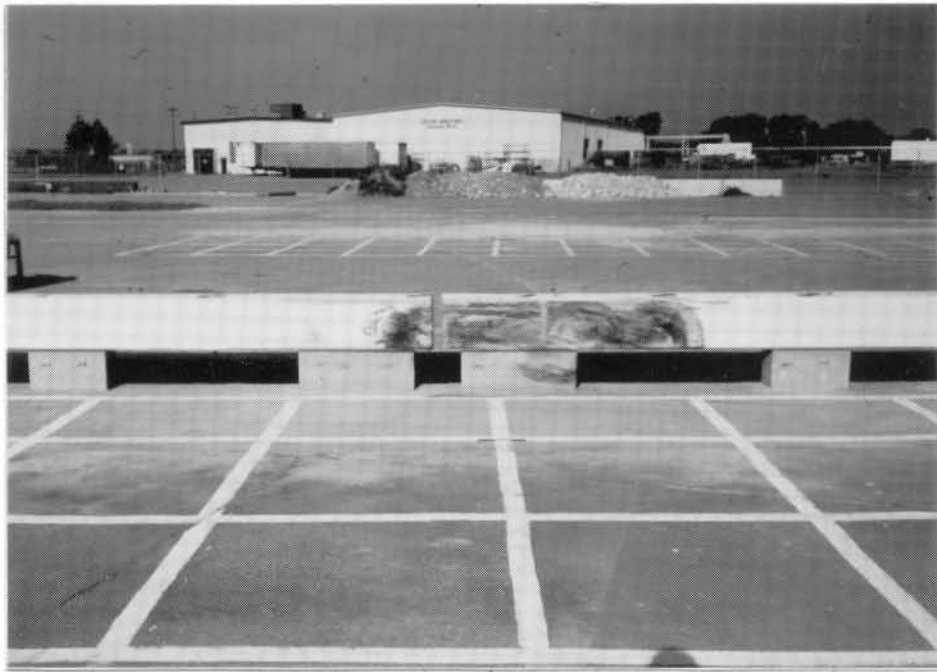
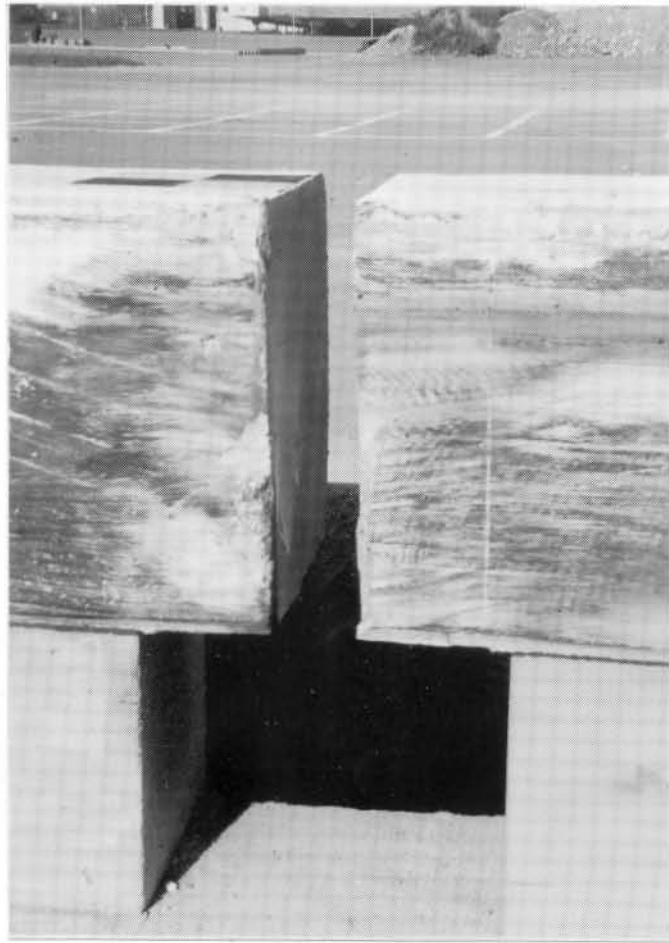
FIGURE 33. Bridge Rail Damage at the 3 in. Gap, NEOCR-1

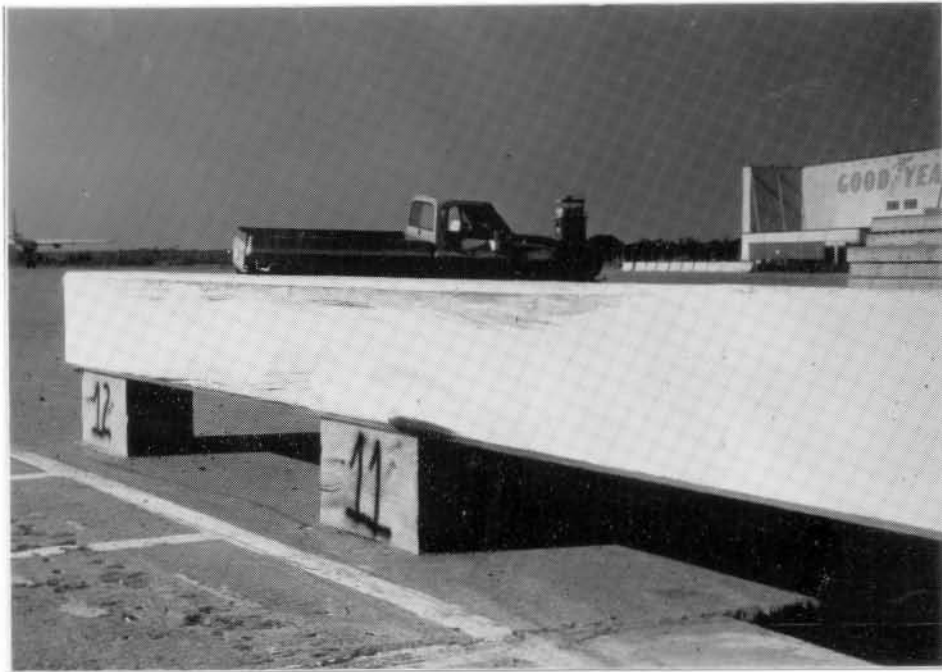
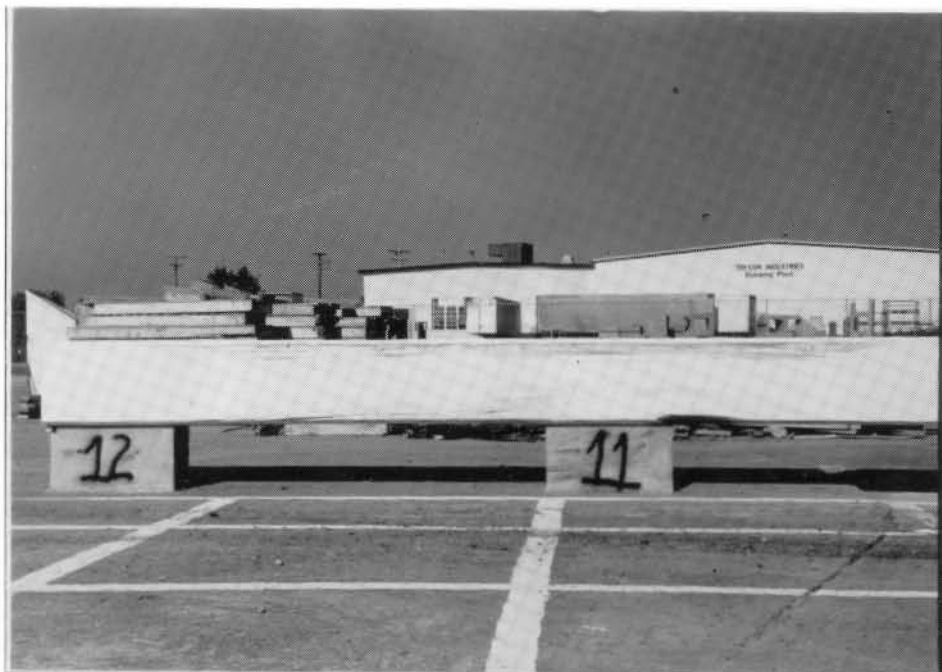
FIGURE 34. Bridge Rail Damage of Second Impact, NEOCR-1

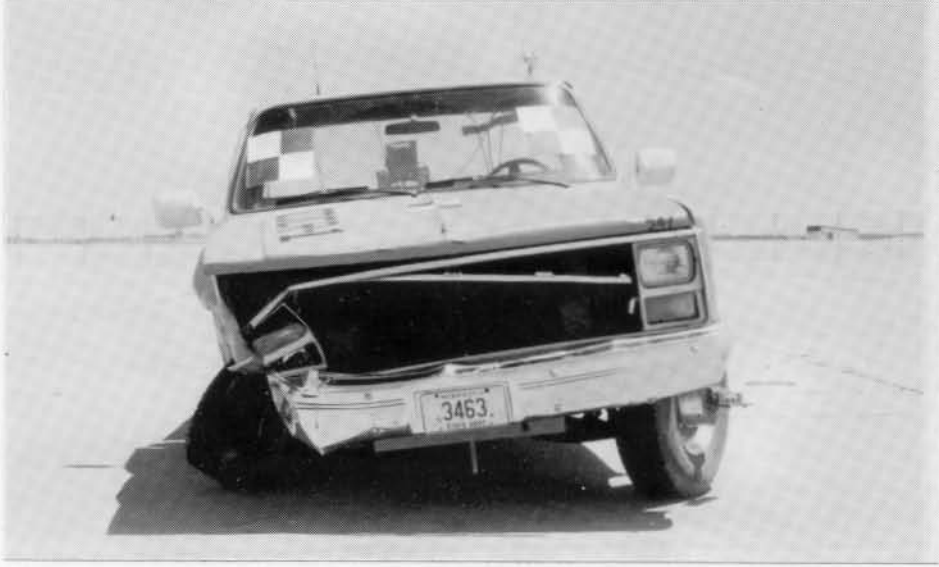
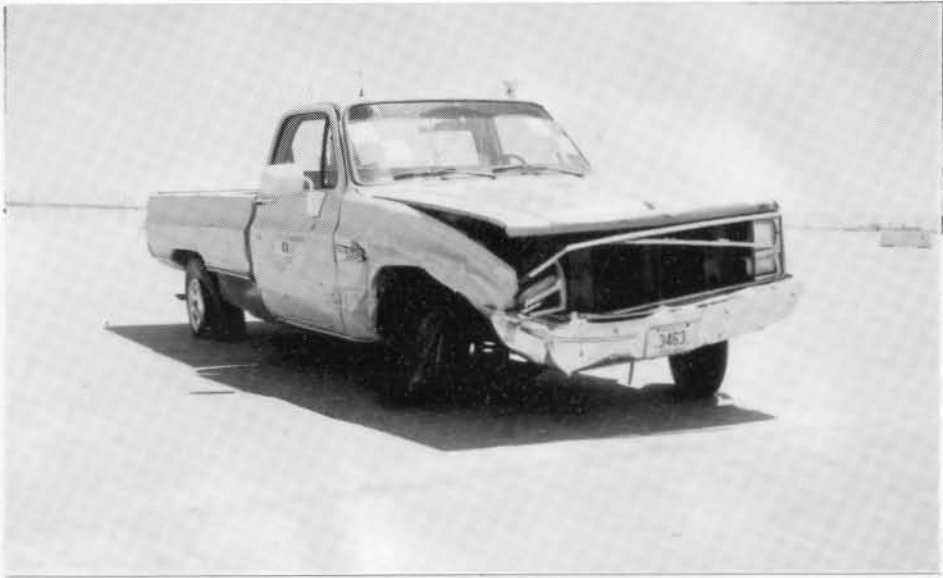
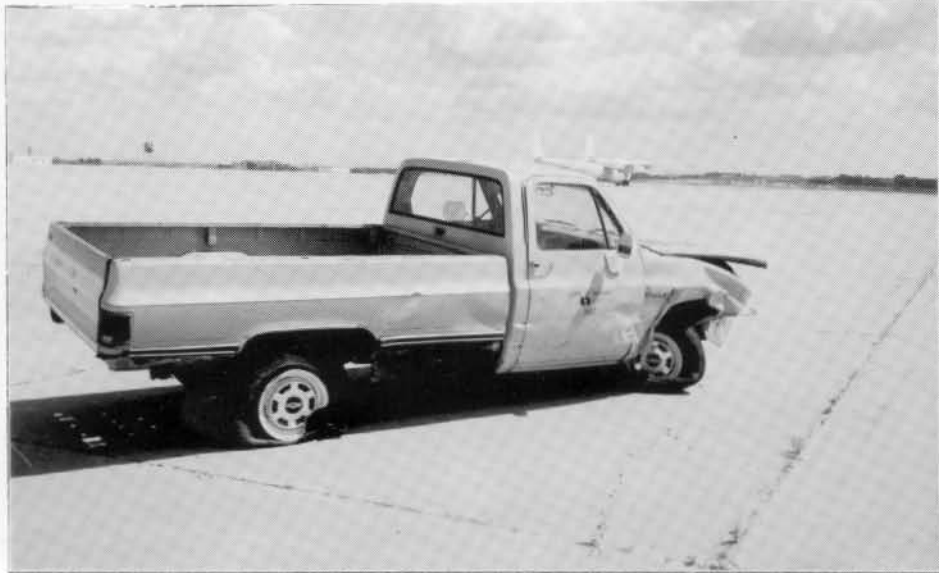
FIGURE 35. Vehicle Damage, NEOCR-1

Vehicle damage is shown in Figure 35. Most of the vehicle damage occurred near the right-front corner of the vehicle, consisting primarily of fender, hood, bumper, and undercarriage damage. Other damage included deformation to the door and pickup box and both right side tires. There was no intrusion nor deformation of the occupant compartment. The vehicle remained upright both during and after the collision. The vehicle damage was assessed by the traffic accident scale (TAD) (8) and the vehicle damage index (VDI) (9), as shown in Figure 29 and Table 12.

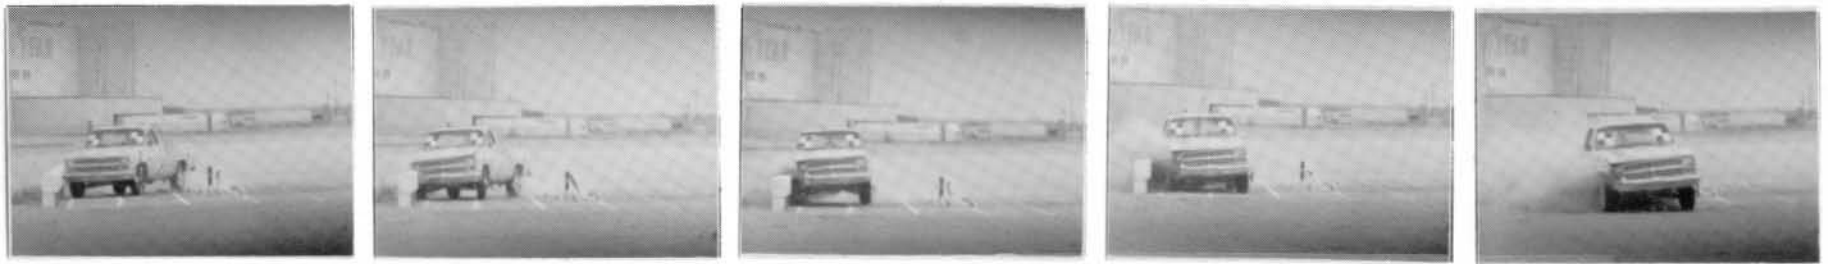
FIGURE 36. Summary and Sequential Photographs, NEOCR-2

The purpose of Test NEOCR-2 was to evaluate the structural adequacy of a rail in which the longitudinal steel reinforcement had been reduced. A summary of the test results and sequential photographs are shown in Figure 36. Additional sequential photographs are shown in Figure 37.

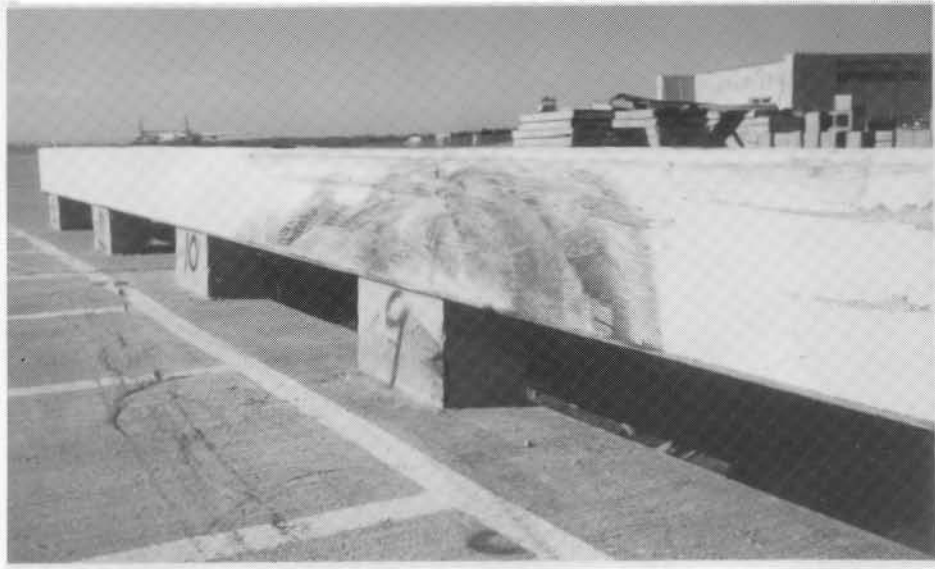
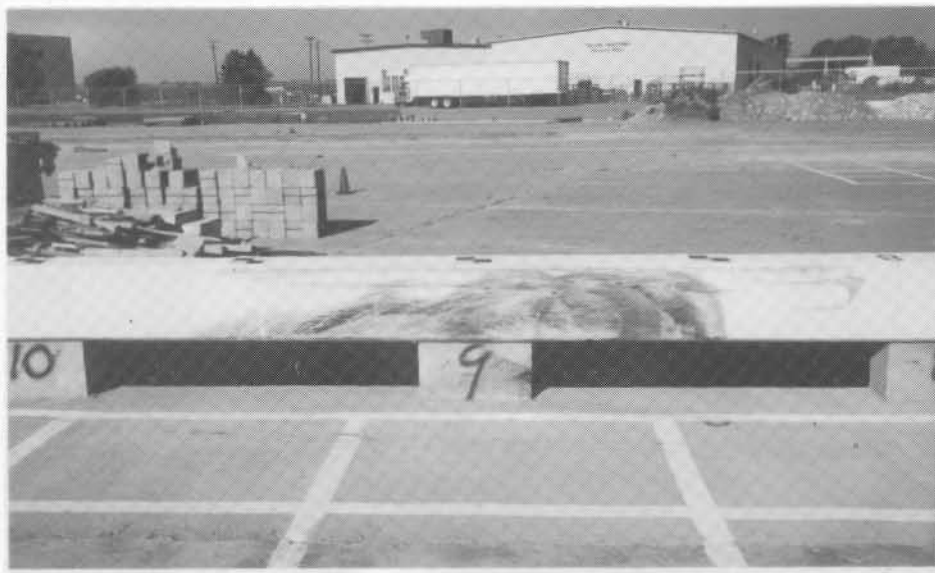
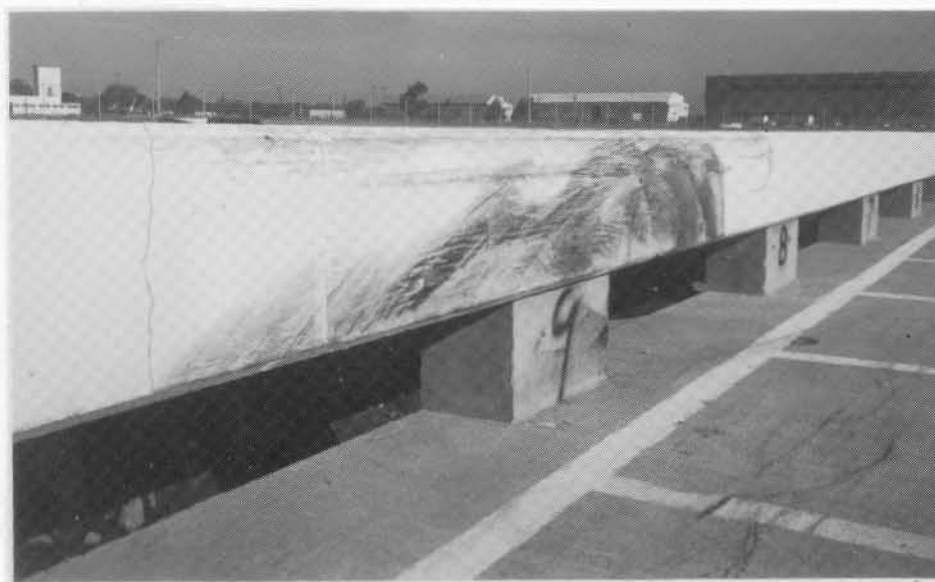
FIGURE 39. Bridge Rail Damage, NEOCR-2

Bridge rail damage is shown in Figure 39. The damage was only cosmetic, consisting of tire marks and minor scrapes. Tire marks on Post No. 9 indicated that it was struck by the right side front tire shortly after impact. There was no visible lateral deflection of the bridge rail.

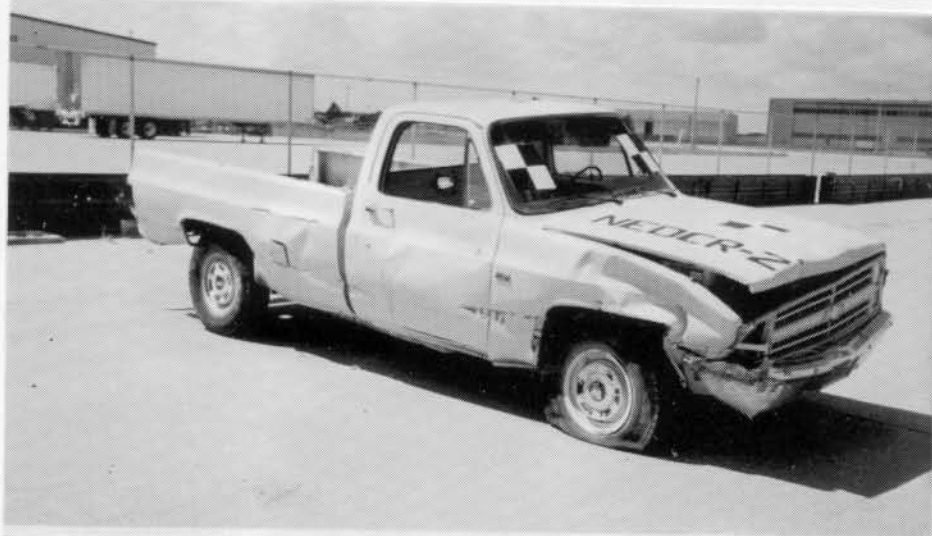
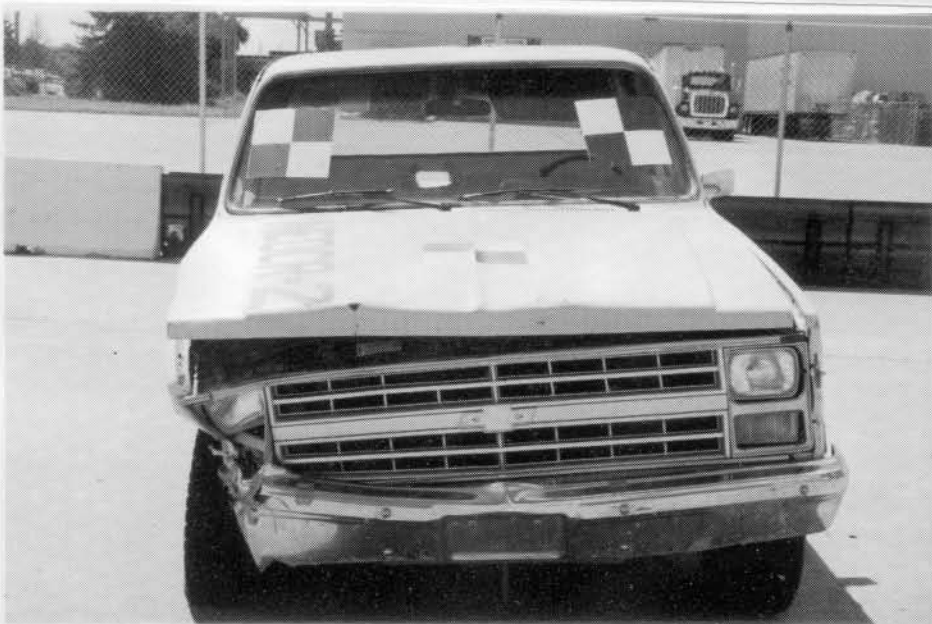
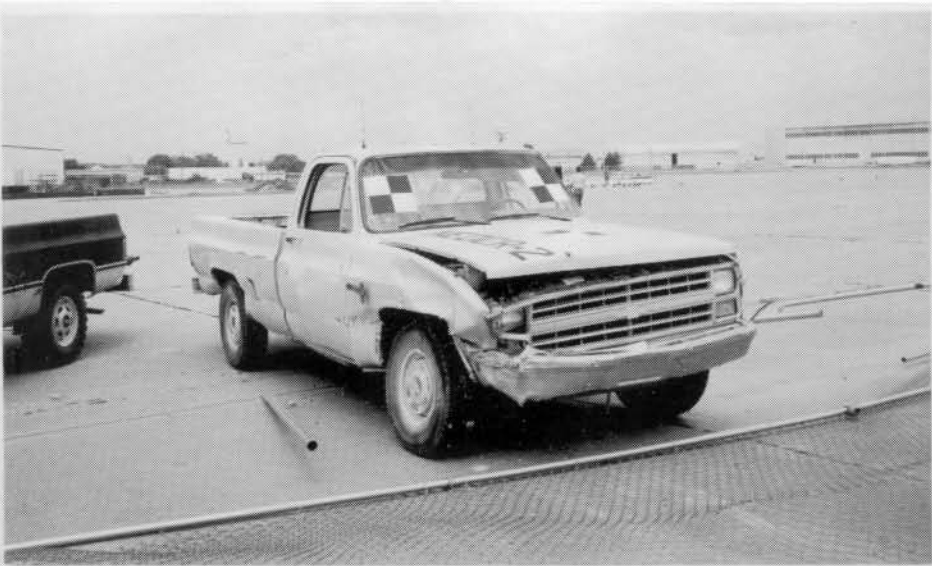
FIGURE 40. Vehicle Damage, NEOCR-2

Vehicle damage is shown in Figure 40. The right-front corner had a maximum crush depth of approximately 24 in. All of the vehicle damage occurred on the right-side. This included damage to the front fender, door, and the pickup box. No tire blowouts or any undercarriage damage occurred as a result of the impact. There was no intrusion nor deformation of the occupant compartment. The vehicle remained upright both during and after the impact. The vehicle damage was assessed by the traffic accident scale (TAD) (7) and the vehicle damage

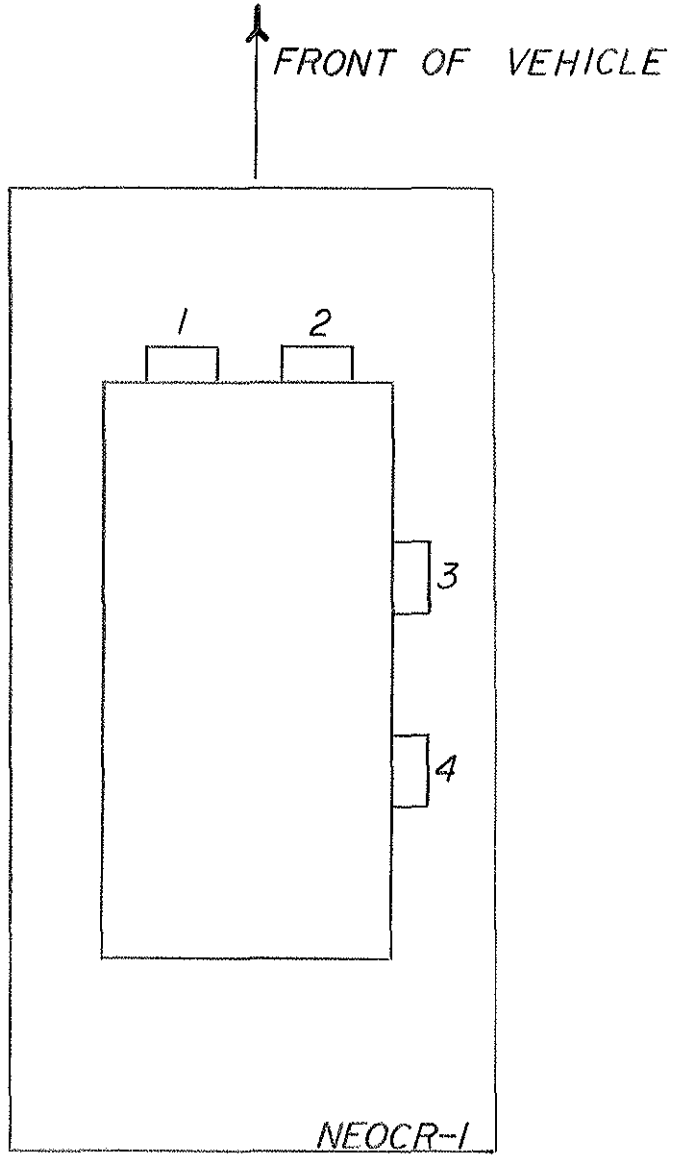
FIGURE D-1. SKETCH OF ACCELEROMETER LOCATIONS, TEST NEOCR-1
