**AASHTO PL-1 PERFORMANCE LEVEL CRASH TESTS  
ON THE NATCHEZ TRACE PARKWAY BRIDGE RAIL**

Midwest Roadside Safety Facility  
Civil Engineering Department  
University of Nebraska-Lincoln  
1901 "Y" St.  
P.O. Box 880601  
Lincoln, Nebraska 68588-0601  
(402) 472-6864

Transportation Research Report No. TRP-03-34-92

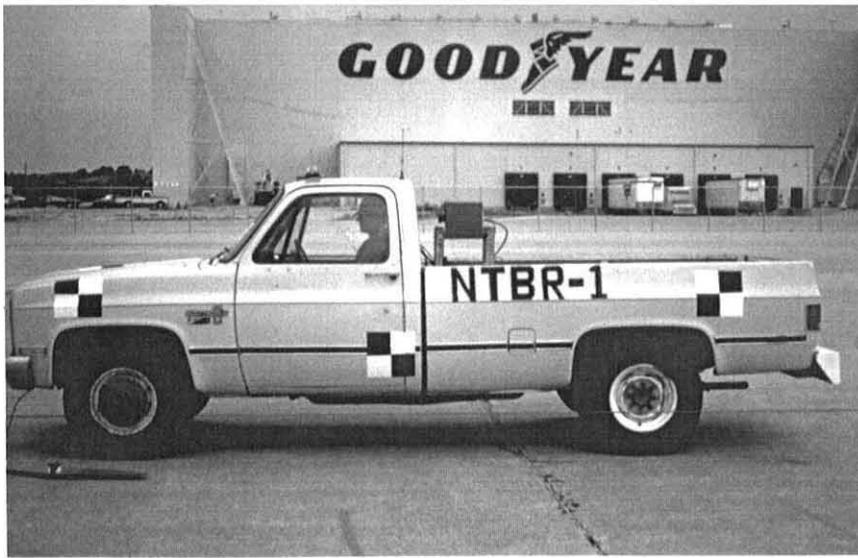
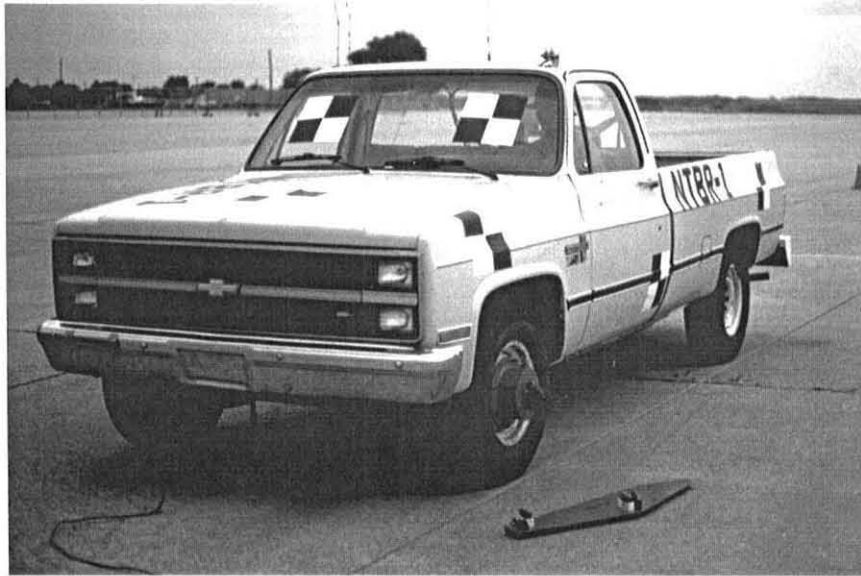
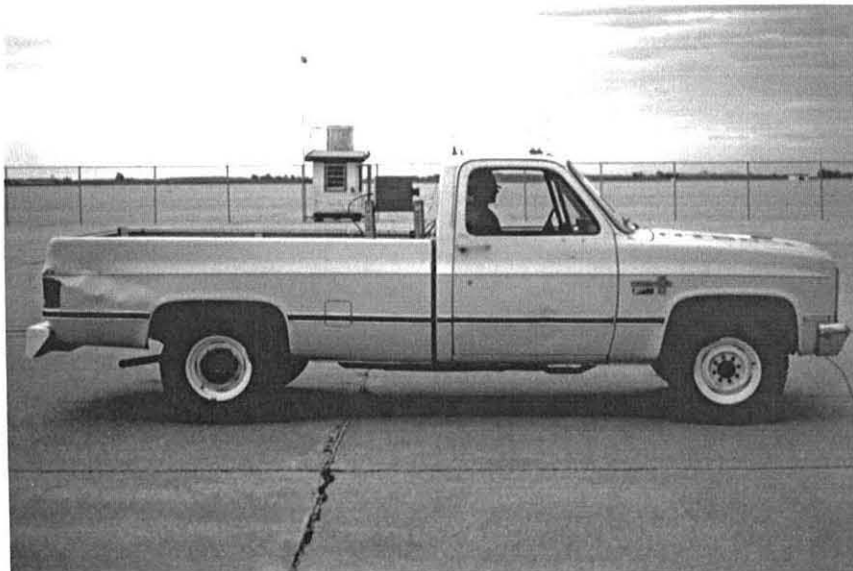
FIGURE 8. Test Vehicle, Test NTBR-1

A 1984 Chevrolet Custom Deluxe 20 pickup, shown in Figure 8, was used as a test vehicle in Test NTBR-1. As shown in Figure 9, the vehicle had a test inertial and a gross static weight of 5,400 lbs and 5,565 lbs, respectively.

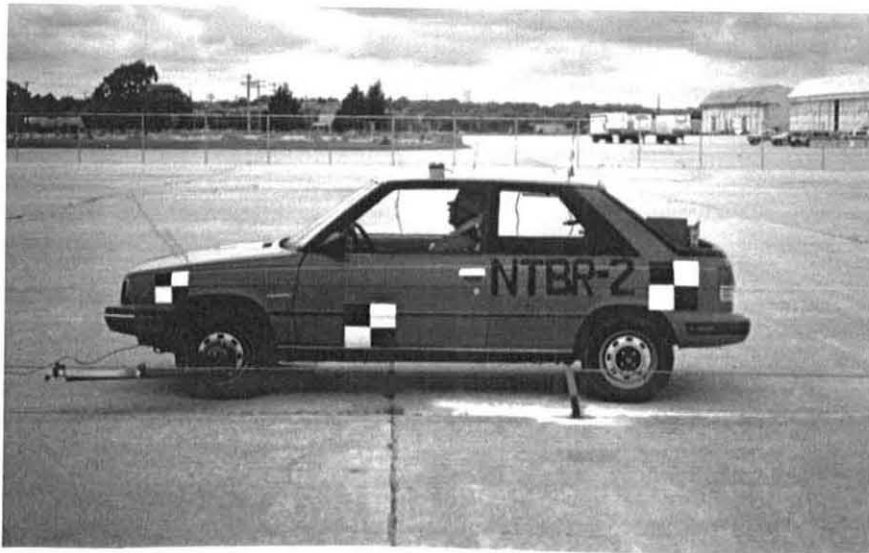
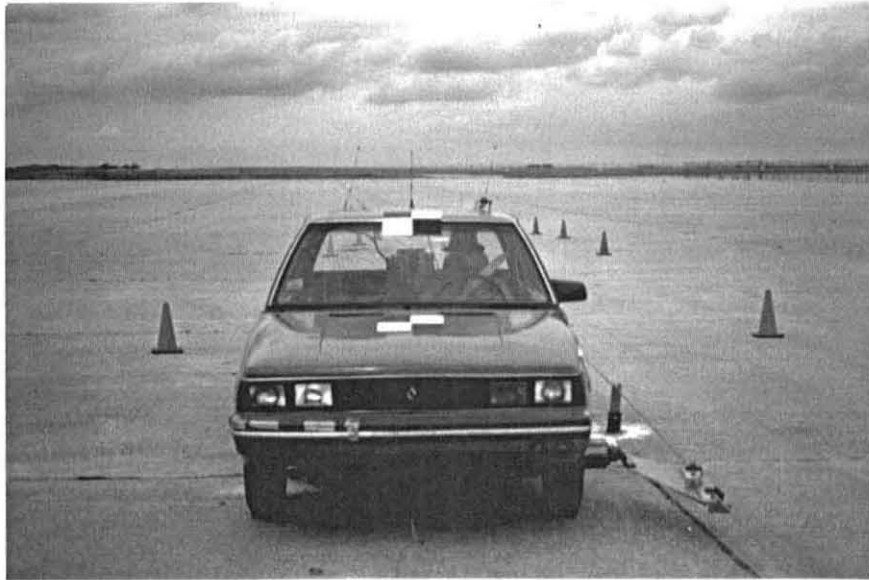
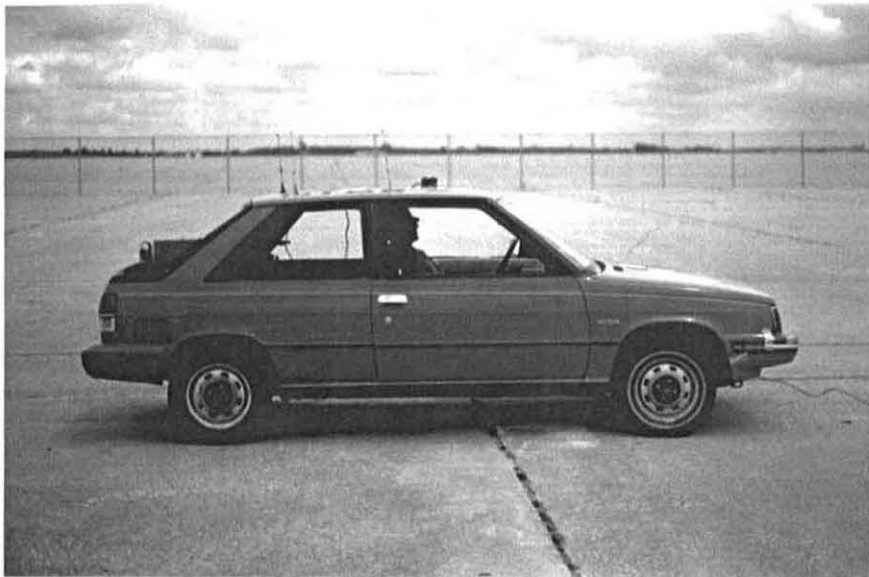
FIGURE 10. Test Vehicle, Test NTBR-2

A 1984 Renault Encore, shown in Figure 10, was used as a test vehicle in Test NTBR-2. This vehicle had test inertial and gross static weights of 1,850 lbs and 2,015 lbs, respectively. Vehicle weights and dimensions are shown in Figure 11.

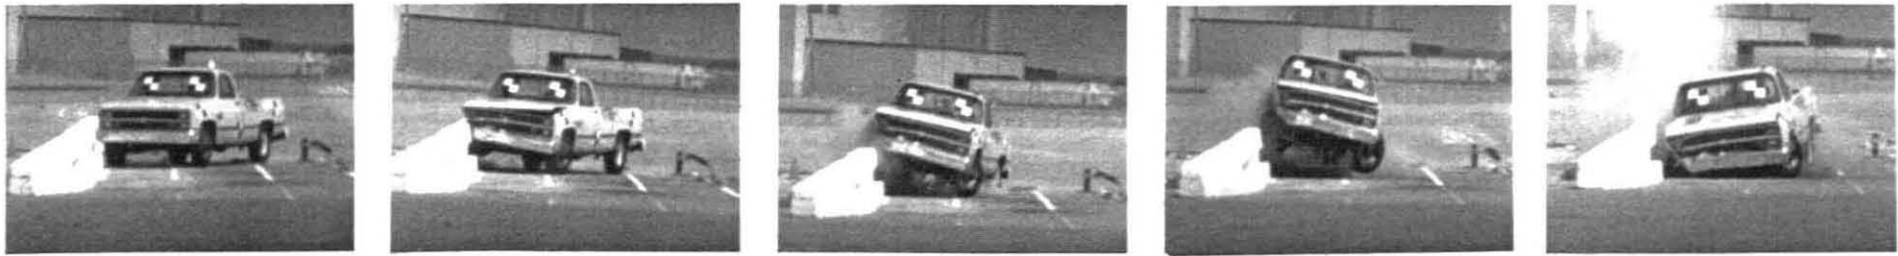
FIGURE 14. Test NTBR-1 Summary

Test Number	NTBR-1
Date	7/9/92
Bridge Rail Installation	Natchez Trace Parkway Curb and Bridge Rail
Total Length (ft)	93.6
Material	
Concrete	Class A AE (4000 psi)
Reinforcing Steel	Grade 60 Epoxy Coated
Concrete Curb	
Length (ft)	93.6
Bottom Width (in.)	18
Top Width (in.)	16.5
Height (in.)	10
Concrete Rail	
Length (ft)	78.7
Bottom Width (in.)	12
Top Width (in.)	10
Bottom Height (in.)	19.5
Top Height (in.)	32.5
Concrete Posts	
Length (in.)	13
Width (in.)	18
Depth (in.)	9
Vehicle Model	1984 Chevrolet Custom Deluxe 20

Vehicle Weight	
Curb (lb)	4,610
Test Inertial (lb)	5,400
Gross Static (lb)	5,565
Vehicle Speed	
Impact (mph)	45.2
Exit (mph)	37.0
Vehicle Angle	
Impact (deg)	22.4
Exit (deg)	1.6
Vehicle Snagging	None
Vehicle Stability	Satisfactory
Effective Coefficient of Friction ( $\mu$ )	0.28 (Fair)
Occupant Impact Velocity	
Longitudinal (fps)	10.8 (30)
Lateral (fps)	22.2 (25)
Occupant Ridedown Deceleration	
Longitudinal (g's)	6.3 (15)
Lateral (g's)	9.5 (15)
Vehicle Damage	Minor
TAD	1-RFQ-3
VDI	01RFEW2
Bridge Rail Damage	Tire marks and minor concrete spalling
Maximum Vehicle Rebound Distance (ft)	0.83

As a result of technical problems incurred during this test, the accelerometer data was not available. As a result, the high speed film was analyzed to obtain longitudinal and lateral occupant impact velocities of 10.8 fps and 22.2 fps, respectively. The highest occupant ridedown decelerations in the longitudinal and lateral directions were 6.3 g's and 9.5 g's, respectively.

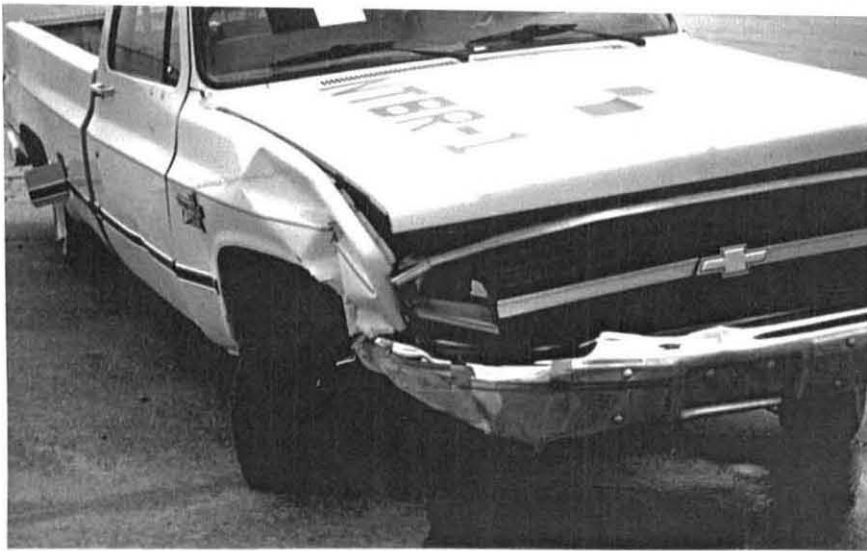
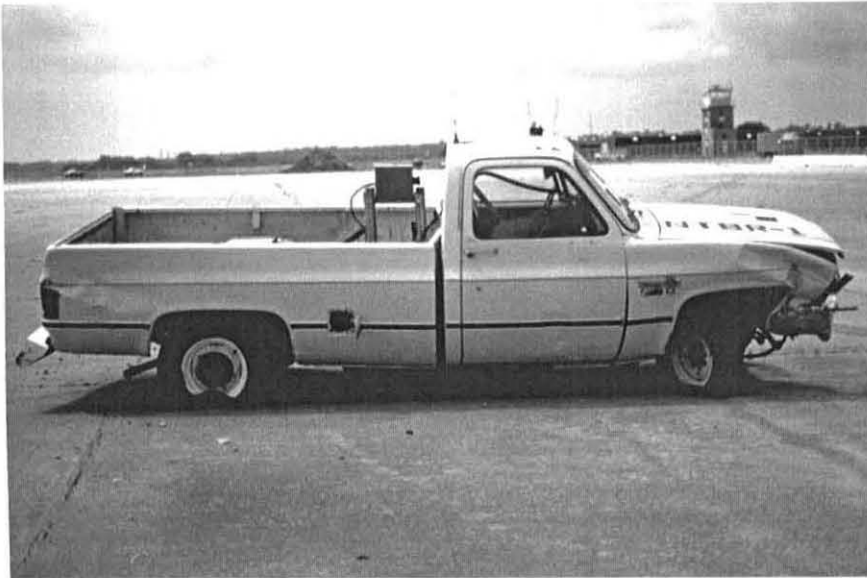
FIGURE 20. Vehicle Damage, Test NTBR-1

Test vehicle damage was relatively minor and was largely limited to the right-front quarter panel and front bumper, as shown in Figure 20. Both right-side tires were blown out and the rims were damaged during the impact. The right-rear bumper also received minor damage. There was no intrusion or deformation of the occupant compartment. TAD (6) and VDI (7) damage classifications are shown in Figure 14. Vehicle crush measurements are shown in Figure 21. The bridge rail received superficial damage, as shown in Figure 22. Heavy tire marks and deep scrapes on the rail indicating large contact forces were found over a 13-ft 11-in. length of the bridge rail. Lighter tire marks and small scrapes were observed over a 13 ft. length of the rail. Evidence of impact with the curb was limited to 4-ft 8-in. of tire marks.

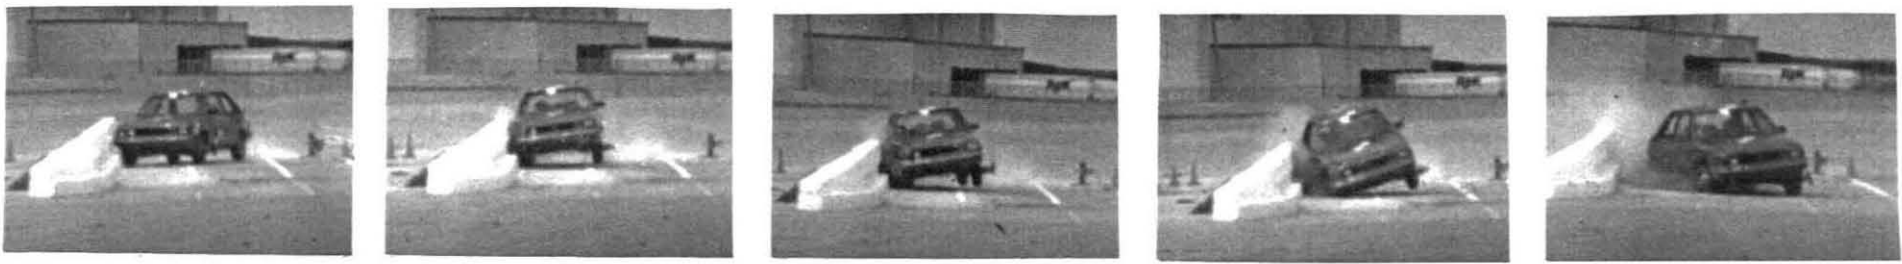
FIGURE 24. Test NTBR-2 Summary

Test Number	NTBR-2
Date	7/21/92
Bridge Rail Installation	Natchez Trace Parkway Curb and Bridge Rail
Total Length (ft)	93.6
Material	
Concrete	Class A AE (4000 psi)
Reinforcing Steel	Grade 60 Epoxy Coated
Concrete Curb	
Length (ft)	93.6
Bottom Width (in.)	18
Top Width (in.)	16.5
Height (in.)	10
Concrete Rail	
Length (ft)	78.7
Bottom Width (in.)	12
Top Width (in.)	10
Bottom Height (in.)	19.5
Top Height (in.)	32.5
Concrete Posts	
Length (in.)	13
Width (in.)	18
Depth (in.)	9
Vehicle Model	1984 Renault Encore

Vehicle Weight	
Curb (lb)	2,070
Test Inertial (lb)	1,850
Gross Static (lb)	2,015
Vehicle Speed	
Impact (mph)	51.5
Exit (mph)	47.7
Vehicle Angle	
Impact (deg)	19.5
Exit (deg)	8.5
Vehicle Snagging	None
Vehicle Stability	Satisfactory
Effective Coefficient of Friction ( $\mu$ )	0.60 (Marginal)
Occupant Impact Velocity	
Longitudinal (fps)	19.35 (30)
Lateral (fps)	26.23 (25)
Occupant Ridedown Deceleration	
Longitudinal (g's)	3.69 (15)
Lateral (g's)	7.79 (15)
Vehicle Damage	Minor
TAD	1-RFQ-3
VDI	01RFEW3
Bridge Rail Damage	Tire marks and minor concrete spalling
Maximum Vehicle Rebound Distance (ft)	25.3

The normalized longitudinal and lateral occupant impact velocities as determined from accelerometer data were 19.35 fps and 26.23 fps, respectively. The highest 10-ms average occupant ridedown decelerations were 3.69 g's (longitudinal) and 7.79 g's (lateral). The results of the occupant risk are summarized in Figure 24. The accelerometer traces are shown in Appendix A.

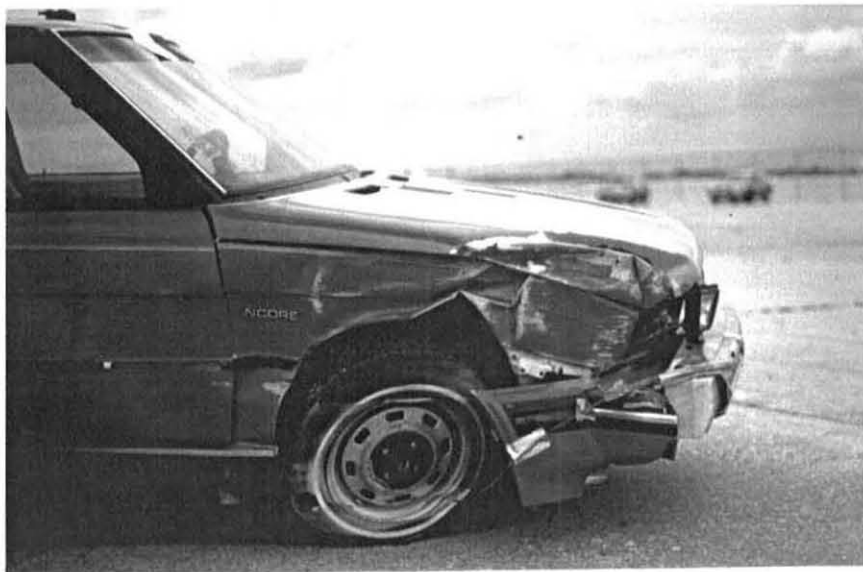
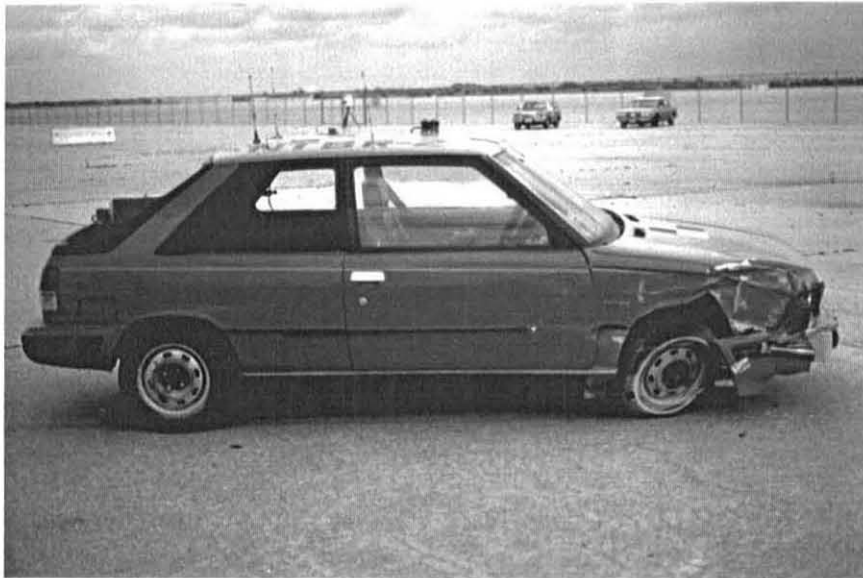
**FIGURE 30.** Vehicle Damage, Test NTBR-2

Test vehicle damage was relatively minor and was largely limited to the right-front quarter panel and wheel, and front bumper, as shown in Figure 30. There was slight buckling of the right-front floorboard and roof due to the force of the impact. The vehicle remained upright both during and after the test, and there was no intrusion of the occupant compartment.

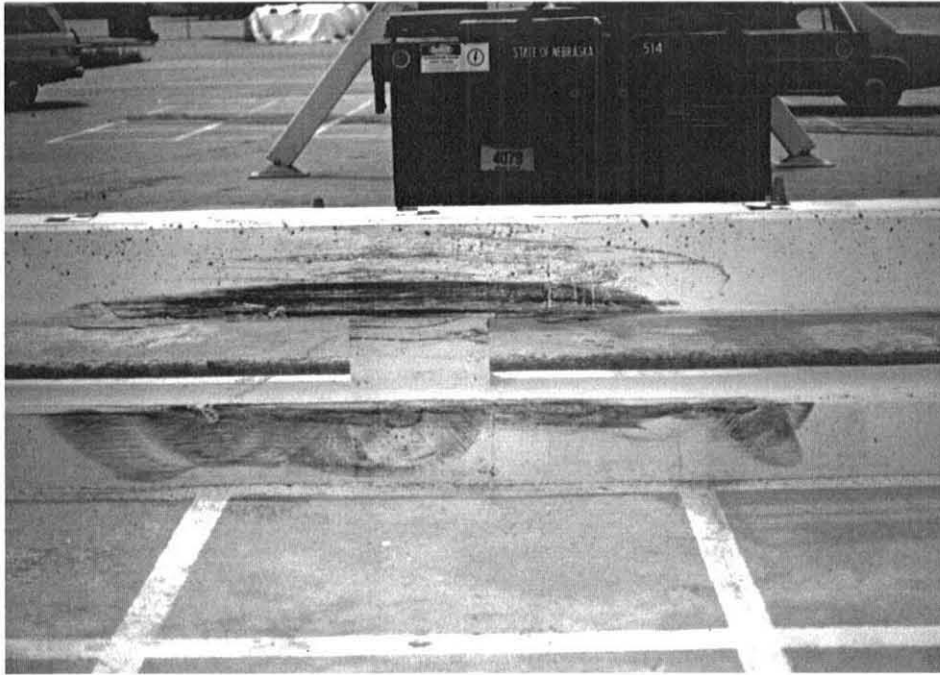
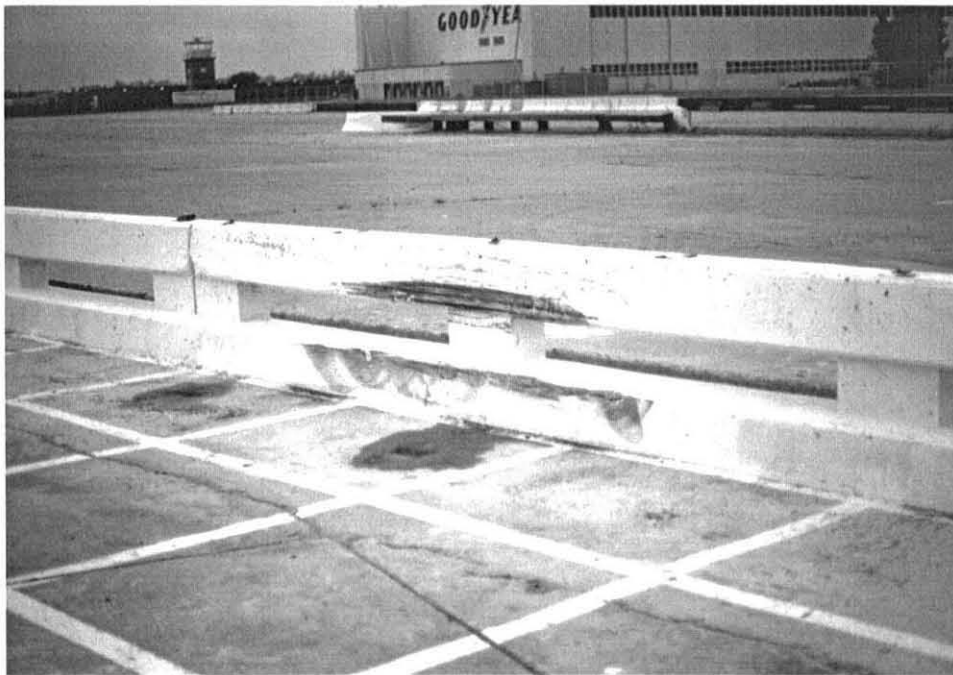
**FIGURE 32.** Bridge Rail Damage, Test NTBR-2

Bridge rail damage is shown in Figure 32. Tire marks and minor concrete spalling accounted for the majority of the damage. The length of the markings on the rail were approximately 7.5 ft, caused by the scraping of the bumper and the fender. The length of the markings on the curb were 8.5 ft, caused by the rubbing of the right-front tire which blew out at impact.
