DYNAMIC IMPACT TESTING OF GUARDRAIL POSTS EMBEDDED IN SOIL

MIDWEST ROADSIDE SAFETY FACILITY

MwRSF Research Report No. TRP-03-77-98

July 21, 1999

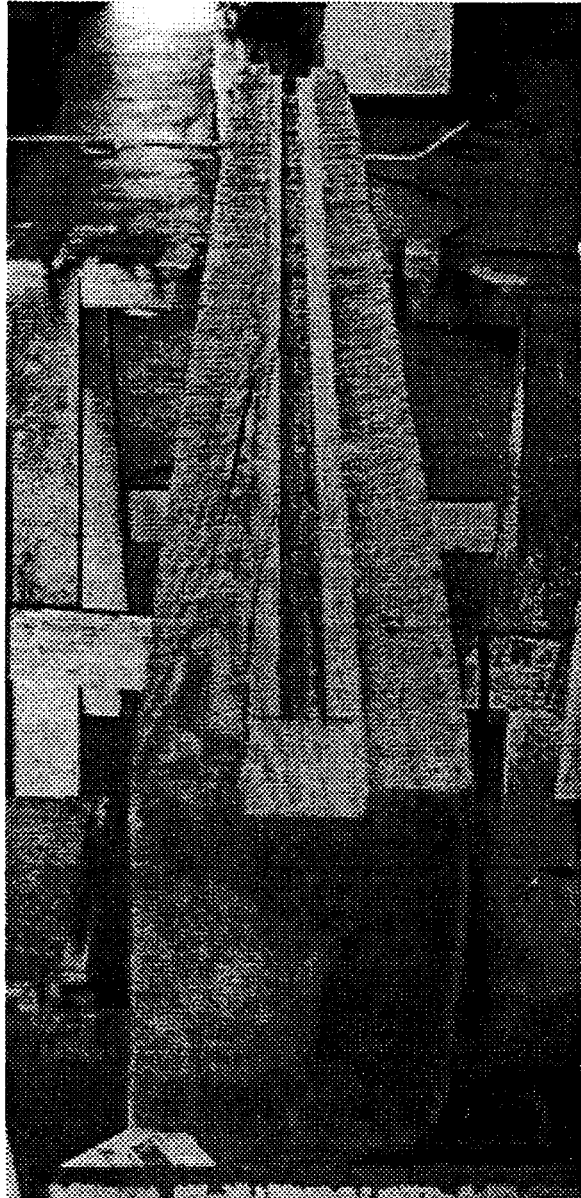
Figure 12. Slotted Wooden Instrumented Post.

Since the notches where the strain gauge wires exit the posts were not along the neutral axis, the moment of inertia, I , would be lessened due to the removal of the wood. Additionally, the insertion of the steel shim stock would increase the moment of inertia. Since a change the rigidity of the posts, EI , due to the instrumentation was not desired, the rigidity change (ΔEI)

caused by the insertion of the steel shim stock was calculated to balance the rigidity change caused by the wood removed for the strain gauge wires. A post during the assembly process is shown in Figure 12.

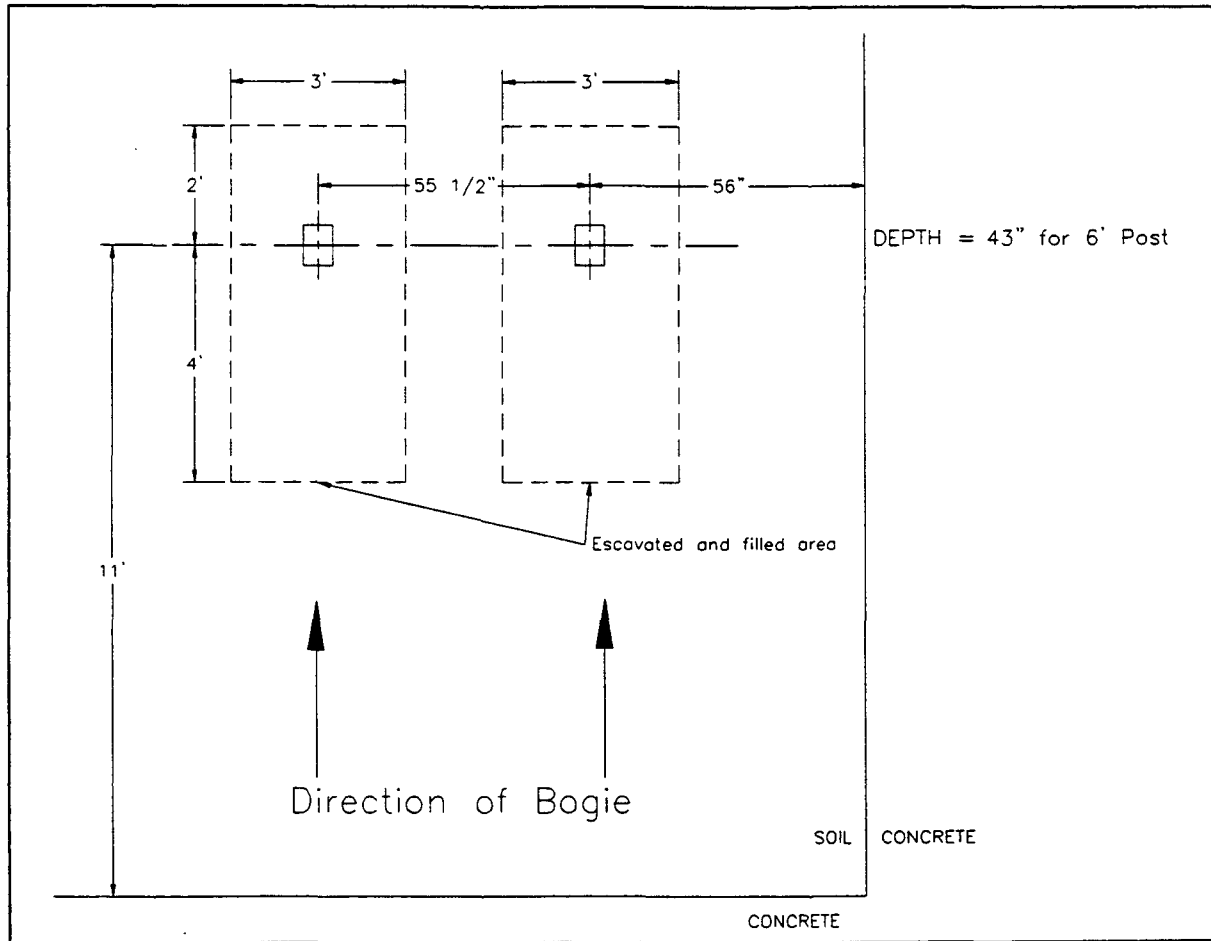
Figure 14. Plan View of Excavated Area

A plan view of the test setup and post test pit is shown in Figure 14. The test pits were located at a sufficient distance from the edge of the concrete apron so as not to interfere with the soil response during impact.

Embedment of the posts consisted of excavating a 91.44-cm by 182.88-cm (3-ft by 6-ft) area to a depth of approximately 1.5 meters (5 ft). AASHTO M 147-65 specification soil was then compacted with a pneumatic hand tamper in 15-cm (6-in.) lifts. Soil density measurements were taken using the sand replacement method (standard sand cone).

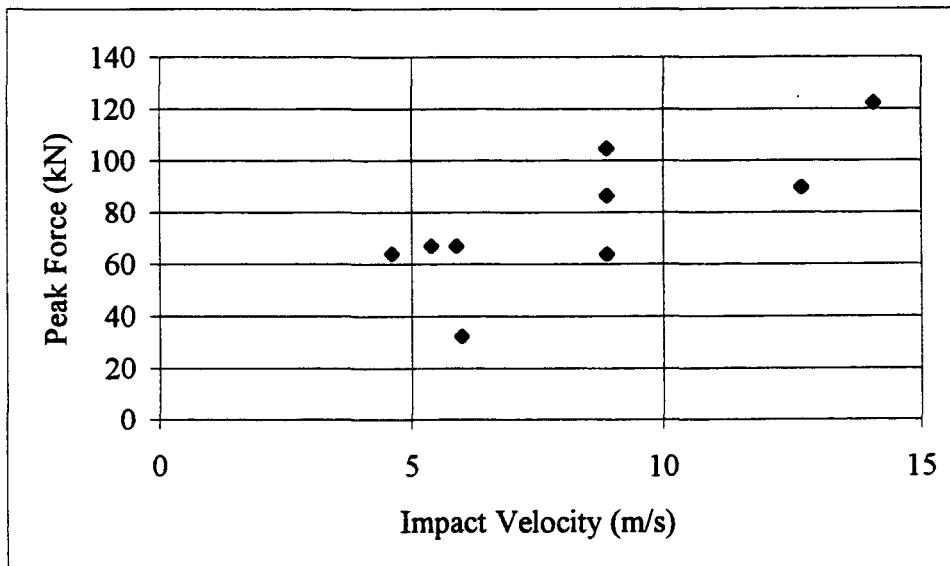
Figure 16. Velocity-Force Relationship for Steel Post Tests.

The relationship between impact velocity and peak force is shown in Figure 16 and the relationship between impact velocity and energy absorbed is shown in Figure 17. In both cases, the correlation coefficient for a linear relationship is significantly less than 1 (0.588 and 0.569, respectively).

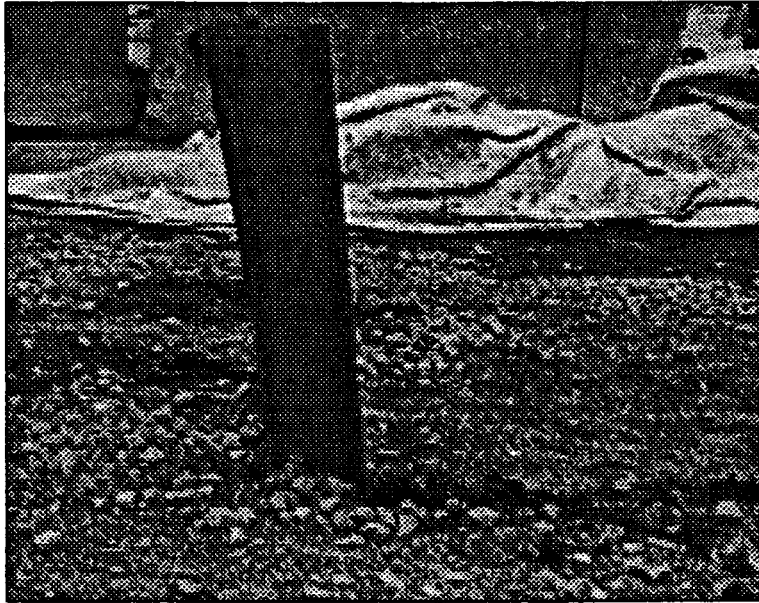
Figure 18. Typical Low-speed Bogie Impact (Test Nos. 1 and 2)

Tests using the W150x13.5 (W6x9) posts were all very similar in nature. In each of the cases, moderate rotation of the posts occurred. After impacting the posts, the bogie vehicle reversed its direction of travel and moved away from the posts. Typical post damage after impact is shown in Figure 18.

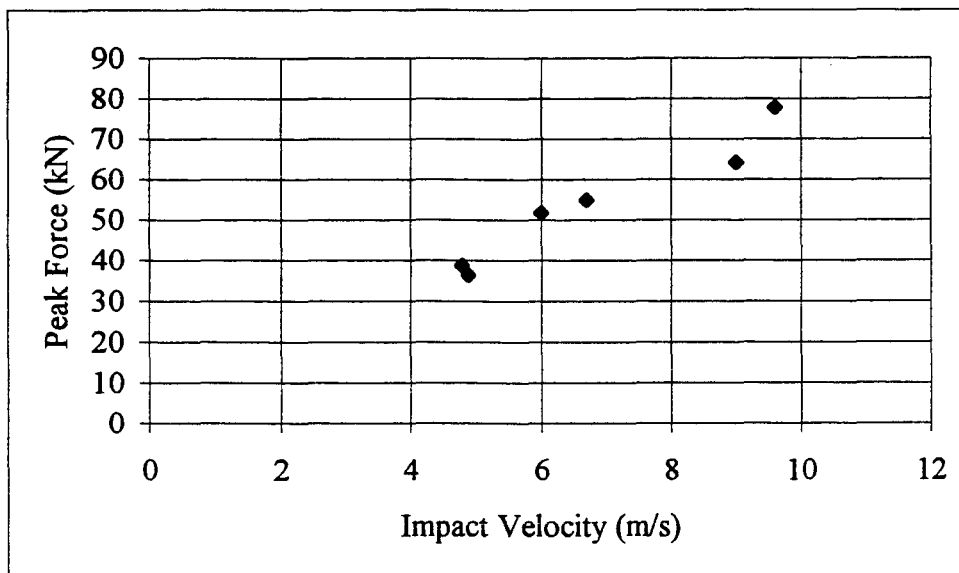
Figure 20. Velocity-Force Relationship for Wooden Post Tests.

The relationship between impact velocity and peak force is shown in Figure 20 and the relationship between impact velocity and energy absorbed is shown in Figure 21. There is a strong linear relationship between the peak force and the impact velocity ($R^2=0.938$), however, there is no linear relationship between energy and velocity ($R^2=0.179$).

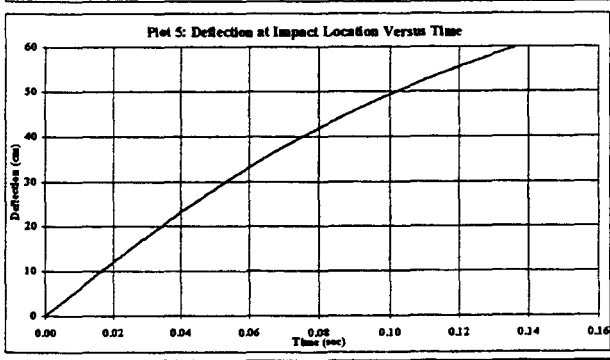
Figure 23. Results of Wisc-2.

Bogie Test Summary	
Test Information	
Test Number:	Wisc-2
Test Date:	21-May-98
Failure Type:	Rotation in soil
Post Properties	
Post Type:	Steel
Post Size:	W150x13.5 mm (W6x9)
Post Length:	182.9 cm (6.0 ft)
Embedment Depth:	109.2 cm (43.0 in)
Soil Properties	
Moisture Content:	Wet (w=26%)
Gradation:	AASHTO M 147-65 (1990), Grading B
Soil Density, γ_s :	2018 kg/m ³ (126 pcf)
Compaction Method:	Pneumatic Tamper
Bogie Properties	
Impact Velocity:	6.0 m/s (13.4 mph) (19.7 fpe)
Impact Location:	54.9 cm (21.6 in.) above groundline
Bogie Mass:	946 kg (2086 lbf)
Data Acquired	
Accelerometer Data	
Rear and Side View, S-VHS

In test Wisc-02, soil moisture was considerably high, approaching 26% at the surface. This increased moisture content caused the post deflection to be much higher than normal and the peak force and energy absorbed to be much lower. An initial peak force is not observed in this test as a result of the high moisture content.
