**TESTING OF W152X23.8 (W6X16) STEEL POSTS -
SOIL EMBEDMENT DEPTH STUDY
FOR THE MIDWEST GUARDRAIL SYSTEM
(Non-Proprietary Guardrail System)**

MIDWEST ROADSIDE SAFETY FACILITY
University of Nebraska-Lincoln
527 Nebraska Hall
Lincoln, Nebraska 68588-0529
(402) 472-0965

MwRSF Research Report No. TRP-03-136-03

June 12, 2003

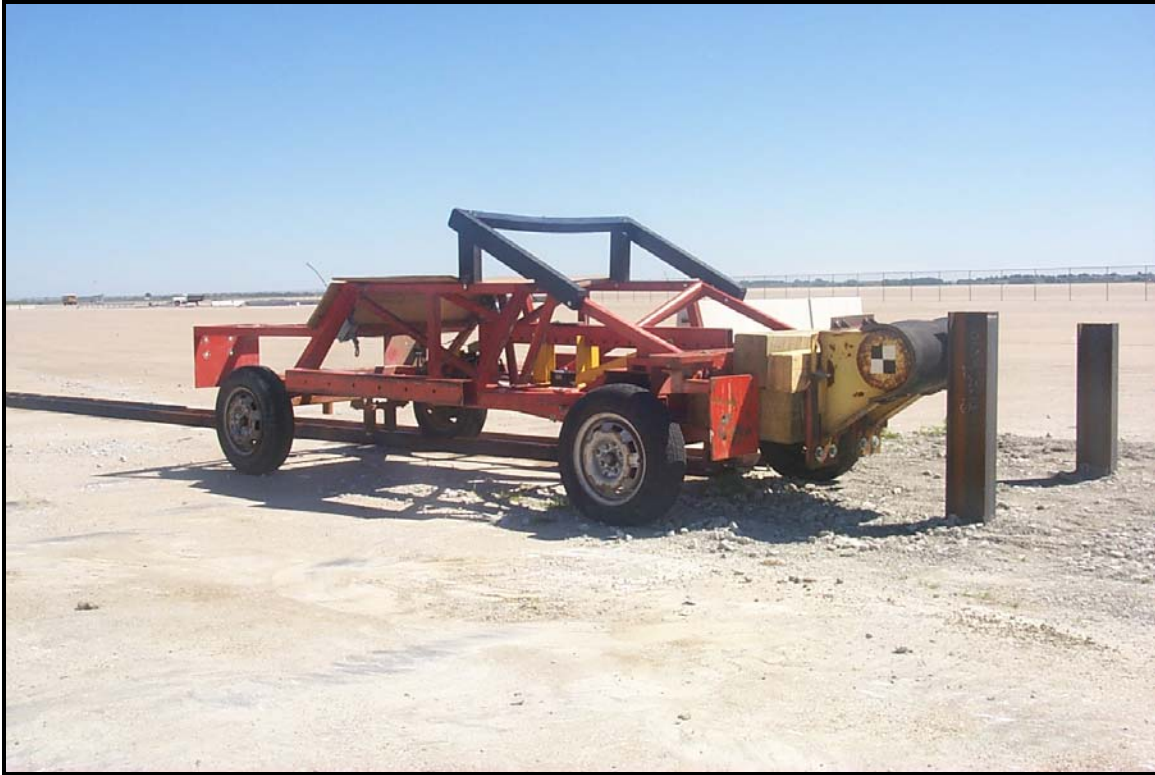
A rigid frame bogie, constructed from FHWA specifications (5), was used to impact the posts. An impact head, made of a 203 mm (8 in.) concrete filled standard steel pipe, was mounted to the bogie at the height of 630 mm (24.8 in.) above the ground. Neoprene belting, 19 mm (3/4 in.) thick, was attached to the steel pipe to minimize the local damage to the post from the impact. The bogie is shown in Figure 2.

Figure 2. Bogie and Test Setup

The bogie weight was 1014 kg (2237 lbs). Calculations and computer simulations prior to testing indicate that this weight, in combination with a velocity of approximately 32 kilometers per hour (20 mph or 8.9 m/s), would closely replicate the actual impact conditions that a post as a part of the guardrail system would be subjected to in a 96 kilometers per hour (60 mph), 25 deg impact with a 2040 kg (4500 lbs) car.

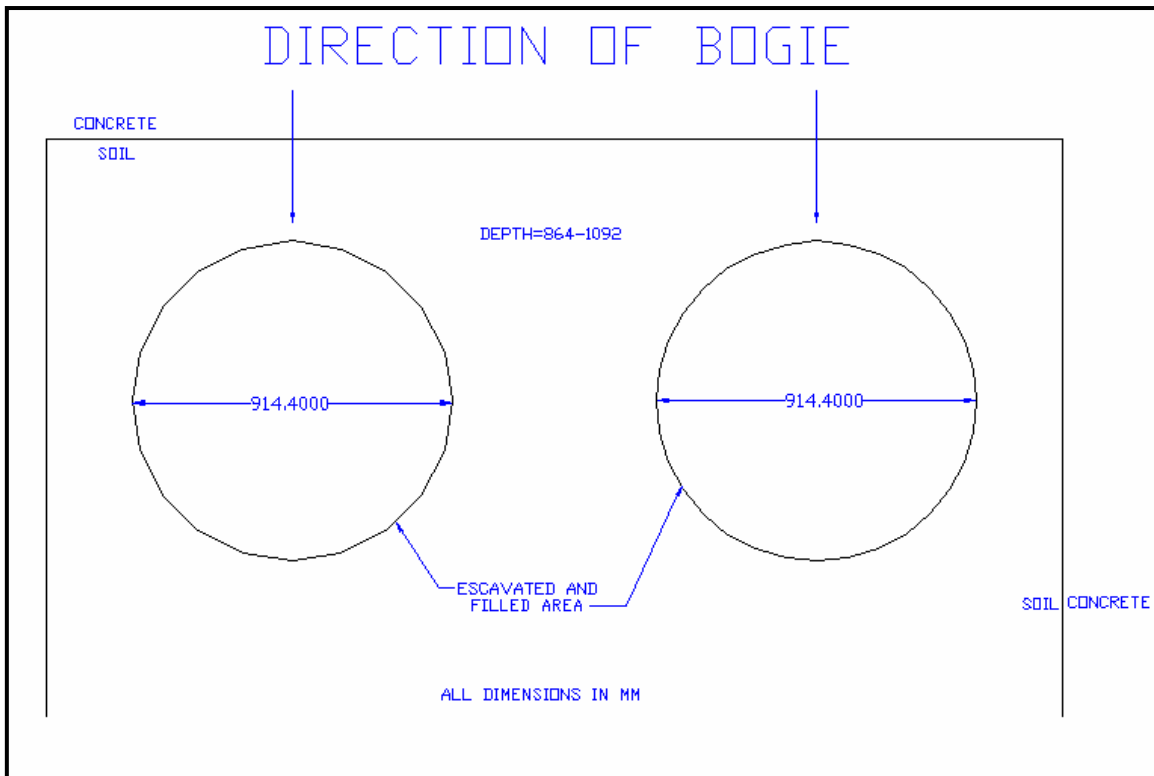
A plan view of the test setup and the post-testing pit is shown in Figure 4. The pits were located at a sufficient distance from the edge of the concrete apron so as not to interfere with the soil response during the impact.

Figure 4. Plan View of the Post Testing Area

For the tests, holes measuring 0.914 m (36 in.) in diameter and 0.864 to 1.092 m (34 to 43 in.) in depth were dug out in the test area. These holes were filled with soil meeting the AASHTO standard specification for “Materials and Aggregates and Soil Aggregates Sub-base, Base and Surface Courses,” designation M147-65 (1990), grading A or B and compacted in accordance with AASHTO guide specifications for highway construction, section 304.05 and 304.07. The moisture content was relatively dry (4% - 6%) with the primary considerations being the homogeneity, consistency and the ease of compaction.

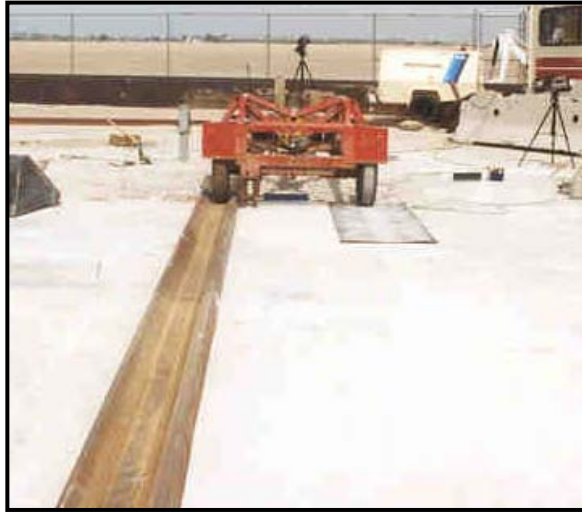
velocity, at which point the pickup truck released, allowing the bogie to become a free projectile as it came off the guide track. The bogie positioned in the guide track can be seen in Figure 5.

Figure 5. Bogie Positioned in the Guide Track Configuration

The bogie wheels rode in the steel corrugated beam, ensuring the proper direction and position of the bogie prior to the impact. In all of the tests conducted the bogie wheels were aligned for caster and toe-in values of zero so that the bogie would track properly along the guidance system. A remote braking system was installed on the bogie to allow the bogie to be brought safely to a stop after the test. Accelerometers, located at the bogie's center of gravity record lateral, horizontal and vertical acceleration data.

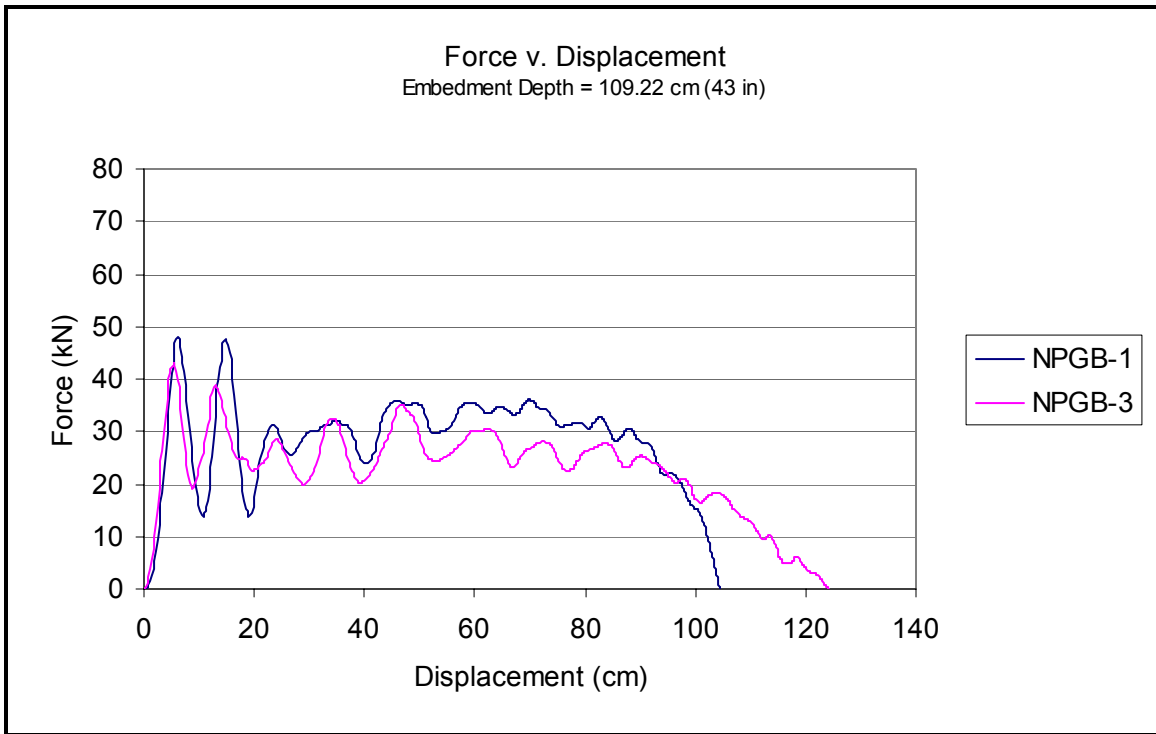
Figure 7. Force-Displacement Curves for Tests NPGB-1 and 3

Tests NPGB-1 and NPGB-3 resulted with the posts rotating in the soil, with only slight yielding (see Figure 11). The profile of the force-deflection curve for these tests indicates that the forces acting on the posts were fairly uniform over the duration of the impact. The post-impact investigation showed that the post had not undergone considerable plastic deformation under the action of the impact forces. As a result, the reaction forces of the post can be attributed to the constant shear failure of the soil. Both test plots show comparable forces during impact and validate the data taken (see Figure 7). Photographs and film analysis of the system clearly indicate that the soil offered resistance to the failure and pivoted the post in the soil.

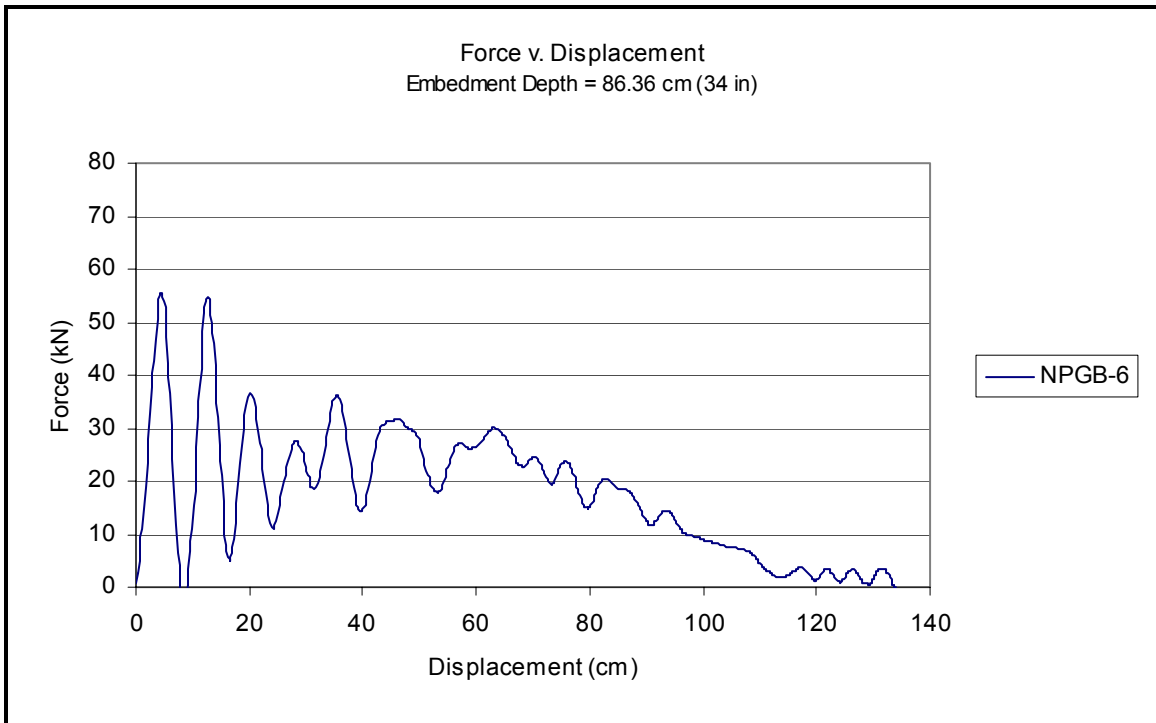
Figure 10. Force-Displacement Curve for Test NPGB-6

This test was not much different in nature as compared to the tests with a post embedment depth of 93.98 cm (37 in.). The forces experienced by the post are of similar nature and magnitude (see Figure 10). Again the force fades in a linear fashion as the post is being pulled out of the ground, as shown in Figure 14. The result was as expected because the embedment depth was so shallow.

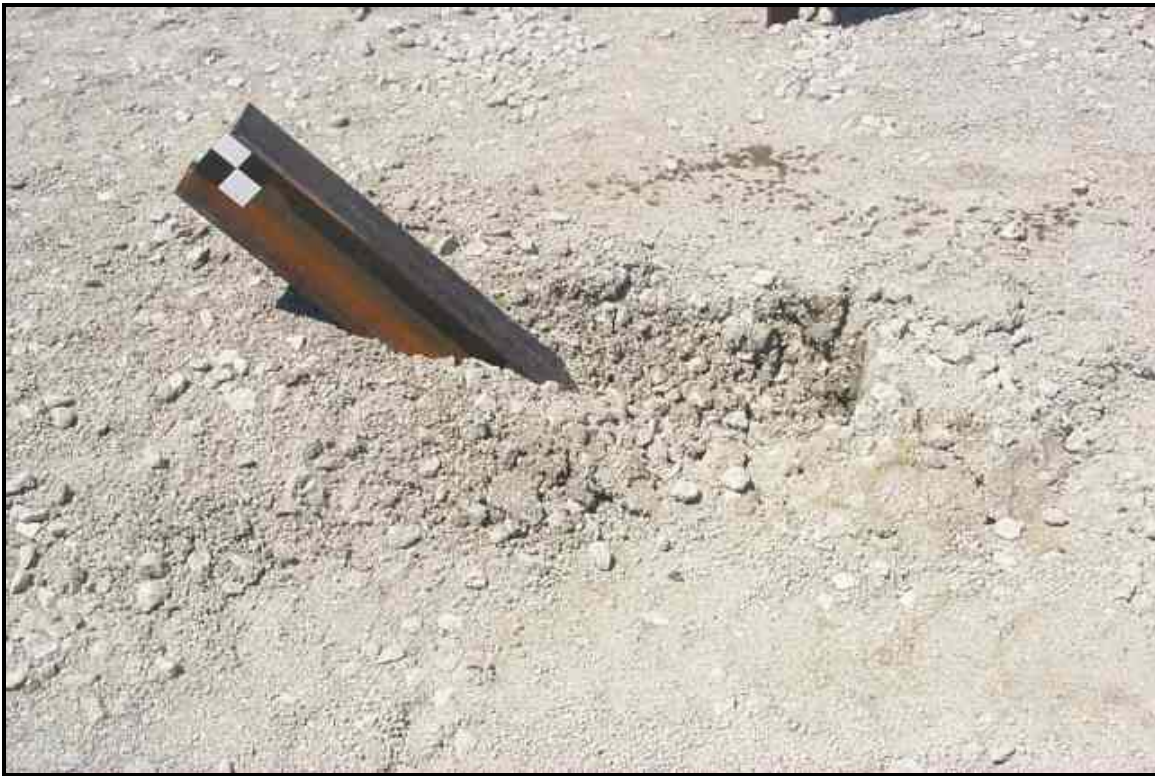
Figure 11. Post-Impact of NPGB-1, Embedment Depth of 109.2 cm (43 in.)

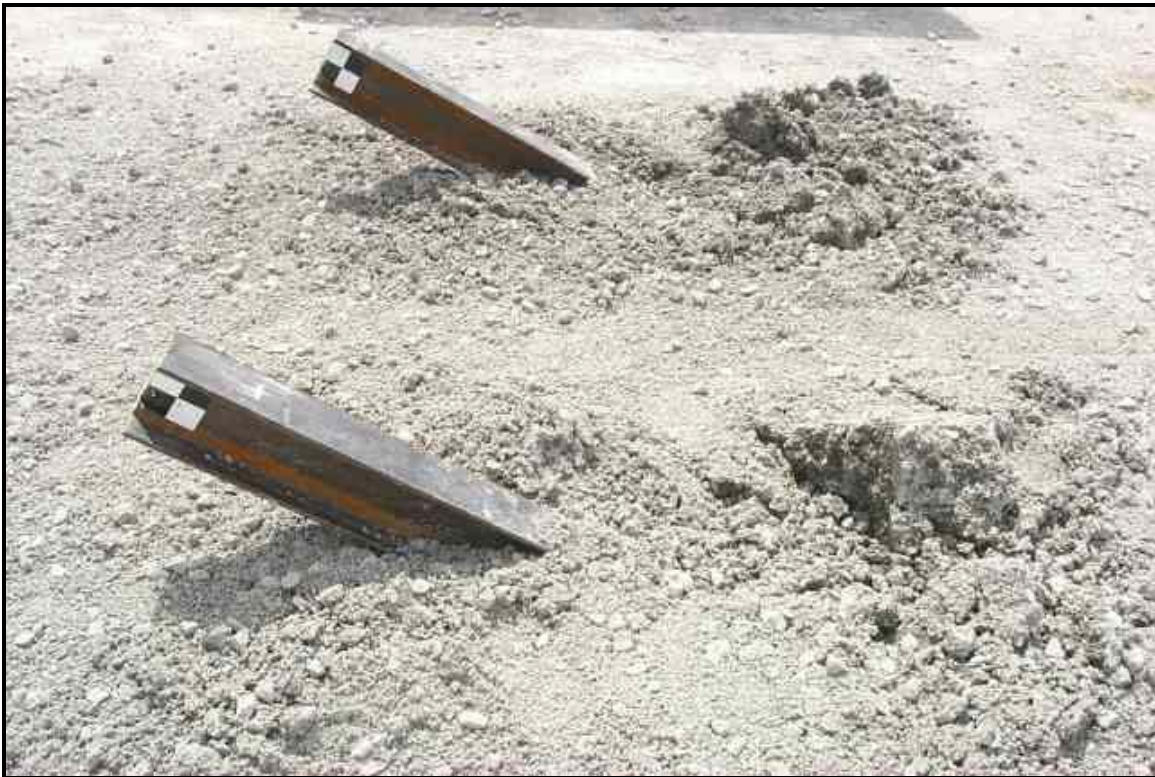
The behavior of tests NPGB-2, NPGB-4, NPGB-9, and NPGB-10 are very similar to tests NPGB-1 and NPGB-3, which during impact the posts rotated in the soil and in two instances, NPGB-9 and NPGB-10, resulted in slight yielding of the post as before (see Figure 12). The profile of the force-deflection curves for the tests NPGB-2, NPGB-4, NPGB-9, and NPGB-10 show the forces were fairly uniform and are of similar magnitude as compared to the previous tests (see Figure 8). All four tests also show comparable forces during impact and validate the data taken. Photographs and film analysis of the system clearly indicate that the soil offered resistance to the failure and pivoted the post in the soil.

Figure 12. Post-Impact of NPGB9 and 10, Embedment Depth of 101.6 cm (40 in.)

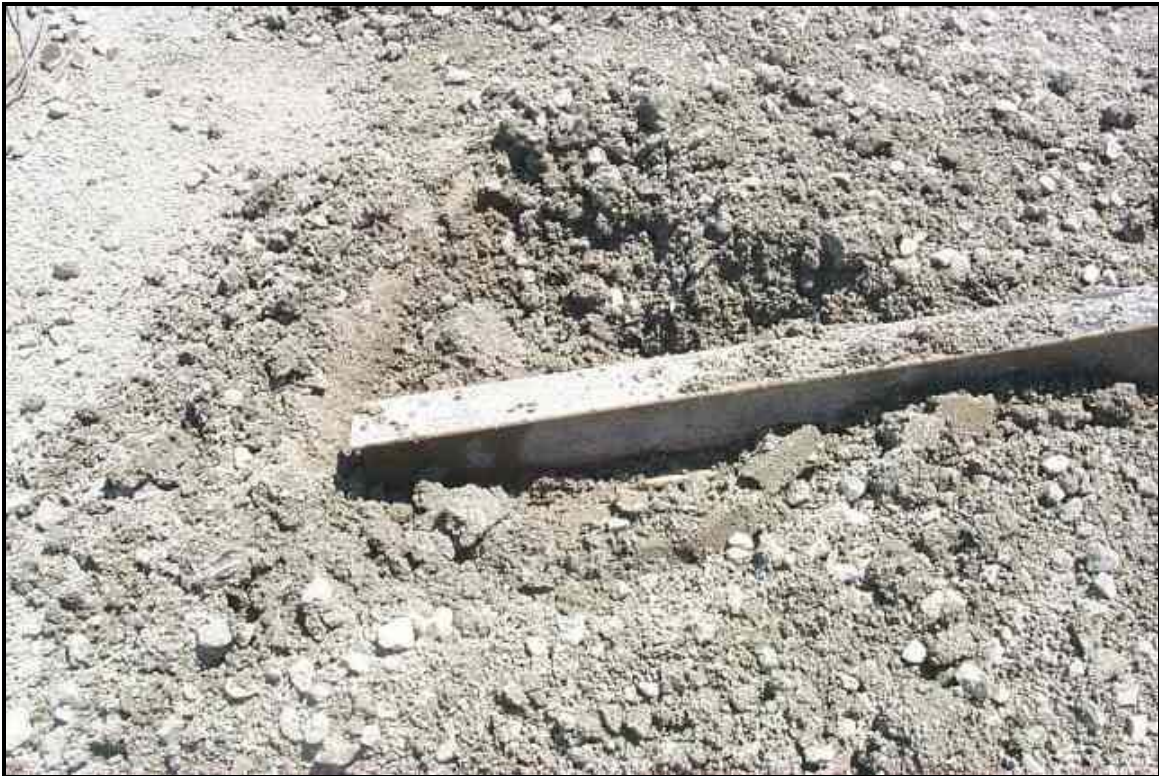
The force-deflection for the tests NPGB-5, NPGB-7, and NPGB-8 is shown in Figure 9. The force during each impact, as seen from the curves, is similar to the previous tests over the initial impact period being fairly level, but a difference is apparent after 60 cm (23.6 in.) of deflection. The force begins to fade in a linear fashion. This phenomenon can be attributed to the post being pulled out of the ground after rotating in the soil for some distance.

Figure 13. Post-Impact of NPGB-8, Embedment Depth of 93.98 cm (37 in.)

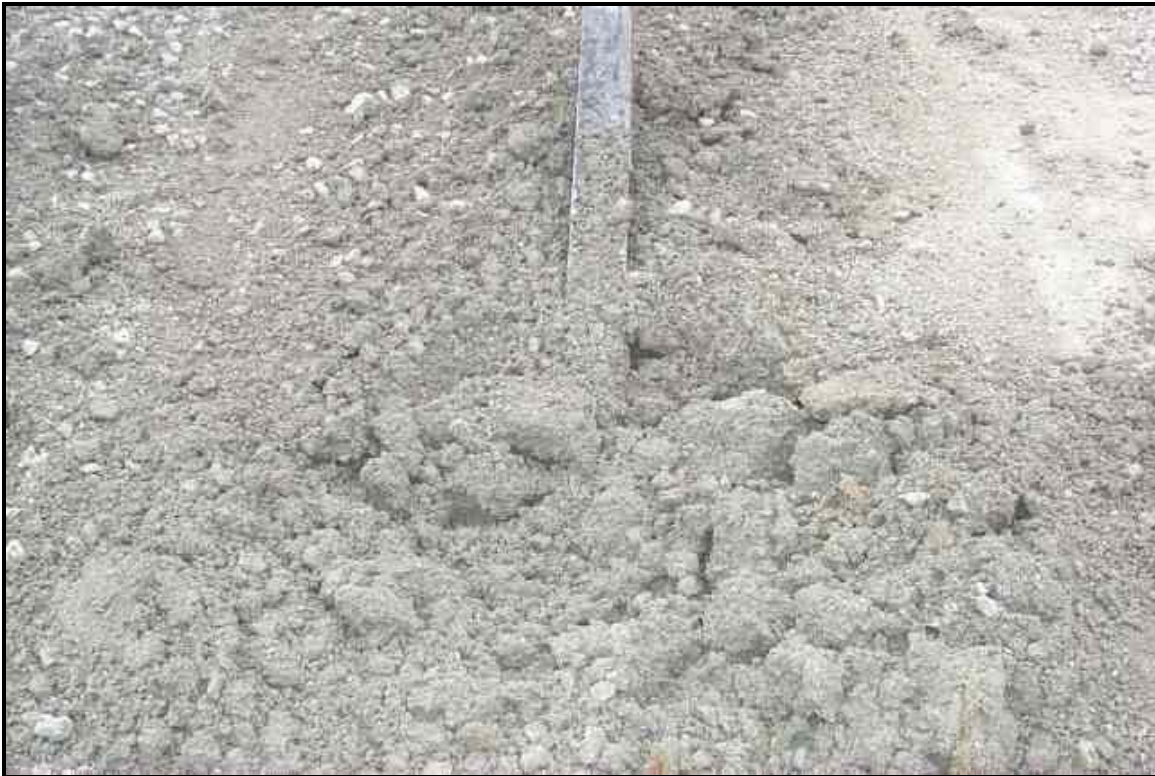
Figure 14. Post-Impact of NPGB-6, Embedment Depth of 86.36 cm (34 in.)

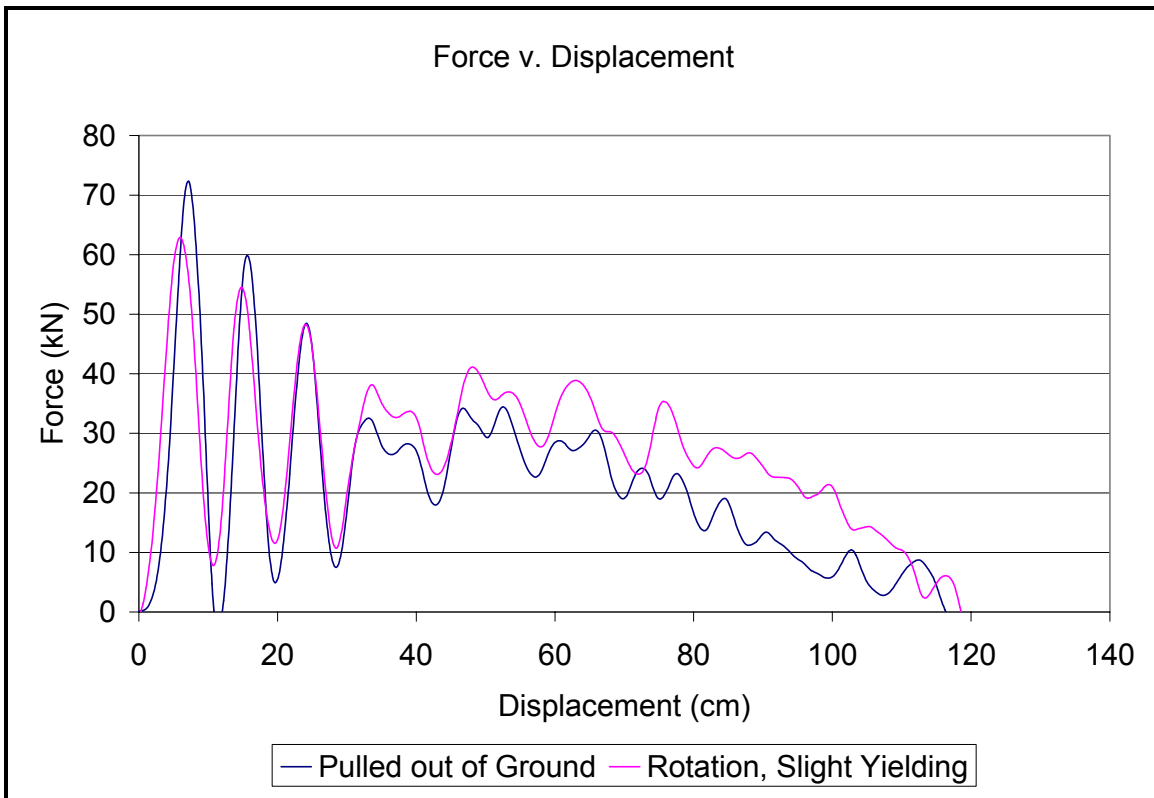
As stated previously, the energy dissipated during the impact is of significant interest. Two failure modes arose during impact testing, either post rotation or having the post being pulled from the ground, after significant rotation. It was also noted previously that there was a difference in the force plots of each failure mode, as shown in Figure 15.

Figure 15. Comparison Force-Displacement Curves for Both Failure Modes

These two curves are typical for each failure mode and are especially important in the following analysis due to their initial force similarities and displacements. The linear decrease in the force is apparent in both curves, but the initiation of the force decrease in the post the pulled out of the ground can be seen to occur first. The area under the curve is then integrated to calculate the energy dissipated as shown in Figure 16.

There were measurable differences in the impact forces between the two modes of failure. For the initial 60 cm (23.6 in.) of displacement, the force-deflection curves for the two failure modes were very similar. At 60 cm (23.6 in.), for the posts that pulled out of the ground, the force levels began to fade in a linear manner. While for the posts which only rotated in the soil, a nearly level force-deflection curve was maintained for 80 cm (31.5 in.) after which it decreased. As a result of measurable differences in the impact forces, the amount of energy dissipated also differed. Posts that failed by rotating in the soil dissipated more energy than posts that initially rotated but eventually pulled out of the ground.

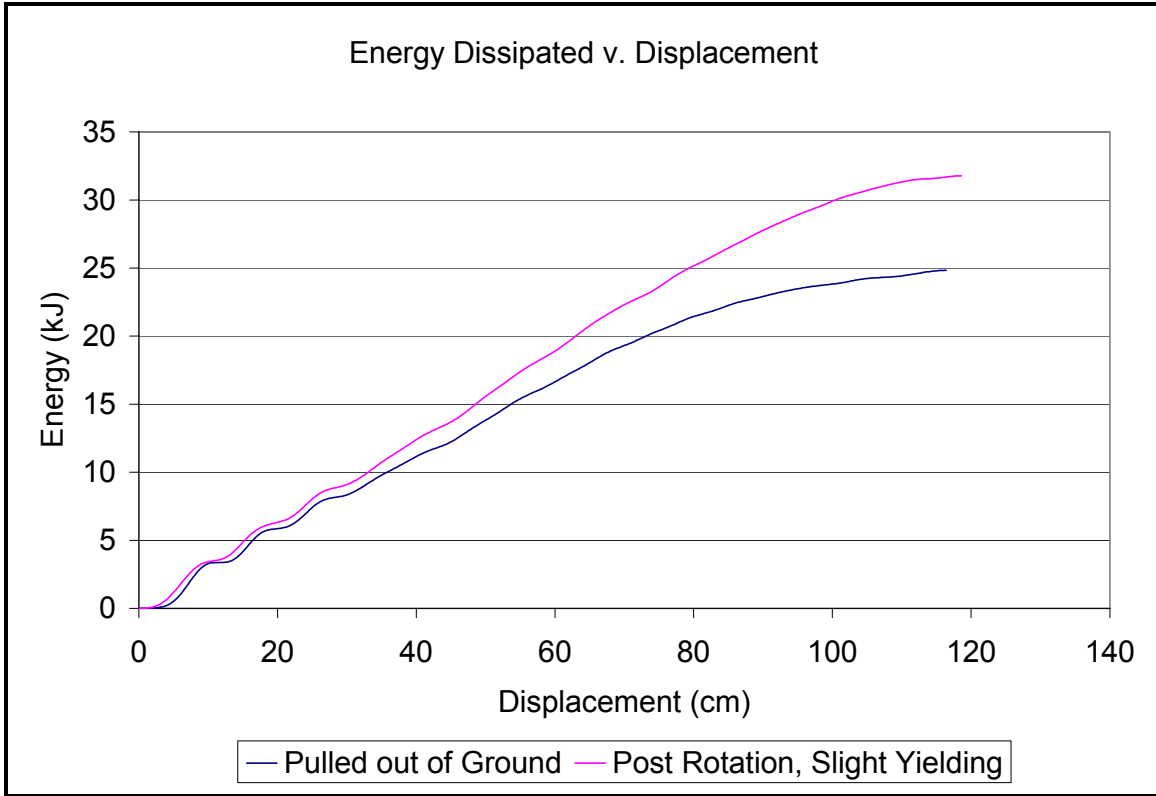
Figure 16. Comparison Plot of Energy Dissipated During Impact

The significance of the post pulling out of the ground is now apparent. More energy is dissipated during an impact as the post pivots in the ground causing it to fail. Pulling the post out of the ground requires less force as evident previously and as an end result more energy will be kept in the bogie system.

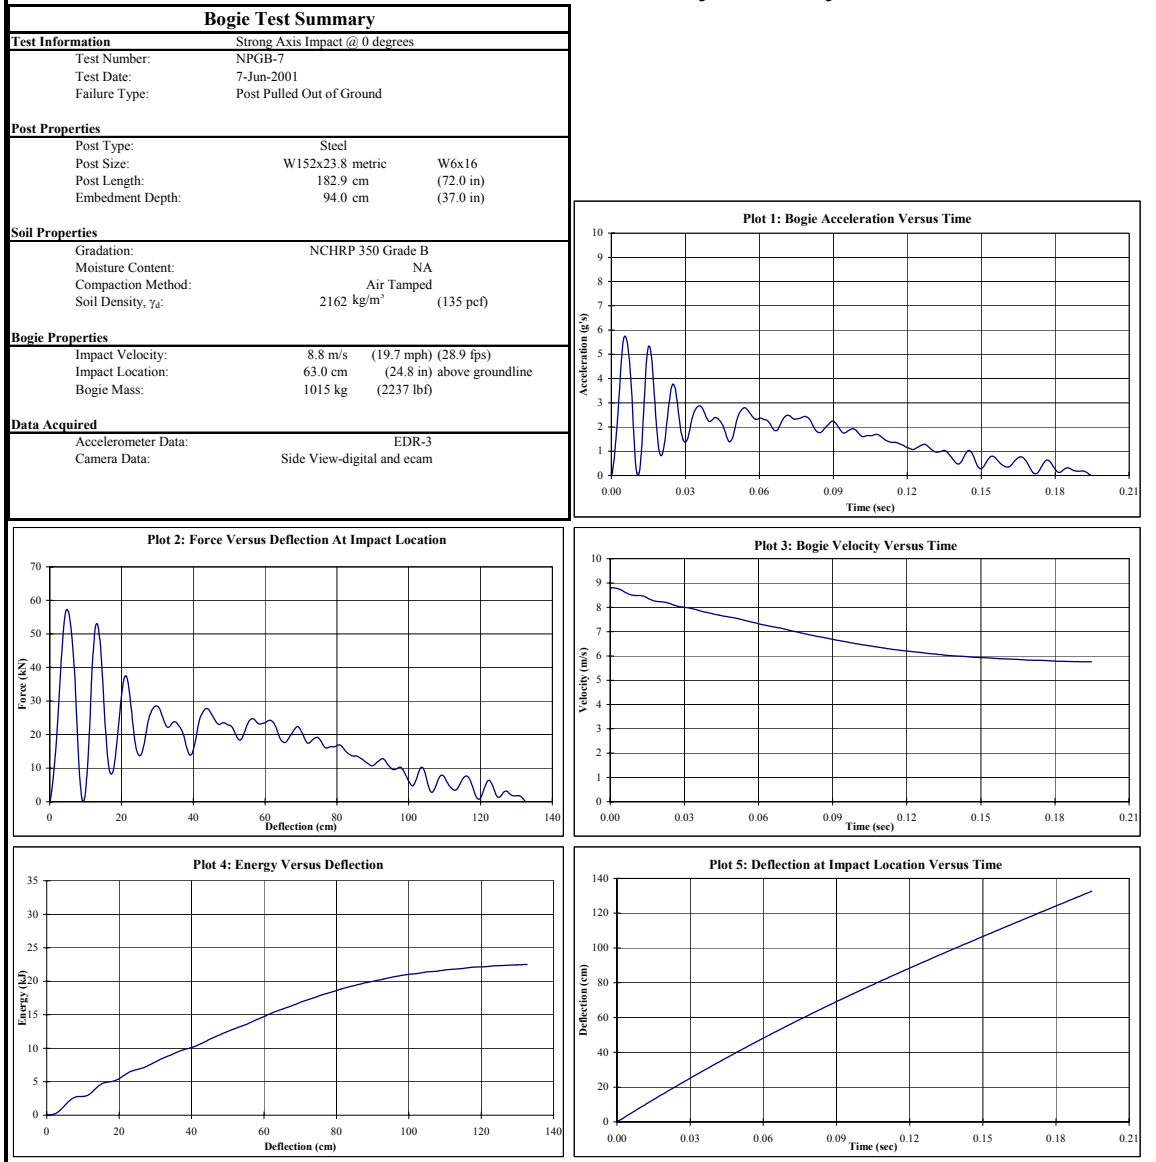
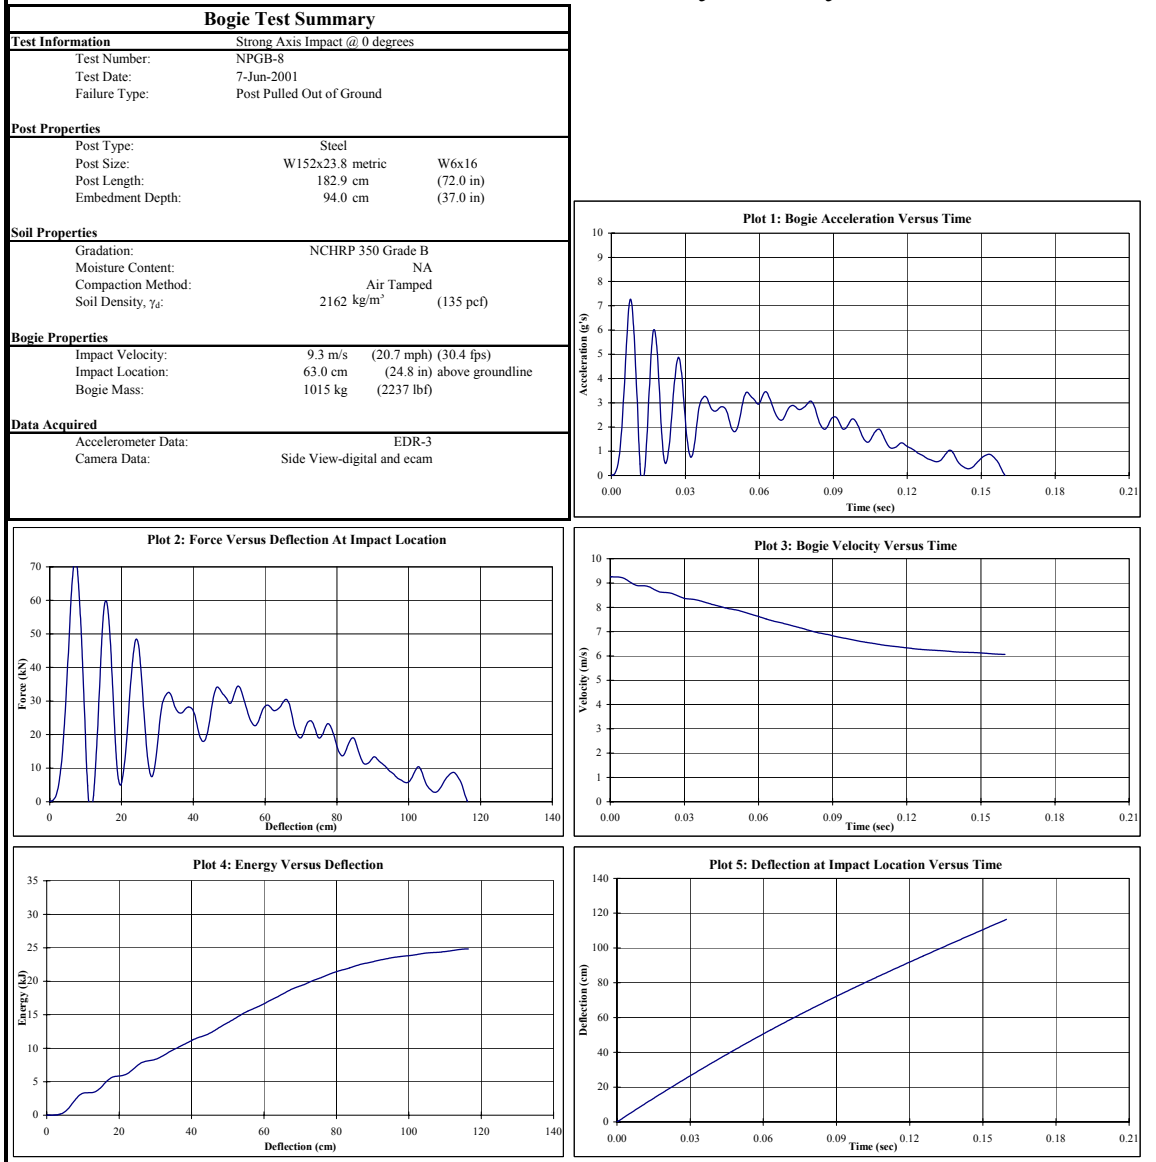
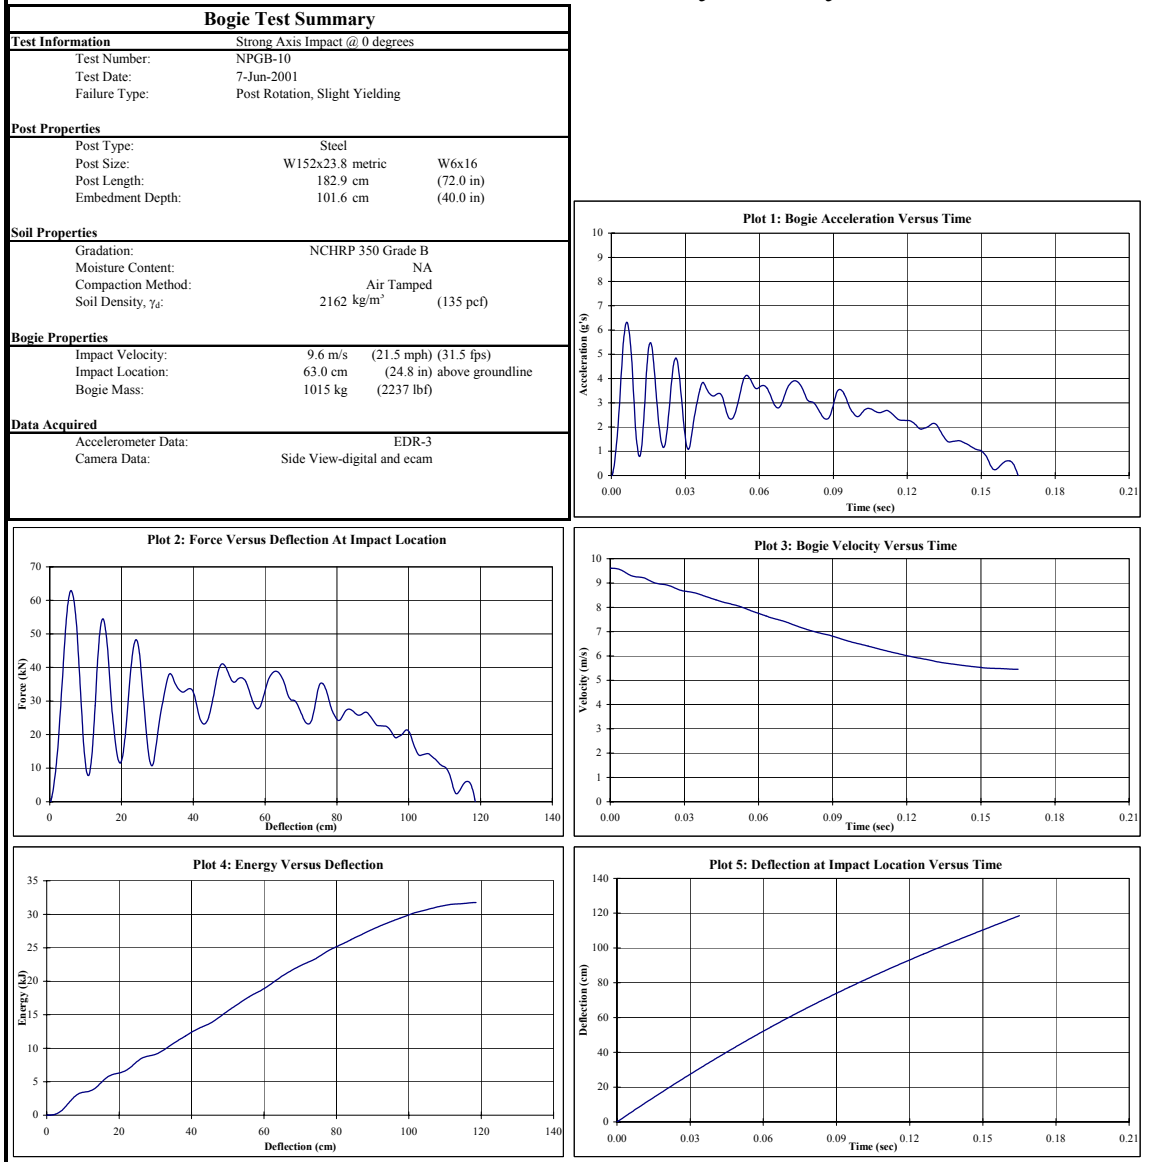
Figure 17. Results of NPGB-1

Figure 18. Results of NPGB-2

Figure 19. Results of NPGB-3

Figure 20. Results of NPGB-4

Figure 21. Results of NPGB-5

Figure 22. Results of NPGB-6

Figure 23. Results of NPGB-7

Figure 24. Results of NPGB-8

Figure 25. Results of NPGB-9

Figure 26. Results of NPGB-10

Test No.	Velocity		Embedment Depth		Moisture Content	Figure Number
	mph	m/s	inches	cm	%	
NPGB-1	20.00	8.94	43	109.22	4.5	Figure 17
NPGB-2	21.00	9.39	40	101.60	4.8	Figure 18
NPGB-3	20.00	8.94	43	109.22	4.9	Figure 19
NPGB-4	20.00	8.94	40	101.60	5.0	Figure 20
NPGB-5	20.00	8.94	37	93.98	4.8	Figure 21
NPGB-6	20.50	9.16	34	86.36	5.7	Figure 22
NPGB-7	19.70	8.81	37	93.98	-NA-	Figure 23
NPGB-8	20.70	9.25	37	93.98	-NA-	Figure 24
NPGB-9	20.75	9.28	40	101.60	-NA-	Figure 25
NPGB-10	21.50	9.61	40	101.60	-NA-	Figure 26
