MID-AMERICA
TRANSPORTATION CENTER

Report # TRP-03-275-12

Cable Median Barrier Failure Analysis and Prevention

CABLE MEDIAN BARRIER FAILURE ANALYSIS AND PREVENTION

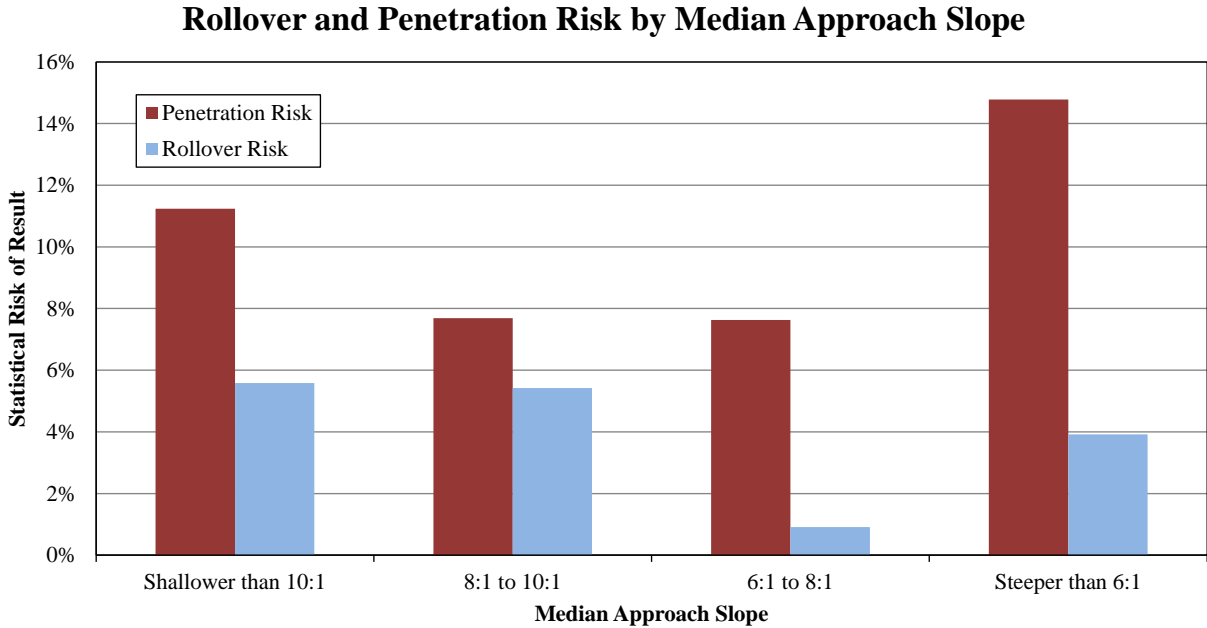
Figure 4. Statistical Analysis of Penetration and Rollover Risk by Median Slope

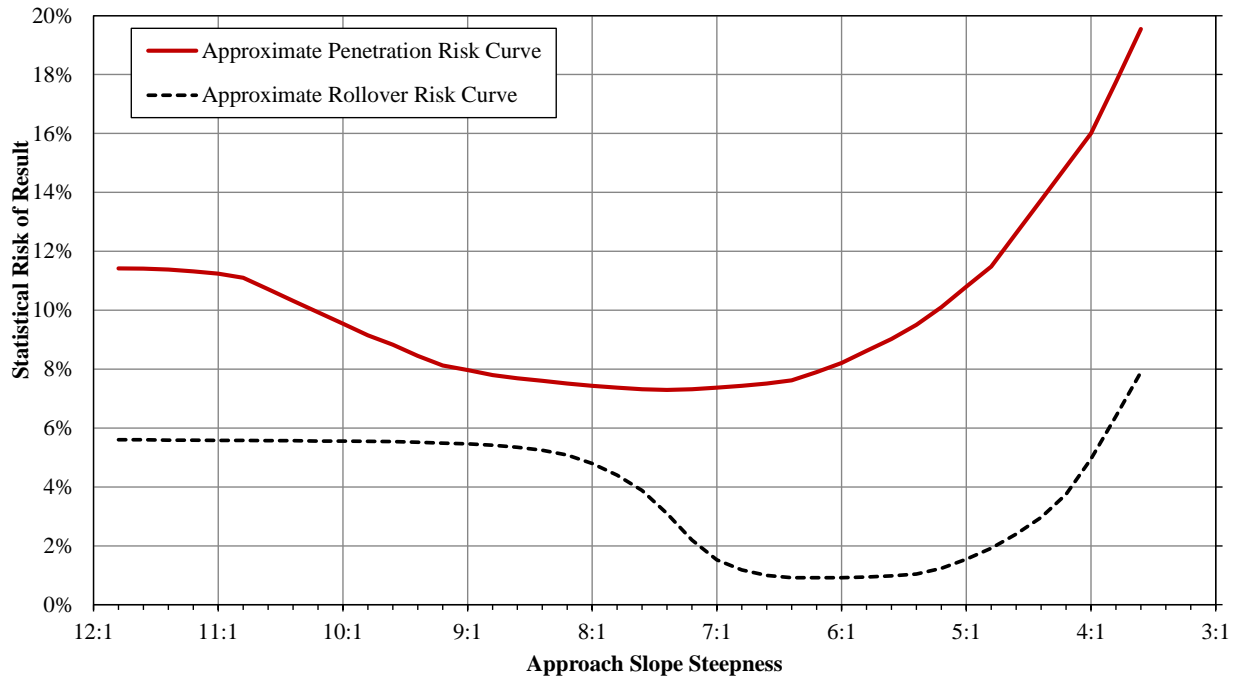
Figure 6. Estimated Median Approach Slope Risk Curves by Approach Slope Steepness

Approximately 80% of the crashes in the Ohio database occurred on Nucor NU-CABLE barrier systems. Precise slope data was not available at the time of this study from most of the other states and barrier systems involved in this research effort. Nonetheless, a concerted effort was made to tabulate approximate median conditions in other states with different barrier systems.

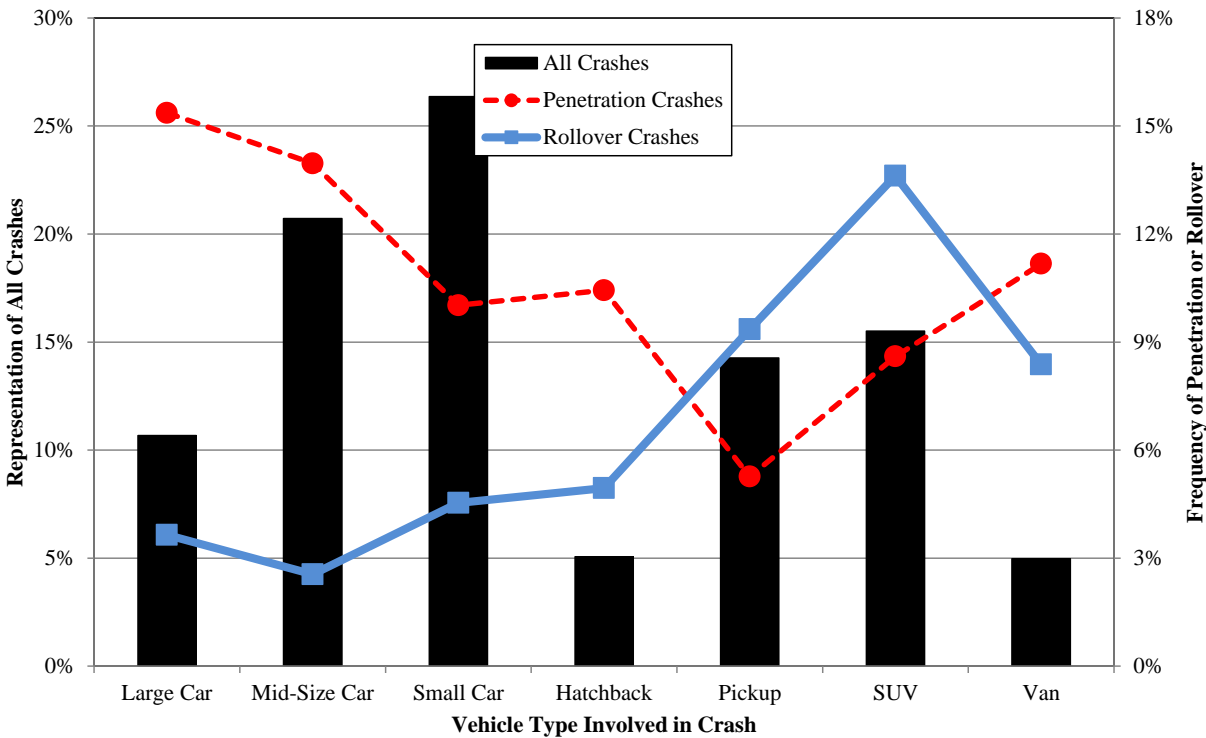
Figure 8. Frequency of Barrier Failure by Vehicle Type

Penetration and rollover occurrence was plotted by vehicle type, and indicated varying susceptibility to certain types of failure mechanisms. For example, mid-size cars had the highest total contribution of penetrations by vehicle type, but mid-size cars penetrated through the barrier less frequently than large cars, on a per-crash basis. Alternatively, large cars represented fewer numbers of penetrations than mid-size or small cars, pickup trucks, or SUVs, but large cars had the highest rates of penetration of any passenger vehicle.

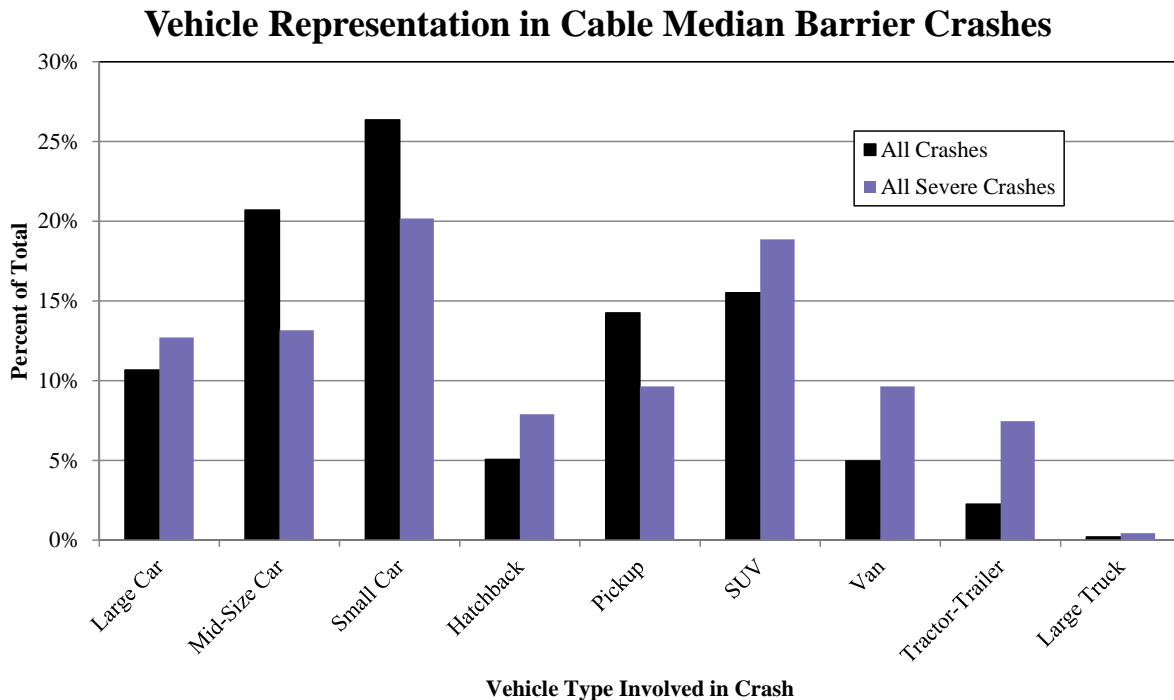
A comparison of vehicles involved in severe crashes indicated that the serious injury and fatal crashes were distributed between all vehicle classes, as shown in Figure 9. The largest proportionate risk of serious injury or fatality occurred with hatchback or station wagon cars. These vehicles were frequently older vehicles with lower safety ratings than vehicles currently being produced. Also, SUV, van, and large car crashes were generally more severe than mid-size and small car crashes as well as pickup truck crashes. Only tractor-trailer crashes, with a high number of cross-median crashes and rollovers, had higher average severity for modern vehicles.

Figure 9. Risk of A+K Crash by Vehicle Type

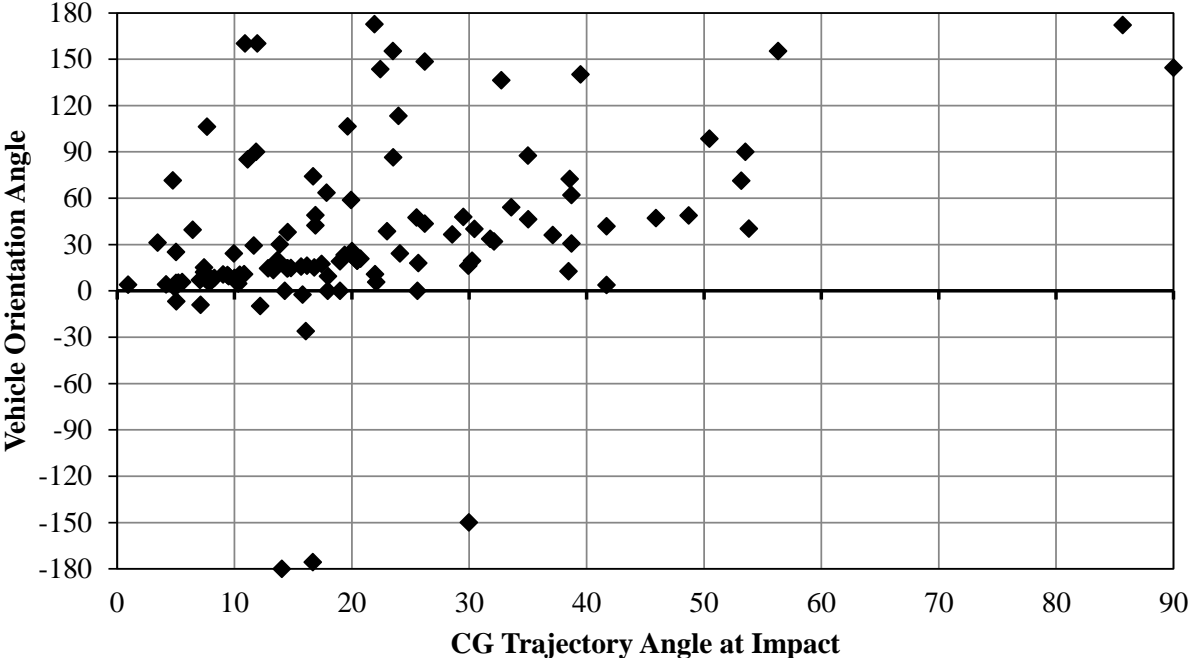
Figure 18. CG Trajectory and Orientation Angles in Severe Cable Median Barrier Crashes

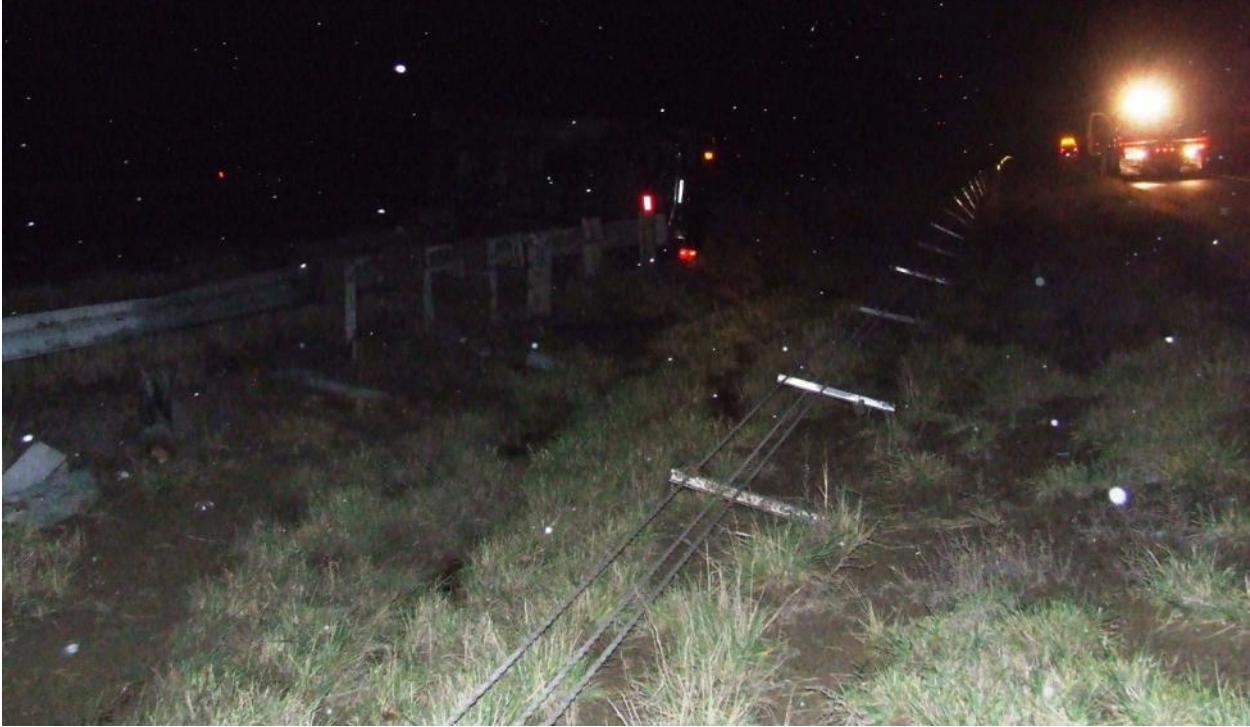
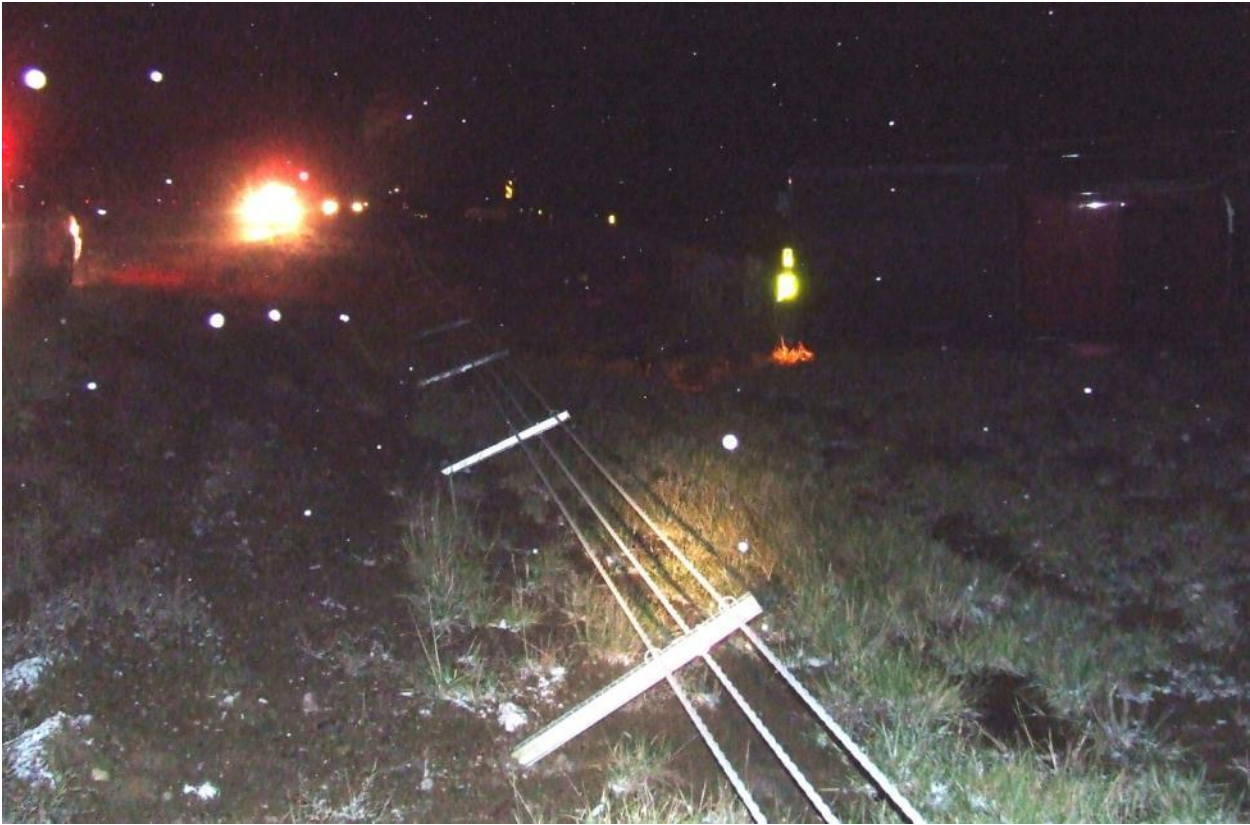
An example of a crash in which the strong cable-to-post attachments contributed to vehicular penetration through the barrier is shown in Figures 46 and 47. In this crash, an impacting pickup lost control due to slick roadways and departed the roadway into the median. The CG trajectory angle was approximately 24 degrees, and the orientation angle of the vehicle at impact was approximately 110 degrees. The vehicle impacted the cables and began to redirect. The first few impacted posts were pulled out of the ground as the pickup was redirecting, and the strength of the cable-to-post attachments retained the posts on the cables. Due to the high orientation angle at impact, the cables did not locally crush the fender at the front of the vehicle. This crush typically fostered proper cable-vehicle interaction and was commonly associated with

Figure 46. Penetration Crash Caused by Strong Cable-to-Post Attachment

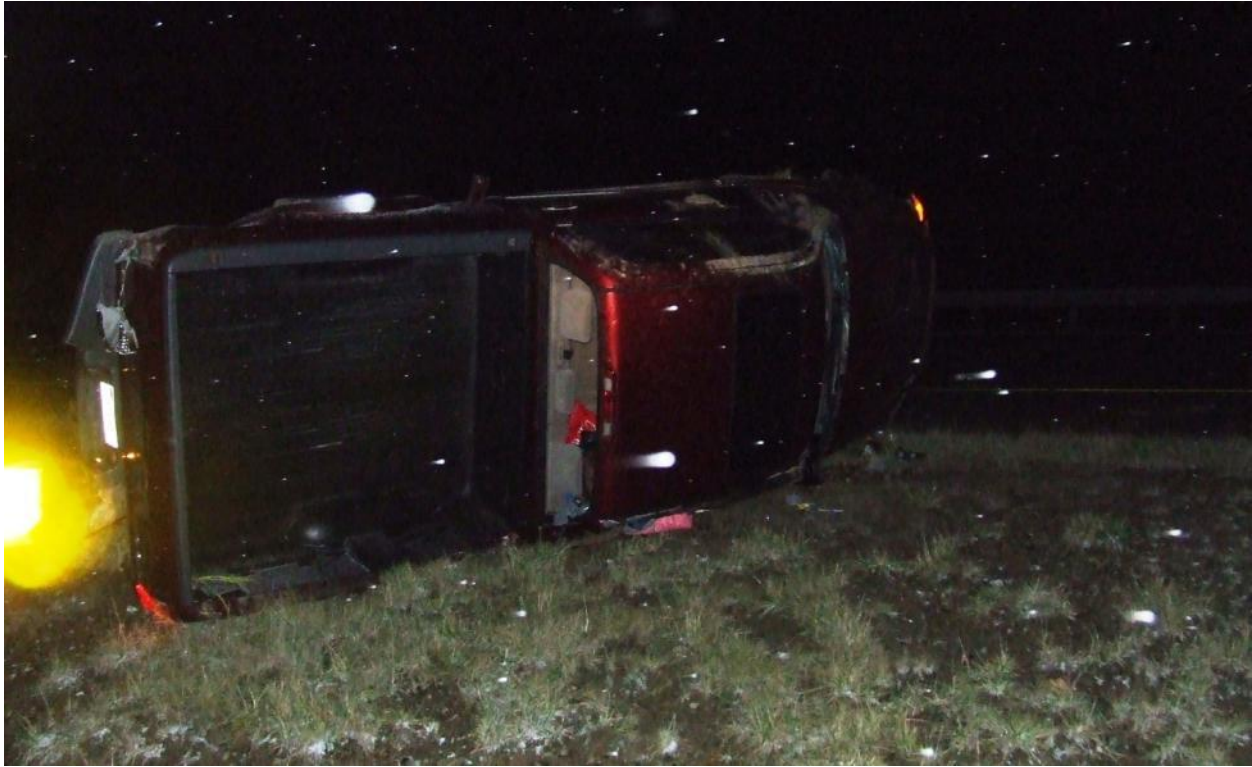
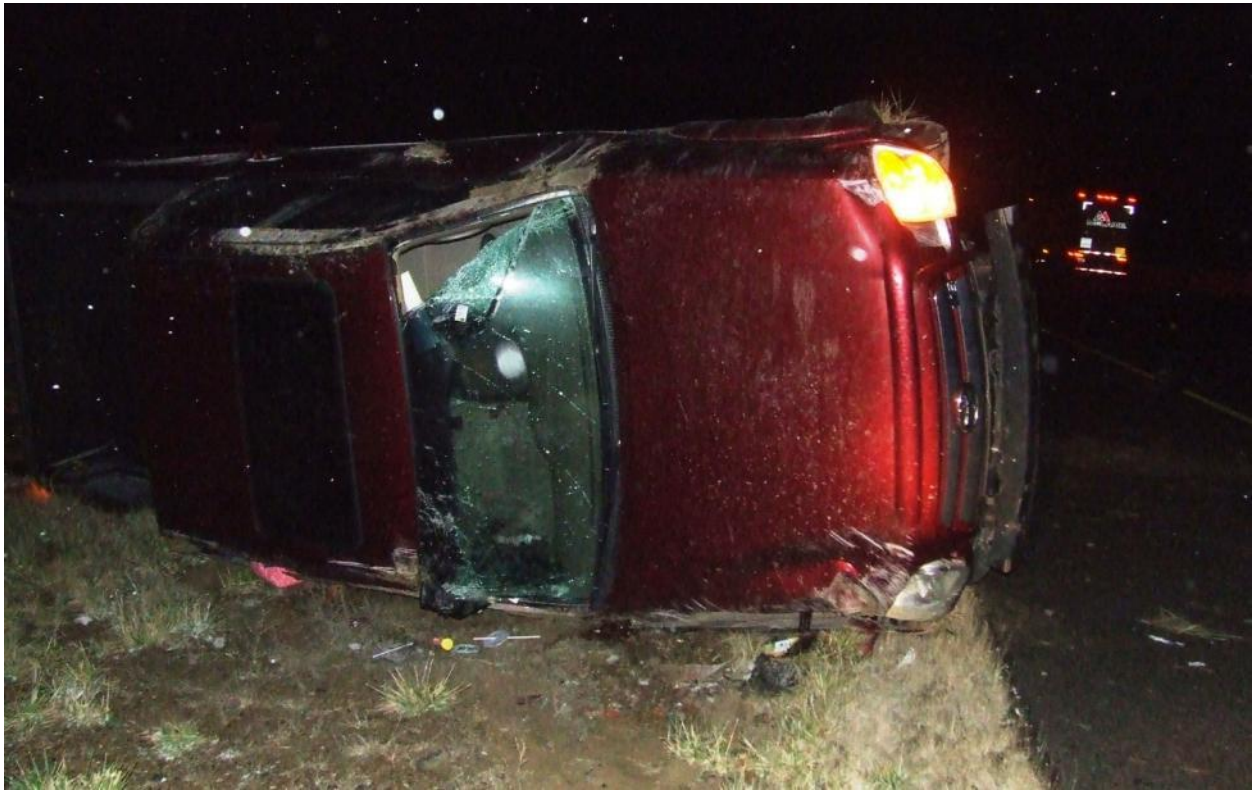
Figure 47. Crash Result Due to Strong Cable-to-Post Connection

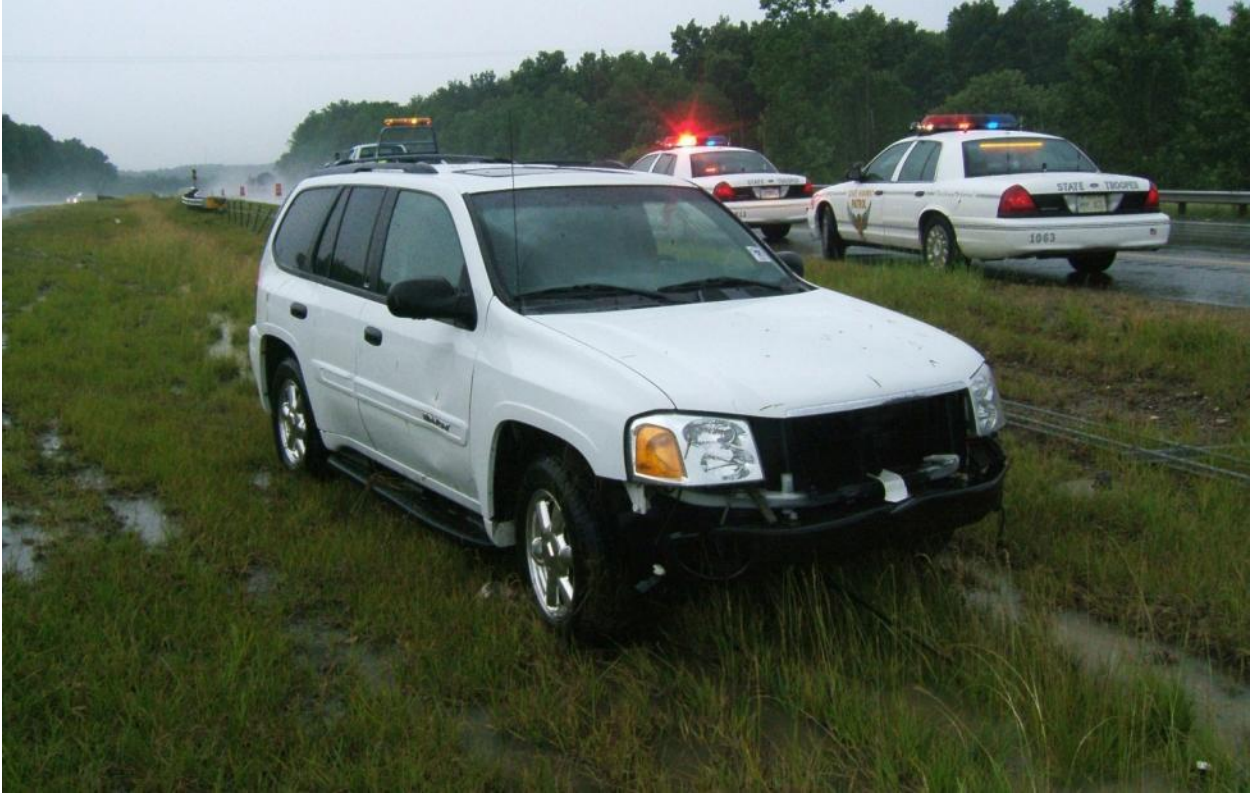
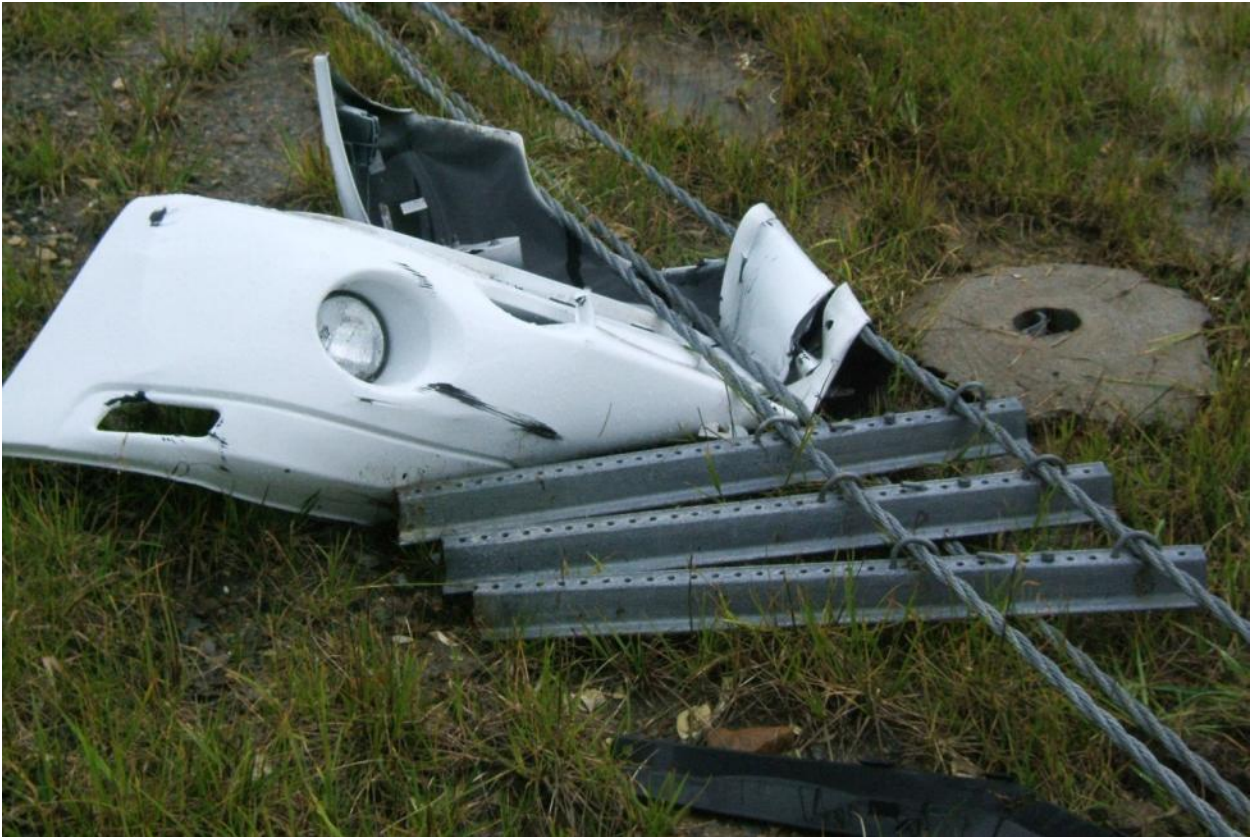
Figure 49. Override Penetration Crash Vehicle Final Position and Removed Bumper Cover

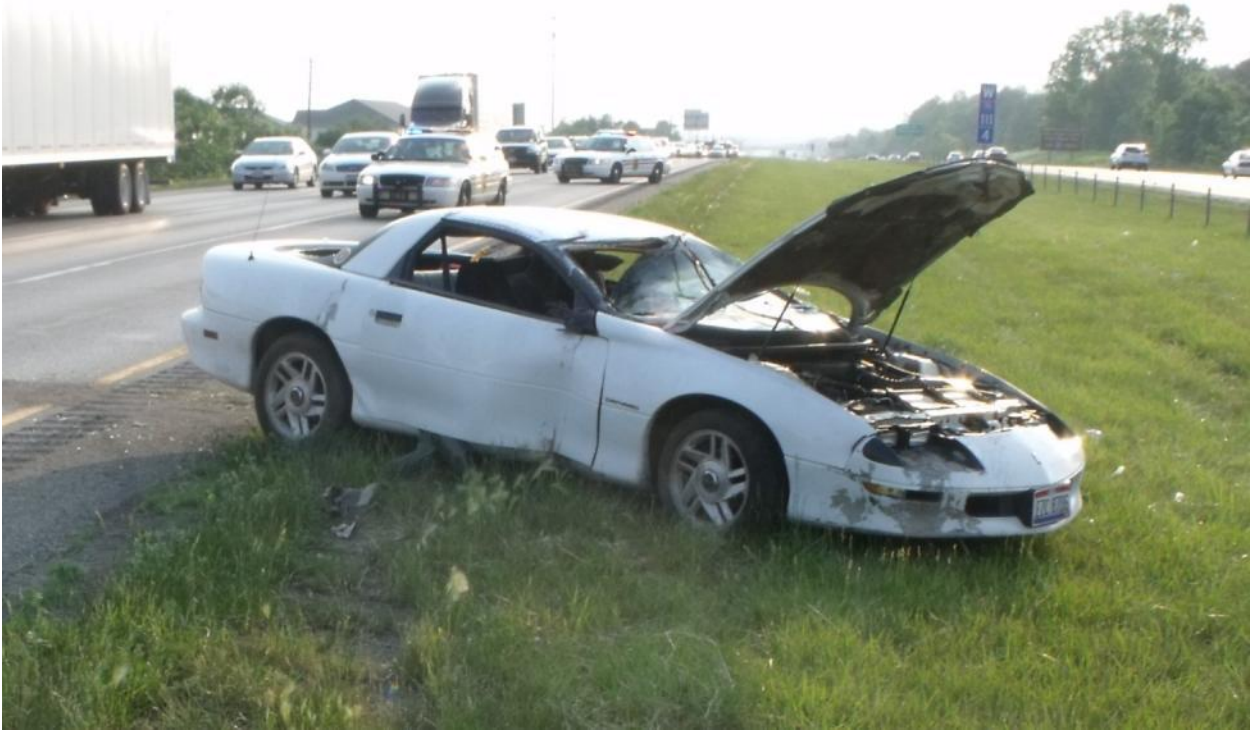
Figure 51. Prying Penetration Failure on Nucor NU-CABLE Barrier

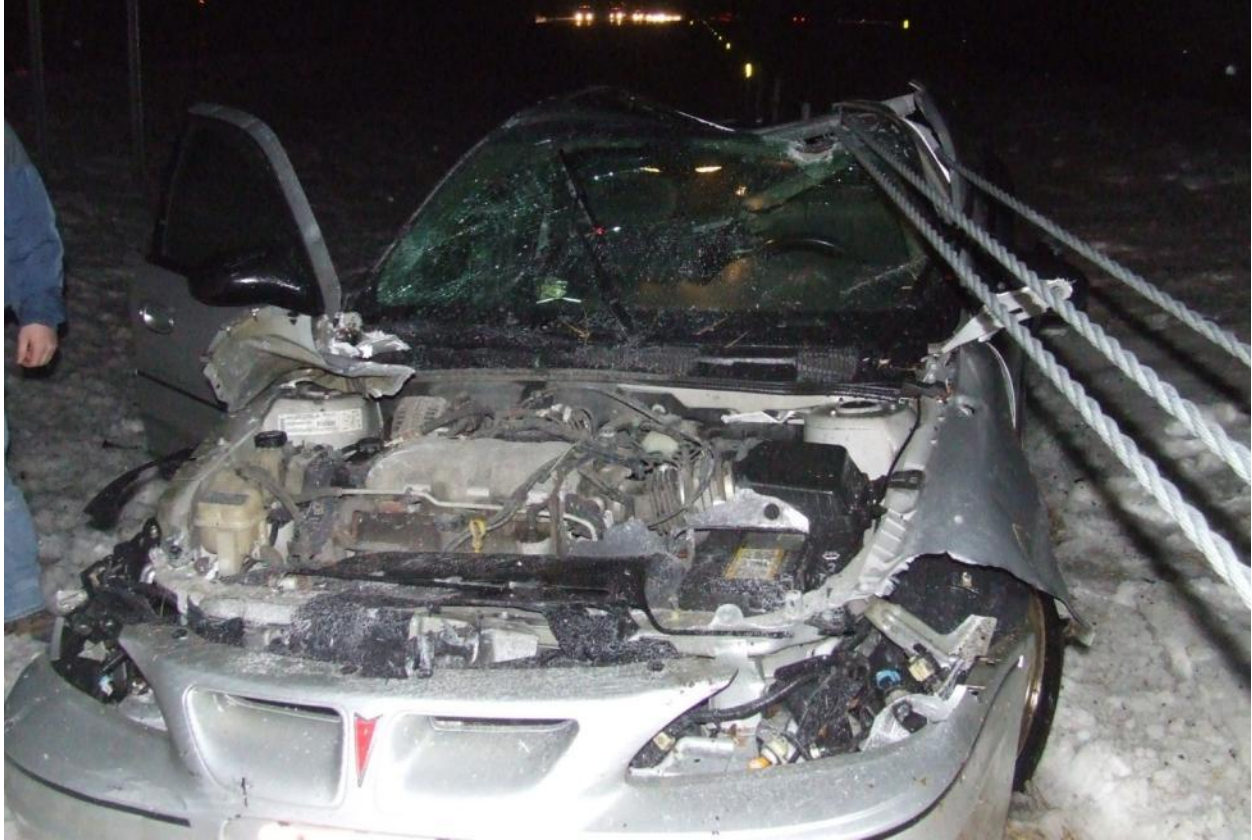
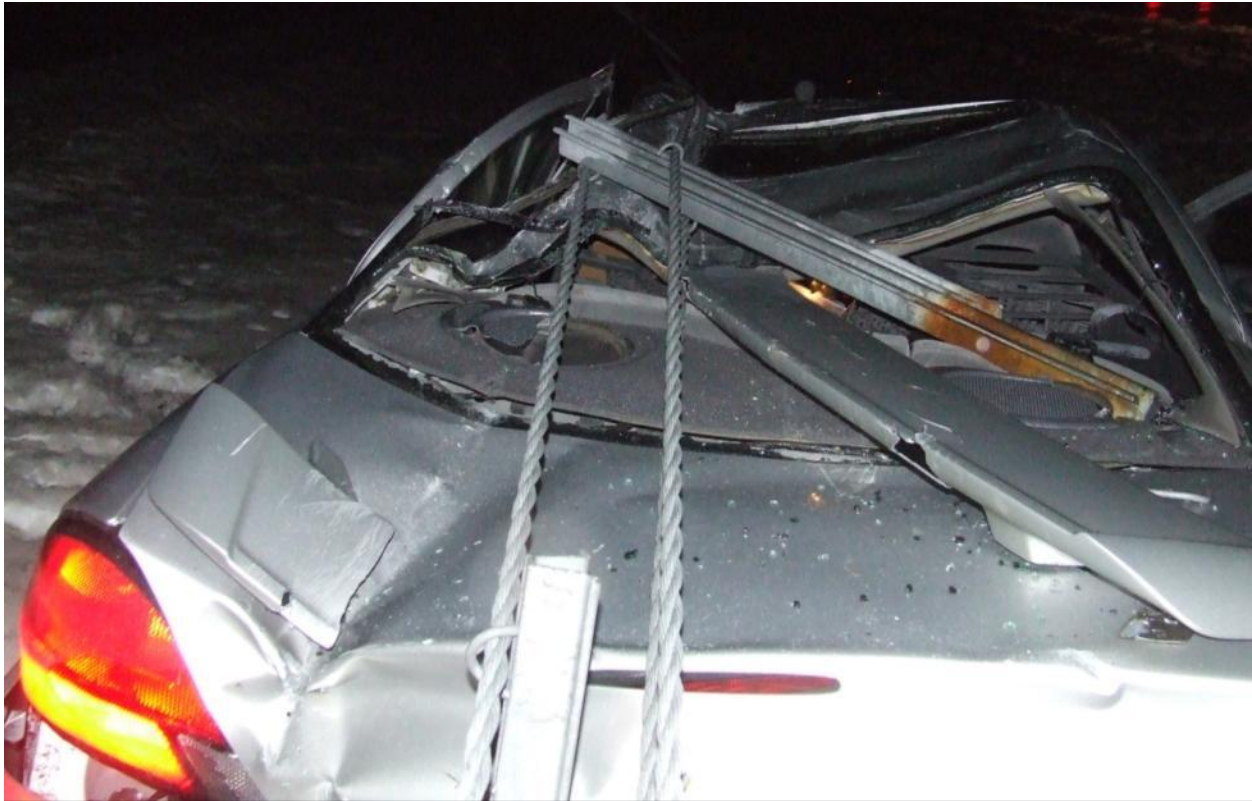
Although the vehicle was brought to a stop in the median, the strong cable-to-post attachment could have seriously injured or killed an occupant in the back seat of the vehicle in this crash because of the retention of the post. Fortunately, no occupants were present in high-risk seat locations, and this crash resulted in only property damage. This crash result further

Figure 52. Potential Penetration Crash on Nucor NU-CABLE Barrier

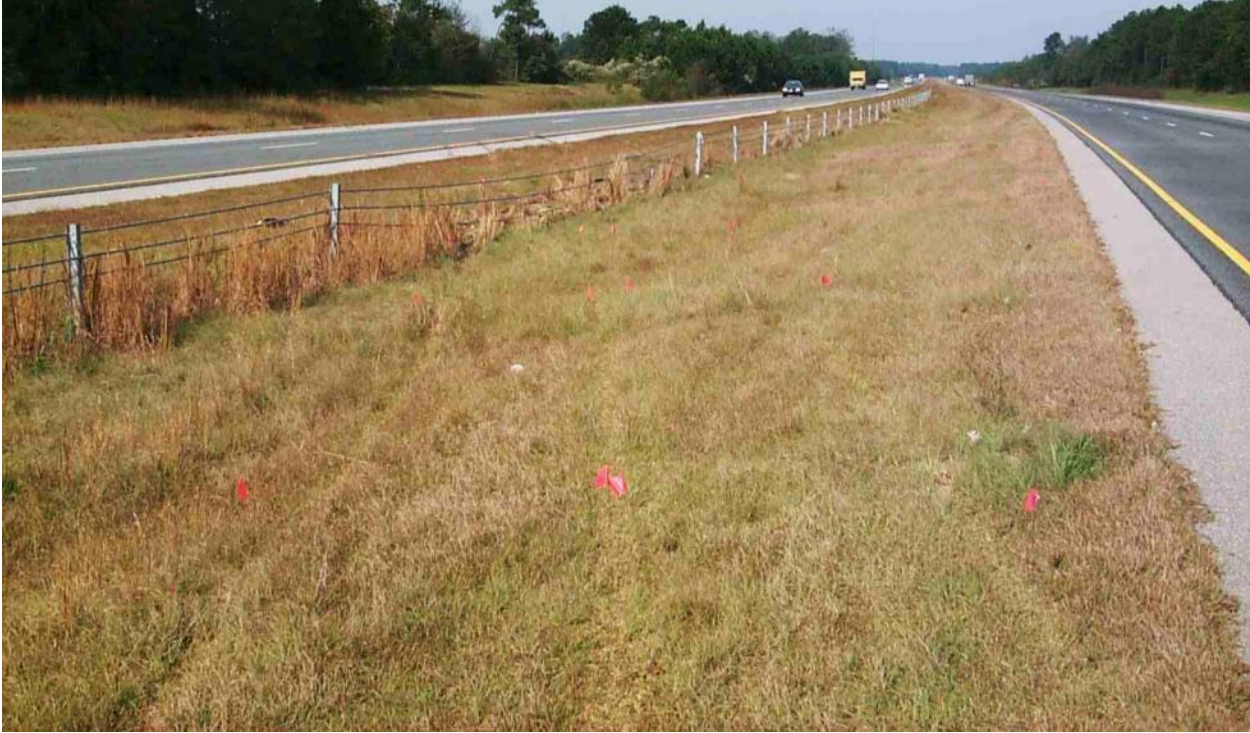
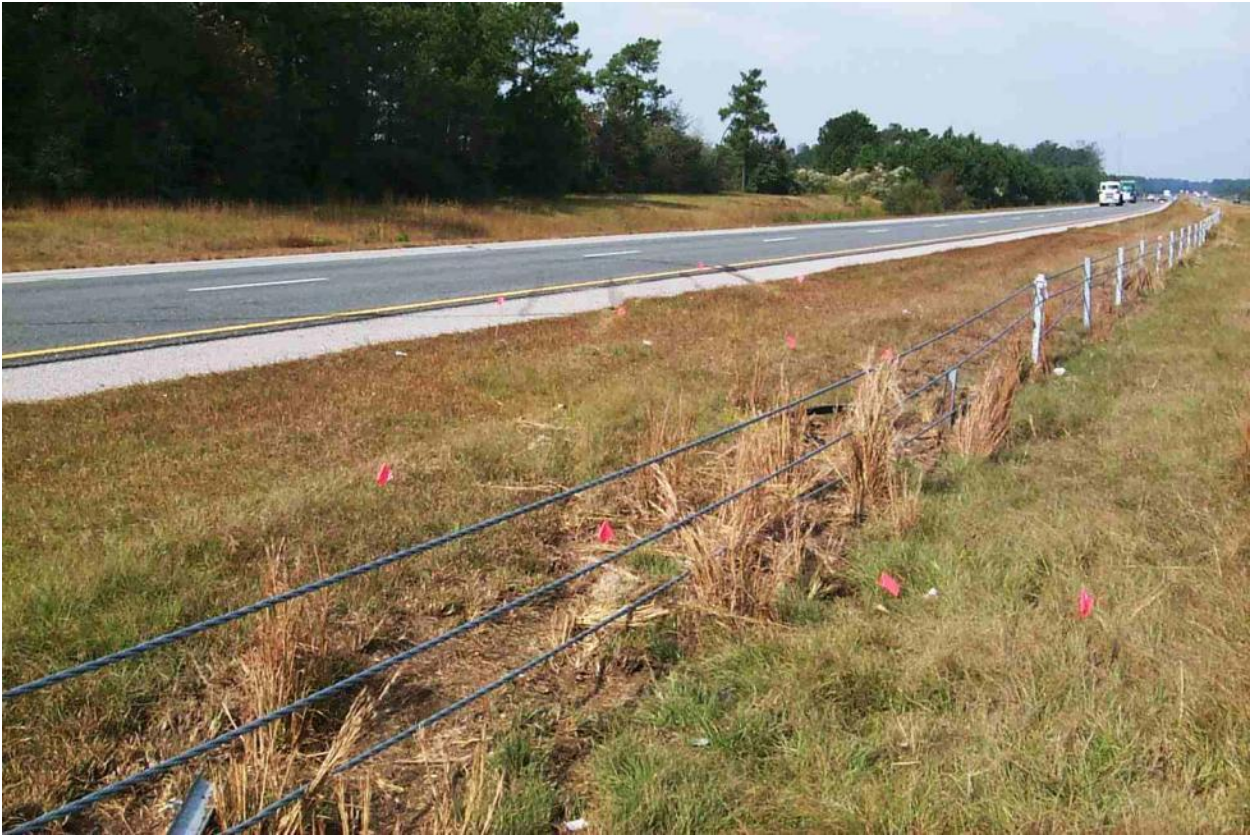
Figure 60. Additional Example of Diving Penetration Crash

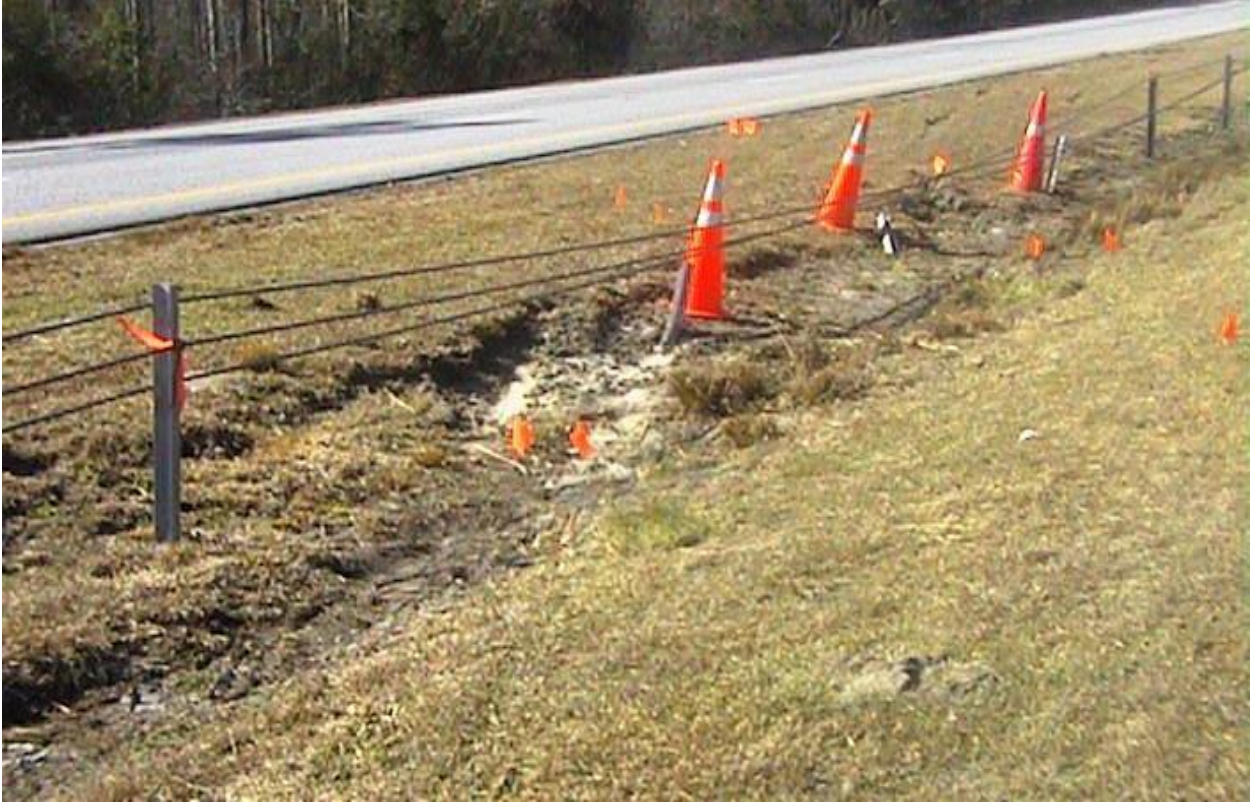
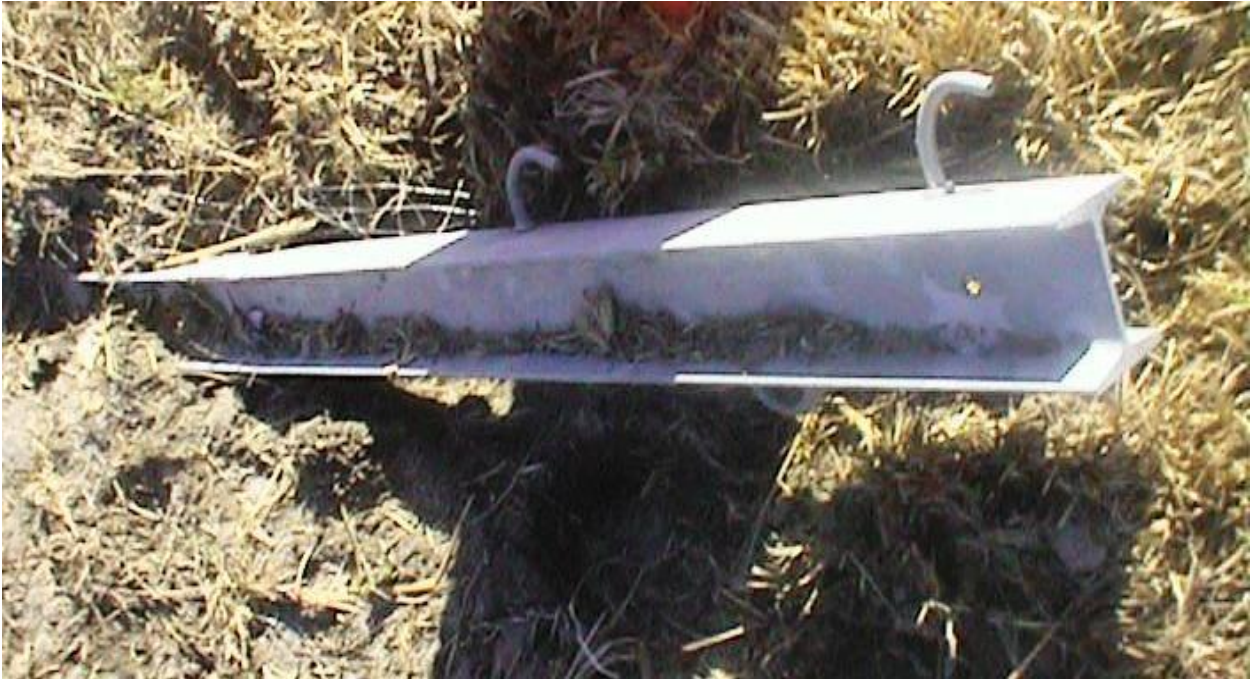
Figure 61. Additional Example of Diving Penetration Crash

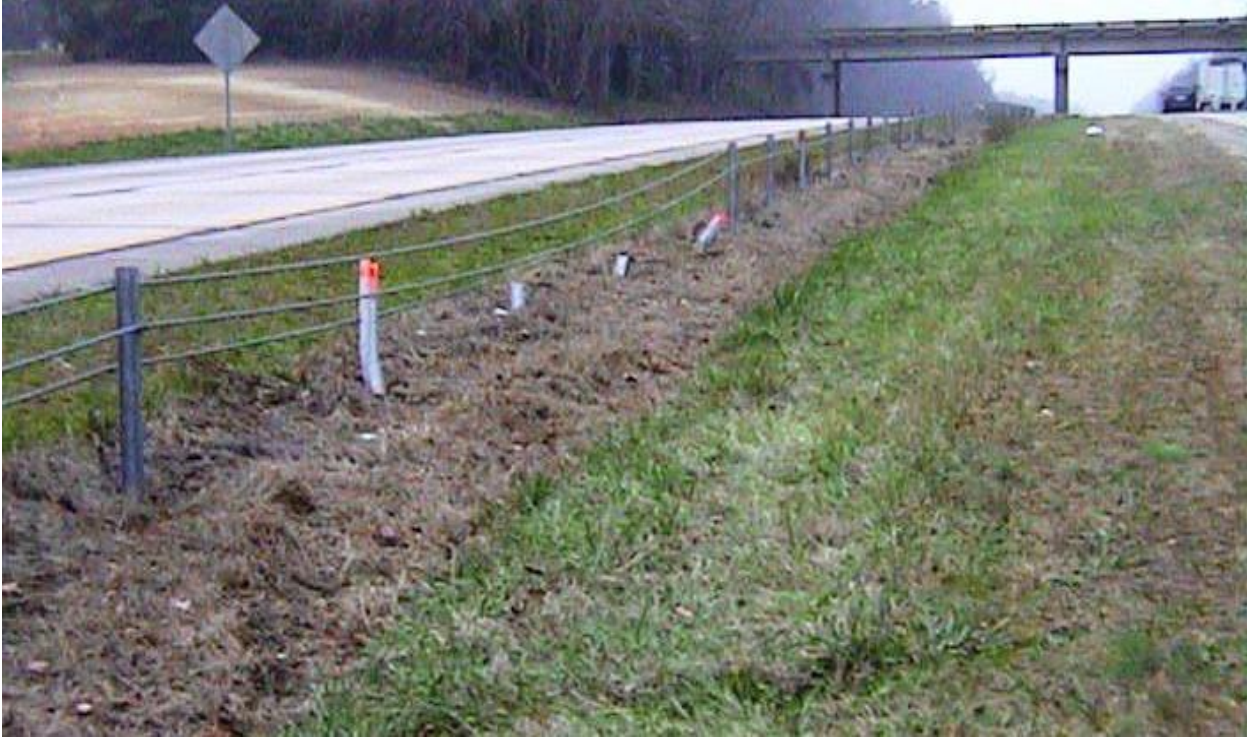
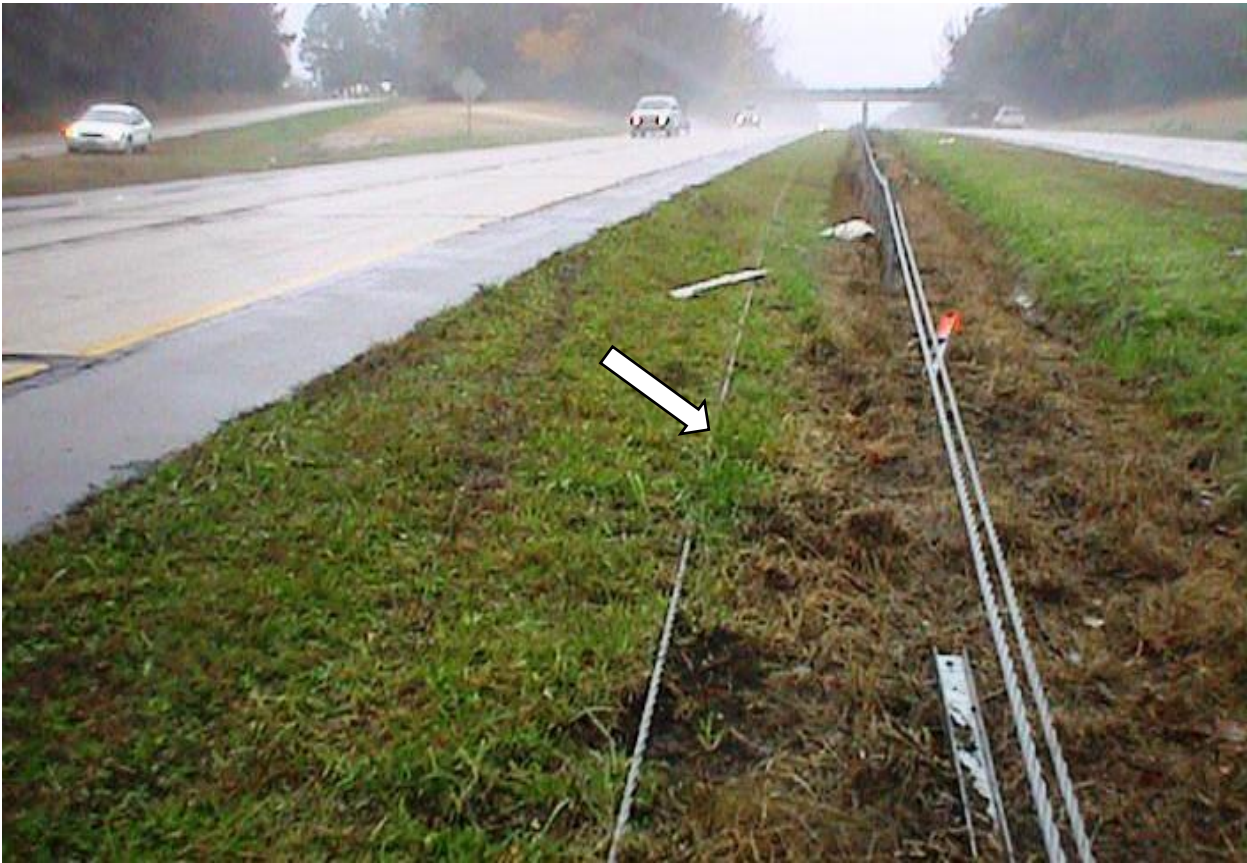
Figure 63. Middle Cable Release from Many Downstream Posts Resulting in Penetration

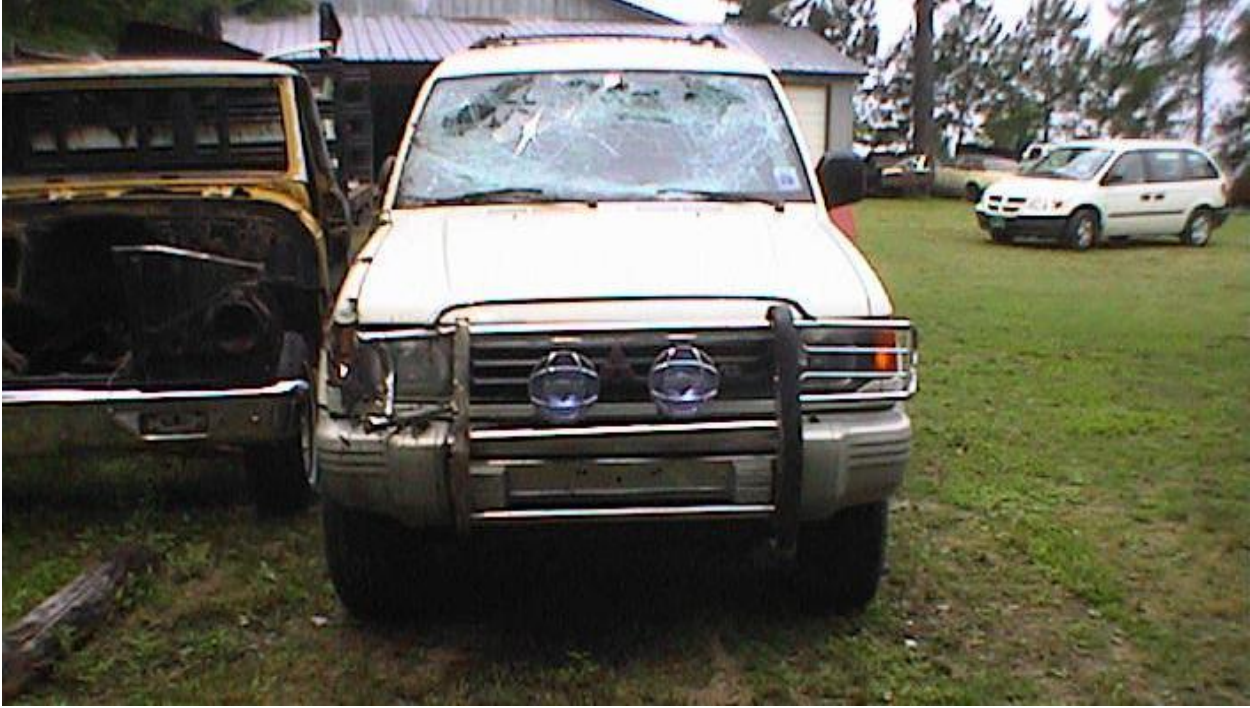
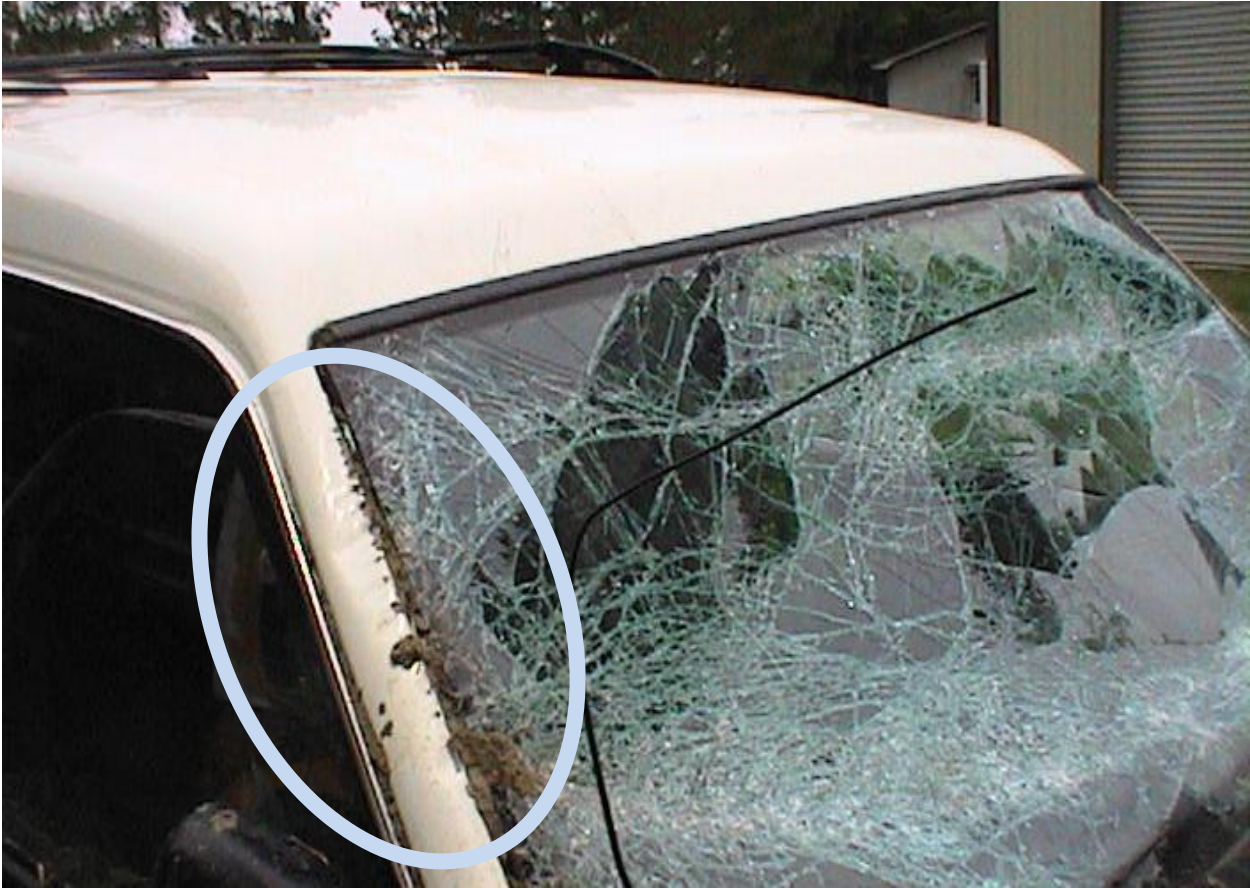
Figure 66. Brush Guard Prying Penetration with Cable Contact Striations on A-Pillar
