MID-AMERICA
TRANSPORTATION CENTER

Report # TRP-03-275-12

Cable Median Barrier Failure Analysis and Prevention

CABLE MEDIAN BARRIER FAILURE ANALYSIS AND PREVENTION

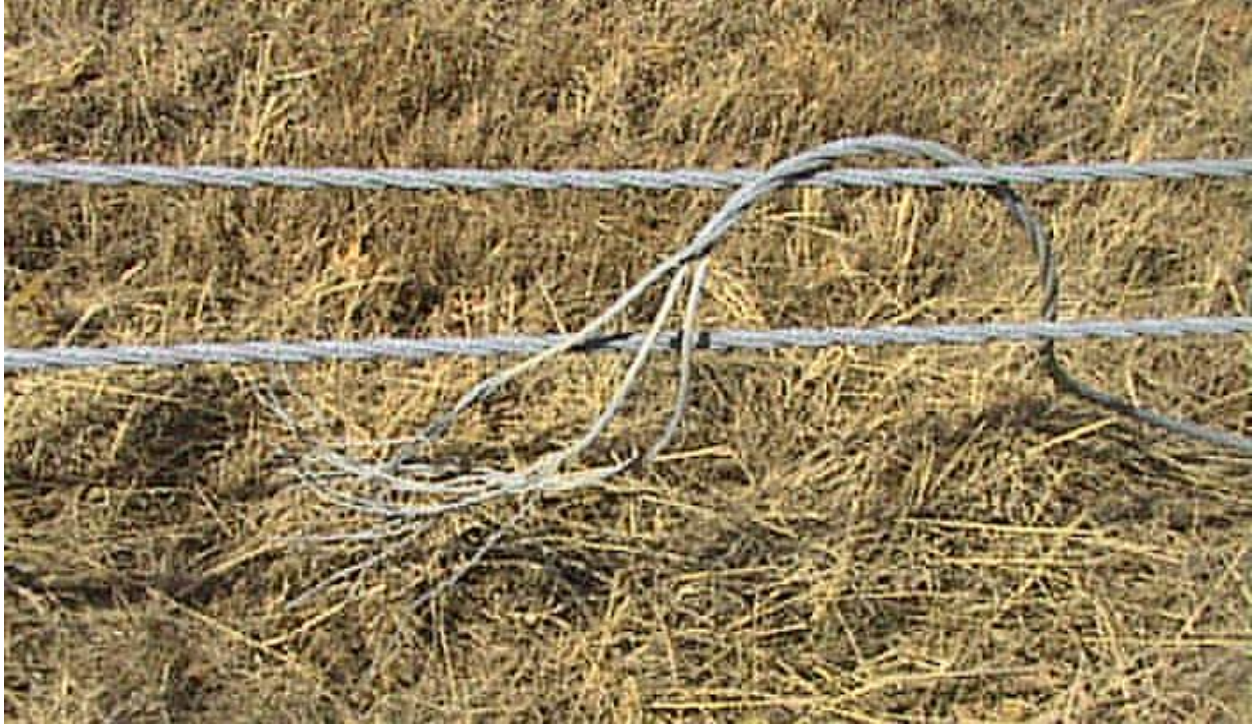
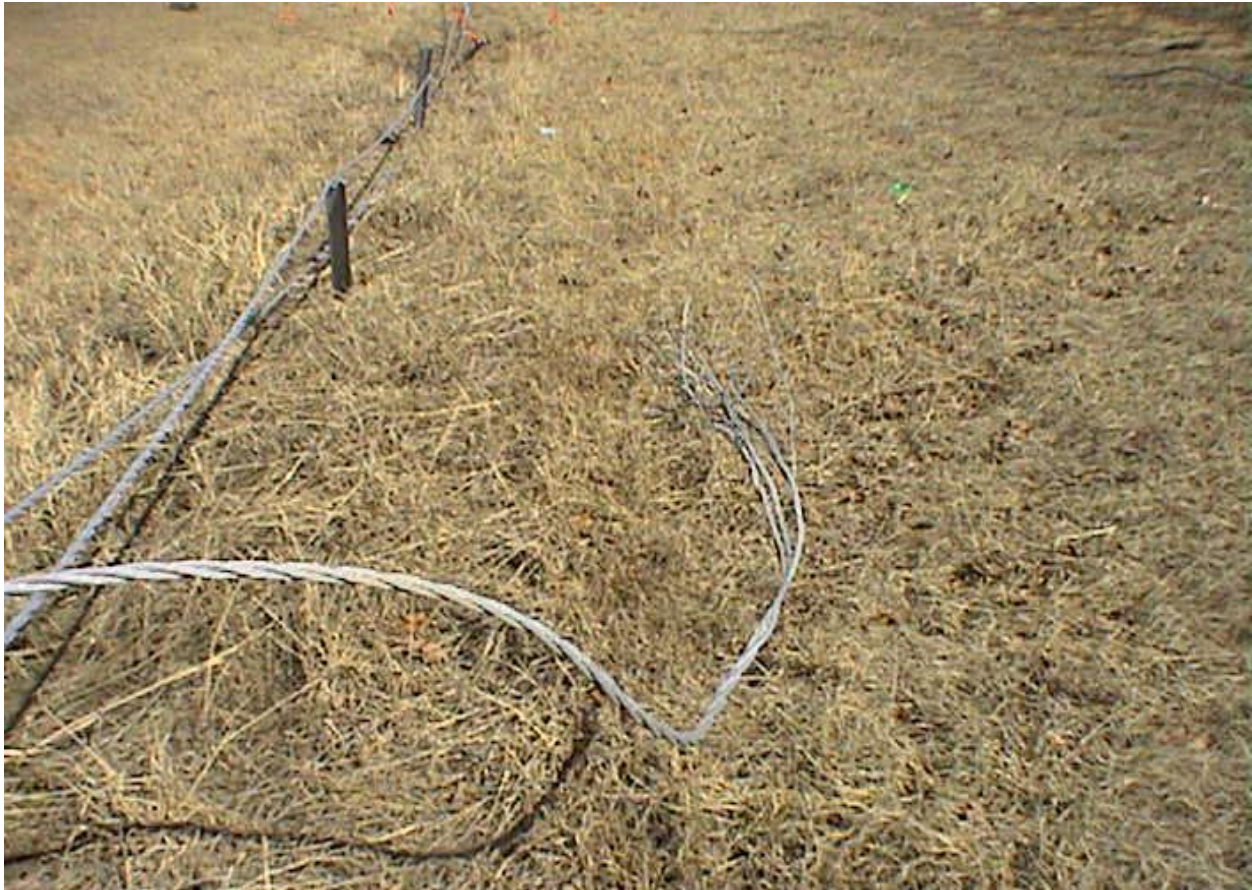
Other penetration causes were identified that led to penetrations on low-tension cable median barrier systems, including impacts with large vehicles (i.e., tractor trailers-or single-unit trucks), and bouncing override penetrations due to median slopes. However, as with the high-tension cable median barrier counterparts, bouncing override penetrations were impact condition dependent, and no cable barrier system manufactured had been tested and approved to redirect large vehicles (i.e. tractor-trailers).

Figure 67. High-Tension Splice Tearout Penetration

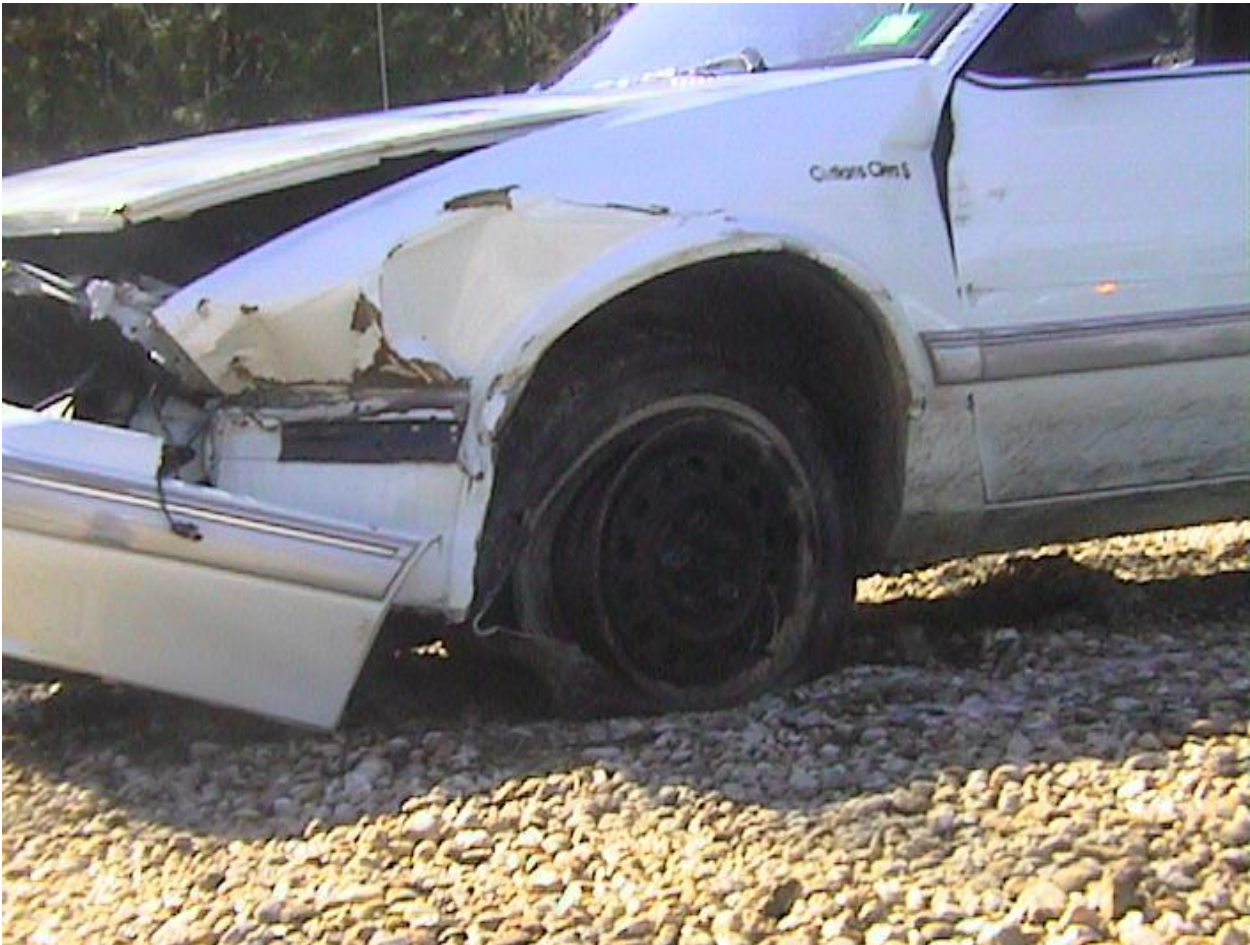
Figure 68. High-Tension Splice Tearout Penetration

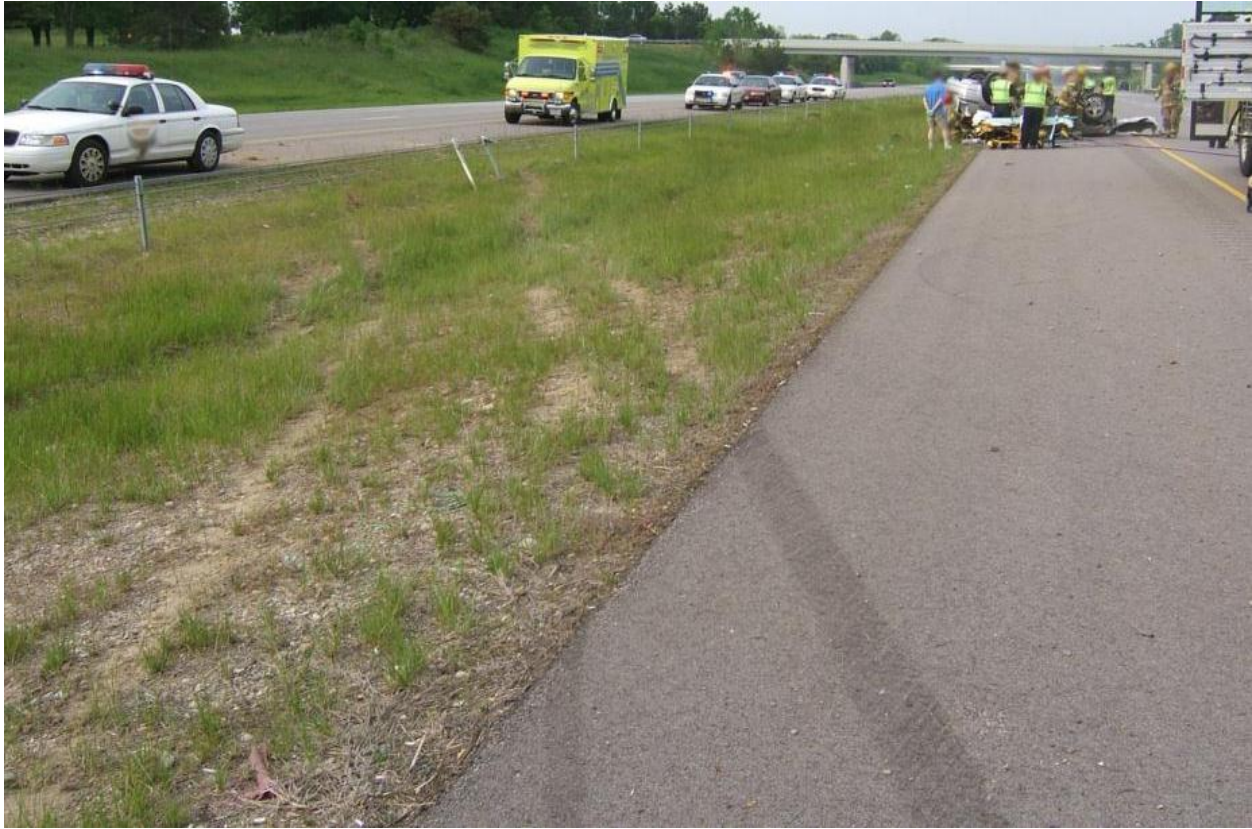
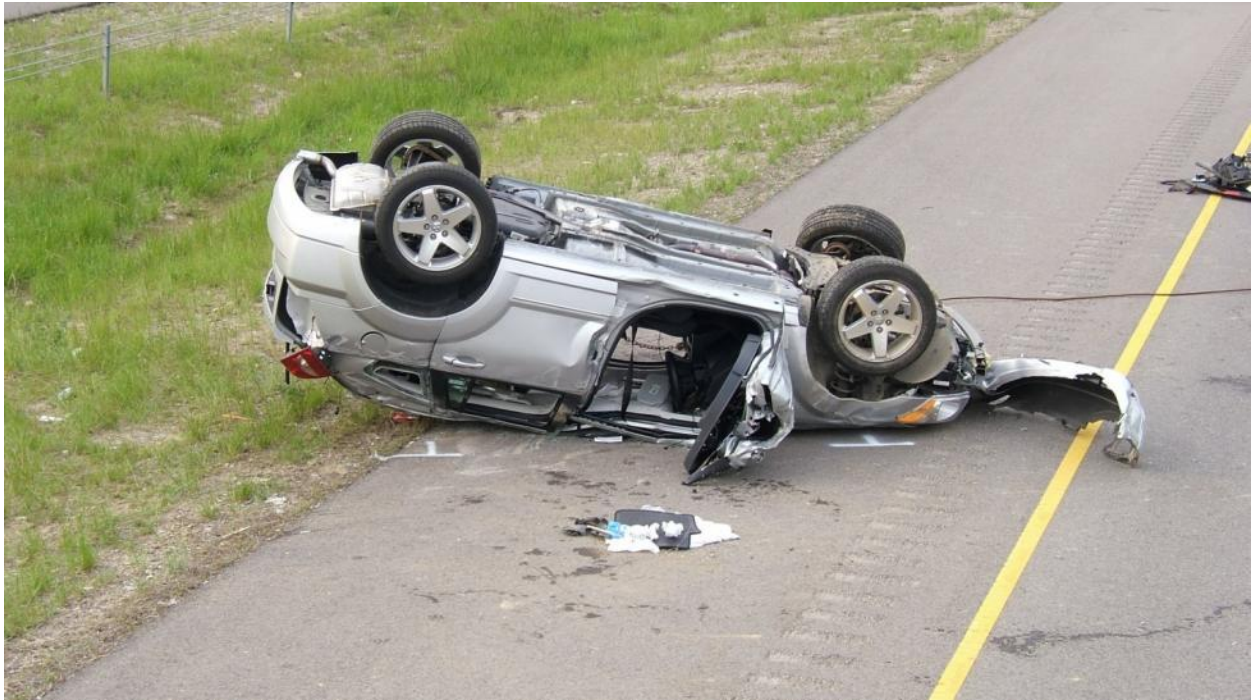
The third type of median slope rollover was caused when vehicles struck a cable median barrier installed on a V-ditch back slope. After redirection, some vehicles skidded laterally into the median and tripped due to the slope transition in the center of the median. An example of this crash type is shown in Figures 70 and 71. In this crash, a Dodge Caliber struck the cable median barrier with an orientation angle of approximately 110 degrees and a CG trajectory angle of approximately 21 degrees. The vehicle displaced one post and yawed to nearly 180 degrees before being redirected, then rebounded down the back slope and tripped. It is believed that the vehicle made two and a half complete revolutions. Because the median rolled through the center of the V-ditch and back up the approach slope, vehicle damage was extensive.

Figure 70. Example Rollover Crash Caused by High Redirection on Back Slope

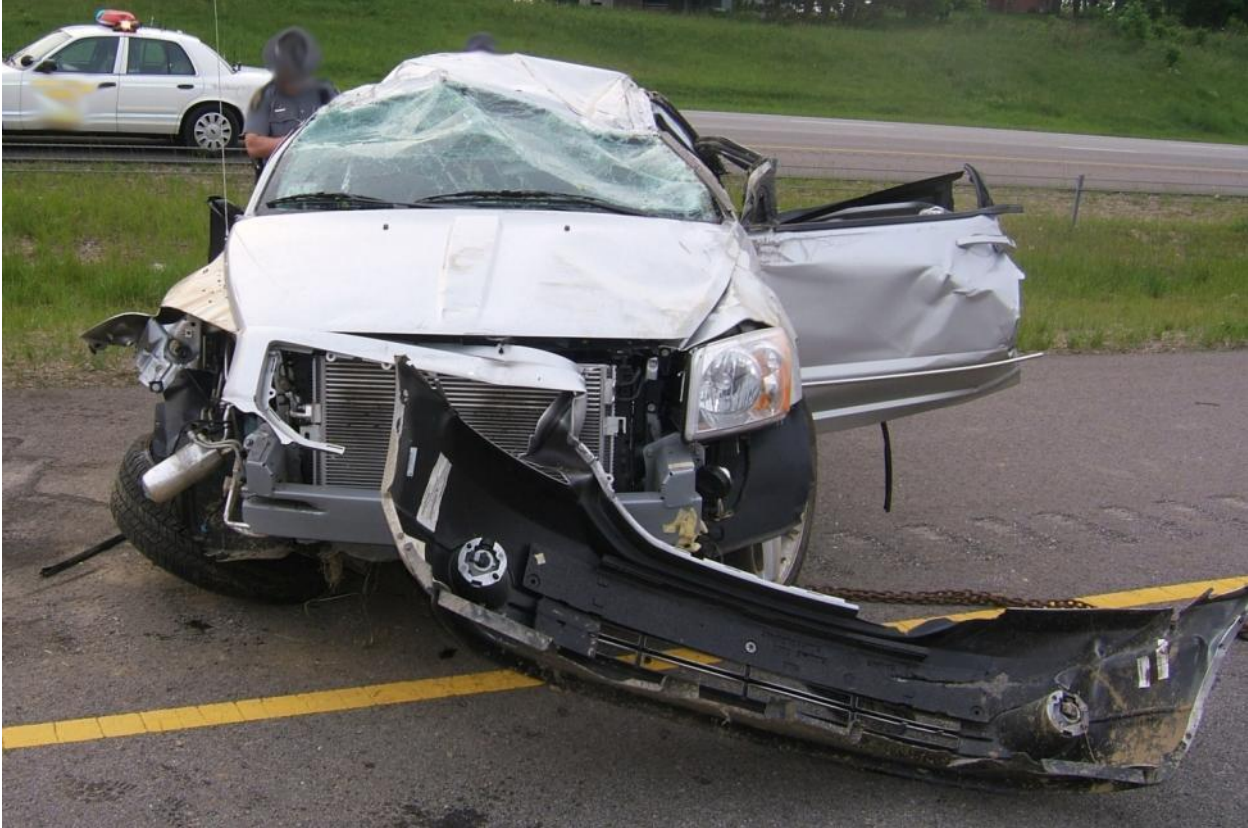
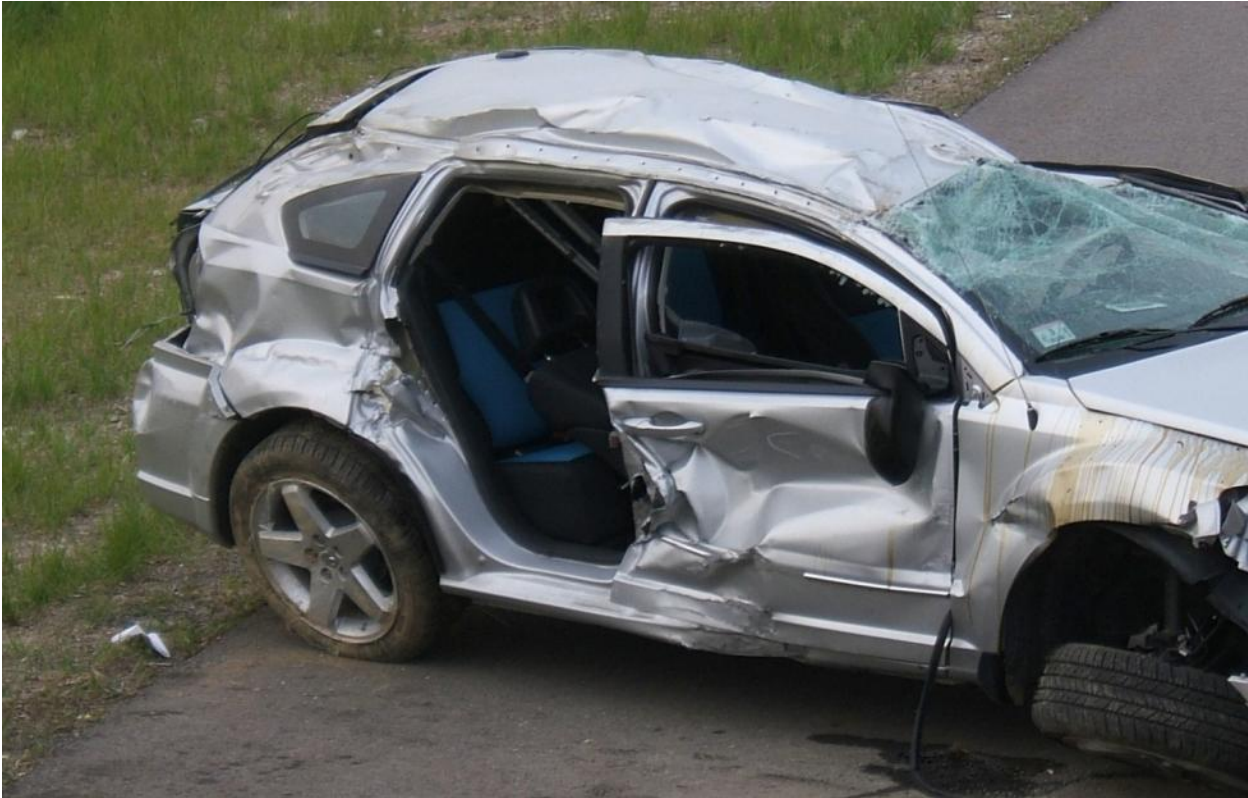
Figure 71. Example Rollover Crash Caused by Redirection on Back Slope (continued)

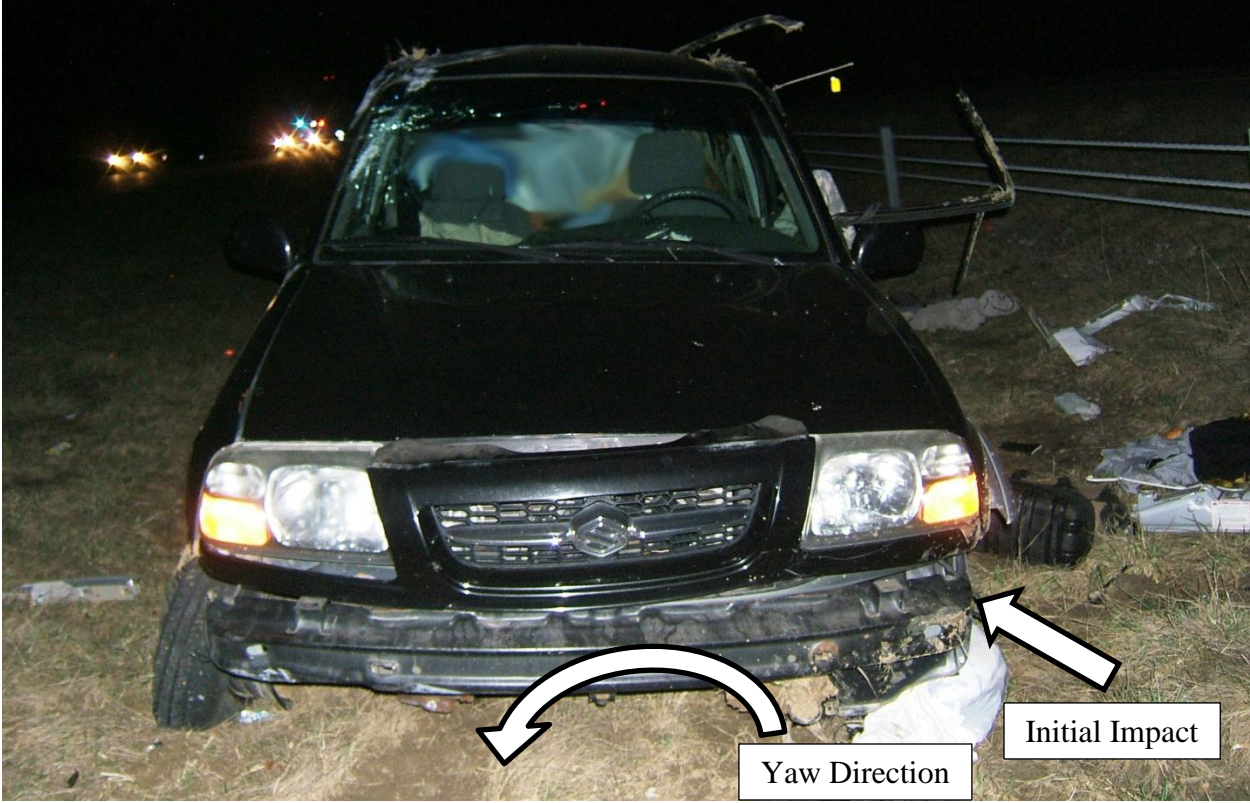
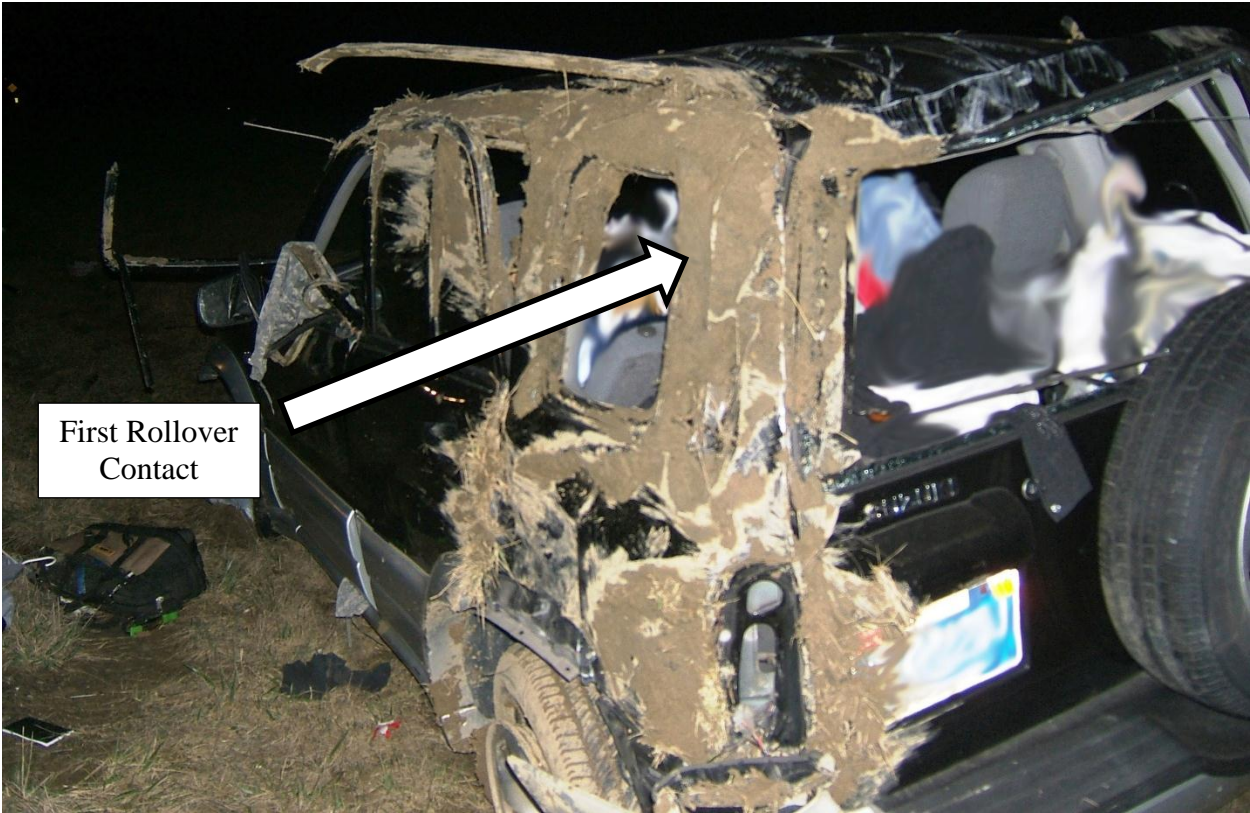
Figure 74. Example Rollover Crash Caused by High Orientation Angle at Impact

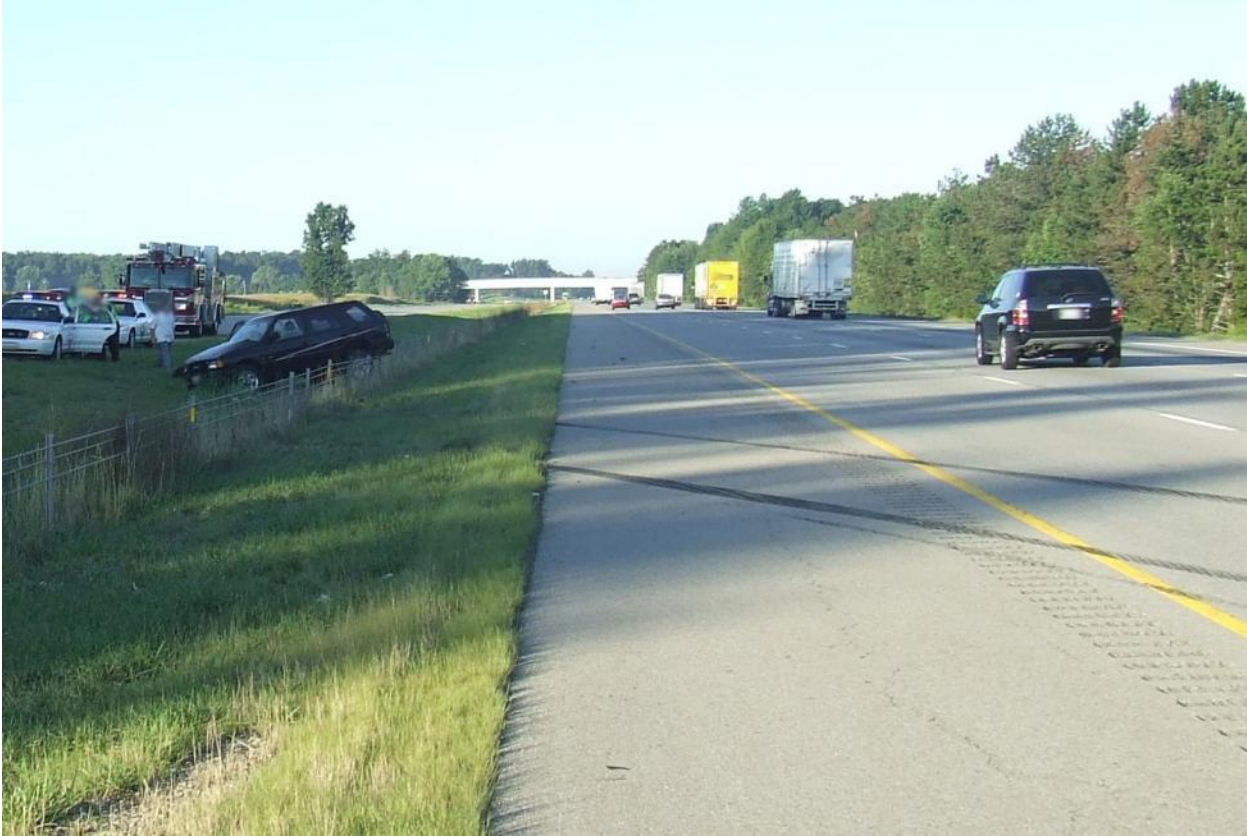
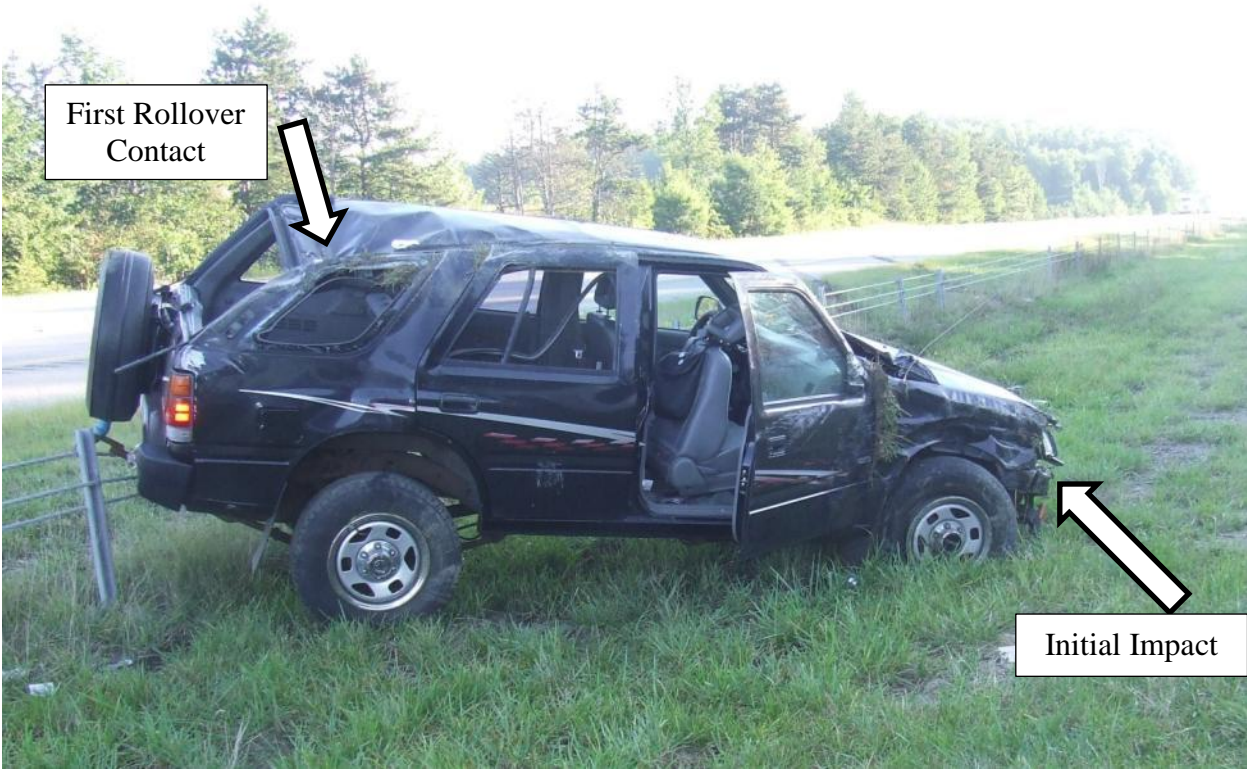
Figure 75. Example Rollover Crash Caused by High Orientation Angle at Impact

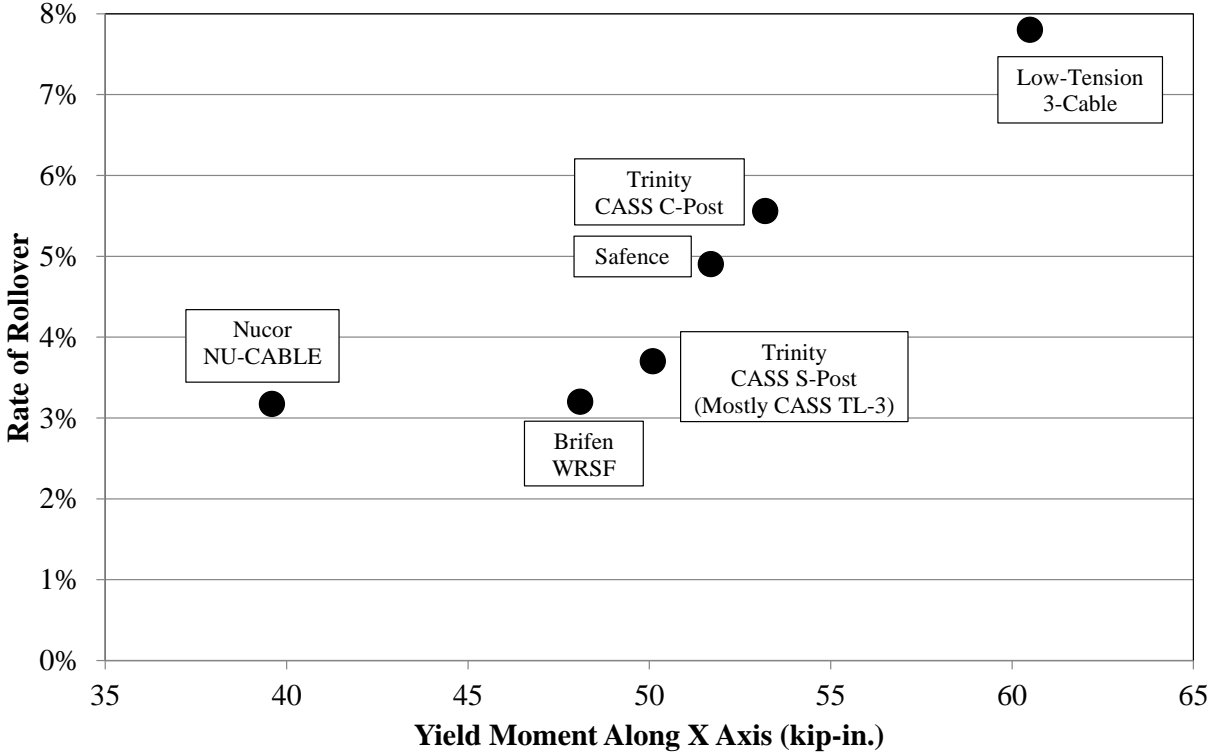
Figure 80. X-Axis (Typ. Strong Axis) Yield Moment Relationship with Rollover Frequency
