# **ZONE OF INTRUSION FOR PERMANENT 9.1-DEGREE SINGLE-SLOPE CONCRETE BARRIERS**

## **MIDWEST ROADSIDE SAFETY FACILITY**

MwRSF Research Report No. TRP-03-292-13

March 14, 2014

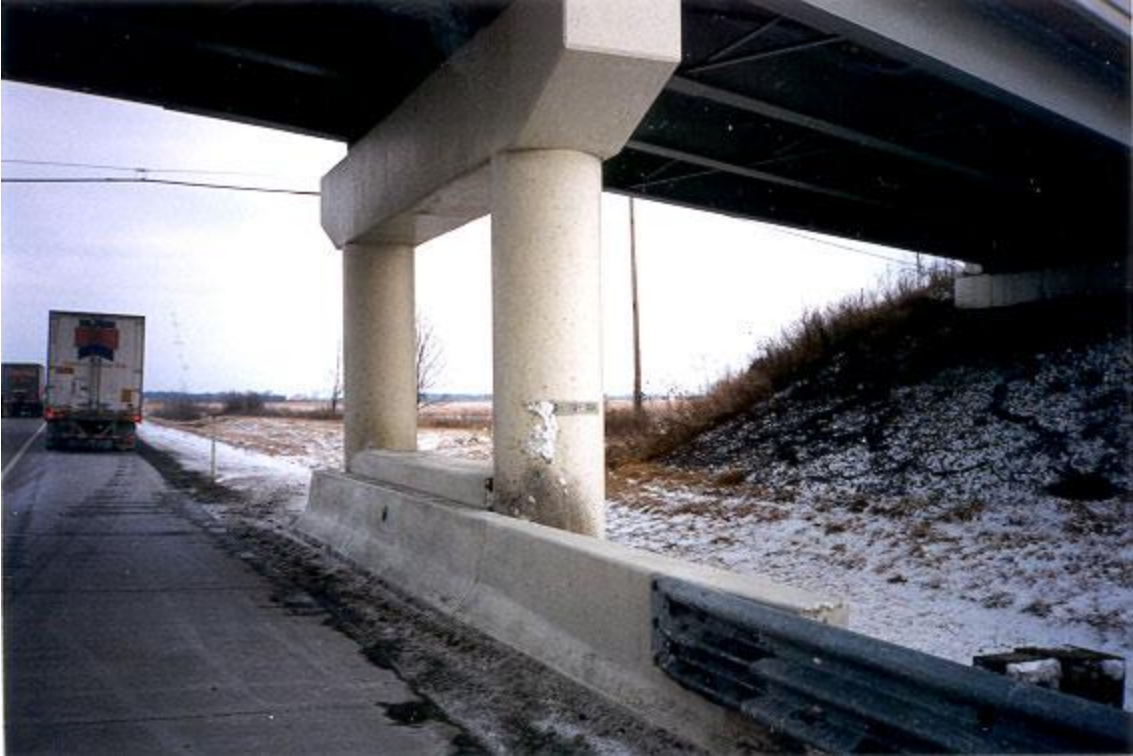
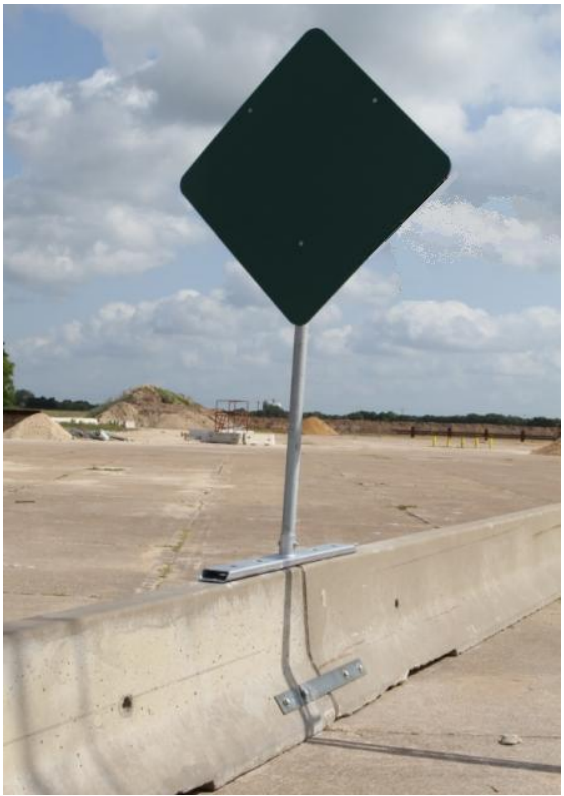
Figure 1. Hazards Located Within the Zone of Intrusion

and cause the system to fail the full-scale crash criteria set forth in MASH and NCHRP Report No. 350. A few examples of hazards located within the zone of intrusion are shown in Figure 1.

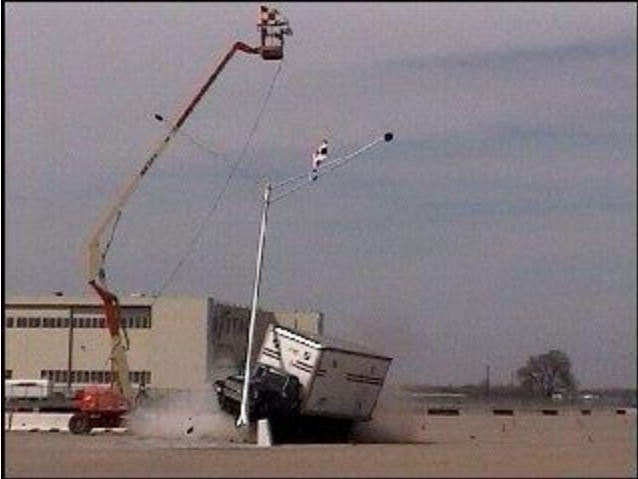
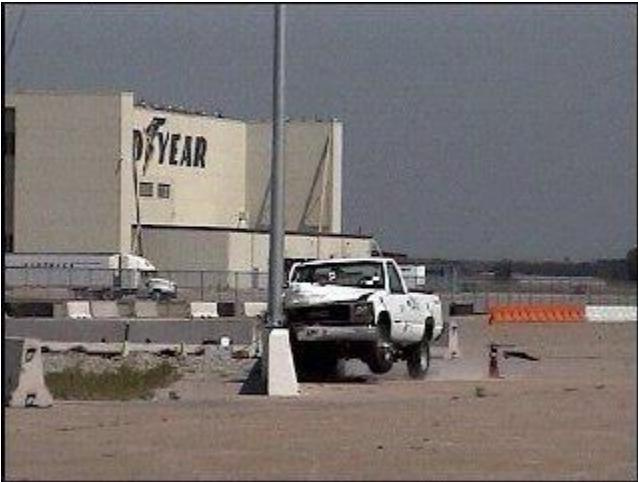
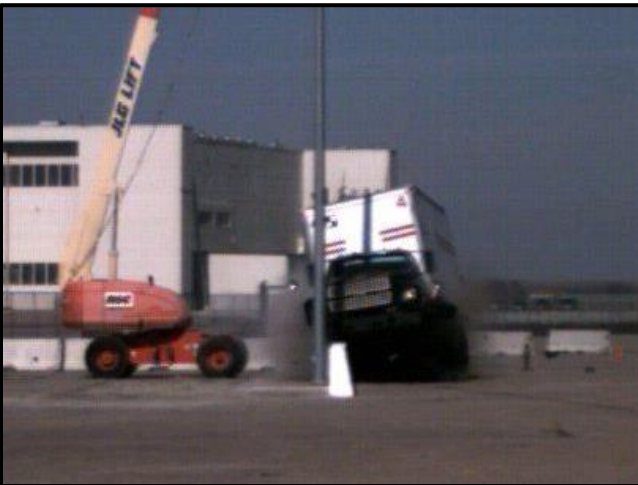
Figure 2. Zone of Intrusion Tests ZOI-1, ZOI-2, and ZOI-3 [11]

In 2008, MwRSF published a follow-up study to the barrier attachments research [11]. Three full-scale tests were conducted on a 32-in. (813-mm) tall, 10.8-degree single-slope concrete barrier, as shown in Figure 2. A luminaire pole was mounted on top of the barrier inside the ZOI. For the first test, a 17,605-lb (7,985-kg) single-unit truck (SUT) impacted the barrier system 55 ft (16.8 m) upstream of the centerline of the luminaire pole, shown in Figure 2a. The vehicle struck the pole, and the pole was dislodged. Researchers determined that the test was acceptable and that the impact with the luminaire pole did not cause significant risk to the occupants.

For the third test, a 17,637-lb (8,000-kg) SUT impacted the single-slope barrier 54 ft 6 in. (16.6 m) upstream of the centerline of the pole. The vehicle struck the pole, but it was not enough force to cause the pole to be dislodged, and no adverse effects were noted on the vehicle due to the impact with the pole.

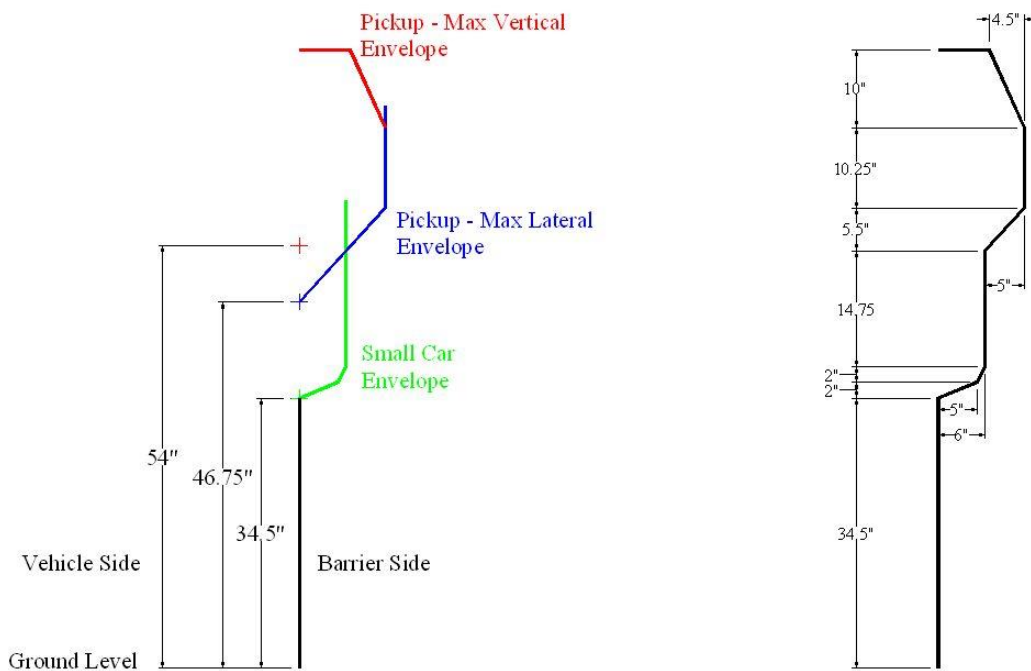
Figure 3. Head Ejection Envelope [12]

MwRSF researchers also developed guidelines for head ejection criteria [12]. During an impact with a roadside barrier, researchers noticed that the occupant's head will occasionally protrude through the impact-side window, potentially impacting hazards outside of the vehicle. Thus, an envelope was created based on measured head protrusions of dummies during full-scale crash tests, as shown in Figure 3. For barriers to meet the head ejection criteria, no hazard may be placed inside the envelope.

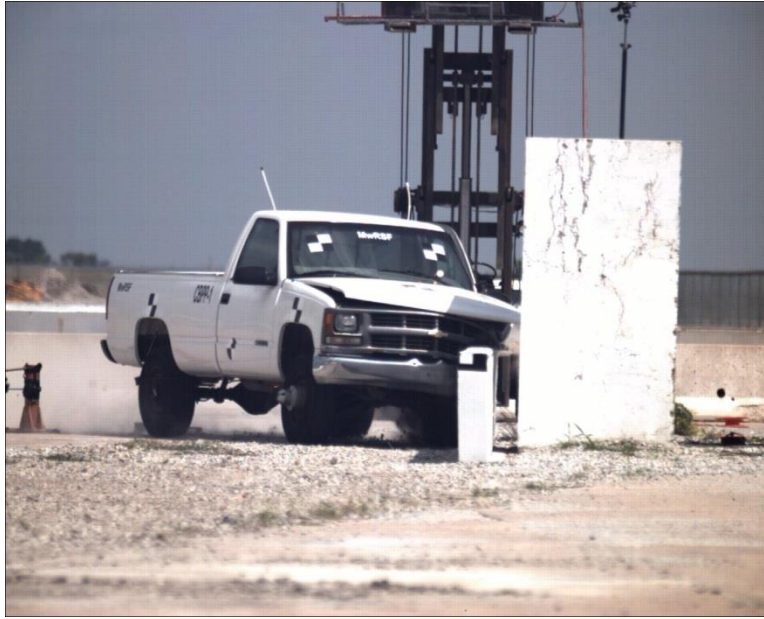
Figure 4. Impacting a Bridge Pier in the ZOI

Similar studies have had similar results. In 2007, MwRSF conducted a test on a concrete bridge pier protection system [14]. The barrier consisted of a 32-in. (813-mm) tall, vertical-faced permanent concrete barrier with bridge piers located 16¾ in. (425 mm) behind the front face of the barrier. As determined by overhead video analysis, the vehicle hood protruded 19.8 in. (503 mm) beyond the front face of the barrier and struck the bridge pier, as shown in Figure 4. This behavior did not negatively affect the test, and after some deformation of the vehicle hood, the vehicle continued to redirect downstream. The occupant safety was not compromised during the test. Once again, no dummy was used during this test, so it is unknown as to whether or not the system would have passed if a dummy was placed in the vehicle.

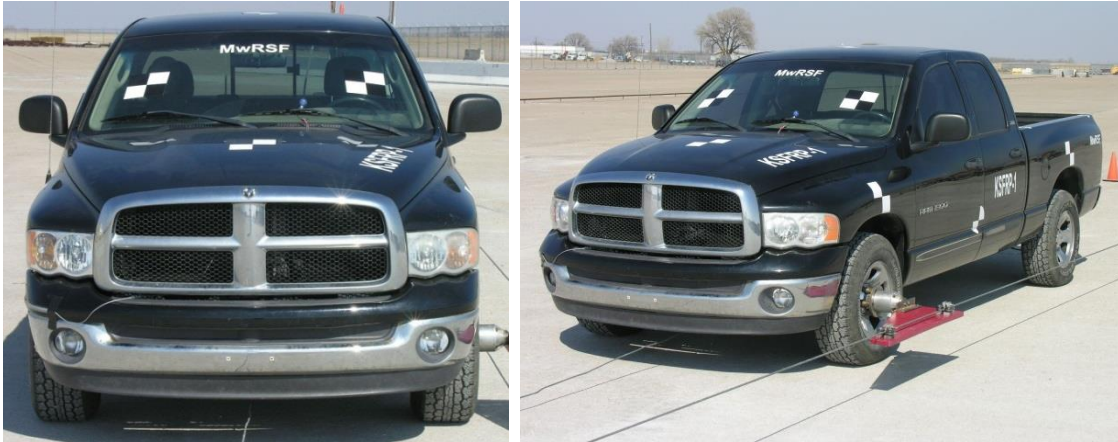
Figure 5. Dodge Ram Hood and Fender Geometry

The ZOI for these barriers may be misleading. ZOI data shown in Table 2 were measured from tests utilizing Dodge Ram pickup trucks, which have a front-end geometry that is very dissimilar to other pickup trucks on the roadway today. For the Dodge Ram pickup truck, the hood is rigidly attached to the grill of the vehicle, and the hood is trapezoidal in shape, as shown

in Figure 5. Some vehicles, such as the Chevy Silverado, have rectangular hoods which are more likely to protrude over a barrier upon impact, as shown in Figure 6. Thus, the actual ZOI may be larger than the ones shown in Table 2.

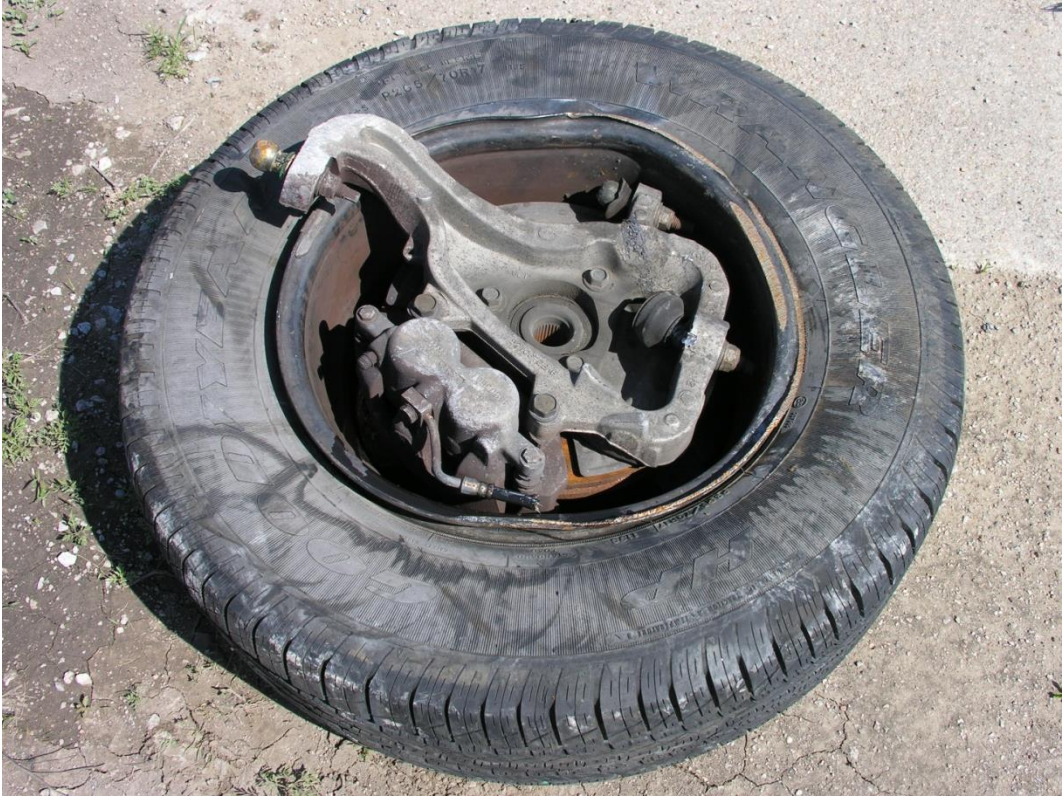
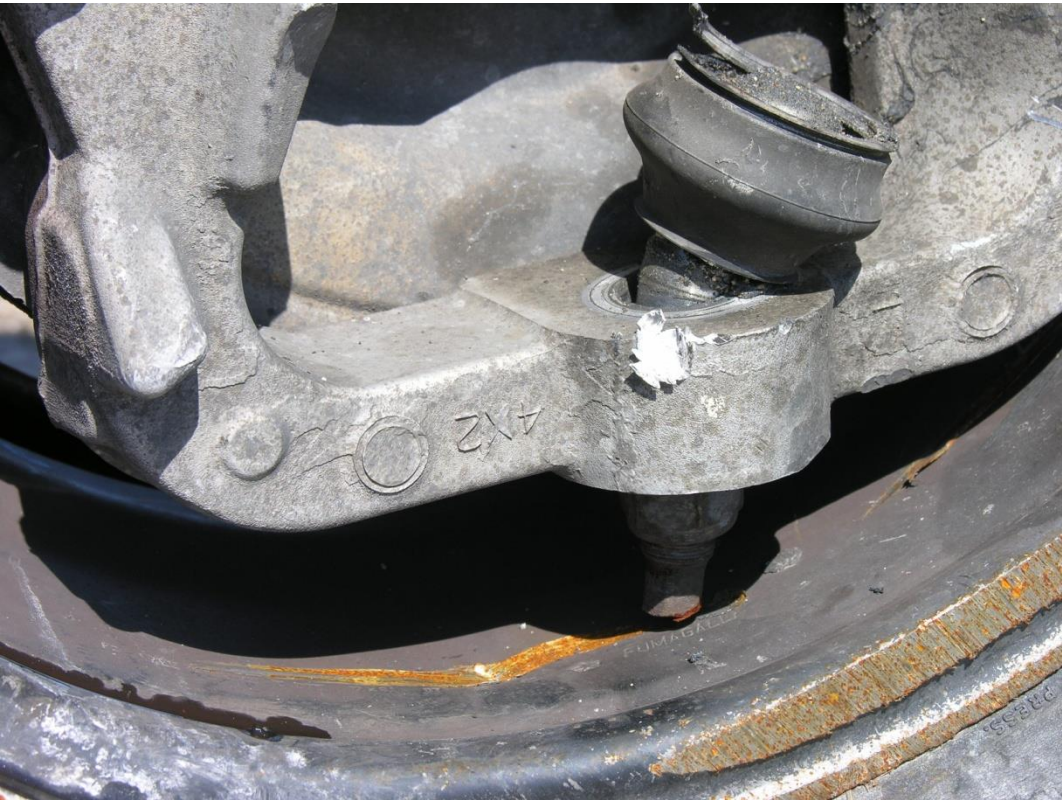
Figure 7. Inside of Wheel Damage, Test No. PCMB-1

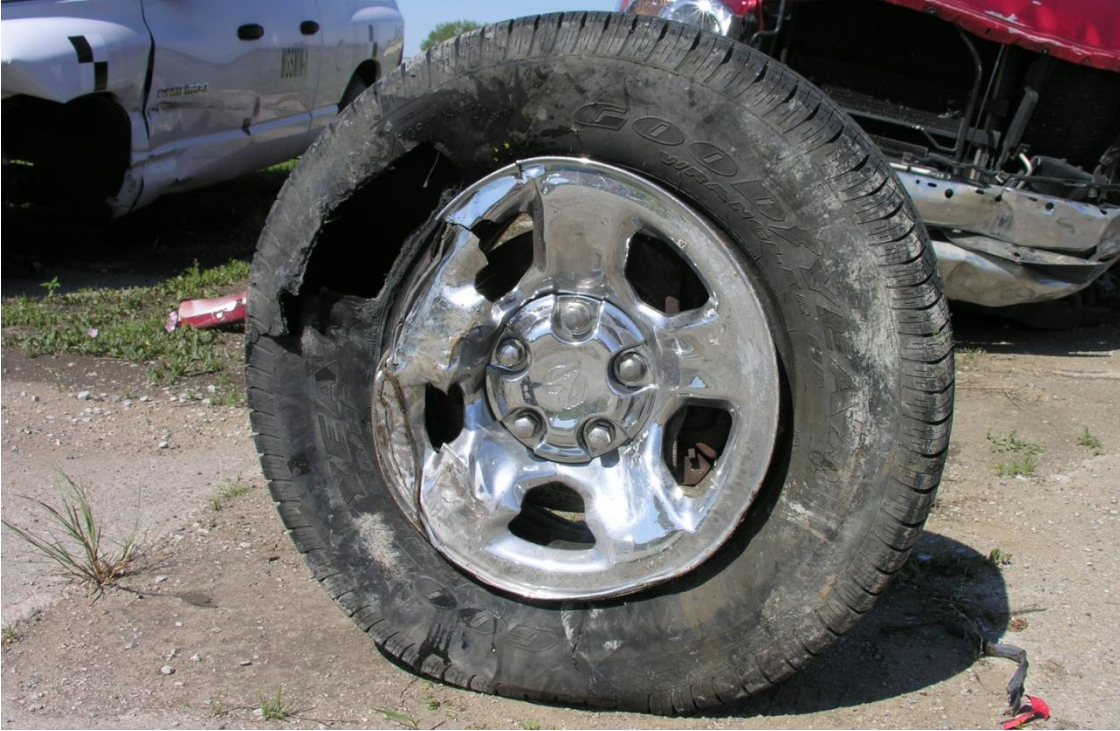
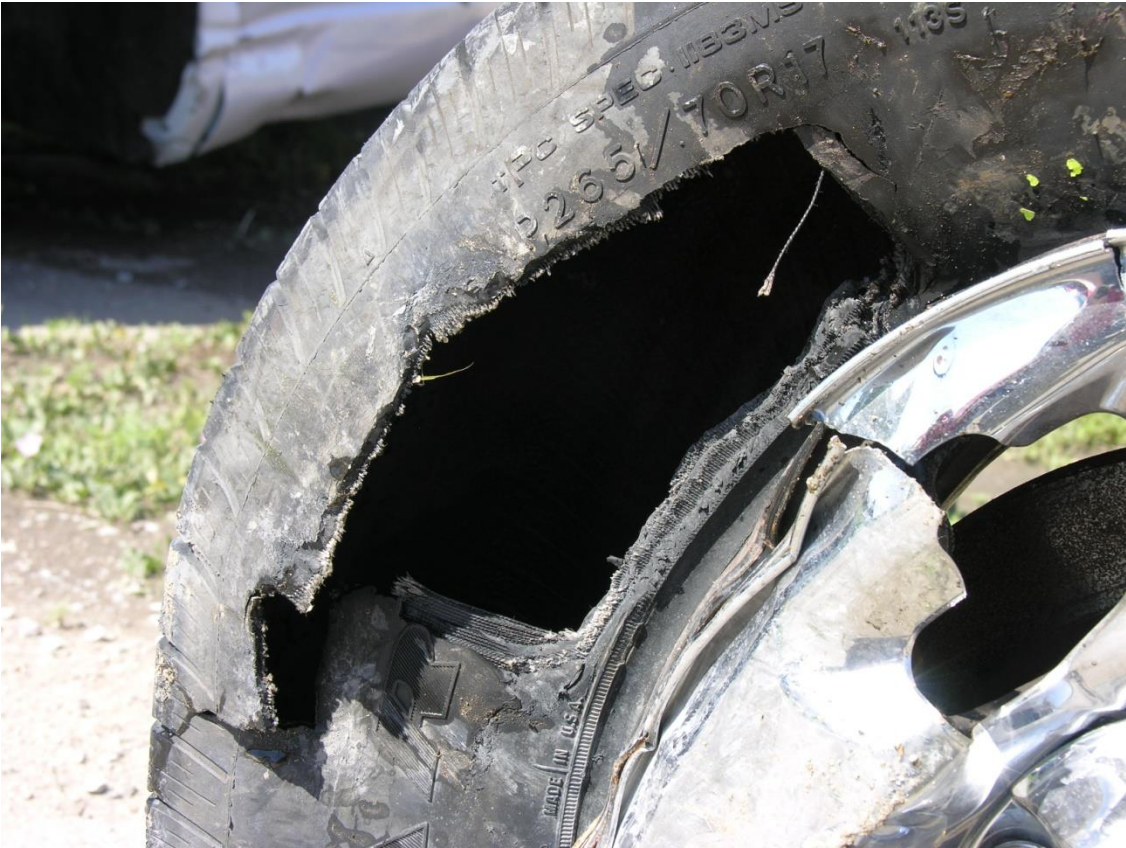
Figure 8. Outside of Wheel Damage, Test No. PCMB-1

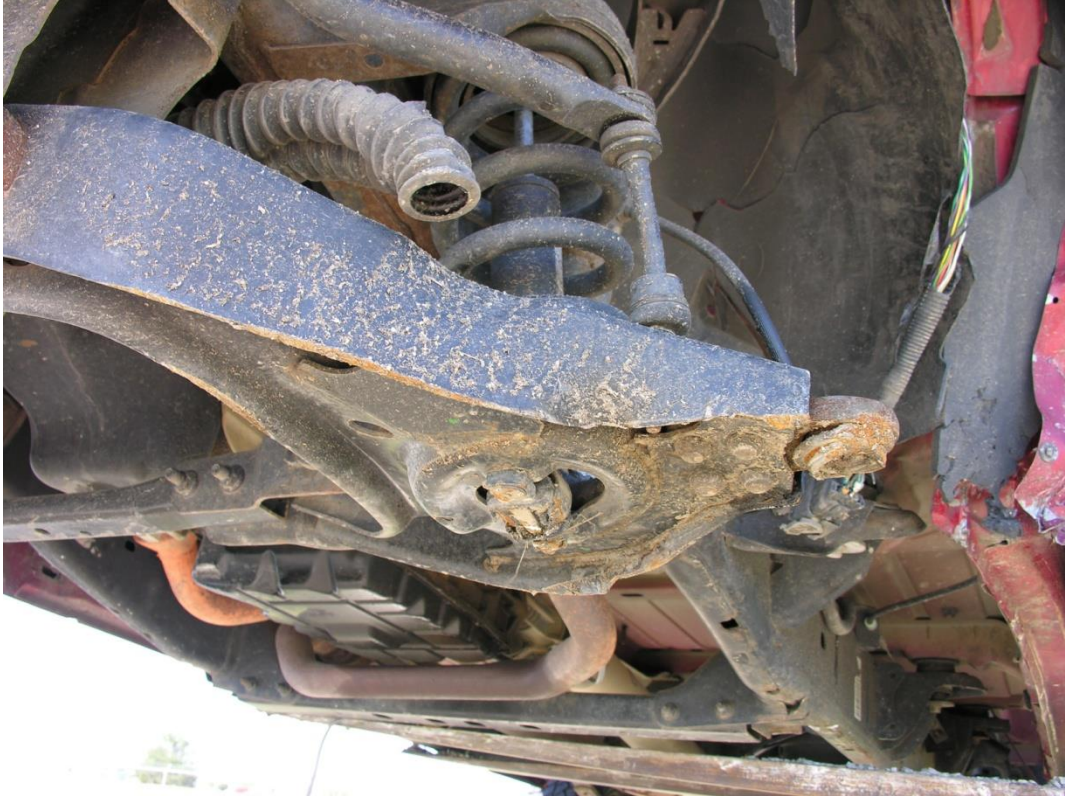
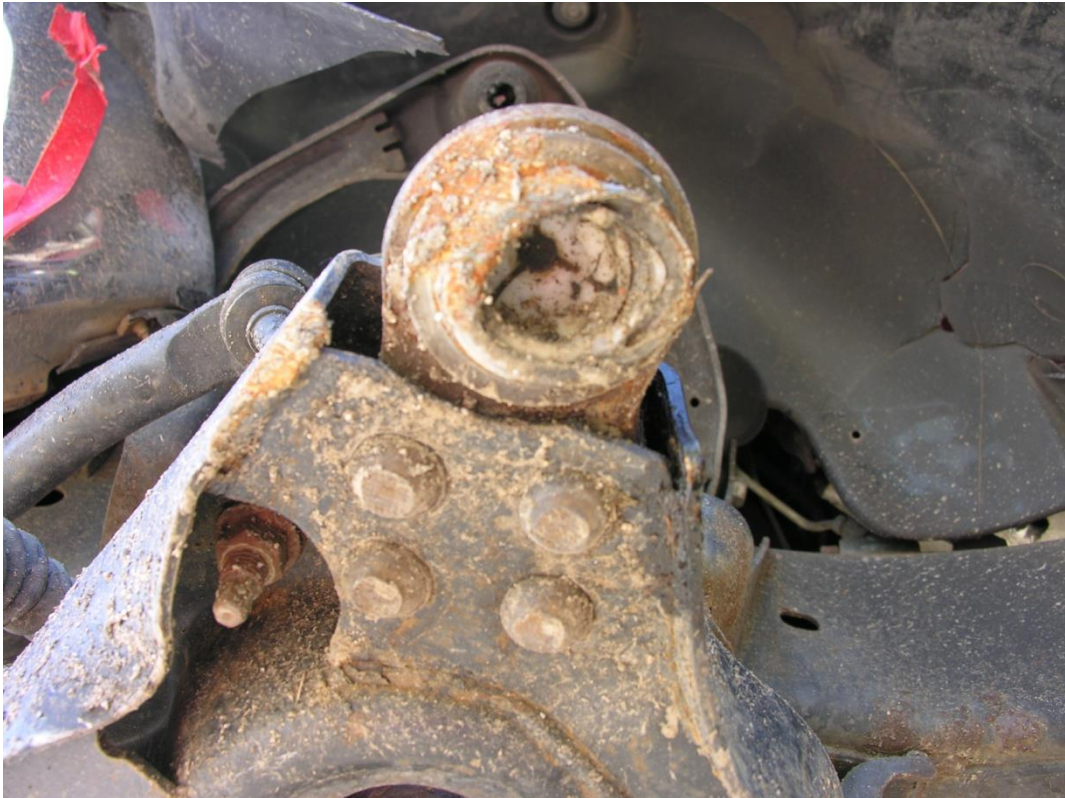
Figure 9. Lower Control Arm Damage, Test No. PCMB-1

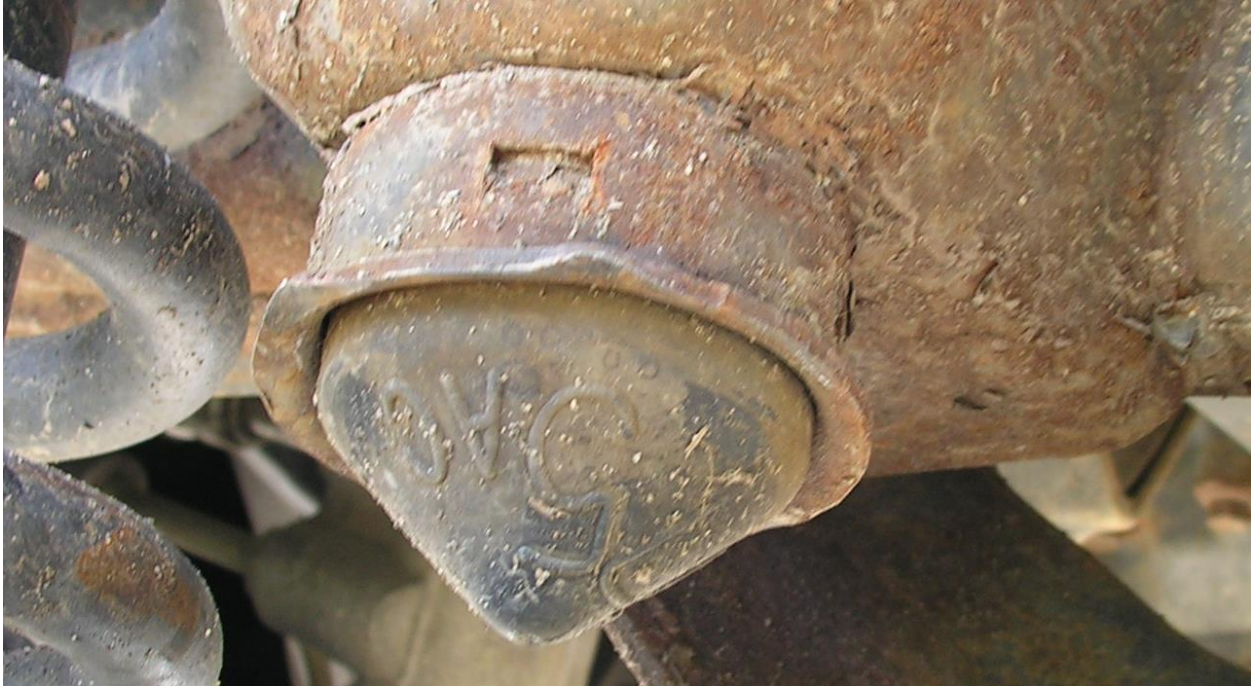
Figure 11. Bump Stop and Upper Control Arm Damage, Test No. PCMB-1

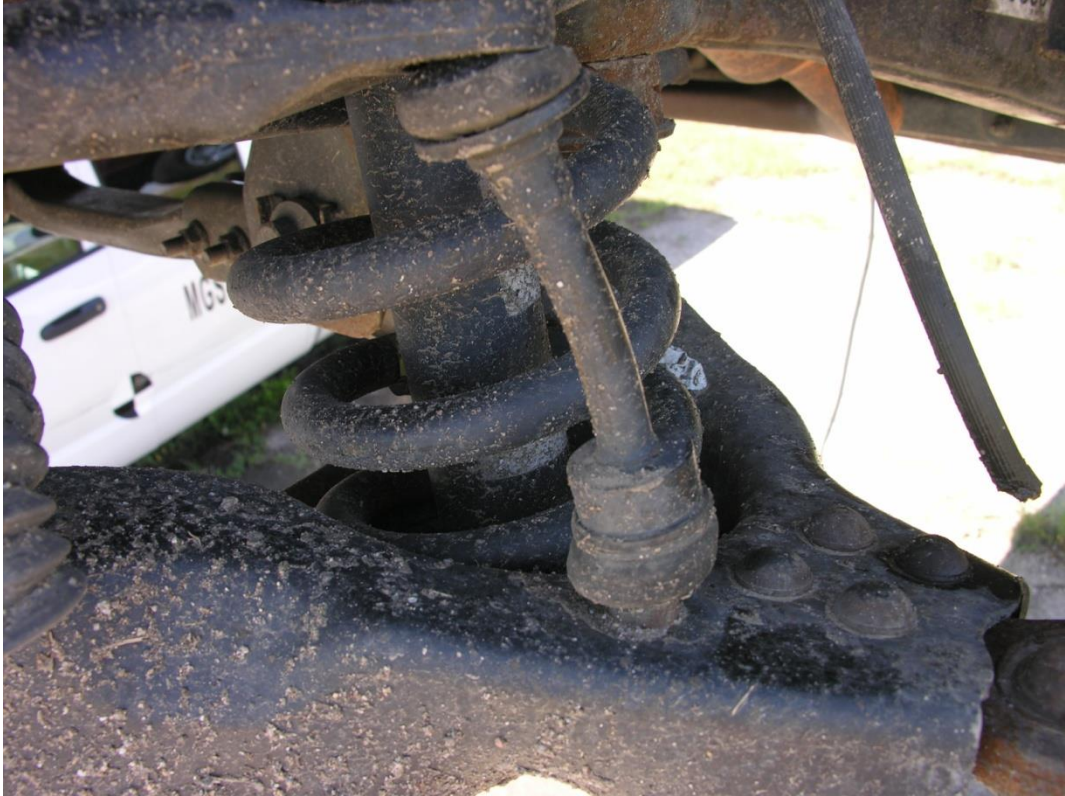
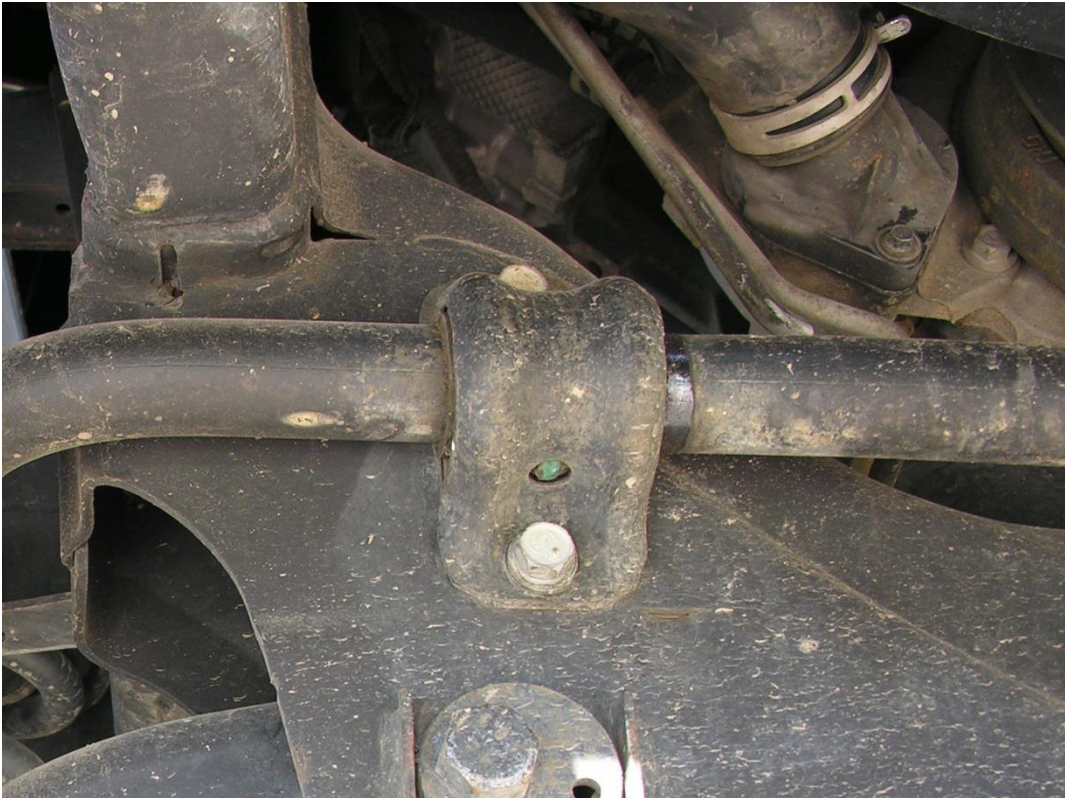
Figure 12. Roll Bar and Connecting Pin Damage, Test No. PCMB-1

The link connecting the roll bar to the lower control arm was bent, as shown in Figure 12. Also, the impact side of the roll bar was twisted and bent downward. The roll bar shifted  $\frac{1}{8}$  in. (3 mm) toward the impacting side, as determined from the scrape marks seen around the link connecting the roll bar to the frame of the vehicle, shown at the bottom of Figure 12.

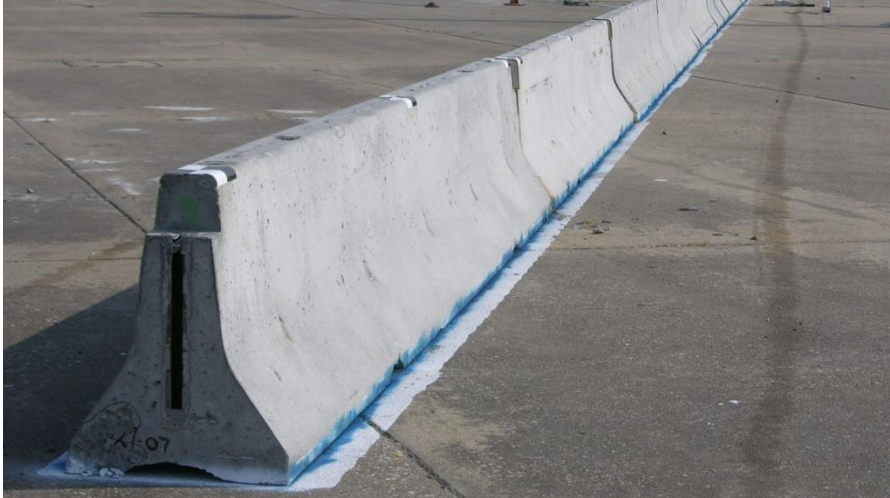
a) Free-Standing Temporary Concrete Barriers

deformation of the vehicle suspension and fender. An unrestrained temporary concrete barrier system is shown in Figure 13a.

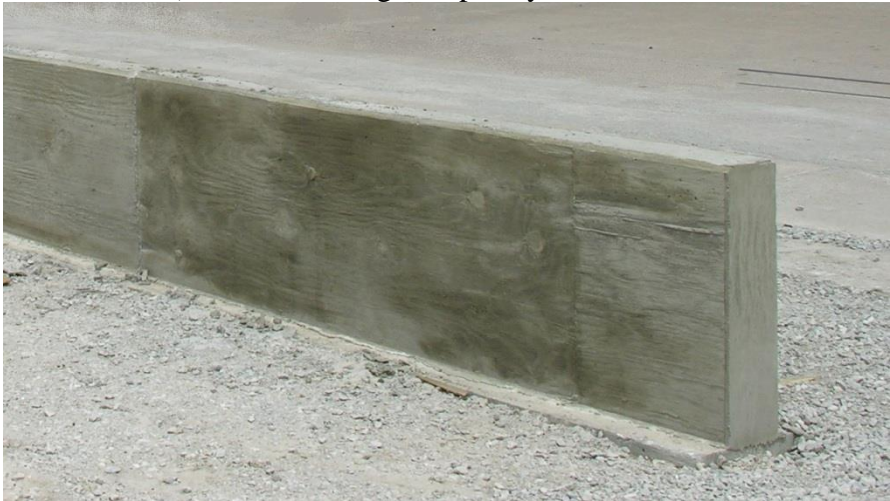
b) Permanent Concrete Barrier

Compared to segmented, free-standing concrete barriers, permanent concrete barrier systems (such as continuous barriers or systems with the base of the barrier buried into the ground) absorb a small amount of the lateral energy during the impact sequence. Energy absorbed by the concrete barrier occurs in the form of compression and deformation of the concrete. Elastic and plastic deformation of the vehicle sheet metal and suspension components absorb part of the lateral energy. Some energy is transmitted into vehicle climb up the barrier and roll, pitch, and yaw motions. A permanent concrete barrier is shown in Figure 13b.

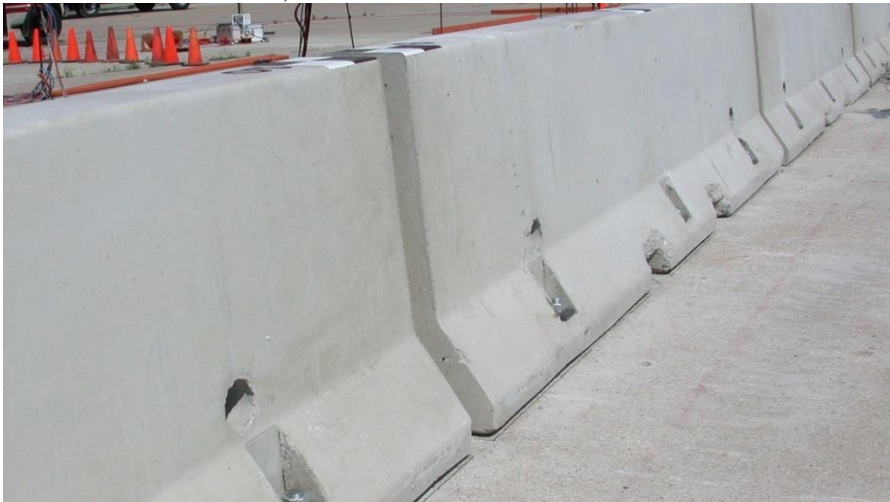
c) Temporary Concrete Barriers with Restrained Movement

Some temporary concrete barrier systems are restrained from having excessive deflections, allowing temporary barriers to be used in places where permanent barriers are necessary. These barriers absorb energy in methods similar to a permanent concrete barrier system, as well as deformation of pins and loops as well as fracture of the barrier near the joints. A restrained-motion temporary barrier is shown in Figure 13c.

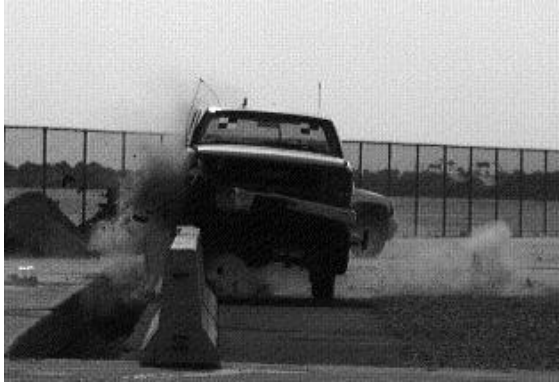
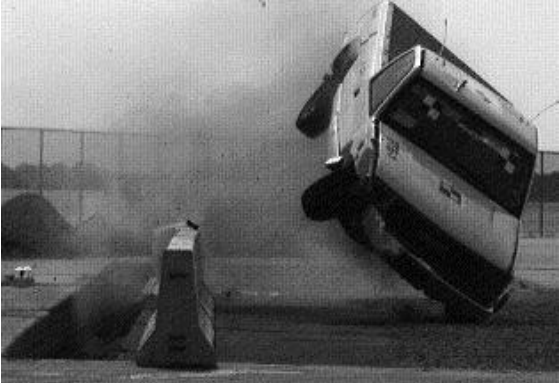
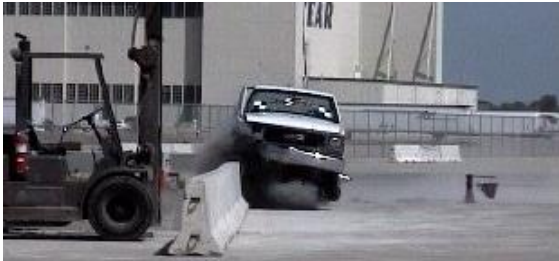
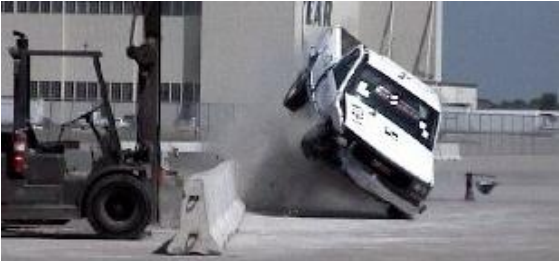
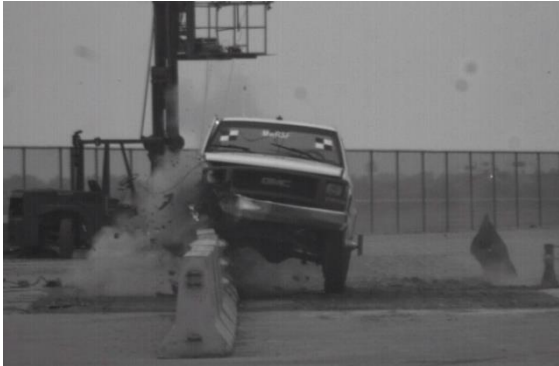
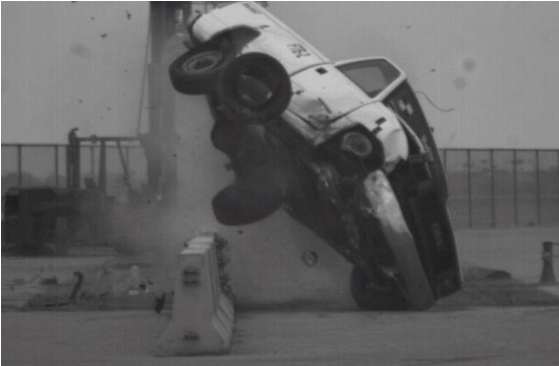
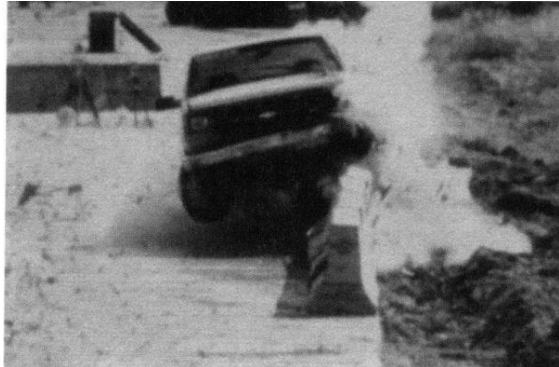
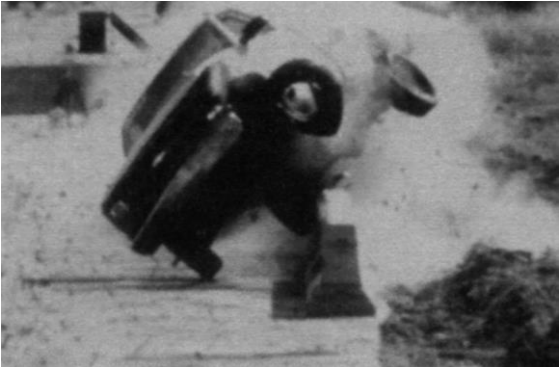
Figure 14. Post-Impact Trajectories of F-Shape Concrete Barrier Crash Tests

The post-impact vehicle trajectory was compared for different F-shape barrier tests, as shown in Figure 14. The sequential images from the fixed barrier full-scale crash test were not included here because of their poor quality [28]. Also, one test was not included in this analysis because the barrier joints failed during the test (which is unrepresentative of the barrier motion during a fixed, permanent barrier test).

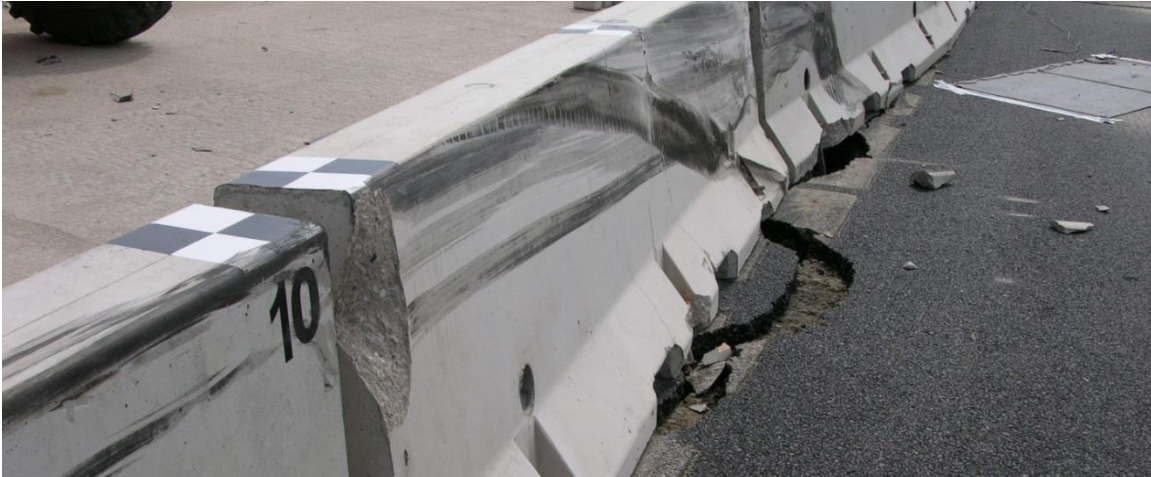
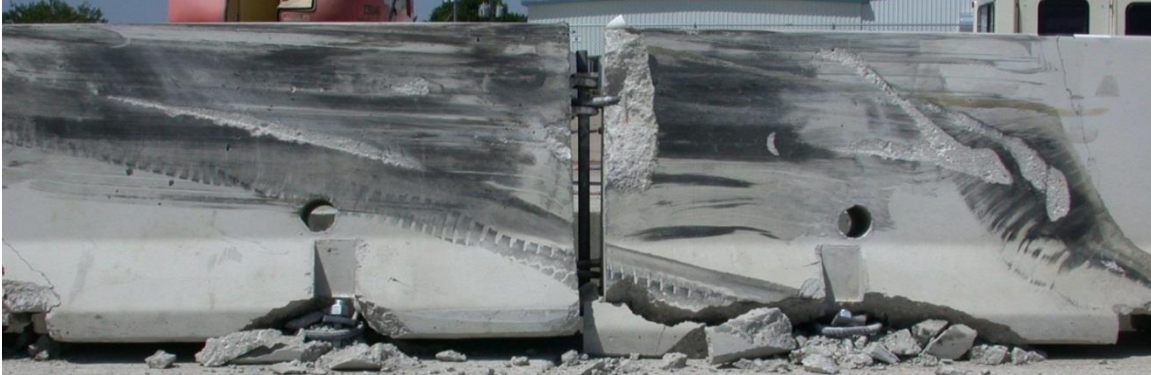
Figure 15. Impacting Tire Ride-Up for Different Full-Scale Crash Tests

All of the full-scale tests showed significant tire climb on the upper sloped face of the barrier, with several of the tires climbing the entire barrier face. The impacting tire ride-up on the barrier for several tests is shown in Figure 15. As the tire climbed the barrier, tire scrubbing occurred, and the rim scraped along the barrier as well. This caused gouging and contact marks to be present along the front face of the barrier for much of the length of contact.

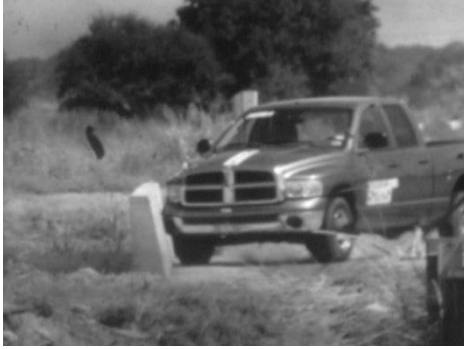
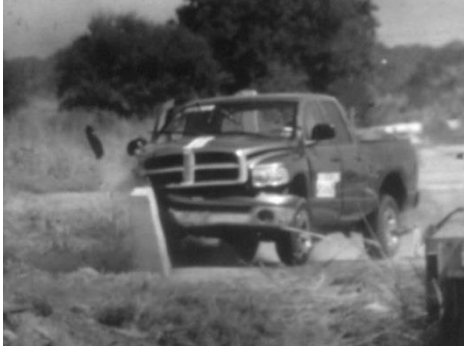
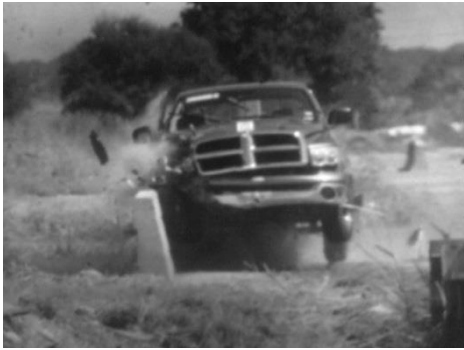
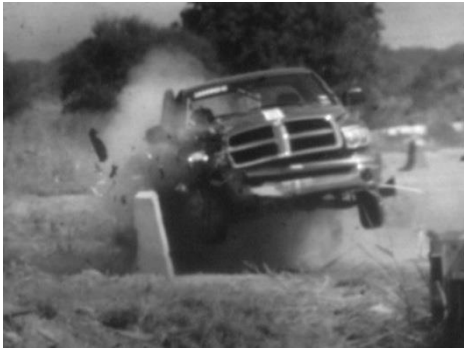
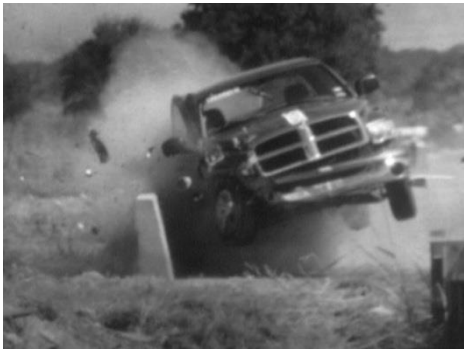
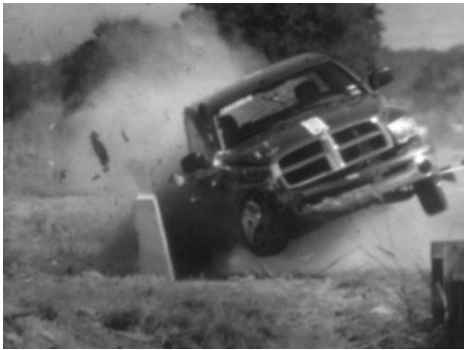
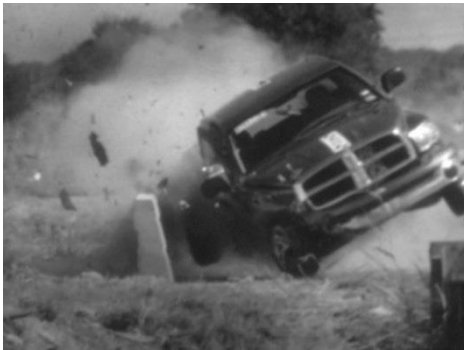
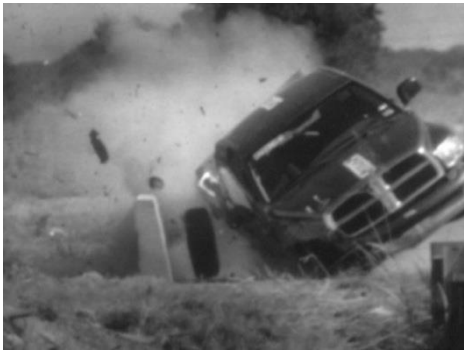
Figure 19. Sequential Events from TTI Test No. 420020-3 [6]

The concrete barrier constructed for test no. 420020-3 consisted of a 36-in. (914-mm) tall, permanent, single-slope half-section bridge rail, as shown in Figure 18. In the full-scale test, the barrier was impacted by a 5,036-lb (2,284-kg) 2005 Dodge Ram 1500 pickup truck [6]. The impacting tire climbed the barrier immediately, and the vehicle began to pitch upward. Despite the tire climb on the barrier, the vehicle rolled toward the barrier as the vehicle became airborne. The vehicle continued to roll toward the barrier until it contacted the ground. Sequential photographs from the full-scale crash test are shown in Figure 19.

Sequential images from the small-mesh baseline simulation with the 2270P pickup truck impacting the Texas single-slope concrete median barrier are shown in Figure 23. The overall vehicle crush, impacting tire motion, and vehicle trajectory were very consistent with the full-scale test results, shown in Figure 19.

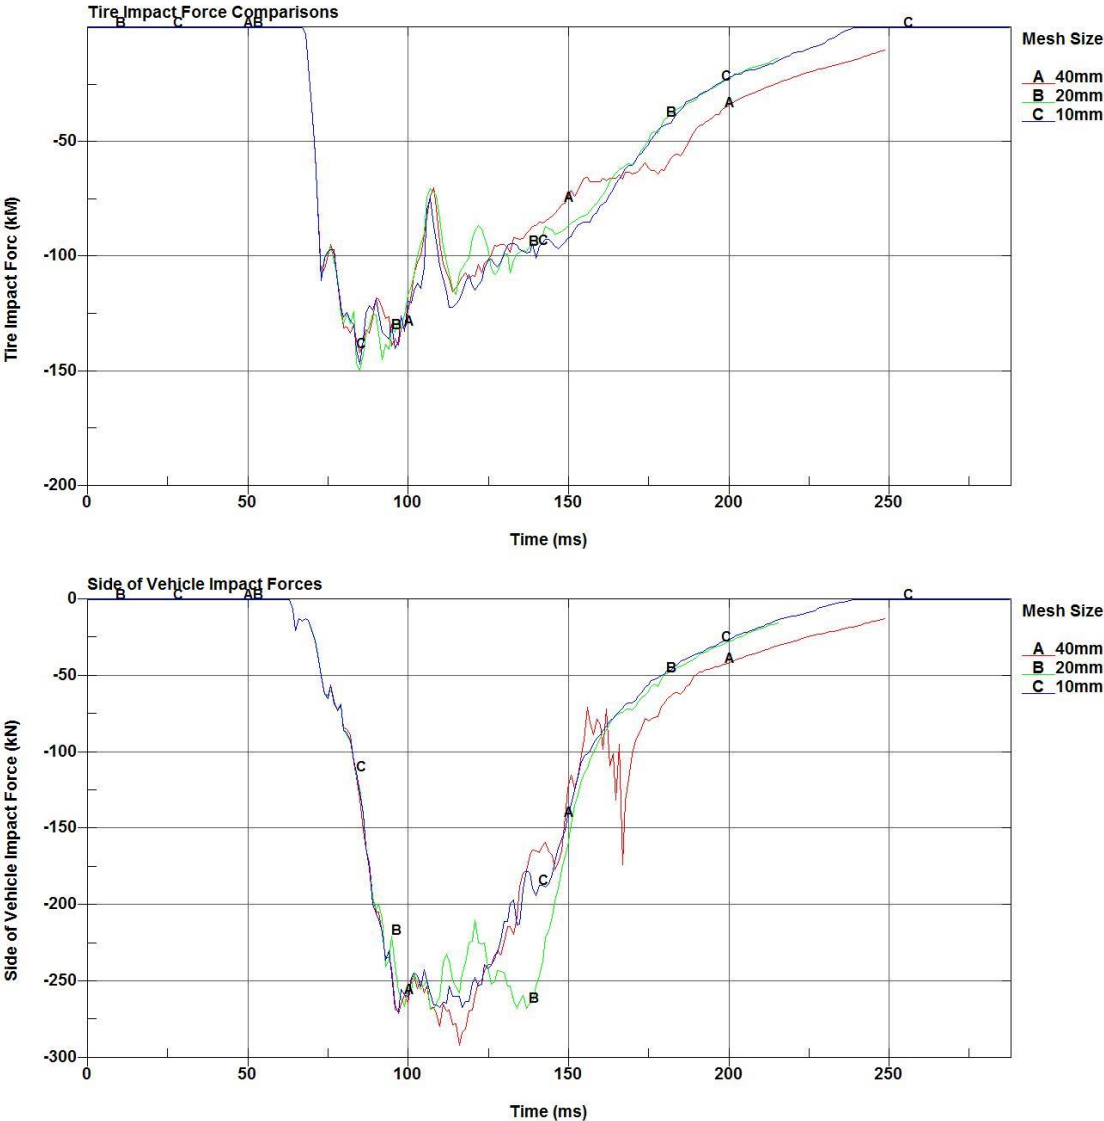
Figure 21. Tire and Vehicle Body Impacting Forces for Varying Barrier Mesh Sizes

Tire and vehicle body impact forces were measured and plotted for the simulation runs, as shown in Figure 21. The smallest mesh produced the softest impact with the lowest peak force values. The largest mesh showed the highest peak lateral forces as the vehicle impacted the barrier. There was a significant difference in the impact forces exerted by the 0.79-in. (20-mm) and 1.57-in. (40-mm) mesh sizes, while the medium and small mesh sizes had similar force values

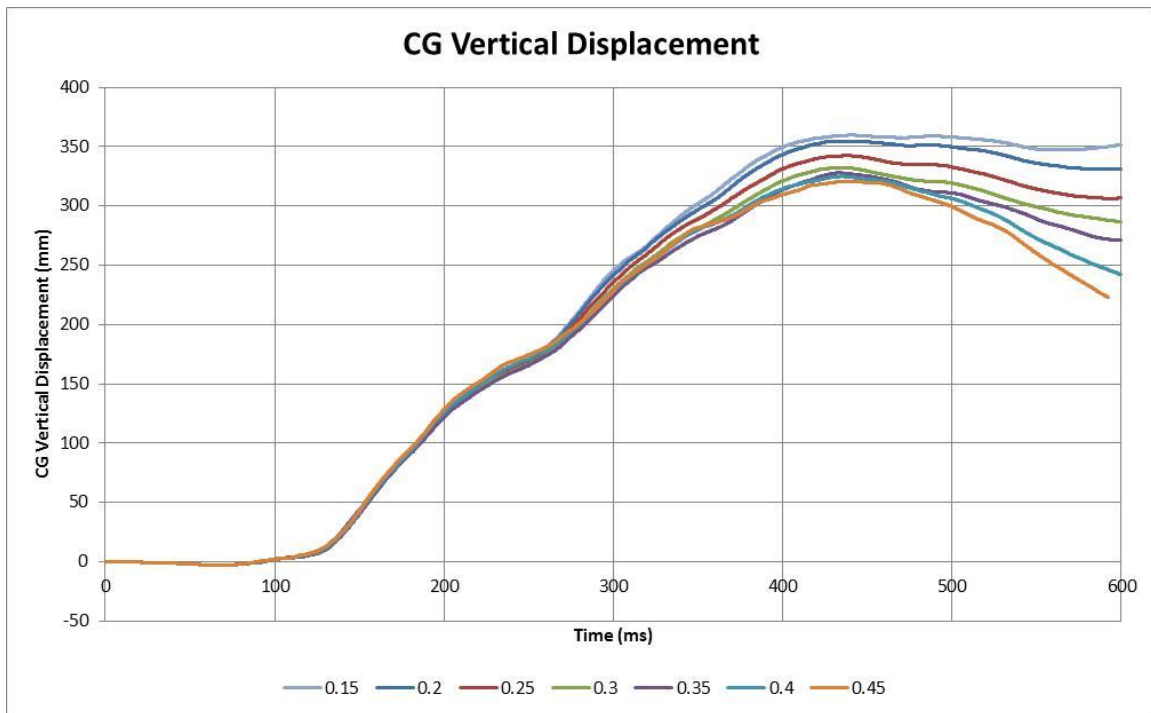
Figure 25. Vehicle Vertical Displacement

The vehicle vertical displacement is shown in Figure 25. The vertical displacement here is due to the tire climbing up the barrier. Two factors affect how high the vehicle is vertically displaced: (1) the suspension stiffness, and (2) the height of the tire climb. Since the suspension stiffness is independent of the friction between the tire and the barrier, the tire climb is the major factor contributing to the disparity in the vertical displacement of the vehicle.

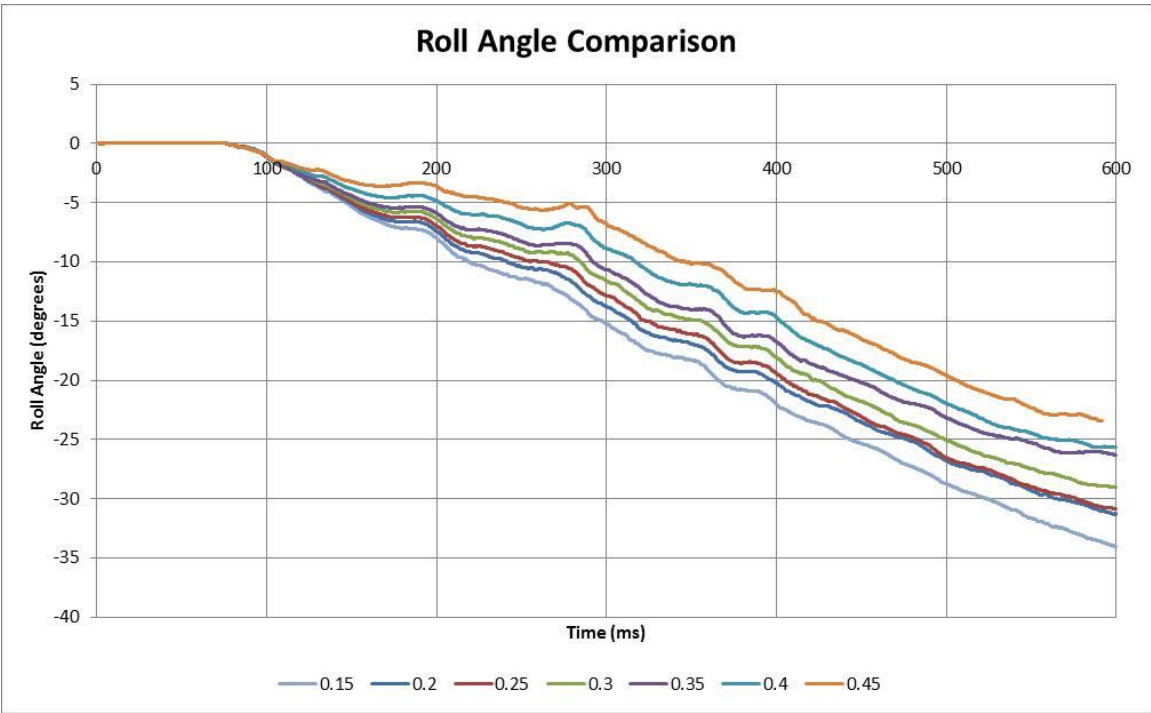
Figure 26. Vehicle Roll Angle for Varying Tire-to-Barrier Friction Coefficients

The roll angles for the different runs were measured and are shown in Figure 26. The roll angle is initially affected by two different factors: (1) the lateral redirecting force exerted on the tire by the barrier and (2) the vertical force exerted by the suspension. The deformed tire from the Silverado impact is shown in Figure 27. Assuming that these results are realistic, the simulations imply that decreased barrier friction causes an increased roll risk.
