# **ZONE OF INTRUSION FOR PERMANENT 9.1-DEGREE SINGLE-SLOPE CONCRETE BARRIERS**

## **MIDWEST ROADSIDE SAFETY FACILITY**

MwRSF Research Report No. TRP-03-292-13

March 14, 2014

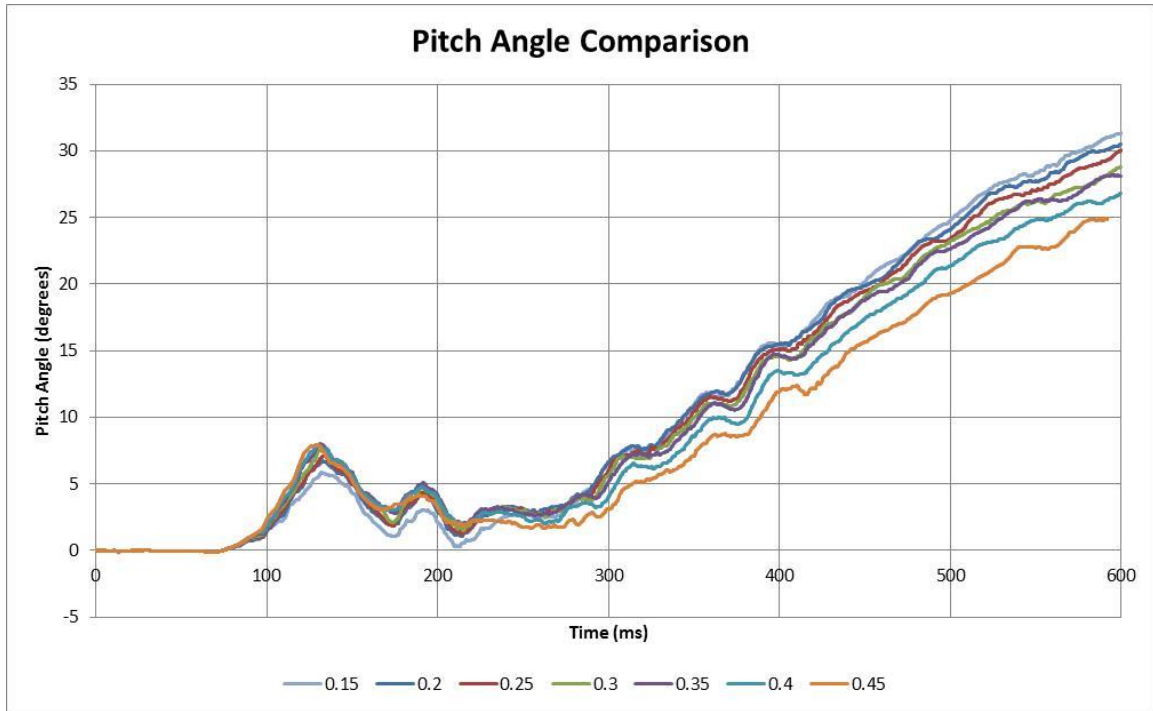
Figure 28. Vehicle Pitch Angle Measured from Local Coordinate Axes

The forces contributing to the pitch angle of the vehicle immediately after impact are the vertical forces acting upward on the suspension and the vertical friction forces acting downward on the tire as the vehicle climbs the barrier and the tire is scrubbed against the barrier. The roll, pitch, and yaw angles were measured using the local coordinate axes set established in the Silverado model at the vehicle c.g. The pitch angles as measured from the local coordinate axes are compared in Figure 28.

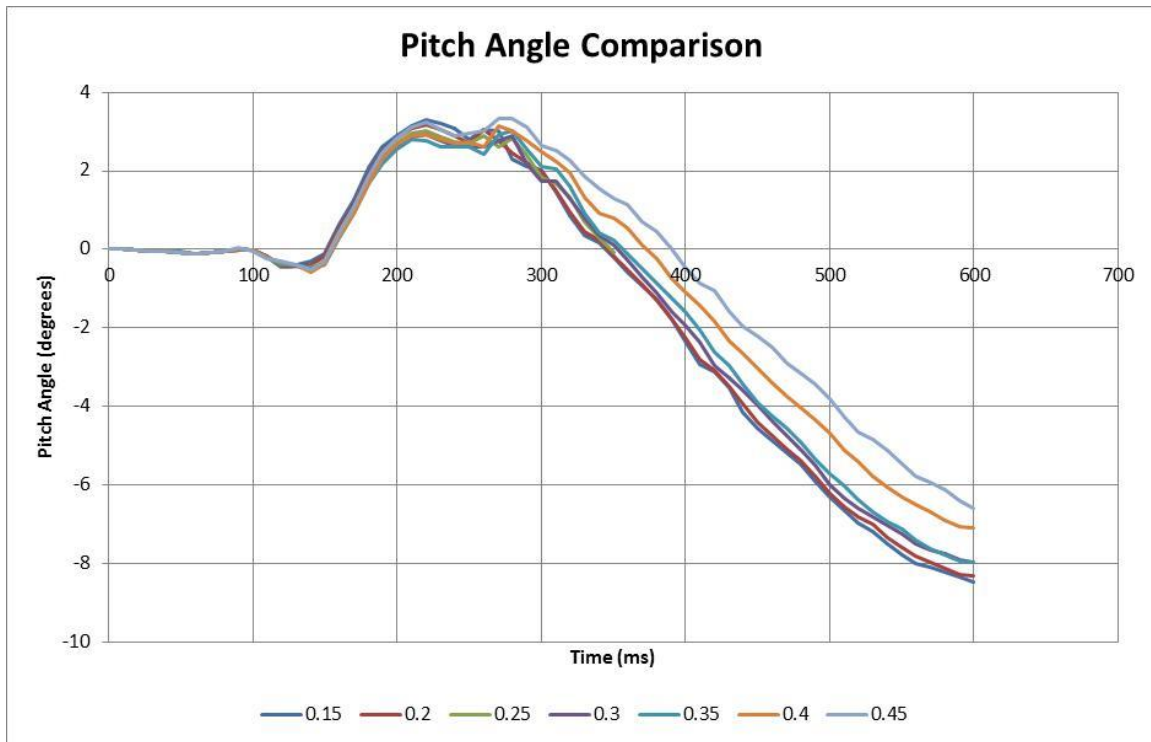
Figure 30. Vehicle Pitch Angle Measured from Instrument Mounting Panel

this panel along the longitudinal axis of the vehicle, and the result was plotted in Figure 30. It was noted that this pitch angle closely resembled the actual pitch angle from visual inspection of the vehicle during the simulation.

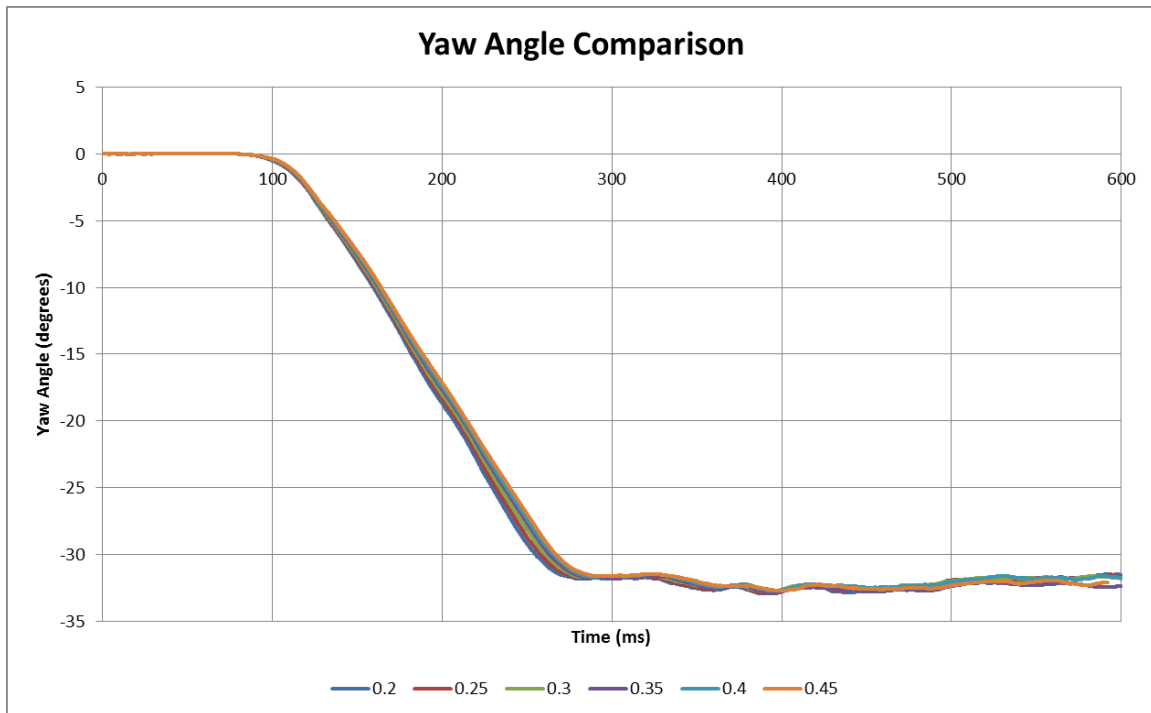
Figure 31. Vehicle Yaw Angle for Varying Tire-to-Barrier Friction Coefficients

The yaw angles are compared in Figure 31 for the varying tire-to-barrier coefficients of friction. The results for each of these runs were very similar, with a near-identical final resting value. However, the yaw rate was slightly less for the simulations with the higher coefficient of friction.

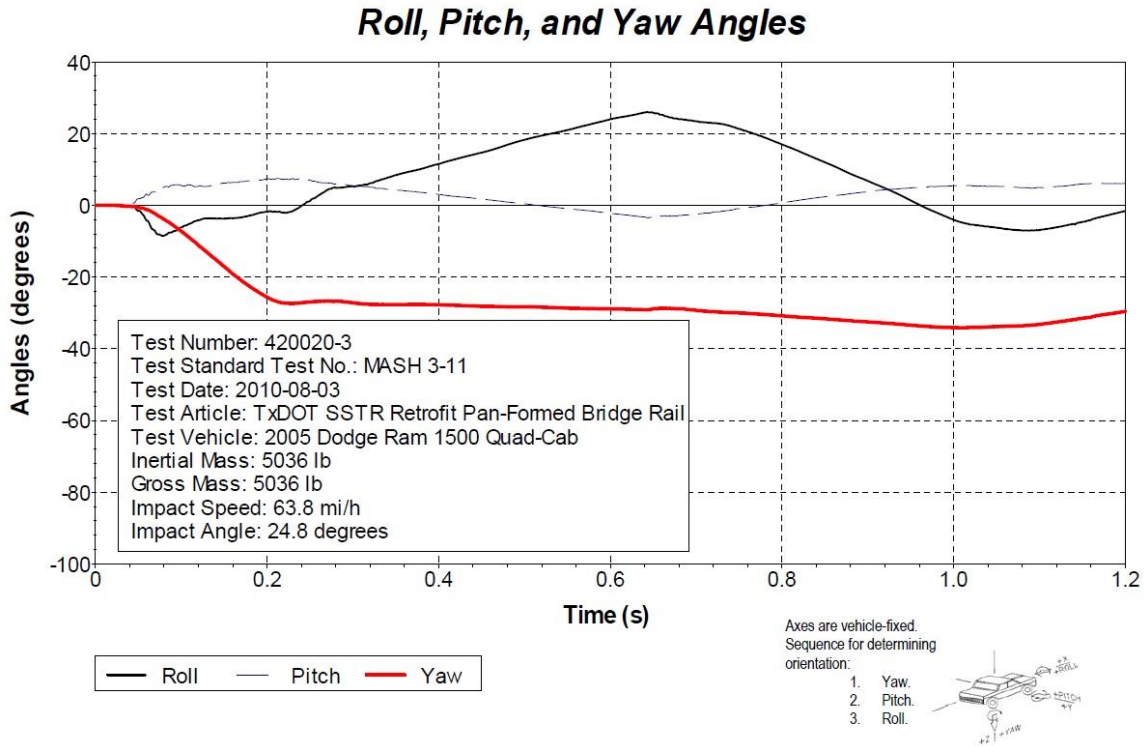
Figure 32. Angular Data from Test No. 420020-3 [6]

Angular data from the full-scale crash test are shown in Figure 32. It should be noted that the vehicle roll angle in the full-scale test was opposite the roll angle for the simulations because the full-scale vehicle impacted the barrier with its right side, and the simulated vehicle impacted the barrier with its left side. In the full-scale test, the vehicle initially rolled away from the barrier with its left side. In the full-scale test, the vehicle initially rolled away from the barrier, whereas in the simulation, the vehicle did not roll away from the barrier at all. Reviewing the forces that affect the vehicle roll motion, either the lateral force transmitted through the wheel assembly was too large or the upward suspension force was too small.

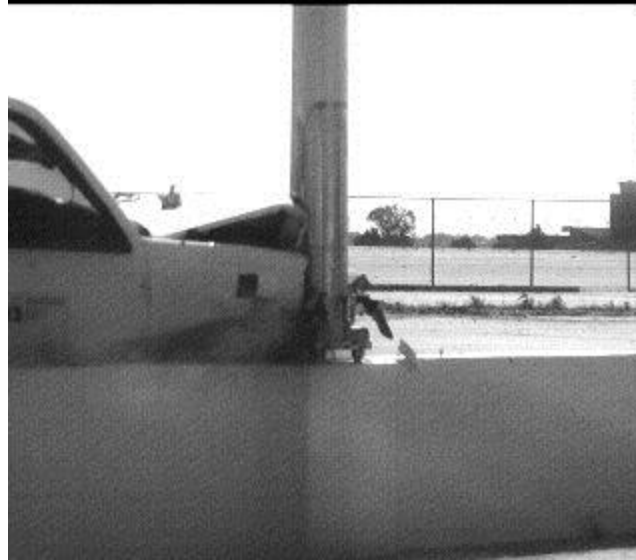
Figure 34. Fender Impact with a Rigid Pole [11]

An impact between the front fender and a hazard behind the barrier may not pose a risk to the occupant. During the initial ZOI study, the fender impacted the rigid pole during the test, which did not pose a significant risk to the occupants, as shown in Figure 34. Longitudinal loads on the fender caused the fender to crush without imparting significant accelerations to the occupant compartment [11]. Plus, the fender protrusion in the simulation is a nodal hardpoint. This point may not be representative of the continuous fender that would be present on a real vehicle. Thus, if a point on the fender was used to determine the maximum ZOI, it may be too conservative of an estimate of the actual ZOI. Note that this test did not utilize a dummy occupant and did not take head ejection criteria into consideration.

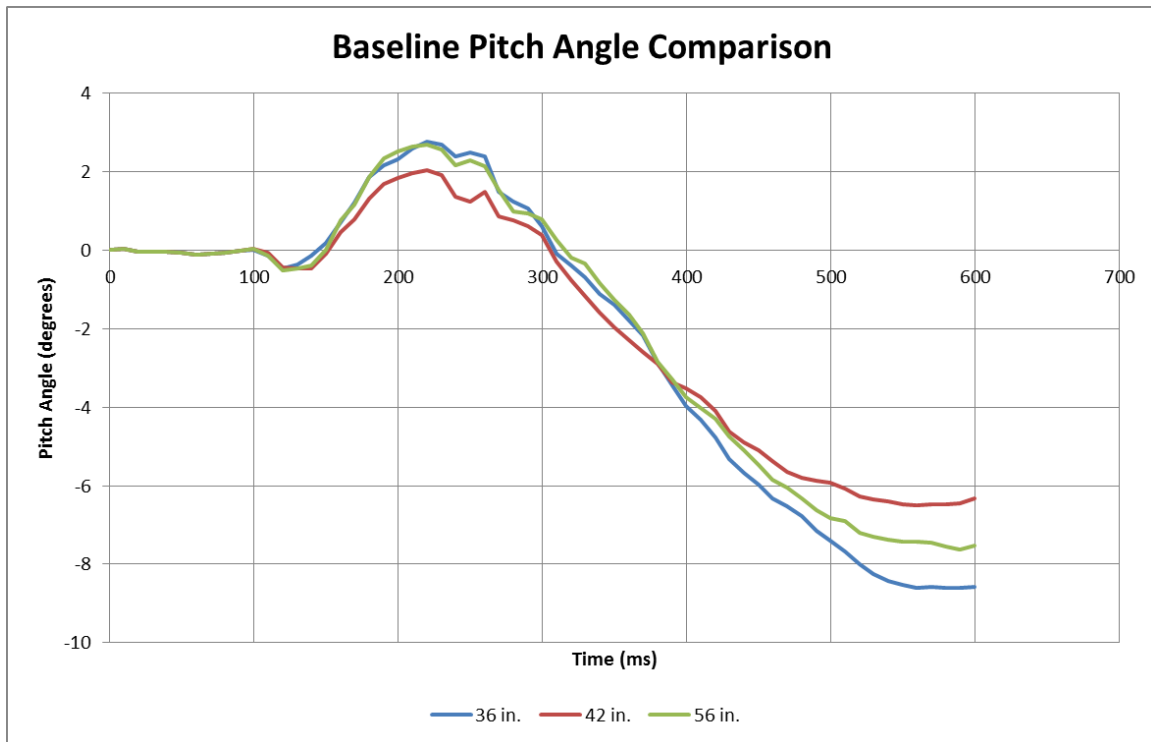
Figure 55. Baseline Simulation Vehicle Pitch Angles

Vehicle pitch angle was difficult to measure, as discussed in Section 4.8. After plotting the pitch angles, the results varied widely, as shown in Figure 55. The 42-in. (1,067-mm) tall barrier experienced the lowest pitch angle, while the 36-in. and 56-in. (914-mm and 1,422-mm) tall barriers both experienced similar pitch behavior. Vehicle pitch motion was caused by sudden compression of the left-front suspension as the impacting tire contacted the barrier and began to climb up the barrier. As the vehicle redirected away from the barrier, the two front tires became airborne, and the front of the vehicle pitched downward. As the vehicle traveled forward, the front of the vehicle contacted the ground, and the front of the vehicle pitched upward.

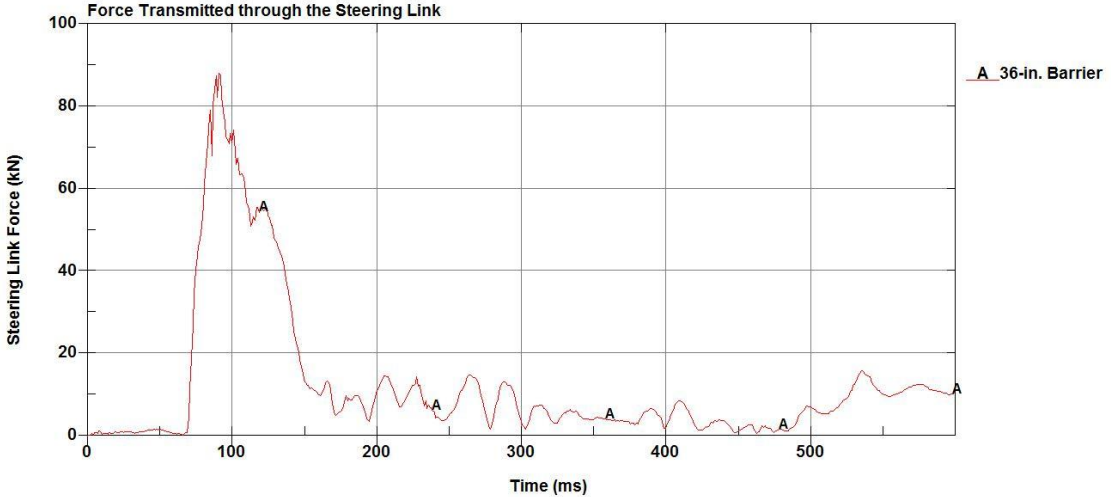
Figure 56. Force Transmitted Through the Steering Link

From the full-scale test review conducted in Section 2.5, the steering link disengages from the vehicle under relatively small impact loads. The total force transmitted through the steering link in the simulation was plotted in Figure 56. The steering link transmitted nearly 20 kips (90 kN) after the vehicle impacted the barrier. Comparatively, the maximum loads transmitted through the lower and upper control arms were approximately 20 kips (90 kN) and 11 kips (50 kN), respectively. From full-scale testing damage, the steering link would be expected to disengage at a significantly lower load than the failure loads of the lower and upper control arms.

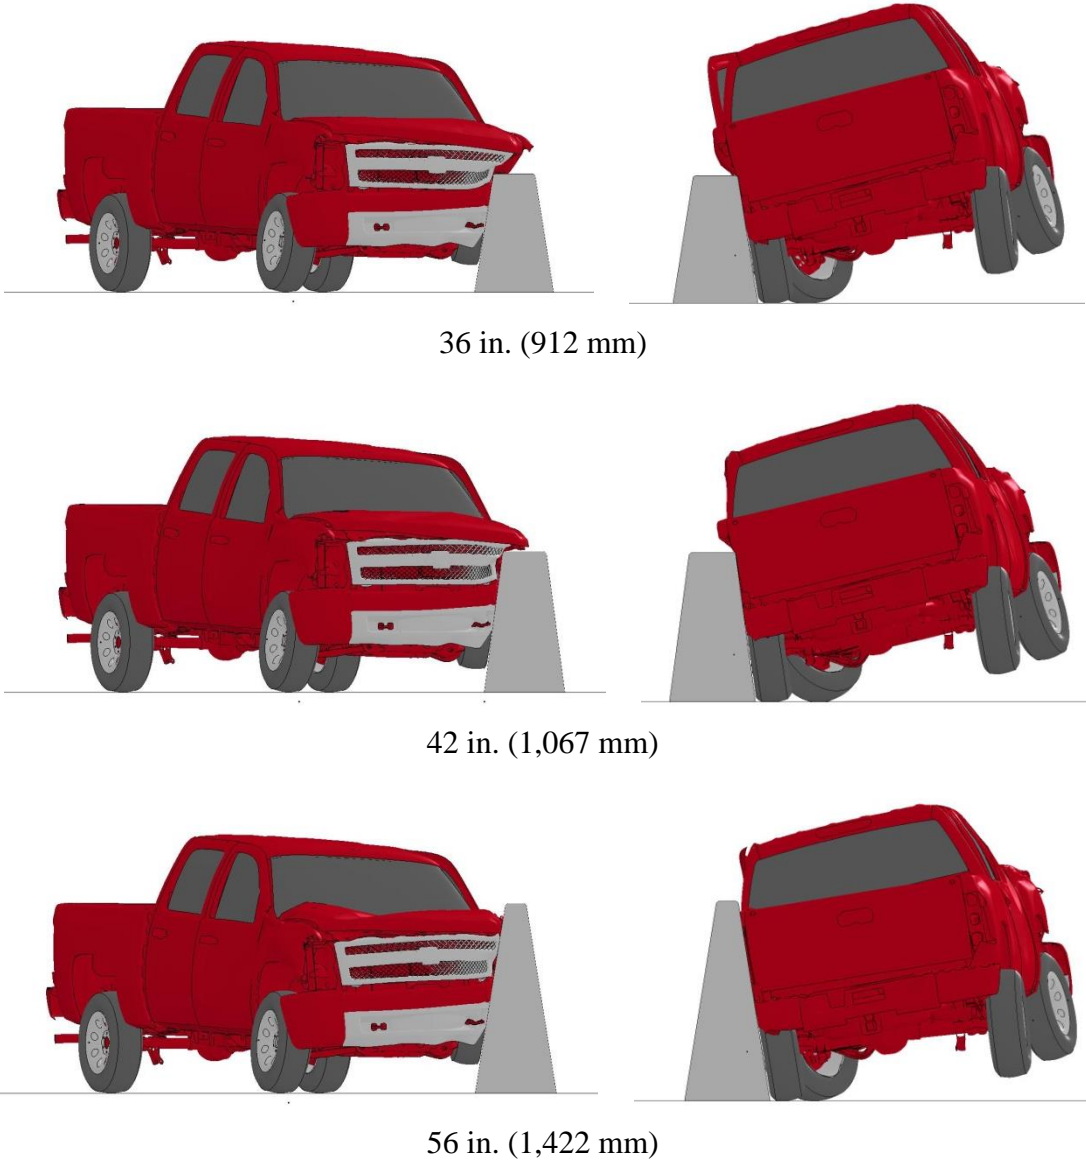
Figure 63. Maximum ZOI Positions for the Full Suspension Failure Simulation

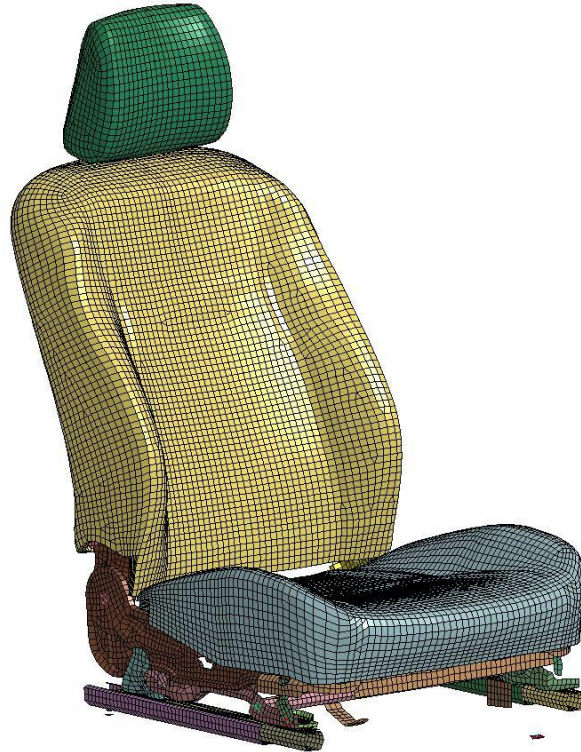
Figure 69. Bucket Seat Model

The front seats in a 2007 Silverado pickup truck are bucket seats, and the optimal simulation would include similar seat geometry. Developing a new seat model would be costly and take a lot of time, and the seat model was outside of the scope of this research. Bucket seats were developed and implemented into the 2008 Toyota Yaris model [38]. The seat from the Yaris model was isolated and used for these simulations, and is shown in Figure 69.

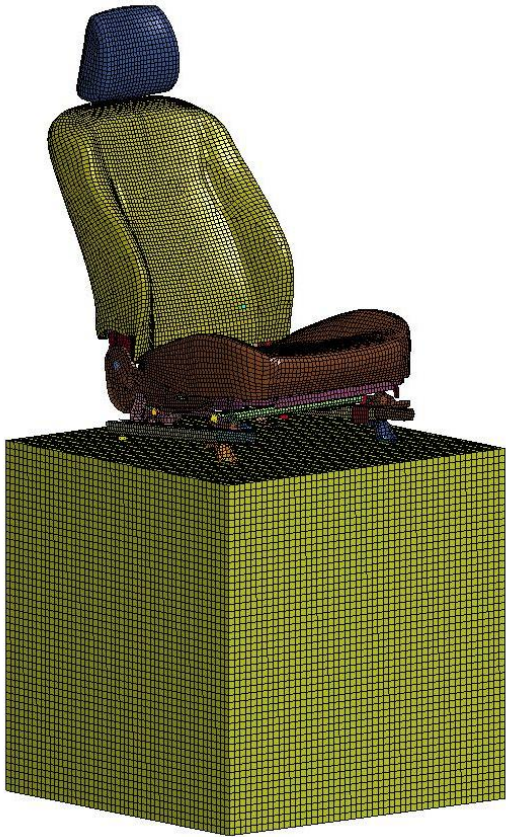
Figure 71. Seat and Rigid Block Model

In order to help verify that the seat model would perform acceptably in the 2270P model, it was set in motion following a trajectory similar to a full-scale crash test. A rigid block was created to simulate the vehicle, and the seat model was rigidly attached to the block, as shown in Figure 71. The block and seat traveled forward at 62.1 mph (100 km/h). After 133 ms, a lateral acceleration was applied to the block, and the simulation was allowed to run for 250 ms. The lateral acceleration curve was similar to the acceleration trace observed in the simulations with the 9.1-degree single-slope concrete barrier. The acceleration curve is shown in Figure 72.

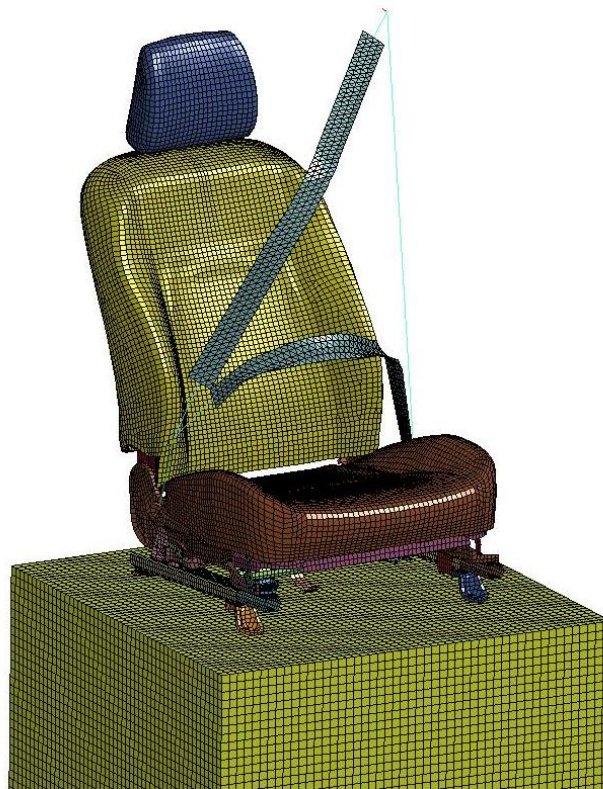
Figure 75. Seatbelt, Seat, and Rigid Block Model

The seatbelt model was positioned in front of the dummy model in the seat, and the ends of the seatbelt were rigidly attached to the seat. The seatbelt was not tight against the occupant to prevent the seatbelt elements from intersecting the dummy elements. A simulation was conducted to determine the stability of the seatbelt with the seat, as shown in Figure 75. For this simulation, the dummy was removed.

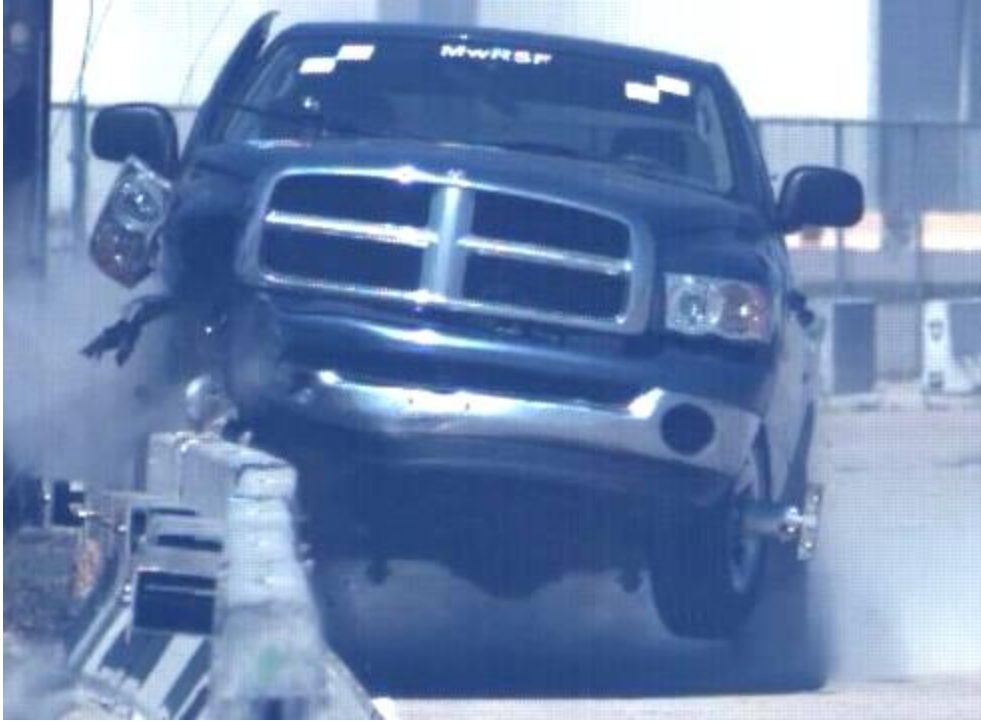
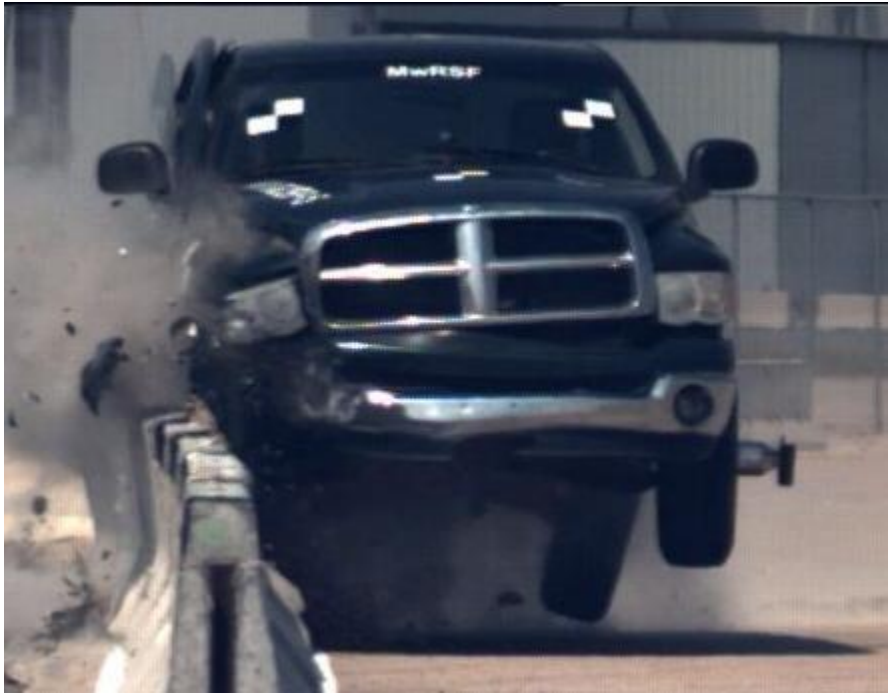
Figure 83. Door Deflection With and Without Dummy Occupants

As the dummy impacted the door of the vehicle, the top of the impact-side door separated from the vehicle and the dummy occupant's head protruded outside of the vehicle, as shown in Figure 82. The deflection of the top of the door was compared between full-scale tests conducted with and without dummies, as shown in Figure 83. Note that both of these tests utilized restrained-motion barriers. There have not been two similar tests conducted with 2270P vehicles on rigid concrete barrier systems.

The window pane separated from the door in the lower photo in Figure 83. This behavior was not observed in every full-scale test, but the deflection at the top of the door was similar to the deflection from other tests (see Reference 20). This behavior was noted in full-scale crash tests into restrained-motion temporary barrier systems. Vehicle trajectory was similar between rigid and restrained-motion concrete barrier systems. Thus, it is believed that the protrusion of the dummy occupant's head out of the window in the simulation was not realistic in this simulation.

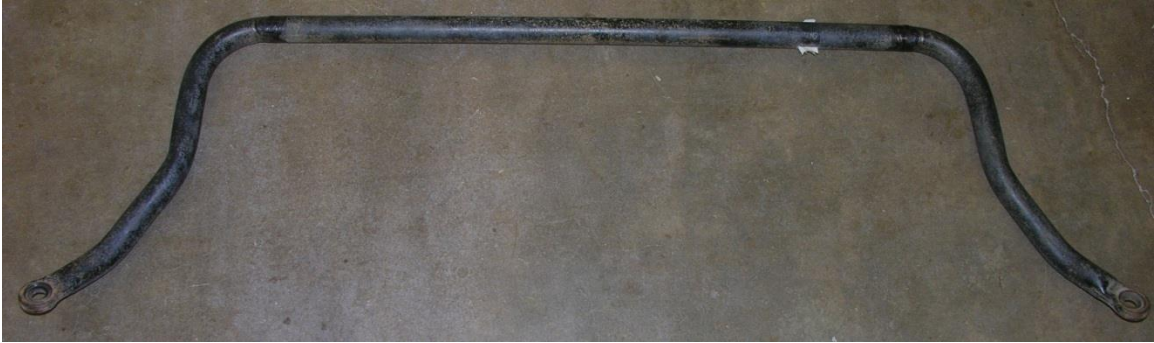
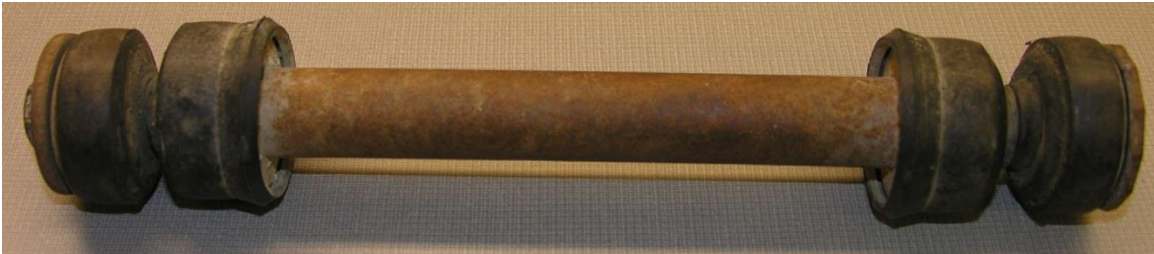
Figure B-1. Actual Anti-Roll Bar and Pin Connection

Pins connect the lower control arm to the end of the anti-roll bar on each side. The pin is composed of a ¼-in. (6-mm) diameter, 8⅛-in. (206-mm) long hex head bolt. A 1⅜-in. (35-mm) diameter washer was placed on the end with a 1⅜-in. (35-mm) diameter semi-stiff rubber gasket. A ¾-in. (19-mm) diameter, 6½-in. (165-mm) long hollow tube with rubber gaskets on both ends was put onto the bolt and a tubular stiffener wrapped around the bolt are used to link the anti-roll bar and the suspension. Rotational tolerance is allowed in the anti-roll bar's connection to the pin. However, no translational motion is allowed, giving the pin connection three degrees of freedom.

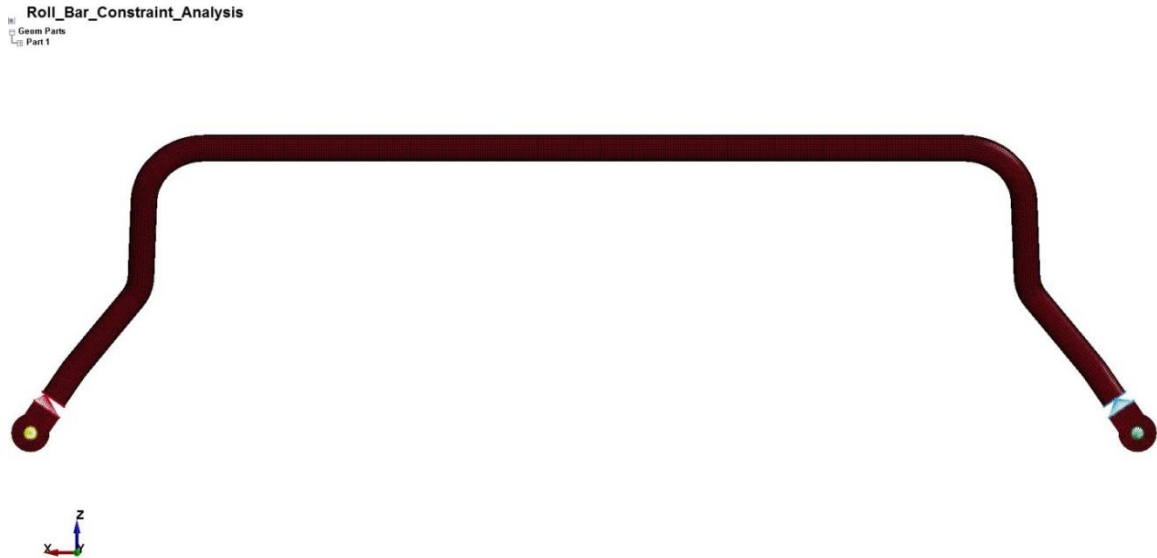
Figure B-3. Simulated Anti-Roll Bar, Pins, and Lower Control Arms

The model of the anti-roll bar, pins, and lower control arms are shown in Figure B-2. The anti-roll bar must be able to transfer torque as the two ends of the anti-roll bar displace, but this is dependent on the connections that define the ends of the anti-roll bar. The pin is modeled as a beam element, and the node at the lower end of the pin is merged with a node on the lower A-arm, acting as a spherical joint. Thus, the connection between the pin and the lower A-arm currently has three unrestrained degrees of freedom. The anti-roll bar is also modeled as a beam element, and the nodes at the ends of the anti-roll bar are merged with the nodes in the pins, giving the joint three unrestrained degrees of freedom. Overall, the anti-roll bar has six unrestrained degrees of freedom in the current simulated model.
