DEVELOPMENT OF A SOCKETED FOUNDATION FOR THE MIDWEST WEAK POST (MWP) V1

MIDWEST ROADSIDE SAFETY FACILITY

MwRSF Research Report No. TRP-03-298-14

July 23, 2014

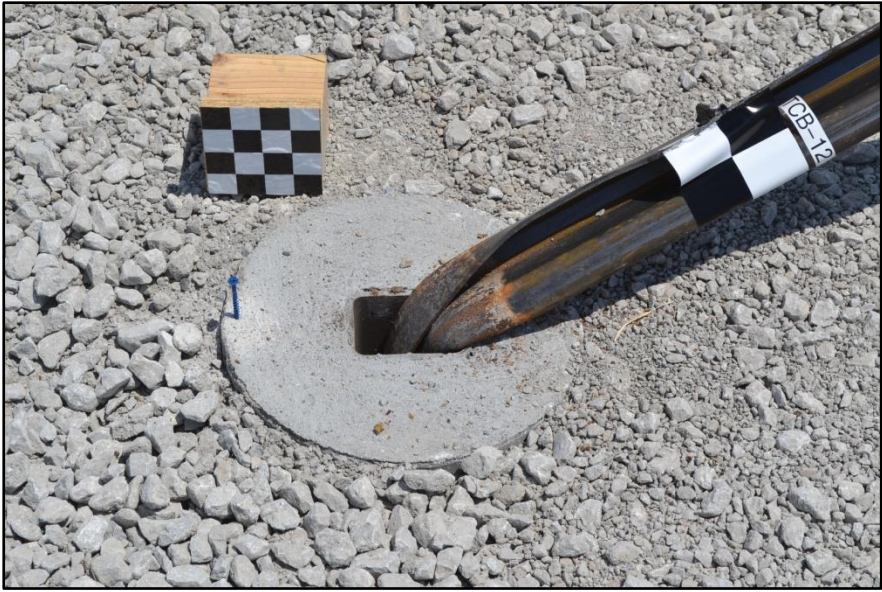
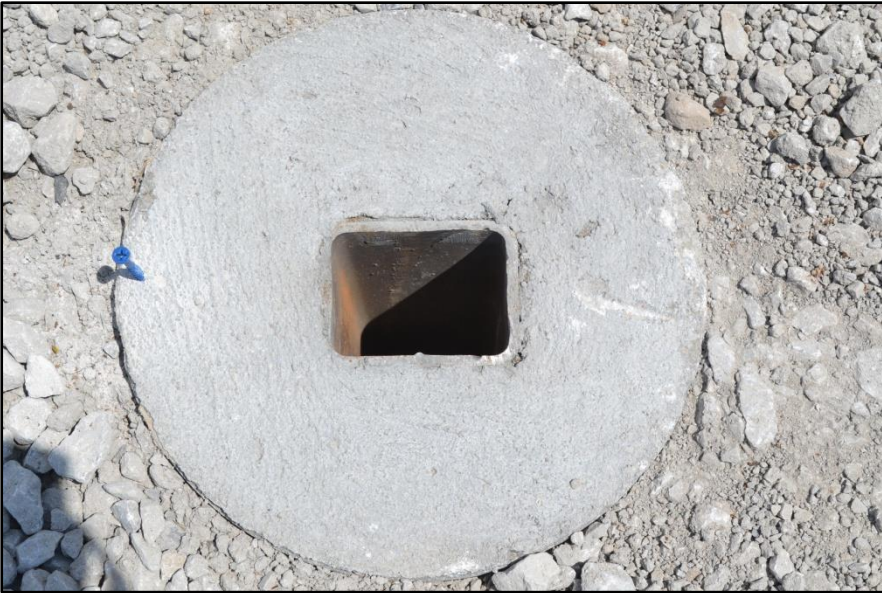
Figure 15. Time-Sequential and Post-Impact Photographs, Test No. HTC B-12

During test no. HTC-12, the bogie impacted the post 11 in. (279 mm) above ground line at a speed of 20.6 mph (33.2 km/h), causing strong-axis bending in the post. Upon impact, the foundation experienced 1/8 in. (3 mm) of dynamic deflection, and a plastic hinge formed in the post. The steel post continued to bend over until the bogie overrode the top of the post 0.120 seconds after impact and at a deflection of 39.4 in. (1,001 mm). Field measurements concluded that the top of the concrete foundation had no visible permanent displacement after the impact event.

Damage to the test article consisted of plastic deformations to the MWP at ground line. The concrete foundation experienced no significant damage, only minor scrapes on the back side of the socket. Time-sequential and post-impact photographs are shown in Figure 15.

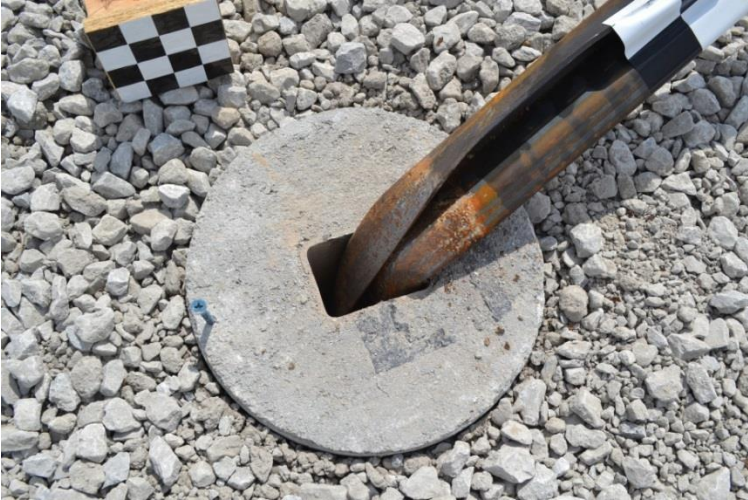
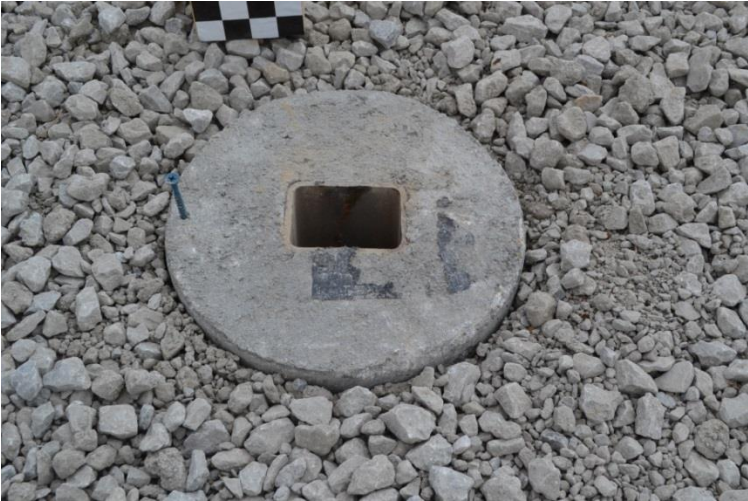
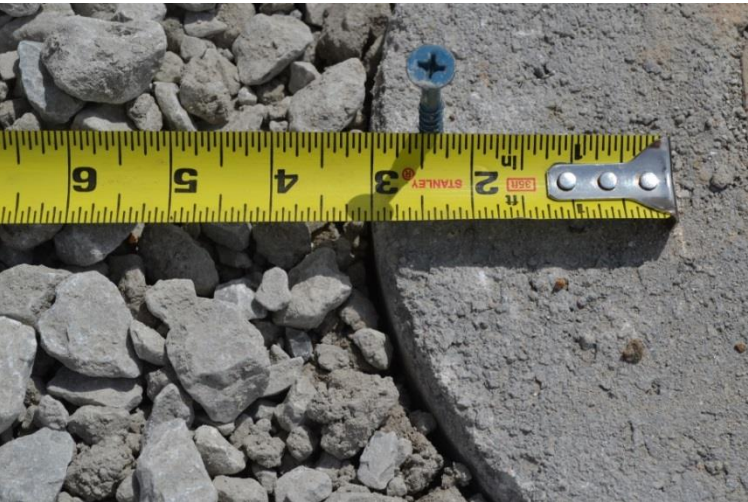
Figure 21. Post-Impact Photographs, Test No. HTC B-15

Damage to the test article was confined to plastic deformations of the post at ground line. The concrete foundation experienced no significant damage. Time-sequential and post-impact photographs are shown in Figure 21. Due to technical difficulties with the high-speed camera, time-sequential photographs were taken from the JVC digital camera.
