# MID-AMERICA TRANSPORTATION CENTER

Report # MATC-UNL: 222

## Development of a Socketed Foundation for Cable Barrier Posts - Phase I

1. Report No. TRP-03-232-11	2. Government Accession No.	3. Recipient's Catalog No.	
4. Title and Subtitle Development of a Socketed Foundation for Cable Barrier Posts – Phase I		5. Report Date February, 2012

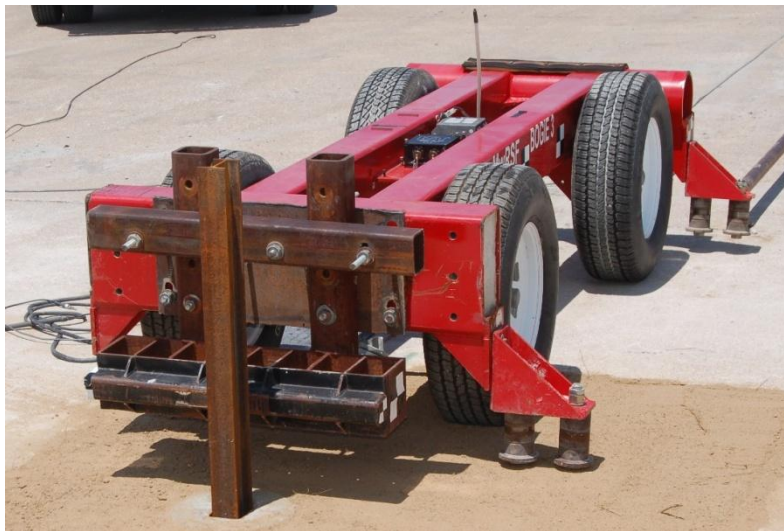
**Figure 4.1** Rigid Frame Bogie with Impact Head

A rigid-frame bogie equipped with a variable height, detachable impact head was used to strike the posts. The bogie impact head consisted of a 2½-in. x 2½-in. x 5/16-in. (64-mm x 64-mm x 8-mm) square tube mounted on the outside flange of a W6x25 (W152x37.2) steel beam with reinforcing gussets. The impact head was bolted to the bogie vehicle, creating a rigid frame with an impact height of 11 in. (279 mm). The bogie and impact head are shown in figure 4.1. The weight of the bogie with the addition of the mountable impact head for test no. HTC B-1 was 1,804 lb (818 kg). After the first test, an additional steel section was used to attach the impact head to the bogie frame. Thus, the nominal bogie weight for test nos. HTC B-2 through HTC B-4 was 1,845 lb (837 kg). Approximate bogie weights are listed in their respective test description sections.

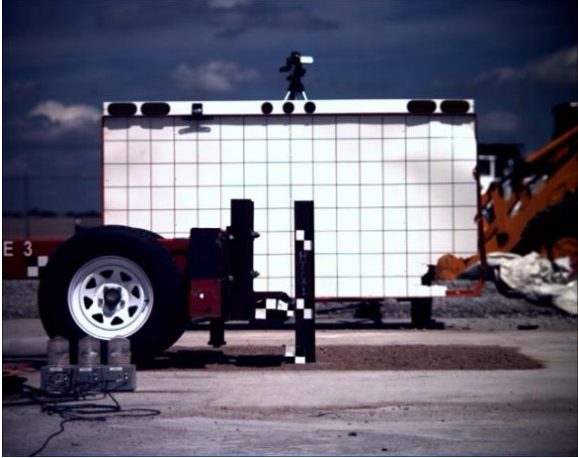
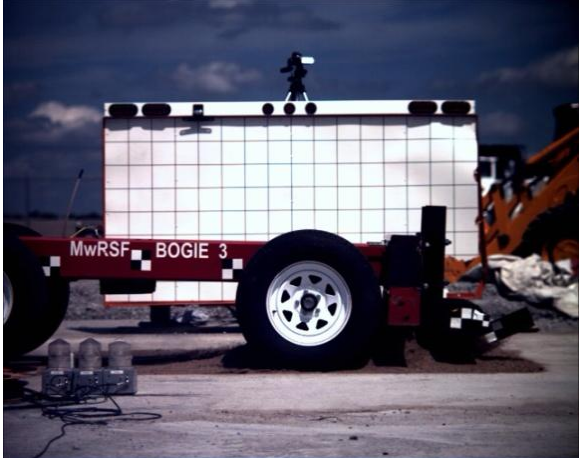
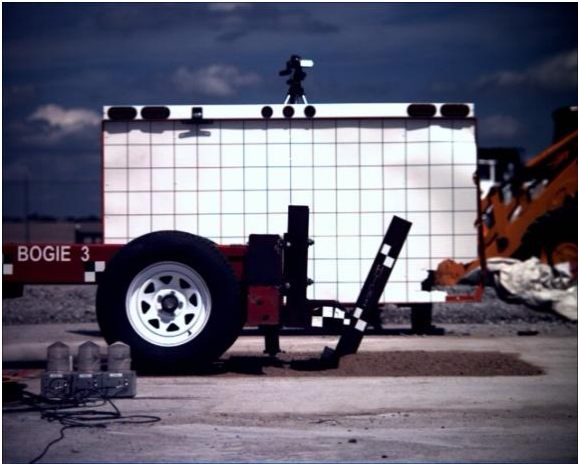
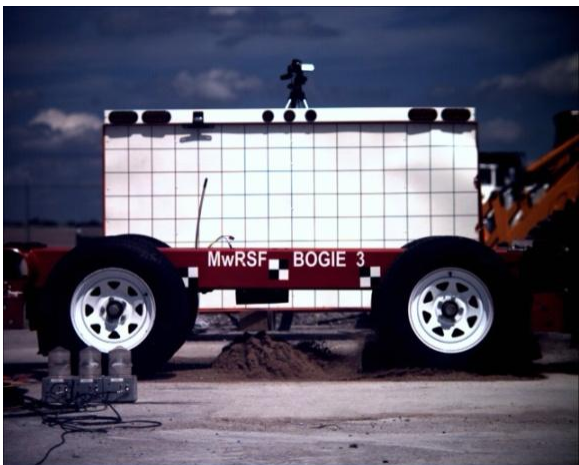
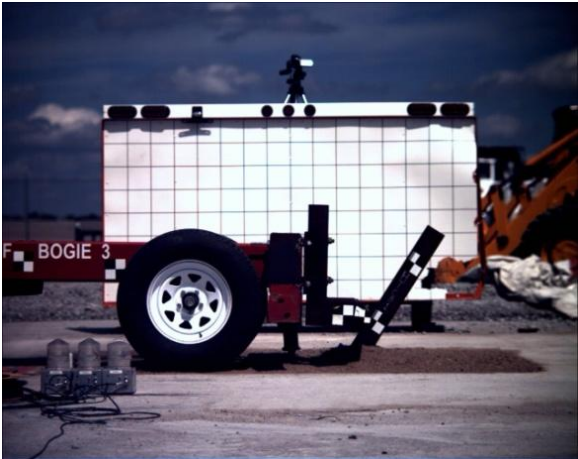
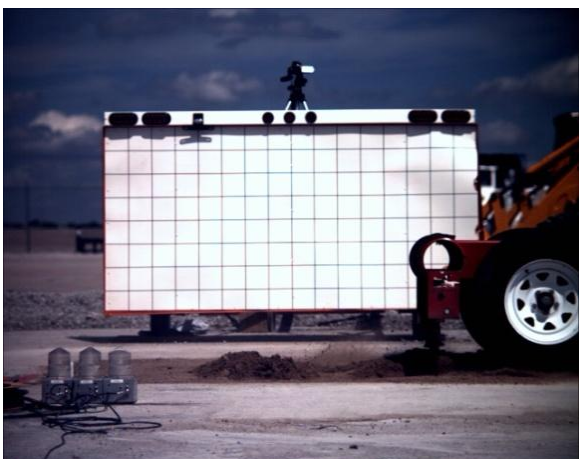
**Figure 5.1** Time-Sequential Photographs, Test No. HTCB-1

The 1,804-lb (818-kg) bogie impacted the post and foundation assembly at a speed of 20.7 mph (33.3 km/h). The centerline of the bogie was aligned perpendicular to the strong-axis of the S4x7.7 (S102x11.5) steel post with the impact head centered on the front face of the post at an impact height of 11 in. (279 mm) above the groundline. Test results are described in the following section and sequential photographs are shown in Figure 5.1. Additional post-test photographs are shown in figure 5.2.

Following impacts, the post and socketed foundation assembly rotated through the sand/soil. At 0.158 sec., the bogie overrode and lost contact with the post assembly. The post assembly rotated backward almost a full 90 degrees with the top of the post just above groundline. Both the steel post and the concrete foundation remained intact and undamaged. Time-sequential photographs are shown in figure 5.1. Component damage and post base deflection are shown in figure 5.2.

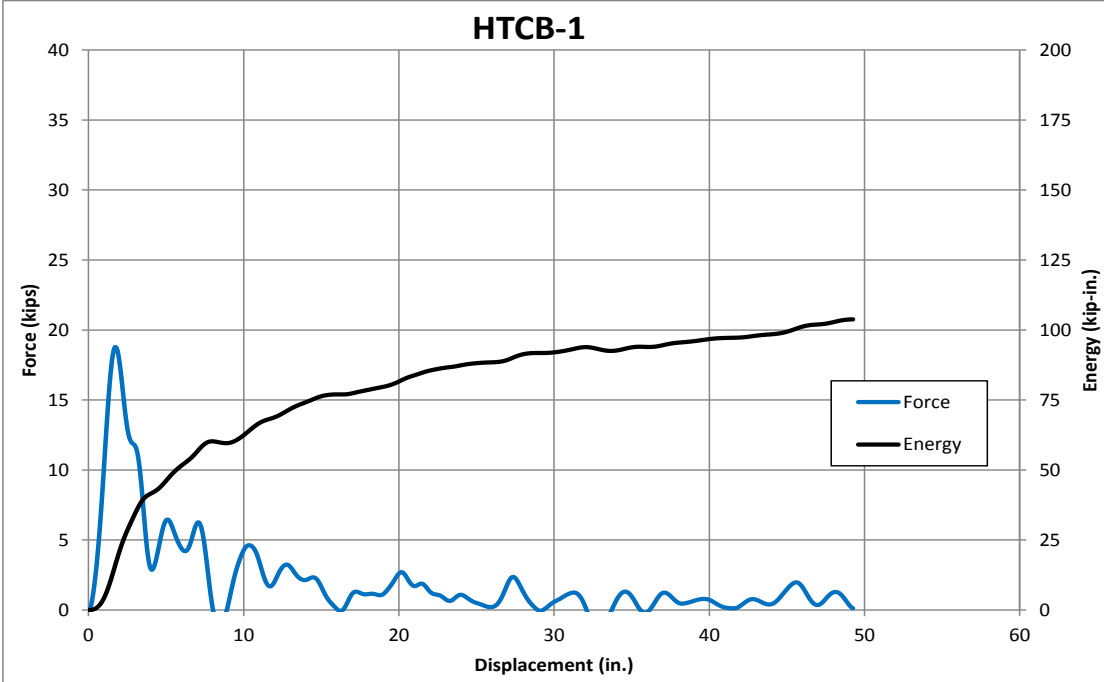
Figure 5.3 Force vs. Deflection and Energy vs. Deflection, Test No. HTCB-1

At the beginning of the impact event, inertial effects resulted in a peak force of 18.8 kips (83.6 kN) at 1.7 in. (43 mm) of deflection. After the initial spike, the force level remained around 5 kips (22 kips) until a deflection of 8 in. (203 mm). After 8 in (203 mm) of deflection, the post and foundation assembly provided minimal resistance; since, the socketed foundation was rotating through the soil, and the bogie vehicle overrode the post. The bogie traveled 49.3 in. (1,252 mm) before overriding and losing contact with the post. A total of 103.8 kip-in. (11.7 kJ) of energy was absorbed by the post and foundation assembly during impact. Force versus deflection and energy versus deflection curves were created from the accelerometer data and are shown in Figure 5.3. According to the string potentiometer, the top of the socketed foundation reached a maximum dynamic and permanent set deflection of 19.8 in. (503 mm) and 19 in. (483 mm), respectively, as shown in Figure 5.4.

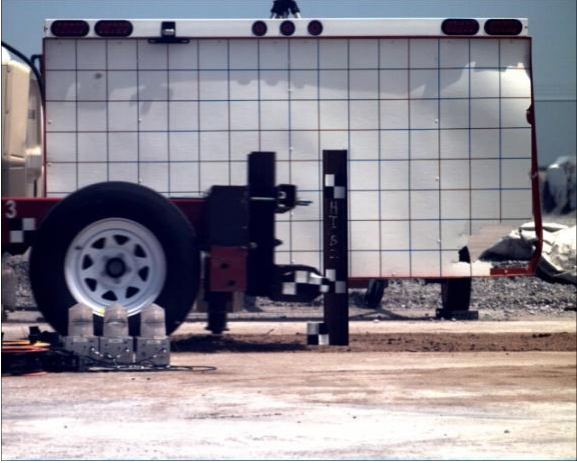
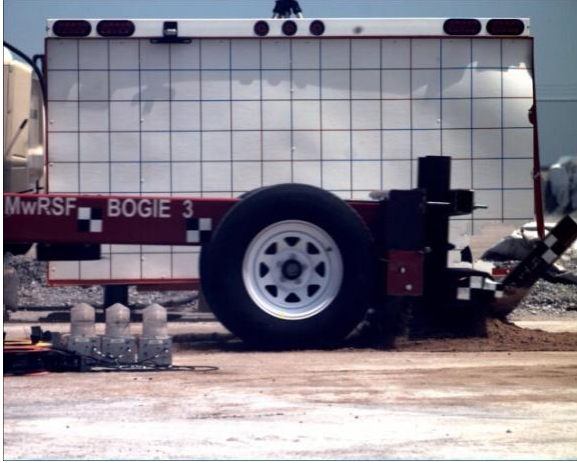
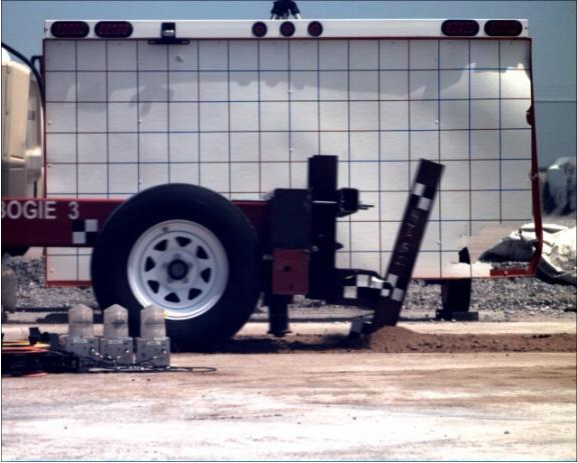
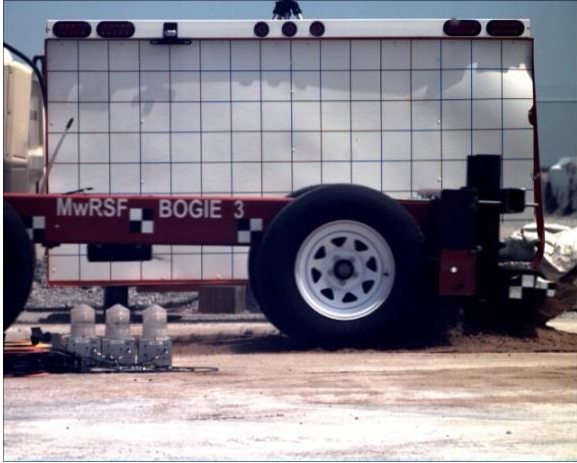
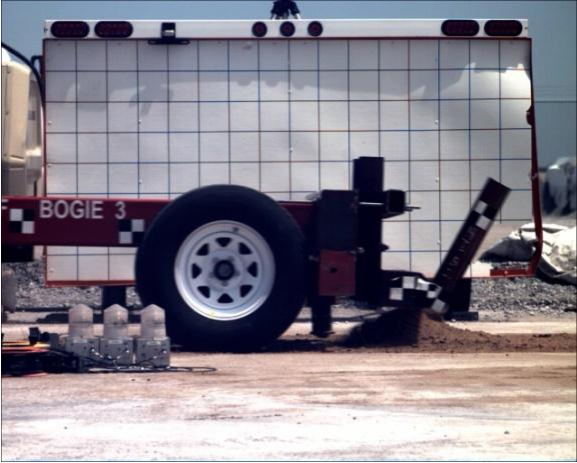
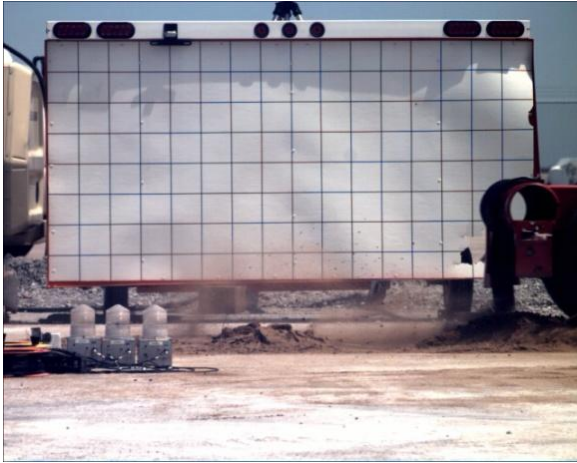
**Figure 5.5** Time-Sequential Photographs, Test No. HTCB-2

Following impact, the post and socketed foundation assembly rotated through the sand/soil. At 0.194 seconds, the bogie overrode and lost contact with the post assembly. The post assembly rotated backward almost a full 90 degrees with the top of the post just above the groundline. The steel post remained undamaged throughout the test, while the concrete foundation received only minor cracking to the top surface downstream of the steel socket and the upstream side 13 in. (330 mm) from the top. The cracks on the upstream side correspond closely with the location of the bottom of the steel socket inside the foundation. Time-sequential

photographs are shown in Figure 5.5. Component damage and post base deflection are shown in figures 6 and 6.

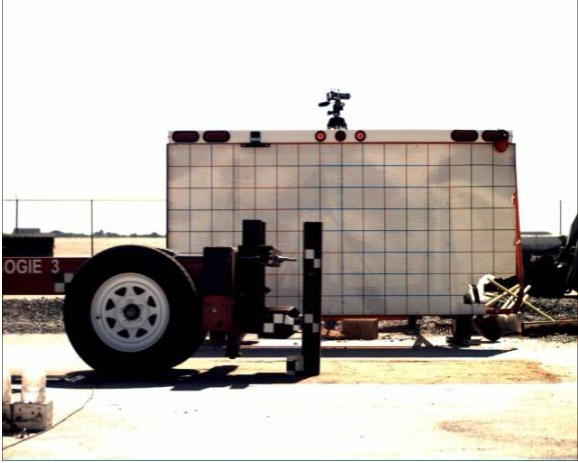
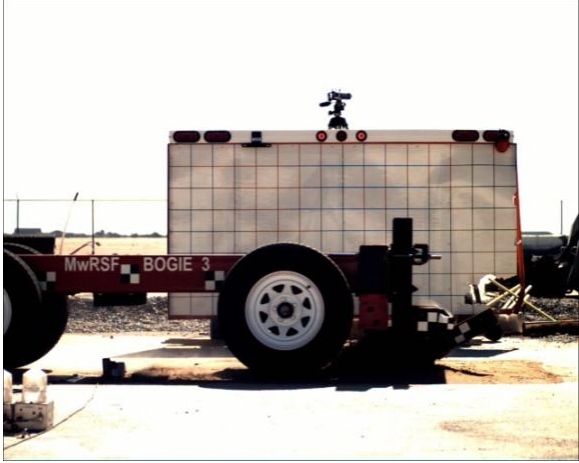
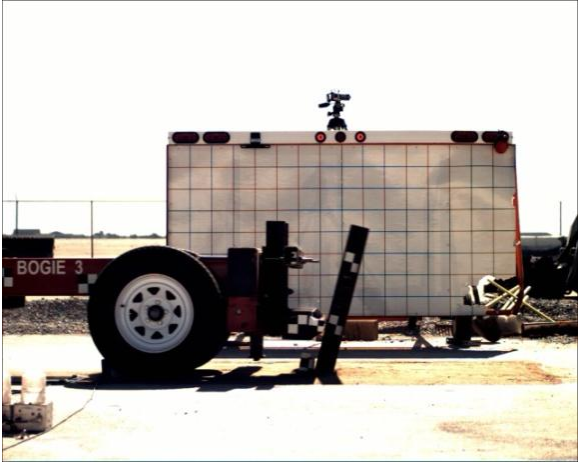
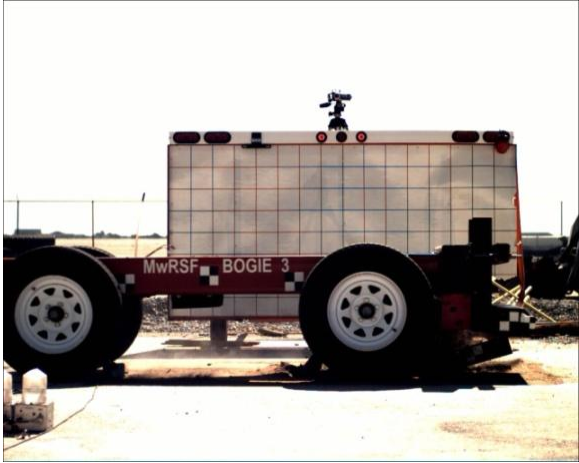
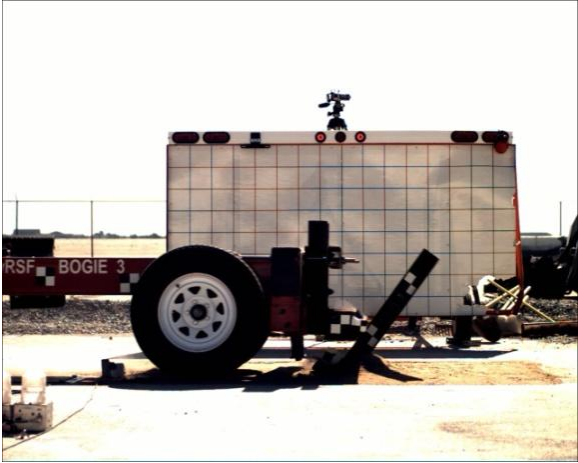
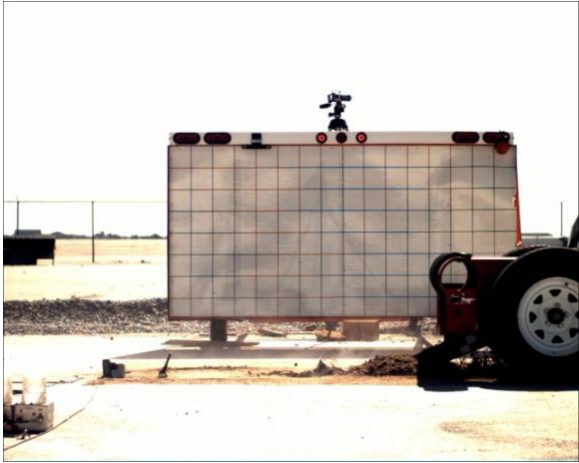
**Figure 5.10** Time-Sequential Photographs, Test No. HTC B-3

Upon impact, the post and socketed foundation assembly began to deflect and rotate backward. At 0.012 seconds after impact, the concrete foundation began to fracture apart around the steel socket. By 0.040 seconds, chunks of concrete from the top of the foundation disengaged allowing the socket to rotate without confinement. At 0.148 seconds, the bogie overrode and lost contact with the post. By this time, the rebar serving as the attachment point for the string potentiometer wire had disengaged from the concrete foundation and was being pulled back toward the transducer. Time-sequential photographs are shown in Figure 5.10.

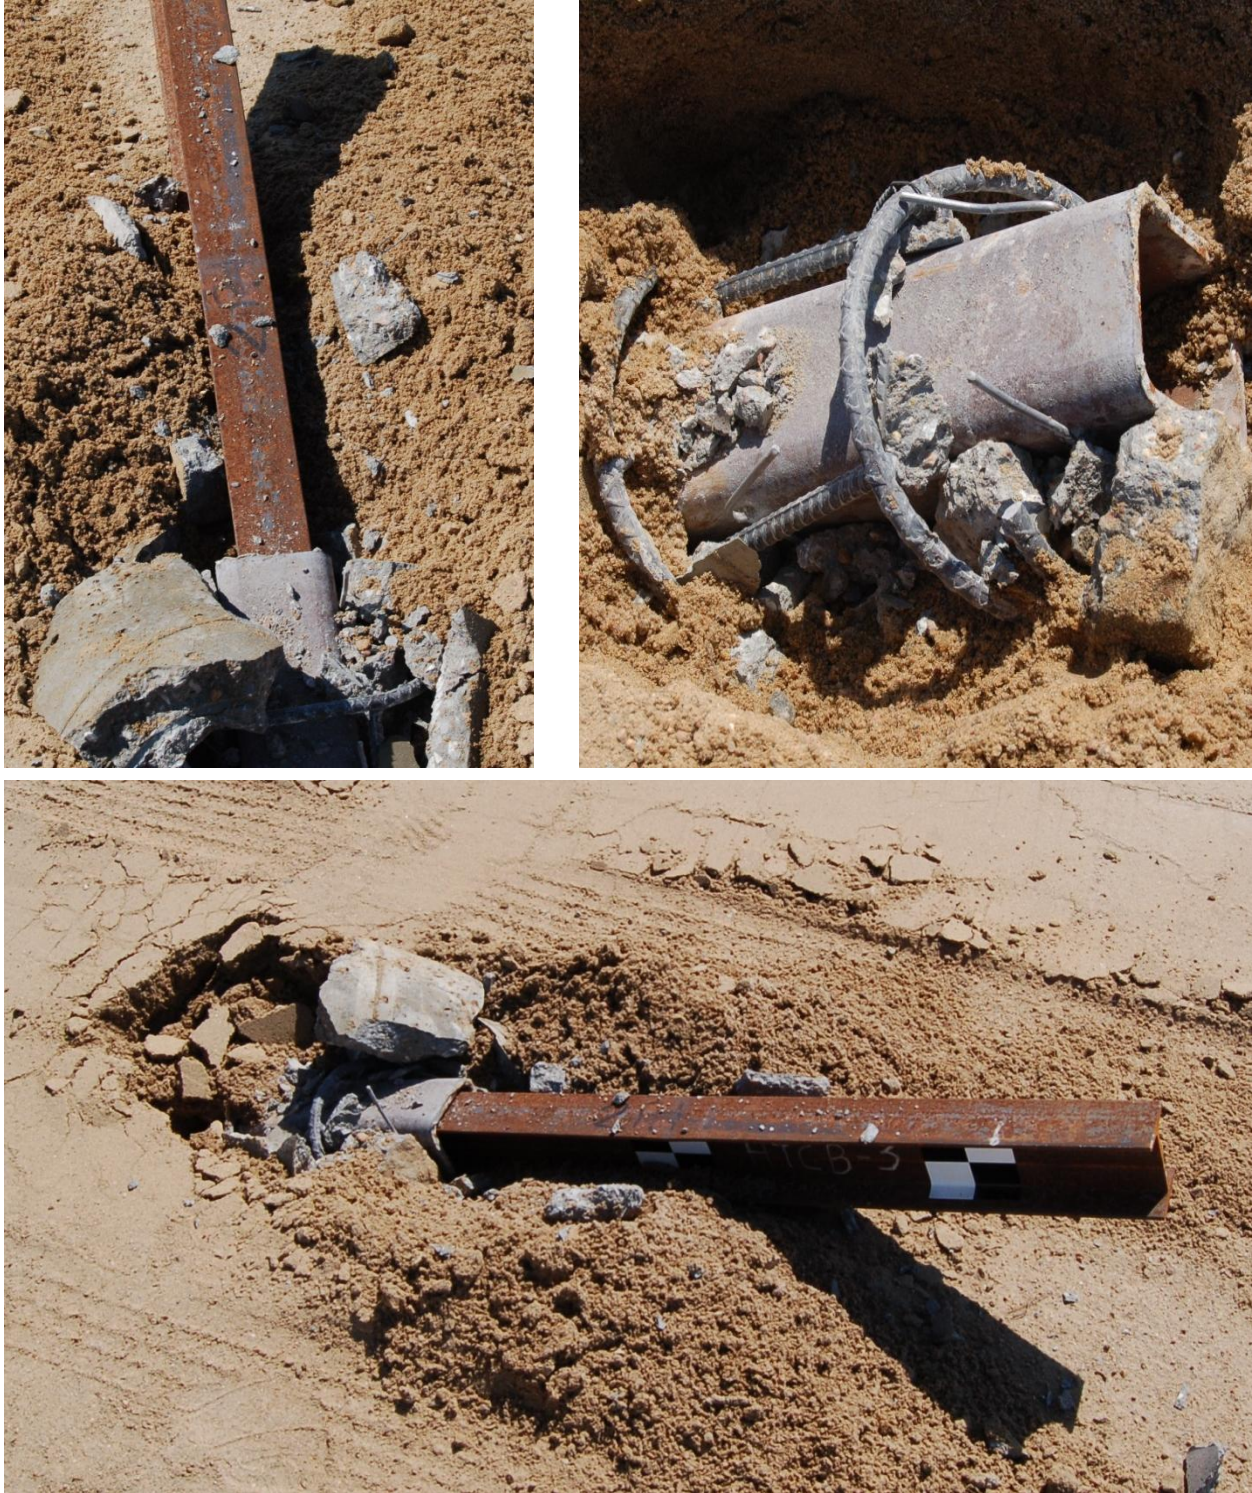
**Figure 5.11** System Damage, Test No. HTC3-3

The post sustained only minor plastic deformation at a location coincident with the top of the steel socket. The top of the socketed foundation sustained severe damage as most of the concrete from the top 17 in. (432 mm) had fractured away. The top circumferential rebar loop was bent and both of the longitudinal bars on the upstream side were sheared off near the center of the socket. Post-test photographs documenting the damage sustained by the footing assembly are shown in figures 5.11 and 5.12.

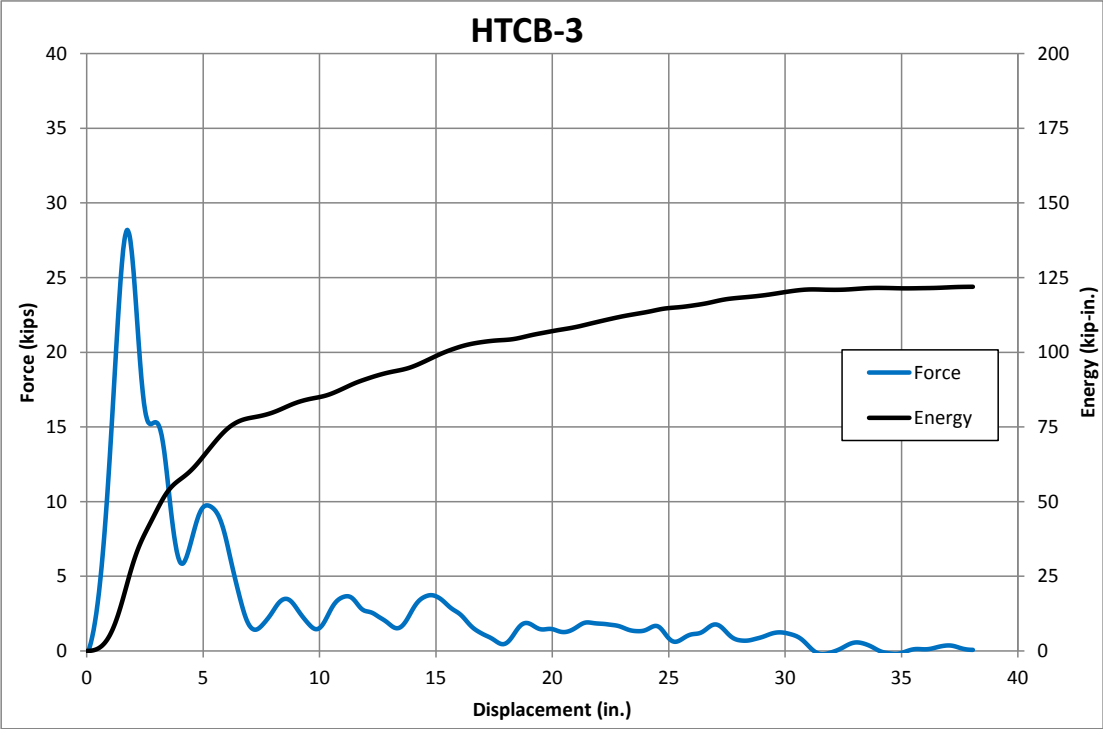
Figure 5.13 Force vs. Deflection and Energy vs. Deflection, Test No. HTCB-3

At the beginning of the bogie test, inertial effects resulted in a peak force of 28.0 kips (124.6 kN) at 1.7 in. (43 mm) of deflection. Substantial resistance was only recorded over 7 in. (178 mm) of deflection. After this point, the concrete foundation had fractured and only small force resistances were present until the bogie overrode the post. According to the accelerometer data, a total of 121.9 kip-in. (13.8 kJ) of energy was absorbed during the impact event. Force versus deflection and energy versus deflection curves were created from accelerometer data and are shown in Figure 5.13. The string potentiometer recorded a maximum deflection of 18.1 in. (460 mm) for the socketed foundation before the attachment point rebar disengaged, as shown in Figure. A true deflection could not be quantified due to the concrete foundation fracturing apart.

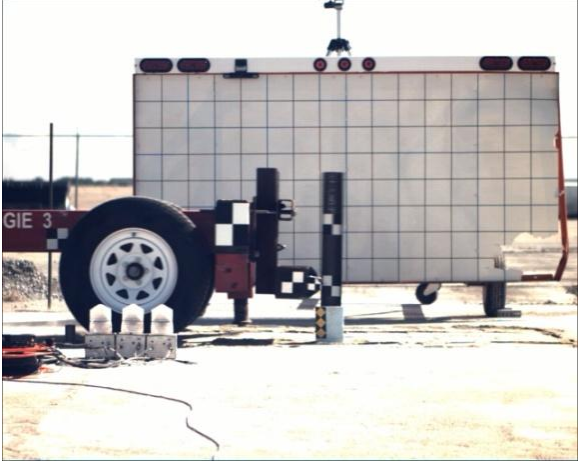
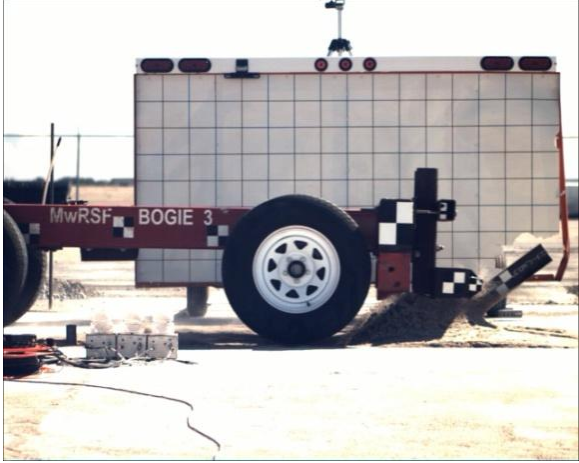
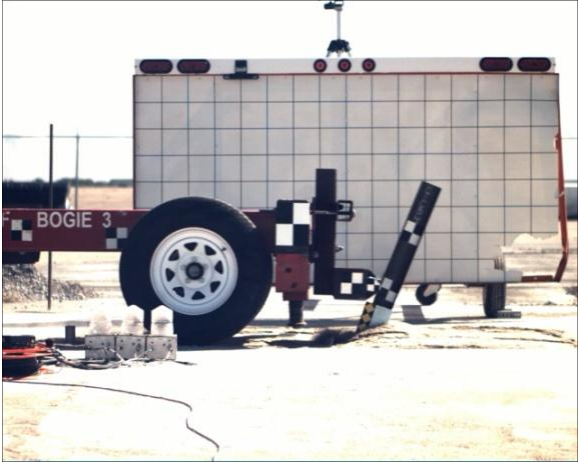
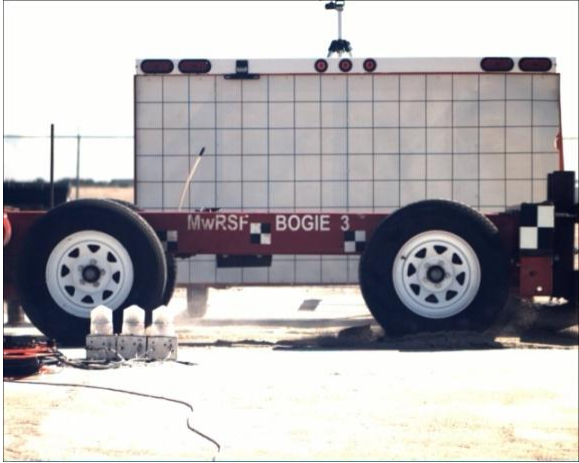
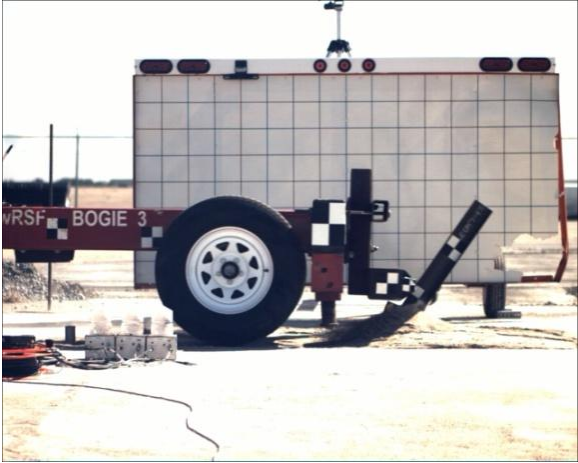
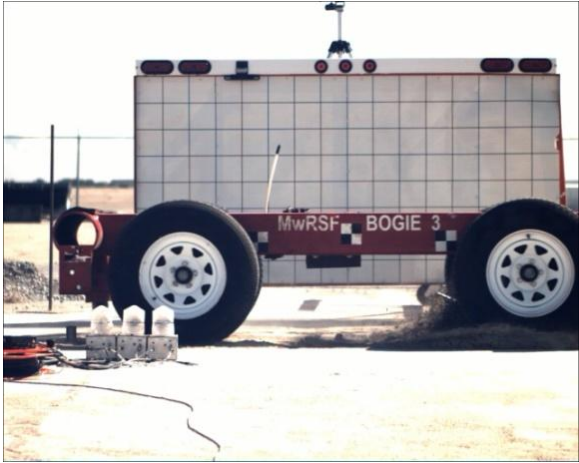
**Figure 5.15** Time-Sequential Photographs, Test No. HTC B-4

Upon impact, the post and socketed foundation assembly began to rotate backward through the sand/soil. By 0.150 seconds after impact, large chunks of concrete had fractured from the socketed foundation. The exact time of fracture could not be determined from the high-speed video due to the displaced debris blocking the view. At 0.200 seconds, the bogie overrode and lost contact with the post. Time-sequential photographs are shown in **Figure 5.15**.

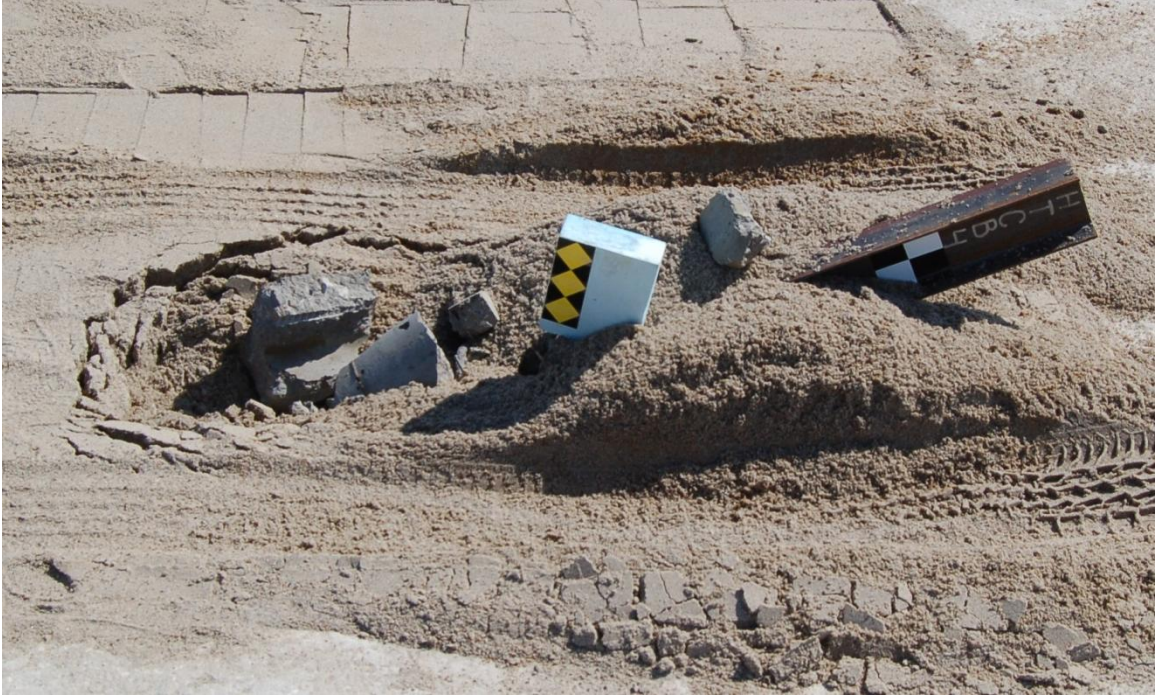
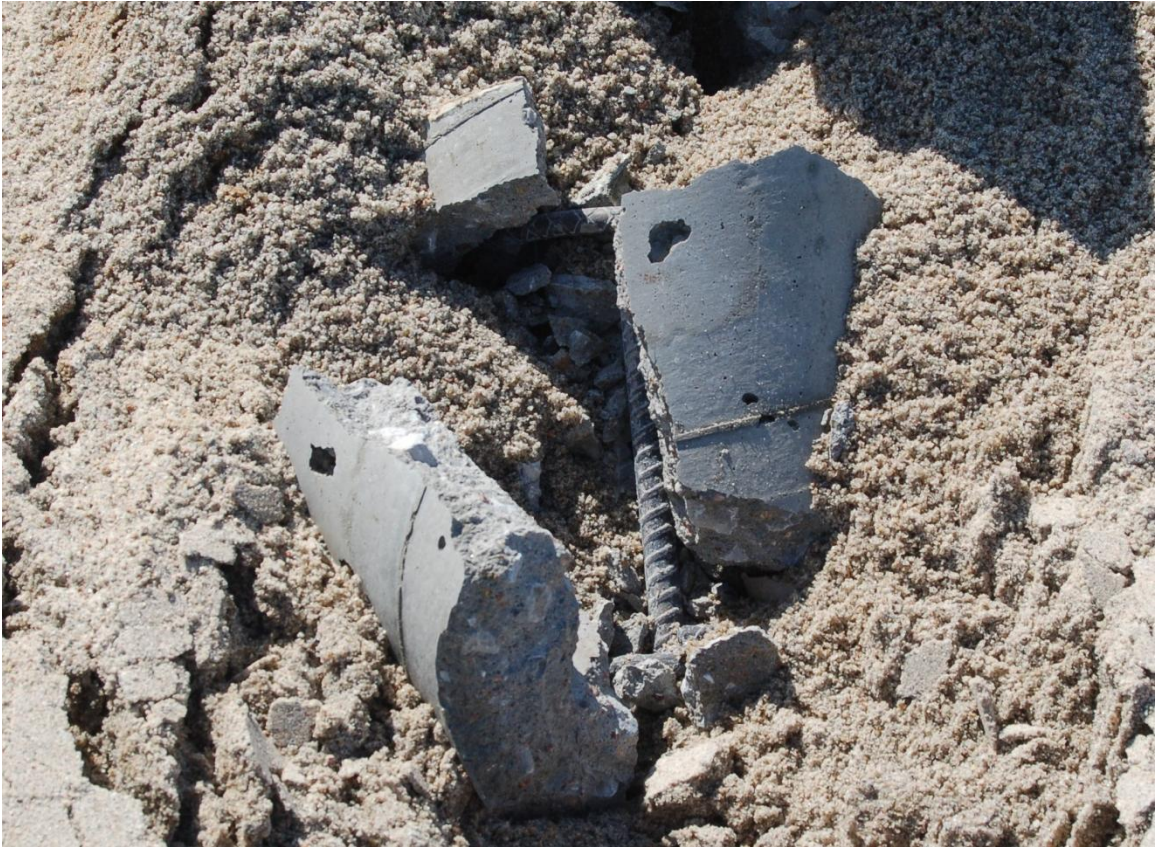
**Figure 5.16** System Damage, Test No. HTCB-4

fractured and disengaged, exposing the socket and upper rebar in the assembly. Significant transverse cracking was found lower on the foundation. The steel socket tube rotated backward and the top three pieces of circumferential rebar were exposed. The top two circumferential rebar pieces were bent and deformed. All four of the vertical bars were bent and the vertical rebar on the upstream side fractured near the bottom of the socket. During excavation of the socketed foundation, an air pocket approximately 1 in. (25 mm) in depth was found along the front side of the assembly that may have contributed to the failure in the base. Component damage is shown in figures 5.16 and 5.17.
