# **LENGTH OF NEED AND MINIMUM SYSTEM LENGTH FOR F-SHAPE PORTABLE CONCRETE BARRIER**

## **MIDWEST ROADSIDE SAFETY FACILITY**

MwRSF Research Report No. TRP-03-337-17

May 3, 2017

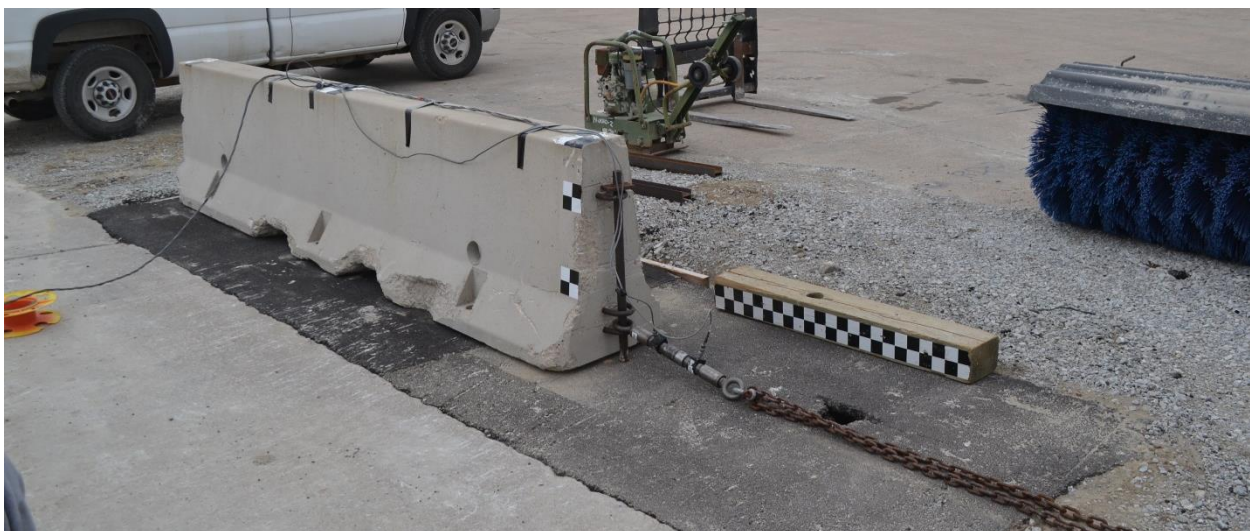
Figure 1. Quasi-Static Pull Test Setup, Test No. TCBFA-1

One quasi-static pull test was conducted on an F-shape PCB segment installed on asphalt paving in order to determine the static and kinetic coefficients of friction between the PCB segment and an asphalt road surface. The test setup is shown in Figure 1. An existing F-shape PCB segment used in a previous research effort was utilized for the quasi-static pull test. The PCB was installed on a 4-in. (102-mm) thick by 4-ft (1.2-m) wide asphalt mow strip. The asphalt mow strip was constructed with a 52-34 grade binder typically utilized in highway shoulder construction in Nebraska.

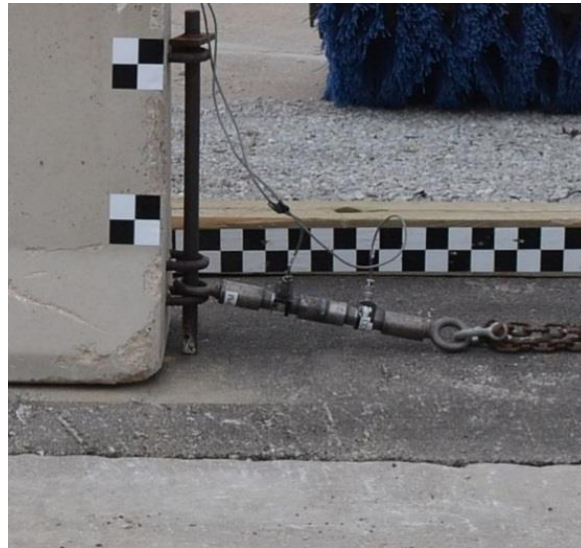
Figure 2. Load Cell Arrangement, Test No. TCBFA-1

Two load cells were mounted in line with the pull cable to measure the tension in the cable for test no. TCBFA-1, as shown in Figure 2. The data from both load cells was processed and compared to ensure accuracy of the readings. The load cells were manufactured by Transducer Techniques and conformed to model no. TLL-50K with a load range up to 50 kips (222 kN). During testing, output voltage signals were sent from the load cells to a National Instruments data acquisition board, acquired with LabView software, and stored permanently on a personal computer. The data collection rate for the load cells was 1,000 samples per second (1,000 Hz).

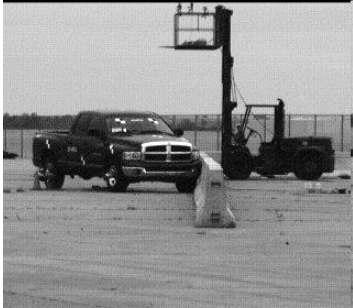
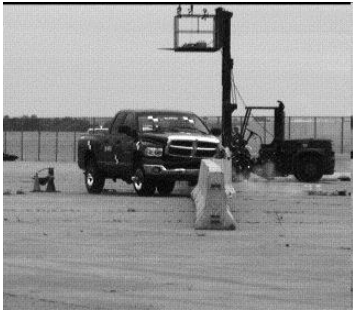
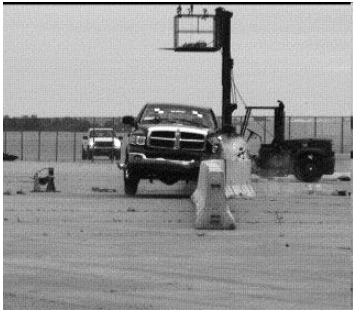
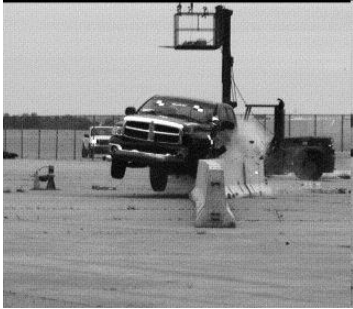
Figure 6. Crash Sequence - Standard Chevy Silverado V3 Model and Test No. 2214TB-2

Analysis of the simulation of the F-shape PCB with the standard Chevy Silverado V3 found that the V3 model did not provide the best correlation with test no. 2214TB-2. Comparison of the high-speed video, shown in Figures 6 and 7, found that the V3 model displayed increased vehicle roll and pitch as compared to the full-scale test. This was confirmed by comparison of the rate gyro data between the simulation and testing. Additionally, the front wheels of the V3 model tended to steer away from the barrier, which was opposite of the steering behavior in test no. 2214TB-2. Comparison of the vehicle transducer data using the RSVVP program found that the standard Chevy Silverado V3 did not meet the single channel or multiple channel metric comparisons. The dynamic deflection of the PCB system in the V3 model was found to be 75.3 in. (1,912 mm) which was slightly less than the 79.6 in. (2,022 mm) deflection measured in the full-scale crash test. Review of the model suggested that the discrepancies between the simulation model behavior and the full-scale crash test were largely due to the combination of the V3 model's increased tire stiffness, higher tire-to-ground friction values, and the differences in the vehicle steering behavior. Vehicle tail slap with the barrier was also observed to be an issue with the V3 model due to the rigid rear axle assembly used on the vehicle. During vehicle tail slap with the PCBs, the axle assembly seemed to increase the severity of the tail slap and produce excess yaw and high lateral accelerations as compared to the full-scale testing.

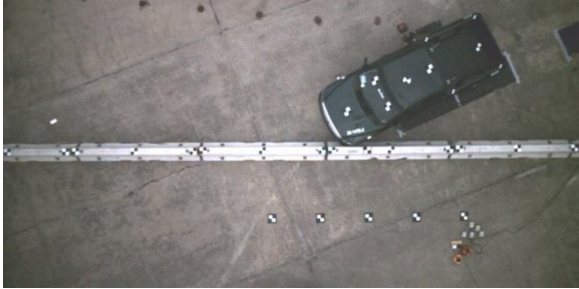
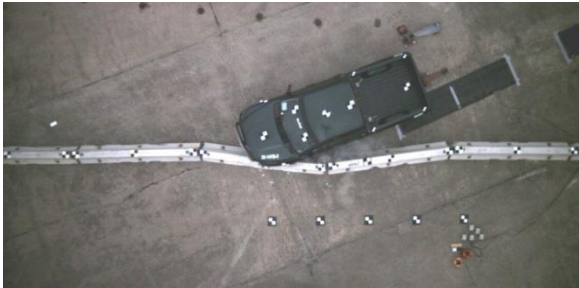
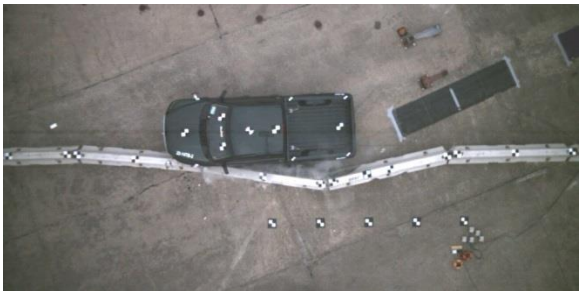
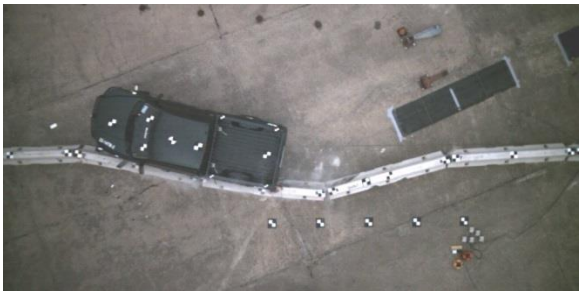
Figure 8. Overhead Sequential Views, Chevy Silverado V2 Model and Test No. 2214TB-2

Comparison of the results from the Chevy Silverado V2 model impacting the F-shape PCB system are shown in sequential images in Figures 8 through 11. This comparison found good correlation between the V2 model simulation and test no. 2214TB-2 in terms of vehicle behavior and the barrier motions. The simulation of the PCB impact with the V2 model had a peak dynamic barrier displacement of 81.1 in. (2,061 mm) which was nearly identical to the 79.6 in. (2,022 mm) displacement observed in test no. 2214TB-2. Additionally, RSVVP comparisons of the vehicle acceleration and rotation data found that the V2 model provided the best correlation with the full-scale test as it passed the single channel correlations for the lateral acceleration and yaw rotation and met the multiple channel comparisons in RSVVP. The results of the RSVVP comparison are shown in Figure 12.

Finally, review of the results from all three truck models found that the Chevy Silverado V2 model of the impact with the F-shape PCB produced the best correlation with full-scale crash test no. 2214TB-2. Vehicle and barrier motions correlated well with the full-scale test based on high-speed video comparisons, and the dynamic lateral barrier deflection of the model was within 2 percent of that observed in the full-scale test. RSVVP analysis of the vehicle transducer data from the model and the test met two of the single channel comparisons and the multiple channel comparison. Thus, the baseline model for the simulation of the beginning and end of LON impacts on the F-shape PCB was selected to use the Chevy Silverado V2 vehicle model with the previously developed F-shape barrier model.

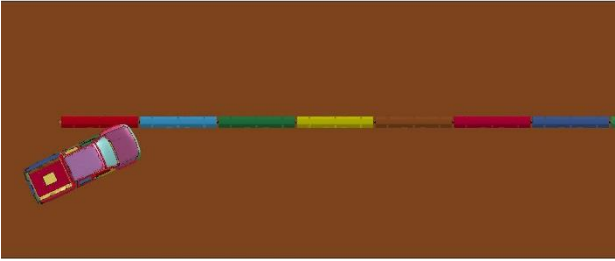
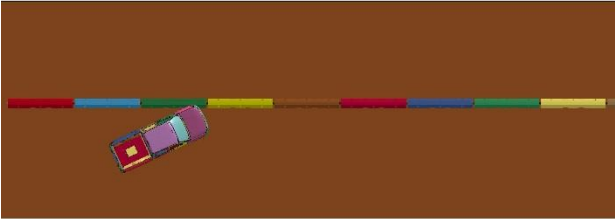
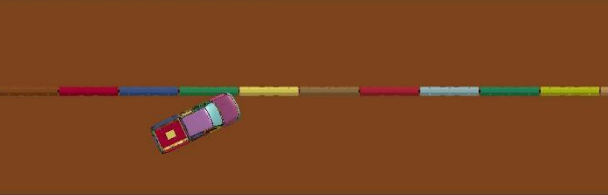
Figure 13. Simulation of Beginning of LON for 16-Barrier F-Shape PCB System, Overhead View, t=0.000 sec

The results from all of the simulations impacting the first eight barrier segments of the sixteen barrier, 200-ft (61-m) long F-shape PCB system were compared to evaluate a potential beginning of LON point. Sequential photographs comparing the behavior of the PCB system at all eight impact points are shown in Figures 13 through 20. Review of the simulations found that the performance of the F-shape PCB system changed significantly when impacted closer to the upstream end of the barrier system. All of the impacts resulted in vehicle redirection. This was largely due to the inertial resistance of the barriers being sufficient to supply the primary redirective forces necessary to prevent gating of the barrier. Similarly, the time required for the vehicle to parallel the barrier during the impacts, the occupant risk values, and the vehicle climb of the barrier were consistent through all eight impacts. Vehicle stability for all of the impacts was acceptable, but vehicle roll tended to increase as the impact point moved upstream.

displayed only minor variations from impacts on the fifth through the eighth barriers in the PCB system. Impacts on the first four barriers of the system showed increasing lateral deflections as the impact approached the end of the system. This was a cause for concern due to increased lateral deflections potentially affecting vehicle stability as well as requiring larger clear areas behind the barrier system.

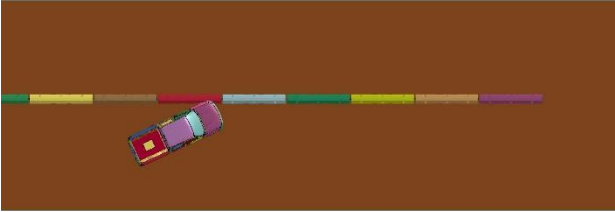
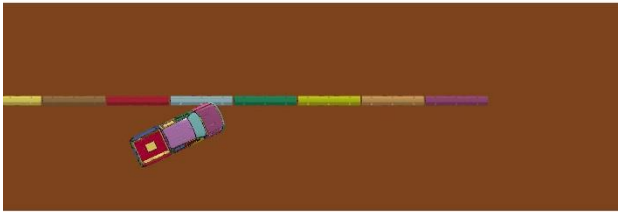
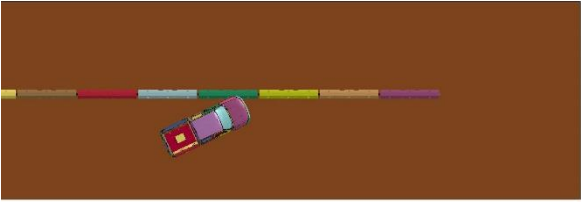
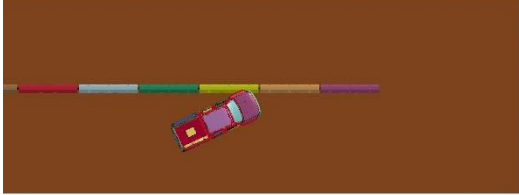
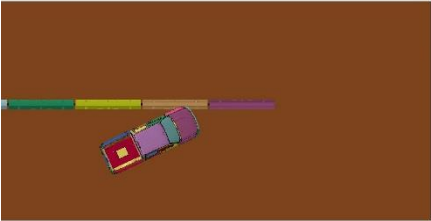
The results from all of the simulations impacting the last eight barrier segments of the sixteen barrier, 200-ft (61-m) long F-shape PCB system were compared to evaluate a potential end of LON point. Sequential views comparing the behavior of the PCB system at all eight impact points are shown in Figures 25 through 32. Review of the simulations found that the performance of the F-shape PCB system changed significantly when impacted closer to the downstream end of the barrier system. Impacts on barrier nos. 9 through 14 resulted in vehicle redirection. This was largely due to the inertial resistance of the barriers being sufficient to supply the primary redirective forces necessary to prevent gating of the barrier. However, impact on barrier nos. 15 and 16 resulted in large deflections of the final barrier segment that represented more of a gating-type behavior for the end of the system. Gating of the system was also observed with respect to vehicle impact on barrier no. 14, but the 2270P vehicle was still effectively redirected in that impact prior to the large displacement of the end barrier segment. The time required for the vehicle to become parallel to the barrier during the impacts was similar for impacts on barrier nos. 9 through 15, but impact on barrier no. 16 yielded a delayed time to parallel due to the lack of downstream barriers and the gating of the end of the system. Occupant risk values were generally consistent for all of the impacts except barrier no. 16, which had much lower deceleration values due to the system gating and not redirecting the vehicle. Vehicle climb of the barrier was consistent through all the impacts. Vehicle stability for all of the impacts was acceptable, but vehicle roll and yaw tended to increase as the impact point moved downstream. Impacts on barrier nos. 12 through 15 displayed increased vehicle roll, while impacts on barrier nos. 15 and 16 yielded a significant increase in vehicle yaw. These increases in yaw and roll of the vehicle potentially indicated a concern for vehicle stability in these impacts on the downstream end of the system.

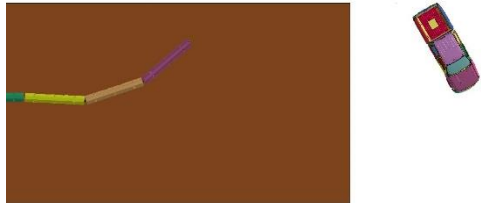
Figure 27. Simulation of End of LON for 16-Barrier F-Shape PCB System, Overhead View, t=0.800 sec

(h) impact US of end of barrier no. 16

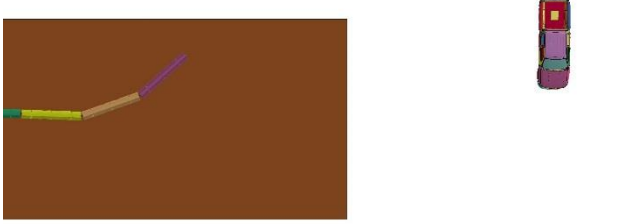
Figure 28. Simulation of End of LON for 16-Barrier F-Shape PCB System, Overhead View, t=1.100 sec

(h) impact US of end of barrier no. 16

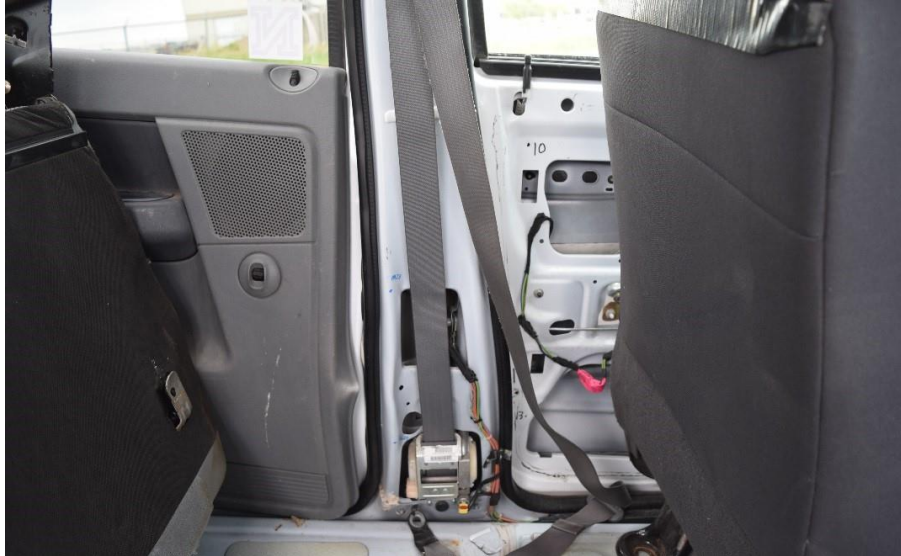
Figure 83. B-Pillar Deformation, Test No. NELON-2

B-Pillar Measurement Location in. (mm)	Undamaged Vehicle Measurement in. (mm)	NELON-2 Vehicle Measurement in. (mm)	Lateral Permanent Set B-Pillar Deformation in. (mm)
Lower B-Pillar, 6¼ (159) above floorpan	64⅞ (1,648)	61¼ (1,556)	3⅝ (92)
Mid B-Pillar, 16½ (419) above floorpan	64¾ (1,645)	60 (1,524)	4¾ (121)

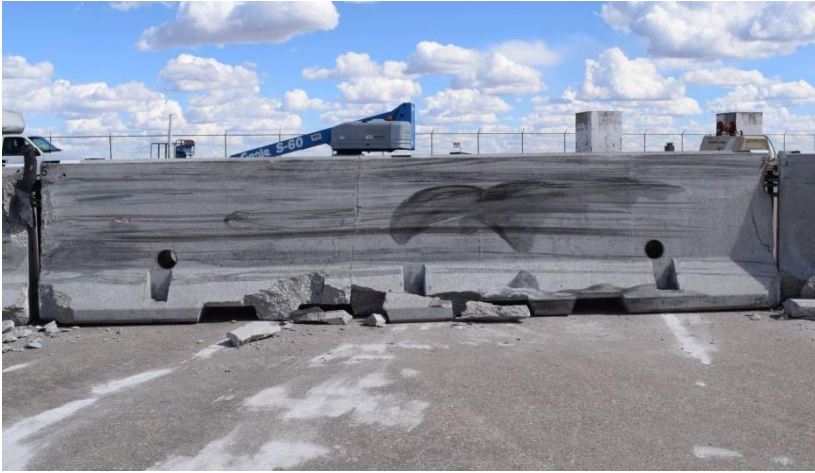
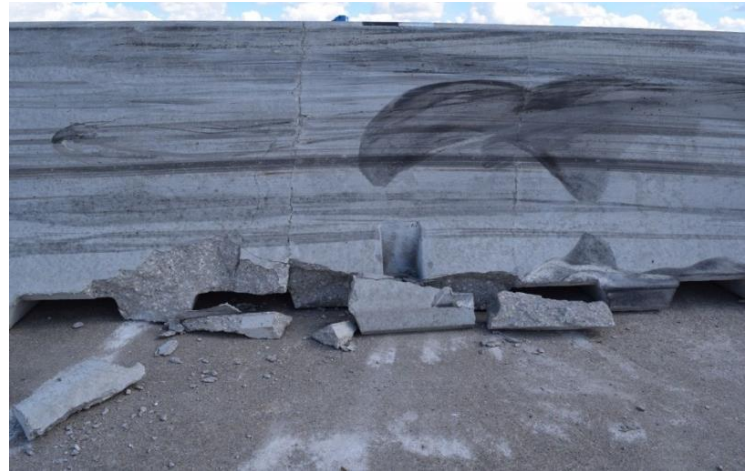
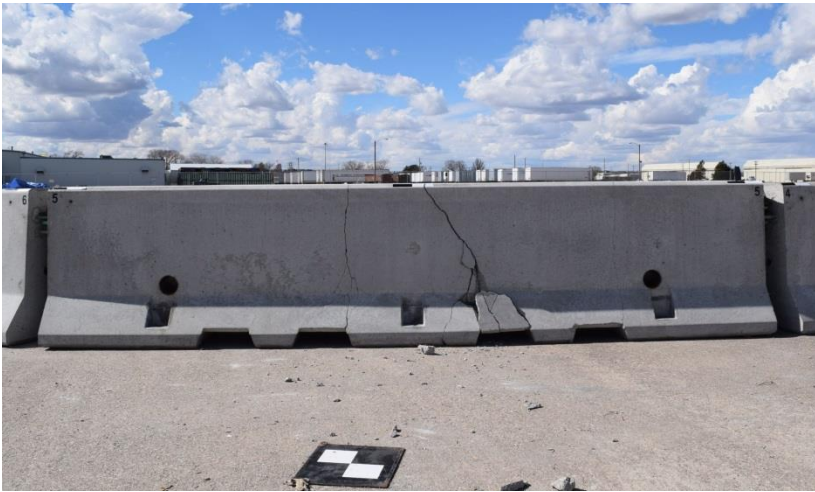
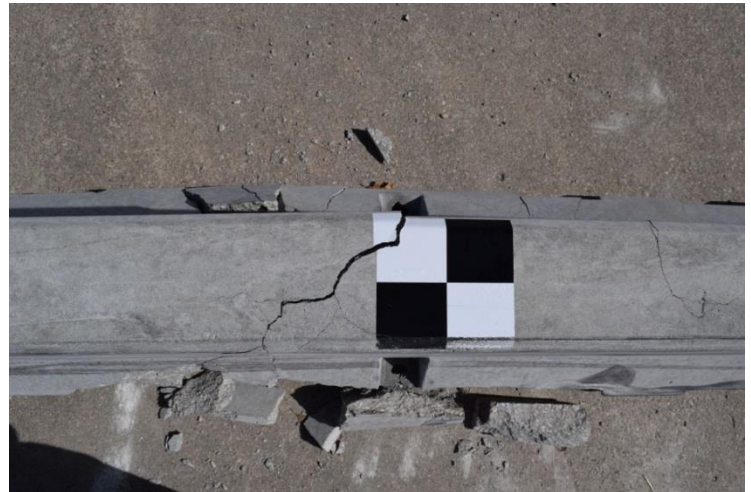
Figure 94. Barrier No. 5 Damage, Test No. NELON-2

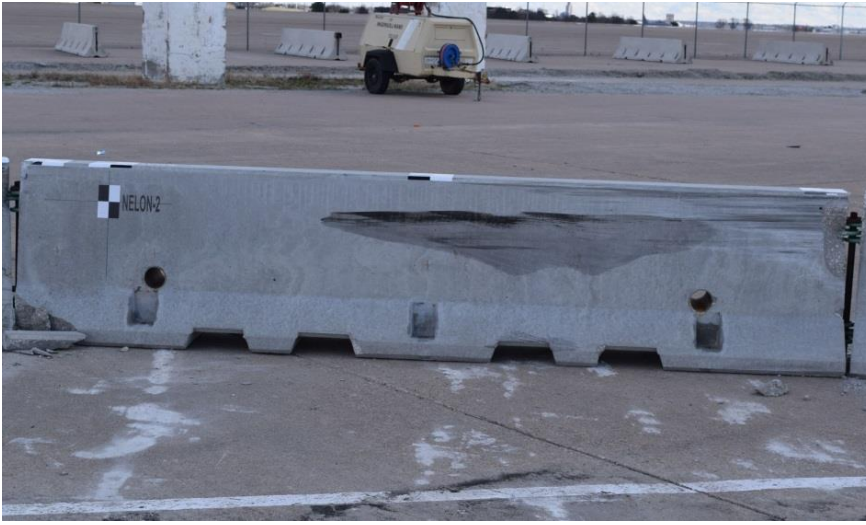
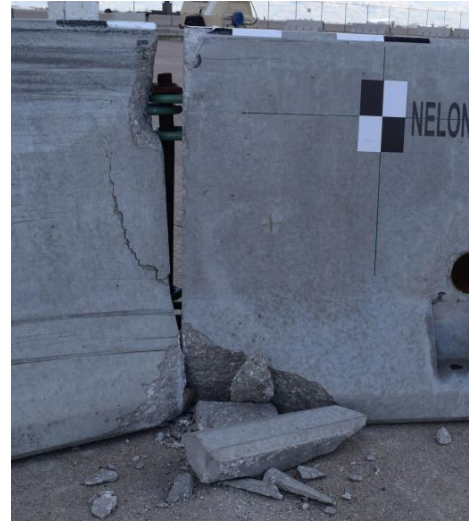
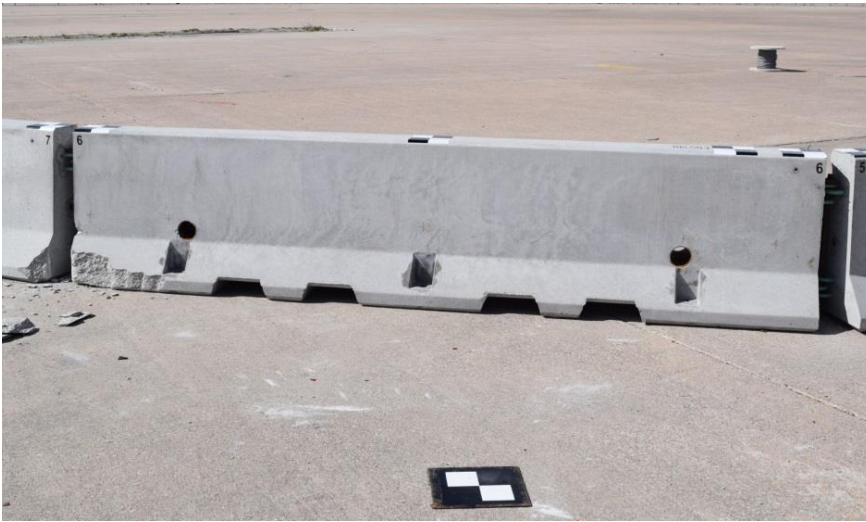
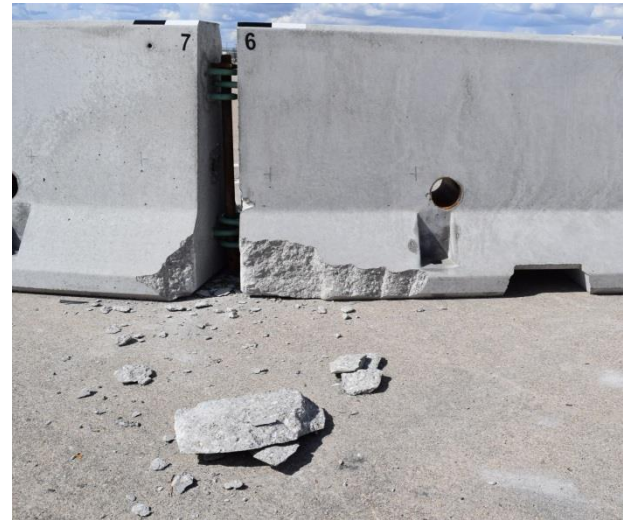
Figure 95. Barrier No. 6 Damage, Test No. NELON-2

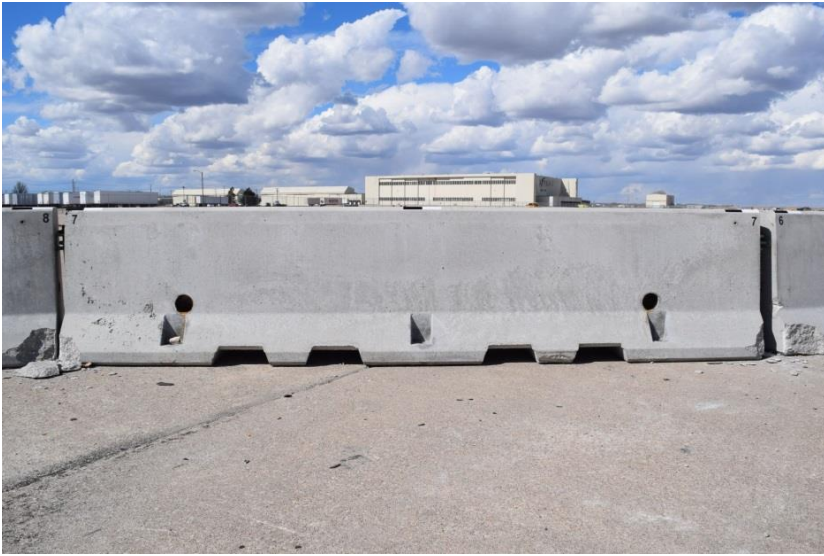
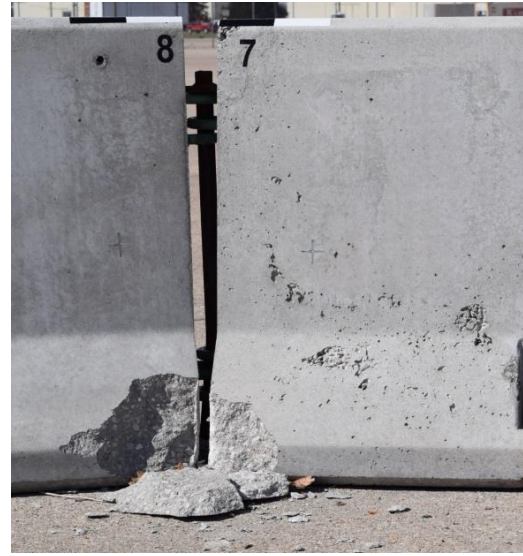
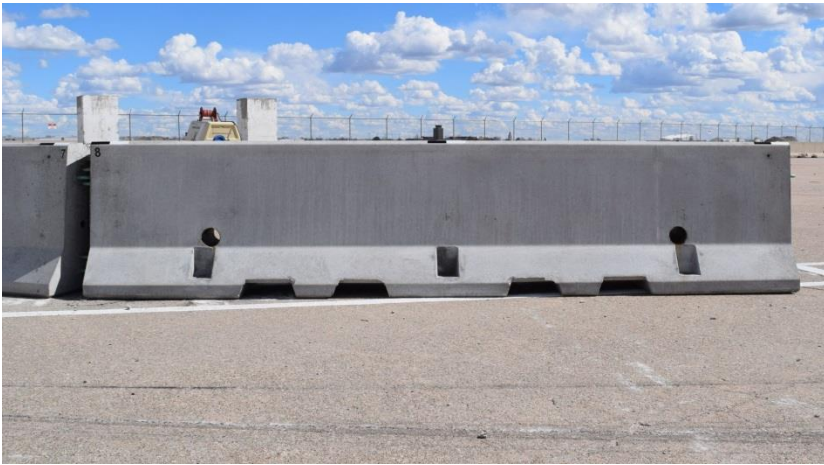
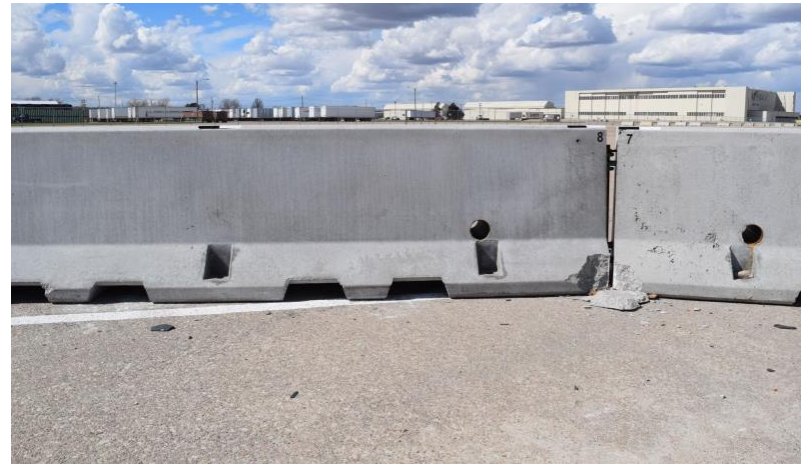
Figure 96. Barrier Nos. 7 and 8 Damage, Test No. NELON-2

A second factor that potentially contributed to the vehicle instability observed in test no. NELON-2 was the impact from a knee formed at the joint between barrier segment nos. 6 and 7. The knee extended forward laterally from the original barrier line and impacted the left-front door of the 2270P vehicle at approximately 0.390 sec after initial impact. The impact of the knee into the door may have further increased vehicle instability.

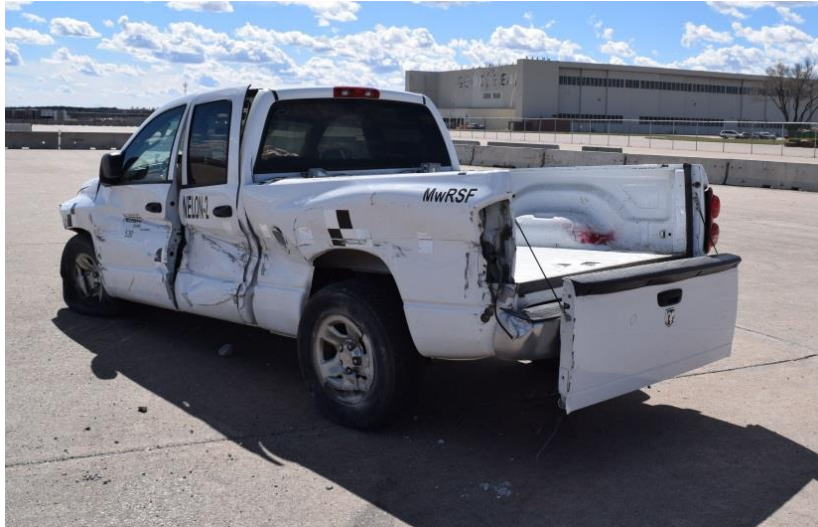
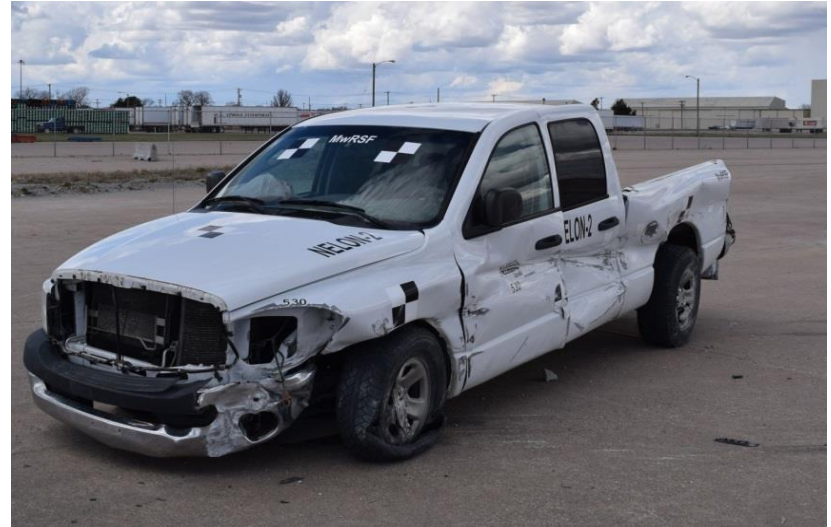
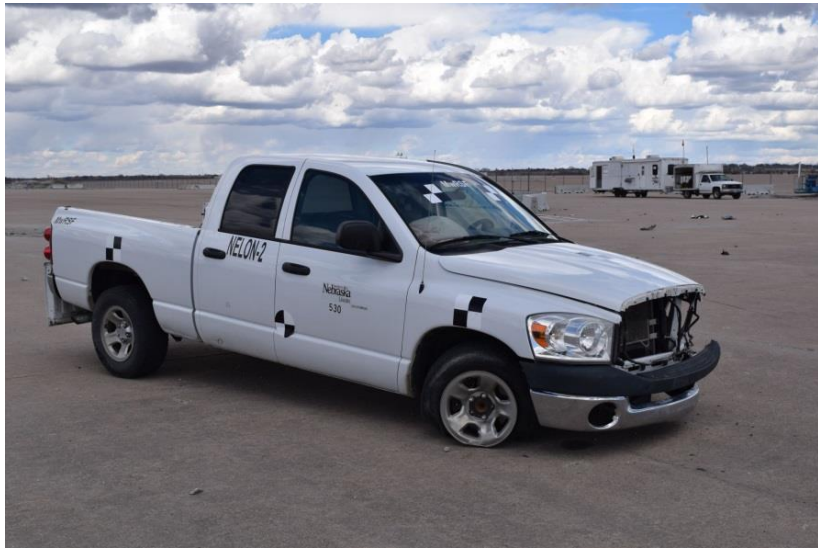
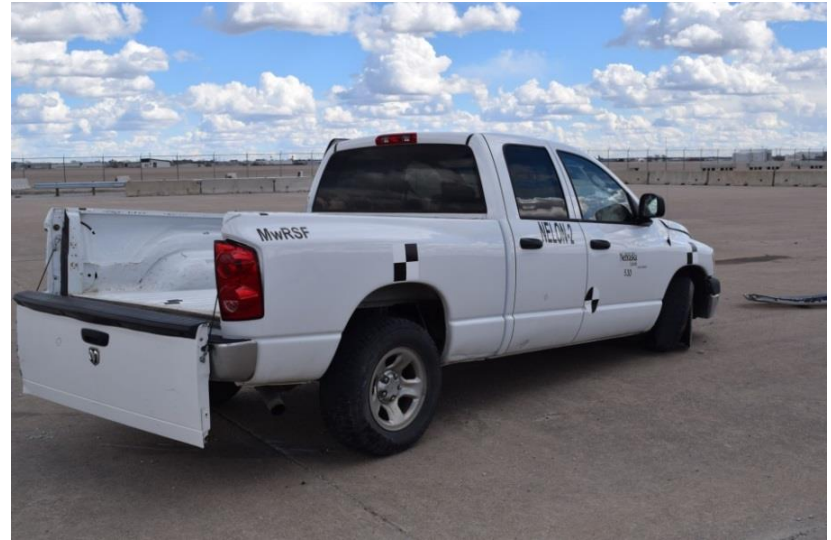
Figure 97. Vehicle Damage, Test No. NELON-2

The damage to the vehicle was moderate, as shown in Figures 97 and 98. The maximum occupant compartment deformations are listed in Table 10 along with the deformation limits established in MASH for various areas of the occupant compartment. Note that none of the

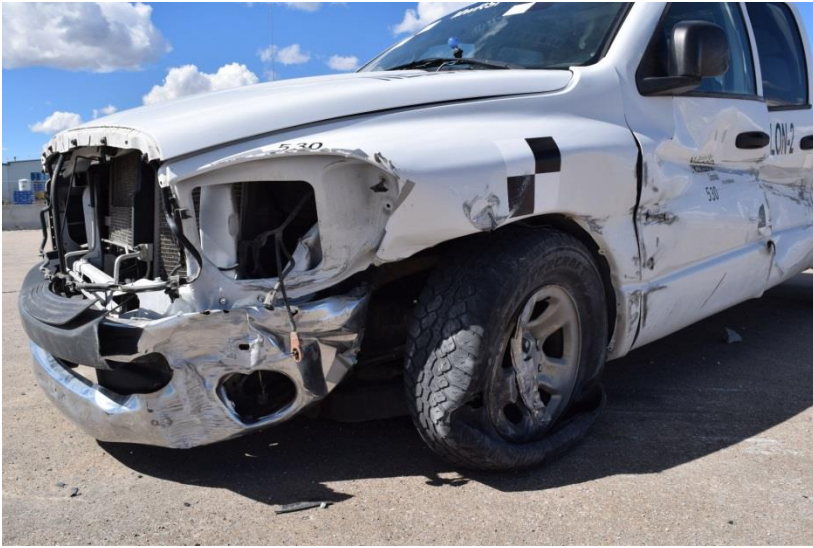
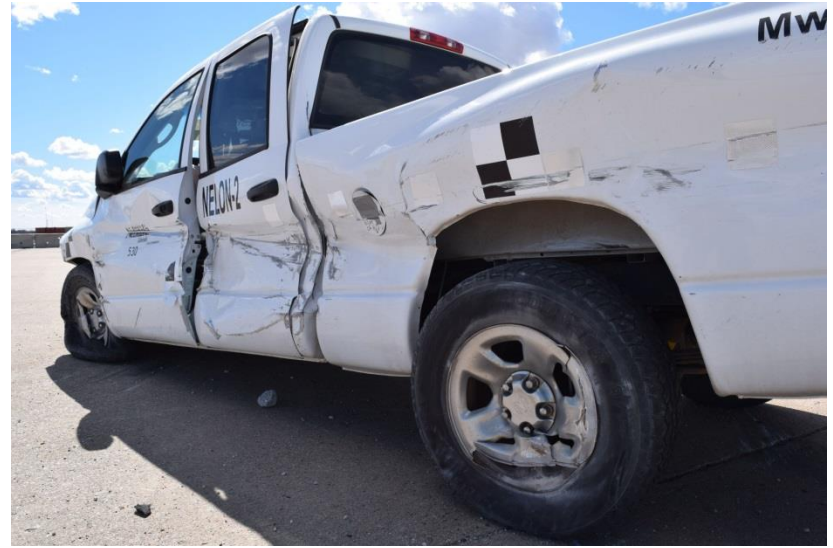
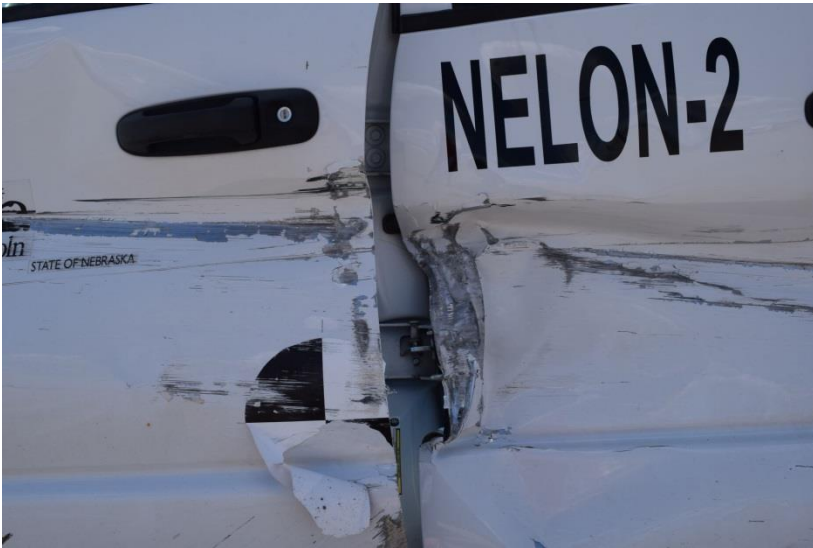
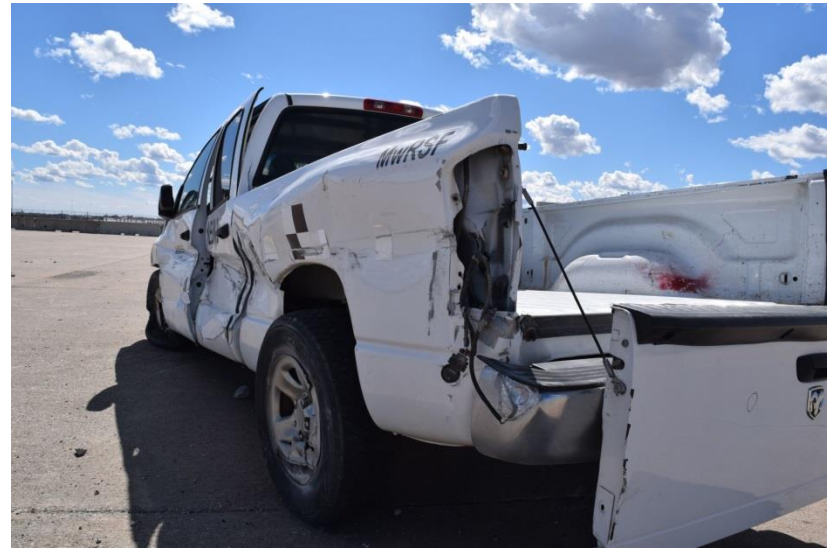
Figure 98. Vehicle Damage, Test No. NELON-2

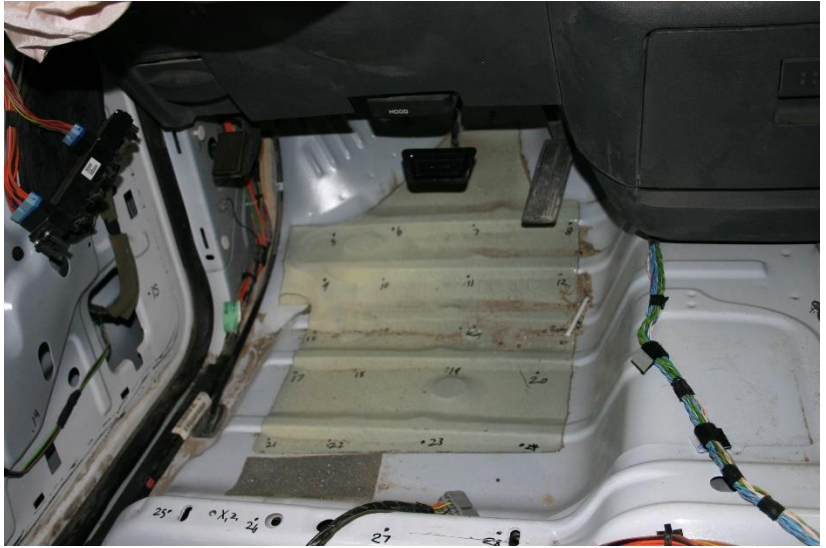
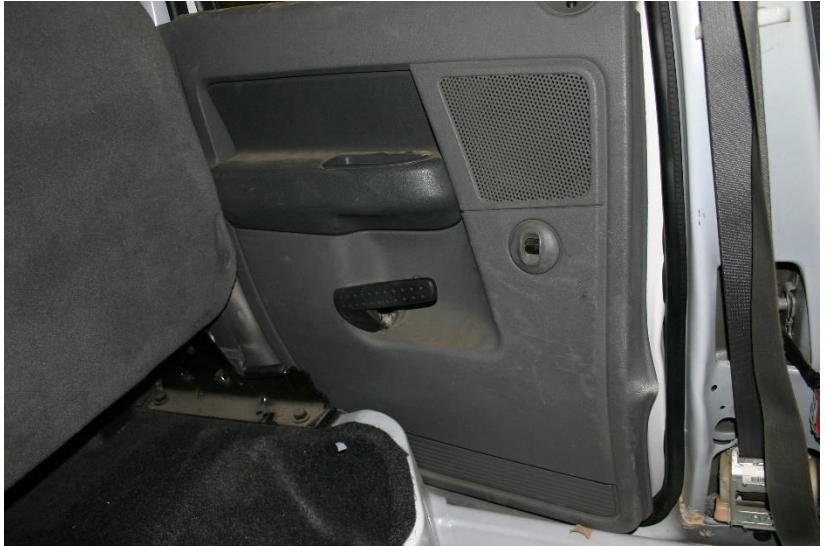
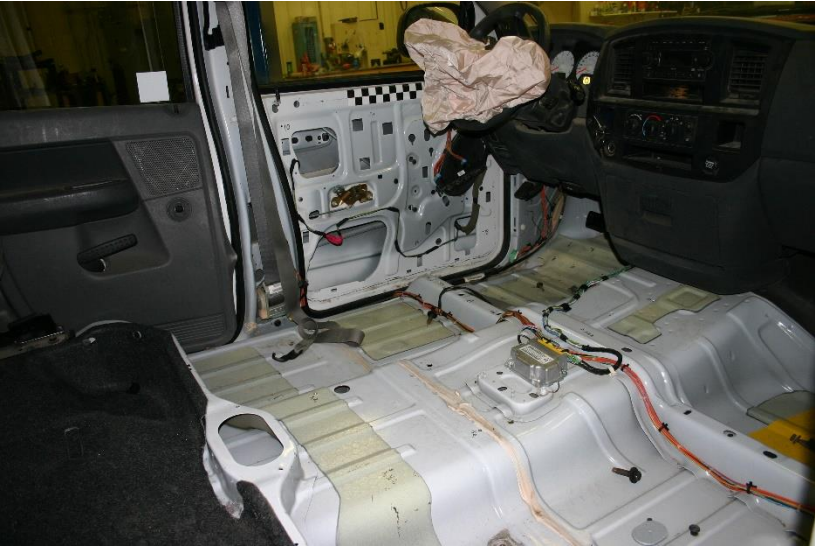
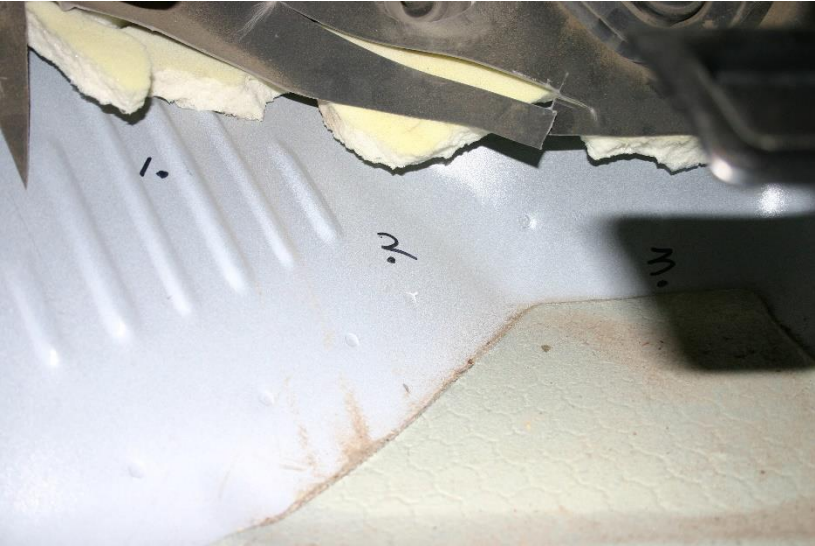
Figure 99. Occupant Compartment Damage, Test No. NELON-2

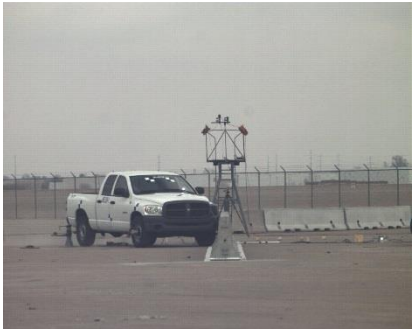
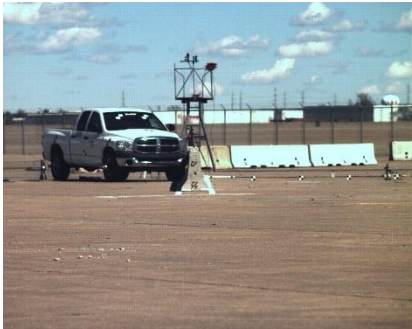
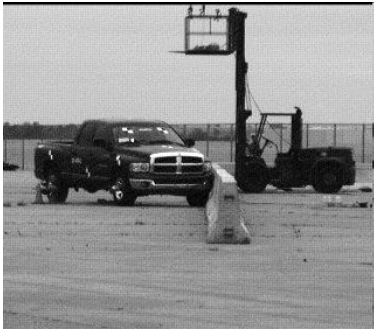
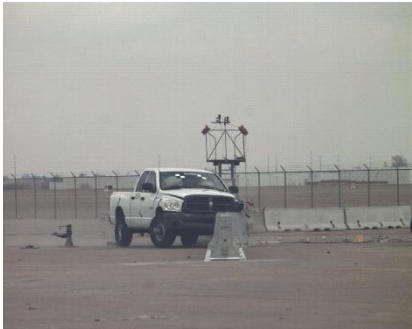
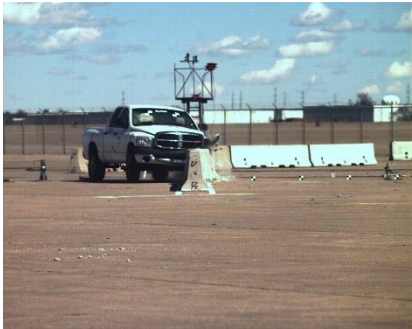
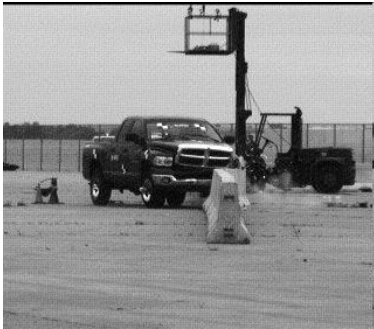
Figure 102. PCB System Comparison, Downstream View

Test no. NELON-2 initially performed similarly to test no. NELON-1 as the vehicle was captured and redirected. Peak lateral barrier deflections were similar to NELON-1 and were again larger than those predicted by the LS-DYNA simulation. However, test no. NELON-2 was deemed unacceptable according to the MASH safety requirements due to vehicle roll that exceeded 75 degrees after it exited the barrier system. Review of the test suggested potential factors that may have contributed to the vehicle rollover. First, the increased barrier deflections observed in test no. NELON-2 due to reduced system length and impact at the downstream LON point may have adversely affected the vehicle trajectory. Comparison of the barrier deflections and vehicle trajectories from test nos. NELON-1, NELON-2, and 2214TB-2 are shown in Figures 100 through 103. Review of these three tests showed that the reduced length system tests displayed higher deflections of barrier segments near the impact of the vehicle and less gradual deflection of adjacent barrier segments as compared to the full-length PCB system. These differences were likely due to both the reduced upstream and downstream tensile forces developed by shorter systems, as evidenced by the increased longitudinal displacement of the ends of the system, and increased barrier damage, as noted previously. The increased deflection of the reduced length systems clearly affected vehicle trajectory. Test nos. NELON-1 and NELON-2 exhibited higher exit angles of 12.3 degrees and 10.4 degrees, respectively, as compared to 7.9 degrees for test no. 2214TB-2. Similarly, comparison of vehicle roll angles during the first 0.500 sec of the vehicle redirection exhibited significantly higher roll for the reduced length systems, as shown in Figure 104. Thus, it was believed that the effect of reduced system length on the PCB deflections contributed to vehicle instability.
