Research Project Number TPF-5(193) Supplement #88

PERFORMANCE EVALUATION OF NEW JERSEY'S PORTABLE CONCRETE BARRIER WITH A PINNED CONFIGURATION AND GROUTED TOES – TEST NO. NJPCB-1

NEW JERSEY DEPARTMENT OF TRANSPORTATION

MwRSF Research Report No. TRP-03-338-18

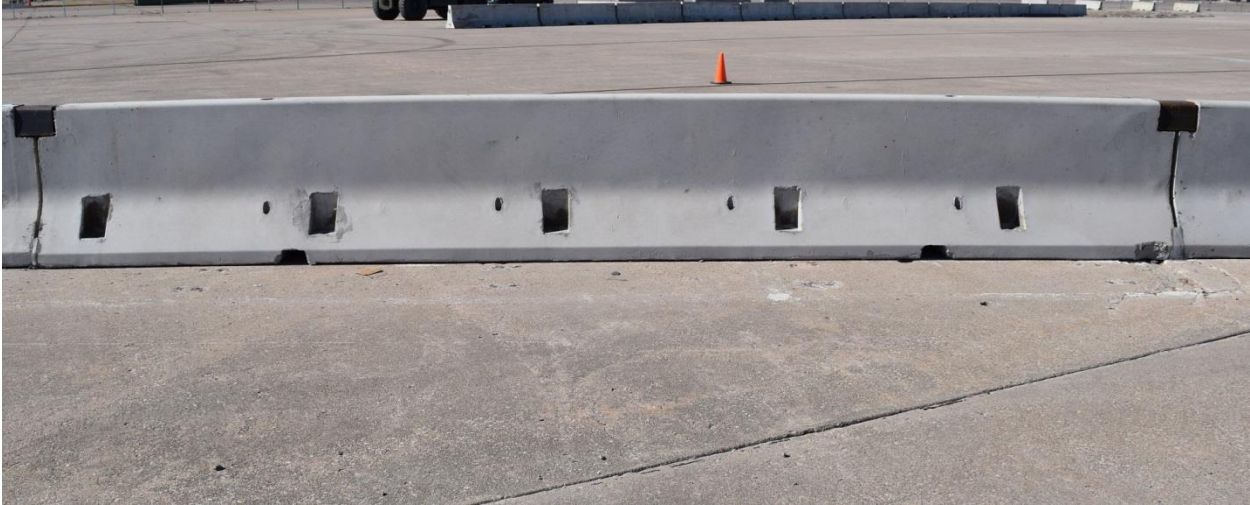
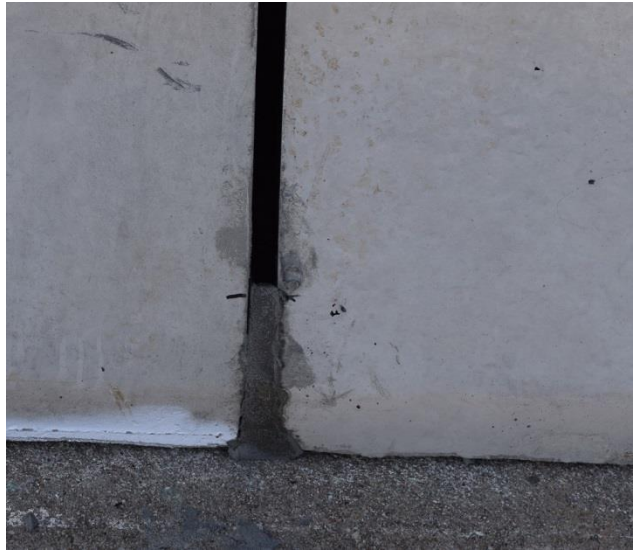
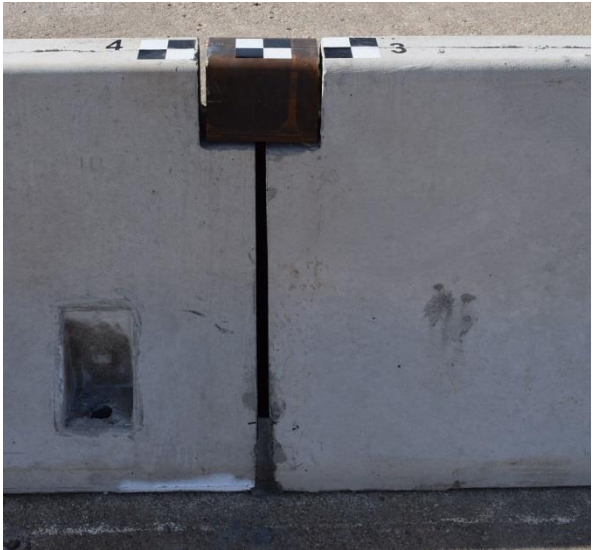
Figure 18. Grout at Toes between PCBs, Test No. NJPCB-1

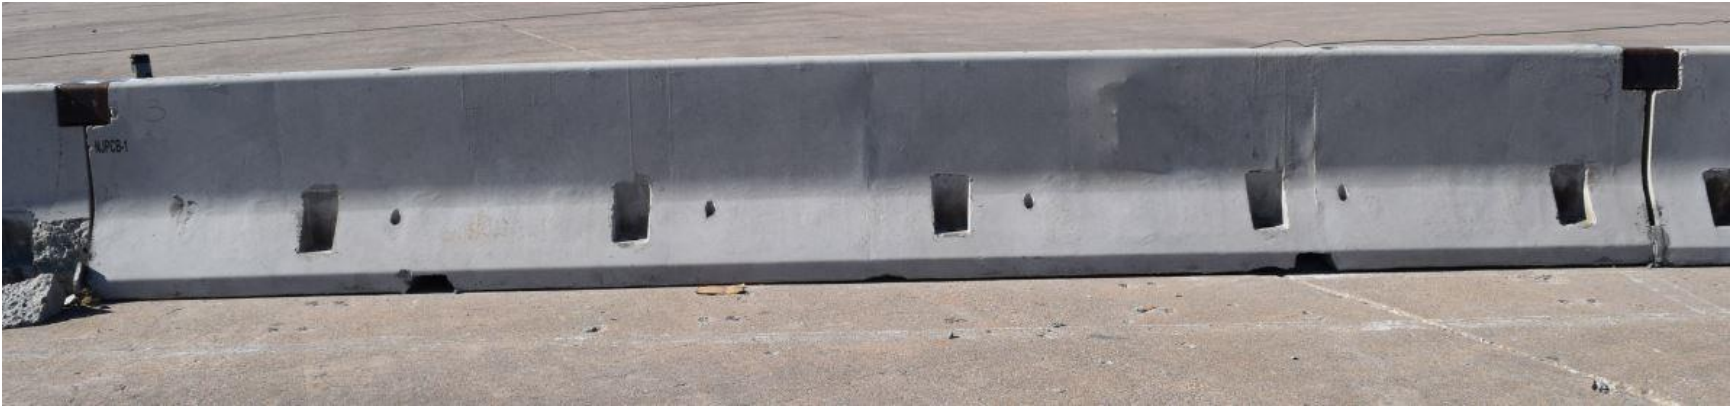
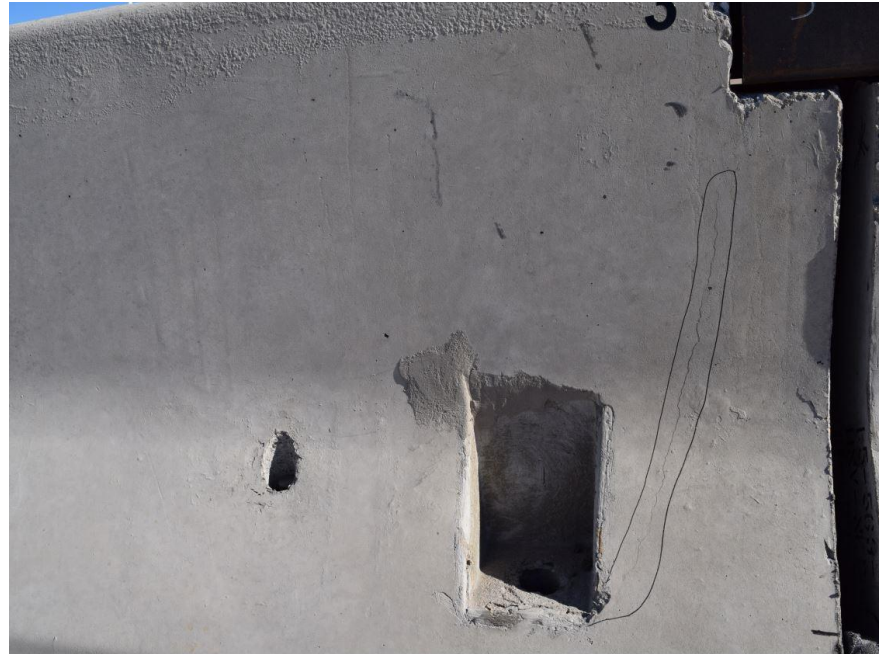
Figure 32. Barrier No. 3 – Traffic and Back Side Damage, Test No. NJPCB-1

Concrete spalling occurred on barrier nos. 3 through 6. A 2-in. × 2½-in. × ¼-in. (51-mm × 64-mm × 6-mm) concrete piece disengaged from barrier no. 3 at the lower-upstream corner on the front face. A 2⅞-in. × 1½-in. × ⅛-in. (73-mm × 38-mm × 3-mm) piece of concrete was removed from the upper-downstream end of barrier no. 3. Concrete spalling of 52¼ in. × 11½ in. × 4¾ in. (1,327 mm × 292 mm × 121 mm) and an 11⅜-in. (289-mm) long crack occurred at the lower-front upstream corner of barrier no. 4. The front side of barrier no. 4 experienced concrete spalling 30¼ in. × 15 in. × 10¾ in (768 mm × 381 mm × 273 mm) at the lower downstream corner. A 4¼-in. × 5½-in. × ⅝-in. (108-mm × 140-mm × 16-mm) piece of concrete was removed from the upper-downstream corner of barrier no. 4 below the connection key socket. Minor spalling occurred below the connection key socket on the front-upstream end of barrier no. 5. Concrete spalling occurred on the back side of barrier no. 5 at the upstream end from top to bottom, and a 24-in. (610 mm) long piece was removed, which exposed the connection key socket tube. Concrete spalling, measuring 42⅝ in. × 16 in. × 3⅝ in. (1,083 mm × 406 mm × 92 mm) occurred below the fractured section on the back side of barrier no. 5. Concrete spalling, measuring 67⅞ in. × 9⅞ in. × 1⅞ in. (1,705 mm × 232 mm × 29 mm) occurred at the back-side downstream end of barrier no. 5. The back side of barrier no. 6 experienced concrete spalling at the lower-downstream corner and near the middle of the barrier.

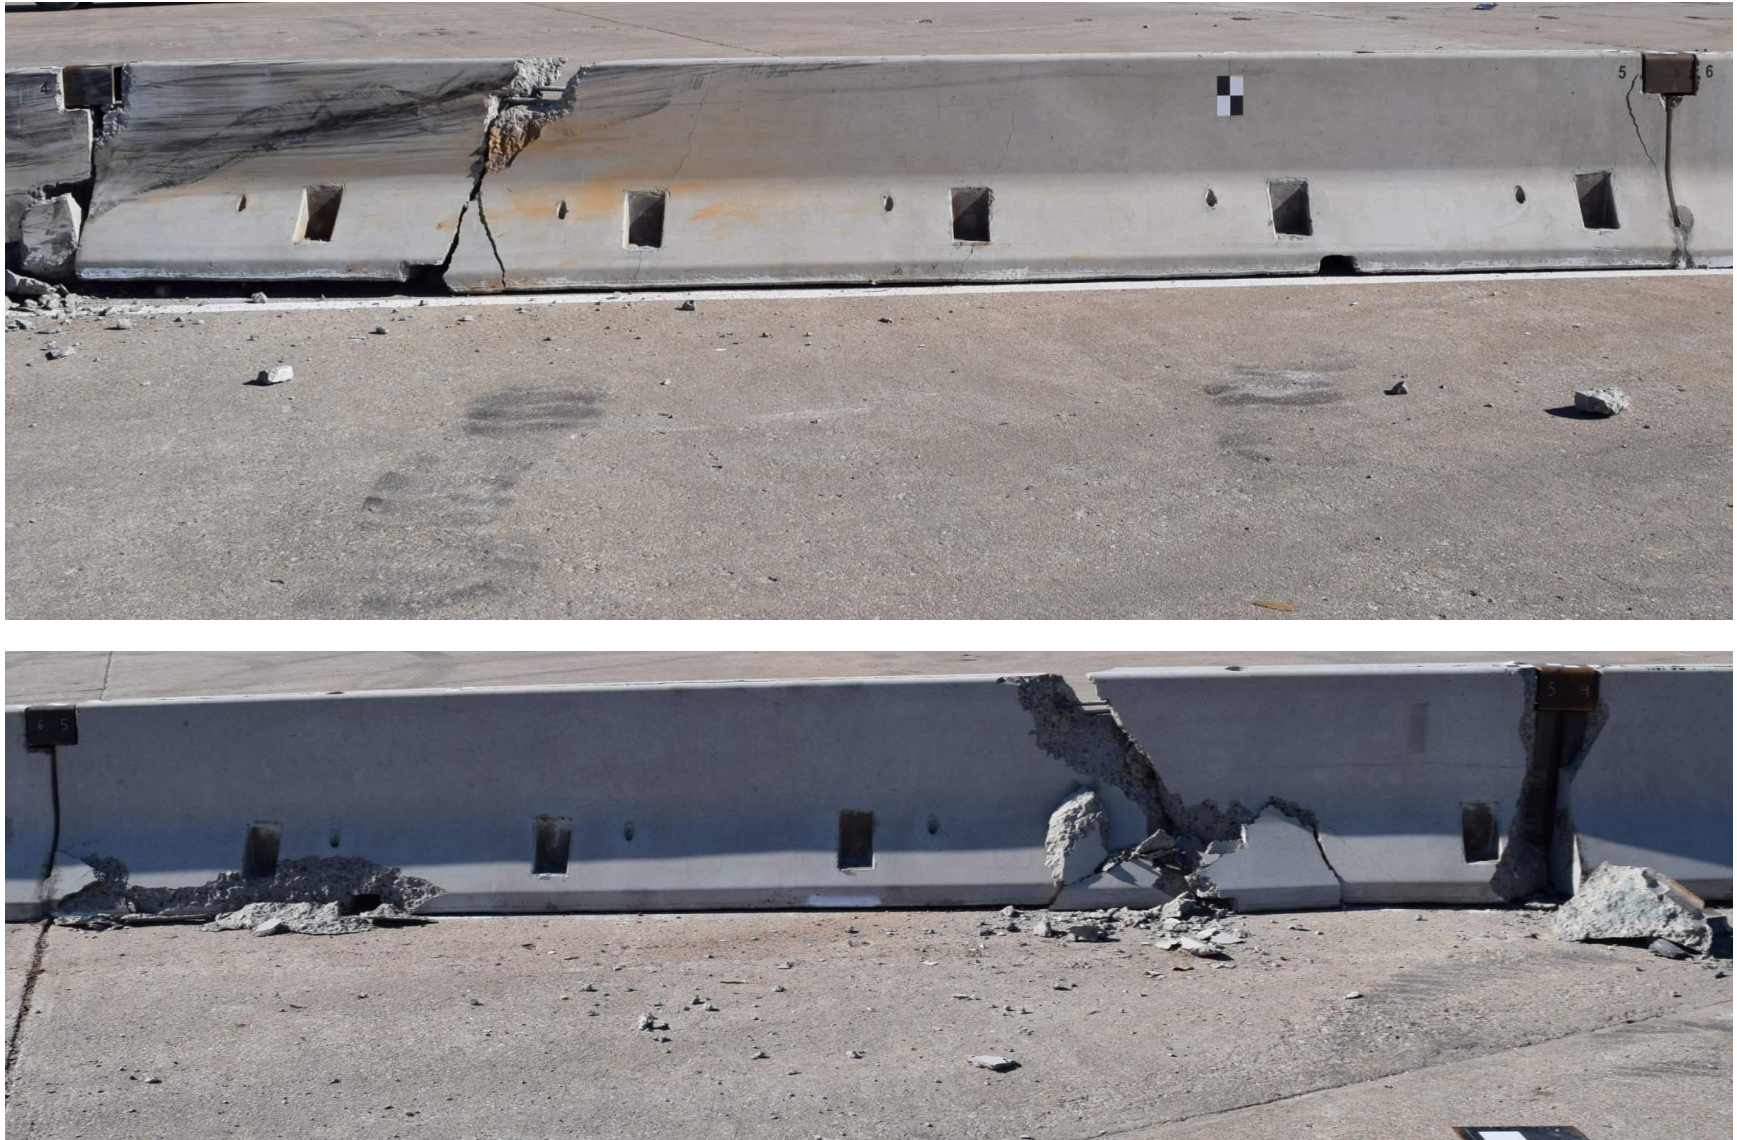
Figure 34. Barrier No. 5 – Traffic and Back Side Damage, Test No. NJPCB-1

Tire marks were visible on the front face of barrier nos. 4 and 5. Scrape marks were also found on the front and top faces of barrier nos. 4 and 5. The traffic-side grout between barrier nos. 3 and 4 was displaced ¼ in. (6 mm) laterally toward back side. Grout between barrier nos. 4 and 5 had crumbled. A 26¼-in. (667-mm) long crack on the front face extended from the upstream end to the toe of barrier no. 4. An 18¼-in. (464-mm) long crack on the front face of barrier no. 4 extended from the downstream end to anchor pocket no. 9. Barrier no. 5 was fractured from top to bottom at 60½-in. (1,537-mm) downstream from the upstream end. A 32¾-in. (832-mm) long crack was found on the front face of barrier no. 5 beginning at the bottom of anchor pocket no. 3. A 15½-in. (394-mm) long crack near the bottom on the back side of barrier no. 5 was approximately 31-in. (787-mm) downstream from the upstream end. A 32½-in. (826-mm) long crack on the back side of barrier no. 5 extended vertically from anchor pocket no. 4. Minor cracks were found on the back side of barrier no. 6. A 2½-in. (64-mm) long vertical crack was found at the corner of the upstream connection key socket on barrier no. 6. A 16-in. (406-mm) long crack was found on the upstream end of the back face of barrier no. 6. Anchor pin nos. 2, 6 and 7 in barrier no. 5 were bent, and the concrete around those pin anchors were cracked.

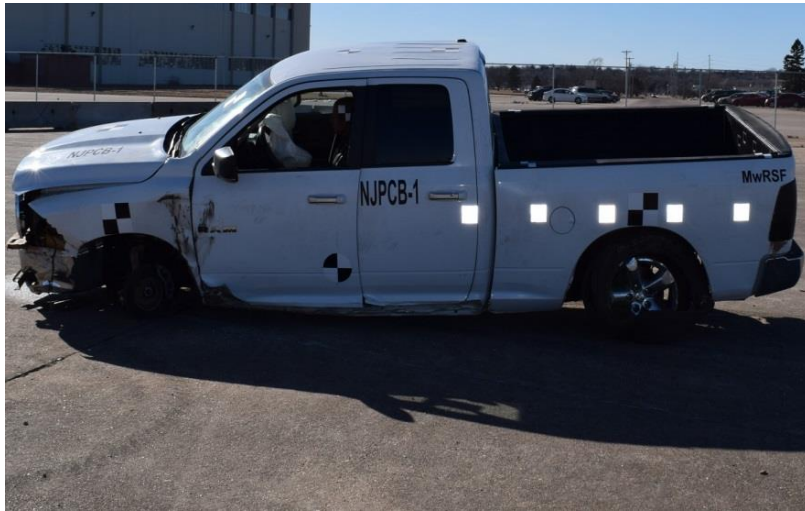
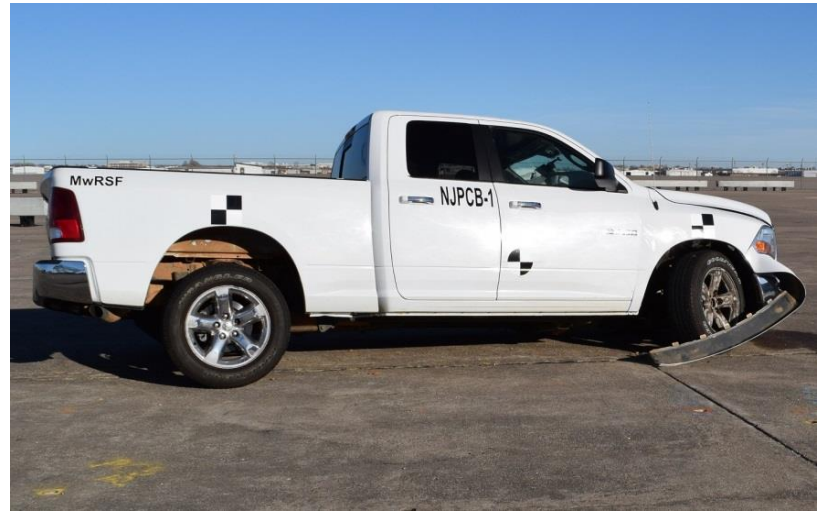
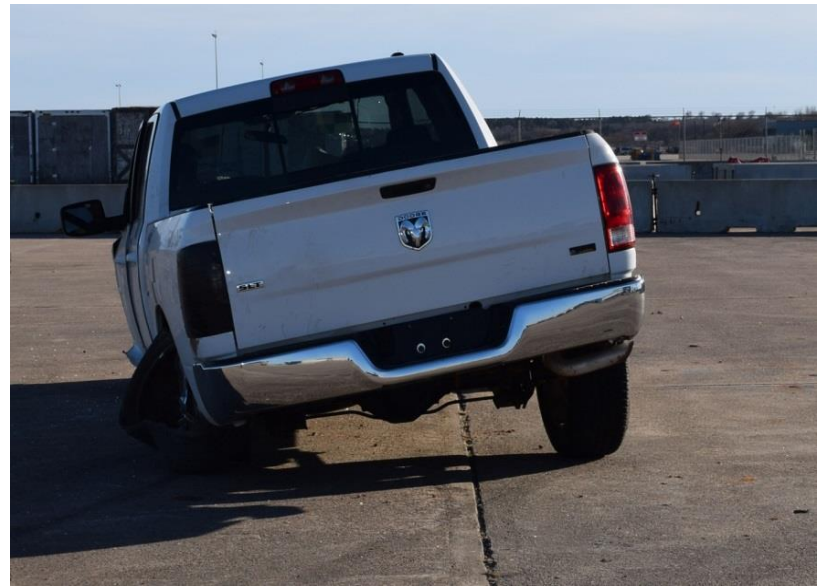
Figure 36. Vehicle Damage, Test No. NJPCB-1

The damage to the vehicle was moderate, as shown in Figures 36 through 40. The maximum occupant compartment deformations are listed in Table 7 along with the deformation limits established in MASH 2009 for various areas of the occupant compartment. Note that none of the MASH 2009 established deformation limits were violated. Complete occupant compartment and vehicle deformations and the corresponding locations are provided in Appendix E.

The majority of the damage was concentrated on the left–front corner and left side of the vehicle where the impact had occurred. The left side of the bumper crushed inward. The plastic bumper portion separated from the left side and bent toward the right side of the vehicle. The hood separated from the right fender. The left-front fender was deformed 4 in. (102 mm) inward toward the engine compartment. A 2-in. × 3-in. (51-mm × 76-mm) dent was found on the rear of the left fender approximately 19 in. (483 mm) from the bottom of the fender. Denting, scraping, and gouging were observed on the entire left side of the cab. Gouging and contact marks were found at the bottom of the left-front door, starting from the front of the door and extending 4 in. (102 mm) backward. Scraping was found at the bottom of the left-front door, extending 21½ in. (546 mm) toward the rear of the door. Contact marks were found on the left-rear door, starting from the front of the left-rear door and extending 15 in. (381 mm) backward. The left-front headlight and tire disengaged from the vehicle. A tear was found on the left-rear tire extending from the outer side wall through the tread and two-thirds of the way around the tire. A 15-in. × 5-in. × 1-in. (381-mm × 127-mm × 25-mm) dent extended from the left edge of the front bumper and 3 in. (76 mm) from the bottom of the bumper. A 3-in. × 2-in. × ¼-in. (76-mm × 51-mm × 6-mm) dent was found 11 in. (279 mm) from the left edge of the bottom of the front bumper.

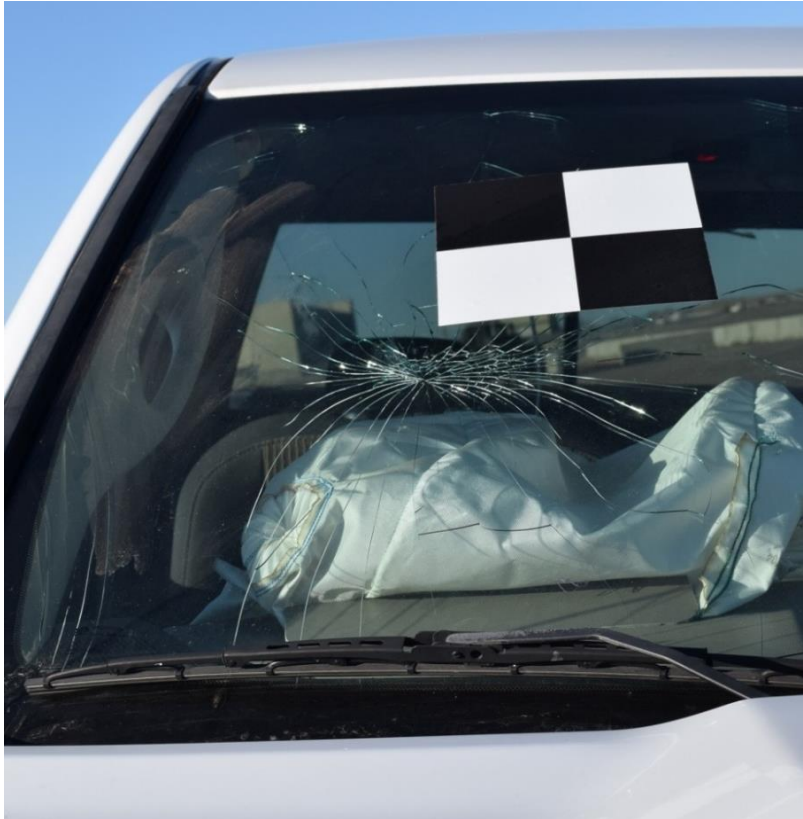
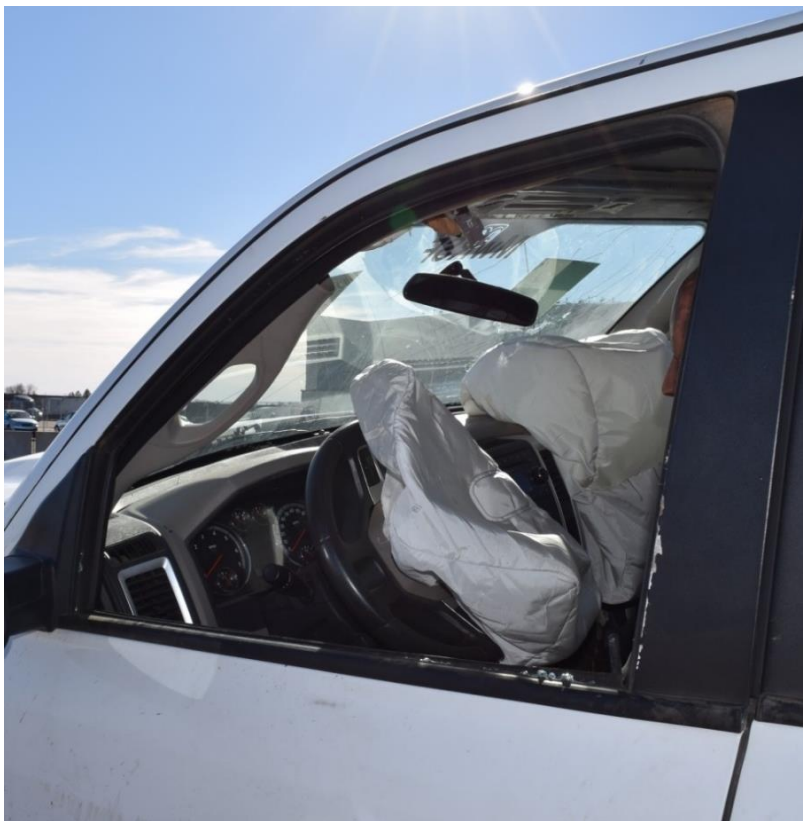
Figure 38. Vehicle Windshield and Window Damage, Test No. NJPCB-1

The lower-left control arm was scraped and crushed. The left-front lower control arm had a 2½-in. (64-mm) tear on the leading edge approximately 5½ in. (140 mm) from the lower ball joint. The left-front wheel and hub were disengaged. The brake disk disengaged from the overall assembly but remained attached. The rear transmission and rear axle were shifted toward the right of the vehicle. Scrape marks were found on the exhaust pipe. The left-front side window glass shattered. The roof remained undamaged. The windshield had 30-in. (762-mm) diameter spider web cracking and an additional crack extending from the spider-web crack to the left-bottom corner.

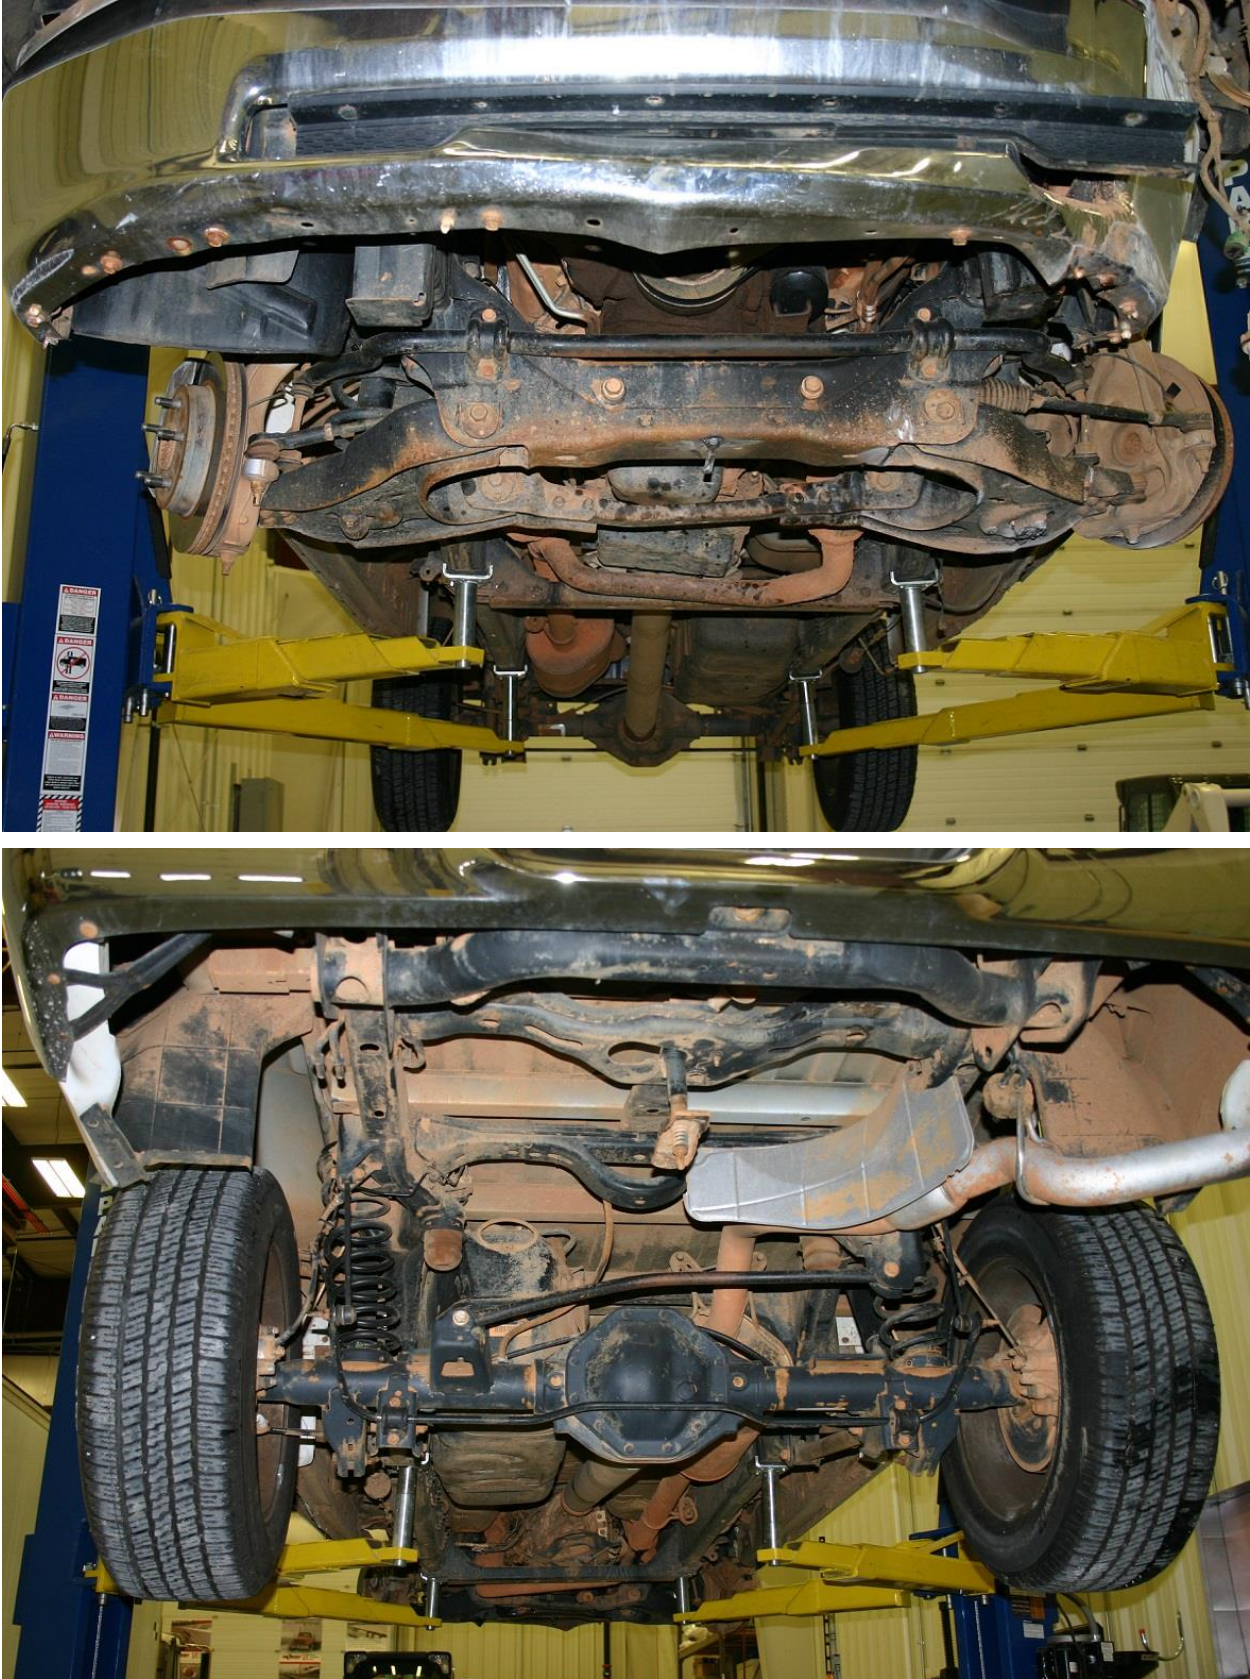
Figure 40. Undercarriage Damage, Test No. NJPCB-1
