Research Project Number TPF-5(193) Supplement #88

**PERFORMANCE EVALUATION OF NEW
JERSEY'S PORTABLE CONCRETE BARRIER
WITH A FREE-STANDING CONFIGURATION –
TEST NO. NJPCB-3**

NEW JERSEY DEPARTMENT OF TRANSPORTATION

MwRSF Research Report No. TRP-03-355-18

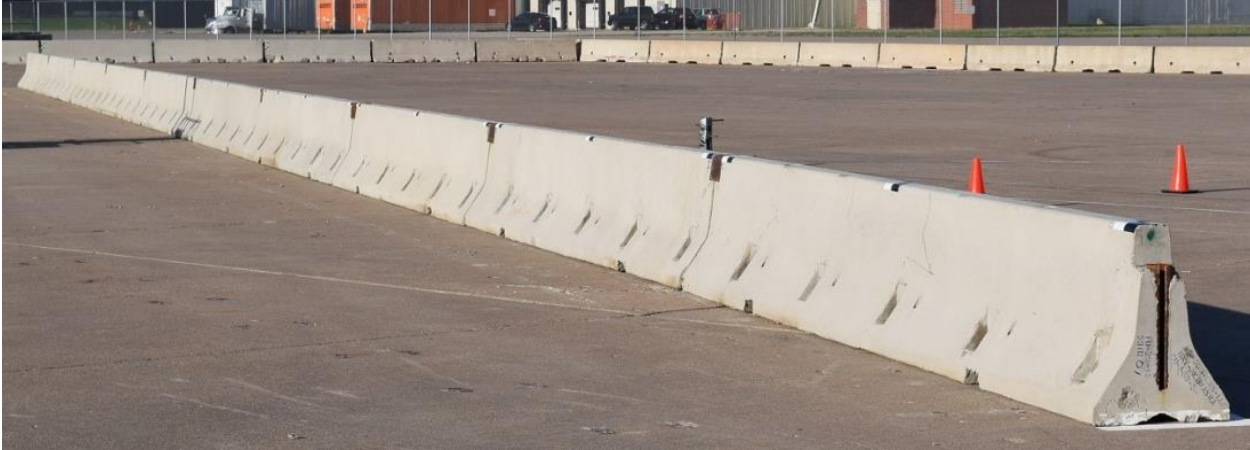
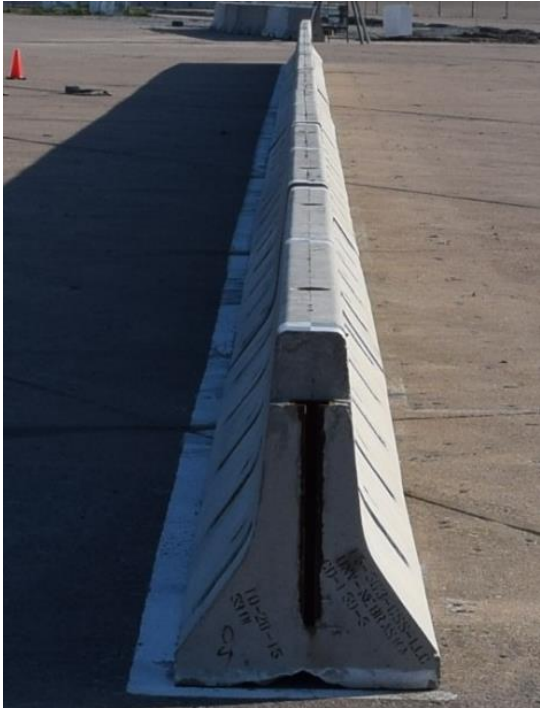
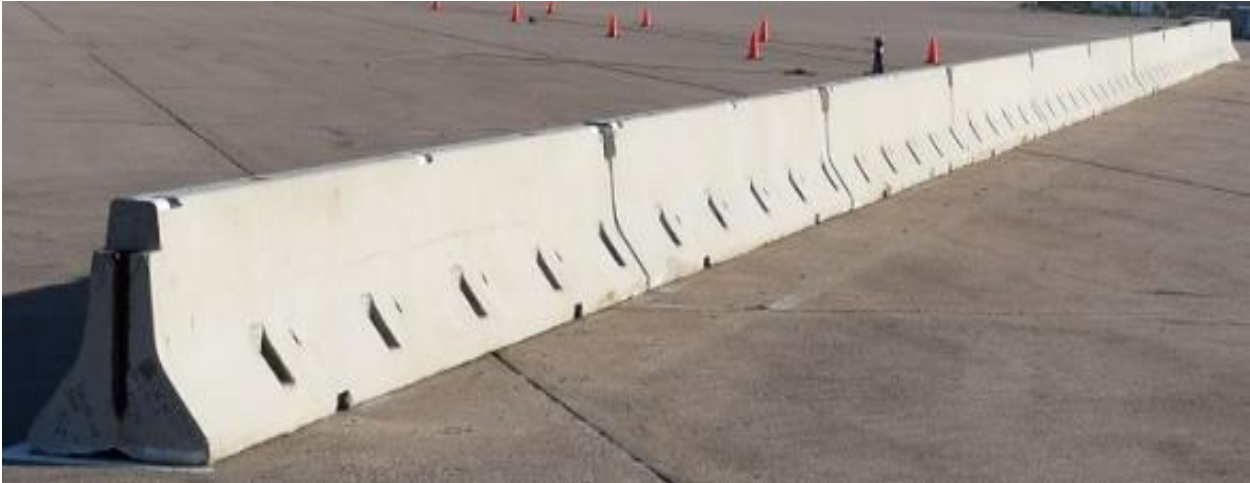
Figure 15. NJDOT PCB with Free-Standing Configuration Test Installation, Test No. NJPCB-3

The test installation consisted of ten 20-ft (6.1-m) long NJDOT PCBs with a free-standing configuration, as shown in Figures 1 through 14. This system uses NJDOT barriers, Type 4 (Alternative B) with joint class A as specified in the 2013 NJDOT *Roadway Design Manual* and connection type A in the 2015 NJDOT *Roadway Design Manual*. Photographs of the test installation are shown in Figures 15 through 17. Material specifications, mill certifications, and certificates of conformity for the system materials are shown in Appendix B.

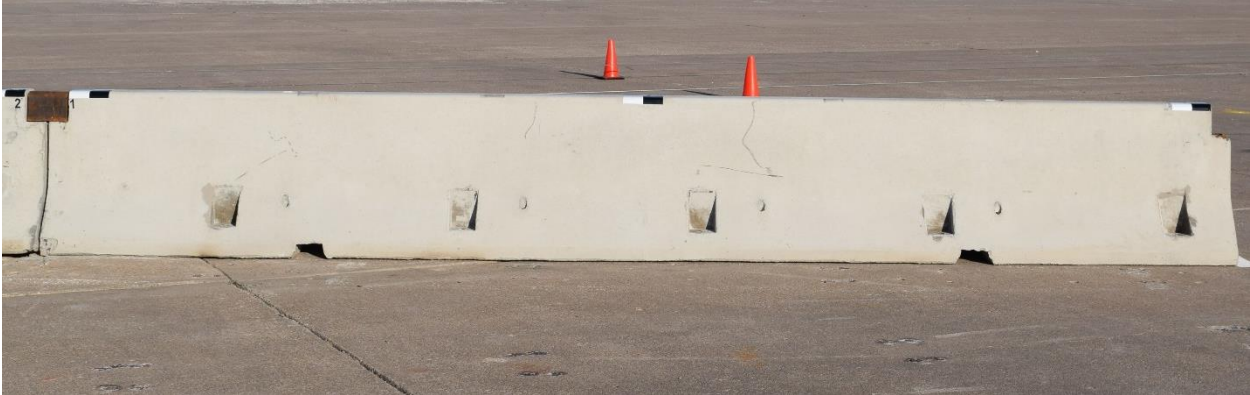
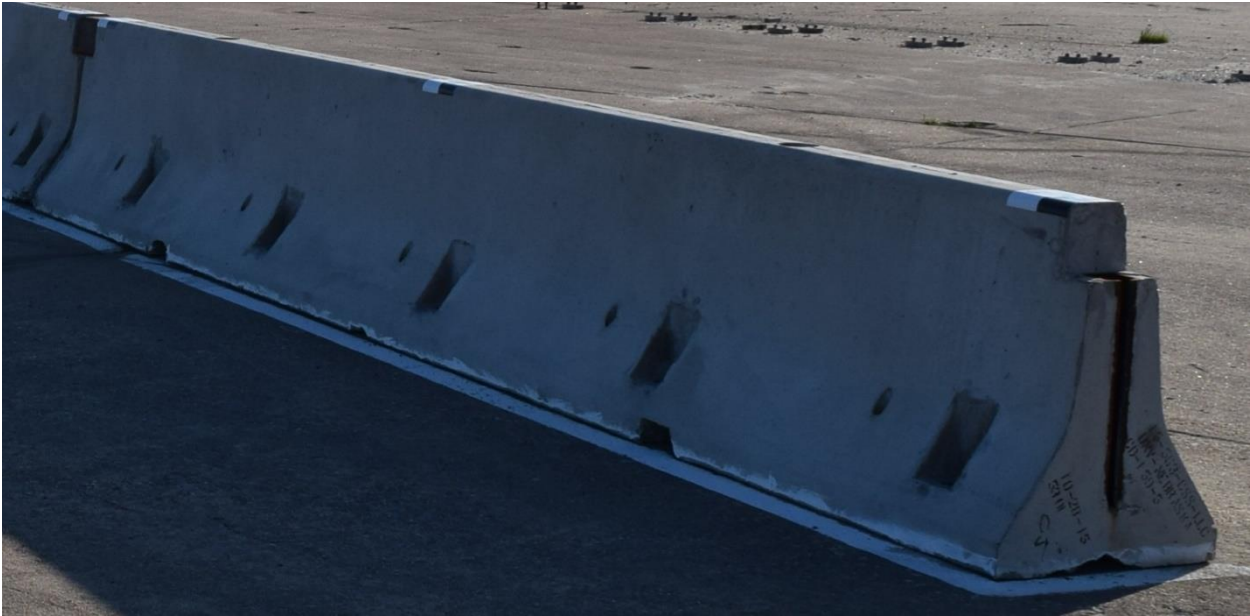
Figure 16. PCB Connection Key and Connection Socket, Test No. NJPCB-3

The barrier sections used a connection key, as shown in Figures 7 through 11, 15, and 16. The connection key assembly consisted of ½-in. (13-mm) thick ASTM A36 steel plates welded together to form the key shape. A connection socket was configured at each end of the PCB section, as shown in Figures 2, 11, 15, and 16. The connection socket consisted of three ASTM A36 steel plates welded on the sides of an ASTM A500 Grade B or C steel tube, as shown in Figures 9 and 10. The connection key was inserted into the steel tubes of two adjoining PCBs to form the connection, as shown in Figure 11.

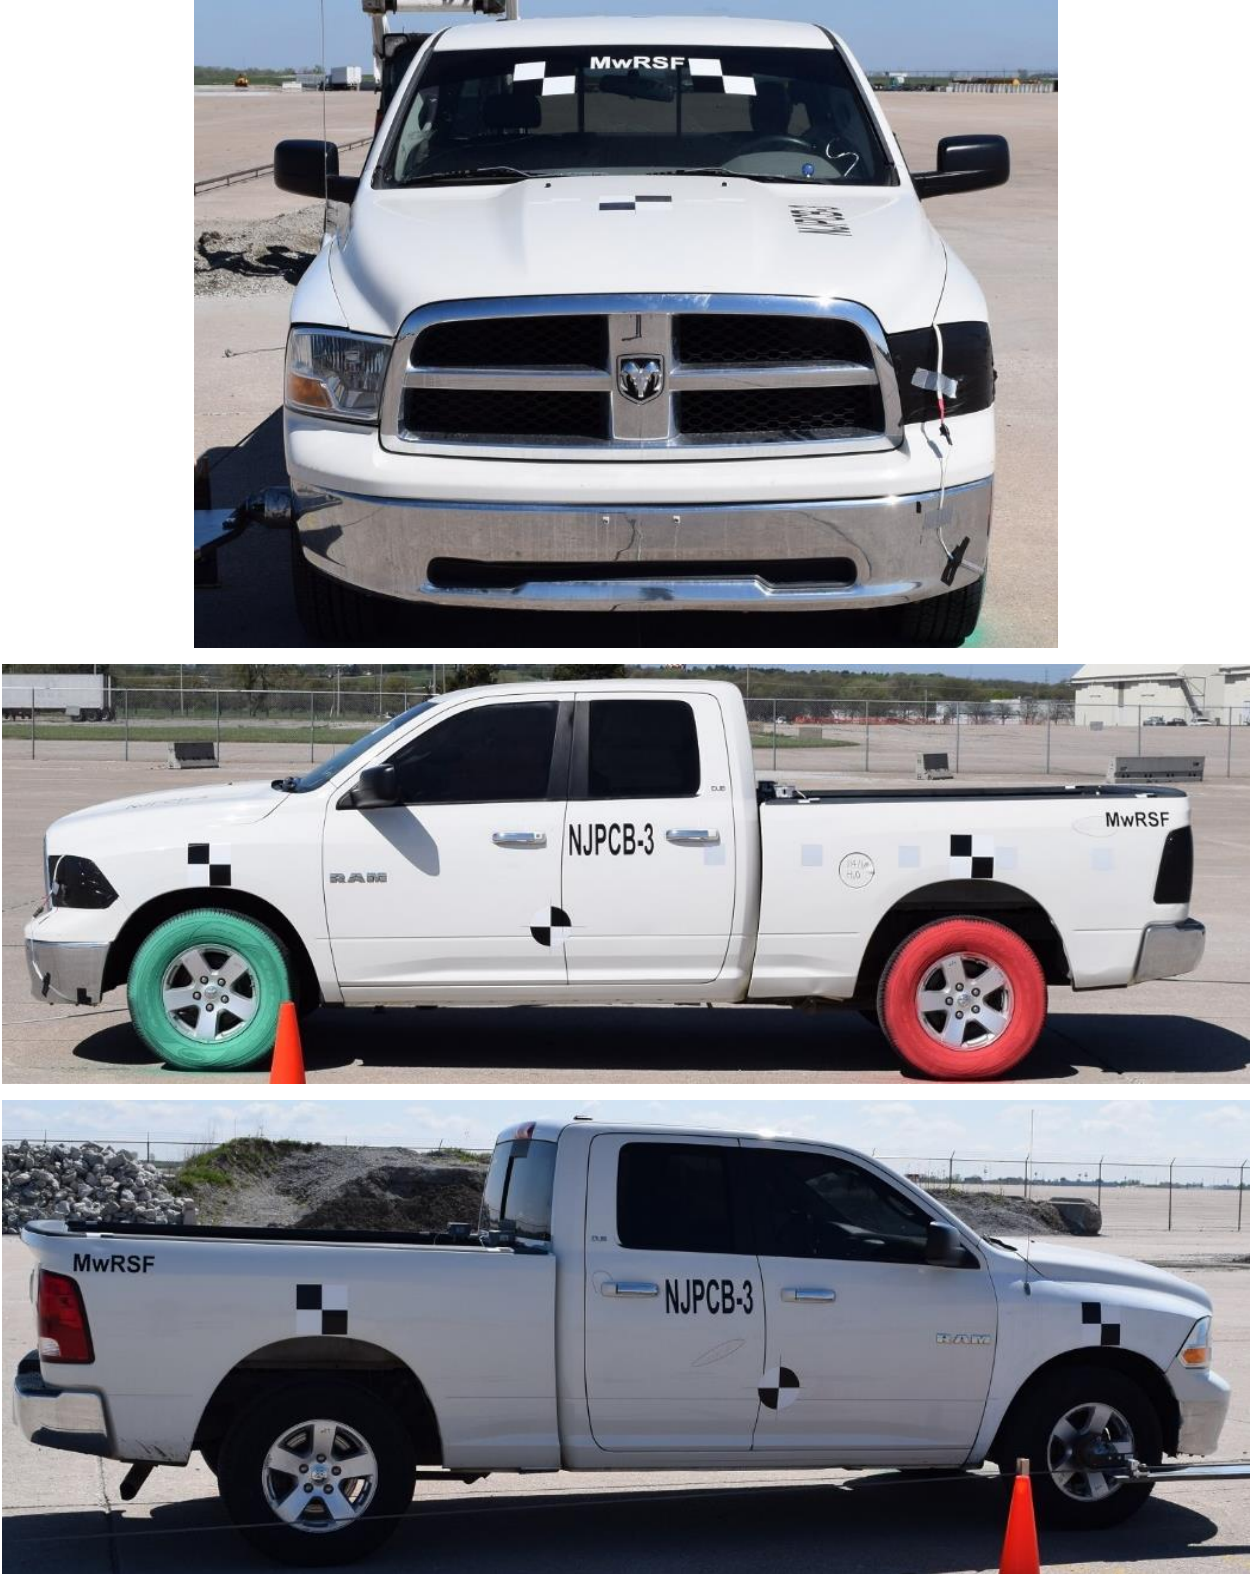
Figure 18. Test Vehicle, Test No. NJPCB-3

For test no. NJPCB-3, a 2010 Dodge Ram 1500 quad cab pickup truck was used as the test vehicle. The curb, test inertial, and gross static vehicle weights were 5,093 lb (2,310 kg), 4,999 lb (2,268 kg), and 5,154 lb (2,338 kg), respectively. The test vehicle is shown in Figure 18, and vehicle dimensions are shown in Figure 19.

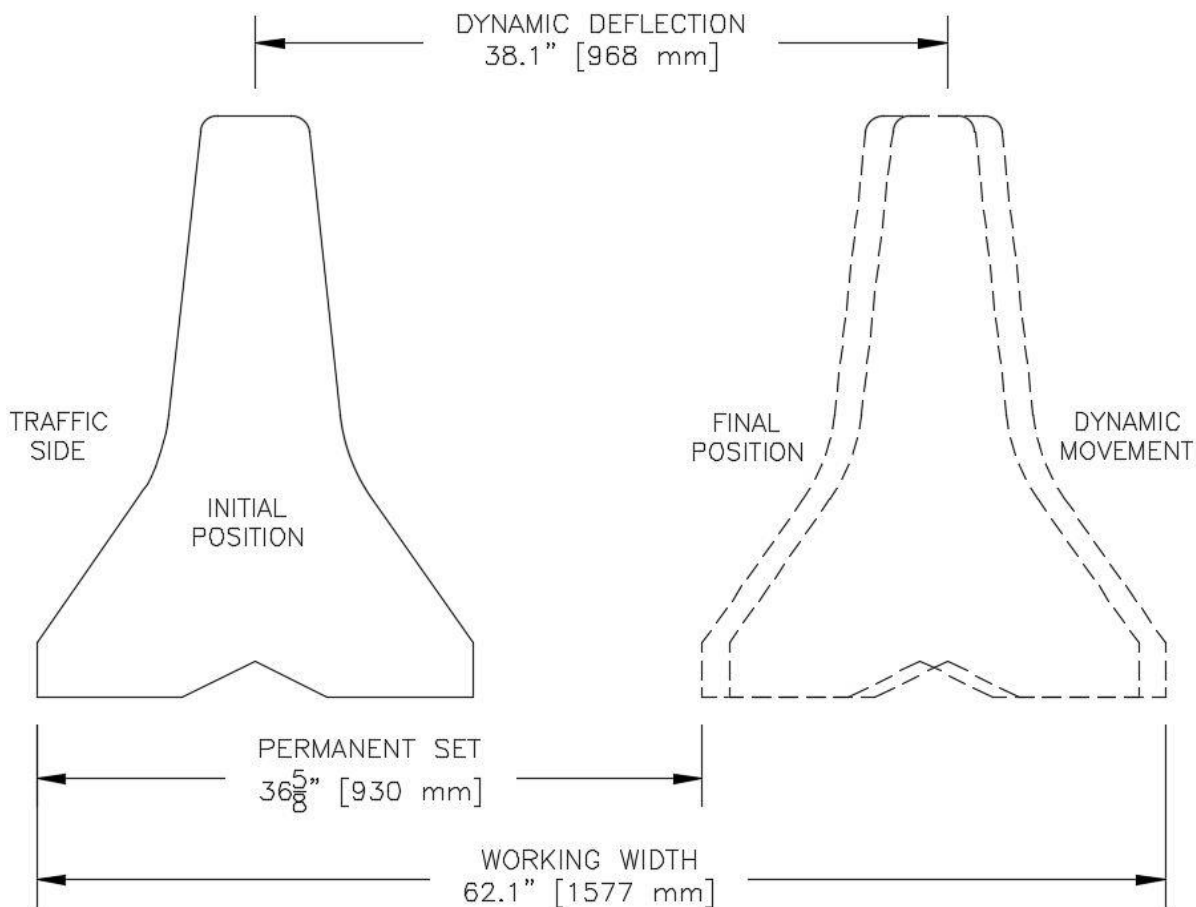
Figure 22. Permanent Set Deflection, Dynamic Deflection and Working Width, Test No. NJPCB-3

The maximum permanent set deflection of the barrier system was 36⁵/₈ in. (930 mm) at the downstream end of barrier no. 4, as measured in the field. The maximum lateral dynamic barrier deflection, including minor tipping of the barrier along the top surface, was 38.1 in. (968 mm) at the downstream end of barrier no. 4, as determined from high-speed digital video analysis. The working width of the system was found to be 62.1 in. (1,577 mm), also determined from high-speed digital video analysis. A schematic of the permanent set deflection, dynamic deflection, and working width is shown in Figure 22. In addition, NJDOT identifies the clear space behind the barrier, which is defined as the maximum deflection of the back of the barrier from its original position. For this test, the clear space behind the barrier was 38.1 in. (968 mm).

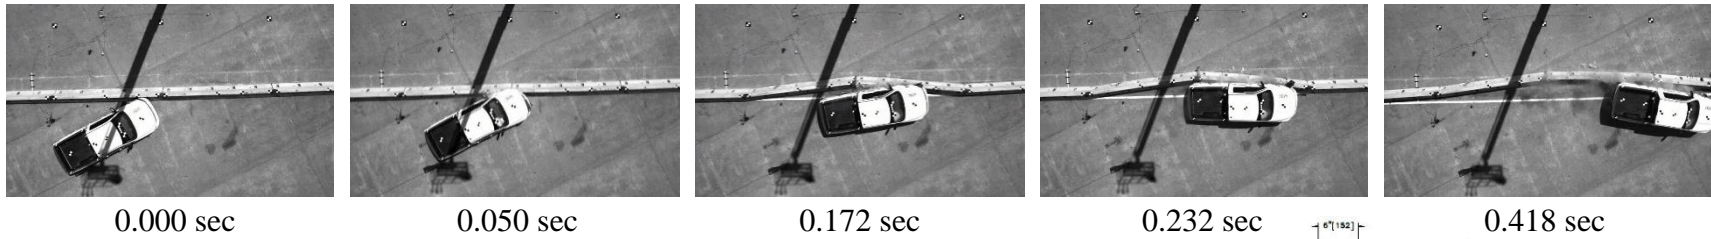
Figure 23. Summary of Test Results and Sequential Photographs, Test No. NJPCB-3

- Test Agency MwRSF
- Test Number..... NJPCB-3
- Date..... 04/22/2016
- MASH 2009 Test Designation 3-11
- Test Article..... Free-standing NJDOT PCB with Joint Class A [1]/Connection Type A [2]

Evaluation Criteria		Transducer		MASH 2009 Limit
		SLICE-1	SLICE-2 (primary)	
OIV ft/s (m/s)	Longitudinal	-13.58 (-4.14)	-13.52 (-4.12)	± 40 (12.2)
	Lateral	15.65 (4.77)	18.01 (5.49)	± 40 (12.2)
ORA g's	Longitudinal	-4.89	-5.23	± 20.49
	Lateral	10.67	9.61	± 20.49
MAX. ANGULAR DISP. deg.	Roll	-20.7	-17.2	± 75
	Pitch	-7.3	-9.0	± 75
	Yaw	105.5	105.0	not required
THIV – ft/s (m/s)		19.58 (5.97)	23.16 (7.06)	not required
PHD – g's		10.68	9.61	not required
ASI		1.09	1.23	not required

The 4,999-lb (2,268-kg) pickup truck impacted the NJDOT PCB, Type 4 (Alternative B) with a free-standing configuration, corresponding to joint class A in the 2013 NJDOT *Roadway Design Manual* and connection type A in the 2015 NJDOT *Roadway Design Manual*, at a speed of 62.3 mph (100.2 km/h) and at an angle of 25.8 degrees. A summary of the test results and sequential photographs are shown in Figure 23. Additional sequential photographs are shown in Figures 24 and 25. Documentary photographs of the crash test are shown in Figure 26.

Initial vehicle impact was to occur 4 ft – $3^{3/16}$ in. (1.3 m) upstream from the centerline of the joint between barrier nos. 4 and 5, as shown in Figure 27, which was selected using Table 2.6 of MASH 2009. The actual point of impact was 5 in. (127 mm) downstream from the target location. A sequential description of the impact events is contained in Table 6. The vehicle came to rest 194 ft (59.1 m) downstream from the impact point and 44 ft – 1 in. (13.4 m) laterally away from the traffic side of the barrier after brakes were applied. The vehicle trajectory and final position are shown in Figures 23 and 28.

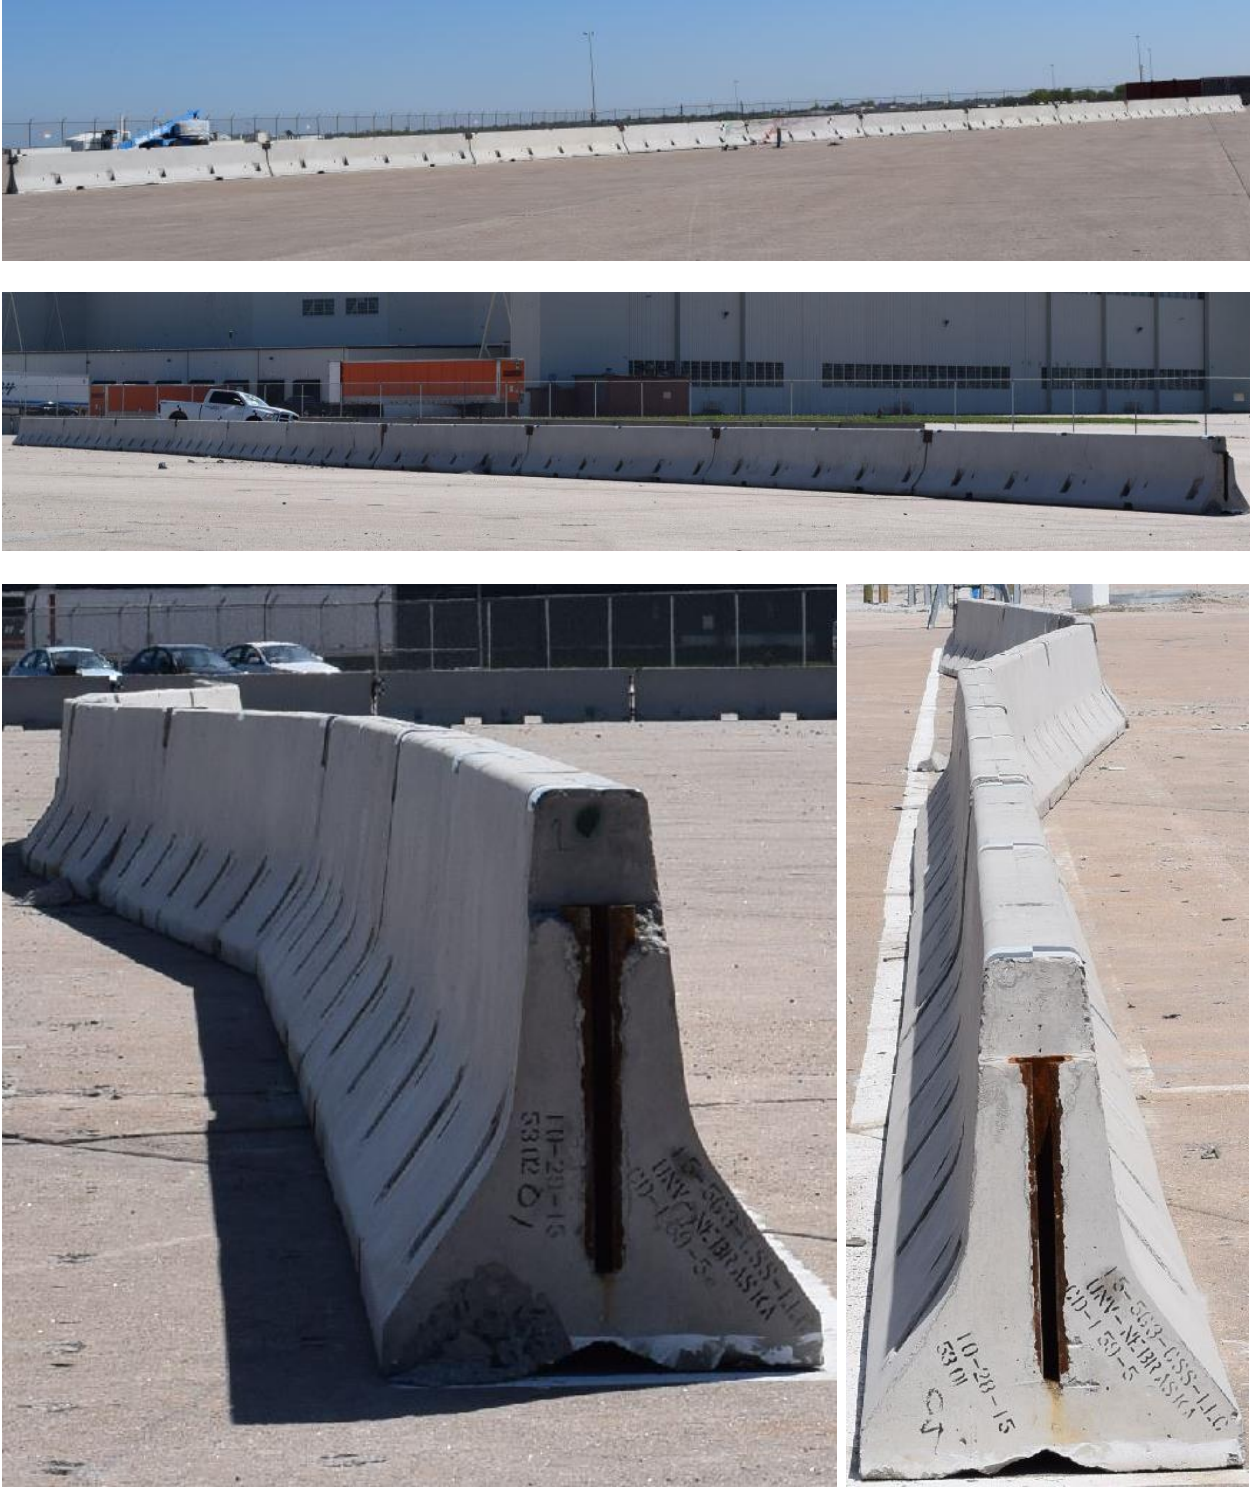
Figure 29. System Damage – Front, Back, Upstream, and Downstream views, Test No. NJPCB-3

Damage to the barrier was moderate, as shown in Figures 29 through 32. Barrier damage consisted of contact marks on the front face of the PCB segments, spalling of concrete, and concrete cracking. The length of vehicle contact along the barrier was approximately 21 ft – 2 in. (6.4 m), which spanned from 3 ft – 8 in. (1.1 m) upstream from the center of the joint between barrier nos. 4 and 5 through 17 ft – 6 in. (5.3 m) downstream from the center of the joint between barrier nos. 4 and 5. The vehicle contacted the system again starting from the upstream end on the top face of barrier no. 7 which spanned approximately 11 ft – 6 in. (3.5 m).

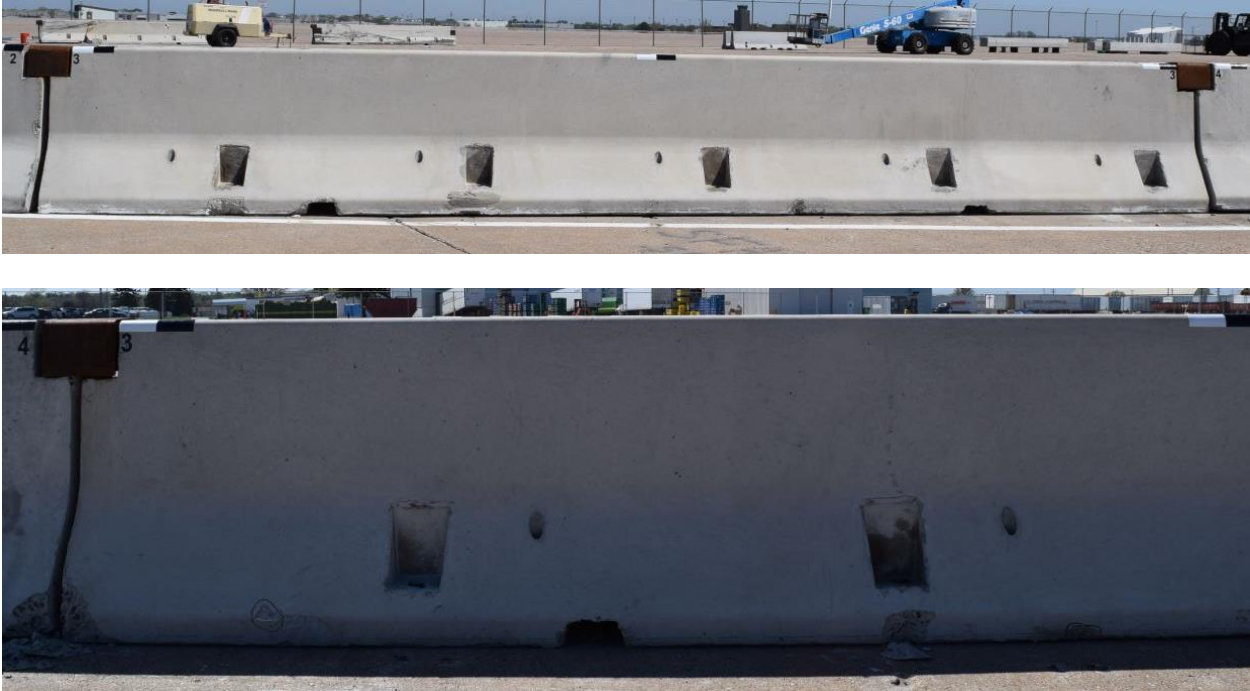
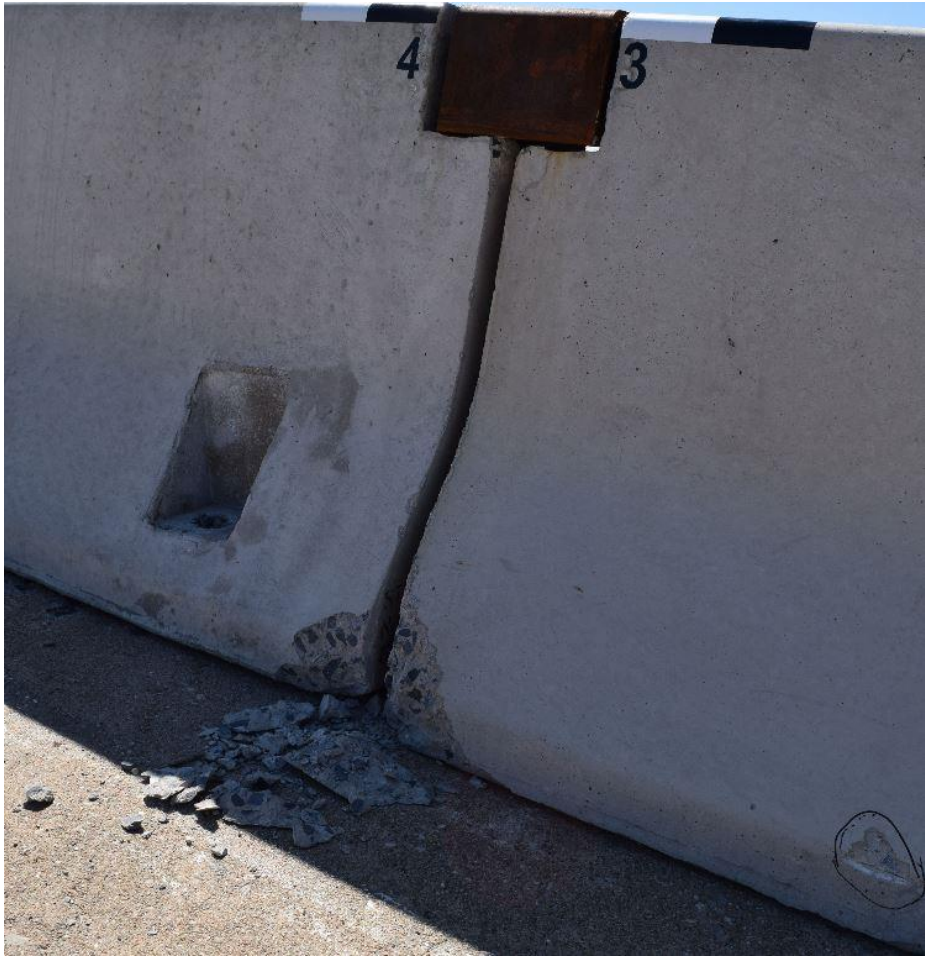
Figure 30. Barrier No. 3 Traffic-side and Back-side Damage, Test No. NJPCB-3

Concrete spalling was found on barrier nos. 3 through 8. The lower back corner on the downstream end of barrier no. 3 spalled. A 5½-in. × 13½-in. × 2-in. (140-mm × 343-mm × 51-mm) piece of concrete was removed from the upper-downstream corner on the front face of barrier no. 4. A 10½-in. × 4½-in. (267-mm × 114-mm) piece of concrete was removed from the lower-downstream corner on the front face of barrier no. 4. Concrete spalling, measuring 29 in. × 11 in. × 4 in. (737 mm × 279 mm × 102 mm), was found 41⅝ in. (1,057 mm) upstream from the downstream end on the back face of barrier no. 4. A 32-in. × 10-in × 3-in. (813-mm × 254-mm × 76-mm) piece of concrete was removed from the bottom-upstream corner on the front face of barrier no. 5. A 13½-in. × 8-in. (343-mm × 203-mm) piece of concrete was removed from the bottom of barrier no. 5, approximately 46½ in. (1,181 mm) downstream from the upstream end. A 15-in. × 4-in × 4½-in. (381-mm × 102-mm × 114-mm) piece of concrete disengaged from the back side of barrier no. 5 approximately 17 in. (432 mm) downstream from the center target. An 8-in. × 12-in. × 5-in. (203-mm × 305-mm × 127-mm) piece of concrete was removed from the lower-downstream corner of barrier no. 6. Concrete spalling, measuring 16½ in. × 4½ in. (419 mm × 114 mm), occurred at the bottom on the front side of barrier no. 7 approximately 48 in. (1,219 mm) downstream from the upstream end. A 2½-in. × 3-in. (64-mm × 76-mm) piece of concrete was removed from the upper-upstream corner on the back side of barrier no. 8 below the connection key socket.

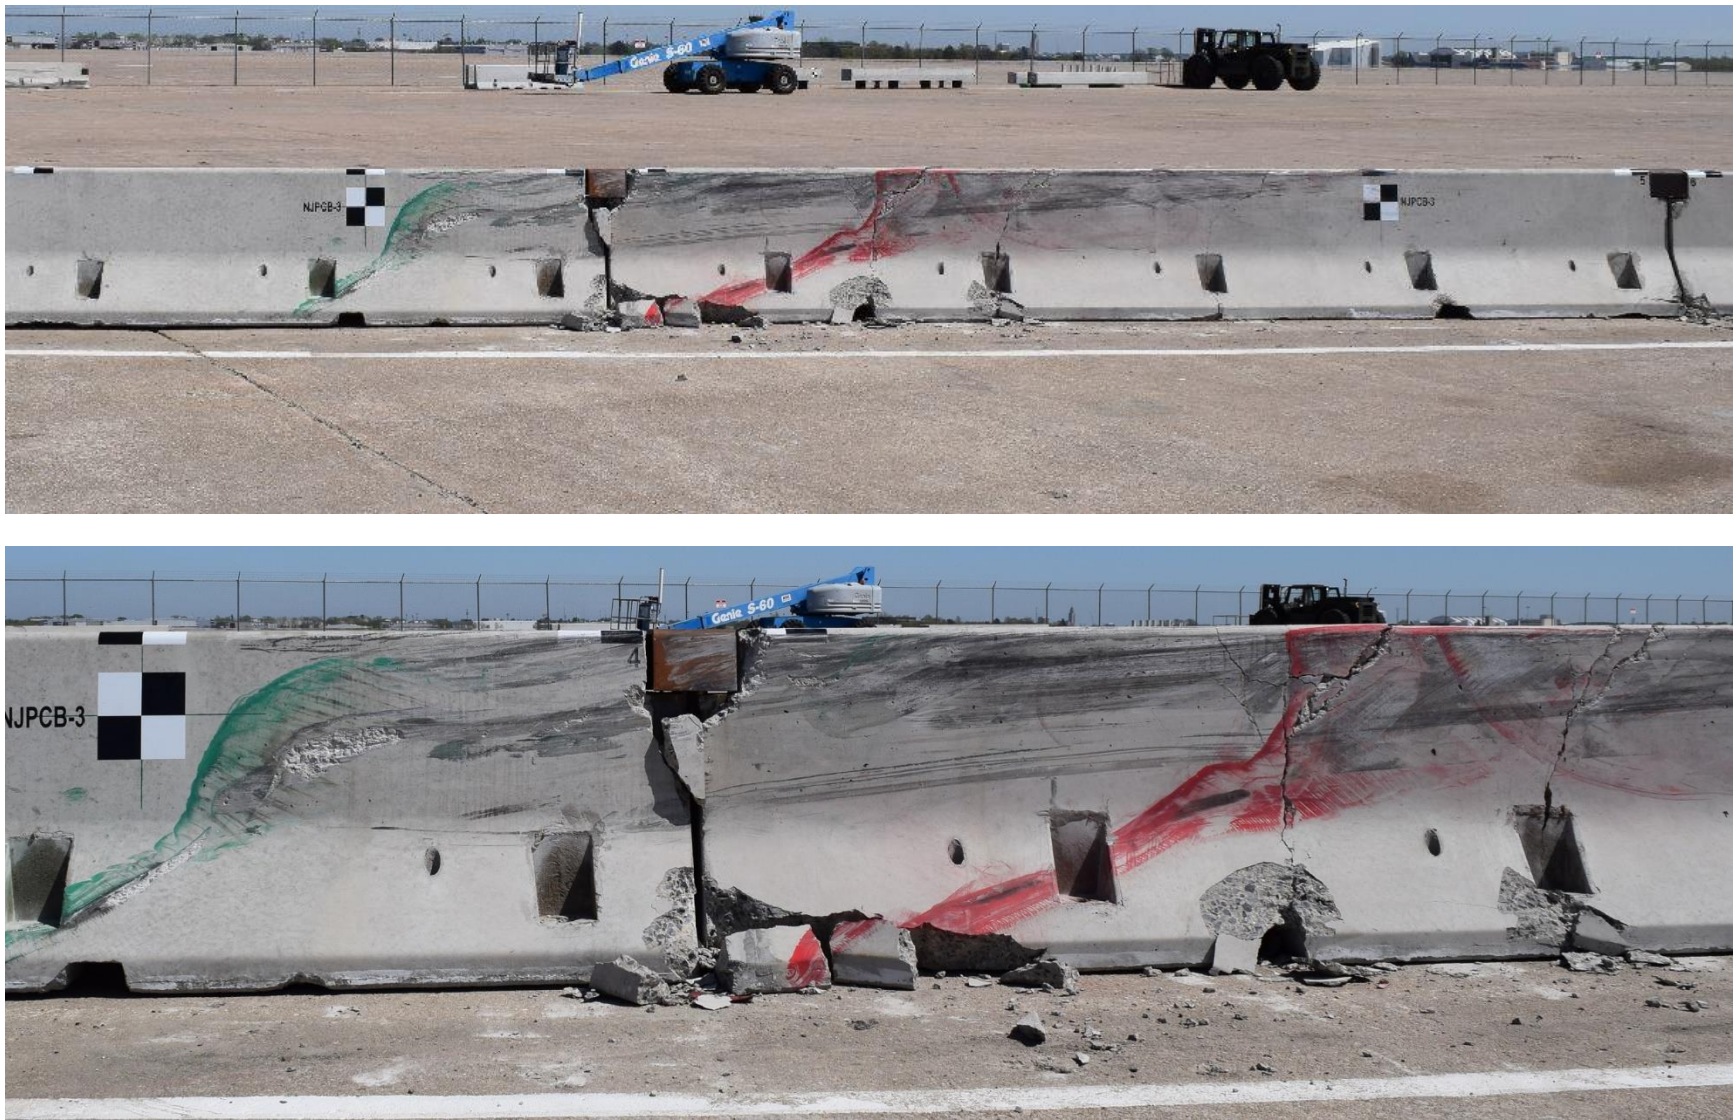
Figure 31. Barrier Nos. 4 and 5 Damage, Test No. NJPCB-3

Tire marks were visible on the front face of barrier nos. 4 and 5. Contact marks were found on the front faces of barrier nos. 7 and 8 as well as on the connection keys between barrier nos. 4 and 5. A 14-in. (356-mm) long gouge on the front face of barrier no. 4 began 57 in. (1,448 mm) upstream from the downstream end. A 41-in. (1,041-mm) long scrape was found on barrier no. 4 beginning 44 in. (1,118 mm) upstream from the downstream end. A 14-in. (356-mm) long gouge was found on barrier no. 4 that began 40 in. (1,016 mm) upstream from the downstream target and 17 in. (432 mm) from the ground.

Minor cracks were found on barrier nos. 3, 7 and 8. A 10¾-in. (273-mm) long vertical crack that began 11½ in. (292 mm) from the bottom of barrier no. 4 extended toward the downstream edge. A crack spanning the front, top, and back faces was found 4¼ in. (108 mm) downstream of the center target on barrier no. 4. A 32-in. (813-mm) long crack was found 47 in. (1,194 mm) upstream from downstream edge of barrier no. 5 on the front face. Vertical cracks were found on the front and back faces of barrier no. 5 at 48 in. (1,219 mm), 101 in. (2,565 mm), and 224 in. (5,690 mm) downstream from the upstream end of the barrier. A 23½-in. (597-mm) long vertical crack was found on the back face of barrier no. 5 that began 7 in. (178 mm) from the bottom and 5 in. (127 mm) upstream from the downstream end. A 19-in. (483-mm) long vertical crack was found 4 in. (102 mm) downstream from the upstream end of barrier no. 6. A 26-in. (660-

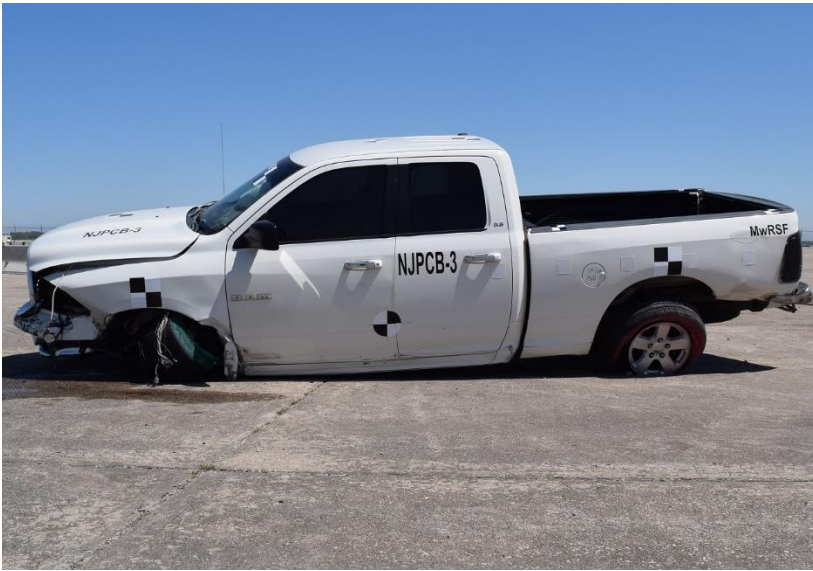
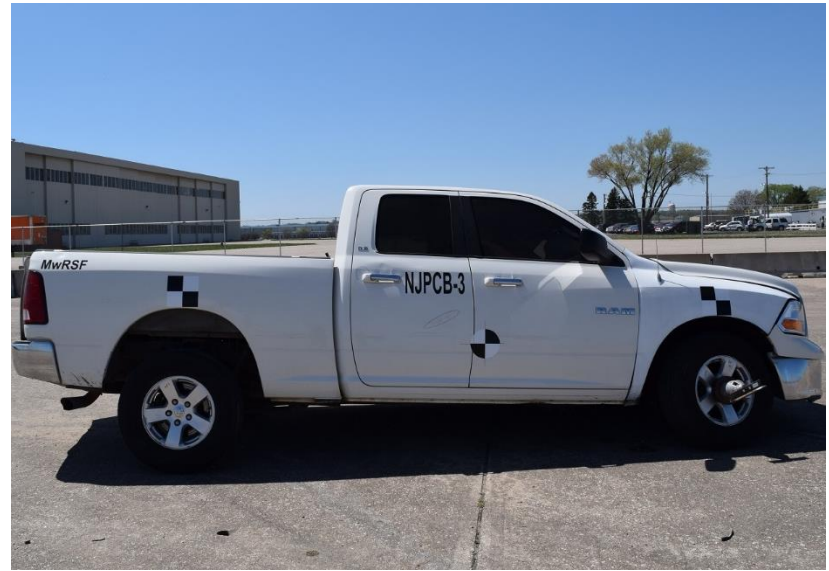
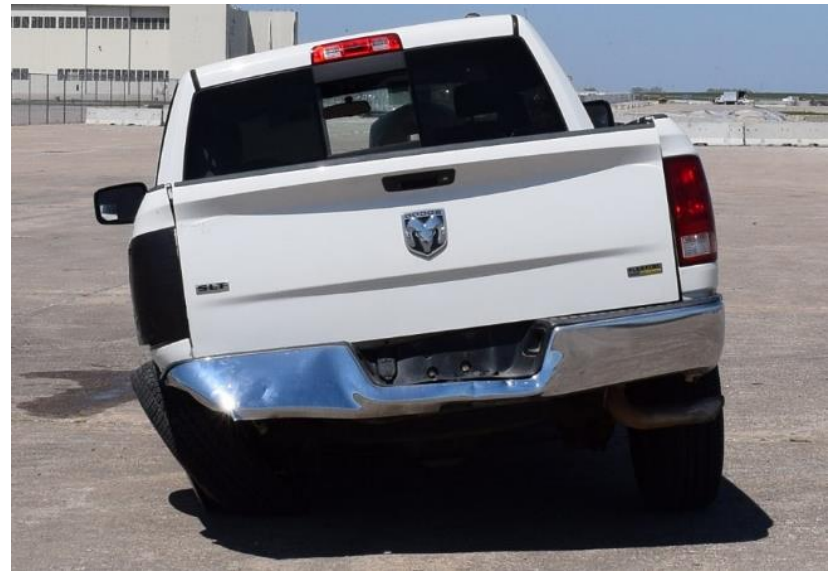
Figure 33. Vehicle Damage, Test No. NJPCB-3

Damage to the vehicle was moderate, as shown in Figures 33 through 36. The maximum occupant compartment deformations are listed in Table 7 along with the deformation limits established in MASH 2009 for various areas of the occupant compartment. Note that none of the

The majority of the damage was concentrated on the left-front corner and left side of the vehicle where the impact had occurred. The left side of the bumper was crushed inward and back. The left-front fender was pushed upward near the door panel, torn, and had a dent behind the left-front wheel. The left-rear steel rim was severely deformed with tears and significant crushing. The left-front and left-rear tires were torn and deformed. The grille was fractured around the left-side headlight assembly. A 20-in. × 6-in. (508-mm × 152-mm) scrape was found on the left side of the front bumper. A 6-in. (152-mm) kink was found on the bottom-front of the left fender, and the front of the fender deformed inward. A 2½-in. (64-mm) gap was found between the vehicle’s hood and the left fender. A 2½-in. × 10-in. (64-mm × 254-mm) buckle was found on the rear of the left fender approximately 15 in. (381 mm) above the bottom of the fender. A 71-in. (1,803-mm) scrape and contact marks were found along the left side of the vehicle cab. The left-rear door was dented and was ajar approximately ¼ in. (6 mm) at the top. A 5-in. × 6-in. (127-mm × 152-mm) dent was found on the bottom of the C-pillar at the rear of the cab.

The left-side quarter panel experienced scraping, buckling, and denting. The left-side headlight and foglight disengaged from the vehicle. The left side of the radiator was pushed backward. The left-front and left-rear tires were deflated. The left-rear tire had a tear 3 in. (76 mm) away from the edge of the tire’s outer face. The left-rear rim had a 1-in. (25-mm) scrape. A 1-in. (25-mm) gap was found between the left-front fender and the left-front door. The left-front anti-roll bar end links contacted the tie rod and were scraped. The left-front steering knuckle assembly was gouged underneath the lower control arm. The middle of the left-rear upper brake caliper was torn. The left side of the steering rack fractured from the mount. The right side of the windshield had a hairline crack, and the lower-left side encountered minor cracking. The roof and remaining window glass remained undamaged.

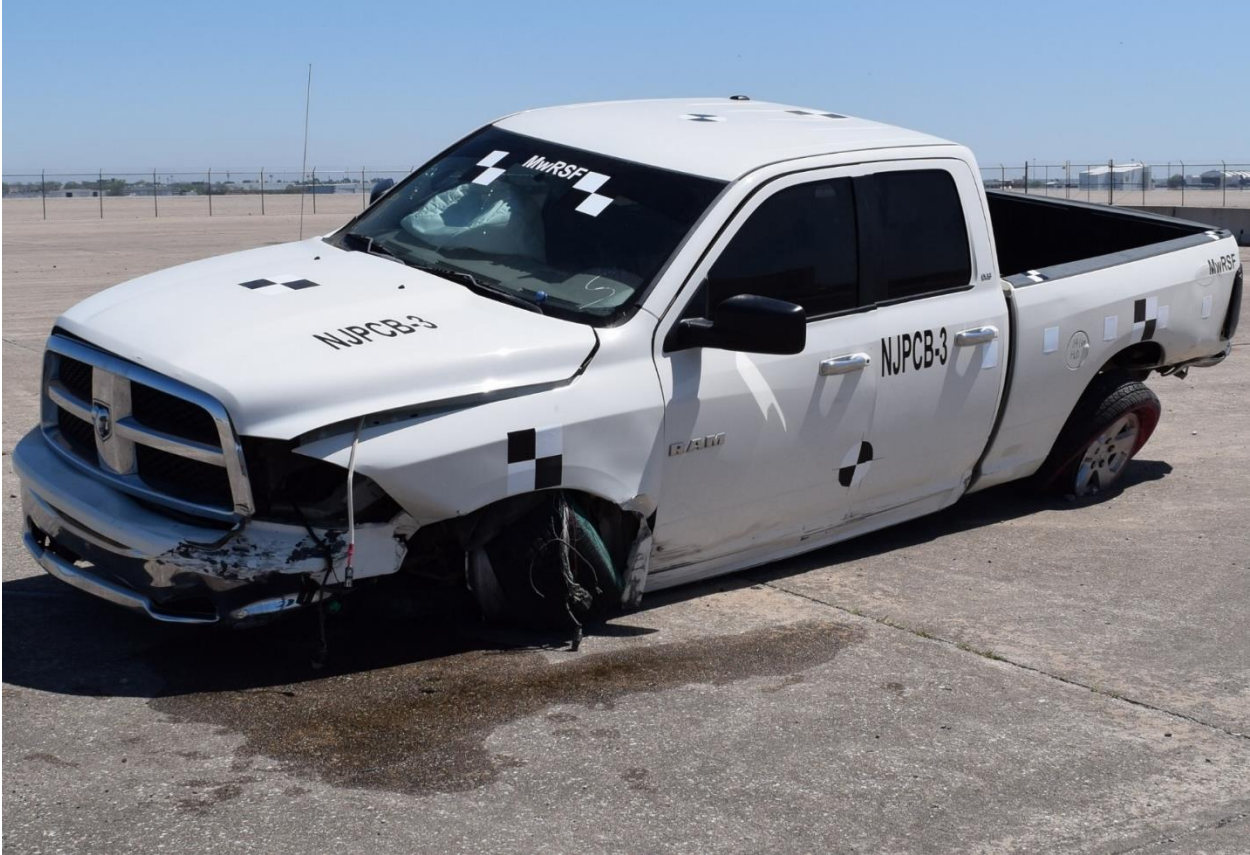
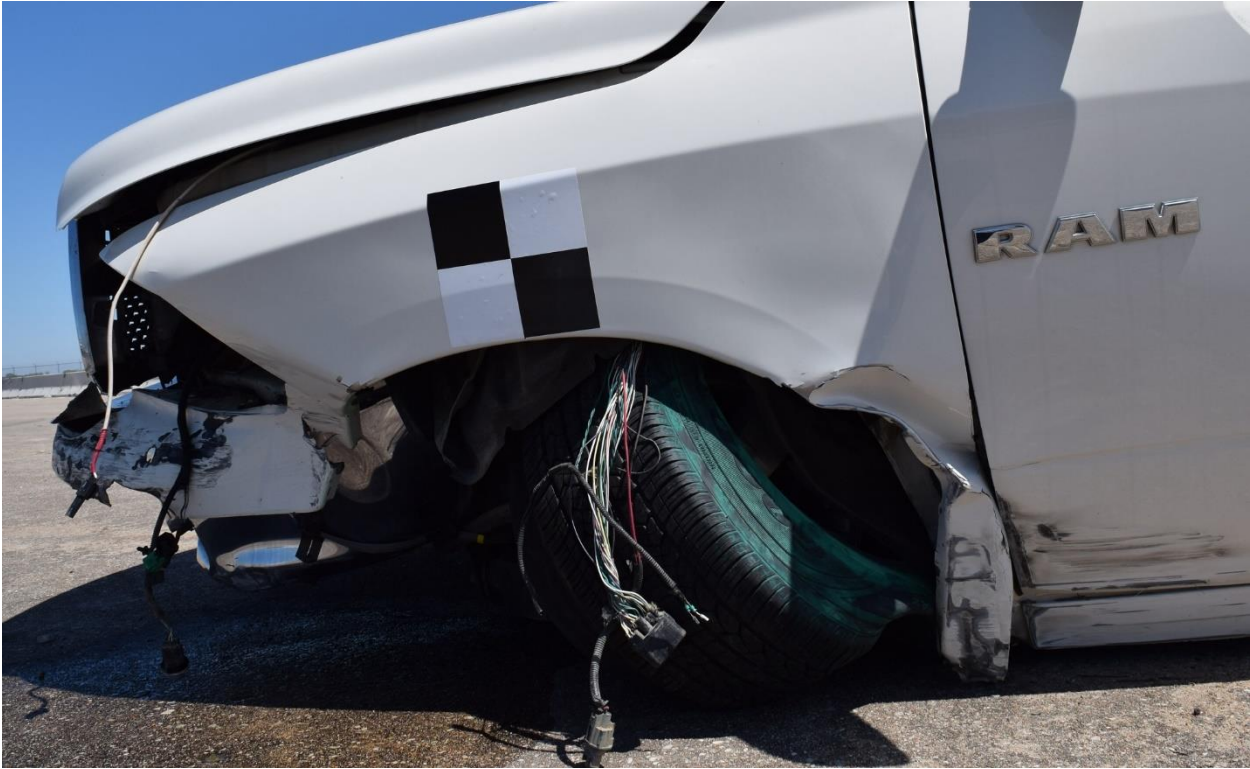
Figure 34. Vehicle Damage on Impact Side, Test No. NJPCB-3
