PERFORMANCE EVALUATION OF NEW JERSEY'S PORTABLE CONCRETE BARRIER WITH A TRAFFIC-SIDE PINNED CONFIGURATION AND GROUTED TOES – TEST NO. NJPCB-7

MIDWEST ROADSIDE SAFETY FACILITY

MwRSF Research Report No. TRP-03-374-18

December 18, 2018

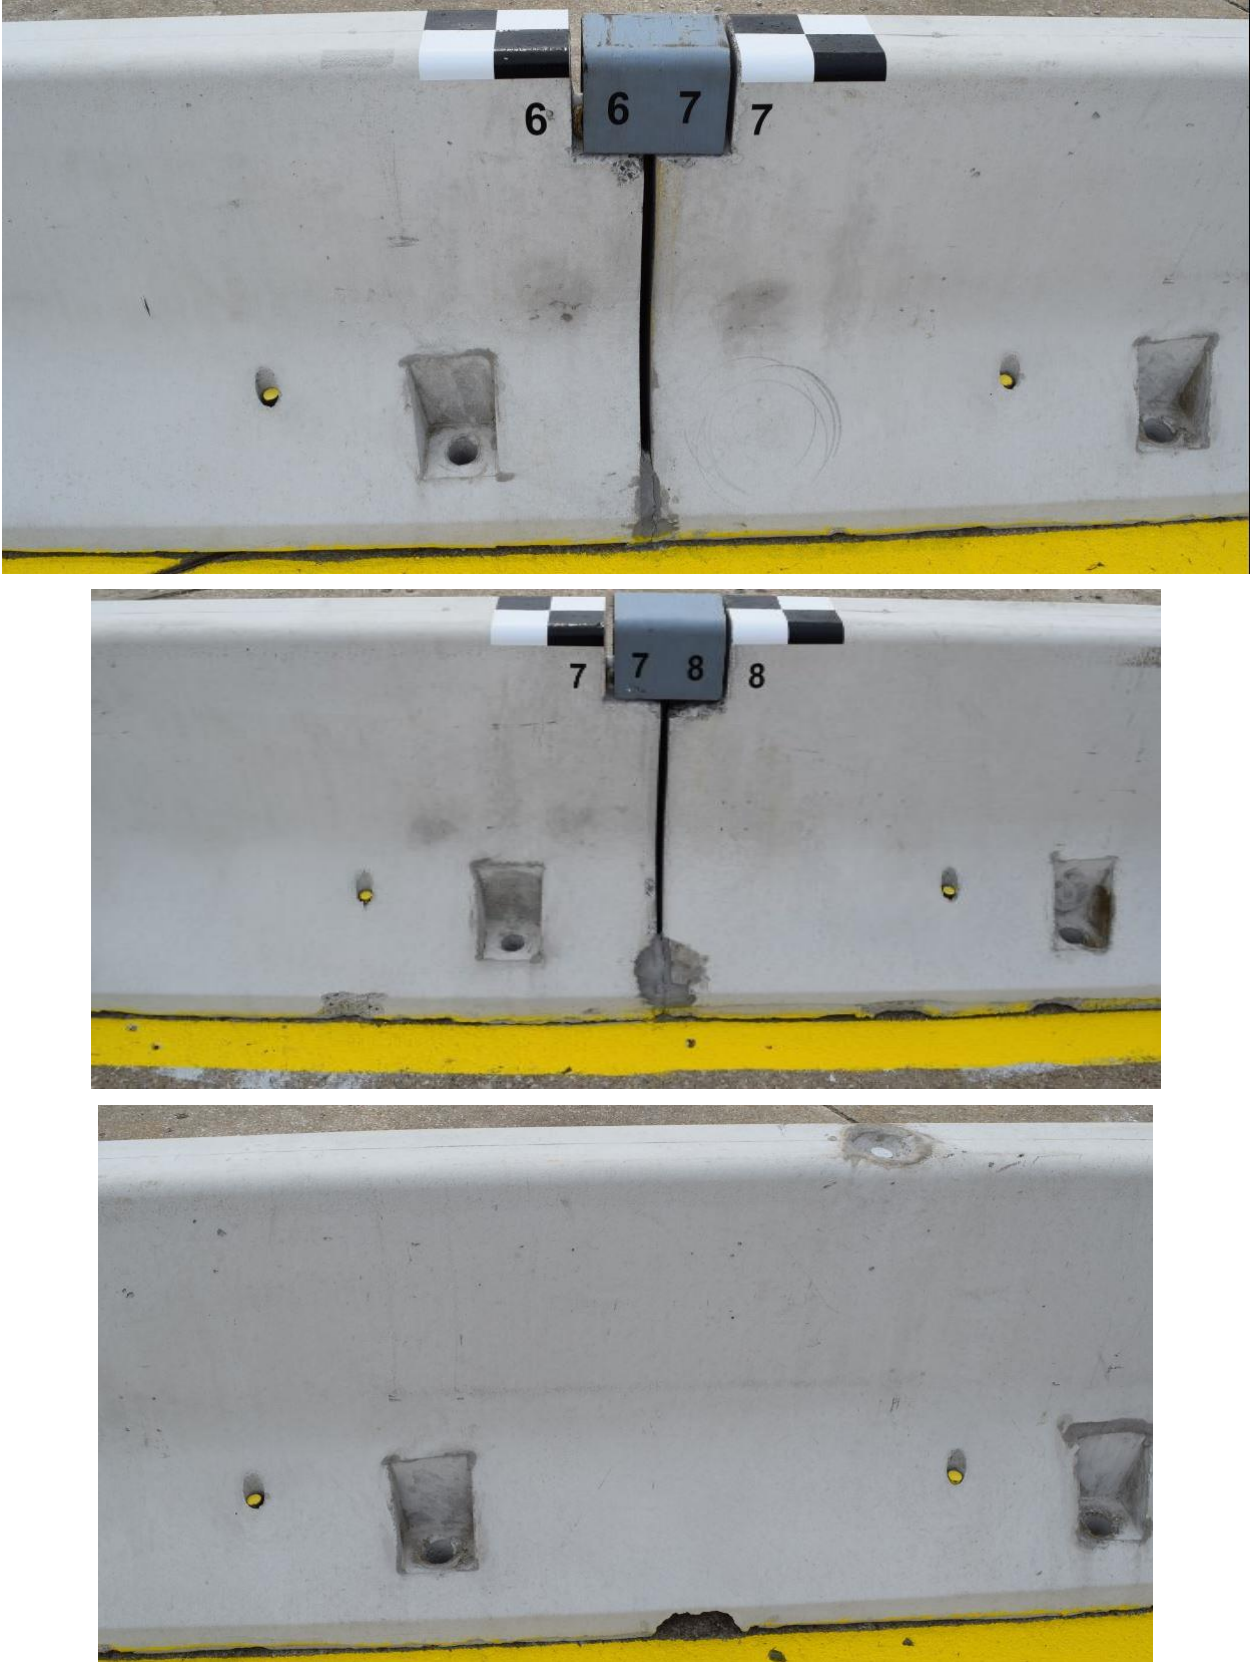
Figure 17. PCB Traffic-Side Pin Anchor Recesses, Test No. NJPCB-7

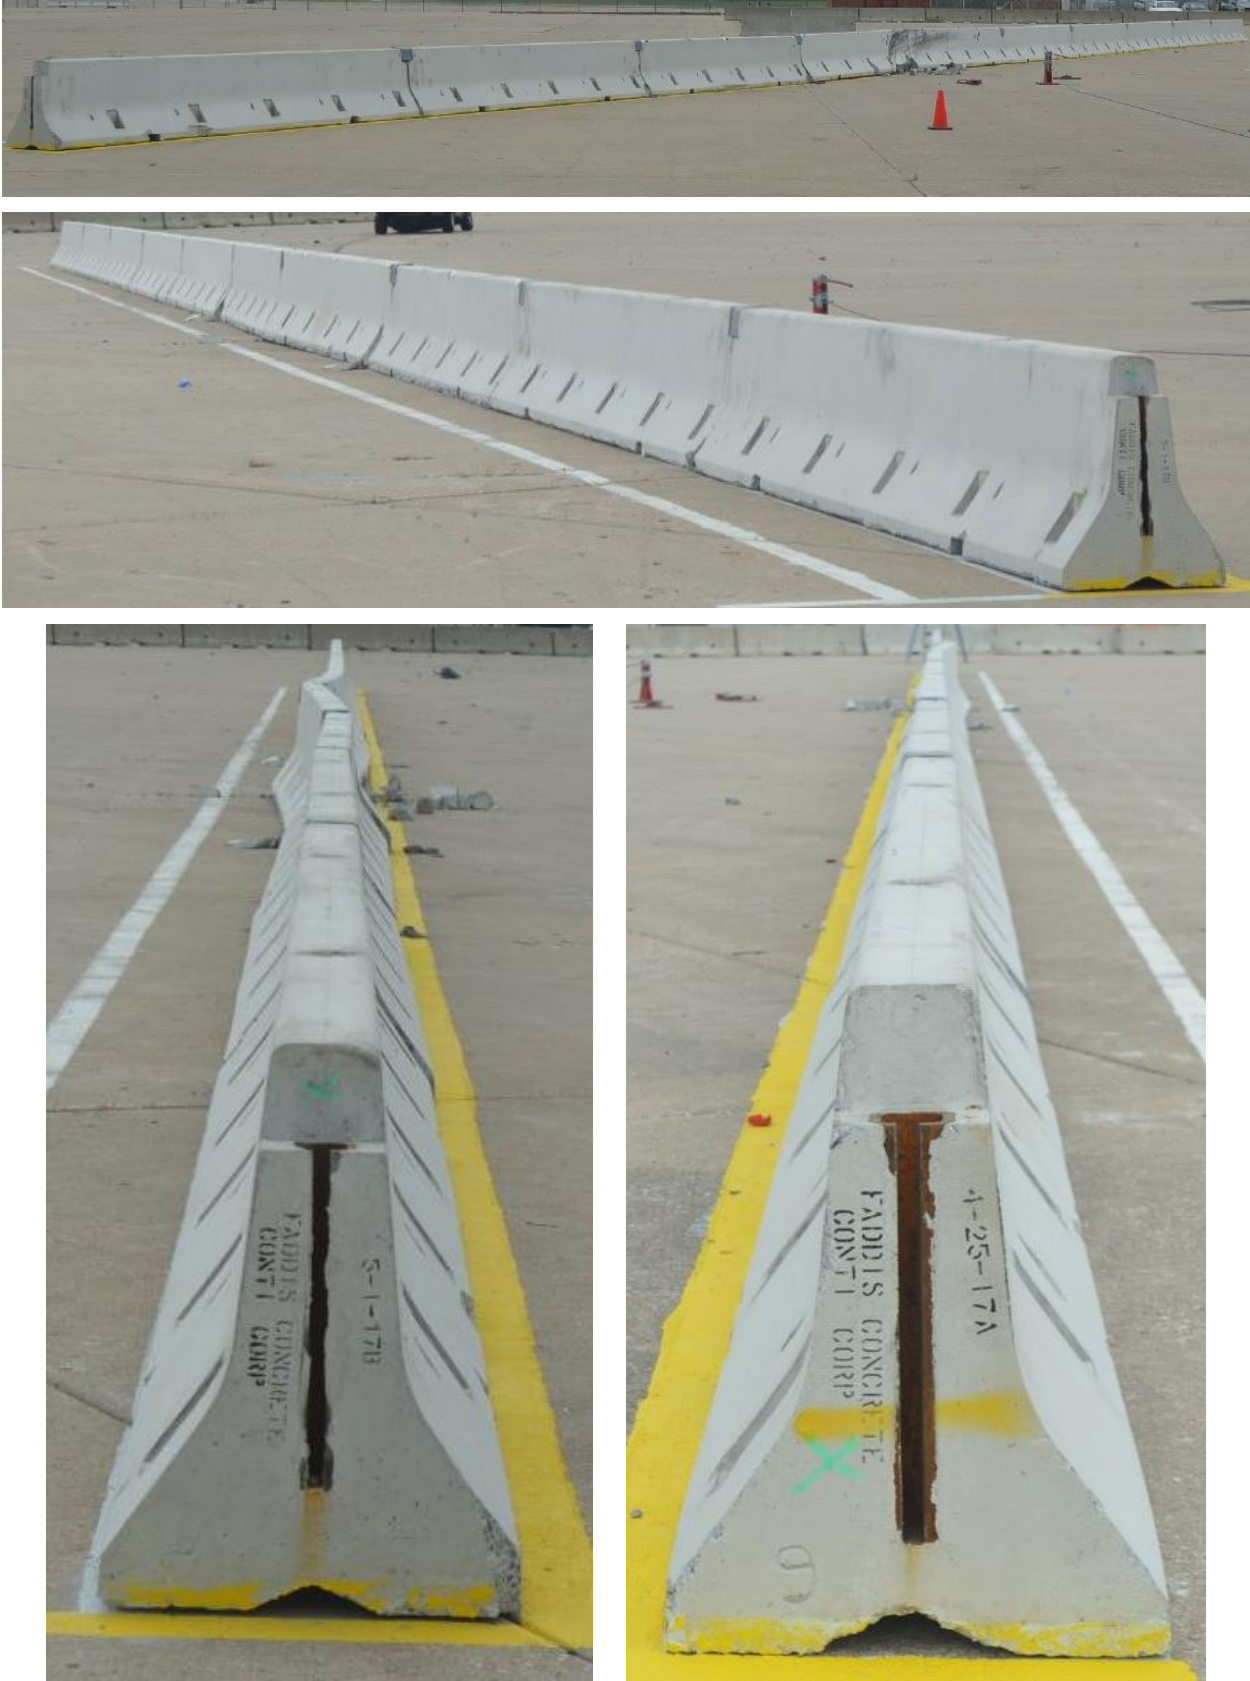
Figure 33. System Damage – Front, Back, Upstream and Downstream Views, Test No. NJPCB-7

Damage to the barrier was moderate, as shown in Figures 33 through 37. Barrier damage consisted of contact and gouge marks on the front face of PCB segments, spalling of the concrete, and concrete cracking and fracture. The length of vehicle contact along the barrier was approximately 22 ft – $\frac{3}{8}$ in. (6.7 m), which spanned from 5 ft – $\frac{8}{8}$ in. (1.7 m) upstream from the center of the joint between barrier nos. 4 and 5 through 16 ft – $\frac{3}{2}$ in. (5.0 m) downstream from the center of the joint between barrier nos. 4 and 5.

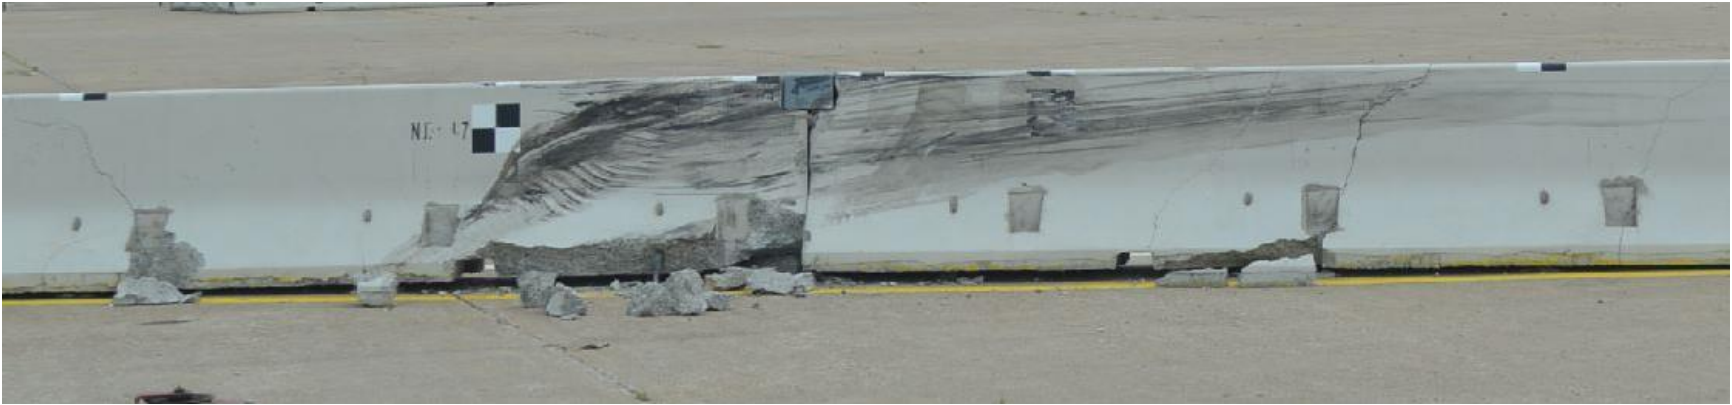
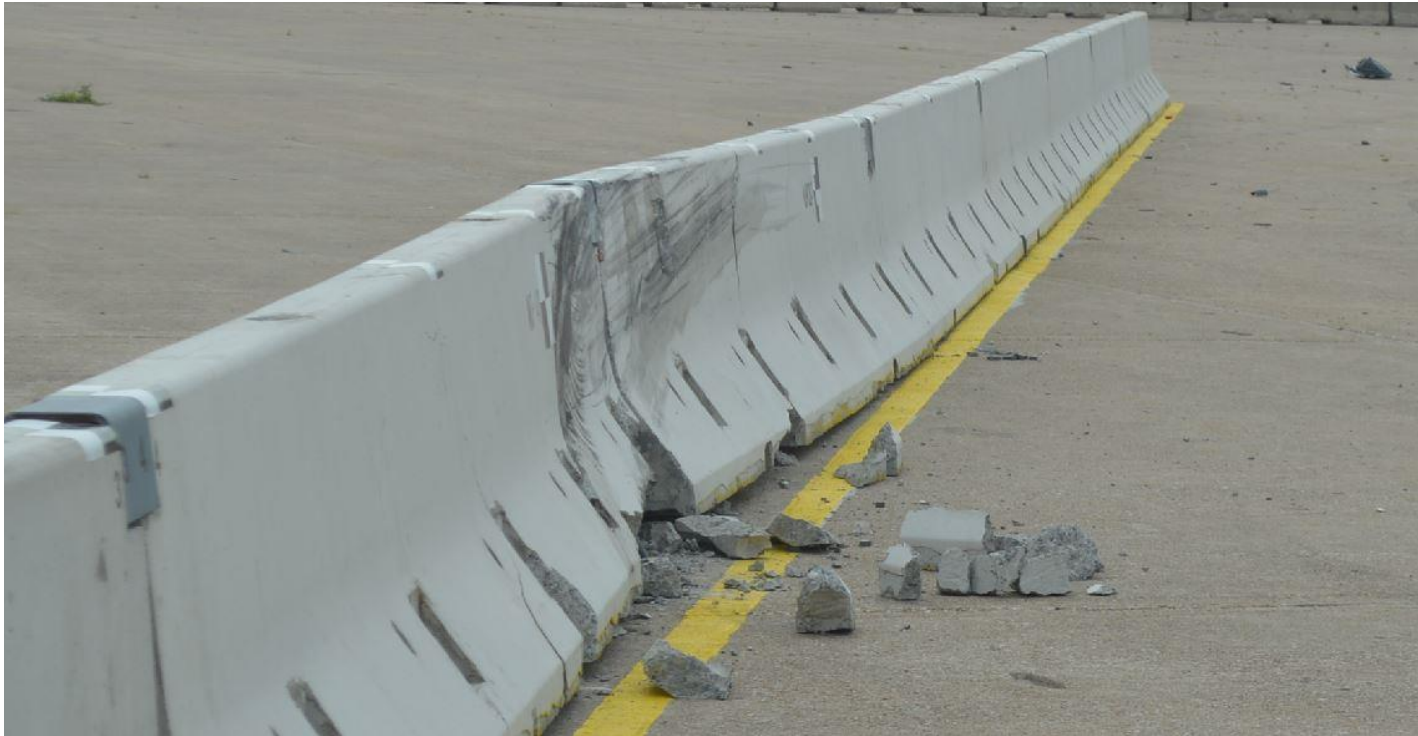
Figure 35. Barrier Nos. 4 and 5 Damage, Test No. NJPCB-7

Tire marks were visible on the front face of barrier nos. 4 and 5. Scrape marks were also found on the front and top faces of barrier nos. 4 and 5. Grout between barrier nos. 3 and 4 and barrier nos. 4 and 5 crumbled. A 31½-in. (800-mm) long vertical crack was found on the front face of barrier no. 4 that started 56 $\frac{7}{8}$ in. (1,445 mm) downstream from the upstream end and 4 $\frac{1}{8}$ in. (105 mm) from the bottom. A 33¾-in. (857-mm) long vertical crack was found on the front face of barrier no. 4 that started 89¾ in. (2,280 mm) downstream from the upstream end. A 45-in. (1,143-mm) long crack was found on the front face of barrier no. 4 located 12 $\frac{7}{8}$ in. (327 mm) downstream from the midspan of the barrier. A 36 $\frac{5}{8}$ -in. (930-mm) long crack was found on the front face of barrier no. 4 located 70¼ in. (1,784 mm) upstream from the downstream end of the barrier. A 26½-in. (673-mm) long crack was found on the back face of barrier no. 4 located 21½ in. (546 mm) downstream from the midspan of the barrier. A 38¼-in. (972-mm) long crack was found on the front face of barrier no. 5 located 35¾ in. (908 mm) upstream from the midspan of the barrier. A 38½-in. (978-mm) long crack was found on the front face of barrier no. 5 located 11¼ in. (286 mm) downstream from the midspan of the barrier. A 23½-in. (597-mm) long vertical crack was found on the back face of barrier no. 5 starting 62 in. (1,575 mm) downstream from the upstream end and 2 in. (51 mm) from the bottom. A 46-in. (1,168-mm) long crack was found on the back face of barrier no. 5 located 13 $\frac{1}{8}$ in. (333 mm) upstream from the midspan of the barrier. Minor cracks were found on the traffic side of barrier nos. 3, 6, and 7. A 35½-in. long × ½-in. wide (902-mm × 13-mm) gouge was found 23½ in. (597 mm) upstream from the downstream end on the front face of barrier no. 5.

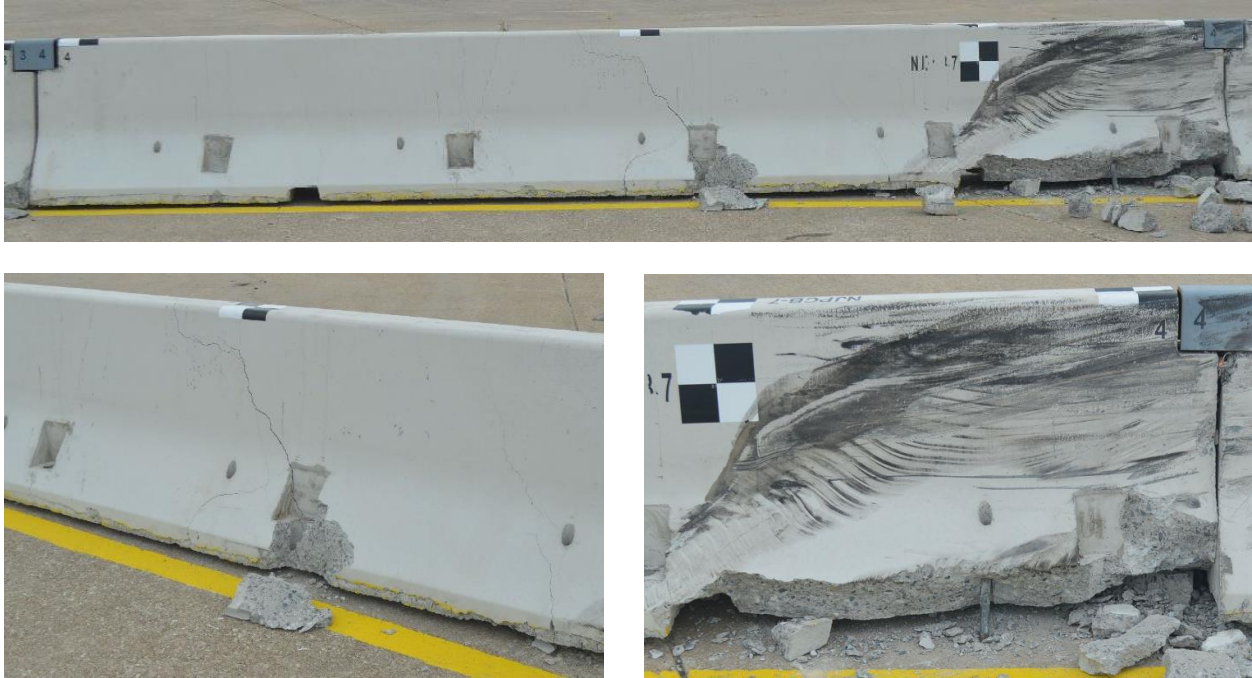
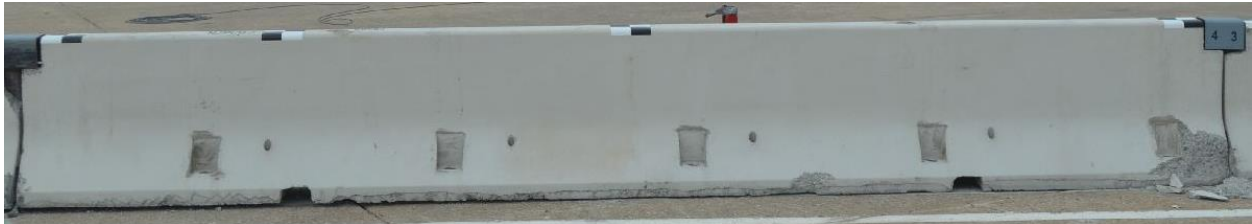
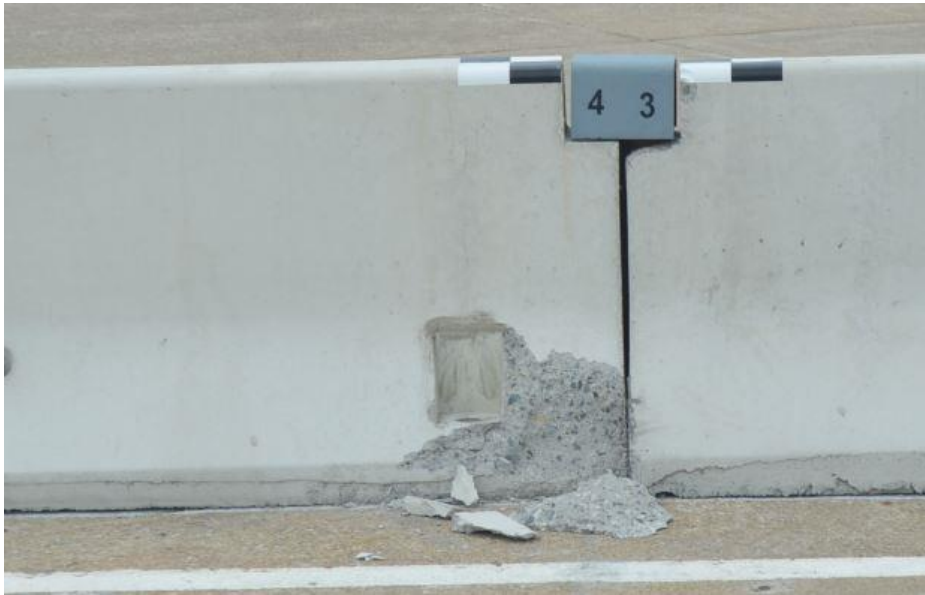
Figure 36. Barrier No. 4 – Traffic and Back Side Damage, Test No. NJPCB-7

Concrete spalling occurred on barrier nos. 4 through 6. The front side of barrier no. 4 experienced 57 in. × 11¾ in. × 9 in. (1,448 mm × 298 mm × 229 mm) concrete spalling at the lower downstream corner. A 17¼-in. × 13½-in. × 3½-in. (438-mm × 343-mm × 89-mm) concrete piece disengaged from barrier no. 4 at the lower-upstream corner on the back face. A 29-in. × 5¾-in. × 4-in. (737-mm × 146-mm × 102-mm) concrete piece disengaged from the front face of barrier no. 5, 57½ in. (1,461 mm) downstream from the upstream end of the barrier. A 4¼-in. × 9⅛-in. × 3¼-in. (108-mm × 232-mm × 83-mm) concrete piece disengaged from the back face of barrier no. 5 at the lower-upstream corner. A 22¾-in. × 9½-in. × 3¾-in. (578-mm × 241-mm × 95-mm) concrete piece disengaged from the back face of barrier no. 5 at the lower-downstream corner. A 5⅜-in. × 2-in. × ¼-in. (137-mm × 51-mm × 6-mm) concrete piece disengaged from the front face of barrier no. 6 at the lower-upstream corner. A 7¼-in. × 3¼-in. (184-mm × 83-mm) concrete piece partially disengaged from the back face of barrier no. 6 at 19½ in. (495 mm) upstream from the downstream end.

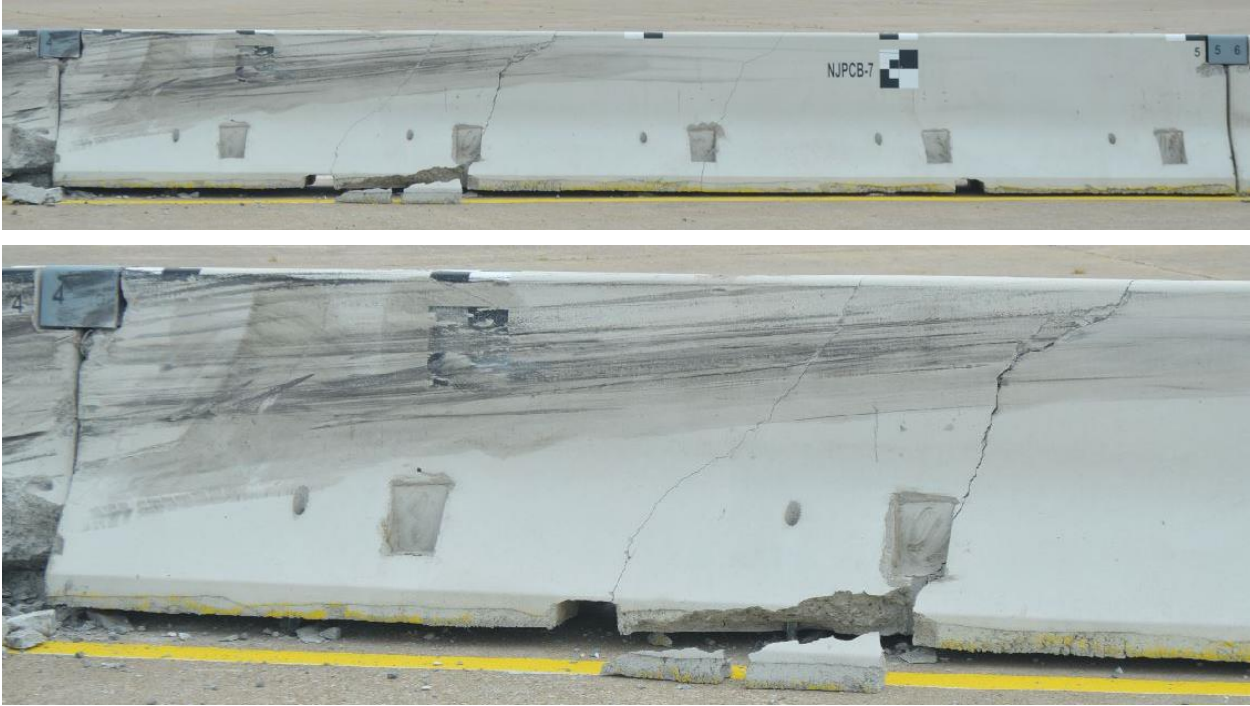
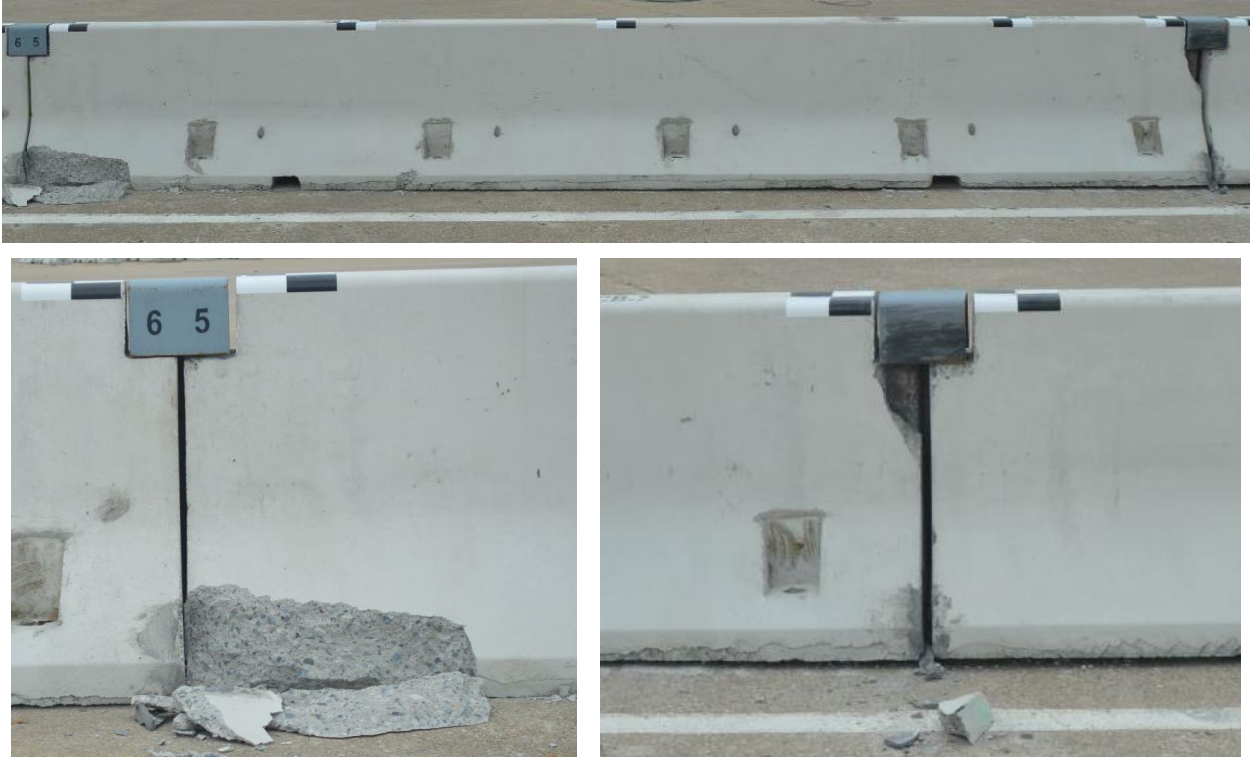
Figure 37. Barrier No. 5 - Traffic and Back Side Damage, Test No. NJPCB-7

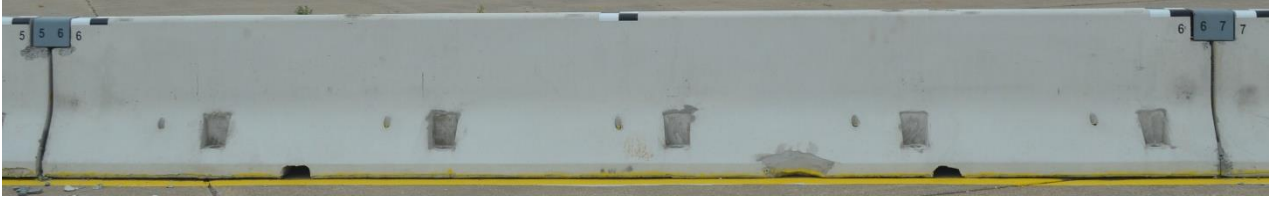
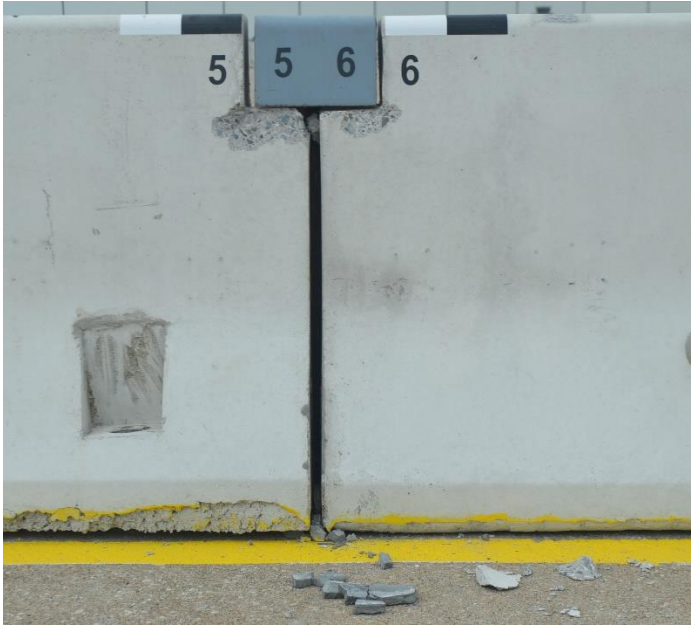
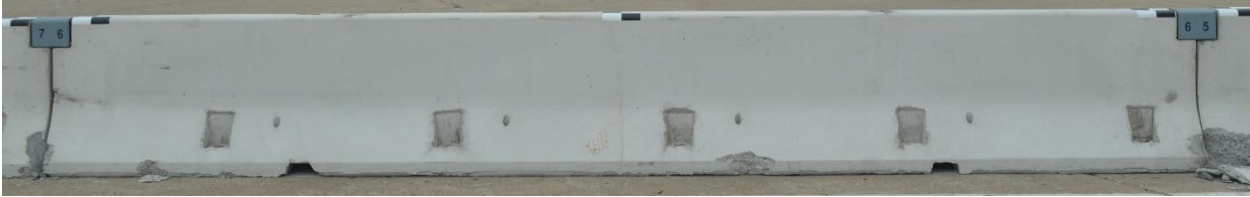
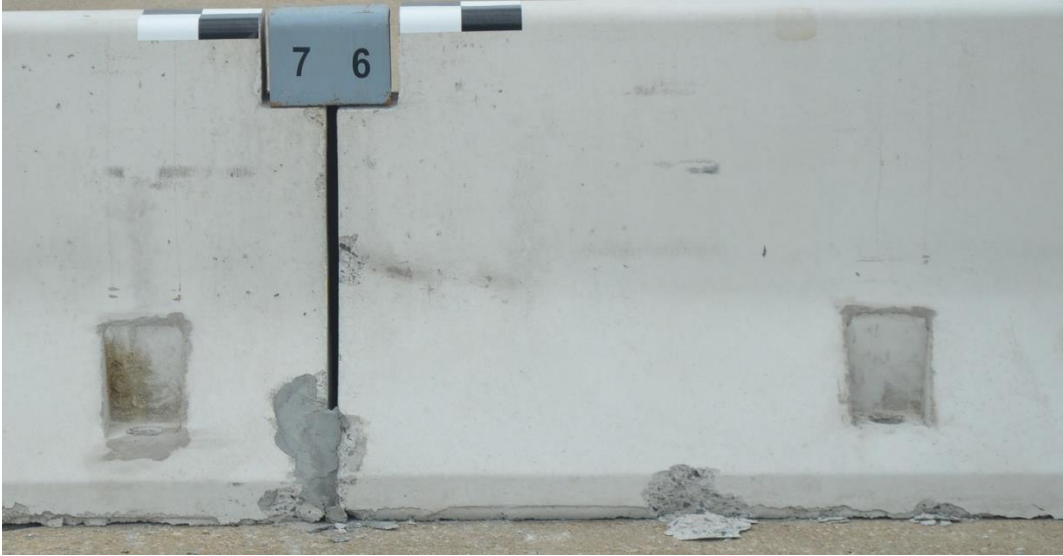
Figure 38. Barrier No. 6 – Traffic and Back Side Damage, Test No. NJPCB-7

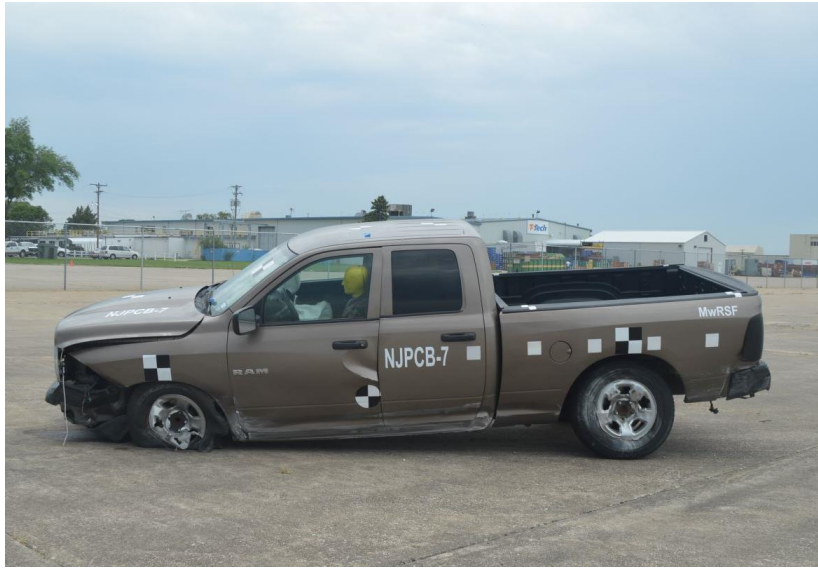
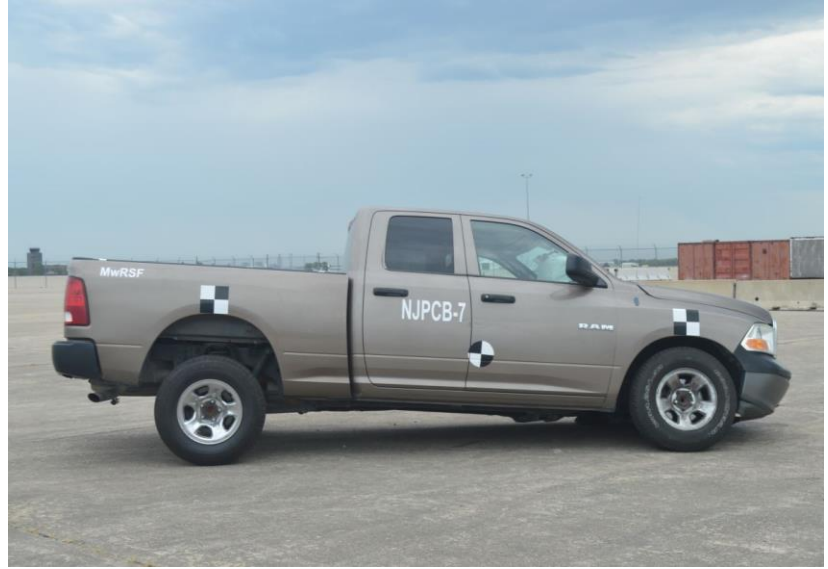
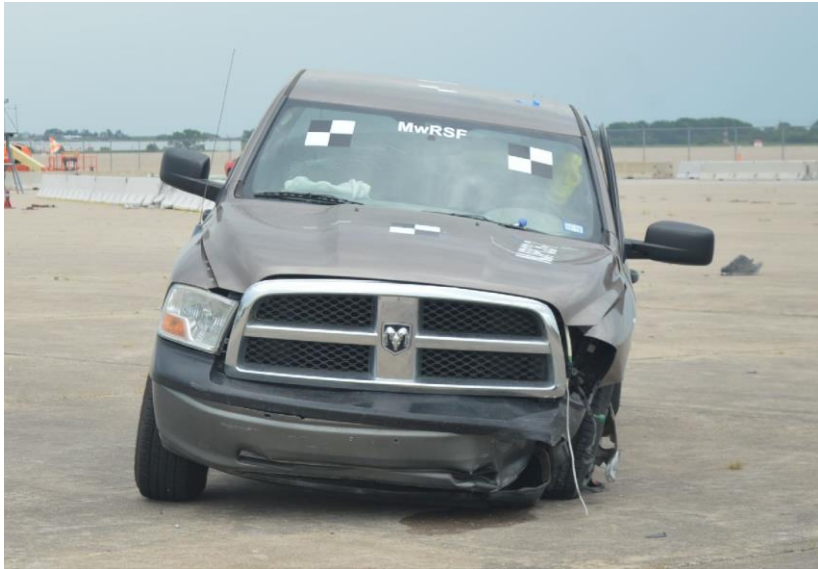
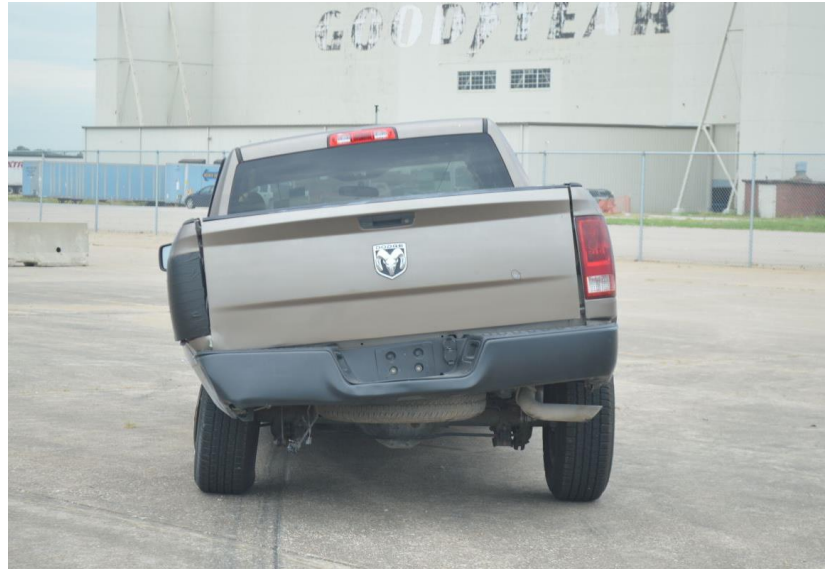
Figure 39. Vehicle Damage, Test No. NJPCB-7

The damage to the vehicle was moderate, as shown in Figures 39 through 43. The maximum occupant compartment deformations are listed in Table 7 along with the deformation limits established in MASH 2016 for various areas of the occupant compartment. Note that none of the MASH 2016 established deformation limits were violated. Complete occupant compartment and vehicle deformations and the corresponding locations are provided in Appendix E.

The majority of the damage was concentrated on the left-front corner and left side of the vehicle where the impact had occurred. The left side of the bumper crushed inward. The engine hood separated from the left fender. The left-front fender was deformed inward toward the engine compartment. The left corner of the front bumper was bent inward from the left side. The left-front corner of the frame rail buckled inward. A 2-in. (51-mm) gap occurred between the fender and the front bumper. Kinks and scrapes were observed on the entire front bumper. Denting, scraping, and gouging were observed on the entire left side of the cab. Gouging and contact marks were found

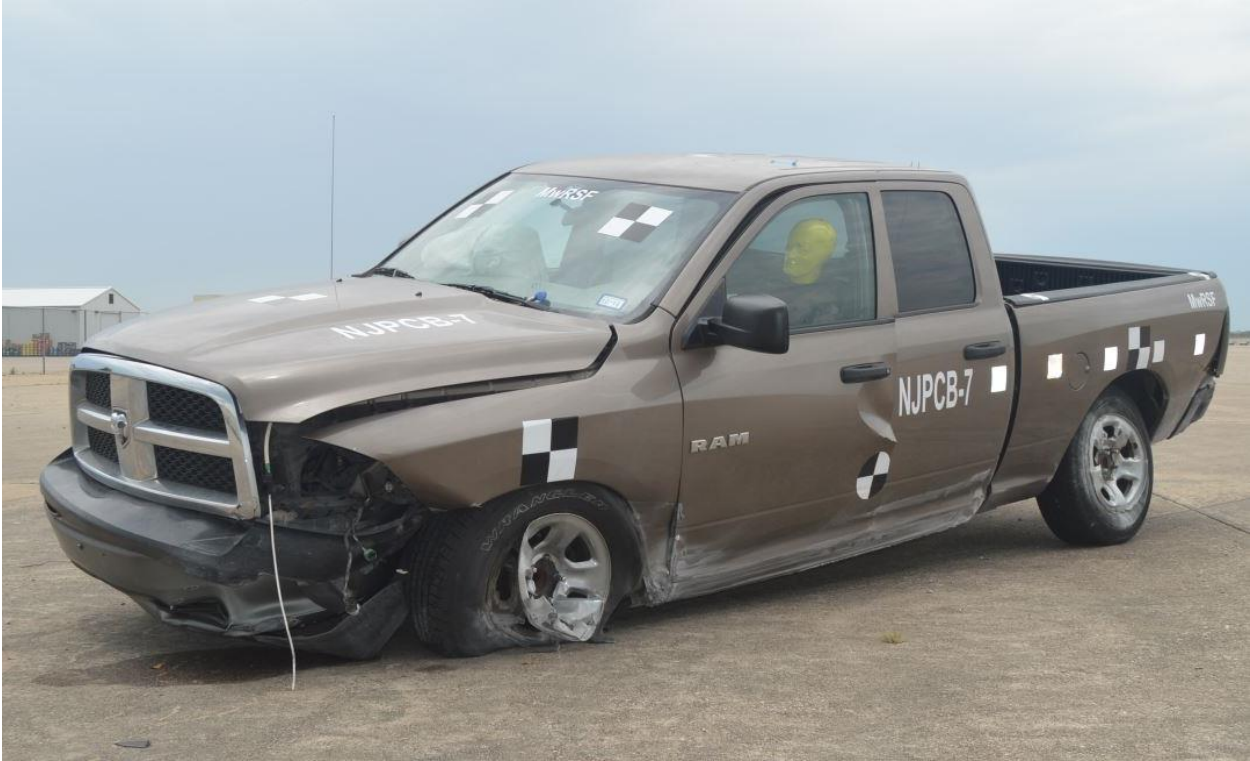
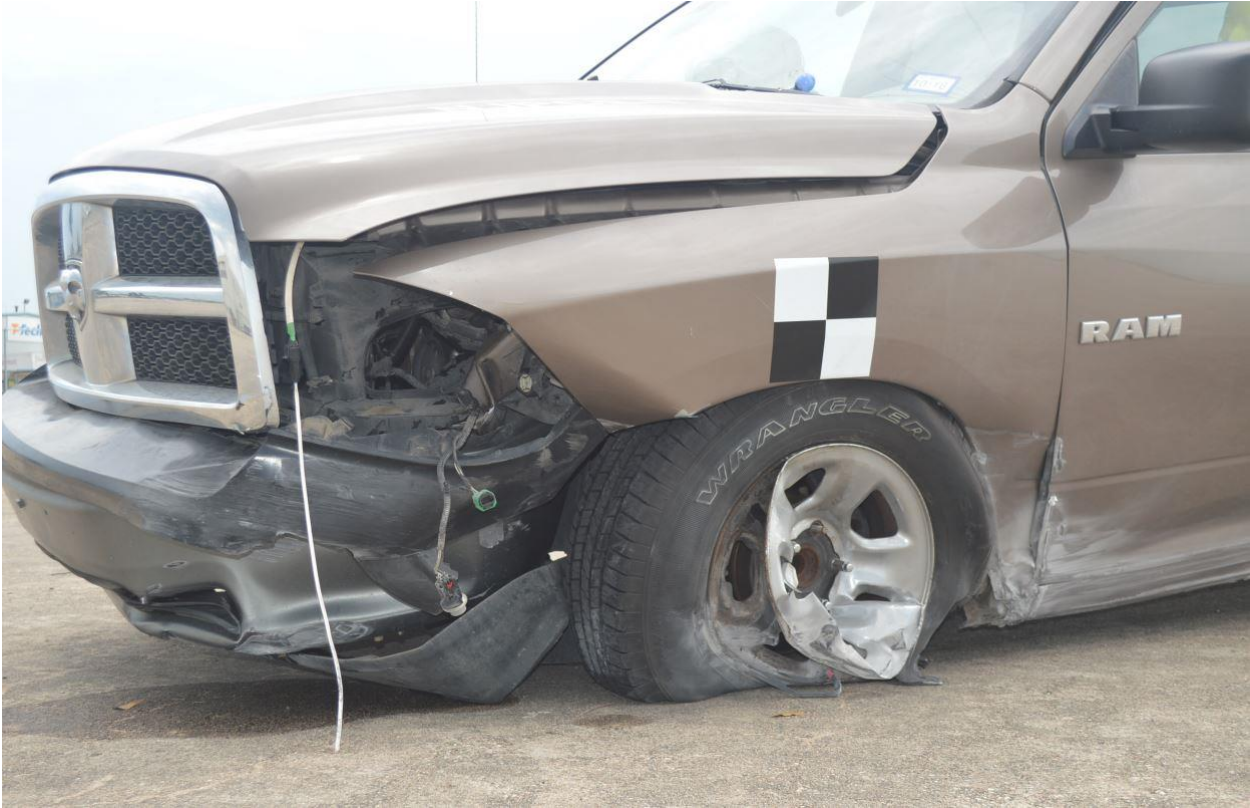
Figure 40. Vehicle Damage on Impact Side, Test No. NJPCB-7

at the bottom of the left-front door, starting at the front of the door and extending across the entire cab and quarter panel. A 13-in. × 10-in. (330-mm × 254-mm) dent was found on the rear of the left-front door. The left headlight disengaged away from the vehicle.

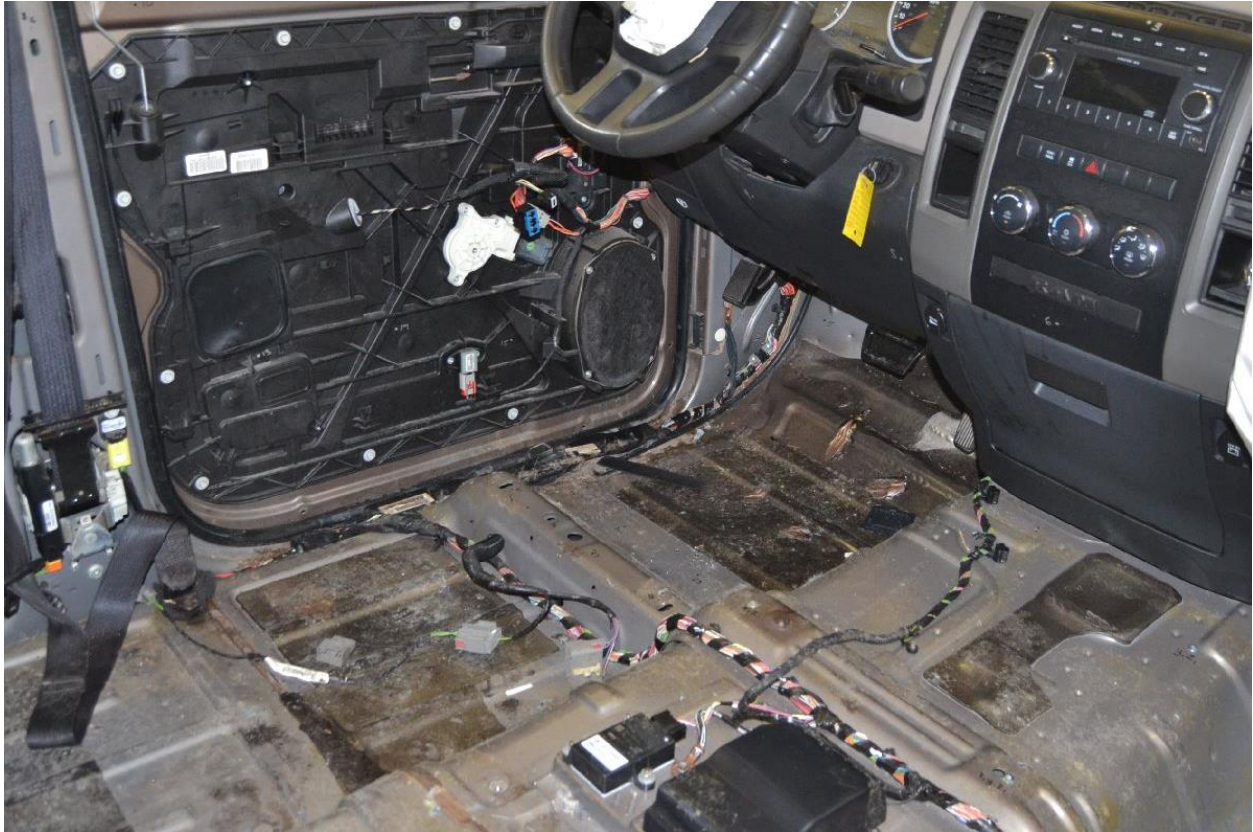
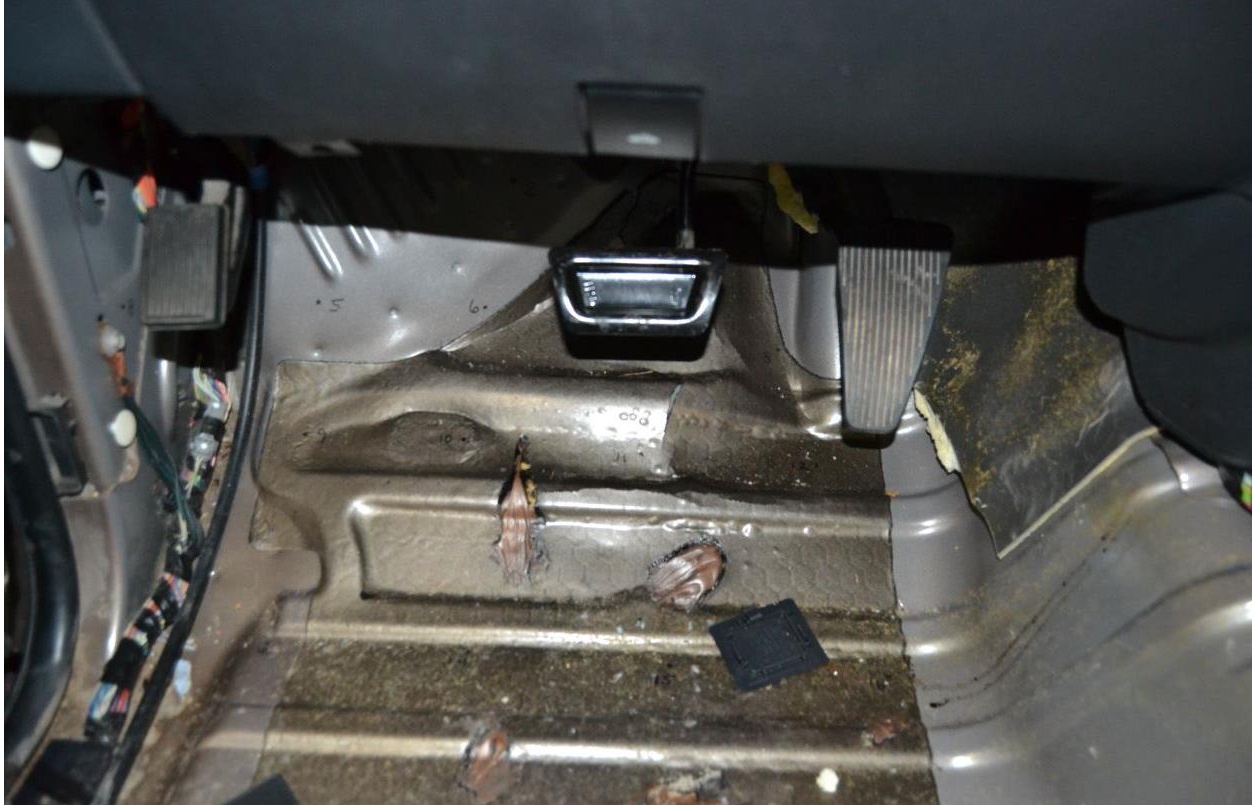
Figure 42. Occupant Compartment Deformation, Test No. NJPCB-7

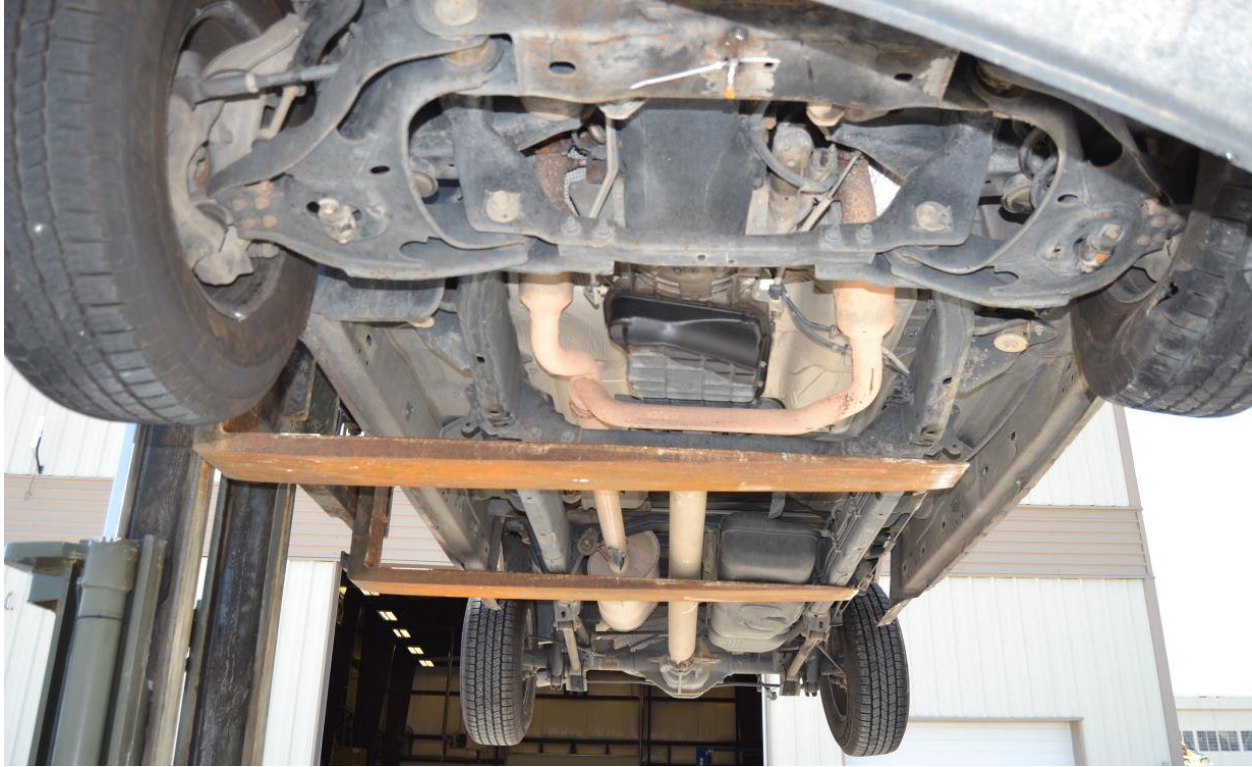
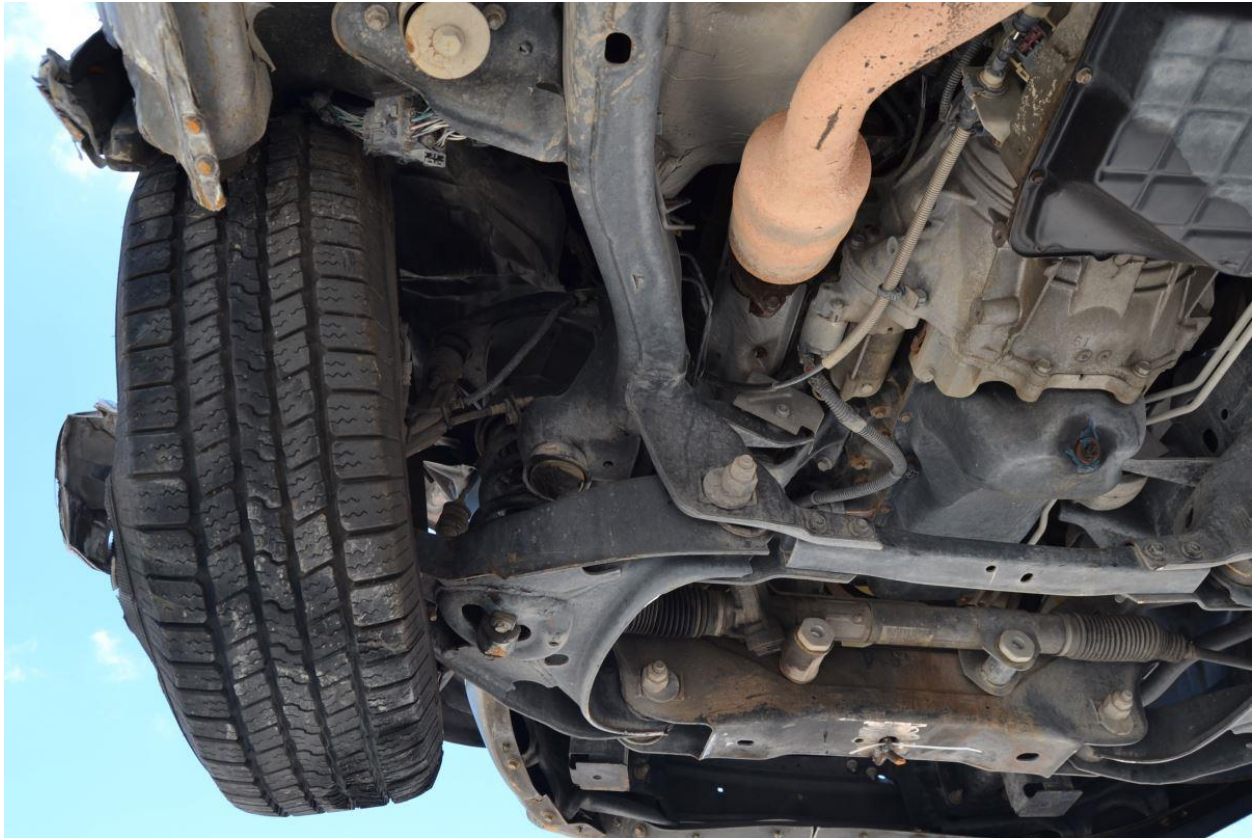
Figure 43. Undercarriage Damage, Test No. NJPCB-7

The lower-left control arm was scraped and bent. The left-front upper control arm was bent 2 in. (51 mm) upward. The left-front wheel and hub partially disengaged. Tears were found in the left-front tire extending from the outer wall through the tread, and the rim buckled. Scrapes were found on the left-rear tire. The right-side engine cross member was bent. The right side of the windshield had 14-in. (356-mm) diameter spider-web cracking from the deployment of the right-side airbag. A crack extended from the spider-web crack to the lower-left corner, and two additional cracks were found in the lower-left corner of the windshield. The roof and the remaining window glass were undamaged.
