# **INVESTIGATING THE USE OF A NEW UNIVERSAL BREAKAWAY STEEL POST**

## **MIDWEST ROADSIDE SAFETY FACILITY**

### **MINNESOTA DEPARTMENT OF TRANSPORTATION (MnDOT)**

MwRSF Research Report No. TRP-03-218-09

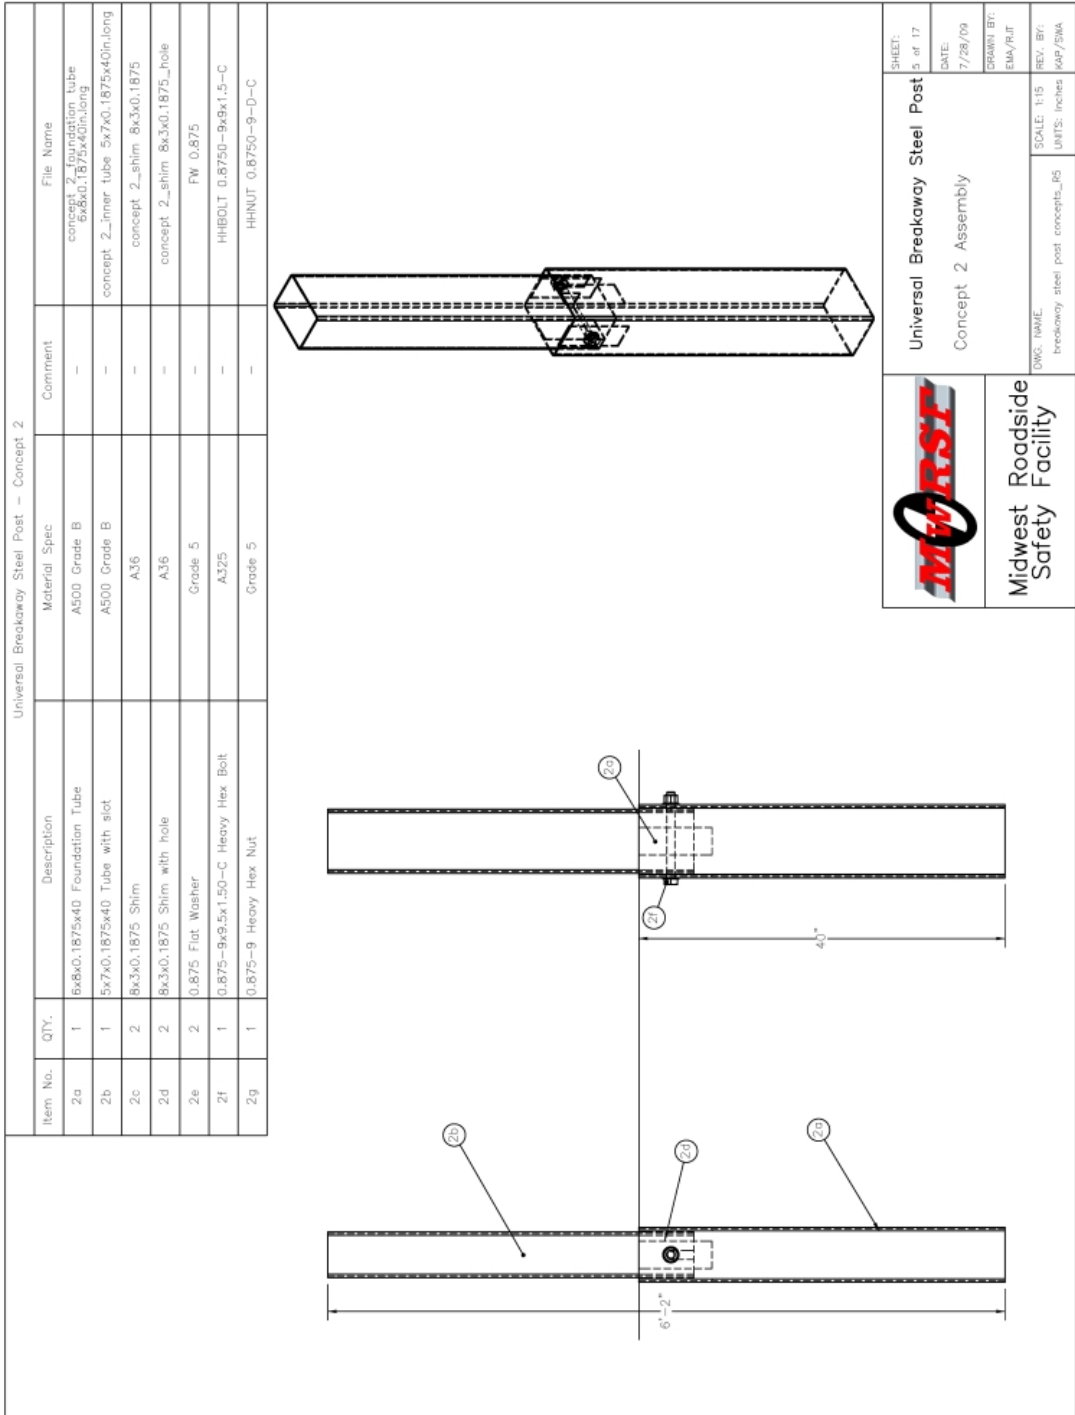
Figure 20. Steel Tube In Steel Tube With Thru Bolt Assembly Details

This concept was nearly identical to the steel tube in steel tube concept. The only difference was the upper tube was connected to the lower foundation tube with a thru bolt. Instead of sitting on top of a support bolt, the bolt passed through the upper tube, as shown in Figures 20 through 22. This concept relied on the bolt tearing out as the upper tube pulled up and out of the lower foundation tube. The thru bolt only passed through the upper tube on the traffic side. The non-traffic side was slotted; since, it is in compression during a strong-axis impact and would not tear out. In order to be consistent, this concept was also tested with a 6-in. (152-mm) embedment depth and a 1/8 in. (3.2 mm) clearance. This concept was believed to be most sensitive to weak-axis impacts. Under weak-axis loading, the post rotation would initially place very low tension on the retaining bolt. Thus, in order to explore the worst case situation, the thru-bolt design was tested in the weak axis.

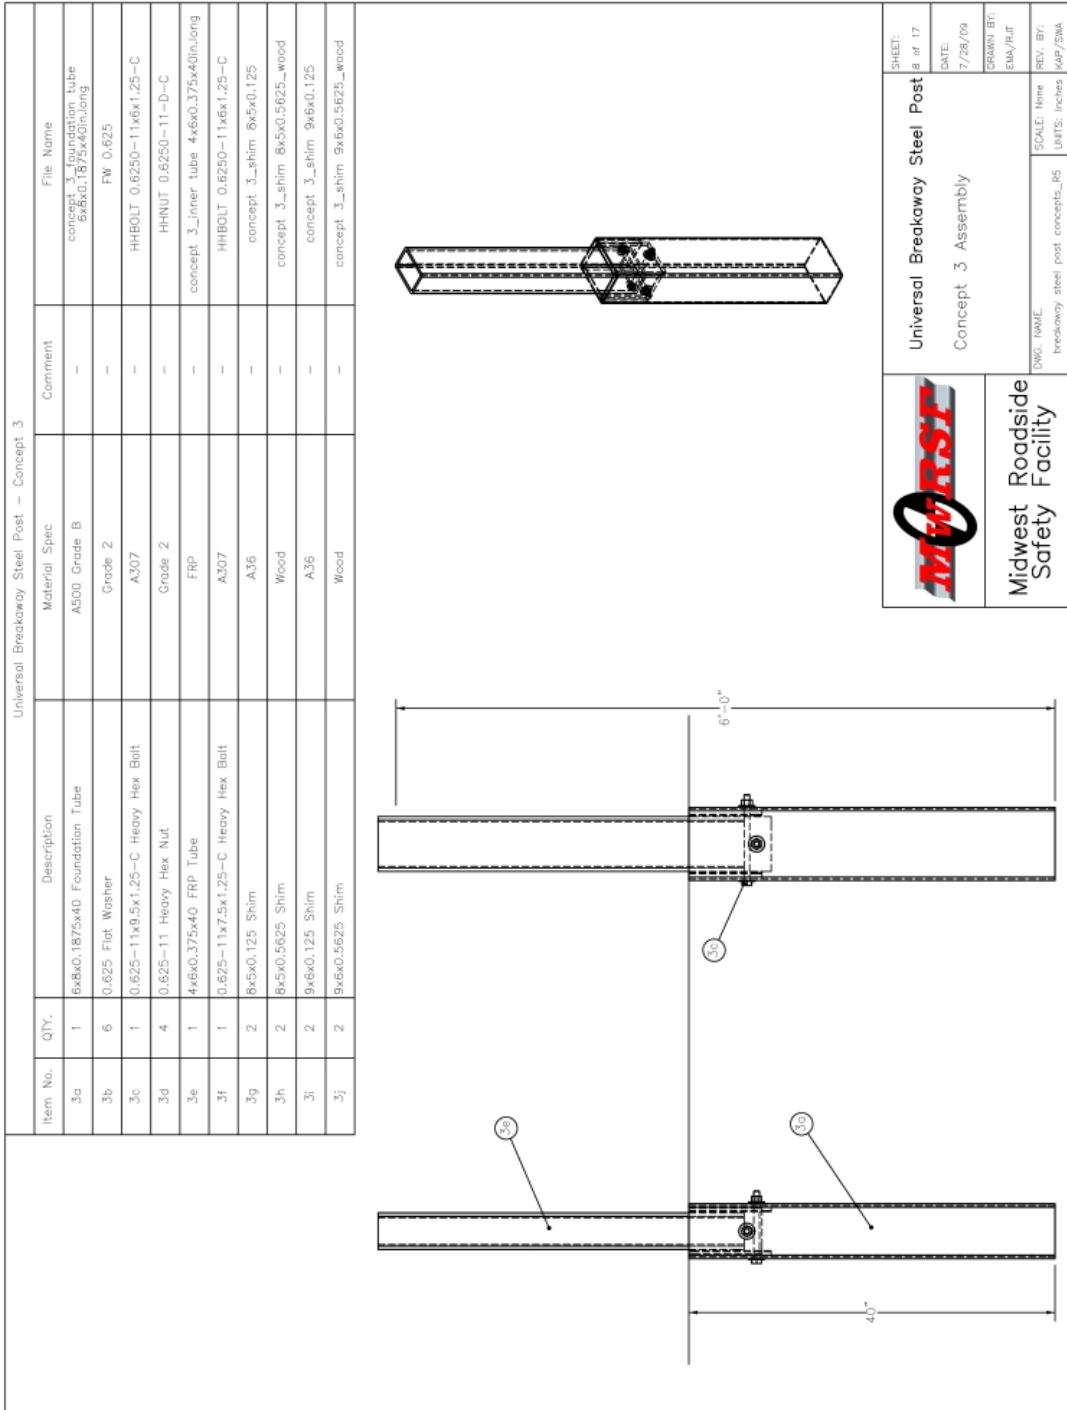
Figure 23. Upper FRP Post Assembly Details

FRP tubing is produced by numerous companies in standard shapes and sizes. The goal was to find the best available size of FRP tubing to fit in and form a 6 in. (152 mm) long “socket” with the lower 6-in. x 8-in. (152-mm x 203-mm) foundation tube. After researching numerous standard sizes, the 4-in. x 6-in. x 3/8-in. (102-mm x 152-mm x 9.5-mm) tubing provided by Advanced Fiber Products was chosen the best option available [15]. This FRP tubing had UV inhibitor and had ample strength for both strong- and weak-axis impacts. Thick shims were used to accommodate the size difference between the FRP tube and the lower foundation tube. For the first round of bogie testing, a wood/steel shim was utilized. These make-shift shims could be replaced if the FRP option proved to have promising potential for use as the universal breakaway post. The details of the upper FRP concept are presented in Figures 23 through 25.

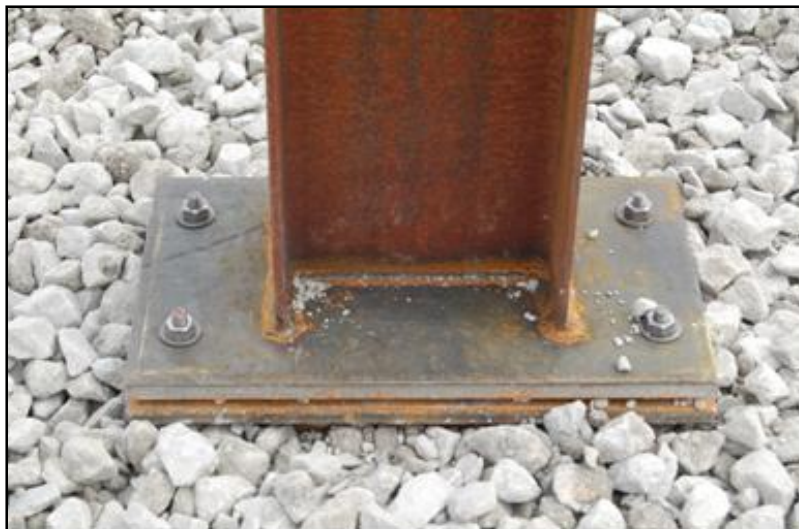
**Figure 26. Assembled Fracturing Bolt (Slipbase) Design**

When impacted, the bolts were expected to break in tension on the impact side and to break in shear on the back side. Step washers were utilized to create a shear plane for the bolts. The size and location of the breakaway bolts control the post fracture load for this concept. The peak post load should be close to the point when a simple bending analysis predicts that the front bolts reach their rated tensile strength. In this manner, the size and locations of the splice bolts were initially selected. This analysis led to the selection of 5/16 in. (7.94 mm) diameter grade 5, fully-threaded rods for the fracturing bolts. The threaded rods were spaced apart 10 in. (254 mm) in the strong axis and 4 in. (102 mm) in the weak axis. A close-up view of the assembled fracturing bolt concept can be seen in Figure 26.

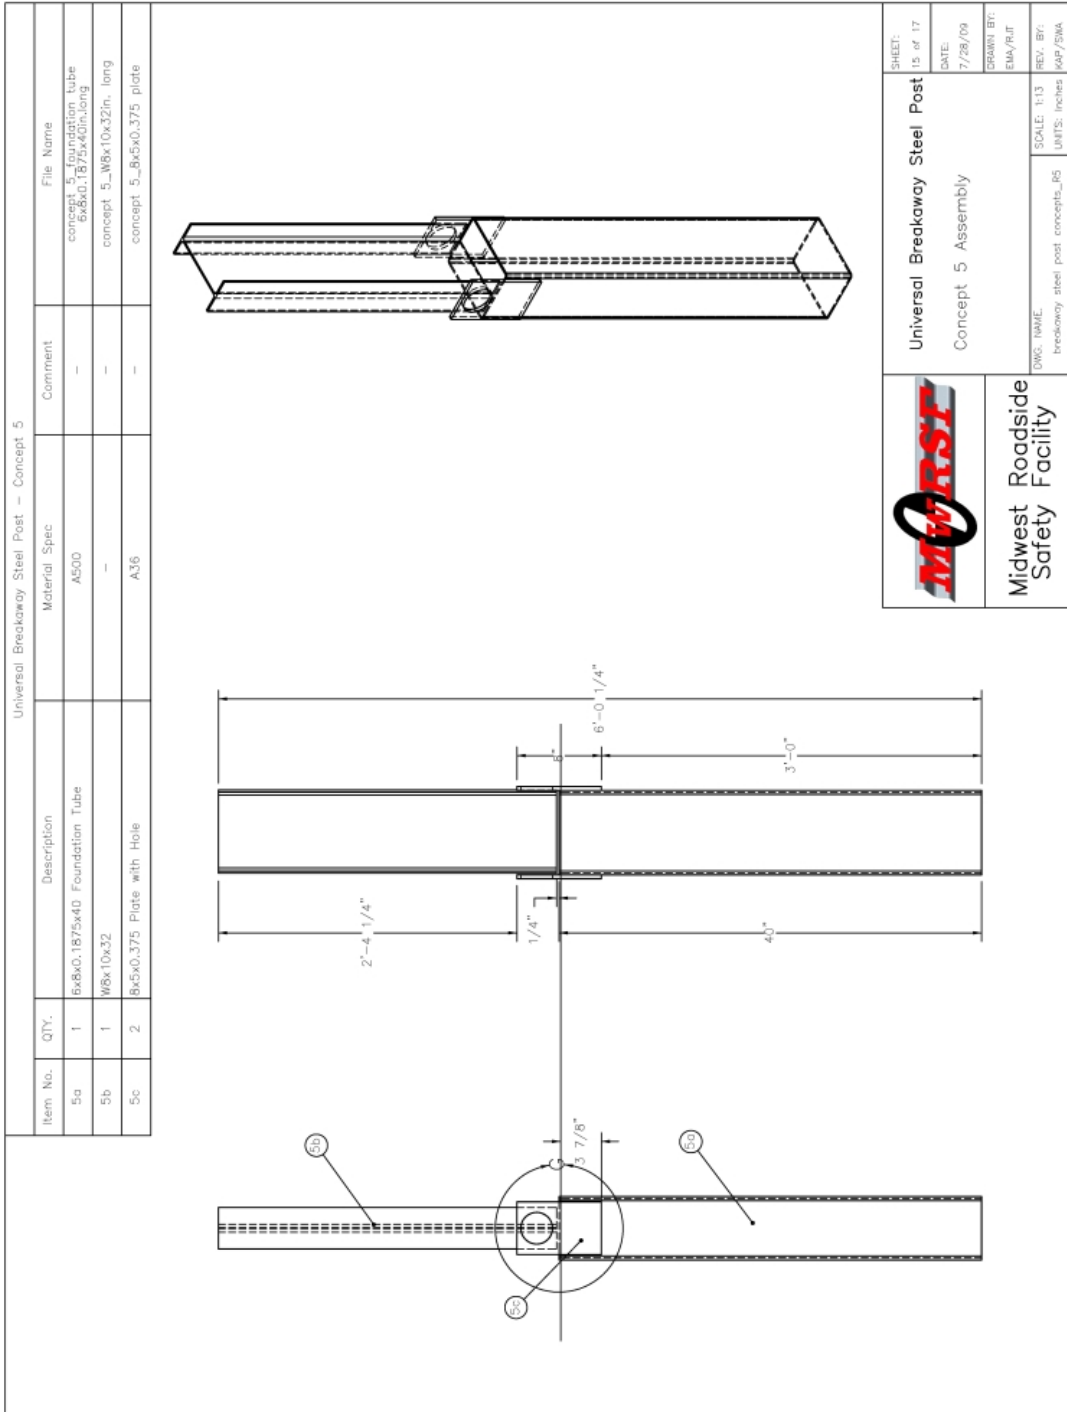
**Figure 31. Circular Fillet Weld Assembly Details**

The circular breakaway welds were expected to rupture due to shear in both the strong and weak axis. In the strong axis, the welds break in transverse shear. In the weak axis, the welds break in shear from torsional loading induced into the circular welds. As seen in Figure 34, calculations were performed to estimate the area of weld needed to obtain the desired strength levels. It was decided to use a circular fillet weld, since this shape allows for the most consistent weld. As a result, this design is very similar to the breakaway steel post in patent number 5,988,598 and described in the “Design and Development of Steel Breakaway Posts” [16]. The difference is this circular fillet concept uses a fillet weld instead of a plug weld.

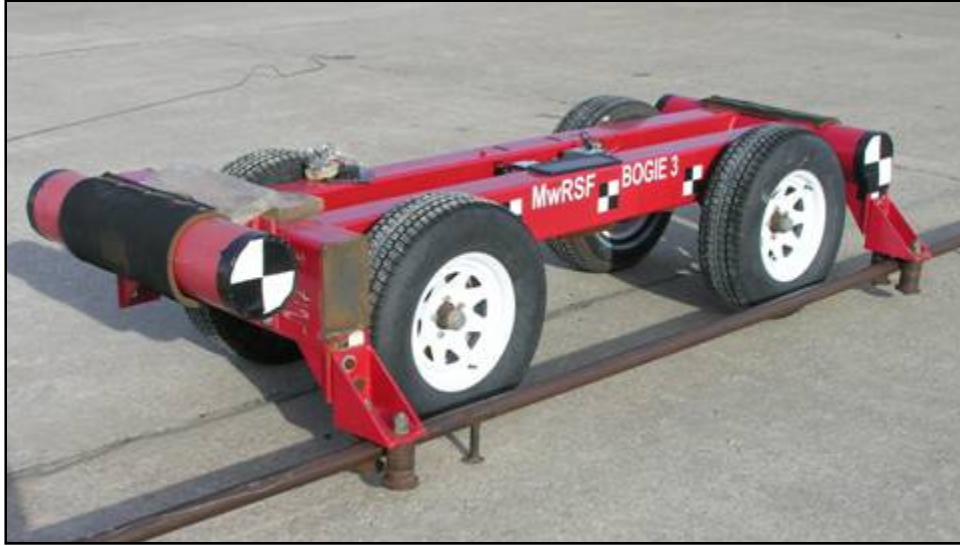
**Figure 35. Rigid Frame Bogie on Guidance Track**

In all tests, a pickup truck with a reverse cable tow and guide rail system was used to propel and direct the bogie. The bogie was accelerated toward the post along the guidance system, which consisted of a steel pipe anchored above the tarmac. In all of the tests, the bogie wheels were aligned for caster and toe-in values of zero so that the bogie would track properly. When the bogie reached the end of the guidance system, it was released from the tow cable, allowing it to be free rolling when it struck the post. A remote braking system was installed on the bogie, to provide for safe deceleration of the bogie after the test.

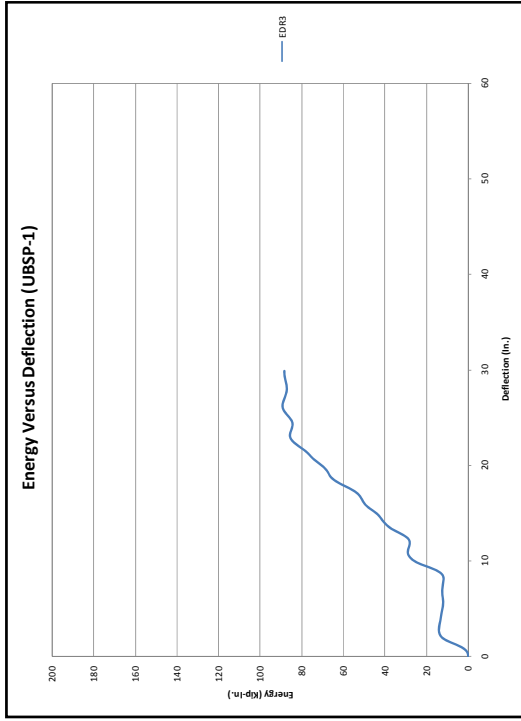
Figure 38a. Energy versus Deflection Curve for UBSP-1 - English

The force versus deflection curve, as provided in Figure 37, indicated an initial peak in the force level, due to the inertial effects of the upper steel tube. After this initial peak, the force level subsided toward zero, while the post rotated freely in the socket area. The force levels increased rapidly when the upper post reached the limits of free rotation. Although the peak force levels were near the desired 12 kips (53 kN), the average force levels were lower than desired from when the post rotated freely. However, there were desirable energy levels for this breakaway post, as shown in energy versus deflection curve in Figure . The post broke away and did not rotate thru the soil absorbing large amounts of energy.

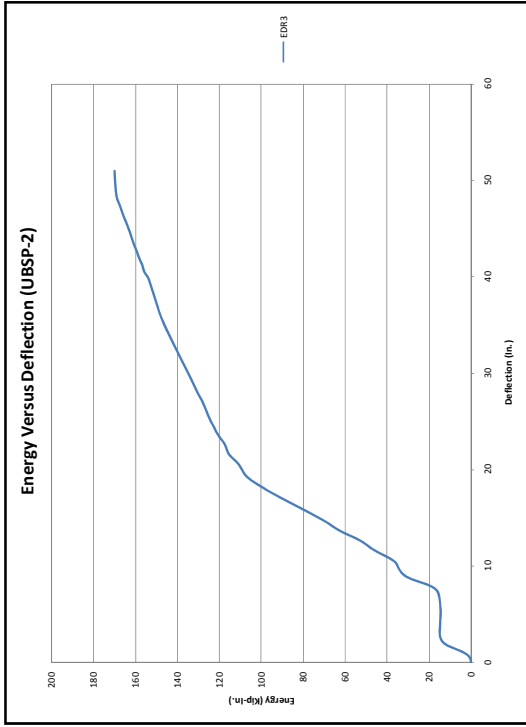
Figure 42a. Energy versus Deflection Curve for UBSP-2 - English

The force versus deflection curve, provided in Figure 41, indicated an initial peak in the force level, due to the inertial effects of the upper steel tube. After this initial peak, the force level subsided towards zero as the post rotated due to the gap between the two tubes. Then, the force levels increased rapidly to undesired levels as the upper tube rotated over and did not break away cleanly. Also, the energy versus deflection curve is shown in Figure 42. By not breaking away cleanly and easily, both the force and energy levels were higher than desired.

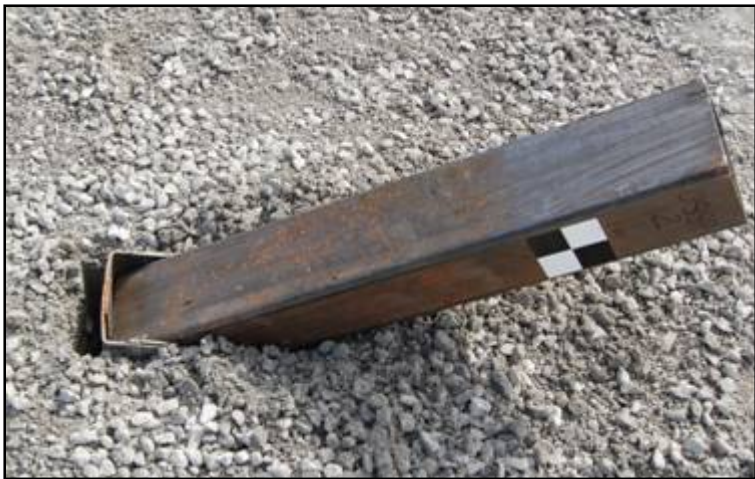
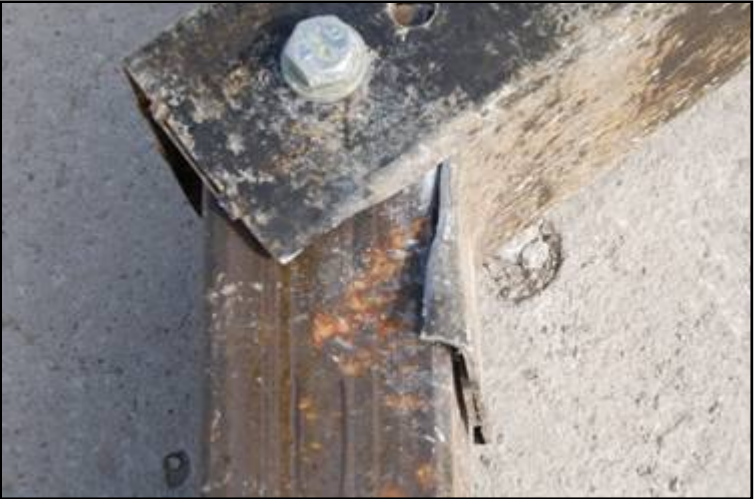
**Figure 44. Post-Impact Images of Test UBSP-2**

Test UBSP-2 was a weak-axis impact at 90 degrees on the steel tube in steel tube with a thru bolt concept. The force and energy data are shown in Figures 41 and 42, respectively. Time-sequential photographs are shown in Figure 43. When impacted by the bogie, the upper tube began to rotate immediately and lost contact with the bogie head at approximately 6 ms. At approximately 22 ms, the bogie regained contact with the post, and 4 1/2 in. (114.3 mm) and 4 3/8 in. (111.1 mm) cracks were formed near the downstream corners of the lower foundation tube. These cracks allowed the upper post to bend over and the bogie to eventually override the post and lose contact at approximately 148 ms. The upper tube also experienced minor deformation, but there was no sign of bolt tear out. As a result, this concept did not perform as desired. The upper tube did not pop up and break away from the lower foundation tube. Post-impact images can be seen in Figure 44.

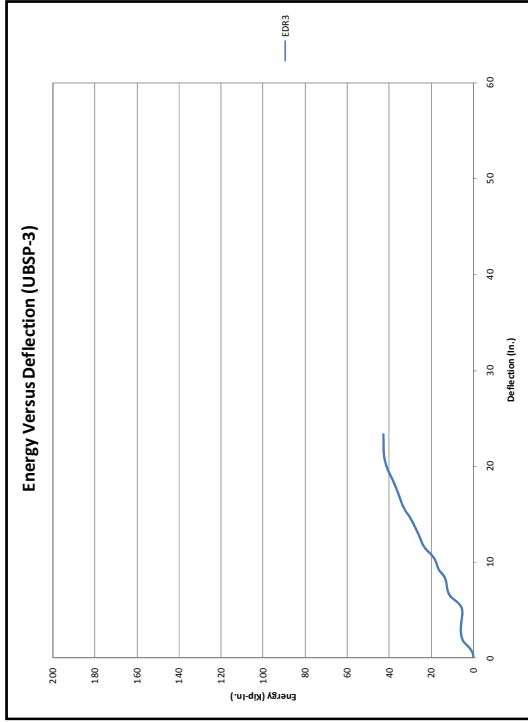
Figure 46a. Energy versus Deflection Curve for UBSP-3 - English

The force versus deflection curve, as provided in Figure 45, indicated an initial peak in the force level due to the inertial effects of the upper FRP tube. After this initial peak, the force level subsided towards zero as the post rotated due to the clearance between the two tubes. Finally, the force levels climbed back up as the upper FRP tube rotated, deformed, and popped out of the lower foundation tube. Although the force levels did increase until the FRP popped out, the force levels were lower than the desired 12 kips (53 kN). Also, the energy versus deflection curve, as shown in Figure 46, reveals the low energy levels absorbed by this post.

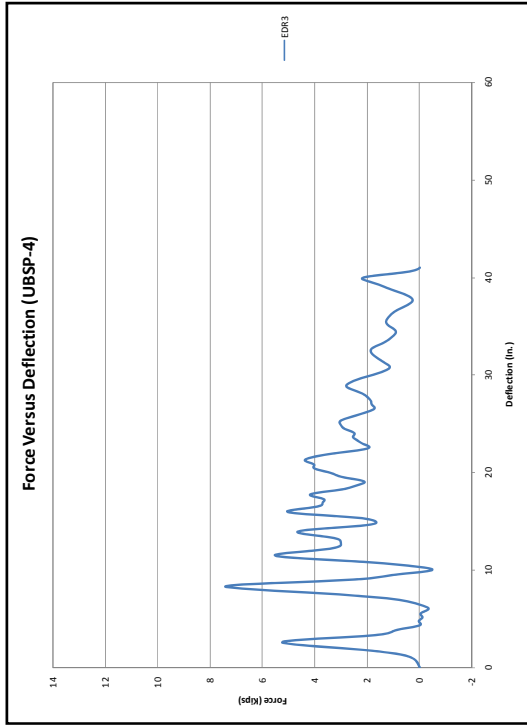
Figure 49a. Force versus Deflection Curve for UBSP-4 - English

As evidenced by the force and energy levels in the force versus deflection and energy versus deflection curves provided in Figures 49 and 50, respectively, the FRP post did not behave as desired. The upper FRP post did not pop out and break away from lower foundation tube. Even though the FRP post popped out as desired in the strong-axis impact in test UBSP-3, this weak-axis test exhibited a different behavior, as the FRP material was not brittle enough and did not crush enough to allow separation of the upper FRP tube. In weak-axis impacts, the upper FRP post needs to crush farther due to the shorter distance between the upstream and downstream faces of the post. This shorter distance decreases the rotation that occurs, and thus, increases the deformation needed to get the upper FRP tube to break away, which helped lead to the undesired behavior in this weak-axis impact.

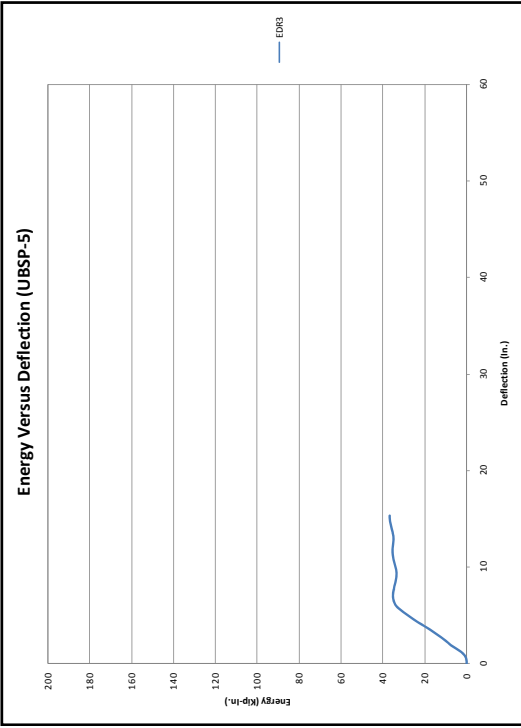
Figure 54a. Energy versus Deflection Curve for UBSP-5 - English

As seen in the force versus deflection curve in Figure 53 and the energy versus deflection curve in Figure 54, the fracturing bolt concept adequately absorbed energy, but the magnitude of the force levels was too low. Even though the impact-side bolts broke in tension as expected, the non-impact side bolts did not affect the peak force levels and did not break due to shearing. The shear load did affect the failure, but the tensile load was the controlling force in the failure of the bolts.

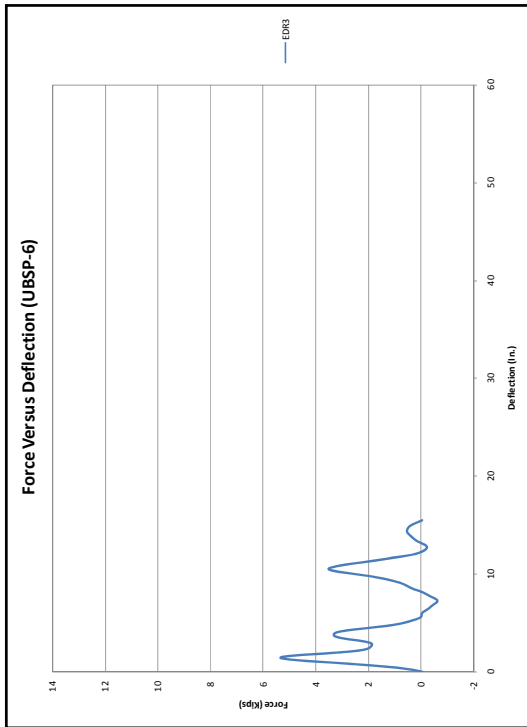
Figure 57a. Force versus Deflection Curve for UBSP-6 - English

As seen in the force versus deflection curve and the energy versus deflection curve in Figures 57 and 58, the fracturing bolt concept in a weak-axis impact had desirable strength and behavior. The impact-side bolts broke away at a peak load of 5.34 kips (23.8 kN) near the desired 6 kips (26.7 kN). Also, the post broke away quickly and absorbed a small amount of energy as desired. Similar to test UBSP-5, the only deformation in the post occurred to the bolts and washers. The bolts tended to break in either a level or 45 degree plane, and the washers were deformed from compression between the nuts, bolt heads, and the base plates. Post-impact images of the posts and fractured bolts can be seen in Figure 60.

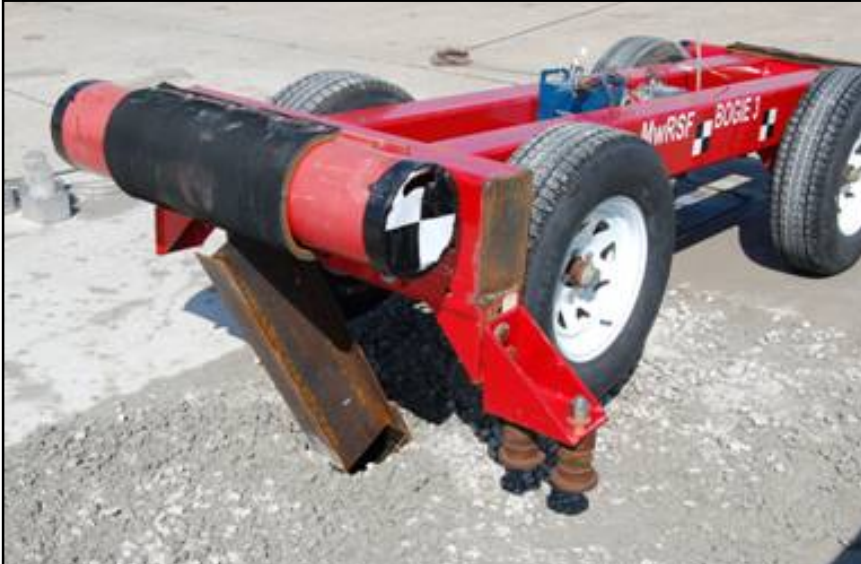
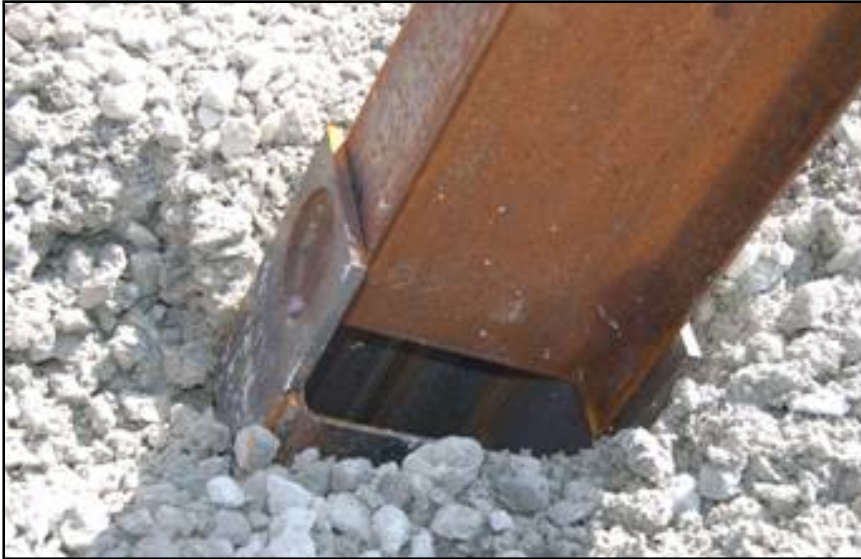
**Figure 62. Post-Impact Images of UBSP-7**

Test UBSP-7 was a strong-axis impact at 0 degrees on the circular fillet weld concept embedded in standard strong soil. Time-sequential photographs are shown in Figure 61. The post began to rotate immediately but did not break away as intended. As a result, the bogie never lost contact with the post and came to rest on top of the post, as seen in Figure 62. For this test, the acceleration transducers did not work, but this was not an issue since the post did not break away. The only deformation that occurred during the test was some slight yielding below ground level on the impact side of the lower foundation tube. This deformation could be a sign of frozen soil, which hindered any rotation of the tube.

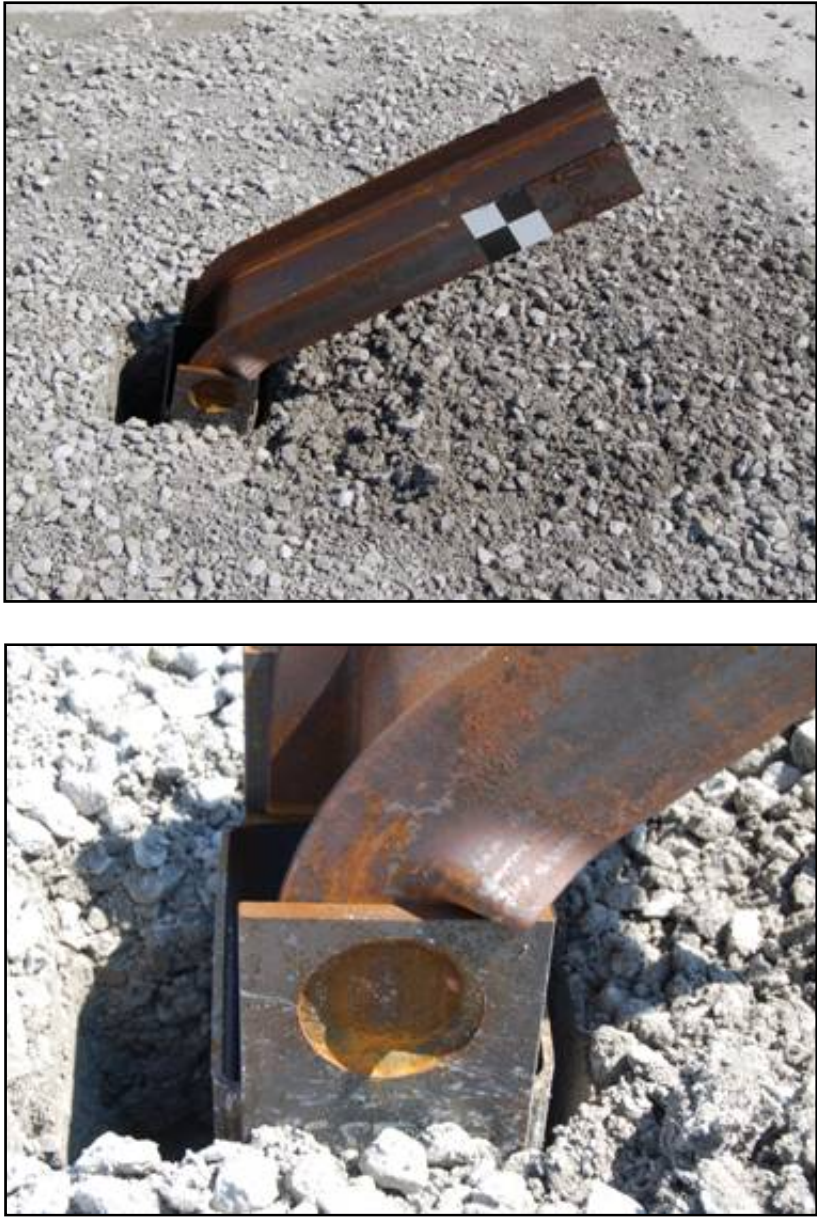
Figure 66. Post-Impact Images of UBSP-8

Test UBSP-8 was a weak-axis impact at 90 degrees on the circular fillet weld concept embedded in standard strong soil. The force and energy data are shown in Figures 63 and 64, respectively. Time-sequential photographs are shown in Figure 65. Upon impact, the post began to immediately rotate in the soil. At approximately 30 ms, the upper W8x10 (W203x14.9) post began to yield and buckle over the steel plates. Like in test UBSP-7, the post did not break away as desired, and the bogie continued to rotate and yield the circular fillet weld post until eventually overriding the post and losing contact at approximately 112 ms. The only deformation in the test occurred to the upper W8x10 (W203x14.9) post as it deformed and bent over the steel plates. There was no evidence of the weld failing, which again was due to an error in judging the strength of the weld. The post-impact images can be seen in Figure 66.

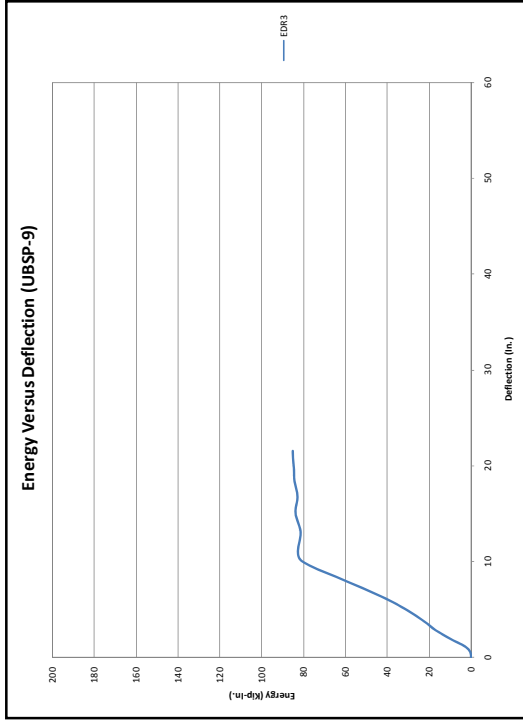
Figure 77a. Energy versus Deflection Curve for UBSP-9 - English

As seen in the force versus deflection curve in Figure 76 and the energy versus deflection curve in Figure 77, the fracturing bolt concept performed sufficiently by breaking at a peak load of 11.0 kips (48.9 kN) and absorbing energy up until the peak load was reached. The only issue was one of the impact-side nuts stripped off of the bolt instead of the bolt fracturing. This behavior was unexpected and may have caused premature failure at the 11.0 kips (48.9 kN) peak load. It was decided to rerun this strong-axis test on the fracturing bolt concept to ensure that the nut failure did not cause any unrealistic behavior. The results from this second test can be seen in test UBSP-13, as shown in Section 6.5.5. Even with the nut stripping, the post did break away as desired.

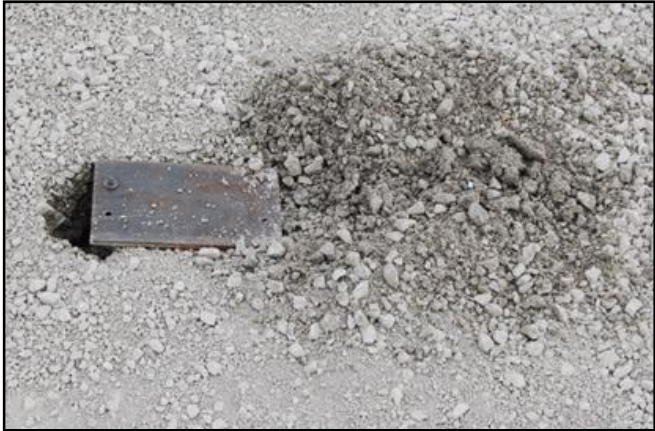
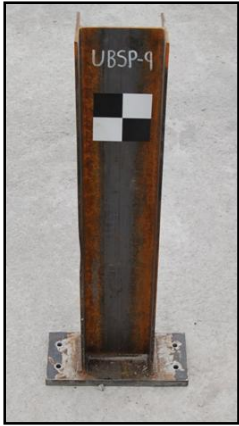
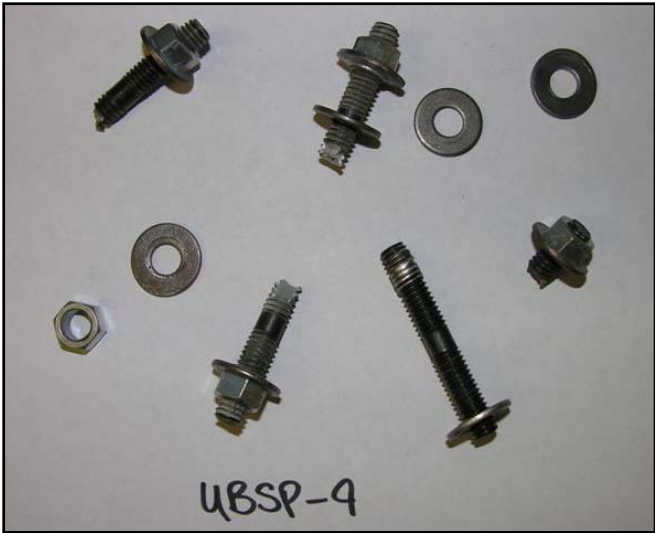
Figure 79. Post-Impact Images of UBSP-9

Test UBSP-9 was a strong-axis impact at 0 degrees on the fracturing bolt concept embedded in standard strong soil. The force and energy data are shown in Figures 76 and 77, respectively. Time-sequential photographs for this test are shown in Figure 78. Upon impact, the post began to rotate in the soil until the impact-side bolts broke in tension at approximately 30 ms. After the bolts broke, the post offered little resistance, and thus, the bogie head lost contact with the post from approximately 34 ms until 58 ms. The bogie regained contact with the post from 58 ms until 70 ms, when the non-impact-side bolts fractured and broke away. However, there was little resistance, and the post was pushed over to the ground. The only deformation in the post occurred to the bolts and washers. The bolts tended in break with either a level or 45 degree plane, and some impact-side washers were deformed from compression between the nuts, bolt heads, and the base plates. Post-impact images can be seen in Figure 79.

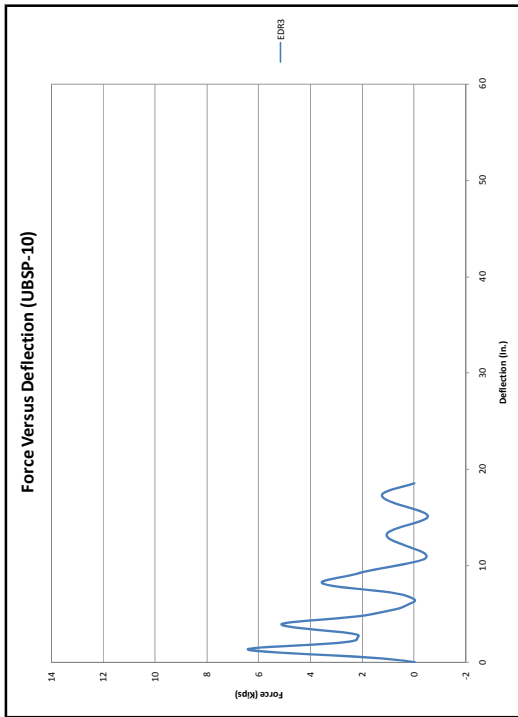
Figure 80a. Force versus Deflection Curve for UBSP-10 - English

As seen in the force versus deflection curve provided in Figure 80, the fracturing bolt broke with a peak force level of 6.42 kips (28.6 kN), close to the 6 kips (26.7 kN) targeted in a weak-axis direction. As desired, the post did not absorb significant energy, as shown in Figure 81. The only post deformation occurred to the bolts and washers. The bolts again tended to break in either a level or 45 degree plane, and some washers were deformed from compression between the nuts, bolt heads, and the base plates. Post-impact images can be seen in Figure 83.

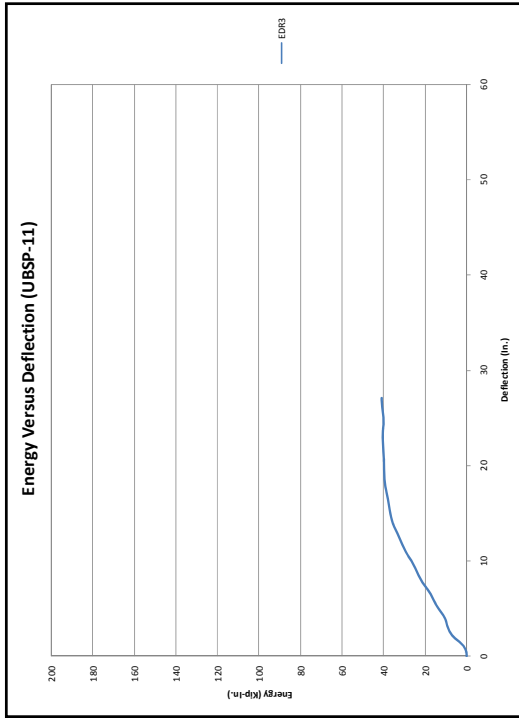
Figure 85a. Energy versus Deflection Curve for UBSP-11 - English

Similar to the fracturing bolt concept evaluated in test UBSP-10 using a weak-axis impact, this weak-axis test revealed that the circular fillet weld broke at low peak force level and did not absorb significant energy, as desired. The force versus deflection curve and energy versus deflection curve for test UBSP-11 are provided in Figures 84 and 85, respectively. The only undesired behavior was that the post did not break away cleanly.

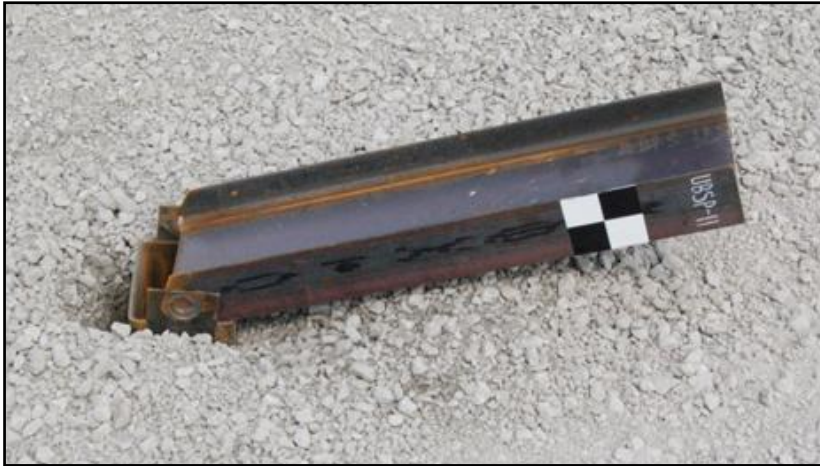
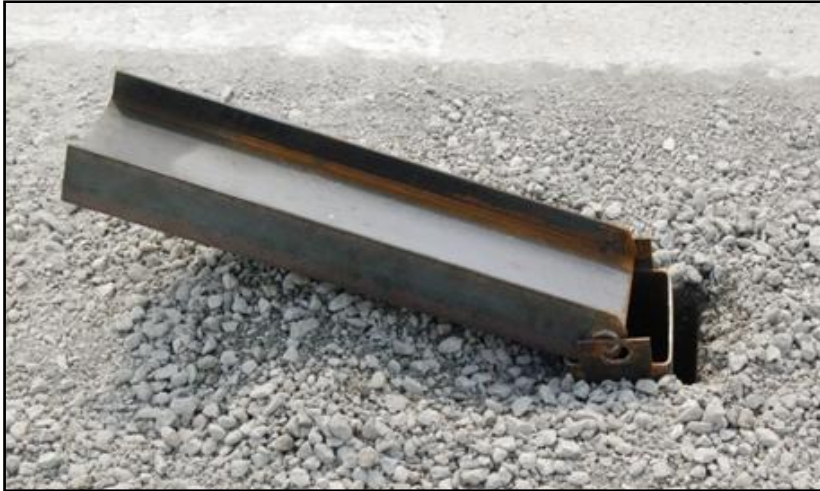
**Figure 87. Post-Impact Images of UBSP-11**

Test UBSP-11 was a weak-axis impact at 90 degrees on the circular fillet weld concept embedded in standard strong soil. The force and energy data are shown in Figures 84 and 85, respectively. Time-sequential photographs are shown in Figure 86. Upon impact, the post began to rotate immediately in soil. At approximately 32 ms, the circular fillet welds began to fracture, and the post began to rotate over to the ground. Eventually, the post lost contact with the bogie head at approximately 100 ms when the bogie overrode the post. Although both fillet welds did fracture, the post got caught up on one of the welds and did not break away cleanly, as desired. The welds were the only visible post damage, as seen in the post-impact images in Figure 87.

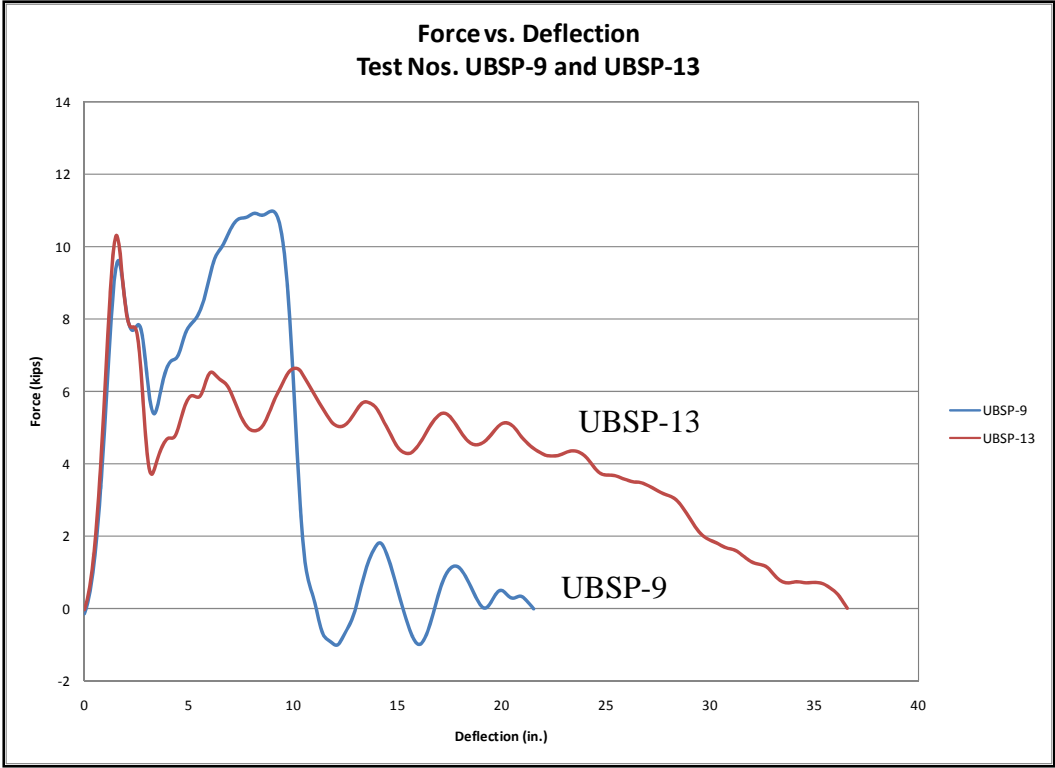
Figure 96a. Force versus Deflection Curves for UBSP-9 and 13 – English

From the force and energy versus deflection curves shown in Figures 96 and 97, respectively, the two nearly identical tests had totally different behavior. In test UBSP-9, the fracturing bolt post rotated through the soil at approximately 11 kips (49 kN). However, in test UBSP-13, the post rotated through the soil at approximately 5 kips (22 kN). Although there were inconsistencies with the soil compaction, the fracturing bolt post performed as desired in both tests. The post broke away when the strong soil had more compaction, and it absorbed energy and rotated through the less compacted soil, as desired. The difference in these tests clearly shows the inconsistency when dealing with soil and also illustrates the attention that needs to be given to the compaction and potential variability of the standard strong soil.

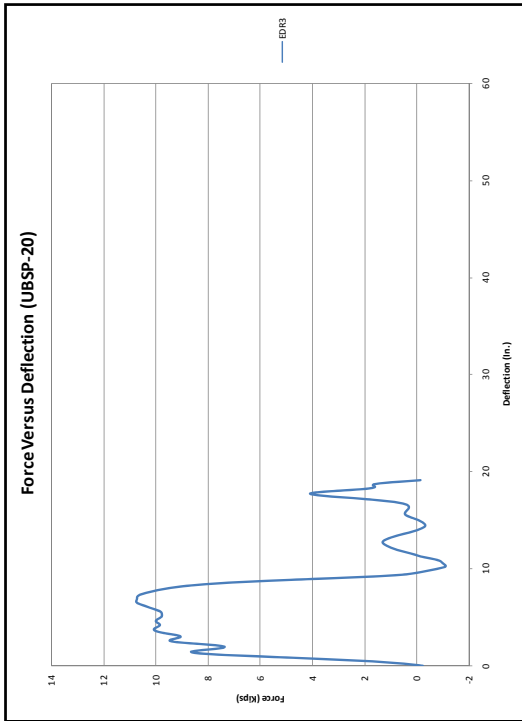
Figure 125a. Force versus Deflection Curve for UBSP-20 - English

As shown in the force versus deflection and energy versus deflection curves provided in Figures 125 and 126, the fracturing bolt concept performed sufficiently by breaking away cleanly at a peak load of 10.8 kips (48 kN) and absorbing energy up to that peak load. All of the bolts fractured as desired but at a slightly lower peak load than expected, which was probably due to the actual moment arm, or distance between the bolts being shorter than anticipated. However, the post strength was close to the 12-kip (53 kN) desired force level, and the post did break away cleanly, thus leaving a 2 1/4 in. (57 mm) gap in the soil. This test performed similar to test no. UBSP-9, when the soil was also well compacted. Post deformation was observed in the bolts and washers with some slight yielding noticed in the two steel plates. Post-impact images of the post, bolts, and soil are provided in Figure 128. Also, close-up images of the fractured bolts and damaged washers are shown in Figure 129.

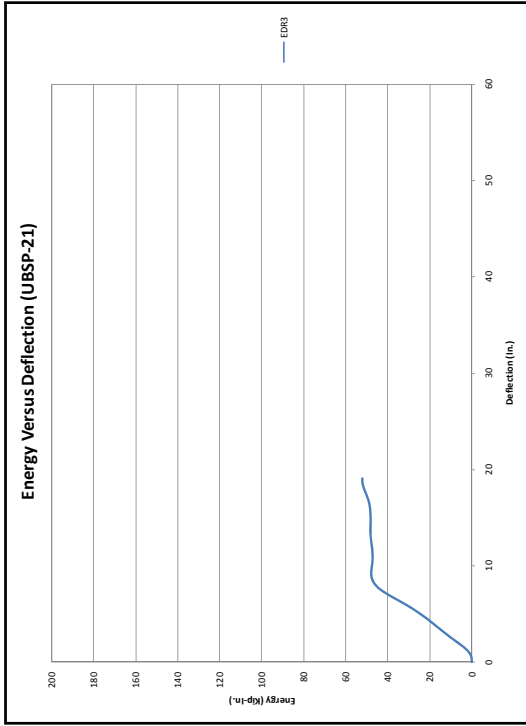
Figure 131a. Energy versus Deflection Curve for UBSP-21 - English

Upon review of the force versus deflection and energy versus deflection curves provided in Figures 130 and 131, it was clear that the test performed as desired. The post broke away cleanly at a peak force level of 8.3 kips (37 kN), which was close to the targeted load value of 8 kips (36 kN) for a 45-degree impact. For this oblique load condition, the fracturing bolt post was impacted on the flange of the upper W6x9 (W152x13.4) post segment. As a result, damage occurred to the flange near the impact location. Also, the 1/2-in. (13-mm) thick, bottom steel plate was bent down on the downstream corner. There was a 1/2-in. (13-mm) gap in the soil. Post-impact images of the post, bolts, and soil are shown in Figure 133. Additional close-up images of the fractured bolts and damaged washers are provided in Figure 134.

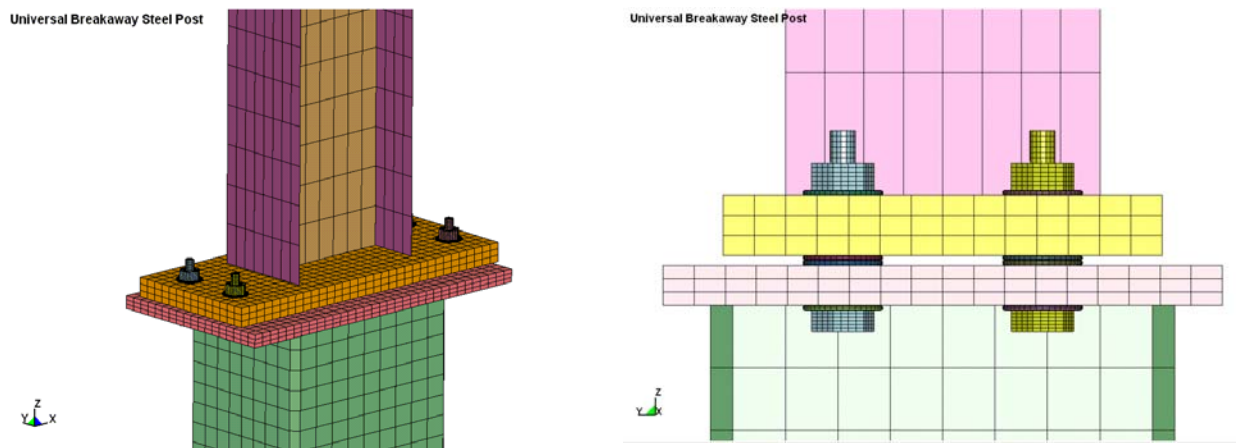
**Figure 136. Meshed Fracturing Bolt Post**

\*The 16 Washers were defined in 16 separate parts

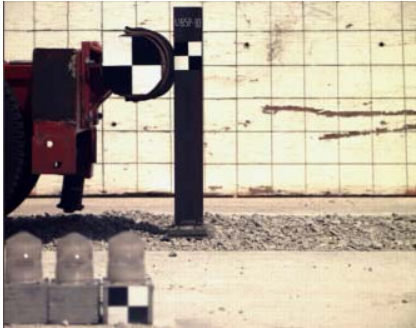
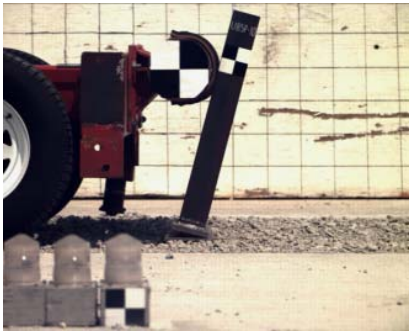
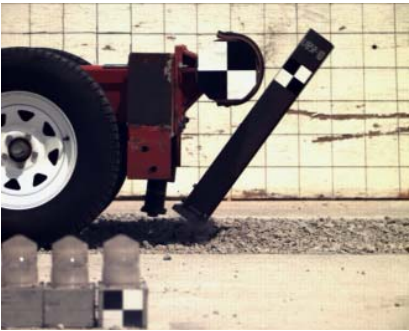
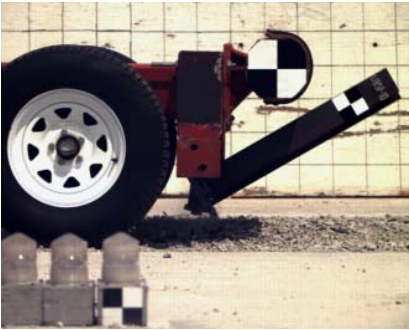
**Figure 146. Time Sequential Photographs – Weak Axis Impact**

The simulation results were very similar to the general post behavior observed in the physical test. As shown in Figure 146, the time-sequential photographs revealed that the general simulated behavior followed the behavior in the actual test with the main difference being more damage to the upper W6x9 (W152x13.4) post in the simulation. There was more deformation where the bogie impacted the post in the simulation than observed in the actual testing. Also, the upper W6x9 (W152x13.4) post buckled slightly in the simulation, which was not observed in the actual bogie test.
