# **INVESTIGATING THE USE OF A NEW UNIVERSAL BREAKAWAY STEEL POST**

## **MIDWEST ROADSIDE SAFETY FACILITY**

### **MINNESOTA DEPARTMENT OF TRANSPORTATION (MnDOT)**

MwRSF Research Report No. TRP-03-218-09

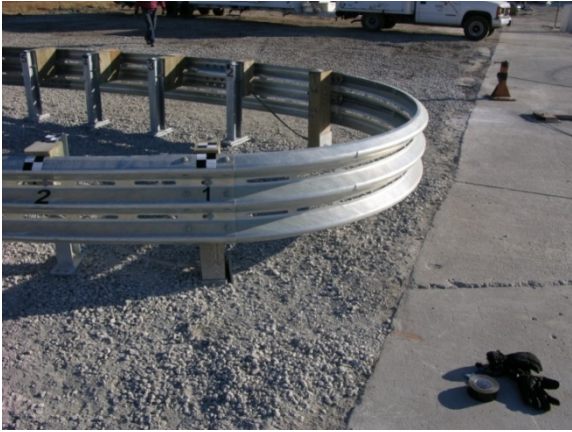
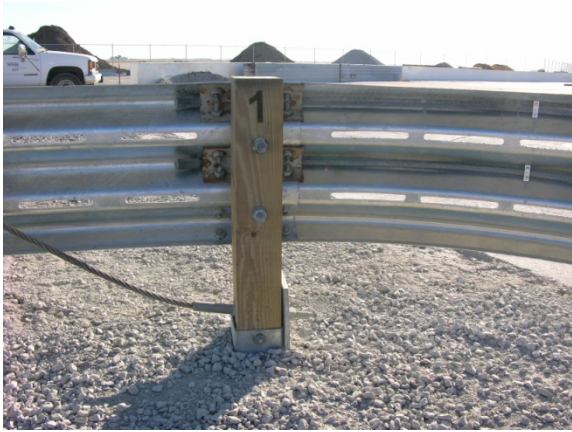
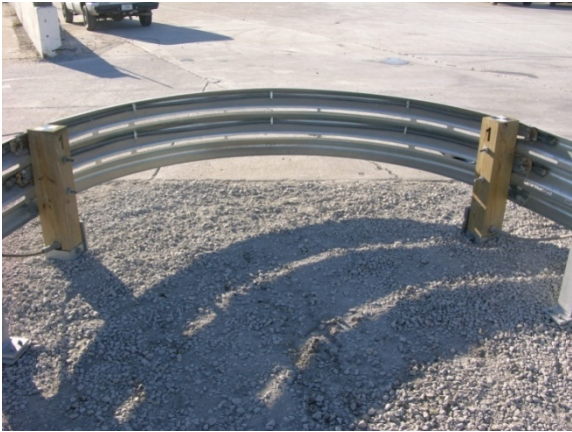
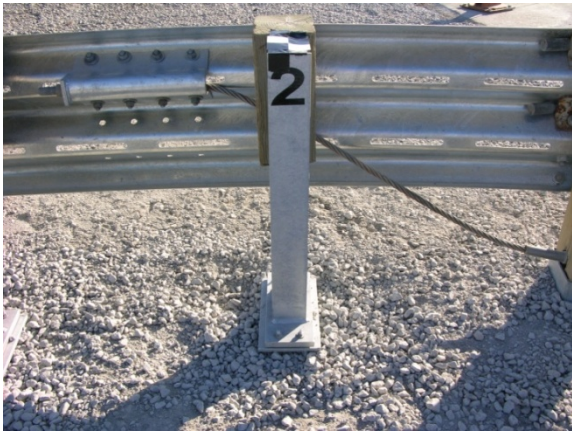
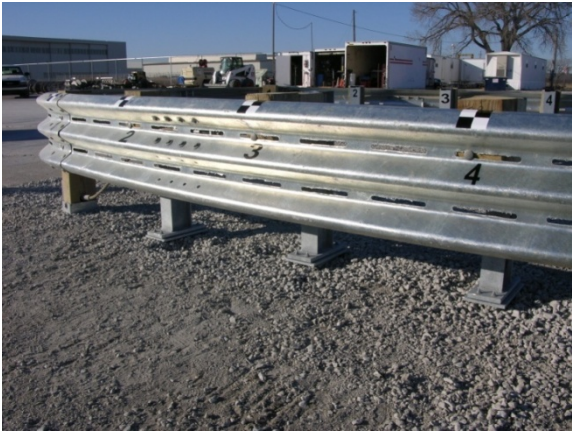
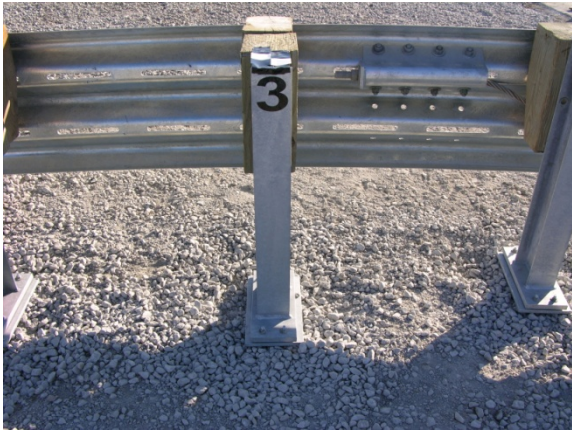
**Figure 168. UBSP Bullnose Barrier**

The complete layout of the three beam bullnose barrier system is shown in Figure 154 with details shown in Figures 155 through 167. Similar to previous testing, a one-half barrier system was utilized for the testing program in order to limit costs and construction time. The bullnose system was constructed with twenty-eight posts, with fourteen posts positioned on each side of the system. The first post on each side of the system was a three beam Breakaway Cable Terminal (BCT) wood post. Although the goal of this study was to develop an all-steel system, it was found in previous testing that using a BCT wood post in the anchorage system allowed for improved performance and the effective capture of the pickup truck [5]. Also, the objective for this study focused on the replacement of the wood CRT posts with steel posts, or other non-wood posts. Anchor posts are different and would require a different steel post design. The new fracturing bolt steel post used in the bullnose median barrier system was the same design previously used in the third round of bogie testing on the breakaway posts. Photographs of the system are provided in Figures 168 through 170.

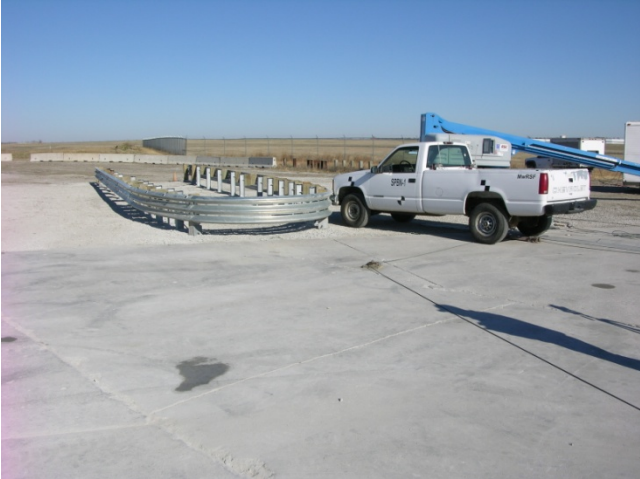
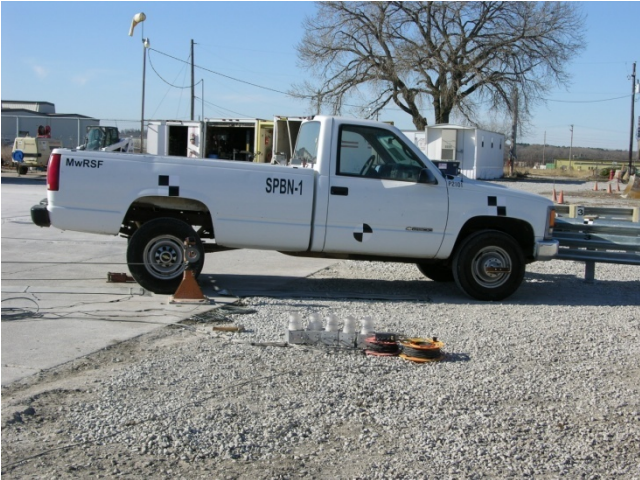
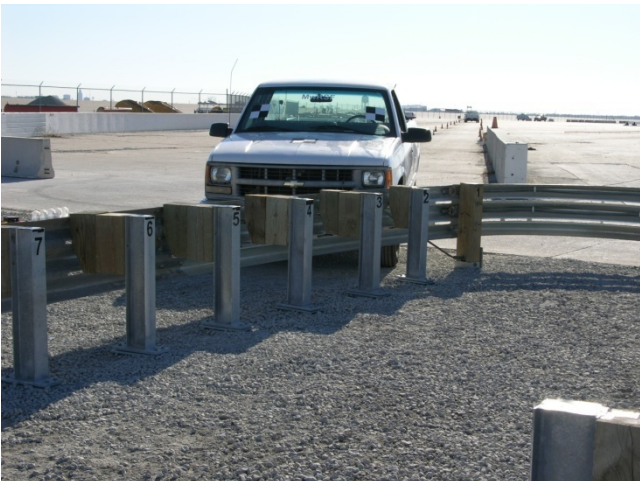
**Figure 171. Test Vehicle, Test USPBN-1**

For test no. USPBN-1, a 2000 GMC C2500 pickup truck was used as the test vehicle. The test inertial and gross static weights were 4,474 lbs (2,029 kg). The test vehicle is shown in Figure 171, with its dimensions shown in Figure 172.

The front wheels of the test vehicle were aligned for camber, caster, and toe-in values of zero so the vehicle would track properly along the guide cable. A 5B flash bulb was mounted on the left quarter point of the vehicle's roof to pinpoint the time of impact with the test article on the high-speed video footage. The flash bulb was fired by a pressure tape switch mounted on the front-left corner of the bumper. A remote-controlled brake system was installed in the test vehicle so the vehicle could be brought safely to a stop after the test.

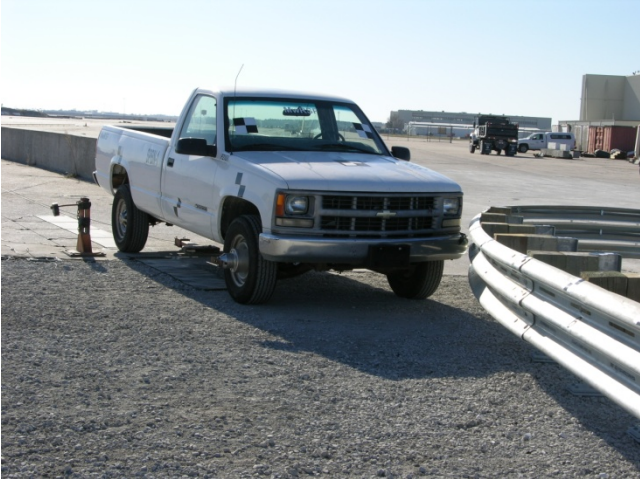
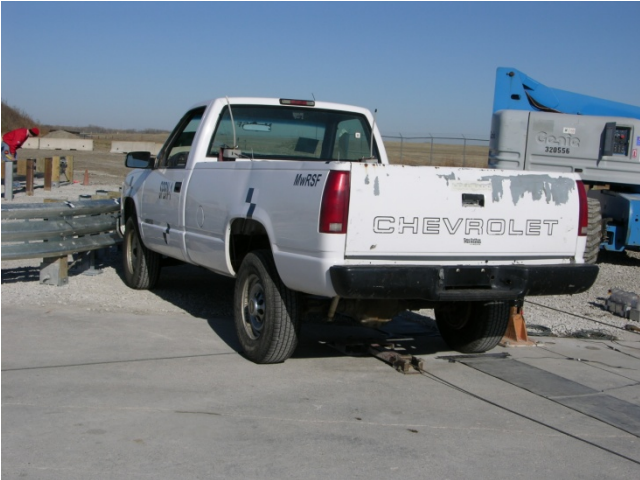
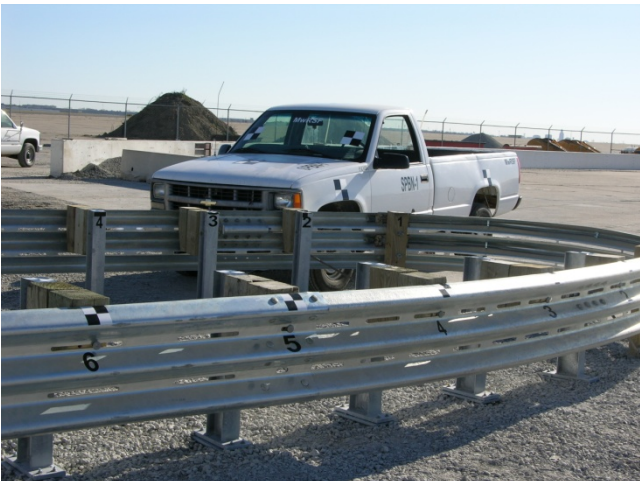
**Figure 175. Impact Location, Test USPBN-1**

Test no. USPBN-1 was conducted according to NCHRP Report No. 350 Test Designation 3-38. The 4,474-lb (2,029-kg) pickup truck impacted the test article at a speed of 63.2 mph (101.7 km/h) and an angle of 22.6 degrees. The target critical impact point was the centerline of post no. 2, as shown in Figure 175. Actual vehicle impact with the barrier system occurred approximately 4 in. (101.6 mm) downstream of the target location. A summary of the test results and sequential photographs are shown in Figure 176. Additional sequential and documentary photographs are shown in Figures 177 through 187.

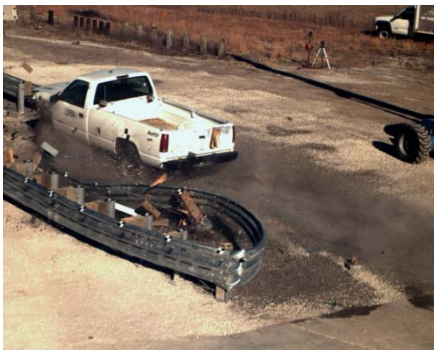
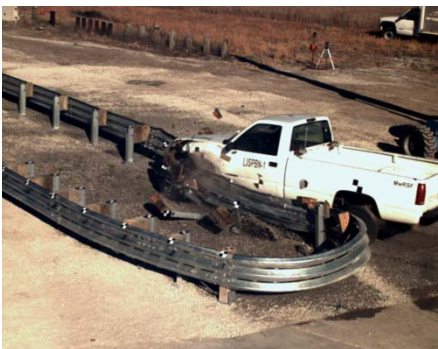
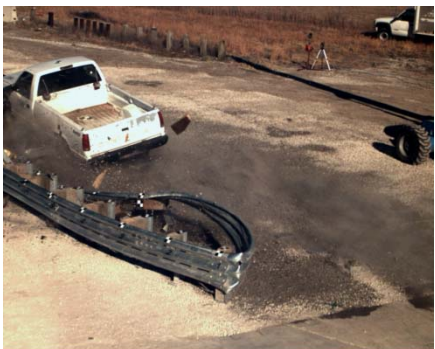
Figure 177. Additional Sequential Photographs, Test USPBN-1

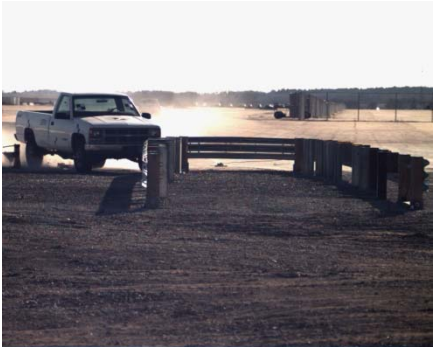
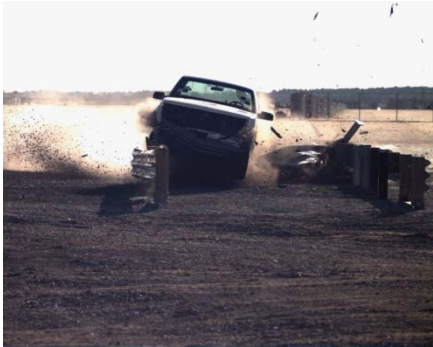
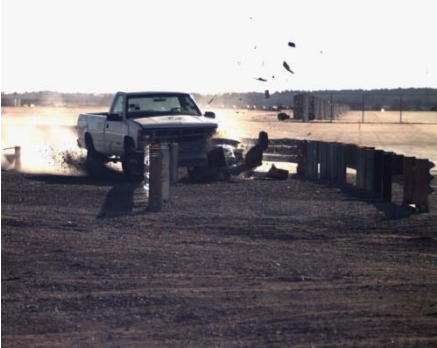
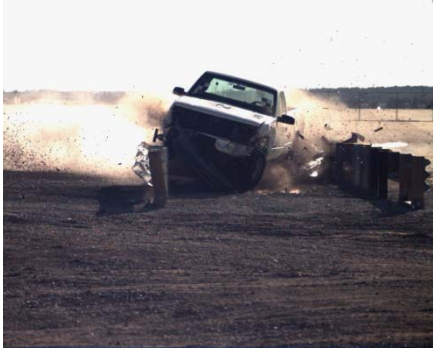
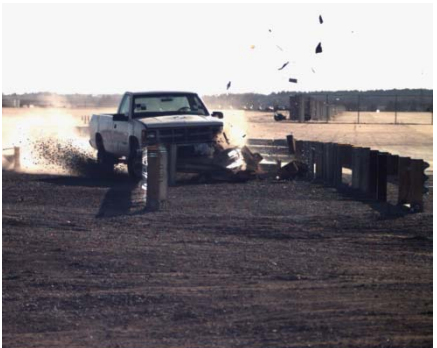
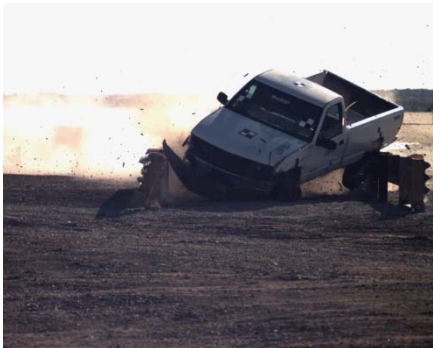
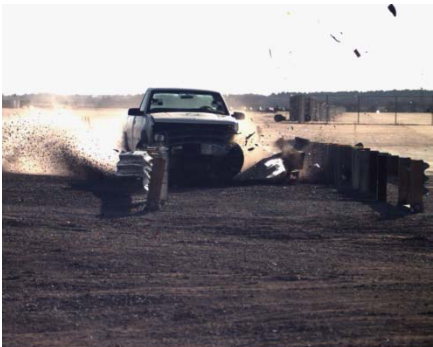
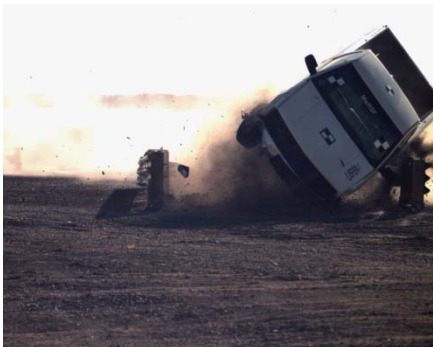
Figure 178. Additional Sequential Photographs, Test USPB-1

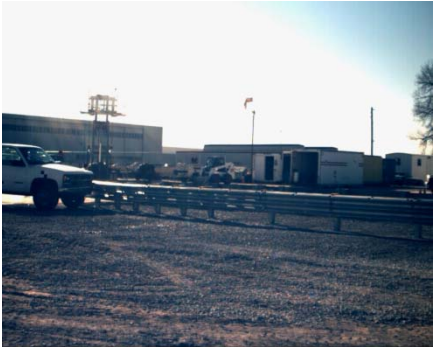
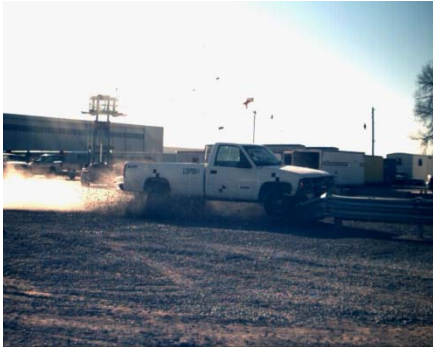
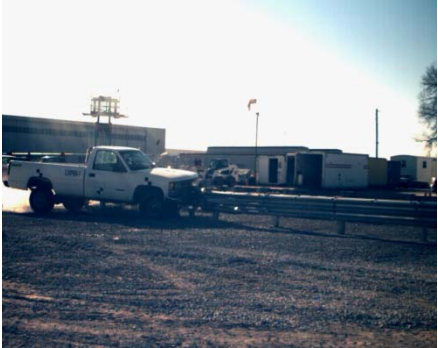
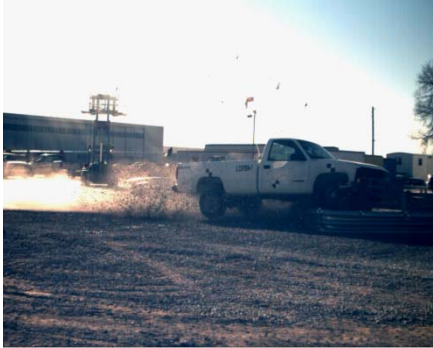
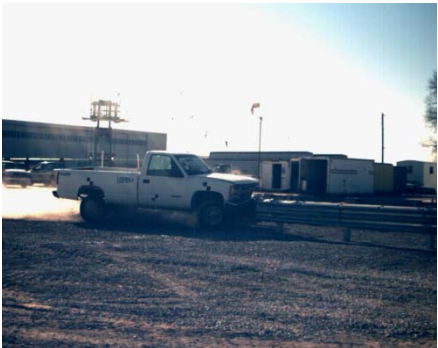
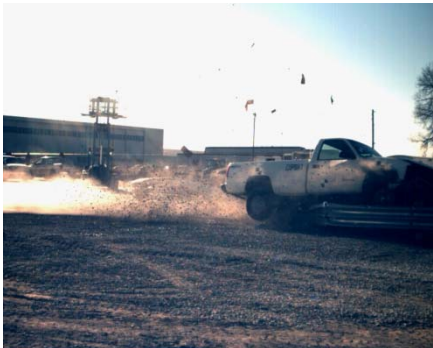
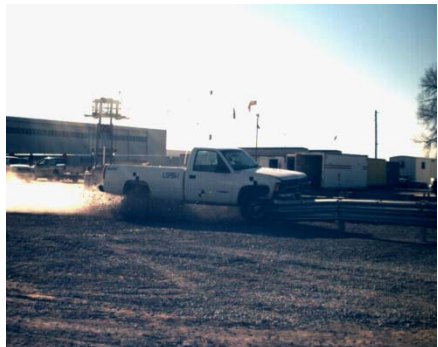
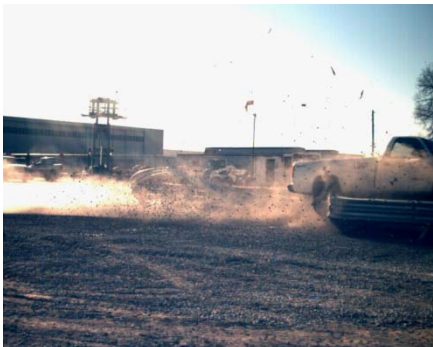
Figure 179. Additional Sequential Photographs, Test USPBN-1

Next, post no. 7 broke in the strong axis at approximately 0.144 sec. Post no. 2 finally broke at approximately 0.210 sec, due to the impact with post no. 1, and the rail began to deform over to post no. 1 on the left side of the system. Also, the rail began to drop on the driver's side of the pickup at 0.210 sec. At approximately 0.270 sec, the front end of the pickup was near the end of the slotted rail at post no. 8, and a buckle point formed in the non-slotted rail near post no. 9, causing the rail to begin to drop on the passenger's side of the pickup. This buckle caused the rail to drop to the ground, and the pickup truck began to override the rail. The truck continued to travel up and over the rail until the left-front corner of the truck contacted the ground at approximately 0.728 sec. The momentum of the truck continued forward, while the left-rear of the truck impacted posts no. 11 and 12 on the left side, or side B, of the system at 0.892 sec. This impact caused the pickup to begin rolling over, and the pickup rolled over top of post nos. 13 and 14 on the left side of the system before coming to rest on its roof approximately 15 ft (4.6 m) downstream of the system. The trajectory of the pickup truck during the crash test and the final position of the vehicle are provided in Figures 181 and 182.

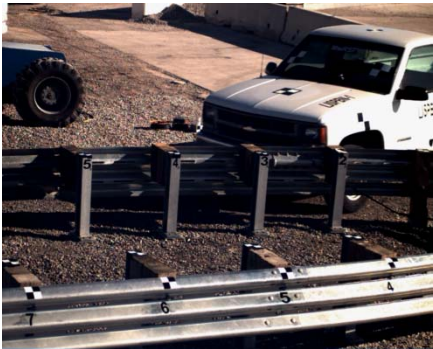
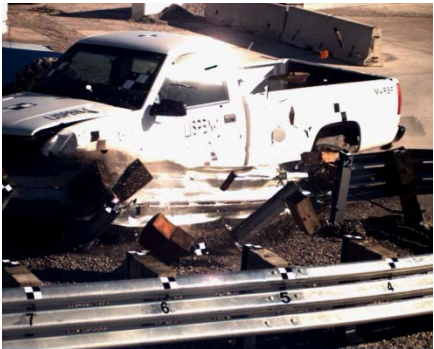
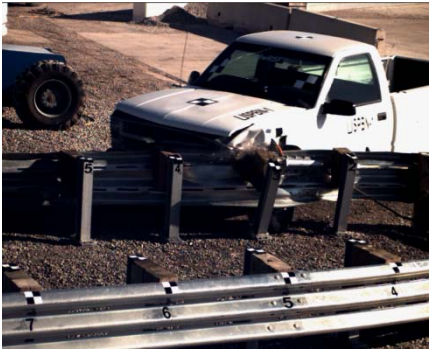
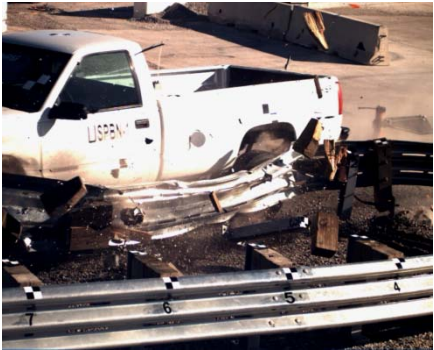
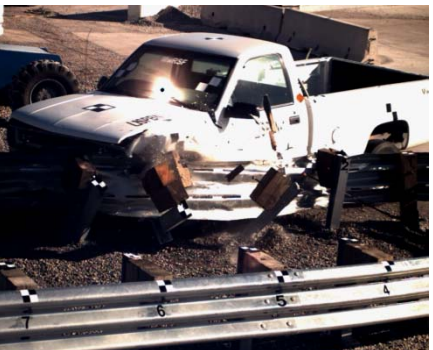
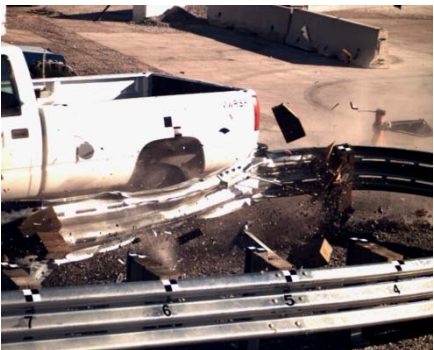
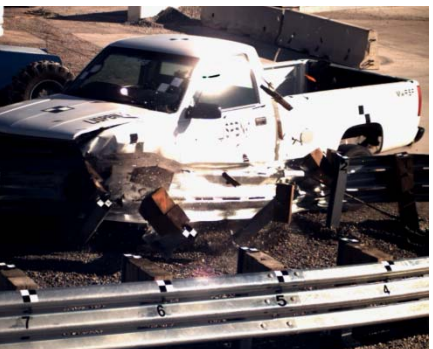
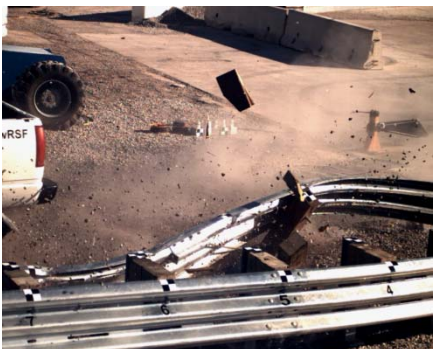
Figure 180. Additional Sequential Photographs, Test USPB-1

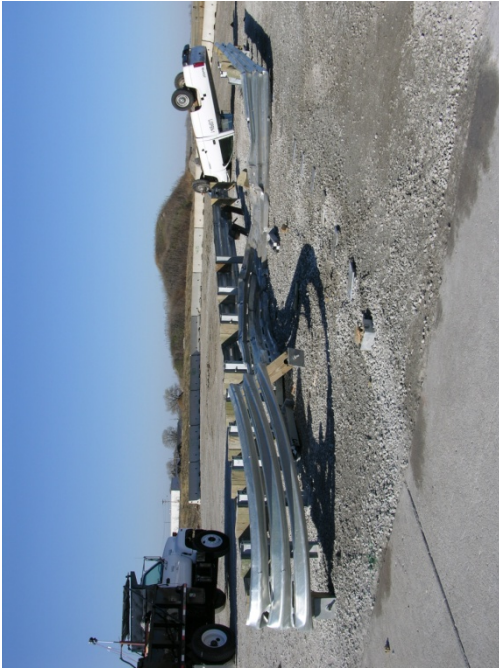
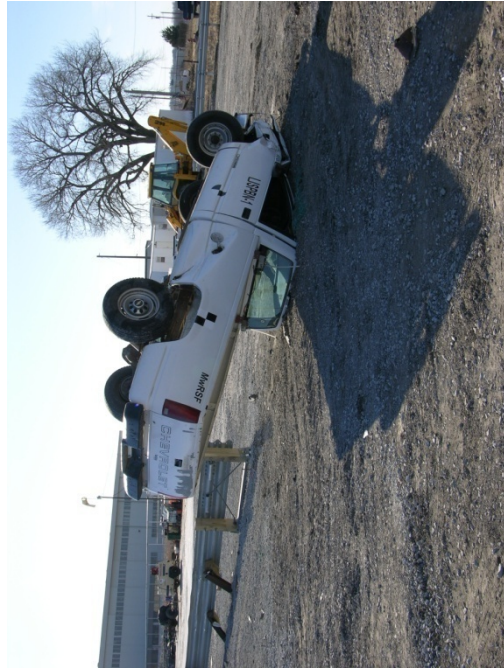
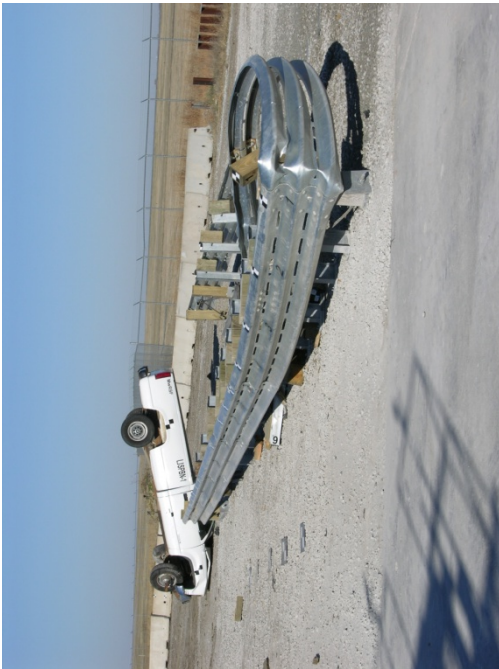
**Figure 182. System Damage and Vehicle Final Position, Test USPBN-1**

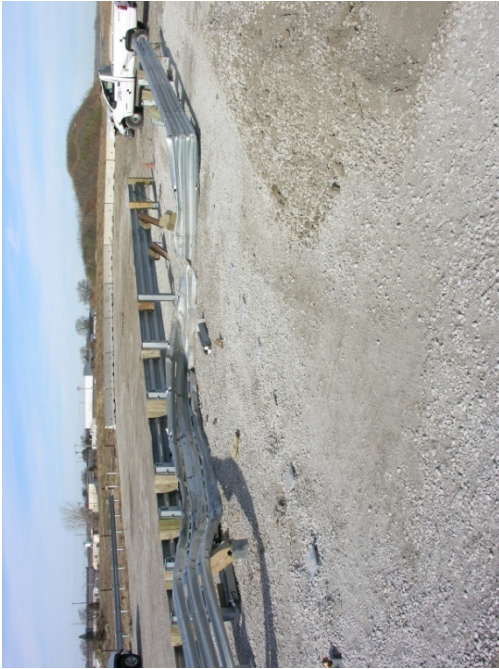
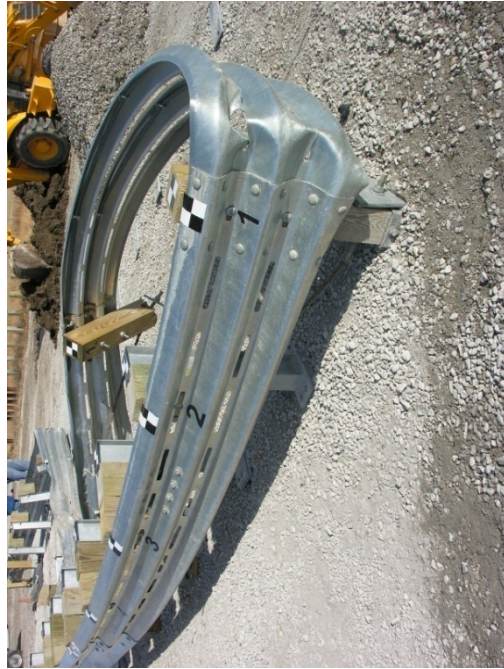
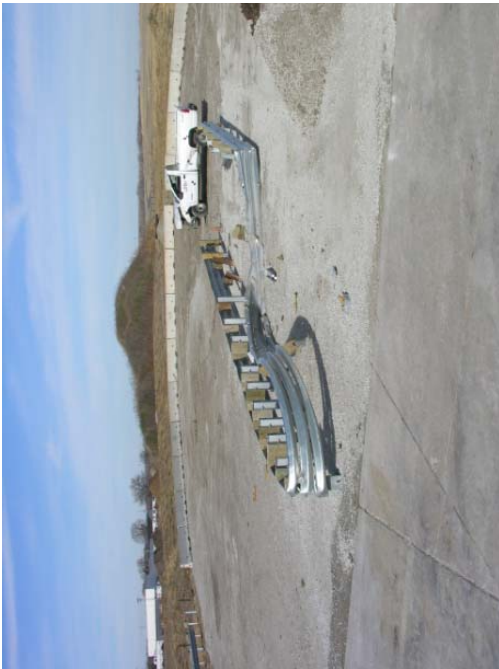
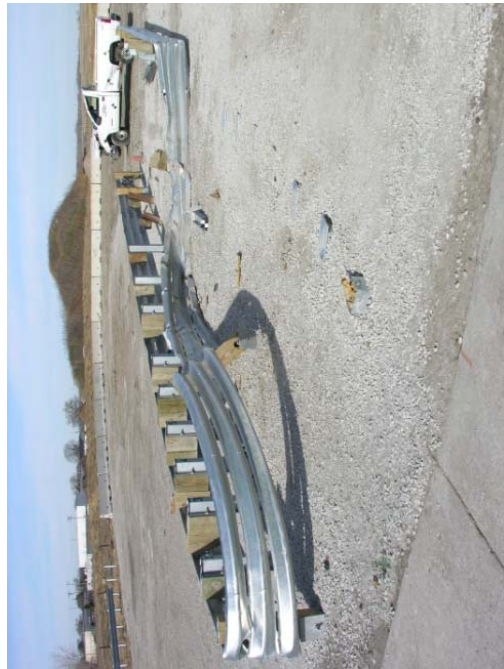
**Figure 183. System Damage, Test USPBN-1**

Barrier damage was extensive, as shown in Figures 183 through 185. Most of the post damage occurred to the right side of the system, or the impact side of the system, Side A. The first eight posts on the right side of the system were fractured and broke away. BCT post no. 1 fractured through the hole at ground level. The universal steel breakaway post nos. 2 through 8 all broke away as the bolts fractured. None of the breakaway posts had any noticeable soil gap except for post no. 2, which had a soil gap of 2 1/2 in. (64 mm). Post nos. 9 and 10 on the right side of the system both bent downstream in the weak axis and were not connected to the thrie beam rail. Post no. 11 was twisted clockwise slightly and was not connected to the rail. Post no.

First, the fracturing bolt posts did not absorb sufficient energy to safely capture and contain the vehicle. The posts broke away quickly and did not rotate much in the soil, which allowed the pickup to penetrate farther into the system. A comparison of the fracture times for the wood and steel posts is provided in Table 25. From this comparison, it appears that the fracturing-bolt, steel posts, except for post no. 2, broke away quicker than the wood counterparts. Second, post no. 2 remained intact significantly longer than the wood counterpart, thus causing the pickup truck to redirect more than that observed in the previous wood-post bullnose testing. Due to these factors, the pickup truck penetrated faster and farther downstream into the system than that observed in previous testing and did not achieve similar lateral penetration, as provided in Table 26. The front end of pickup was not sufficiently captured before contacting the end of the slotted rail near post no. 8. A buckle formed in the non-slotted rail section located near post

no. 9, which caused the rail to buckle toward the ground. This behavior allowed the pickup truck to climb up and over the rail.

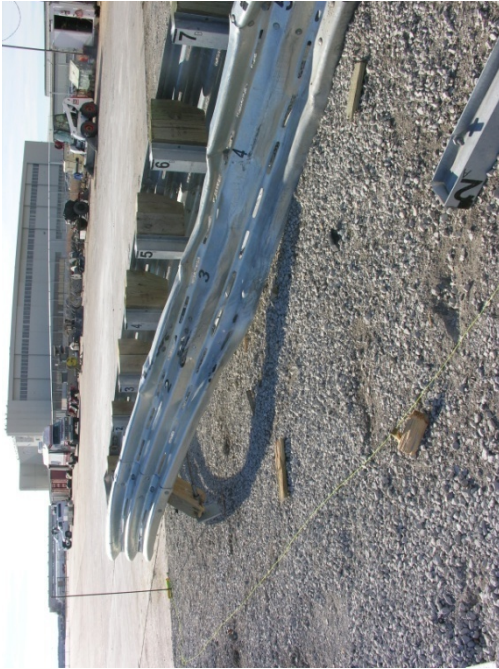
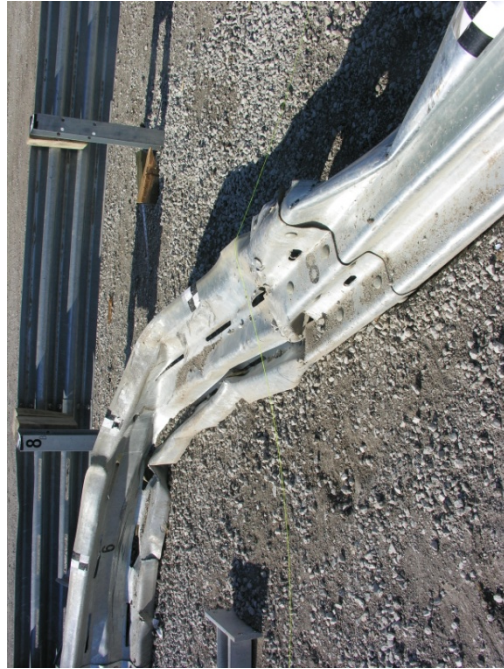
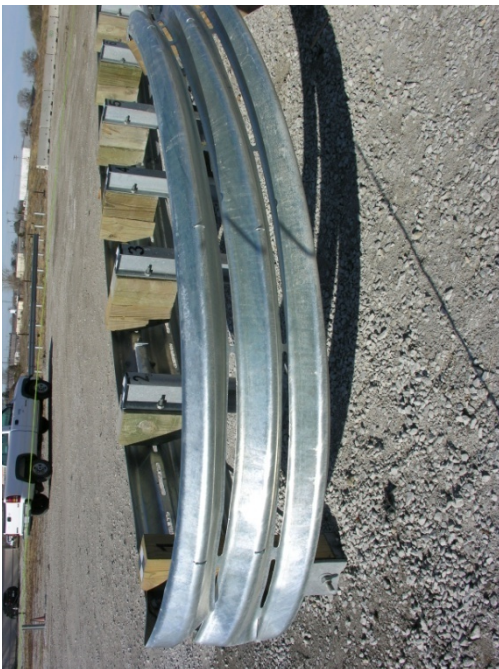
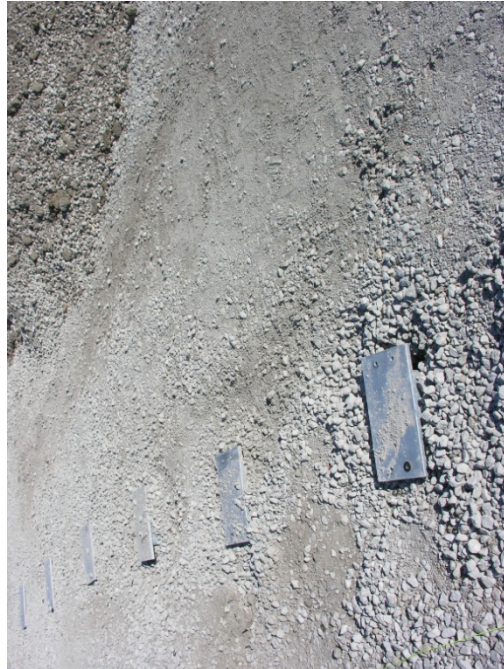
**Figure 184. System Damage, Test USPB-N-1**
