*Midwest State's Regional Pooled Fund Research Program - Fiscal Year 1994
NDOR Research Project Number SPR-3(017)*

DEVELOPMENT AND TESTING OF AN APPROACH GUARDRAIL TRANSITION TO A SINGLE SLOPE CONCRETE MEDIAN BARRIER

*MwRSF Research Report No. TRP-03-47-95
November 1995*

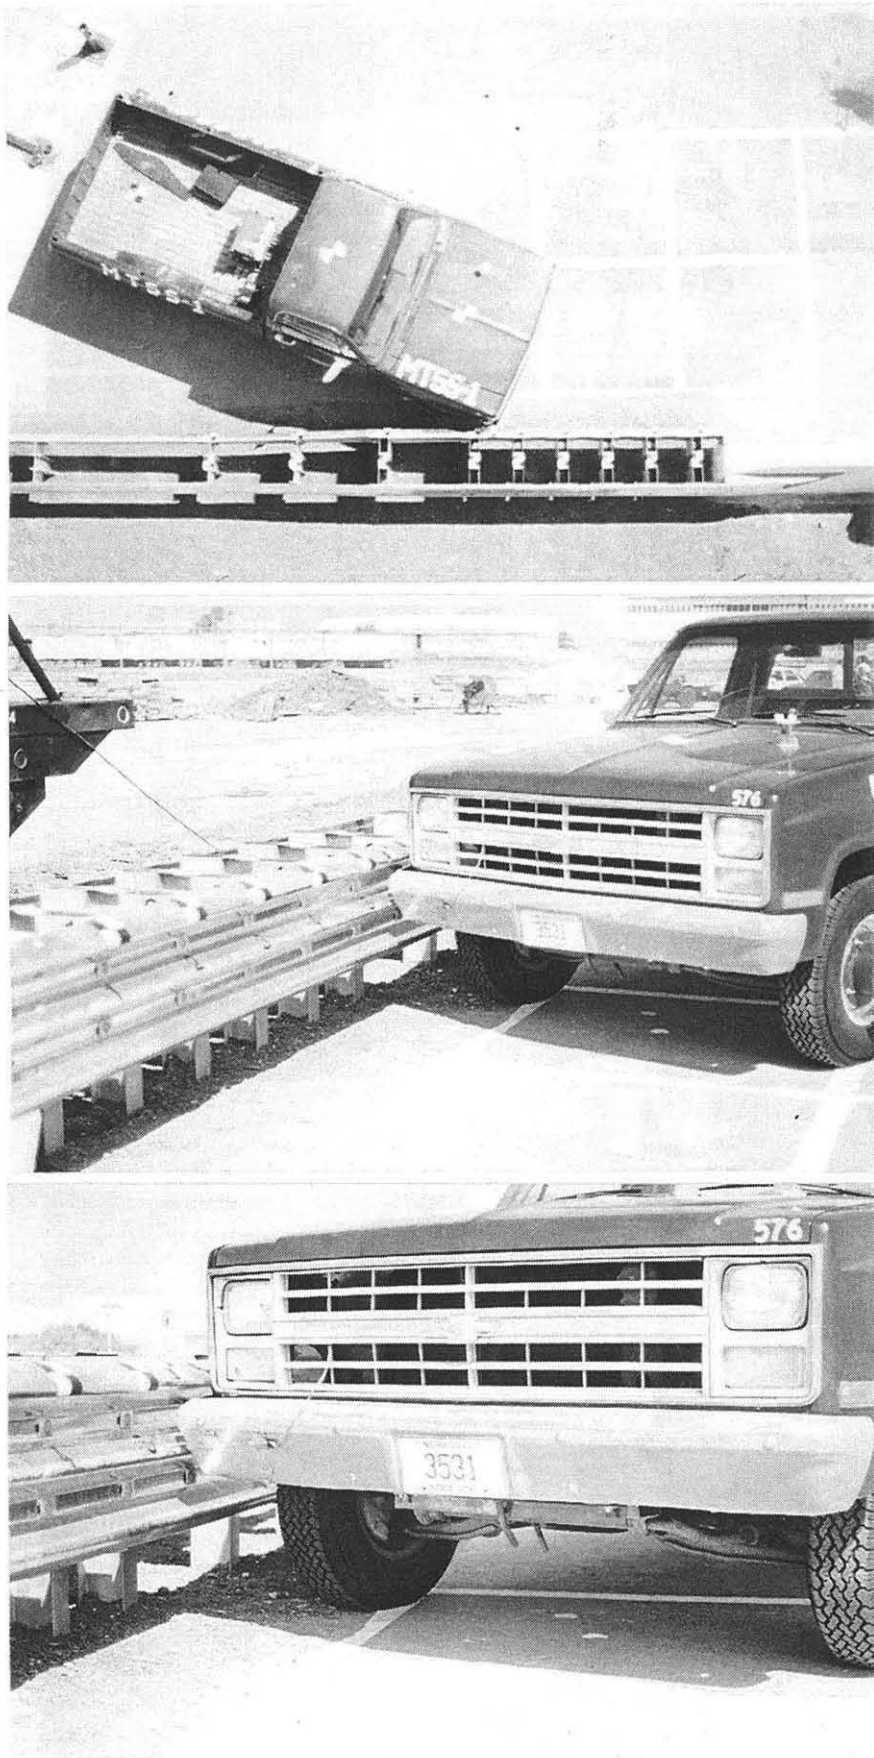
Figure 17. Impact Location, Test MTSS-1

The pickup impacted the approach guardrail transition attached to the single slope CMB approximately 2.44 m (8 ft) from the upstream end of the CMB (Figures 17 and 18). A summary of the test results and the sequential photographs is presented in Figure 19. Additional sequential photographs are shown in Figure 20.

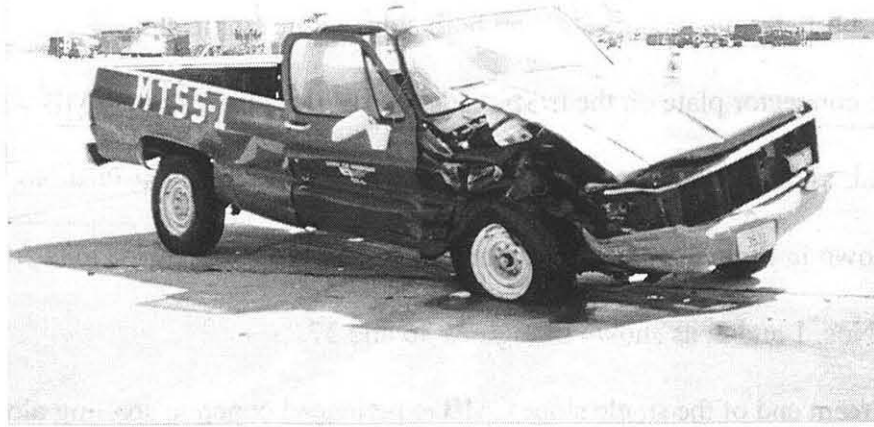
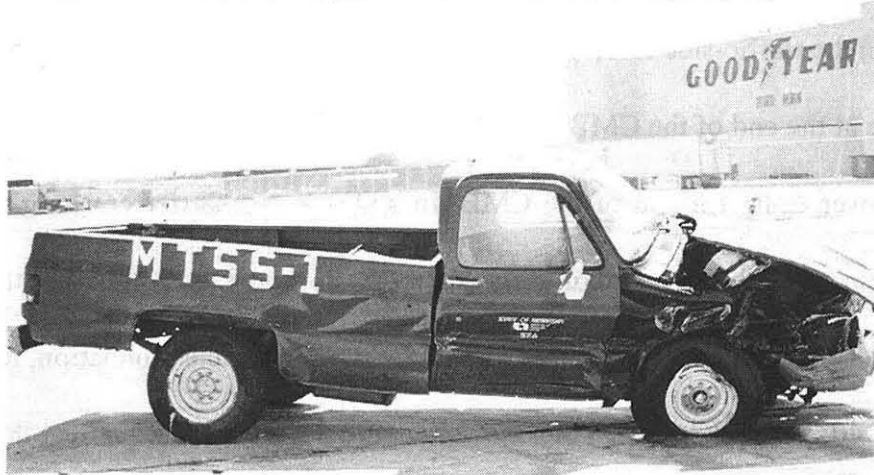
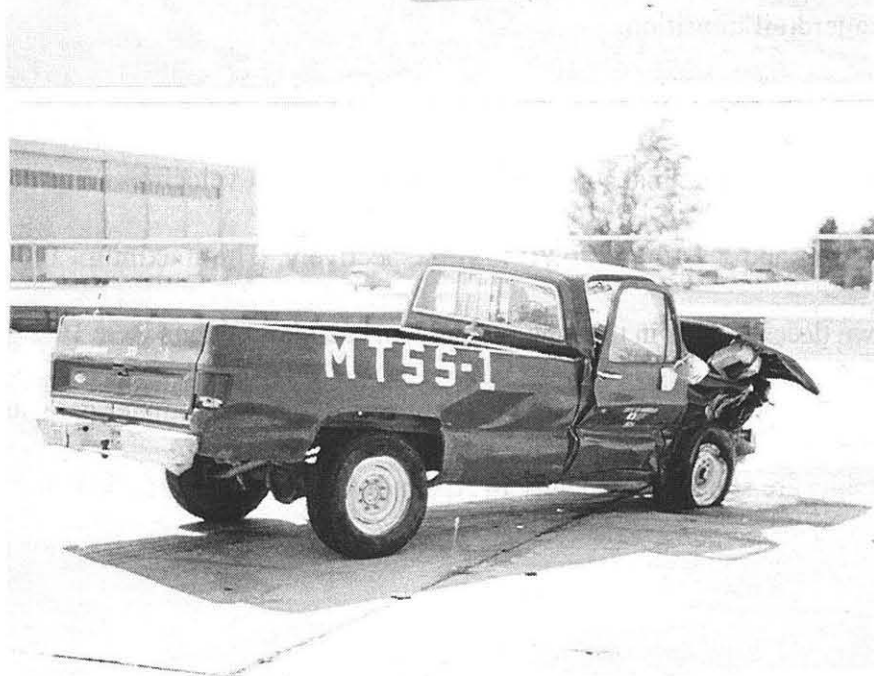
Figure 21. Vehicle Damage, Test MTSS-1

Exterior vehicle damage was extensive and occurred to several body locations, including the right-side door and quarter panels, front and rear bumpers, right-side wheels and rims, engine hood, roof, windshield, occupant compartment, and steel frame, as shown in Figures 21 through 29. The right-side door was severely deformed and had evidence of the vehicle-rail interlock, as shown in Figures 21 and 22. The right-front quarter panel received extensive deformation due to contact with the top of the upstream end of the single slope CMB and vehicle-rail interlock, as shown in Figures 21 and 22. The right-front bumper was crushed inward and deformed over its entire length, as shown in Figure 23. During the impact sequence, the right-front tire was deflated. In addition, the right-front steel rim was deformed due to localized contact with the lower thrie beam corrugation and pushed backward into the engine firewall, as shown in Figure 22. Minor deformation and scrapes were observed on the right-rear steel rim and rear bumper, as shown in Figure 21. Evidence of vehicle-rail interlock occurred over the entire length of the right-side of the pickup box, as shown in Figure 21. Figures 21 through 23 show the deformed engine hood with the right-side attaching hardware fractured. The front windshield was also fractured, as shown in Figures 23 and 24. Figures 25 through 27 show the severe occupant compartment deformation to the right-side and center of the floorboard as well as the transversely buckled and deformed front dashboard. The back vertical wall of the right-side of the truck compartment was also deformed, as shown in Figure 27. The deformation of the floorboard, dashboard, and the truck compartment walls was judged to be sufficient to cause injury to vehicle occupants. Other vehicle damage consisted of slight deformation to the left-front quarter panel. The frame and engine housing were also shifted toward the left, away from the longitudinal center line of the vehicle. Significant vehicle undercarriage damage is shown

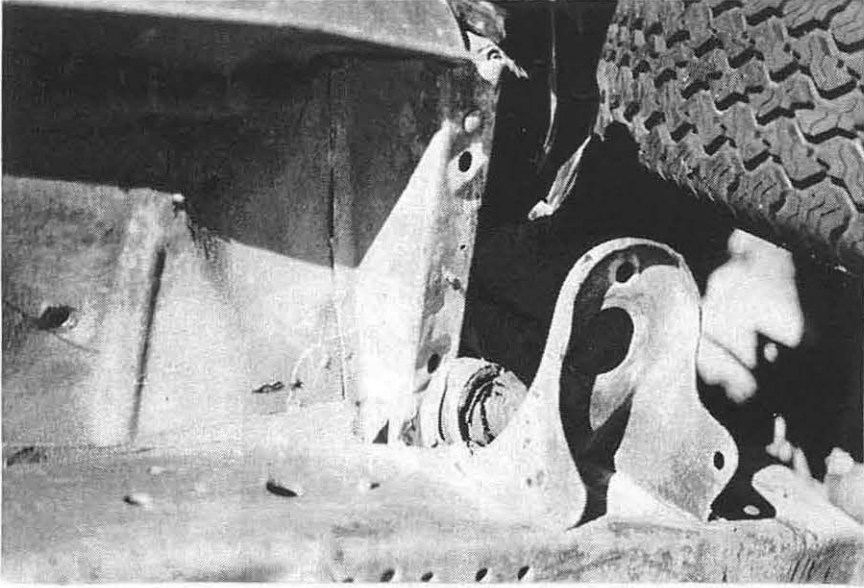
Figure 28. Vehicle Undercarriage Damage, Test MTSS-1

in Figures 28 and 29.

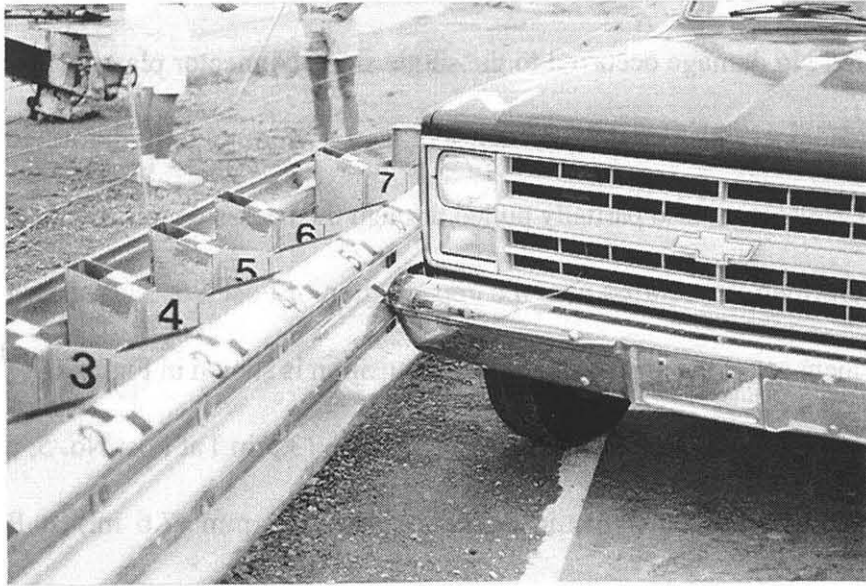
Figure 49. Impact Location, Test MTSS-2

Test MTSS-2 impacted the approach guardrail transition attached to the single slope CMB approximately 3.08 m (10 ft - 1¼ in.) from the upstream end of the CMB (Figures 49 and 50). A summary of the test results and the sequential photographs is presented in Figure 51. Additional sequential photographs are shown in Figure 52. Documentary photographs of the crash test are shown in Figures 53 and 54. It is noted that technical difficulties were encountered near the end of the vehicle tow process, causing the actual impact conditions of 92.5 km/h and 28.7 degrees to deviate slightly from the target impact conditions of 100.0 km/h and 25 degrees. Although the actual impact conditions for test MTSS-2 deviated slightly from the target impact conditions, the actual impact severity (or a measure of the severity of the impact) of 155.5 kJ (114.7 kip-ft) was greater than the nominal impact severity of 138.3 kJ (102.0 kip-ft). Therefore, it was judged that test MTSS-2 was a valid indicator of the barrier's performance. Prior to testing, the CMB and foundation were realigned and compacted on the back-side to prevent foundation movement from occurring during the retest.

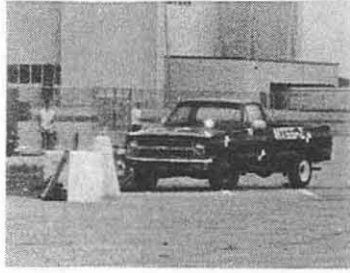
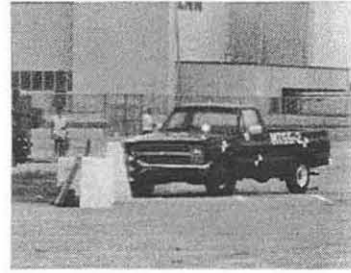
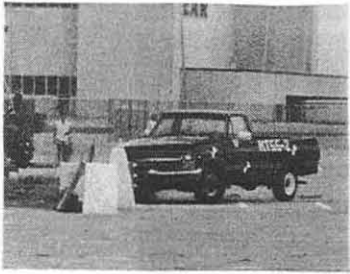
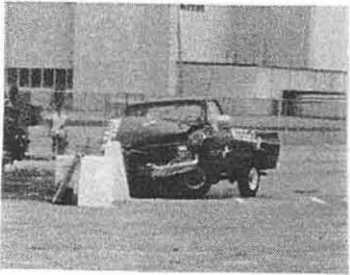
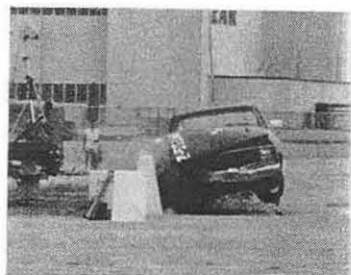
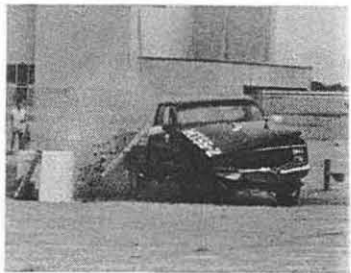
Figure 52. Additional Sequential Photographs, Test MTSS-2

After the initial impact with the approach guardrail transition, the right-front corner of the bumper and quarter panel crushed inward. At 0.040 sec, the right-front corner of the vehicle coincided with Post No. 5, while the grill and hood were disengaged. At 0.062 sec, the right-front corner of the vehicle coincided with Post No. 4, and the left-front wheel started to steer to the right. At 0.083 sec and 0.105 sec, the right-front corner of the vehicle was near Post Nos. 3 and 2, respectively. The maximum dynamic rail deflection of 193 mm (7.6 in) was observed at Post No. 3 at 0.119 sec. At 0.127 sec, the right-front corner of the vehicle was at Post No. 1 and at the

upstream end of the single slope CMB at 0.143 sec. At 0.169 sec and 0.190 sec, the left-front and left-rear wheels lost contact with the ground, respectively. The vehicle became parallel to the transition at 0.298 sec with a velocity of 55.6 km/h (34.6 mph). At 0.324 sec, the right-front corner of the vehicle was at the downstream end of the single slope CMB. At 0.427 sec, the rear-end of the vehicle was at the upstream end of the CMB. The vehicle exited the system at approximately 0.456 sec after impact at a speed of 54.7 km/h (34.0 mph) and an angle of 9.8 degrees. The vehicle's post test trajectory is shown in Figure 51. The vehicle came to rest approximately 23.8 m (78 ft) downstream from impact and 5.5 m (18 ft) laterally in front of a line projected parallel to the traffic-side face of the rail.

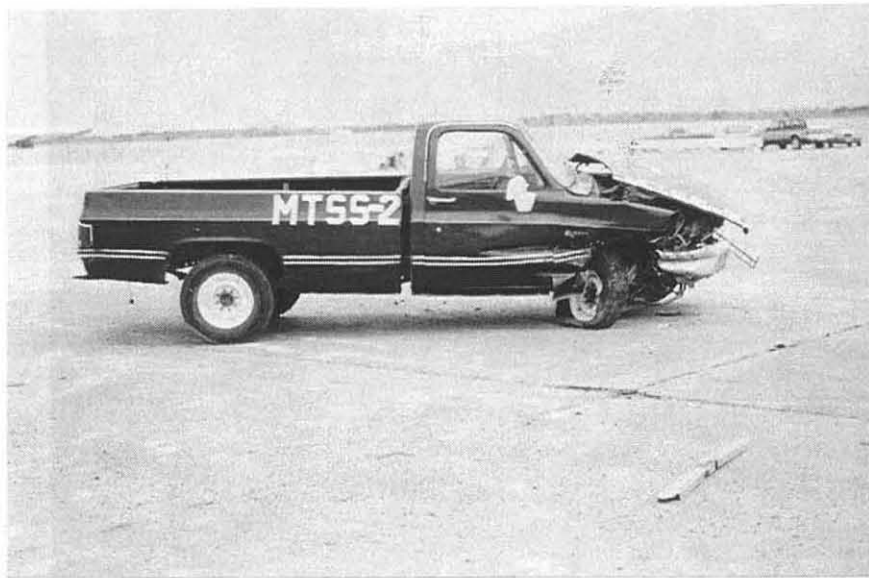
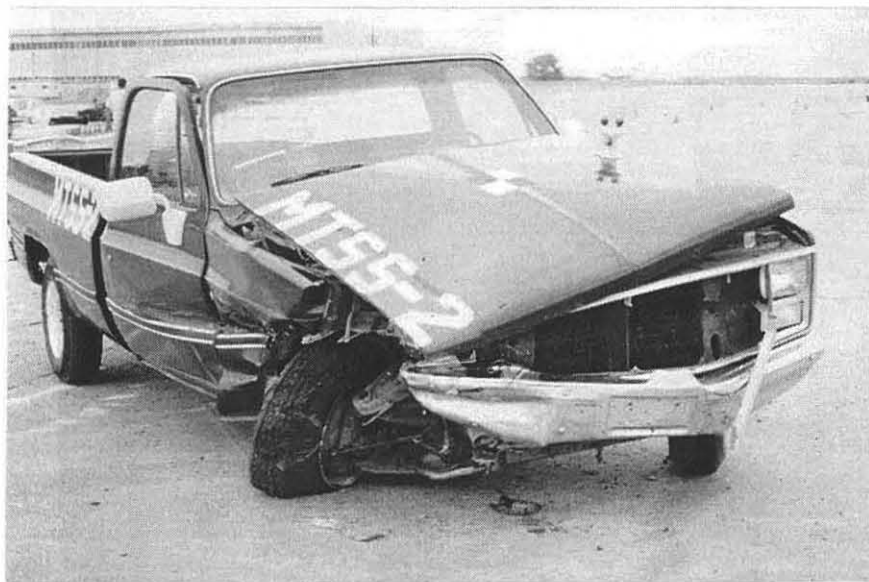
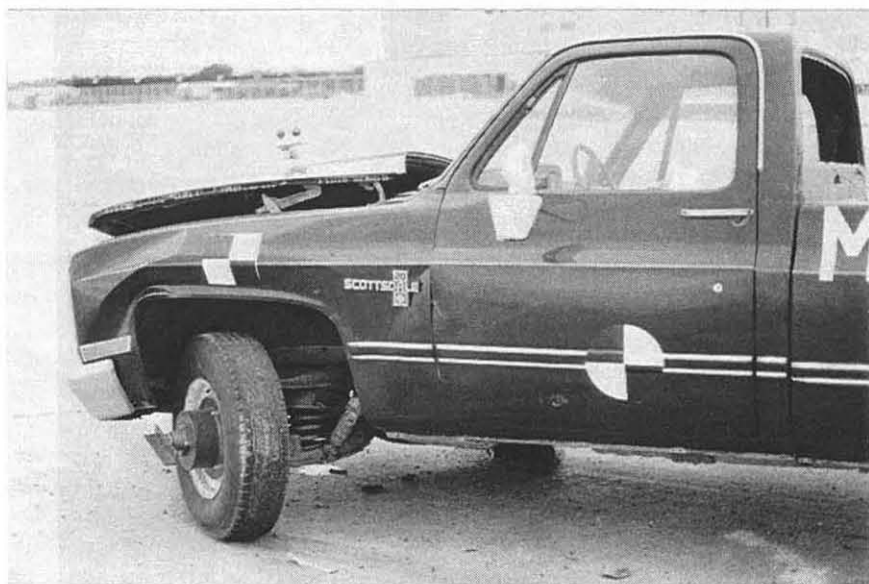
Figure 55. Vehicle Damage, Test MTSS-2

Vehicle damage was moderate and occurred to several body locations, including the right-side door and quarter panels, front and rear bumpers, right-front wheel and rim, engine hood, windshield, occupant compartment, and steel frame, as shown in Figures 55 through 60. The right-side door was deformed and has evidence of the vehicle-rail interlock, as shown in Figures 55 and 56. The right-front quarter panel received deformation due to contact with the top of the spacer blocks and/or posts and vehicle-rail interlock, as shown in Figures 55 and 56. The right-front bumper was crushed inward, and the center bumper region was buckled, as shown in Figure 55. During the impact sequence, the right-front tire was deflated and the rim was deformed due to localized contact with the lower thrie beam corrugation and pushed backward into the engine firewall, as shown in Figures 55 and 56. Minor deformation was observed at the right-rear corner of the rear bumper, and no damage occurred to the right-rear wheel, as shown in Figures 55 and 56. Evidence of vehicle-rail interlock occurred at the rear end of the right-side of the pickup box, as shown in Figure 55. Figure

55 shows the deformed hood with the right-side and the left-side attaching hardware fractured and deformed, respectively. The front windshield was also slightly cracked, as shown in Figures 55 and 57. Figure 57 shows the minor occupant compartment deformation to the right-side and center of the floorboard. No deformation or buckling occurred to the front dashboard or the back vertical wall of the truck cab. The deformation of the floorboard, was not judged to be sufficient to cause injury to vehicle occupants. Other vehicle damage consisted of slight deformation to the left-front quarter panel and to the front of the left-side door, as shown in Figure 55. The frame and engine housing were also shifted toward the left, away from the longitudinal centerline of the vehicle, as shown in Figure 58. Moderate vehicle undercarriage damage is shown in Figures 59 and 60.

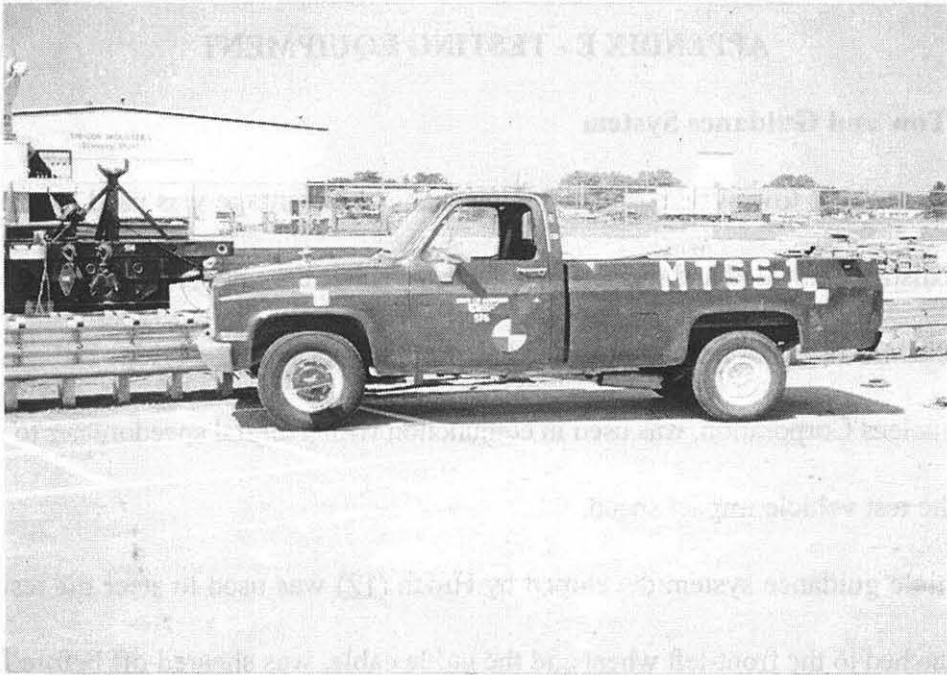
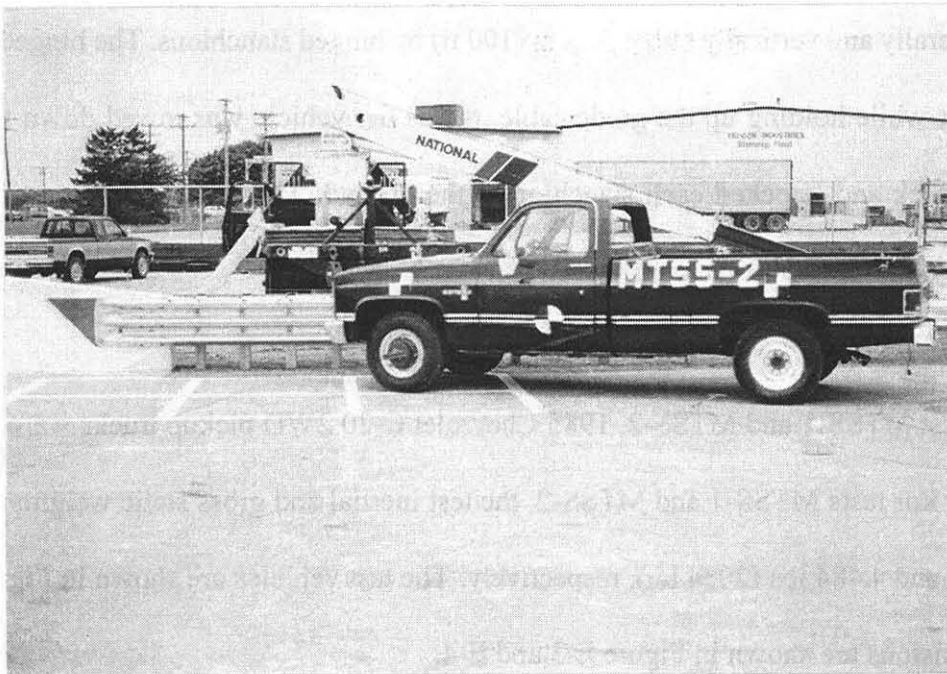
Figure E-1. Test Vehicles, MTSS-1 and MTSS-2

For test MTSS-1 and MTSS-2, 1985 Chevrolet C-20 2WD pickup trucks were used as the test vehicles. For tests MTSS-1 and MTSS-2, the test inertial and gross static weights were 4,504 lbs (2043 kg) and 4,484 lbs (2034 kg), respectively. The test vehicles are shown in Figure E-1 and vehicle dimensions are shown in Figure E-3 and E-4.
