Midwest Guardrail System Without Blockouts

Transportation Research Board

92nd Annual Meeting
January 13-17, 2013
Washington, D.C.

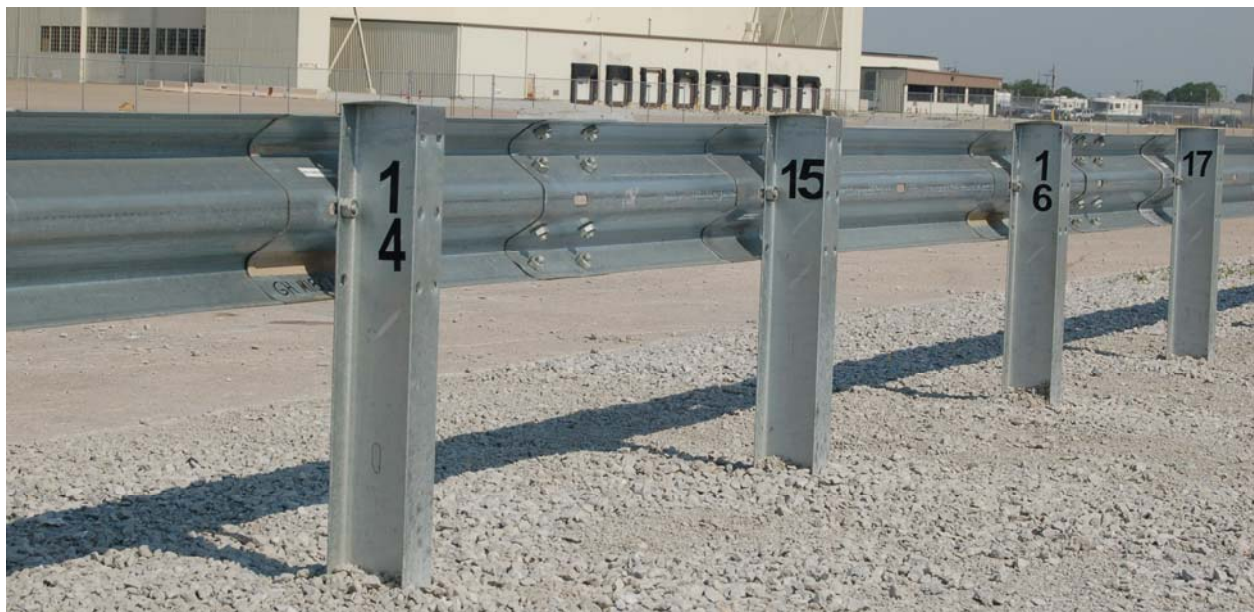
FIGURE 1 System Layout

The standard MGS formed the basis for the barrier system. However, the MGS was modified by removing the 12-in. (305-mm) deep wood spacer blocks and incorporating W-beam backup plates. The test installation consisted of 181 ft-3 in. (55.25 m) of standard 12-gauge (2.66-mm thick) W-beam supported by steel posts. Complete design details as well as the results of the testing are provided in MwRSF report TRP-03-262-12 [15]. System layouts of the tested systems are shown in Figure 1.

The system was constructed with twenty-nine guardrail posts spaced 75 in. (1,905 mm) on center. Post nos. 3 through 27 were galvanized ASTM A992 steel W6x8.5 (W152x12.6) sections measuring 6 ft (1.8 m) long with a soil embedment depth of 40 in. (1,016 mm). Post nos. 1, 2, 28, and 29 were breakaway cable terminal (BCT) timber posts measuring 5½ in. wide x 7½ in. deep x 46 in. long (140 mm x 191 mm x 1,168 mm) and were placed in 6-ft (1.8-m) long foundation tubes. All posts were placed in a compacted coarse, crushed limestone material as recommended in MASH.

Rail splices were placed at the midspan locations between guardrail posts. All lap splice connections between the rail sections were configured with the upstream segment in front to reduce vehicle snag at the splice during the crash test. For post nos. 3 through 27, 12-in. (305-mm) long, 12-gauge (2.66-mm thick) W-beam backup plates were located between the rail and the front face of the steel posts. Anchorage systems similar to those used on tangent guardrail terminals were utilized on both the upstream and downstream ends of the guardrail system.

The mounting height of the W-beam was test dependent. For the pickup test, MGSNB-1, the top mounting height was 31 in. (787 mm) above ground with a 24⅞ in. (632-mm) center mounting height. While for the small car test, MGSNB-2, the rail was raised 1 in. (25 mm) such that the height to the top of the guardrail was 32 in. (813 mm). The rail was attached to the posts using ASTM A307 5/8" x 1½" [M16x38] long guardrail bolts and nuts.

During MGSNB-1 and MGSNB-2, the locations of the post bolts were varied within the rail slots in order to investigate rail release away from the posts, as indicated in Figure 1 and shown in Figure 9. Post 15 was determined to be the most likely worst case scenario if the rail did not release from the post during impact. As a result, the post bolt was located at the downstream end of the rail slot. For both the pickup and small car tests, the guardrail detached from post 15 as the bolt head was pulled through the rail. Slight tearing of the rail was evident around the rail bolt hole, but not of significance to cause concern for rail rupture. Video analysis also showed that the release of the rail occurred considerably before the post could pull the rail down as the posts rotated in the soil.

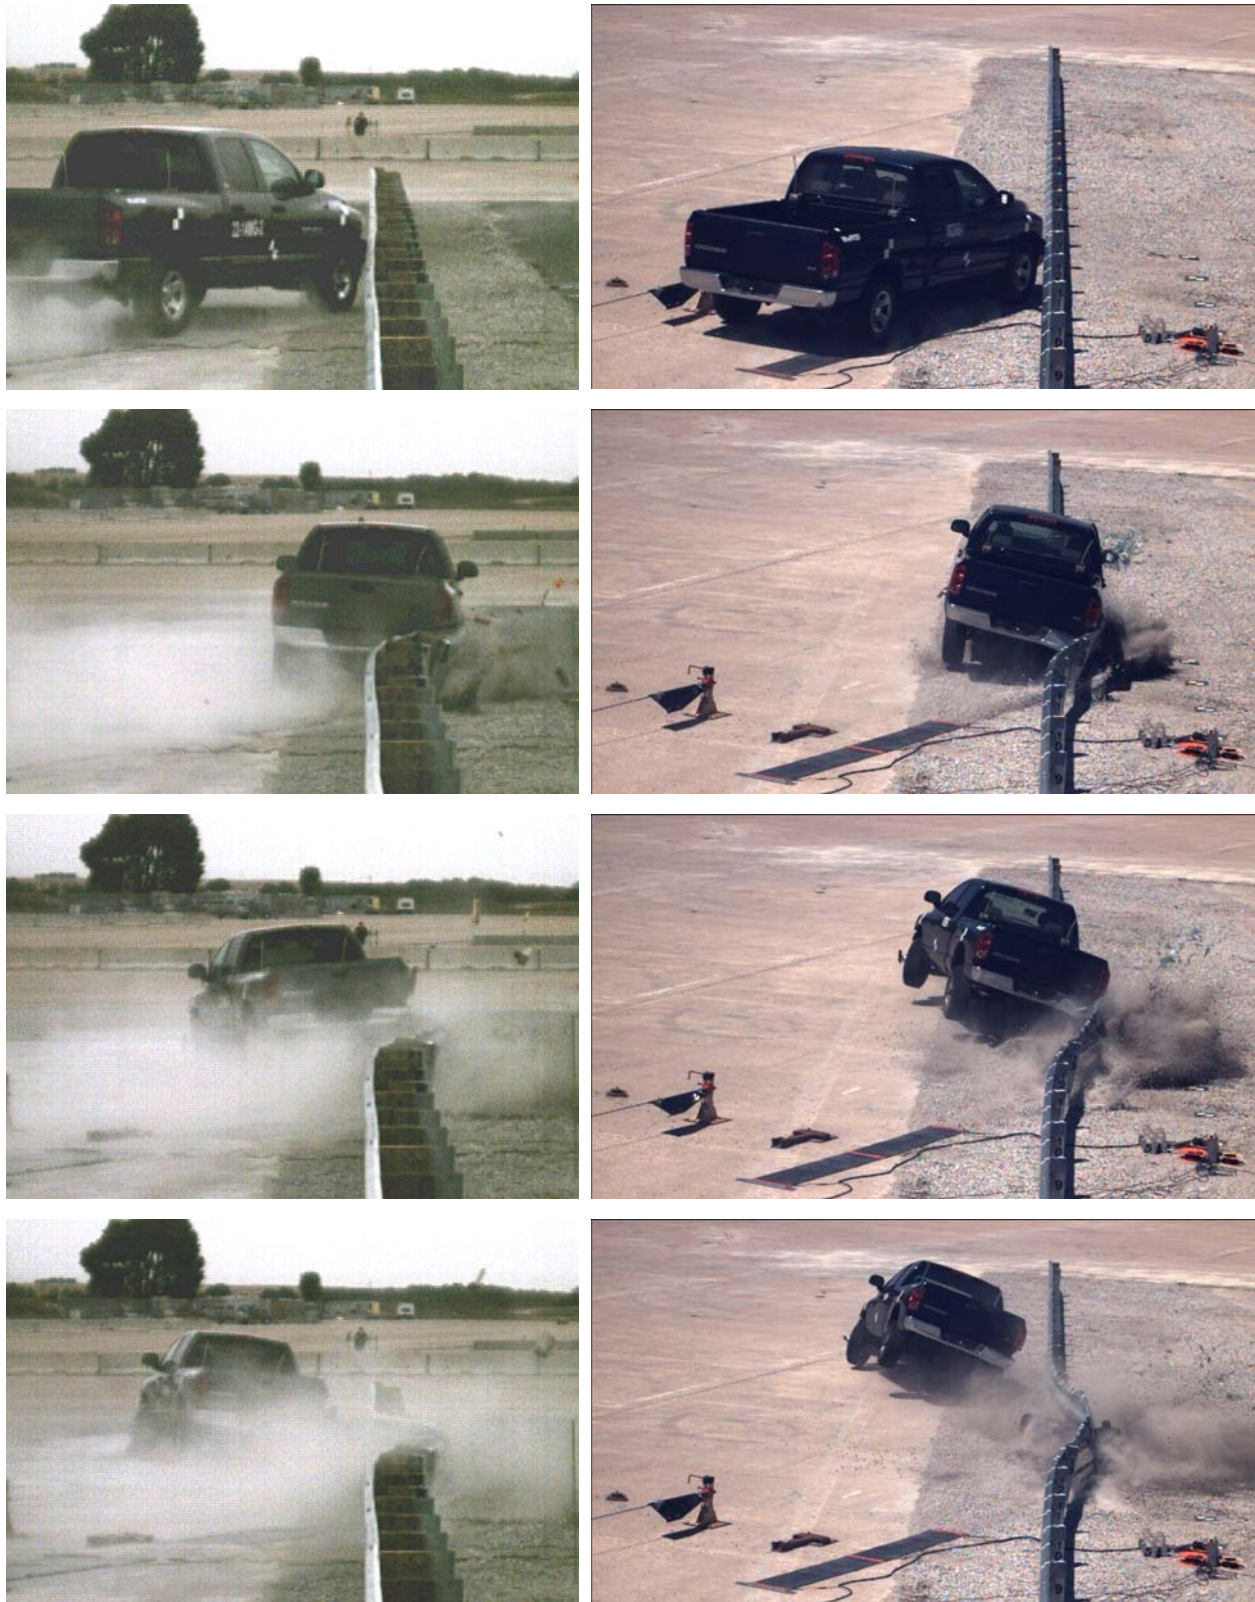
FIGURE 4 Rear View of 2270p Truck Tests – 2214MG-2 (left) and MGSNB-1 (right)

A comparison between the blocked and non-blocked MGS for both the 2270p truck and 1100c small car is presented in Table 1. Rear view sequentials for the 2270p and 1100c tests are shown in Figures 4 and 5, respectively. Barrier damage and vehicle damage are shown in Figures 6 and 7, respectively. Longitudinal and lateral change in velocity plots are shown in Figure 8.

For the 2270p vehicle, the non-blocked test when compared to the blocked test had significantly reduced rail deflections, a roll into the barrier as opposed to away from the barrier, fewer posts detached from the rail, and fewer posts snagged by the tire. The occupant ridedown decelerations (ORD) and occupant impact velocity's (OIV) were, percentage wise, much higher for the non-blocked system; these differences are also somewhat evident by examining the change in velocity plots. However, the occupant risk measures for both systems were small enough to not cause undue concern. In general, the blocked MGS had higher rail deflections and lower occupant risk numbers.

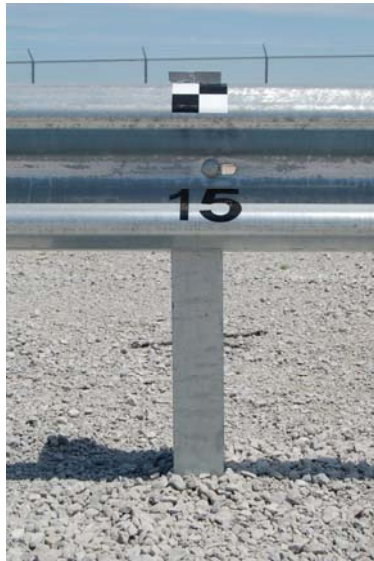
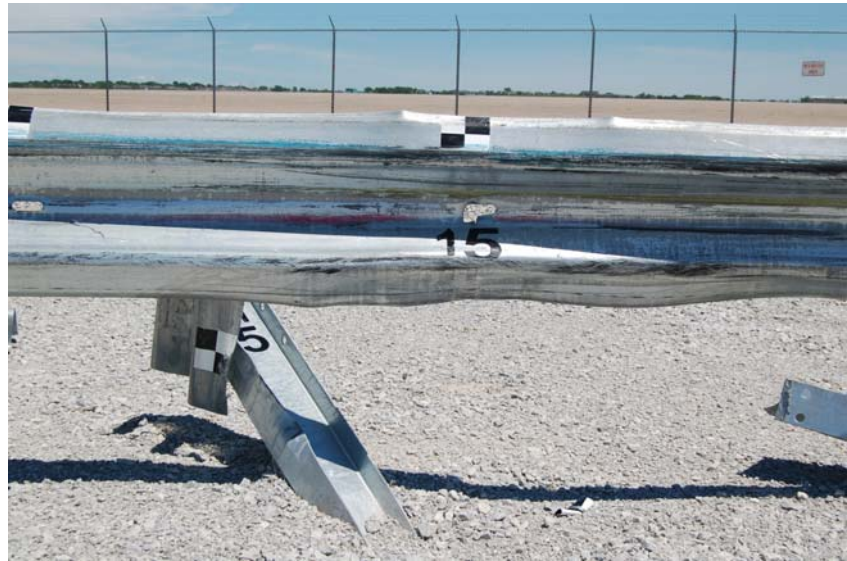
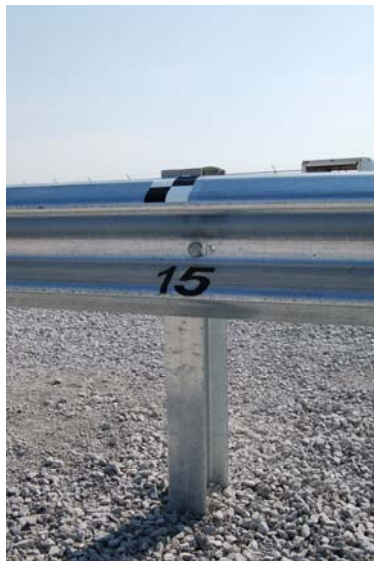
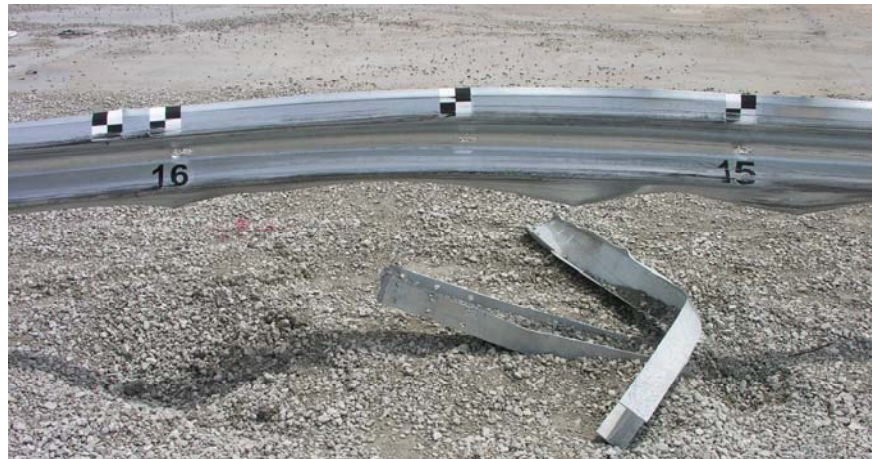
FIGURE 9 Bolt Located in Worst Case Location – Pull-Through Behavior Still Occurred

Further, for both tests, the post bolt at post 16 was initially in the center of the slot. For the truck test, MGSNB-1, post 16 rotated in the soil, the rail did not release from the post, and the tire did not snag on the post. Although in the impact zone, release of the rail for this post was not required for good redirection performance. For the small car test, MGSNB-2, the rail slipped along the bolt, causing the bolt to butt up against the end of the slot. The bolt head was then pulled through the rail in a timely manner, this time without any tearing of the rail around the bolt hole.

(a) MGSNB-1 (2270p, non-blocked)

(b) MGSNB-2 (1100c, non-blocked)

In order to prevent the rail from being pulled down as a post rotates in the soil, as well as a possible vehicle override of the barrier during an impact event, the rail may need to detach away from the post. Fortunately, it has been shown that the bolt attachment mechanism used for the MGS, the same one used for standard W-beam guardrail systems for several decades, provides for satisfactory rail detachment.

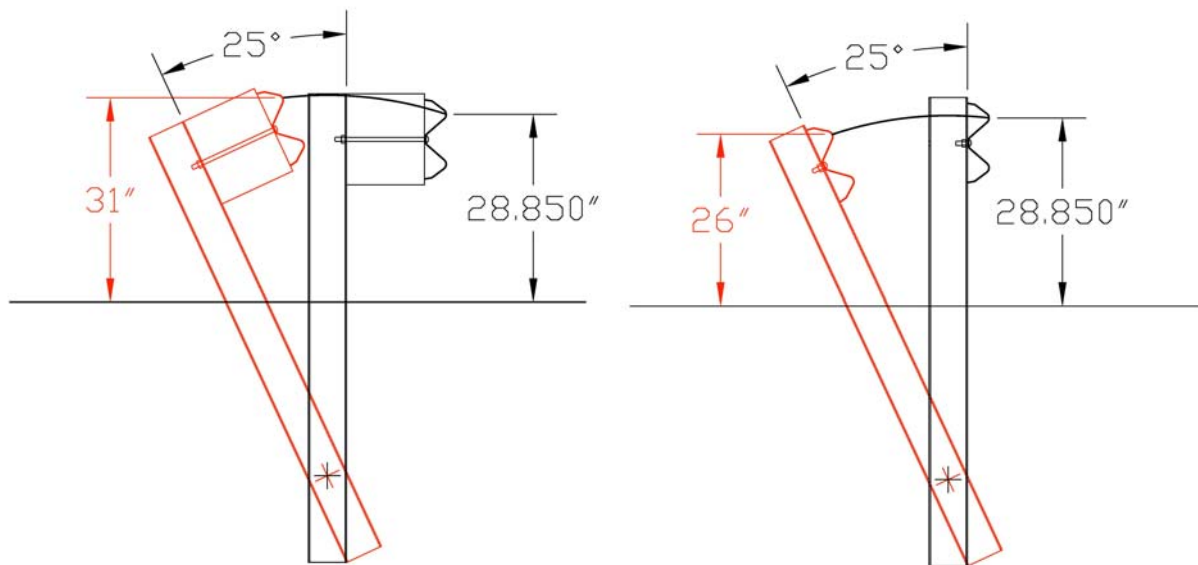
FIGURE 10 Post/Rail Rotation During Impact - Blockout Holds Rail Up

The 31-in. mounting height is only one component which contributes to the enhanced performance of the MGS. It is well acknowledged that blockouts serve two primary purposes in the strong-post system. The first, and most important, is causing the rail to rise during an impact. As illustrated in Figure 10, during an impact, the rotation of the posts in conjunction with the blockout causes the rail to rise in the MGS (as well as in Standard W-Beam Guardrail Systems). This is not the case for the 31-in. W-Beam Guardrail System without blockouts; where the rail immediately begins to drop as the post rotates in the soil. The deeper blockout on the MGS has significantly improved performance in concert with the increased mounting height.

As indicated by the successful crash testing, this does not mean that the non-blocked MGS system is unsafe. Even though the rail is dropping upon post rotation in the non-blocked system, it is not dropping below a critical height during the initial 25 degrees of rotation. In fact, the rail of the 31-in. height MGS with no blockout after 25 degrees of rotation is approximately at the initial height of standard metric W-beam guardrail system. Post-in-soil rotation of 25 degrees is considered a reasonable amount for absorbing a significant amount of energy of the impacting vehicle. However, the larger blockout depth clearly increases the effective guardrail height.

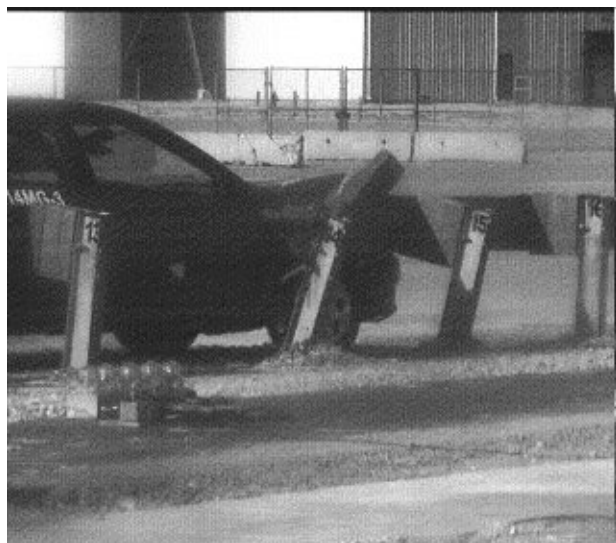
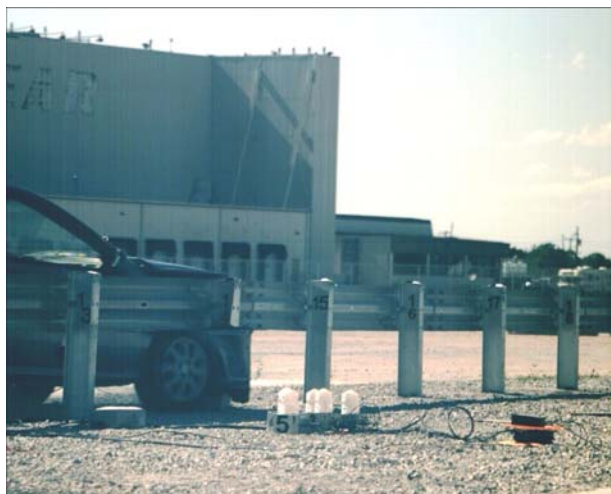
FIGURE 11 1100c Crash Tests at Post 14 – Blockout Reduces Wheel Snag

A significant wheel snag occurred at post 14 during test MGSNB-2 which did not occur during test 2214MG-3, as shown in Figure 11. Initial impact for both tests was just upstream of post 13, and each vehicle easily cleared post 13 without tire-post overlap. The wheel snag at post 14 during MGSNB-1 was the cause for the relatively abrupt change in longitudinal velocity (see Figure 8), as well as the relatively high OIV compared to the blocked test, 2214MG-3 (31.3 ft/s versus 14.8 ft/s). It also helped pull post 14 out-of-the-ground as well as helped disengage the tire/wheel during the test.

2214MG-3 – Blocked

MGSNB-2 – Non-Blocked

The second function of the blockout is to keep vehicles away from the posts, thus reducing both the potential for wheel snag and the amount of wheel snag if it were to occur. Although in all of the testing of the MGS and its' variations over the past decade, wheel snag has never proven to be a problem. However, it is prudent to avoid unnecessary impacts of major components. While our surrogate test vehicles may function without blockouts, many other vehicles on the road may suffer degraded performance when interacting with a no-blockout system.
