Test Level 4 Evaluation of the Minnesota Combination Bridge Rail

TRANSPORTATION RESEARCH REPORT TRP-03-53-96

Midwest Roadside Safety Facility (MwRSF)
Center for Infrastructure Research
Civil Engineering Department
University of Nebraska-Lincoln
1901 Y Street, Building C
Lincoln, Nebraska 68588-0601

March 1996

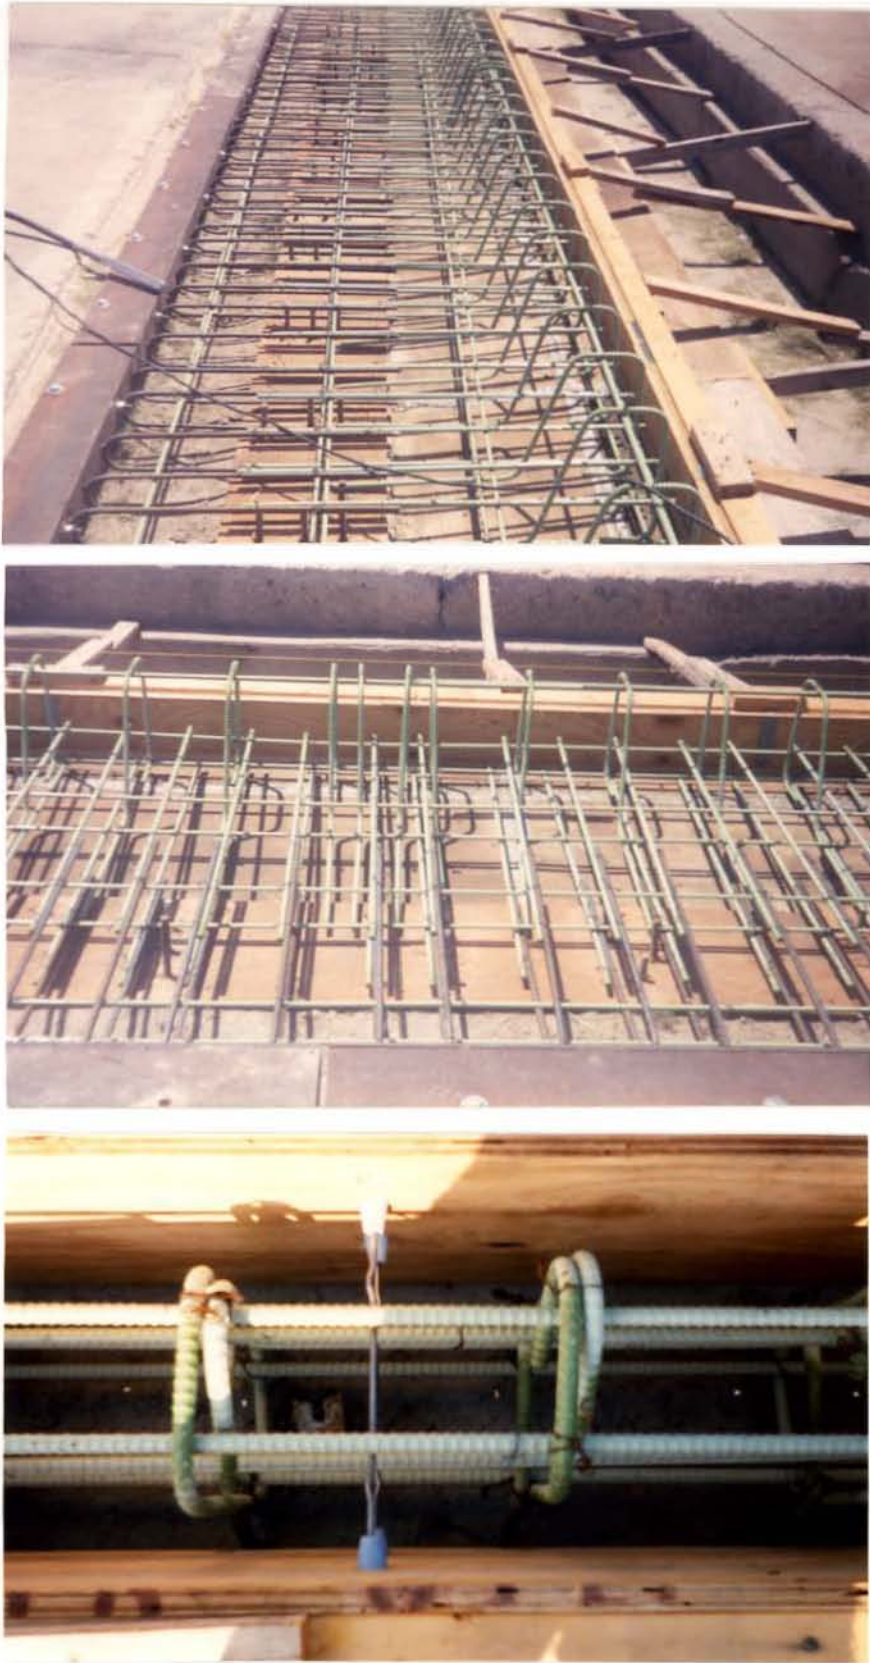
Figure 4. Reinforcement layout for bridge deck and parapet.

Detailed drawings of the Minnesota Combination Bridge Rail as it was installed for tests MN-1 and MN-2 are shown in Figures 1 and 2. The overall layout of the tested system is shown in Figure 3. Photographs taken during the construction of the deck and concrete parapet are shown in

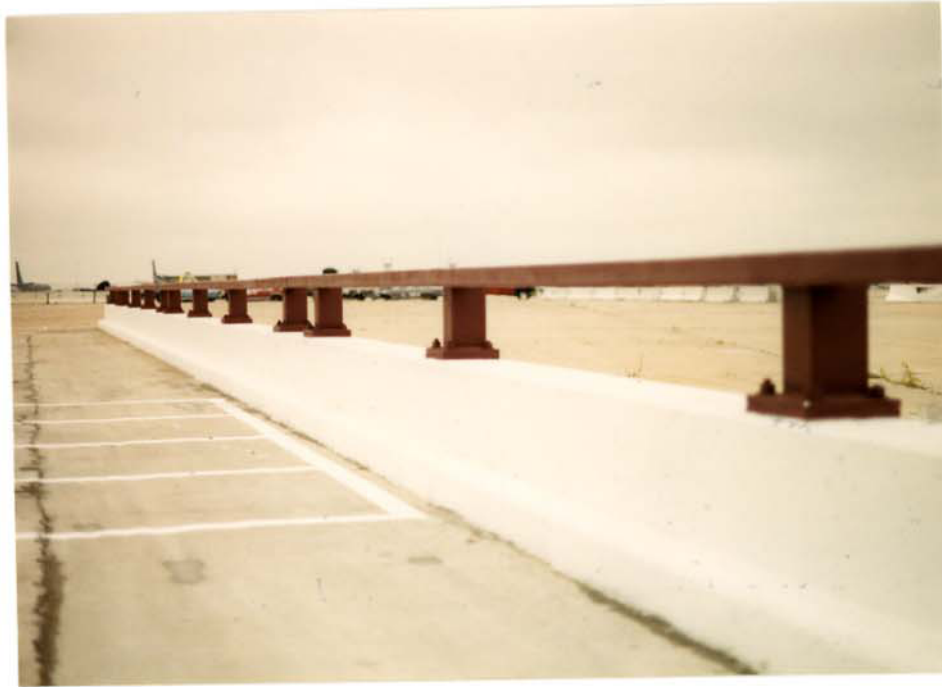
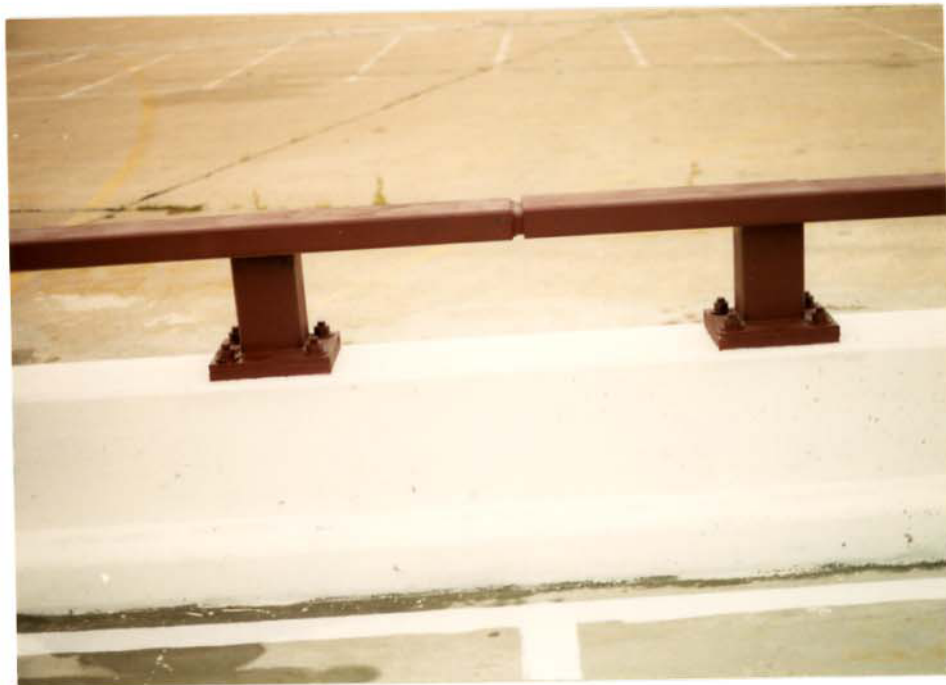
Figure 5. The Minnesota Combination Bridge Rail.

Figure 4, and photographs of the completed installation are shown in Figure 5.

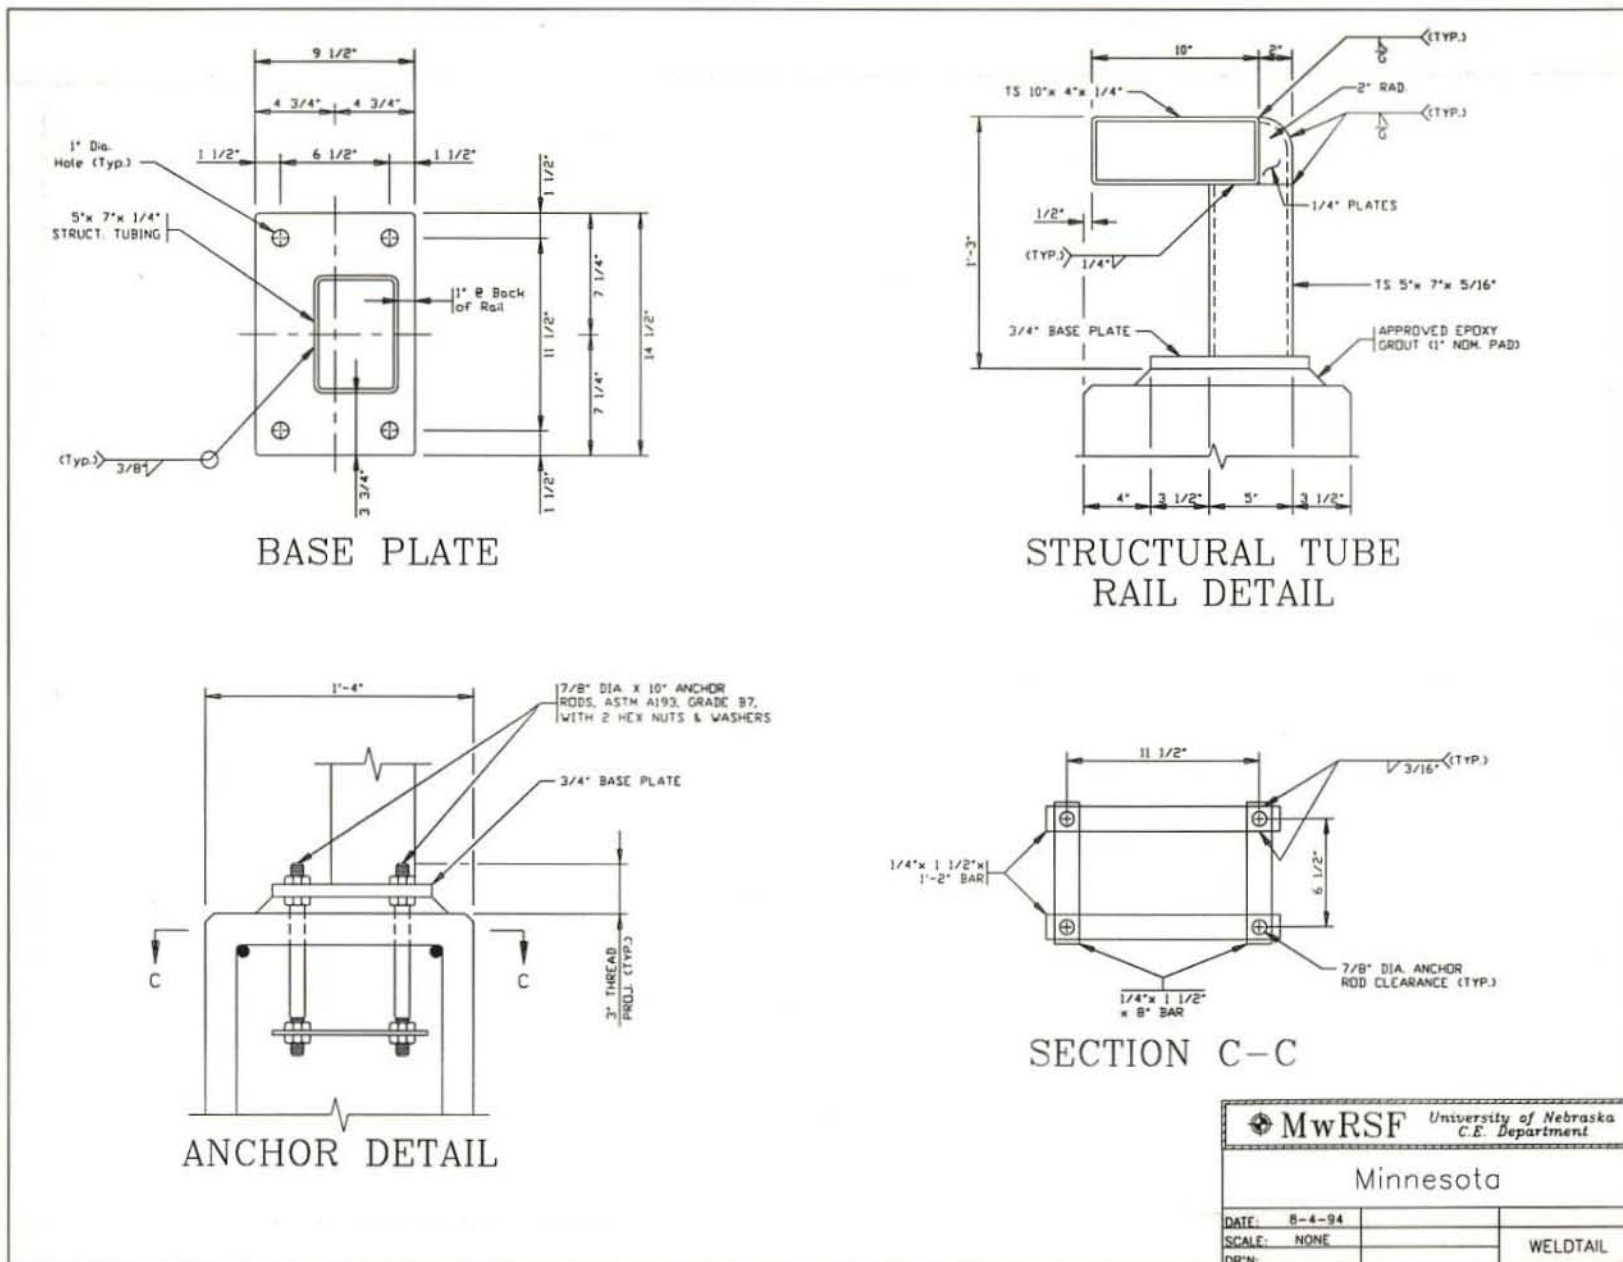
Figure 9. Minnesota Combination Bridge Rail Details, Design No. 3.

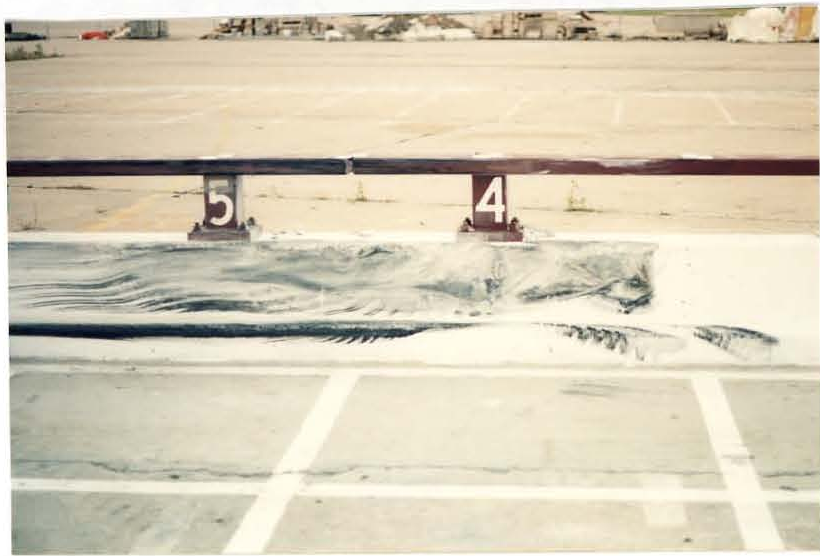
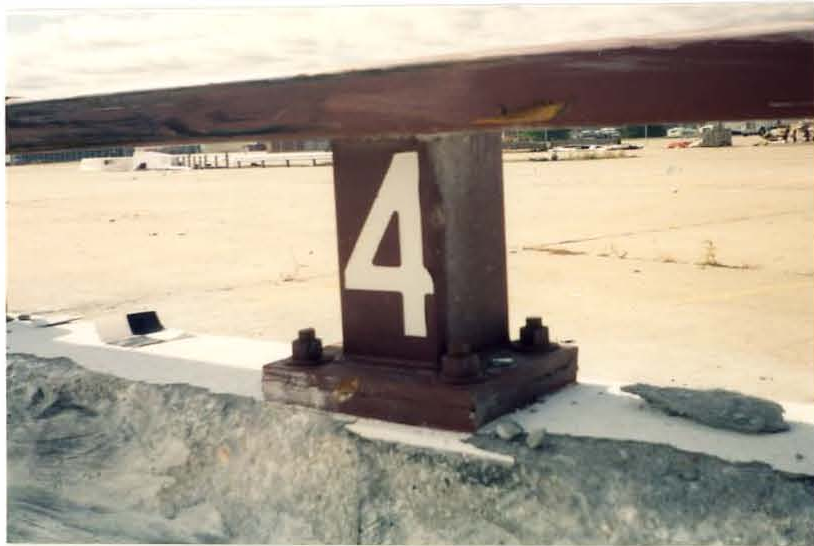
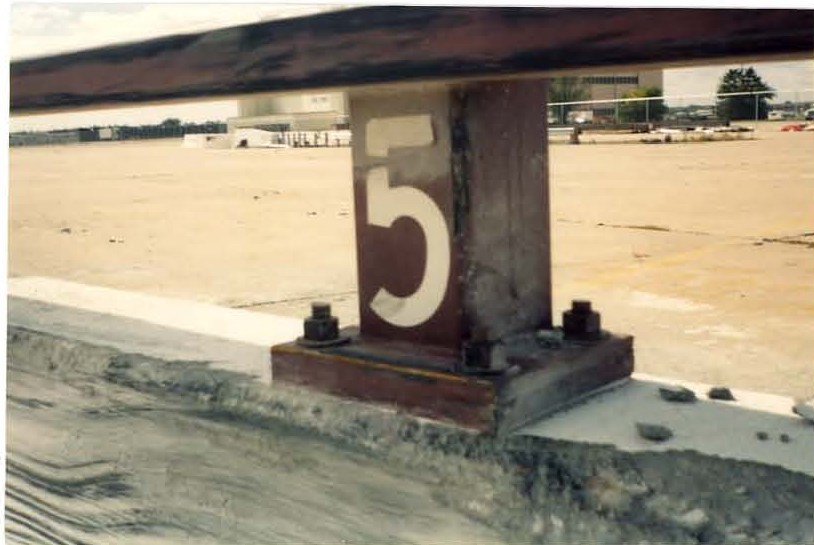
Damage to the bridge rail included tire marks, as well as concrete gouging and spalling along the length of the concrete curb and parapet. Damage to the steel rail and posts included scrapes and gouges along the rail and posts, as well as a maximum permanent set deformation of 5/16 in. (8 mm) in the lateral direction, and 1/2 in. (13 mm) downward. This damage is shown in Figure 15.

Figure 15. Bridge Rail Damage, Test MN-1.

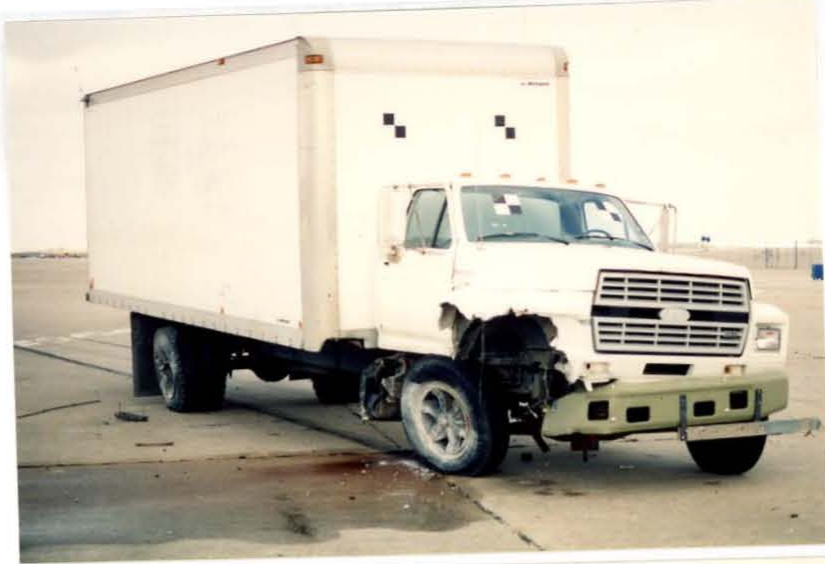
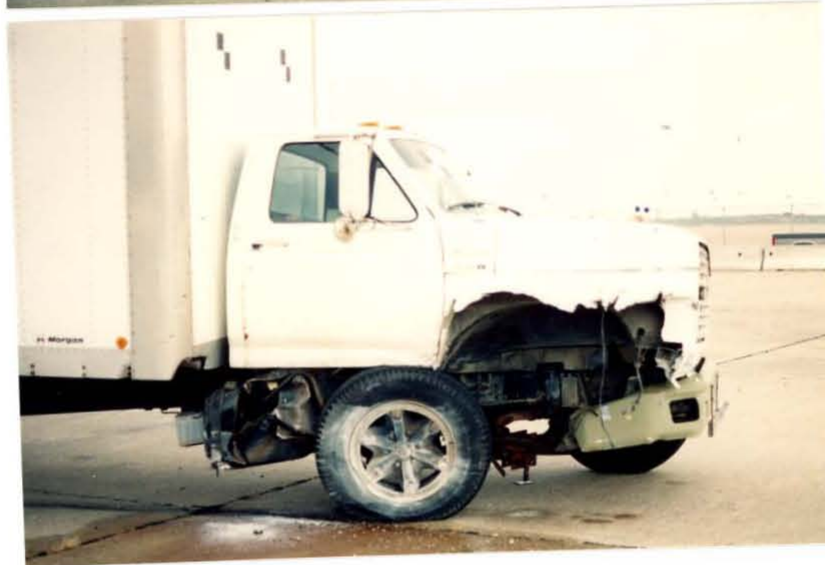
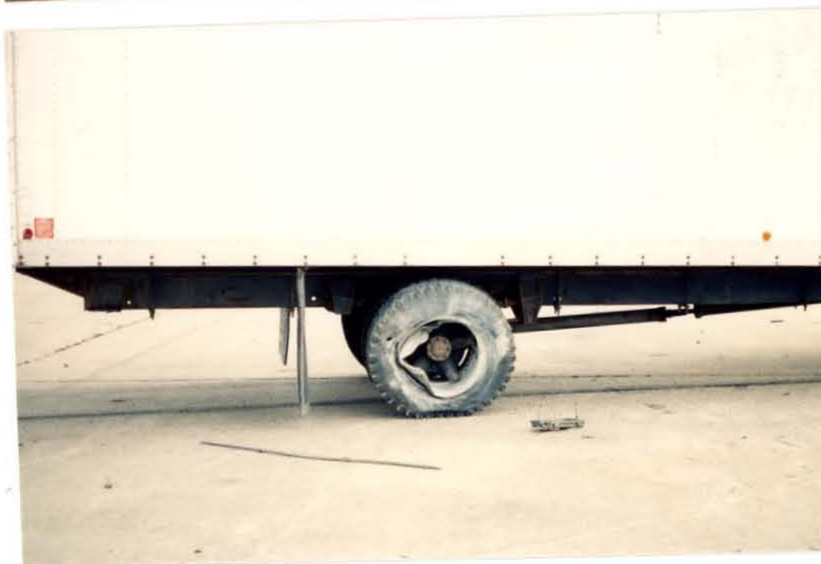
Damage to the test vehicle was minimal considering the impact conditions, as can be seen in Figure 16. There was very little damage to the van box, and all of the glass in the truck remained intact. There was no occupant compartment damage, and no visible damage to the truck on the drivers side. There was damage to the right-front fender and the right side of the front bumper. The front axle was pushed back and the frame was bent. There was considerable deformation of the right-rear wheel which resulted from contact with bridge rail. The gas tank (which had been purged and filled with water before the test) was punctured and deformed considerably.

Figure 16. Test Vehicle Damage, Test MN-1.

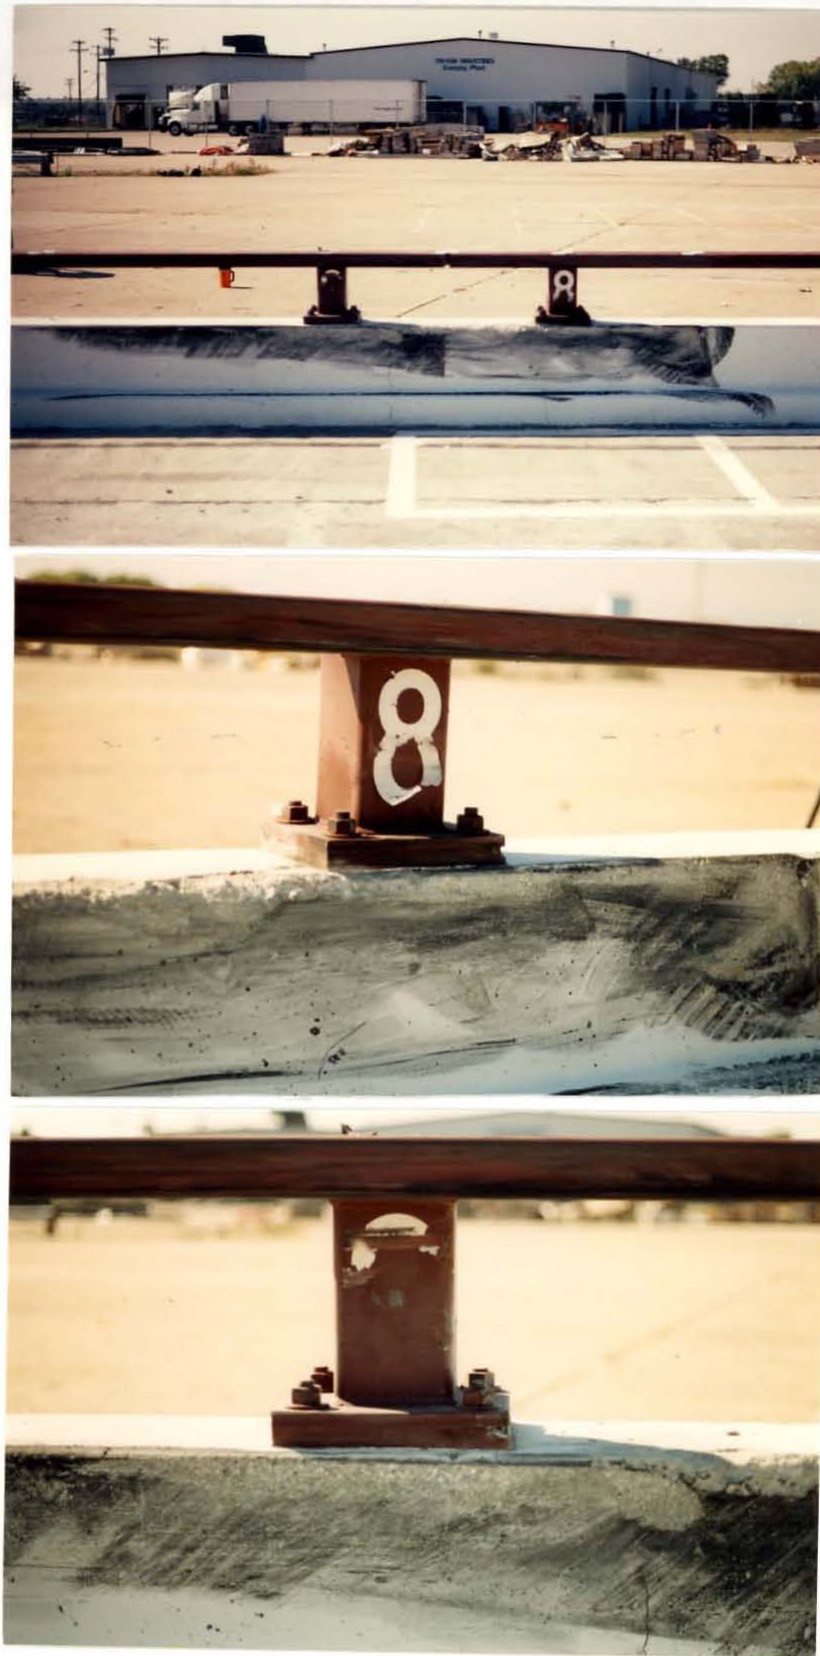
Figure 21. Bridge Rail Damage, Test MN-2.

and tires climbed the 6-in. (152 mm) high barrier curb, causing the vehicle bumper to rise up between the concrete parapet and structural steel tube rail. This penetration allowed the bumper to snag on the epoxy grout pad, steel base plate, steel nuts, anchor bolt ends, and structural steel tube post. Contact marks extended in approximately 1 in. (25 mm) on the upstream side of Post No. 9, indicating that the vehicle penetrated approximately 4.5 in. (114 mm) from the traffic-side face of the concrete parapet. It is noted that the top and bottom height of the vehicle's front bumper is 26.5 in. (673 mm) and 15 in. (381 mm), respectively. The total height to the top of the concrete parapet is 20 in. (508 mm). The distance from the front face of the post to the front face of the concrete parapet is 3.5 in. (89 mm).

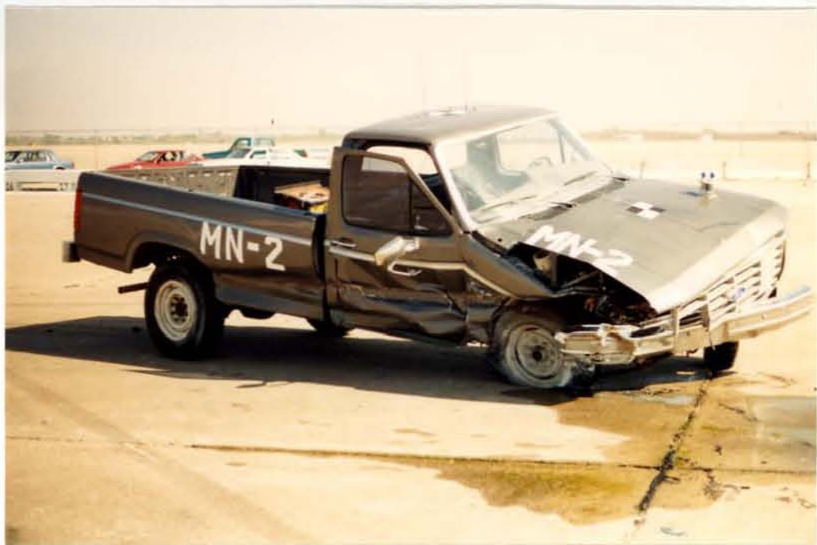
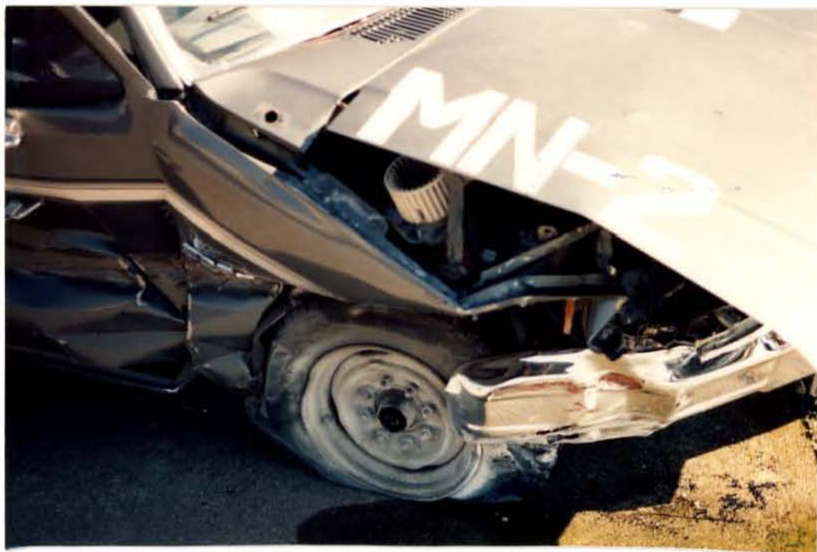
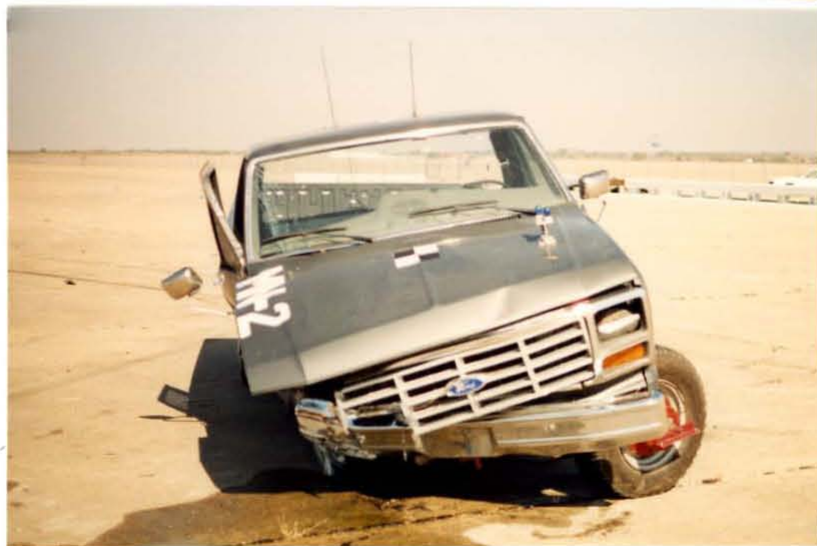
Evidence of snagging was also found on the damaged vehicle, as can be seen in Figure 22. The front bumper had several tears and gouges near the lower right-side end. In addition, the right-side bumper support and adjacent frame were pushed backward and deformed, causing the left-side of the front bumper to push outward. The deformed bumper contacted the right-front tire, pushing the tire into the right-side floorboard. The backward movement of the tire assembly caused the right-side door and lower body to buckle. Significant undercarriage damage and deformation to the frame was observed, causing the right-side floorboard to be pushed toward the center of the vehicle.

Figure 22. Vehicle Damage, Test MN-2.

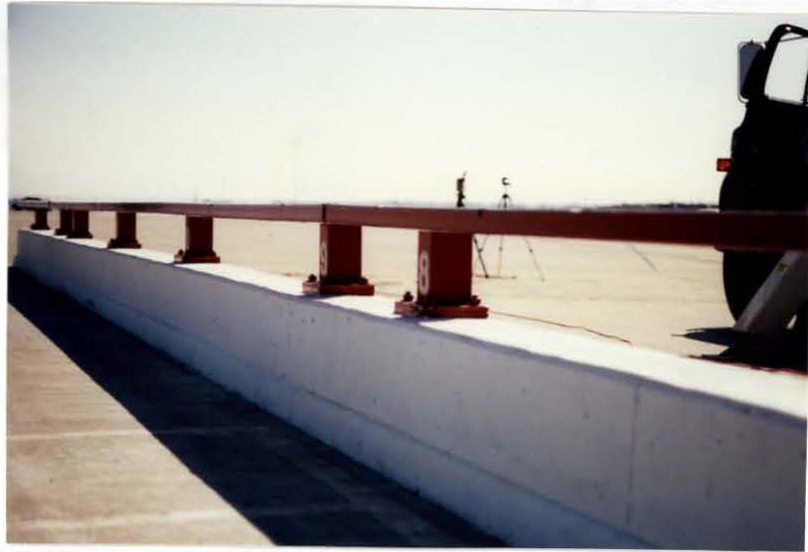
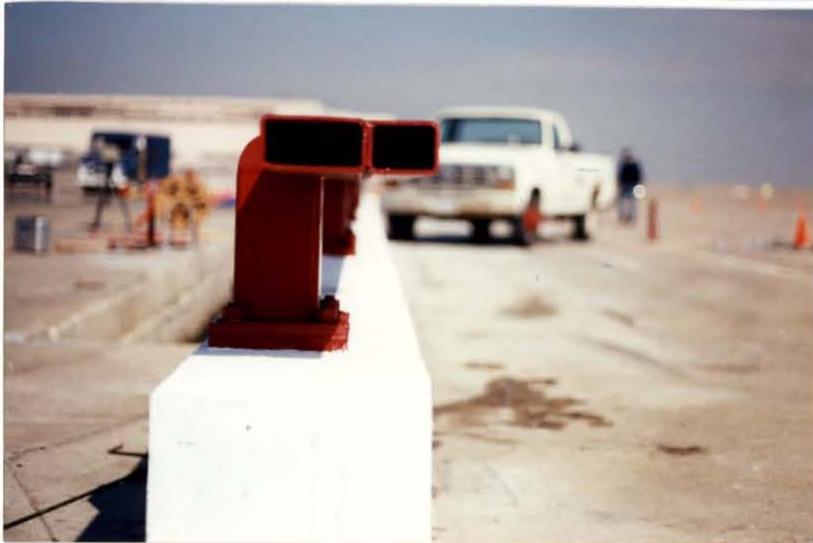
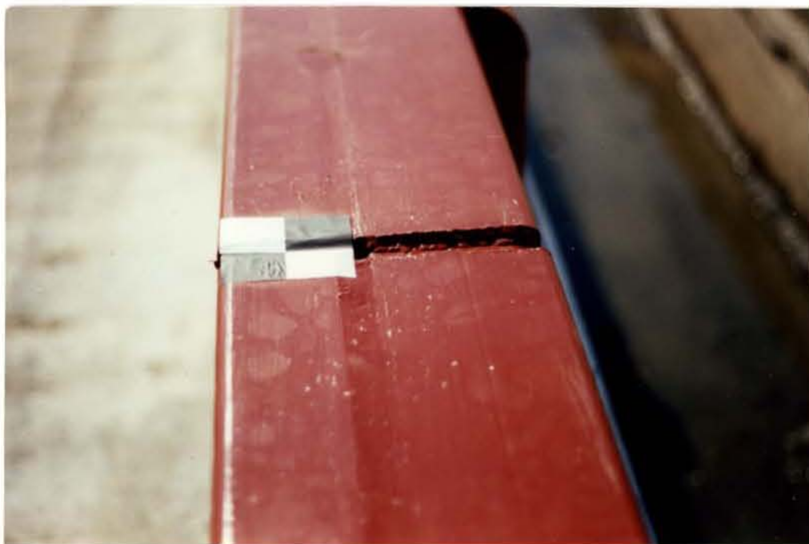
Figure 23. Retrofit of Minnesota Combination Bridge Rail for tests MN-3 and MN-4.

Following this test, several retrofit options were considered to reduce the potential of the vehicle snagging on the steel posts. The retrofit option chosen for Test MN-3 is shown in Figure 7 and described in Section 2.2. This retrofit option included extending the structural steel rail and concrete parapet 4 in. toward the roadway to reduce the potential of the vehicle snagging on the posts. This also minimized the

amount of curb extending from the parapet, reducing the potential for this curb to cause the vehicle to ride up and cause the bumper to snag on the posts.

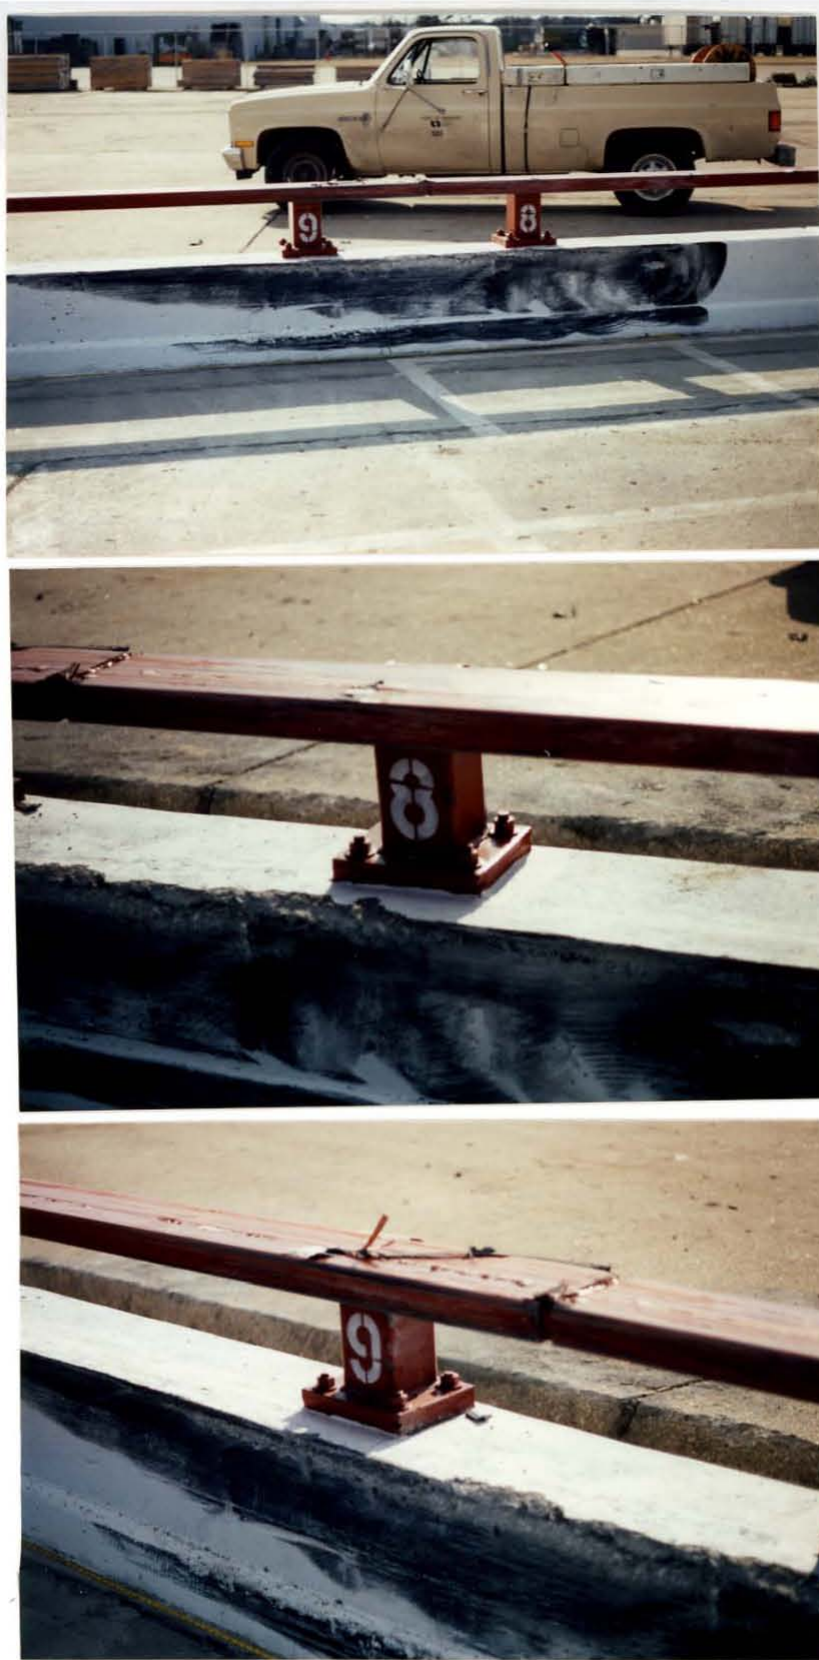
The damage to the bridge rail was relatively minor, as can be seen in Figure 26. This damage consisted mainly of tire marks along the rail, and minor spalling of the concrete parapet. The maximum permanent set deflection of the rail was $\frac{1}{8}$ in. (3 mm) at post No. 7.

Figure 26. Bridge Rail Damage, Test MN-3.

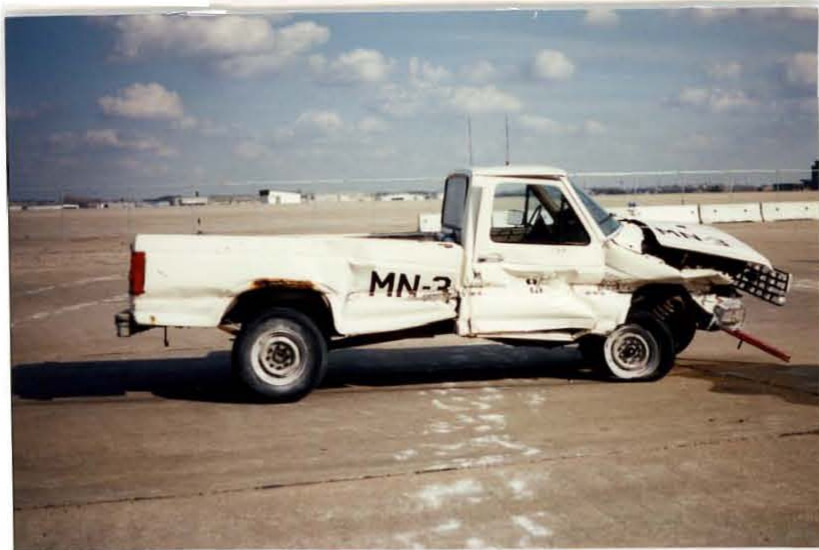
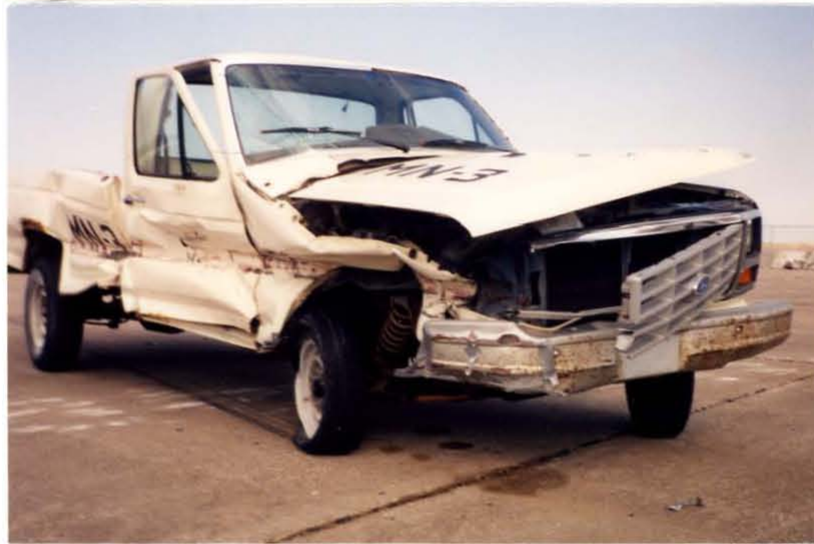
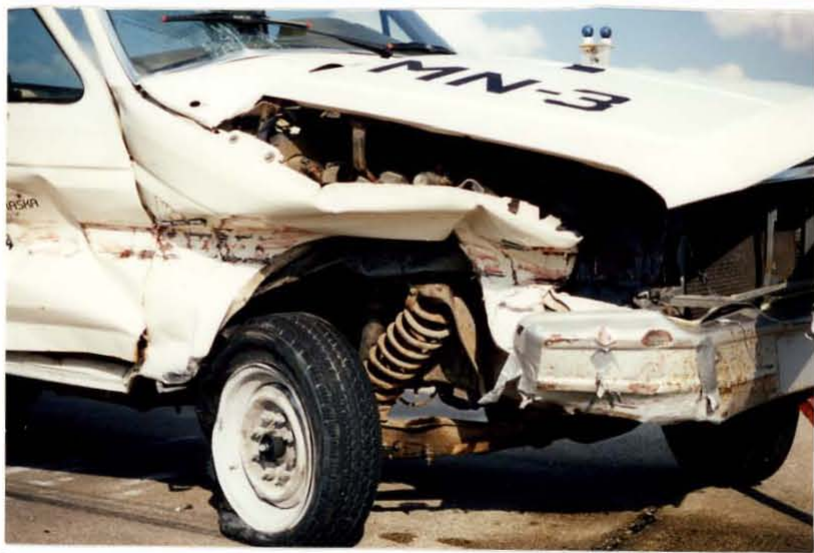
Figure 27. Vehicle Damage, Test MN-3.

Although snagging between the test vehicle's bumper and the steel posts was again observed, the extent of overlap was reduced to approximately $\frac{1}{2}$ in. (12 mm), and the snag forces were therefore judged to be relatively small. However, lateral forces generated between the concrete parapet and the vehicle's

front wheel and floor pan again caused deformations in the floor pan area with some deformation of the dash board and kick panel. The extent of deformation and the locations thereof are expected to cause injuries to an occupants foot and ankles and are probably not life threatening. Careful review of the high-speed films indicate that the source of the occupant compartment deformations can be contributed largely to lateral forces generated by the vertical concrete parapet. Also, prior testing of a Nebraska open concrete bridge railing (Z) exhibited similar damage patterns during an impact at 60 mph (96.5 km/h) and an angle of 20 degrees. Thus, vehicle deformations observed during this test and shown in Figure 27 are believed to be representative of any impact into a rigid rail with a 2000P vehicle at a speed of 62.2 mph (100 km/h) and an angle of 25 degrees. Note that the impact speed and angle associated with this test have been shown to be extremely rare and therefore the extent of occupant compartment deformation observed during this test will seldom be replicated in the field. There was a notable improvement in the performance of the system between tests MN-2 and MN-3, as the retrofit reduced the amount of snagging on the rail posts. This was evident in the analysis of the high-speed film, as well as in the reduced degree of occupant compartment deformation.

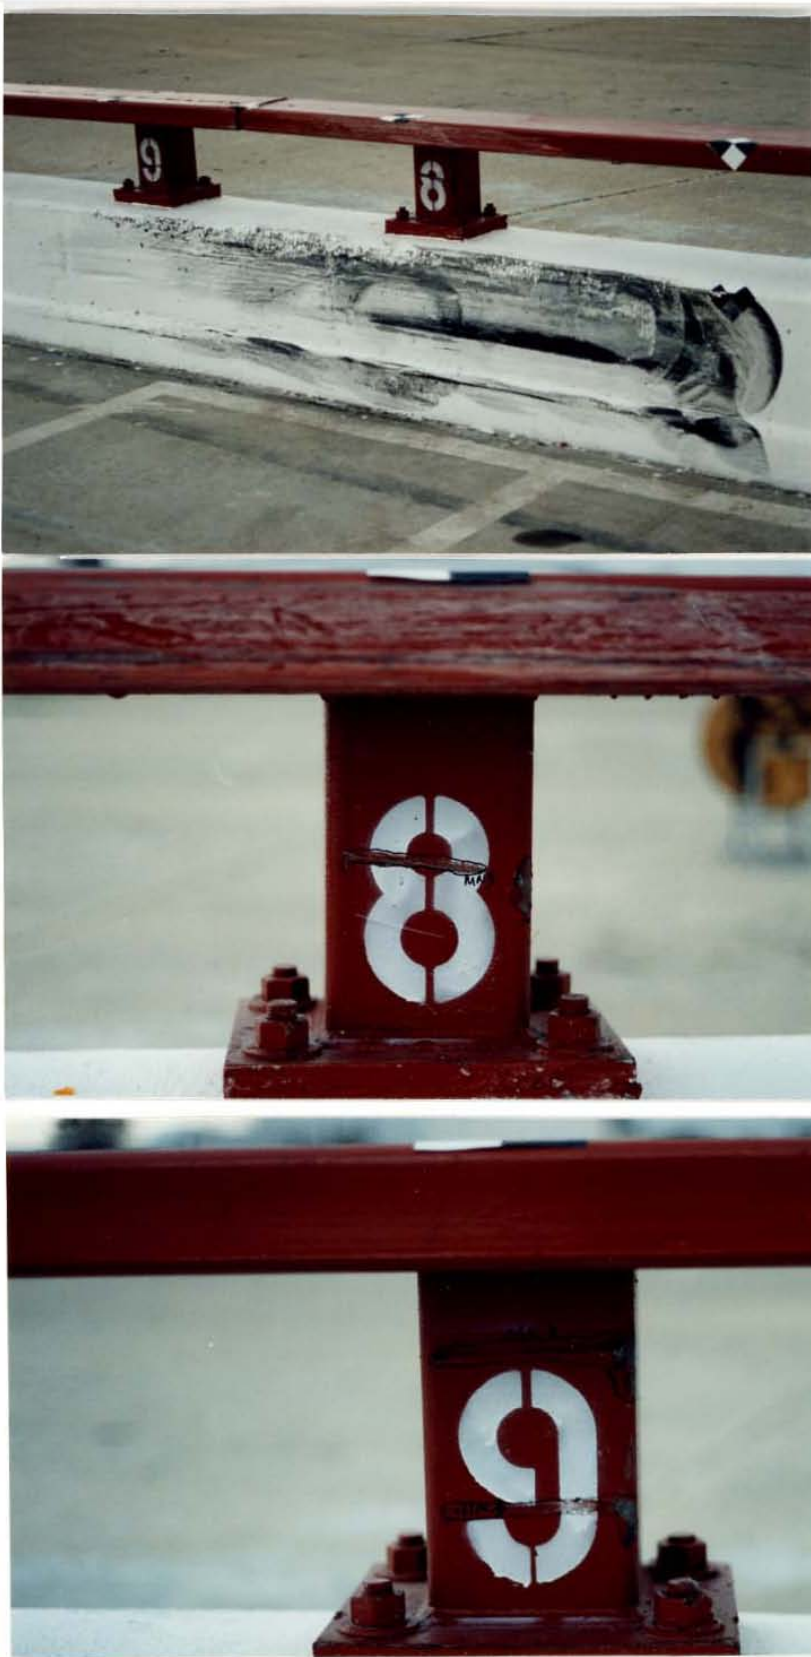
There was virtually no damage to the bridge rail, as seen in Figure 30. The vehicle damage was deemed to be relatively light for this type of impact, as shown in Figure 31.

Figure 30. Bridge Rail Damage, Test MN-4.

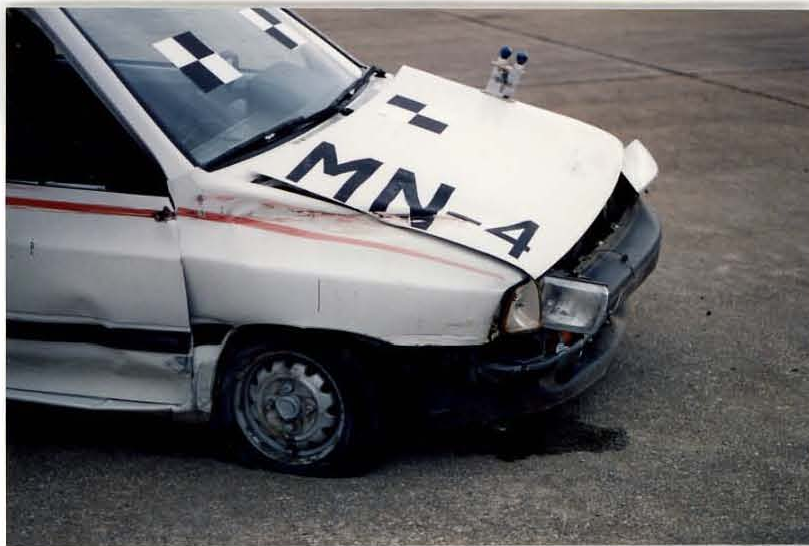
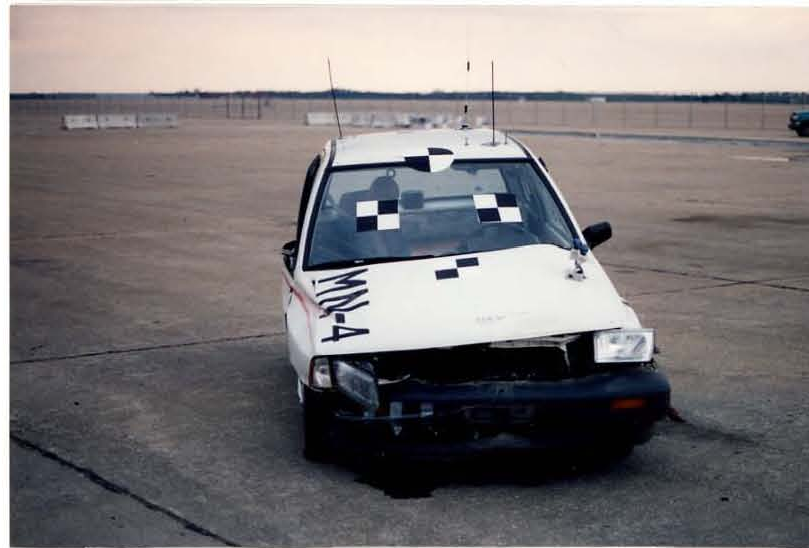
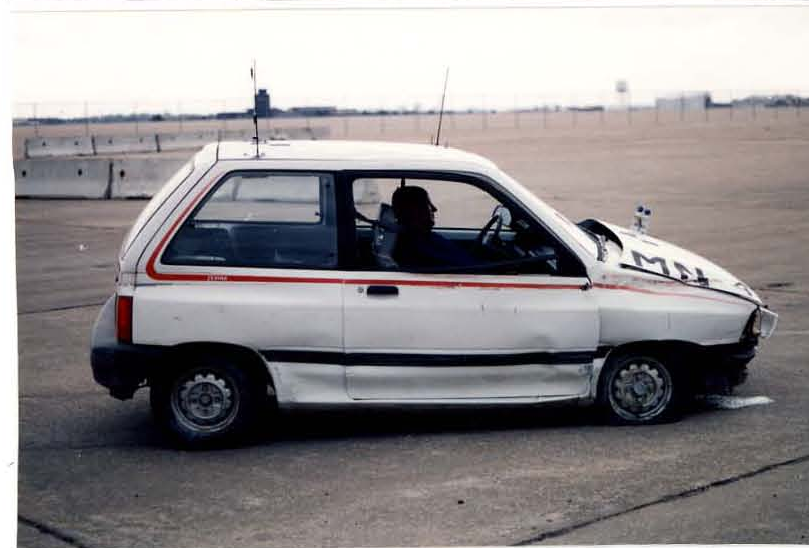
Figure 31. Vehicle Damage, Test MN-4.

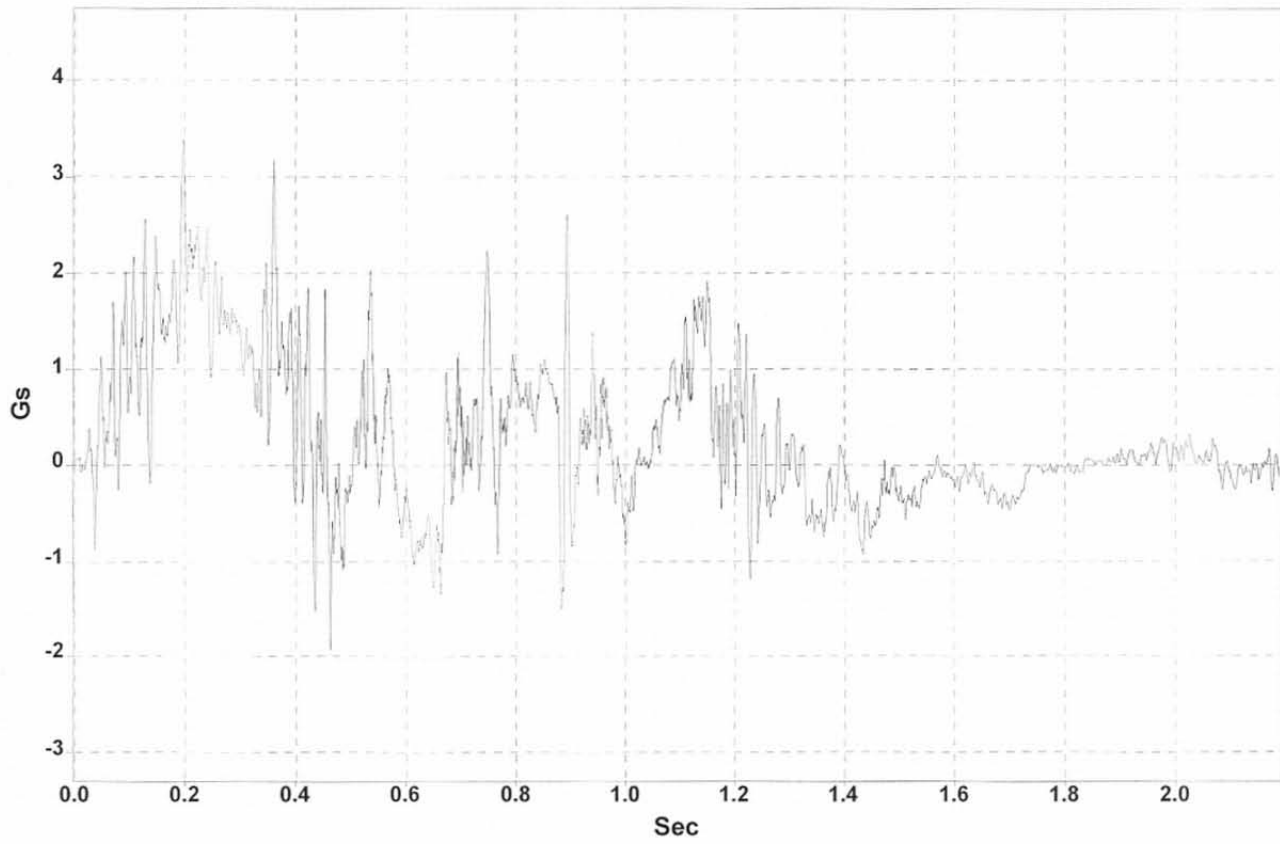
Figure B-1. Lateral Deceleration, Test MN-1.

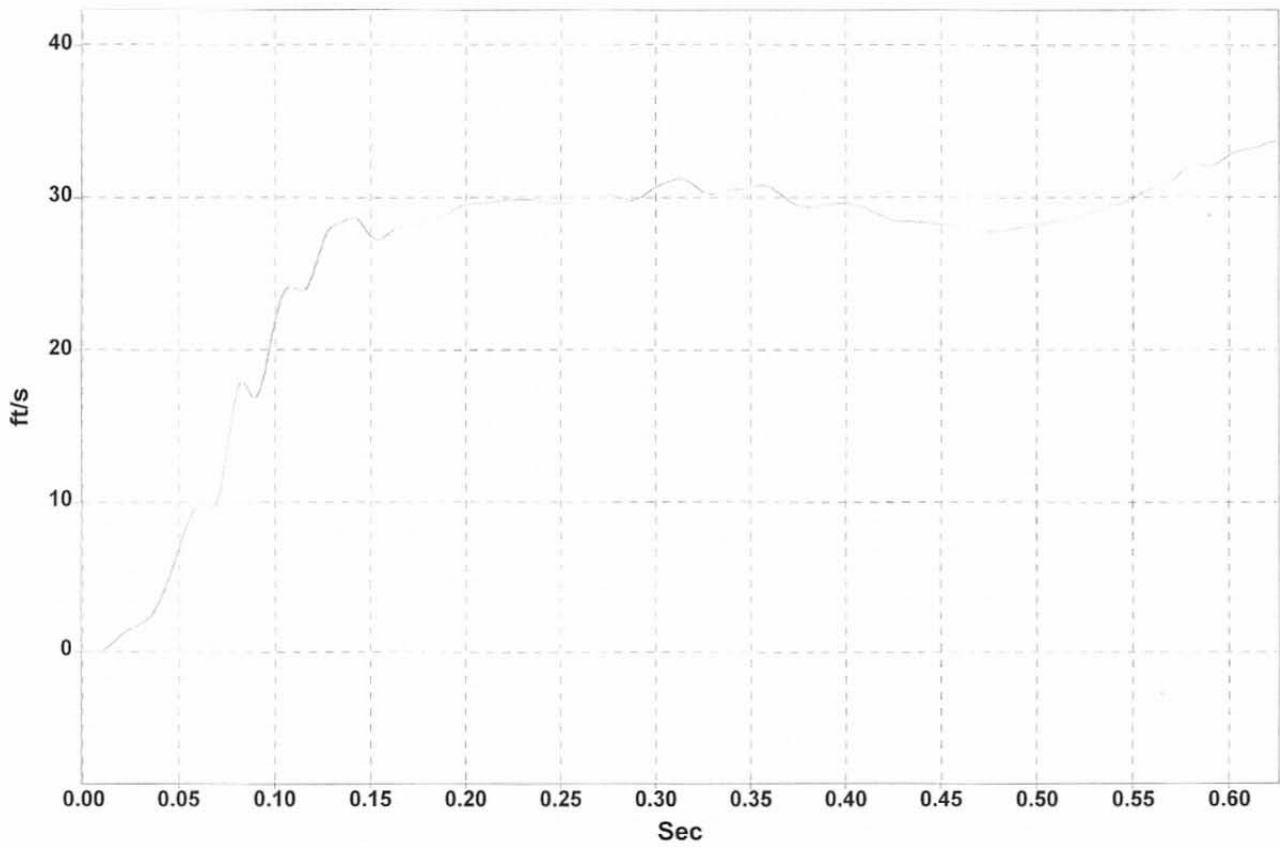
Figure C-4. Relative Longitudinal Change in Velocity, Test MN-2.

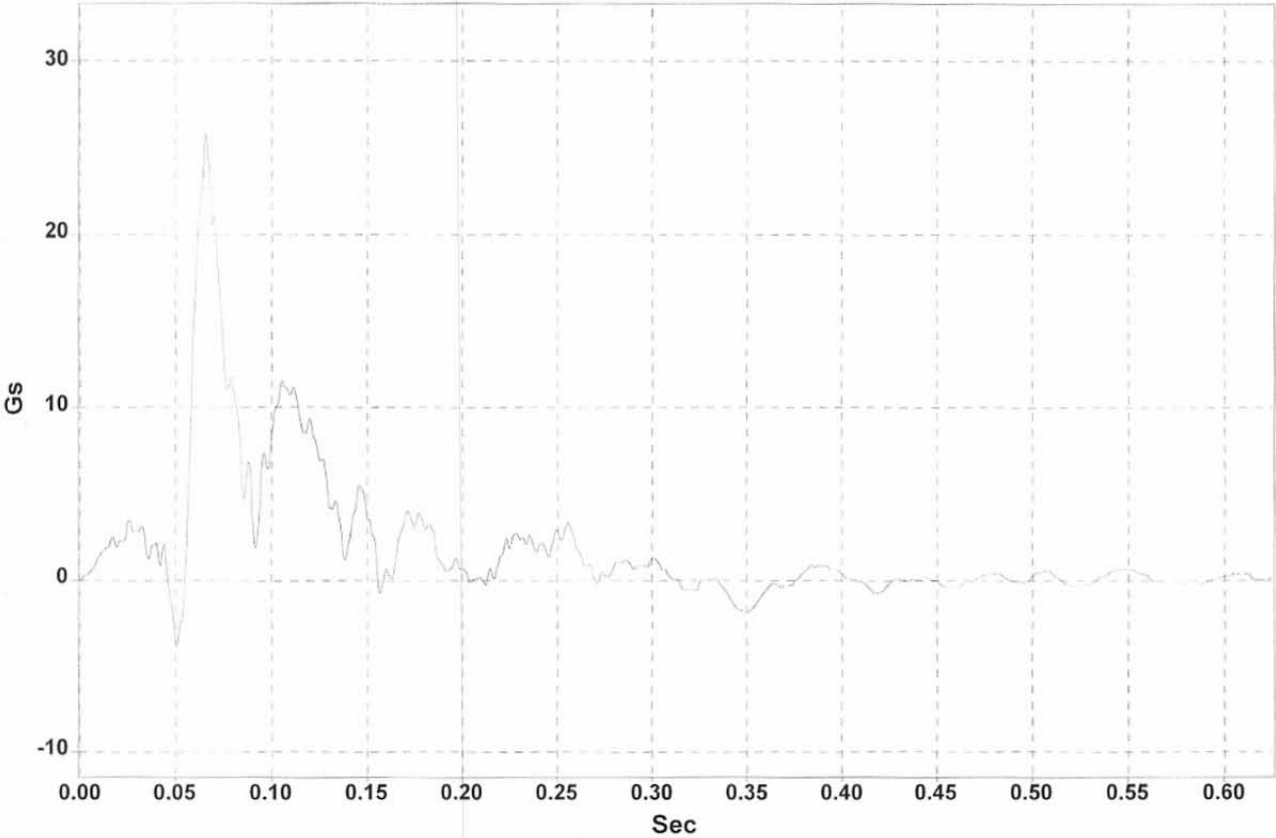
Figure D-1. Lateral Deceleration, Test MN-3.

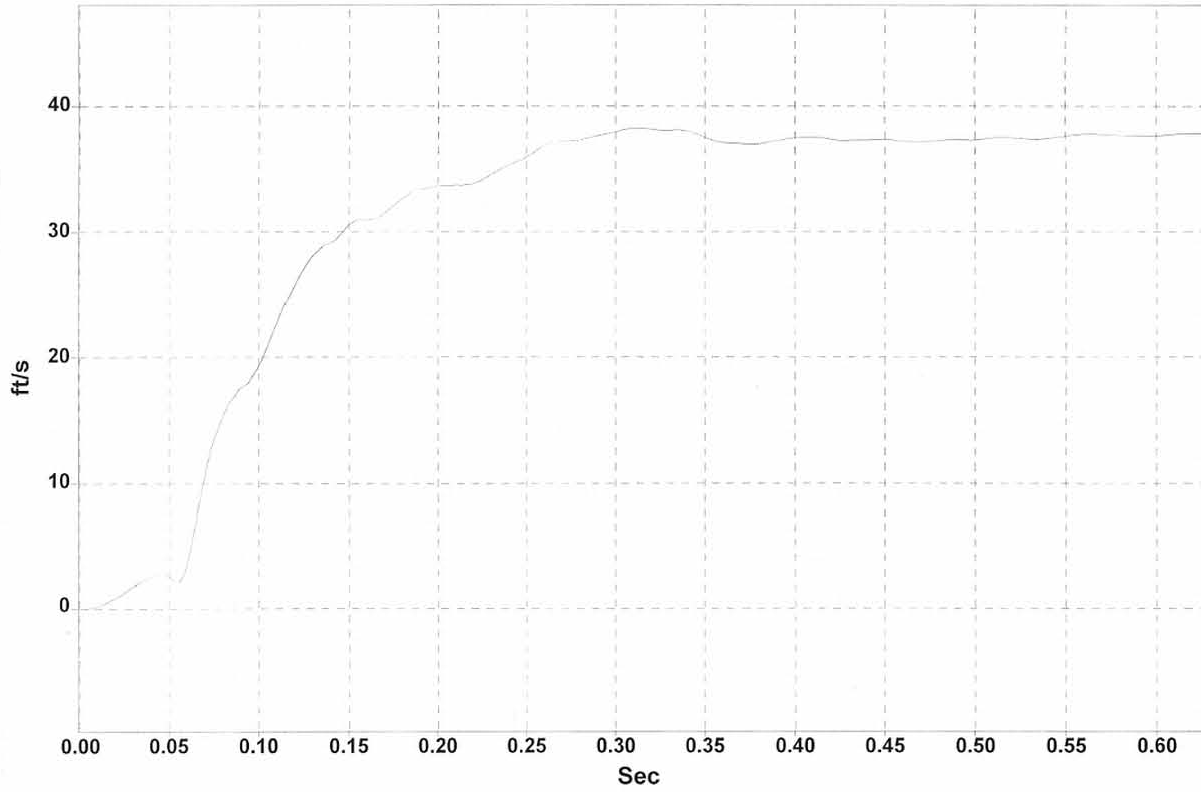
Figure D-2. Lateral Change in Velocity, Test MN-3.
