DEVELOPMENT, TESTING, AND EVALUATION OF NDOR'S TL-5 AESTHETIC OPEN CONCRETE BRIDGE RAIL

1. Report No. TRP-03-148-05	2.	3. Recipient's Accession No.

12. Sponsoring Organization Name and Address Nebraska Department of Roads 1500 Nebraska Highway 2 Lincoln, Nebraska 68509-4759	13. Type of Report and Period Covered Final Report 2003-2005
	14. Sponsoring Agency Code

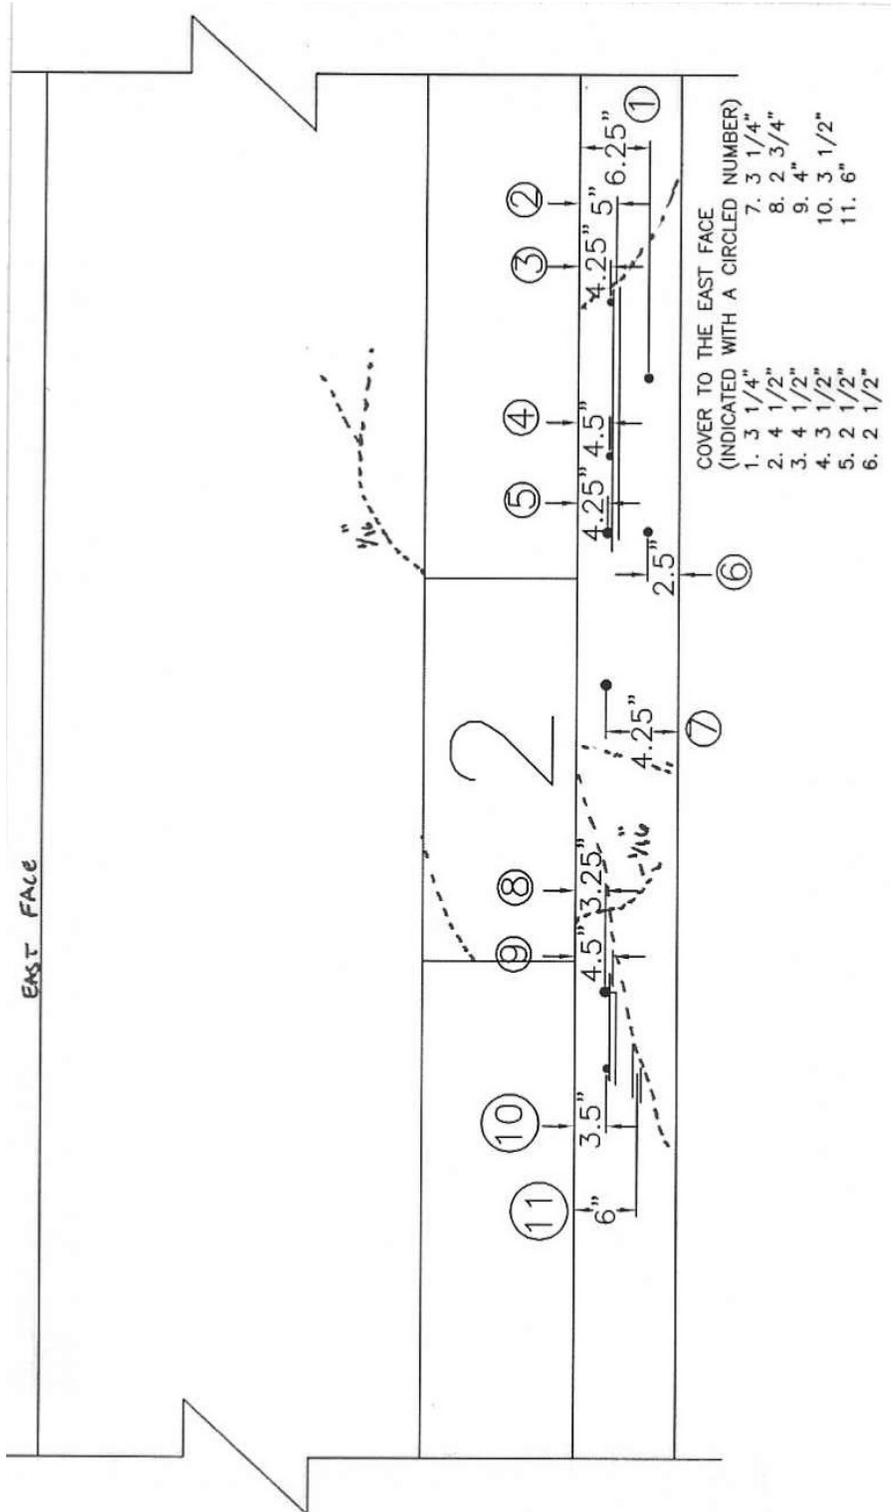
Figure C-2. Concrete Damage – Back-side of Rail at Post No. 2, Test ACBR-1

Damage to the open concrete bridge rail was moderate, as shown in Figures 34 through 52. Barrier damage consisted of contact and gouge marks, concrete deck, post, and rail cracking, and spalling of the concrete. The length of vehicle contact along the concrete bridge rail was approximately 19 m (63 ft), which spanned from the upstream edge of post no. 3 through 305 mm (12 in.) downstream from the downstream edge of post no. 10.

Damage to the rail also consisted of major cracking. One 1.6-mm (0.0625-in.) wide crack originated at the bottom edge of the bottom groove at 813 mm (32 in.) upstream of the upstream edge of post no. 3 and continued to the top edge of the top of the rail at the downstream edge of post no. 3. Another 1.6-mm (0.0625-in.) wide crack originated on the bottom edge of the bottom groove at 864 mm (34 in.) upstream of the upstream edge of post no. 6 and continued up to the top edge of the top of the rail near the upstream edge of post no. 6. A third 1.6-mm (0.0625-in.) wide crack originated at the bottom edge of the bottom groove at 406 mm (16 in.) downstream of the upstream edge of post no. 6 and propagated to the top edge of the rail's top portion near the upstream edge of post no. 7. A fourth 1.6-mm (0.0625-in.) wide crack originated at the bottom edge of the bottom groove at 457 mm (18 in.) upstream of the upstream edge of post no. 7 and continued to the top edge of the top of the rail at the downstream edge of post no. 7. A fifth 1.6-mm (0.0625-in.) wide crack originated at the bottom edge of the bottom groove at 610 mm (24 in.) downstream from the downstream edge of post no. 7 and propagated to the damage at the top edge of the rail at post no. 8. A final 1.6-mm (0.0625-in.) wide crack originated at the bottom edge of the bottom groove at 508 mm (20 in.) upstream of the upstream edge of post no. 8 and continued to the top edge of the top of

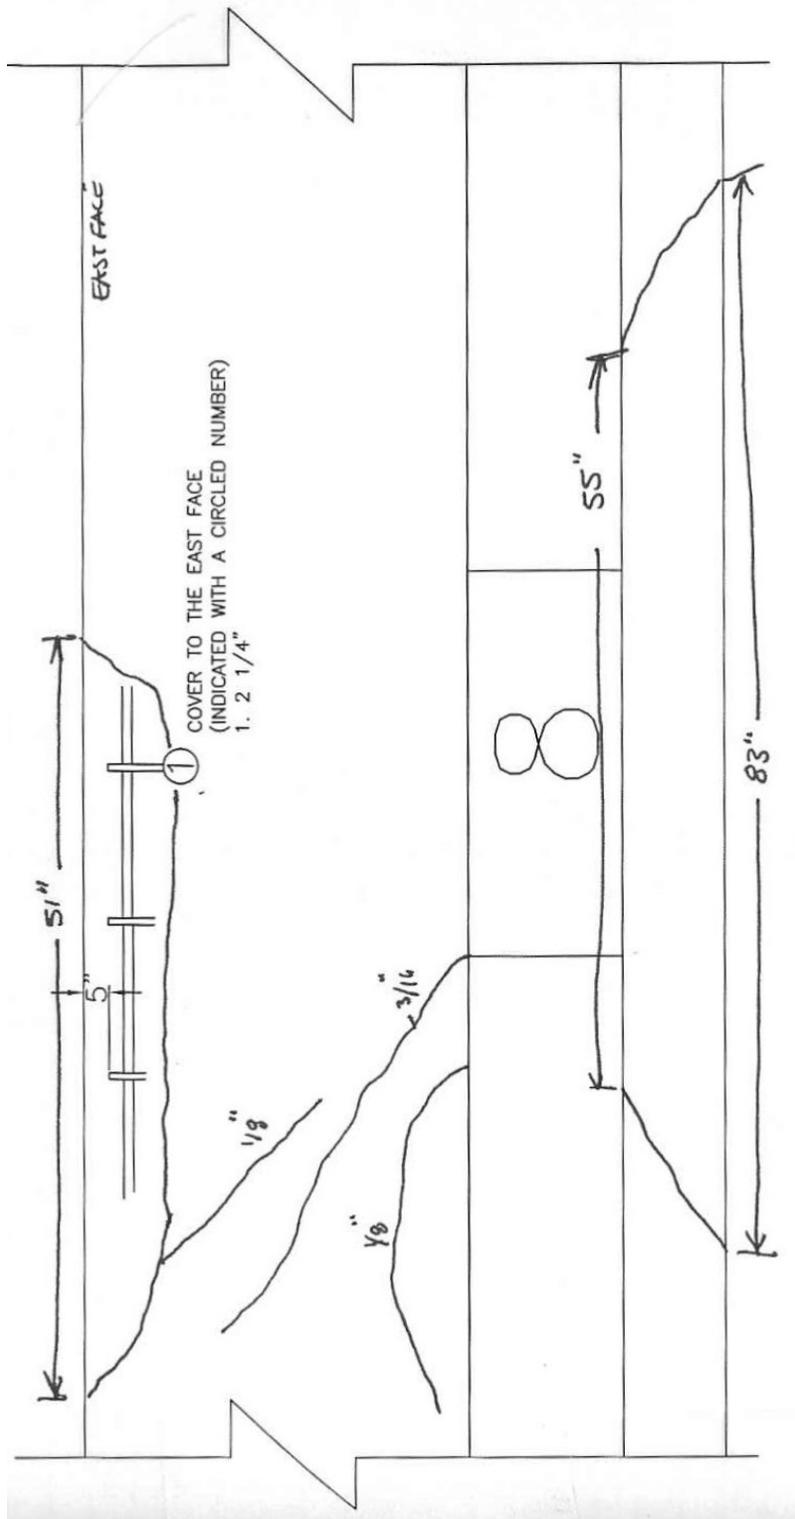
Figure C-8. Concrete Damage – Back-side of Rail at Post No. 8, Test ACBR-1

the rail at the center of post no. 8. Minor cracks were also found in the rail between post nos. 1 and 10.
