SAFETY PERFORMANCE EVALUATION ON THE NEBRASKA  
TURNED-DOWN APPROACH TERMINAL SECTION

Project RES 1 (0099) P464  
TRANSPORTATION RESEARCH REPORT TRP-03-32-92

October 1992

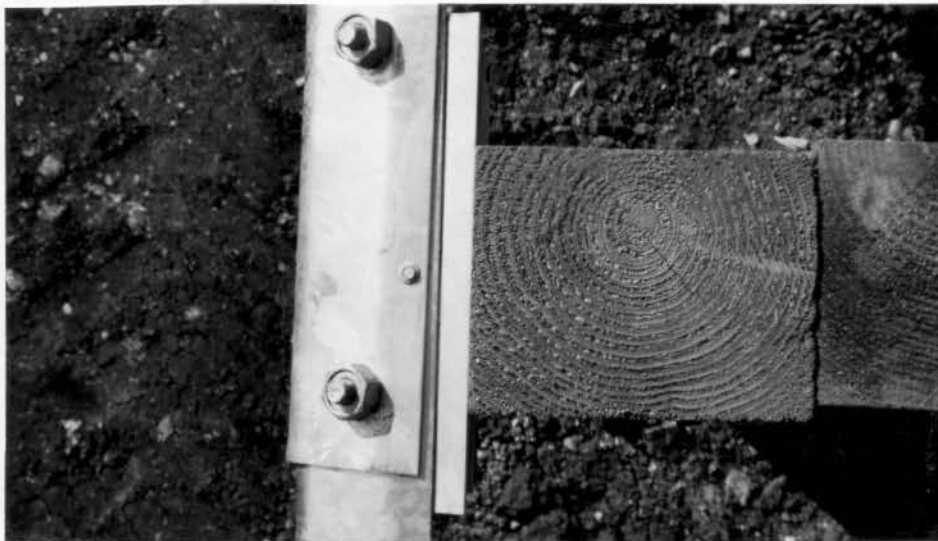
FIGURE 6. Guardrail Connection Detail, Post No. 3

Twelve gauge W-beam guardrail sections were used at all remaining locations of the installation. W-section backup plates were mounted on Post Nos. 1 through 8 and Post Nos. 10 and 11 (Figure 5). A 6-in. long backup plate was placed at Post No. 5, while all remaining backup plates were 12-in. long. The W-beam guardrail was not connected to Post Nos. 1 through 5. The guardrail was bolted to the backup plates at Post Nos. 1 and 3 with a No. 10 bolt (Figure 3 and 6).

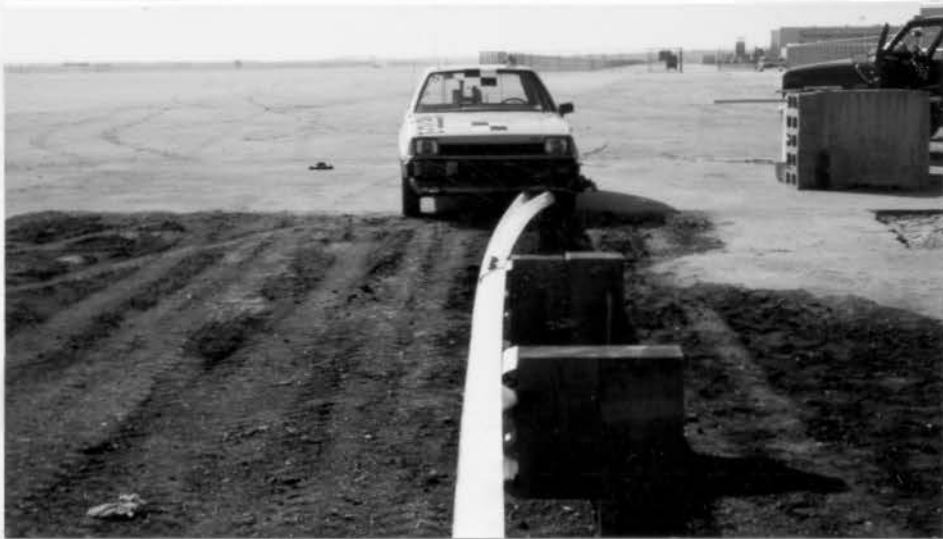
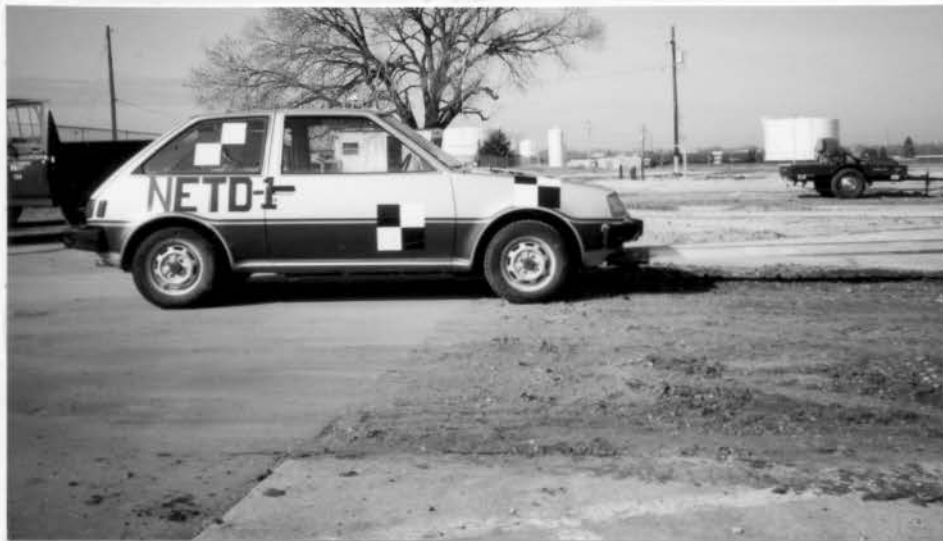
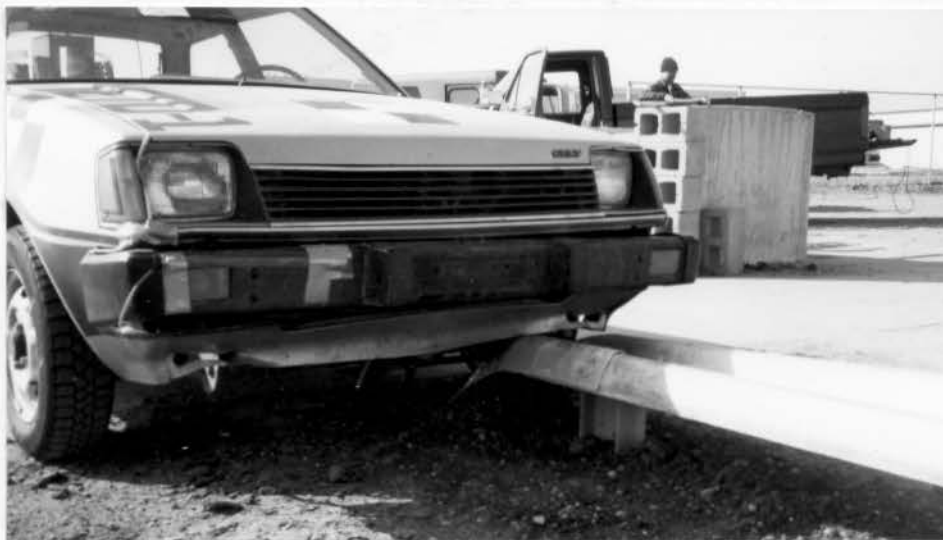
FIGURE 11. Impact Location, Test NETD-1

Test NETD-1 was conducted with 1984 Dodge Colt under the impact conditions of 59.0 mph and 0 degrees (head-on) with respect to a line parallel to the roadway and offset 1.25-ft toward the roadway (Figure 11). A summary of the test results and sequential photographs are shown in Figure 12. Additional sequential photographs are shown in Figures 13 through 16.
