# **SAFETY PERFORMANCE EVALUATION OF MICHIGAN'S 4X5 PORTABLE SIGN SUPPORT**

### **Michigan Department of Transportation**

MwRSF Research Report No. TRP-03-135-03

June 20, 2003

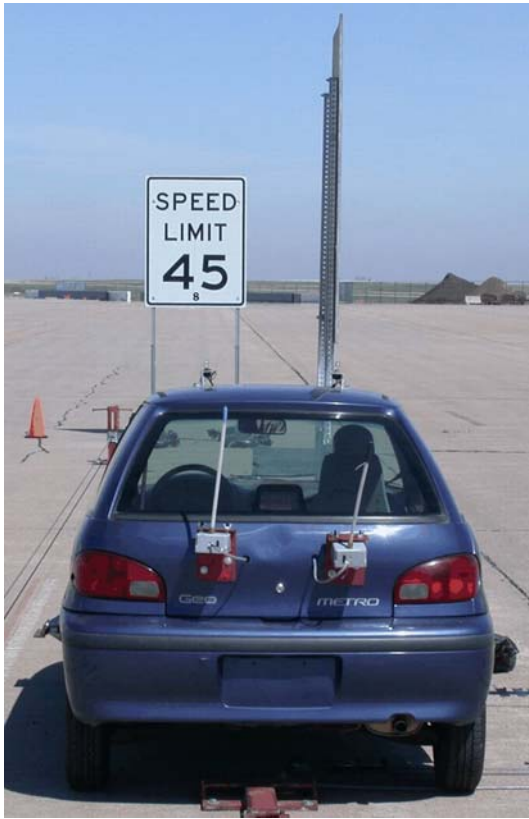
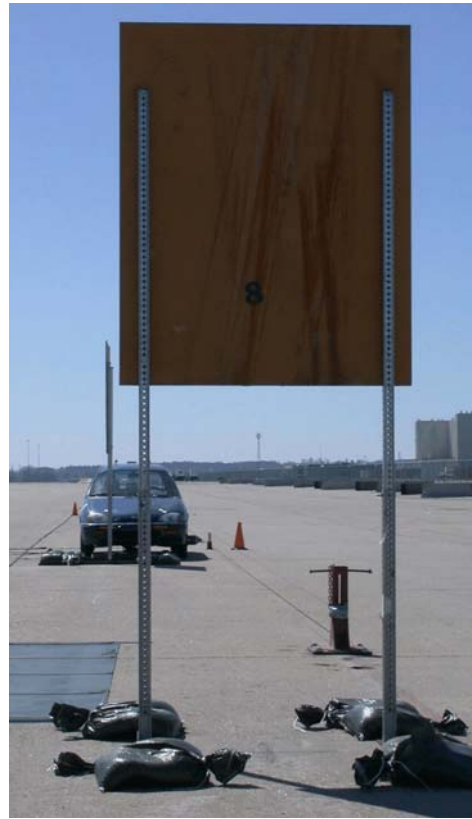
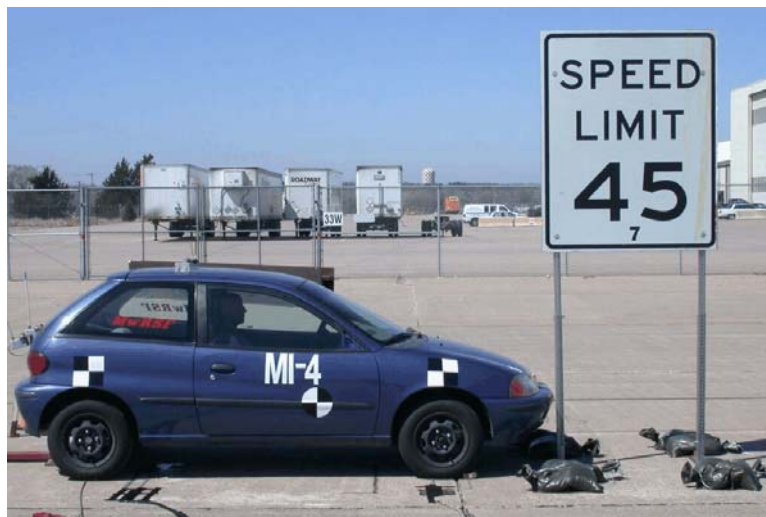
Figure 16. Impact Location, Test MI-4

The test vehicle impacted System No. 7 with the right-front quarter point of the vehicle aligned with the centerline of the sign support, as shown in Figure 16. At 0.014 sec after initial contact, the impacted mast deformed around the front of the vehicle and translated toward the non-impacted mast. At 0.042 sec, the sign panel rotated counter-clockwise (CCW) down toward the vehicle as the non-impacted mast rotated away from the vehicle. At this same time, the impacted mast deformed around the front of the vehicle and contacted the non-impacted mast. Shortly thereafter, the non-impacted leg disengaged from the mast. At 0.062 sec, the impacted mast disengaged from the leg and was deformed to approximately a 90 degree angle around the front of the vehicle. At this same time, the sign panel continued to rotate CCW toward the vehicle. At 0.098 sec, the sign panel contacted the roof and windshield. At 0.118 sec, the sign panel crushed the roof inward toward the occupant compartment. At 0.144 sec, the sign panel, which was positioned

Approximately 0.73 sec after impact with System No. 7, the vehicle impacted System No. 8 with the centerline of the vehicle aligned with the centerline of the sign support, as shown in Figure 16. At 0.020 sec, both masts deformed around the front of the vehicle as the top of the sign panel rotated down toward the vehicle. At 0.038 sec, the sign panel, both masts, and both legs all still intact traveled along with the vehicle. Shortly after this time, the sign panel released from the top-left, bottom-left, and the bottom-right panel bolts. At 0.064 sec, the masts were still in contact with the front of the vehicle as they rotated about the front of the vehicle. At this same time, the sign panel descended toward the vehicle. At 0.106 sec, the bottom of the sign panel contacted the roof and upper region of the windshield. At this same time, the top of the left mast remained attached to the sign panel. At 0.140 sec, the entire sign panel was in contact with the roof as the right-side
