DEVELOPMENT OF A STEEL H-SECTION TEMPORARY BARRIER FOR USE IN LIMITED DEFLECTION APPLICATIONS

MIDWEST ROADSIDE SAFETY FACILITY

MwRSF Research Report No. TRP-03-120-03

May 30, 2003

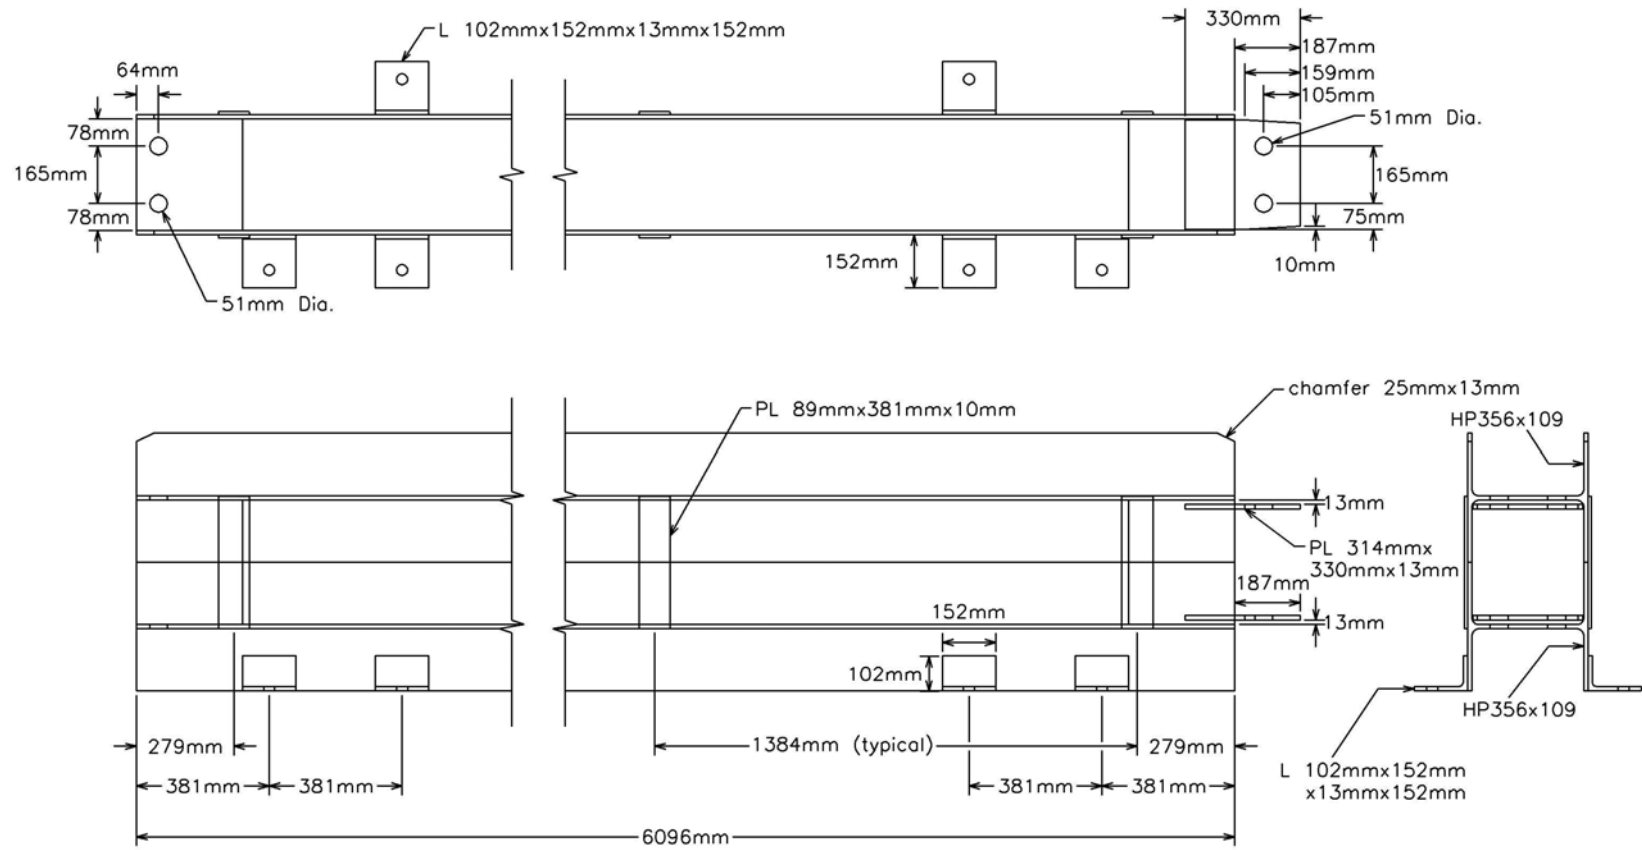
Figure 1. Steel H-section Temporary Barrier Design Details

The H-section barrier rails were also retrofitted with a series of steel angle brackets that were used as tie-downs to constrain the barrier motion, as shown in Figures 1, 3, and 8. Four 102 mm x 152 mm x 12.7-mm thick by 152-mm long ASTM A36 steel angle brackets were welded to the base of each side of the steel barrier and placed at 381 mm and 762 mm from each end. The base of each angle bracket was drilled with a 32-mm diameter hole. The brackets were fastened to the concrete bridge deck using 19-mm Red Head drop-in anchors with 19-mm diameter by 57-mm long ASTM A325 bolts and using 64-mm wide x 64-mm long x 4.8-mm thick steel plate washers.

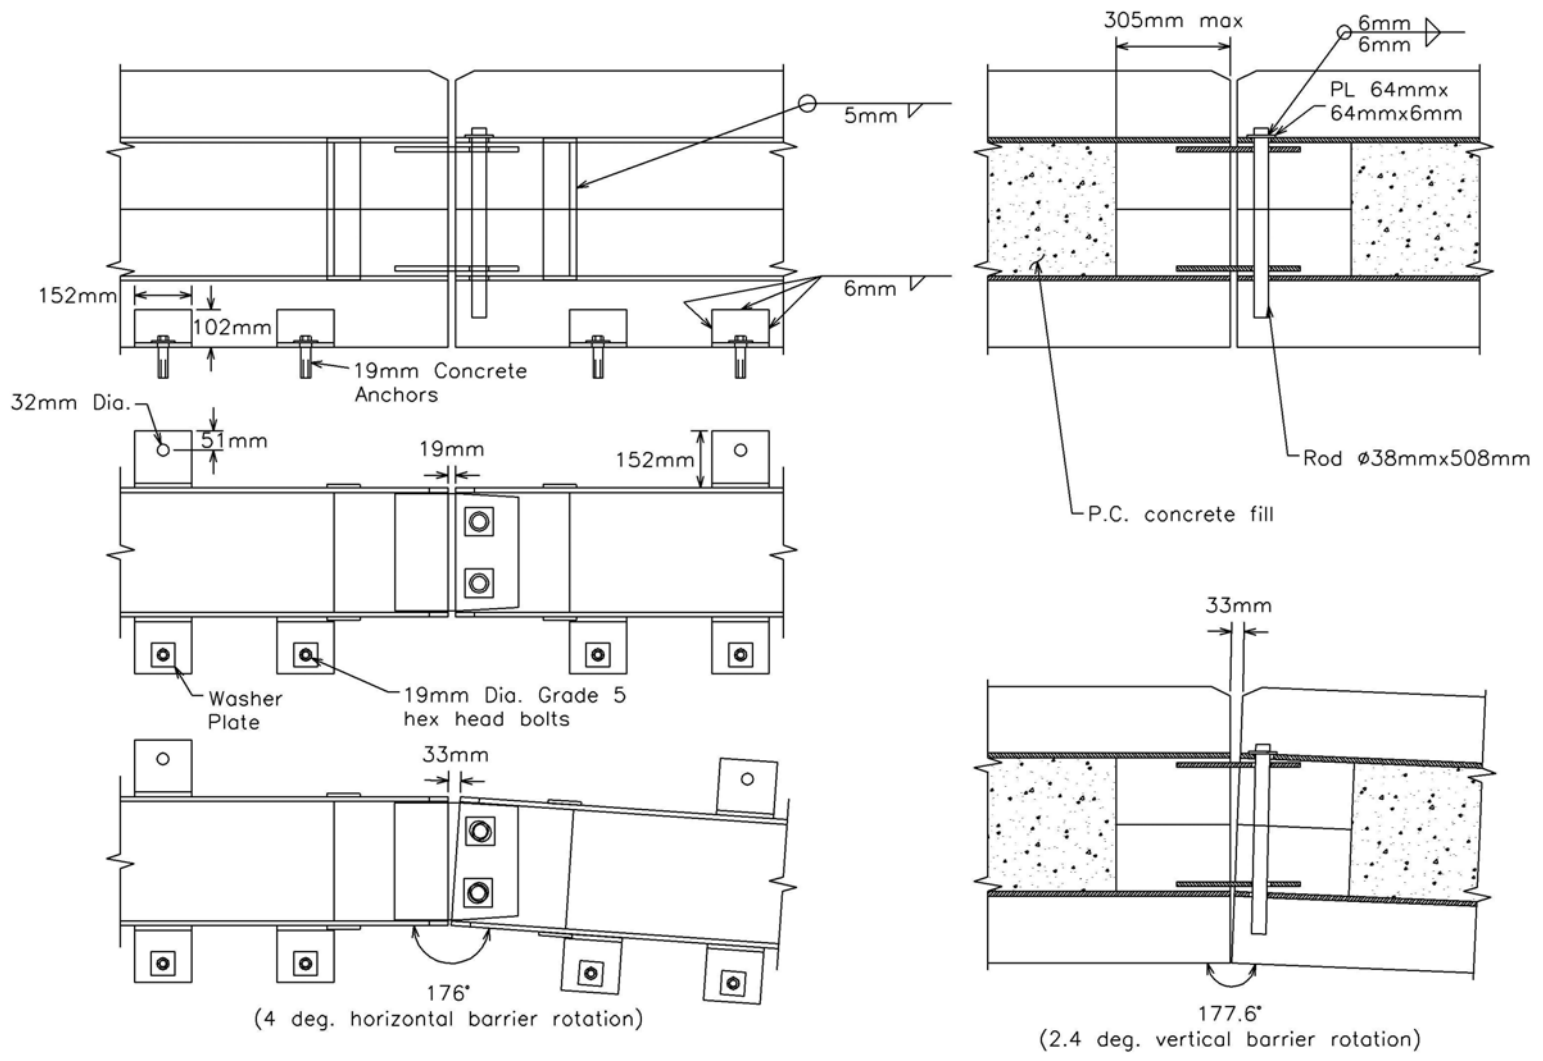
Figure 3. Steel H-section Temporary Barrier Splice Details

However, each barrier connection was redesigned to use two drop pins and two steel shear plates, as shown in Figures 1 through 3, 6, and 7. A pair of 330-mm wide x 314-mm long x 12.7-mm thick steel shear plates, each with two 51-mm diameter holes, were welded to the two webs from the HP sections which formed the box section on one end of the barrier rail. The ends of shear plates were tapered to a width of 295 mm and extended 168 mm into the adjacent barrier rail. Each shear plate was positioned 13 mm away from the adjacent web surface. The opposite end of the barrier had two matching 51-mm diameter holes cut into the webs of the HP shapes. When the barrier ends were pushed together, two 38-mm diameter by 308-mm long ASTM A36 steel pins dropped through the holes to complete the moment connection. The combination of the tapered shear plates, their welded vertical location, and the 13-mm diameter difference between the connecting pins and the holes allowed the barrier to meet the design rotation requirements of 4.0 and 2.4 degrees about the transverse and vertical axes, respectively.

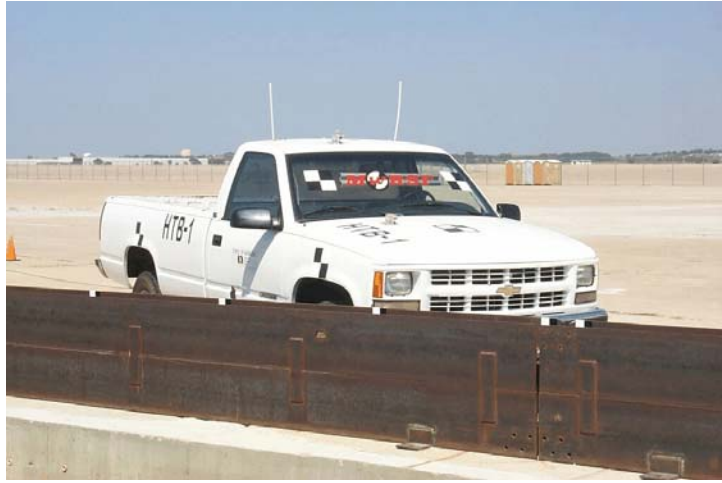
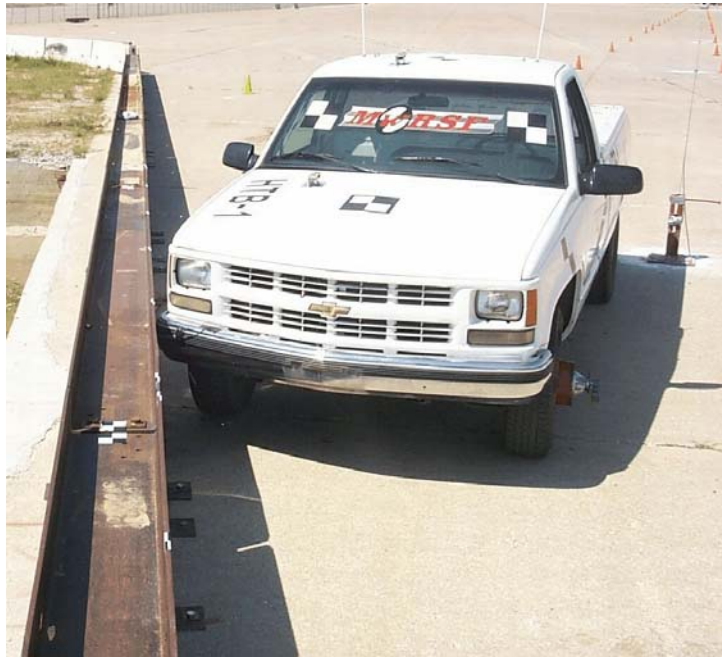
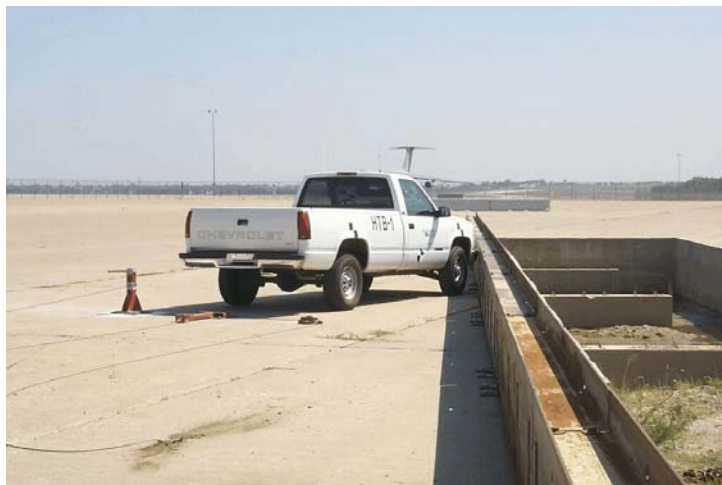
Figure 22. Impact Location, Test HTB-1

Initial impact was to occur 1,295-mm upstream from the splice between barrier nos. 5 and 6, as shown in Figure 22. Actual vehicle impact occurred 1,549-mm upstream from the splice between barrier nos. 5 and 6. At 0.036 sec after impact, the grill deformed inward as the front bumper twisted downward. At 0.048 sec, the right-front corner of the vehicle began to deform inward. At 0.094 sec, the right-front corner of the vehicle reached its maximum intrusion of 581 mm over the barrier as the vehicle began to redirect. At this same time, the top of the right-side door jarred open as the middle of it deformed inward. At 0.108 sec, the front of the vehicle was lifted by the contact with the barrier. At 0.123 sec, the left-front tire became airborne. At 0.150 sec, the right-front corner of the vehicle's box contacted the barrier. At 0.171 sec, the left-rear tire became airborne as the vehicle's cab rolled approximately 25 degrees clockwise (CW) toward the barrier and the box rolled slightly counterclockwise (CCW) away from the barrier. At 0.212 sec, the vehicle became parallel to the barrier with a resultant velocity of 73.1 km/hr. At this same time, the grill disengaged from the front. At 0.222 sec, the bottom of the vehicle's rear bumper contacted the top of the barrier causing the vehicle to continue to roll CW toward the barrier and pitch the rear of the vehicle upward. At 0.238 sec, the vehicle's right-front corner lost contact with the barrier as the cab

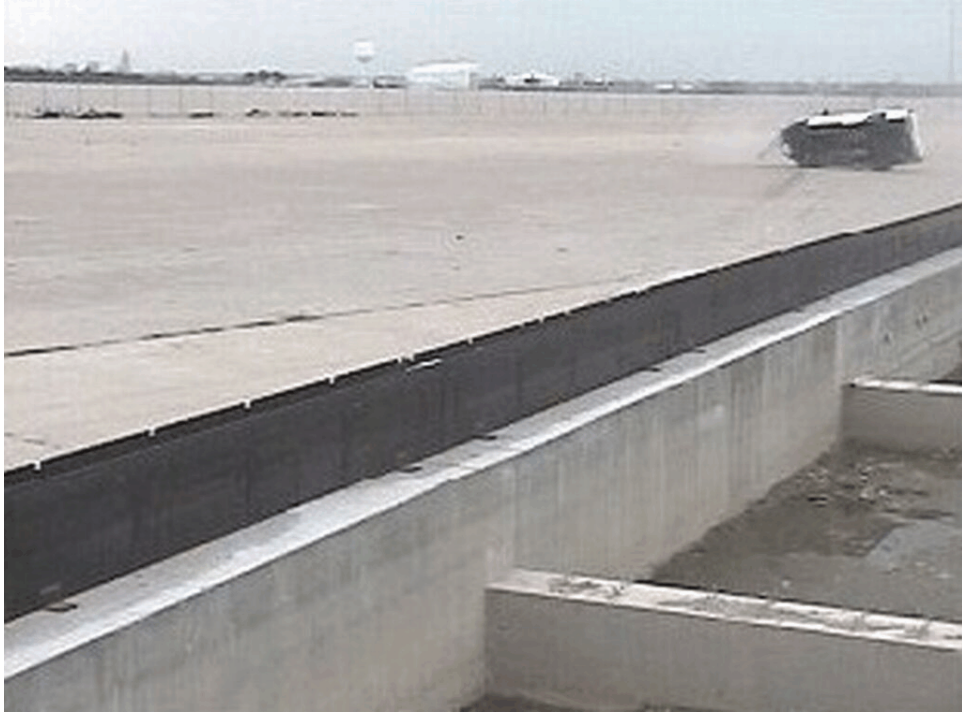
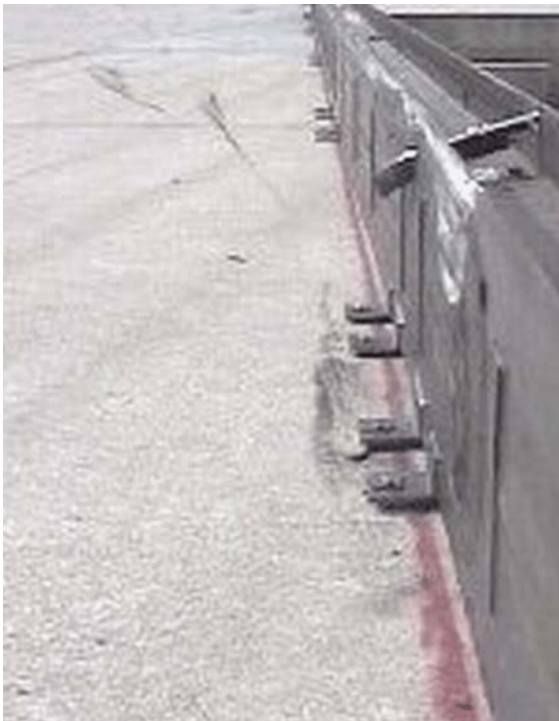
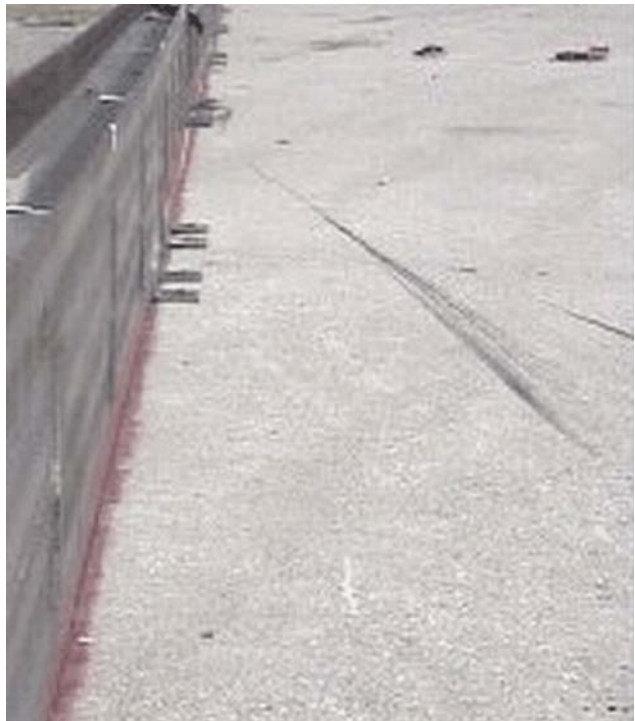
Figure 23. Vehicle Final Position and Trajectory Marks, Test HTB-1

The permanent set of the barrier system is shown in Figures 23 through 25. The maximum lateral permanent set barrier deflection was 32 mm at the downstream end of barrier no. 5 and at the upstream end of barrier no. 6, as measured in the field. The maximum lateral dynamic barrier

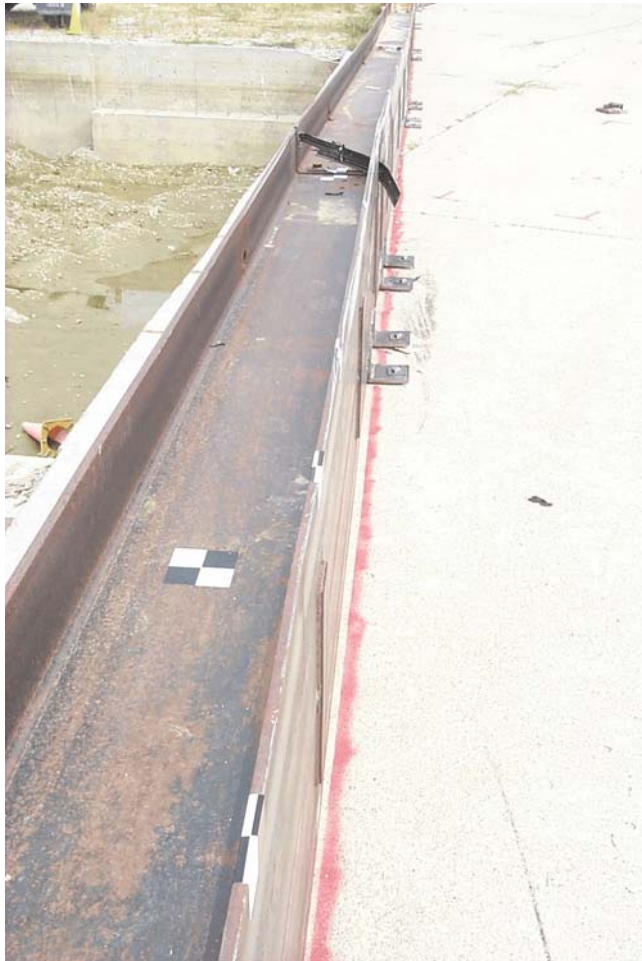
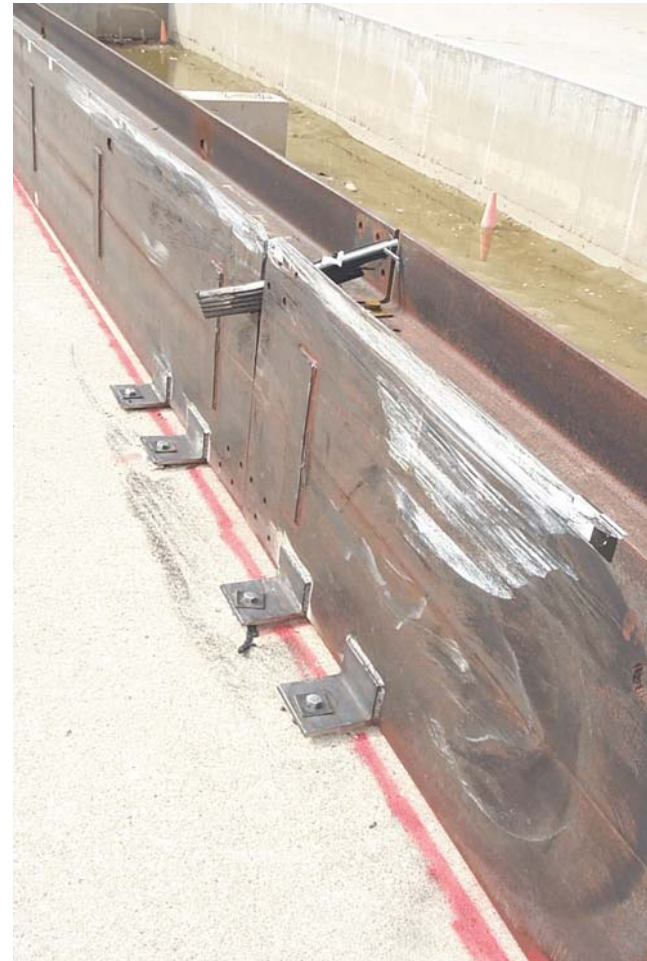
Figure 24. Steel H-section Barrier System Damage, Test HTB-1

Damage to the barrier was minimal, as shown in Figures 24 through 27. Barrier damage consisted mostly of minor damage to the tie-down angle brackets, cracking of the concrete near a few of the drop-in anchors, and scraping and tire marks on the barrier. Contact marks were found on barrier nos. 5 and 6 from impact to approximately 2,540-mm downstream of initial contact. Slight concrete failure occurred around the drop-in anchors at the joint between barrier nos. 5 and 6. Minor deformations to the tie-down angle brackets were found at the downstream end of barrier no. 5 and upstream end of barrier no. 6.
