SAFETY PERFORMANCE EVALUATION OF MICHIGAN'S TEMPORARY TRAFFIC CONTROL DEVICES

Michigan Department of Transportation

MwRSF Research Report No. TRP-03-128-02

January 27, 2003

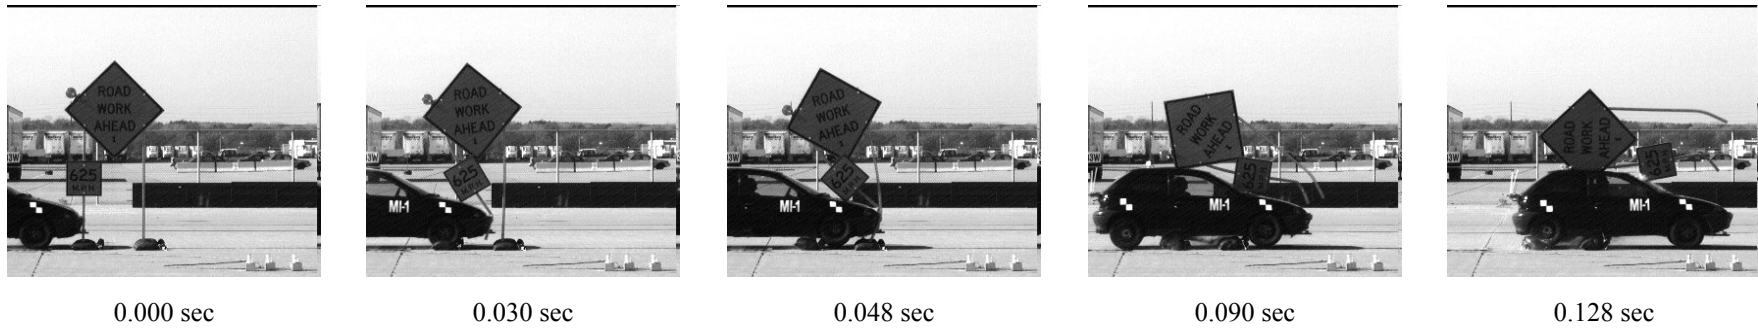
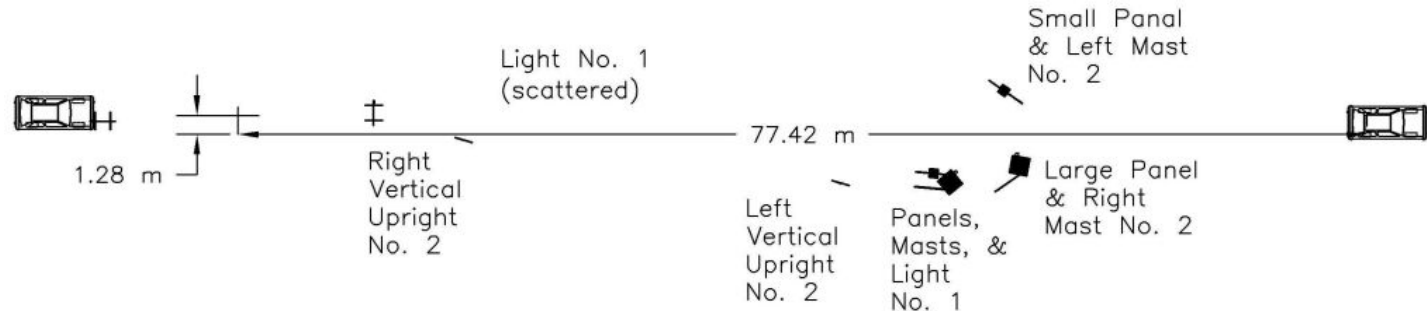
Figure 22. Summary of Test Results and Sequential Photographs, Test MI-1, Impact No. 1

traffic control device, System No. 1 was determined to be unacceptable according to the NCHRP Report No. 350 criteria. It was deemed unacceptable due to the “spider web” cracking, indentation, and hole in the windshield, resulting in obstructed driver visibility and loss of structure of both glass layers. In addition, deformations of, or intrusion into, the occupant compartment did occur as detached elements and debris from System No. 1 penetrated the right region of the windshield and the right side of the roof.

- Longitudinal NA
 - Lateral (not required) NA
- Occupant Impact Velocity (Normalized)
 - Longitudinal NA
 - Lateral (not required) NA
- Vehicle Damage Roof and windshield penetration

- TAD²⁷ 12-FR-1
 - SAE²⁸ 12-FRAN9
- Vehicle Stopping Distance 77.42 m downstream
 - 1.28 m right
- Test Article Damage Moderate – Broke apart

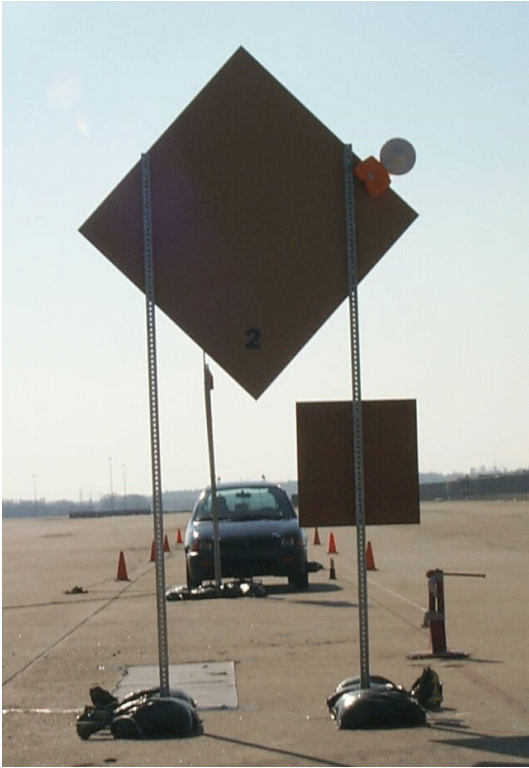
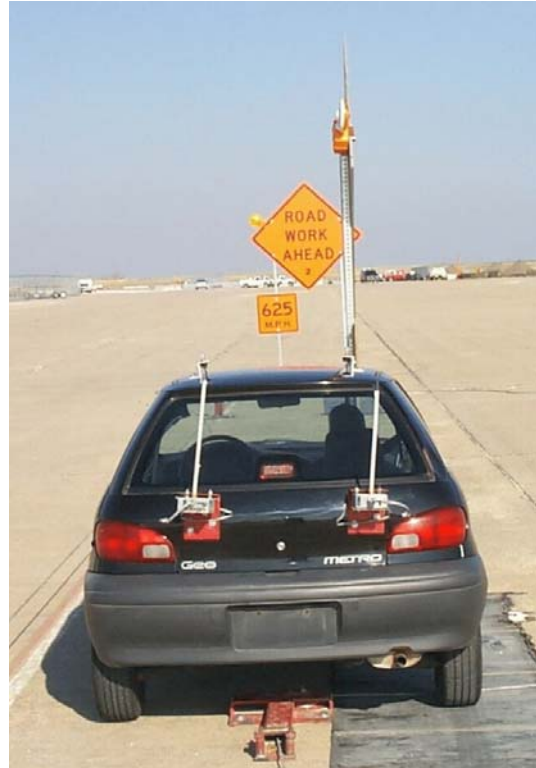
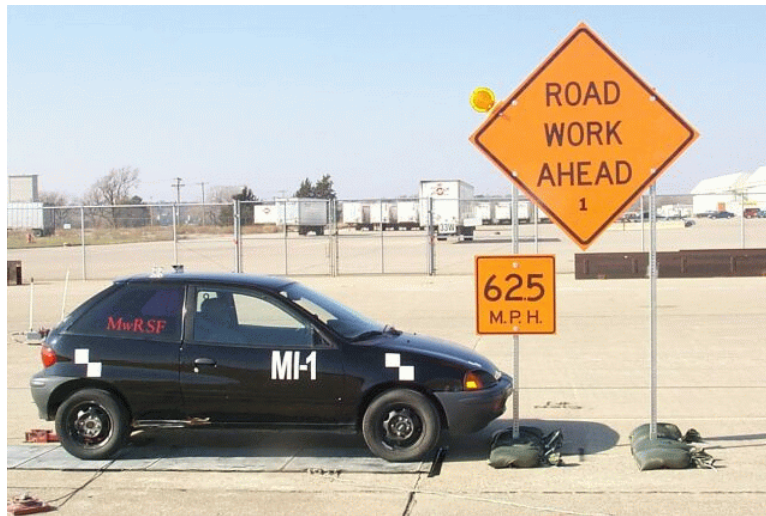
Figure 27. Impact Location, Test MI-1

The test vehicle impacted System No. 1 with the right-front quarter point of the vehicle aligned with the centerline of the sign support, as shown in Figure 27. At 0.014 sec after initial impact, the impacted mast deformed around the front of the vehicle and moved toward the other mast. At this same time, the impacted mast disengaged from the impacted leg as the top of the sign panel rotated toward the vehicle. At 0.030 sec, the speed advisory sign panel impacted the hood of the vehicle. At 0.038 sec, the impacted mast and vehicle contacted the other mast. At 0.048 sec, the non-impacted mast disengaged from the corresponding leg. At 0.074 sec, the top corner of the speed advisory sign panel impacted the windshield as both sign panels and masts continue to rotate counter-clockwise (CCW) toward the vehicle. At 0.090 sec, the impact-side corner of the large sign panel impacted the roof as the masts were positioned above the vehicle's hood. At 0.128 sec, the

Approximately 0.67 sec after impact with System No. 1, the vehicle impacted System No. 2 with the centerline of the vehicle aligned with the centerline of the sign support, as shown in Figure 27. At 0.008 sec after initial impact, both masts deformed around the front of the vehicle and disengaged from their respective legs. At 0.028 sec, both masts were severely deformed at the bumper height. At this same time, the top of the sign panel rotated down toward the vehicle. At 0.048 sec, both masts lost contact with the vehicle and were positioned in front of the vehicle. At 0.092 sec, the sign panels and masts rotated to a position parallel with the ground. At 0.102 sec, the top-left portion of the sign panel contacted the roof. At 0.110 sec, the sign panel was creased at the top of the masts while the top of the sign panel remained flat against the roof. At this same time, the masts continued to rotate up and over the vehicle. At 0.150 sec, the right side of the sign panel lost contact with the vehicle as it began to rotate toward the left side of the vehicle. At 0.226 sec, the sign panel continued to rotate off the left side of the vehicle. At 0.350 sec, the sign panel was positioned perpendicular to the ground and behind the vehicle. Both legs remained at their original positions. The vertical upright of the right-side leg was located 6.10-m downstream and 1.68-m right from the original position. The vertical upright of the left-side leg was located 31.55-m downstream and

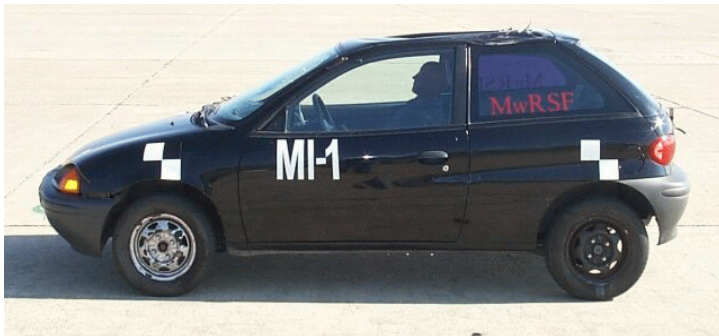
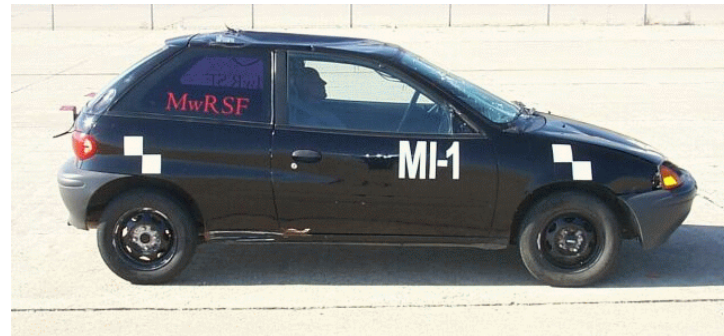
Figure 31. Vehicle Damage, Test MI-1

Exterior vehicle damage is shown in Figures 31 through 33. The front bumper and lower plastic shield encountered minor dents and contact marks. Both sides of the bumper disengaged from the bumper clips. The right-front fender was dented and scratched. A small dent was located along the right-side quarter point of the engine hood. The right side of the roof encountered a major indentation and subsequent penetration. The left-rear of the roof encountered a minor dent. The entire roof also sustained scuff and scrape marks. Both fog lights broke. The right-side headlight was pushed inward toward the engine compartment but remained undamaged. The windshield sustained major “spider web” cracking on the right side, with both layers of the right-side windshield being cracked. Most of the structural integrity of the windshield on the right side was lost and the windshield indented inward toward the occupant compartment. A large hole (slice) through the windshield was located near the center region of the right side. No damage was found to have occurred to the left side, rear-end, left-side headlight, nor parking lights.

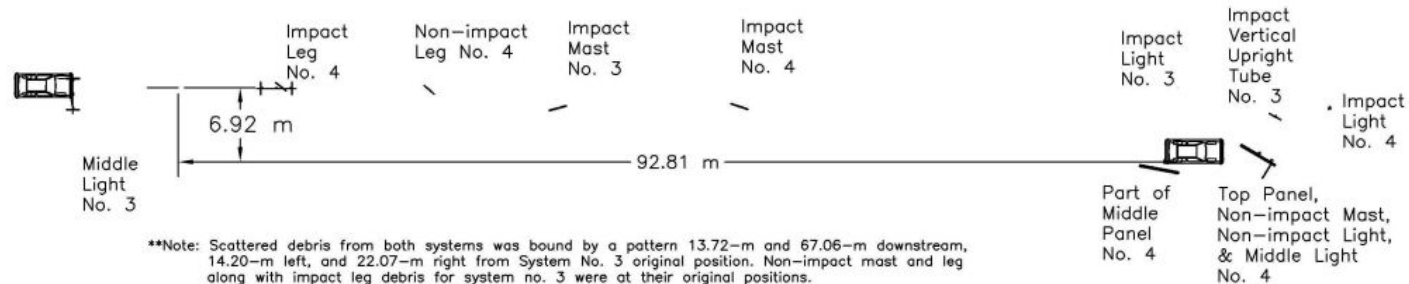
Figure 34. Summary of Test Results and Sequential Photographs, Test MI-2, Impact No. 1

- Longitudinal NA
 - Lateral (not required) NA
- Occupant Impact Velocity (Normalized)
 - Longitudinal NA
 - Lateral (not required) NA
- Vehicle Damage Windshield and side window penetration

- TAD²⁷ 12-FL-1
 - SAE²⁸ 12-FLEN5
- Vehicle Stopping Distance 92.81 m downstream
6.92 m right
- Test Article Damage Moderate – Broke apart

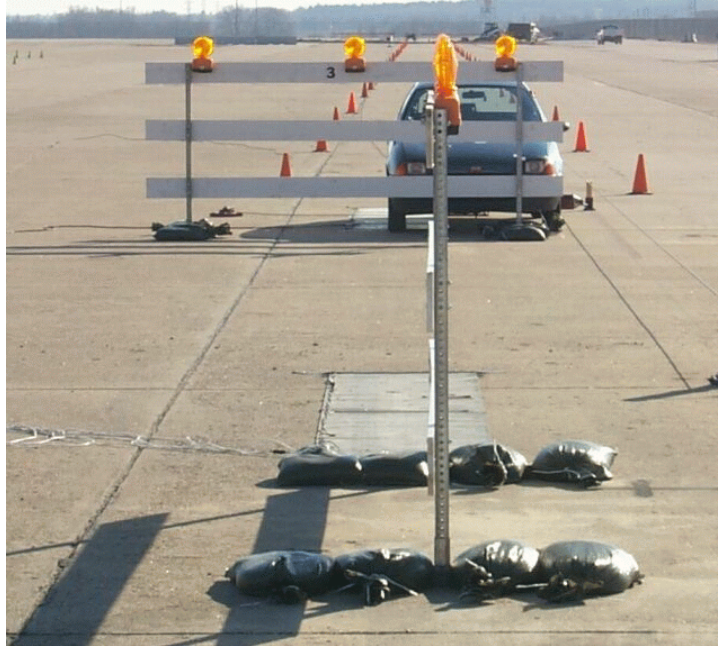
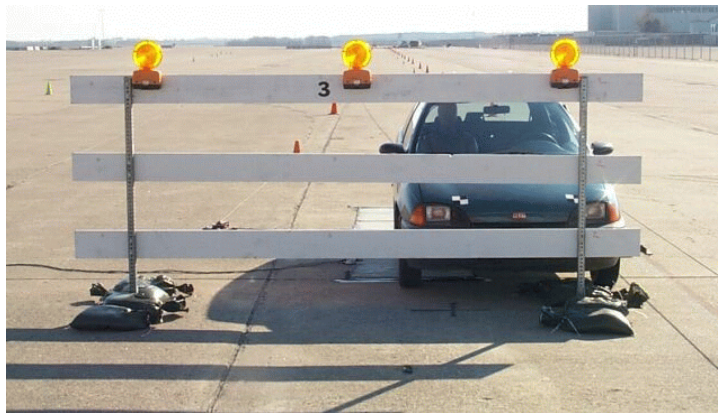
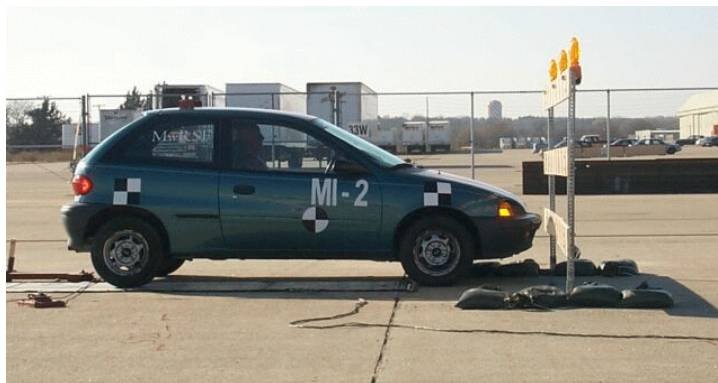
Figure 39. Impact Locations, Test MI-2

The test vehicle impacted System No. 3 with the left-front quarter point of the vehicle aligned with the centerline of the barricade's left leg, as shown in Figure 39. At 0.006 sec after initial impact, the impacted mast disengaged from the impacted leg. At this same time, the bottom barricade panel fractured. At 0.018 sec, the impacted mast deformed around the front of the vehicle as the top of this same mast rotated down toward the vehicle. At 0.044 sec, the top of the impacted mast and light contacted the windshield. At this same time, the middle barricade panel was positioned on top of the vehicle's hood. At 0.062 sec, all three of the barricade boards fractured apart as the center warning light and barricade board impacted the rear right-side window. At this same time, the impacted mast remained in contact with the windshield and began to slide upward toward the vehicle's roof. At 0.134 sec, the fractured pieces of the system traveled along with the vehicle. At this same time, the non-impacted mast and leg remained unmoved and positioned behind and alongside the vehicle. At 0.162 sec, the fractured pieces of the system continued to travel in front of and with the vehicle. The non-impacted mast and leg with half the barricade's panels remained

Approximately 0.63 sec after impact with System No. 3, the vehicle impacted System No. 4 with the right-front quarter point of the vehicle aligned with the centerline of the barricade, as shown in Figure 39. At 0.006 sec after initial impact, the bottom barricade panel moved away from the vehicle as the vehicle contacted it. At this same time, both masts deformed slightly. At 0.016 sec, the front of the vehicle contacted the impacted mast. At 0.032 sec, the entire system deformed as it traveled away from the vehicle. At 0.046 sec, both masts deformed extensively as the lower barricade panel fractured. At this same time, the impacted mast disengaged from the impacted leg. At 0.064 sec, the middle barricade panel fractured. At this same time, the impacted mast deformed extensively and moved toward the other mast. At 0.086 sec, the middle and top barricade panels contacted the hood and lower portion of the windshield, respectively. At 0.120 sec, the non-impacted mast rotated downward toward the ground. At this same time, the bottom barricade panel contacted the ground as the top barricade panel fractured. At 0.150 sec, the bottom of both masts contacted one another as the entire system encountered major deformation. At 0.188 sec, pieces of the system traveled along with the vehicle. At 0.217 sec, the impacted mast rotated and contacted the lower portion of the windshield. The impacted leg was located 0.91-m downstream and 0.30-m right from the original position. The non-impacted leg was located 14.63-m downstream and 0.61-m right from

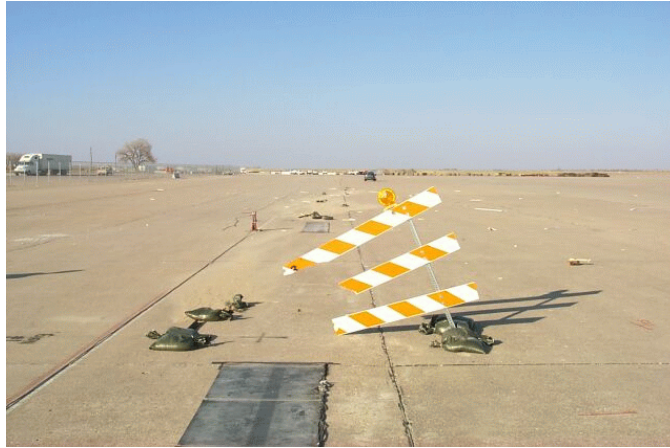
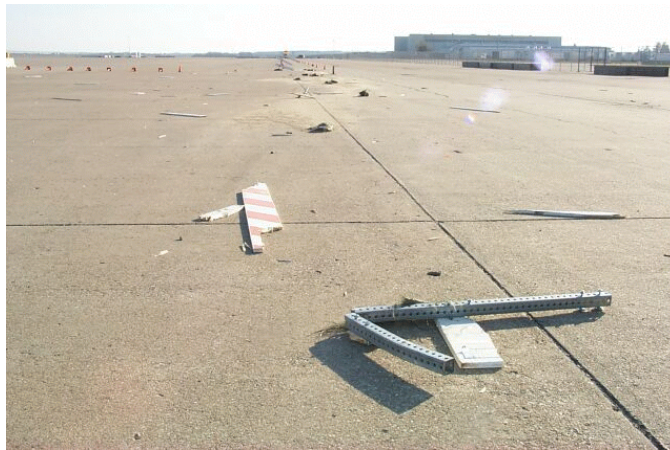
Figure 40. Overall Damage and Final Positions, Test MI-2

the original position. The impacted mast was located 43.28-m downstream and 2.13-m right from the original position. A piece of the middle barricade panel came to rest 81.99-m downstream and 7.92-m right from the original position. The top barricade panel, the non-impacted mast, the non-impact-side warning light, and the middle warning light still attached were located 91.14-m downstream and 6.71-m right from the original position. The impact-side warning light was located 97.69-m downstream and 2.29-m right from the original position of the barricade. Pieces of debris from both systems were scattered in a patterned bound by 13.72-m and 67.06-m downstream, 14.20-m left, and 22.07-m right from the original position of the first system. The vehicle subsequently came to rest 92.81-m downstream from the longitudinal midpoint of the two impact points and 6.92-m right from the centerline of the vehicle's original path. The final positions of the vehicle and the sign supports are shown in Figures 34, 35, and 40.

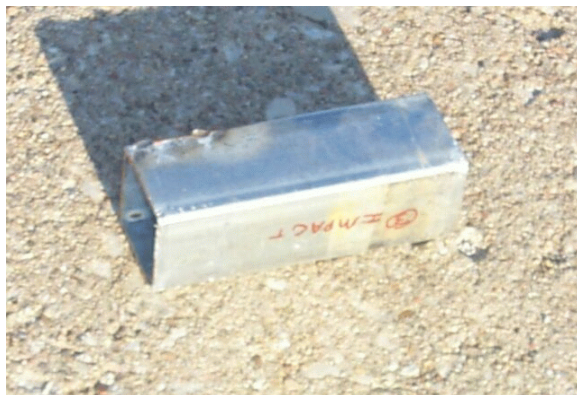
Figure 41. System No. 3 Damage, Test MI-2

Damage to System Nos. 3 and 4 is shown in Figures 40 through 44. System No. 3 encountered moderate damage. The non-impacted mast, leg, and warning light remained intact with half of all three barricade panels and undamaged. The impacted leg disengaged from the mast. The welds holding the vertical tubes to the impacted leg fractured, causing the tube to be disengaged from the angle leg. The impacted mast was disengaged from the rest of the system and was deformed at the bumper height. The warning lights near the impacted mast and at the center of the barricade disengaged from the rest of the system. The barricade panels fractured into many small pieces and were scattered downstream. Two of the sandbags were torn open with the sand scattered along the path of the vehicle, starting at the initial position of the first barricade. The other six sandbags remained undamaged.

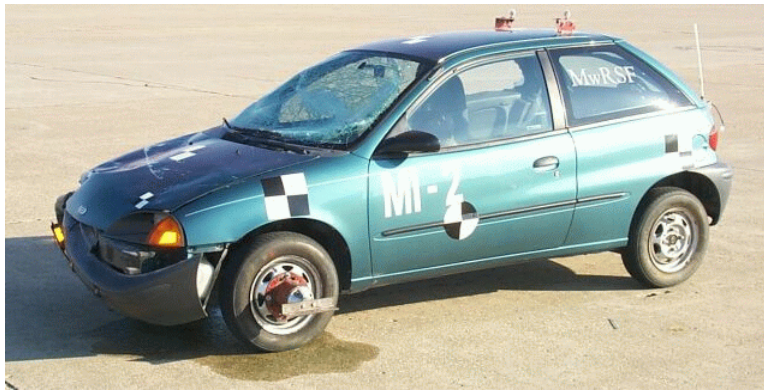
Figure 45. Vehicle Damage, Test MI-2

Exterior vehicle damage is shown in Figures 45 through 47. The vehicle sustained significant front-end damage. The bumper was deformed and pushed inward toward the radiator. The hood encountered dents and major scrape marks. The right-side quarter point of the hood also encountered a buckle point. The right-side fog light broke and the park light was removed from the light housing. The windshield sustained major “spider web” cracking throughout, with both layers of the windshield being cracked. Major indentation and penetration through the windshield was located near the central region of the left side. The right-rear window was shattered. Part of the lower barricade panel was embedded in the right-side of the engine compartment. No damage was found to have occurred to the roof, rear-end, headlights, nor the left-side fog and parking lights.

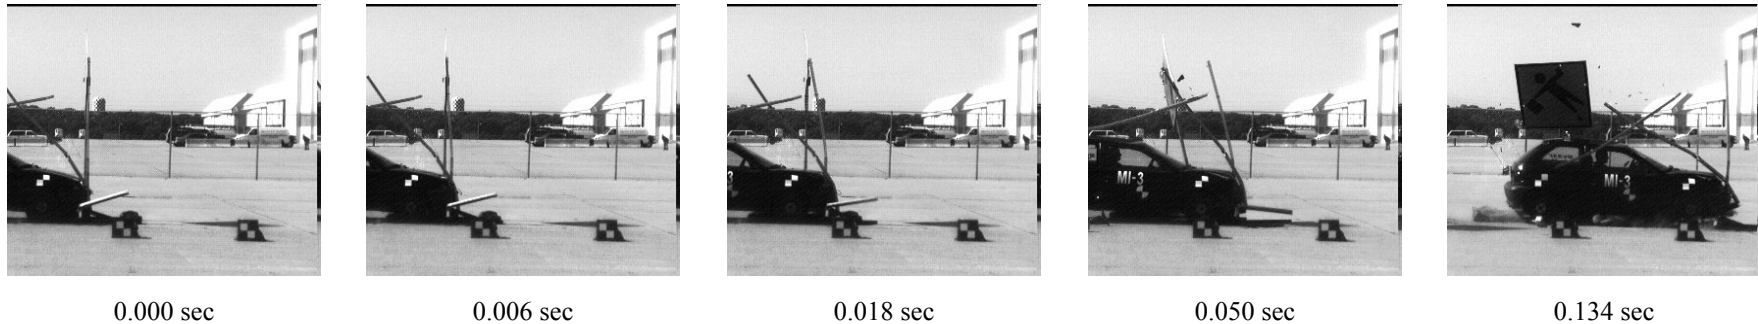
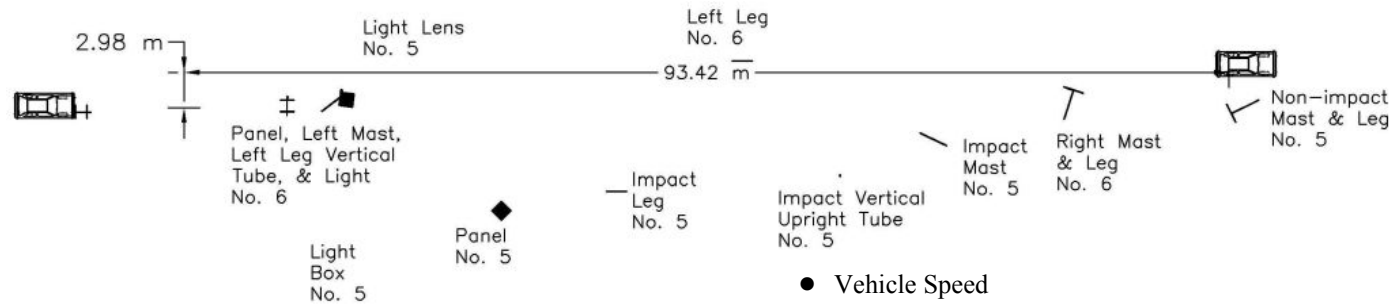
Figure 48. Summary of Test Results and Sequential Photographs, Test MI-3, Impact No. 1

- 2.98 m left
- Test Article Damage Moderate – Broke apart

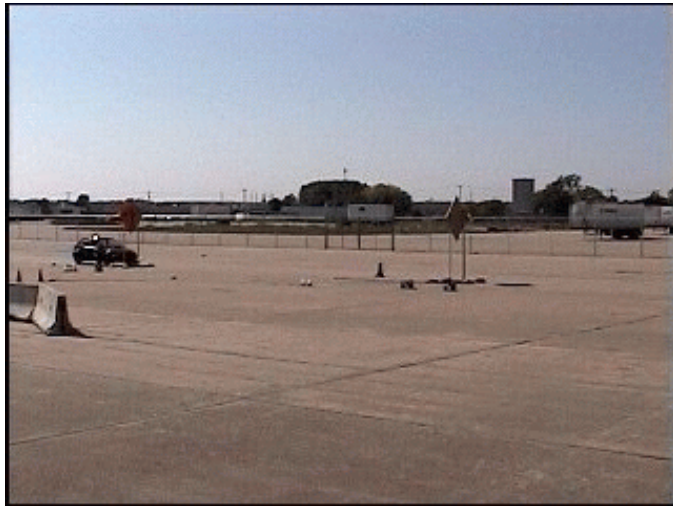
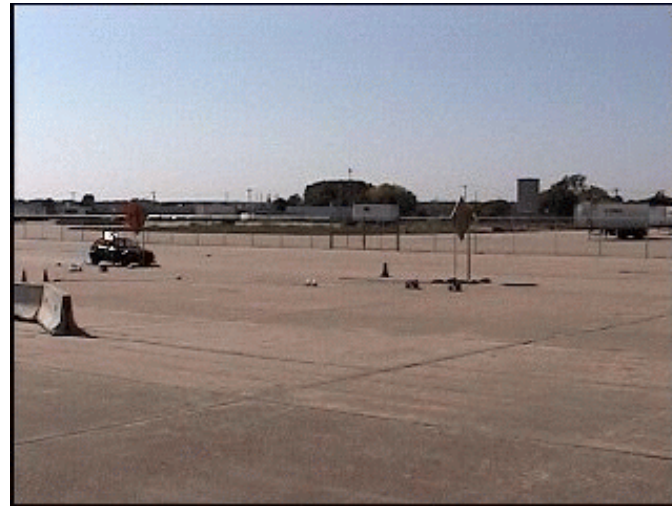
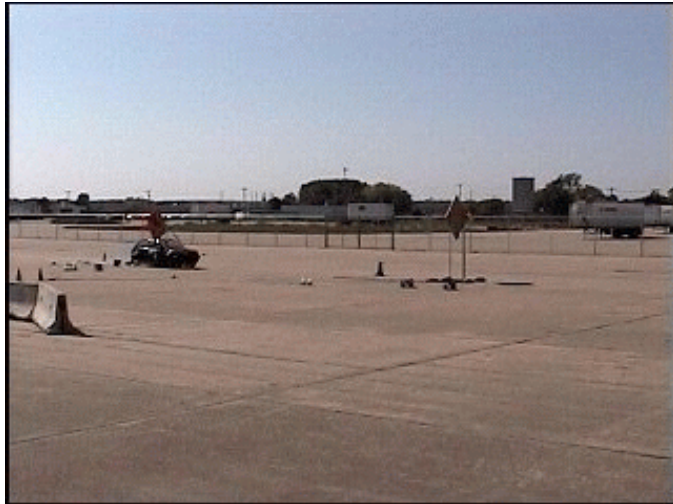
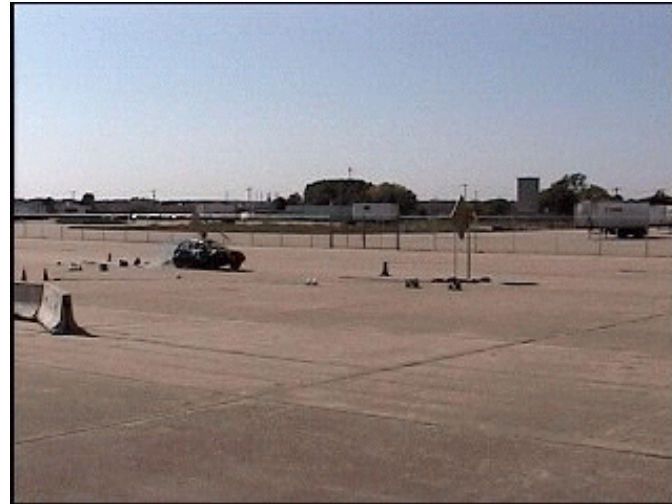
Figure 51. Documentary Photographs, Test MI-3

The 896-kg small car impacted System No. 5, a sign support with a diamond-shaped plywood panel oriented end-on to the vehicle, at a speed of 101.0 km/hr and at an angle of 90 degrees. The small car then impacted System No. 6, a sign support with a diamond-shaped plywood panel oriented head-on to the vehicle, at a speed of 91.3 km/hr and at an angle of 0 degrees. A summary of the test results and the sequential photographs are shown in Figures 48 and 49. Additional sequential photographs are shown in Figure 50. Documentary photographs of the crash tests are shown in Figures 51 and 52.

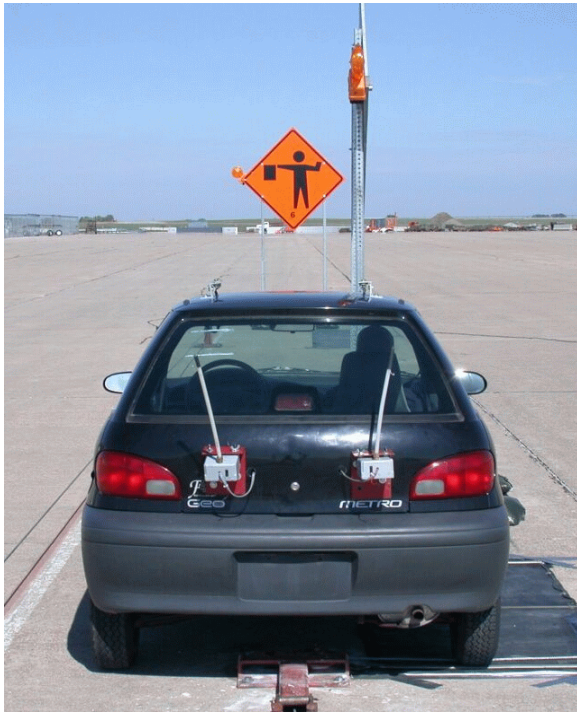
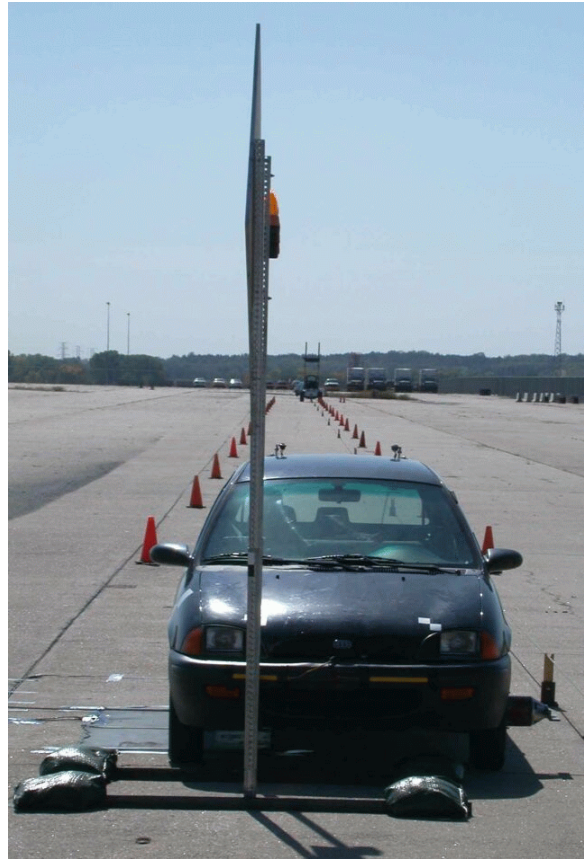
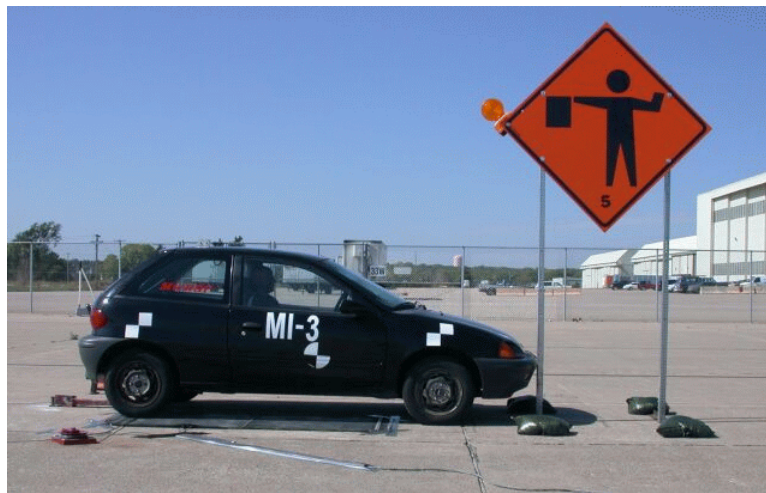
Figure 53. Impact Location, Test MI-3

The test vehicle impacted System No. 5 with the right-front quarter point of the vehicle aligned with the centerline of the sign support, as shown in Figure 53. At 0.008 sec after initial impact, the impacted leg deformed and moved toward the non-impacted leg. At 0.036 sec, the impacted leg contacted the other leg which began to travel away from the vehicle. At this same time, the sign panel rotated CCW toward the vehicle. At 0.060 sec, both legs became airborne. At 0.084 sec, the sign panel rotated CCW approximately 45 degrees. At 0.090 sec, the warning light impacted the right side of the roof. At 0.148 sec, the system stopped rotating CCW with the deformed legs airborne and lodged under the bumper. Shortly after this time, the legs disengaged from the masts as the non-impact mast disengaged from the sign panel. At 0.256 sec, the sign panel lost contact with the roof. The warning light box was located 25.30-m downstream and 11.56-m right from the original position. The light portion of the warning light was located 28.04-m downstream and 2.62-m left from the original position. The sign panel came to rest 37.64-m downstream and 8.97-m

Approximately 0.69 sec after impact with System No. 5, the vehicle impacted System No. 6 with the centerline of the vehicle aligned with the centerline of the sign support, as shown in Figure 53. At 0.006 sec after initial impact, the right-side mast deformed and the lower-right sign panel bolt pulled through the sign panel. At 0.018 sec, the upper-right sign panel bolt pulled through the sign panel and completely released the sign panel from the right mast. At 0.022 sec, the sign panel contacted the mast from the first system. At this same time, the right mast traveled along in front of the vehicle. At 0.050 sec, the sign panel rotated parallel to the vehicle as it impacted the other mast from the first system. At 0.134 sec, the sign panel and the left mast rotated down toward the left side near the rear of the vehicle. At this same time, the right mast and leg traveled along in front of the vehicle. At 0.254 sec, the sign panel descended toward the ground behind the vehicle. The sign panel, warning light, left mast, left outer tube, and vertical upright tube of the left leg, which were all still attached, were located 6.10-m downstream and 0.30-m left from the original position. The angle portion of the left leg was located 41.00-m downstream and 3.81-m left from the original position. The right mast, outer tube, and leg all intact were located 70.10-m downstream and 0.61-m left from the original position. The vehicle subsequently came to rest 93.42-m downstream from the longitudinal midpoint of the two impact points and 2.98-m left from the centerline of the
