COMPLIANCE TESTING OF IOWA'S SKID-MOUNTED SIGN DEVICE

MIDWEST ROADSIDE SAFETY FACILITY

MwRSF Research Report No. TRP-03-86-99

July 23, 1999

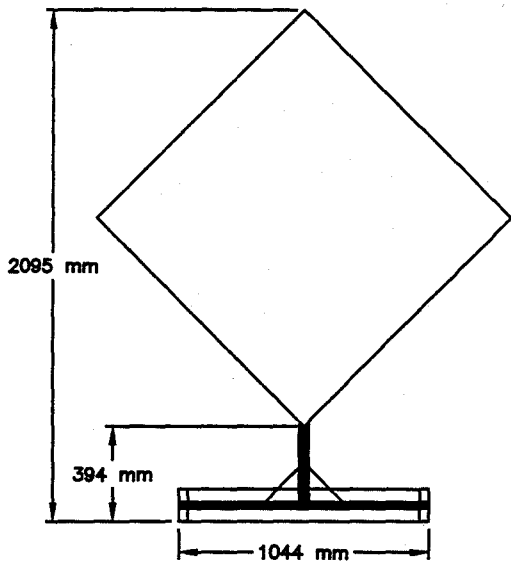
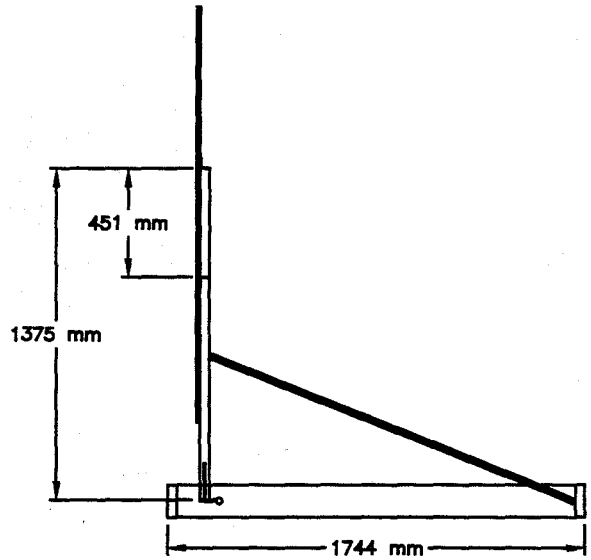
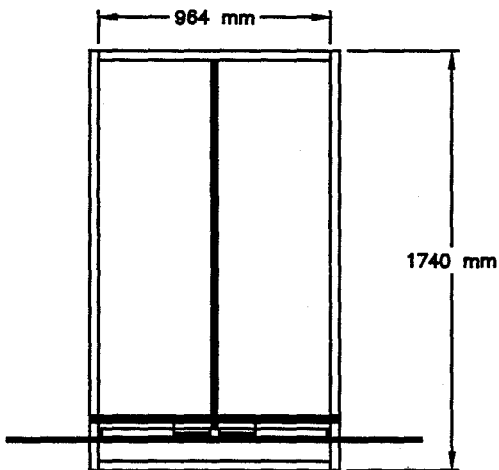
Figure 1. System Nos. 1 and 2 Sign Support Details, Tests I-1 and I-2

- * Base - rectangular 135 mm wide x 38.35 mm thick treated wood
- * Pipe Base - 27.28 mm sq. galvanized steel tube
- * Support Rod - 21.52 mm dia. pipe

- * Panel - Plywood with reflective material, 1220 mm x 1220 mm
- * Vertical Upright - 38.61 mm sq. x 1.52 mm wall x 1375 mm long galvanized steel
- * Top Bracket - 2 pcs of 3.35 mm th. x 38.40 mm x 938 mm long galvanized steel welded together
- * Bottom Bracket - 2 pcs of 3.35 mm th. x 38.40 mm x 450 mm long galvanized steel welded together

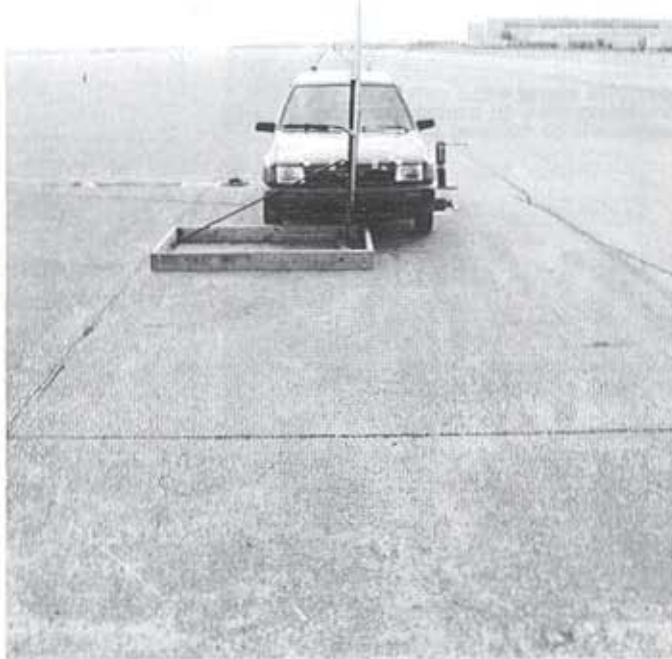
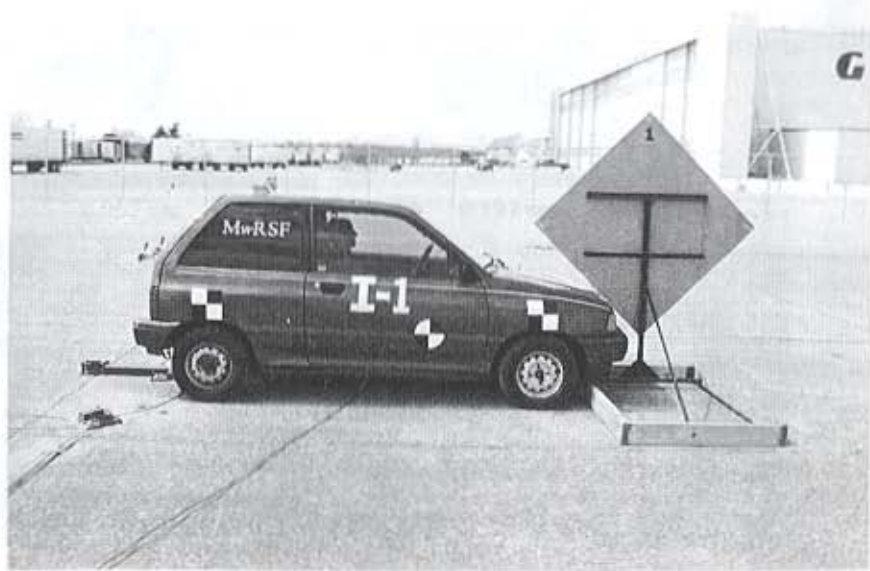
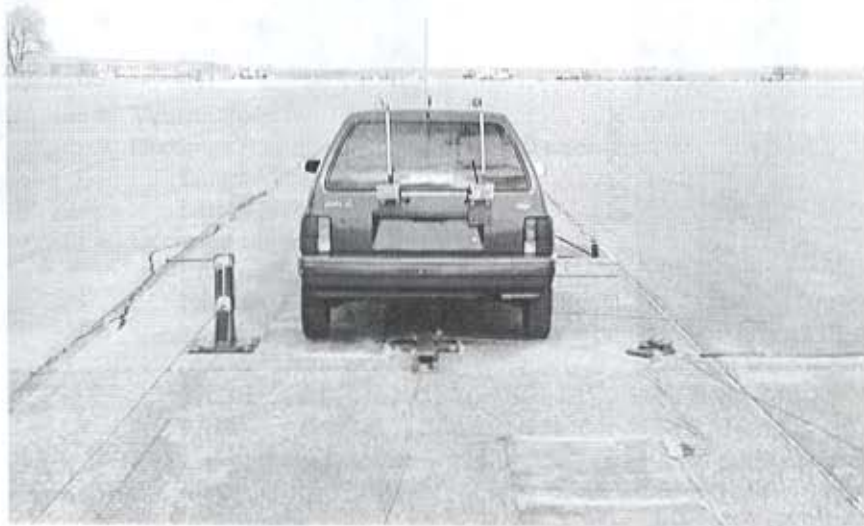
Figure 13. Impact Location, Test I-1

The test vehicle impacted System No. 1 with the centerline of the vehicle aligned with the centerline of the sign support, as shown in Figure 13. At 0.014 sec after impact, the hood was creased down the center and the outside edges buckled upward around the sign panel. At this same time, the vertical support deformed about the vehicle's bumper which caused the top of the sign panel to rotate toward the vehicle. After 0.030 sec, the corner of the sign panel closest to the vehicle impacted the lower-center of the windshield. At 0.032 sec, the vertical support ripped away from the wooden base as the vehicle began to travel over it. After 0.057 sec, the wooden base broke into several pieces. At this same time, the sign panel, with the vertical support still attached, was still in contact with the windshield and hood and continued to travel with the vehicle. At 0.107 sec, the sign panel, which was not in contact with the vehicle, traveled along in front of and at about the same speed as the vehicle. One of the larger pieces of the wooden base was along side the right-front side of the vehicle at 0.110 sec. At 0.179 sec, the sign panel and vertical support began to rotate counter-clockwise (CCW) in front and above the vehicle. At 0.220 sec, the sign panel was above the vehicle's hood and continuing to rotate CCW. At 0.275 sec, the large piece of the wooden base was near the right-side door, while the sign panel continued to rotate CCW.

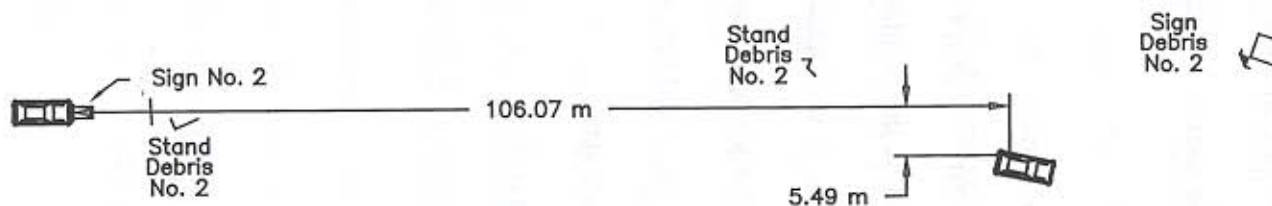
Figure 18. Summary of Test Results and Sequential Photographs, Test I-2

The final position of one of the larger pieces of the wooden base was 9.14 m downstream from the original position. Another large piece of the wooden base was located 12.19 m downstream and 1.83 m right from its initial position. The other piece of wooden base, which was still attached to the support rod, was found 83.82 m downstream and 5.79 m left from the original position. The pipe base, vertical tubing, mast, and sign panel, while still intact, came to rest 134.11 m downstream and 5.79 m left of the initial position. The vehicle subsequently came to rest 106.07 m downstream from the midpoint of the impact point and 5.49 m right from the centerline of the vehicle's original path. The final positions of the vehicle and the sign support are shown in Figure 18.

Following test I-2, a safety performance evaluation was conducted, and the work zone traffic control device at 0 degrees, System No. 2, was determined to be unacceptable according to the NCHRP Report No. 350 criteria. It was deemed unacceptable due to the “spider web” cracking and indentations in the windshield which resulted in obstructed driver visibility and loss of structure of both glass layers. Detached elements and debris from System No. 2 did not penetrate, but showed potential for penetrating the occupant compartment due to the indentation of the cracked windshield. Deformations of, or intrusion into, the occupant compartment did occur as the roof was indented downward toward the occupant compartment. The vehicle’s trajectory did not intrude into adjacent traffic lanes.
