PHASE I DEVELOPMENT OF A NON-PROPRIETARY, FOUR-CABLE, HIGH TENSION MEDIAN BARRIER

MwRSF Research Report No. TRP-03-213-11

December 28, 2011

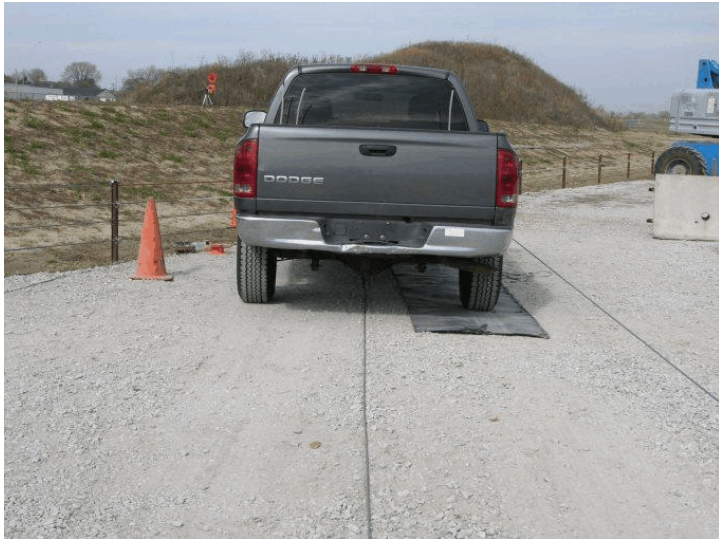
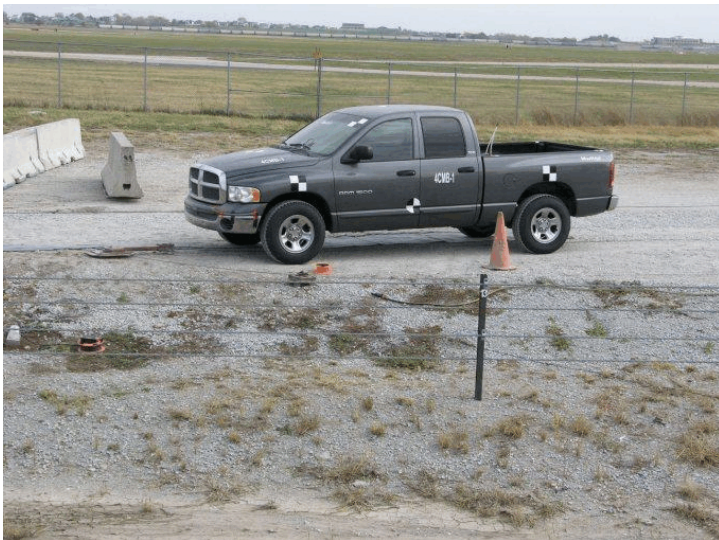
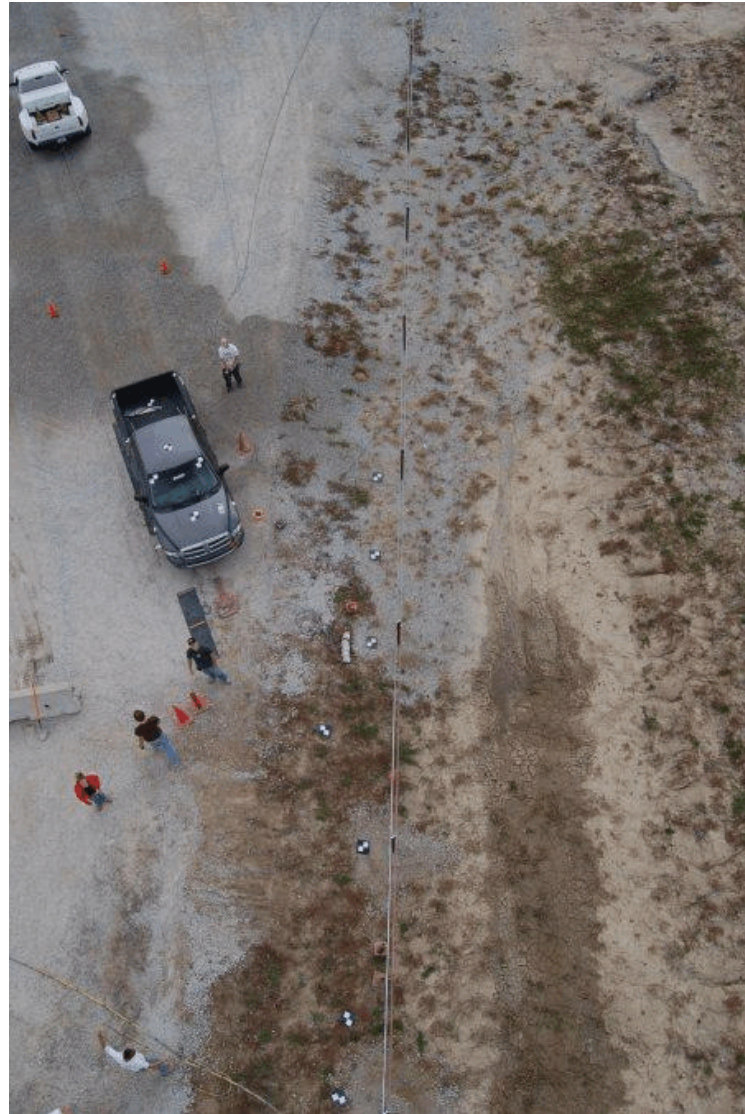
Figure 38. Impact Location, Test No. 4CMB-1

Initial vehicle impact was to occur between post nos. 15 and 16, or 36 in. (914 mm) downstream from post no. 15, as shown in Figure 38. Table 5 contains a sequential description of the impact events. The final position of the vehicle was determined to be 143 ft (43.6 m) downstream of impact and 4 ft - 6 in. (1.4 m) laterally behind the barrier as shown in Figure 39.

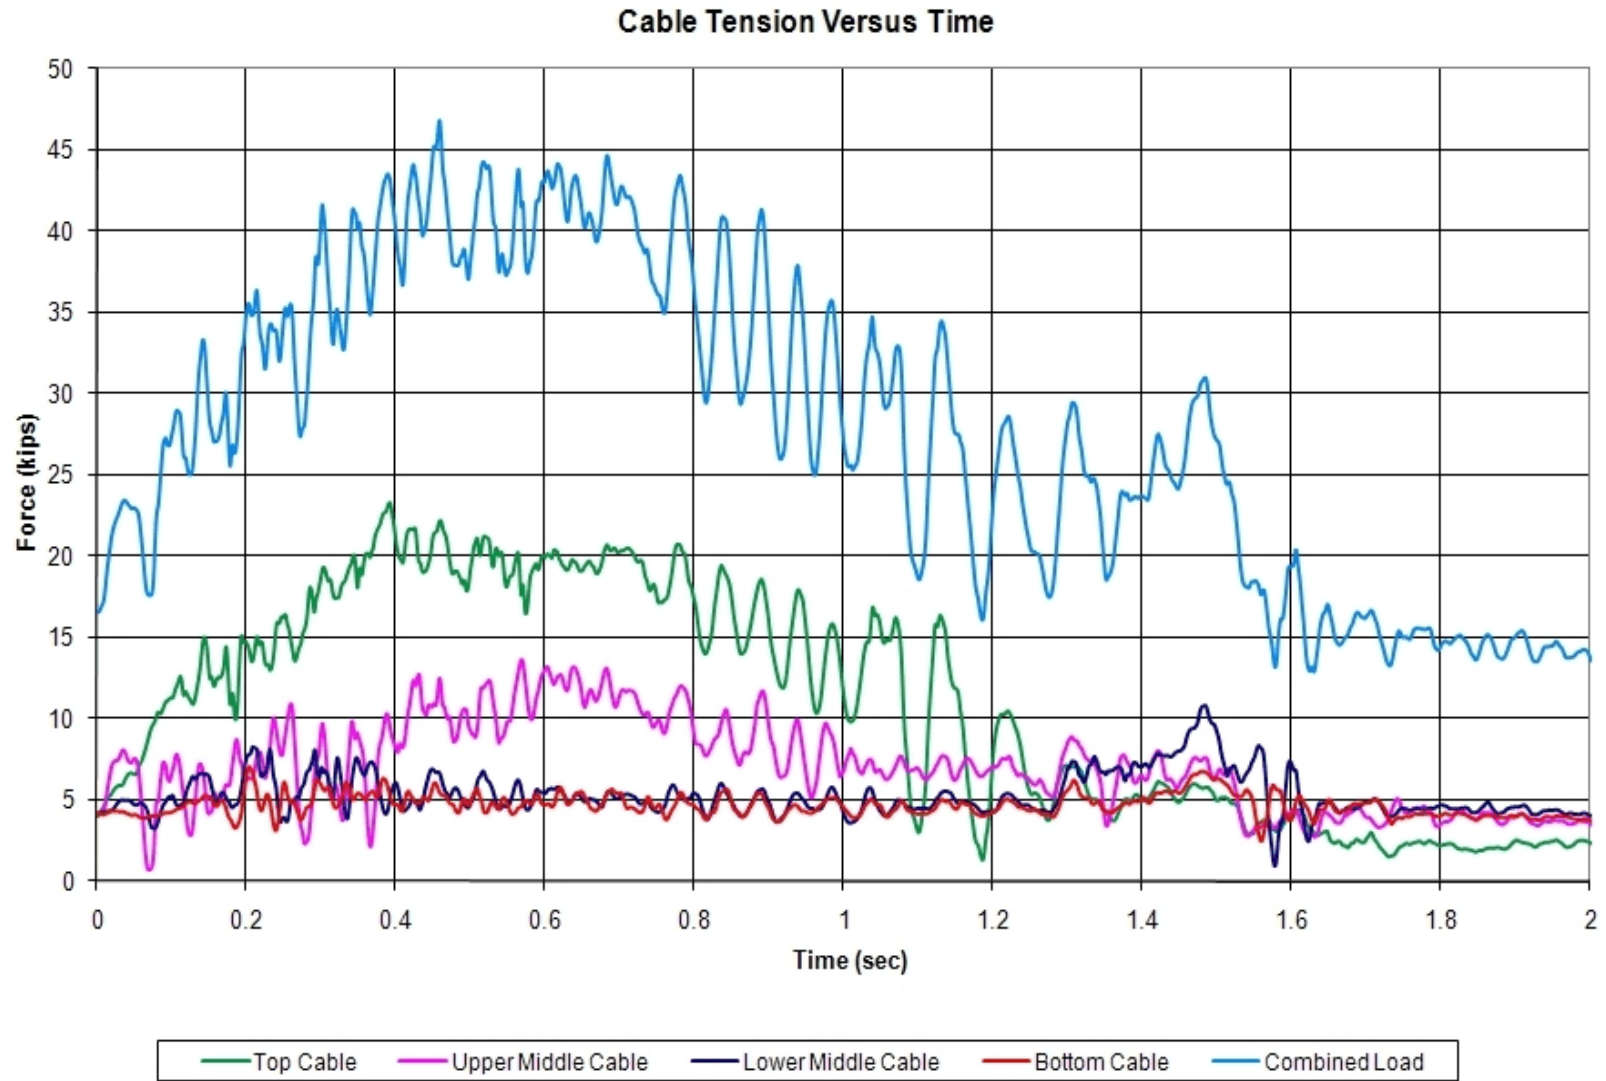
Figure 49. Cable Tension Versus Time, Test No. 4CMB-1

The individual cable loads, along with the total combined cable load imparted to the upstream end anchor, were determined and are shown graphically in Figure 49. The total axial force imparted to the upstream anchor was 46.82 kips (208.3 kN) and occurring at 0.459 sec after vehicle impact with the barrier system. The maximum cable force was 23.28 kips (103.6 kN) and occurred in the top cable. The upper middle and lower middle cables experienced a maximum load of 13.67 kips (60.81 kN) and 10.86 kips (48.31 kN), respectively. The bottom cable experienced a maximum load of 7.08 kips (31.49 kN).

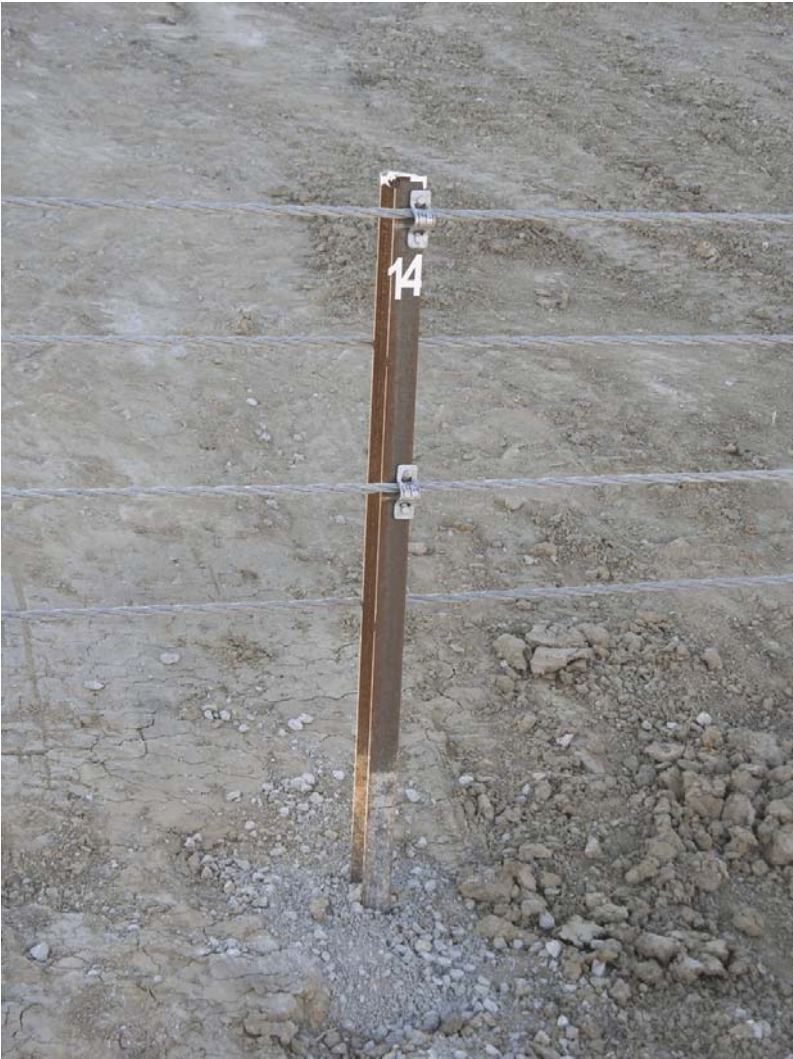
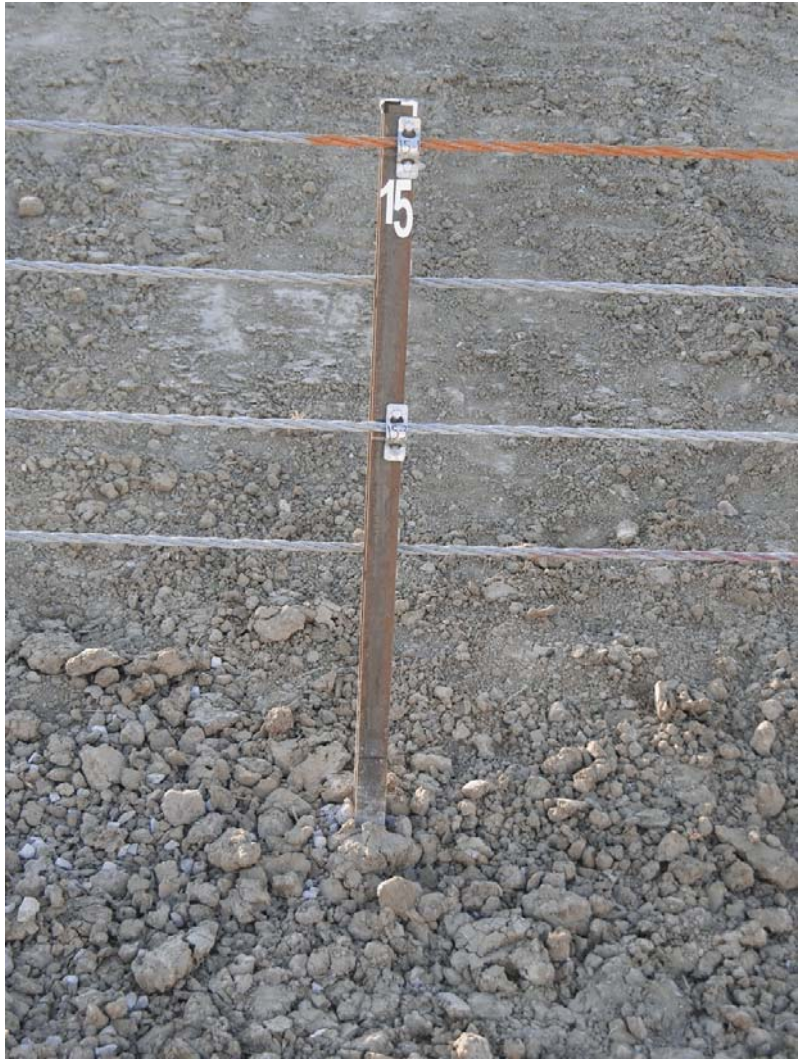
Figure 72. System Damage, Test No. 4CMB-2

Damage to the barrier was minimal, as shown in Figures 72 through 74. Barrier damage consisted of bent and twisted guardrail posts and detached cables. The length of vehicle contact along the cable median barrier system was about 24 ft (7.3 m) which spanned from post nos. 17 to 19.

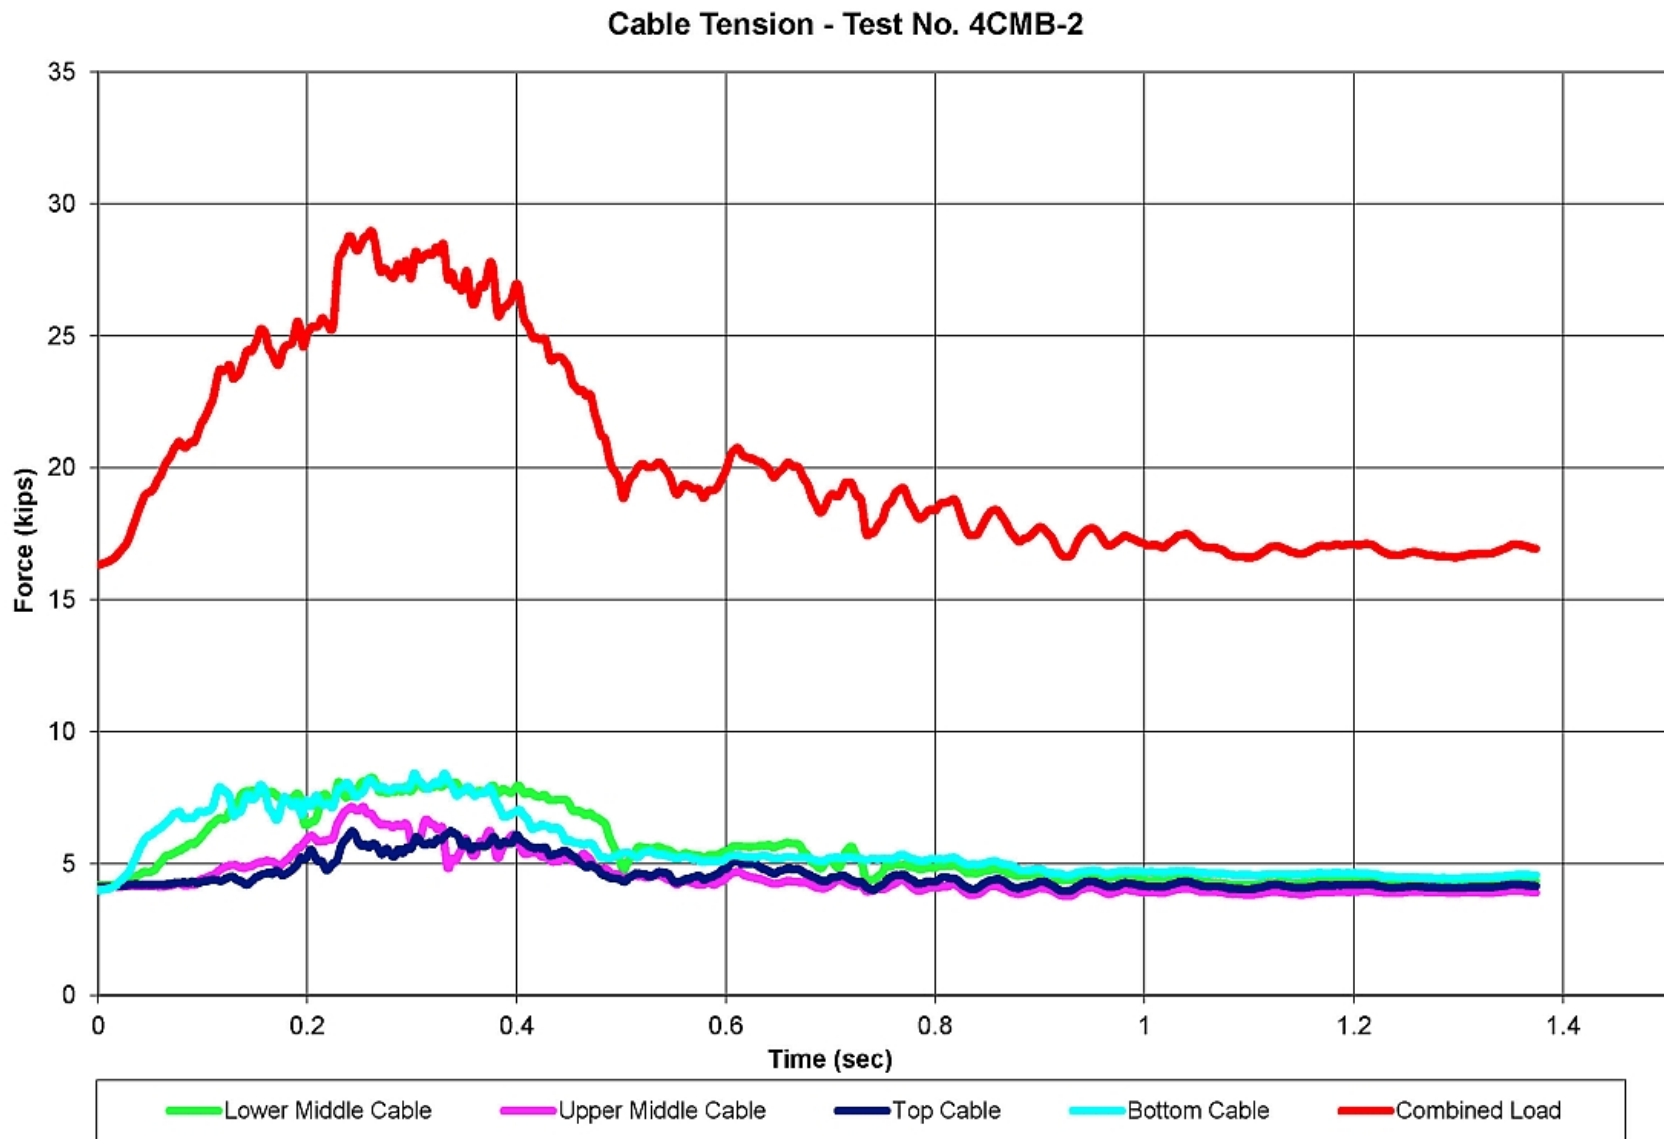
Figure 79. Cable Tensions, Test No. 4CMB-2

The individual cable loads, along with the total combined cable load imparted to the upstream anchor, were determined and are shown graphically in Figure 79. The total axial force imparted to the upstream anchor was 28.97 kips (128.9 kN) and occurring at 0.363 sec after vehicle impact with the barrier system. The maximum force was 8.41 kips (37.4 kN) and occurred in the bottom cable. The upper middle and lower middle cables experienced a maximum load of 7.15 kips
